Thermomechanical Characterization of SiC/SiC Ceramic Matrix Composites in a Combustion Facility

Abstract: A combustion facility which includes uniaxial mechanical loading was implemented that enables environmental conditions more akin to jet engine environments compared to conventional static environment tests. Two types of woven SiC/SiC ceramic matrix composites (CMCs), melt-infiltrated (MI) and chemical vapor infiltrated (CVI), were subjected to fatigue loading in the combustion facility and under isothermal furnace conditions. Some CVI test coupons were coated with a multilayer environmental barrier coating (EBC) of mullite + ytterbium monosilicate using slurry infiltration process to demonstrate the performance with a coating. Combustion conditions were applied using a high velocity oxy fuel gun on the front side of the specimen and mechanical loading was applied using a horizontal hydraulic MTS machine. All the specimens considered were subjected to tension-tension fatigue loading at 100 MPa, stress ratio of 0.1 and specimen front-side surface temperature of 1200 ± 20 °C. Nondestructive evaluation (NDE) methods, such as electrical resistance (ER), was used as an in-situ healt

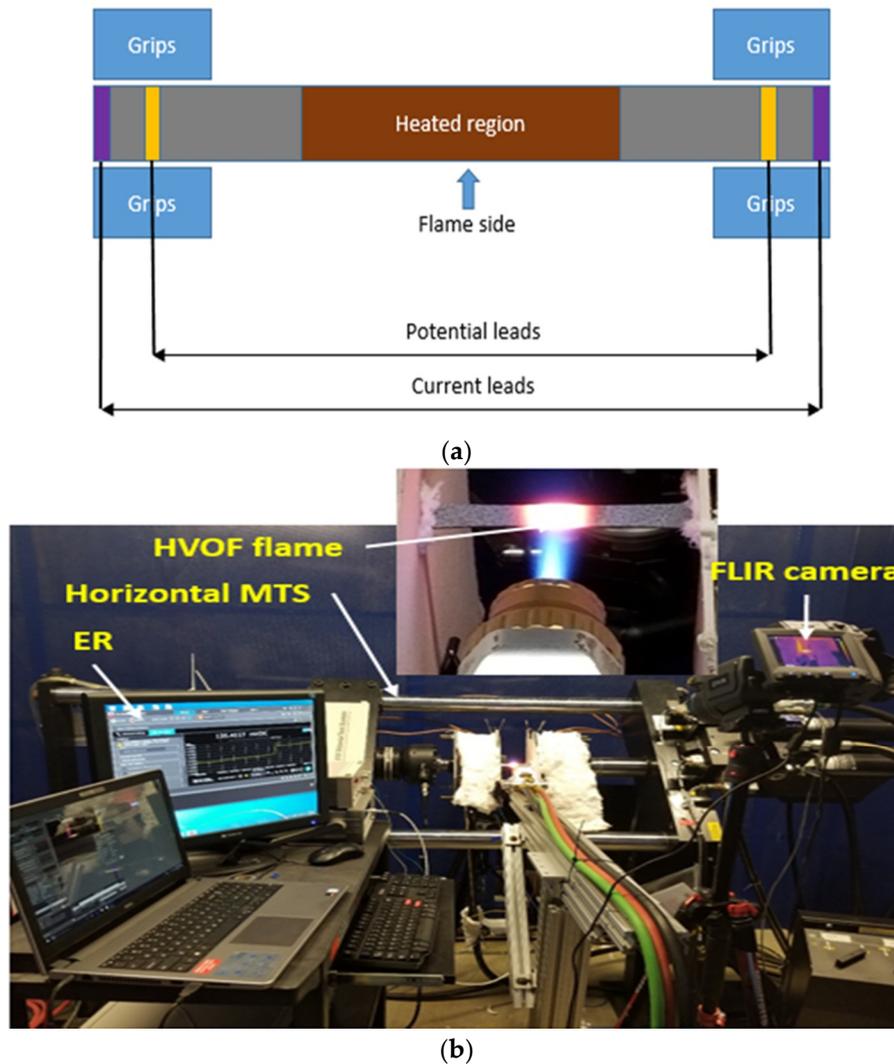
Figure 1. (a) Specimen showing electrical resistance (ER) configuration; (b) high-velocity oxygen fuel (HVOF) combustion facility setup.

To produce the combustion environments, a unique burner rig facility is developed which can simulate coupled thermomechanical loading. A high-velocity oxygen fuel (HVOF) gun (HP 2700 HVOF system, Plasma Powders & Systems, NJ, USA) is used to simulate the jet engine combustion environment while the mechanical loading is applied using a horizontal hydraulic MTS machine (MTS 810 system). The HVOF gun uses propane and oxygen as fuel and oxidizer to create a high-temperature, high-velocity flame. Peak temperature of 2200 °C with expanding gas velocities approaching 933 m/s can be achieved based on the equivalence ratio (ratio of actual fuel to air to stoichiometric fuel to air) of

gases. Test coupons were mounted in the hydraulic grips at an angle of 45° (which we believe is the severe degrading condition a CMC can experience) and subjected to directional heating of the flame produced by HVOF gun. By adjusting the parameters of the gun, different combustion conditions are achieved (Temperature, %Water vapor, and velocity). Heating the front surface of the specimen while natural convection occurs on the back surface creates thermal gradient stresses. The expanding gases are travelling at a speed up to 933 m/s, generating excessive noise. Therefore, the experimental facility was set up in a noise-cancelling room as shown in Figure 1. To protect the hydraulic grips from heating, steel plates, and multilayer ceramic insulation sheets are used. Cold water is fed through the wedges to cool the ends of the specimen.

Expanding gases velocity was calculated by spraying chrome carbide particles using the inlet provided on the control panel. A high-speed camera was used to record the images of the particles sprayed. Velocity was calculated by tracking the distance travelled by particles at a given time using an open source Tracker software.

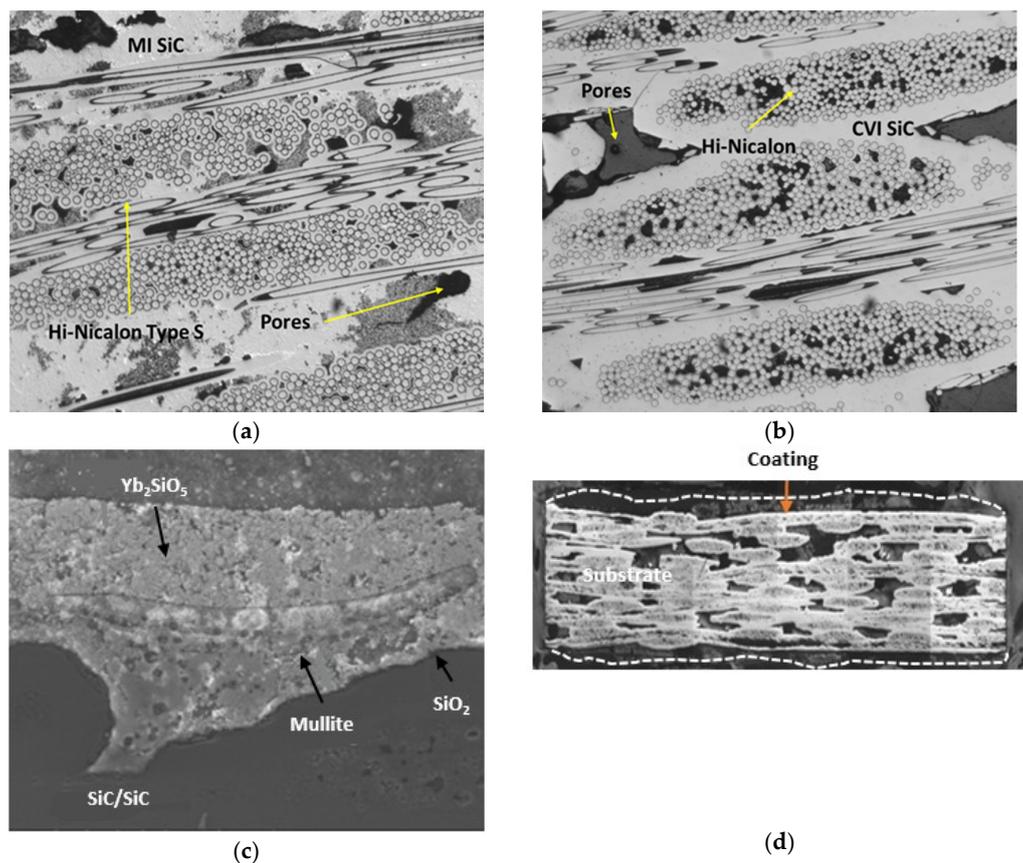
Figure 2. Microstructure of (a) melt-infiltrated (MI) Hi-Nic-S/BN/SiC, (b) CVI Hi-Nic/BN/SiC, (c) environmental barrier coating (EBC) coated CVI Hi-Nic/BN/SiC, (d) Microscope image showing coating thickness.

MI specimens considered were dog bone-shaped and CVI specimens were straight-sided. All the specimens had as-machined edges, i.e., there was no seal-coat which made their exposure a worst-case scenario. Material dimensions and as-produced mechanical properties are shown in Tables 1 and 2 and microstructures are shown in Figure 2. UTS for the CVI is not shown as the specimen failed close to the top grip. Proportional limit is determined using ASTM C1275-15 based on the 0.05% strain offset method.

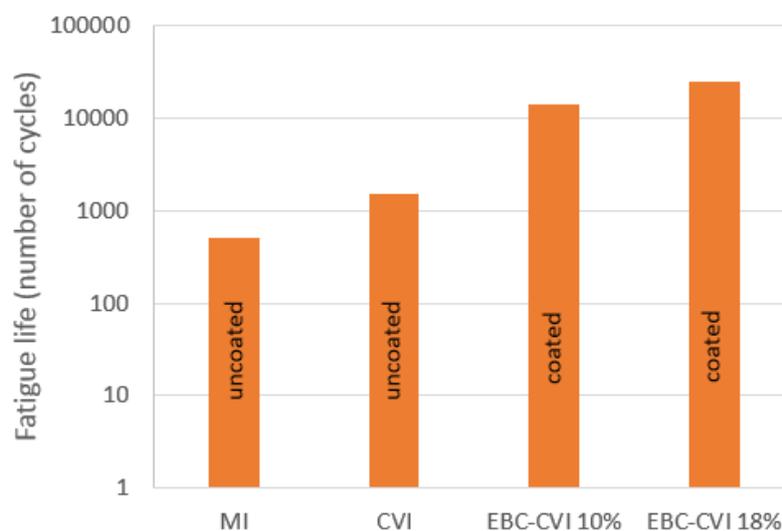
Figure 3. Fatigue life of MI, CVI, and EBC-CVI test coupons in combustion environment.

Uncoated MI, CVI, and environmental barrier coating (EBC) coated CVI test coupons were tested in tension-tension fatigue loading at a peak stress of 100 MPa with combustion flame impinging on front surface. In this study fatigue life of the specimens considered is defined up to failure. Fatigue life of the test coupons tested in combustion environment is shown in Figure 3. Uncoated specimens had a shorter fatigue life compared to the EBC coated. Shorter fatigue life of the uncoated test coupons indicates the adverse effect of harsh combustion environment.

Fatigue life of 500 cycles (8 min) was observed for the MI specimen. It should be noted that the MI specimens used here were relatively weak compared to modern state-of-the-art MI composites, which could be a reason for such a low fatigue life. The uncoated CVI specimen survived 1500 cycles (25 min) while the EBC coated CVI specimens with 10% and 18% porosity content survived 14,400 cycles (240 min) and 25,200 cycles (420 min). Application of EBC coating significantly increased the fatigue life in combustion environment. Presence of voids, the exposure of as-machined edges, and the 45°

angle of incidence of the flame most likely accelerated material degradation. Comparing the two EBC coated CVI specimens, specimen with high porosity (18%) content showed a significant increase in fatigue life. This may be due to the increased infiltration of oxide into the composite. In addition, prior to testing some regions along the edges of the EBC-CVI 10% specimen were observed to not completely cover the edge exposing the as-machined edges to the environment. Also, presence of micro-cracks on the EBC coating due to slurry infiltration technique makes them more susceptible to spallation where oxidative gases can easily reach the substrate.

Coated specimen of same porosity (10%) content showed an increased fatigue life than the uncoated specimen shown in Figure 3, indicating EBC coatings are beneficial for SiC/SiC CMCs to survive in combustion environments. Although coatings significantly increase the fatigue life, spallation is a serious issue in burner rig environment. Figure 11 shows the images of EBC-CVI 18% test coupon after 4 h of testing and at failure in combustion facility. Mass of the test coupon is 11.27 g prior to testing and after 4 h of testing a reduction in weight by 0.27 g is seen due to coating spallation. A significant amount of spallation is seen after 7 h of testing on the surface. As mentioned earlier, these coatings have micro-cracks due to slurry infiltration and susceptibility in high-velocity flame to spallation, exposing the as-machined edges. Failure initiated from the bottom edge of the test coupon where coating started to spall as shown in Figure 11.

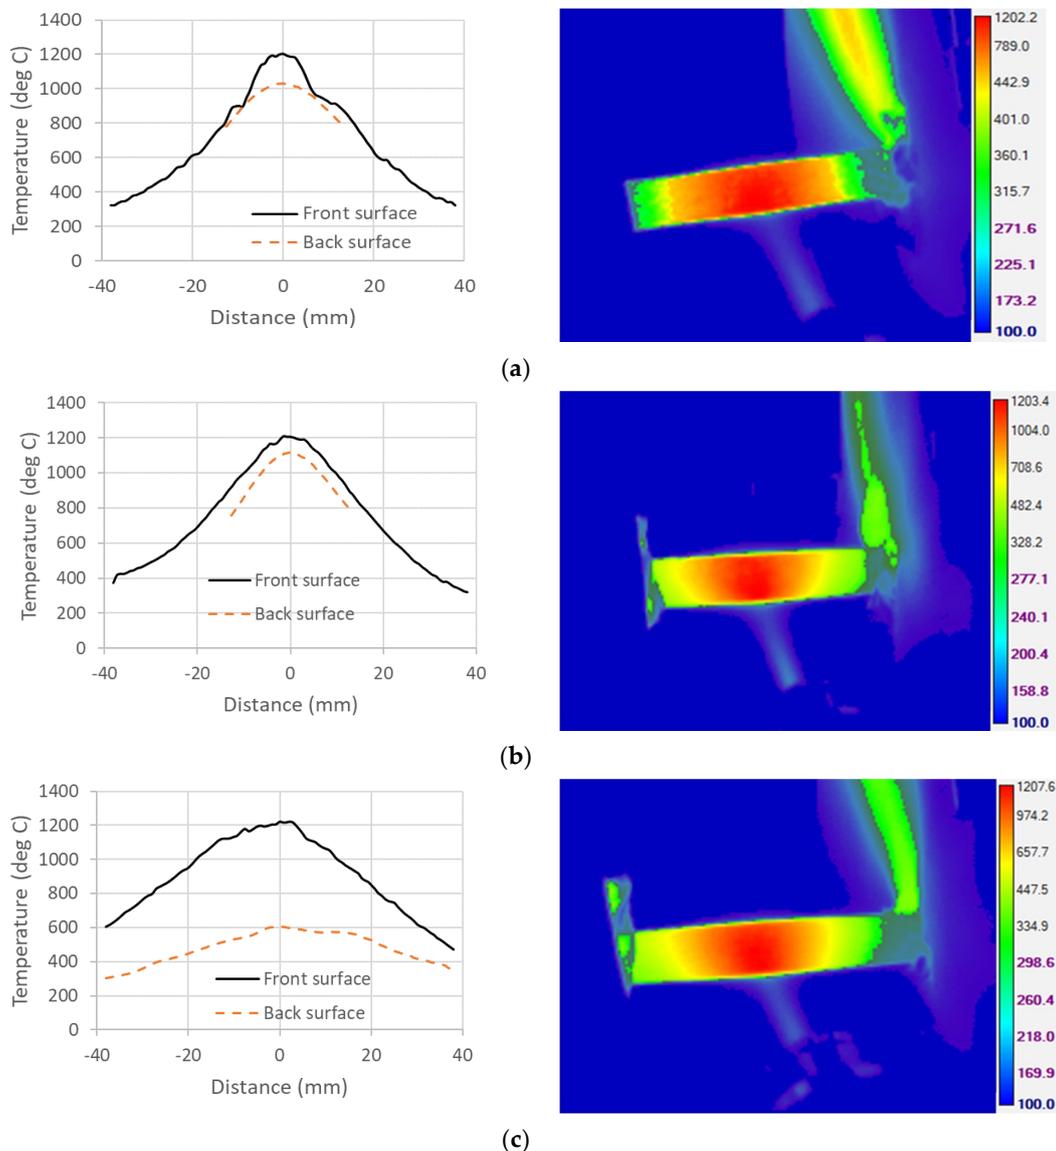
Figure 4. Temperature distribution along length from FLIR camera (front side shown) (a) MI SiC/SiC, (b) CVI SiC/SiC, (c) EBC-CVI SiC/SiC.

Temperature distribution along the length of the specimen for coated and uncoated test coupons are shown in Figure 4. Front side FLIR camera captured the entire gauge section while the back side FLIR camera captured only an inch length because of different calibration settings. A thermal gradient of 175 °C, 100 °C, and 600 °C is seen for MI, CVI, and EBC coated CVI. From the literature [1], it is observed that MI SiC/SiC has higher thermal conductivity compared to CVI SiC/SiC. However, the CVI specimens tested in this study are thinner (Table 1) than the MI specimens which would explain the lower thermal gradient for CVI.

This behavior is not seen in the burner rig MI specimens, which we believe to be due to difference in the temperature distribution along the length of the specimen. The three-inch furnace and the burner rig both have a hot zone (1200 °C) of approximately 25 mm (Figure 4). However, the furnace temperature both within and outside the hot zone is uniform across the cross-section of the composite and the axial temperature gradient is relatively stable. The burner rig has a temperature gradient through the thickness of the specimen so that the hottest region of the specimen is at the surface of the flame side. The resistivity of the regions outside the flame-side surface are higher for temperatures from ~900 to 1200 °C. These high resistances presumably would mask the decrease in resistance experienced in the hot zone above the saturation temperature, resulting in a continuous increase in resistance. With loading, an increase in resistance is seen, and finally, failure where resistance changes is abrupt. Observed ER trend for CVI and EBC coated CVI composite in furnace is similar to the burner rig where the resistance decreased with heating and with loading resistance increased until failure.

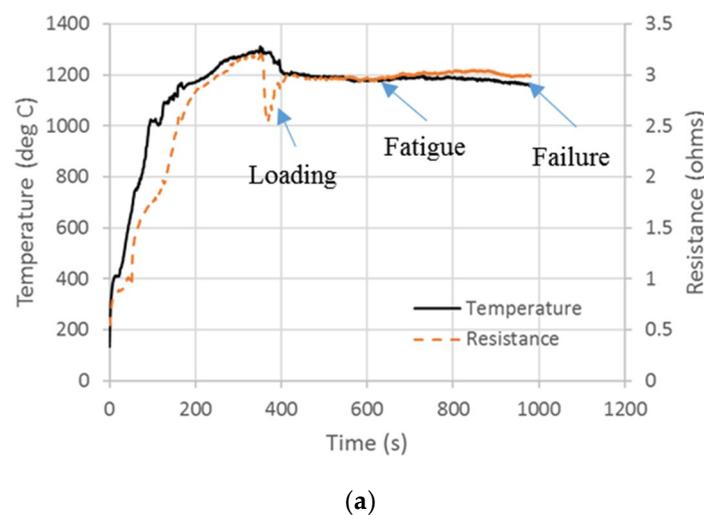
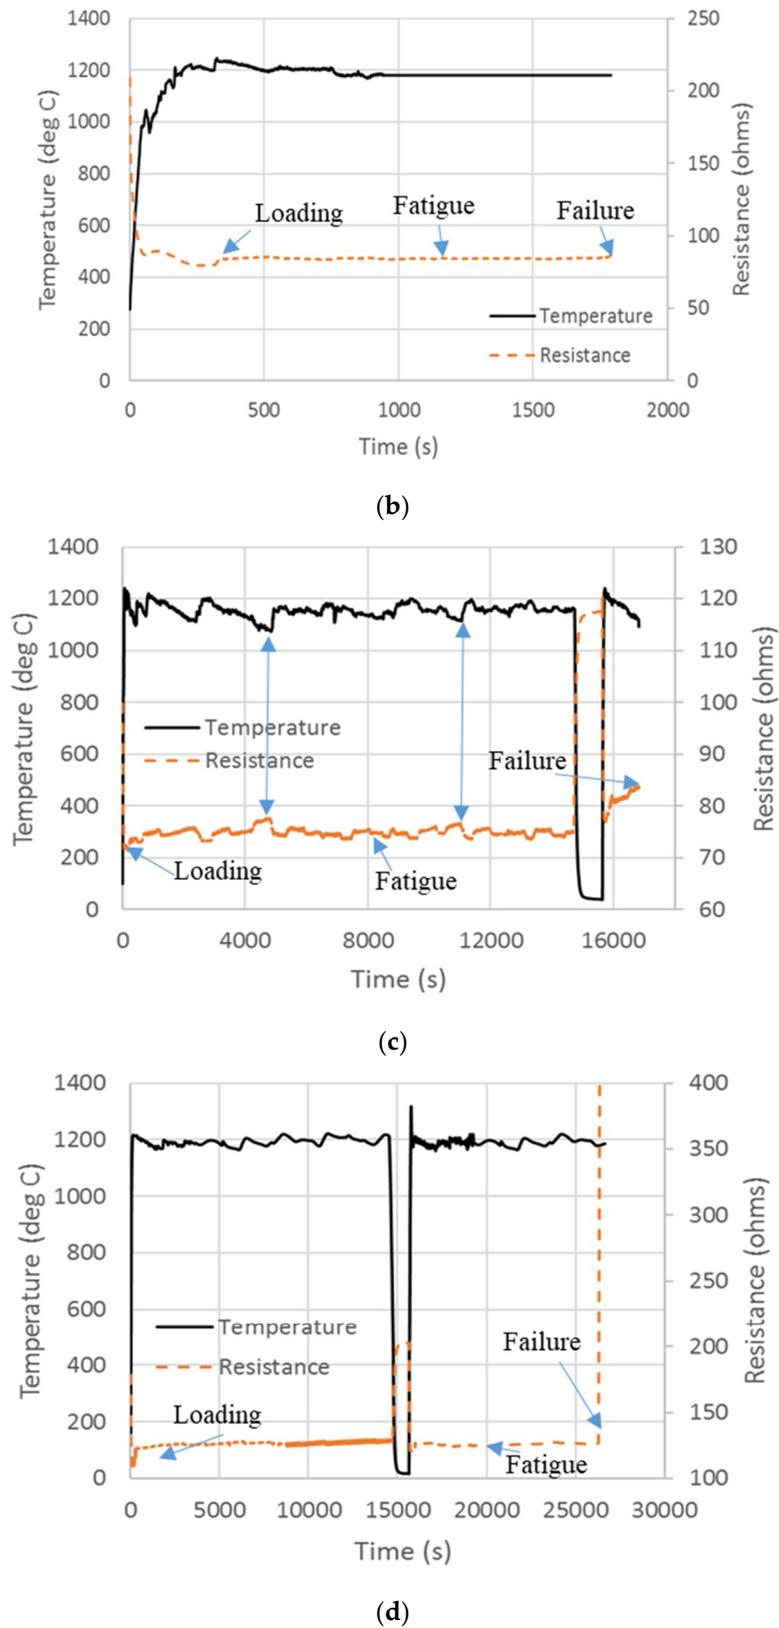
Figure 5. ER profile with temperature in combustion environment (a) MI SiC/SiC, (b) CVI SiC/SiC, (c) EBC-CVI 10%, (d) EBC-CVI 18%.

Resistance change with temperature for the uncoated and EBC coated test coupons are shown in Figure 5. To understand the ER behavior, the current flow path for the two material systems considered in this study has to be explained. Many researchers [17,20–22] have extensively investigated the ER behavior of MI and CVI SiC/SiC CMC systems at room temperature and high temperature under various loading conditions. MI composites are electrically more conductive compared to the CVI. In MI SiC/SiC, the matrix is the more conducting phase in comparison to the fiber. This is due to the presence of free doped silicon (Si) present in the matrix. Si is more conductive than that of the pure CVI. Morscher et al [17] estimated the resistivity of Si to be $0.046 \Omega\text{-mm}$ for iBN composite and $0.056 \Omega\text{-mm}$ for ZMI composite. Any damage to the matrix (i.e., matrix cracking) breaks the electrical network resulting in an overall increase in the resistance. The literature reported resistivity values of the CMC constituents are listed in Table 4 [17,23,24]. CVI SiC/SiC considered in this study had Hi-Nicalon fibers. From Table 4, it can be seen that resistivity of Hi-Nicalon fibers is significantly lower compared to the pure CVI SiC, and it is reasonable to assume that fibers are the majority charge carriers. Therefore, CVI SiC/SiC system is less sensitive to matrix damage compared to MI SiC/SiC.

The high-temperature ER response of the MI SiC/SiC system is significantly different compared to the CVI SiC/SiC due to the presence of silicon enriched matrix. Resistance of Si increases with temperature, whereas the resistance of SiC decreases with temperature. Similar ER behavior, as discussed above, is observed in the burner rig for MI and CVI SiC/SiC composites, respectively (Figure 5). MI composite resistance significantly increased with heating and upon loading a more gradual increase in resistance was observed until failure (Figure 5a). CVI composite resistance significantly decreased with heating and an increase in resistance is seen with loading (Figure 5b–d). This gradual increase in resistance could be attributed to fatigue loading and possible oxidative degradation [25].

For one of the EBC coated CVI SiC specimens (Figure 5c), there were intermittent increases and decreases in resistance during burner rig fatigue. The increases corresponded with temperature decreases and the decreases with temperature increases, showing the sensitivity of resistance to temperature fluctuations possible due to open-flame heating. The resistance of the specimens before, during, and just prior to failure in burner rig is shown in Table 5. Some measurements were made at room temperature (RT) and others at temperature. An increase in resistance was observed for all the CVI specimens at temperature and the CVI-EBC specimens after 4 h of testing when measured at room temperature. This residual or irreversible resistance is presumed to be due to nonrecoverable damage to the fibers and matrix. The MI specimen actually showed a little net increase in resistance at temperature. However, this was probably due to the apparent gradual reduction in temperature during the test (Figure 5a).

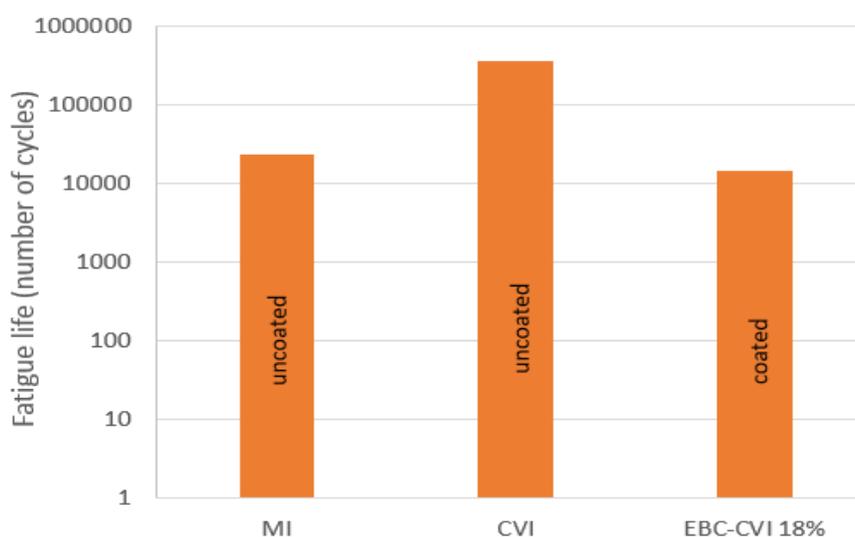
Figure 6. Fatigue life of uncoated and coated test coupons in isothermal furnace.

To compare to the combustion test results, test coupons were tested in isothermal furnace at a peak temperature (1200 °C), the same as the surface temperature of the combustion test. Fatigue life of the uncoated and coated specimens is shown in Figure 6. The fatigue life for MI was 6.5 h (23,400 cycles); for CVI as-produced, it was 100 h (360,000 cycles); and for the EBC coated CVI, it was 4 h (14,400 cycles). Furnace tested specimens showed a significant increase in fatigue life compared to the combustion tested uncoated specimens. Higher fatigue life observed in the furnace could be due to the absence of water vapor and thermal gradient stresses. Higher fatigue life seen for the EBC-CVI 18% porosity specimen in burner rig compared to furnace tested specimen could be due to increased infiltration of oxide into the composite. The significance of thermal gradient stress and watervapor on fatigue life is discussed in detail in the "General discussion" section.

Surprisingly, the uncoated CVI significantly outperformed the EBC coated CVI for the furnace fatigue condition. EBC coating processing required sintering at 1450 °C for several hours. Heat-treating the composite for such a long duration exposes the Hi-Nicalon fibers to temperatures well above their processing temperature and is known to degrade the fiber strength by 60% [26–29]. This suggests that application of EBC coating using slurry infiltration technique provides the oxidation resistance but significantly reduces the fiber strength for this composite system due to thermal exposure during coating processing. However, if Hi-Nicalon S fibers were used in the CVI SiC system, such degradation would not be expected.

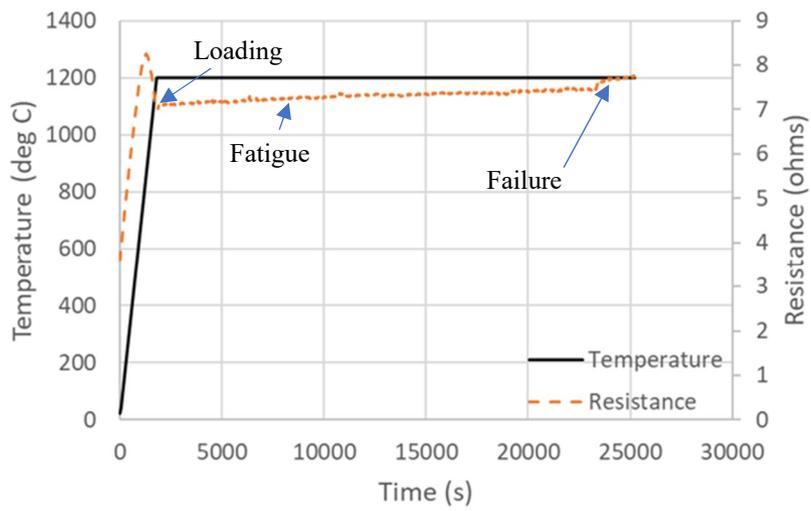
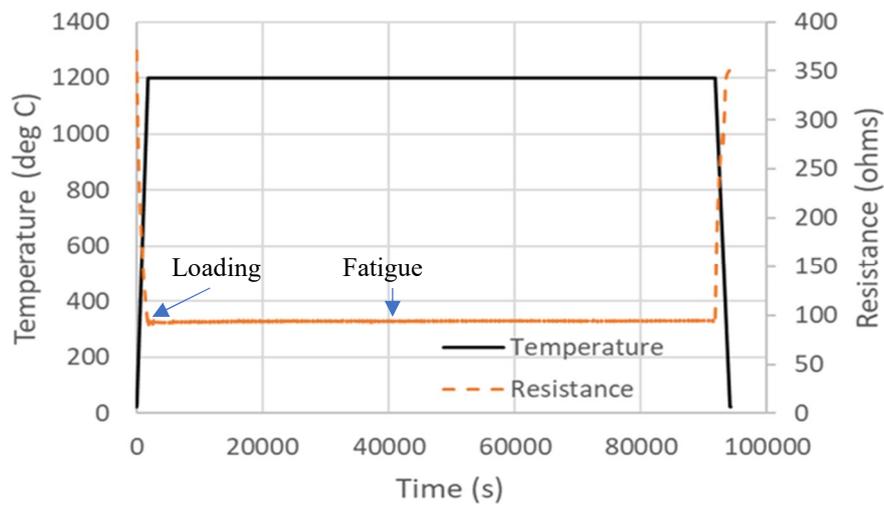
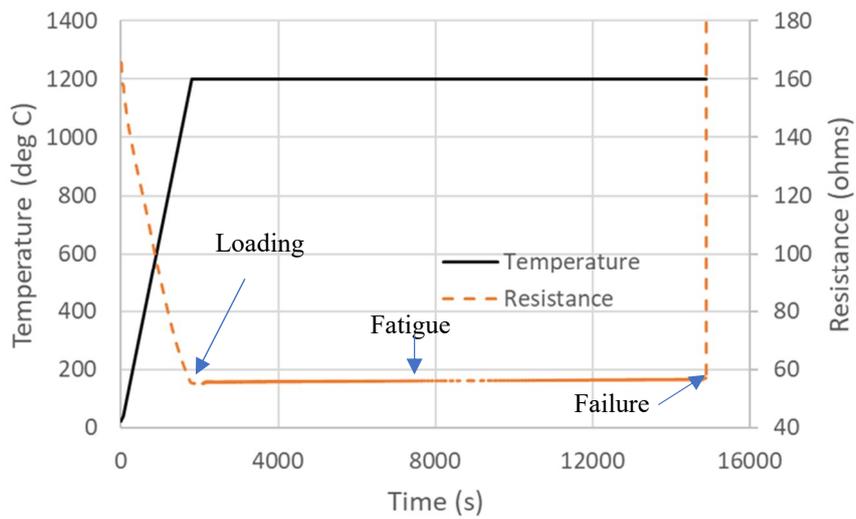
Figure 7. ER trend with temperature in isothermal furnace (a) MI SiC/SiC and (b) CVI SiC/SiC for first 25 h of testing (c) EBC-CVI 18%.

ER profiles with temperature for the MI, CVI, and EBC coated CVI specimens are shown in Figure 7. For the MI specimen, resistance increased with heating up to 950 °C and beyond this resistance decreased. Smith et al [23] reported that resistivity of silicon varies with dopant level and there is a saturation temperature where the resistance increases with time (below the saturation temperature) and above saturation temperature resistance decreases. The increase in resistance below the saturation temperature is attributed to the precipitation of dopants from the silicon and the decrease above saturation temperature is attributed to the increase in carrier concentration due to reabsorption of dopants.

ER change in furnace tested specimens is shown in Table 6. Uncoated CVI specimen showed no change in ER after 100 h of testing, which implies that the applied stress did not cause any significant matrix cracking to the composite. The smooth ER trend in the furnace is due to uniform increase of temperature.

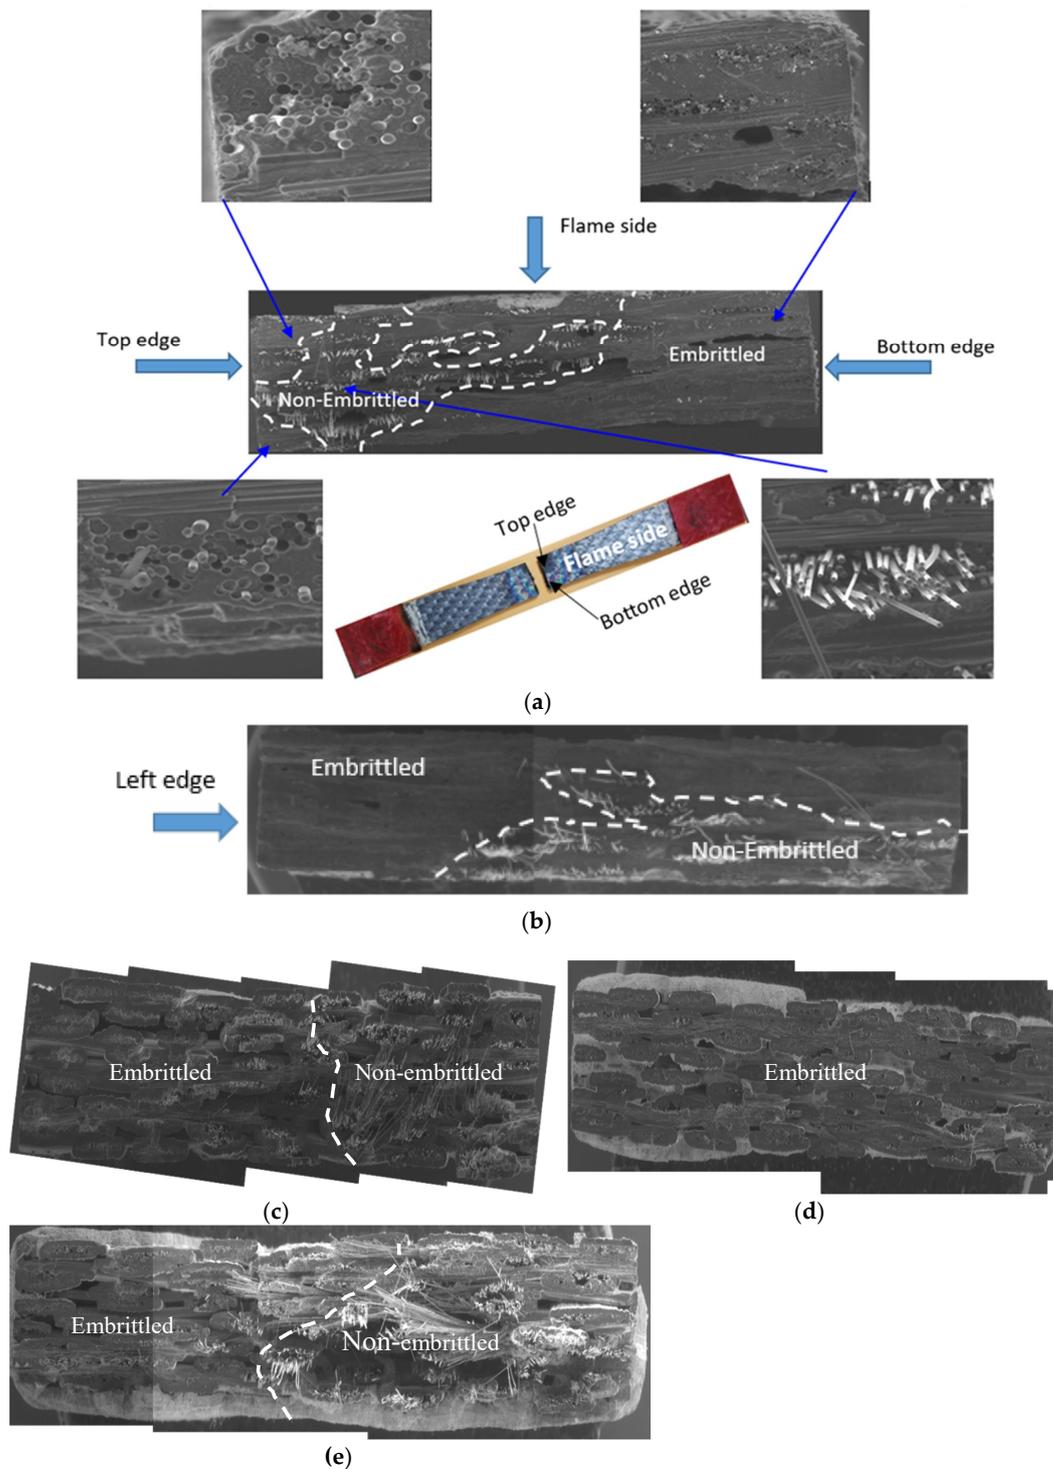
Figure 8. Microscopic images of fracture surface (a) MI combustion test, (b) MI furnace test, (c) CVI combustion test, (d) EBC coated CVI combustion test, (e) EBC coated CVI furnace test.

Fracture surfaces of the failed test coupons were observed under SEM to understand the damage mechanisms and the extent of oxidation. Microscopy images of fracture surfaces of MI, CVI, and EBC coated CVI test coupons tested under combustion and furnace conditions are shown in Figure 8.

From SEM images, it is clearly evident that majority regions of the fracture surface of the test coupons tested in combustion facility (Figure 8a,c) are oxidized with little fiber pullout. Oxidized regions are indicated as embrittled and unoxidized/fiber pullout regions are indicated as non-embrittled. The two regions are separated by a white dotted line. In oxidized regions, matrix and the BN interphase are completely oxidized, and the fibers are fused together by the oxides, whereas no signs of oxidation are seen on the fibers in the pullout area. Burner rig test coupons suffered significant oxidation, which could be attributed to the hostile environment with harsh combustion gases. Edges of the test coupons (Figure 8a) tested in combustion environment are completely oxidized clearly indicating an edge effect. Edge effect is predominantly seen in burner rig due to angular impingement (45°) of flame on test coupons. As a result, top and bottom edges of the specimen were completely exposed to high temperature high velocity flame. It appears that loading initiated micro-cracks, which serve as a free path for the high-temperature gases to enter the composite system, causing embrittlement and finally a dominant crack is originated from the edges. Figure 9 shows the FLIR image of the CVI test coupon near failure in burner rig indicating the failure from the bottom edge. This is consistent with the fracture surface (Figure 8a) where the embrittled region extends more deeply from the bottom edge (nearest to nozzle) than the top edge.

Fracture surface of the EBC coated CVI specimens (Figure 8d) showed a planar fracture with no fiber pullout and complete oxidation of BN interphase. Application of EBC coating increased the fatigue life of the specimen. However, coating spallation, which leads to the exposure of the as-machined edges, formation of micro-cracks due to loading, and longer time for the cracks to propagate, made the hot combustion gases diffuse through the cracks leading to complete oxidation of fibers and matrix.

For the furnace tested specimen, oxidation likely appeared to be originated from the left edge (Figure 8b,e) and a little fiber pullout is seen on the other edge. In the oxidized areas, BN interphase is completely oxidized, causing fibers to bond together, whereas no oxidation is seen on fibers in non-embrittled areas. Fracture surface reveals that cracks are initiated from the machined edges. As the crack grows, more regions are exposed to oxidative environment, causing embrittlement. Presumably embrittled areas transfer the load to remaining intact areas, which are incapable of carrying the load leading to final failure [30,31].

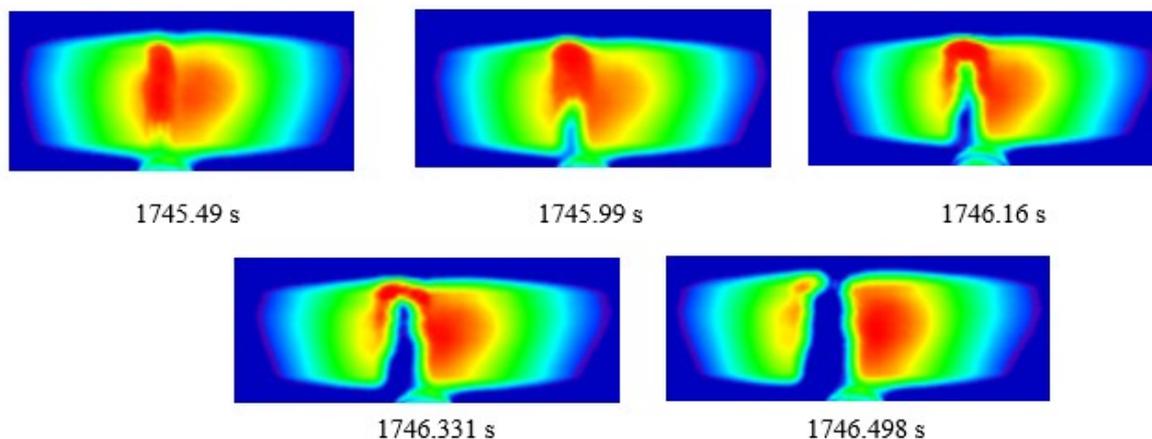
Figure 9. Backside FLIR images of CVI specimen in combustion environment showing failure originating from the edge.

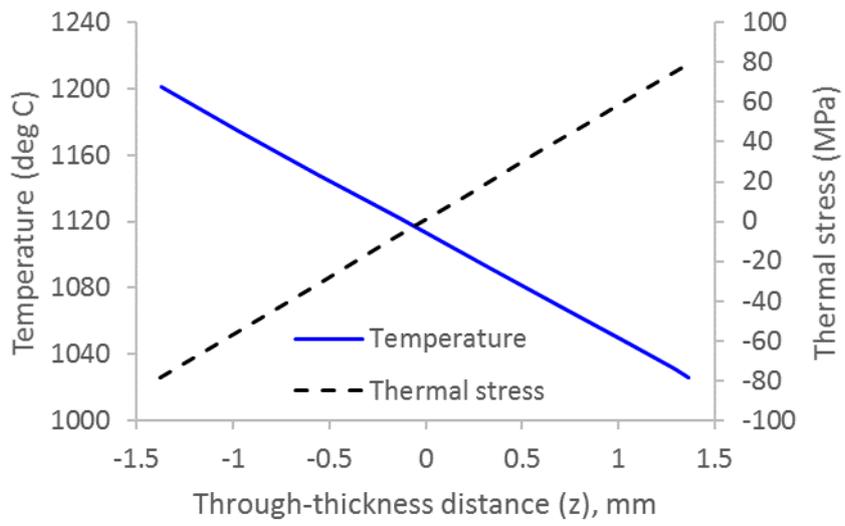
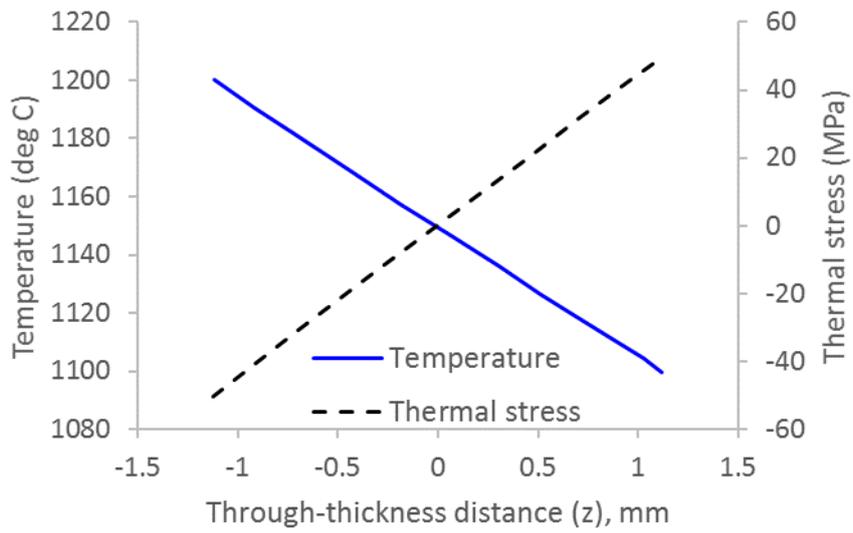
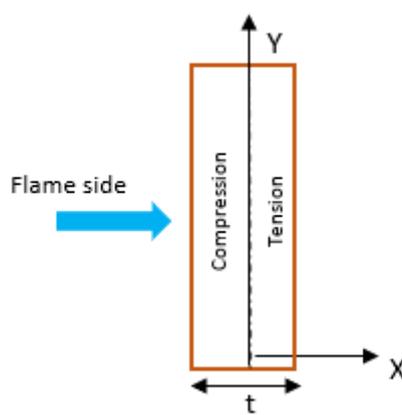
Figure 10. Through thickness thermal stress and temperature (a) MI SiC/SiC, (b) CVI SiC/SiC, (c) test coupon showing tension and compression planes in burner rig.

the induced thermal stress and temperature distribution along the through-thickness direction for the uncoated specimens is shown in Figure 10. Through-thickness temperature distribution is calculated using simplified 1D steady state heat transfer approximation and thermal stress is calculated based on the simplified equation deduced by Appleby [32] as shown in Equation (1).

Elastic modulus and coefficient of thermal expansion are taken from the literature [33,34] and front and back surface temperatures are taken from FLIR. High velocity of the flame induces compressive stress on the front surface of the specimen while back surface experiences tensile stress. A net thermal stress increase/decrease of 79 MPa is estimated for the back/front sides of the MI specimen and a net increase/decrease of 50 MPa is estimated for the back/front of the CVI specimen. Addition of the thermal stress to the applied stress (back side) would be expected to induce increased matrix cracking and accelerated material degradation leading to embrittlement and failure. Note that the oxidation embrittlement was more pronounced on the back side of the burner rig tested MI and CVI specimens, Figure 8a,c, respectively. It should be noted that thermal stress estimated here is an approximation based on steady state assumptions and simplified Equation (1). However, these results indicate that thermal stress has a deleterious effect in burner rig environment, and significantly reduces fatigue life when combined with water vapor.

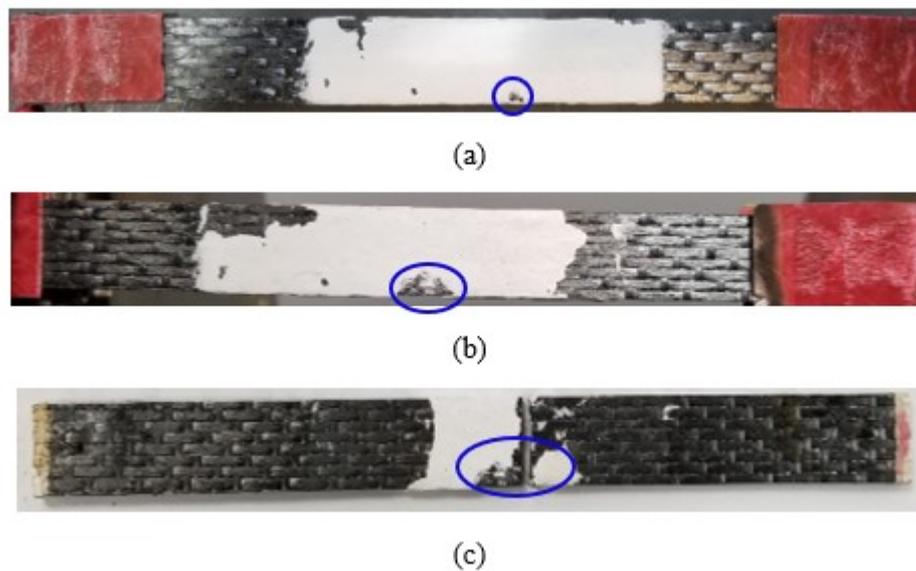
Figure 11. EBC-CVI 18% test coupon showing spallation after (a) 4 h of testing, (b) 7 h of testing, and (c) at failure.
