Article

Effects of Surface Roughness on the Electrochemical Properties and Galvanic Corrosion Behavior of CFRP and SPCC Alloy

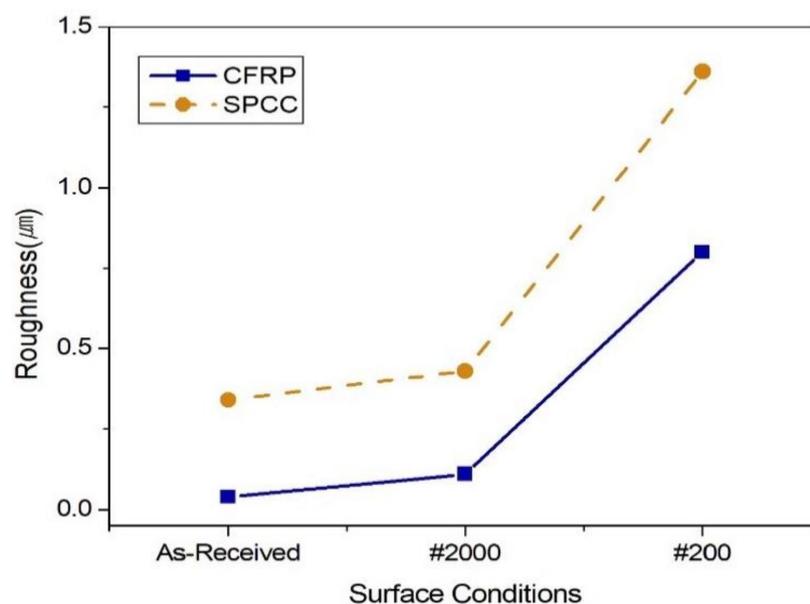
The surface roughness of the specimens was compared to the values of the Korea Standard (KS) B 0161 specification [13]. The surface roughness of the as-received CFRP corresponded to the value of N2 (0.04 μm), the #2000 surface-polished to N3 (0.11 μm), and the #200 surface-polished to N6 (0.80 μm) (Figure 1) [13,14]. The as-received SPCC corresponded to the value of N5 (0.34 μm), the #2000 surface-polished to N5 (0.43 μm), and the #200 surface-polished to N7 (1.36 μm) [13,14]. The as-received SPCC specimen was formed via cold rolling; therefore, its surface roughness value was dependent on the surface condition of the roller used during cold rolling. The random surface conditions of the #200 and #2000 surface-polished SPCC specimens were determined using sandpaper, and the Ra value, in turn, depended on the type of sandpaper used.

Figure 1. Surface roughness of CFRP (orange) and SPCC (blue).

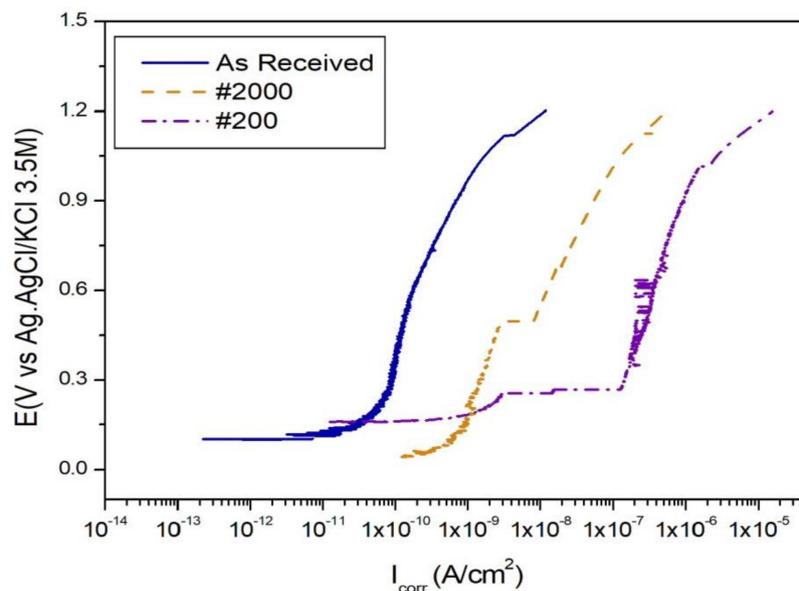
The as-received CFRP specimen exhibited a corrosion current density ($I_{CORR.}$) of 4.547×10^{-11} A/cm² during potentiodynamic corrosion testing, that increased to 5.397×10^{-8} and 7.691×10^{-7} A/cm² in the #2000 and #200 surface-polished specimens, respectively (Figure 2). Because the corrosion current density is related to the corrosion speed, the CFRP specimens corroded faster as the surface roughness increased. Furthermore, the coarse particles of the #200 sandpaper exposed some of the carbon fibers during polishing; these exposed fibers reacted with the electrolyte and underwent rapid oxidation-reduction.

Figure 2. Corrosion current density of CFRP during potentiodynamic corrosion testing with a 5.0 wt.% NaCl aqueous solution electrolyte.

Therefore, in this study, the corrosion rate of the CFRP specimens increased, with an increase in surface roughness, thereby expanding the reaction surface area.

These results indicated that regular CFRP materials are covered with polymer materials, particularly carbon fiber, as a passivation layer. However, the exposed carbon fiber, due to sandpapering using #200 emery paper in this experiment, was related to an increased corrosion rate (Figure 2). In this experiment, the exposed carbon fiber acted as a conductor to electrons in the electrolyte solution, thereby increasing corrosion speed.

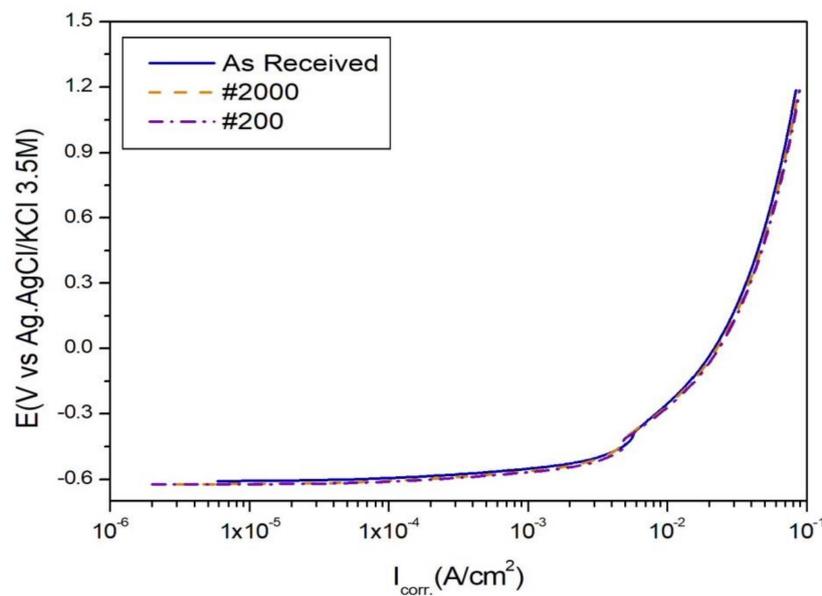
The corrosion current density of the as-received SPCC specimen was 7.986×10^{-3} A/cm², which increased slightly to 8.866×10^{-3} and 1.039×10^{-2} A/cm² for the #2000 and #200 surface-polished specimens, respectively (Figure 3). Although the surface roughness tendencies of the SPCC specimens were similar to those of the CFRP specimens, surface roughness had a negligible effect on the corrosion current density.

Figure 3. Corrosion current density of SPCC during potentiodynamic corrosion testing with a 5.0 wt.% NaCl aqueous solution electrolyte.

Therefore, all types of SPCC specimens exhibited significantly higher corrosion speeds than CFRP. The SPCC specimen, being a metallic material, was easily dissolved and oxidized in the 5.0 wt.% NaCl aqueous solution compared with CFRP, a non-metallic material [15].

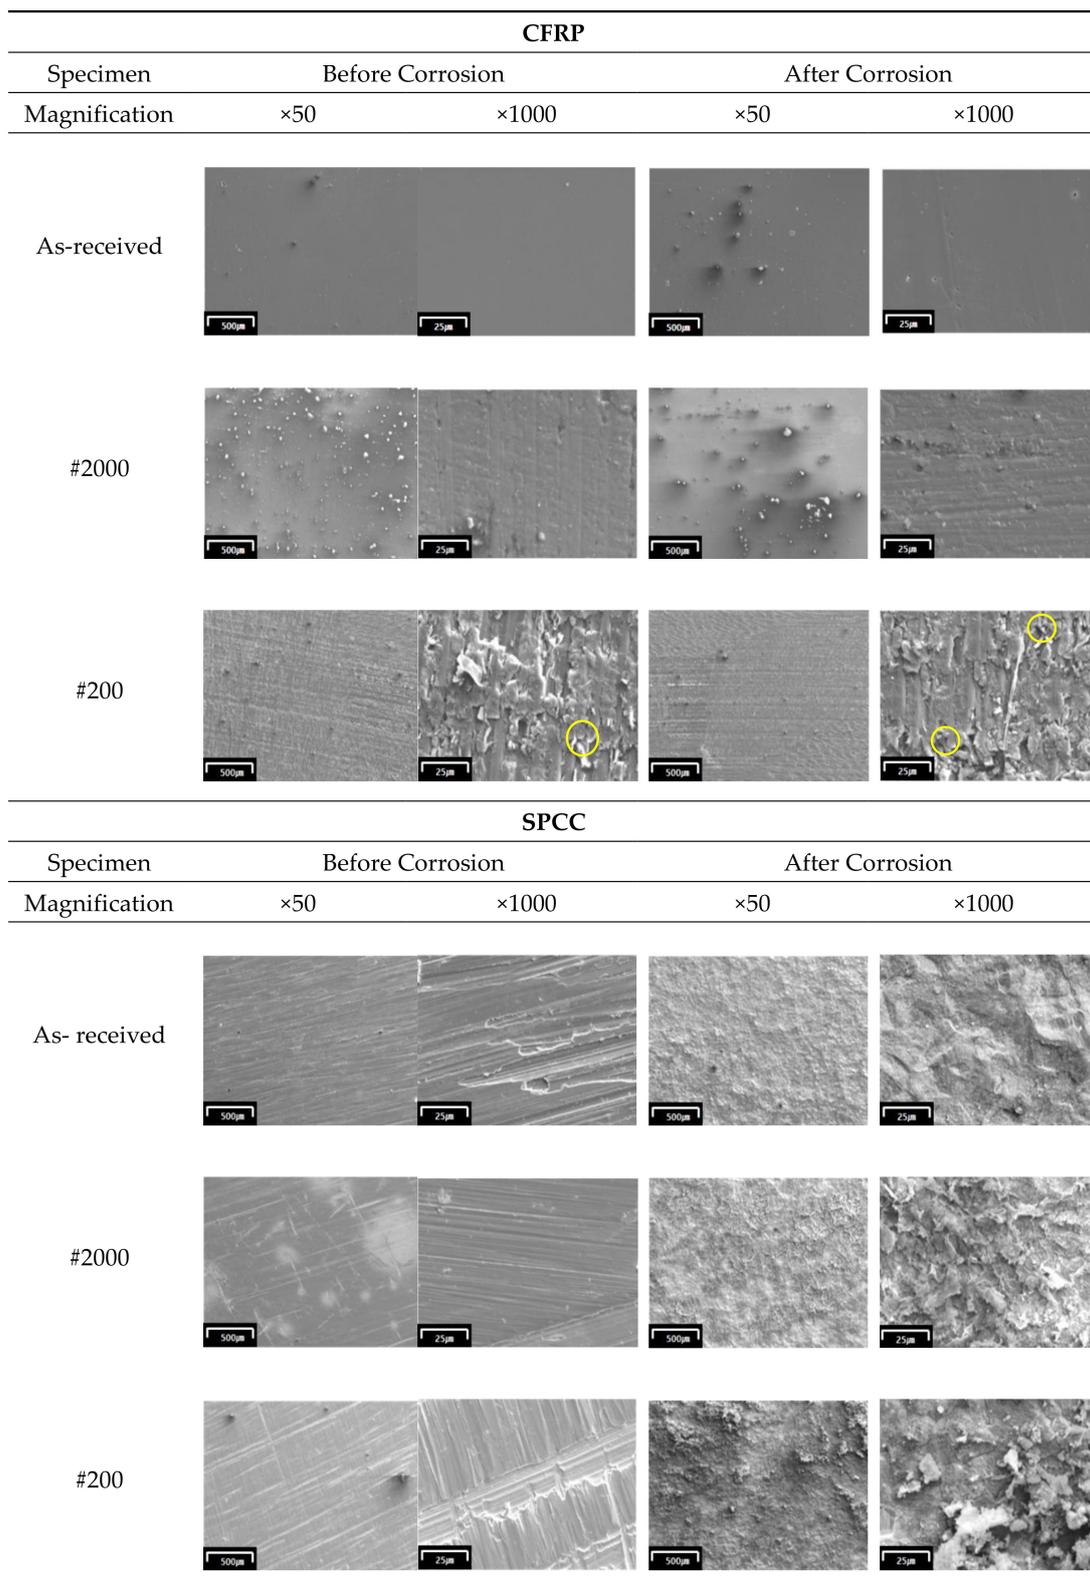
The microstructural analysis revealed exposed carbon fibers on the #200-sandpapered CFRP specimen with the formation of haphazard surface roughness (Figure 4, yellow circle indicated). All the CFRP specimens only exhibited slight microstructural changes after corrosion testing. Furthermore, negligible changes in the chemical composition of the specimens were observed (Table 3).

Figure 4. Microstructure of CFRP and SPCC, before and after corrosion testing.

The SPCC specimens exhibited significant microstructural changes after corrosion (Figure 4). Consequently, various oxides were generated on the surface during corrosion (Table 2).

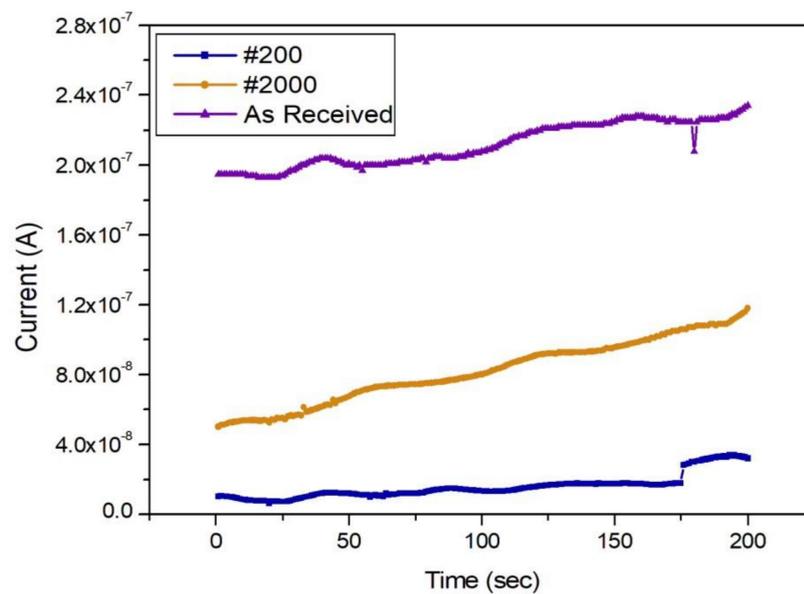
The galvanic corrosion of the as-received CFRP specimen (with the most intact surface) and the #200-sandpapered CFRP specimen (with the roughest surface) was compared with the galvanic corrosion of the corresponding SPCC specimens (Figures 5 and 6). The as-received SPCC specimen corroded less than the other SPCC specimens, where the #200-sandpapered SPCC specimen exhibited the largest corrosion on the as-received CFRP condition. All the SPCC specimens exhibited a gradual increase in corrosion rate as time elapsed.

Figure 5. Graph of galvanic corrosion results at all SPCC surface conditions for as-received CFRP.

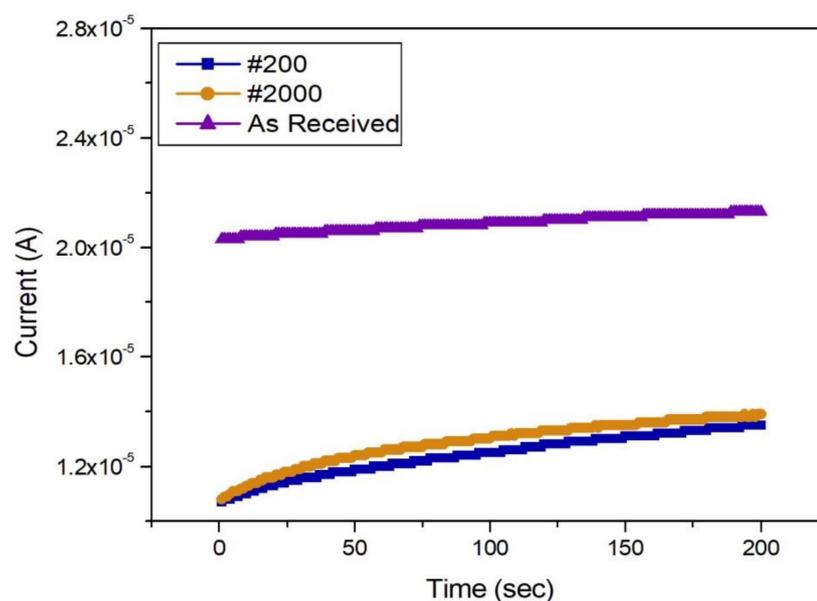
Figure 6. Graph of galvanic corrosion results at all SPCC surface conditions for #200 CFRP.

Furthermore, the as-received SPCC specimen exhibited the least corrosion on the #200-sandpapered CFRP condition, while the #200-sandpapered SPCC specimen corroded the most. The corrosion rate of all the SPCC specimens increased continuously with time.

Three types of SPCC and CFRP surface condition specimens were compared. The galvanic corrosion of the #200 CFRP was found to have the fastest corrosion rate among all the CFRP specimens (Figure 6). The results also indicated that the extent of corrosion of the as-received SPCC specimen was the lowest among all the SPCC specimens and corrosion increased as the galvanic corrosion reaction progressed. The #2000- and #200-sandpapered SPCC specimens showed similar galvanic corrosion behavior, and the #200-sandpapered SPCC specimen was found to have undergone the most extensive corrosion.
