In Situ Scanning Electron Microscopy Observation of Crack Initiation and Propagation in Hydroxide Films Formed by Steam Coating on Aluminum-Alloy Sheets

Abstract: Hydroxide film was formed on 6061 Al-alloy (Al-1.00Mg-0.62Si(wt.)) sheets by steam coating with the temperature of 220 °C for 24 h. During bending test of the coated specimens, the crack initiation and propagation processes in the hydroxide film were investigated using in situ SEM observations. The hydroxide film formed exhibited a dual-layer structure composed of an inner amorphous layer and an outer polycrystalline γ -AlO(OH)-phase layer. On the compressively strained surface, lateral cracks are preferentially initiated inside the inner amorphous layer, and propagate either inside this layer or on its interface with the outer γ -AlO(OH) layer. Digital image correlation analyses of the in situ observed SEM images suggested that the concentrated tensile strain along the surface normal localized at some parts of the amorphous layer could contribute to the crack initiation. On the tensile-strained surface, a number of cracks were initiated inside the inner amorphous layer along the surface normal and propagate into the out

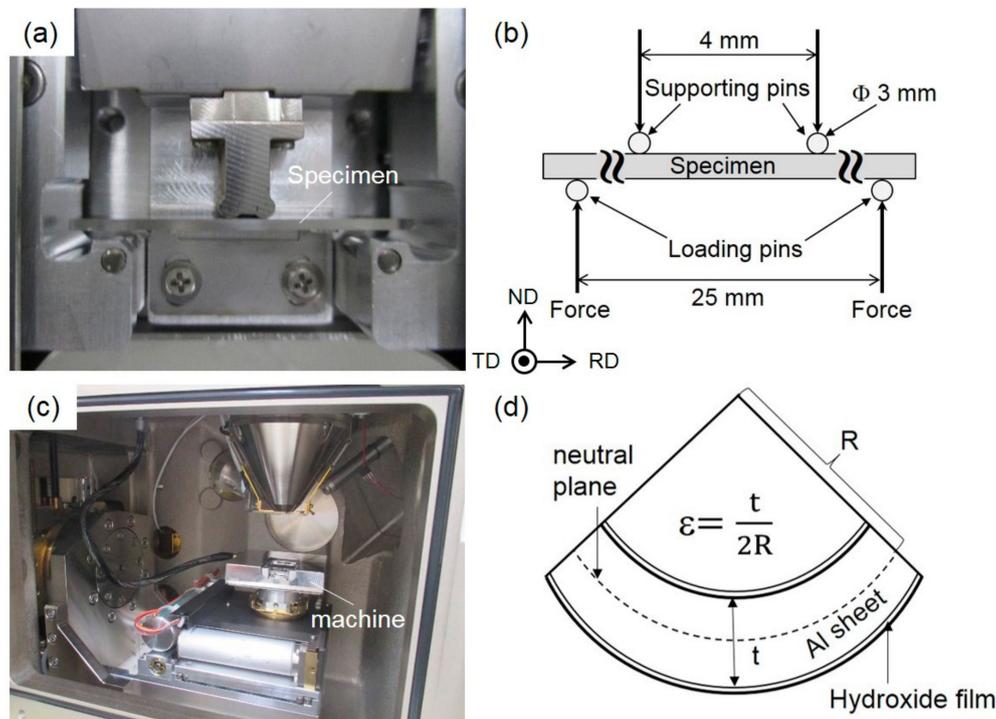
Load-displacement curves of bent specimens were obtained by 4-points bending tests using a newly designed miniature-sized bending test machine (Figure 1a) at room temperature and a constant displacement rate of 5.8 μm/s.

The geometry in the 4-points bending test is schematically presented in Figure 1b. The bending test machine loaded with a used specimen was placed inside the vacuum chamber of the SEM instrument (JEOL JSM-6610) for in situ observation of the ion-polished surfaces, as presented in Figure 1c. The strain (ε) applied to the surface of the bent specimen was calculated by the following equation:

where t is the specimen thickness and R is the radius of curvature, as schematically shown in Figure 1d. R was determined from the low-magnification in situ SEM image during the bending test in the SEM chamber. The local strain distribution around the hydroxide/Al interface in the bent specimens was quantified by digital image correlation (DIC) analysis [15,16] using the in situ observed SEM images at different states of deformation. In the present study, DIC analyses were performed using high-magnification SEM images at a subset size of approximately 81×81 pixels.

Figure 1. (a) Photograph of the specimen set in the miniature-sized bending test machine; (b) Schematic geometry used for the 4-points bending test; (c) The miniature-sized bending test machine placed in the SEM vacuum chamber for in situ observation; (d) Schematic of the bent specimen's geometry. TD: transverse direction, RD: rolling direction, ND: normal direction, strain: ϵ , t : specimen thickness, R : radius of curvature.

The measured R values can be used to calculate the macroscopic strains (ϵ) of the specimen following Equation (1) (as schematically illustrated in Figure 1(d)). The calculated ϵ ranged from 3.3% to 14.6% for different displacements, as labeled on the flow curve in Figure 7.

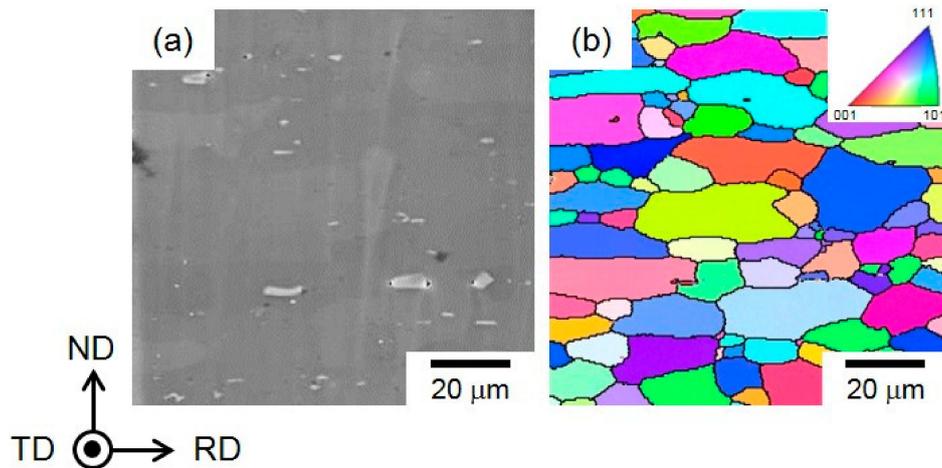
Figure 2 presents secondary electron image (SEI) of the α -Al (face-centered cubic (fcc)) matrix in the steam-coated specimen and corresponding orientation color map (measured by EBSD analyses). In the map, the color code key for the transverse direction (TD) orientation of the α -Al matrix is represented in the unit triangle.

The white and black particles were distributed in the α -Al matrix (Figure 2a), and they correspond to the Mg_2Si phase with dark contrast [17] and the β -AlFeSi (τ_6 - $Al_9Fe_2Si_2$) phase with bright contrast [18] formed in the α -Al matrix [12]. The orientation map indicates that the α -Al matrix exhibits relatively equiaxed grains with a mean size ranging from approximately 5 to 20 μm (Figure 2b).

Figure 2. (a) Secondary electron image (SEI) and (b) corresponding orientation color maps (obtained by electron backscattered diffraction (EBSD) analysis) showing the microstructure of the polished cross section in steam-coated 6061 alloy.

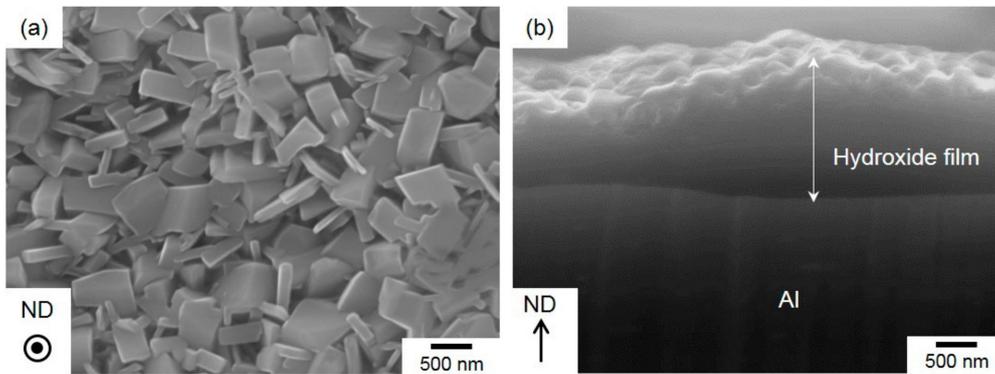
Figure 3 presents the top and cross-sectional views of the hydroxide film in the steam-coated specimen.

The film consisted of numerous polyhedral particles approximately 300 nm in size (Figure 3a), which corresponds well to previous reports on the surface morphologies of hydroxide films [19–21]. Cross-sectional observation revealed that the thickness of hydroxide film was approximately 2 μm , noting that the top surface shows an irregular shape and bottom had a flat interface on the Al-alloy substrate (Figure 3b).

Figure 3. High-magnification SEIs showing the (a) top view and (b) cross-sectional view of the hydroxide films on the steam-coated Al-alloy sheets.

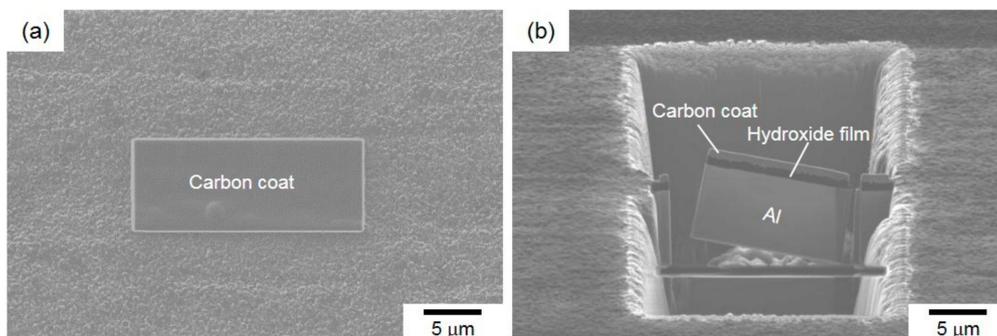
Figure 4 presents the preparation process of the TEM sample using a FIB pickup technique for observation of the hydroxide film. The sample surface was ion-milled by using FIB operated at an accelerating voltage of 30 kV and various probe current values ranging from 50 to 5000 pA. A deposited protection layer (carbon layer) was used to avoid Ga ion damage to the surface of hydroxide film (Figure 4a).

Figure 4. Preparation process of site-specific TEM samples of Al-alloy sheet (containing a hydroxide film) using a focused ion beam (FIB) pickup technique: (a) a deposited carbon layer on the surface of hydroxide film on the steam-coated Al-alloy sheet; (b) a cross-section sample milled out by FIB.

A thin cross-section sample with the thickness of less than 100 nm (containing with hydroxide film) was milled out from Al-alloy sheet by FIB (Figure 4b). This sample was picked up using a glass probe and

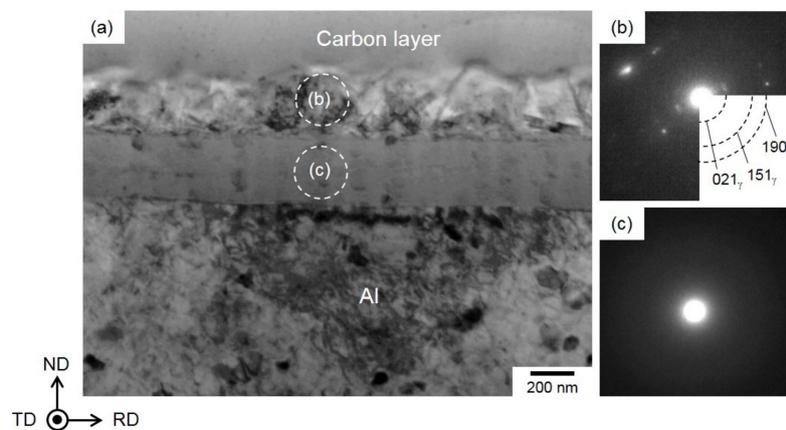
Figure 5. (a) TEM bright-field image and (b,c) selected-area electron diffraction (SAED) patterns for (b) the top γ -AlO(OH) layer and (c) the bottom continuous amorphous layer of hydroxide film that was formed on the steam-coated Al-alloy sheet.

The hydroxide film shows a dual-layer structure with the two layers having almost the same thickness (Figure 5a). The γ -AlO(OH) phase in the upper layer was determined by the SAED pattern (Figure 5b). The captured diffraction spots obviously indicate a polycrystalline γ -AlO(OH) phase composed of a number of fine γ crystals with a mean size below 300 nm (Figure 5a). Note that no clear diffraction spots were detected in the SAED pattern of the lower layer within the hydroxide film (Figure 5c), indicating that this layer adjacent to the Al-alloy substrate was amorphous. The EDS composition analyses revealed that the Al and O elements were enriched inside the hydroxide film (Figure 6a–c), and there was no clear difference in their contents between the upper and lower layers. Hence, Mg- and Si-alloy elements were not enriched in the hydroxide film, indicating that the composition of the second phases (Mg_2Si phase and β -AlFeSi phase) did not obviously affect the initial formation of hydroxide film.

In the present study, we observed the bending-induced fracture process of hydroxide film in steam-coated Al-alloy sheets at the elevated temperature of 220 °C. With a dual-layered structure, the film comprised an amorphous layer on inside and an γ -AlO(OH)-phase layer on the outside (Figure 5). Bending tests revealed that the fracture morphology of the hydroxide film depends on the applied strain state (Figure 9). In situ SEM observation (Figures 10 and 11) demonstrated that the cracks are preferentially initiated inside the lower amorphous layer during sample bending. A number of vertical cracks occurred on the hydroxide film on the tensile-strained surface, but the hydroxide film was not removed from the Al sheet (Figure 11). On the compressively strained surface, lateral cracks propagate into the lower amorphous layer or along its interface with the upper γ -AlO(OH) layer (Figure 10). The propagation of lateral cracks could be responsible for the local delamination observed on these film surfaces (Figure 9a). The preferential cracking might be due to the peculiar dual-layered structure of the hydroxide film. In compressive deformation (Figure 10), concentrated stress/strain might be localized near the interface between the amorphous layer and Al-alloy substrate, resulting in crack initiation in the amorphous layer.

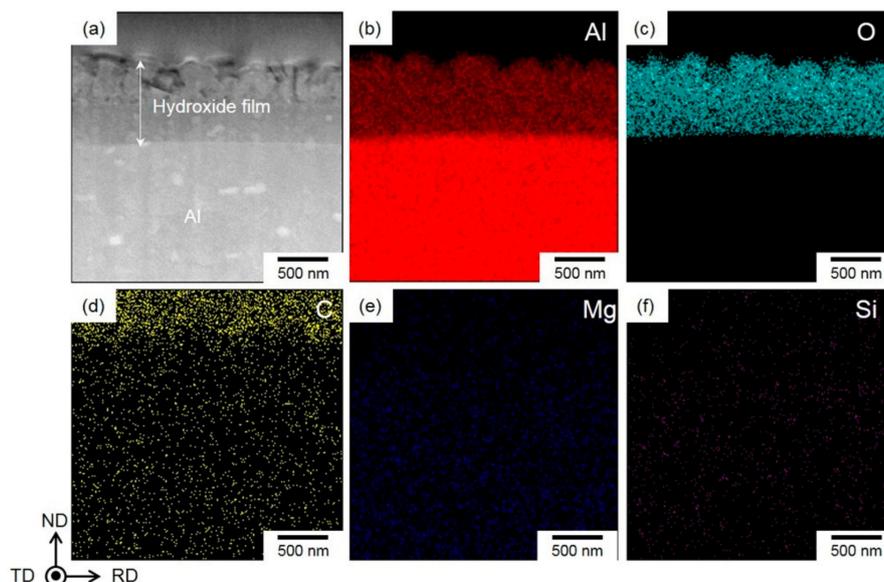
Figure 6. (a) Scanning TEM (STEM)–high-angle annular dark field (HAADF) image showing the hydroxide film formed on the steam-coated Al-alloy sheet and the corresponding (b) Al; (c) O; (d) C; (e) Mg and (f) Si element maps by energy dispersive X-ray spectroscopy (EDS) analysis.

These microstructural characteristics indicated that the hydroxide film formed had a dual-layered structure, composed of an outer γ -AlO(OH)-phase layer on the surface and a continuous inner amorphous layer on the Al substrate.

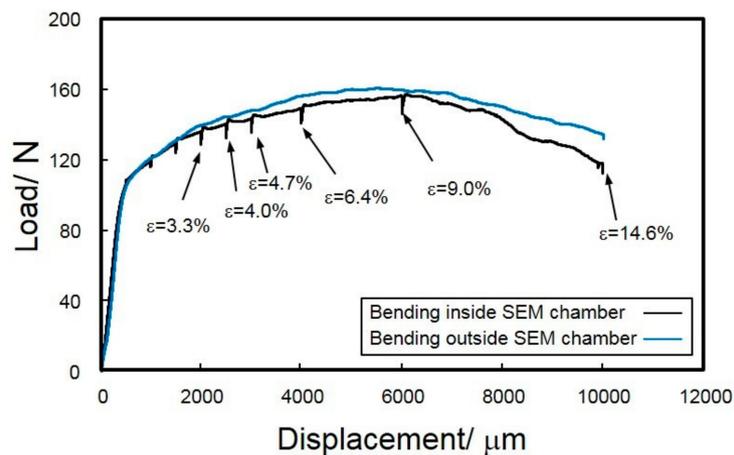
Figure 7 presents two representative load-displacement curves of steam-coated specimens in the bending tests.

Figure 7. Load-displacement curves of the steam-coated Al-alloy sheets obtained from 4-points bending tests.

Stress drops are often observed in the flow curve of bending tests conducted in the SEM chamber, when the bending must be interrupted to allow minute SEM observations of microstructure. These stress drops correspond to the stress relaxations in the specimen during the interrupting bending test for in situ SEM observations. Nevertheless, the flow curves exhibit a yielding and subsequent strain hardening behavior and agree well with the curve from uninterrupted bending tests conducted outside the SEM chamber. Low-magnification in situ SEIs obtained during the bending test are displayed in Figure 8. The specimen was uniformly deformed with an increasing punch stroke (displacement). For the specimens deformed at different displacements, the radius (R) of curvature was experimentally measured using the in situ observed SEIs (Figure 8). Note that the observed V-shaped area on the cross section of the specimen corresponds to the observed ion-polished surface by the argon-ion beam cross-section polisher (CP).

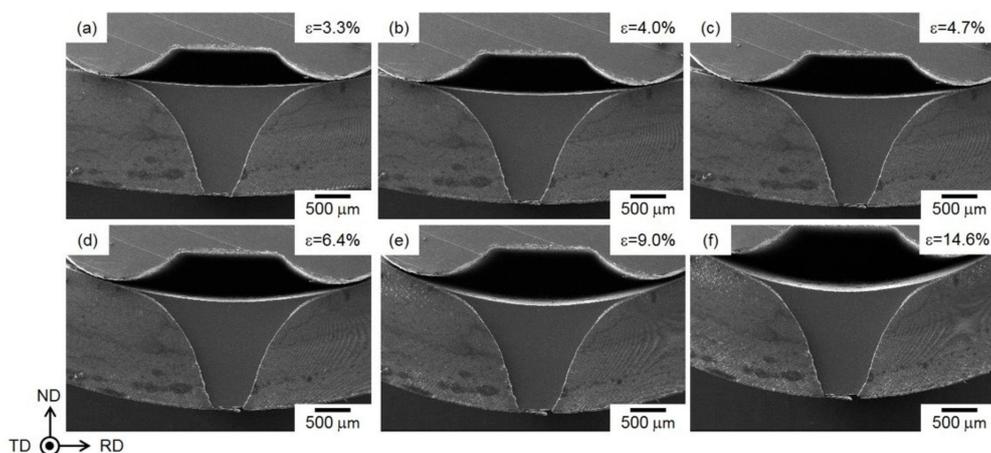
Figure 8. SEIs showing the bent steam-coated specimens, in which the applied strain was measured to be approximately (a) 3.3%, (b) 4.0%, (c) 4.7%, (d) 6.4%, (e) 9.0%, and (f) 14.6%.

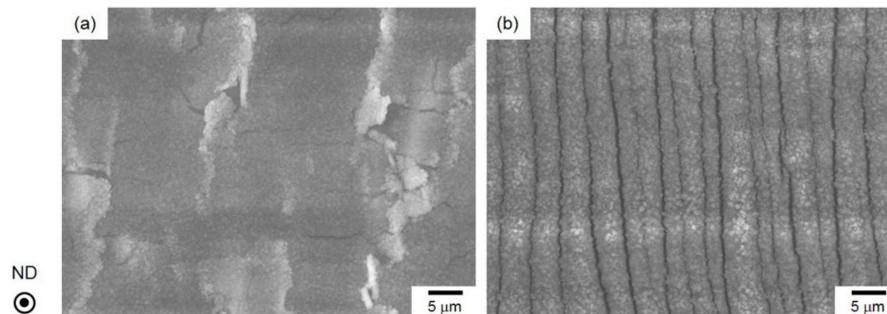
Figure 9 displays representative SEIs of the hydroxide film after the specimen was deformed at a large displacement of 10 mm.

Figure 9. Top-view SEIs showing the fracture morphology in the (a) compressively and (b) tensile-strained surfaces of hydroxide films on the steam-coated 6061 alloy sheet with the higher applied strain of 14.6%.

The applied strain was calculated as 14.6%. The fracture morphology depends on the strain state of the surface. Local delamination occurs for the hydroxide film on the compressively strained surface (Figure 9a), while parallel cracks with a spacing of approximately $2.5 \mu\text{m}$ were found on the tensile-strained surface (Figure 9b). These results correspond well to the previous study about fracture morphologies of hydroxide film on the Al-alloy sheet [12]. It is noteworthy that no peeled parts of a lower amorphous layer on the Al substrate were observed on either surface, suggesting the hydroxide film on the Al-alloy substrate has a higher cohesive strength.

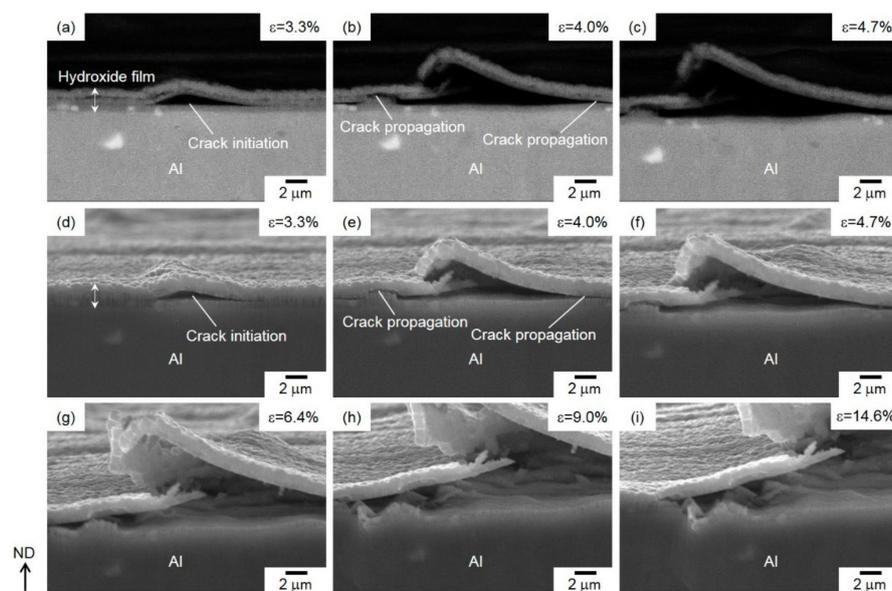
Figure 10 presents high-magnification, in situ observed backscattered images (BEIs) and SEIs, in order to show the cracking process of the hydroxide film on the compressively strained surface of the bent specimen.

Figure 10. (a–c) High-magnification backscattered images (BEIs) and (d–i) SEIs showing cracks initiated and propagated on the compressively strained surface of hydroxide films formed on Al-alloy sheet, under a growing macrostrain of approximately (a,d) 3.3%, (b,e) 4.0%, (c, f) 4.7%, (g) 6.4%, (h) 9.0%, and (i) 14.6%.

A selected area of the deformed specimen was captured using both BEI (Figure 10a–c) and SEI (Figure 10d–i) modes. These images show that a lateral crack was initiated inside the hydroxide film when the specimen was under a macroscopic strain of $\varepsilon = 3.3\%$ (Figure 10a,d). The BEI (Figure 10a) clearly demonstrates that the crack was initiated within the lower amorphous layer. This lateral crack propagated not only inside the amorphous layer but also along the interface between the lower amorphous layer and the upper γ -AlO(OH) layers (Figure 10b,e). In addition, note that the cracking process of hydroxide film was not affected by the second β -AlFeSi phase with bright contrast. The propagated lateral crack appeared to distort the hydroxide film, resulting in the fracture of the upper γ -AlO(OH) layer (Figure 10c,f) by applying a higher strain of $\varepsilon = 4.7\%$. The fracture process proceeded under further strain, leading to the delamination of the upper γ -AlO(OH) phase and top portions of the amorphous layer (Figure 10g–i). This result corresponds to the delamination of the hydroxide film that occurred locally along the surface normal (Figure 9a). For in situ SEM observation, on the other hand, it demonstrated that the lower amorphous layer did not peel off from the Al-alloy substrate even under a high applied strain of 14.6% (Figure 10i).

To confirm the speculated mechanism, the strain distribution around the hydroxide film was quantified by DIC analysis of the in situ observed SEM images showing the fracture process (as displayed in Figure 10). The results from the DIC analysis are summarized in Figure 12.

No cracks were observed inside the hydroxide film before the bending test (Figure 12a). At a low strain of 3.3%, one crack appeared in the outer γ -AlO(OH) layer, but there was none in the lower amorphous layer (Figure 12b). Further straining ($\varepsilon = 4.0\%$) led to crack initiation in the amorphous layer and the associated delamination of the γ -AlO(OH) layer (Figure 12c). In order to investigate the effect of concentrated strain on crack initiation, the strain distribution around the hydroxide film deformed at $\varepsilon = 3.3\%$ was quantified by DIC analyses. The visualized strain maps of ε_{xx} and ε_{yy} and the corresponding strain profiles are presented in Figure 12d–g, with the horizontal and vertical directions defined as x and y directions, respectively. In the distribution map of the ε_{xx} component (Figure 12d), negative values from -5% to -10% were found in all analyzed areas in the amorphous layer (Figure 12b). The strain profile in Figure 12e along a line across the amorphous layer (as indicated in Figure 12d) shows an almost constant strain of approximately -6% . These results obviously indicate a uniform compressive strain (along the x direction) applied by bending deformation. In contrast, the distribution of the ε_{yy} component in the hydroxide film was inhomogeneous: negative values of ε_{yy} (compressive strain) were found in the Al-alloy substrate, whereas positive values (tensile strain) were detected inside the amorphous layer (Figure 12f). In other words, the sign of ε_{yy} changes near the interface between Al-alloy substrate and the amorphous layer, as presented by the line profile of ε_{yy} strain in Figure 12g. Importantly, it was found that the compressive strain (along the surface normal) was applied in the Al-alloy substrate, whereas the tensile strain (along the surface normal) was localized at the neighbor amorphous layer on the compressively strained surface of specimens deformed by bending. The site of localized tensile strain corresponds well to that of crack initiation (Figure 12c). Thus, the variation of strain state around the amorphous layer could facilitate the opening of cracks near the amorphous layer/Al-alloy interface. Since the Al substrate is more ductile than the adjacent amorphous layer, cracks are preferentially initiated inside the latter. This varied strain state around the hydroxide film might be responsible for a difference in elastic deformation between the amorphous phase and α -Al (fcc) matrix. Overall, the present strain-distribution analysis demonstrates that the concentrated tensile strain along the surface normal (positive ε_{yy}) at some parts of the amorphous layer contributed to crack initiation in this layer (as presented in Figure 10).

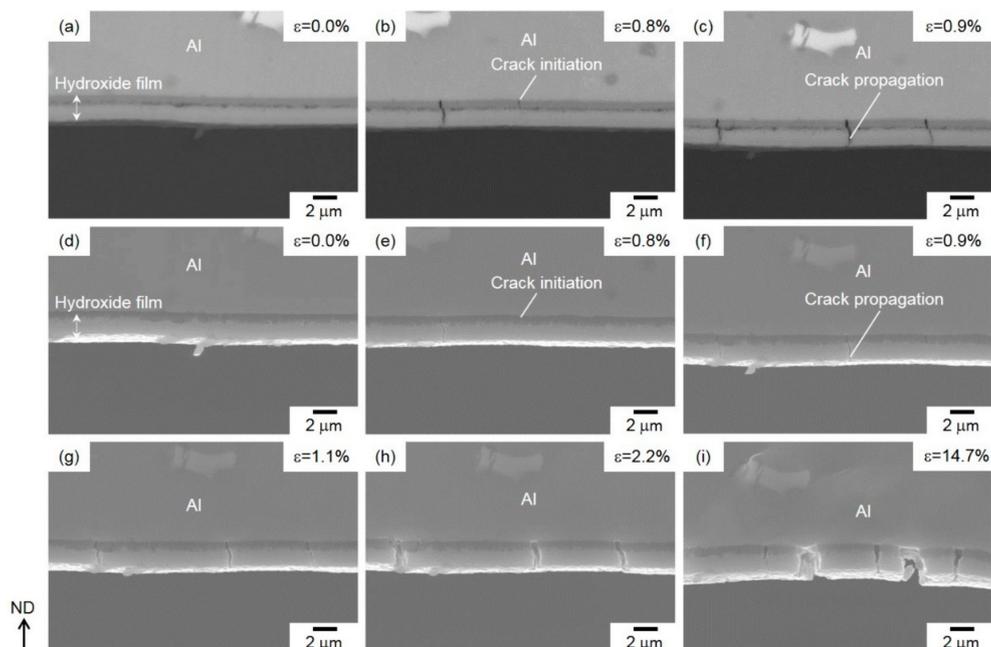
Figure 11 displays the high-magnification in situ observed BEIs (Figure 11a–c) and SEIs (Figure 11d–i) in the hydroxide film on the tensile-strained surface of the bent specimen.

Figure 11. (a–c) High-magnification BEIs and (d–i) SEIs showing cracks initiated and propagated in the tensile-strained surface of hydroxide films on the Al-alloy sheet with increasing applied macrostrains of approximately (a,d) 0.0%, (b,e) 0.8%, (c, f) 0.9%, (g) 1.1%, (h) 2.2%, and (i) 14.7%.

No cracks were found inside the hydroxide film before the bending test (Figure 11a,d), while at a relatively low $\varepsilon = 0.8\%$, a couple of vertical cracks were initiated in the lower amorphous layer (Figure 11b,e). The initiated vertical cracks penetrate the upper γ -AlO(OH)-phase layer along the surface normal (Figure 11c,f). Under further tensile loading, different vertical cracks were initiated and passed through both the upper and lower layers (Figure 11g). The opening of the propagated cracks was clearly observed by further straining (Figure 11h,i), resulting in a constant spacing of the cracks observed along the surface normal (Figure 9b). These vertical cracks were arrested around the Al-alloy substrate, where removal of a lower amorphous layer on the Al substrate was not found, even on the highly strained surface (Figure 11i), implying a high cohesive strength of the lower amorphous layer on the Al-alloy substrate.

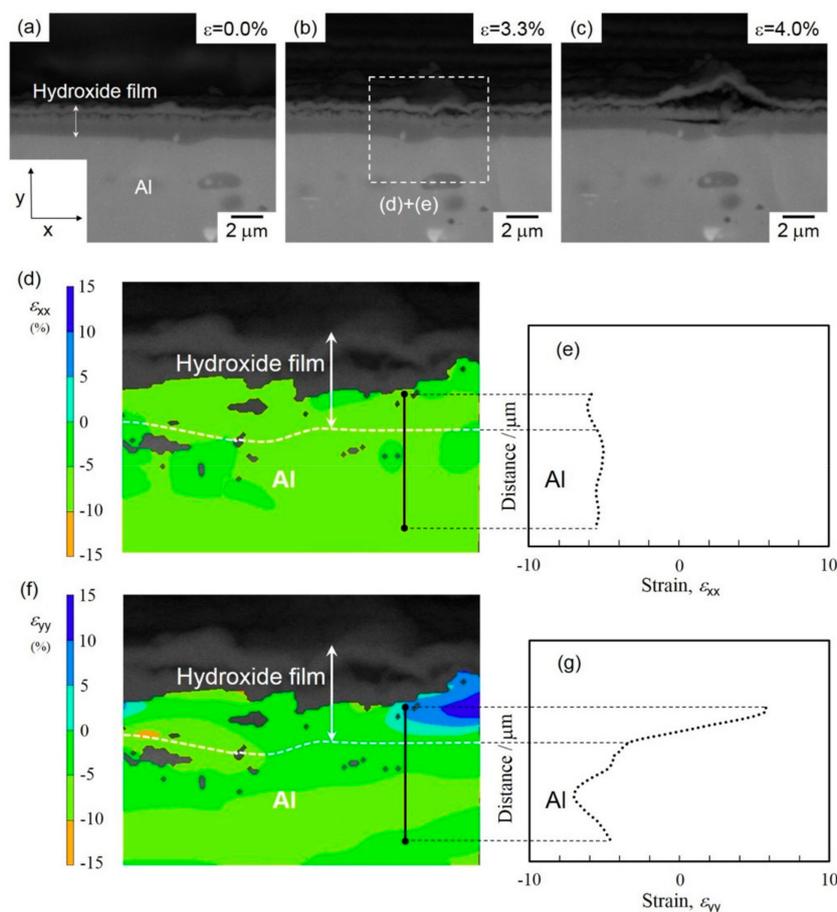
Figure 12. (a–c) High-magnification BEIs showing cracks initiated and propagated in the compressively strained surface of hydroxide films on the Al-alloy sheet under an increasing compressive strain. The applied macrostrain was calculated to be approximately (a) 0.0%, (b) 3.3%, and (c) 4.0%. The corresponding (d,f) strain distribution maps for the selected area in (b) and (e,g) strain-distribution profiles for the selected line containing the initiated cracks in hydroxide film of (d,e) ε_{xx} and (f,g) ε_{yy} (obtained by digital image correlation (DIC) analysis) along the x and y directions.
