Article

Exploitation Characteristics of Teeth Flanks of Gears Regenerated by Three Hard-Facing Procedures

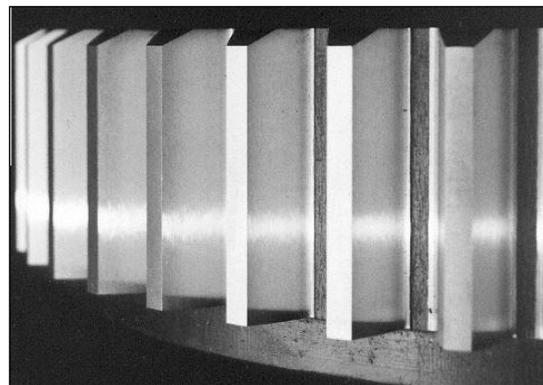
Figure 1. Newly manufactured gear.

This research did not deal with the regeneration of already damaged gears taken out of machine systems that had been in use for a certain period. On the contrary, new gears were made, which were then intentionally damaged and then regenerated. Thus, all the tested gears were made of the same material (steel for cementation, 20MnCr5, whose chemical composition is shown in Table 1) and belonged to one batch. In addition, they were all machined on the same machines with the same machining modes. The gears made this way, Figure 1, had the characteristics presented in Table 2.

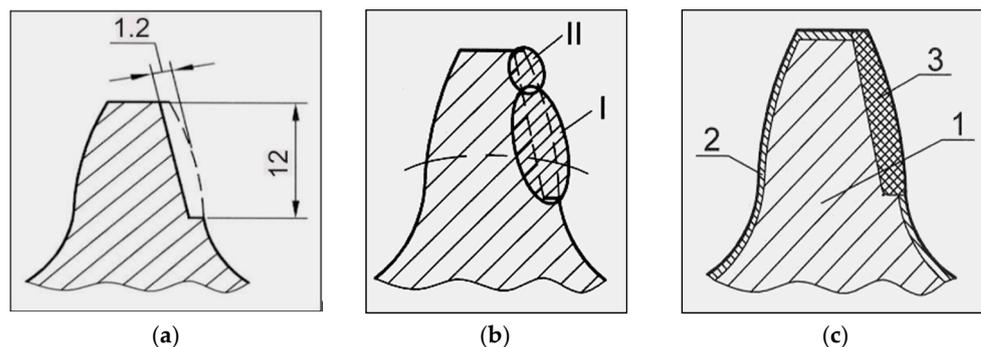
Figure 2. Schematic presentation of the tooth: (a) prepared for hard-facing; (b) hard-faced in two passes (I—the first pass, II—the second pass); (c) cross-section after the hard-facing and machining: 1—tooth core, 2—cemented layer, 3—hard-faced portion.

Hard-facing of teeth was done in two passes. In the first pass (I), the tooth base and part of the head were hard-faced, while, after removing the slag, in the second pass (II), the remaining portion of the tooth head was hard-faced. The appearance of the tooth after the hard-facing, heat treatment and machining is shown in Figure 2c. During the hard-facing, it was taken into account that the thickness of the weld must be increased by the size of the additions for the intended subsequent machining. The appearance of the gear regenerated by the hard-facing is shown in Figure 3.

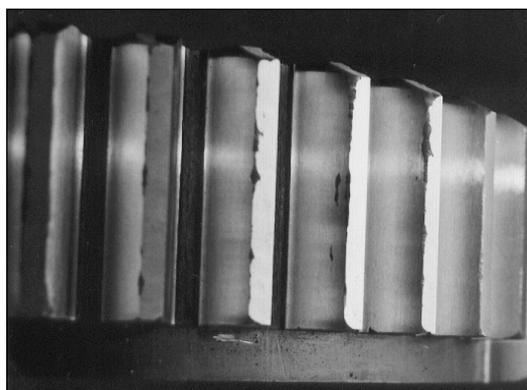
Figure 3. Appearance of the tooth regenerated by hard-facing.

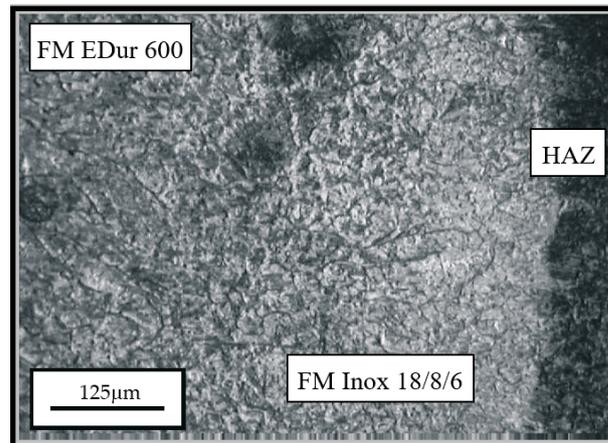
Figure 4. Appearance of microstructure of the hard-faced sample obtained by the two filler metals combination: FM EDur 600—left, FM Inox 18/8/6—middle; HAZ—right.

The hard-faced layers’ microstructure, obtained by the combination of filler metals (Inox 18/8/6 + EDur 600), is presented in Figures 4 and 5. On the left-hand side of Figure 4, one can notice the needle-like dendritic structure of the hard-faced layer executed by the “hard” electrode EDur 600. In the central area of the figure, one can see the weaker exhibited dendritic structure, which was obtained by hard-facing with the Inox 18/8/6 filler metal, while in the right-hand portion is the heat-affected zone. The joining line between the FM Inox 18/8/6 layer and the HAZ of the base metal is relatively clearly visible, and it is quite uneven. One can notice the mixing of the two materials within the HAZ, Figure 5.

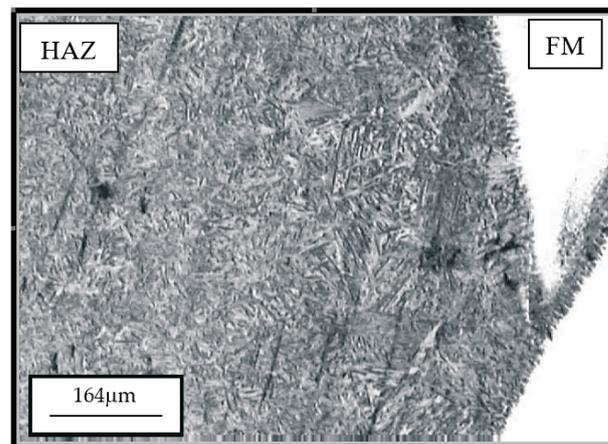
Figure 5. Appearance of microstructure of the hard-faced sample obtained by the two filler metals combination: transition from the HAZ (left) to the FM (right).

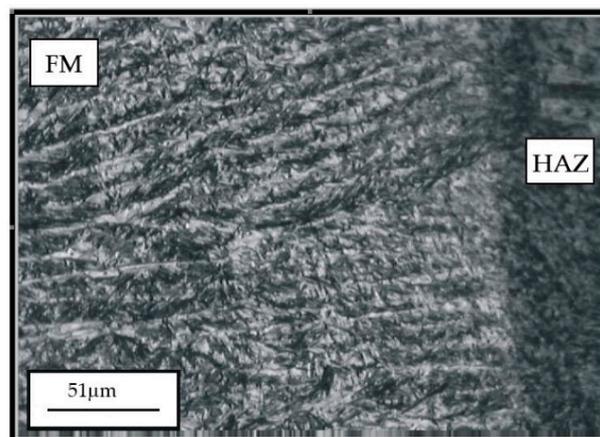
Figure 6. Appearance of microstructure of the hard-faced sample obtained by the Castolin 2 filler metal at the transition between the hard-faced layer and the heat-affected zone.

Appearance of microstructure of the hard-faced sample obtained by the Castolin 2 filler metal is presented in Figures 6 and 7, while the microstructure obtained by hard-facing with the UTP 670 filler metal is given in Figure 8.

According to Figures 6 and 7, hard-facing with filler metal Castolin 2 produced a prominent dendritic structure of the hard-faced layer. The average width of the dendritic needles was 10 to 15 μm, which is very convenient. However, the dendrites were characterized by inhomogeneity, which was proven by the various level of surface etching. The carbide phase (primary carbides) was present in the hard-faced layer, as well, mainly extruded along the grain boundaries. The dendrites' growth direction was mainly perpendicular to the hard-faced layer surface.

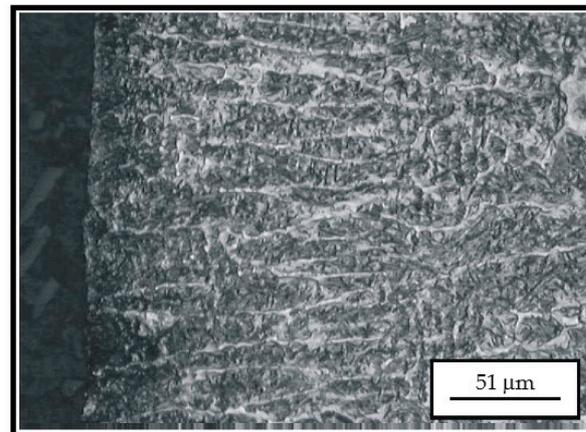
Figure 7. Appearance of microstructure of the hard-faced sample obtained by the Castolin 2 filler metal.

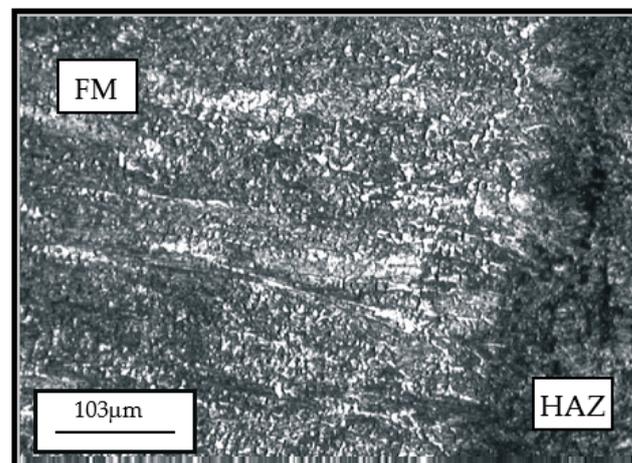
Figure 8. Appearance of microstructure of the hard-faced sample obtained by the UTP 670 (brighter areas) and the heat-affected zone of the base metal (darker areas).

The tooth hard-faced with the UTP 670 filler metal possessed a medium-coarse structure with an individual dendrite width of 30 to 80 μm. A high share of the carbide phase was present in the structure, which can be seen as the brighter areas in Figure 8. Carbides were extruded along the grain boundaries; however, the largest portion was in the grains themselves.

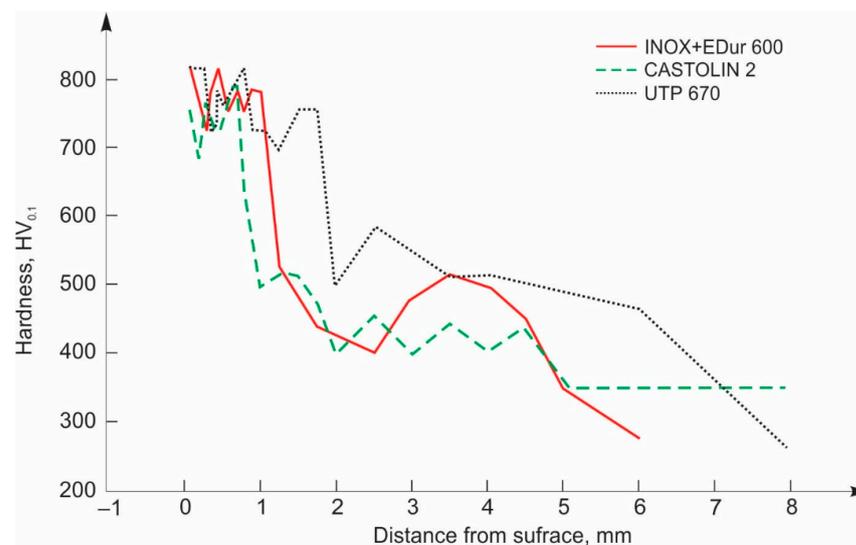
Figure 9. Microhardness distribution of samples regenerated by the hard filler metals.

The microhardness was measured along the cross-section of individual teeth, by the Vickers method (HV_{0.1}) with a load force of 1 N and indentation time of 15 s. Results are presented in Tables 8–10 and Figure 9.

If one analyzes the hardness distribution of the hard-faced gears, it can be unequivocally confirmed that better properties of hardness in the surface layers of teeth were achieved by application of the hard-facing. The results show that hardness at the teeth surface has high values of about 800 HV, while it decreases toward the bulk of the teeth (Figure 9). At the beginning (up to the depth of 1 mm) that decrease is rather small, almost nonexistent, for all the applied filler metals. Then, the sudden drop in hardness begins, down to about 400 HV, primarily for electrodes Inox + EDur and Castolin. For the third filler metal (UTP 670), the hardness drop occurs later (at depth of about 2 mm) and goes down to 500 HV. The decreasing trend then continues and remains at the similar rate for all the three filler metals, moving toward the base metal, where the hardness becomes uniform. These results are confirmed by the microstructure recordings, which show that the structure is coarse-grained, needle-like and dendritic, characterized by the high hardness [30]. By increasing the surface hardness, the teeth's resistance to wear increases, as well as their service life [13]. The typical damages that appear on such surfaces are the appearance of initial holes and pitting on the teeth surfaces, which cause the irregular operation of gears. The appearance of pitting can be delayed by increasing the surface layers' hardness [26]. In addition, it should be emphasized that the initial damage is the most likely to appear on the joint of the two electrode passes during the hard-facing. It is thus extremely important that the layers are well welded and joined to each other, so that no point could exist that could later act as a stress concentrator.
