The Corrosion Susceptibility of 304L Stainless Steel Exposed to Crevice Environments

Abstract: The present study focuses on the corrosion behavior of 304L stainless steel in crevice corrosion environments. The specimen with a salt deposit of 0.1 g/m^2 was assembled with a crevice former made of Poly-tetra fluoroethylene (PTFE) to make a test device. The assembled test devices were kept at the ambient temperature of 45°C in combination with a relative humidity of 45%, 55%, and 70%. After testing for 5000 h, the corroded area of the specimen exposed to 70% humidity was three times larger than that subjected to 45% humidity. For the specimen sustaining a tensile force, the crack growth rate was approximately 1.4 mm/year at the stress level of 300 MPa in a crevice corrosion environment with 0.1 g/m^2 of sea salt deposited on the surface. The small portion of intergranular cracking occurred at the surface due to the existed strain on the surface. As cracks propagate in a grain, the grain undergoes a greater localized deformation, and some secondary cracks would develop inside the grain; transgranular cracking was vigorous due to the path corrosion that nucleated at the slip steps.

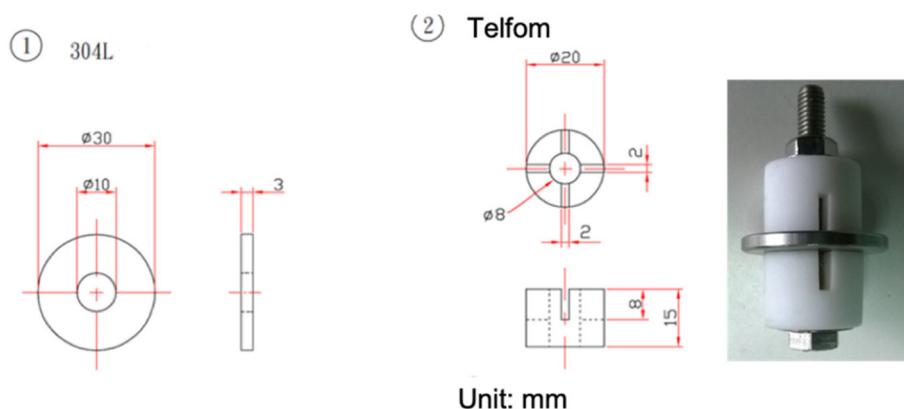
Figure 1. The dimensions of: (1) the SS 304L specimen and (2) crevice former device.

The compositions of commercial 304L (OLARRA S.A.) stainless steel plates are listed in Table 1. There were two kinds of specimens used in this work, which were mechanically polished with 2400-grit sandpaper and washed with distilled water. After the specimens' surfaces were clean, they were firstly sprayed with sea salt mist, and the sea salt composite is revealed in Table 2. Then, the specimens were dried on a hot plate at the temperature of 60 °C for 10 min to leave residuals of 0.1 g/m², 1 g/m², and 4 g/m² of salts on the specimens. Figures 1 and 2 show the specimens' dimensions and set-up of the crevice corrosion test and tensile test, respectively. Then, the crevice former of Poly-tetra fluoroethylene (PTFE)

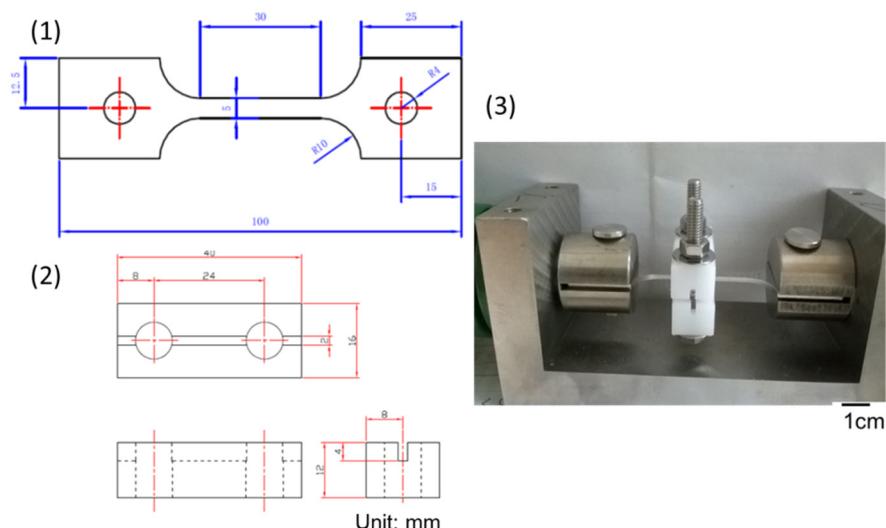
Figure 2. The dimensions of the SS 304L tensile test specimen and crevice former under tensile stress: (1) SS 304L specimen, (2) crevice former device, and (3) photo of the specimen set-up.

was fixed on the specimens' surfaces with an M6 screw by applying a torque of 1.12 N·m (10 pound-inch) to form a crevice configuration. For the tensile test specimen, a jig was used to apply the load, as shown in Figure 2. The tensile stress loading apparatuses were acknowledged from the results published by Tokiwai et al. [6]. Before the specimen was set up on the jig, the tensile force was applied by a torque wrench and measured by a load cell at the end of the jig. The torque was recorded when the tensile force reached the scheduled stress. Accordingly, the tensile stress applied to the specimen was adjusted by using the torque wrench with the pre-set torque. The test environment chambers were kept at a combination of the ambient temperature of 45 °C and relative humidity of 45%, 55% a and 70%, respectively, for 400, 1500, and 5000 h each.

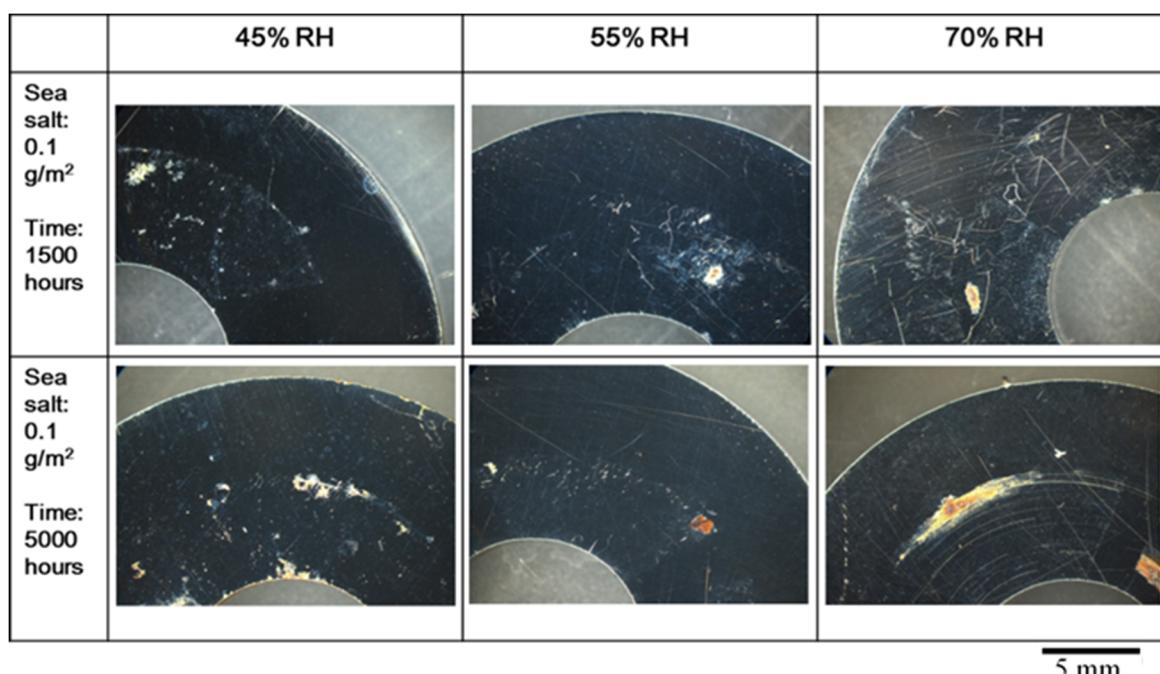
Figure 3. The specimens with 0.1 g/m² of sea salt deposited on the surface were tested at different relative humidity levels and temperatures of 45 °C.

Figures 3 and 4 show the round specimens after testing at 45 °C in the crevice corrosive environments of different humidity levels for 1500 h and 5000 h. They were sprayed with 0.1 g/m² and 1 g/m² of sea salt onto their surface, respectively. The corrosion area increased with an increase in the relative humidity, the amount of salt, and test time. The increase in humidity will increase the wetting of the salt to attack the passive films of stainless steel. For the specimens with 0.1 g/m² of sea salt on the surface, SCC was not perceived and the pitting corrosion mostly lead to the growth of a single pit.

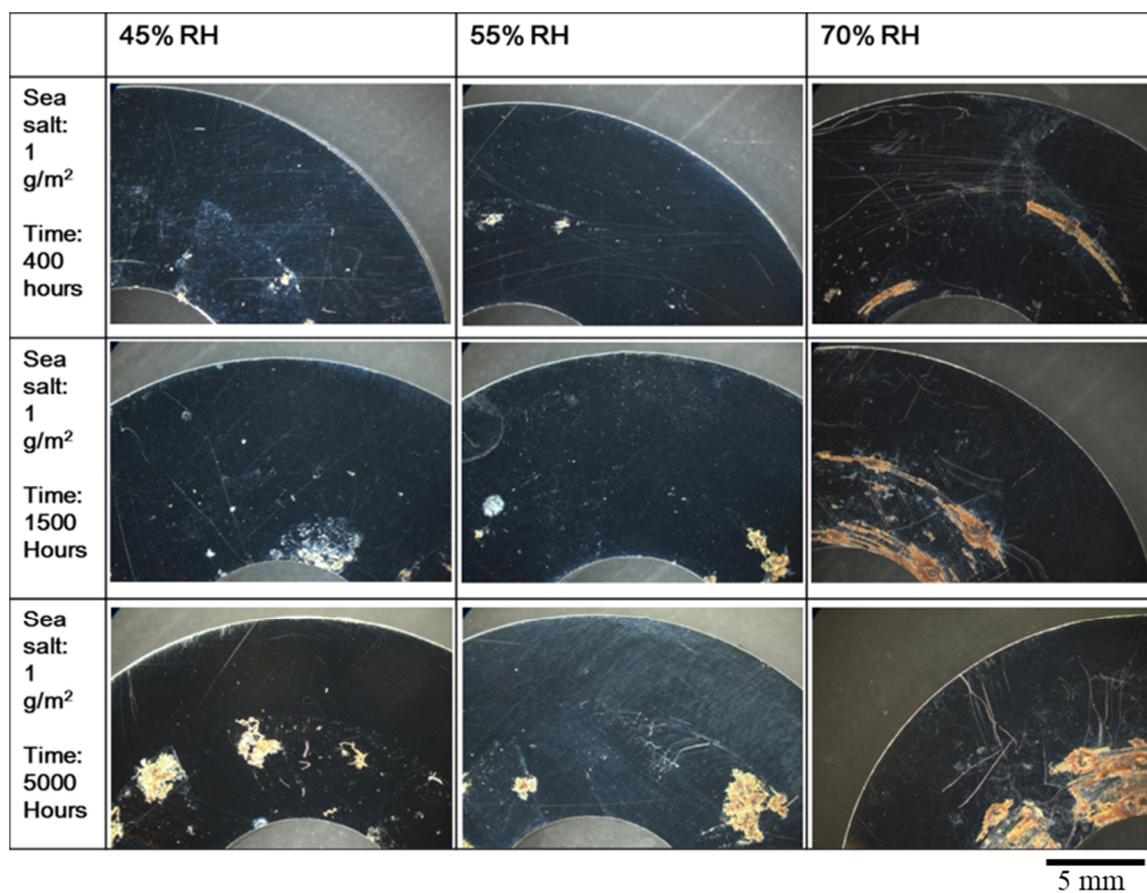
Figure 4. The round specimens with 1 g/m^2 of sea salt deposited on the surface were tested at different relative humidity levels of 45%, 55%, and 70%, and a temperature of 45°C .

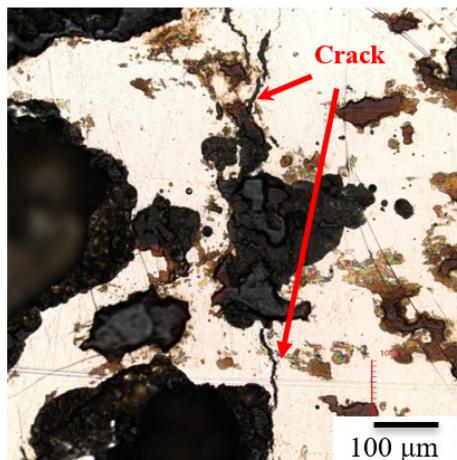
Figure 5. The round specimens show cracks after crevice corrosion testing at the relative humidity of 70% for 5000 h with 1 g/m^2 of sea salt deposited on the surface.

The SCC developed after crevice tests for 5000 h, with which an amount of 1 g/m² of sea salt was deposited on the specimen surface at a relative humidity of 70%, as shown in Figure 5. In addition, corrosion pits, as well as corrosion products, were observed beneath the former crevice; no notable corrosion pit or corrosion products were shown in the uncovered area. This suggests that the crevice increased the corrosion rate. For the corrosion specimens tested for 5000 h, the corroded area of the specimen in 70% humidity was 3 times higher than that in 45% humidity.

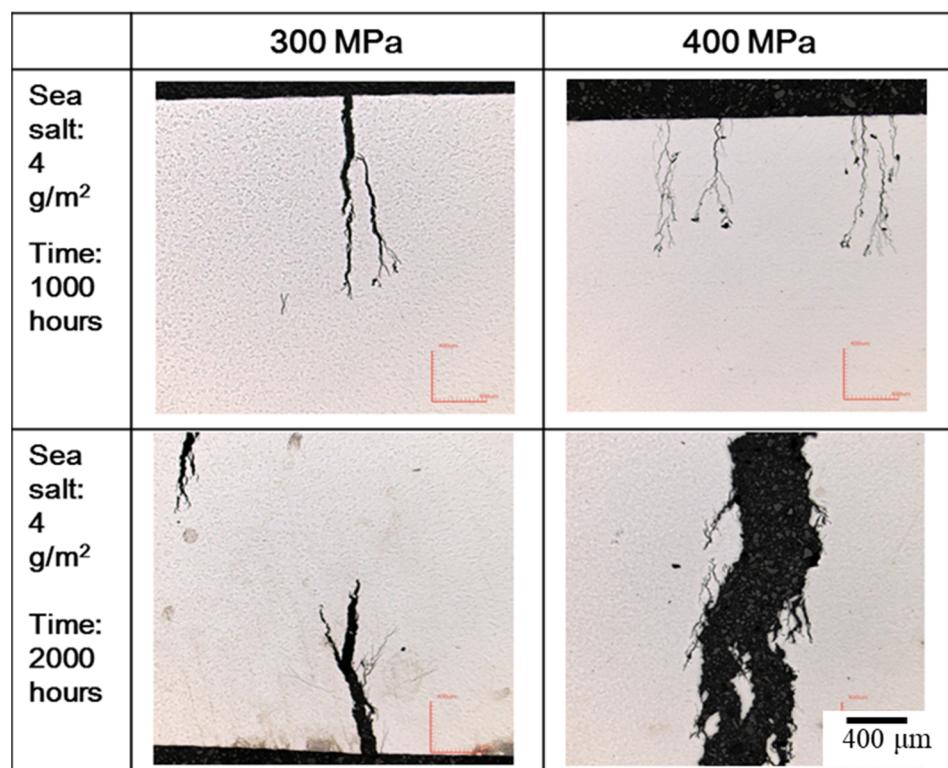
Figure 6. The crevice corrosion specimens with 4 g/m^2 of sea salt deposited on the surface were subjected to tensile stresses of 300 MPa and 400 MPa at a temperature of 45°C .

Figures 6 and 7 reveal the crevice corrosion specimens after being tested under tensile stress at 45°C and 45% relative humidity. The specimens were sprayed with 4 g/m^2 and 0.1 g/m^2 of sea salt on their surfaces, respectively. It was expected that an increase in the tensile stress would increase the possibility of SCC, in terms of crack numbers and crack size. For the specimen deposited with 4 g/m^2 of salt, cracks were found on all the specimens, and more cracks developed as the applied stress was increased; for the salt deposit of 0.1 g/m^2 ,

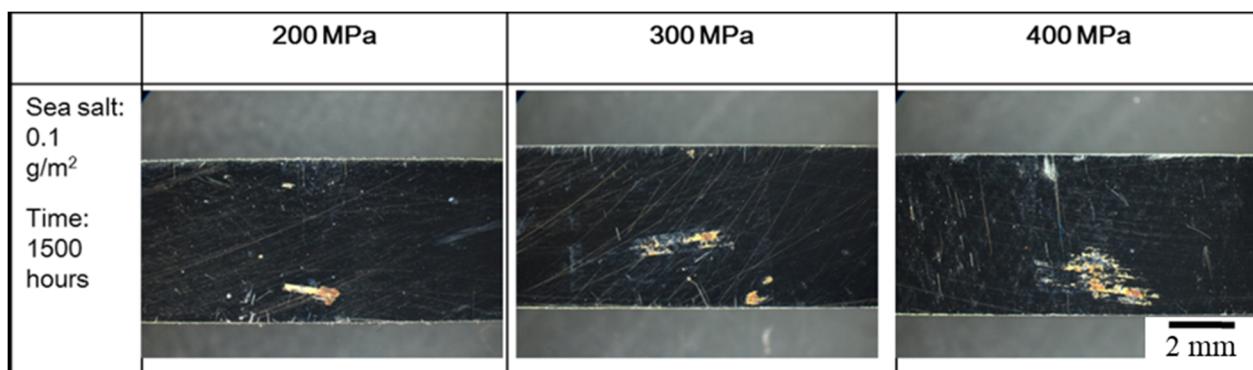
Figure 7. The crevice corrosion specimens with 0.1 g/m^2 of sea salt deposited on the surface were subjected to tensile stresses of 200 MPa, 300 MPa, and 400 MPa at a temperature of 45°C for 1500 h for each testing condition.

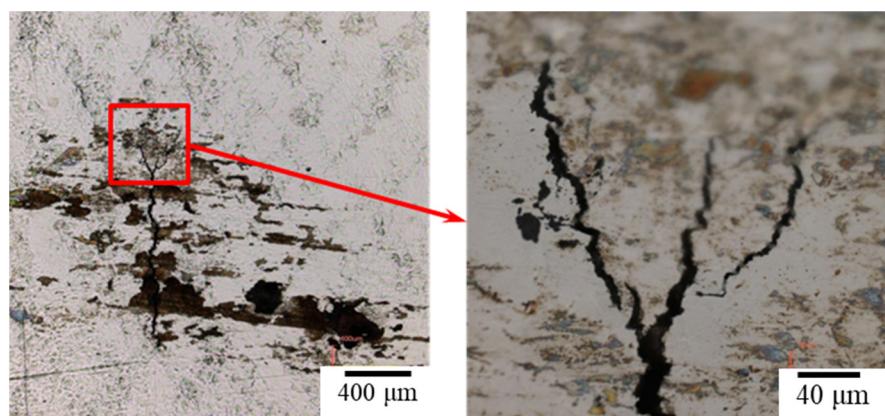
Figure 8. The crevice corrosion specimen with 0.1 g/m^2 of sea salt deposited on the surface subjected to tensile stresses of 400 MPa reveals cracks after 1500 h of testing at 45°C and a relative humidity of 45%.

SCC was not observed at the low stress of 200 MPa for the 1000 h crevice corrosion test. As the stress was increased, small cracks were found on the specimens subjected to the applied stress of 400 and 300 MPa, as shown in Figures 8 and 9, respectively. For the stress level of 400 MPa, cracks were obviously observed for the specimens with high deposits of salt. For the specimens sprayed with a salt deposit of 0.1 g/m^2 , one crack was observed on the surface. For the test at the stress level of 300 MPa, the crack initiated from the surface defect. The length of the crack was less than $400 \mu\text{m}$, as shown in Figure 9, and the depth was about $240 \mu\text{m}$, as shown in Figure 10. Therefore, the crack growth rate was about $0.16 \mu\text{m/hour}$, approximately 1.4 mm/year . The surface defects of the specimen were confirmed to be sulfide by EDX, as shown in Figures 11 and 12. The sulfide near the surface delaminates the passive film and increases the acidity, owing to the dissolution of sulfide [19,20]. As sea salt contains chloride and thiosulphate, the EDX results revealed the presence of sulfide and chloride, which produced acidic conditions. They supplement the stainless steel matrix in the process of corrosion. The chromium content increased on the corrosion surface, owing to the fact that the constant hydrolysis of chromium hydroxide is significantly different from that of iron and the other metal hydroxide [21]. The chloride and sulfide ions migrated into the crevice and conversely other cations not involved in the hydrolysis reactions migrated into the bulk solution environment. As a consequence, the EDX results presented more chromium at the surrounding fissure than the matrix, and a small amount of sulfide and chloride remained at the fissure.

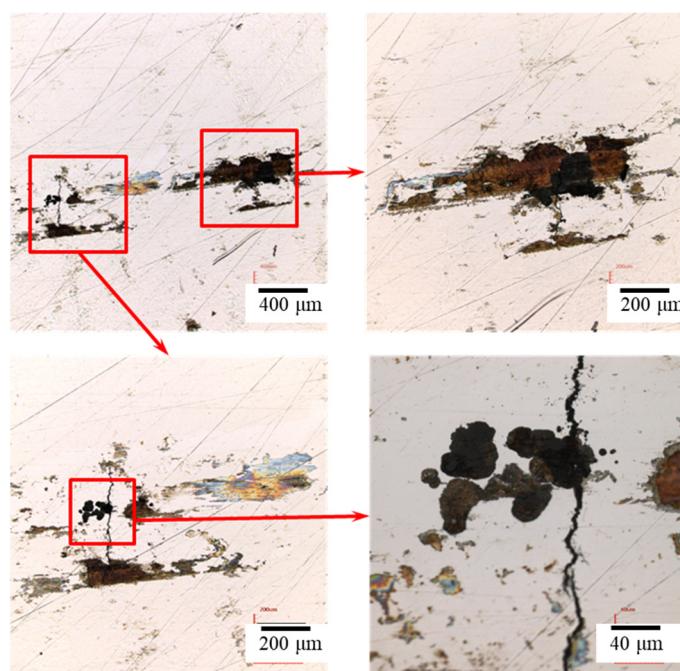
Figure 9. The crevice corrosion specimen with 0.1 g/m^2 of sea salt deposited on the surface subjected to tensile stresses of 300 MPa reveals cracks after 1500 h of testing at 45°C and a relative humidity of 45%.

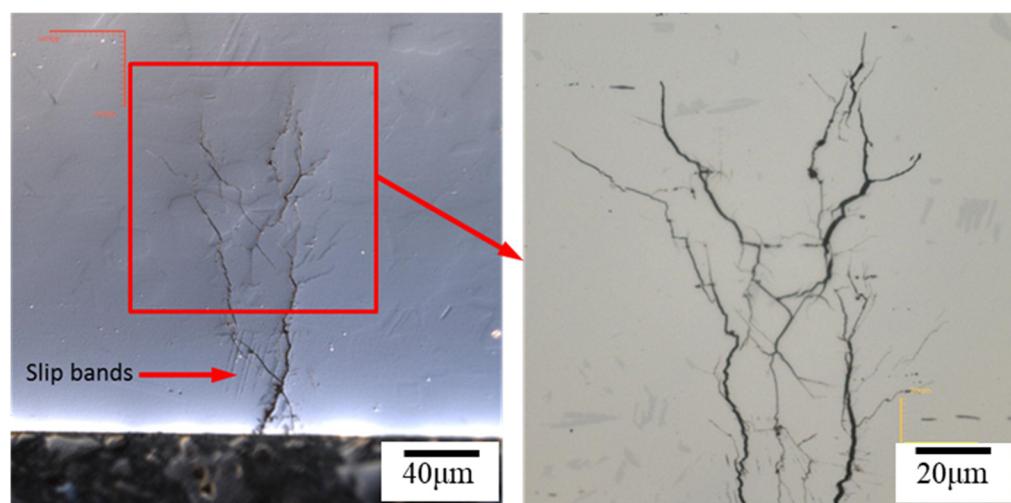
Figure 10. The cross-section of the specimen with 0.1 g/m^2 of sea salt deposited on the surface reveals cracks after testing at 300 MPa tensile stress for 1500 h of testing at 45°C and a relative humidity of 45%.

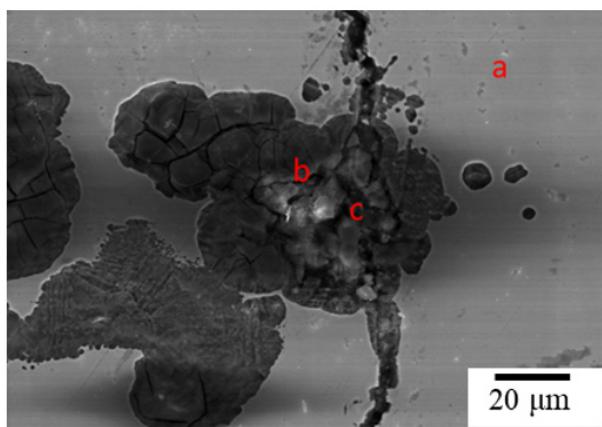
Cr	Ni	Cl	S
a	18.3	8.7		
b	30.2	2.7	7.55	0.95
c	34.5	6.1	5.68	0.79

Figure 11. The inclusions in the cracks were examined by the EDX technique.

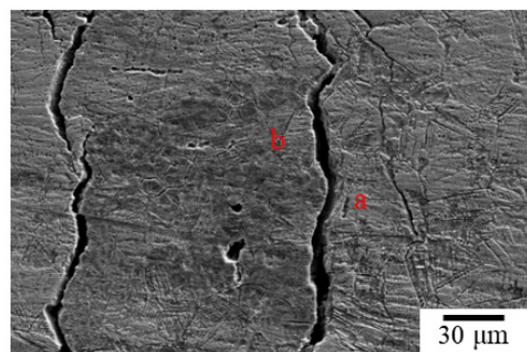
O	Si	S	Cr	Mn	Fe	Ni
a		0.62	0.85	25.8	1.85	63.2	7.7
b	28.5	0.63	1.22	24.2	0.95	39.76	4.6

Figure 12. The oxide films at the specimen surface around the cracks were examined by the EDX technique.

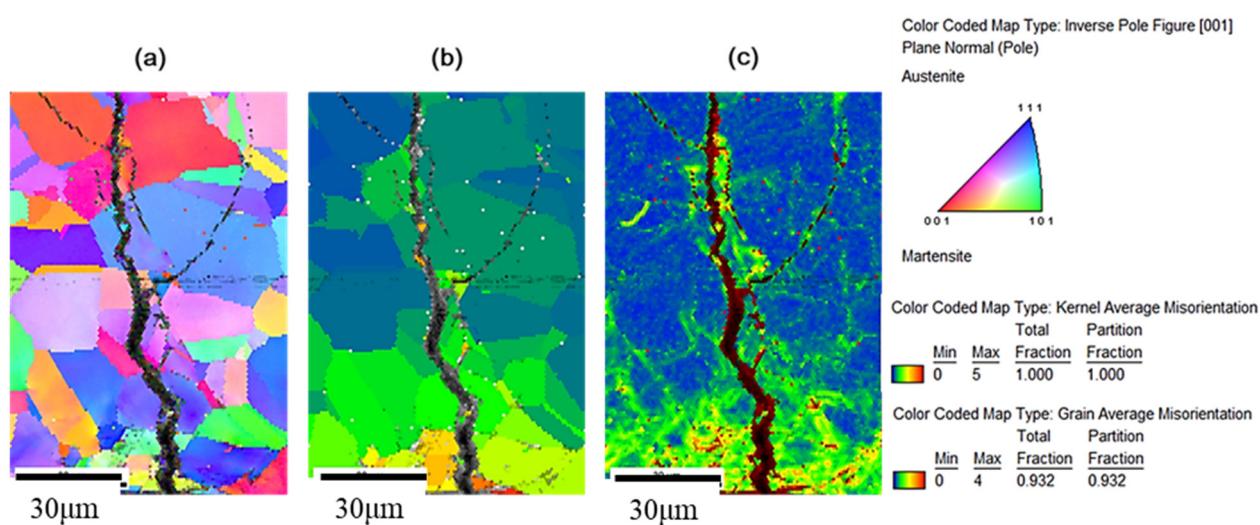
Figure 13. (a) Crystal orientation, (b) GAM, and (c) KAM maps by EBSD analysis of the specimen with 4 g/m^2 of sea salt deposited on the surface after testing at 300 MPa tensile stress for 1500 h at 45°C and 45% relative humidity.

Figures 13 and 14 show the crystal orientation map of inverse pole figure (IPF) coloring, the grain average misorientation (GAM) map, and the kernel average misorientation (KAM) map by electron backscatter diffraction (EBSD) analysis. Crystal orientation maps show that the cracks are mainly transgranular. The GAM maps illustrate the localized deformation of the grain. This suggests that the strain energy is stored in the grains containing cracks. In addition, the surface shows a higher strain and it is possible that the strain gradually decreases with increasing the distance from the specimen's surface, as shown in Figure 13. As the crack develops, as shown in Figure 14, the local electrochemical activity within the grain dominates the crack growth process, and the cracks branch inside the grain and then discontinue. The crack tip absorbs hydrogen and enhances the local plasticity of the grain, which increases the resistance of the dislocation movement [10]. Furthermore, discontinuous micro-cracks enhance the effective stress intensity and crack propagation [22]. In Figures 13 and 14, the kernel average misorientation (KAM) maps show that the strain occurs within a short distance around cracks. In addition, the GAM maps show that the cracks are mainly transgranular, with a small portion of cracks along the grain boundary.

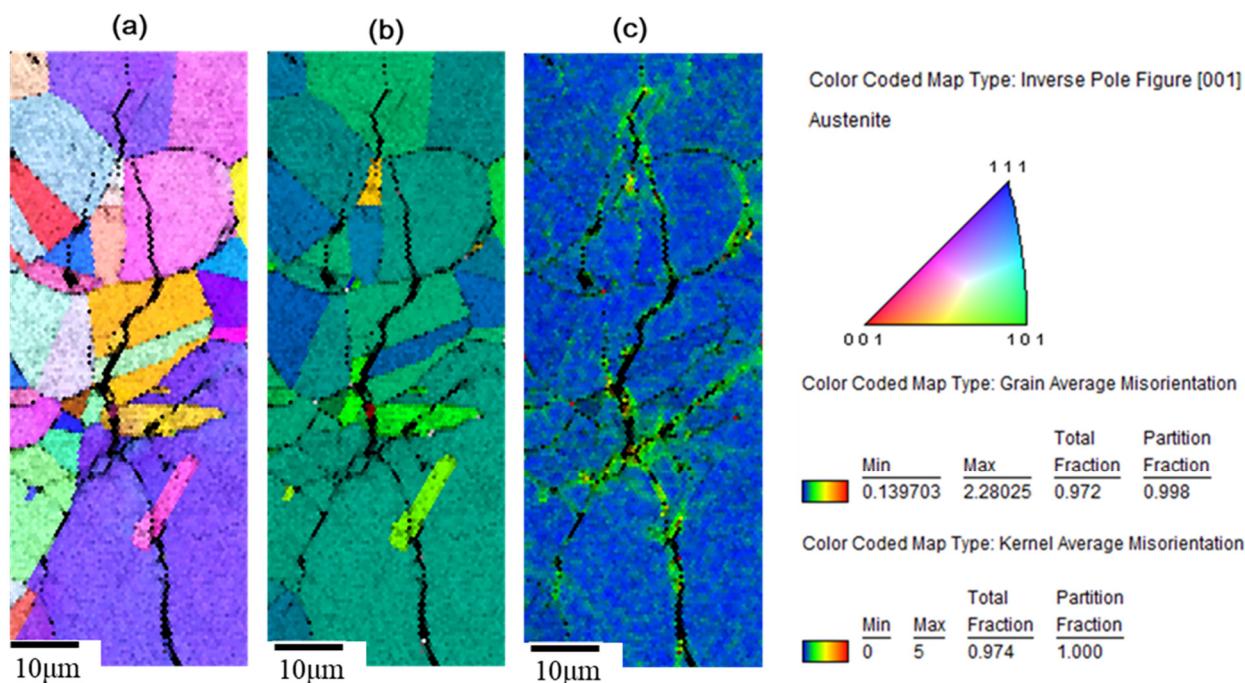
Figure 14. (a) Crystal orientation, (b) GAM, and (c) KAM maps by EBSD analysis of the specimen, as shown in Figure 11.

The hydrogen-enhanced localized plasticity mechanism and adsorption-induced dislocation emission were proposed [9,10,15]. The results of this study supplement the mechanism of hydrogen embrittlement that suggests that the deformation occurs within the grain containing a crack tip, since hydrogen is generated at crack tips in a moist environment. In addition, the mechanism for intergranular cracking might be the formation of martensite on the grain boundary, while transgranular cracking takes place by propagating cracks nucleated at the slip steps by dissolution [12]. As shown on the KAM maps, a higher strain exists on the surface, which opts to form martensite on the surface [16]; the small portion of intergranular cracking mainly occurred at the surface due to grain boundary martensite induced by hydrogen embrittlement. As the crack developed, the transgranular cracking became more vigorous due to the path corrosion that nucleated at the slip steps by dissolution [12], or by the absorption of hydrogen into the austenite [18]. As shown in Figures 10 and 14, a heavy attack along the slip lines nearby the cracks, which is evidence that heavy plastic deformation developed in this region.
