# Investigation of the Mechanical Behaviors and Damage Mechanism of C/C Composites Impacted by High-Velocity Jets

**Abstract:** Carbon/Carbon (C/C) composites exhibit excellent mechanical properties at high temperatures, making them widely used in aerospace, such as the leading edges of spaceplane wings and the nose cones of hypersonic aircraft. However, damage caused by rain erosion to C/C composites affects their mechanical properties and poses significant challenges during operational service periods. A jet impingement test platform was employed to conduct single and multiple water-jet erosion tests on three-dimensional orthogonal C/C composite materials and to investigate the residual mechanical properties of the specimens after jet impact. The damage was characterized using optical microscopy, scanning electron microscopy, and X-ray computed tomography. The results showed that the damage types of the C/C composite materials under water-jet impingement included fiber bundle fracturing, delamination, and debonding. The extent of erosion damage was positively correlated with the jet velocity and diameter. The changes in the multi-jet damage indicated a cumulative expansion proce

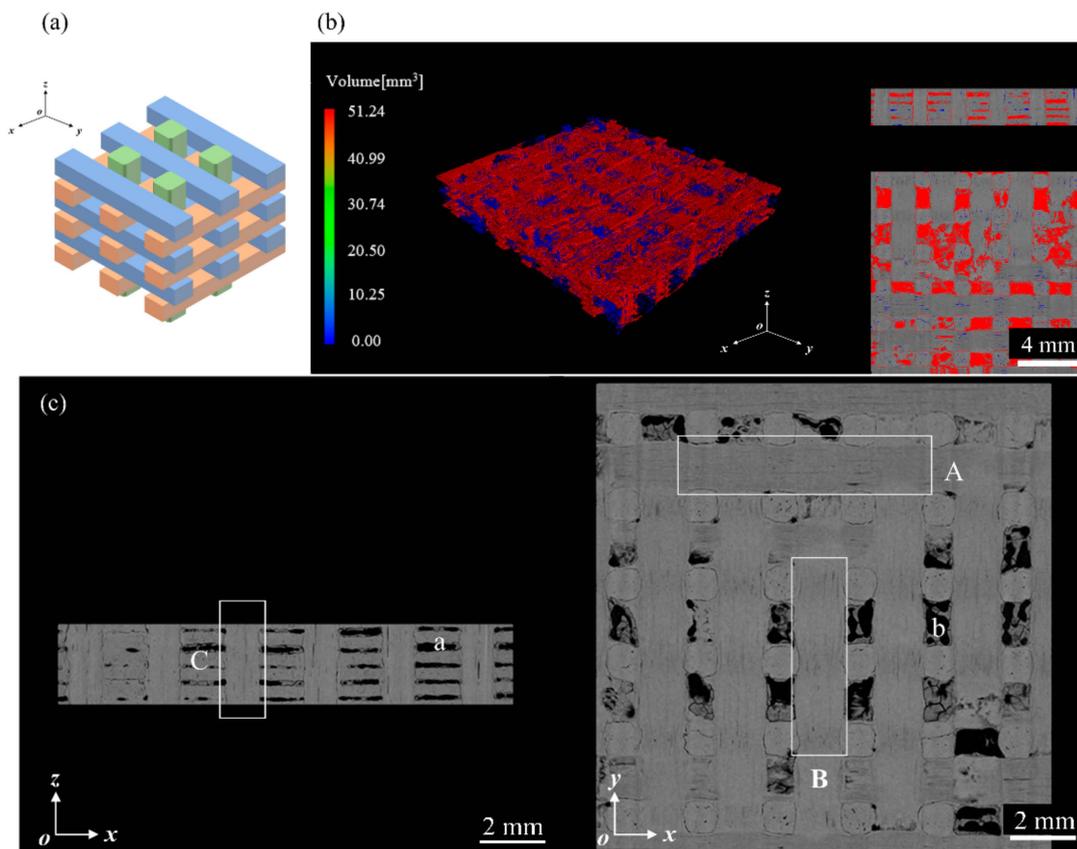
The material studied in this experiment was a composite with a three-dimensional orthogonal structure [32], reinforced with C fibers, and had a matrix composed of pyrolytic carbon. As depicted in Figure 1a, the C fibers were arranged in bundles along the  $x$ ,  $y$ , and  $z$  directions in an orthogonal distribution, whereas the matrix material, along with other fillers, occupied the voids.

**Figure 1.** Internal characterization of C/C composite materials: (a) three-dimensional orthogonal fiber schematic diagram; (b) distribution of material voids; (c) X-CT scan of the material structure.

X-ray computed tomography (X-CT) was used to analyze the structure of the materials. Based on the images depicted in Figure 1c, points A, B, and C correspond to the C fiber bundles in three different directions. The  $z$ -direction fiber bundles were uniformly dispersed on the  $xz$ -plane, and the  $x$ - and  $y$ -direction fiber bundles were arranged at right angles to each other on the  $xy$ -plane. The fiber bundle configuration was filled with a pyrolytic carbon matrix; however, some voids were present (Figure 1c). Such defects significantly affect the ability of a material to withstand rain erosion. The interior cavities of the samples were examined using X-CT imaging, as shown in Figure 1b. Determination of the void volume resulted in a material porosity of 10.34%.

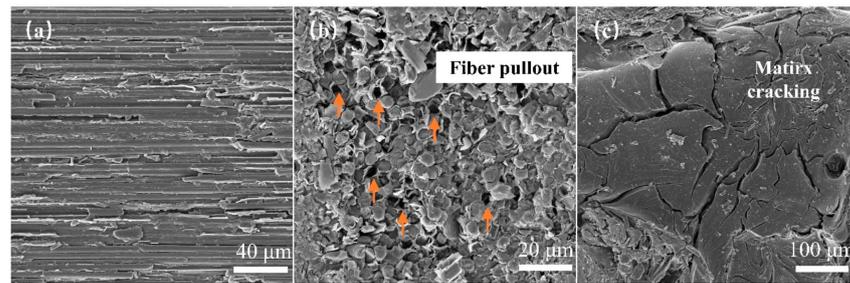
Surface defects in the material were observed at the microscopic level via scanning electron microscopy (SEM, TM4000Plus, Hitachi, Tokyo, Japan), with an EHT value of 10.00 kV and a WD value of 30.8 mm. As shown in Figure 2a, the surface of the material exhibited uneven fiber bundle areas with significant roughness. As shown in Figure 2b, a few debonding flaws were observed between the fibers and the matrix in the  $z$ -directional fiber bundles, causing fiber pull-out phenomena. Additionally, matrix cracking defects were observed in the samples (Figure 2c).

**Figure 2.** SEM observation of specimen defects: (a) fiber bundle in the  $x$ -direction; (b) fiber bundle in the  $z$ -direction; (c) matrix.

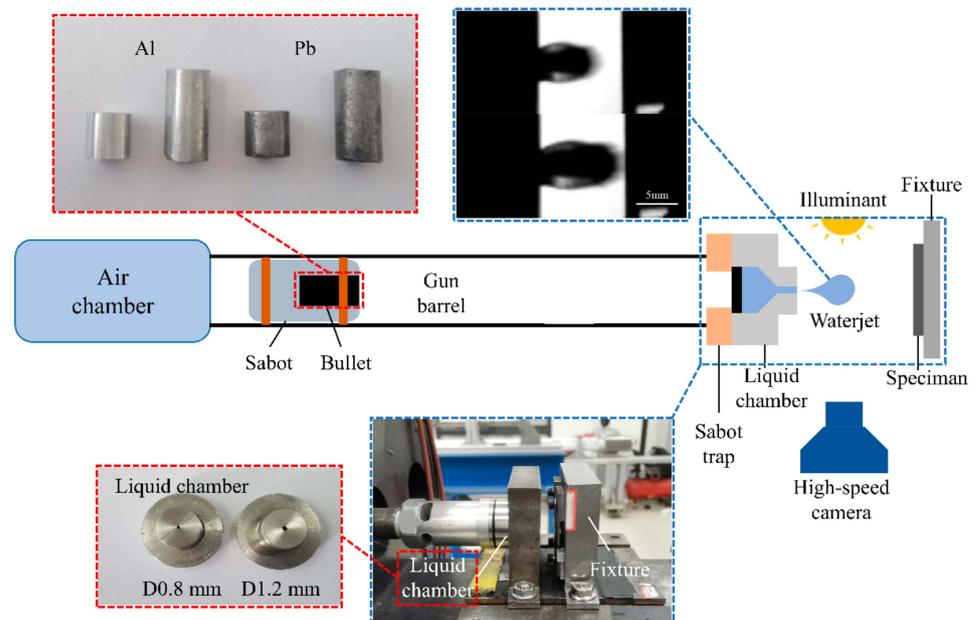
The single-jet impact test platform used in this study was developed based on the single impact jet generator principle of the Cavendish Laboratory's Single Impact Jet Apparatus (SIJA) and was modified to a single-stage 10 mm light gas gun. As shown in Figure 3, the bullet is accelerated using an air gun, and at the end of the gun barrel, a sabot trap separates the bullet from the sabot. The bullet impacts a rubber plug at the end of the liquid chamber, and under the enormous pressure generated by the impact, high-speed liquid jets are ejected from the nozzle tip. Ultimately, these high-speed liquid jets impact the test specimen, completing the impact process. A high-speed camera (Phantom V711, Vision Research, Wayne, NJ, USA) was used to capture the jet's morphology, and the jet velocity was measured during the experiment.

**Figure 3.** Single-jet impact test platform.

Calibration and preliminary tests were performed before the experiments. As shown in Figure 3, the 10 mm displacement jet satisfied the requirements of a rounded leading edge and stable diameter, making it suitable for simulating the impact of rain erosion [20]. The pre-experimental results demonstrated that the diameter of the jet was not affected by the jet velocity. In this study, we assumed that the jet diameter was solely related to the nozzle diameter. For this experiment, we used nozzles with diameters of 0.8 and 1.2 mm to produce jet streams with diameters of 4.7 and 5.8 mm, respectively. Two types of projectiles were used in the experiment to obtain water jets with different velocities and diameters: aluminum and lead. The relevant experimental parameters are listed in Table 1.

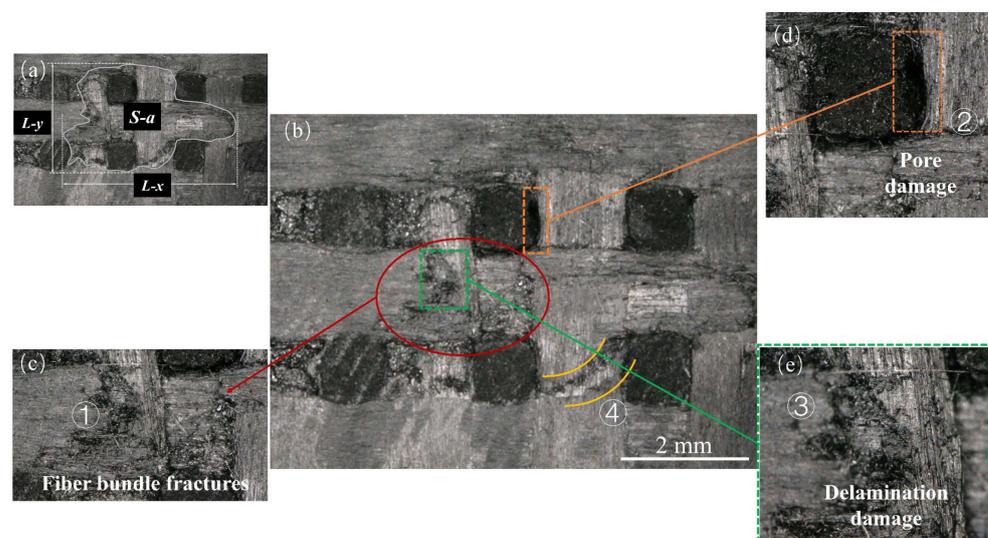
Figure 4b shows the overall shape of the damage observed in the specimens. The damage was characterized by extensive fiber delamination and matrix detachment, C fiber bundle fractures (Figure 4c ①), delamination damage (Figure 4e ③), matrix detachment leading to z-directional fiber bundles debonding and subsequent pore damage (Figure 4d ②), damage along the edges in the form of platforms (Figure 4b ④), partial fiber bundle pull-out, and disordered fiber arrangement after fracturing. The surfaces of the specimens exhibited noticeable craters. Referring to Figure 4a, it can be observed that the damage extension stops on the right side of the z-directional fiber bundles. This is attributed to the higher strength of the z-directional fiber bundles, giving them enhanced resistance to lateral jet impingement.

**Figure 4.** Surface damage under typical operating conditions: (a) damage dimension; (b) pore damage; (c) fiber bundle fractures; (d) delamination damage; (e) delamination damage.

Figure 4a shows the quantitative characterization of the surface damage resulting from a high-velocity jet stream impact.  $L-x$  and  $L-y$  signify the total lengths of damage in the  $x$ - and  $y$ -directions, respectively, and  $S-a$  indicates the area of damage. This study employed GIMP 2.10.34 to measure both the length and the area of the damage. Table 2 shows the characterization results for the damage caused by the variation of the jet velocities and diameters, which are analyzed further in subsequent sections.

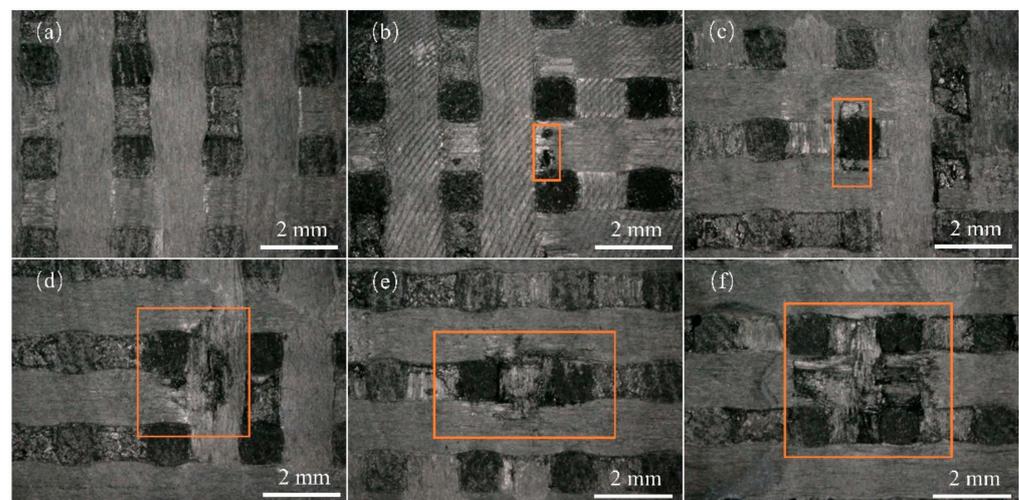
Figure 5 shows the surface damage of the specimens at different jet velocities observed using an optical microscope with a nozzle diameter of 0.8 mm. Under the impact of a jet with a velocity of 240 m/s, the surface of the specimen appeared smooth and undamaged (Figure 5a). As the jet velocity increased to 323 m/s, some fibers within the transverse fiber bundle on the specimen surface were partially severed (Figure 5b); however, the surface remained relatively flat without significant depressions. The remaining specimens did not exhibit any visible damage. Therefore, in this experiment, the threshold velocity for single impact damage with a nozzle diameter of 0.8 mm was considered to be 323 m/s. As the jet velocity continued to increase, the extent of the damage became more pronounced, with complete fracture of the fiber bundles, detachment of the C matrix, debonding between the fibers and matrix, and severe splitting of the fiber bundles being observed. At a jet velocity of 450 m/s, delamination damage occurred in the specimens, and there was a light-colored damage platform at the edge of the damage zone.

**Figure 5.** Surface damage caused by different jet velocities for a 0.8 mm nozzle: (a) 240 m/s; (b) 323 m/s; (c) 380 m/s; (d) 450 m/s; (e) 510 m/s; (f) 570 m/s.

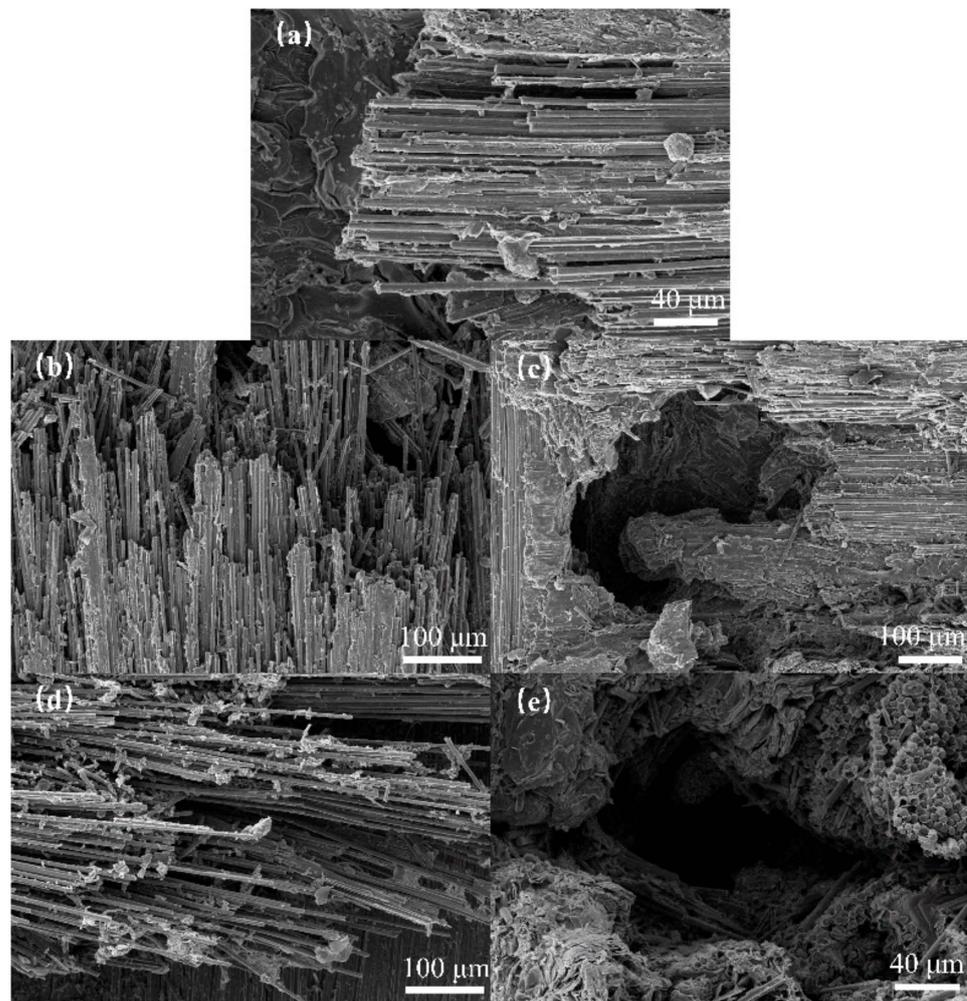
Figure 6 shows the surface damage of the specimens observed using SEM after impact with jet velocities of 380, 450, and 570 m/s using a nozzle diameter of 0.8 mm. The images show that as the jet velocity increased, the extent of damage to the fiber bundle on the specimen surface increased. Partial fiber fractures gradually progressed to complete fiber bundle fractures, with more disordered fiber bundle breakage. In addition, matrix-fiber debonding became more pronounced, with entire sections of the fiber bundles detaching and peeling off. Delamination and splitting damage occurred in z-directional fiber bundles, resulting in the formation of voids and holes within the surrounding fiber bundles. Figures 5 and 6 show that as the jet velocity increased, the severity of the debonding and delamination damage, fiber fracture, and delamination damage increased. This indicated that both the water hammer pressure and the lateral jet stream action were amplified.

**Figure 6.** SEM characterization of damage for different jet velocities with a 0.8 mm nozzle: (a) 380 m/s; (b,c) 450 m/s; (d,e) 570 m/s.

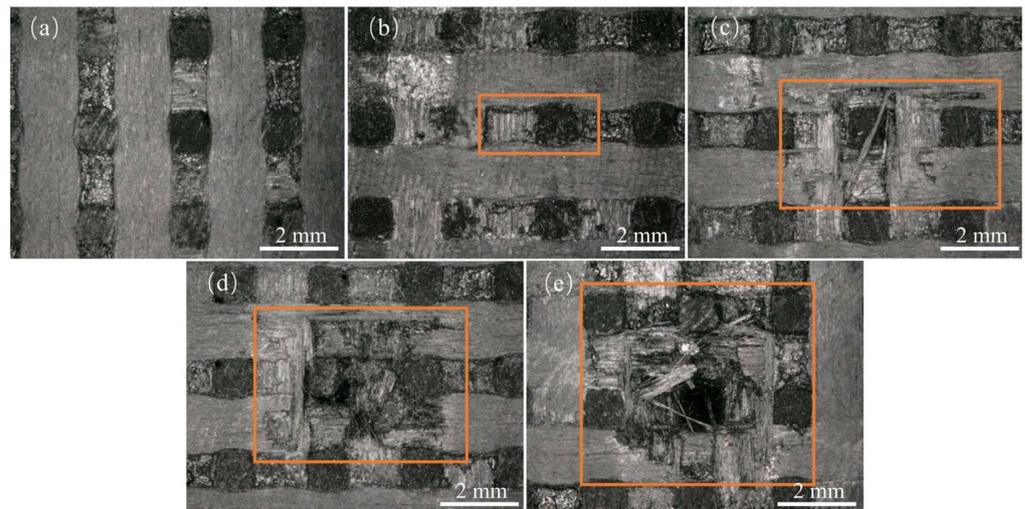
Figures 7 and 8 depict the surface damage of the specimens for different jet velocities, as observed using optical microscopy and SEM, respectively, using a nozzle diameter of 1.2 mm. Based on image observations, the threshold velocity for single-impact damage with a nozzle diameter of 1.2 mm was determined to be 300 m/s. Similar to the 0.8 mm nozzle diameter, the severity of debonding and delamination damage, fiber fracture, and delamination damage increased with increasing jet velocity. When the jet velocity reached 570 m/s, the damage at the center of the specimen was close to penetration, indicating that the damage depth also increased with increasing jet velocity.

**Figure 7.** Surface damage caused by different jet velocities for a 1.2 mm nozzle: (a) 300 m/s; (b) 360 m/s; (c) 450 m/s; (d) 510 m/s; (e) 570 m/s.

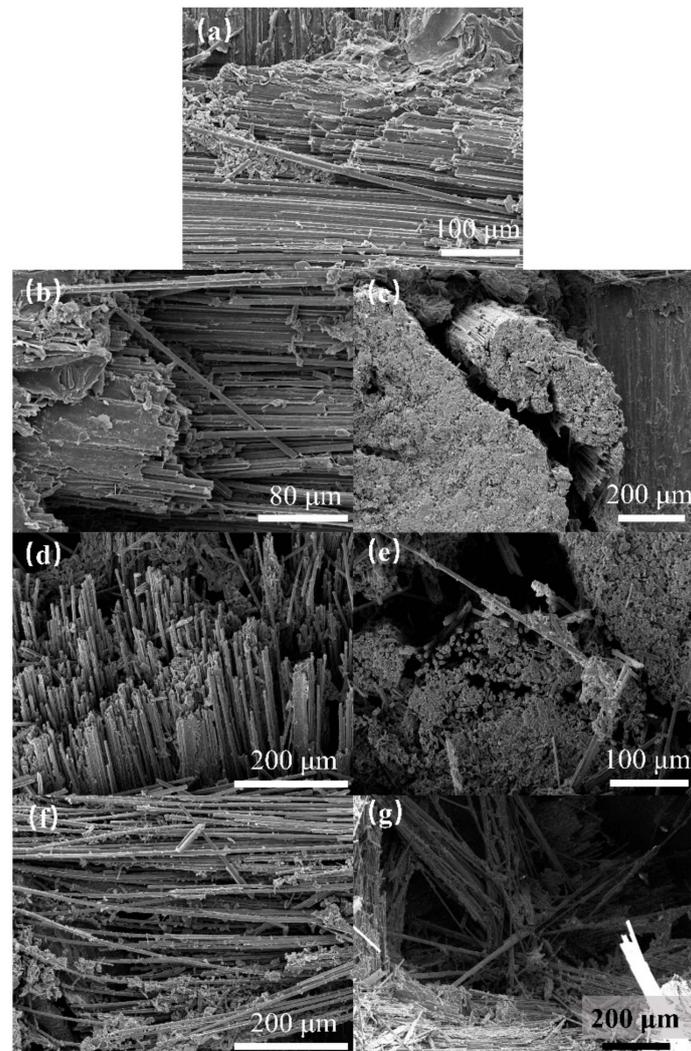
**Figure 8.** SEM characterization of damage for different jet velocities with a 1.2 mm nozzle: (a) 360 m/s; (b,c) 450 m/s; (d,e) 510 m/s; (f,g) 570 m/s.

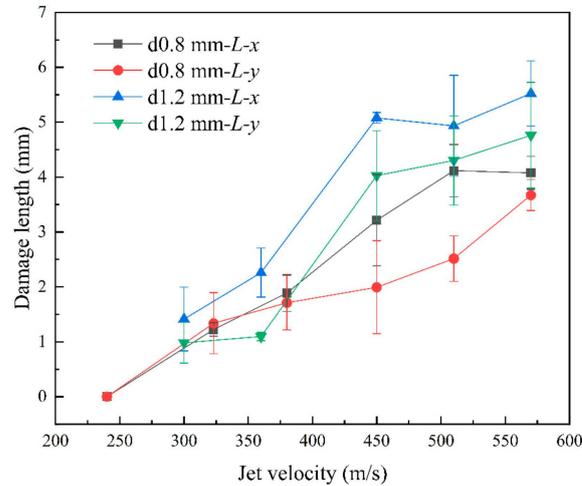
Figures 9 and 10 show that as the jet velocity increased, the maximum damage lengths in both directions and the damage area increased. The delamination damage became more pronounced, indicating a significant enhancement in the shearing effect of the lateral jet stream.

**Figure 9.** Length of damage at different jet velocities.

Figures 9 and 10 show that at the same jet velocity, the damage length and area were both greater for the 1.2 mm nozzle diameter than for the 0.8 mm nozzle diameter. Moreover, based on the slope of the curves, for the nozzle diameter of 1.2 mm, as the jet velocity

increased, the increase in the damage length and area became more significant, indicating a faster rate of damage expansion. This further confirmed the positive correlation between jet size and the extent of damage.

Figures 9 and 10 show that as the jet velocity increased, the extent of damage increased. However, for a nozzle diameter of 1.2 mm, at velocities greater than 450 m/s, the rate of increase in the surface damage area decreased significantly. During the jetting phase, the lateral jet encountered the defects and initial damage caused by water hammer pressure, as well as the process leading to shear damage, this disrupted its morphology and dissipated impact energy. As a result, damage could not form on a larger scale.

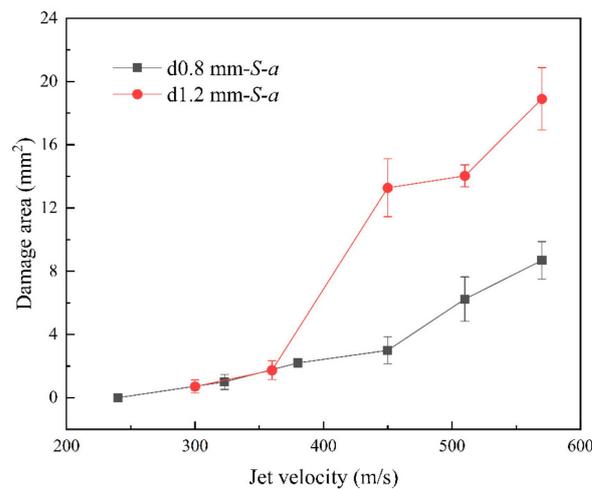
**Figure 10.** Area of damage at different jet velocities.

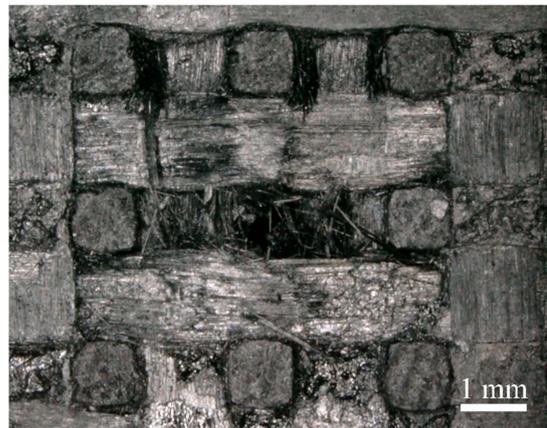
Please note, that at a jet velocity of 570 m/s for the two different jet diameters, as shown in Figure 11, fiber fractures were observed on the rear side of the specimens after the jet impact. For a nozzle diameter of 1.2 mm, some specimens experienced penetration damage.

**Figure 11.** Damage to the backside of the specimen.

At a jet velocity of 570 m/s for two different jet diameters, damage was observed on the rear side of the specimens after the jet impact. This was attributed to the generation of stress waves (compression waves) on the surface of the specimen owing to the jet impact, which propagated towards the backside of the specimen. The stress waves reaching the rear side of the specimen were reflected and resulted in the formation of tensile waves. Under the combined action of compression and tensile waves, a significant tensile stress was exerted on the backside of the specimen, resulting in damage, such as fiber fracture and delamination.

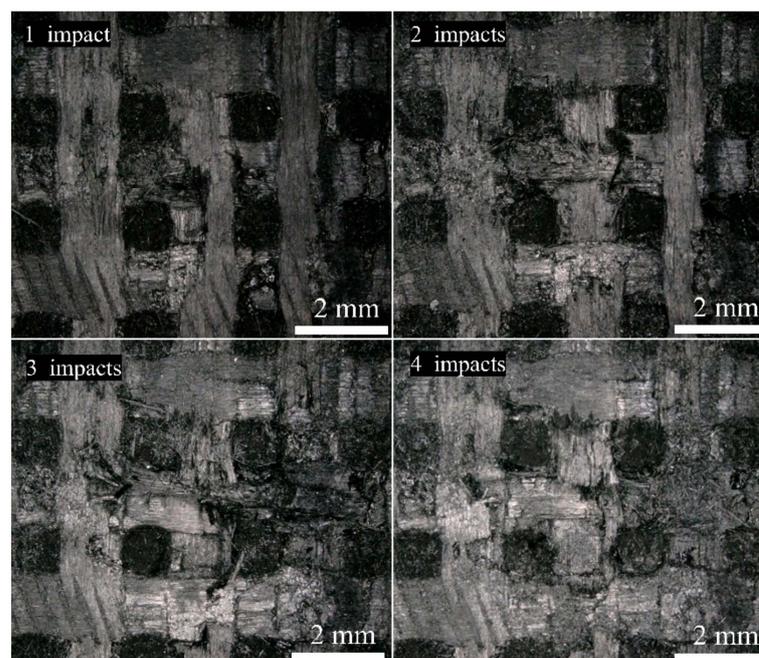
Figure 12 shows the damaged images of the same specimen after one–four jet impacts. As the number of jet impacts increased, the fiber bundle fracturing and peeling became more severe, resulting in an increased area of surface damage. In addition, the delamination intensified, and the damage depth increased. The presence of inherent voids, cracks, and other defects in the specimen significantly influenced the expansion of the damage. As the number of impacts increased, the damage was more likely to connect with the defects and continue to expand, resulting in an increased area of damage in both the surface and depth directions. This indicated that multiple jet impacts involved a cumulative damage process.

**Figure 12.** Surface damage evolution after multiple jet impacts.

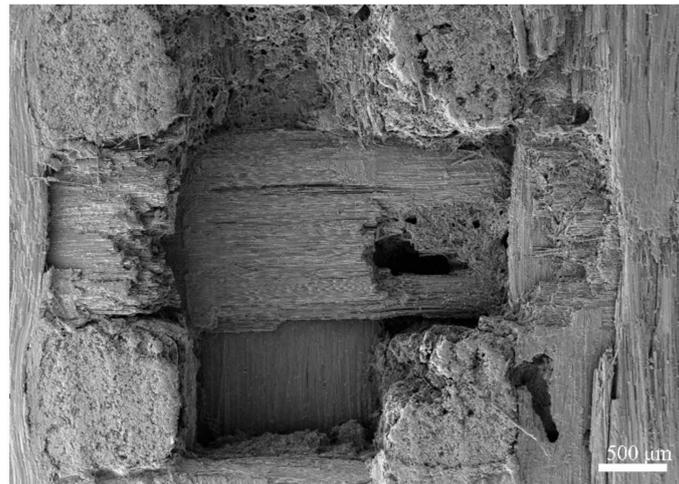
Figure 13 shows the damage characterization of the specimen after four jet impacts. We observed that the internal fiber bundle fractured within the specimen. Under multiple jet impacts, the fiber bundles experienced progressive damage layer-by-layer, with a consistent damage pattern, increased damage depth, and increased delamination. It is worth noting that the extent of damage to the z-directional fiber bundles at the impact site is relatively minimal, exhibiting mainly interfacial delamination and fiber fracture at the boundary. Damage propagates along the central direction of the z-directional fiber bundles with minimal expansion compared to the other directions.

**Figure 13.** Surface damage of the specimen after four jet impacts.

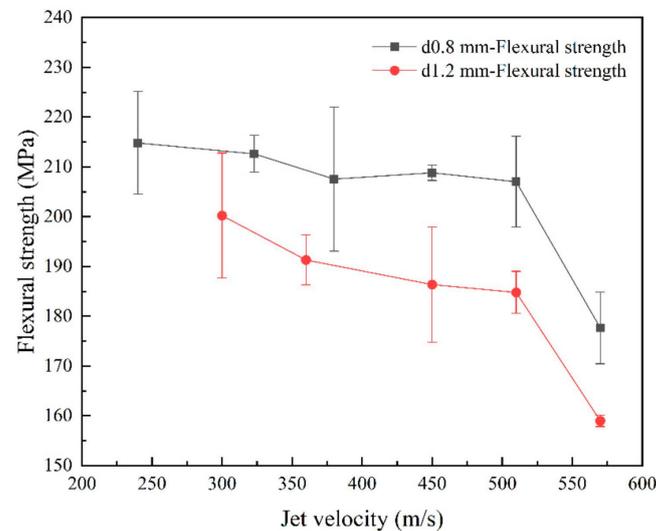
In order to investigate the impact of jet on the mechanical properties of the material, three-point bending tests were carried out on the specimens subjected to jet impact. The strength results of single-jet impact specimens (Figure 14) show that as the jet velocity and jet diameter increased, the flexural strength of the specimens gradually decreased. The flexural strength of the specimens decreased with increasing jet velocity, but it decreased relatively slowly below 510 m/s, exhibiting a nearly linear trend. When the jet velocity reached 570 m/s, there was a significant decrease in the bending strength of the specimens.

In addition, the images show that as the diameter of the jet increased, the flexural strength of the specimens decreased. Experiments revealed that as both the jet diameter and velocity increased, the residual flexural strength of the specimens decreased.

**Figure 14.** Flexural strength of specimens after different jet impingements.

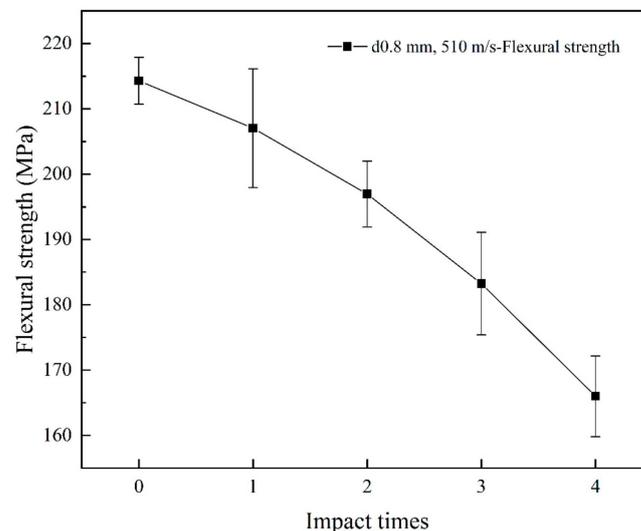
The strength results of multi-jet impact specimens indicated that the flexural strength of the specimens gradually decreased as the number of jet impacts increased. After four jet impacts, the flexural strength decreased by more than 20%. The experimental results are presented in Figure 15.

**Figure 15.** Flexural strength of specimens after different jet impingement cycles.

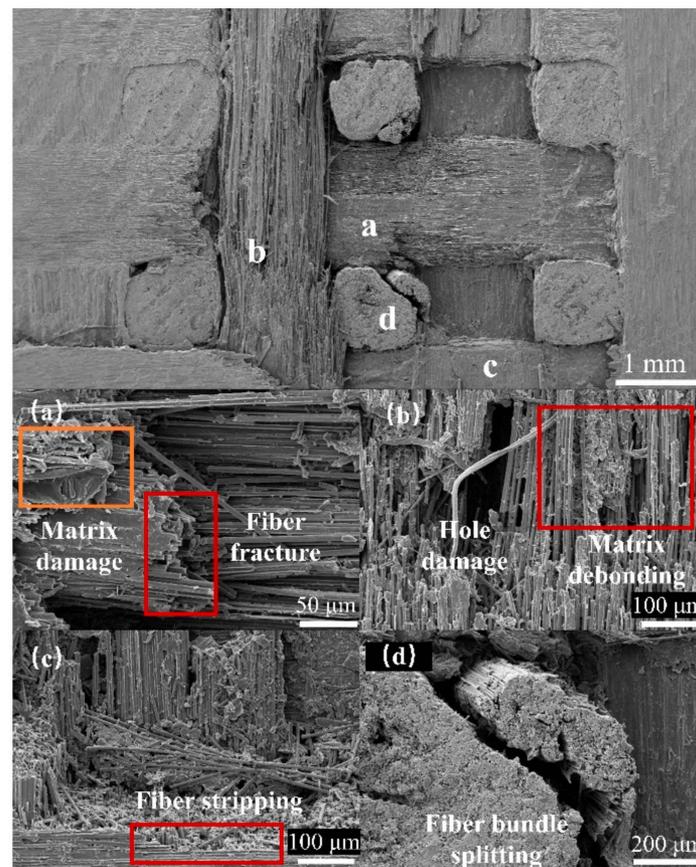
microdamage at a nozzle diameter of 1.2 mm and a jet velocity of 510 m/s. The surface damage primarily consisted of fiber bundle fracturing and delamination, fiber–matrix debonding and peeling, pore damage, and matrix damage. During the liquid compression phase, the high water hammer pressure [25,26] exerted by the jet on the specimen surface caused initial damage, such as fiber bundle fracture, matrix debonding, and detachment. In addition, a significant water hammer pressure near the impact center resulted in the propagation of downwardly extending cracks. In the second impact phase, the high-speed lateral jet penetrated the subsurface cracks and preexisting surface defects, resulting in extensive peeling damage and, in severe cases, delamination. When the jet velocity was high, debonding and peeling occurred at the boundaries of the z-direction fiber bundles, resulting in surface pore damage.

**Figure 16.** Typical damage characterization using SEM: (a) matrix damage and fiber fracture; (b) hole damage and matrix debonding; (c) fiber stripping; (d) fiber bundle splitting.

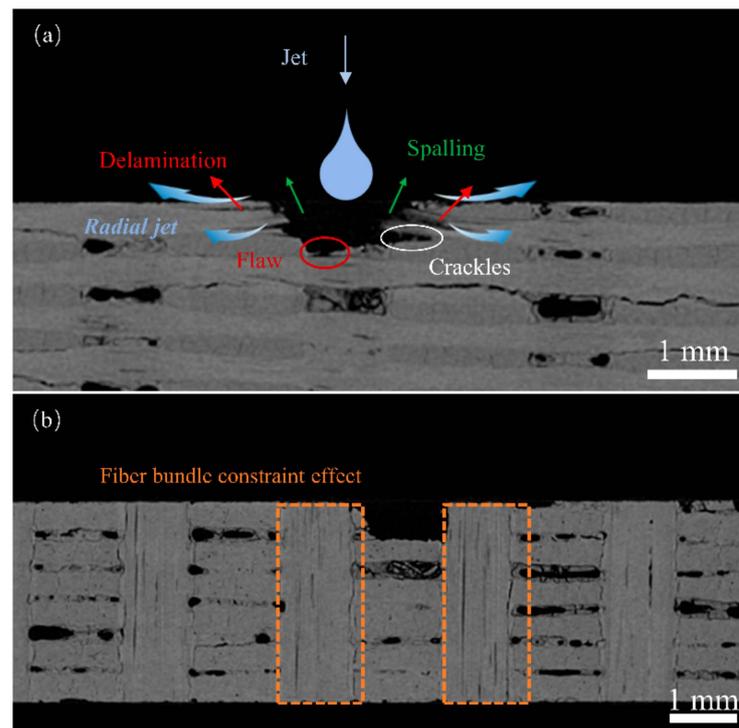
Figure 17a shows the internal damage to the specimen. During the liquid compression phase, the water hammer pressure caused inclined cracks to extend downward near the impact center, resulting in severe debonding between the fibers and the matrix. Additionally, the initial damage was linked to pre-existing internal defects. In the lateral jet impact phase, a high-speed lateral jet penetrated the subsurface cracks caused by the water hammer pressure and discontinuities of pre-existing surface defects. The lateral jet velocity was several times the initial jet velocity, causing further damage propagation at the sites of initial damage and preexisting defects under the impact of the lateral jet, resulting in deeper layer damage. From the X-CT images of the cross-section of the specimen, we observed that debonding damage occurred at the intersection of the fiber bundles, forming internal cracks.

**Figure 17.** Internal damage: (a) damage mechanism; (b) square-shaped pit damage.

In contrast to 2D woven materials [23], equally dense z-directional C fiber bundles in the jet impact direction. When the impact center was near the z-directional fiber bundles, the internal damage differed from that shown in Figure 17a. As shown in Figure 17b, the damage to the inner pit occurred as relatively flat squares. Due to the z-directional fiber bundles being perpendicular to the lateral jet, the jet impact had a minimal effect on them, resulting in a limited damage range imposed by the z-directional fiber bundles on both sides during the impact. This led to the formation of square pits.

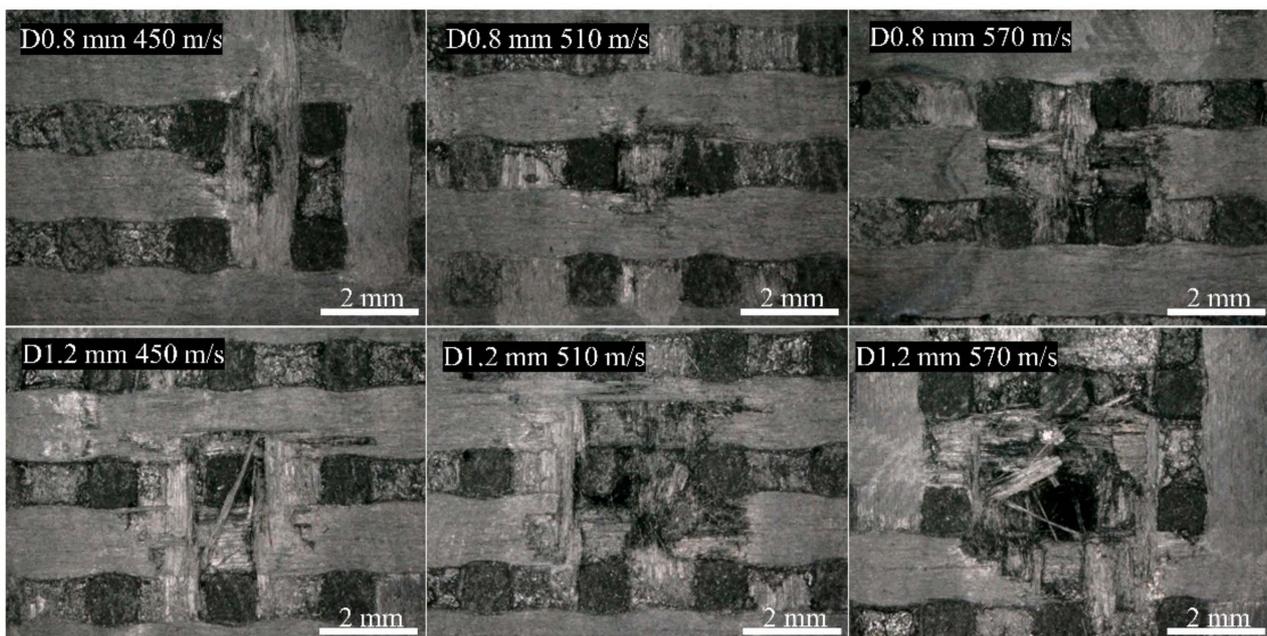
Figure 18 shows that at the same jet velocity, the extent of damage was greater with a nozzle diameter of 1.2 mm than 0.8 mm, with apparent aggravation of the delamination damage. During the liquid compression phase, the water hammer pressure was higher for the 1.2 mm condition at the same jet velocity, resulting in more severe initial damage, including a larger range of fiber fracture and debonding. In addition, the lateral jet in the 1.2 mm condition had a higher water flow rate and stronger shearing action, penetrating the initial damage and material defects with greater intensity during the jetting phase, resulting in a larger range of delamination and peeling damage. When the jet velocity reached 570 m/s, the specimen for the 1.2 mm nozzle diameter almost experienced penetrating damage, indicating a greater depth of damage than for the 0.8 mm diameter. Because of the increased initial damage, the initial damage to the specimen was more likely to be connected to pre-existing voids and defects in the material, resulting in a greater depth of initial damage. During the lateral jetting phase, the depth of crack invasion beneath the surface increased, accompanied by increased water flow and shearing action, ultimately resulting in a greater depth of shear-induced damage.

**Figure 18.** Surface damage at different jet diameters.

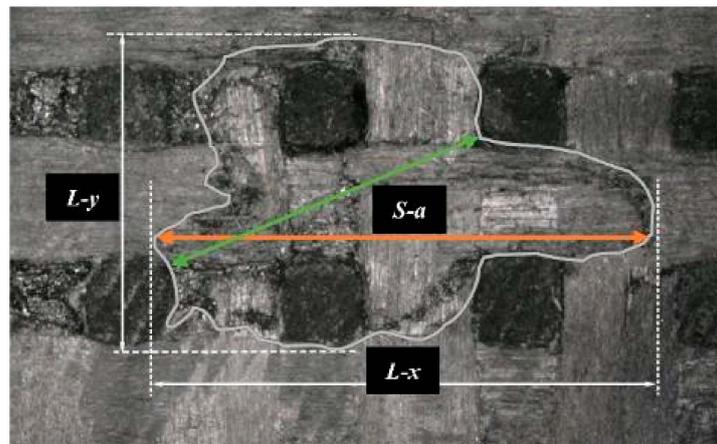
**Figure 19.** Damage dimension in different directions.

The damage image (Figure 19), under typical conditions, revealed that the initial damage extends from the center [22], with the length of damage propagation in the z-directional fiber bundles being significantly smaller than in other directions, due to the woven structure of the material.

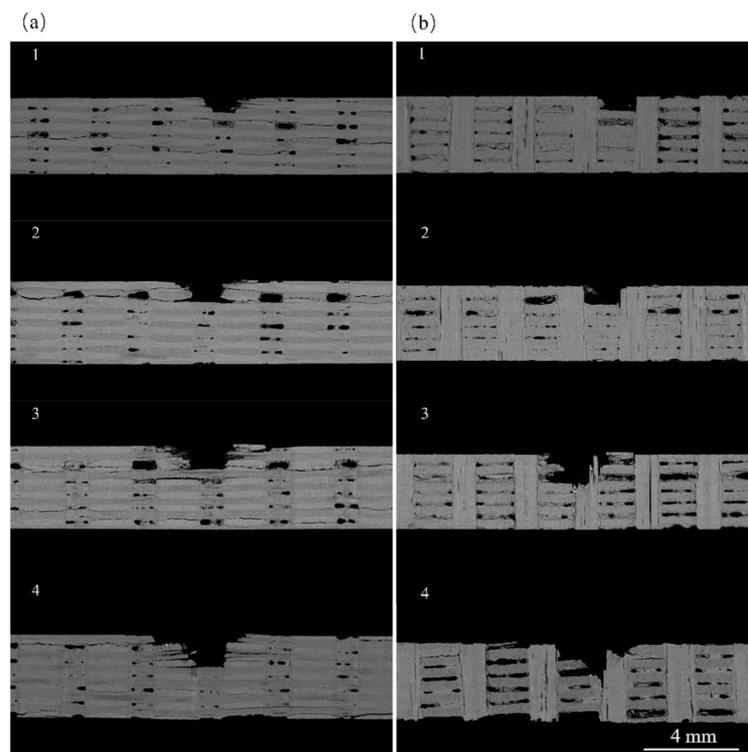
**Figure 20.** Internal damage of the specimen under different jet impact numbers: (a)  $xz$ -plane; (b)  $yz$ -plane.

The analysis of specimens after four impact events assessed the resistance of  $z$ -directional fiber bundles to damage propagation. Figure 20a shows the internal damage within the  $yz$ -plane for jet impacts 1–4, and the damage extension in this direction is not constrained by the  $z$ -directional fiber bundles. The predominant damage modes of the specimens were fiber bundle fracturing, peeling, and delamination. As illustrated in Figure 21a, during the first jet impact, surface fiber bundle fracturing and peeling occurred accompanied by subsurface cracks, resulting in a small inverted trapezoidal pit. Internal defects in the specimen connected with the impact damage, enabled the lateral jet to penetrate a larger area during subsequent impacts, resulting in increased internal damage. Under the combined effects of the water hammer pressure and lateral jet, the damage depth gradually increased, causing deeper layers of fiber bundles to experience fracture and peeling damage.

Figure 20b shows the image of internal damage in the  $xz$ -direction, exhibiting an overall “square” pattern of damage. As illustrated in Figure 21b, when the lateral jet passes through the z-directional fiber bundles, the interface is identified as a weaker region. Accordingly, the lateral jet initiates shear action on the interface between the z-directional fiber bundles and the matrix. Cracks propagate along the interface, resulting in interface debonding and matrix delamination. Subsequently, the z-directional fiber bundles experience a vertical impact. This is due to the vertical arrangement of the z-directional fiber bundles in the lateral jet spray direction, resulting in minimal in-plane cracks and defects along the lateral jet spray direction. Therefore, this hindered the shearing action of the lateral jet spray and restricted damage propagation.

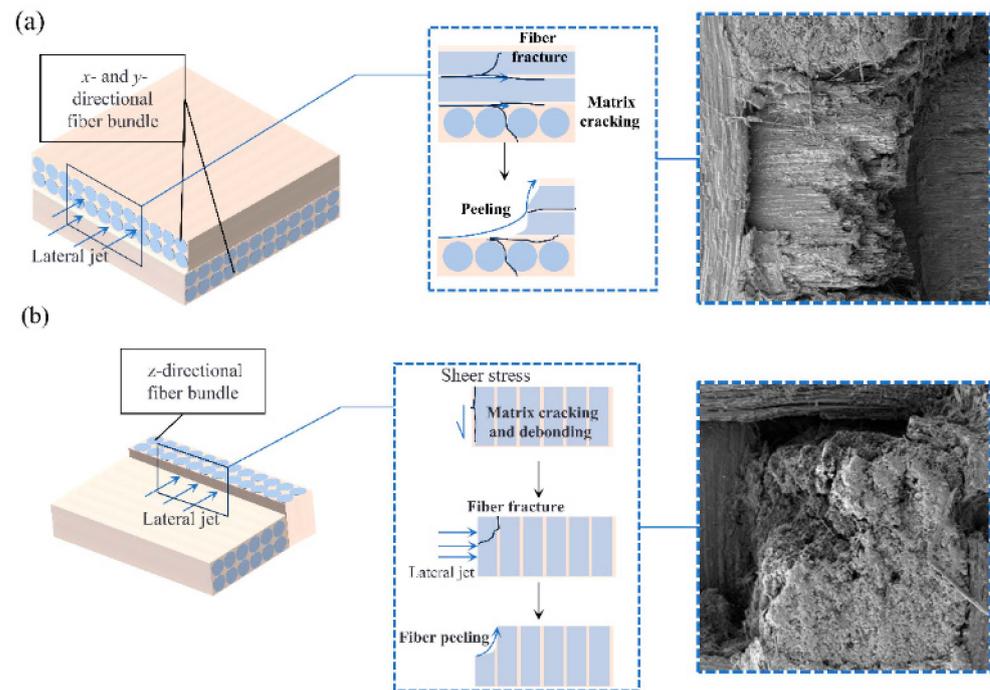
**Figure 21.** Damage mechanisms at different fiber bundle locations: (a) in-plane fiber bundles; (b) z-directional fiber bundle.

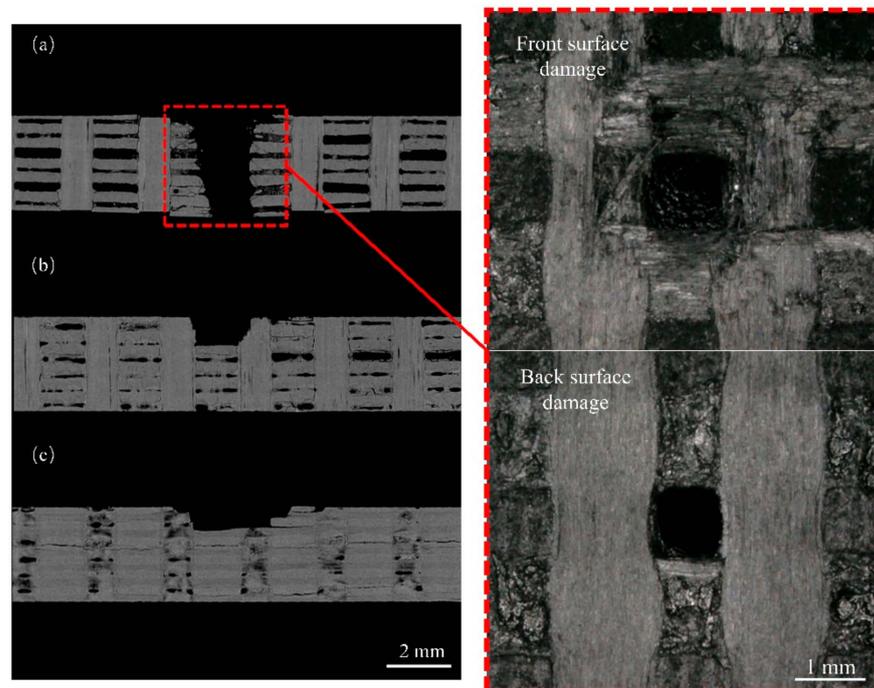
**Figure 22.** Internal damage characterization of four impinging jet impacts at different center locations: (a)  $z$ -directional fiber bundle; (b)  $y$ -directional fiber bundle; (c) intersection of  $xy$ -fiber bundles.

By comparing Figure 22b,c, it can be observed that the internal damage length in (b) is significantly lower than in (c), indicating that the z-directional fiber bundles exhibit a pronounced inhibitory effect on in-plane damage.

Note that under the four jet impacts, some specimens experienced penetration damage. As shown in Figure 22a, when the impinging jet center was located in the z-directional fiber bundle, the main damage modes were debonding and penetration of the z-directional fiber bundle. Owing to the poor adhesion between the C matrix of the specimen material and the fiber bundle, the interface between the z-directional fiber bundle and the other fiber bundles was relatively weak. After multiple impacts, the C matrix severely detached, making it prone to debonding and penetration when the impinging jet center was on the z-directional fiber bundle. Observation of the front and back damage of the specimen (Figure 22a) revealed square fracture surfaces on the front side, indicating fracturing and delamination damage to the plane fiber bundle caused by the lateral impinging jet. On the back side, a neat square aperture was observed, indicating the complete penetration of the entire z-directional fiber bundle and significant debonding damage.

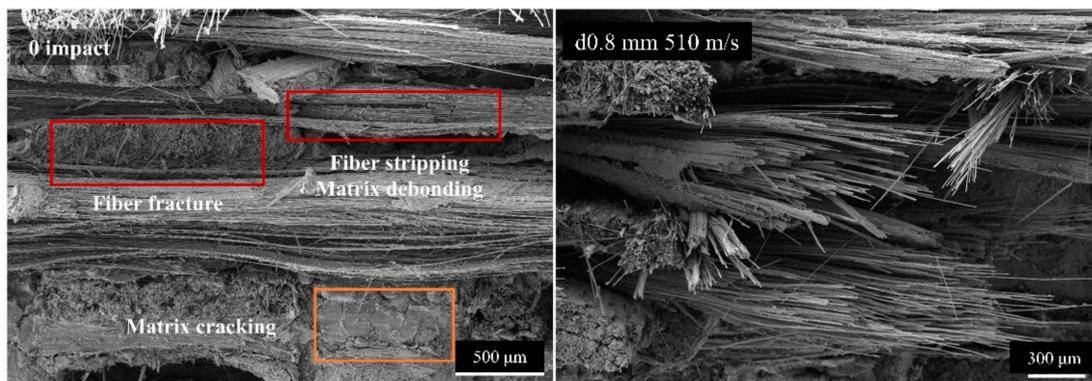
Figure 23. Characterization of bending fracture surfaces using SEM.

As shown in Figure 23, SEM examination of the fracture surface of the specimen revealed three types of damage during bending: matrix cracking, fiber–matrix interface debonding and splitting, and fiber fracturing. After the jet impact, the types of bending damage in the specimens remained unchanged, indicating that the failure mode during bending did not change. A comparison of the fracture morphologies revealed that the post-jet impact specimens exhibited a more disordered arrangement of fractured fiber bundles and increased debonding damage. An analysis and comparison suggested that this was the result of the initial damage caused by the intensification and extension of the impact. The initial jet impact resulted in the fracturing of the surface fiber bundles and the formation of cracks. During the bending process, the damage was more likely to spread to locations with lower resistance, where fiber bundles were fractured and cracks had occurred. This resulted in more severe splitting, debonding, and other forms of damage, ultimately resulting in a decrease in the residual flexural strength.

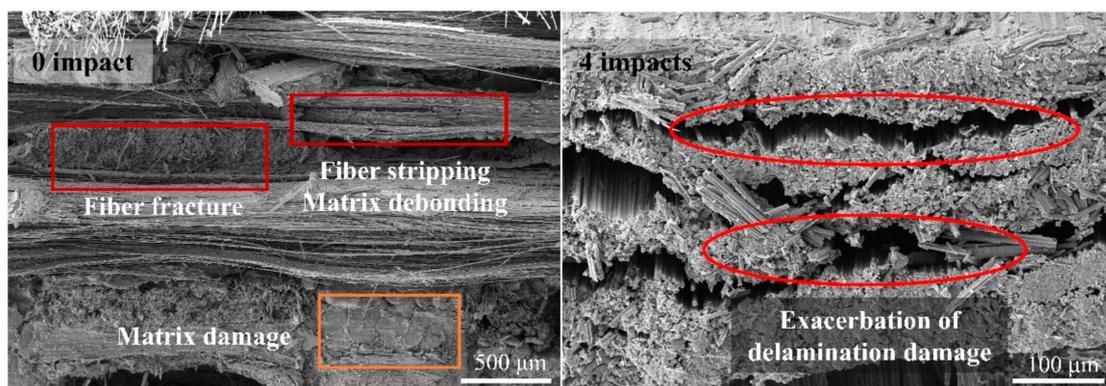
Figure 24. Bending fracture surface of specimens after multiple jet impacts.

As shown in Figure 24, the damage pattern during the bending process was the same as that observed in the specimens after a single-drop jet impact. A comparison of the fracture morphologies showed that, as the number of jet impacts increased, debonding, splitting, and other forms of damage intensified, resulting in a decrease in the residual flexural strength.
