# The Effects of Strong Earthquakes on Built Heritage: A Preliminary Case Study of Rector's Palace in Dubrovnik's Old City

**Abstract:** The Old City of Dubrovnik's historical urban heritage architecture, consisting of poorly to well-built irregular stone masonry construction, is at high risk of earthquakes. It was enlisted as a UNESCO World Heritage after the severely damaging 1979  $M_w = 7.1$  Montenegro earthquake. Retrofitting strategies to a certain degree of earthquake protection have been made to the monument heritage architecture after repeating destructive earthquakes for several centuries. The originally 13th-century Rector's Palace underwent several major modifications throughout history after disastrous events: fire in 1435, a gunpowder explosion in 1463, and earthquakes in 1520, 1667, and 1979. The design and construction information were collected from historical records and studies performed by various researchers, including field measurements and laboratory tests. Based on the data gathered, the building's resistance to destructive earthquakes in compliance with contemporary building codes was determined using simulations on a calibrated spatial structural model.

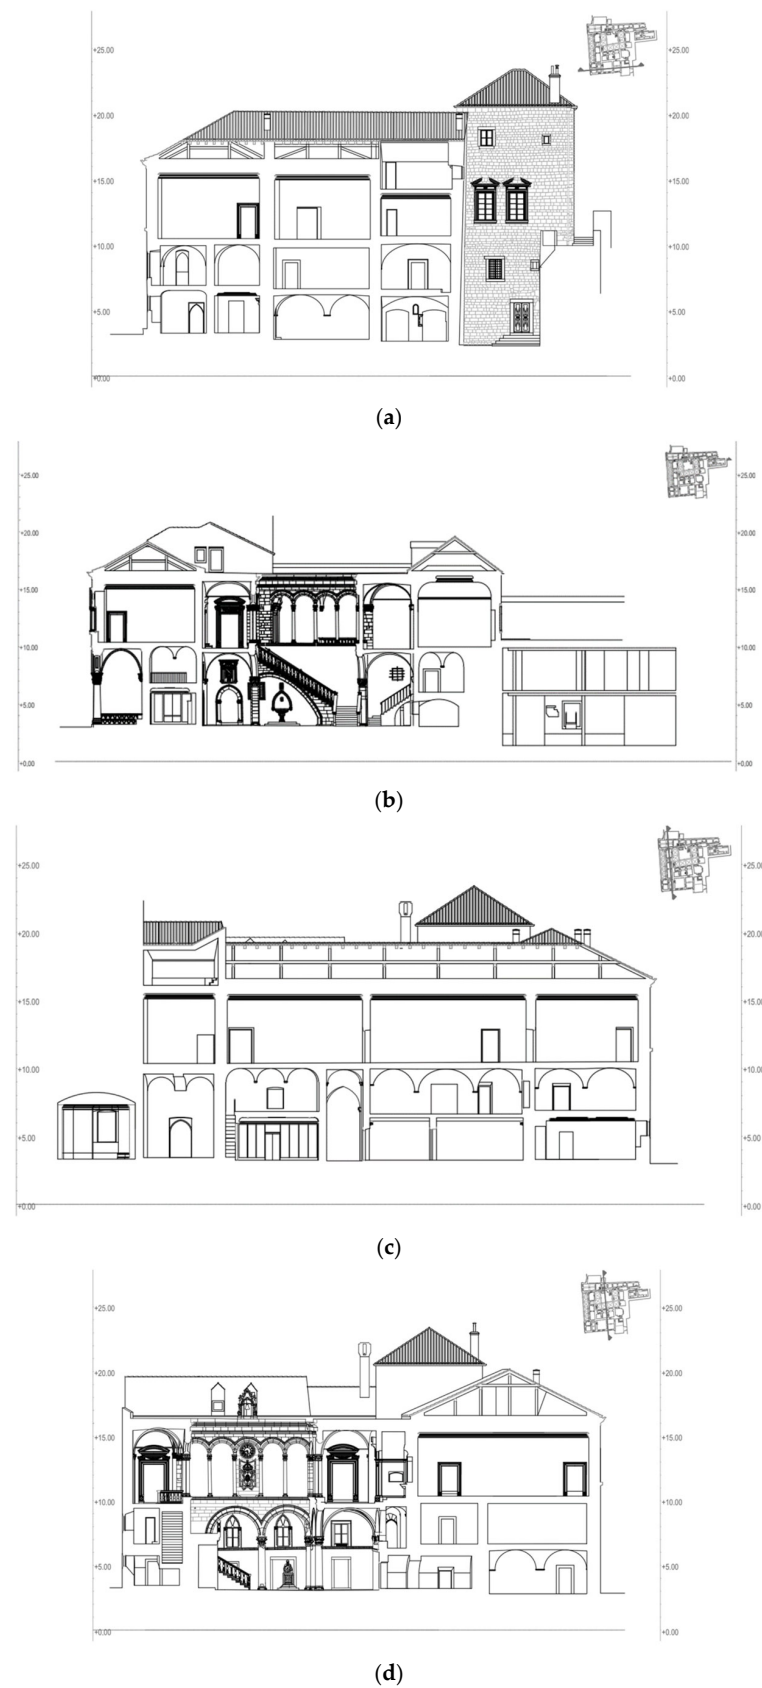
**Figure 7.** Selected cross-sections of the Rector's Palace: (a) "2-2"; (b) "3-3"; (c) "6-6"; (d) "9-9" as specified in original architectural drawings (courtesy of the Institute for the Restoration of Dubrovnik).

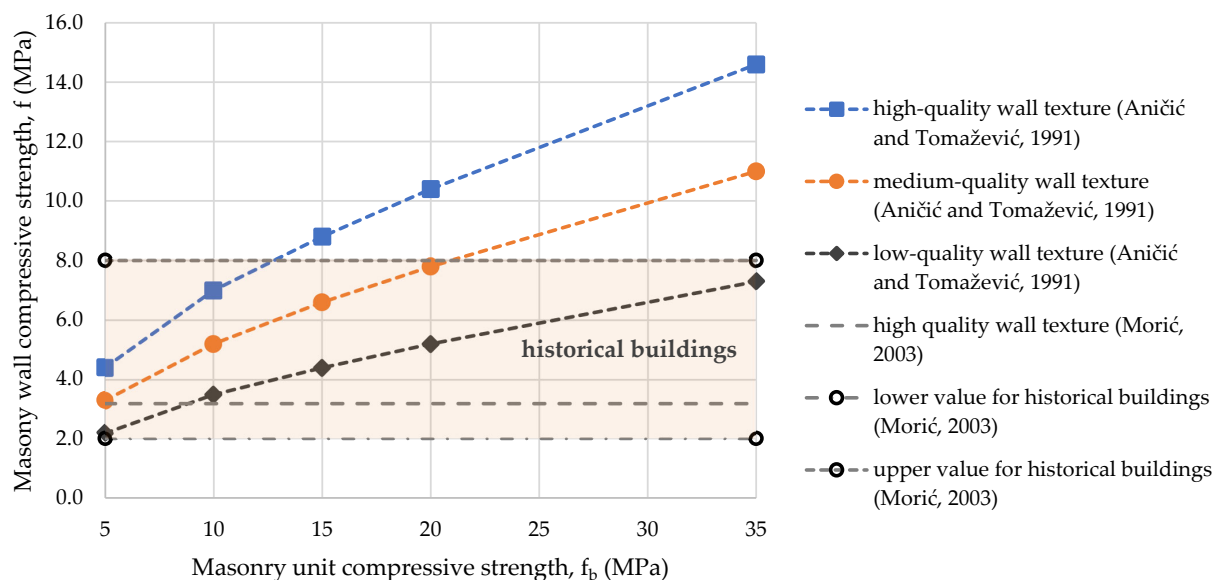
**Figure 9.** Compressive strength of natural stone masonry walls made with lime mortar,  $f$  (MPa), belonging to the eastern Adriatic coast with reference to the corresponding compressive strength of masonry units,  $f_b$  (MPa), in correlation with the quality of the wall texture (high, medium, and low) and reference values for historical buildings as given by [54,55,58,59].

Figure 9 shows the compressive strength of natural stone masonry walls made with lime mortar,  $f$  (MPa), belonging to the eastern Adriatic coast with reference to the corresponding compressive strength of masonry units,  $f_b$  (MPa), in correlation with the quality of the wall texture (high, medium, and low) and reference values for historical buildings as given by [54,55,58,59]. The walls are of high-quality texture, finely dressed stone masonry with an intermediate layer of fill. Based on the relations shown in Figure 9, the lower and upper limits of the compressive strength of stone masonry walls are 2.2 and 14.6 MPa [54,55]. The upper and lower values for historical buildings of 2.0 and 8.0 MPa, respectively, also stated in Figure 10, refer to (lime) mortar strength  $f_m < 2.5$  MPa.

where  $K$  is constant with a value of 0.45 for dimensioned natural stone;  $f_b$  is normalized compressive strength of a masonry unit; and  $f_m$  is the compressive strength of a mortar, ranging from 1.83 MPa (for  $f_b = 5$  MPa and  $f_m = 2.5$  MPa) to 8.8 MPa (for  $f_b = 35$  MPa and  $f_m = 5.0$  MPa), which corresponds to limits shown in Figure 9 as defined in [54,55].

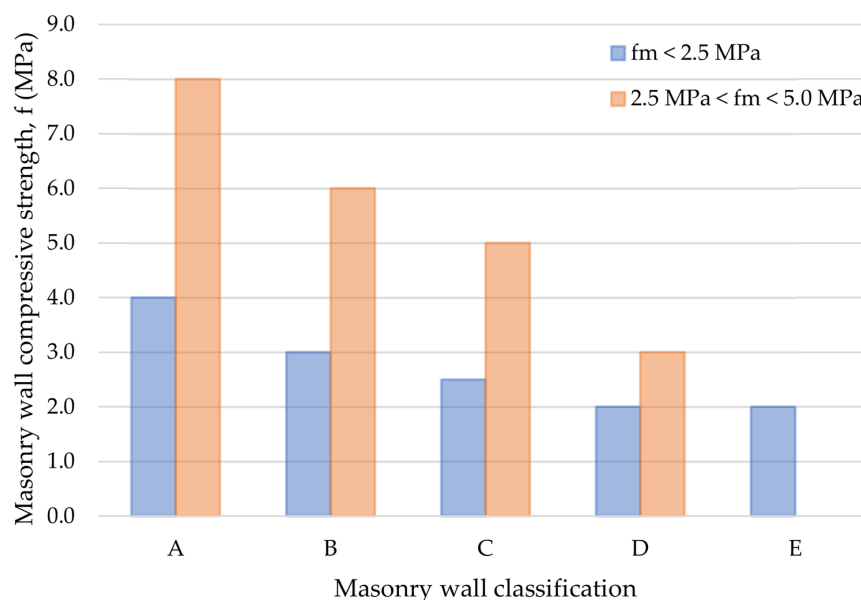
**Figure 10.** Compressive strength of natural stone masonry walls made with lime or cement–lime mortar,  $f$  (MPa), belonging to the eastern Adriatic coast with reference to wall classification (A–E) as proposed by [54,55] where letter symbols refer to (A) designated walls made of finely dressed and properly arranged stone blocks, without intermediate layers; (B) walls made of large regularly dressed stone blocks with a relatively narrow central layer filled with fill material and stone chippings; (C) walls made of large irregularly dressed stone blocks with a relatively narrow central layer filled with fill materials and stone chippings; (D) walls made of roughly dressed irregular stone blocks with a large number of stone chippings and fill material in the central layer, and with irregular joints; and (E) walls made of undressed stone with a large quantity of fill.

In addition, Figure 10 shows the compressive strength of natural stone masonry walls made with lime  $f_m < 2.5$  (MPa) or cement–lime mortar,  $2.5 < f_m < 5.0$  (MPa), belonging to the eastern Adriatic coast with reference to wall classification (A–E) as proposed by [54,55] where letter symbols refer to (A) designates walls made of finely dressed and properly arranged stone blocks, without intermediate layers; (B) walls made of large regularly dressed stone blocks with a relatively narrow central layer filled with fill material and stone chippings; (C) walls made of large irregularly dressed stone blocks with a relatively narrow central layer filled with fill materials and stone chippings; (D) walls made of roughly dressed irregular stone blocks with a large number of stone chippings and fill material in the central layer, and with irregular joints; and (E) walls made of undressed stone with a large quantity of fill. According to the EN 1996-1-1:2005 [24] building code, the wall compression strength estimate is based on the constituent contribution, i.e.,

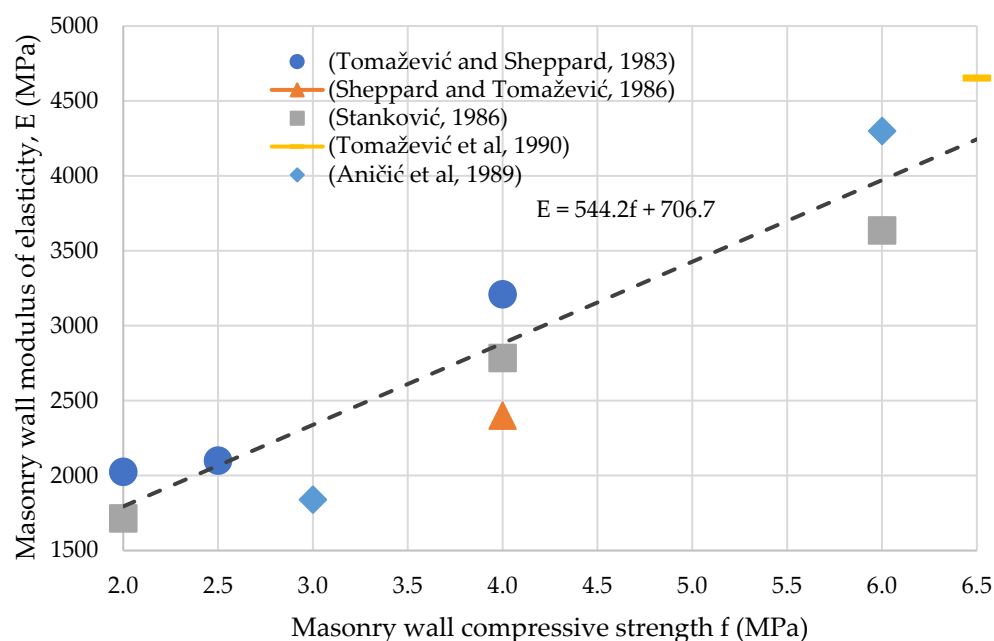
**Figure 11.** Modulus of elasticity of natural stone masonry walls made with lime mortar,  $E$  (MPa), belonging to the eastern Adriatic coast with reference to corresponding wall compressive strength,  $f$  (MPa), from test results, as given by [54,55,60–64].

(B class in the case of Rector's Palace). The modulus of elasticity, besides the structure's mass, is critical in the calculation of the natural frequency of the building and, therefore, the earthquake performance. The adequate modulus elasticity was determined by structural model calibration with reference to measured natural frequencies. The initial, i.e., orientation values of the modulus of elasticity of natural stone masonry walls made with lime mortar,  $E$  (MPa), belonging to the eastern Adriatic coast with reference to corresponding wall compressive strength,  $f$  (MPa), from test results, as given by [54,55,60–64], are shown in Figure 11 and Table 1. As proposed by [54,55], and based on Figure 11 and Table 1 information, the lower limit (referring to walls of low-quality texture) of the modulus of elasticity can be expressed as  $E = 650 \times f$  (MPa), while the upper limit (referring to walls of high-quality texture) as  $E = 900 \times f$  (MPa), which is lower than the prediction  $E = 1000 \times f$  (MPa) given in the EN 1996-1-1:2005 [24] building code. The corresponding value of stone masonry wall shear modulus  $G$  ranges from  $E/6$  to  $E/4$ . In addition, the recommended values of stone masonry wall tensile strength  $f_t$  range from 0.09 to 0.3 MPa in relation to corresponding compressive strength ranging from 2.0 to 8.0 MPa, respectively.

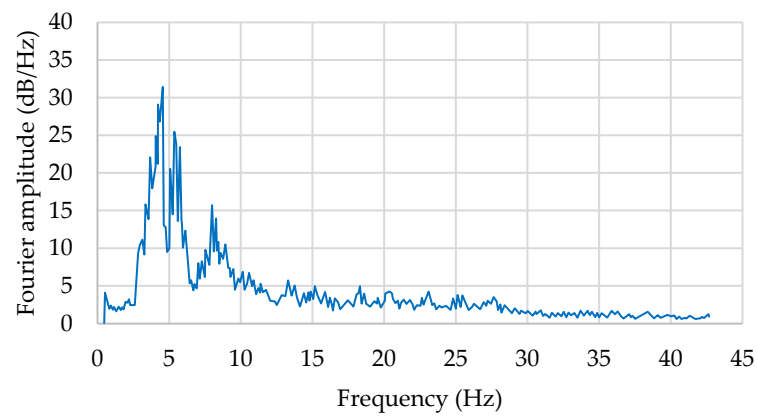
**Figure 12.** Example of Fourier amplitude spectra obtained via ambient vibration measurement in Rector's Palace for (a) N-S direction, (b) E-W direction, and (c) torsion, as given in [67].

The vibrational characteristics of the Rector's Palace were determined via ambient vibration measurement performed by the Institute of Earthquake Engineering and Engineering Seismology (abbr. IZS) of the Saints Cyril and Methodius University in Skopje, FYR Macedonia, Yugoslavia (today's North Macedonia) in 1981, prior to the building's retrofitting, as described in [67] (see Figure 12).

By inspection of the averaged Fourier spectra (Figure 12a–c), it was observed that the dominant resonant frequencies of the building are within the range of 3.0 to 5.0 Hz, which corresponds well to the expected values of the dominant (period) frequency range of earthquake action, i.e., 0–5 Hz [68], and poses a risk to a building. More specifically (see Table 2), in terms of natural periods, the dominant period of the earthquake action of 0.3–0.4 s could cause very heavy damage or destruction of the building. This also corresponds to Type 1 and Type 2 elastic response spectra peak values used to represent the seismic action by EN1998-1:2004 [25]. The wooden joists used for floor structures (2nd floor in a post-retrofitted building) were indirectly represented in the model by weight, i.e., as the loading on the supporting walls, including the corresponding permanent and variable loads acting on the floor [69]. The concrete class C25/30, namely elasticity modulus,  $E_{cm} = 31$  GPa [30], was adopted for the RC slabs in the mezzanine and the first floor in the post-retrofitted building. The direct modeling of the wooden joists, e.g., wooden beams with their exact geometry semi-hinged to supporting walls, was avoided because their contribution to the overall earthquake resistance of the building is ideally 10 to 30% compared to the building with “absolutely rigid floor structures” [54,55]. The building considered is in fact a historical building with diminished structural capacity caused by its use, aging, and several major earthquakes and other disastrous events throughout its history. Therefore, with their omission in the model the most unfavorable building's structural response overall and, in particular, of structural walls was obtained.

In considering the frequencies of vibration obtained from the field measurements, besides the building's (dominant) natural frequencies (see Table 2 and Figure 15), the ones from the individual structural components or structural parts could be observed (see Figure 12), which is an indicator of the poor structural inter-connectivity or damage. However, eight modes were observed by measurements, which was helpful for assessing the model by performing its calibration and validation. The total effective mass participation for the first six modes of vibration corresponds to approximately 30% in the EW and 25% in the NS building's direction, respectively. In order to reach higher mass participation,
