Article

Effect of Thermal Ageing on the Impact Damage Resistance and Tolerance of Carbon-Fibre-Reinforced Epoxy Laminates

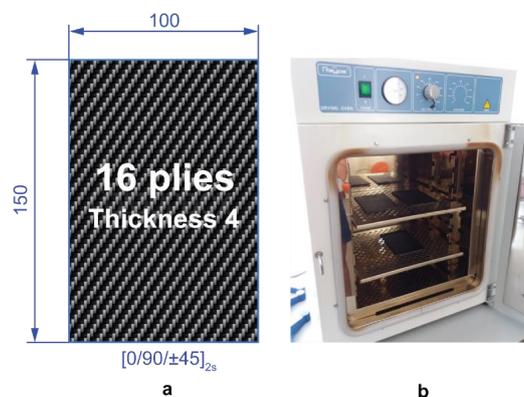
Figure 1. (a) Standard impact specimens according to ASTM D7136 recommendations. (b) Programmable oven used for the thermal ageing treatments.

The CFRP laminates were laid up by hand in 200-mm wide by 200-mm long plates following the quasi-isotropic stacking sequence $[0/90/\pm 45]_{2s}$ with fibres oriented along the principal directions. Each laminate consists of 16 plies which corresponds to a total thickness of 4 mm, each one being the thickness of 0.25 mm approximately.

The standard cure cycle recommended by Hexcel Composites Ltd. was used for these laminates. The plates were cured at 7 bar hot-pressing system together with slow heating (3 °C/min), hold at 180 °C for 120 min, and followed by cooling at 5 °C/min. After the post-curing, the panels were ultrasonically C-scanned to ensure panel integrity. The ASTM D7136 [17] drop weight method was followed for testing impact specimens. The characteristic impact specimen length and width were 150 mm and 100 mm, respectively (Figure 1a). Thermal ageing treatments were performed in an oven at different temperatures (Figure 1b). For that purpose, the chosen temperatures were 190 and 210 °C, below and above the glass transition temperature of the epoxy resin (195 °C), respectively. The effect of ageing was evaluated at two different periods of time: 10 days and 20 days, and the results were compared with those obtained from non-aged laminates. For each sample, three specimens were tested, and the average results were taken as the final values.

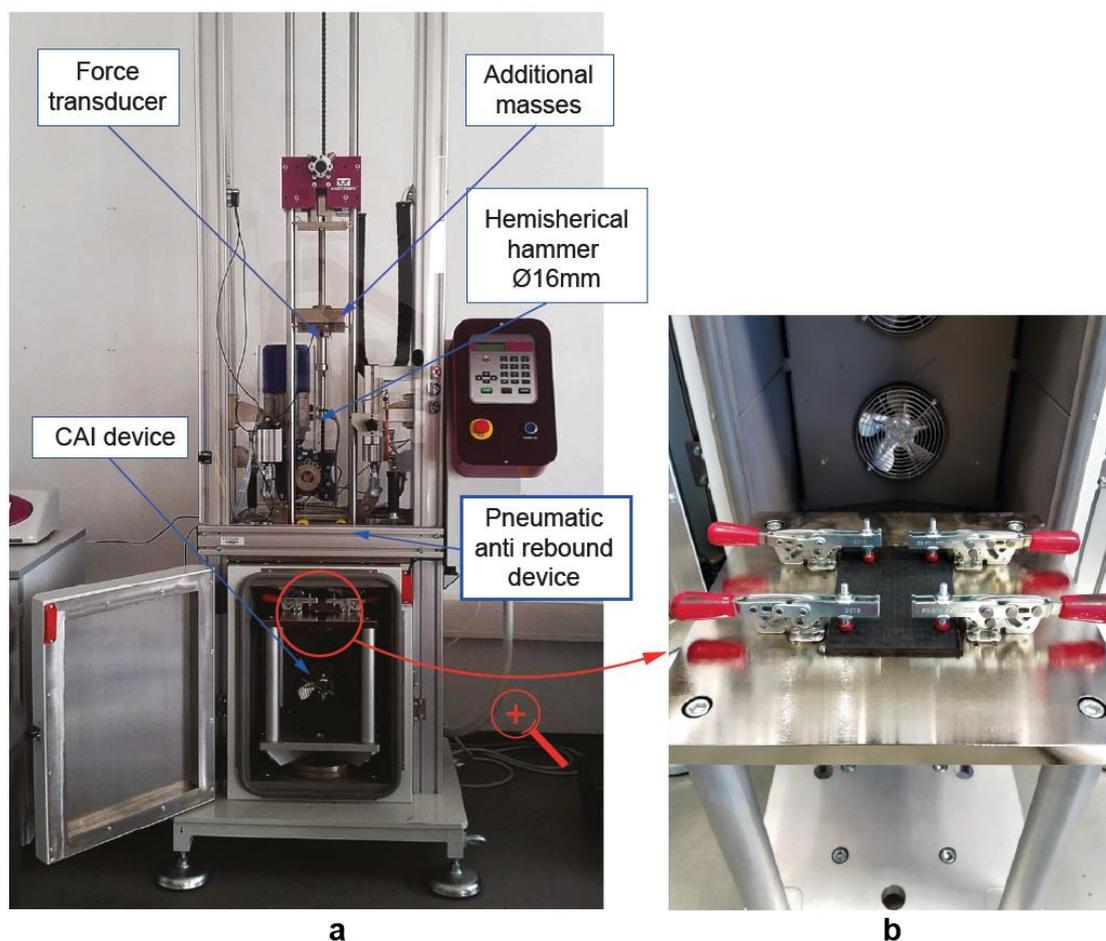
Figure 2. Experimental setup for drop-weight impact test. (a) Drop-weight column device. (b) Compression after impact (CAI) support fixture according to ASTM D7136 standard.

Impact tests were performed in an instrumented drop-weight tower INSTRON CEAST 9340 (Instron Ltd., Norwood, MA, USA) (Figure 2a) according to the standard. This method of damage introduction determines the damage resistance of multidirectional composite laminates subjected to a drop-weight impact event. Furthermore, it simulates typical in-service damage on composite aircraft structures, such as accidentally dropping a tool during maintenance or fabrication, bird strikes or hailstorms [45]. The indenter consisted of a hemispherical head with a 16-mm diameter and a mass of 4.5 kg. The specimens were impacted on its smoother side to facilitate the measurement of the indentation depth. In addition, each specimen received a single impact, and the rebound was prevented by an anti-rebound system. The maximum impact energy is limited by the adjustable falling weight. The specimens were clamped to the drop tower fixture using a CAI support fixture with four toggle clamps (Figure 2b). All clamps had rubber attachments to avoid damaging the specimen during clamping. The impact location was located in the centre of the specimen. The design of the testing was restricted to the analysis of low velocity below 5 m/s to avoid penetration and the energy levels were selected in order to cause BVID in non-thermal aged specimens. Some initial tests at different energies were required to select the level of energy which causes BVID. Finally, the selected impact energy was 20 J, with a drop height of 0.46 m. Impact velocity was calculated according to the previous parameters.

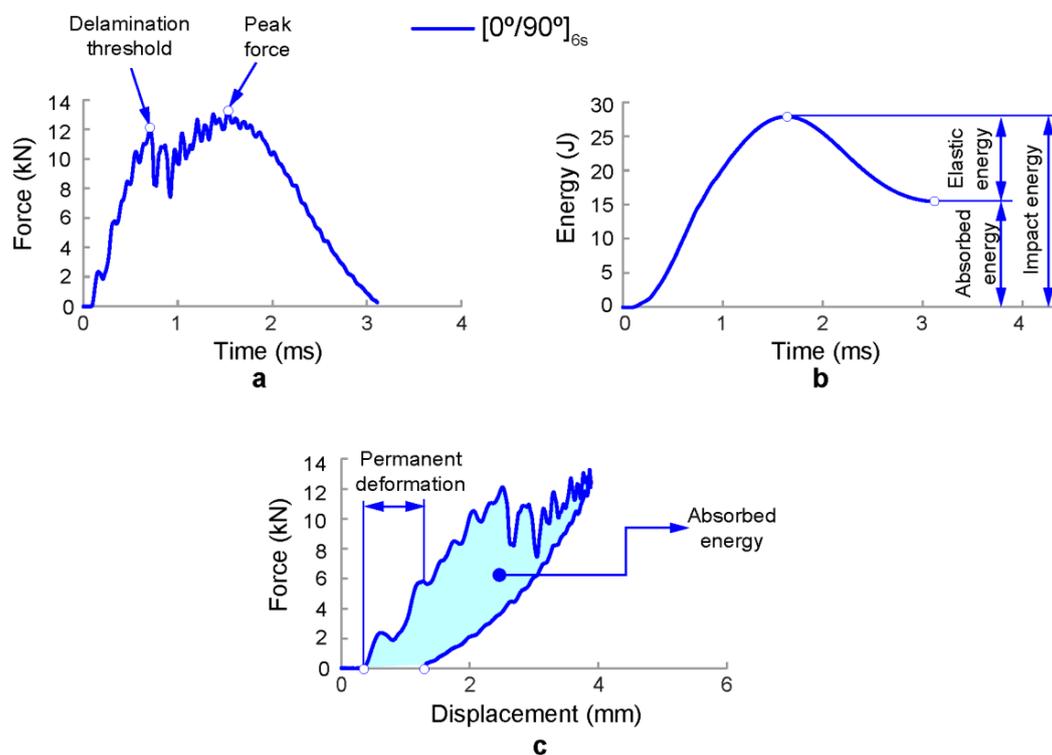
Figure 3. Impact damage response histories of typical composite laminates under drop-weight impact test: (a) force–time history, (b) energy–time history, and (c) force–displacement history [3].

Impact resistance can be determined in terms of the absorbed impact energy, peak force, peak deformation, duration of impact contact, and the resulting extent and type of damage. The damage response parameters can be obtained using the recorded impact histories of force-time,

force-displacement, and absorbed energy-time (Figure 3). Peak force refers to the maximum value of force registered during the contact event between the impactor head and the specimen and the absorbed energy is the amount of energy transferred from the impactor to the specimen at the end of the test. Figure 3a depicts a typical force–time history of a drop-weight impact test. In the initial phase of contact, slight oscillations can be observed due to the elastic vibration induced by the initial contact between the impactor and the composite laminate. After that, some oscillations are observed which indicates the presence of damage. The first abrupt drop of force is due to a reduction of bending stiffness because of the brittle impact damage behaviour of CFRP and the delamination threshold is reached. After the first drop, the contact force increases again. Smaller force drops indicate crack growth in the specimen. The maximum contact force is reached at the peak force. The impactor then bounces back, and the load is reduced to zero. Hence, the impact force history of the low-velocity impact event provides important information regarding the damage initiation and propagation [12]. Figure 3b shows the absorbed energy–time relationship. The initial kinetic energy of the impactor is transferred to the composite plate once contact is made. During the impact event, part of this energy is the absorbed energy by the plate in the form of elastic deformation (elastic energy). The energy in excess is dissipated through several failure mechanisms, such as fibre breakage, delamination, fibre-matrix debonding, and matrix cracking. Hence, the absorbed energy by the specimen is an indication of the magnitude of damage [11]. Finally, force–displacement curves are shown in Figure 3c. The first part of the curve represents the stiffness of the non-damaged laminate. The second part of the curve depicts the unloading phase with elastic recovery. In addition, some permanent deformation can be observed. In this case, a part of the impact energy has contributed to form internal damage within the composite laminate.

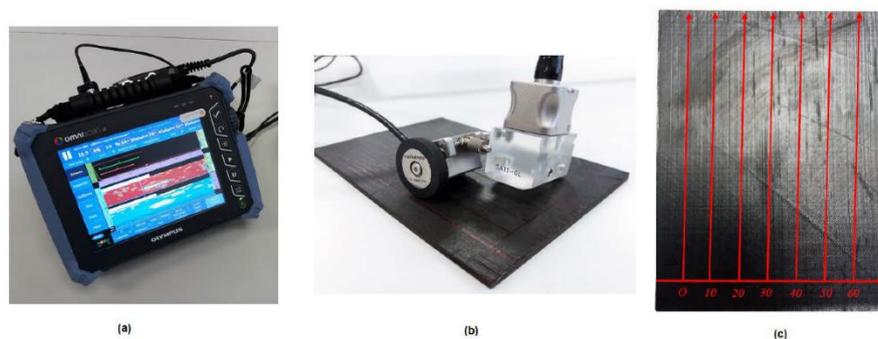
Figure 4. Experimental setup of phased array ultrasonic testing. (a) Olympus Omniscan SX. (b) Phased-array transducer of 64 elements at 5 MHz with coupled encoder. (c) Details of the raster scan scheme for the composite laminates.

Phased array ultrasonic inspections were performed using the Olympus OmniScan SX (Olympus Ltd., Tokyo, Japan) equipment with a phased-array transducer of 64 elements at 5 MHz (Figure 4a).

The purpose of the ultrasonic inspection was to locate and measure the area of the laminate affected by the low-velocity impact. Internal delamination causes the beam reflection due to a discontinuity in the material. The C-Scan images provide a complete view of the damage extension after each impact test. A mechanical scanner with encoders was used to track the transducer coordinates to the desired index resolution (Figure 4b). The method selected for the inspection was a raster scan as depicted in Figure 4c. Several sweeps have been performed to obtain a complete view of the damage extension.

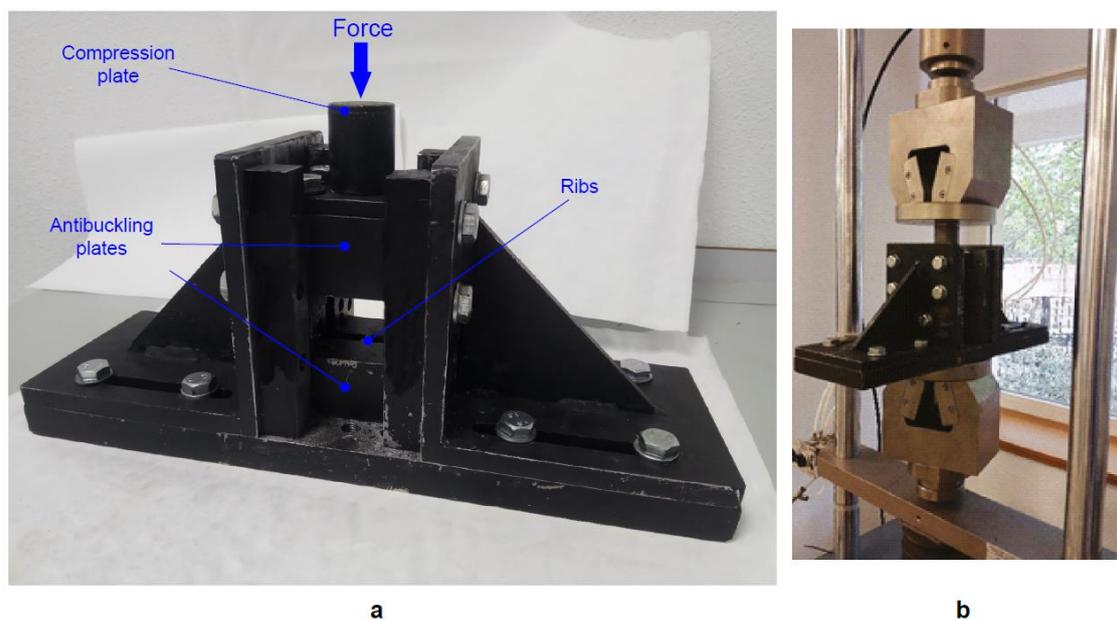
Figure 5. (a) Description of the non-standard adjustable CAI device proposed in this study. (b) Experimental setup for CAI testing.

Compression after impact tests were performed in order to evaluate the influence of temperature and time of thermal ageing on the residual strength of CFRP laminates. Compression after impact tests were carried out on a universal electromechanical MICROTTEST EM1/100/FR testing machine with a 100 kN load cell at a constant displacement rate of 0.5 mm/min. The ASTM 7136 [17] proposes a standard CAI device for testing polymer matrix composite materials with a maximum thickness of 4 mm. However, a non-standard CAI device was designed in a previous study [19] to ensure that the failure (local buckling) does not occur in the top or bottom edges of the specimen due to compression-shear when testing specimens with a thickness lower than 4 mm. Because of its design, this CAI fixture ensures compression failure instead of global buckling and allows damage propagation perpendicular to the applied load. Figure 5 shows a schematic description of the non-standard CAI device and the experimental setup for CAI testing. The device is composed of a support structure with two pairs of anti-buckling plates, containing a set of vertical ribs that stabilize the specimen during test, increasing the buckling load. Anti-buckling plates are divided in two parts and they are fixed to the loading plates. The specimen is placed between the two pairs of anti-buckling plates, being supported by all the vertical ribs. Between the anti-buckling plates, a square central gap allows deformation during compression. The vertical ribs have sharp edges to minimize friction by reducing contact area. The compression after impact strength (σ_{CAI}) was calculated based on the ultimate load (P_{max}) and the specimen cross-section dimension ($\sigma_{CAI} = P_{max}/b \times h$), where b and h were the specimen width and thickness, respectively.

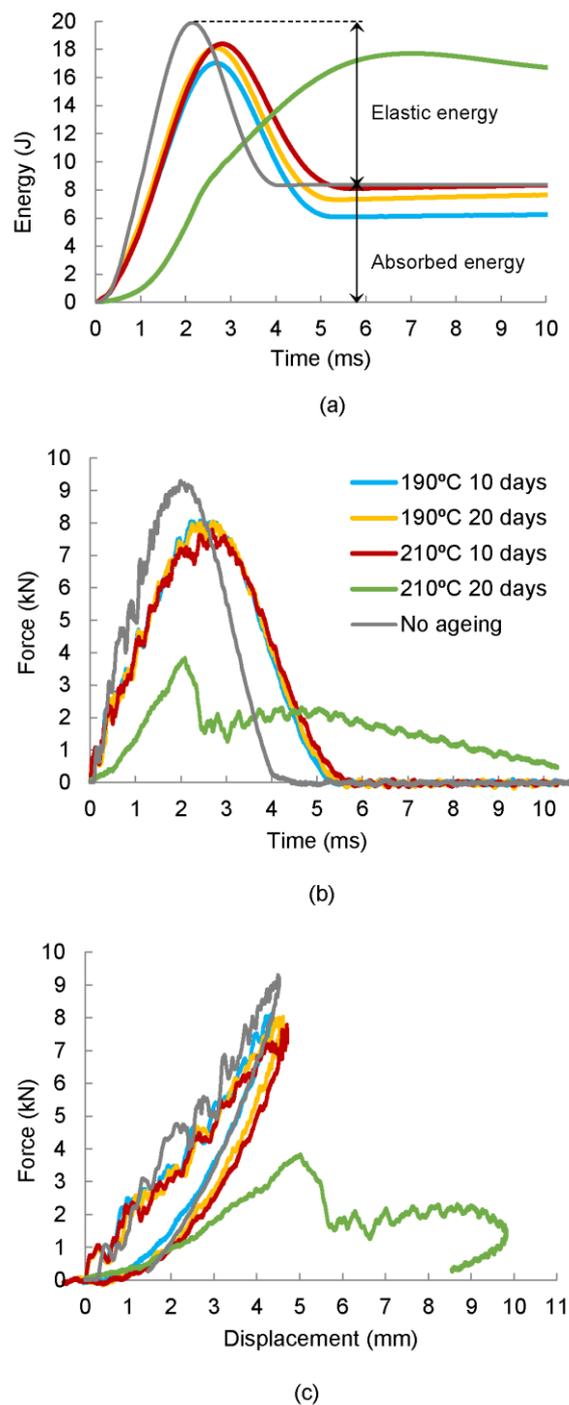
Figure 6. (a) Average energy and (b) force histories and (c) force–displacement curves of non-aged $[0/90/\pm 45]_{2s}$ quasi-isotropic composite laminates with different ageing processes.

In this study, two types of behaviour in relation to the maximum force (peak force) and the absorbed energy in the form of damage with permanent deformation were observed in the curves due to thermal ageing. It was found that non-aged specimens absorbed more energy in the form of permanent damage than those aged at 190 °C (Figure 6a). This fact can be related to a process known as post-curing which occurs at temperatures lower than the glass transition temperature and improves the mechanical properties of the laminates. The loss of mechanical properties of the material is an indication that the first stage of consolidation has ended, and a second stage of degradation has started, in which the oxidation of the epoxy matrix and the decomposition of the fibre interface take place [50]. The curves reveal that the effect of ageing is significant for temperatures above the glass transition temperature and long periods of time (210 °C and 20 days), which is evident in the reduction of the maximum force in the force–time history (Figure 6b), as well as the loss of stiffness associated with a lower slope in the force–displacement curve (Figure 6c). These observations were in accordance with previous works [51]. A general increasing trend of the absorbed energy was observed as the severity of the ageing treatment increases, being especially remarkable the value of absorbed energy for the specimens aged at 210 °C and 20 days that have almost completely lost the ability to absorb elastic energy (Figure 6a). The results demonstrate that the impact response of composite laminates changed significantly as the temperature and time of ageing increase.

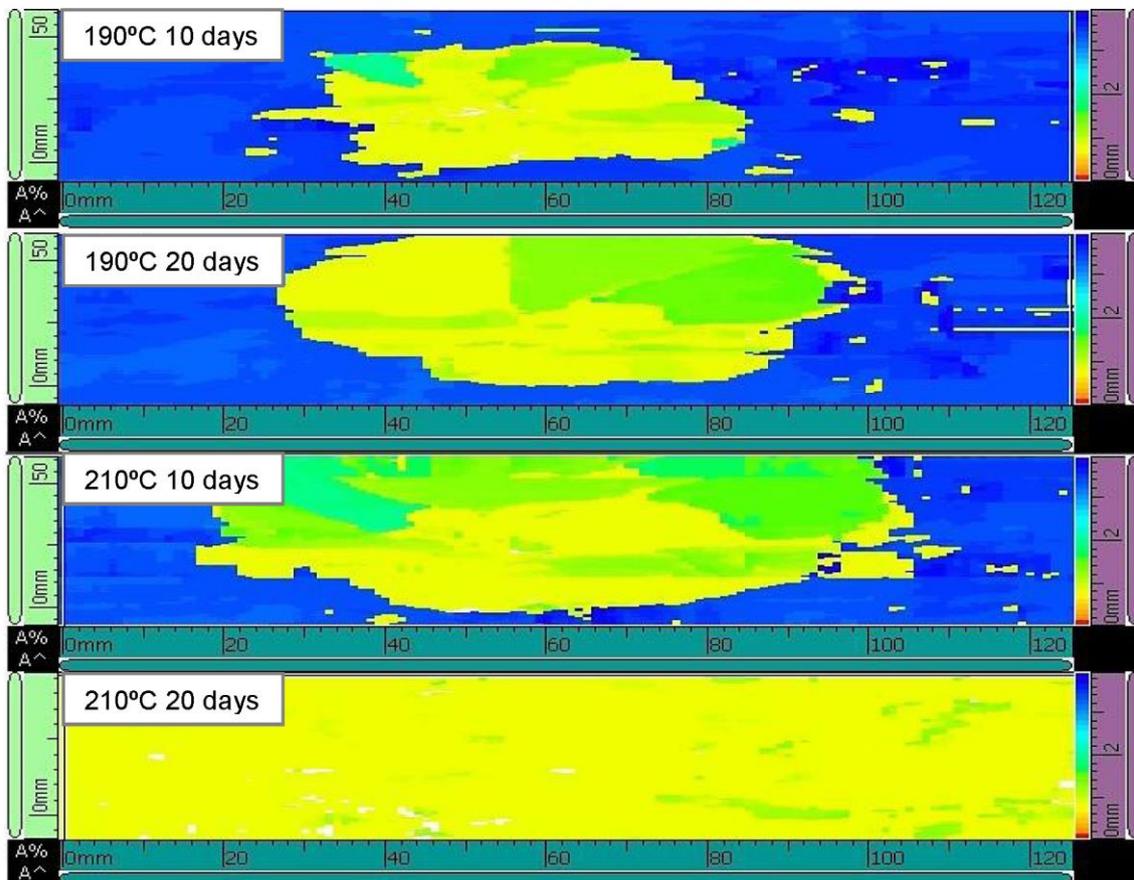
Figure 7. Ultrasonic C-scanning images of the damaged area of $[0/90/\pm 45]_2$ s quasi-isotropic composite laminates aged at different temperatures and periods of time. The effect of ageing on the impact damage response. ($E_{\text{impact}} = 20 \text{ J}$).

The impact energy value in this study (20 J) is not enough to cause visible damage but promotes internal damages areas in the form of delaminations. Hence, higher absorbed energy causes larger damaged areas, as C-scanning images shown in Figure 7. It should be noted that the most undesirable situation corresponds again to the specimen aged at 210 °C and 20 days because severe delaminations, which expand over the entire specimen, are observed.

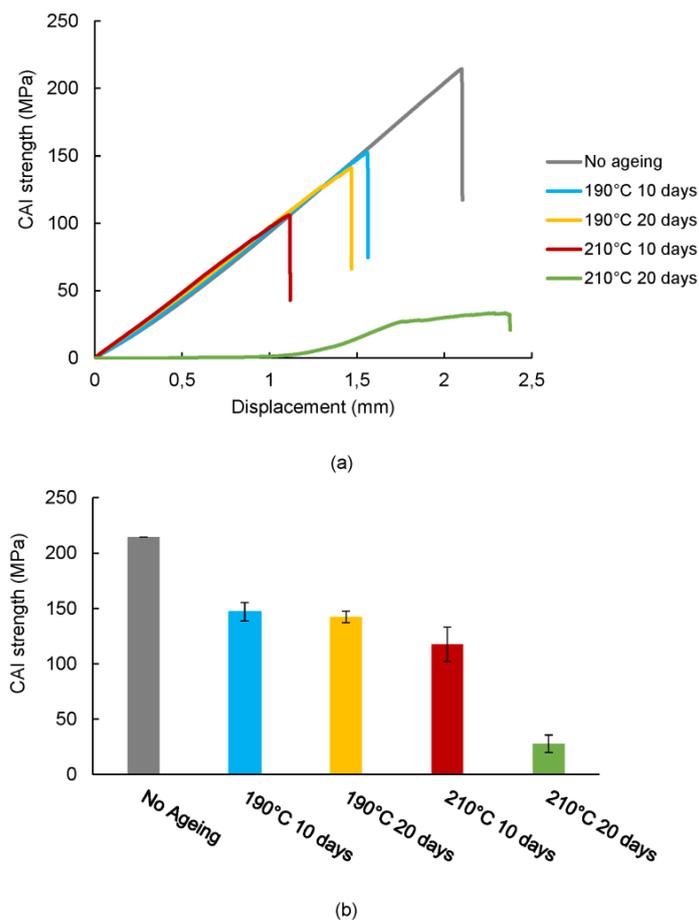
Figure 8. CAI test of thermal-aged $[0/90/\pm 45]_{2s}$ quasi-isotropic laminates. (a) Averaged CAI stress–displacement curves. (b) Average CAI results and standard deviation.

The influence of temperature and time of ageing on the impact damage tolerance and compressive failure mechanism of CAI specimens were analysed in this section. Figure 8 shows the effect of ageing on the CAI strength of quasi-isotropic laminates. As a general remark, specimens that have been exposed to ageing processes present a reduced compressive strength with respect to non-aged specimens. It was observed that both temperature and time of ageing affect gradually the residual strength. It should be notice that specimens aged for 20 days at 210 °C have been specially affected and a reduction of their residual strength from 214.47 to 27.87 MPa (87%) was observed. Nevertheless, a significant loss of compressive strength is also observed at temperatures slightly below the glass transition temperature. Despite the consolidation stage observed in the impact damage resistance of aged CFRP laminates, the CAI strength values are reduced even for ageing at temperatures below the glass transition temperature. Thermal ageing causes a progressive loss of the properties of the matrix and the degradation of the fibre/matrix interface. This effect becomes more noticeable as the ageing time and temperature increases and causes mainly a reduction of the interlaminar resistance. These results were in accordance with previous works [54–56].

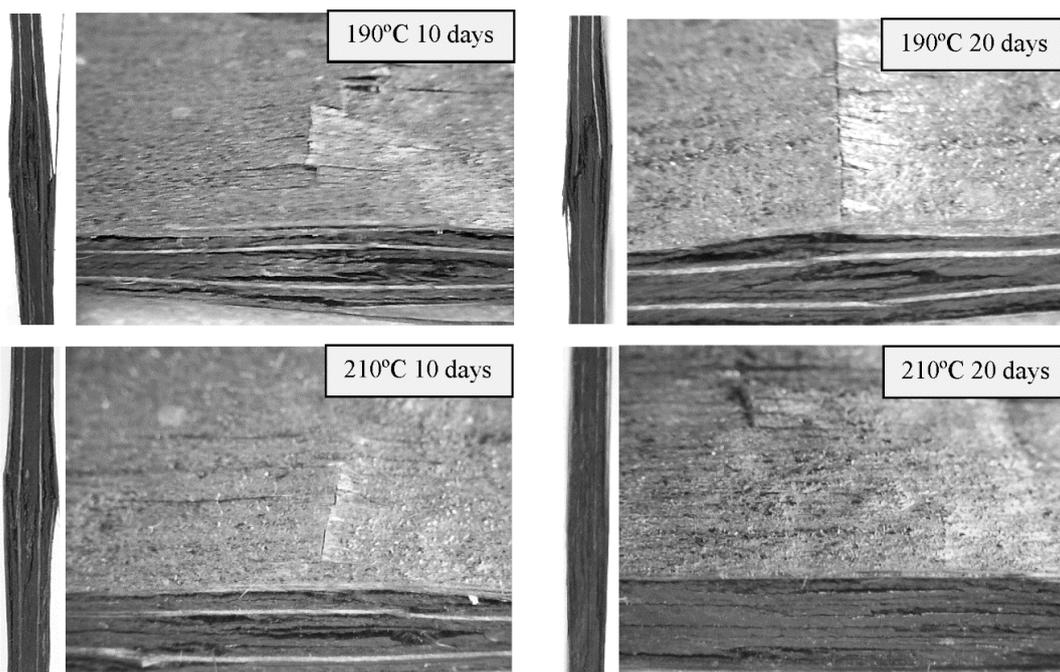
Figure 9. CAI damage profiles during the CAI test of $[0/90/\pm 45]_{2s}$ quasi-isotropic laminates aged at 190 °C and 210 °C for 10 and 20 days. An impact load of 20 J was applied on the front face.

Finally, failure mode of thermal-aged quasi-isotropic laminates $[0/90/\pm 45]_{2s}$ subjected to compression loading are presented in Figures 9 and 10. Compression crack initiates around the impact zone located in the central section where delamination causes by the impact acts as stress concentrator, resulting in shear compression failures. Final failures for all the different aged specimens show similar behaviour (Figure 9), but impacts at the same energy cause delaminations and more extensive matrix cracking in aged specimens at 210 °C and 20 days (Figure 10), decreasing the mechanical properties of the polymer matrix composites, and in particular, impact damage tolerance.

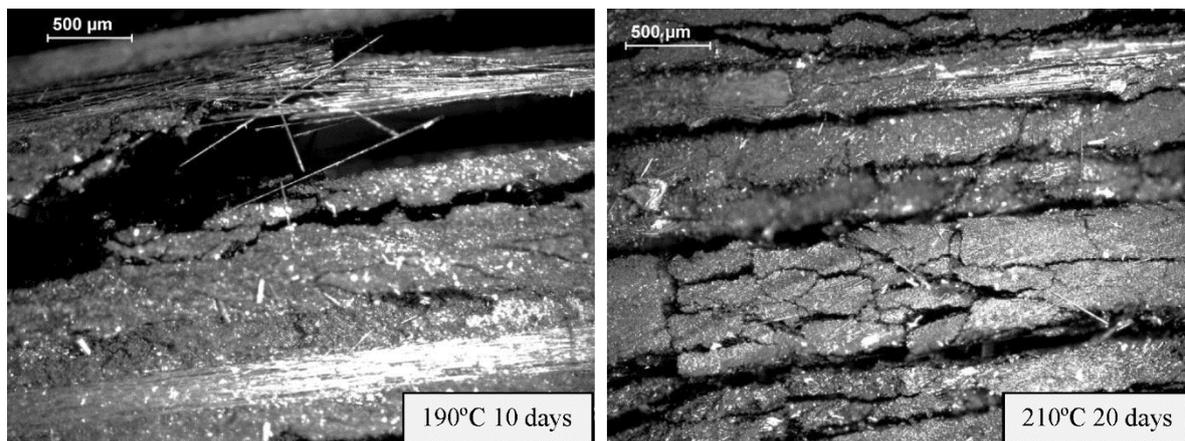
Figure 10. Details of the CAI damage profiles during the CAI test of $[0/90/\pm 45]_{2s}$ quasi-isotropic laminates aged at 190 °C for 10 days and 210 °C for 20 days.
