Effect of Scarf Repair Geometry on the Impact Performance of Aerospace Composites

Abstract: This experimental study investigates the effect of scarf geometry in restoring the impact response of scarf-patched 3 mm thick glass-fiber reinforced polymer (GFRP) matrix composite laminates. Traditional circular along with rounded rectangular scarf patch configurations are considered repair patches. Experimental measurements revealed that the temporal variations of force and energy response of the pristine specimen are close to that of circular repaired specimens. The predominant failure modes were witnessed only in the repair patch which includes matrix cracking, fiber fracture, and delamination, and no discontinuity in the adhesive interface was witnessed. When compared with the pristine samples, the top ply damage size of the circular repaired specimens are larger by 9.91%, while that of the rounded rectangular repaired specimens is larger by 434.23%. The results show that circular scarf repair is a more suitable choice of repair approach under the condition of a 37 J low-velocity impact event even though the global force-time response is similar.

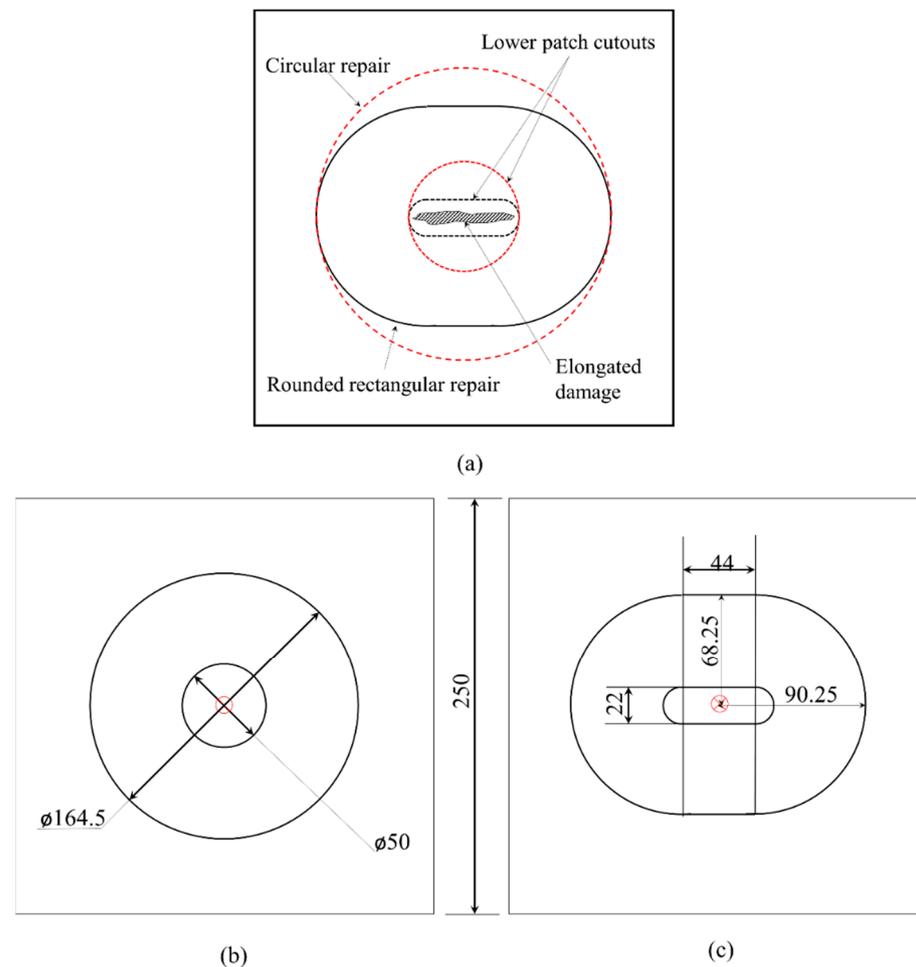
Figure 1. (a) Aerial difference between circular and rounded rectangular repairs for same elongated damage profile. Patch designs for a 3° scarfed repair with similar volume of material removed in (b) circular, and (c) rounded rectangular profiles (all dimensions are in mm).

Therefore, from the limits determined, a scarf angle of 3° was chosen. The manufactured laminates were machined using an abrasive water jet to dimensions of 250 × 250 × 3 mm. To repair the damaged region, it must be completely removed and encapsulated within the cut-out of a lower patch, which dictates the shape of the upper repair region. Wang and Gunnion [14] developed a numerical study to present an optimum scarf shape. Their results revealed that significant savings can be made to the amount of material removal (between 26% and 76%), by adopting optimum repairs over conventionally designed repairs under in-plane loading conditions. Furthermore, for low scarf angles, their optimum scarf shape resulted in close to a concentric ellipse with the aspect ratio being approximately equal to the biaxial stress ratio. Additional results also indicated that a hybrid square ellipse profile for high aspect ratio damage could further reduce repair size. Figure 1a illustrates typically seen elongated damaged profiles and commensurate circular and rounded rectangular designs. A rounded rectangular repair patch has 27.5% less volume than a circular repair patch, which also translates to lower undamaged material removal during the machining process.

The damage areas are approximately 181.63 mm², 199.64 mm², and 970.33 mm², for pristine, circular, and rounded repair specimens, respectively. It is also noticed that the size of the damage is influenced by the patch symmetry, as depicted in Figure 1, despite circular and rounded rectangular scarf repaired samples having similar bonding areas of 19,315.13 mm² and 19,317.9 mm², respectively. The damages witnessed in rounded rectangular scarf repaired laminates are oriented towards the major axis of the patch. In contrast, the damage propagation in minor axes is limited within the bottom cut-out.

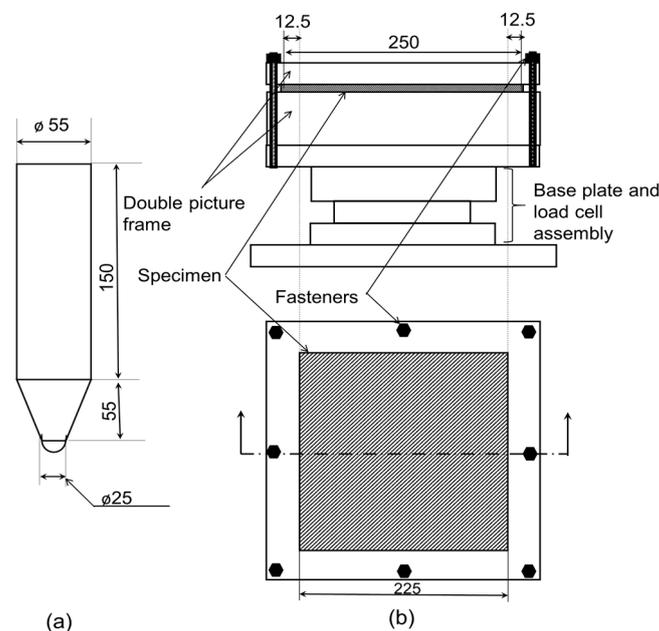
Figure 2. (a) projectile profile and (b) impact fixture setup (all dimensions are in mm).

A cone-shaped steel impactor with a diameter of 25 mm hemispherical head shown in Figure 2a was used as the drop weight impactor. An accelerometer was fastened to the 3.5 kg impactor to measure the acceleration of the impactor during the testing. The experimental setup of the tool drop test is shown in Figure 2b, the outer 12.5 mm width of the specimen is clamped by a hollow double picture frame such that the central 225 × 225 mm area is not supported. The impactor was allowed to slide freely inside a PVC guide tube at a predetermined height. A slit was cut on the guide tube for the wires on the accelerometer to move freely with the impactor. All specimen edges were fixed with a picture frame on a metal surface plate. The larger side of the repair patch was facing the impactor. A force sensor was sandwiched between a surface plate and a heavy metal base to obtain the impact force. An oscilloscope was used to collect data from the force sensor and the accelerometer. A high-speed camera was placed at the same height as the panel surface to record the impact process and calculate impact velocity and rebound velocity. The initial impact velocity was estimated based on the potential energy of the impactor. The actual

In the current impact experiments, the impactor drop height was set to 1.07 m, resulting in an impact velocity of 4.61 m/s and loading the samples at 37 J. This is a typical high energy (beyond 25 J), these tests were conducted as part of evaluating component repair during the event of accidental tool drop during MRO procedures [4].

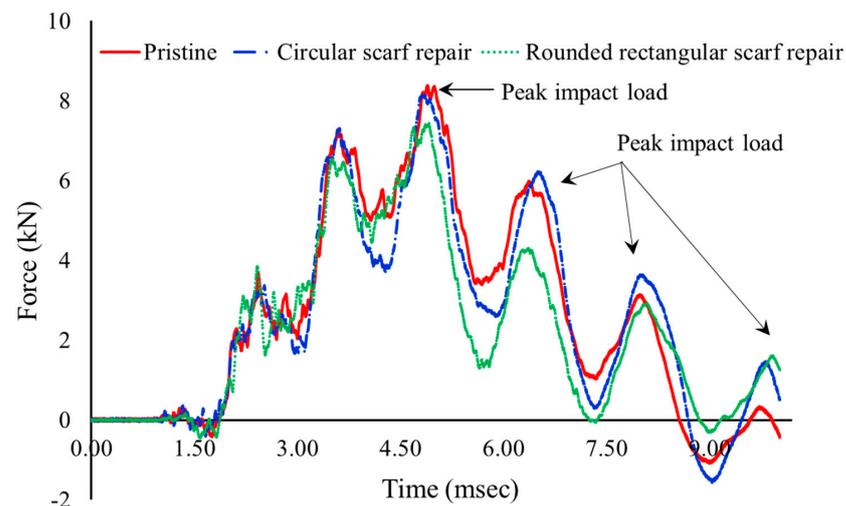
Figure 3. Force versus time response of impacted samples.

The force-time history of the impacted samples is plotted in Figure 3, as the impactor impinges the test sample initially it can be observed that the load increases sharply due to Hertzian contact and has a sudden drop. The Hertzian contact force of pristine and circular repaired samples is (3.68 kN) and that of the rounded rectangular repair sample is 3.87 kN which is 5.1% higher than the pristine sample. Hirai et al. [18] in their work which dealt with the impact response of the woven fabric found that the incipient damage load in their tests on woven GFRP laminates was a consequence of interface failure or matrix cracking near the tension dominant side (bottom side) of the laminates and is given in terms of mode-II fracture toughness (G_{IIc}) as [19] (the predictions of threshold load value

where, E (24 GPa) and ν are the flexural moduli, Poisson's ratio of the laminate, t is the thickness, and G_{IIc} is the mode-2 fracture toughness of the laminate (4.55 kJ/mm² [21]). Through Equation (4), it was found that the critical failure load (P_{cr}) for the GFRP laminates used was 5.1 kN. The peak force observed from the tests is listed in Table 1 (an average of three samples): pristine samples are at 8.39 kN, circular patch repair samples are at 7.72 kN, and rounded rectangular ones are at 7.14 kN. The oscillations within the Hertzian contact and subsequent rise of load can be attributed to impactor ringing and flexural vibration of the impacted specimen. After the Hertzian contact, the load exceeded the P_{cr} along with large oscillations to the peak observable load. Following peak load, the impactor was allowed to rebound three times till the energy completely dissipated and was able to mimic accidental tool drop in the targeted component.

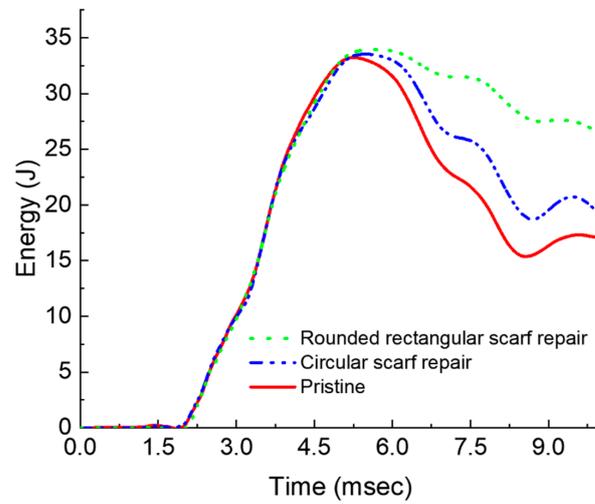
Figure 4. Energy versus time response of impacted laminates.

Typical impact energy versus time responses is depicted in Figure 4. Within experimental scatter, the peak energy absorbed by all three samples is around 33.5 J, close to that of 37 J potential energy imparted by the drop-weight. It is to be clarified that the energy plot in Figure 4 has been plotted for the total duration of the experiment. In contrast, in Figure 3 the impact event starts at ~1.5 ms and ends at about 9.5 ms with the impact event duration being approximately 8.5 ms. According to the energy profile diagram (EPD) proposed by Liu [22], the closeness of impact and the absorbed energy indicate the laminate failure by projectile through penetration. It can be observed that the rounded rectangular repaired sample (I) has absorbed 52% more energy compared to pristine and 36% more compared to circular scarf repaired laminates post-peak energy at the point of impact. High energy absorption by the rounded rectangular scarf repair can directly correlate to the damaged area (Figure 5), which will be discussed in Section 4.1. Similarly, the energy absorbed by

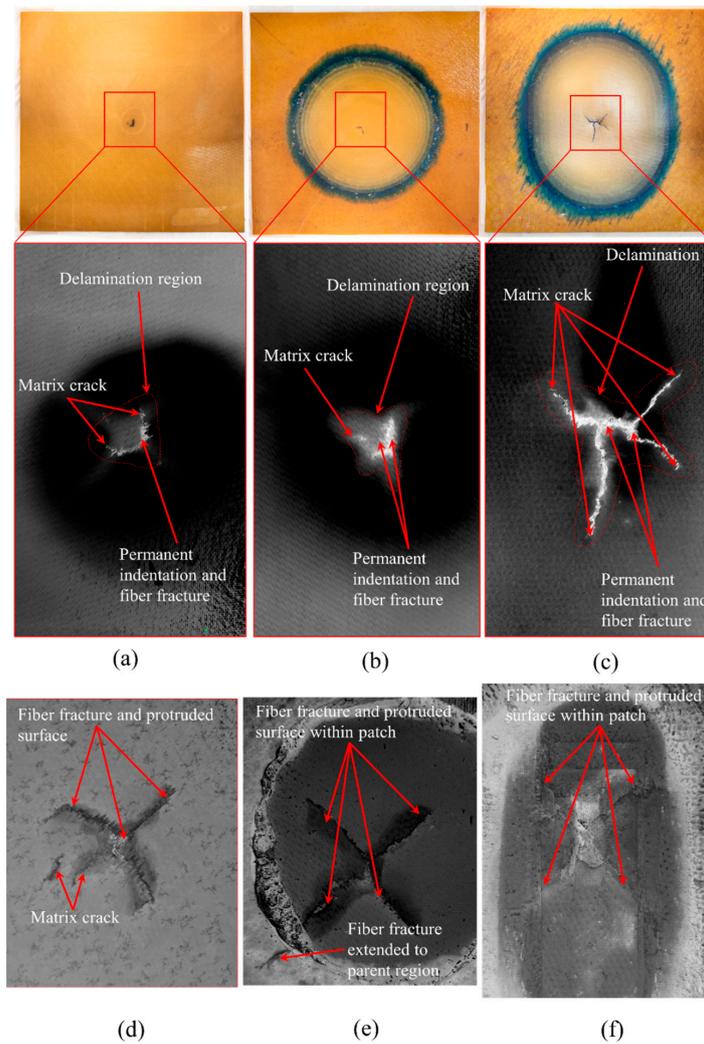
Figure 5. Visually observed (top view, bottom view) impact damages of (a,d) pristine laminate; (b,e) circular scarf repaired laminate; and (c,f) rounded rectangular scarf repaired laminate.

Following impact tests, the samples were retrieved for failure examination and was observed that all the samples impacted at 37 J had a damaged region which included a centrally depressed region/permanent indentation, matrix cracking, localized delamination areas, and fiber fracture. Figure 5 shows visually observed impact damage on the three tested specimens. Prior to taking images (with a Nikon Z camera with NIKKOR Z 35 mm f/1.8 S lens on a manual focus setting) the samples were coated with black ink and wiped such that the intricate cracks were filled with isopropanol-based graphite ink and the samples were dried in a convection oven at 85 °C. The samples were placed in the picture frame with high-intensity white light behind the sample. The translucency of the samples enabled us to discern discontinuous fibers as well as matrix and black ink helped accentuate the difference more lucidly. The damaged region was cropped with greyscale inversion to discern the surficial cracks from the undamaged surface.

The damage region of the pristine and circular scarf repair specimens are relatively symmetrical quatrefoil and trefoil shapes, respectively, whereas rounded rectangular scarf repair specimens are asymmetrical with predominant delamination towards the major axis of the rounded rectangle. The damage area was calculated in such a way that the point of impact was considered as the center of damage and the crack that propagated to the maximum length from the center is the radius of the circle of damage. The area of the circle is what gives us the damaged area. The reason for the circle being considered as the damaged area is that one must machine this area for repair purposes. Thus, the damaged area is computed as a circular region whose radius is the furthest point of the delamination region from the impact point. The damage size in circular and rounded rectangular repairs is on average greater by 9.91% and 434.23% when compared to the pristine sample.

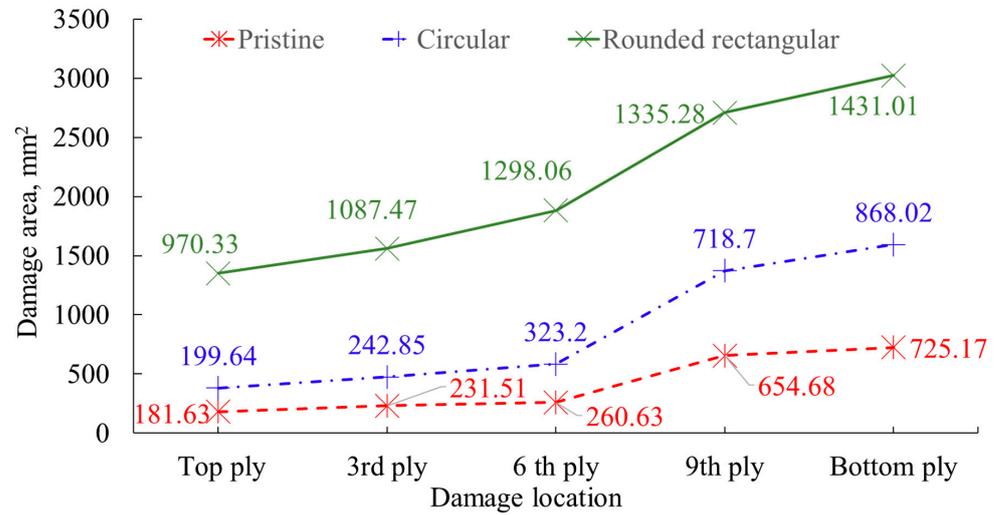
Figure 6. Damaged area for different plies for tested configurations.

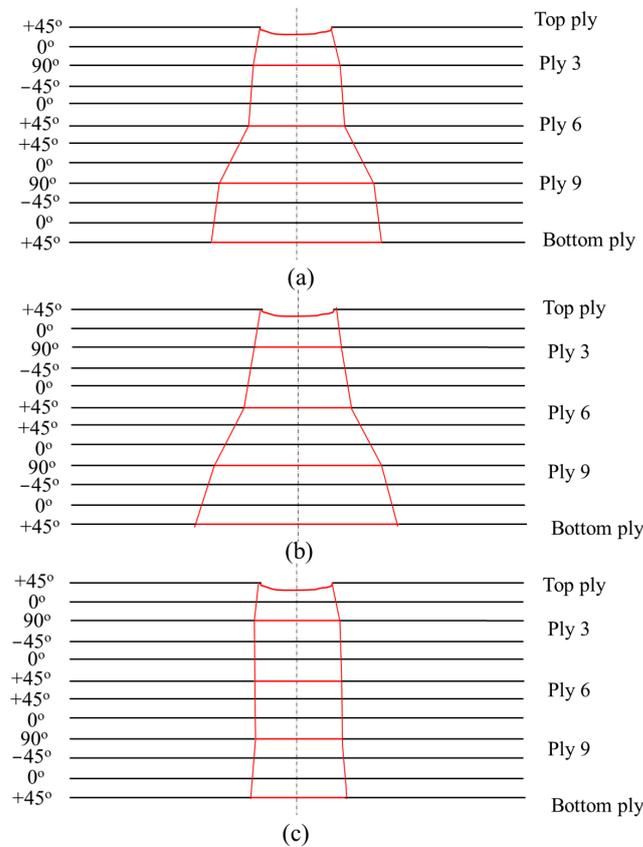
Figure 7. Cross-sectional damage profile with respect to the size of the top ply damage area of (a) pristine laminate; (b) circular scarf repaired laminate and (c) rounded rectangular scarf repaired laminate.

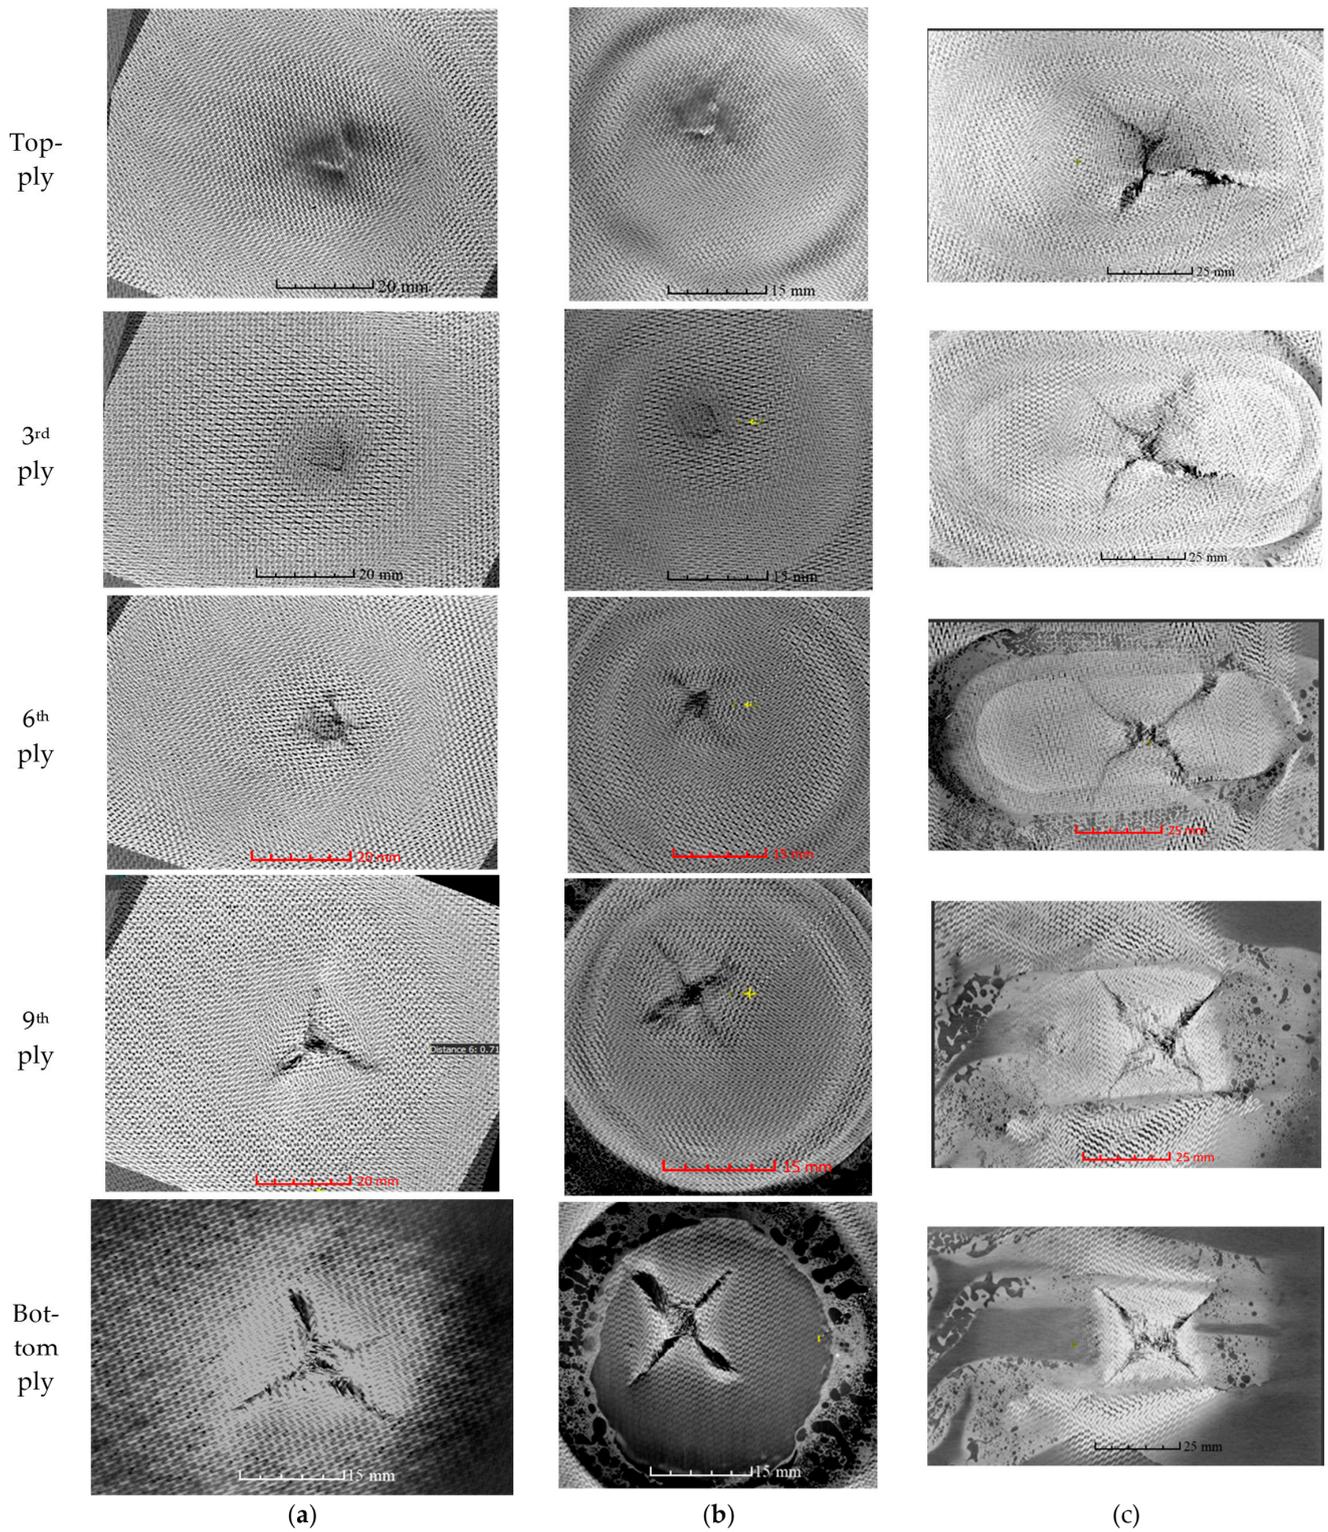
Figure 8. CT scan images for various plies for (a) pristine, (b) circular repair, and (c) rounded rectangular repair.

Figures 8 and 9 show CT scan image slices in the top, third, sixth, ninth, and bottom plies, and depicts the cross-sectional view of the damaged laminates. We observe that the damage size from top to bottom ply gradually increases for both pristine and circular patch-repaired laminates. In contrast, it is almost constant for the rounded rectangular patch laminates. In both pristine and circular repaired patch laminates the evidence of fiber breakage can be witnessed in the plies beneath ply 6 (Figure 9a) and ply 5 (Figure 9b), respectively, in the case of rounded rectangular patch repaired laminate the onset of fiber failure is witnessed from ply 3 onwards (Figure 9c). Figure 8 reveal that all three tested sample undergo permanent indentation at the point of impact. The permanent indentation in the rounded rectangular scarf repaired laminate is most obvious due to maximum roving failure at the bottom side of the laminate enabling greater projectile penetration. It is also

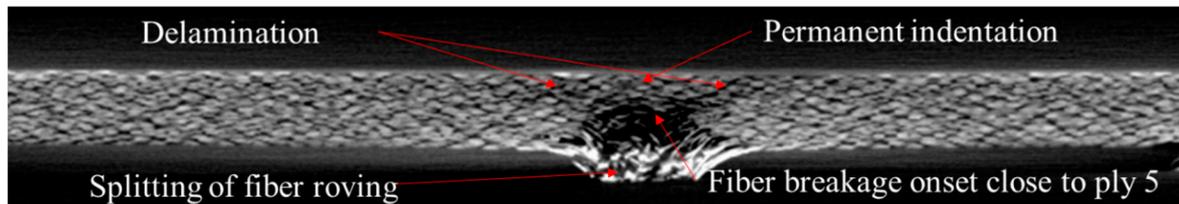
(b) Circular repair sample

Figure 9. Cross-sectional view of (a) pristine, (b) circular, and (c) rounded rectangular repair.
