Article

Erosive Wear of Structured Carbon-Fibre-Reinforced Textile Polymer Composites under Sands Blasting

Keywords: erosive wear; carbon-fibre-reinforced polymer (CFRP); carbon fibre structures; architectural topology; solids particle impacts

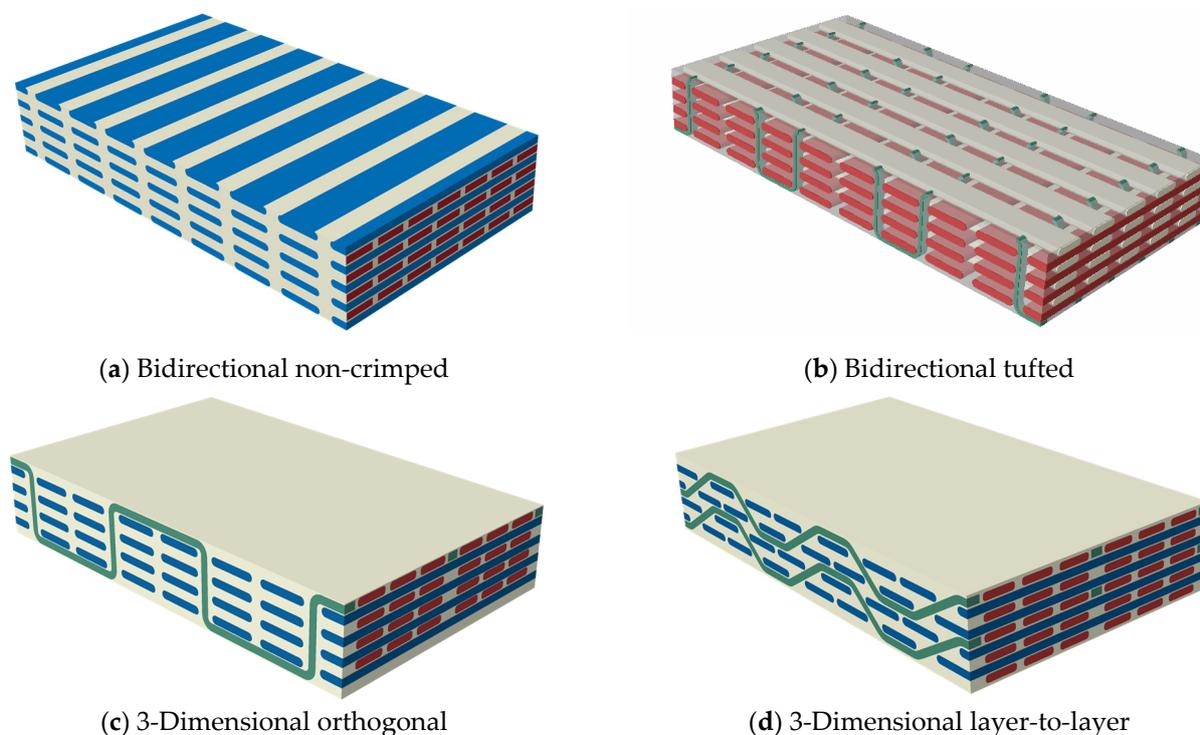
Figure 1 illustrates the four types of specimen target composites with the carbon fibre reinforcement structures; two bidirectional (BD) and two 3-dimensional (3D), which were designed and fabricated at the Engineering Composites Research Centre, School of Engineering, Ulster University [26].

Figure 1. Schematic images of the CFRP composites tested and the structures of the architectural topology: (a) bidirectional non-crimped, (b) bidirectional tufted, (c) 3-dimensional orthogonal, and (d) 3-dimensional layer-to-layer architectures.

The matrix/substrate material was an epoxy resin called LY564 with hardener HY 2954 (cycloaliphatic amine-based hardener). The fibre was the HexTow 12k continuous carbon fibre material, which was selected by the suitability for the composite fabrication. The composites were manufactured using the resin transfer moulding technique, and well-consolidated composite plaques were obtained. The composite sheets were subsequently cut into the right sizes (25×25 mm) for the erosion tests.

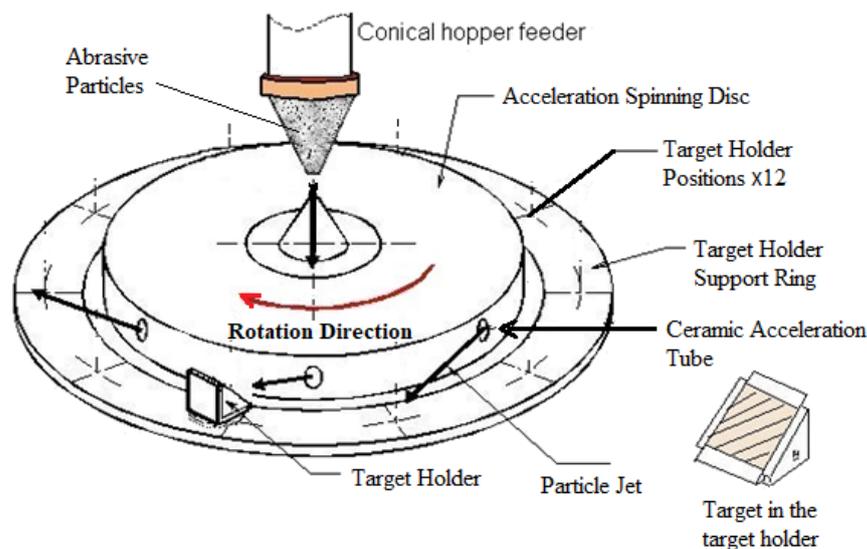
A centrifugal erosion tester was used in this study, which was developed at the Wolfson Centre, University of Greenwich, UK [27]. As shown in Figure 2, it consists of a feeder, a spinning disc with ceramic acceleration tubes inside, target holders which hold the test targets at desired angles and a control unit to drive the spinning disc at designed rotational speed so the particles can be accelerated to a designed impact velocity. Eroder particles are continuously fed into the spinning disc at the central feeding point of the disc and accelerated through the radial acceleration tubes by centrifugal force. The particle velocity is controlled by the rotational velocity of the disc. When the particles are ejected from the end of the tubes, the particles travel at the pre-set velocity and strike the target at a designed impact angle which is set by rotating the target holder. The detailed calibration of the impact velocity and impact angle can be found in the previous study [28].

Figure 2. Schematic diagram of the centrifugal erosion tester and a target holder [27].

The specimen targets are set around the disc on the holders, which face the direction of particle jet perpendicularly and are rotated at the designed impact angle [28]. Edge and back faces of the targets are protected from the particle jets to prevent unnecessary erosion at unwanted locations. Up to twelve target positions on the holder support ring are available in one test, which can generate erosion data of the targets at different impact angles.

Prior to the erosion test, the test targets were prepared to the same size (25×25 mm square and 5 mm thick) so they could be fitted into the target holder (see Figure 2). The target surface was kept at the original manufacturer's finish conditions without any further polishing because surface polishing could damage the surface structures of the polymer composites. The test specimens were cleaned thoroughly in an ultrasonic cleaning bath for 15–20 min using isopropyl alcohol. After drying in a low-temperature heat oven at 80°C for 15 min, the initial weight of the targets before testing was taken on an electronic balance, accurate to 0.1 mg. Two samples for each impact angle were tested simultaneously to ensure good repeatability. For each erosion test, 500 g of olivine sand was pre-weighed, dried and used for the erosion test. The erodent was fed to the tester at a feeding of 2.1 g/s using a small feeding hopper, which gave the particle concentration of approximately 0.5 kg/m^3 at the impact points. Minimum of 8 repeated runs of erosion tests were performed to ensure a steady weight loss of the materials was achieved. After each test, the targets were collected and cleaned using the same cleaning procedure. Then, the weight of the targets was measured to find out the weight losses.

Four different impingement angles (20° , 30° , 45° and 90°) were tested by rotating the angle of the targets horizontally. The targets were adjusted to face the particle jets perpendicularly according to the existing angle of the particle jets (see Figure 2). The rotational speed of the spinning disc was fixed to 2342 rpm (measured by a tachometer), which gave an impact velocity of particles at 40 m/s. The particle velocity was calibrated using the Ruff and Ives double-disc method [29]. In this work, the specific erosion rate (E_r)

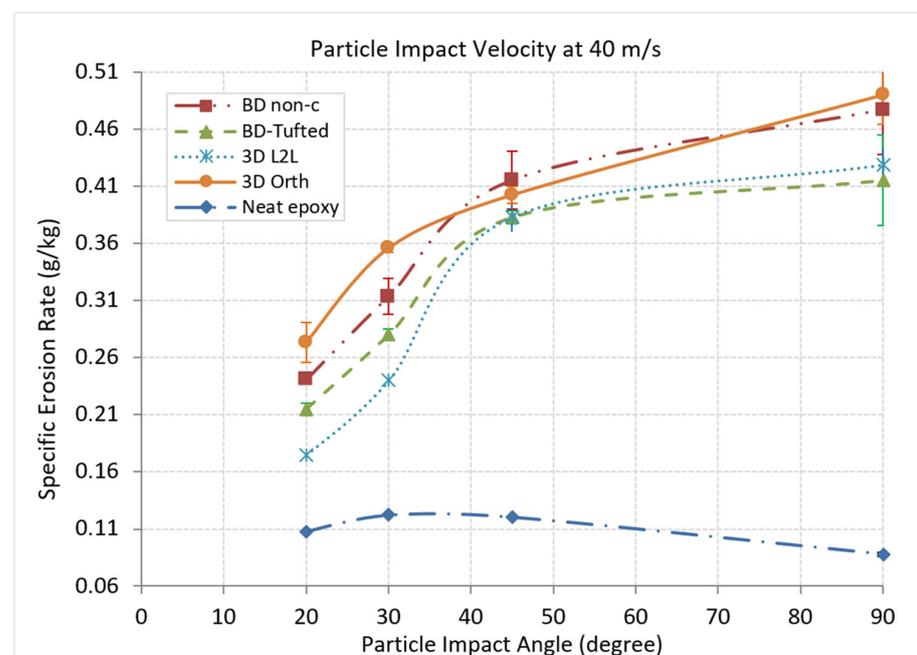
Erosion experiments were undertaken to evaluate the erosion of the CFRP textile composites. The specific erosion rates are shown in Figure 3 as a function of impact angles. The result of neat epoxy is also included for the same erosion conditions but with a smaller erodent particle size (D_{50} at 238 μm), which is taken from a previous study [25].

Figure 3. Specific erosion rates of bidirectional non-crimped, bidirectional tufted, 3D orthogonal, 3D layer-to-layer architecture carbon-fibre-reinforced epoxy composites and neat epoxy at four impact angles of 20°, 30°, 45° and 90°.

For the results shown in Figure 3, the textile composites tested clearly exhibited as brittle materials because the erosion rates raised with increased impact angles and the highest erosion rates were at the impact angle of 90°. Between the textile composite materials, erosive behaviours are broadly the same, but with a small difference in erosion rates. Compared to the neat epoxy material tested previously, the textile composites showed a change from ductile material erosion to brittle material erosion.

The results in Figure 3 show the difference clearly at the high impact angle, in which the erosion rate of the CFRP composites is about five times more than that of the neat epoxy.

The difference in the erosion rates between the bidirectional and 3D architectures is not so big, which is about 18% of the lowest value of the bidirectional tufted composite. 3D architectures show a similar erosive behaviour, in which the 3D layer-to-layer architecture shows good erosive resistance, but the 3D orthogonal architecture has a high erosion rate. The reason for this phenomenon is thought that the tightened carbon fibre bundles lead to enhanced out-of-plane properties [34], which consequently limits the erosion rate of the 3D layer-to-layer architecture composites, as shown in Figures 5 and 6c,d.

The results in Figure 3 also indicate the influence of carbon fibre structures on erosion mechanisms of the composites, although the influence is small. Generally, the CFRP composites have a similar behaviour to a brittle material due to the influence of carbon fibres. However, the types of structures may alter the erosion rate slightly because of how the fibre is broken or protected. The SEM photos show that the carbon fibres can be damaged and lost quickly once they are broken into small pieces. As the fibres are about 7–9 μm in diameter and the longitude dimension is hundreds of times bigger, it is likely the fibre is removed as a chunk once it is broken, although the fibres could be more rigid than the epoxy and its behaviour in matrix could be influenced by many other factors [35]. Unlike other brittle materials, the hardness of carbon fibre could be influenced by its orientations. Epoxy behaves differently, which is like ductile materials. At the high impact angle, the results show the difference between the fibres and epoxy polymer.

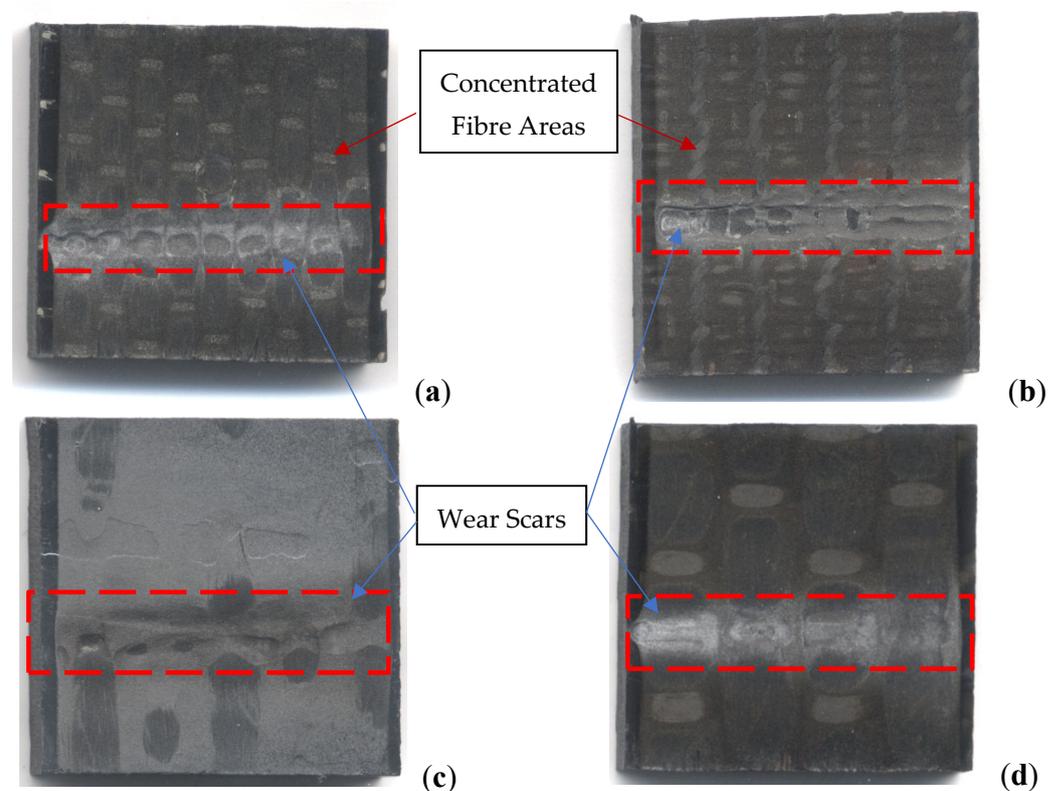
Because of the influence of the reinforcement structures on the erosion of the composite materials, the eroded surfaces of the tested materials have been examined and shown in Figure 4. The surface morphology of the tested carbon fibre/epoxy composite samples on a millimetre scale shows that a thin superficial strip of epoxy is more likely to be removed easily than the carbon fibre, although the resolution of the photos is low. It shows clearly that erosive crater patterns in macro-scale indicate that substrate material (epoxy) is lost more than the carbon fibres, as in the photos, the brighter area represents the carbon fibres, and the darker area is the epoxy resin. Obviously, the darker area has been worn more under sandblasting compared to the brighter area, and the edges (carbon fibre structures) have remained, but it does not mean the carbon fibre is more rigid.

Figure 4. Eroded surfaces impacted at 90° -degree impact angle for: (a) bidirectional non-crimped, (b) bidirectional tufted, (c) 3D orthogonal, and (d) 3D layer-to-layer architectures. The depth of the craters is about 1 mm approximately in the middle, although it has not been shown in the diagram.

For the bidirectional composites (Figure 4a,b), it shows that the substrate (epoxy resin) is separated by the carbon fibre structures and the losses are more likely patterned pockets rather than the 3D architectures which do not have a clear pattern on the surfaces due to a big structural interval. In the erosion results, the difference between the bidirectional and the 3D architecture composites is not clear; however, the tufted and the 3D structures have a smaller erosion rate than the non-crimped structure. The erosion craters also show that the carbon fibre is more rigid compared to the epoxy.

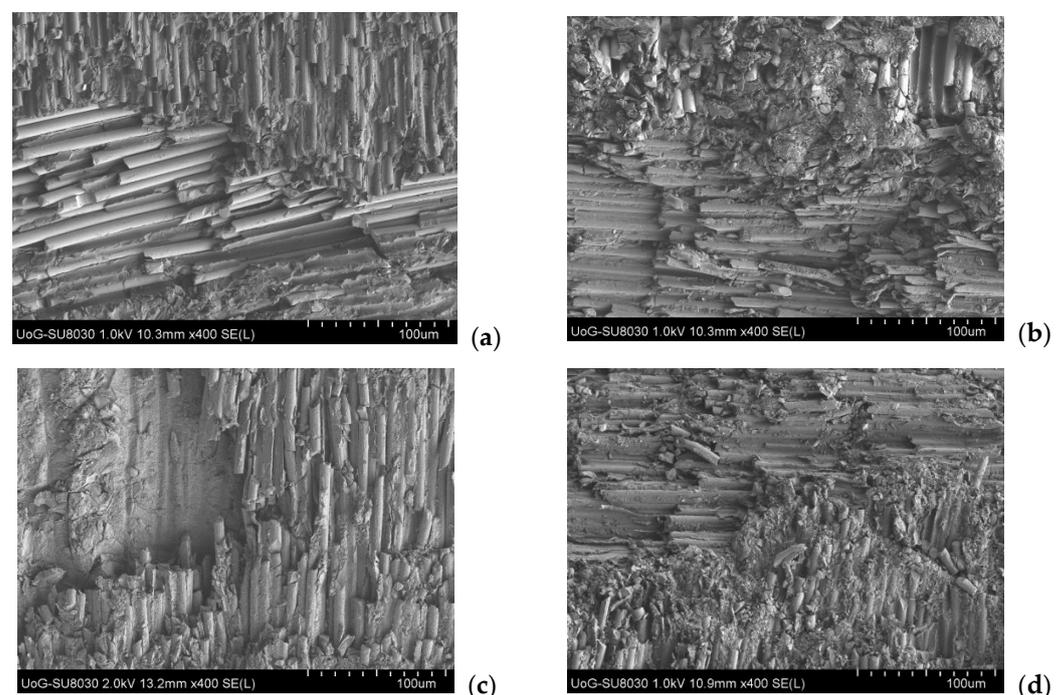
From the damaged surfaces, it can be found that the erosion of textile composites can be very different due to the architectural structures at different impact angles. SEM photos of the eroded surfaces at high and low impact angles for the tested materials were taken, and the results are presented in Figure 5 for 90° and Figure 6 for 20° impact angle.

Figure 5. SEMs of the eroded surfaces: (a) bidirectional non-crimped, (b) bidirectional tufted, (c) 3-dimensional orthogonal, and (d) 3-dimensional layer-to-layer composites eroded by olivine sands at 40 m/s and 90° degree impact.

For the composites eroded at the 90° impacts as shown in Figure 5, it shows that the bidirectional composites had clearly broken fibre layers. As a comparison, the 3D structured composites also had broken fibre layers, but the broken layers are not as clear as the bidirectional composites. The results in Figure 3 show higher erosion rates for the 3D architectural materials, and they behave like brittle materials. The SEM photos clearly show the fracture of the fibres is the major erosion mechanism for the CFRP textile composites. The bidirectional tufted and 3D layer-to-layer composites have a better erosion resistance compared to the bidirectional (non-crimped) and the 3D orthogonal composites. This is thought to be due to tufted fibres and a higher density of the fibre structures [30].

Because neat epoxy has a much better erosion resistance compared to carbon fibres, it was observed that the fibres experienced more material losses once they were broken. For the composites with denser carbon fibre architecture, epoxy contributed more wear resistance, as seen in Figure 5b,d. Therefore, the architectural topology of the textile composites predisposes the structure to more matrix-rich and matrix-pockets to have a better erosion resistance, as the fibres break down quickly. So, the broken fragment of the

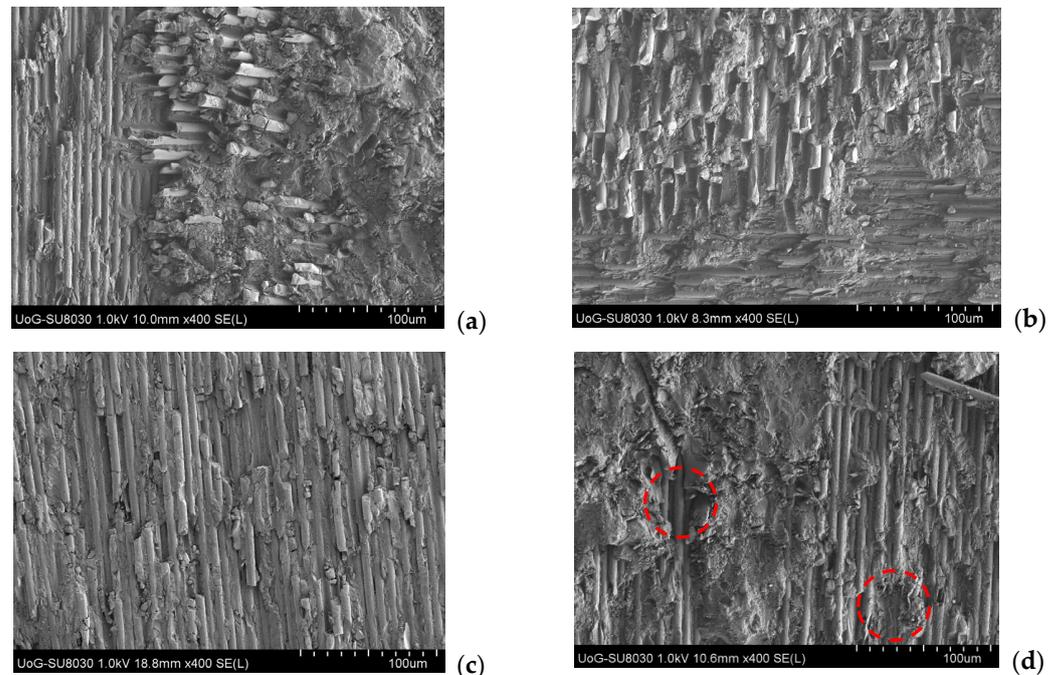
Figure 6. SEMs of the eroded surfaces: (a) bidirectional non-crimped, (b) bidirectional tufted, (c) 3-dimensional orthogonal, and (d) 3-dimensional layer-to-layer composites eroded by olivine sands at 40 m/s and 20° degree impact (where in red circle, more resin material was removed).

individual fibre bundles is the erosive mechanism for the textile composites studied. SEM photos of the eroded surfaces of the composites tested at the 20° impact angle are shown in Figure 6, which may give a different angle of the erosion mechanism. The SEM photos show little difference in the eroded surfaces in comparison with those profiles at the high impact angle. The composite materials all have a similar response across the two angles. Therefore, scratching and cutting can be the main wear mechanisms for erosive wear of these types of composite materials, as reported in the literature [14,23].

As shown in Figure 6d, deep cavities at specific localized regions (in the red circles) can be observed for the 3D layer-to-layer architecture (3D L2L), although erosion results show that the material has the lowest erosion rate compared to the other structured composites. The 3D orthogonal architecture composite has the highest erosion rate in the results. As 3D textile composites comprise of a highly heterogeneous arrangement of fibre bundles in an epoxy matrix, the erosion results are prone to be stochastic depending on how the regions of the architecture are damaged during the erosion process. If the structure of the fibre bundle is broken, there may be a significant material loss, while in the regions where fibre bundles are rigid with the epoxy, say around the binder material, there will be less material loss. Therefore, it will be important that the fibre structures are tightened with more binder materials filled in the pockets.

For the bidirectional architectures, the SEM photos show more consistent results at both high and low impingement angles, but at the high impingement angle, more aggressive loss of the fibres and deep cavities can be found compared to that at the low impact angle. It is noticed that the bidirectional tufted and the bidirectional non-crimped composites show a similar erosion rate at a low-impact angle but a large difference in the erosion rate at the high-impact angle. Hence, it suggests that the erosion mechanisms of the CFRP textile composites are mainly due to the breakdown of the fibres. The epoxy is filled in the matrix of the carbon fibres and contributes less to the erosion resistance of the composites. Therefore, the structures of the carbon fibre matrix will not have significant influences on the erosion performance of the composites, but the denser carbon fibre bundles and enhanced coverage of the epoxy give a slightly high erosion resistance of the composites.

In Figure 6d, it shows the epoxy is scratched and ploughed, but the fibre is cut into large pieces and removed as whole. The SEM photo in Figure 7a shows that the epoxy is scratched and ploughed without any debris, although micro-cracking can be found in Figure 7b. For the CFRP composites, because a major part of the material is the carbon fibres, erosion of the composites will be subject to the carbon fibres and can be influenced by the fibre structures and how good the shielding is by the epoxy, but the influence of the structures will not be as big as the materials.

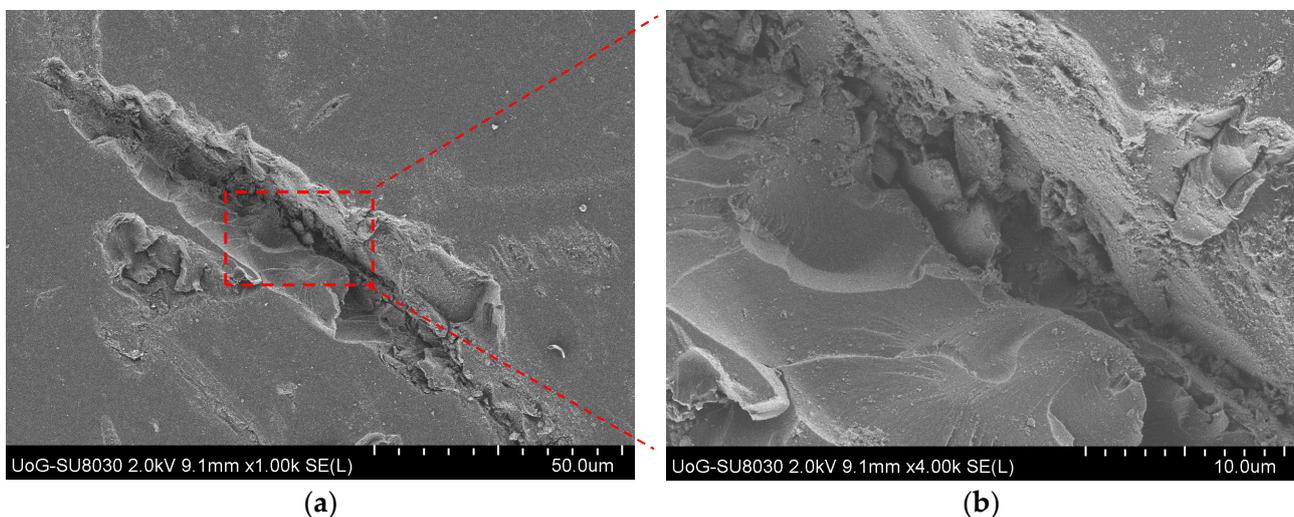
As a comparison, SEM photos on the eroded surface of the neat epoxy polymer were taken and shown in Figure 7. The erosion results in Figure 3 indicate that the neat epoxy polymer has an erosion mechanism that is different from the CFRP composites, as the neat epoxy behaves like a ductile material. The photos in Figure 7a clearly show that the neat epoxy polymer is eroded by cutting and scratching. In the figure, it shows a long cutting crater along the material surface and almost no debris appeared in the image. With the zoomed-in photo (Figure 7b), the cutting mechanism is shown clearer. Compared to the images of CFRP composites, which show a lot of fibre debris, the eroded neat epoxy surface is clean. Thus, the SEM photos indicate the differences in erosion mechanisms between the two types of materials.

Figure 7. SEM photos of the eroded surfaces of neat epoxy polymer: (a) a large scale, (b) zoomed in, eroded by olivine sands at 40 m/s and 20° degree impact.
