Mechanism of Microstructural Alterations of M50 Bearing Steel during Rolling Contact Fatigue under High Loads

Abstract: Rolling contact fatigue (RCF) of vacuum induction melted–vacuum arc remelted (VIM-VAR) M50 bearing steel under high loads was carried out, using a three-ball-rod RCF tester. Dark etching regions (DER) and butterflies were found in the subsurface region below the raceway of the RCF-tested sample. The DER appeared in the region of maximum shear stress located at a depth of 30 μm to 170 μm below the raceway. Carbon atoms migrated through high-density dislocations, and part of the martensite plates was transformed into cellular ferrites, due to the redistribution of dislocations during the deformation of martensite under the action of cyclic shear stress. Butterflies appeared in the region of maximum shear stress located at a depth of 20 μm to 314 μm below the raceway. Butterflies were initiated in the primary carbides, with length values ranging from 5 μm to 15 μm . The plate martensite in the butterfly wings was transformed into nanocrystalline ferrites, due to the increase in the dislocation density and rearrangement of dislocations during the extension of fatigue

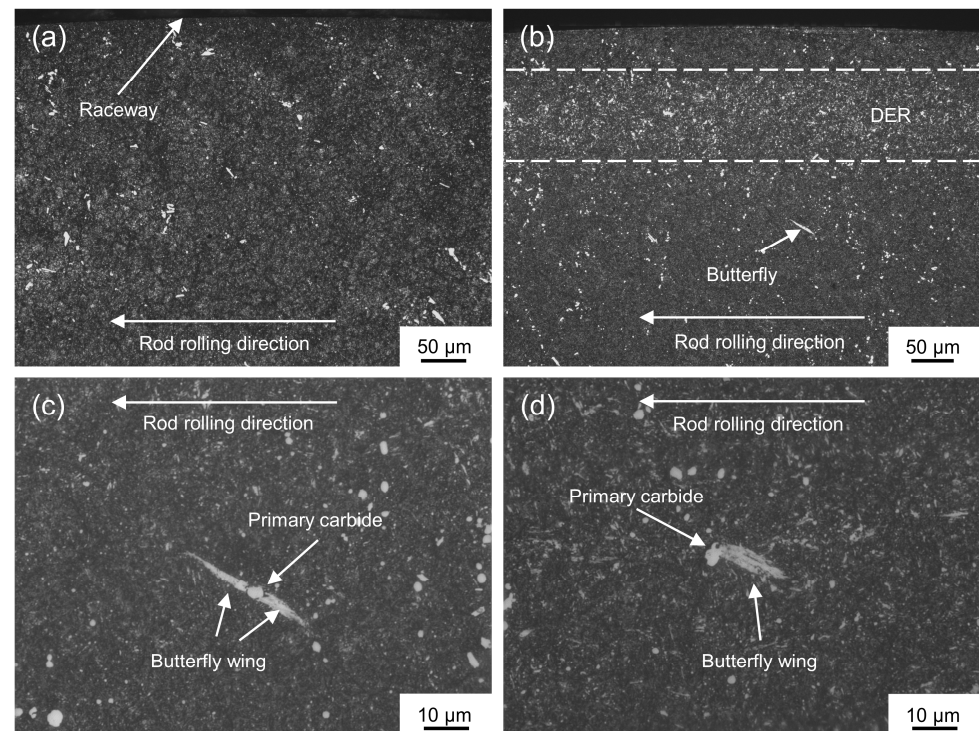
Figure 2. Optical micrograph of the radial cross-section of the center of the raceway of the RCF-tested samples: (a) optical micrograph of the RCF-tested sample under 5 GPa after 1.33×10^7 cycles; (b) optical micrograph of the RCF-tested sample under 5 GPa after 1.14×10^8 cycles; (c) optical micrograph of a butterfly with two wings ($P_0 = 5$ GPa, $N = 1.14 \times 10^8$ cycles); (d) optical micrograph of a butterfly with a single wing ($P_0 = 5$ GPa, $N = 1.14 \times 10^8$ cycles).

Microstructural observation of the radial cross-section in the center of the raceway of the RCF-tested samples was conducted using an optical microscope. No DERs and butterflies were observed in the radial cross-section in the center of the raceway of the RCF-tested samples under 4 GPa and 5 GPa, after 1.37×10^7 cycles and 1.33×10^7 cycles, respectively. Figure 2a shows an optical micrograph of the radial cross-section in the center of the raceway of the RCF-tested sample under 5 GPa after 1.33×10^7 cycles. DER located at a depth of 30 µm to 130 µm below the raceway was observed in the radial cross-section of the RCF-tested sample under 4 GPa after 2.33×10^8 cycles. The distribution of DERs was similar in the radial cross-section of the RCF-tested samples under 4 GPa after 2.33×10^8 cycles and 5.11×10^8 cycles. DER located at a depth of 50 µm to 170 µm below the raceway was observed in the radial cross-section of the RCF-tested sample under 5 GPa after 1.14×10^8 cycles, as shown in Figure 2b. The distribution of DERs was similar in the radial cross-section of the RCF-tested samples under 4 GPa after 1.14×10^8 cycles, 2.12×10^8 cycles, and 5.65×10^8 cycles. The depth of the DER increased as the maximum contact stress was increased from 4 GPa to 5 GPa.

Figure 2c,d show the typical morphology of the butterflies. Butterflies with single or two wings were found to be initiated at the primary carbides. Butterflies were found to form not only in the DER but also outside of the DER, as shown in Figure 2b.
