Article

A New Module for the Evaluation of Bridges Based on Visual Inspection through a Digital Application Linked to an Up-to-Date Database of Damage Catalog for Colombia

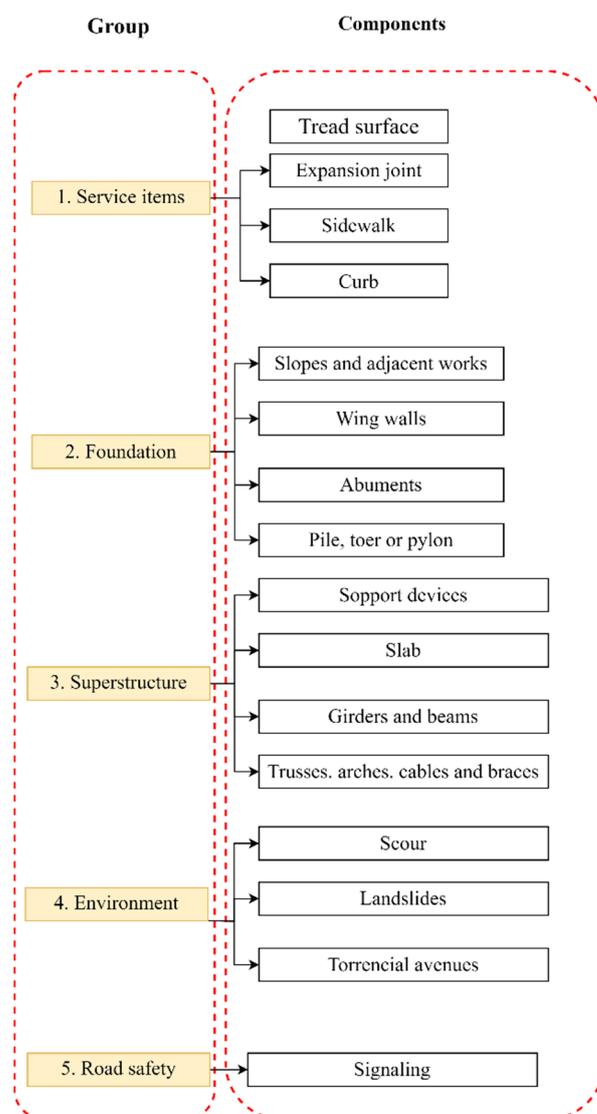
Five (5) groups have been defined for the bridges, each containing a set of components according to their typology. Figure 1 shows their standard confirmation. These groups represent the parts that make up bridges, where the components of groups 2, 3, and 4 are related to structural stability. The components of groups 1 and 5 are related to functionality and road safety, respectively.

Figure 1. Groups and components of the inspection module.

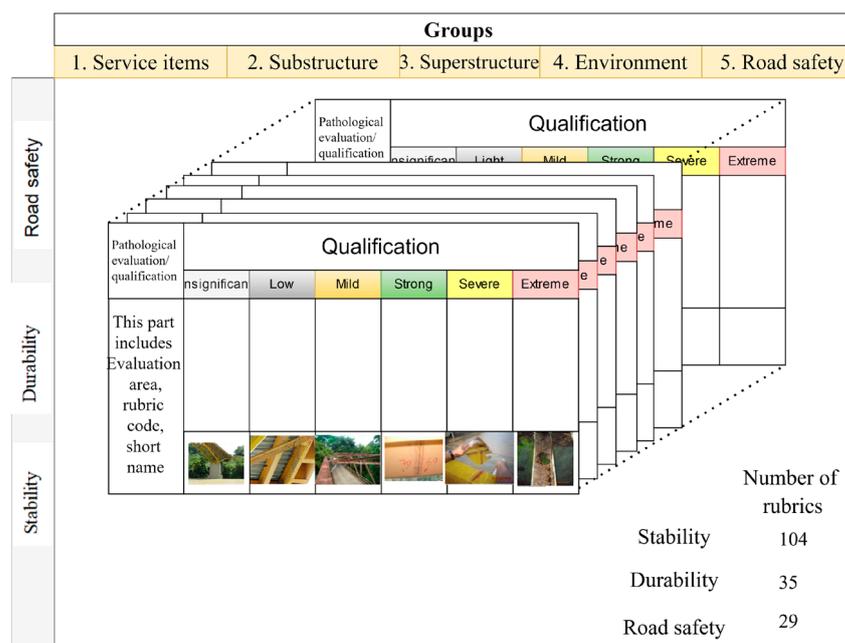
Figure 3 shows the structure of this damage catalog, which includes the number of headings of the three (3) assessment components stored in the inspection application used for field inspection work, as shown in Figure 4. It serves as a dynamic damage catalog that can be expanded or refined as the system is implemented, allowing for the inclusion or adaptation of additional damage types. This ensures a comprehensive examination of the primary pathologies affecting bridge components during visual inspections in the field. Figure 3 shows the number of rubrics for each evaluation area that are part of the damage catalog. This was determined based on the number of identified damages in each area for each component, with a higher number related to stability compared to durability or road safety.

Figure 3. General damage catalog.

Visual inspection tasks were performed using the application developed for this module (stage 3), and Figure 10 summarizes the results of the inspection. The main pathologies of each component were identified based on the damage catalog (Figure 3). In addition, multiple unconnected cracks greater than 12 mm in width and cracks with an opening greater than 3 mm were identified on the tread surface of the flexible pavement. The extensive detachment of fine and coarse aggregate was also noted, with separations of less than 0.05 m, resulting in a very rough surface with loose aggregate. In terms of road safety, the bridge has the required retroreflective studs along its entire length. Regarding the expansion joints, 40–60% of the joint is loose or with loss of sealing; and there are relative movements between the elements that make it up between 1.5 cm and 2 cm. Also, 40–60% of the length of the joints show infiltration. As far as the sign road is concerned, the reduction in operating speed is less than 10 km/h. The curbs have crack widths of less than 0.1 mm, indicating that they are non-structural, and less than 0.25 m² of the concrete has concrete jams and/or exposed steel with no signs of corrosion. There are no sidewalks inside the bridge that would adequately support pedestrian and bicycle traffic (which must travel on the roadway), and there is no lighting. The handrails are mixed, and there are cracks greater than 0.6 mm wide, indicating high stresses and a problem with load bearing capacity. For the concrete parts, there are cracks between 0.2 and 0.4 mm thick, indicating high stresses and partial structural and geometric resistance to impact. For the steel parts, there is a loss of steel section due to corrosion.

The fieldwork was also conducted using the app developed for this module (stage 3). Figure 12 summarizes these results (stages 4, 5, and 6). The main pathologies of each component were identified based on the damage catalog (Figure 3).

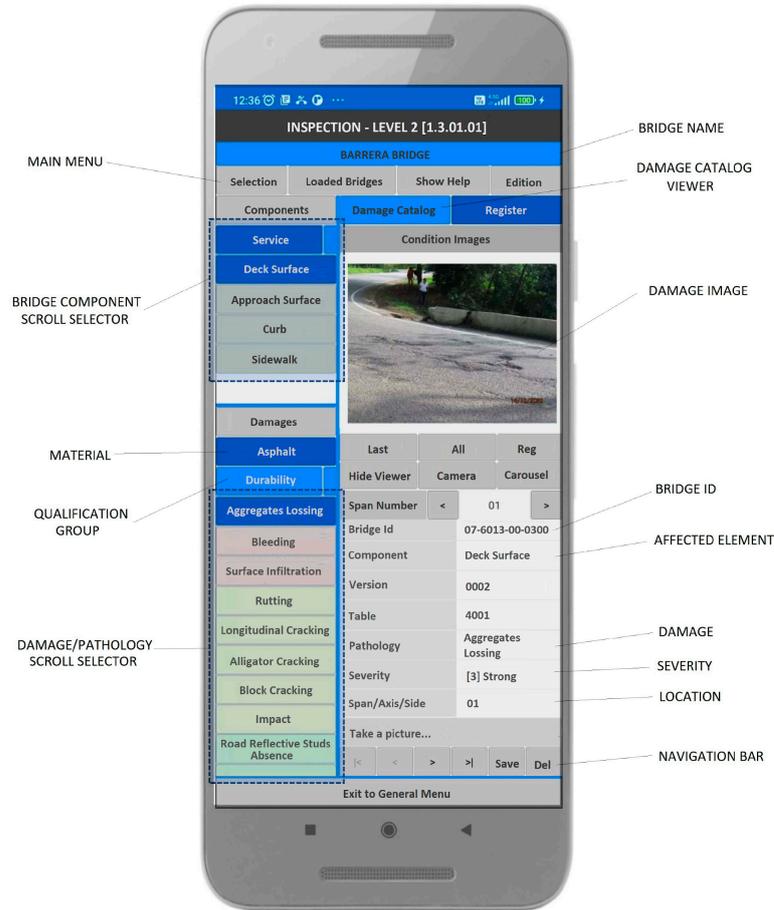
A mobile application (shown in Figure 4) has been implemented to digitally capture data associated with visual inspection tasks. This increases the data acquisition on field. It is important to document any damage and record its extent and severity using built-in rubrics. Relevant inspection information should be imported to identify components associated with the inventory. The status of routine and preventive maintenance should also be recorded. Finally, the collected data should be exported to a central geodatabase in the cloud. This development is part of a line of research around the world where technological applications are being implemented to support visual inspection and damage detection on bridges [30,33–38]. The time during which this application should be used in the field depends on the index of each bridge, as explained in Table 3. This time varies from an immediate visit to the bridge if it has an index of “Susceptible to partial or total failure” to 5 years for an index of “Satisfactory”.

Figure 4. App for collecting information in fieldwork.

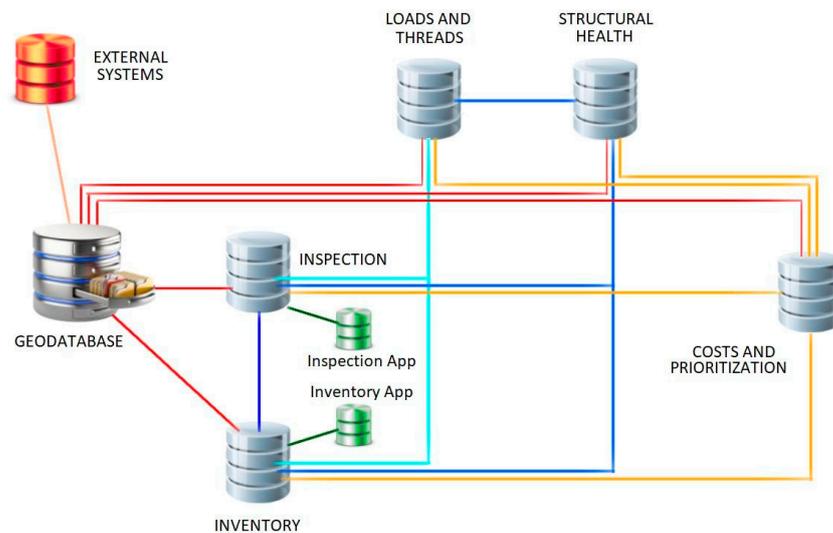
areas with no or very low cellular coverage due to its topography and extension. This application is part of Inspection Module 2, as shown in Figure 5, which shows the system architecture. The system includes several important modules such as inventory, loads and hazards, structural health, and prioritization.

Figure 5. Software architecture of the intelligent bridge management system.

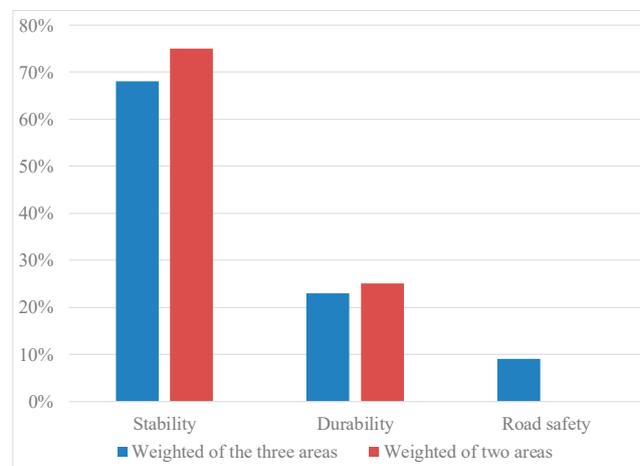
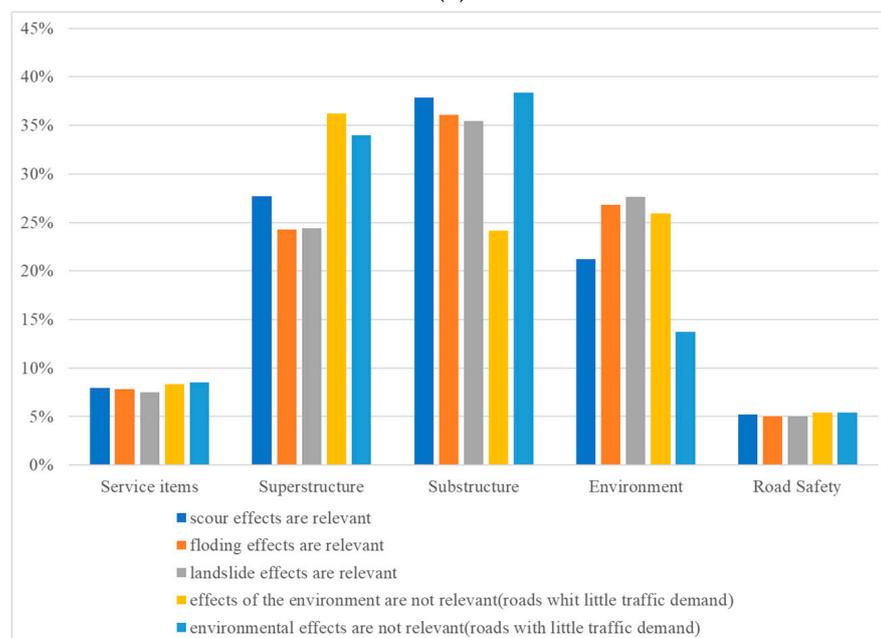
Based on the above, a survey was developed and completed by nineteen (19) experts in the field of bridges at the national level. Some of the results of the determined weights are shown in Figure 6 by evaluation areas and groups of bridges. As can be seen in Figure 6a, the order of importance at the level of the evaluation areas is as follows: stability, durability, and traffic safety. Durability and road safety have one-third of the importance, and the rest corresponds to stability, which is mainly related to relevant structural damage, as well as to the problems of scour and torrential flooding on bridges. Figure 6b shows the importance levels of the bridge groups for different conditions related to their environment, such as scours, torrential flows, and landslides.

Figure 6. Survey results: (a) assessment areas; (b) the bridge group.

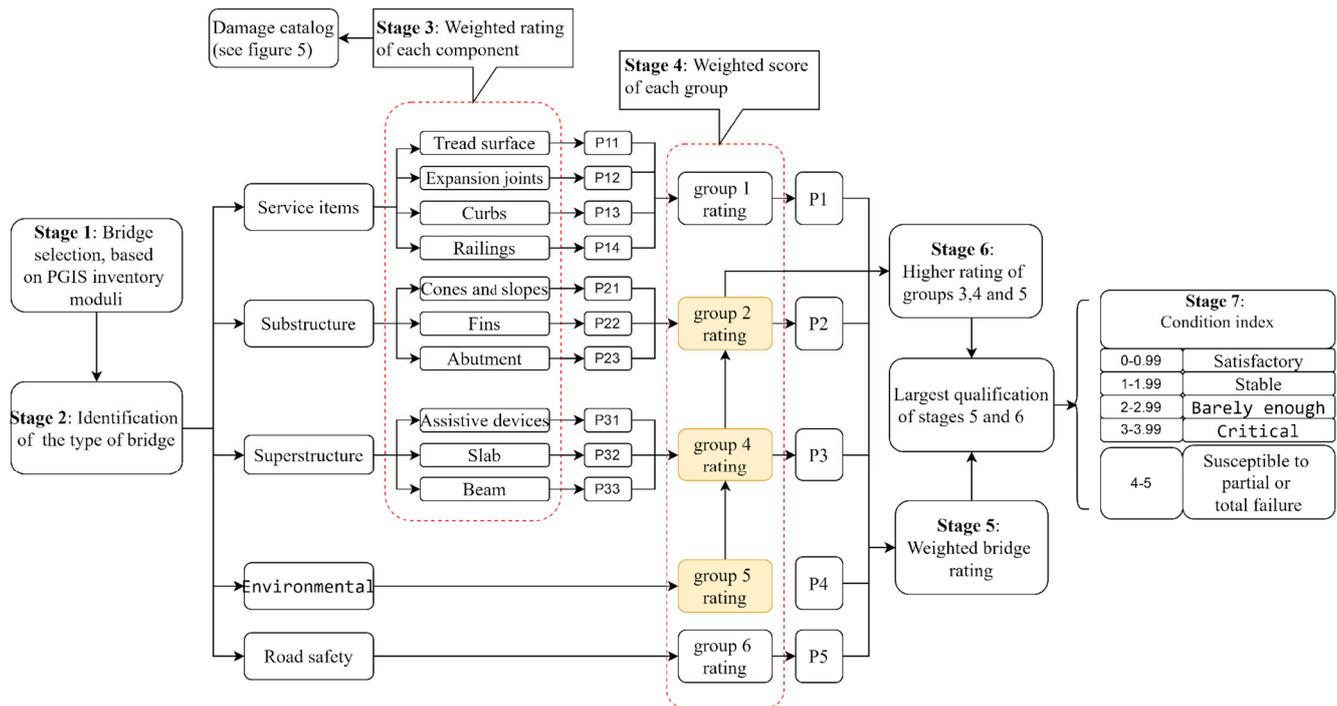
Figure 7 shows a flowchart with the different steps to determine the weighted rating of the bridge and its performance index. In step 1, the bridge is selected based on the inventory module database [23]. In step 2, the bridge typology is determined, and in step 3, the weighted rating of each component is provided. In step 4, the weighted rating of each group is determined, and in step 5, the weighted rating of the bridge is assigned. In step 6, the highest rating of groups 2, 3, and 4 is determined. Finally, in step 7, the performance index is calculated using the highest rating from steps 5 and 6. Table 3 shows the frequency of inspections as a function of the condition index obtained for each bridge.

Figure 7. Flowchart that determines a bridge condition index.

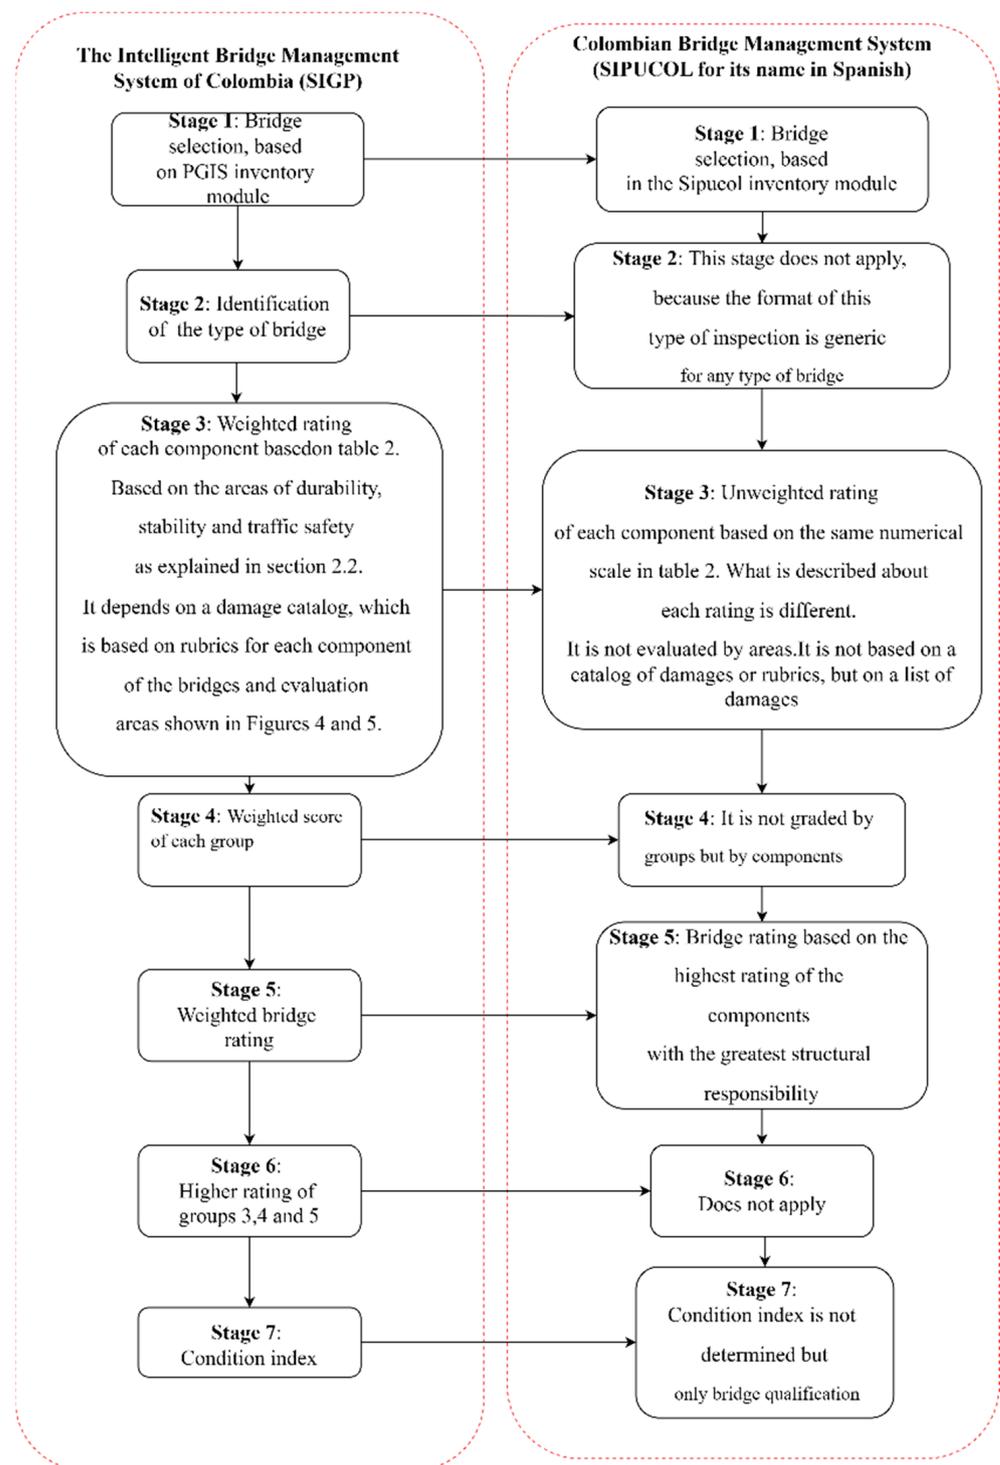
Figure 8 shows a flowchart with the stages of the new visual inspection module (SIGP) developed in this research compared to those of the current visual inspection module of the current Colombian bridge management system (SIPUCOL). Based on this comparison, the advantages of the new inspection tool are identified as follows: (i) innovation, since it includes more variables in the determination of the condition rating of the bridge, (ii) new areas, since the new visual inspection module is based on three (3) evaluation areas and a damage catalog, (iii) the new tool has a comprehensive and reliable diagnosis of the condition of the bridge, (iv) it includes the determination of a condition index that is evaluated in the bridge subgroup called environment, which includes scour, torrential rains and slope, and (v) it includes damage related to traffic safety.

Figure 8. Comparison between the inspection of the new system and the existing one.

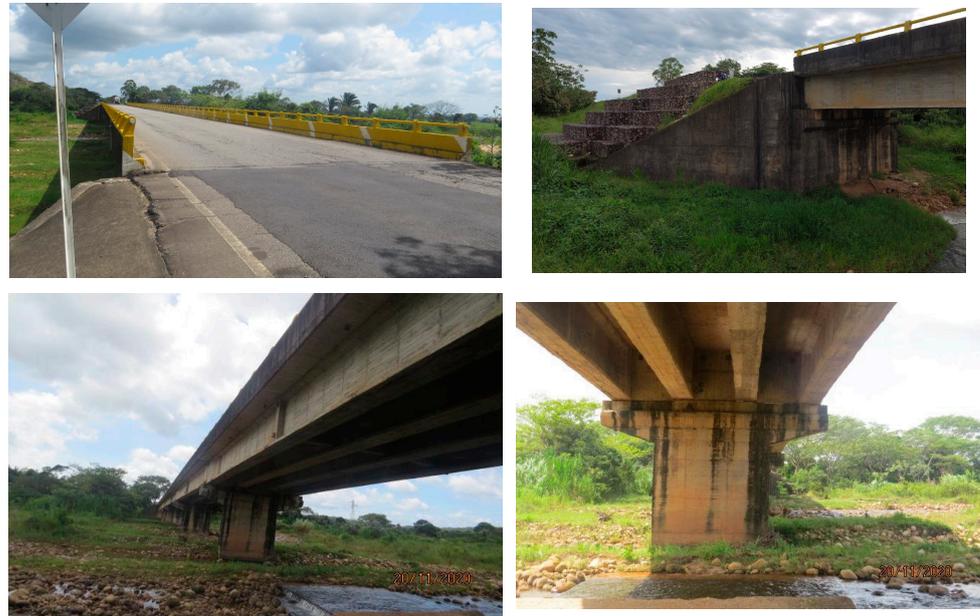
application of the methodology. The Guacharí Bridge is located on the Paz de Ariporo highway in Yopal, Casanare, Colombia. The bridge was built in the 1970s, and its typology includes five simply supported spans, consisting of a deck and slab in prestressed concrete. It has four reinforced concrete piers of the wall type with header beams and two abutments, also of reinforced concrete, with shallow foundations (see Figure 9).

Figure 9. Guacharí Bridge typology.

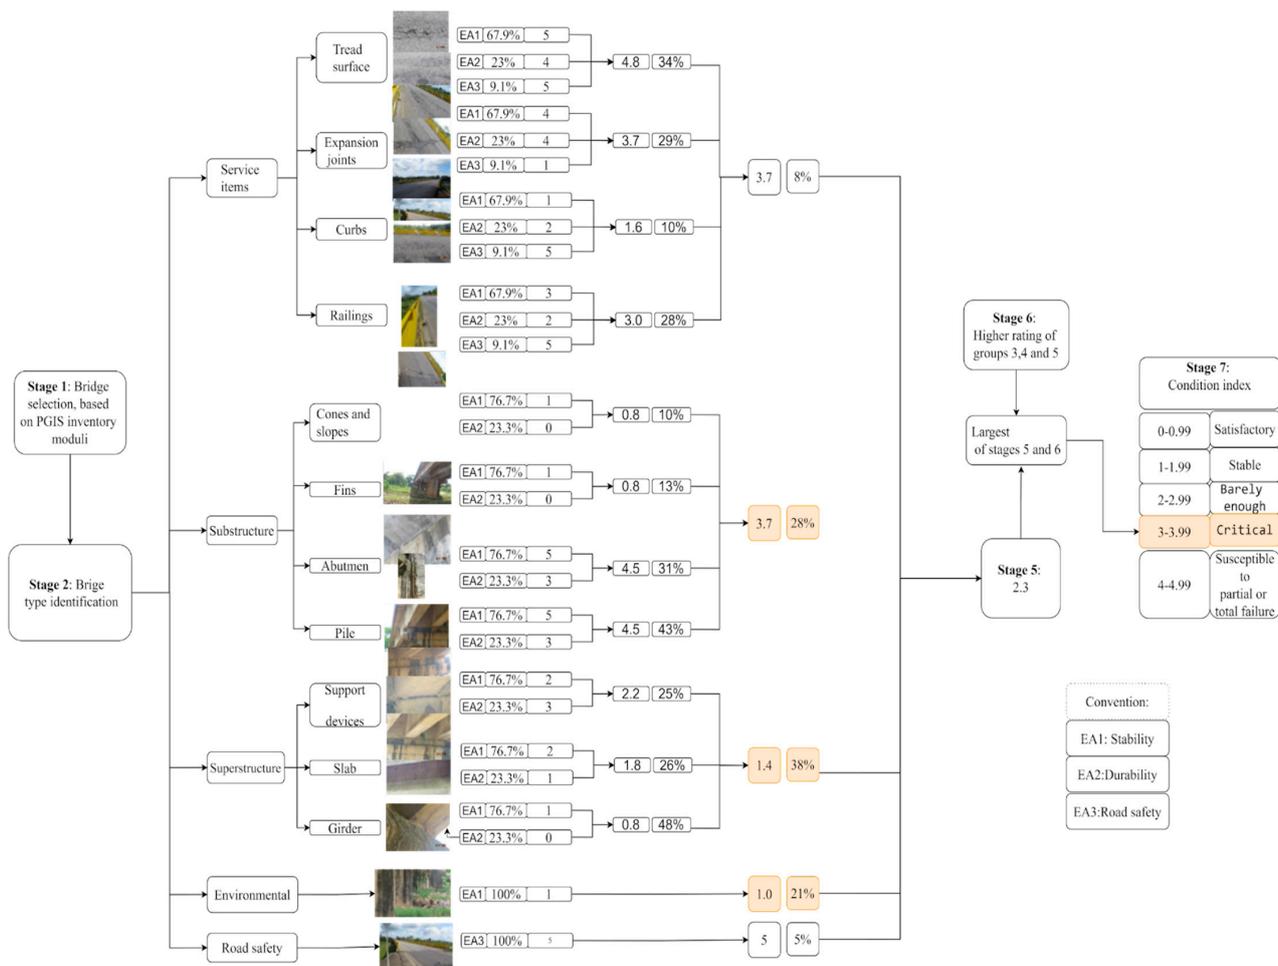
Figure 10. Stages for determining the condition index—Guachiria Bridge.

Finally, the concrete is partially carbonated with no loss of any portion of the main reinforcing steel. Therefore, 80% to 90% of the surface of the element, with partial loss of section, and road safety conditions would not be met. In addition, erosion is evident at the base of the abutment access slope, with a height of between 30 and 40% of the total height of the slope, where it coincides with the bank of the riverbed. Crack widths greater than 0.5 cm were found in the fins and abutments, indicating high stresses and a problem with their bearing capacity. Between 40 and 50% of the fin area is affected. On the other hand, crack widths greater than 5 mm were detected in the slab, indicating high stresses and a problem with its bearing capacity.

As for the metallic structure, there is an inadequate connection due to the absence of 20 to 30% of the anchors and/or screws, accompanied by intermediate levels of corrosion. In the girders, the stiffeners in the bearing area were found to be buckled and affected by corrosion. In the supports, a deterioration between 60 and 100% was found, as well as between 0.3 m² and 0.4 m² of active moisture area, which affects their durability. Regarding torrential floods and scour, the width of the valley in the area of the bridge is reduced by more than 40%, resulting in an insufficient hydraulic area and possible collapse of the access embankment and flaps. More than 80% of the existing vertical signs are in poor condition. A summary of the results for this bridge is presented below. In addition, a qualitative description of the main results of the visual inspection of each component of this bridge is given. Regarding the slope, there is no evidence of erosion at the foot of the slope of the abutment where it coincides with the bank of the riverbed. The abutment fin has a rotation between 0 and 2° with its longitudinal or transverse axis. The bridge is located in a high seismic hazard zone, and it is a bridge with two or more spans, but the abutments

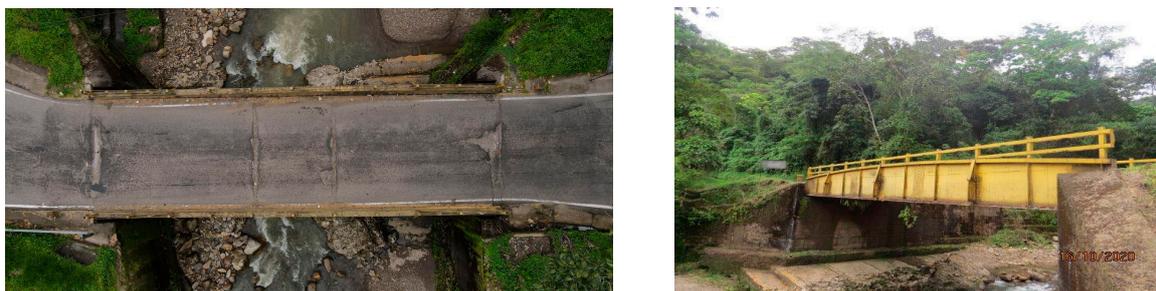
The Chichaca Bridge, which is the second bridge, also belongs to the Casanare area and is located on the Yopal-Paz de Ariporo highway in Colombia (Stage 1). The typology of the bridge consists of a simply supported span, composed of a steel beam deck and a reinforced concrete slab. It also has two reinforced concrete abutments with shallow foundations (Figure 11).

Figure 11. Chichaca Bridge typology.

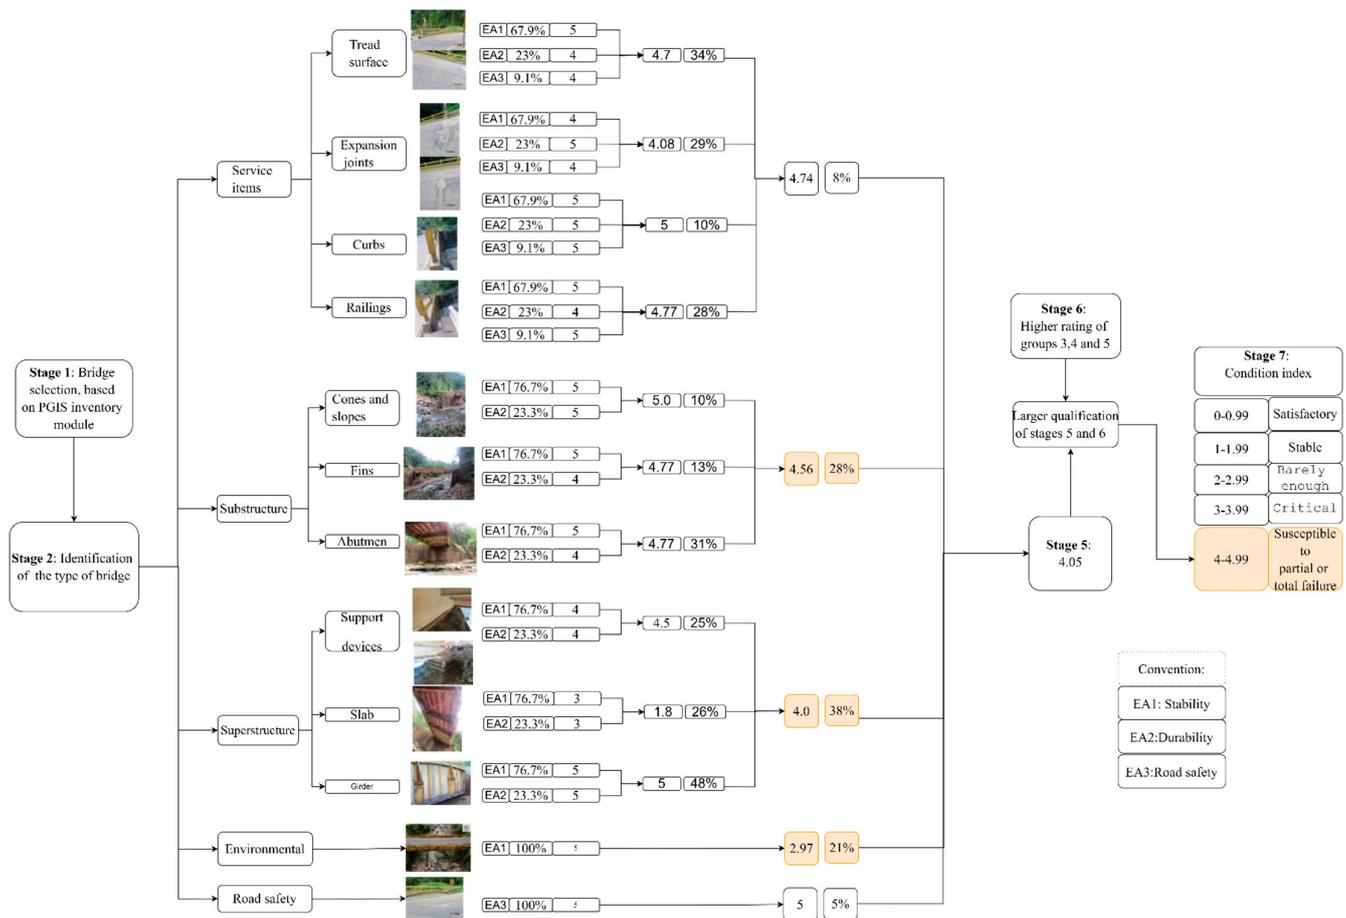
Figure 12. Flowchart for determining a condition index—Chichaca Bridge.

It was found that 25% of the deck and access areas of the pavement were affected, including continuous loss. There is a high degree of aggregate detachment, with separations between 0.05 and 0.15 m. There is evidence of the poor functional condition of the pavement, with potholes of high severity. In turn, more than 60% of the length of the expansion joints is affected by the impact. Between 40 and 60% of the length of the joints show infiltration, and the curbs show crack widths greater than 0.6 mm, indicating high stresses and a problem in their load bearing capacity. In addition, the railing post anchorage was found to be compromised, which may affect its strength.

For this bridge, a qualitative description of the main results of the visual inspection of the components of this bridge is also provided. The bridge does not have sidewalks for non-motorized traffic (pedestrians and cyclists), so they are forced to travel on the roadway. There is a loss of steel section in the railings due to severe corrosion. There are no adequate expansion joints. There are generalized corrosion problems in the main steel elements such as the main side girders, secondary cross girders, connections, and supports. The buckling of some stiffeners of the main lateral girders was also observed, as well as

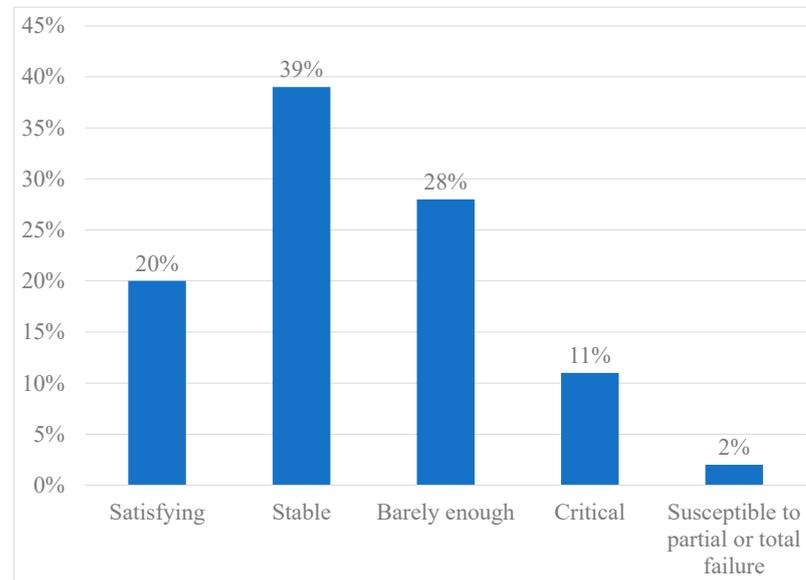
Figure 13 shows the results of the condition indexes of the 94 bridges that were part of the pilot selection, showing that only 2% are susceptible to partial or total failure and 11% are in critical condition. Figure 14 also shows the overall weighted rating of these bridges for stability, durability, and road safety. According to these results, the ratings

Figure 13. Condition index of the bridges of the pilot section.

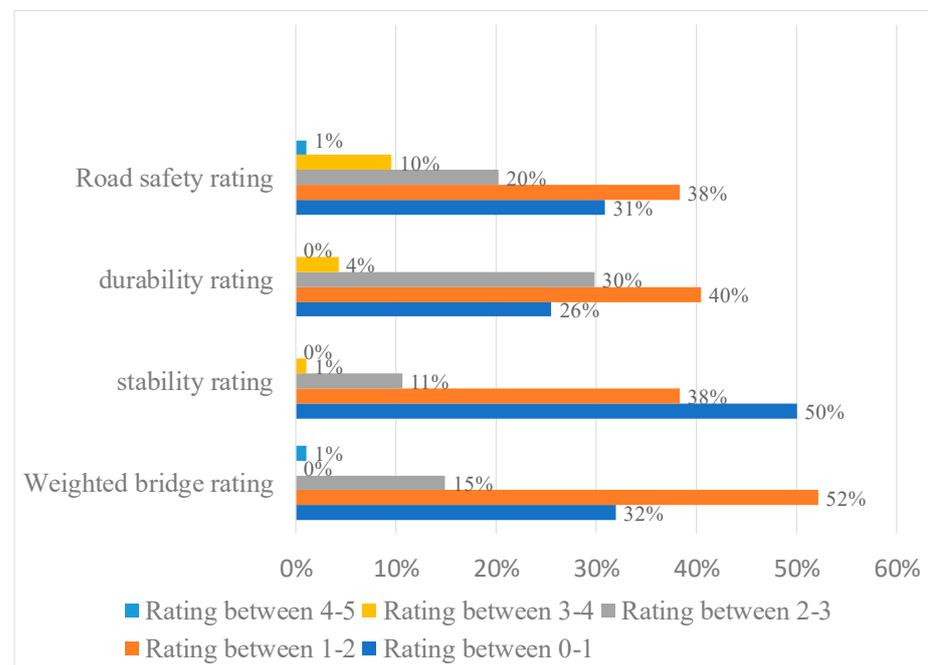
and, therefore, the identified damages of the bridges are higher for traffic safety than for durability and stability. And there are more relevant damages for durability than for stability.

Figure 14. Weighted, stability, durability, and road safety rating indices for the evaluation of the bridges.

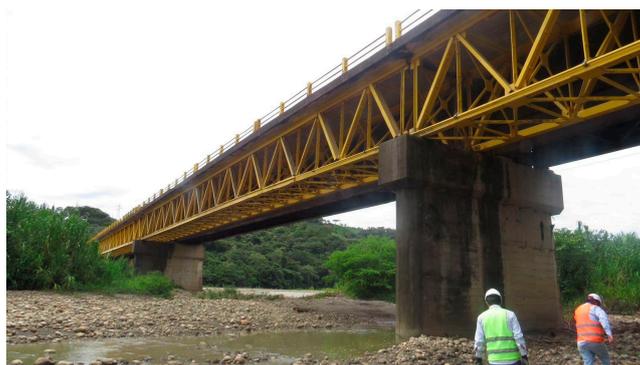
The findings led the Instituto Nacional de Vías to make the necessary temporary or permanent interventions to prevent the bridge from collapsing. As a result, traffic on the Ramón Nonato Pérez Bridge was restricted to one lane, as shown in Figure 15, where the main finding was cracking in the welded joints of the truss bridge. This bridge has a combined typology because one lane is steel reinforced, and the other is a mixed steel–concrete section.

Figure 15. Ramon Nonato Pérez Bridge.

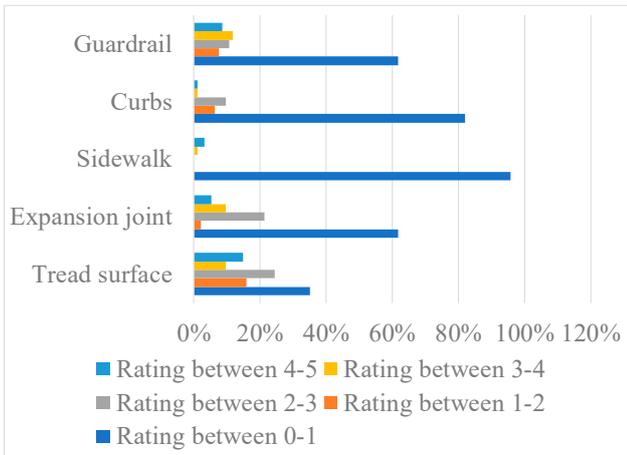
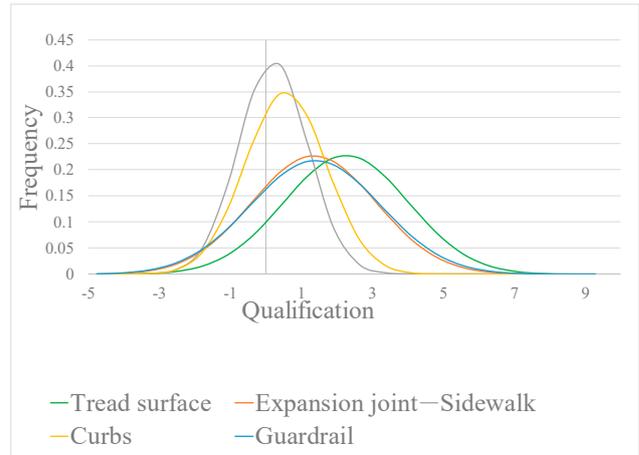
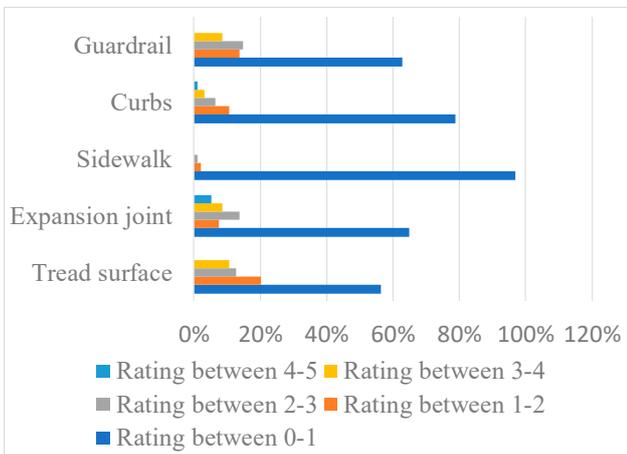
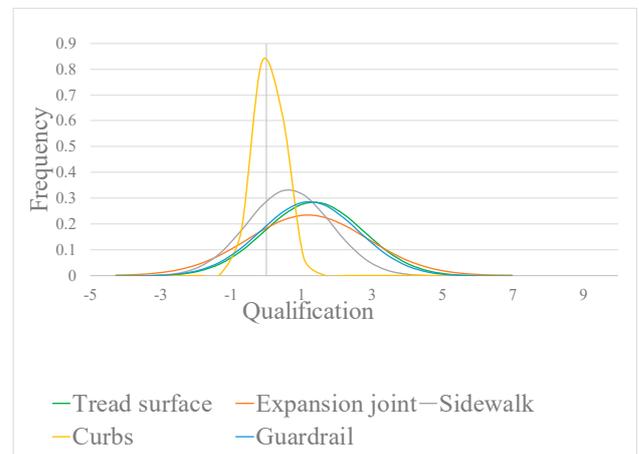
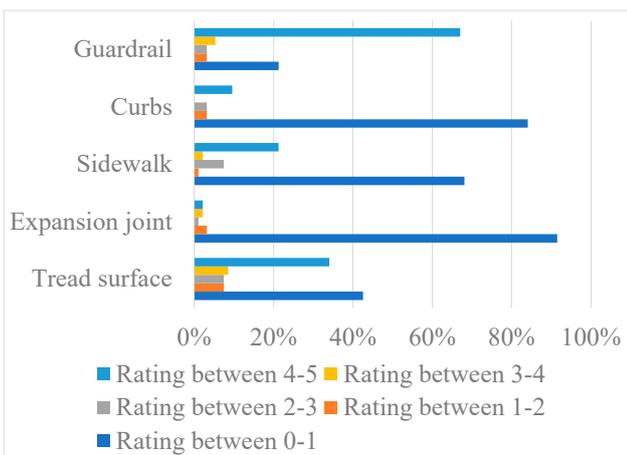
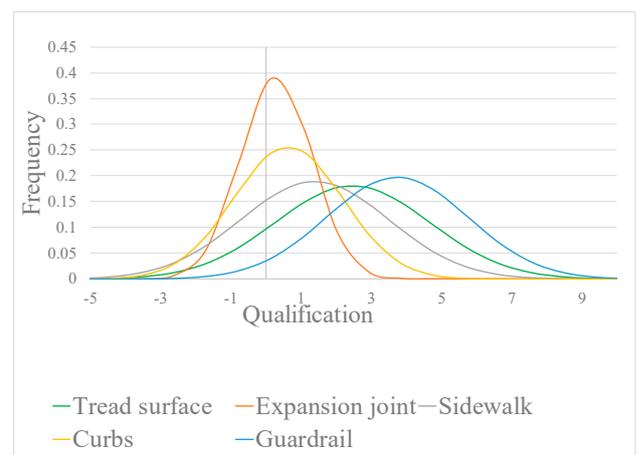
Figures 16–20 graphically present the statistical results for the components of the five groups of the 94 bridges of the pilot section and each evaluation area. It also includes the presentation of the results using normal distribution probability curves of the ratings obtained for each of the components based on the mean and standard deviation. Figure 16 shows the results of the qualification of the severity levels in each evaluation area of the bridges of the pilot section, particularly the components that are part of the group of service elements. In the stability area, higher damage was observed in the guardrail and expansion joint components, with an “extreme” severity level of 9 and 5 percent, respectively. In addition, a severity level of “severe” was observed at 12 and 10 percent, respectively. From a probabilistic perspective, the average rating had the following order from highest to lowest: pavement, guardrails, expansion joints, sidewalk, and curbs. A higher standard deviation was found for guardrails and a lower one for sidewalks.

In terms of durability, the expansion joint and guardrail components were more severely damaged, with percentages of 14 percent and 9 percent, respectively, when the extreme and severe severity levels are combined. From a probabilistic perspective, the average rating followed a similar order to the stability area: pavement, guardrails, expansion joints, platforms, and curbs. A higher standard deviation was found for the pavement and a lower one for the sidewalk.

In the area of road safety, higher damage was detected in the guardrail, with a percentage of 67 percent at the “extreme” severity level, which represents a warning to make the appropriate corrections in the intervention tasks. From a probabilistic point of view, the average rating had the following order from highest to lowest in the area of road safety: guardrails, expansion joints, sidewalks, curbs, and expansion joints. A similar standard deviation was found for all components in this group.

Figure 16. Qualification of the components of the service for each evaluation area.

Figure 16 show an in-depth visual inspection evaluation of the bridges in the pilot section, providing critical input for decision making within the system. The innovation lies in the results, which detail different levels of severity in the evaluation areas: stability, durability, and traffic safety. The information includes not only the numerical ratings of the bridges but also their geographic distribution based on severity levels throughout Colombia, as shown in Figure 20. This allows for the identification of critical bridges across different rating areas and condition indices.

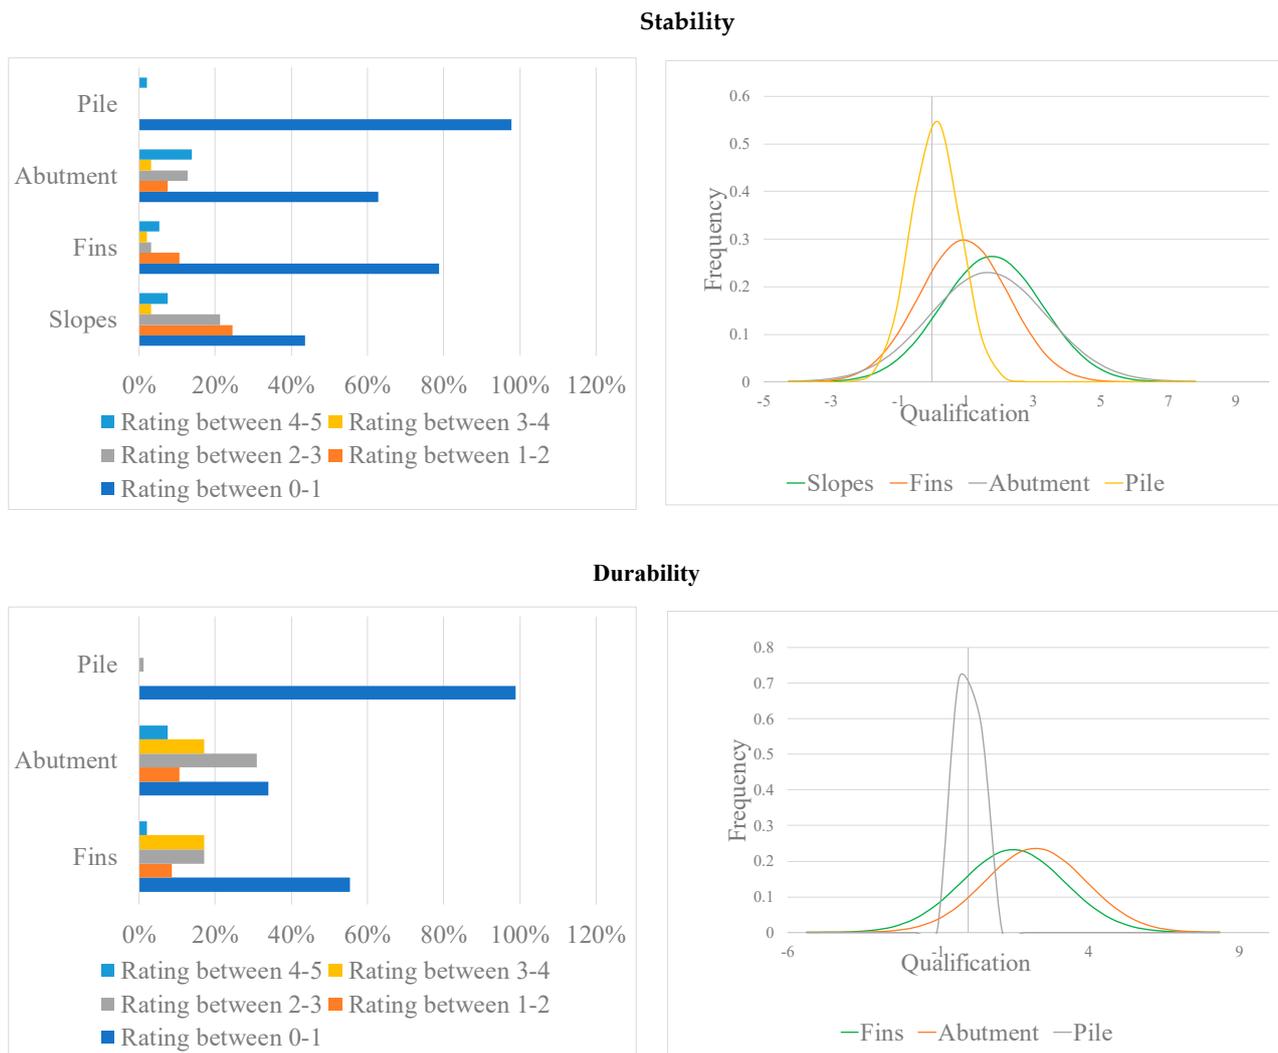
Figure 17 shows the results of the evaluation of the severity levels in each evaluation area of the components that are part of the substructure group. In the stability area, higher damage was observed in the abutments and slopes, with a percentage of 14 and 7 percent, respectively, at the “extreme” severity level. In addition, 3 percent damage was observed in these same components at the “severe” severity level. From a probabilistic perspective, the average rating had the following order from highest to lowest: slopes, abutments, fins, and piles. A higher standard deviation was found for abutments and a lower one for piles.

In terms of durability, the fins and abutments were found to have greater damage, with a percentage of 7 and 2 percent, respectively, at the “extreme” severity level. In addition, 17 percent damage was observed in the same components at the “severe” severity level. For this area, the average rating from a probabilistic perspective was as follows (from highest to lowest): abutments, fins, and piles. A higher standard deviation was found for the abutments and a lower one for the piles.

Figure 17. Qualification of the components of the substructure for each evaluation area.

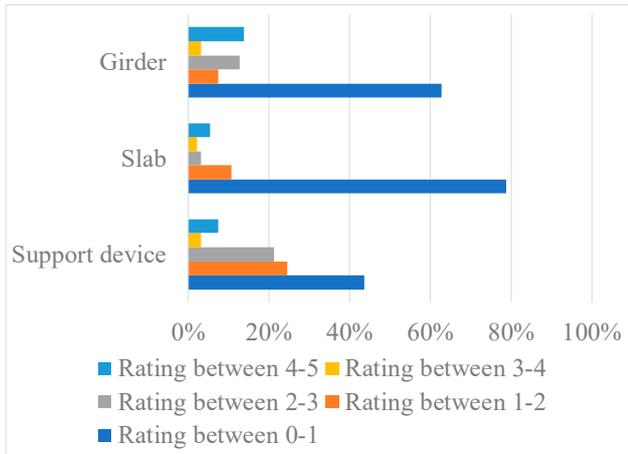
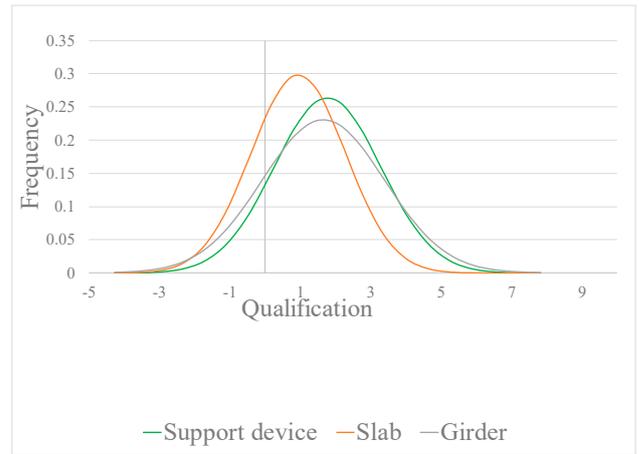
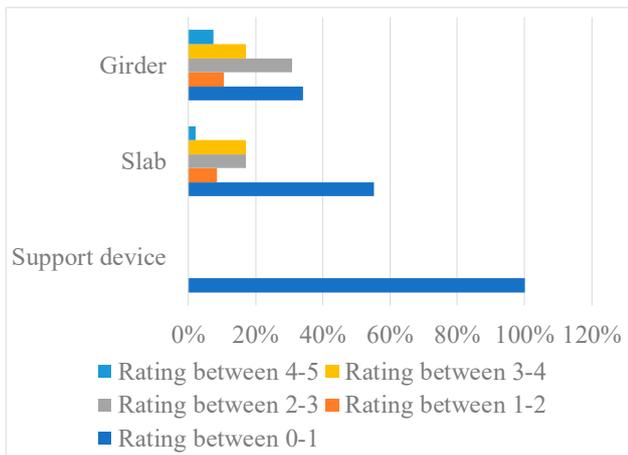
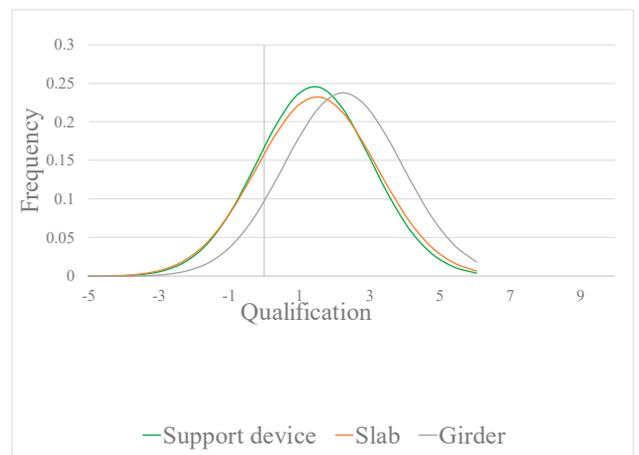
Figure 18 shows the severity evaluation results for each evaluation area of the components that are part of the superstructure group. In the stability area, higher damage was observed in the beam and support components, with a percentage of 15 and 7 percent, respectively, at the “extreme” severity level. In addition, 3 percent damage was observed in these same components at the “severe” severity level. From a probabilistic perspective, the average rating had the following order from highest to lowest carrier, beam, and plate. A higher standard deviation was found for the beams and a lower one for the slab.

In terms of durability, the beam and slab components had greater damage, with a percentage of 7 percent and 2 percent, respectively, at the “extreme” severity level. In addition, 16 percent damage was observed in the same components at the “severe” severity level. For this area, the average rating followed the order from highest to lowest from a probabilistic perspective: support, beam, and plate. A higher standard deviation was found in the beams and a lower one in the slab.

Figure 18. Qualification of the components of the superstructure for each evaluation area.

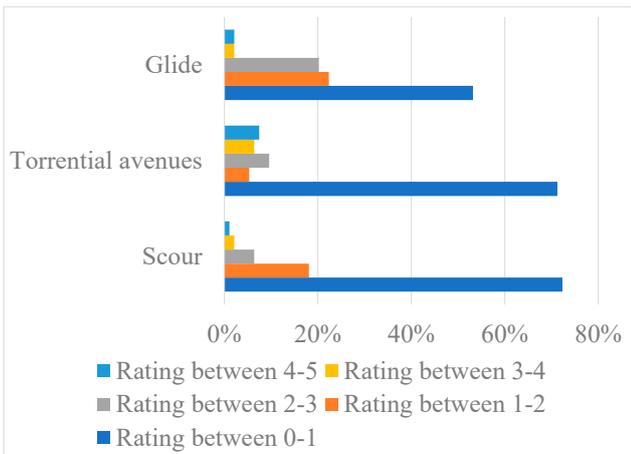
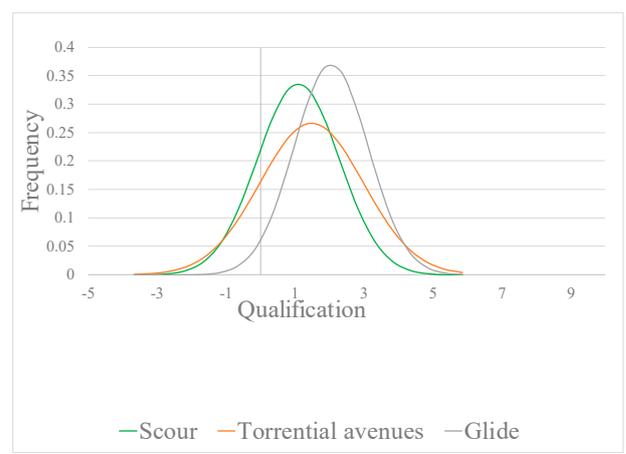
Figure 19. Scoring of environment components for each assessment area.

In the context of the environment, Figure 19 illustrates that the severity levels in the stability domain, from highest to lowest, are as follows: torrential flooding, landslides, and scour. In the environmental group, damage due to scour and torrential flooding was found in the foundations of fins, abutments, and piers, as most of these bridges were not designed to avoid this risk. Some bridges were also found to have problems with landslides or mass movements on the slopes near and parallel to these structures.

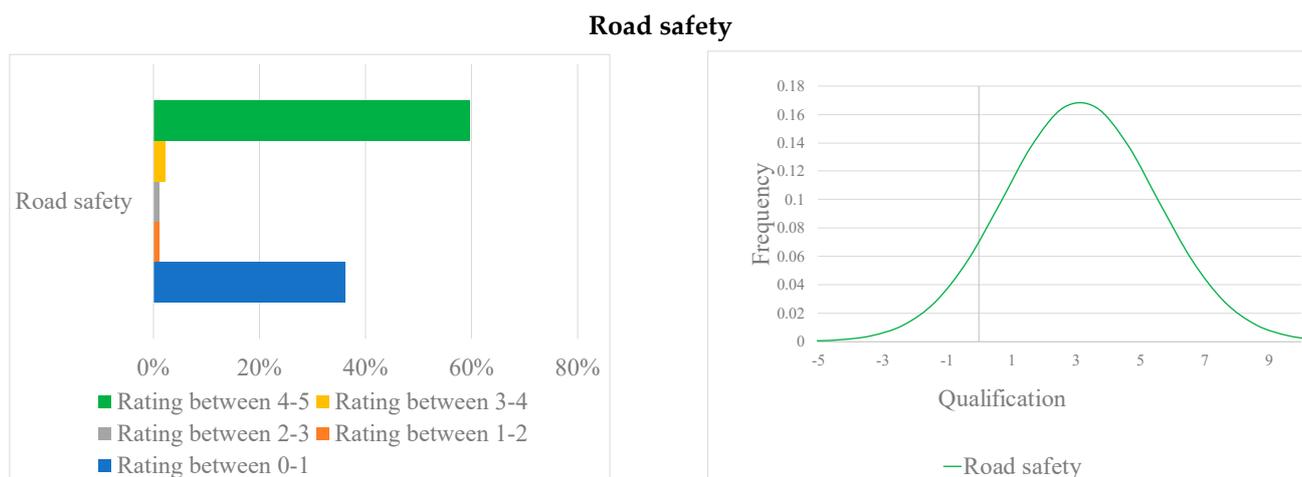
Figure 20. Scoring of road safety components for each assessment area.

Figure 20 shows the results of the road safety severity rating; 60 percent was rated with an “extreme” severity level, which serves as a warning to consider in the maintenance and rehabilitation tasks of this part of the bridges. From a probabilistic perspective, the average rating is 3.2 with a standard deviation of 2.4, which is also high compared to components in other groups. Most bridges do not meet traffic safety requirements, as they lack pedestrian crossings and signage.
