Article

A New Module for the Evaluation of Bridges Based on Visual Inspection through a Digital Application Linked to an Up-to-Date Database of Damage Catalog for Colombia

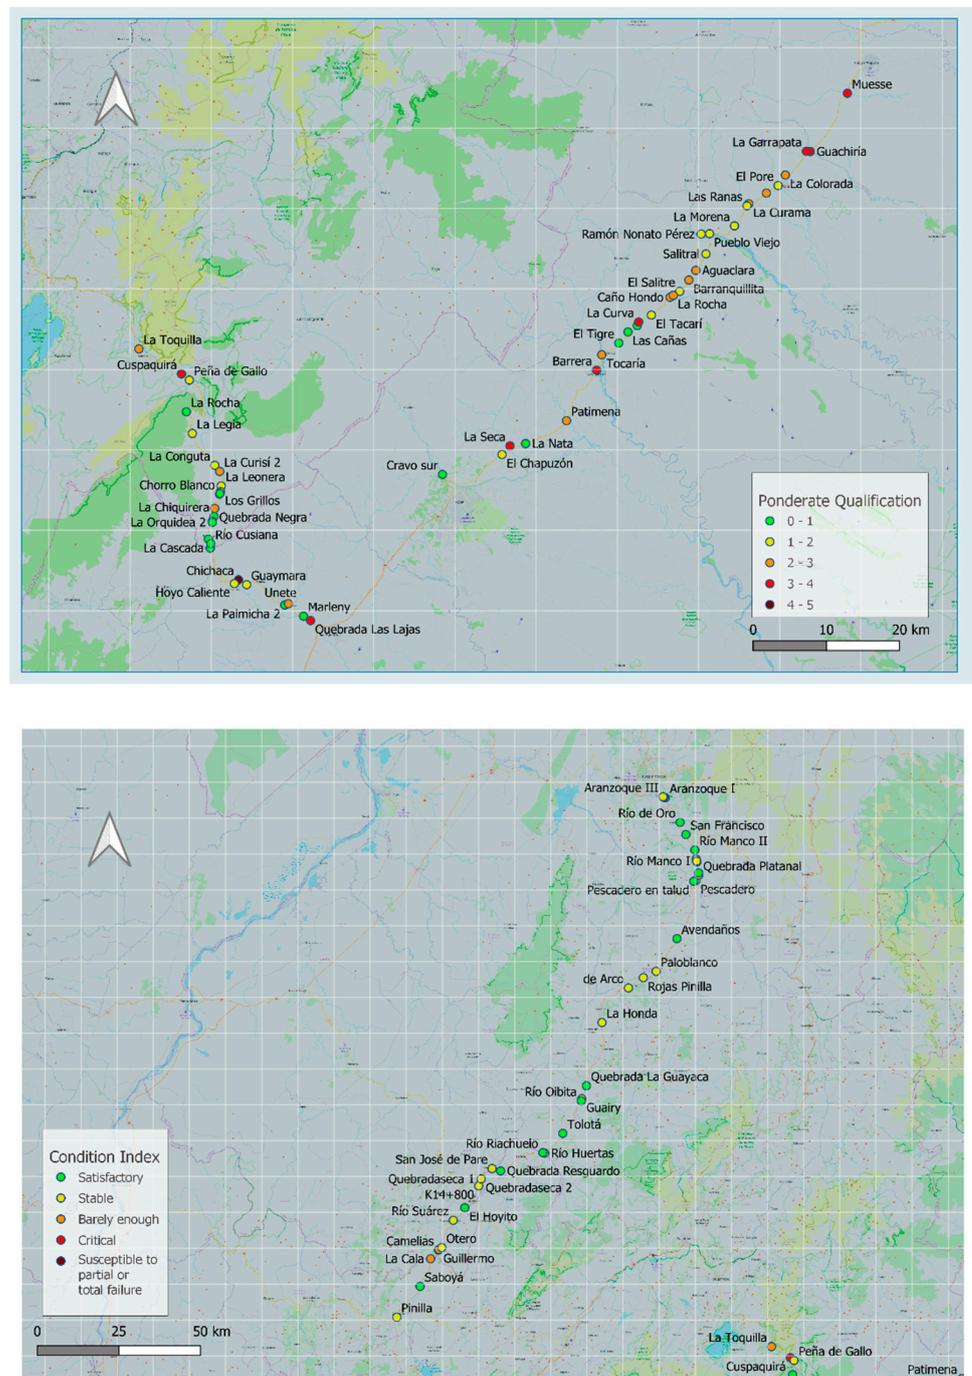
For the substructure group, significant damage was found in the fins and abutments in the areas of stability and durability. For the superstructure group, significant damage was identified in the following order: girders, supports, and slabs. In the environmental group, the main damages were identified in the following order: torrential floods, landslides, and scours. Traffic safety is the group with the highest ratings, indicating that most of these bridges do not meet the minimum design requirements for roads. Figure 21 shows the results of the visual inspection of the 94 bridges in the pilot section using thematic maps with a color scale of the condition indexes and the overall weighted rating. The map in Figure 21 identifies locations of varying severity levels among the bridges in the pilot section. This includes critical areas that require intervention such as maintenance, rehabilitation, and/or monitoring and instrumentation. This information is critical to decision making because it takes into account the environment, traffic levels, and social and economic conditions.

Figure 21. Bridge rating summary map according to assessment.
