Article

Crack Detection in an Aluminium Oxide Grinding Wheel by Impact Hammer Tests

Abstract: Grinding is widely used as the last step of the manufacturing process when a good surface finish and precise dimensional tolerances are required. However, if the grinding wheels have cracks, they may lead to a hazardous working environment and produce poor tolerance in machined products. Therefore, grinding wheels should be inspected for cracks before being mounted onto the machine. In this study, a novel method of finding possible internal cracks in the aluminium oxide grinding wheel will be explored by examining the natural frequency and displacement of wheels using an impact hammer testing method. Grinding wheels were cracked into two segments using a three-point bend fixture and then bonded intentionally to simulate cracks. The impact hammer test indicated that cracks in the grinding wheels caused a drop in natural vibration frequency and an increase in the maximum displacement of the accelerometer sensors.

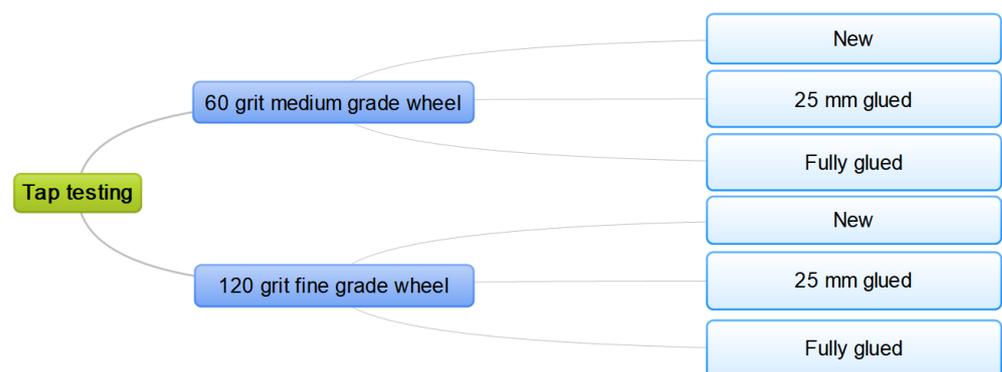
Figure 1 illustrates how the two grades of wheels are prepared for testing; 3 aluminium oxide grinding wheels were prepared for each abrasive grit size (60 and 120 grits). To compare undamaged grinding wheels with cracked and glued grinding wheels, the grinding wheels were cracked using a three-point bend fixture and subsequently glued back together with the stated length of glue.

Figure 1. Grinding wheel test materials.

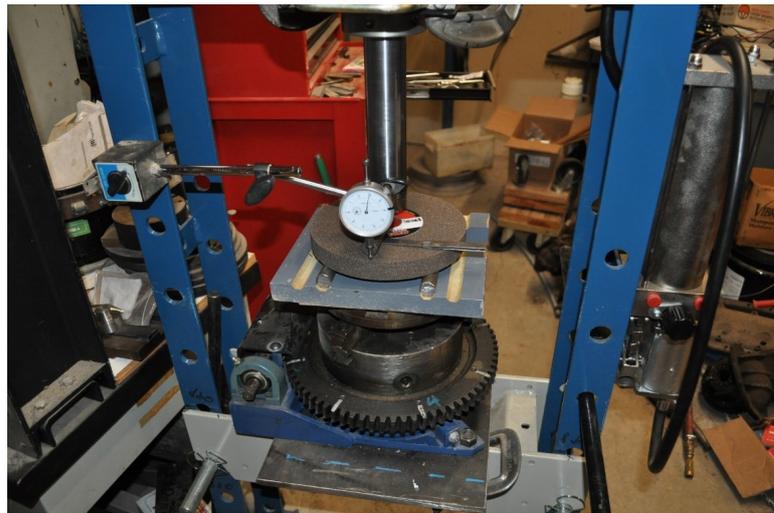
The grinding wheels were cracked, as shown in Figure 2, using a three-point bend fixture in a 20 ton hydraulic load frame.

The load and deflection were monitored with a pressure gauge on the load frame hydraulic cylinder and a dial indicator on the wheel directly adjacent to the loading point. The loading points were 203 mm long by 19 mm diameter steel bars. The outer load points were 178 mm apart and the centre loading point was midway, 89 mm, between the two outer bars. The cracked wheels were glued either with 25 mm of glue radially or glued completely, as shown in Figure 3, so that we could determine the effect of the amount of glued surface in the vibrational response of the grinding wheel during impact hammer testing. In this study, a water-curing single part glue was used to bond the grinding wheel segments since it can bond the vitrified grinding wheels. After applying the glue, mechanical steel clamps were used to hold the wheels until the glue was set.

Figure 2. Three-point bending fixture to crack the grinding wheels.

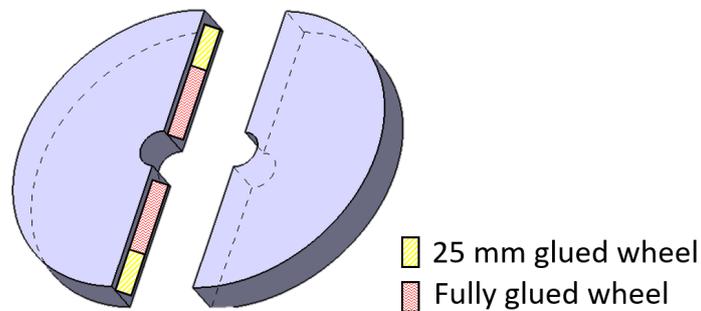
Figure 3. Glued segments of the grinding wheel.

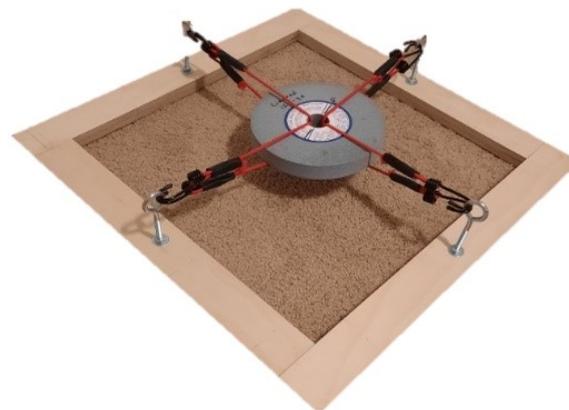
Following OSHA’s recommendation, ring testing is performed on all the tested wheels to determine if there was a difference in the audible ring tone. As shown in Figure 4, grinding wheels were suspended in the air, and then the audible ring test was performed using a screwdriver handle by gently tapping the grinding wheel to note the sound made by the handle.

Figure 4. Test fixture to suspend the grinding wheel.

The grinding wheels were held on a fixture, as shown in Figure 4, suspending the wheel in the air to allow impact hammer testing with an impact hammer and three accelerometers

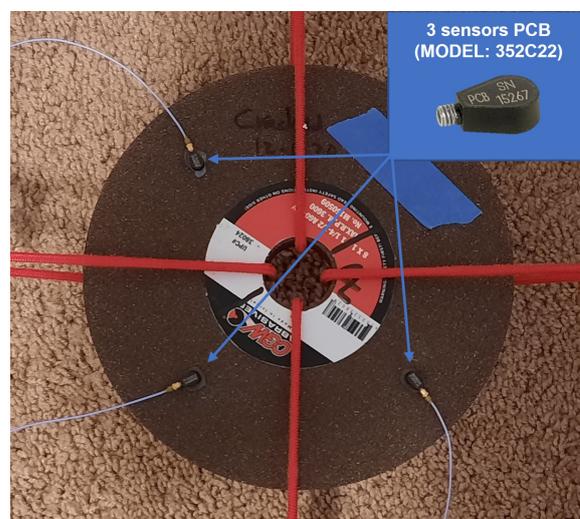
Figure 5 shows the placements of the accelerometers, and the wheel's cracked direction is indicated by the black line drawn along the 1st and 3rd quadrants. The accelerometers were located on the 2nd, 3rd, and 4th quadrants, and 15 taps were made on each quadrant using the impulse hammer. To improve the consistency and reliability of the test, a total of 60 taps were made for each grinding wheel. The measurement direction of the accelerometer is along the direction of the cable shown in Figure 5.

Figure 5. Measurement setup for impact hammer testing.

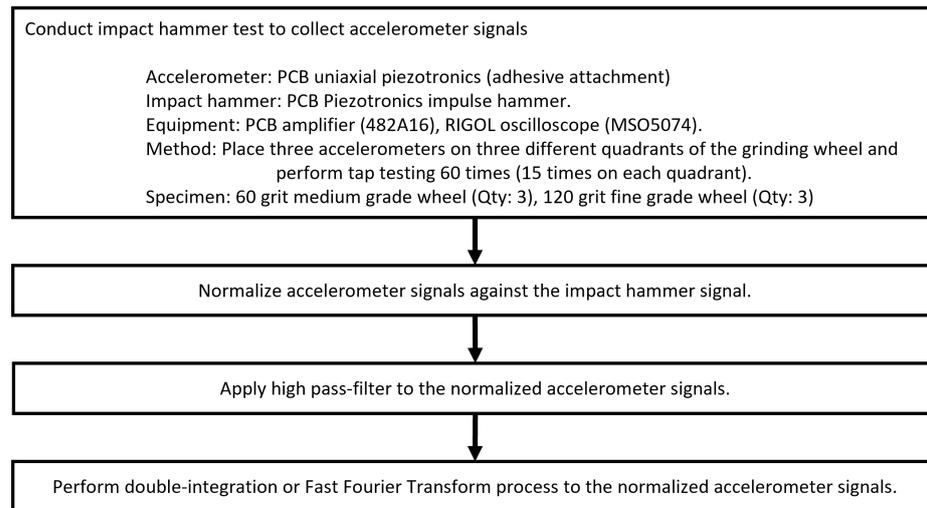
Figure 6 shows how the signals were collected and processed. The accelerometer signals were normalized against the impact hammer signal, using MATLAB R2021a software, since the impact energy of the hammer may not be the same during testing. The normalized signals were then filtered with a high-pass filter of 0.5 Hz to match the operating range of 0.5 to 10,000 Hz of the accelerometer [14]. To obtain the displacement at the accelerometer location, $s(T)$, double integration of the measured acceleration, $a(t)$, was conducted using the integration time step of 10^{-6} seconds (the sampling frequency of accelerometers is 1 MHz) and it can be written as [15]:

Figure 6. Accelerometer signal processing procedure.

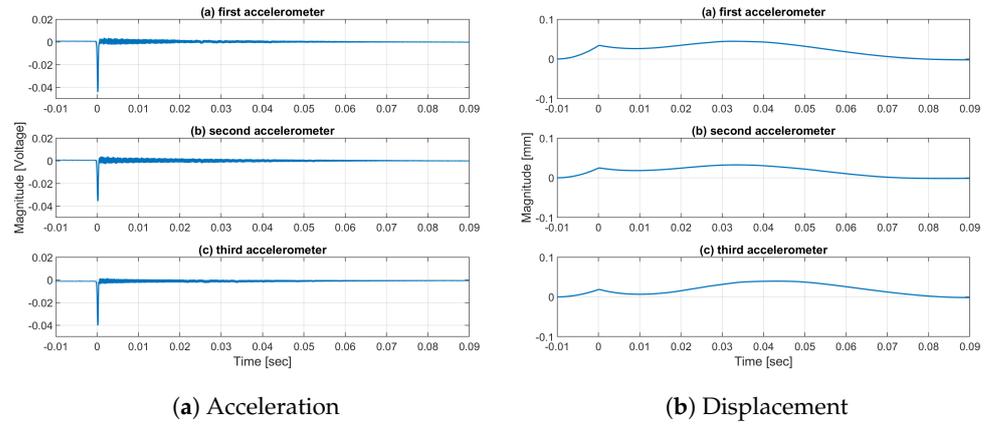
Since cracks in a structure will result in changes in stiffness, defects in a grinding wheel will lead to changes in the measured displacement of the accelerometers [17]. Figures 7–12 show the typical (a) measured acceleration and (b) computed displacement of the tested wheels. Figure 7 shows the response of a new intact 60-grit wheel, and Figures 8 and 9 show the response of fully glued and 25 mm glued broken 60-grit wheels, respectively.

Figure 7. Typical acceleration and displacement of the new 60 grit wheel.

Summary of the displacements of the new, fully glued, and 25 mm glued 60-grit wheels, obtained from Equation (1), are listed in Table 2. It can be seen from Table 2 that the displacement of the wheel is dependent on the stiffness of the wheel. It is expected that the undamaged wheel is the stiffest, then the 25 mm glued wheel is the least stiff. This hypothesis was proven true in Table 2 that shows that the stiffer wheel has the least displacement. Also, the wheel bounced back (displaying positive displacement) after impact events, whereas the broken and glued wheels moved along the impact direction (negative displacement).

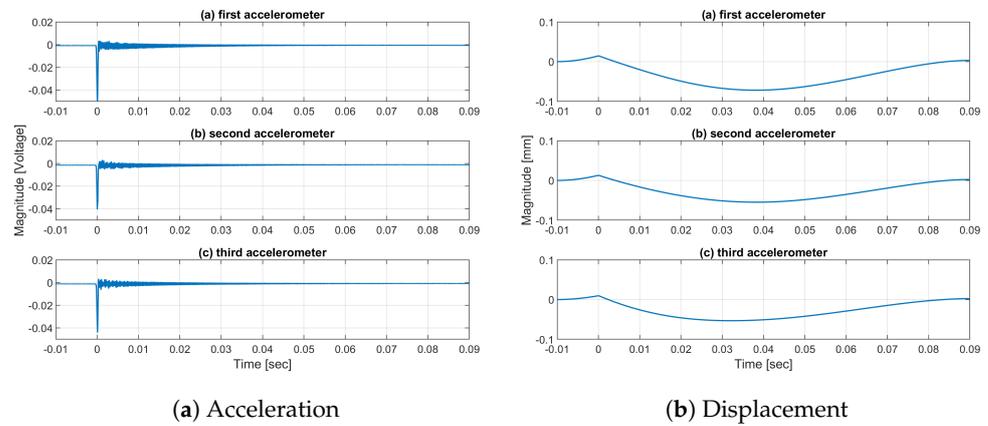
Figure 8. Typical acceleration and displacement results of the fully glued 60 grit wheel.

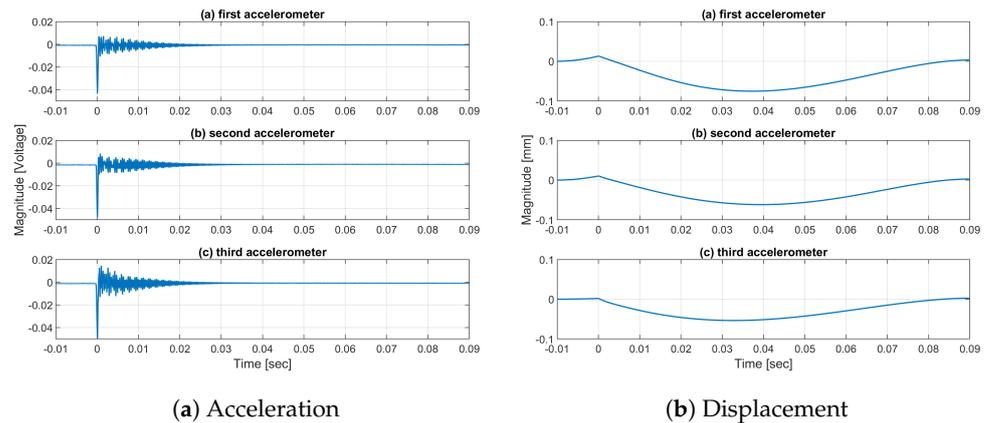
Figure 9. Typical acceleration and displacement results of the 25 mm glued 60 grit wheel.

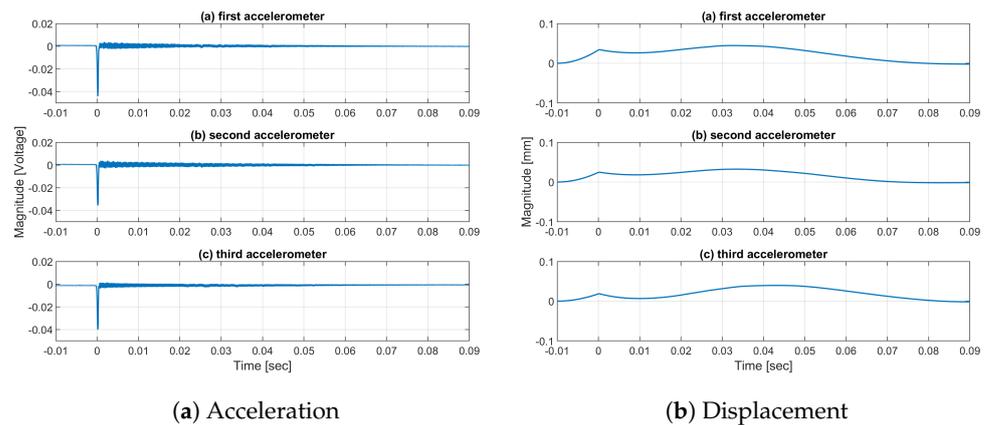
Similar acceleration and displacement for the 120-grit grinding wheels are shown in Figures 10–12. Figure 10 shows the acceleration and computed displacement for the new wheel, while Figures 11 and 12 show wheels that were fully glued and 25 mm glued.

Figure 10. Typical acceleration and displacement of the new 120 grit wheel.

Table 3 shows the compiled displacement for the 120-grit wheels. It was observed that the 120-grit wheels behaved like the 60-grit wheels, where the new wheel had greater stiffness and lower displacement, while the 25 mm glue wheel had the lowest stiffness and correspondingly highest displacement. The 120-grit wheels behaved like the 60-grit wheels where the new wheel had the bounce back phenomenon where the broken wheel’s displacement was in the impact direction.

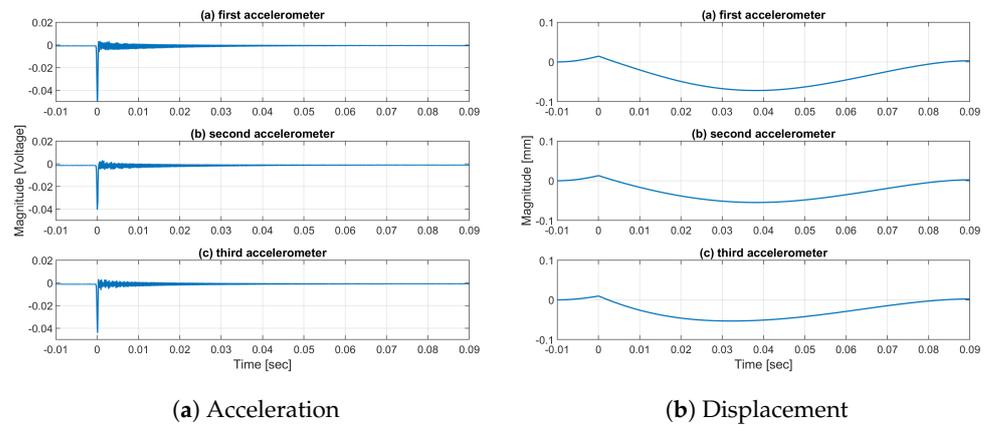
Figure 11. Typical acceleration and displacement results of the fully glued 120 grit wheel.

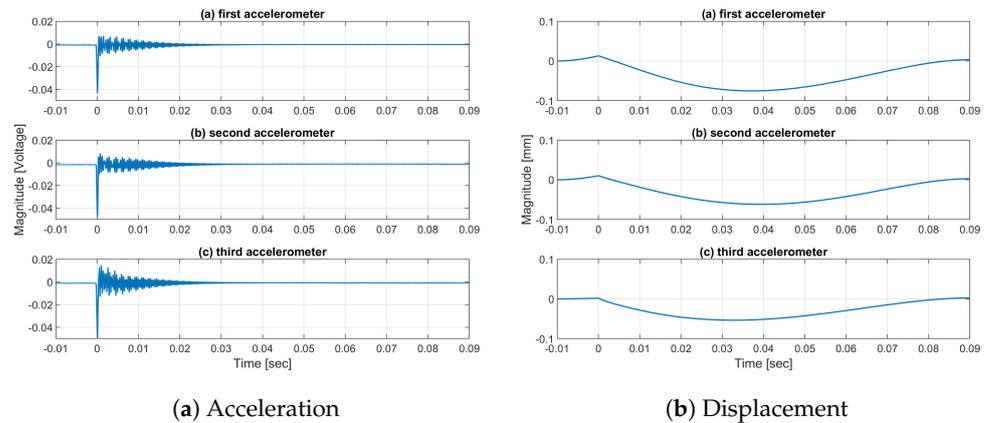
Figure 12. Typical acceleration and displacement results of the 25 mm glued 120 grit wheel.

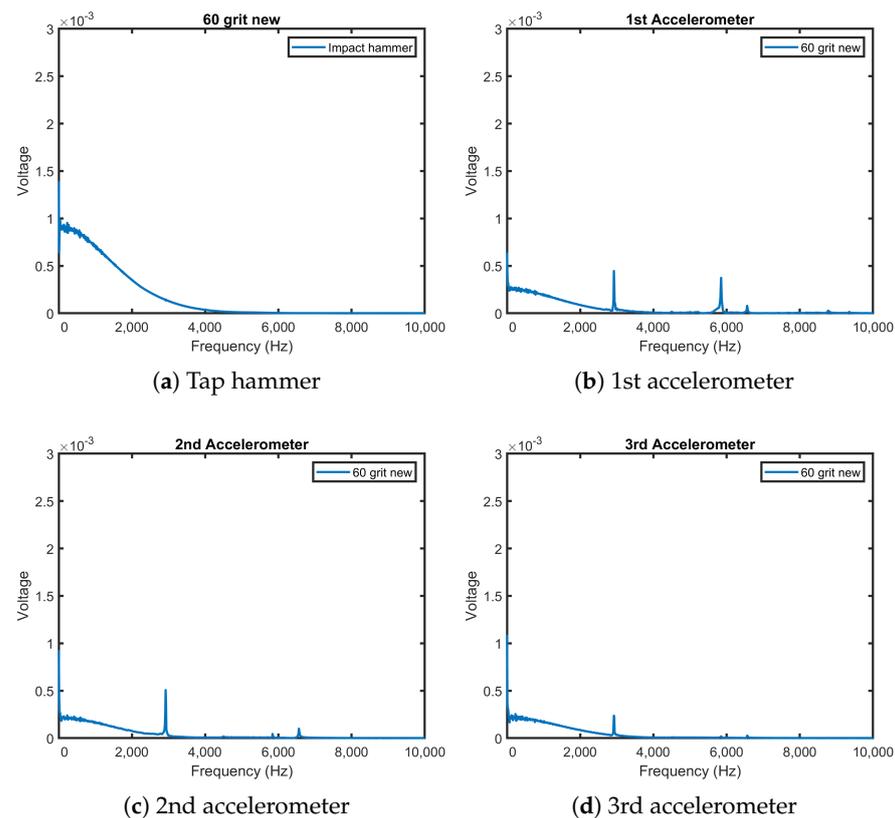
The Fast Fourier Transform (FFT) of the accelerometer signals allows us to observe the resonant frequencies of the wheel. Figure 13 shows the FFT of the typical signals for the hammer and accelerometers for the undamaged 60-grit wheel. Even though three accelerometers were placed at different distances from the tap hammer striking locations, the primary natural frequency of 2920 Hz was identically obtained from all three accelerometers for the undamaged 60-grit medium-grade wheel. It was also observed that accelerometer placement, relative to the crack location, did not have an influence on the computed natural frequency.

Figure 13. Typical natural frequency result of the new 60 grit wheel.

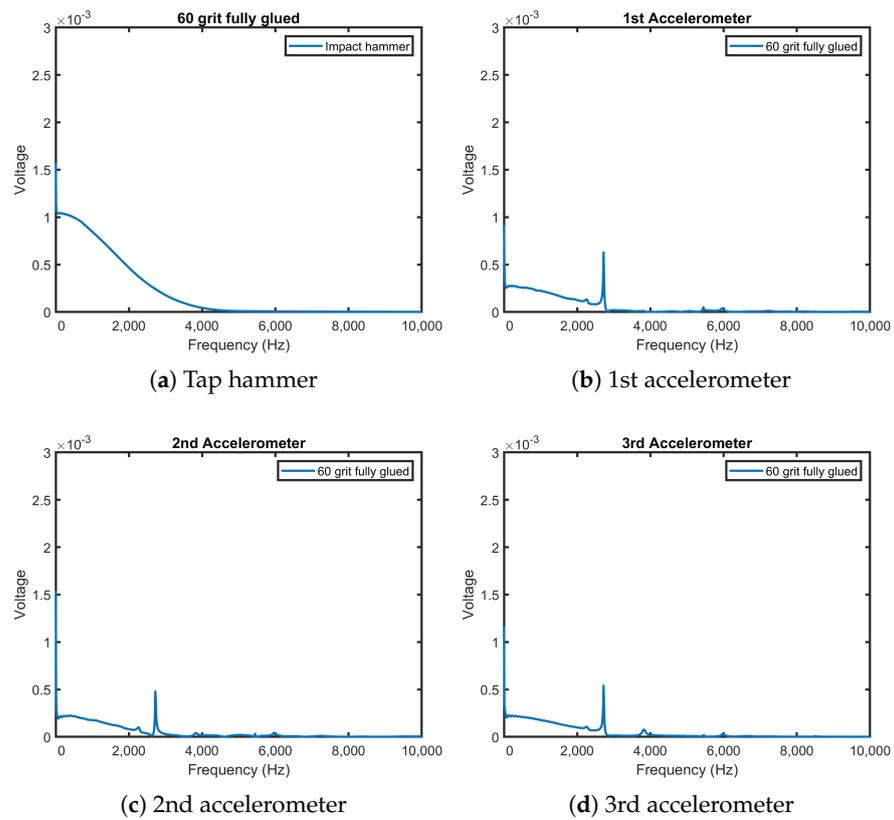
Figures 14 and 15 show the typical FFT of the fully glued and 25 mm glued 60-grit wheel, respectively. When the wheel was fully glued, the natural frequency response of 2720 Hz was consistently measured by all three accelerometers. Moreover, on the 25 mm glued wheel, the primary natural frequency changed to 2470 Hz. The average natural frequencies are listed in Table 5. It can be seen that cracks on the wheel reduced the resonant frequency of the 60-grit wheel by over 200 Hz. Thus, it can be concluded that impact hammer testing can be used to detect defects of this type in the grinding wheel structure examining the natural frequency.

Figure 14. Typical natural frequency result of the fully glued 60 grit wheel.

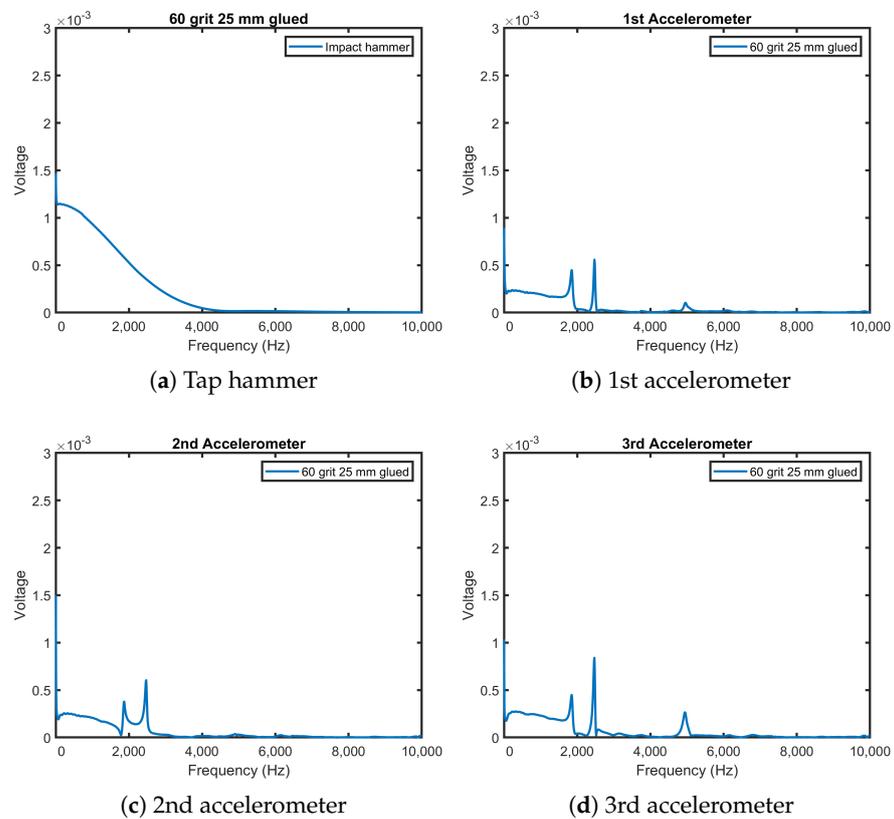
Figure 15. Typical natural frequency result of the 25 mm glued 60 grit wheel.

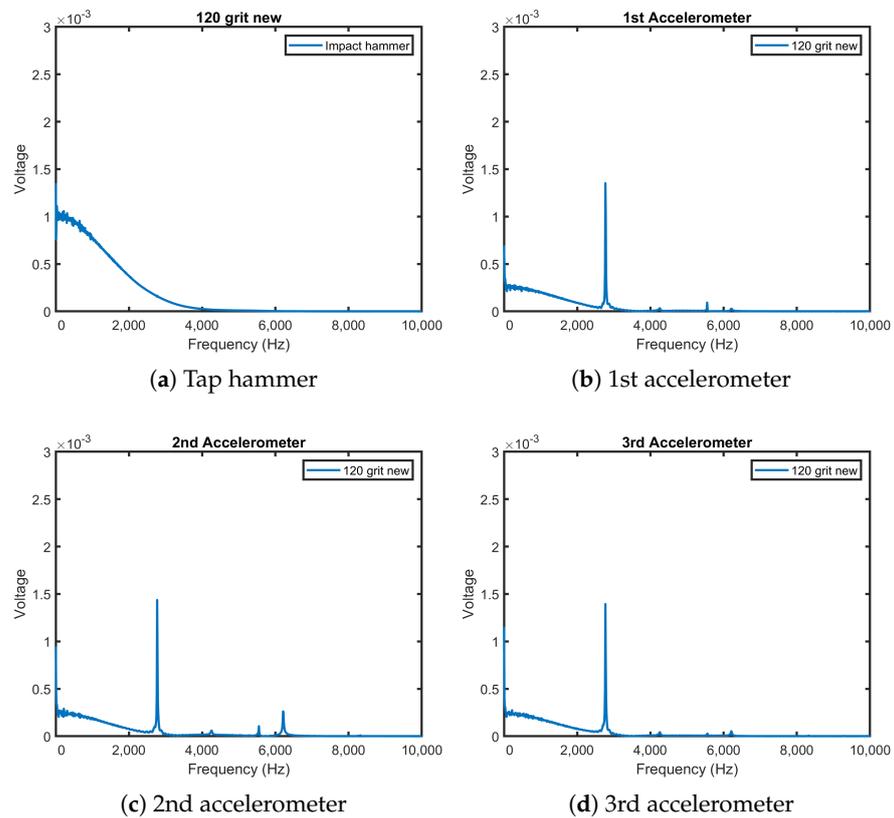
Figures 16–18 show the typical results for the 120-grit wheels. A similar trend in the primary natural frequencies was observed for the 120-grit wheels. Figure 16 shows that the natural frequency of an undamaged 120-grit medium-grade wheel was 2770 Hz. When the wheel was repaired with an entire length of glue, as shown in Figure 17, the natural frequency changed to 2570 Hz. Concerning the 25 mm glued wheel, as shown in Figure 18, the primary natural frequency changed to 2550 Hz. A summary of the natural frequencies in the 120-grit wheels are listed in Table 6. Thus, it is evident that impact hammer testing can be used to detect changes in the structure of 120-grit grinding wheels. In addition, even though 60- and 120-grit wheels have similar dimensions, the differences in grit size and wheel hardness lead to a different primary natural frequency.

Figure 16. Typical natural frequency result of the new 120 grit wheel.

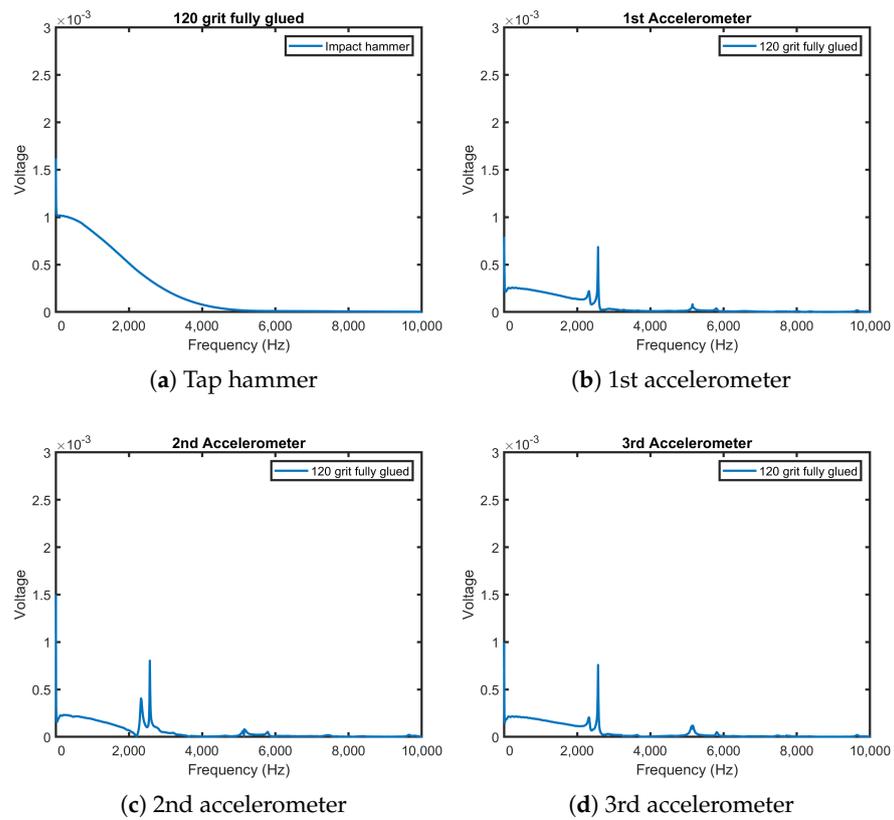
Figure 17. Typical natural frequency result of the fully glued 120 grit wheel.

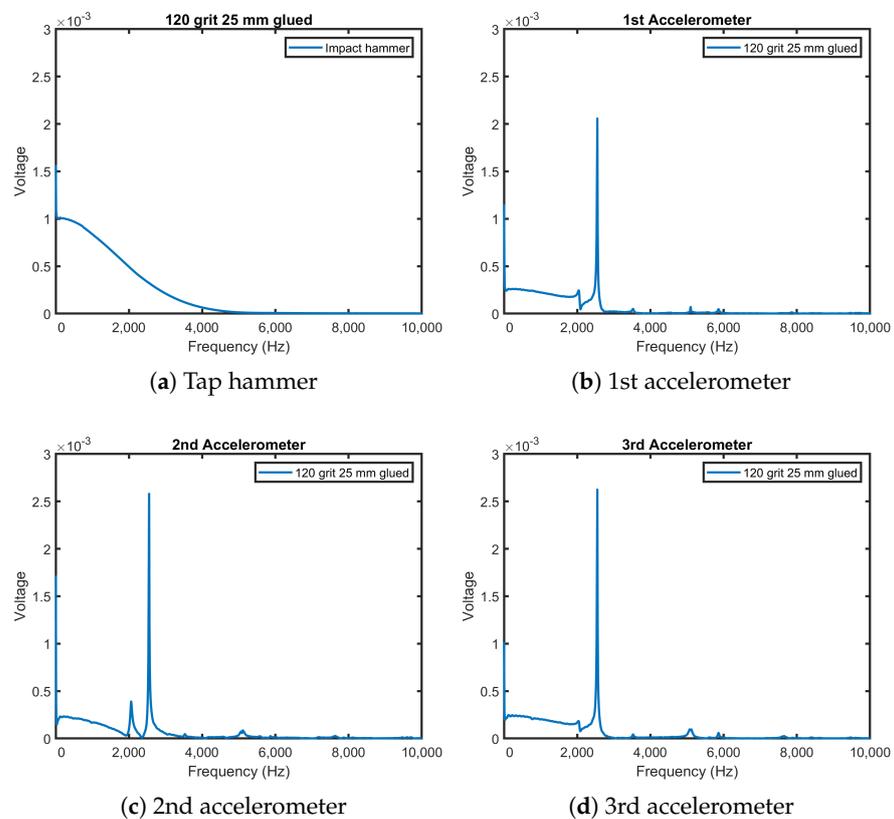
Figure 18. Typical natural frequency result of the 25 mm glued 120 grit wheel.
