Article

Laser Cleaning Combined with Cladding Improves Cladding Quality for Repairing Steel Plates in Pressure Vessels

Citation: Fan, K.; Shi, Y.; Xu, Y.; Wang, S.; Wang, Q.; Li, Y.; Zhang, C.; Li, Z. Laser Cleaning Combined with Cladding Improves Cladding Quality for Repairing Steel Plates in Pressure Vessels. *Coatings* **2024**, *14*, 508. <https://doi.org/10.3390/coatings14040508>

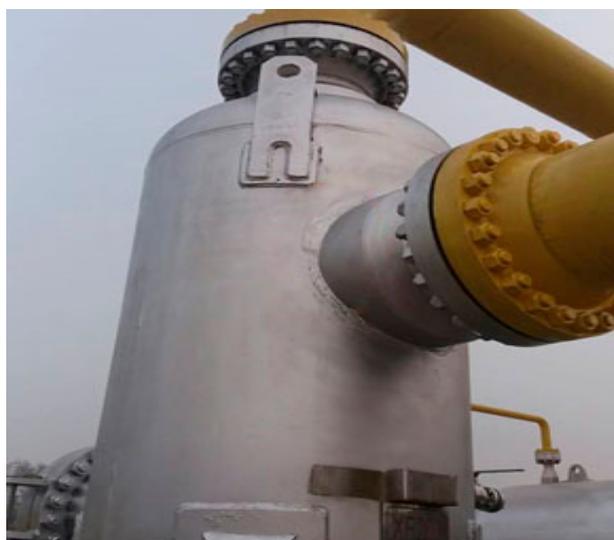
Figure 1. A large cyclone separator in a natural gas station.

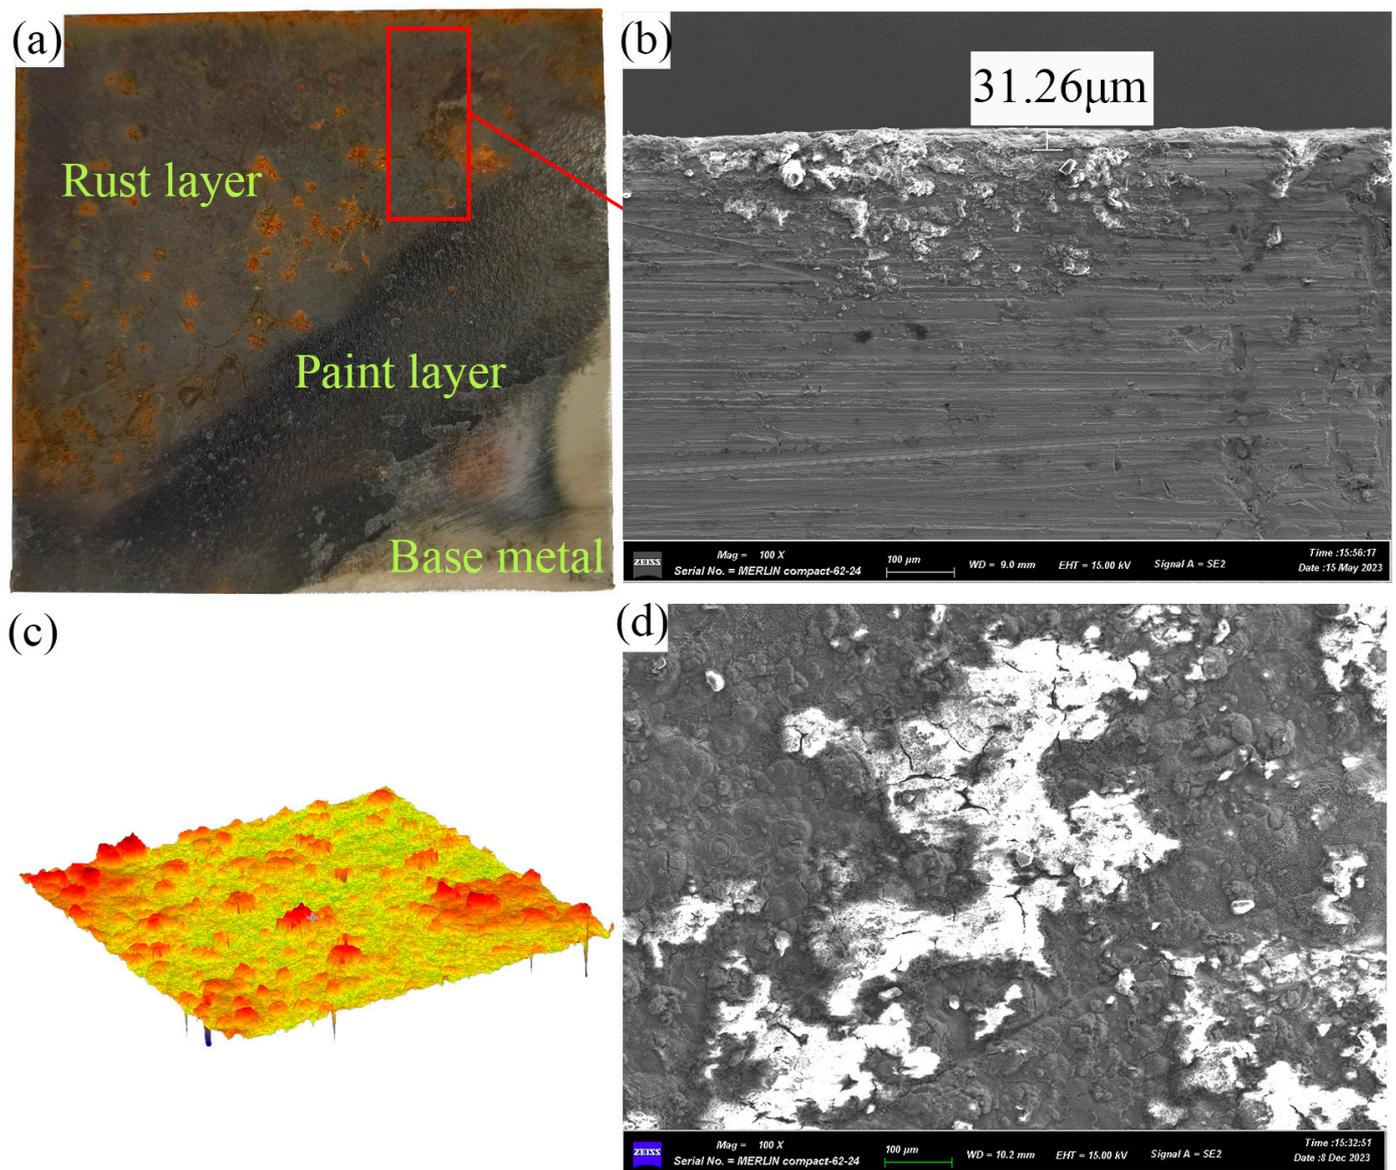
Figure 2. The rusted Q345R plate surface: (a) surface; (b) cross section; (c) 3D morphology; and (d) microscopic morphology.

Painted Q345R steel plates for pressure vessels (10 mm in thickness) were exposed to an outdoor environment for three months. The rusted steel plates were then cut into two samples of different dimensions. One was 10 × 15 mm, which was used to determine the optimal laser cleaning process parameters, and the other was 60 × 60 mm for the cladding experiments. As shown in Figure 2a, the specimens consisted of an outer rust layer, an intermediate grey paint layer, and a steel substrate. Figure 2b shows the scanning electron microscopy (SEM) images of the cross section, indicating that the average thickness of the impurity layer was 30 µm. As can be seen from Figure 2c,d, the oxide layer on the surface of the specimen was loose and continuous.

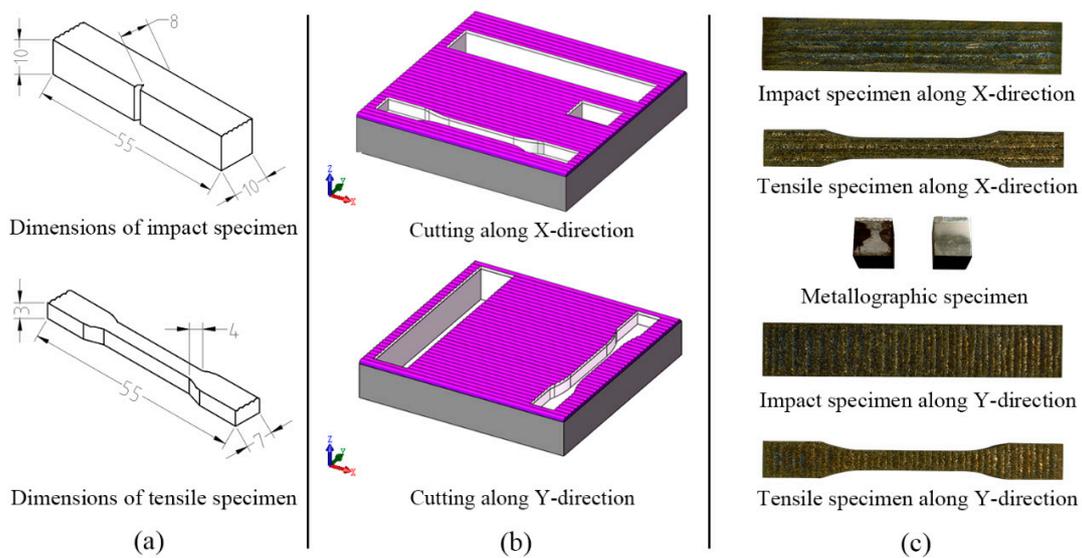
Figure 3. Manufacturing of specimens: (a) dimensions; (b) cutting directions; and (c) tensile, impact, and metallography specimens.

The clad specimens were cut from the plates using electrical discharge machining (EDM). The dimensions of the specimens are shown in Figure 3. Prior to the test, a V-shaped slot was cut from the side where the impact was applied. Three tensile and three impact specimens were prepared for each experimental condition and cutting direction (LCC-X, LCC-Y, MPLC-X, and MPLC-Y).

Metallographic, impact and tensile specimens were prepared after cladding as shown in Figure 3. The metallographic specimens were then sanded and polished. One piece was chemically etched with aqua regia to observe the cladding layer, and the other piece was etched with nitric acid in alcohol to observe the heat-affected zone (HAZ) and substrate. A metallographic microscope (Imager.M2m, ZEISS) was used for the microstructural observations. The SEM (MERLIN Compart, ZEISS) was used for the microstructural observations and elemental analysis with an acceleration voltage of 15 kV in the secondary electron mode. The microhardness of the samples was measured using a microhardness tester (HV-1000) at an interval of 0.2 mm, a loading force of 300 g, and a loading time of 10 s. A universal material testing machine (WDW-50) was used to study the tensile properties at room temperature (25 °C) and a loading rate of 1 mm/min. In the tensile experiment, the original size was 4 mm × 3 mm, and the cross-sectional area was 12 mm². A Charpy pendulum impact test was conducted to determine the impact resistance of the specimens at 25 °C. The average yield strength, ultimate tensile strength, elongation, and impact energy of the three specimens were considered. As shown in Appendix A, the influence of electric discharge wire cutting on the performance of the specimen was not considered.

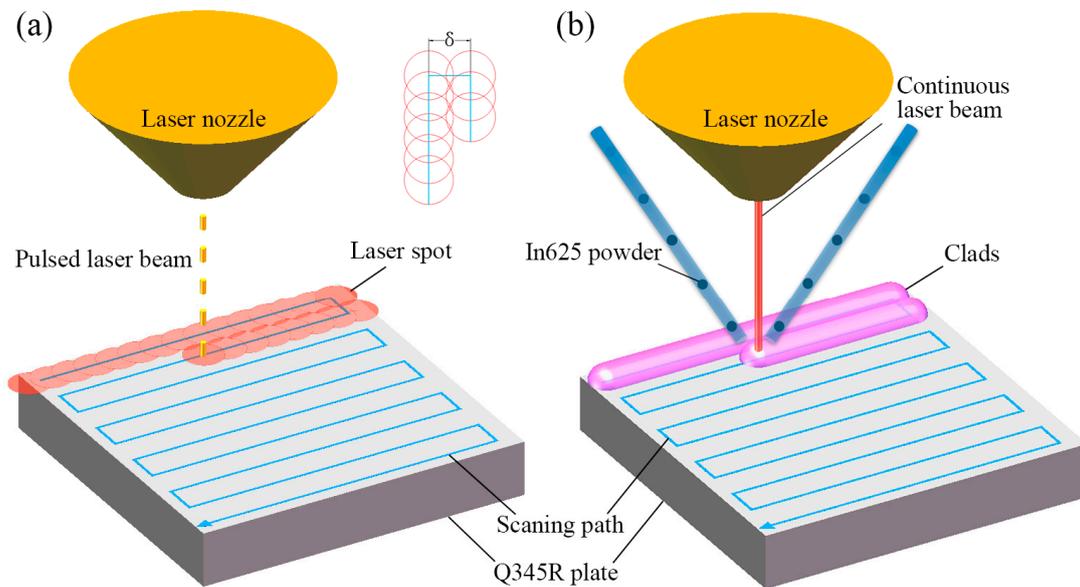
Figure 5. Principle of laser working: (a) laser cleaning; and (b) laser cladding.

As shown in Figure 5a, the laser cleaning was performed by moving a single laser spot progressively in alternating directions. The high-frequency pulsed laser could efficiently remove the impurity layer while minimising damage to the substrate. Specifically, the high-energy laser beam instantly ablates the rust layer, and the pulsed mode reduces the amount of irradiation received at a given point and, therefore, avoids excessive substrate removal. The optimal combination of the parameters was determined by designing an orthogonal experiment. The main factors, such as the laser power, laser scanning speed (V_{se}), and number of scans, were selected for the L25 (5^5) orthogonal experiments. The specific parameters are listed in Table 3. To minimise the laser damage to the metal beneath the impurity layer and to simultaneously increase the cleaning efficiency, the frequency of the laser cleaning process was set to 20 kHz and the pulse width was set to 2.5 μs . In addition, to ensure that the vaporised impurities were removed in time, the protective gas pressure was set to 0.5 MPa. Regarding the laser scanning path, a lap rate of 30% and a column offset of $\delta = 1.4$ mm were used together with the fixed laser spot size in order to overlap adjacent irradiated areas and completely remove the impurity layer.

During the cladding process, the laser beam continuously irradiates the substrate to form a melt pool. A conveyor transports metal powder to the coaxial powder feeder in the cladding head, where the powder is metallurgically bonded to the substrate under the action of the high-energy laser. A protective gas is delivered to the melt area to prevent material oxidation at high temperatures and to apply a pressure to the powder feeder to ensure a continuous and uniform powder delivery. The pressure from the protective gas also helps to improve keyhole stability and thus minimises pore defects during the laser cladding process [27]. However, an excessive protective gas pressure can cause irregularities in the cladding profile. Similar to the cleaning process, the robotic arm drives the cladding head to scan the area to be repaired and completely covers it with the cladding material. A schematic of the cladding process is shown in Figure 5b.

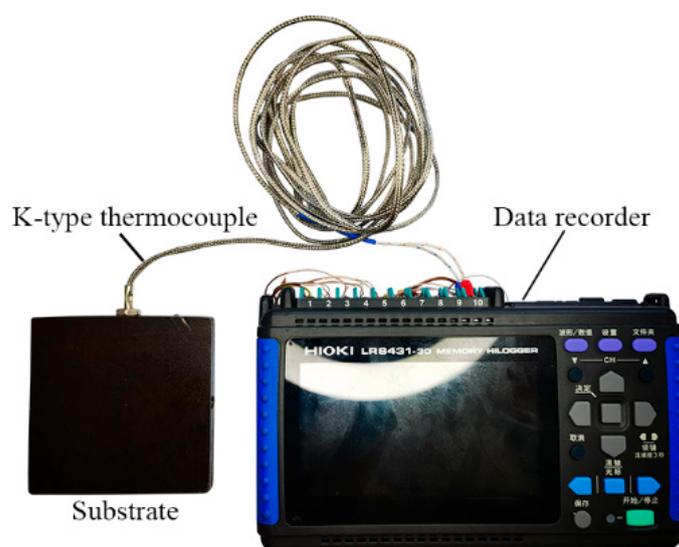
Figure 6. Temperature data acquisition system.

Two groups of four substrates were prepared for the cladding experiments, with one substrate not subjected to cladding treatment for comparison. The first group of substrates was cleaned with a laser using the optimum parameters described in Section 2.2.1. The second group was sanded by skilled workers using an angle grinder equipped with a grinding disc, rinsed, and dried with anhydrous ethanol prior to the laser cladding. As shown in Figure 6, a K-type thermocouple was used during the laser cleaning and manual polishing with a data recorder (HIOKI, Nagano, Japan, LR8431-30) to obtain the substrate temperature. The cleaned substrate was then laser-clad.

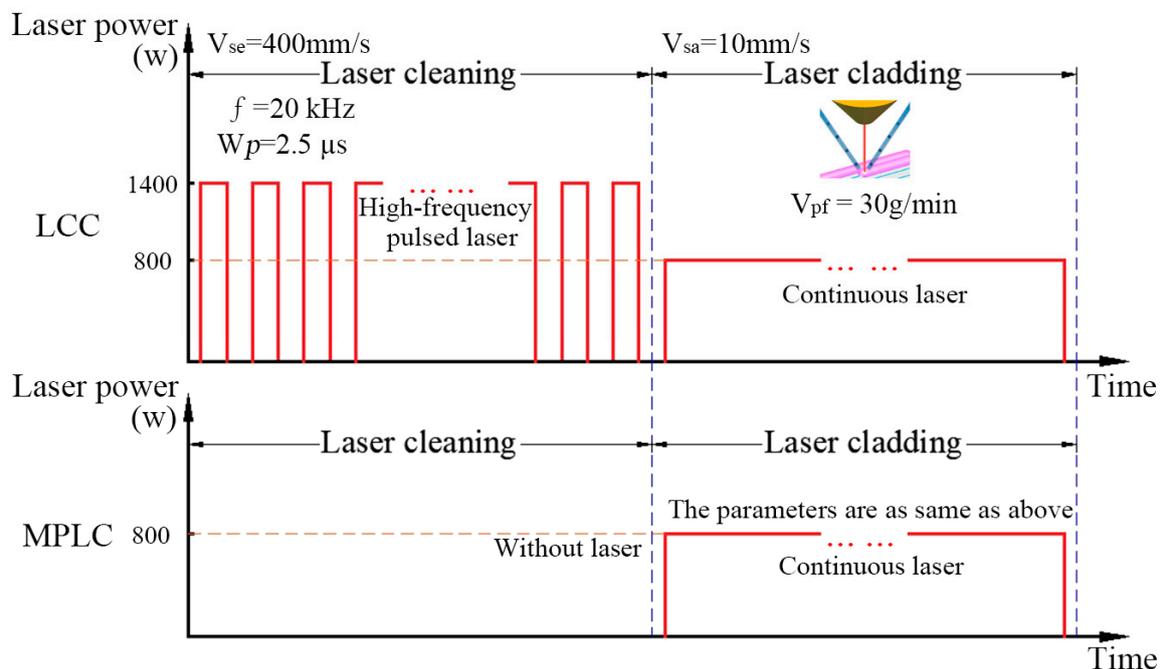
Figure 7. Comparison of process parameters between LCC and MPLC.

protective gas pressure of 0.2 MPa. Figure 7 shows a comparison of the laser parameters used in the cleaning and cladding steps.

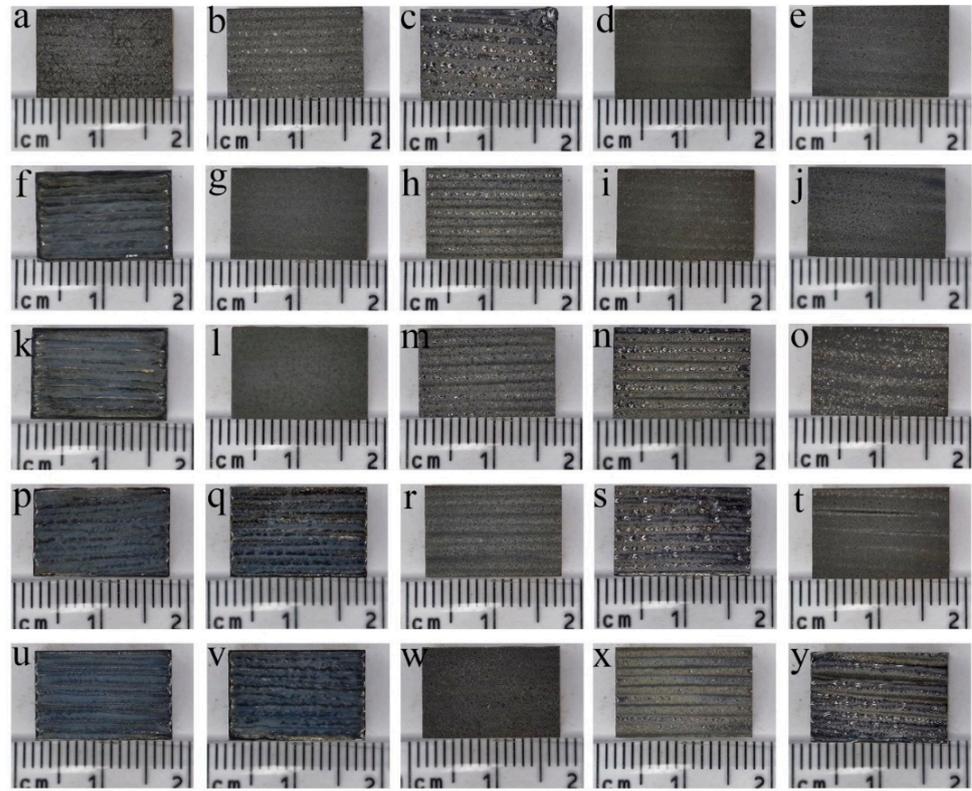
Figure 8. Macro-morphology of samples (a–y) 1–25, respectively, under different laser process parameters.

Figure 8 shows the macroscopic morphologies of the specimens after the laser cleaning at different laser powers, scanning speeds, and times. The cleaned specimens exhibited four rough surface states. (1) The surface morphology was flat with fewer residual impurities, as shown in Figure 8d,e,g,l. (2) The surface morphology was uneven, and black or white particles with laser scanning traces could be clearly observed, as shown in Figure 8a,b,h,m,r,x. (3) A partial remelting of the surface occurred, with many bright white particles remaining and a darker colour in some areas, as shown in Figure 8c,n,o,s,y. (4) The surface was remelted and oxidised, becoming darker in colour, as shown in Figure 8f,k,p,q,u,v.

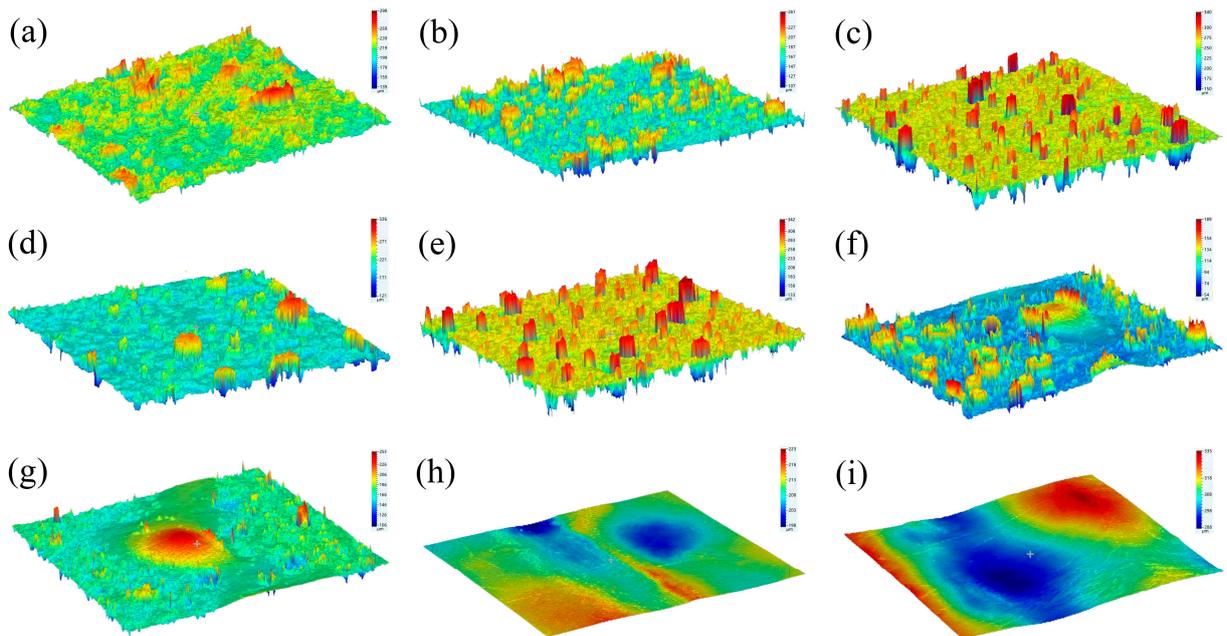
Figure 9. Three-dimensional morphology of sample (a) 1, (b) 2, (c) 4, (d) 7, (e) 12, (f) 14, (g) 19, (h) 21, and (i) 22.

Figure 9a shows that, with a laser power of 1400 W, under a single scan, the cleaning depth was insufficient, and some thicker impurities could not be removed. As the power

and scanning frequency increased, the surface smoothness improved; however, some small particles remained on the surface, as shown in Figure 9b–e. Sample 7 contained fewer residual particles. Figure 9f,g show that, as the power was further increased, remelted particles appeared on the surface of the sample. When the sample reached 2000 W, a large area of remelting formed on the surface and the morphology became smoother.

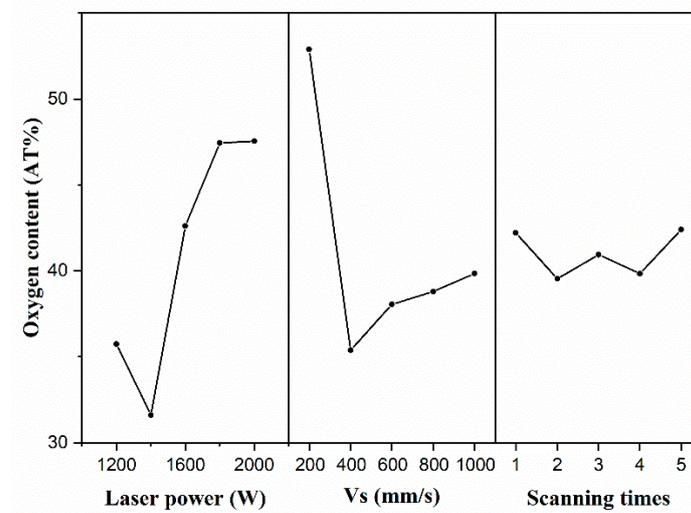
Figure 10. Responses of three factors to oxygen content.

As shown in Figure 10, the surface oxygen content decreased, increased, and finally stabilised with an increasing laser power over the range of experimental factors. At lower laser powers, the impurity layers could not be sufficiently ablated, because the laser ablation was weaker and thicker. As the laser power increased, remelting occurred on the surface, generating new oxides. When the scanning speed was low, the laser acted on each area for a long time, and the substrate remelted under the action of the laser energy for a long period of time, resulting in a high oxygen content. As the scanning speed increased, the laser

irradiation time of the substrate decreased, the ablation of the impurity layer gradually became insufficient, and the oxygen content gradually increased.

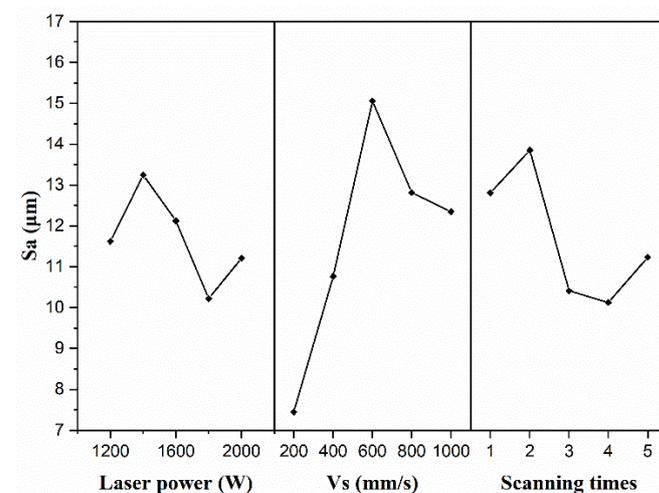
Figure 11. Responses of three factors to surface roughness.

where R_i is the reflectivity of the ideal smooth Q345R surface for the laser and λ is the laser wavelength, which is a fixed value. According to Equation (1), a larger Sa value leads to a lower laser reflectance. The roughness of the specimen surface could be improved by fully absorbing the cladding laser. Combining this with Figures 10 and 11 of the orthogonal experimental analysis, to ensure that the oxygen content of the cleaning of the specimen's surface was as low as possible, a laser power of 1400 W and a scanning speed of 400 mm/s should be selected, and to ensure a high degree of roughness, the number of scans should be 2.

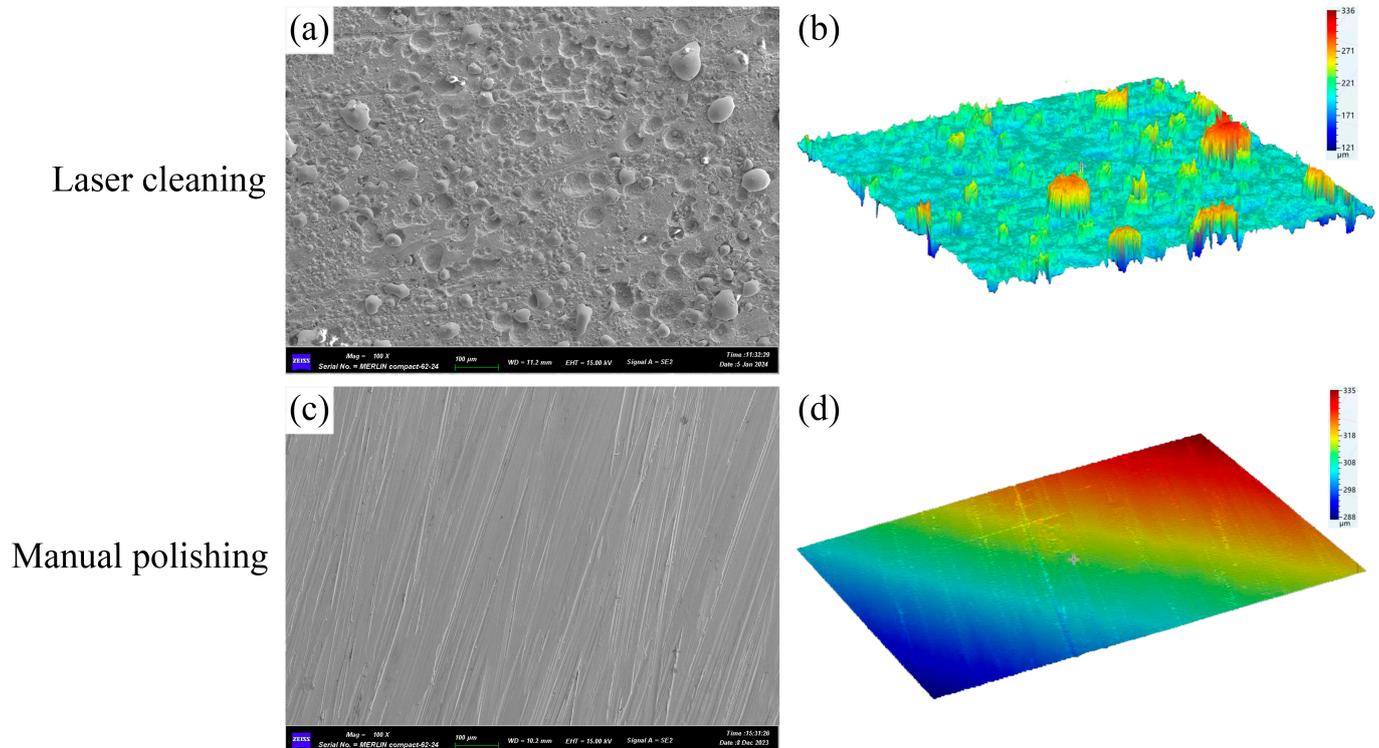
Figure 12. Comparison of surface morphology between laser cleaning and manual polishing: (a) microscopic morphology of laser cleaning; (b) 3D morphology of laser cleaning; (c) microscopic morphology of manual polishing; and (d) 3D morphology of manual polishing.

Figure 12 compares the surface morphologies of the samples after the laser cleaning and manual polishing using the optimal process conditions. Compared with laser cleaning,

the surface after manual polishing is smoother, with residual scratches caused by particle cutting. The measured roughness of the laser-cleaned specimen was 14.22, and the roughness of the manually polished specimen was 7.09.

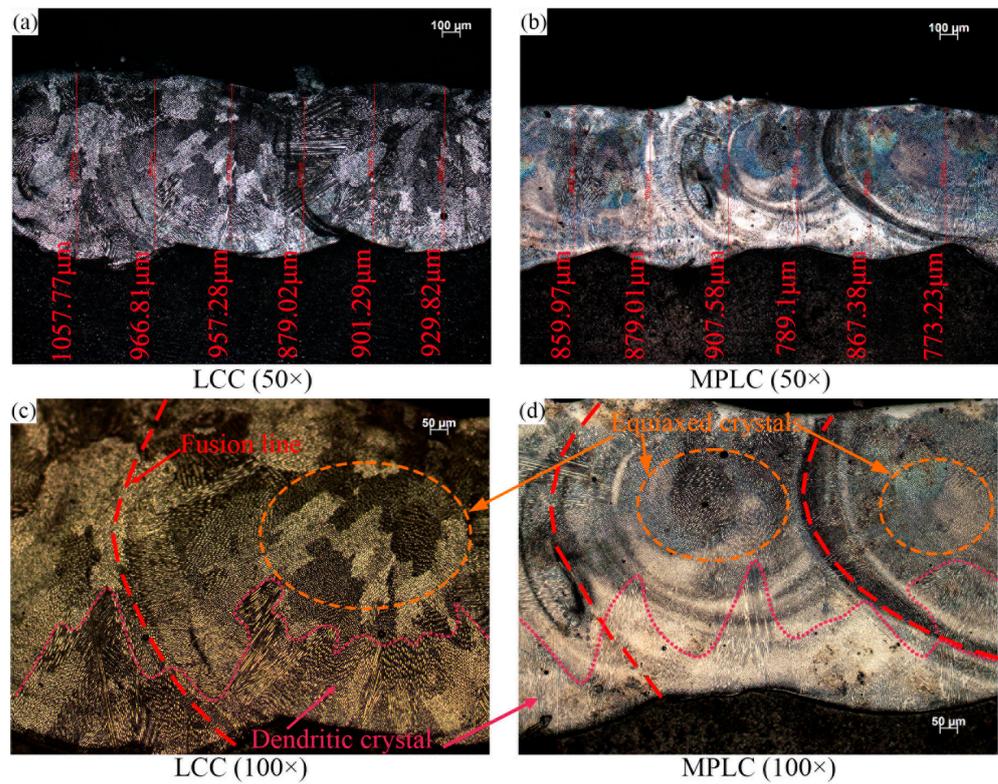
Figure 13. Cross-sectional microstructures: (a,b) 50× metallographic images; and (c,d) 100× metallographic images.

Figure 13 shows metallographic images of the LCC and MPLC specimens (Image acquisition: Axio Vision, Zeiss, Jena, Germany). Six positions were randomly selected to measure the thickness of the cladding layer to calculate the average thickness. The average thickness of the cladding layer was 948.7 μm for the LCC specimen and 846 μm for the MPLC specimen, as determined by the measurement software. This indicates that, compared to manual polishing, cleaning with a pulsed laser can allow more Inconel 625 powder to melt during the subsequent laser cladding step. As shown in Figure 13c,d, the bottom of the clad layer is a dendritic crystal growing upward in the direction of the heat flow, whereas the middle of the layer is a cellular structure consisting of small grains of equiaxed crystals. In addition, columnar crystal growth occurred at the lap of two cladding layers, because this is where the cladding material was thermally remelted and the grains grew again in the direction of the new cladding heat flow.

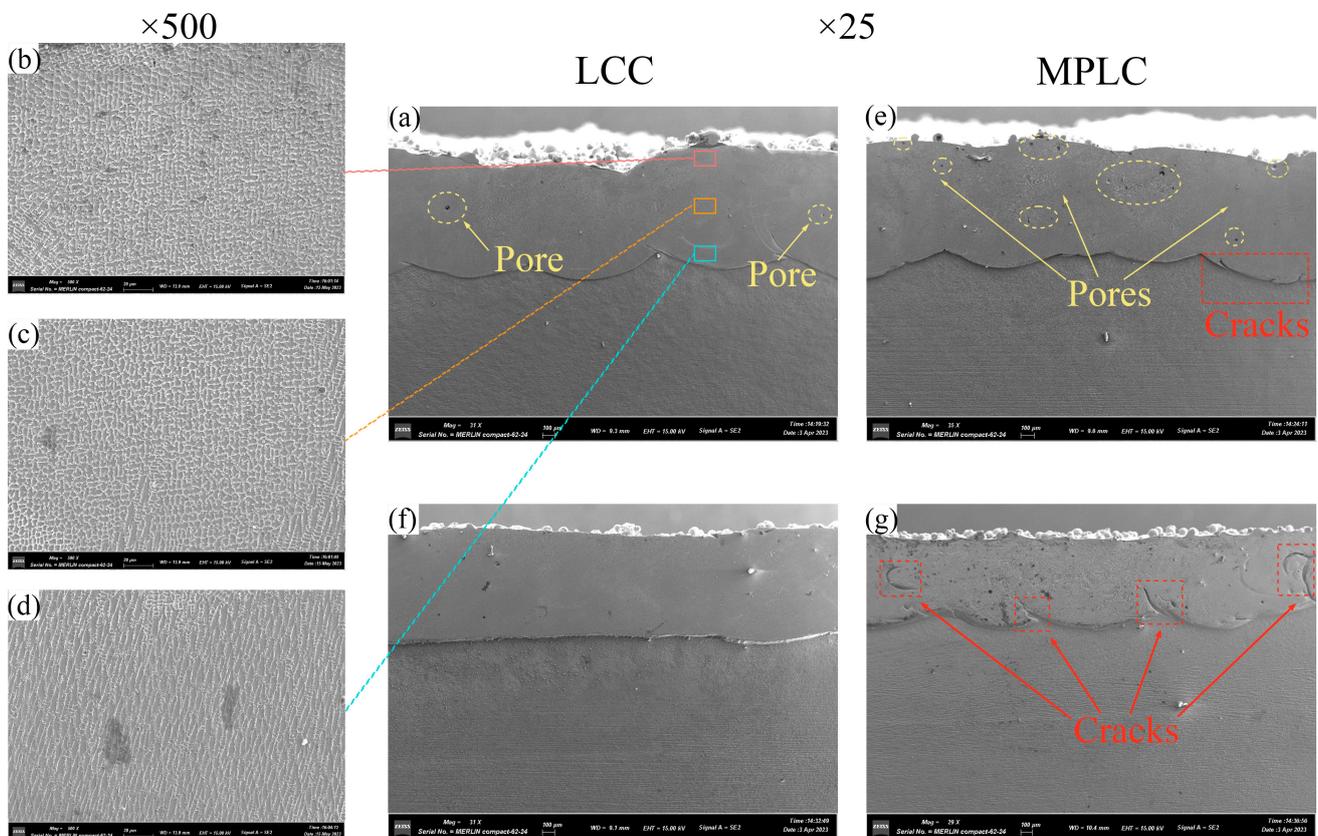
Figure 14. SEM micrographs of specimens: (a–e) cross sections along the Y-direction; and (f,g) cross sections along the X-direction.

Figure 14a–e show SEM cross-sectional images of the specimens cut along the Y-direction. The cladding layer prepared using the LCC was less porous than that prepared using the MPLC. The former exhibited a clear white bright band at the gap between the clad layer and the substrate, suggesting a better bonding effect. In contrast, the MPLC process produced larger voids in some gaps. Such voids tend to develop into larger cracks under practical conditions and decrease the cladding layer performance [28].

Figure 14f,g show the SEM images of the specimens cut in the laser scanning direction (the X-direction). The fusion line in the MPLC specimen was wavy and contained more unfused voids, whereas that in the LCC specimen was flatter and exhibited a higher bonding quality. After the laser cleaning and preheating, the cracks at the fusion line along the X-direction almost disappeared [29]. The manually cleaned substrate had a low temperature, and the laser beam heated both the powder and part of the substrate to melt it. The substrate was heated from very cold to very hot during the cladding. The powder formed a melt pool that progressively advanced in the direction of the laser scan, with wavy fusion lines observed in Figure 14g in the longitudinal section. Small holes were present in the lower part of the clad layer, which was due to the keyhole effect during the laser cladding [30]. The presence of voids at the bottom of the clad layer indicated that the new melt pool was not fully fused with the old pool before laser irradiation. The resultant voids in the clad layer were observed in the SEM images of the cross sections, both perpendicular and parallel to the laser scanning direction.

- (1) The LCC process left fewer defects in the microstructure of the clad layer than the MPLC process (Figure 14), thereby enhancing the resistance to impact loads. Consequently, the LCC specimen demonstrated a superior impact on the energy absorption compared to other specimens cut in the same direction.
- (2) The cracks tend to propagate parallel to the Y-direction (i.e., the scanning direction during the laser cladding). The location of the cladding overlap acted as a stress concentration area, and the residual stresses were parallel to the Y-direction. Therefore, among the specimens processed under the same conditions, those cut along the X-direction exhibited a higher impact on the energy absorption.
- (3) Due to the use of two laser scans, the LCC specimens should exhibit enhanced hardness and reduced plasticity at overlapping locations within the HAZ of the clad layer.

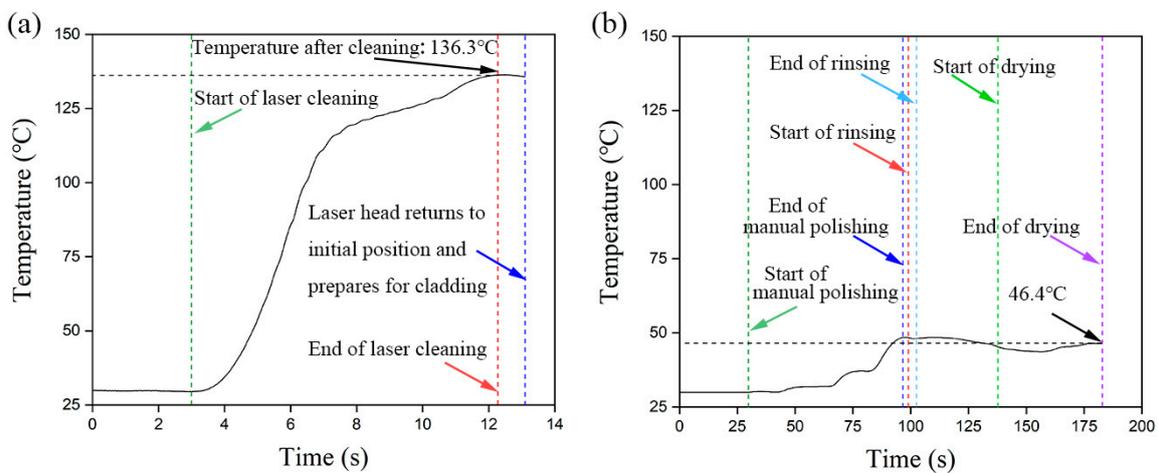
Figure 15. Temperature curve of the substrate: (a) during laser cleaning process; and (b) during manual polishing process.

In addition, the temperature rise curve of the substrate obtained during the laser cleaning, using the data recorder in Figure 15a, indicated that the substrate was preheated at the end of the cleaning process, and the substrate temperature reached 136.3 °C before the cladding.

During the laser cleaning, a high-energy laser beam ablated and vaporised the rust layer. Simultaneously, the substrate absorbed the excess laser energy and was thus preheated. Such preheating is known to change the defect type in specimens from a mixture of microcracks and small holes to a single type of small holes [31]. In contrast, the temperature of the manual polishing process only slightly increased. As shown in Figure 15b, the substrate temperature after polishing is about 46.4 °C, which is not sufficient to affect the subsequent cladding.

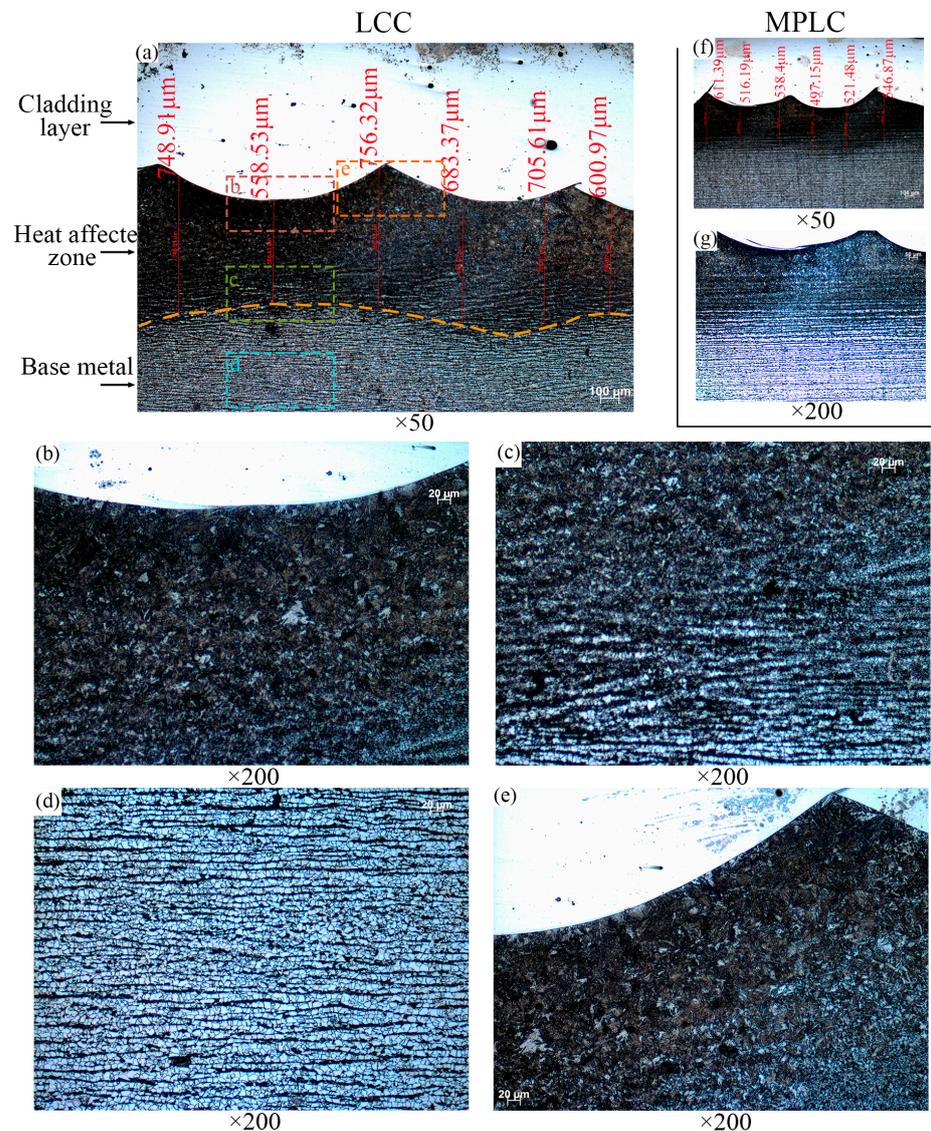
Figure 16. Microstructure of the HAZ: (a–e) LCC specimens; and (f,g) MPLC specimens.

Figure 16 shows micrographs of the HAZ for the LCC and MPLC specimens cut in the X-direction. Figure 16a shows the clad layer, HAZ, and substrate from the top to the bottom. Six positions were randomly selected to measure the depth of the HAZ to calculate the average depth. The average depth of the HAZ is approximately 675 μm for the LCC specimen and 629 μm for the MPLC specimen. Because the LCC specimen underwent an additional laser scanning step compared to the MPLC specimen, the HAZ of the substrate increased in thickness. Figure 16d shows that white streaks of ferrite and black pearlite were observed in the substrate area. Figure 16c shows that streaks of ferrite and a transformation to a Widmanstätten structure by heat treatment were observed at the bottom of the HAZ. Figure 16b–e illustrate that the material was completely transformed into an acicular Widmanstätten structure at the top of the HAZ. The laser scanning caused quenching in the substrate, which increased its hardness. The presence of the Widmanstätten structure also led to a reduction in toughness.

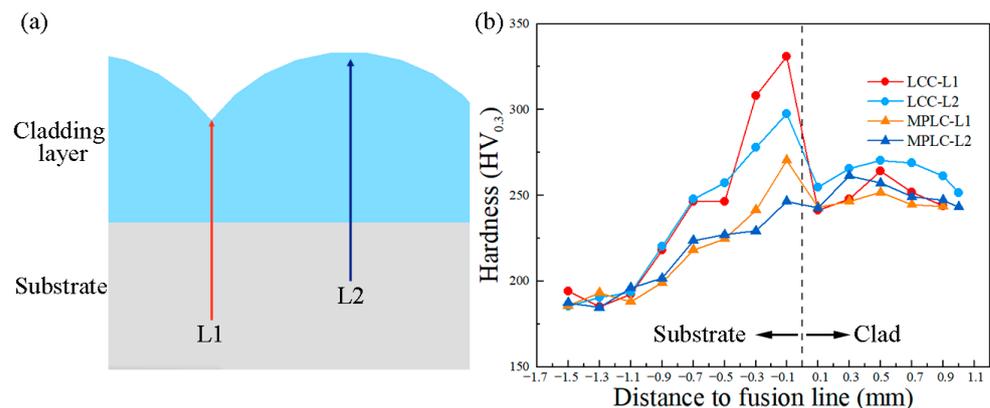
Figure 17. Microhardness test: (a) two test paths; and (b) microhardness distribution for each specimen.

Microhardness tests were performed on sections of the metallographic specimens to determine the effects of the LCC process on the hardness distribution. As shown in Figure 17a, two paths were selected for each specimen for microhardness testing. Path L1 passes through the area where the two cladding layers overlap, whereas Path L2 is parallel to L1 but passes through the middle of a single cladding layer. Test points were taken along each path at 0.2 mm intervals. Figure 17b shows the microhardness values of the specimens in the Z-direction from the substrate to the surface of the cladding layer. Using the fusion line between the cladding and substrate as a reference, the points above and below it are indicated by positive and negative distances, respectively. The hardness of each specimen tends to first increase and then decrease along the upward test path. The Q345R substrate has a hardness ranging from 185 to 192 HV, and it exceeded 230 HV in the HAZ. The hardness of the clad layer ranges from 240 to 286 HV. Overall, the hardness of the Inconel 625 clad layer is more than 30% higher than that of the Q345R substrate.

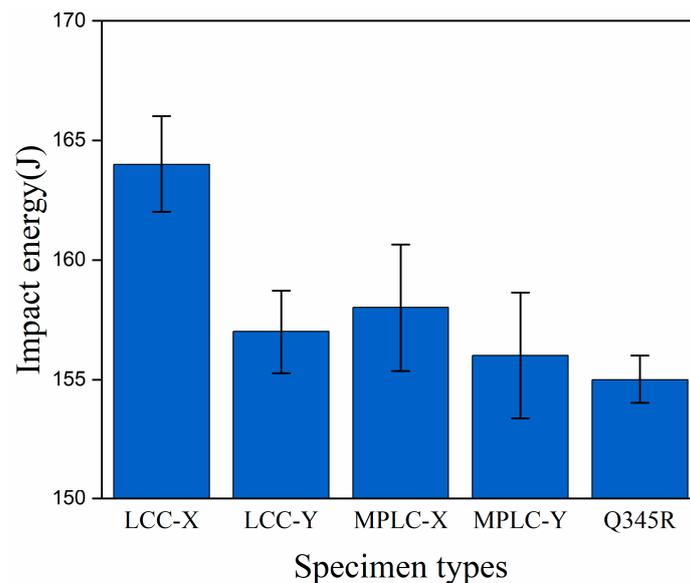
**Figure 18.** Results of the impact test.

As shown in Figure 7, specimens cut along the X-direction (LCC-X and MPLC-X), and the Y-direction (LCC-Y and MPLC-Y) were prepared for Charpy pendulum impact tests. The experimental results are shown in Table 5 and Figure 18.

According to the results in Figure 18, the LCC process achieved a maximum impact on the energy absorption of 164 J when the impact was applied perpendicular to the direction of the laser scans during the cladding. This value is 5.8% higher than that of the rusted Q345R substrate. Moreover, all other clad specimens showed a slightly higher impact on the energy absorption than the substrate. Specifically, the LCC-Y specimen cut along the Y-direction absorbed 157 J of impact energy, merely 2 J higher than that of the substrate. This can be attributed to the following factors.

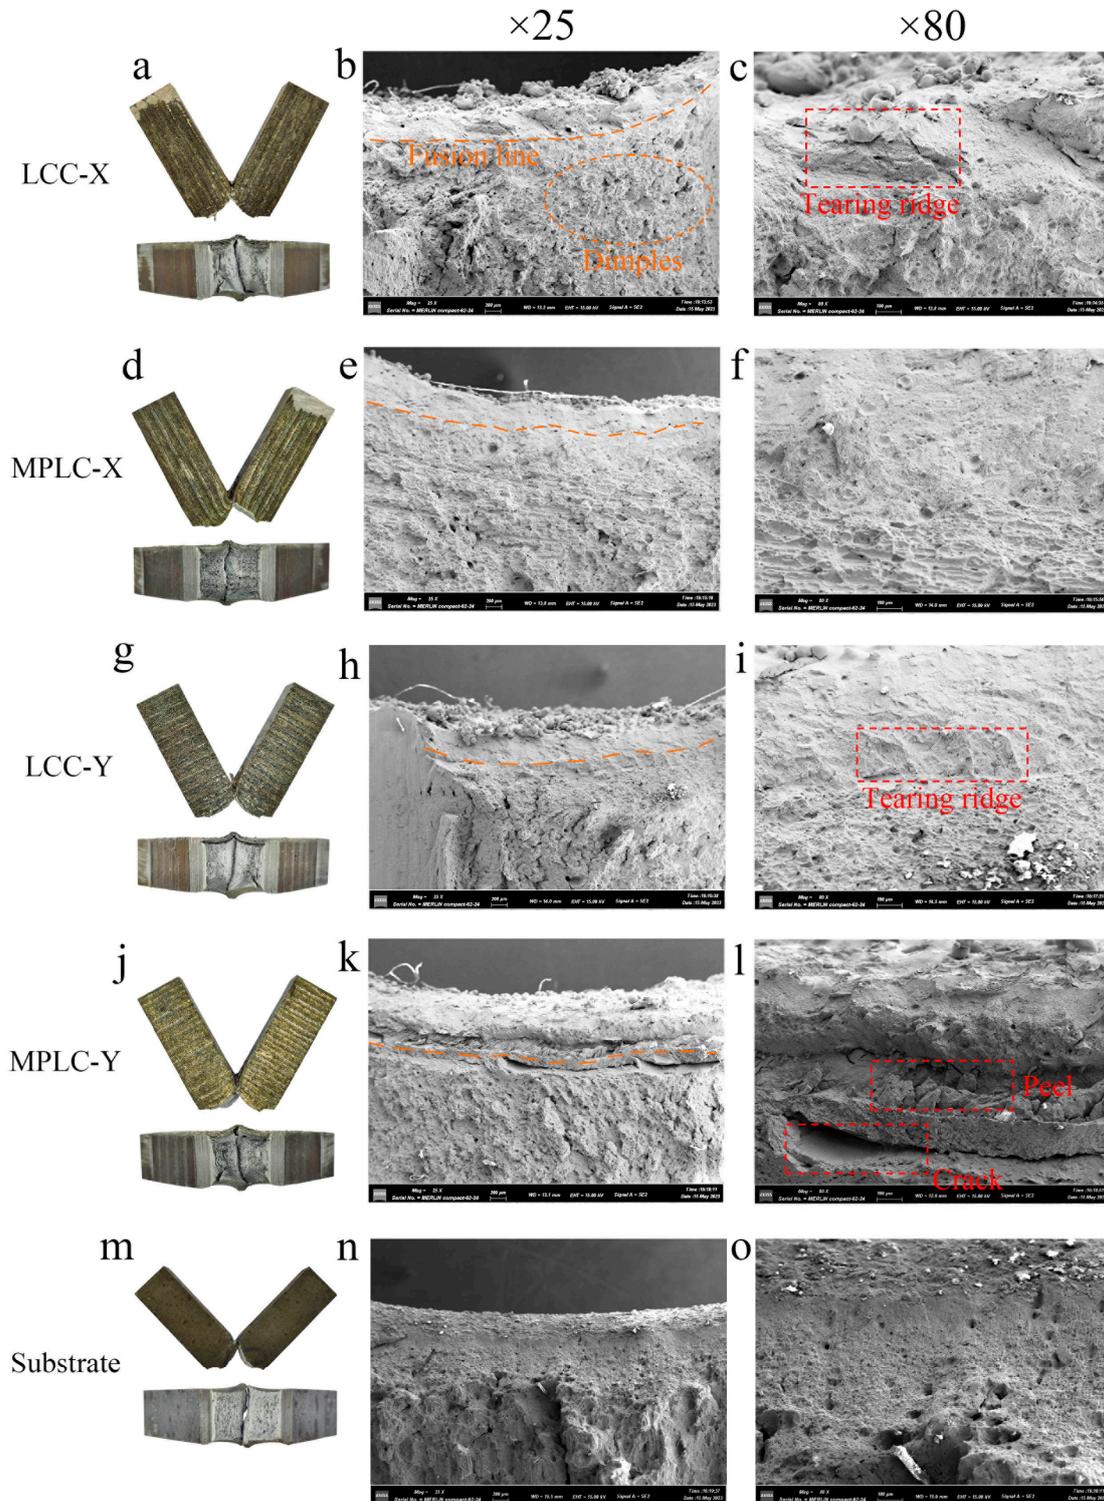
Figure 19. Macro-morphology and SEM micro-morphology of impact fracture specimens: (a–c) LCC-X; (d–f) MPLC-X; (g–i) LCC-Y; (j–l) MPLC-Y; and (m–o) substrate.

Figure 19 shows the morphology of the impact fracture observed using the SEM. From Figure 19a,d,g,j,m, all specimens exhibited a significant deformation at the top and bottom of the fracture, indicating that there was an overall ductile fracture characteristic due to extrusion deformation during impact. The fracture mechanism of the fused layer is significantly different from that of the substrate. As shown in Figure 19b, high-density

dimples were clearly observed on the substrate, indicating that the substrate had a ductile fracture mechanism. In contrast, Figure 19c shows the cladding layers had rougher cross sections and multiple fold-like tearing edges, indicating a brittle fracture mechanism. At the same laser power, the temperature gradient created in the Inconel 625 powder was less in the LCC specimen than that in the MPLC specimen, which reduced the pores and cracks in the cladding layer [33] and enhanced the impact toughness of the LCC specimen.

The HAZ of the specimens cut along the Y-direction exhibited a fracture shape significantly different from that of the substrate. Figure 19g,j show that the fracture of the specimens cut in the Y-direction occurred along the lap line of the cladding layer. Figure 19i reveals a significant tearing ridge in the HAZ of LCC-Y, indicating a lower toughness of the HAZ. Figure 19l shows the MPLC-Y specimen with many peels at the fusion site of the clad layer and substrate, as well as a step-like tear in the HAZ. Owing to the presence of the fusion line cracks along the Y-axis of the clad specimen, the cracks did not have sufficient time to gradually expand under a rapid impact, and many peels were generated instantaneously as a result. The specimens containing a clad layer absorbed more impact energy than the substrate. However, considering the high hardness of the HAZ at the lap position and the reduced plasticity, the overall impact performance of the LCC specimens cut along the Y-direction was not significantly better than that of the substrate.

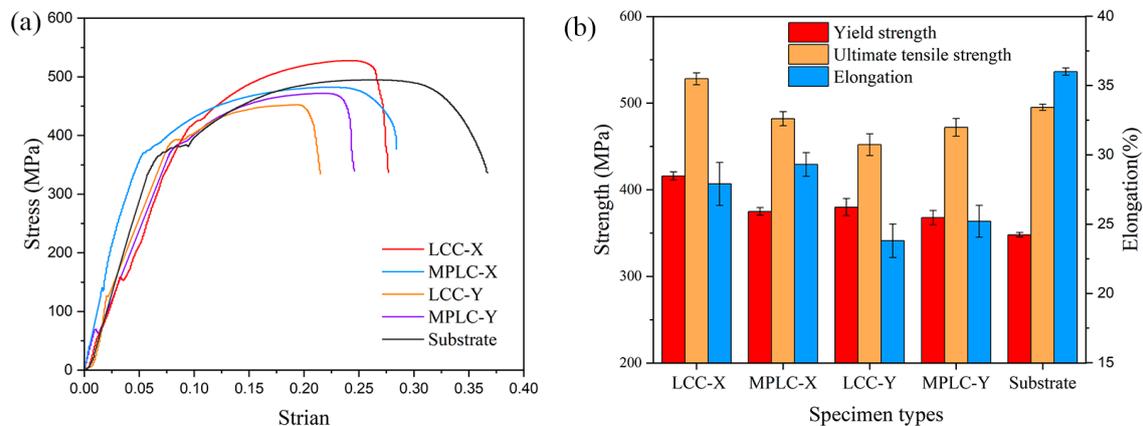
Figure 20. Results of the tensile test: (a) stress–strain curves; and (b) tensile strength and elongation of different specimens.

Table 6 and Figure 20 show the results of the tensile tests. The yield strength of the substrate was 348 MPa, and its tensile strength was 495 MPa. When the tensile direction was parallel to the cladding direction, the yield strength of the MPLC specimens was 375 MPa and their tensile strength was 482 MPa. The corresponding values for the LCC specimens were 416 and 528 MPa. The LCC specimens exhibited a superior performance compared to the MPLC ones, with a 19.5% increase in the yield strength and 6.6% increase in the tensile strength compared to the substrate. When the tensile direction was perpendicular to the cladding direction, the yield strength of the MPLC specimens was 368 MPa and their tensile strength was 472 MPa, while the corresponding values for the LCC specimens were 380 and 452 MPa. The yield strengths of the specimens containing a cladding layer were higher than that of the substrate, indicating a protective effect of the cladding layer on the substrate material.

Figure 20a reveals three stages during the tensile tests for the specimens containing a cladding layer. In the early elastic phase, the harder Inconel 625 cladding layer deforms elastically with the Q345R substrate and accommodates the same strain. However, the harder cladding layer carries a large portion of the load. Because the cladding layer is thinner than the substrate, the yield point at the beginning of the tensile phase indicates that the cladding layer enters the yielding phase, and the cladding layer starts to deform plastically. Meanwhile, the Q345R remains in the elastic deformation phase until the cladding layer fractures. In the second stage, the substrate continues to be stressed after the cladding layer fractures and reaches its own yield limit. In the third stage, the substrate

material begins to deform plastically until it also fractures. Because the harder cladding layer shares a part of the load with the substrate, the final yield strength of the specimen with a cladding layer is higher than that of the substrate specimen.

According to Figure 20b, all specimens with a cladding layer have a lower elongation than the substrate, which displays the largest elongation of 36%. Because the fracture of the cladding layer occurred after the pre-yield point, the clad specimens actually bore the subsequent load using a thinner substrate than the pure substrate specimens, and, thus, the fracture occurred earlier. Among the specimens cut along different directions, the LCC specimens showed a lower elongation than the MPLC specimens, because the cladding layer was thicker in the former. The fracture of the specimens cut in the Y-direction occurred at the lap position of the two cladding layers, which were harder and less plastic than the specimens cut in the X-direction, resulting in an earlier fracture and a lower elongation.
