Article

Laser Cleaning Combined with Cladding Improves Cladding Quality for Repairing Steel Plates in Pressure Vessels

Citation: Fan, K.; Shi, Y.; Xu, Y.; Wang, S.; Wang, Q.; Li, Y.; Zhang, C.; Li, Z. Laser Cleaning Combined with Cladding Improves Cladding Quality for Repairing Steel Plates in Pressure Vessels. *Coatings* **2024**, *14*, 508. <https://doi.org/10.3390/coatings14040508>

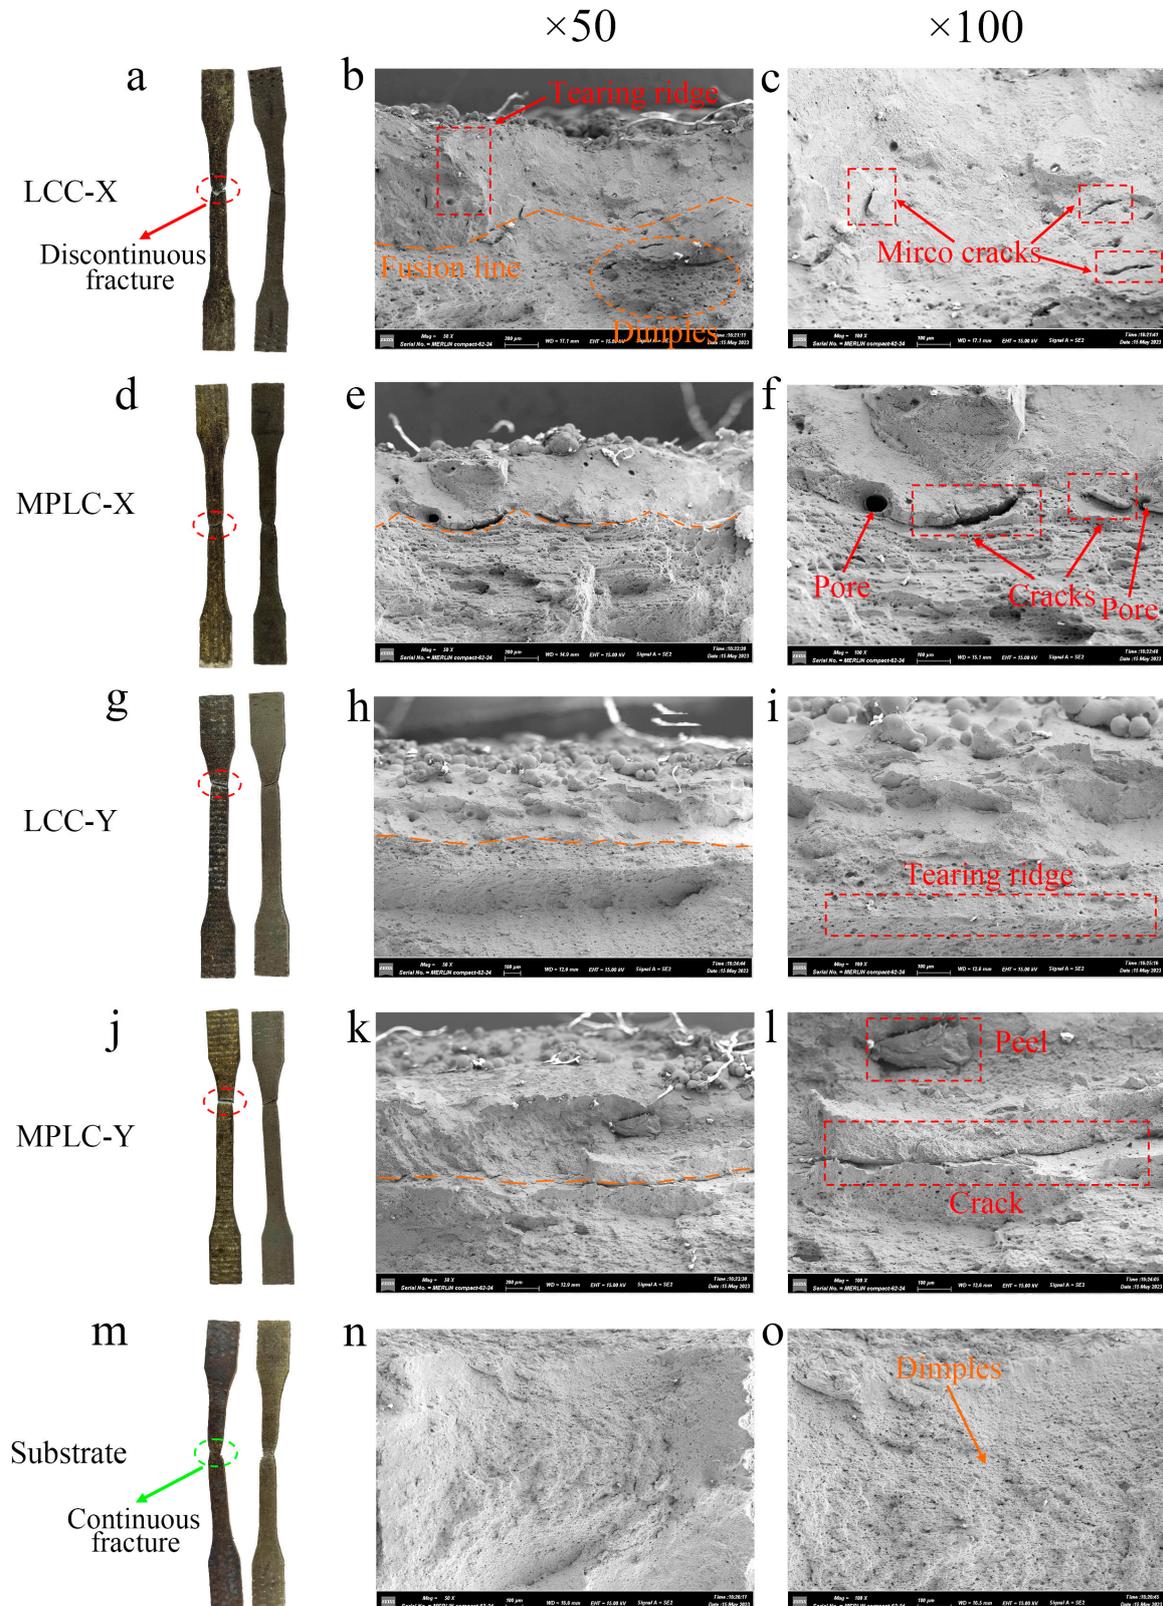
Figure 21. Macro-morphology and SEM micro-morphology of tensile fracture specimens: (a–c) LCC-X; (d–f) MPLC-X; (g–i) LCC-Y; (j–l) MPLC-Y; and (m–o) substrate.

Figure 21 shows the macroscopic and SEM images of the tensile fractures. When the broken specimen was spliced together, a discontinuous fracture appeared in the cladding layer but no such discontinuity was observed in the fractured substrate specimen. This indicates that fracture of the cladding layer and substrate is not continuous, and it corresponds to the phenomenon of pre-yielding in the curve of Figure 19a. The SEM images show that the fractured substrate contained high-density dimples, which exhibited evident ductile fracture characteristics. In contrast to the fractured substrate, Figure 15b shows many tearing ridges were observed in the fractured cladding layer, indicating partial brittle fracture characteristics.

Figure 21c,f show that many cracks developed at the bond between the cladding layer and substrate in the tensile specimen cut along the X-direction. The cracks in the MPLC specimens were significantly larger than those in the LCC specimens. In addition, larger holes were observed in the MPLC specimens. This is due to some original cracks at the bond between the cladding layer and substrate in those specimens, which gradually expanded into larger cracks, as well as due to pores that developed into larger holes under slow tensile action. In contrast, the LCC specimens were preheated after the laser cleaning step, and the cladding layer formed a better metallurgical bond with the substrate during melting with fewer original cracks; thus, no larger cracks appeared. As shown in Figure 19, the LCC-X has a higher yield and tensile strength than the MPLC-X.

Figure 21i,l show that brittle fracture characteristics appeared below the fusion line of the tensile specimens cut along the Y-direction. As shown in Figure 21i, the apparent tearing ridge below the fusion line of the LCC specimen was caused by the formation of numerous Widmanstätten structures in the HAZ, resulting in decreased hardness and toughness. Figure 21l shows that the MPLC specimen exhibited original cracks at the bond, which gradually expanded into long cracks under slow tension. The MPLC specimens

contained more pores in the cladding layer and were more likely to produce peel when the impact cracking occurred.

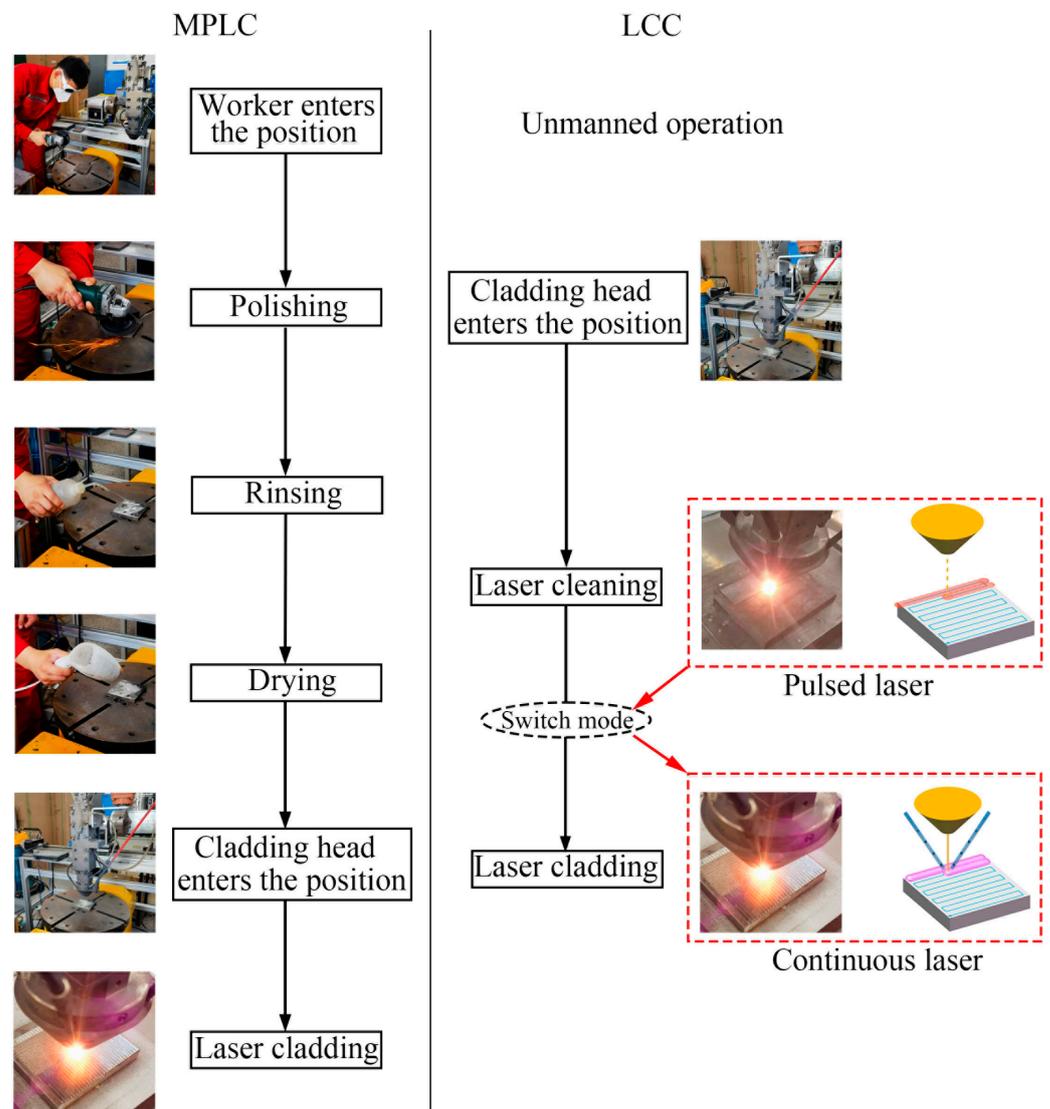
Figure 22. Comparison of the process flows of MPLC and LCC.

As shown in Figure 22, the MPLC process requires six steps from the entry of the worker to the completion of the final laser cladding, whereas the LCC process requires only three steps. During the manual polishing, the worker faces potential electric shocks, falls, and mechanical injuries. Because the rapidly rotating shuttering wheels will leave some SiO₂ particles on the substrate surface, rinsing with anhydrous ethanol is necessary after the grinding to minimise the impurities in the cladding layer. Although the polishing process also preheated the substrate to a small extent, this is partially cancelled by the rinsing step. Moreover, halfway through the MPLC process, one has to switch from manual polishing to laser cladding, while the LCC process can use the laser throughout. After the substrate surface was heated by the pulsed laser cleaning, the laser was immediately switched to the continuous mode for the cladding. The laser cladding head is driven by a manipulator throughout the entire LCC process, without the need for manual intervention. Compared to the MPLC, the LCC effectively reduces the process flow, makes full use of the laser energy, eliminates the need to manually change equipment, and enhances personnel safety.

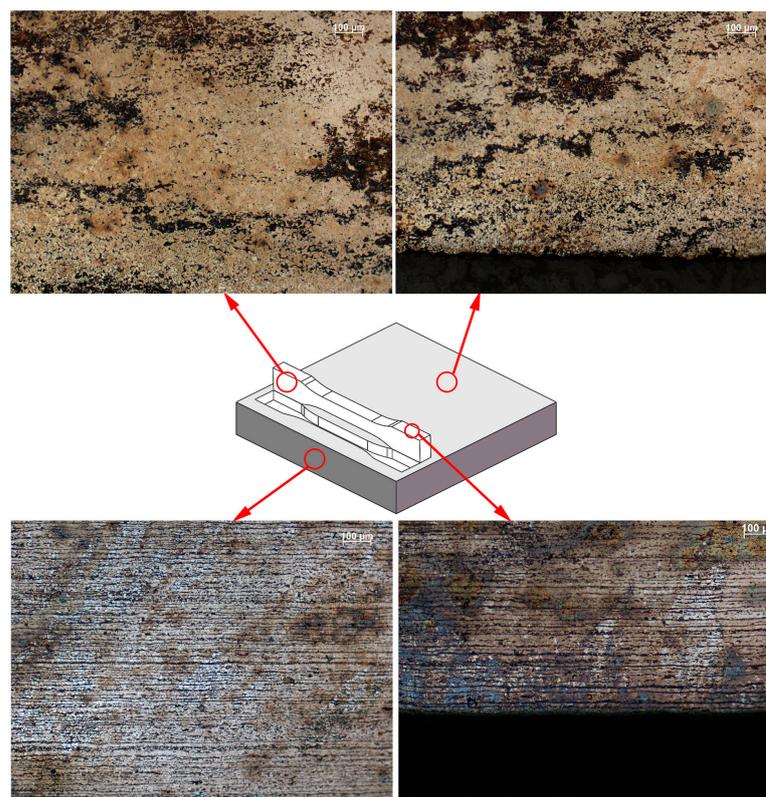
Figure A1. Comparison of metallographic structure before and after cutting.

As shown in Figure A1, there is no obvious difference observed in the metallographic structure before and after the electrical discharge wire cutting. In this study, the influence of electric discharge wire cutting on the performance of the specimen was not considered.
