# Supplementary Materials

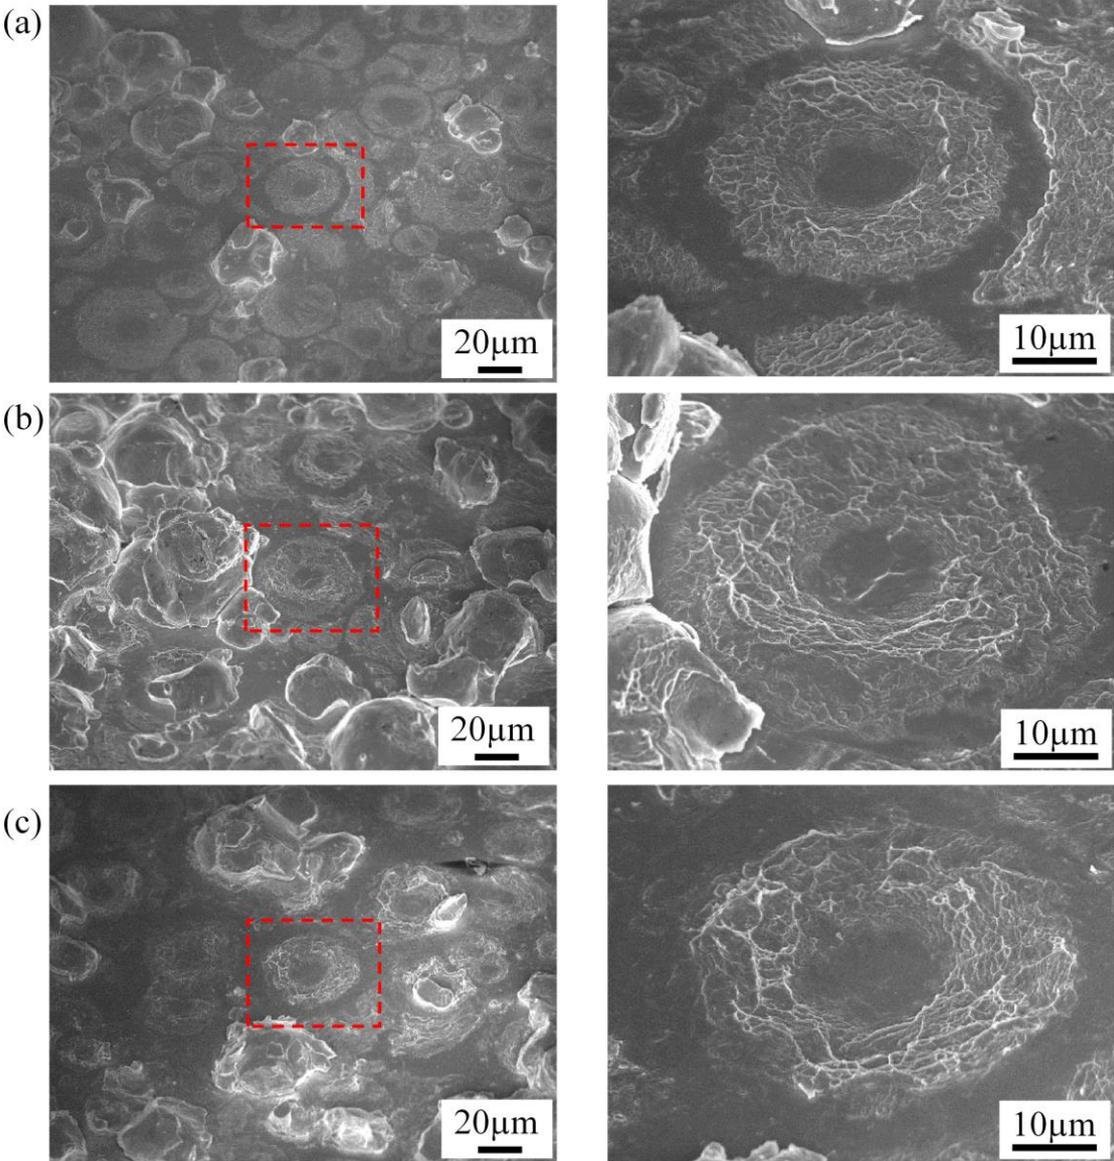
**Figure S1.** SEM micrographs of fractured interfaces on the substrate side for the coatings deposited at particle velocities of (a) 760, (b) 800 and (c) 827 m/s, observed under different magnifications at a tilted angle of 45°.

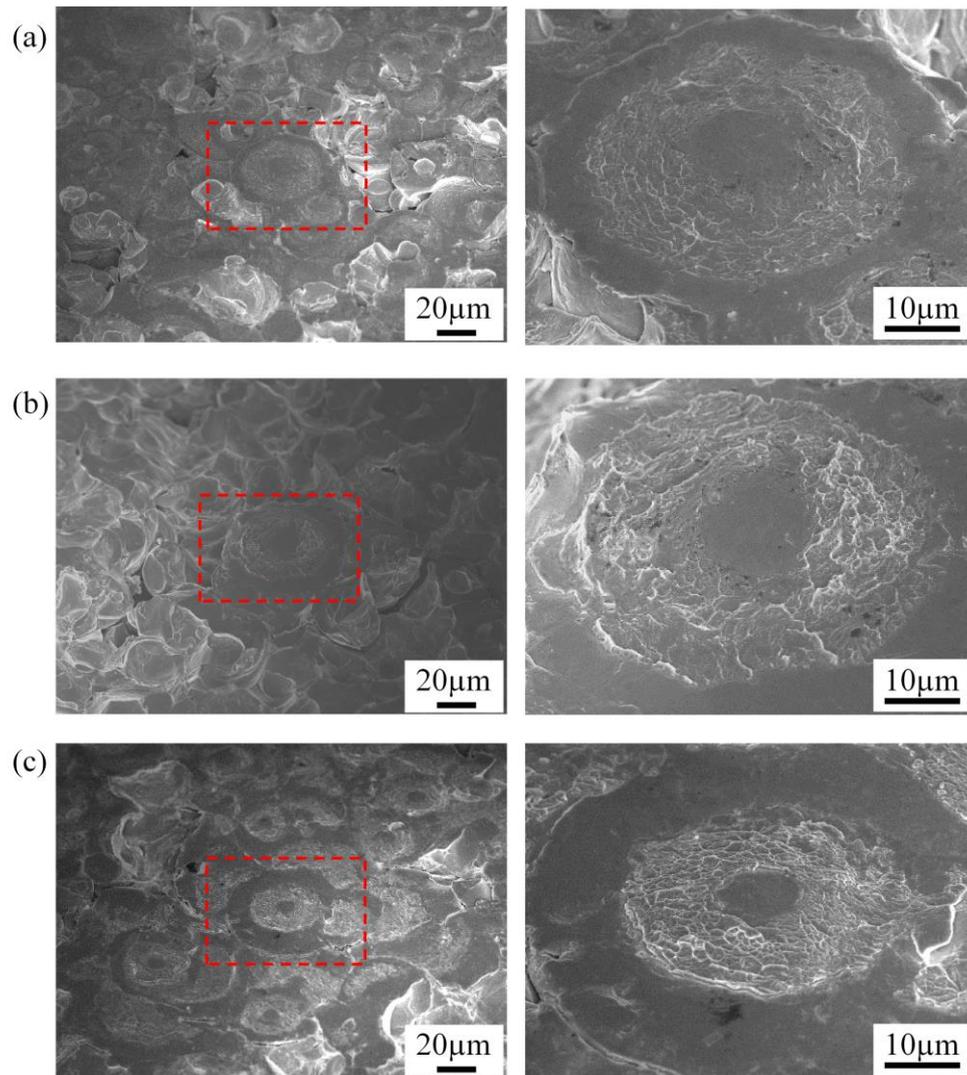
**Figure S2.** SEM micrographs of fractured interfaces on the coating side for the coatings deposited at particle velocities of (a) 760, (b) 800 and (c) 827 m/s, observed under different magnifications at a tilted angle of 45°.

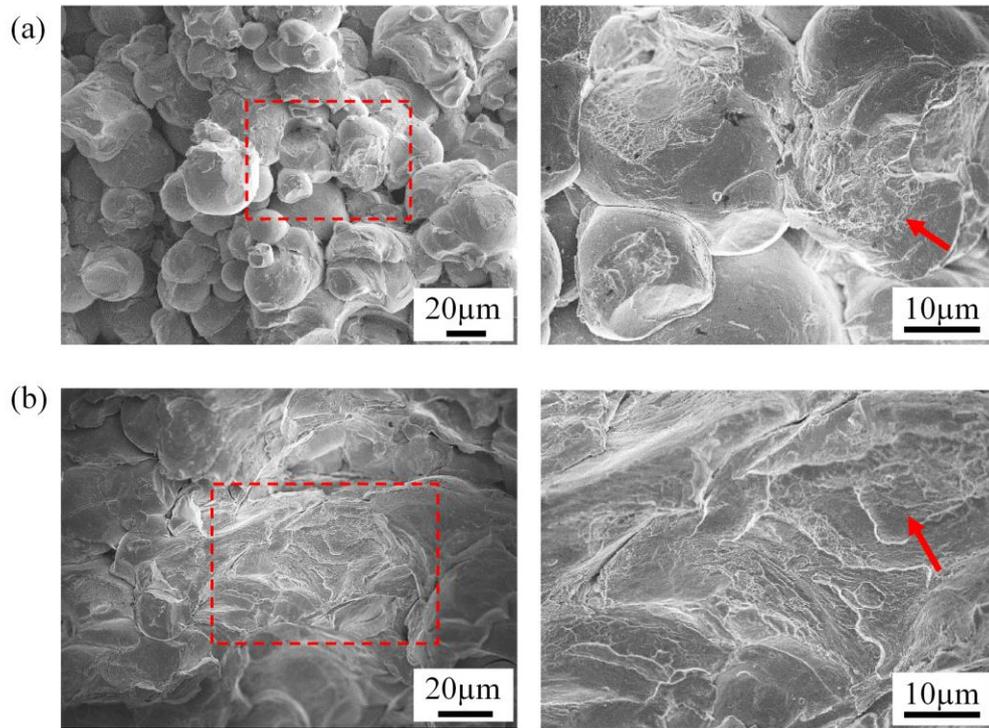
**Figure S3.** SEM micrographs of fractured cross-sections of the coatings deposited at particle velocities of (a) 760 and (b) 827 m/s under different magnifications.

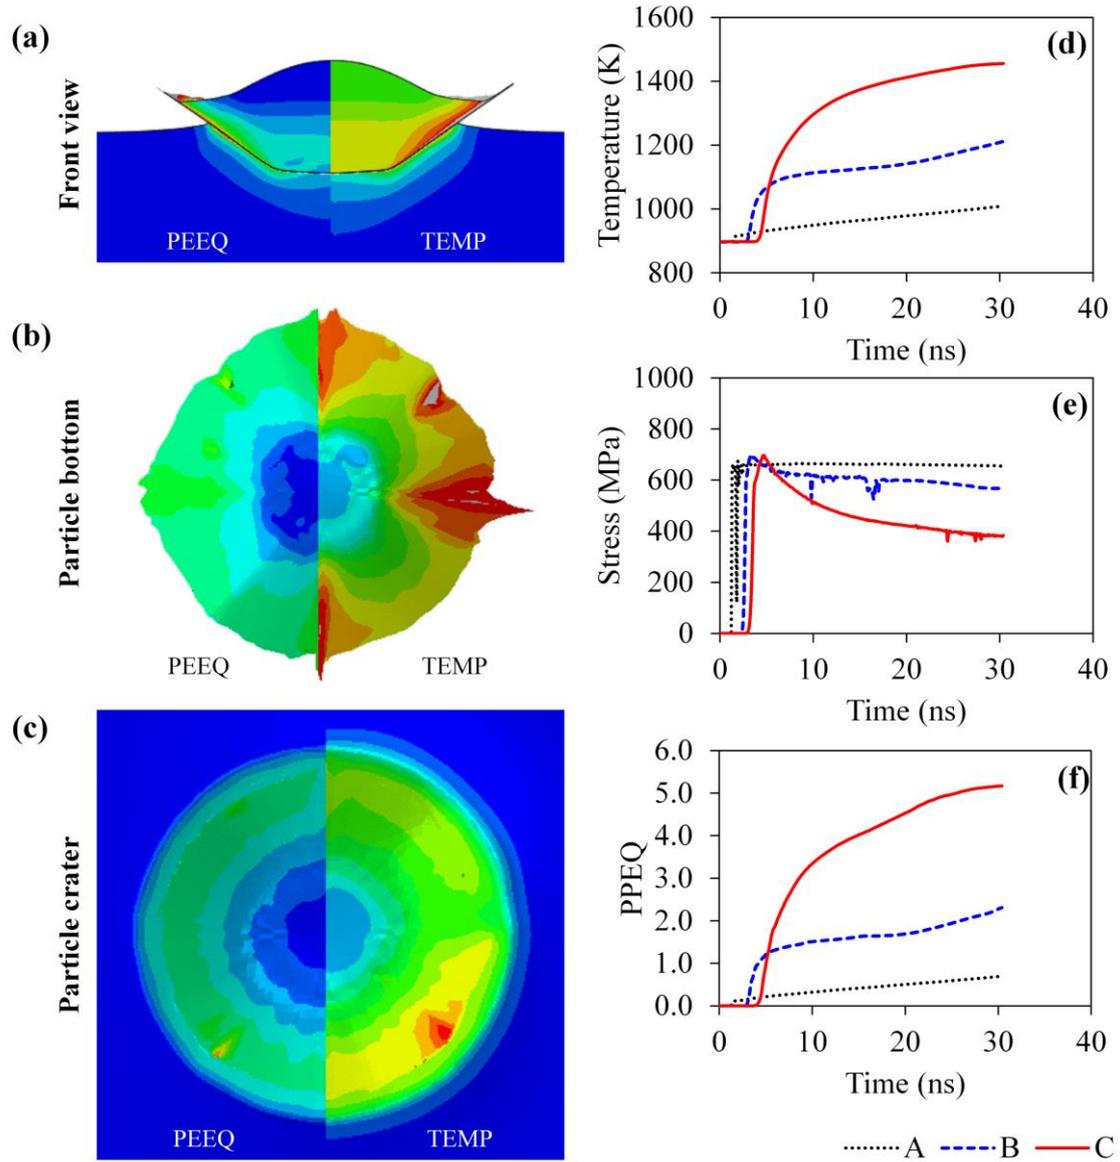
**Figure S4.** (a-c) Simulated deformation and temperature profiles of a Ti64 particle impacted on a Ti64 substrate at particle velocity of 800 m/s at 30 ns for different views and (d-f) temperature, stress and strain evolutions of elements A, B and C at the interfaces of Ti64 particles impacted at 800 m/s, for the duration of 30 ns. The scale bar for temperature and equivalent plastic strain, PEEQ, of particle impact is shown in Figure 12.
