## Basalt FRP Spike Repairing of Wood Beams

**Abstract:** This article describes aspects within an experimental program aimed at improving the structural performance of cracked solid fir-wood beams repaired with Basalt Fiber Reinforced Polymer (BFRP) spikes. Fir wood is characterized by its low density, low compression strength, and high level of defects, and it is likely to distort when dried and tends to fail under tension due to the presence of cracks, knots, or grain deviation. The proposed repair technique consists of the insertion of BFRP spikes into timber beams to restore the continuity of cracked sections. The experimental efforts deal with the evaluation of the bending strength and deformation properties of 24 timber beams. An artificially simulated cracking was produced by cutting the wood beams in half or notching. The obtained results for the repaired beams were compared with those of solid undamaged and damaged beams, and increases of beam capacity, bending strength and of modulus of elasticity, and analysis of failure modes was discussed. For notched beams, the application of the BFRP spikes was able to restore the original bending capacity of undamaged beams, while

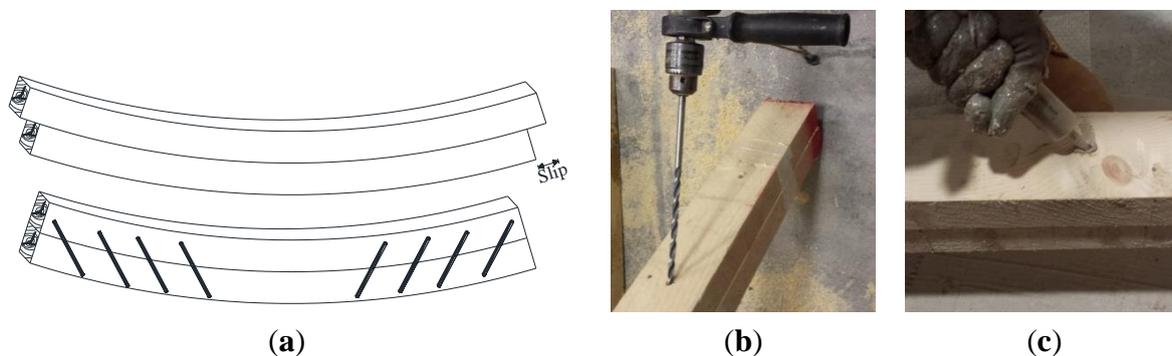
**Figure 1.** (a) Schematic arrangement of Basalt Fiber Reinforced Polymer (BFRP) spikes; (b) Diagonal hole drilling; (c) Injection of epoxy putty.

in Figure 1a: no connection (materials acting completely independent) and a perfect connection between the materials (full composite action). In the first case, slip occurs between the two timber elements resulting in two materials reacting independently to the bending loads and consequently to compressive and tensile stresses. In the second case, both elements are forced to act as a single element. The mechanical behavior of the joint has a significant importance for the behavior of the structure and it has a direct impact on the stress pattern as well as in its deformation mode.

In this investigation, eight BFRP spikes were inserted into diagonal holes (45 °) drilled in the timber beams (Figure 1b) at a center-to-center distance of 200 mm. The use of inclined spikes was chosen because several experimental and numerical studies have shown how the increase of screw inclination affords an increase of the resistance and stiffness of the joints [23,24]. No spikes were applied to the central part of the softwood beams where shearing force is equal to zero. Bi-component epoxy putty was injected inside the holes before inserting the BFRP spikes to facilitate the connection between timber and reinforcement (Figures 1c and 2). By considering that the spike and hole diameters were 6 and 8 mm, the epoxy bond thickness was approximately 1 mm.

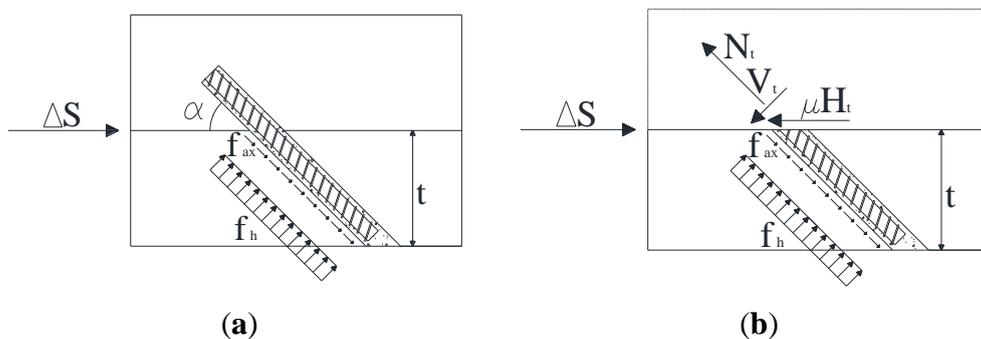
**Figure 3.** Failure mode A: (a) stresses in the joint; (b) load on the interface between the timber elements.

In order to calculate the diameter ( $d$ ) of the spikes (Table 1), the Johansen yielding theory [25] was used and adapted. The Johansen approach identifies three different failure modes for a timber to timber joint: in the first mode (mode A), the final load-bearing capacity is obtained when the wood yields along the reinforcement (Figure 3); the second (mode B) is characterized by a combination of the embedment failure in the timber and a single yield failure in the connector. The last failure mode (mode C) occurs when there is a combination of the embedment failure in the timber and a double yield failure in the connector.

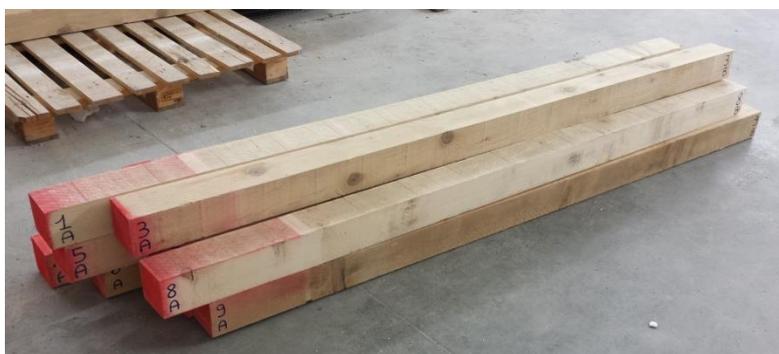
**Figure 4.** (a) Softwood beams; (b) BFRP spikes.

All beams were made of softwood (fir-wood). Tests were carried out on sharp-edged timber beams (Figure 4a) in fir wood (*Abies Alba*). All the timber beams had the same width (96 mm), height (96 mm) and length (2000 mm). The average weight density and moisture content were 417 kg/m<sup>3</sup> (dev. 24 kg/m<sup>3</sup>) and 14.31% (dev. 0.89%), respectively. Moisture content was measured according to EN 13183-1: 2002 standard [27].

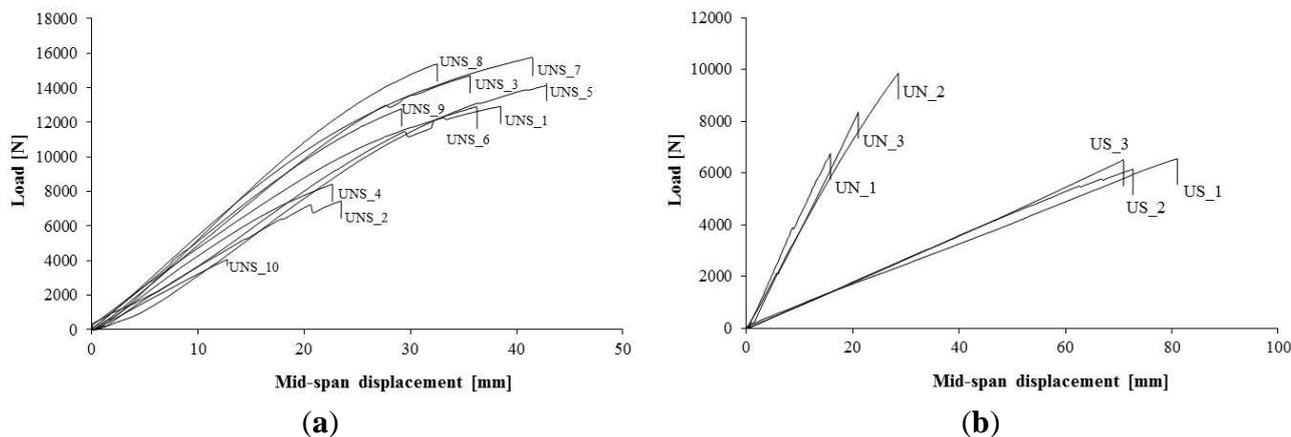
**Figure 6.** Load-Displacement curves: (a) control un-damaged beams; (b) beams that were cut in half or notched.

Load-displacement curves (Figure 6a) are initially linear. As the load increases, timber begins to yield in the compression zone and failure occurs in the tension zone when the tensile strength is reached. Three beams (UNS\_2; UNS\_4 and UNS\_10) exhibited an early failure influenced by the presence of a large defect (knot) in the tension side (Figure 5b). The scatter in the capacity values of control beams, where the presence of grain deviation and knots influence the failure mode, is very high.

clearly recorded during the tests. All the artificially damaged (cut in half and notched timber beams) usually showed an elastic-linear response up until the failure (Figure 6b).

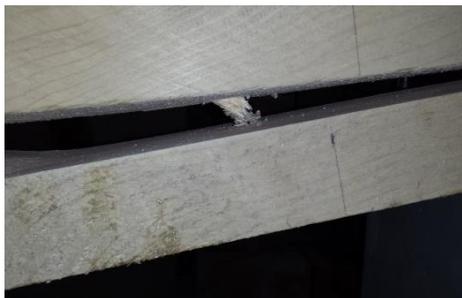
**Figure 8.** Pull out of the BFRP spike.

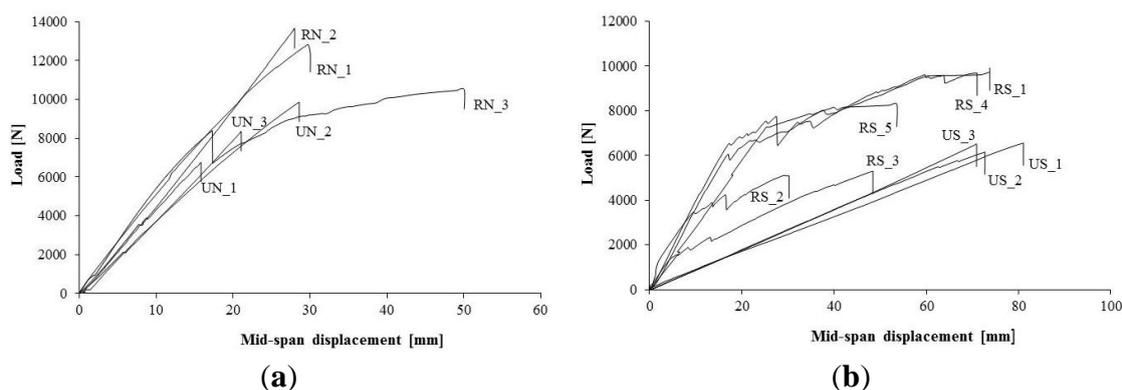
**Figure 9.** Load-Displacement curves: (a) control (US-series) and repaired (RS-series) beams cut in half, notched beams; (b) control (UN-series) and repaired (RN-series) beams that were cut in half.
