Study on Properties of High-Vanadium Full-Locked Cable with Alloy Coating with Defects

Abstract: The Zn-5%Al-rare earth alloy coating has been used in High-Vanadium Full-Locked Cable (HVFLC) that is made in China. This application has shown excellent protective performance. However, during practical use, the coating may appear to be deteriorated in various degrees, which may further worsen the corrosion resistance and mechanical properties of the cable. This paper focuses on High-Vanadium Full-Locked Cable (HVFLC). Firstly, different types of prefabricated defect treatments have been applied into the wires of the cable, followed by corrosion paste accelerated corrosion test and mechanical tensile properties test. The aim of this act is to figure out the effects on the corrosion resistance and mechanical properties of the wire due to different types of defects in alloy plating. The results show that the corrosion resistance of the wires has been greatly affected because of the solder joint defects. Furthermore, the tensile strength of the wire indicates a drop of about 40%. This research makes up the gap in the related fields in China. In addition, basic data has been provided for

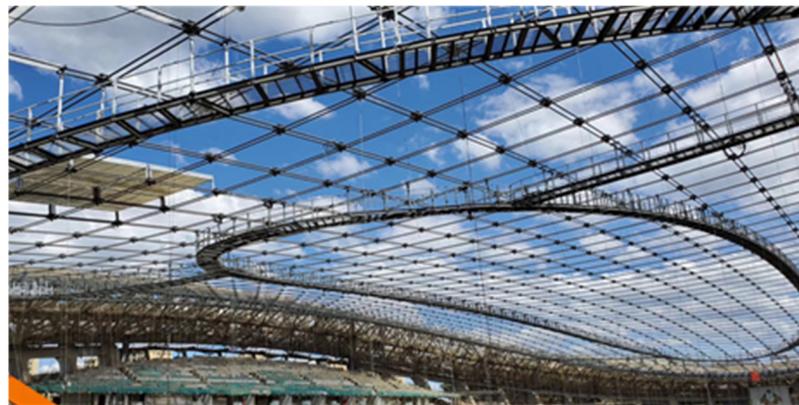
Figure 2. The roof of the cable mesh structure.

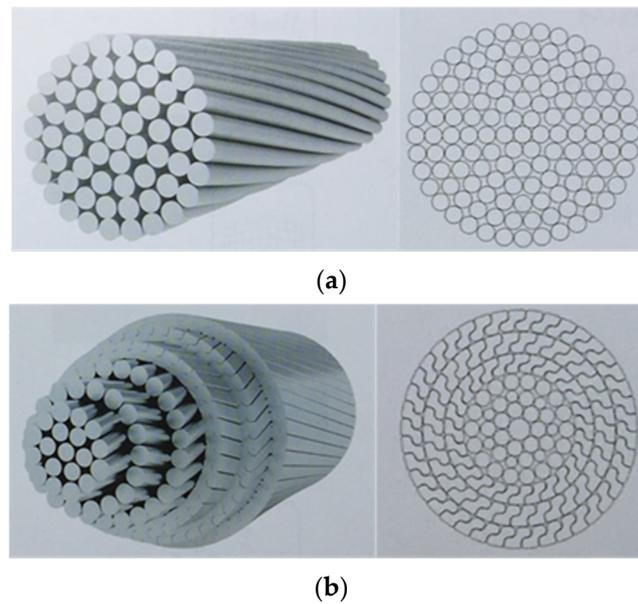
Figure 3. The schematic diagrams of ordinary cable structure and high vanadium closed cable structure. (a) The structure of an ordinary cable, and (b) the structure of the HVFLC.

The HVFLC has obvious differences from the ordinary cable in the structure. The structure is shown in Figure 3. The HVFLC adopts a double-layer structure. The inner layer is twisted around wire, and the outer layer is multi-strand Z-type wire to form a fully closed structure. The HVFLC has excellent properties such as high axial stiffness, low elongation, and not easy to jump [5]. It is very suitable for building structures as the main force-bearing material. The surface of each wire of the HVFLC is coated with Zn-5%Al-rare earth alloy. The alloy coating has excellent corrosion resistance, which is about 2–3 times higher than that of ordinary galvanized coatings. In harsh environments such as outdoor, humid environments and marine climates, the alloy coating has better corrosion resistance than ordinary hot-dip galvanizing and electro-galvanizing. The presence of alloy plating plays an important role in the corrosion resistance of steel wires. The effectiveness of the alloy coating is a key factor affecting the serviceability and longevity of the steel cable. However, the alloy coating may be damaged during the construction process, such as scratches, abrasion, and welding spots (Figure 4).

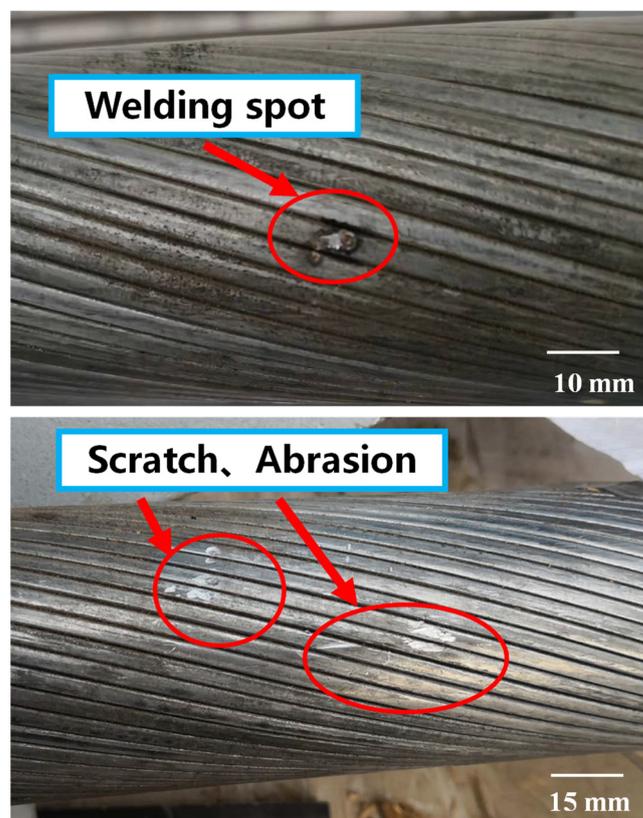
Figure 4. Damage mode of alloy coating.

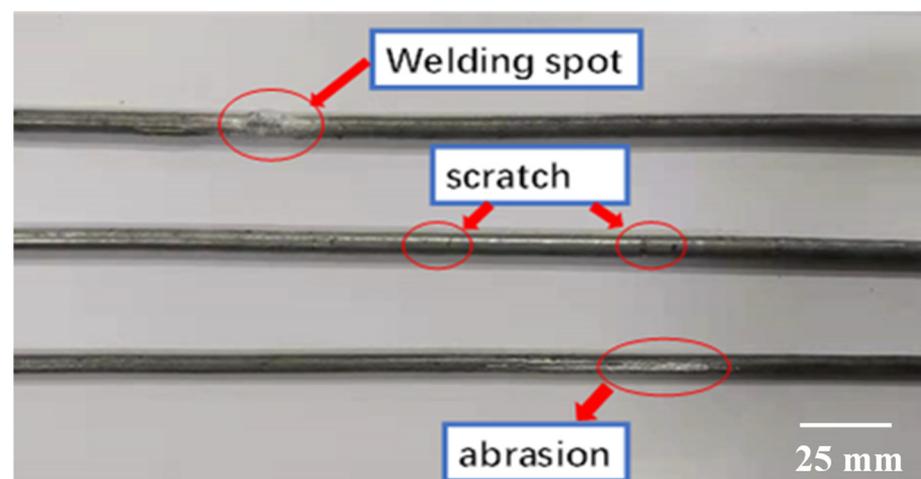
Figure 5. Schematic of defective specimen.

The specimens include two types of steel wires with Z-section and round section. The round section wire specimens are available in three different sizes $\phi 2.6$ mm, $\phi 4.0$ mm and $\phi 5.0$ mm. Three types of defective specimens, namely scratches, abrasions and welding spots, were produced to take into account the damage that may occur in the actual use of the HVFLC. According to the diversity of scratch defects, three types of axial scratches, radial scratches and spiral scratches were produced. All types of specimens are shown in Figure 5. The specimens can be divided into normal specimen group, scratch defect group, abrasion defect group and welding spot defect group. Each group has three specimens, and the test data are averaged.

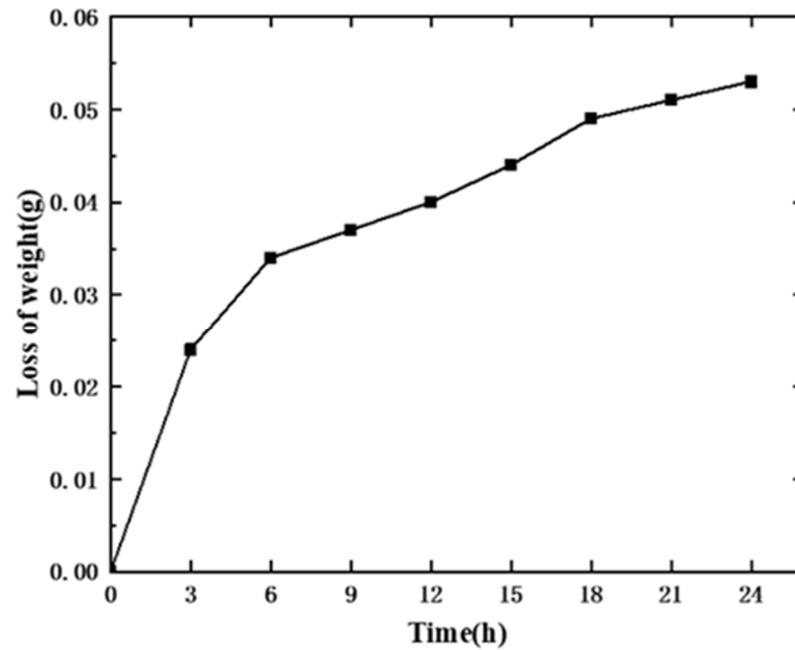
Figure 6. Variation in weight loss of specimens at different times.

In order to investigate the regularity of the corrosion effect with time, a group of specimens was taken out every 3 h during the 24 h of the corrosion paste test. The weight of the specimens after the test was measured after treatment. The weight loss method is used to analyze the weight variation of samples with time before and after corrosion during the test. The corrosion weight loss of standard specimens of type Z varies with time within 24 h as shown in Figure 6. It can be seen that the weight loss of the specimen is large in a short time after the test starts. As the test proceeds, the weight loss of the specimen tends to stabilize. It may be due to the fact that after a period of corrosion, the Zn and Al in the coating were oxidized to form a dense oxide film, which hindered the development of

corrosion. In addition, after removing the corrosion paste from the surface of the specimen at different times, it can be observed that the surface of the specimen gradually loses its metallic luster. The surface of the specimen eventually becomes dark black. The gradual loss of metallic color of the specimen surface can also prove the formation of oxide film.

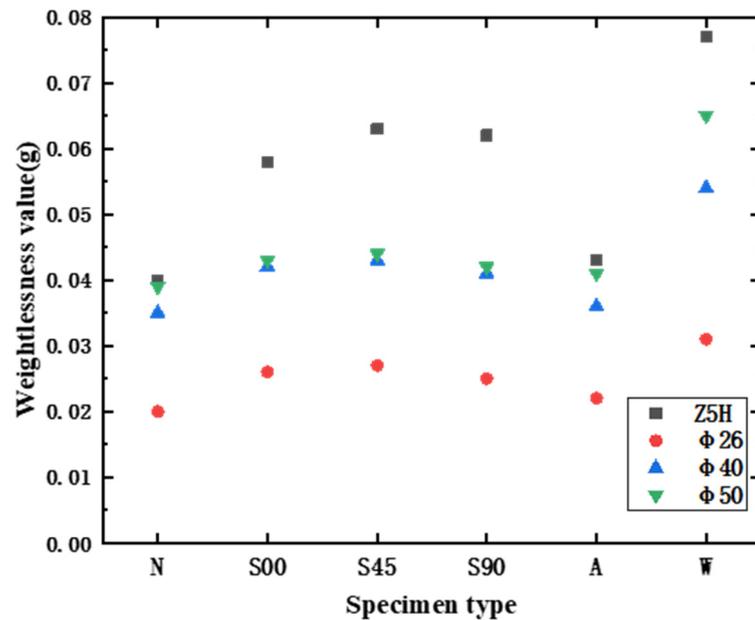
Figure 7. Mass change value of each specimen before and after corrosion.

The weight variation of the specimen groups with different defects during one test cycle (16 h) is shown in Figure 7.

Some trends can be found in the data. For specimens with circular cross-section, the weight loss of the specimen before and after the corrosion test increases with the diameter. As the diameter of the specimen increases, the contact area between the specimen and the corrosion paste becomes larger, and the corrosion effect is more serious. In addition,

the weight loss of normal specimens was the smallest for both Z-section specimens and circular-section specimens. This indicates that the presence of an intact alloy coating has a good corrosion protection effect. Other defective specimens have different degrees of weight loss increase. Among them, the largest weight loss is the group of welding spot. It can be initially judged that the corrosion effect of the group of welding spot is more serious. Welding spots are formed at high temperatures. The coating in the weld area will be oxidized at high temperature. Additionally, the surface will be rough, white in color and decarburized at high temperature compared with the normal structure (Figure 8). In addition, the high temperature affects the area near the weld, making the actual affected area larger than the surface weld of the specimen [7,8].

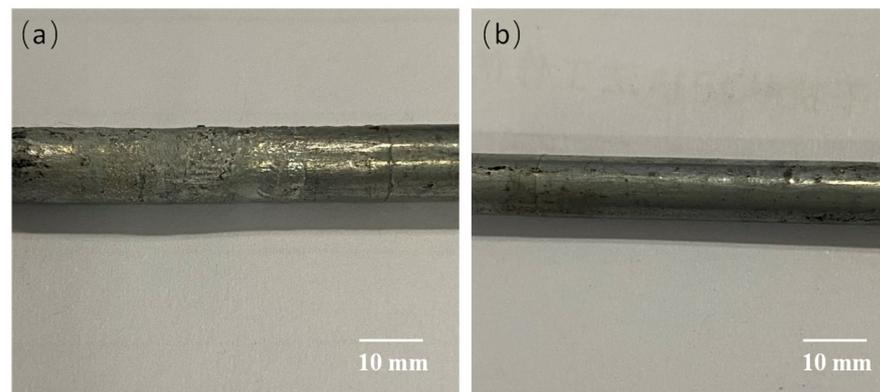
Figure 8. (a) Morphology of weld area of specimen. (b) Morphology of normal area of specimen.

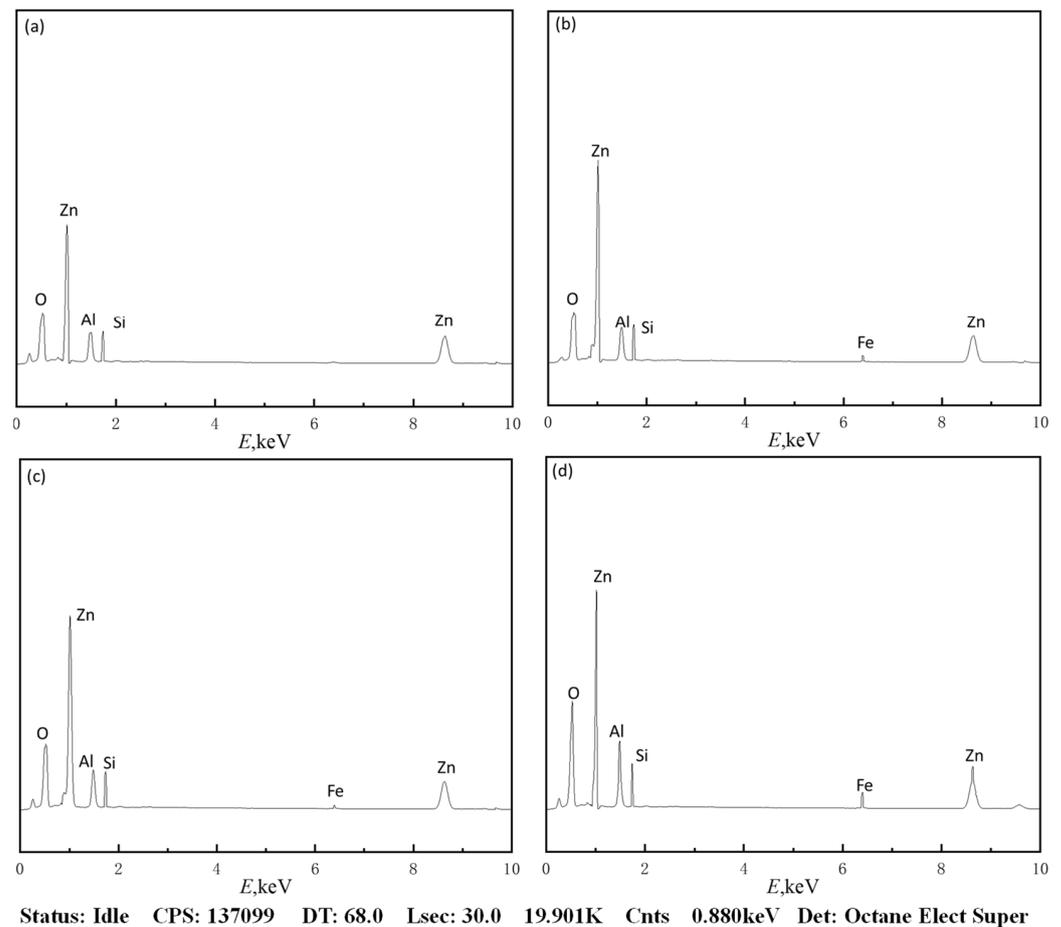
Figure 9. EDS of corrosion products. (a) Normal specimens. (b) Scratched specimens. (c) Abrasion specimens. (d) Welding spot specimens.

The corrosion products of each group of specimens were scanned and analyzed by EDS. The results are shown in Figure 9. The corrosion products consisted mainly of the elements O, Al, Si, Fe, and Zn. The characteristic peak of Zn was the highest, followed by O. The presence of Si probably due to the fact that the main component of kaolinite is SiO_2 . The mixture of SiO_2 and corrosion products resided on the surface of the specimens [9]. Furthermore, it can be clearly observed that the characteristic peaks of Fe in the normal specimens are not very pronounced in the EDS pattern compared to the other specimens. Fe is probably originated from $\text{FeCl}_3 \cdot 6\text{H}_2\text{O}$ in the corrosion paste. The characteristic peak of Fe is higher in the other specimen groups, which may be due to the damage of the alloy coating causing the corrosion of the corrosion paste on the carbon steel substrate, increasing the Fe content. It could also be due to the damage of the coating that exposed the internal carbon steel substrate. In the group of welding spot, the characteristic peak of Fe is most obvious, indicating a more severe corrosive effect on the carbon steel matrix. In addition, the normal specimen surface intact alloy coating effectively protects the internal carbon steel substrate, so that the corrosive medium does not contact the substrate. Corrosion occurs mainly on the surface of the alloy coating.

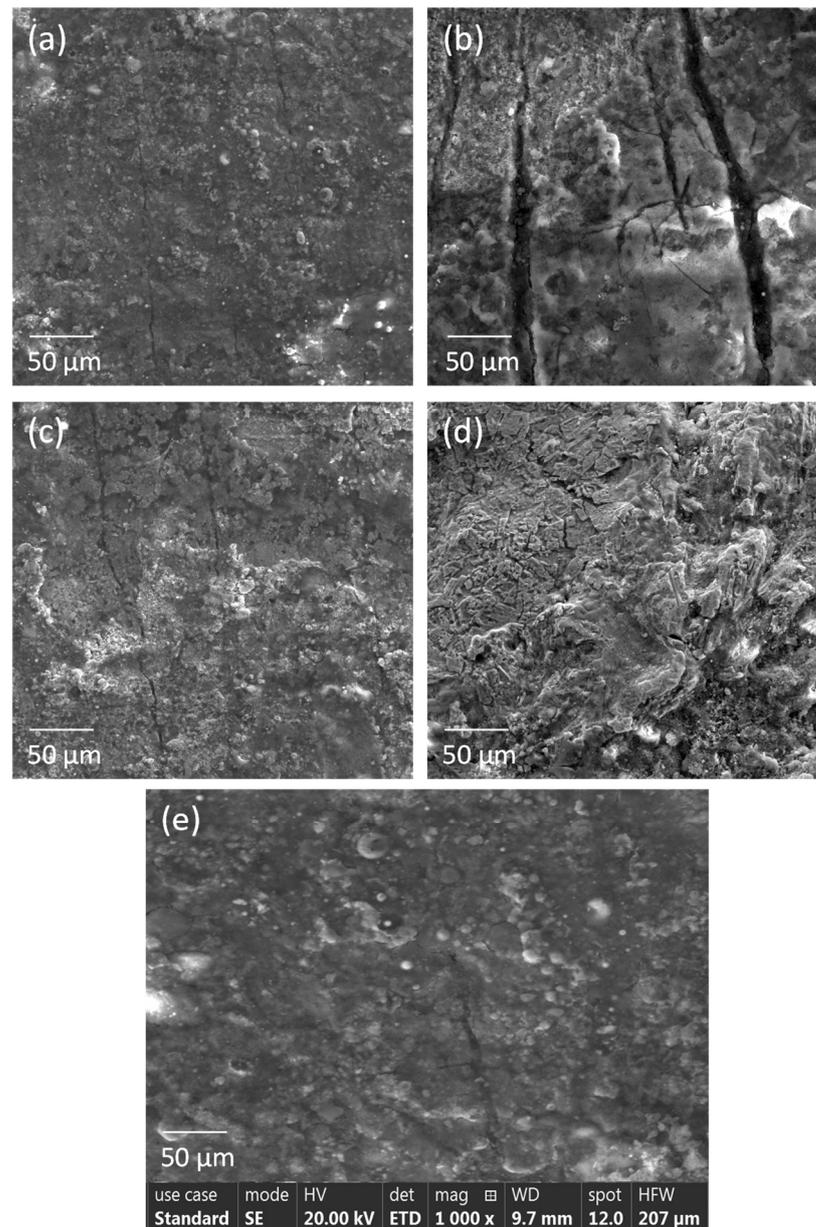
Figure 10. Microscopic morphology of SEM. (a) Normal specimens. (b) Scratched specimens. (c) Abrasion specimens. (d) Welding spot specimens. (e) Microstructure of the specimen before corrosion test.

The microscopic morphology of each group of specimens after the removal of corrosion products was observed by SEM. The results are shown in Figure 10. The normal specimens had a flat surface with a small number of corrosion pits. Scratch specimens were more severely corroded near the scratch, with more corrosion pits. Abrasion specimens show obvious, but weaker corrosion marks in the abrasion damage area. This may be due to minor abrasion, which does not completely fail the alloy coating. The welding spot specimens had very rough surfaces in the welding spots and adjacent areas. There are many corrosion pits and the corrosion effect is severe. The welding spot defect is very damaging to the alloy coating, making the surface of the alloy coating very rough. In the test, the contact area between the rough surface and the corrosion paste is large. Local corrosion may also occur in the area of the crater, which will worsen the corrosion effect.

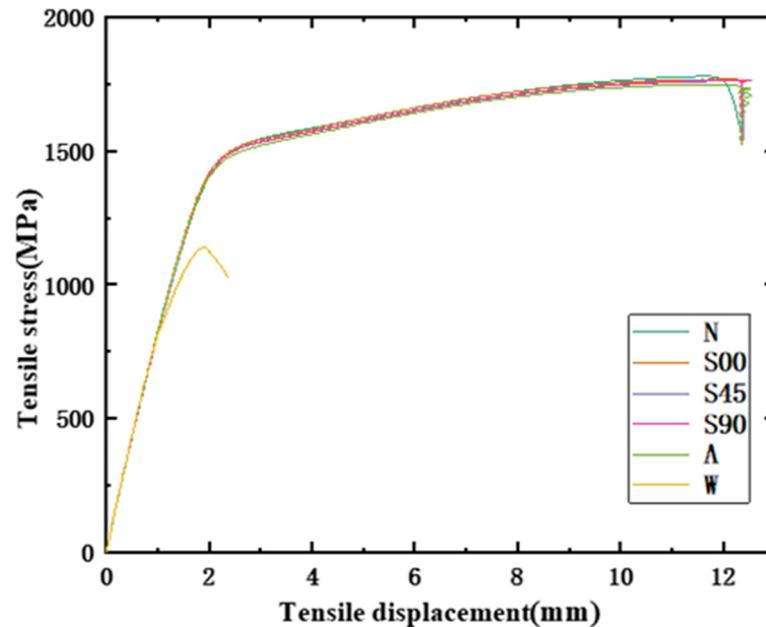
Figure 11. Tensile curve of Z-section specimen.

Mechanical tensile tests were carried out on the normal specimens group, scratch specimens group, abrasion specimens group and welding spot specimens group with hydraulic servo fatigue tester Instron 8801. Tensile curves of each group were obtained. The tension curve of the Z-section specimen is shown in Figure 11. Tensile curves of $\phi 50$ specimens are shown in Figure 12. Tensile curves of $\phi 40$ specimens are shown in Figure 13. The tensile curves of $\phi 26$ specimen groups are shown in Figure 14.

The tensile curves of the specimens show that the defects of the specimens of the HVFLC have different effects on the mechanical tensile properties of each group of specimens. Scratch defects and abrasion defects had little effect. The tensile curves of welding spot specimens were significantly different from the other specimens. The welding spot specimens fractured at low tensile stresses and short tensile displacements. This indicates that the presence of weld joint defects resulted in a significant change in the specimen properties. The presence of welding spots significantly reduced the mechanical tensile properties of the specimens compared to the other specimens.

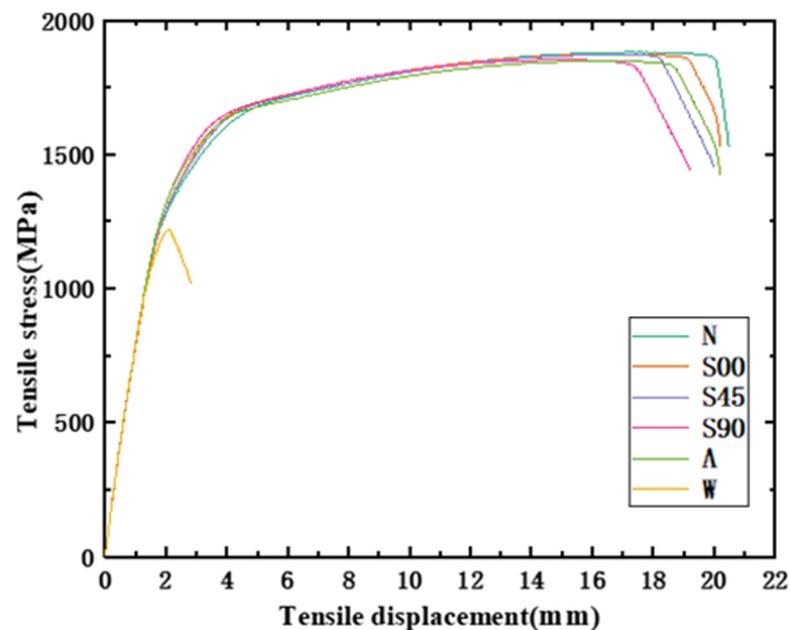
Figure 12. Tensile curve of $\phi 50$ specimen.

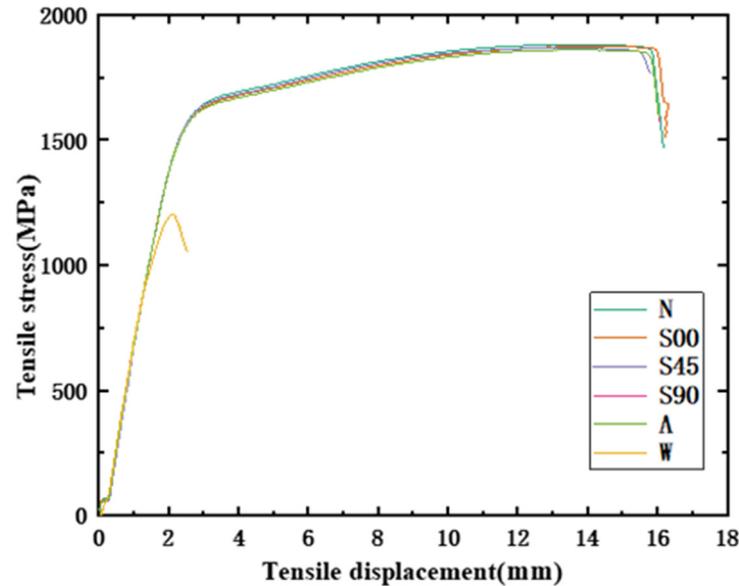
Figure 13. Tensile curve of $\phi 40$ specimen.

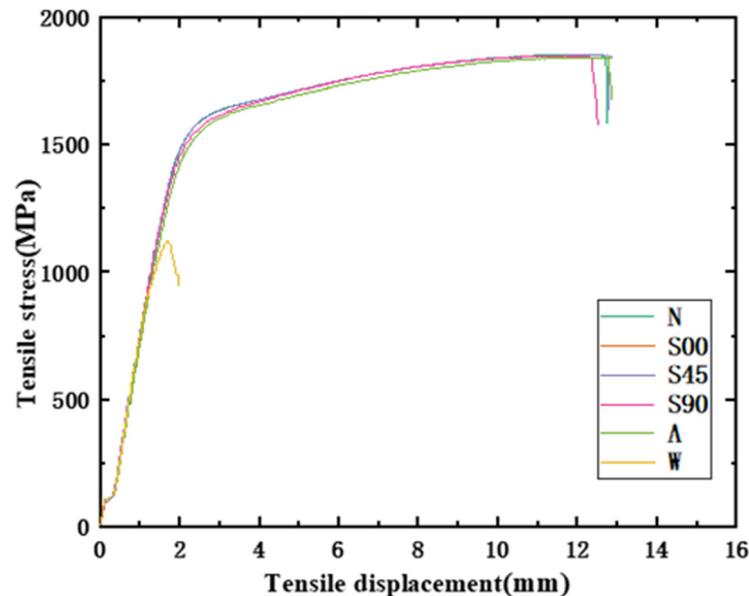
Figure 14. Tensile curve of $\phi 26$ specimen.

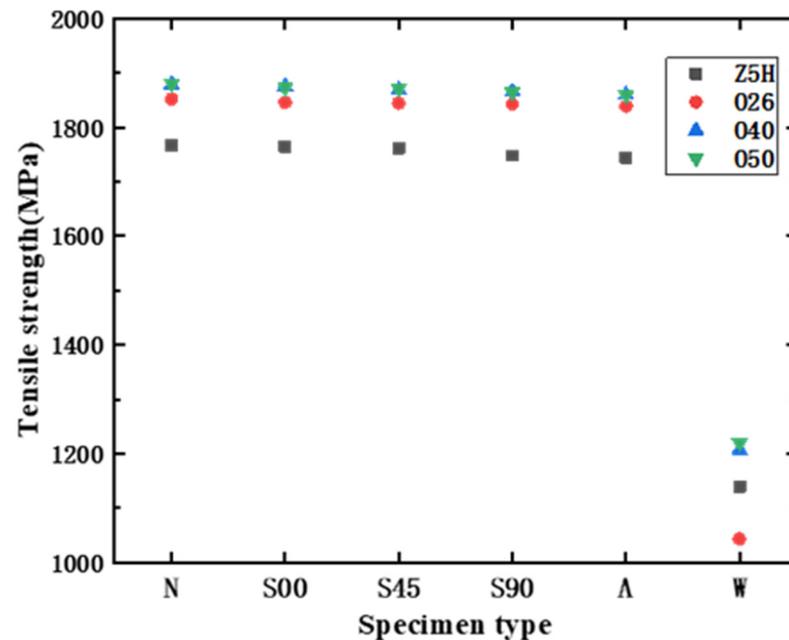
Figure 15. Tensile strength of each specimen group after test.

Tensile strength is an important index for evaluating the mechanical properties of materials. In order to accurately analyze the mechanical properties of the specimens, the tensile strength data of each group of specimens were obtained from the tensile curves of each group (as shown in Figure 15).

From the tensile strength data of each group of specimens, it can be found that the presence of various defects and the effect of corrosion caused the tensile strength of the specimens to weaken to different degrees. The presence of scratch, abrasion, and welding spot reduced the tensile strength of the material compared to the normal specimens with a complete alloy coating. Welding spot defects had the greatest effect, with the tensile strength of the welding spot group of specimens decreasing by about 40% compared to the normal specimens. The intact alloy coating of the standard specimens prevented the material from corroding to a great extent. The presence of various defects makes the wire specimen surface alloy coating damage, so that the corrosive medium can be in direct contact with the metal matrix, corrosion occurs. In addition, the presence of defects in

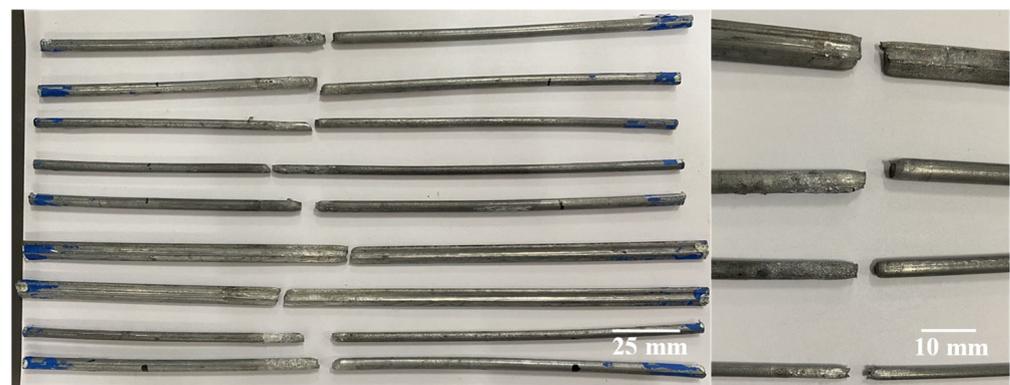
Figure 16. Fracture location of specimen.

the welded joints seriously damaged the flatness of the alloy coating. The area where the welding spots exist in the tensile test produces a stress concentration phenomenon, making the specimen very susceptible to fracture in this area (as shown in Figure 16).

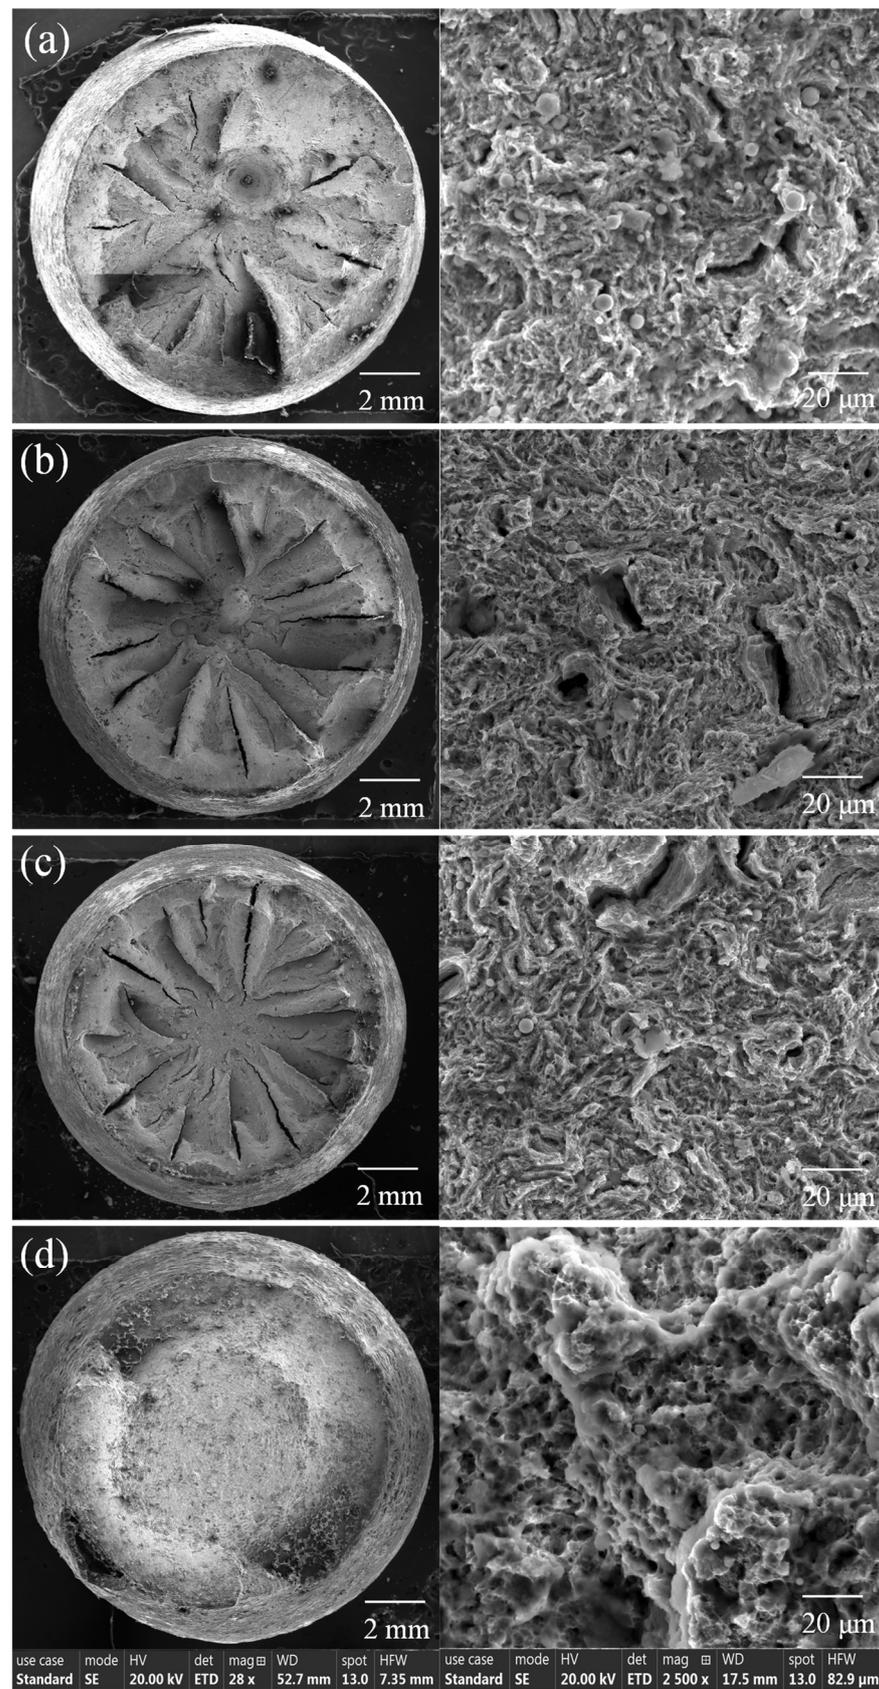
Figure 17. Tensile fracture morphology by SEM. (a) Normal specimens. (b) Scratched specimens. (c) Abrasion specimens. (d) Welding spot specimens.

The microscopic morphology of the tensile fracture of each group of specimens was observed by SEM. The microscopic morphology of the tensile sections of each group of specimens is shown in Figure 17. It can be seen from Figure 17a–c that the tensile fractures of the normal, scratch and abrasion specimens have obvious ductile fracture characteristics. A necking zone was formed on the fracture surface of the specimens. The tensile fracture region can be observed in the low magnification morphology consisting of the fiber zone, radiation zone and shear lip zone. The fiber zone is rough and fibrous in the center of the fracture. Fracture usually occurs first in the fiber zone and then spreads rapidly to form

the radiation zone. Radial lines are formed during the rapid propagation of the fracture. The junction of the fibrous and radial zones can be seen where the crack transitions from formation to unstable propagation and finally fractures to form a shear lip. The smooth surface of the shear lip indicates the rapid, unstable propagation of the crack. In addition, tough fossa features can be observed under high magnification. Many elongated tough fossae were observed in the microscopic morphology. The size, depth and number of tough nests are closely related to the toughness of the material. The greater the plastic deformability of the material, the greater the depth of the tough fossa.

The microscopic morphology of the fracture of the welding spot specimen is shown in Figure 17d. It is obvious to observe that the fracture of the welding spot specimen has obvious differences from the fracture of other specimens. There is a necking area at the fracture of the specimen, but there is no obvious ductile fracture feature under the low magnification. The fracture surface is flat and the shear lip is not obvious. The fracture

originates from the lower left edge, corresponding to the weld area on the specimen. In addition, the fracture showing partial toughness fracture characteristics can be observed under high magnification. It can be tentatively concluded that a mixed fracture of ductile fracture and brittle fracture coexisted during the tensile fracture of the group of welding spot specimen.

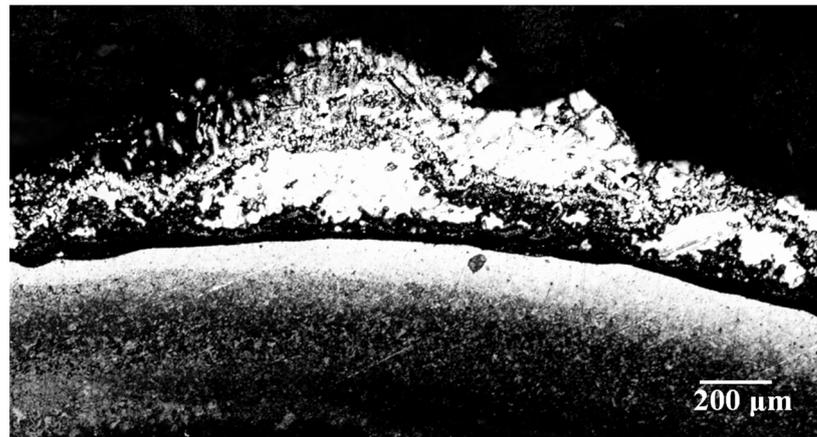
Figure 18. Microstructure characteristics of the area near the welding spot.

In order to determine the reason for the significant decrease in tensile strength of welding spot specimens, metallographic specimens were taken near the fracture of welding spot break specimens. The metallographic structure is shown in Figure 18. It can be seen that the structure consists of three parts, similar to welding, with welding spots (bumps), heat affected zone, and matrix [10,11]. The structural characteristics of the welding spots (bumps) are shown in Figure 19. It can be seen that the structure has an individual martensite and bainite, while the normal organization of the site is soxhlet (Figure 20). Needle martensite is hard and brittle, has no plastic deformation ability and poor toughness [12]. Additionally, in the process of martensite transformation will make the internal volume expansion, forming a large internal stress. The formation of martensite in the area near the weld joint is the root cause of the brittle fracture of the specimen in the mechanical tensile test. It is also the key factor that causes the decrease in tensile strength of welding spot specimens by about 40%.

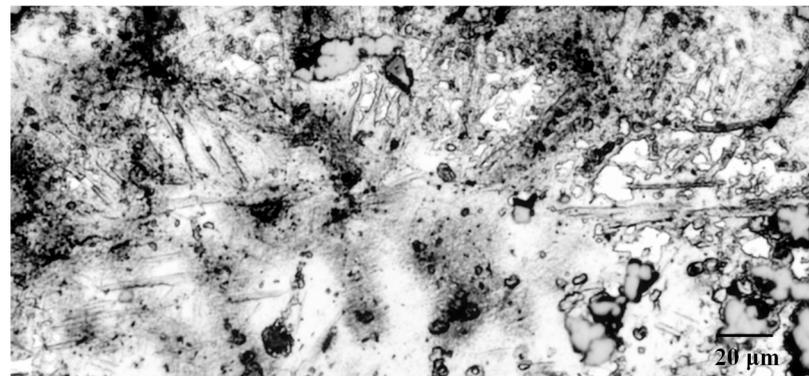
Figure 19. Metallographic structure characteristics of welding spot.

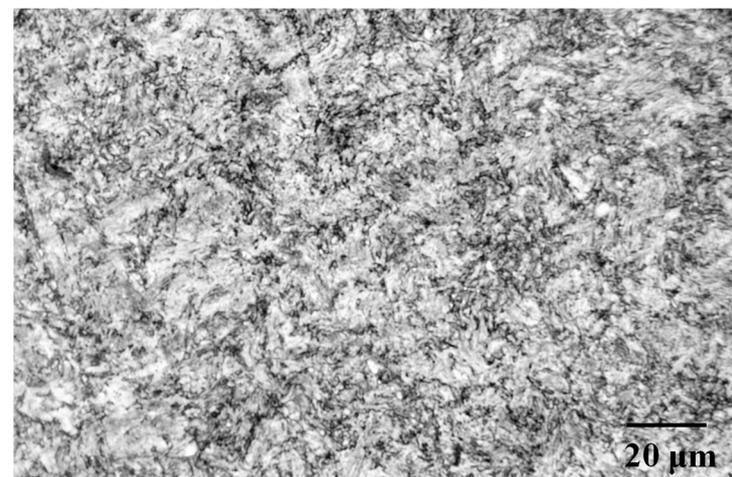
Figure 20. Metallographic structure characteristics in normal area.
