Article Experimental Research on Seismic Behavior of Haunched Concrete Beam–Column Joint Based on the Bolt Connection

Abstract: Studying the seismic performance of assembled beam-column joints is essential for the development of assembled frame structures. In this paper, a novel dry connection beam-column joint with a high degree of modularity and a simple structure is proposed and tested using a pseudostatic test. The joint is composed of a precast concrete beam with a steel axillary plate at the end and a precast concrete column connected by long bolts. By analyzing the characteristics of the hysteresis curve, skeleton curve, and stiffness degradation curve, we were able to investigate the seismic performance of this novel new joint under low circumferential reciprocating load as well as the impact of bolts of various strength grades on the joint's seismic performance. The results illustrated the robust overall bearing performance of the newly assembled beam-column joint. However, when connected with common bolts, the joint deforms more, exhibits good ductility, clearly displays semi-rigid characteristics, and performs better in terms of energy dissipation. This contrasts with c

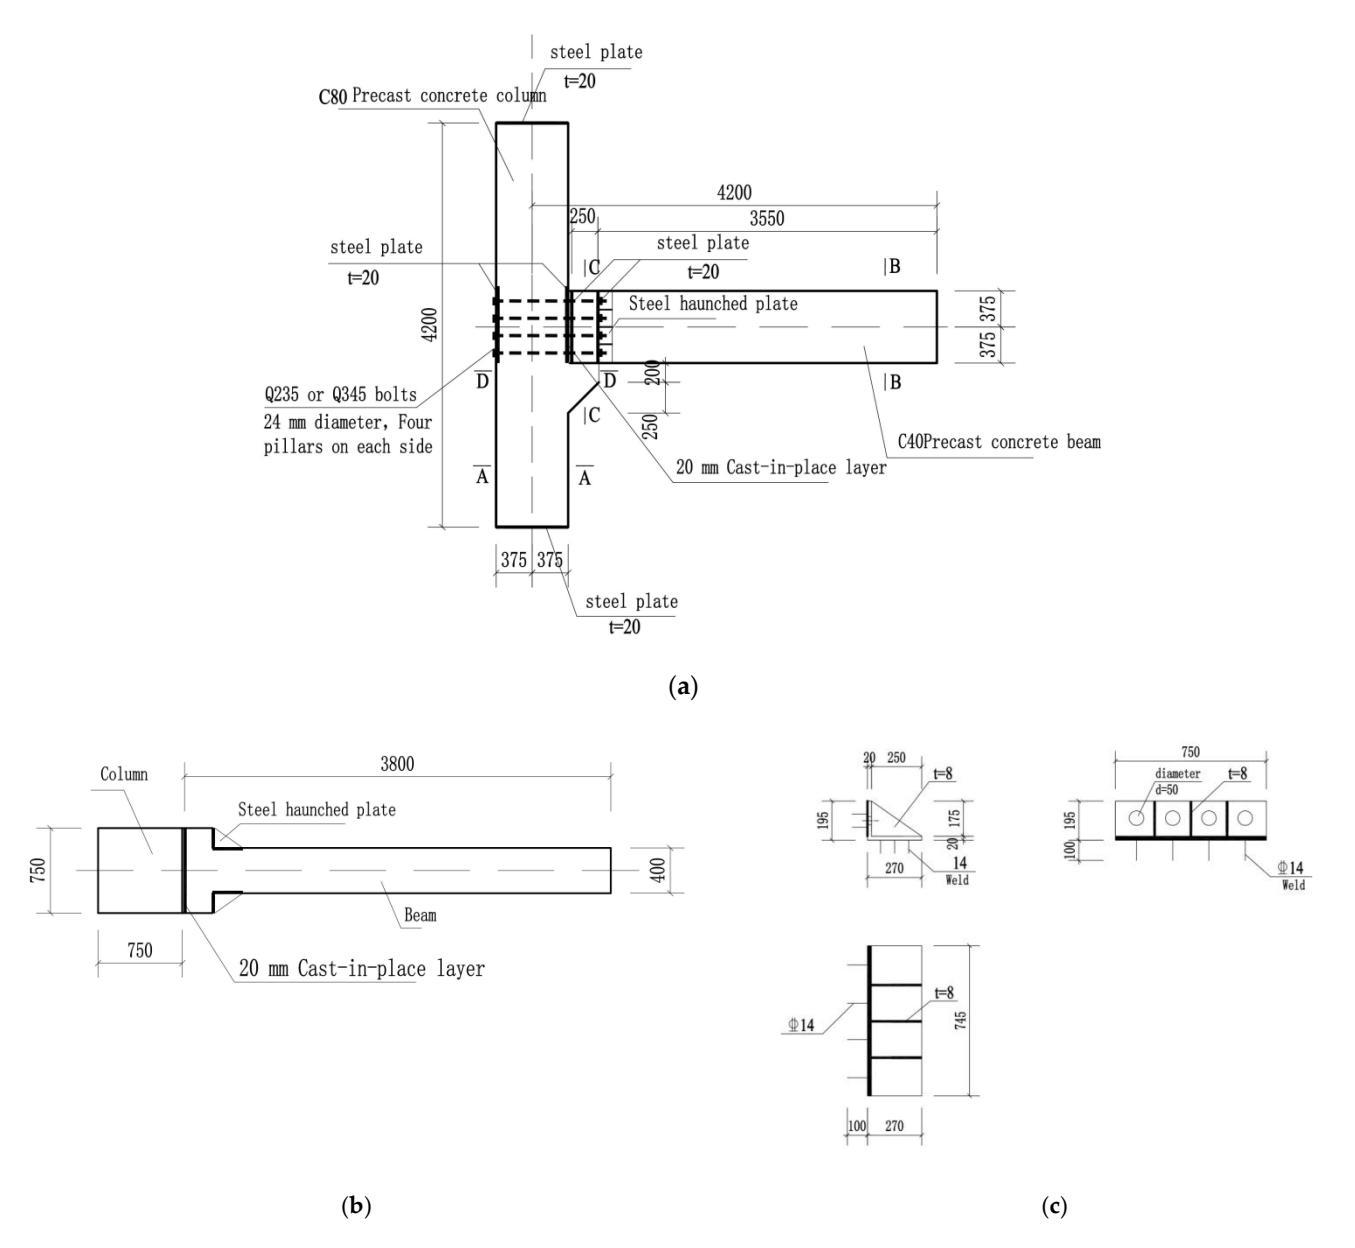
Figure 1. Design drawing of specimen: (**a**) Overall elevation of specimen; (**b**) Top view of prefabricated beam; (**c**) Detailed drawing of steel haunched plate.

The two groups of specimens used in this test's beam and column components are made of precast concrete. After being poured and allowed to cure for 28 days, the concrete was assembled, and bolts were used to join the beams and columns. The beam–column joint uses a semi-rigid connection, while specimen S1 uses a Q235 low-strength bolt and specimen S2 uses a Q345 ordinary-strength bolt. The section dimensions of the column are 750 by 750 mm², the beam is 400 by 750 mm², and the enlarged end of the T-beam is 750 by 750 mm². The concrete grades for the column and beam are C80 and C40, respectively, and Q345 steel was used for the haunched and pressure-bearing steel plates as well as

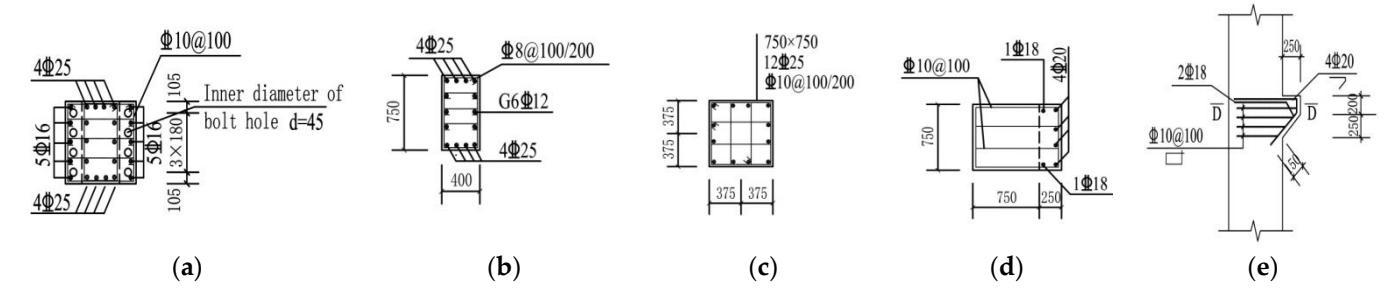
Figure 2. Rebar arrangement of specimen: (**a**) Rebar arrangement of T-shaped beam end; (**b**) Rebar arrangement of B-B beam section; (**c**) Rebar arrangement of A-A column section; (**d**) Rebar arrangement of D-D corbel section; (**e**) Detailed reinforcement arrangement of corbel.

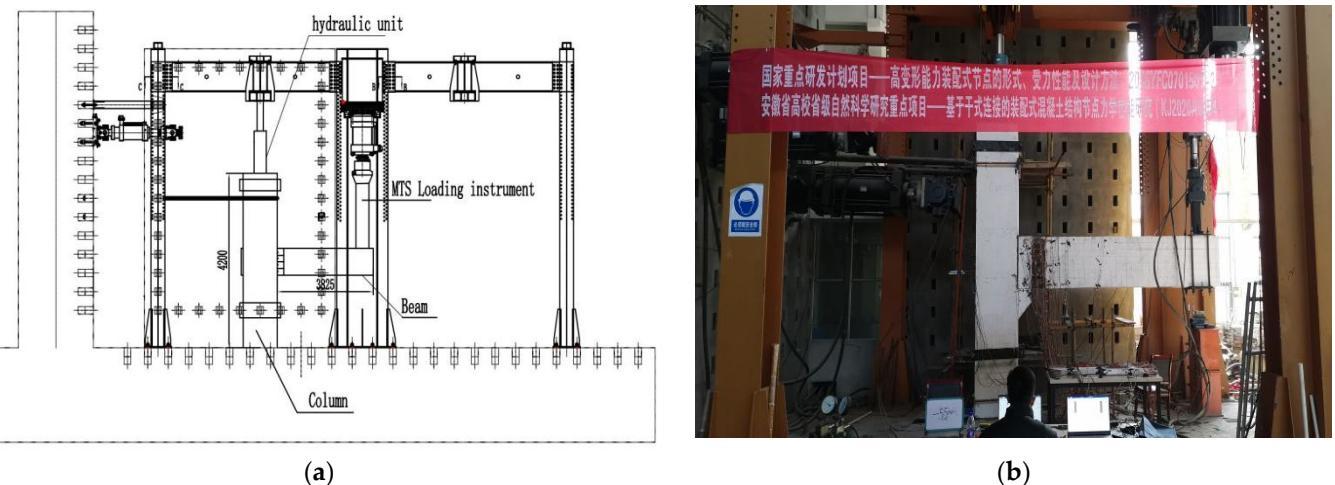
Figure 3. Illustration of specimen and loading device: (a) Loading device diagram; (b) Photo of the test site.

The lateral actuator is attached to the end of the prefabricated beam using a splint in the current pseudo-static test. The pseudostatic test uses a displacement-controlled loading scheme and applies a lateral load with an axial compression ratio of 0.05 to the top of the column. A low-cycle reversed load is applied to the free end of the beam end through the loading system, and lateral loading is accomplished using an electro-hydraulic servo loading system. The stroke of the actuator's displacement is ± 150 mm. Figure 3 depicts the specific loading device on specimens. The entire test-loading procedure is carried out in two stages, the first of which involves loading the displacement for one cycle at each load grade until the specimen yields. The second stage involves loading the displacement for three cycles at each load grade, and the loading is stopped when the specimen strength falls to 85% of its peak load or when the bolts bend. The amount of applied axial pressure should be considered during the loading process, and using the oil pressure gauge, the proper pressure compensation should be carried out. Figure 4 shows the loading plan for constant axial pressure throughout the entire loading procedure.

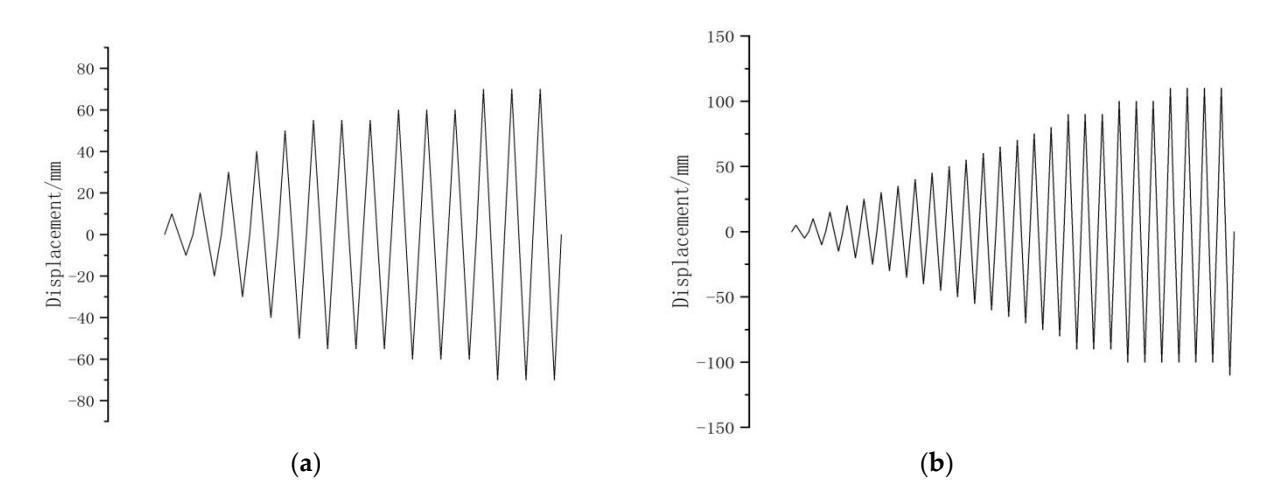
Figure 4. Displacement loading scheme: (a) Q235a. Loading scheme for Q235 low strength bolt; (b) Q345b. Loading scheme for Q345 ordinary strength bolt.

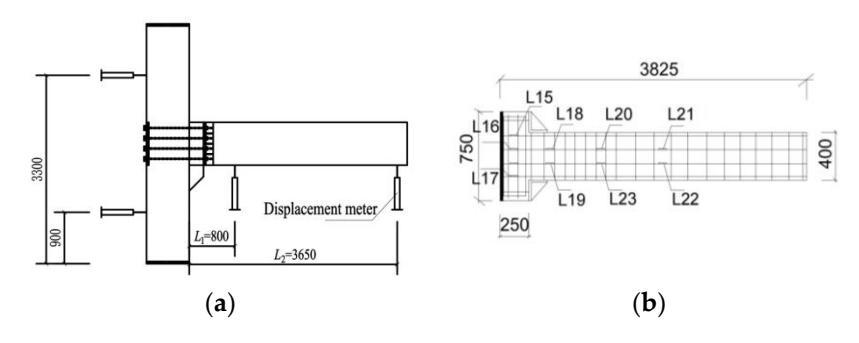
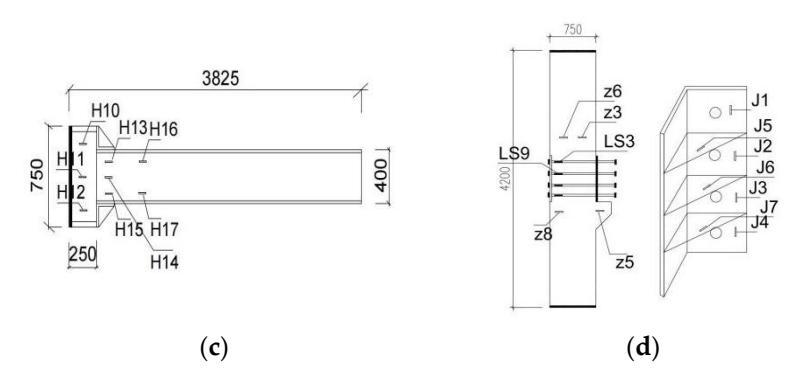
Figure 5. Strain gauges layout: (a) Displacement meter layout; (b) Rebar strain gauges layout on beam; (c) Part concrete strain gauges layout on prefabricated beam surface; (d) Part strain gauges layout on bolt and steel made haunched plate.

To record displacement values, four displacement sensors are installed at the bottom of the prefabricated beam and the side of the prefabricated column. Rebar strain gauges are installed in strategic locations such as the bracket, steel hunched plate, bolt, junction area, beam end, and column and column bottom ends. Figure 5 shows a portion of these strain gauges, where LS stands for bolt strain, Z for column and beam rebar strain, L for beam rebar strain, H for concrete strain, and J for steel-made haunched plate strain.

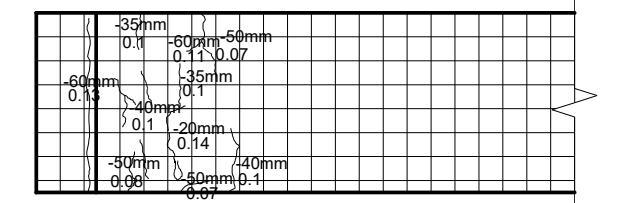
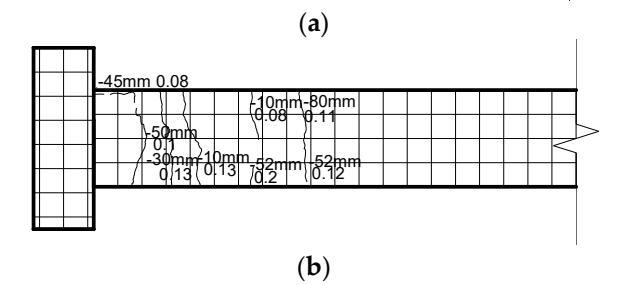
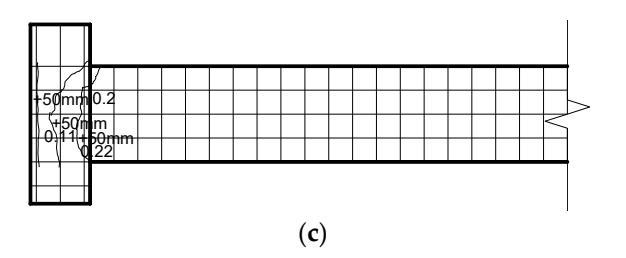
Figure 6. Crack map on specimen S1: (**a**) Crack map on beam side surface; (**b**) Crack map at beam bottom surface; (**c**) Crack map at beam top surface.

The Specimen S1 uses a 24 mm-diameter Q235 low-strength bolt. When loaded to -10 mm, the lower beam surface (65 cm from the T-shape end) experiences the first crack, which has a width of 0.08 mm, and the grouting layer surface experiences cracks with a width of 0.09 mm. On the left and right beam surfaces when loaded to -40 mm, lateral cracks appear and grow longer as the loading increases. Minor annular cracks appear in the T-shaped end area of the upper beam surface when loaded to +50 mm; these cracks spread outward to the area of greatest stress, and 2 mm-wide cracks appear in the grouting layer. The actuator now shows that there is no longer an increase in the bearing capacity at the beam end. There are no cracks on the column or corbel during the testing process; only the beam develops cracks. Figure 6 depicts the morphology of beam cracks.

- 1. Failure characteristics and morphology of Specimen S1
 - Under the displacement effect, small-diameter initial cracks first show up at the bottom of prefabricated beams.

- The specimens eventually fail at the junctions due to the bending of the bolts as a result of the minor annular cracks that develop with increased loading at the stress concentration area of the T-shaped end area.

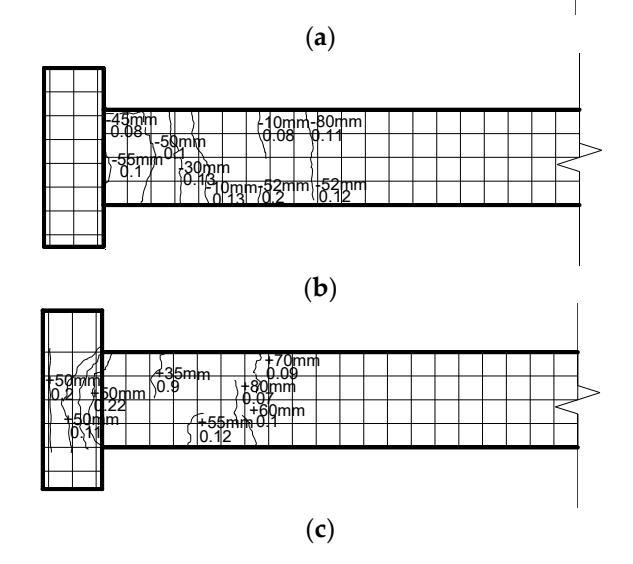
Figure 7. Crack map on specimen S2: (**a**) Crack map on beam side surface; (**b**) Crack map at beam bottom surface; (**c**) Crack map at beam top surface.

The Q345 ordinary strength bolt with a 24-mm diameter is used in the Specimen S2. When loaded to -40 mm, the lower beam surface (165 cm from the T-shape end) experiences the first crack, which has a width of 0.09 mm. When loaded to -75 mm, the steel-made hunched plate's interface with the concrete develops 0.1 mm-wide cracks. Multiple cracks develop on the T-shaped end surface with increased loading, and 2 mm-wide cracks develop in the grouting layer. Delamination occurs at the bottom of the grouting layer when the rebar is loaded to -80 mm, and the rebar strain at the T-shaped end exhibits mutation, indicating that the longitudinally stressed rebar has started to bear load. Cycled loading is now used as the loading strategy. When the cycled load is increased to -100 mm, cracks 0.12 mm wide appear at the concrete/steel-made hunched plate interface, and some surface peeling also takes place. On the beam's surfaces and T-shaped end, cracks continue to form as the load increases, and their width gradually widens. The bolts on the upper part of the joint show obvious bending when recycled and loaded to -110 mm. There are no cracks on the column or corbel during the testing process; only the beam develops cracks. In Figure 7, the crack morphology of beams is depicted.

- 2. Failure characteristics and morphologies of Specimen S2
 - Under the displacement effect, the upper beam surface—rather than the T-shaped end area of the joint—seems to be the location where the first cracks appear. The cracks lengthen and widen as the load increases, and more cracks also form and spread from the beam end to the beam tail. Concrete peels off in the grouting layer, the steel-made hunched plate and prefabricated beam interface develops cracks, and the specimen ultimately fails at the joint as a result of the bending of the bolts.

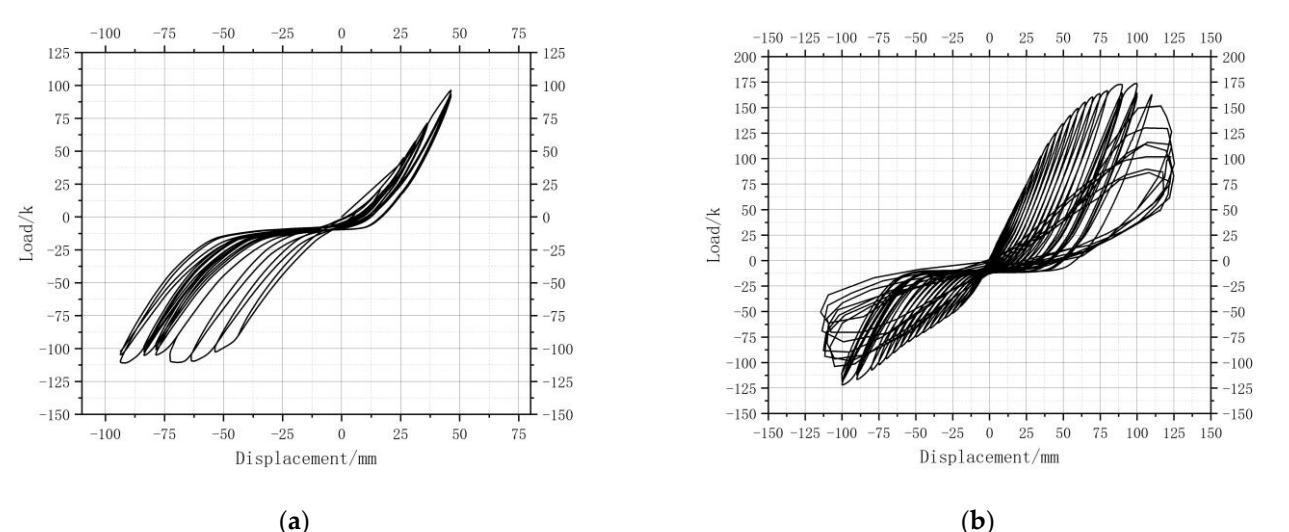
Figure 8 shows the load-displacement hysteretic curves for the two specimen groups, where the load is the lateral load at the end of the beam.

Figure 8. Load-displacement hysteresis curve: (**a**) Load-displacement hysteresis curve of specimen S1; (**b**) Load-displacement hysteresis curve of specimen S2.

The two hysteretic curve groups can be analyzed to reveal that: at the beginning of the displacement loading, a clear pointed fusiform appears in both curve groups. The hysteretic curve's slope gradually rises with the increasing load, and the hysteresis loop area expands as well, indicating a good initial capacity for energy consumption. When the cycled loading period begins, the stiffness decreases and the curve clearly exhibits an anti-S shape, indicating that the capacity for energy consumption gradually declines. Because of the weak bolt used in Specimen S1, the reduction in bearing capacity during the entire loading process is negligible, and the pinch phenomenon of the hysteresis curve is not readily apparent, indicating a poor capacity for energy consumption. The slope of Specimen S2's hysteretic curve is larger and steeper, indicating good deformation recovery and potent plastic deformation. However, the two groups of members' hysteretic curves as a whole are relatively flat, indicating insufficient energy consumption capacity under low-cycle reserved loading. The ultimate bearing capacity of joint components can be effectively improved by increasing bolt strength, according to a comparison of the two specimen groups, but overall the two specimen groups exhibit poor energy consumption capacity. The two groups of specimens have asymmetric hysteresis curves that are asymmetric in both positive and negative directions. Analysis has demonstrated that the self-weight of the prefabricated beam has an asymmetrical effect on the load during the reserved loading process of the actuator. Additionally, when the actuator is reserved for loading, the prefabricated beam attached to the corbel and bolted to the column has an asymmetrical shear effect on the upper and lower surfaces.

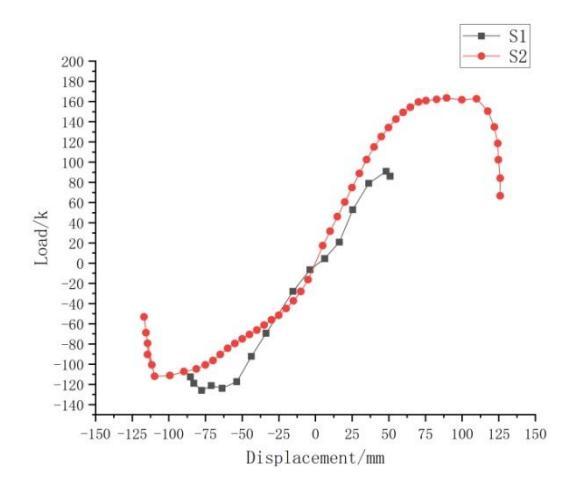
Figure 9. Skeleton curve.

The two specimen groups' load-displacement skeleton curves are plotted in Figure 9, and it is clear that because specimen S1 uses a low-strength bolt, it exhibits no discernible descending stage, indicating poor ductility. Specimen S2's skeleton curve exhibits a dual-stage characteristic trend. The skeleton curve evolves linearly prior to the turning point, indicating that the specimen is in the elastic working period. After the turning point, the specimen stiffness starts to decline, indicating that it enters an inelastic working period. After the maximum value, the specimen's bearing capacity sharply declines. The descending stage of the skeleton curve of specimen S2 is more stable and has a higher ductility coefficient than specimen S1. This new type of joint has good deformation capacity and ductility, and the bearing capacity is proportional to the bolt strength. When specimen S2 reaches the limited displacement, the bearing capacity decreases by 59.2%.

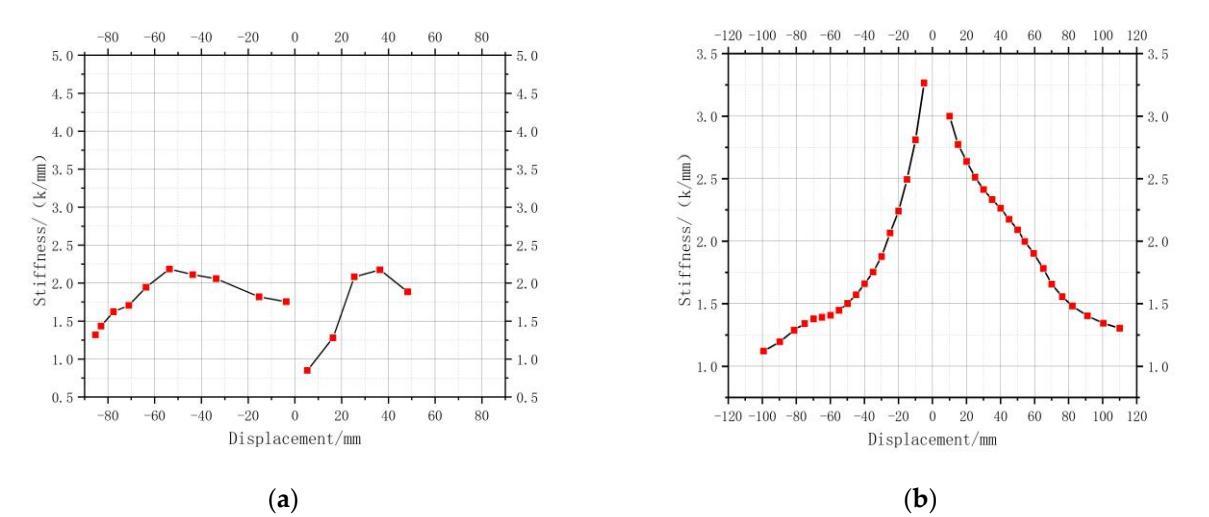
Figure 10. Stiffness degradation curve: (**a**) Stiffness degradation curve of specimen S1; (**b**) Stiffness degradation curve of specimen S2.

Figure 10 displays the stiffness degradation curves of the two groups of specimens, revealing their striking differences. Specimen S1 has a weak ability to resist lateral movement, while specimen S2 has a strong ability, as can be seen in more detail. Additionally, as

the loading displacement increases, specimen S1's stiffness does not change significantly, whereas specimen S2's stiffness changes significantly. It degrades quickly at first; as the loading increases, cracks are generated and existing ones continue to grow; the bolts at the joints are deformed, which causes an increase in joint cracks; and as the speed decreases in the later stage, the curve tends to become flat. Since the bolts are primarily responsible for these specimens' stiffness, specimen S1's stiffness slightly increases during the initial stage of positive loading, but it gradually decreases as the bolts move into the plastic stage.

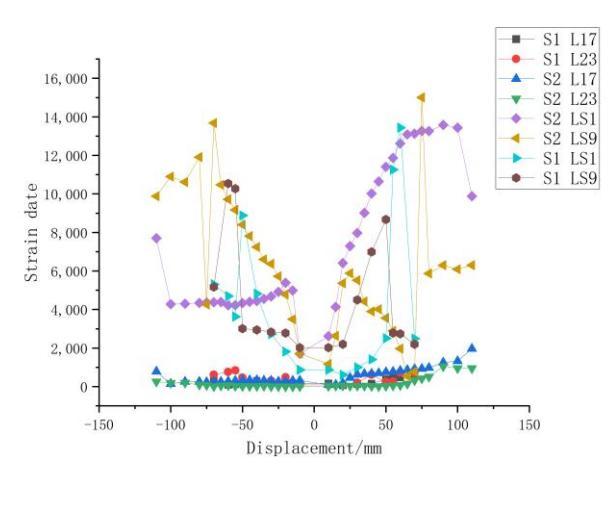
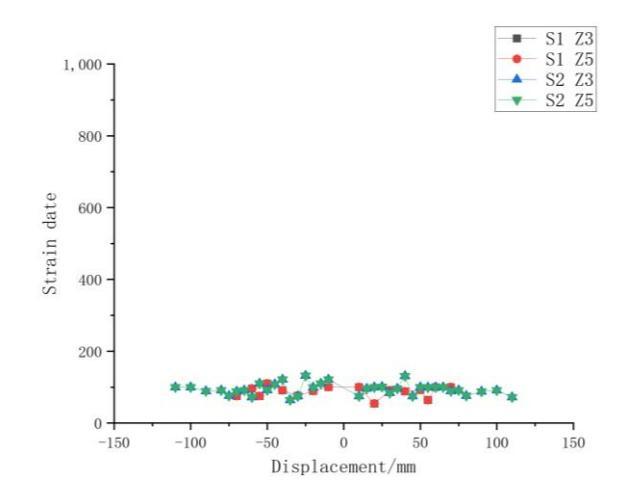
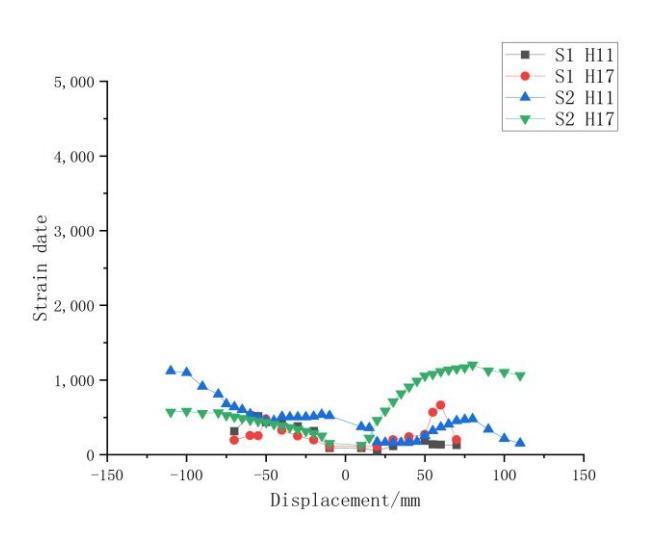
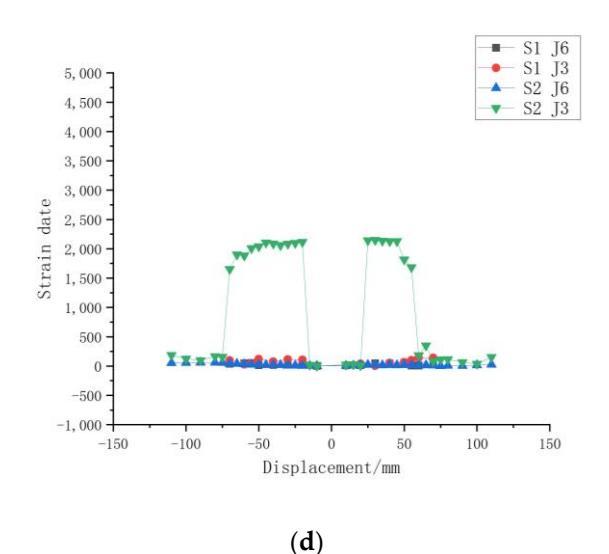
Figure 11. Strain data of rebar, concrete, steel haunched plate and column: (a) Strain data of reinforcement and bolt; (b) Strain data of prefabricated column; (c) Concrete strain data of prefabricated beam; (d) Strain data of steel haunched plate.

Figure 11 shows the strain data for the two specimen groups, where LS stands for bolt strain, *Z* for column and beam rebar strain, L for beam rebar strain, H for concrete strain, and J for steel-made haunched plate strain. According to an analysis of the strain data from the two specimen groups, the strain evolution law for each component is essentially the same, meaning that the strain on stressed rebar and concrete in prefabricated beams is minimal and does not vary much prior to cracking, and that it increases after cracking. The strain values of the rebar and concrete continuously increase with the increasing load, and the rebar strain at the T-shaped end is greater than the beam tail. Significant concrete cracking can be seen in the middle of the T-shaped end and the middle of the beam, where concrete strain mutation also occurs. The internal longitudinal rebar that has undergone stress does not exhibit any significant mutations, which suggests that plastic deformation has not occurred. The prefabricated column's overall rebar strain is minimal and shows no discernible change, indicating that the deformation of the prefabricated column under low-cycle reserved loading is minimal. The haunched plate made of bolts and steel has a strain evolution trend that is consistent with the rebar of the prefabricated beam's T-shaped end.

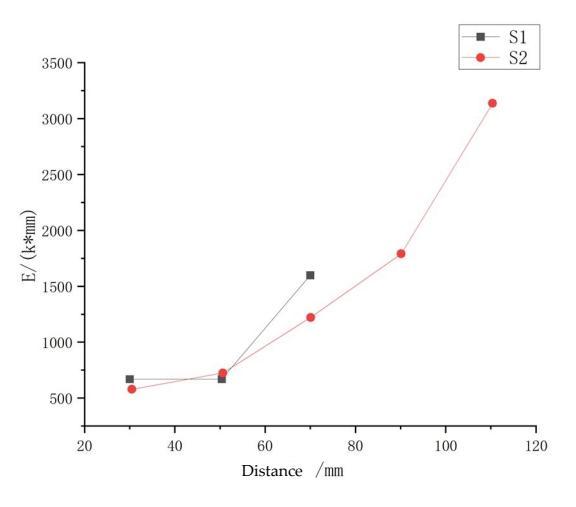
Figure 12. Energy consumption curve.

The hysteresis area under different displacement loading conditions are abstracted to calculate the energy consumption curve of each hysteresis. This result is plotted in Figure 12. Through comparison, it can be seen that the energy consumption of the two specimen groups during the initial loading phase is essentially the same. The bolt of specimen S2 starts to deform with increasing displacement, which causes the slope of the energy consumption curve to decrease. The energy consumption curve of S2 reaches a turning point and steepens when the displacement reaches 70 mm. Analysis reveals that as the longitudinally stressed rebar inside the prefabricated beam begins to bear load, the specimen's energy consumption rises and the specimen's overall energy consumption rises. However, these two specimen groups' energy consumption coefficients are low, indicating that they have poor energy consumption capacities when subjected to low-cycle reserved loading.
