# Detection and Characterization of Damage in Quasi-Static Loaded Composite Structures Using Passive Thermography

## Joseph Zalameda \* and William Winfree

NASA Langley Research Center, MS231 Hampton, VA 23681, USA; william.p.winfree@nasa.gov \* Correspondence: joseph.n.zalameda@nasa.gov; Tel.: +1-757-864-4793

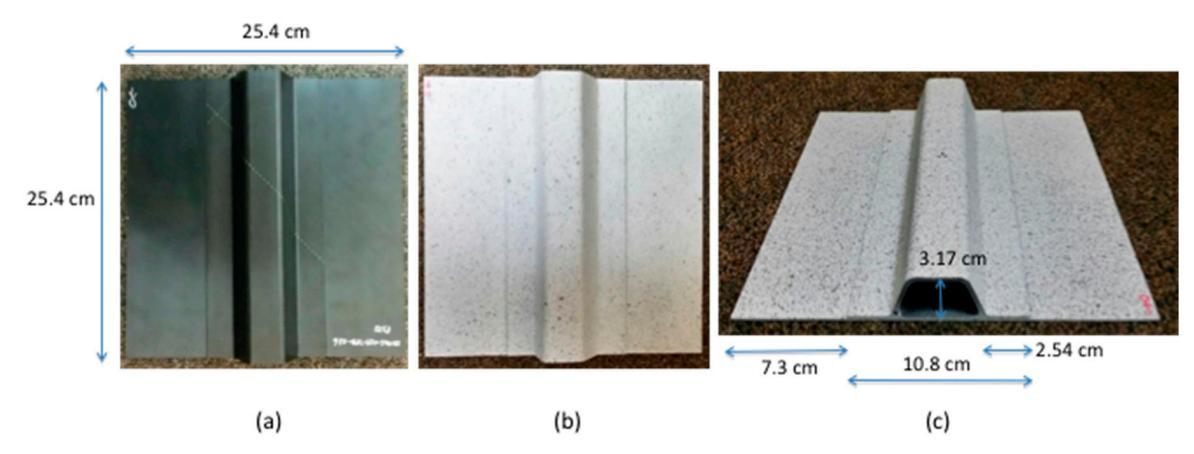
**Figure 1.** Single stringer hat-stiffened composite panel: (**a**) stringer side; (**b**) stringer side painted for digital image correlation measurements; (**c**) cross sectional side view.

The hat-stiffened single stringer composite panel skin was 12 plies with a thickness of 0.22 cm; the stiffener flange was 12 plies thick with a thickness of 0.24 cm. The skin material was an IM-7 tape with 8852 matrix and the stiffener was a woven composite AS4 Fabric with 8852 matrix. The dimensions of the panel are shown in Figure 1. Figure 1a–c show the stiffened composite panel stringer side, a painted specimen, and a cross sectional view, respectively. The panel was painted for digital image correlation measurements to record panel out-of-plane deformation. The paint did not affect the passive thermography measurements. Digital image correlation results are not discussed in this paper.

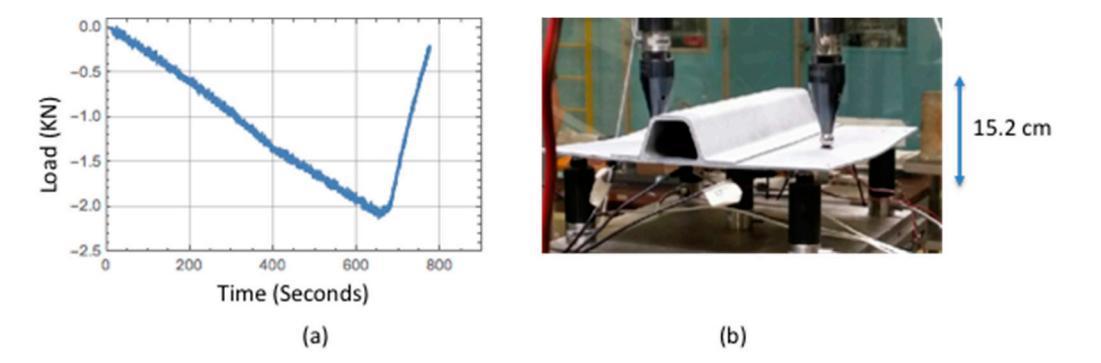
**Figure 2.** Single stringer hat-stiffened composite panel applied quasi-static load: (**a**) example applied load as a function of time; (**b**) panel deformation due to seven-point bend test.

Quasi-static loads were applied using seven application points: two on top (located in middle just outside of the flange) and five on the bottom (located at each corner and center). The load was applied from the bottom while the top was held stationary at two points. This seven-point bend test configuration allowed for panel deformation that results in damage formation between the stiffener flange and skin. The load was applied collectively from the bottom five pins and is measured with a load cell attached to the two top pins. Example of a typical applied load for a given test panel and deflection are shown in Figure 2a,b respectively. The load rate was applied under displacement control and was reduced past a load point where damage formation might occur. For a typical load run as shown in Figure 2a, the load rate was reduced from -0.0033 Kilonewtons/s to -0.0020 Kilonewtons/s. The applied quasi-static maximum load varied from 2.22 to 4.45 Kilonewton, and for each load run, the maximum applied load would increase successively as new damage was formed. After each load run the panel was removed for inspection. Twelve panels were tested and load runs for each panel varied up to a maximum of fifteen runs.

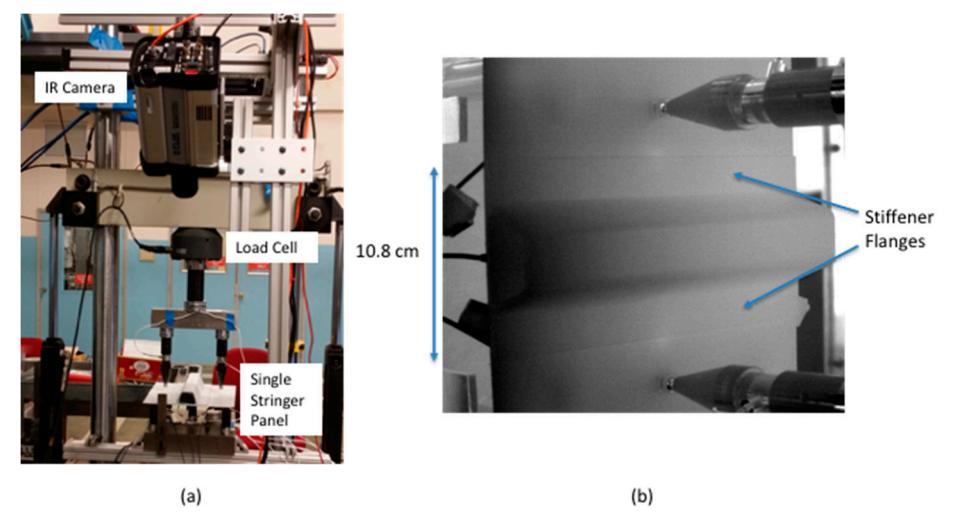
Figure 3. Passive thermography test setup (a) with IR camera view (b).

Passive thermography was used to track damage on the stringer side. The passive inspection captured the thermal variations in real time during the quasi-static loading. When damage was detected, the loading was stopped and the sample is removed for further damage characterization using ultrasound or X-ray CT [28]. The test setup is shown in Figure 3a along with the IR camera view Figure 3b. The basic system consists of a cooled IR camera and an image data acquisition computer. The IR camera specifications are listed in Table 1. The setup required a Plexiglas<sup>®</sup> shield to filter out spurious IR background sources (not shown in Figure 3a). The camera frame rate was externally triggered. The load signal was also acquired using a USB based 12-bit data acquisition module. For each IR camera frame, a load value was acquired. A typical test would last 15 to 20 min, and up to 60 gigabytes of thermal data would be acquired for each run. The IR camera was connected to a custom developed data acquisition system (via GigE interface) for image acquisition. The custom developed image acquisition system allowed for simultaneous acquisition of load data, real-time processing of the IR imagery using averaging, delayed subtraction, and real time contrast adjustment.

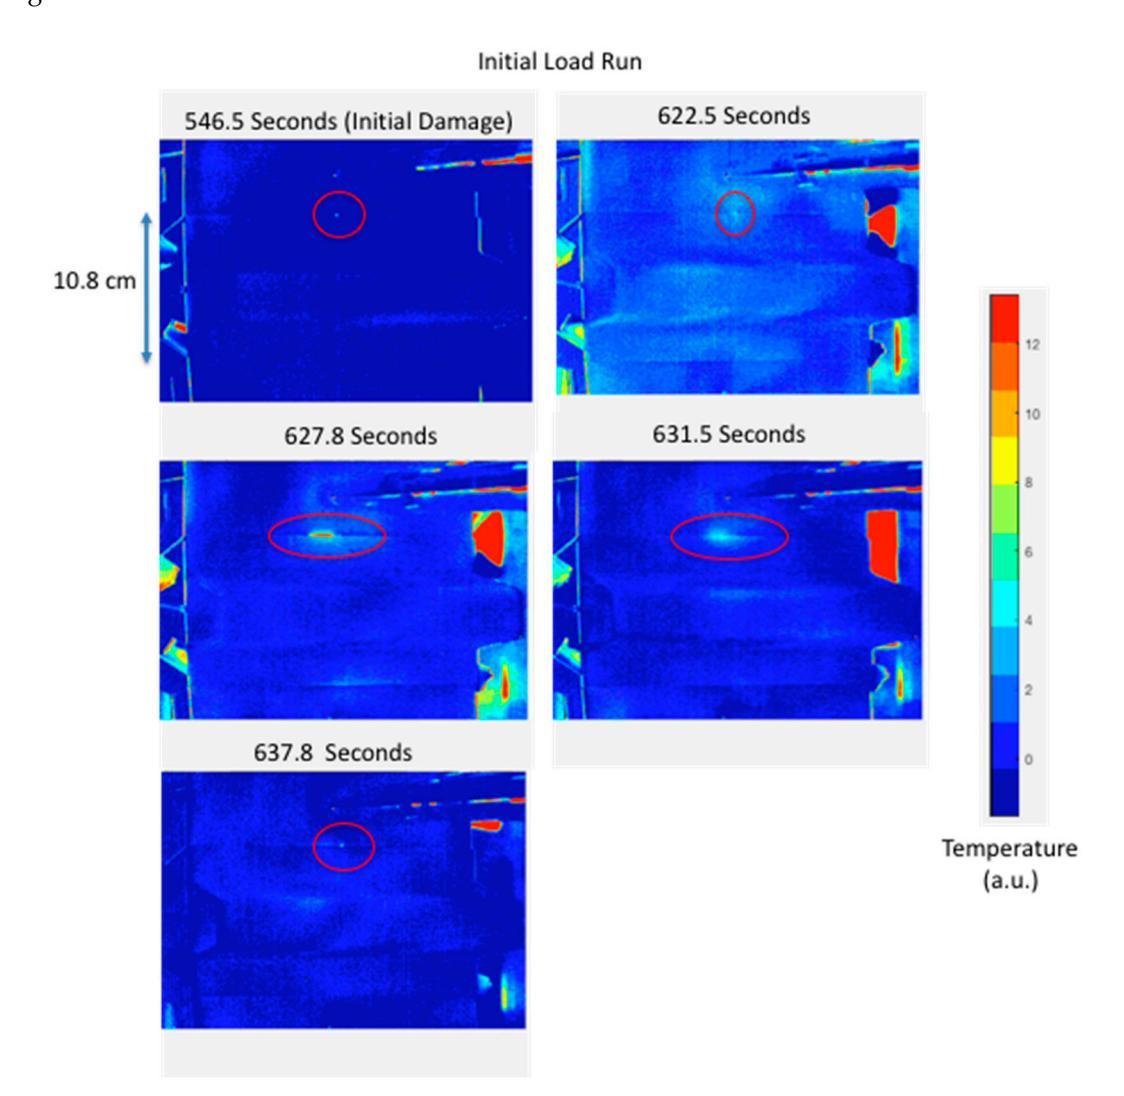
Figure 4. Processed thermal inspection images during initial quasi-static load run.

Digital image processing was required to enhance detection of thermal events during load and to facilitate comparison of the thermal inspection imagery to the ultrasonic data. To enhance detection in real time, a delayed subtraction algorithm was implemented [27,28]. Typical parameters of 100 frames were averaged and a delayed subtraction of 20 averaged frames were generally used for real time processing [28]. The delayed subtraction of 20 averaged frames, given a frame rate of 80 Hz (640  $\times$  512 resolution) results in a time delay of approximately 25 s. This was sufficient time to provide contrast of thermal transients that typically last much less than 25 s. The delayed subtraction removed fixed background IR radiation while increasing sensitivity to changes. The thermal damage was identified over camera noise and background reflections using three criteria: observing a bright area that appears suddenly, stays in one location, and then slowly decays in intensity over time. Comparison to ultrasonic data required an image perspective transformation. The image perspective transformation corrected for the IR camera look angle since the optical line of sight was not normal. The image correction is performed by defining 4 points mapped to a new set of 4 desired points (normal view) [29]. Figure 4 shows the typical processed thermal images for an initial quasi-static load. The thermal images show heating resulting from a small edge delamination growing along the edge of the stiffener flange. The thermal damage was identified over camera noise and background reflections using three criteria: observing a bright area that appears suddenly, stays in one location, and then slowly decays in intensity over time. The ultrasonic inspection image is shown in Figure 5. The ultrasonic inspection was performed using a non-immersion inspection system [30]. The ultrasonic data were obtained using a captive water column with a flexible membrane that allows scanning without immersion into a water tank. The ultrasonic transducer used was a 10 MHz broadband transducer, with a 1.27 cm diameter, and 50.8 cm focus. Full waveform capture was performed using a 12-bit digitizer with mechanical scanning resolution of 0.025 cm. The ultrasonic results confirm a successful capture of an early delamination formation using passive thermography. This damage

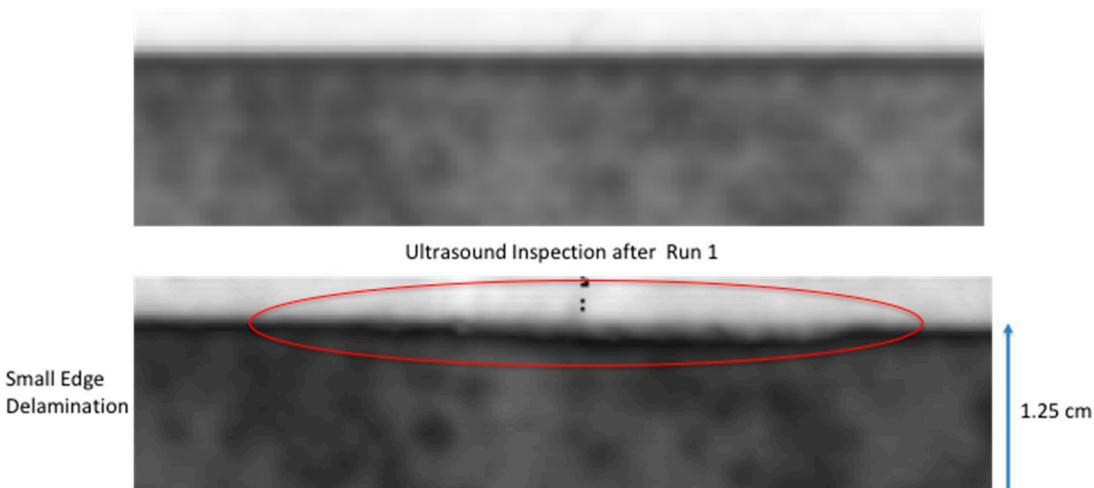
Figure 5. Ultrasonic inspection image after initial quasi-static load run with comparison to baseline

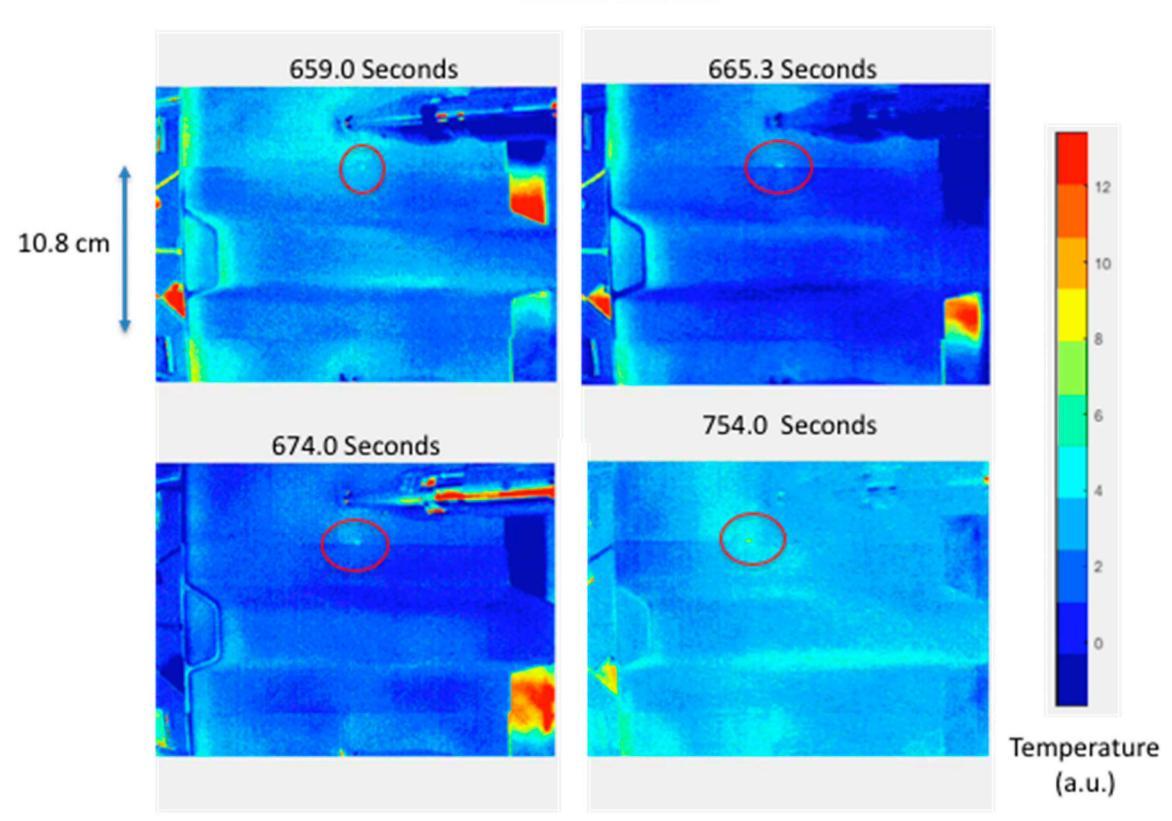
Figure 6. Processed thermal inspection images during second quasi-static load run.

can be grown and characterized during subsequent load runs. The damage grew during the second quasi-static load run as shown in the passive thermography images of Figure 6. Figure 7 shows the corresponding ultrasonic inspection image. The ultrasonic inspection shows the small edge delamination growing slightly inward toward the stiffener hat. The thermal indications, shown in Figures 4 and 6 (circled), prove passive thermography successfully detected the formation and growth of small edge delaminations for this test setup. The thermal indications from the second load run are not as pronounced as the initial load run. This indicates that initial damage formation releases more heat as compared to incremental damage growth. This was observed testing numerous panels. The passive thermography was able to provide the necessary information to detect damage onset and growth.

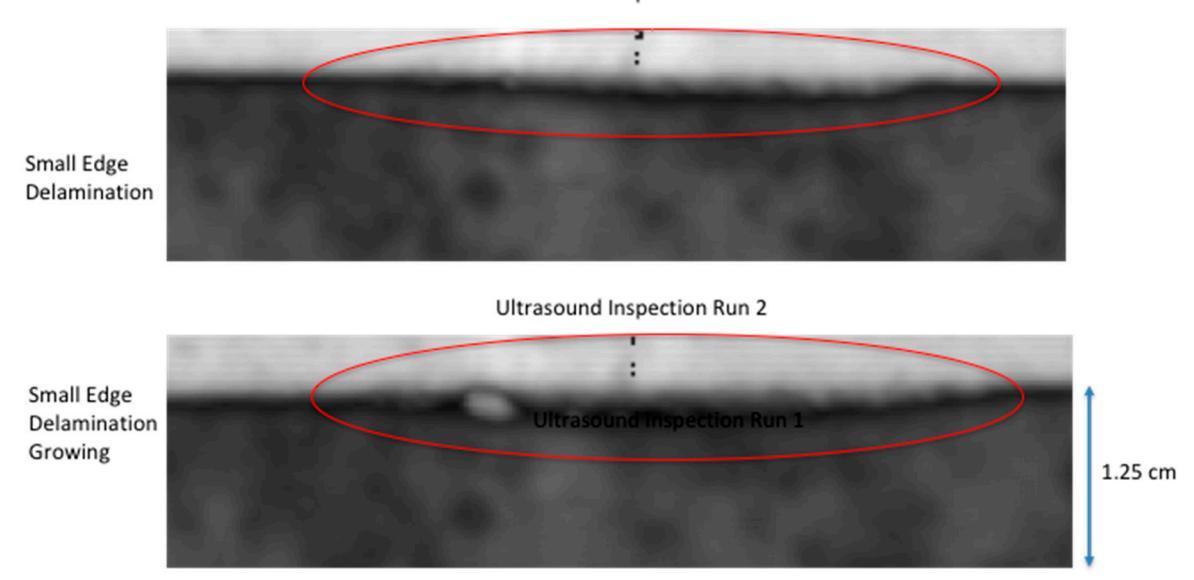
**Figure 7.** Ultrasonic inspection image after quasi-static second load run with comparison to initial run ultrasonic inspection.

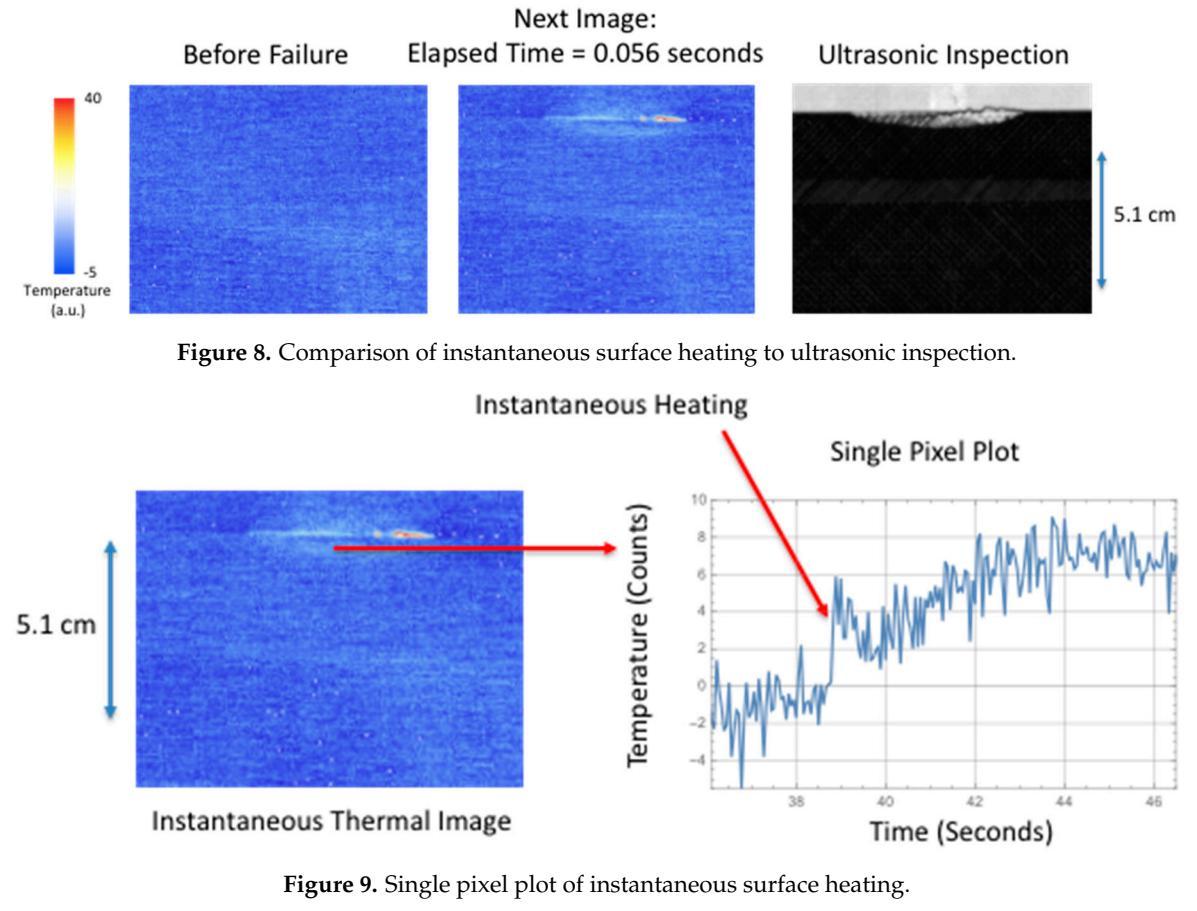
Next Image: Before Failure Elapsed Time = 0.056 seconds Ultrasonic Inspection

the thermal time to reach maximum temperature is a function of damage depth and thermal diffusivity. Similarly, in Figure 10, the instantaneous thermal response for the large area of failure is shown in the middle image where at 0.056 s the thermally detected damage is similar in size and shape to the ultrasonic inspection. The instantaneous heating component can be seen more clearly in Figure 11 where a single pixel, located at the delamination center and halfway up toward hat, is plotted as a function of time. The instantaneous surface temperature increase occurs at approximately 41.7 s. Afterwards there is a dominant transient increase in temperature at around 43 s and this heating is due to the heating at the interface.

Figures 8 and 10 compare the size and shape of the delamination, determined thermally from the instantaneous response to the ultrasonic inspection results. A full width half max calculation, taking into account noise, is used to estimate the crack length of the delamination at two locations. The first location is along the edge of the flange and the second location is half way into the flange toward the hat. These results are compared to the ultrasonic measurements and compiled in Table 2. The thermally estimated crack length is consistently less (to within 25%) than the ultrasonically measured crack length. This is expected since the noise in the thermal signal will affect the length measurements. Another issue is the composite weave pattern introduces surface spatial variations in temperature and thus does not produce a clear boundary. The thermal estimate of the large area damage crack length is in better agreement with the ultrasonic results due to improved thermal signal to noise.

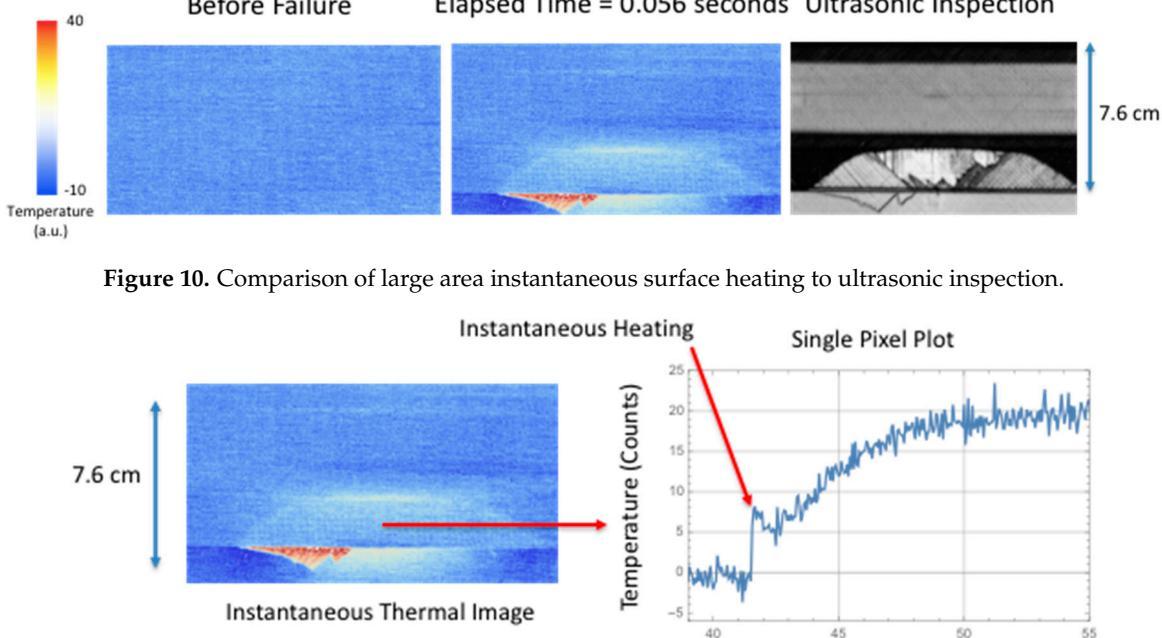
Figure 11. Single pixel plot of instantaneous surface heating for large area failure.

The instantaneous surface temperature increase occurs at approximately 38.8 s. Afterwards, there is a significant transient increase in temperature at around 40.0 s. This heating is due to the mechanical heating or heat flux generated at the failure interface. This heat diffuses to the surface and

The transient rise in temperature, as shown in Figures 9 and 11, is due to the fracture damage (mechanical heating) at the interface. This is modeled as an instantaneous heat flux buried at the damage depth. A two-dimensional thermal model is implemented using the quadrupole method presented previously in a paper by Winfree and verified by comparison to finite element modeling [31,32]. The advantages of the quadrupole method are: easily extendable to multiple layers, faster computation time as compared to finite element method simulations, and easy to insert realistically shaped flaws into simulations [31,32]. For this case, shown in Figure 12, with no convection losses at the vertical or horizontal edges, the heat flux generated is at the flaw location depth within the structure. For static loading, the heat flux at the interface buried at a depth d is modeled as an impulse heat flux. A two-layer configuration with top view, top view drawing and side view drawing is shown in Figure 12. The finite lateral dimension, x, is shown in Figure 12 with no heat flow across the vertical edges at x = 0 and x = L.

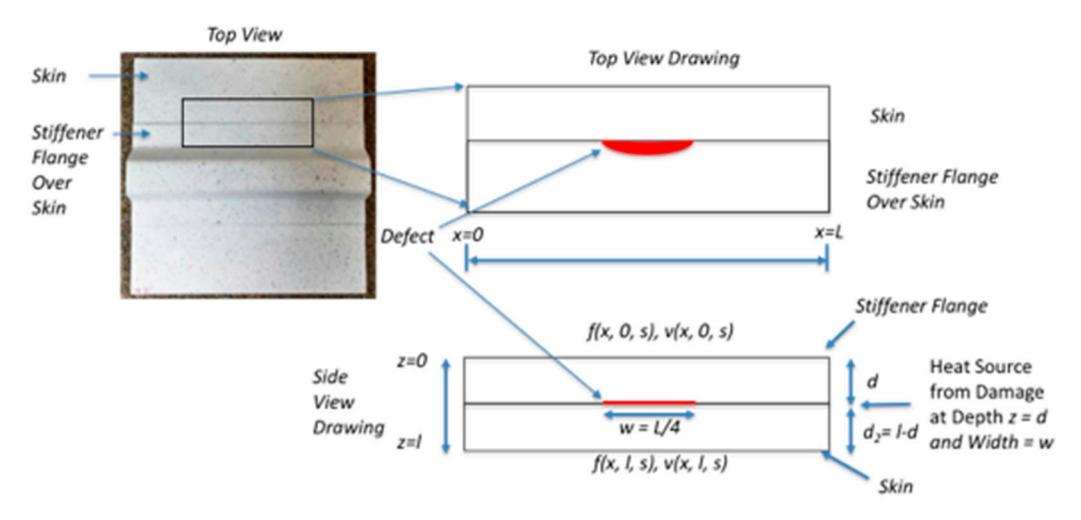
Figure 12. Configuration for two-dimensional model with embedded heat source as a defect.

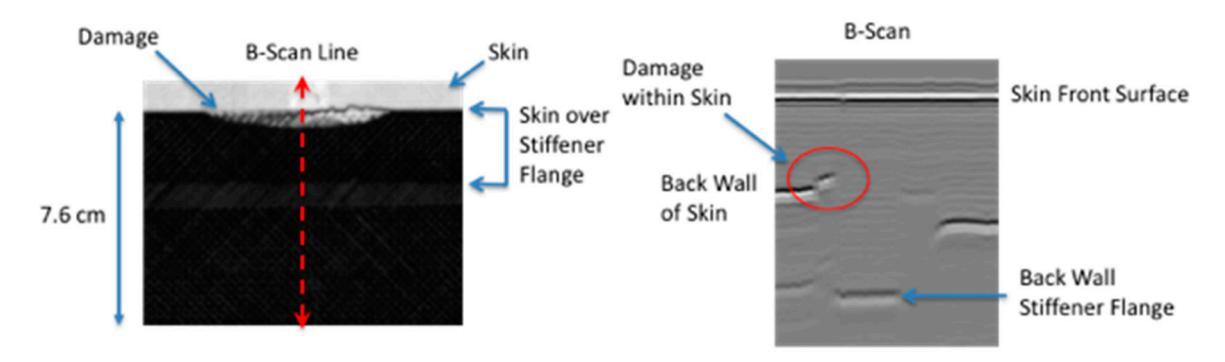
Figure 14. Ultrasonic data to estimate damage depth for small area damage.

A comparison is made between the two-dimensional simulation and the measured thermal response for a delamination located near the interface between the stiffener flange and skin. The instantaneous thermal response provides an estimate of the damage size and start time. The damage depth was estimated using the ultrasonic data. This is shown in Figure 14 where the ultrasonic B-scan inspection of the small area failure reveals damage within the skin. The skin is

12 plies thick. Since the thermal data were obtained from the hat side, the depth of damage would be the stiffener flange thickness (12 plies with a thickness of each ply @ 0.020 cm each for a total thickness of 0.240 cm) plus one skin ply (0.018 cm thick) for a total damage depth 0.258 cm. The thermally estimated damage width, from Table 2 for a line within the delamination located halfway down toward hat, was used in the simulation. Shown in Figure 15 is the comparison of the two-dimensional thermal simulation to the surface temperature response as a function of time, for a flaw source buried at 0.258 cm. By estimating the noise level, the thermal responses were offset corrected and normalized to the maximum temperature obtained at 5.55 s. The simulation response was also normalized at the same time. Figure 15c,d show the simulation slightly overestimates the lateral size (right side of plots) as compared to the thermal data. This perhaps is due to an overestimation of the lateral diffusion or variation in the delamination crack depth due to both intralaminar or interlaminar damage. Shown in Figure 16 is a temporal single pixel plot comparison to the simulation response for flaw source buried at 0.258 cm. The start time is determined from the instantaneous response. As can be seen, the early

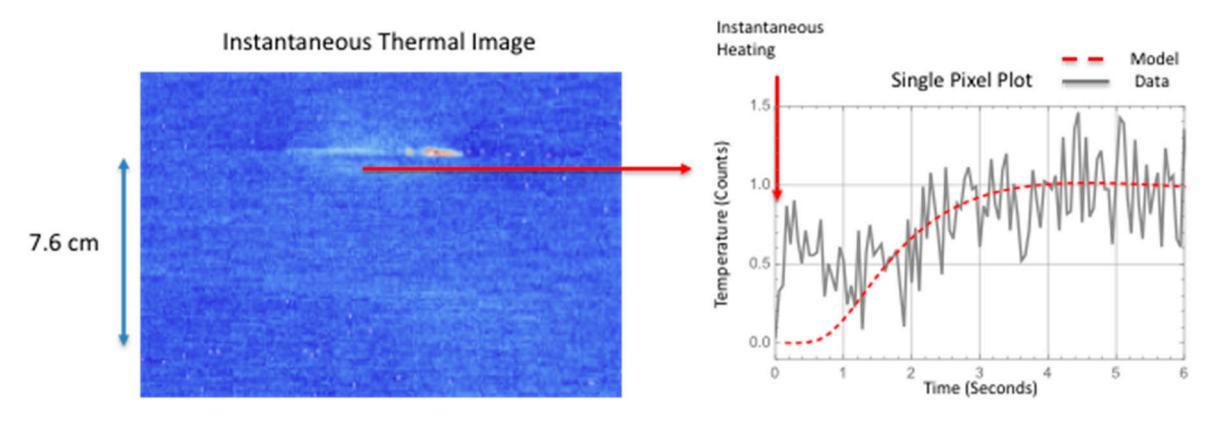
Figure 16. Temporal pixel plot comparison to model response for flaw source buried at 0.258 cm.

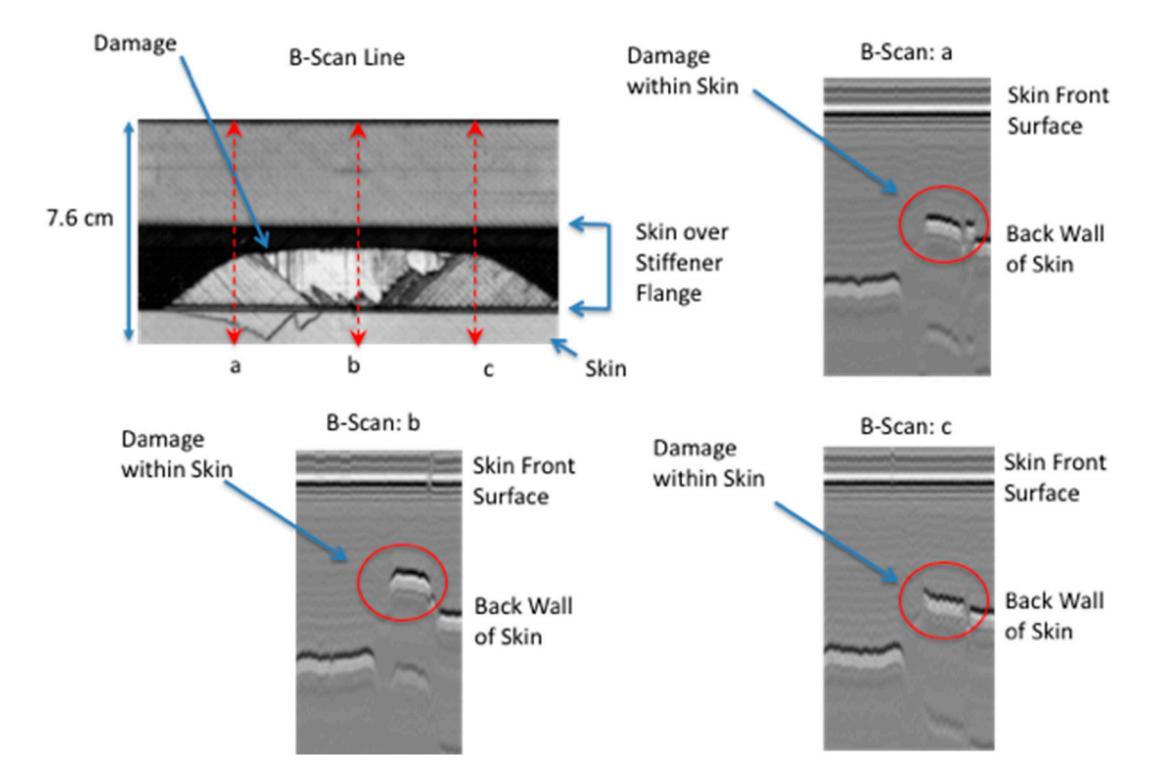
Shown in Figure 17 is the ultrasonic B-scan inspections for the large area failure where the damage is at multiple interfaces. The B-scan images reveals estimated damage depth within the skin to be from one ply deep (B-Scan: a and c) and two plies deep (B-Scan: b). The skin is 12 plies thick. The thermally determined damage width, from Table 2 for a line within the delamination located halfway up toward hat, was used in the simulation.

**Figure 17.** Ultrasonic data to estimate damage depth: (**a**) and (**c**) indicate damage one ply within skin; (**b**) indicate deeper damage two plies within skin.

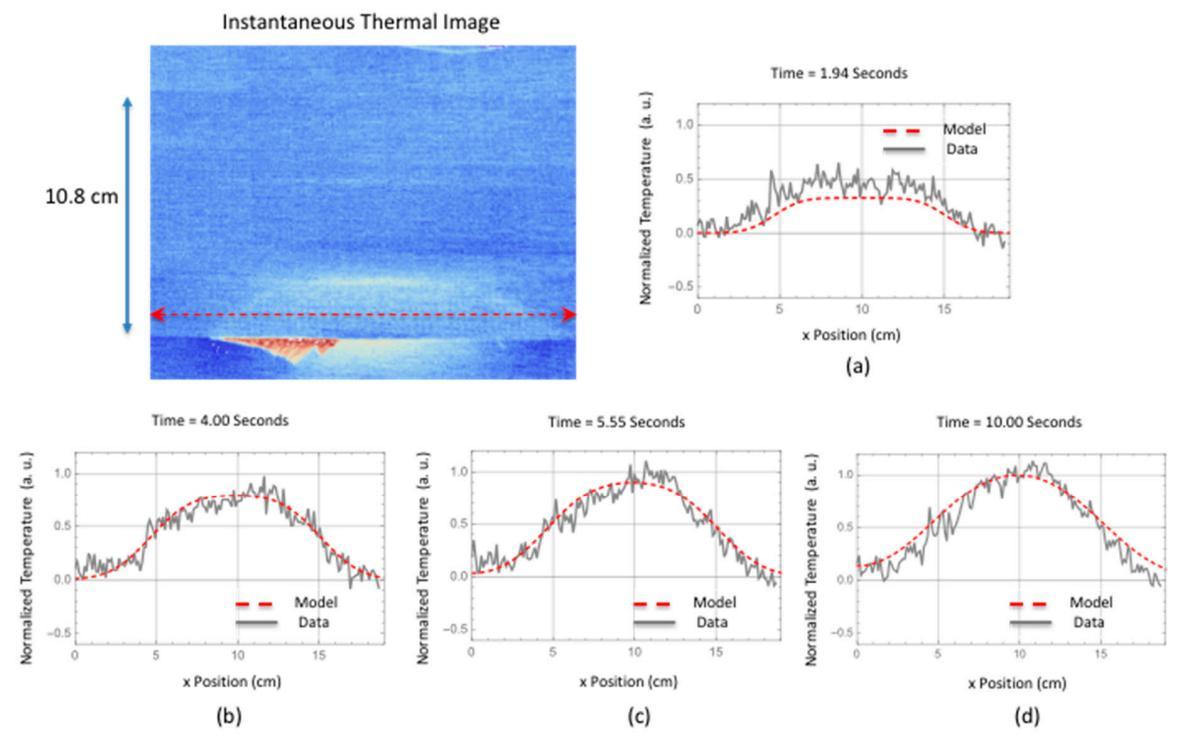
Shown in Figure 18 is the comparison of the two-dimensional simulation to the surface temperature response as a function of time, for a flaw source buried two plies within the skin. The stiffener flange is 0.24 cm plus two skin plies (0.018 cm thick each) which gives an averaged damage depth of 0.276 cm. Estimating the noise level, the thermal response was offset corrected and normalized to the maximum temperature obtained at 10.00 s. Fairly good agreement between the thermal simulation and the data is obtained for all the plots except the early time plot Figure 18a. The early time plot error is due to the instantaneous heating which is more pronounced for the large area failure at the early times. Shown in Figure 18d, the simulation slightly overestimates the lateral size but is in better agreement as compared to the small delamination shown in Figure 15d. The better

**Figure 18.** Two-dimensional simulation comparison to surface temperature response as a function of time for a flaw source buried at 0.276 cm.

agreement in Figure 18d is most likely due to an overestimation of the lateral diffusion in combination with the left and right delamination depth being more shallow. Shown in Figure 19 are temporal plot comparisons to the model response at different locations on the large area damage. As can be seen, the early time is dominated by the instantaneous heating, similar to the temporal plot in Figure 16, for all three averaged pixel plots. The plots were generated by averaging a  $5 \times 5$  pixel area. The fitting response is shown in Table 4 where the mean squared difference between the model response and the thermal data is calculated for different thicknesses. The mean squared difference is calculated for a time window of 1 to 10 s to remove the influence of the instantaneous heating that is not included in the model. The results in Table 4 show, by minimization of the mean squared error, the middle area b damage is at a depth of 0.276 cm and the left and right areas a and c respectively is at a depth of 0.258 cm. This is in agreement with the B-scan results in Figure 17 that show the delamination is buried deeper for middle area B-scan line (b) as compared to B-scan lines (a) and (c) which indicate the damage is less within the skin layer and therefore not as deep.

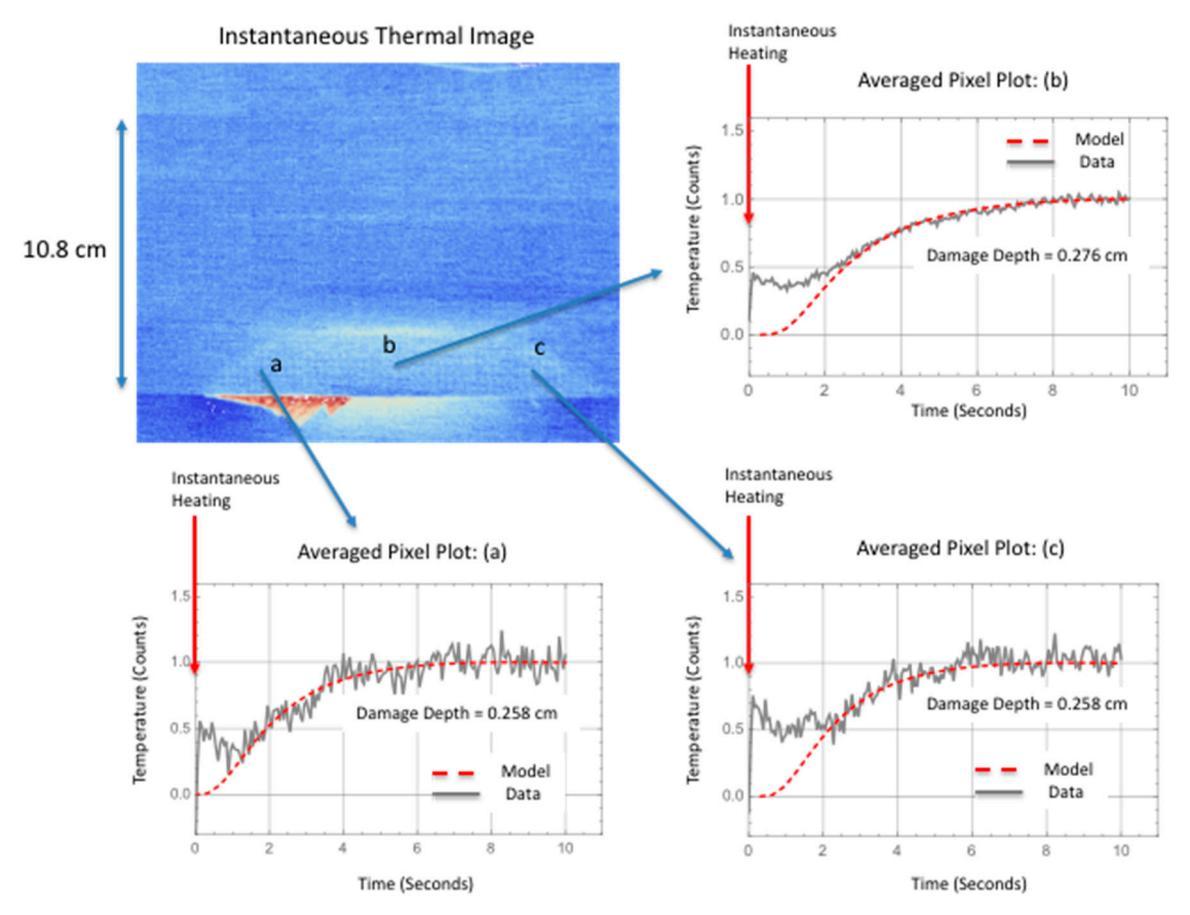
**Figure 19.** Temporal pixel plot comparison to model response for large area delamination at various locations.
