Article Piezoelectric Wafer Active Sensor Transducers for Acoustic Emission Applications

Connor Griffin * and Victor Giurgiutiu *

Department of Mechanical Engineering, University of South Carolina, Columbia, SC 29208, USA

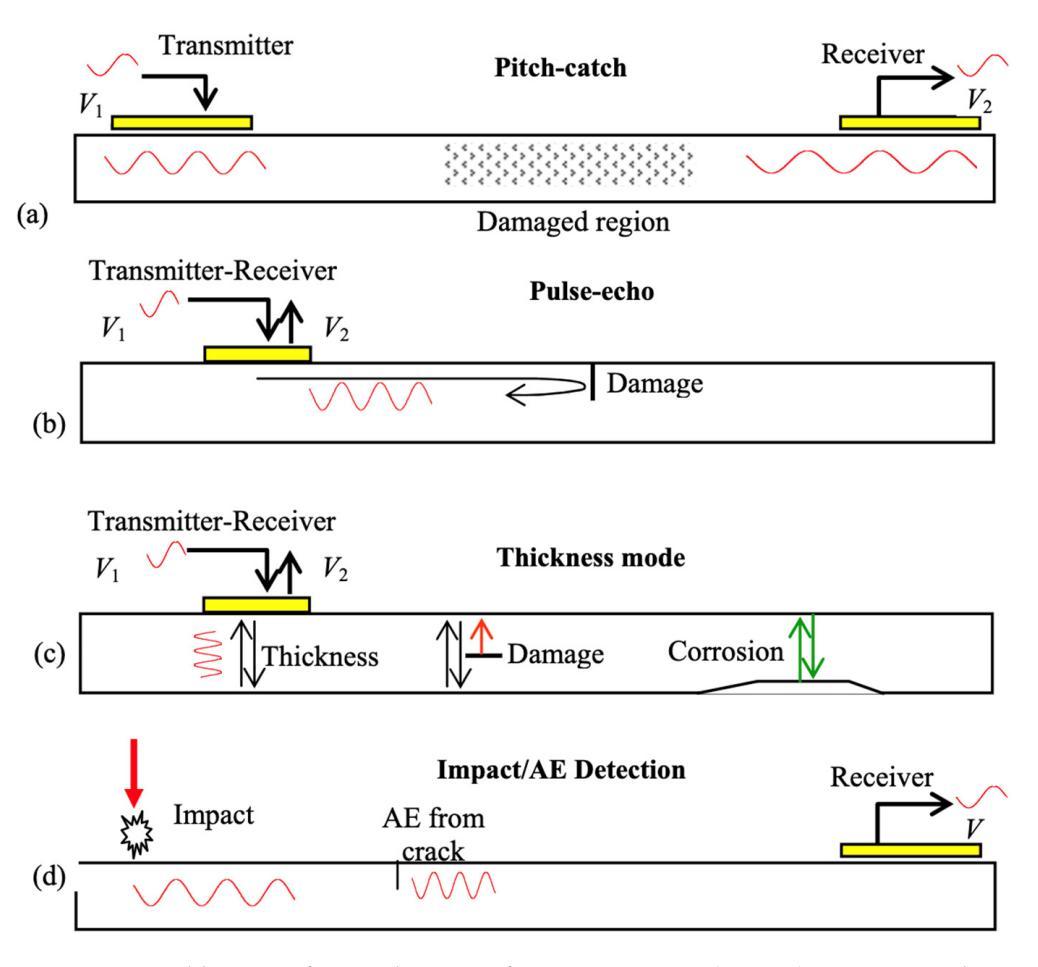
Figure 1. Possible uses of piezoelectric wafer active sensors (PWASs) in SHM applications; (a) pitch-catch; (b) pulse-echo; (c) thickness mode; (d) impact/AE detection [3].

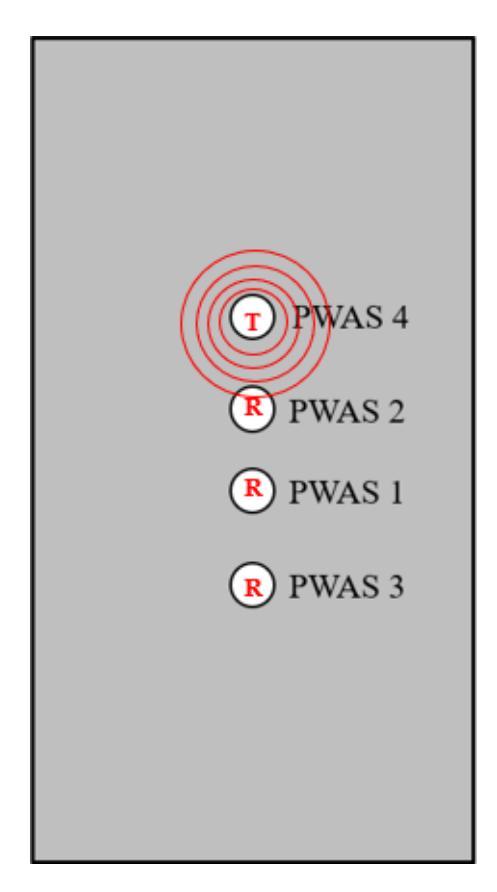
Figure 2. Diagram of pitch-catch experimentation where T represents the transmitting PWAS and R represents the receiving PWAS.

Using the numbering convention pictured in Figure 2, it is expected that due to the symmetry of instrumentation, the waveforms received at PWASs 4, 2 and 1 when PWAS 3

is transmitting should be the similar to the waveforms received at PWASs 3, 1 and 2 when PWAS 4 is transmitting. This would be the same case at symmetric PWASs while PWASs 1 and 2 are the transmitting PWASs.

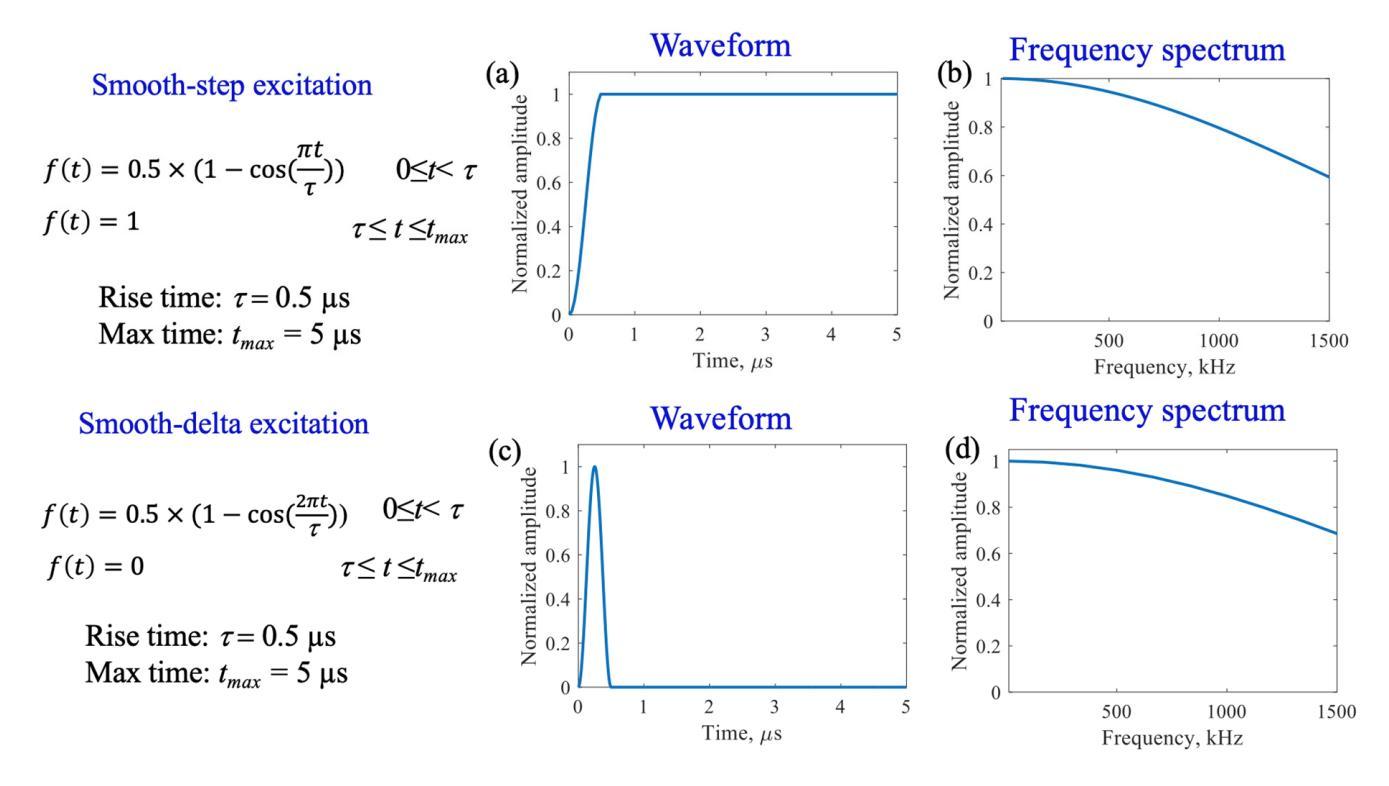
Figure 3. Equations, waveforms and frequency spectrum for excitation signals. (a) Smooth–step waveform; (b) Smooth–step frequency spectrum; (c) Smooth–delta waveform; (d) Smooth–delta frequency spectrum.

In order to check our instrumentation in this round robin fashion, two actuation functions were used for the transmitting PWAS. One function was a smooth-step function associated with fatigue crack growth acoustic emissions in the finite element modeling of fatigue cracks, while the other function was a smooth-delta function associated with fatigue crack rubbing and clapping [16–18]. Each function had a rise time of 0.5 microseconds, with each function's equations, waveforms and frequency spectrums being shown in Figure 3. The frequency spectrums show the ability of the numerically simulated step and delta functions to excite high-frequency components with only a gradual decrease as the frequency increases. The spectra are similar, but the step spectrum decreases faster than the delta spectrum. Please note that, in the step spectrum, we eliminated the DC component for f = 0 Hz, which is not of interest to our study.

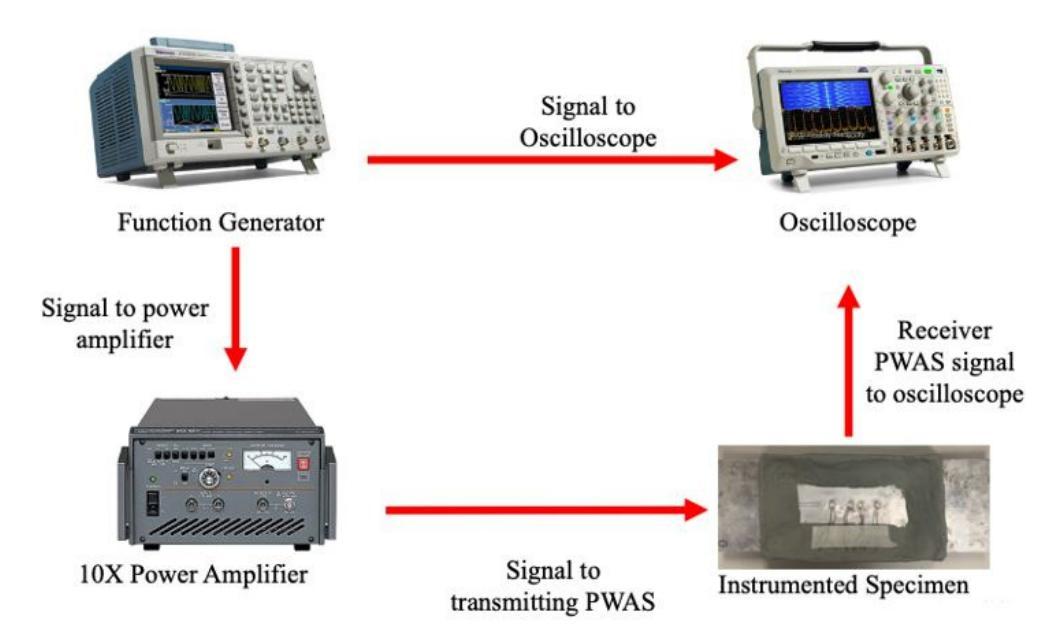
Figure 4. Experimental setup for pitch-catch experimentation.

For the actuation of PWASs, as well as the collection of received signals from PWASs, the experimental setup shown in Figure 4 was used. This setup consisted of a function generator that communicates the actuation signal, either the smooth-step or smooth-delta function, to the connected oscilloscope as well as the $10 \times$ power amplifier. From the power amplifier, the actuation signal is then sent to the transmitting PWAS. The signal from each sensing PWAS is then sent to the oscilloscope to be collected. Collection of signals from the oscilloscope lends the actuation function sent to the transmitter and the signals received at each of the receiving sensors.

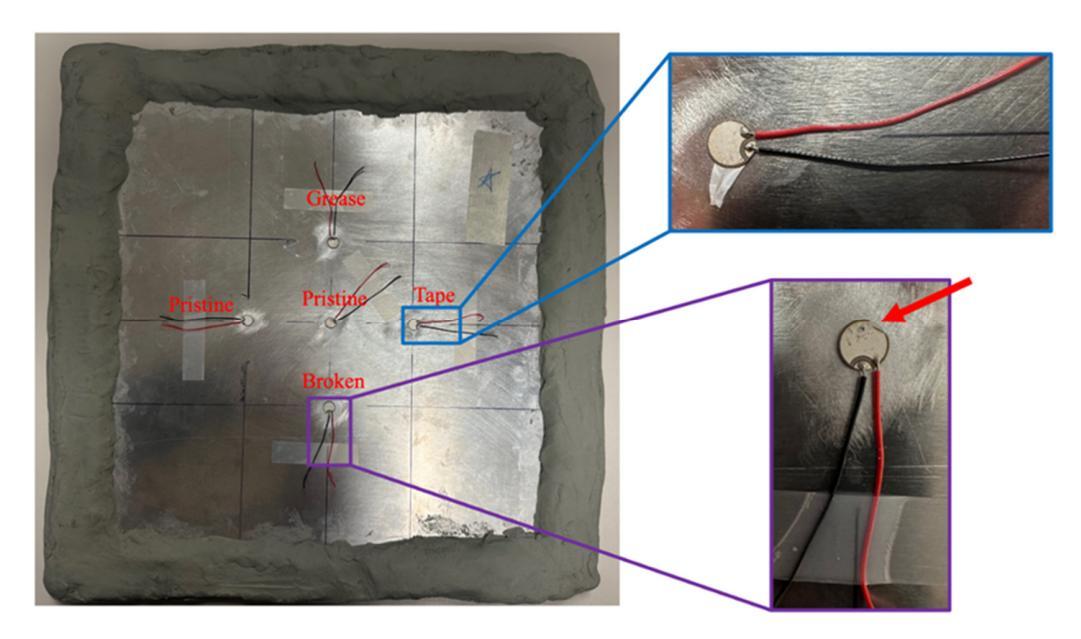
Figure 5. Specimen instrumented with two pristine PWASs, one broken PWAS, one PWAS with tape beneath the bonding layer and one PWAS with grease beneath the bonding layer.

Additionally, for investigation into the effects of defects on the PWAS response, a specimen was instrumented with defective instrumentation and pitch-catch testing was performed. The specimen was a 12 in. \times 12 in. Al-2024 plate, again instrumented with 7 mm diameter, 0.5 mm thick, circular PWAS. M bond AE 15 adhesive was again used to fix the PWAS to the specimen and the same clay non-reflective boundary was applied. The PWASs selected for instrumentation on both specimens possessed similar capacitance and EMIS values to best maintain signal similarity between sensors. This specimen was instrumented with five PWASs, two pristine, one broken, one with a small dollop of grease between the bonding layer of the PWAS and the plate and one with Teflon tape beneath the bonding layer of the PWAS and the plate. In instrumenting the defective specimen, grease and tape were placed between the plate and bonding agent for the PWASs, and the broken PWAS was damaged after being bonded to the specimen. The distance from each outer PWAS of this specimen to the inner pristine PWAS was 50 mm, equivalent to the distance between PWAS 3 and PWAS 4 in Figure 2. Figure 5 depicts the specimen instrumented with defective PWAS. The broken PWAS had a small chip in the top right of the sensor, referenced by the arrow in the figure. Each defective PWAS was used as both a transmitter and a receiver in experimentation, with the pitch-catch results compared with those of a pristine PWAS.

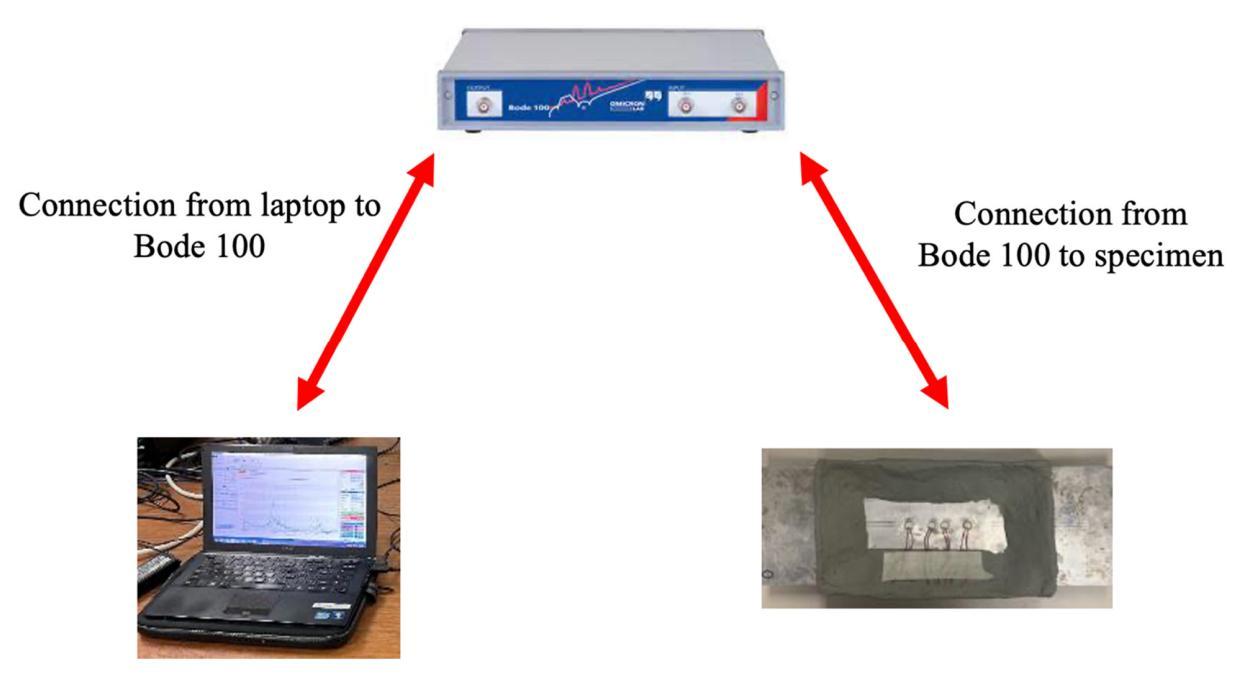
Figure 6. Experimental setup for conducting EMIS testing.

For this second specimen instrumented with defective instrumentation, EMIS testing was also performed. The experimental setup for the monitoring of PWAS bond quality by means of the EMIS is shown in Figure 6. In this experimental setup, a laptop was connected to the BODE 100 analyzer which communicates the test parameters. The specimen being tested was then connected to the analyzer and, while the test is being ran, the results are displayed to the laptop.

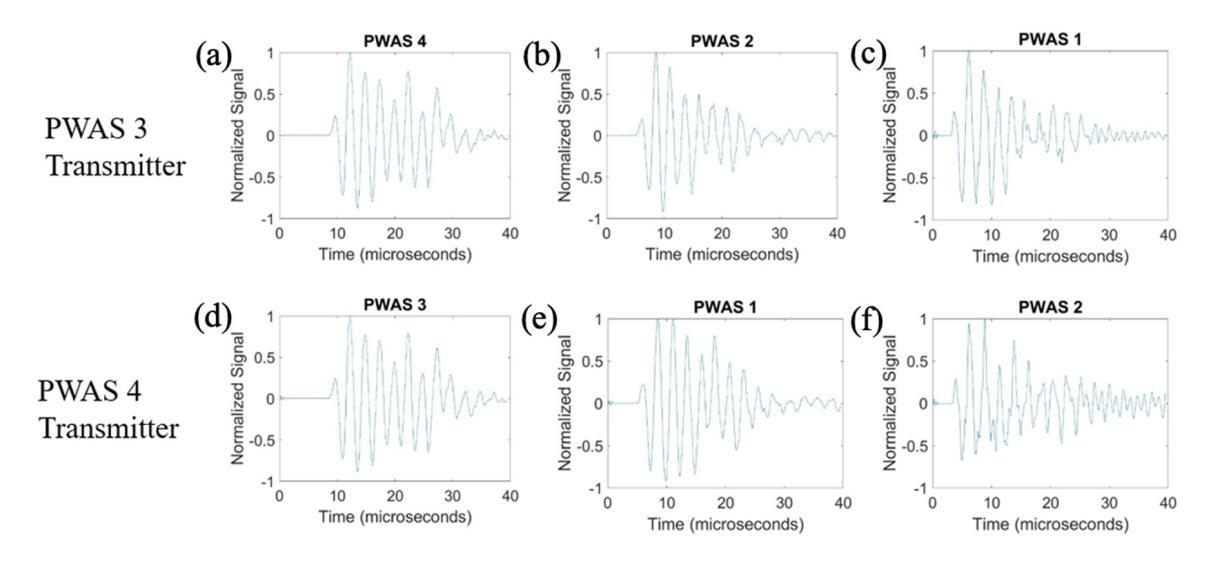
Figure 7. Comparison of received signals at (**a**) PWAS 4, (**b**) PWAS 2 and (**c**) PWAS 1 when PWAS 3 is actuating a smooth–delta function and (**d**) PWAS 3, (**e**) PWAS 1 and (**f**) PWAS 2 when PWAS 4 is actuating with a smooth–delta function.

On a specimen instrumented with four pristine PWASs, as pictured in Figure 2, the first excitation function used in pitch-catch experimentation is the smooth-delta function. Results for the comparison of the normalized signal received at each PWAS when PWASs 3 and 4 are the transmitting sensors are displayed in Figure 7. To account for slight

variations in the EMISs of each PWAS, normalized signals are used for comparison. This is because the amplitude of signals may differ slightly between sensors due to their unique resonant frequencies when compared to the frequencies of the signal received. Normalizing the signal creates a uniform basis for comparing each signal received across all PWASs. When PWAS 3 is transmitting, the signals received at PWASs 4, 2 and 1 should be nearly identical to the signals received at PWASs 3, 1 and 2 when PWAS 4 is the actuating PWAS. By performing a fast Fourier transform of the signal received at each PWAS, the frequency spectrum of each signal is obtained. Comparisons of the frequency spectrum of signals received for when PWAS 3 and PWAS 4 are actuating, corresponding to the normalized signals in Figure 7, are shown in Figure 8.

From Figure 7, it can be seen that signals between PWAS 3 and PWAS 4 when the opposite is transmitting are nearly identical, while signals between PWAS 1 and 2 are not. The best comparison of the signals comes from analyzing the frequency spectrums, as differences in the signals become more apparent. From Figure 8, the frequency spectrums

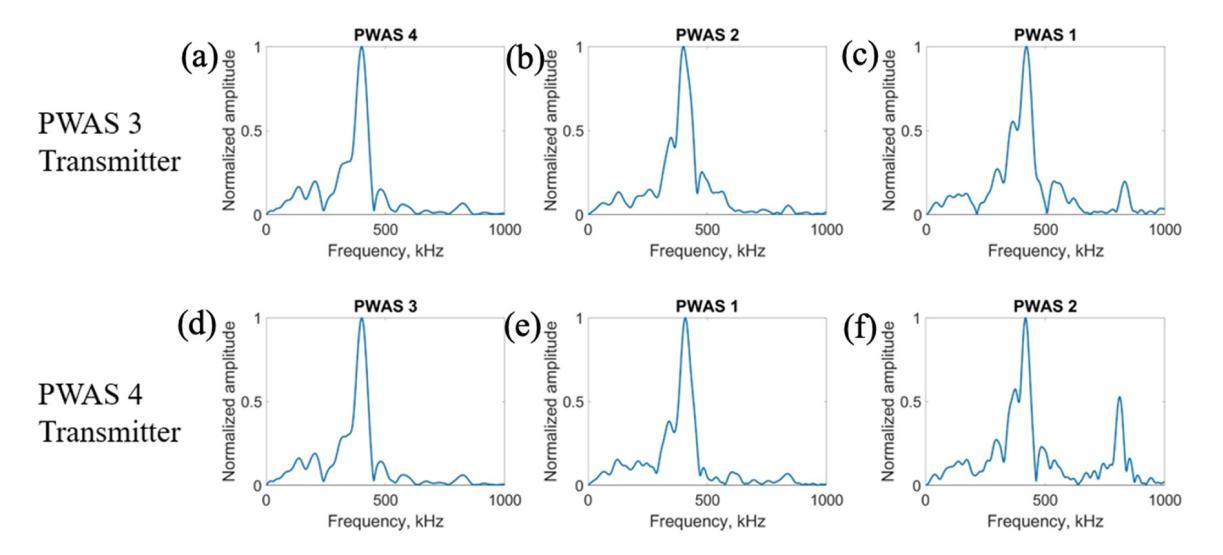
Figure 8. Comparison of frequency spectrums of received signals at (**a**) PWAS 4, (**b**) PWAS 2 and (**c**) PWAS 1 when PWAS 3 is actuating a smooth–delta function and (**d**) PWAS 3, (**e**) PWAS 1 and (**f**) PWAS 2 when PWAS 4 is actuating with a smooth–delta function.

of the received signals at PWAS 3 and PWAS 4 are nearly identical when the opposite is actuating, as was the expected result with pristine instrumentation. It can be established that due to the nearly identical normalized signals received as well as the frequency spectrums of these signals, the instrumentation quality of both PWAS 3 and PWAS 4 are of matching and good quality. The frequency spectrums of PWAS 1 and PWAS 2 do not have this same identicality such that primary peak frequencies occur at similar values, but the secondary frequency peaks differ in their normalized amplitude as well as their values. The reasons for this disagreement in both the normalized signals received at PWAS 1 and 2, as well as the frequency spectrums of the signals, will be discussed later.

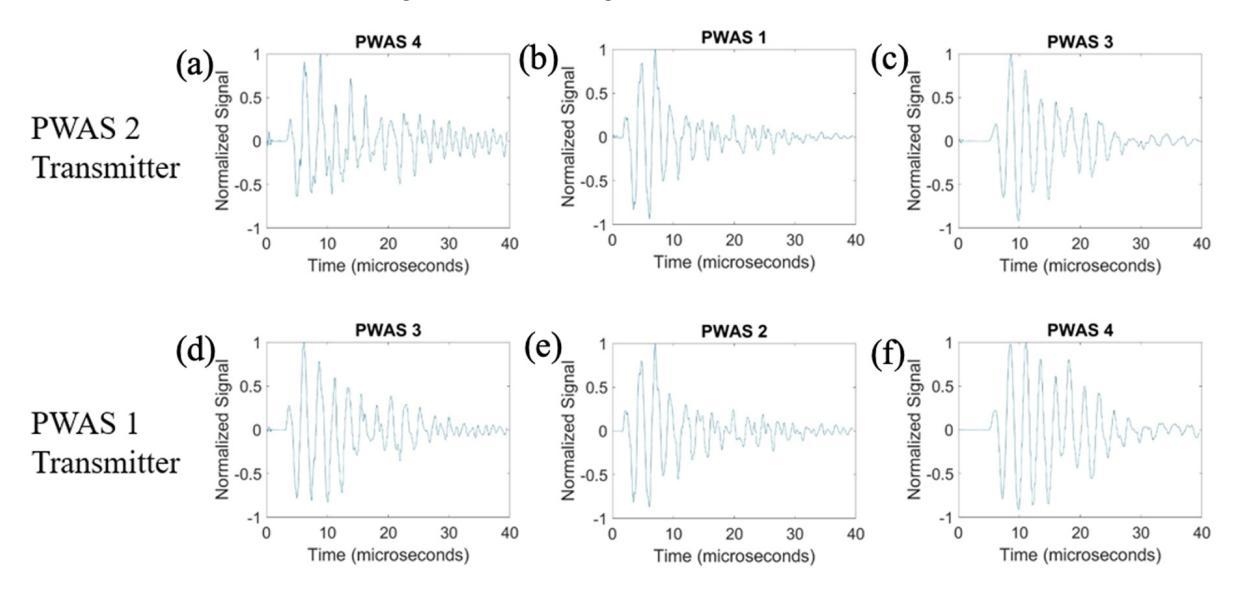
Figure 9. Comparison of received signals at (**a**) PWAS 4, (**b**) PWAS 1 and (**c**) PWAS 3 when PWAS 2 is actuating a smooth–delta function and (**d**) PWAS 3, (**e**) PWAS 2 and (**f**) PWAS 4 when PWAS 1 is actuating with a smooth–delta function.

The results for transmitting a delta function with PWASs 1 and 2 are displayed in Figure 9. The frequency spectrums of the signals received when PWASs 1 and 2 are transmitting are shown in Figure 10.

When PWAS 2 is transmitting, the signals received at PWASs 4, 1 and 3 should be nearly identical to the signals received at PWASs 3, 2 and 4 when PWAS 1 is transmitting. From Figure 9, the normalized signals received at PWASs 1 and 2 when the other is actuating are nearly identical to each other, which is the expected result with defect-less instrumentation quality. This identicality is again better seen in the frequency spectrums. For this actuation, there are differences in the signals received at PWASs 1 and 2 are nearly identical to each other, which is the same normalized amplitude occurring at the same frequencies. However, for PWASs 3 and 4, the frequency spectrums are not identical. The frequency spectrums of PWASs 3 and 4 have peak frequencies at similar values but the similarity between the signals received ends there, with different secondary peaks as well as high frequency peaks.

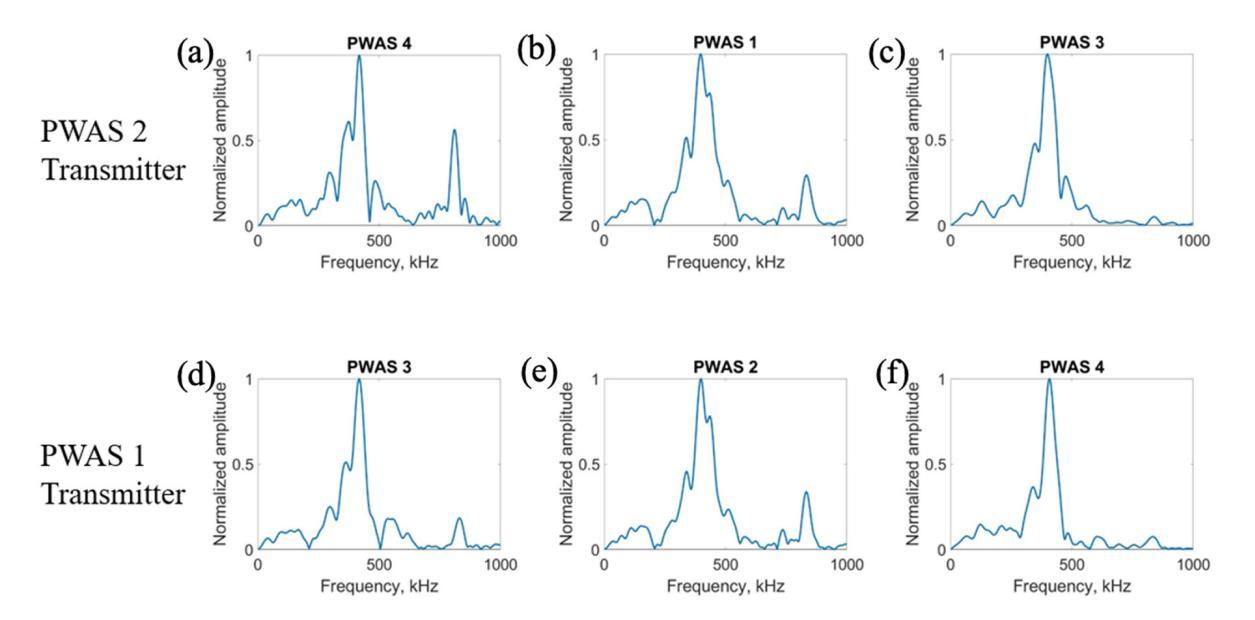
Figure 10. Comparison of frequency spectrums of received signals at (**a**) PWAS 4, (**b**) PWAS 1 and (**c**) PWAS 3 when PWAS 2 is actuating a smooth–delta function and (**d**) PWAS 3, (**e**) PWAS 2 and (**f**) PWAS 4 when PWAS 1 is actuating with a smooth–delta function.

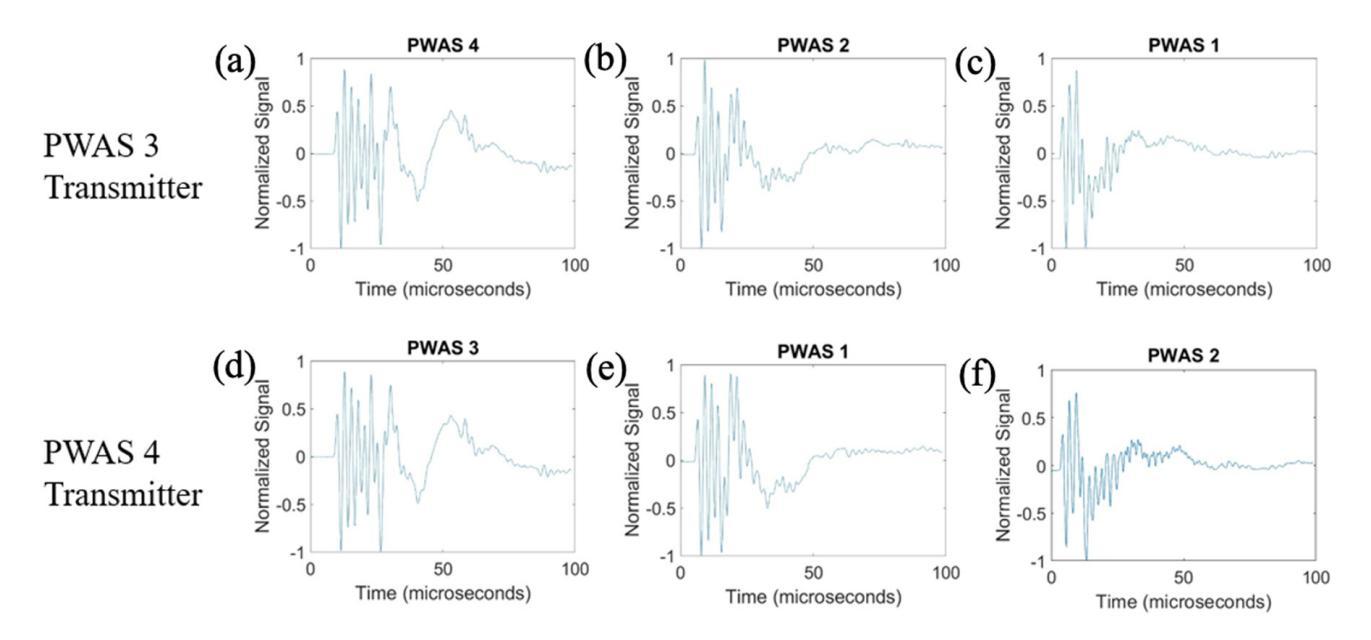
Figure 11. Comparison of received signals at (**a**) PWAS 4, (**b**) PWAS 2 and (**c**) PWAS 1 when PWAS 3 is actuating a smooth—step function and (**d**) PWAS 3, (**e**) PWAS 1 and (**f**) PWAS 2 when PWAS 4 is actuating with a smooth—step function.

After actuation with the delta function, the pristine specimen is then tested using the smooth-step function as the excitation function. Beginning with the actuation for PWASs 3 and 4, the results for normalized signals are displayed in Figure 11 and, by performing a fast Fourier transform of the signals, the frequency spectrums are obtained and pictured in Figure 12. It is again expected that when PWAS 3 is actuating, the signals received at PWASs 4, 2 and 1 should be nearly identical to the signals received at PWASs 3, 1 and 2 when PWAS 4 is actuating.

The received signals at PWASs 3 and 4 are nearly identical to each other when the other is actuating, which was to be expected with defect-less instrumentation quality. Between PWAS 1 and PWAS 2, the signals received are not identical to each other. The waveforms of PWASs 1 and 2 have similar shapes but differ in some oscillatory components in the signal. From Figure 12, the frequency spectrums of the signals received at PWAS 3 and PWAS 4 are identical to each other, with frequency peaks at nearly the same values and normalized amplitudes, while the frequency spectrums of the signals received at PWAS 1 and PWAS 2 are not. The signals between PWAS 1 and PWAS 2 have similar peak frequency values, but differences occur in the values of the secondary peaks and their normalized amplitudes. Again, we can establish that, due to the nearly identical normalized signals received and the frequency spectrum of these received signals, the instrumentation quality of both PWAS 3 and PWAS 4 are of matching and good quality.

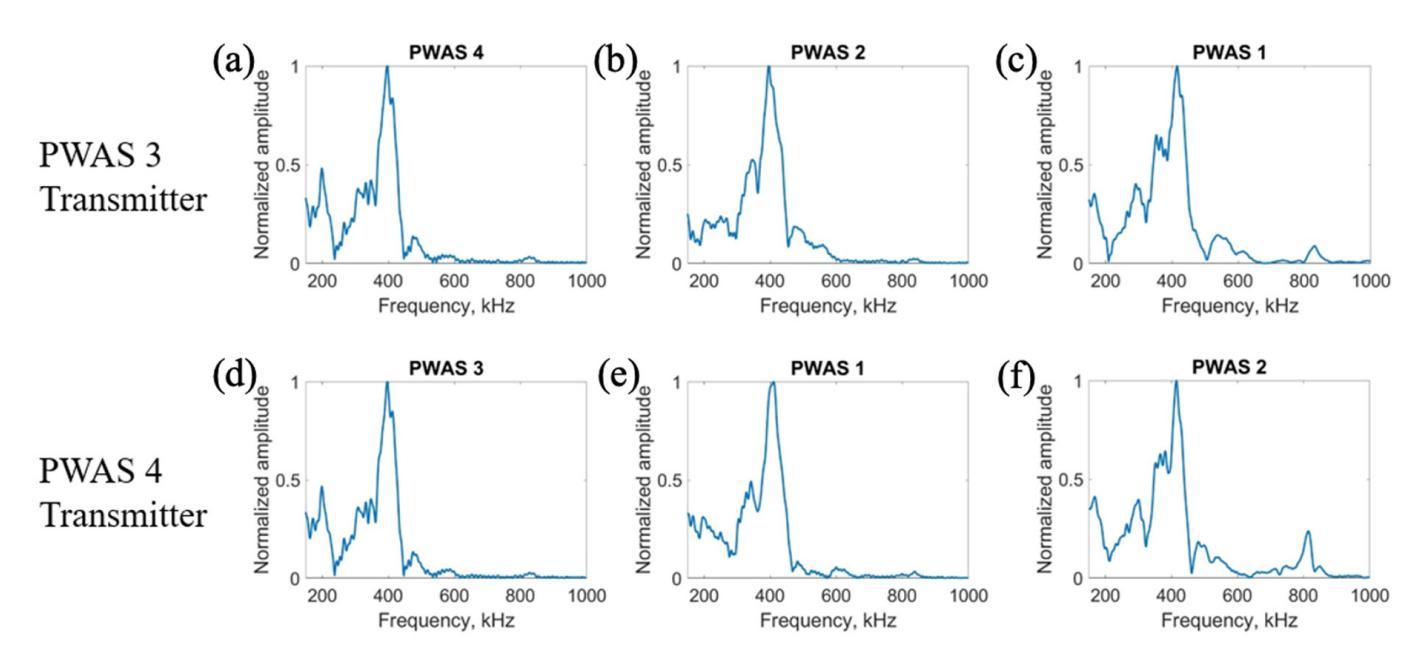
Figure 12. Comparison of frequency spectrums of received signals at (**a**) PWAS 4, (**b**) PWAS 2 and (**c**) PWAS 1 when PWAS 3 is actuating a smooth—step function and (**d**) PWAS 3, (**e**) PWAS 1 and (**f**) PWAS 2 when PWAS 4 is actuating with a smooth—step function.

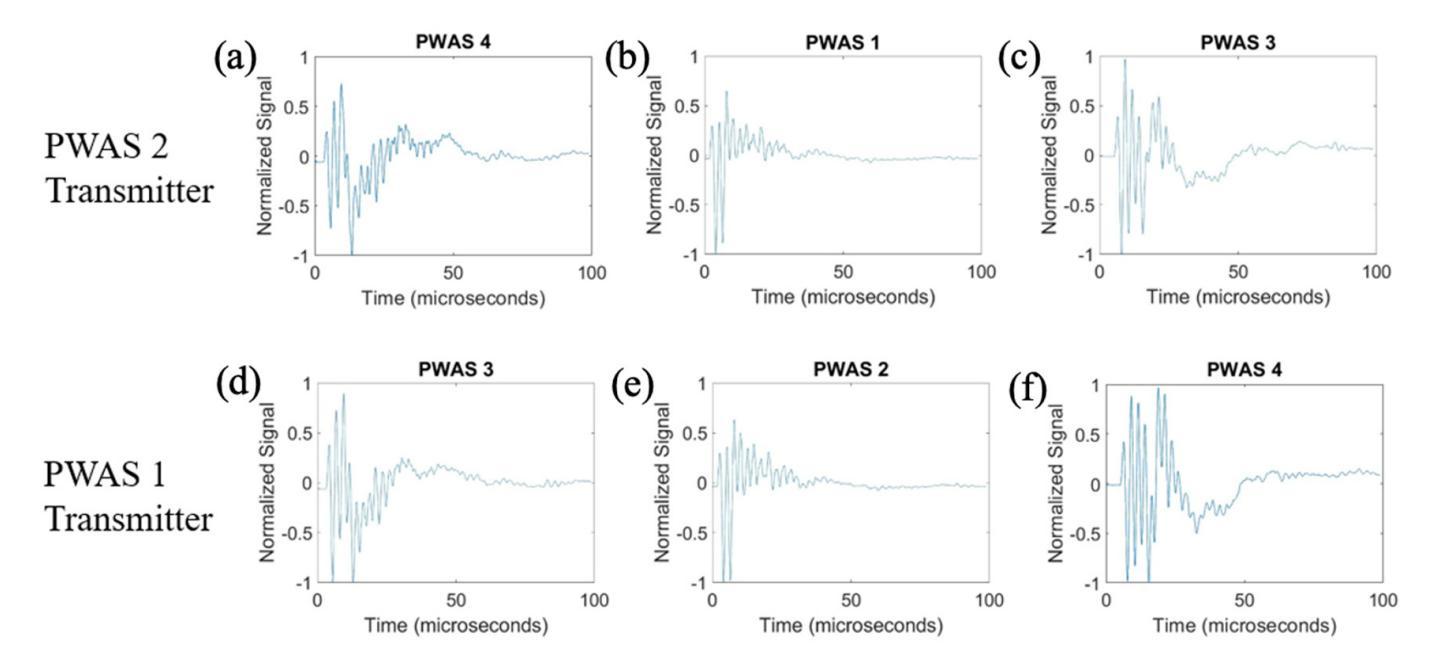
Figure 13. Comparison of received signals at (a) PWAS 4, (b) PWAS 1 and (c) PWAS 3 when PWAS 2 is actuating a smooth—step function and (d) PWAS 3, (e) PWAS 2 and (f) PWAS 4 when PWAS 1 is actuating with a smooth—step function.

Moving to the actuation of PWAS 1 and PWAS 2, it is again expected that when PWAS 2 is actuating, the signals received at PWASs 4, 1 and 3 should be nearly identical to the signals received at PWASs 3, 2 and 4 when PWAS 1 is actuating. The comparison of the normalized received signals is shown in Figure 13 and the comparison of the frequency spectrums of these received signals is pictured in Figure 14.

The signals received at PWAS 1 and PWAS 2 are again nearly identical to each other, while the other signals received at both PWAS 3 and PWAS 4 are not. The frequency spectrums for PWAS 1 and PWAS 2 are identical to each other, with frequency peaks and amplitudes of the same values, while the frequency spectrums for PWASs 3 and 4 are not identical to each other, with differing secondary frequency peaks and their normalized amplitudes. Again, due to the nearly identical normalized signals received and the frequency spectrums of these received signals, we can confirm that the instrumentation quality of both PWAS 1 and PWAS 2 are of matching and good quality.

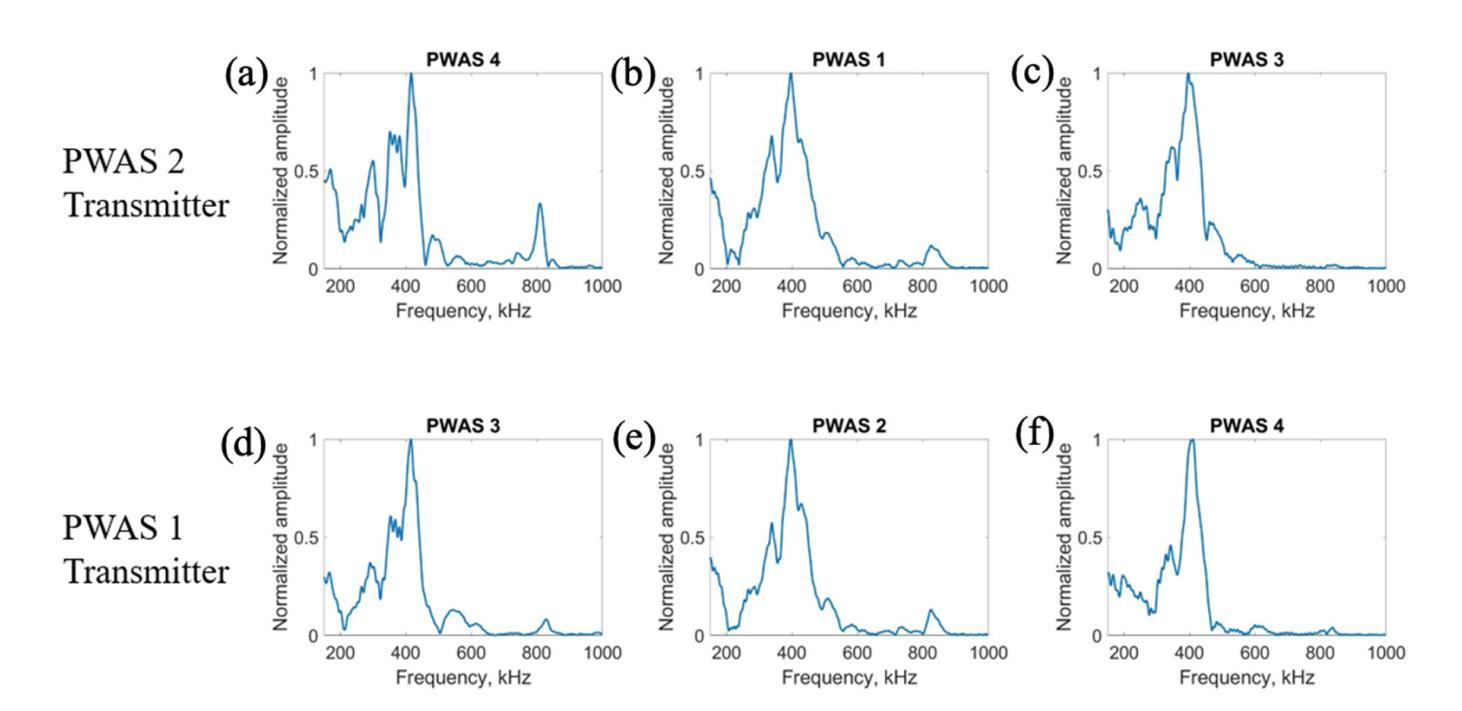
Figure 14. Comparison of frequency spectrums of received signals at (**a**) PWAS 4, (**b**) PWAS 1 and (**c**) PWAS 3 when PWAS 2 is actuating a smooth—step function and (**d**) PWAS 3, (**e**) PWAS 2 and (**f**) PWAS 4 when PWAS 1 is actuating with a smooth—step function.

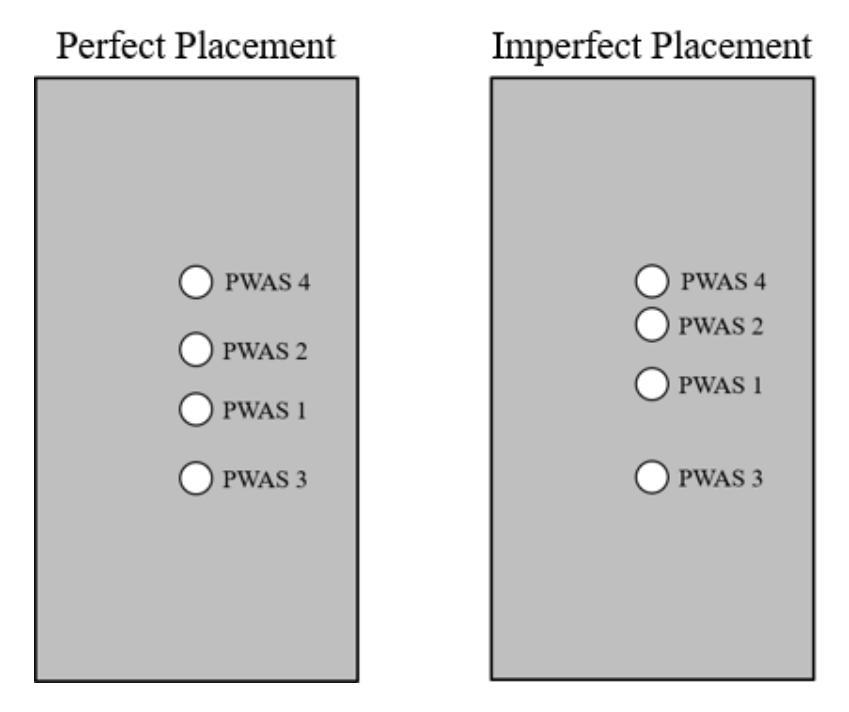
Figure 15. Comparison of perfect and imperfect placement of PWAS on specimen.

Explanations behind the result that some PWASs do not receive identical waveforms can be reduced to human error in the placement of the sensor. Slight differences in the distances between sensors due to their placement results in differences in the signals received based on travel distance of the signal. Seen in Figure 15, two fixed distances in placement of the sensors are the distance between PWAS 1 and PWAS 2 and the distance between PWASs 3 and 4, or the distance between the two inner and two outer PWASs. Regardless of the placement of the PWASs, the distance between these PWASs is fixed and does not change based on which PWAS is actuating. Because of this, signal comparison between these sensors should result in near-identical signals if the instrumentation of the specimen is defect-less. Comparisons of signals between transmitting and receiving PWASs. Figure 15 depicts the difference between imperfect and perfect placement. The differences in distances in PWASs that should be symmetrical can be seen in the imperfect placement graphic, such as the differences in distances between PWASs 1 and 3 and PWASs 1 and 4. In this experiment, where the focus was identifying variations between nominally identical

sensors, the distinct primary and secondary peaks were maintained across the experimental results and the similarly shaped frequency spectrums observed. This proved that nominally identical sensors give consistent results, though slight human error in placement may lead to slight changes in the spectrum.

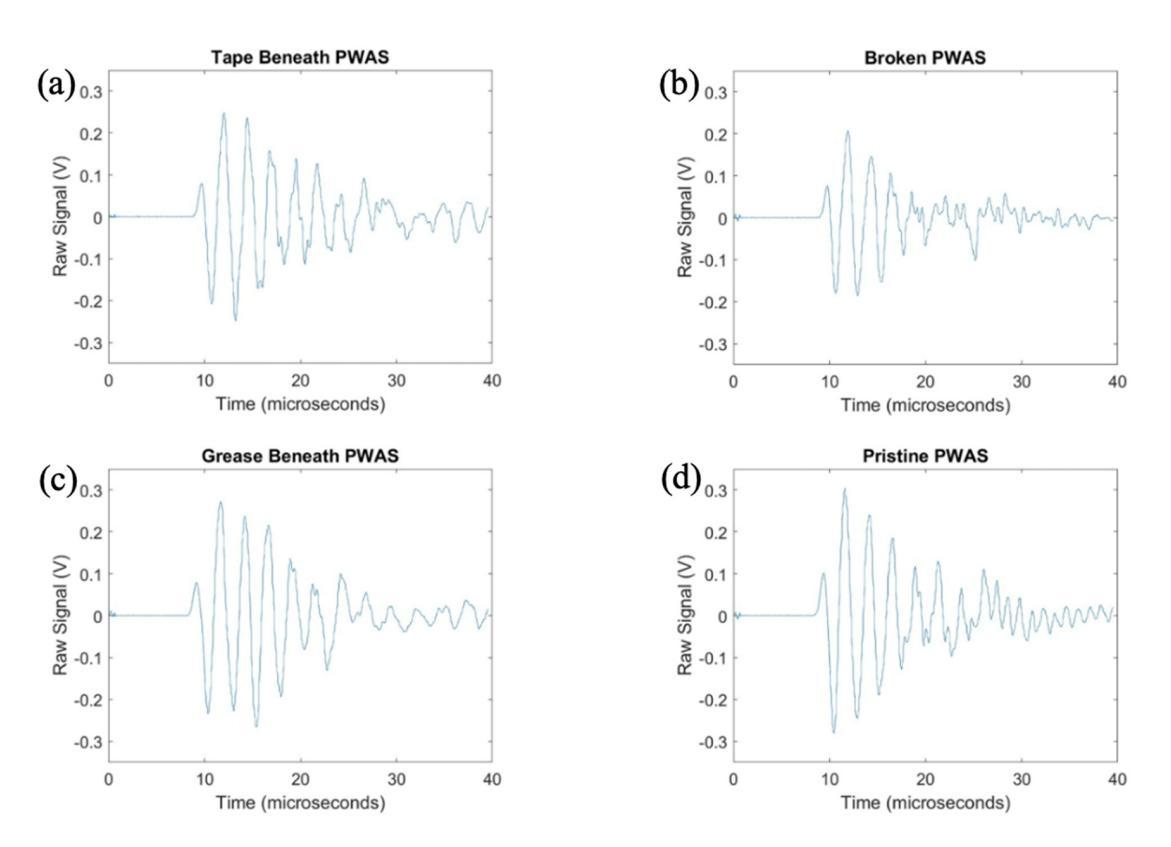
Figure 16. Comparison of delta function excitation signals received at (**a**) PWAS with tape beneath bonding layer, (**b**) a broken PWAS, (**c**) PWAS with grease beneath bonding layer and (**d**) a pristine PWAS.

After exploring the use of the pitch-catch method for the determination of PWAS instrumentation quality, pitch-catch testing was performed on a specimen with defective instrumentation, pictured in Figure 5, to investigate the effects of defects on the PWAS response. When performing pitch-catch experiments for this specimen, each of the outer defective PWASs were analyzed in a pair with the inner pristine PWAS. The effects of defective instrumentation were analyzed, with defects occurring in both the transmitting and receiving PWASs. In this case, opposed to the normalized signal in previous experiments, the raw signal was analyzed to investigate the effect of defects in piezoelectric sensor instrumentation on the amplitude of the PWAS response. The same experimental setup was used, and the same smooth-step and smooth-delta functions shown previously in Figure 3 were used in the excitation of the sensors. In Figure 16, waveforms received at the outer PWASs are compared when the center pristine PWAS is transmitting a smooth-delta function. As compared to waveforms received at a pristine PWAS, all piezoelectric sensor instrumentation defects resulted in a decrease in the amplitude of the signal received. A broken PWAS experiences a greater decrease in signal amplitude compared to that of a PWAS with tape beneath and a PWAS with grease beneath the bonding layer. A comparison of the frequency spectrum of these signals is shown in Figure 17. The bonding layer defects of tape and grease between the plate and sensor bond result in the elimination of the high frequency peaks occurring at around 850 kHz in the frequency spectrum of the signals. Signals received at a broken PWAS retain the same peaks as those of signals received by a pristine PWAS. Differences in the frequency spectrum of broken and pristine PWASs occur at around 600 kHz, where the spectrum of a broken PWAS has increased amplitude compared to a pristine PWAS.

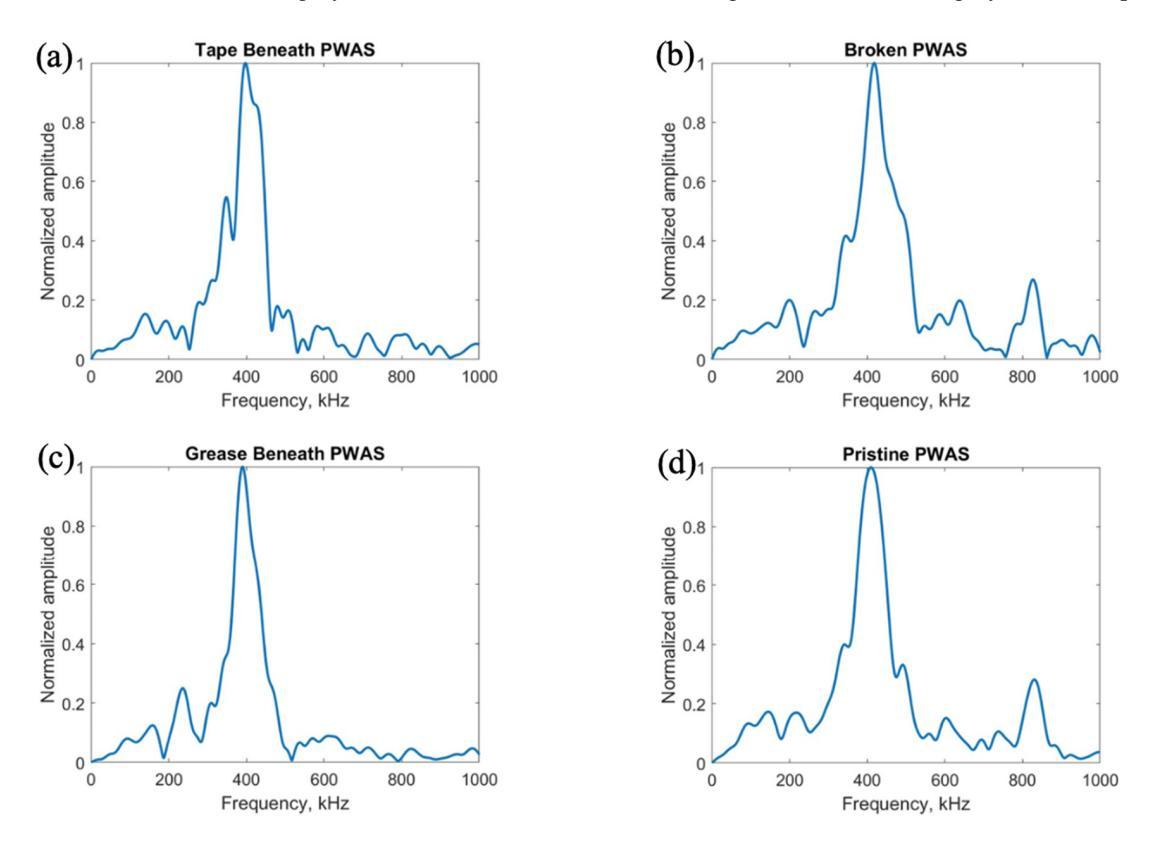
Figure 17. Comparison of the frequency spectrum of delta function excitation signals received at (a) PWAS with tape beneath bonding layer, (b) a broken PWAS, (c) PWAS with grease beneath bonding layer and (d) a pristine PWAS.

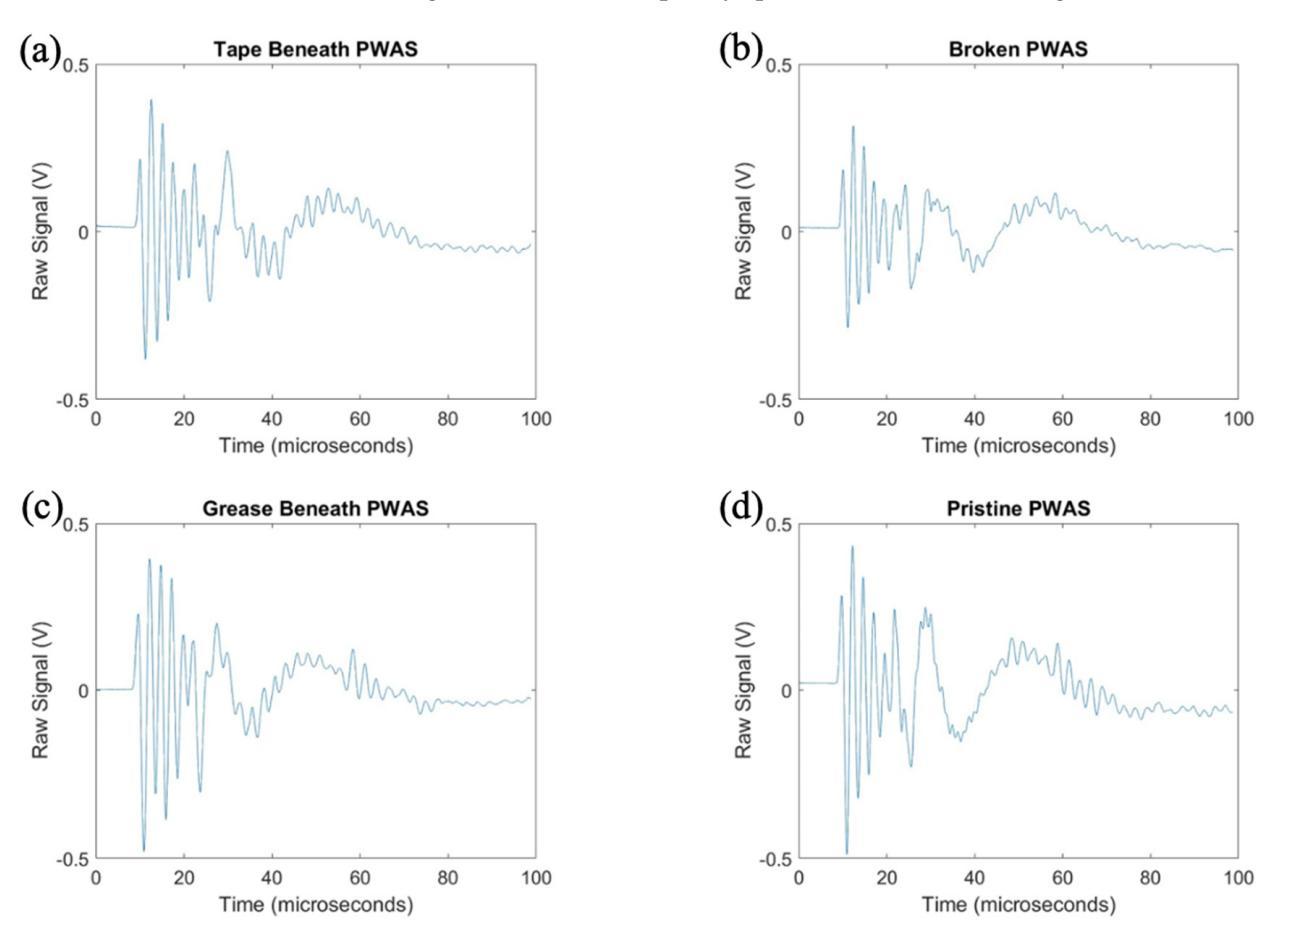
Figure 18. Comparison of step function excitation signals received (**a**) PWAS with tape beneath bonding layer, (**b**) a broken PWAS, (**c**) PWAS with grease beneath bonding layer and (**d**) a pristine PWAS.

After delta function excitation, the central PWAS was then excited using the smoothstep function, with comparison of the received signals shown in Figure 18. Similar to results obtained for delta function excitation, compared to a pristine PWAS, all PWAS instrumentation defects result in a decrease in the amplitude of the signal received. A broken PWAS continues to experience the greatest decrease in signal amplitude, while grease and tape bonding layer defects result in only a minor decrease in amplitude. The frequency spectrums of the signals are compared in Figure 19.

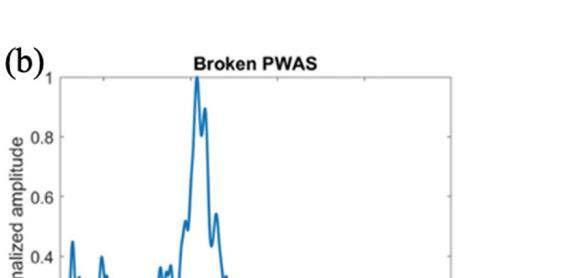
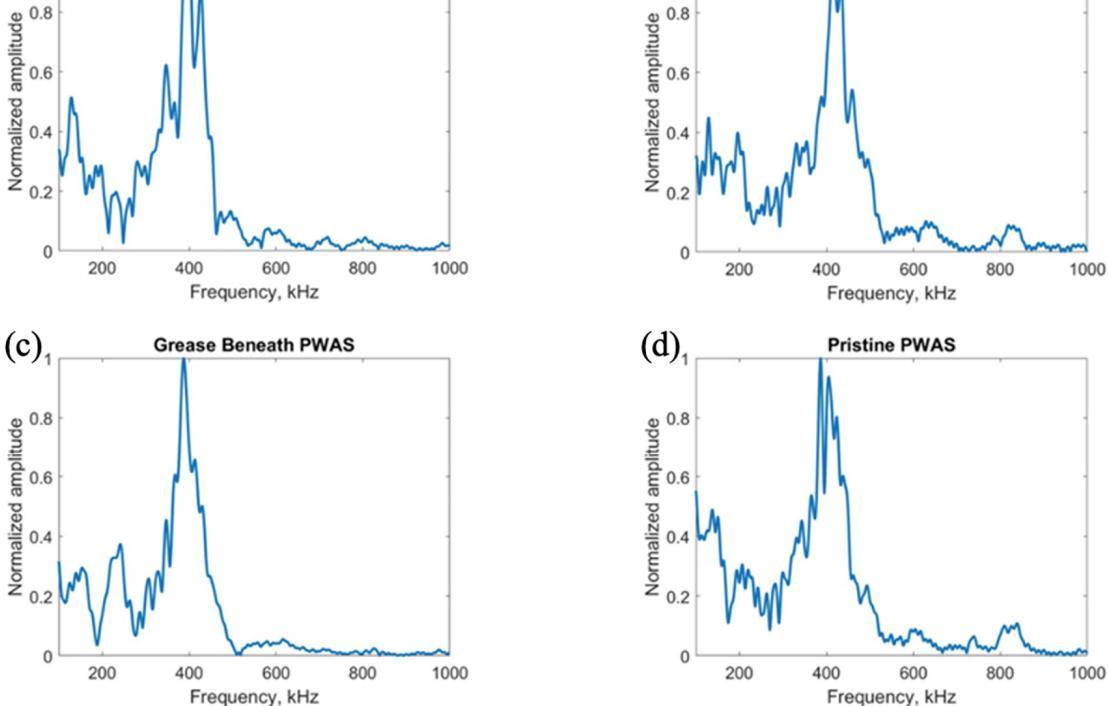
Figure 19. Comparison of the frequency spectrum of step function excitation signals received at (a) PWAS with tape beneath bonding layer, (b) a broken PWAS, (c) PWAS with grease beneath bonding layer and (d) a pristine PWAS.

Like the frequency spectrums of signals received for delta function excitation, PWASs with defects in the bonding layer have similar peak frequencies but lack the secondary high frequency peak in the signal received by a pristine PWAS around 850 kHz. The signal received by a broken PWAS contains the same peak and secondary frequencies, but experiences increased amplitude of the frequency spectrum at around 600 kHz, similar to the case of delta function excitation.

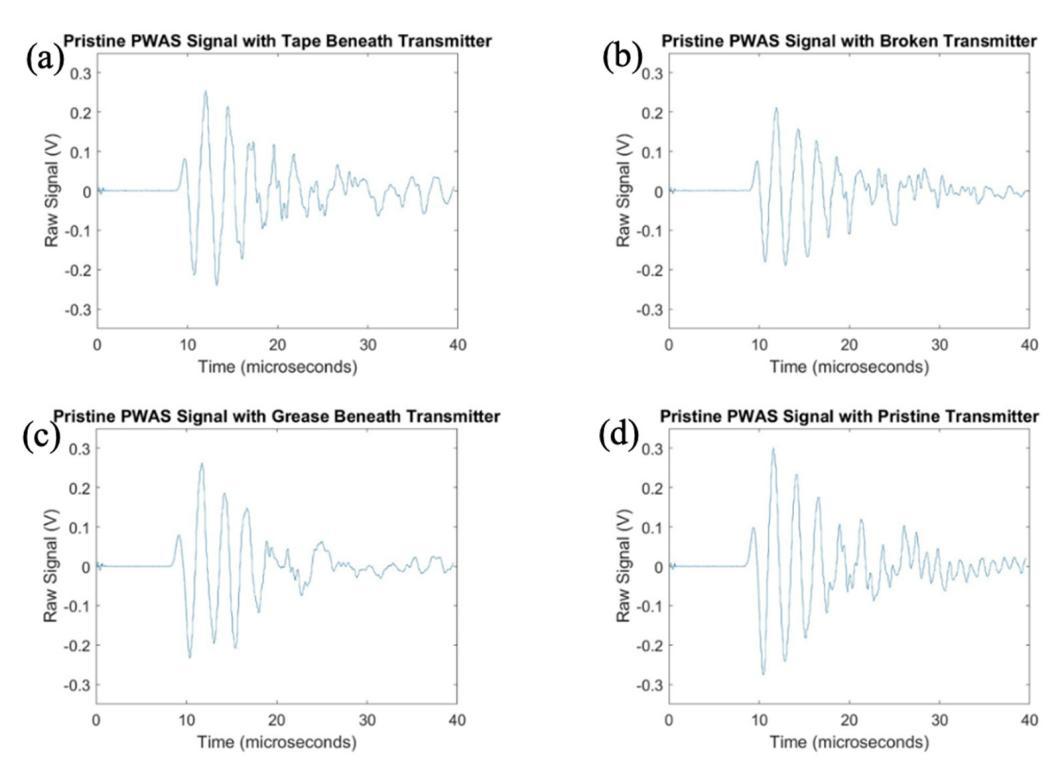
Figure 20. Comparison of delta function excitation signals received at a pristine PWAS with transmitting signals from (**a**) PWAS with tape beneath bonding layer, (**b**) a broken PWAS, (**c**) PWAS with grease beneath bonding layer and (**d**) a pristine PWAS.

After investigation of the effects of PWAS instrumentation defects on receiving PWAS during pitch-catch testing, the experimentation was flipped, and the signal transmitted by defective sensors was analyzed. The pristine center PWAS was used as the receiver and the outer defective PWAS used as the transmitting sensors. The signals received at the center pristine PWAS when each of the four outer PWASs are transmitting a delta function are shown in Figure 20, and the frequency spectrums are shown in Figure 21.

The signals transmitted by defective PWAS also have a decreased amplitude compared to a pristine transmitting PWAS. The greatest decrease in signal amplitude occurs with a broken PWAS, as both tape and grease beneath the transmitting sensor reduce the amplitude of the signal but not to the extent of a broken PWAS. Once again, the secondary frequency peak around 850 kHz has been eliminated in the signals transmitted from PWASs with tape and grease beneath the sensor bond. The broken PWAS contains similar primary and secondary frequency peaks as a pristine PWAS but also contains an increased amplitude in the spectrum at around 600 kHz. The signals received at the pristine inner PWAS, when each outer PWAS is transmitting a step function is shown in Figure 22.
