Article Piezoelectric Wafer Active Sensor Transducers for Acoustic Emission Applications

Connor Griffin * and Victor Giurgiutiu *

Department of Mechanical Engineering, University of South Carolina, Columbia, SC 29208, USA

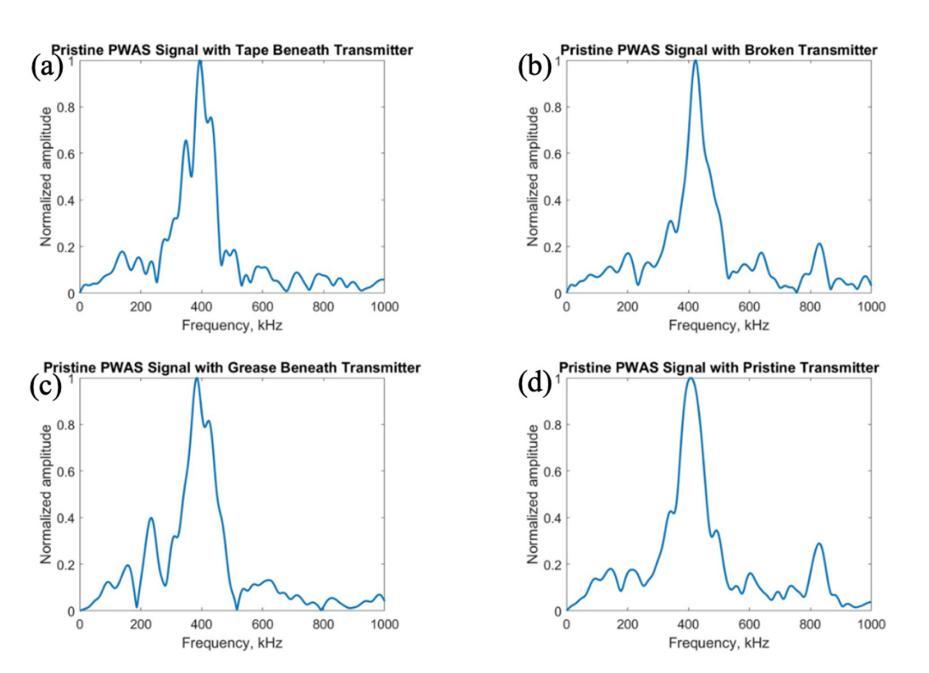
Figure 21. Comparison of frequency spectrums of delta function excitation signals received at a pristine PWAS with transmitting signals from (**a**) PWAS with tape beneath bonding layer, (**b**) a broken PWAS, (**c**) PWAS with grease beneath bonding layer and (**d**) a pristine PWAS.

After investigation of the effects of PWAS instrumentation defects on receiving PWAS during pitch-catch testing, the experimentation was flipped, and the signal transmitted by defective sensors was analyzed. The pristine center PWAS was used as the receiver and the outer defective PWAS used as the transmitting sensors. The signals received at the center pristine PWAS when each of the four outer PWASs are transmitting a delta function are shown in Figure 20, and the frequency spectrums are shown in Figure 21.

The signals transmitted by defective PWAS also have a decreased amplitude compared to a pristine transmitting PWAS. The greatest decrease in signal amplitude occurs with a broken PWAS, as both tape and grease beneath the transmitting sensor reduce the amplitude of the signal but not to the extent of a broken PWAS. Once again, the secondary frequency peak around 850 kHz has been eliminated in the signals transmitted from PWASs with tape and grease beneath the sensor bond. The broken PWAS contains similar primary and secondary frequency peaks as a pristine PWAS but also contains an increased amplitude in the spectrum at around 600 kHz. The signals received at the pristine inner PWAS, when each outer PWAS is transmitting a step function is shown in Figure 22.

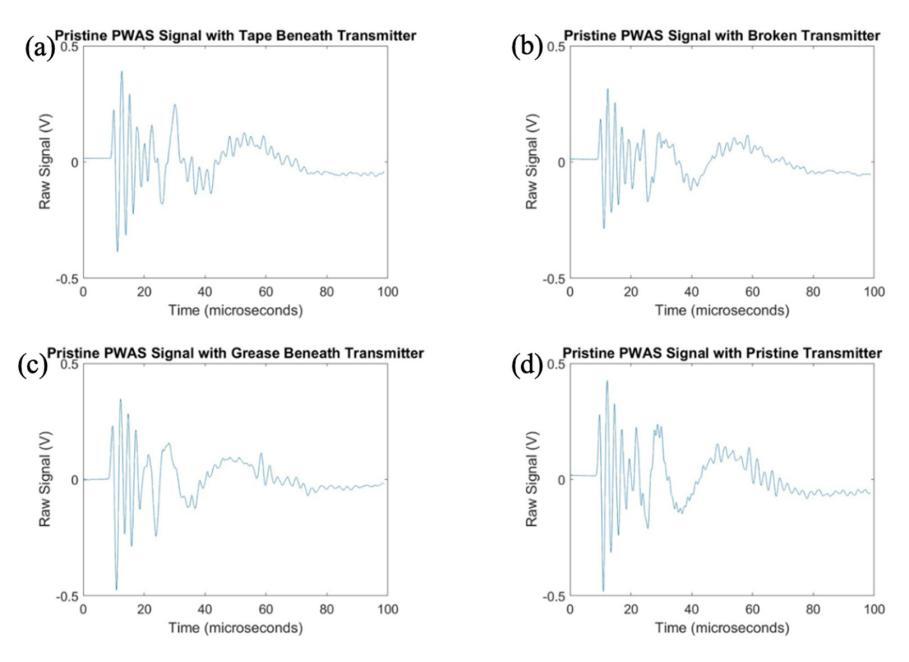
Figure 22. Comparison of step function excitation signals received at a pristine PWAS with transmitting signals from (**a**) PWAS with tape beneath bonding layer, (**b**) a broken PWAS, (**c**) PWAS with grease beneath bonding layer and (**d**) a pristine PWAS.

Consistent with previous results, the broken PWAS has had the greatest decrease in amplitude in comparison, and the sensors with tape and grease beneath the transducer also continually have decreased amplitude signals compared to a pristine PWAS but not to the degree of a broken sensor. Frequency spectrums for these signals are compared in Figure 23. Differences in frequency spectrums for PWASs with tape and grease beneath the bonding layer continue to include the lack of a secondary frequency peak around 850 kHz, as well as an increase in the amplitude of the frequency spectrum around 600 kHz for a broken PWAS.

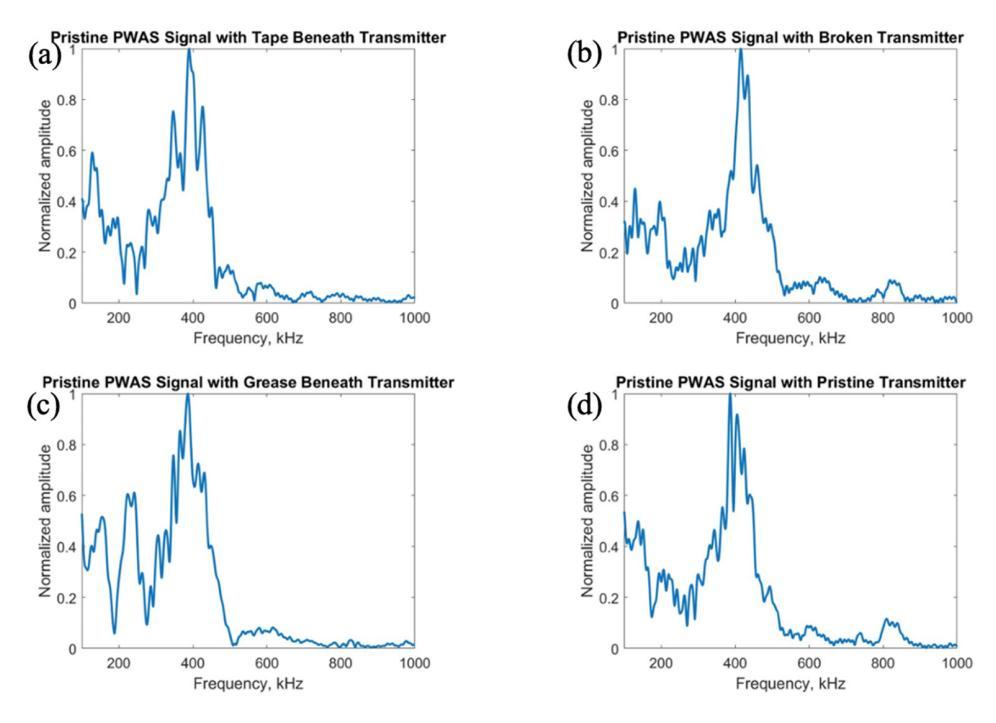
Figure 23. Comparison of frequency spectrums of step function excitation signals received at a pristine PWAS with transmitting signals from (**a**) PWAS with tape beneath bonding layer, (**b**) a broken PWAS, (**c**) PWAS with grease beneath bonding layer and (**d**) a pristine PWAS.

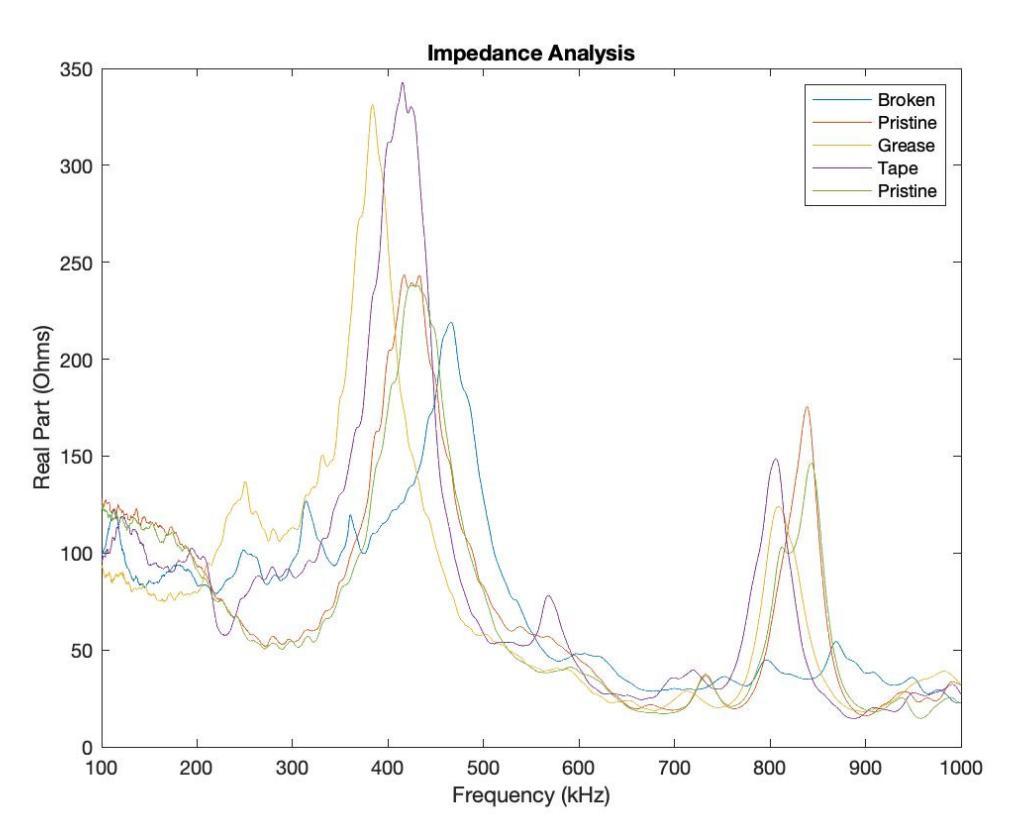
Figure 24. Complete EMIS for pristine, broken and defectively bonded PWAS.

EMIS testing was also performed on the specimen with defective instrumentation. In this instance, the real part of the impedance spectrum was analyzed. Results for testing are shown in Figure 24. Figure 25 provides an enhanced view of the primary and secondary frequency peaks. From these figures, it is seen that defects in bonding, in this case with grease and tape beneath the bond, result in an increased amplitude of the primary peak of the spectrum. This increased amplitude is accompanied by a downward shift in the frequency peak compared to a pristine PWAS. With bonding defects, the secondary peak maintains a similar amplitude but also experiences a downward shift in its frequency. A broken PWAS leads to a decrease in amplitude, as well as an upward shift of the primary frequency peak with the secondary peak becoming nearly completely eliminated. The EMIS testing confirms the instrumentation defects and gives confidence in the results obtained.

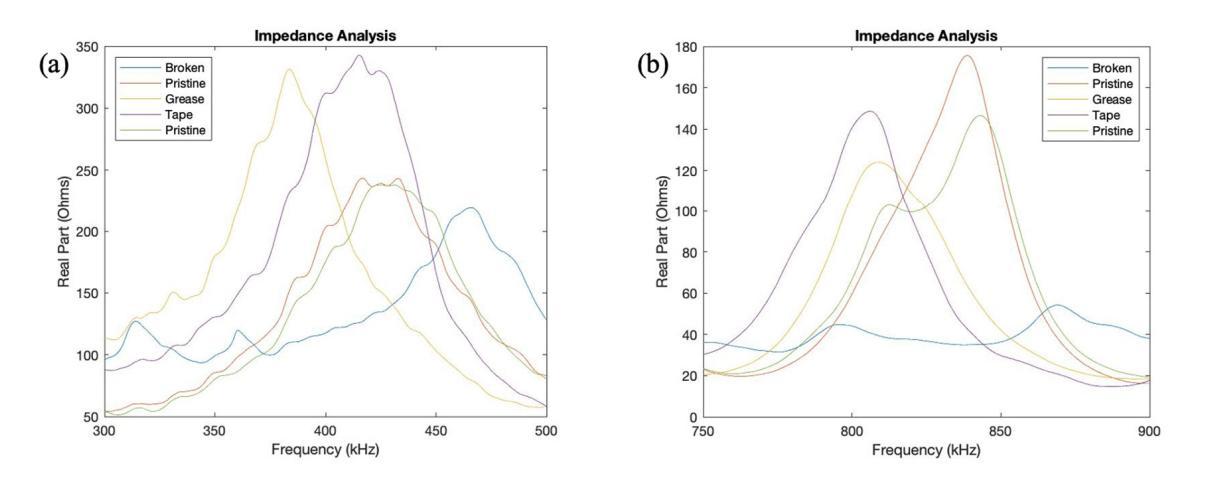
Figure 25. (**a**) Primary and (**b**) secondary peaks in the frequency spectrum for pristine, broken and defectively bonded PWAS.

When excited as a transmitter and when used as a receiver, a broken PWAS experienced the greatest decrease in signal amplitude. PWASs with bonding defects experienced only a minor decrease in signal amplitude when used as both the transmitting and receiving PWAS. Symmetry between signals was observed between defects occurring in both the actuating and receiving PWASs, in that they both produced the same variation in signal. Effects of defective bonding on the PWAS signal included the elimination of the high frequency peak around 850 kHz when both the delta and step function are used. A broken piezoelectric sensor results in increased amplitude of the frequency spectrum around 600 kHz. Broadly speaking, PWAS instrumentation defects result in a decrease in amplitude of the signal received, as well as a change in the frequency spectrum of the signal regardless of whether the defect is in the transmitting or receiving sensor. EMIS testing on defective sensor instrumentation gave confidence in the pitch-catch results obtained, while concluding that defects in the bonding layer of the sensor increase the primary frequency peak's amplitude and cause a downward frequency shift. The secondary peak also experiences a downward shift but maintains similar amplitude. The EMIS of a broken sensor has a decreased amplitude while shifting the primary peak upward and nearly eliminating the secondary peak.
