Article

Corrosion Development of Carbon Steel Grids and Shear Connectors in Cracked Composite Beams Exposed to Wet–Dry Cycles in Chloride Environment

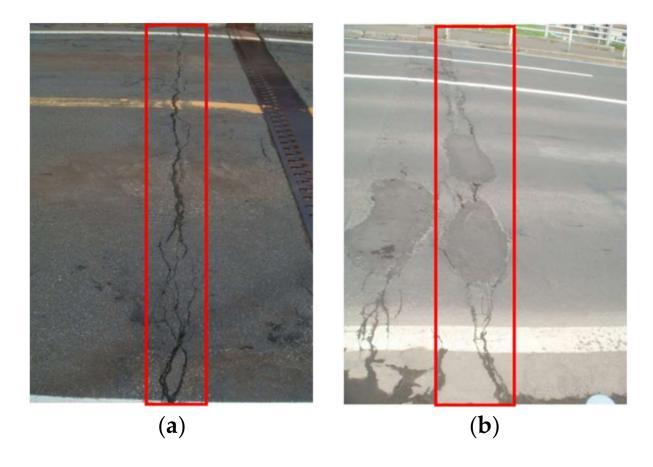
Figure 1. Cracks in the hogging moment region of steel-composite bridges (**a**: in Hokkaido, Japan; **b**: in Sapporo, Japan).

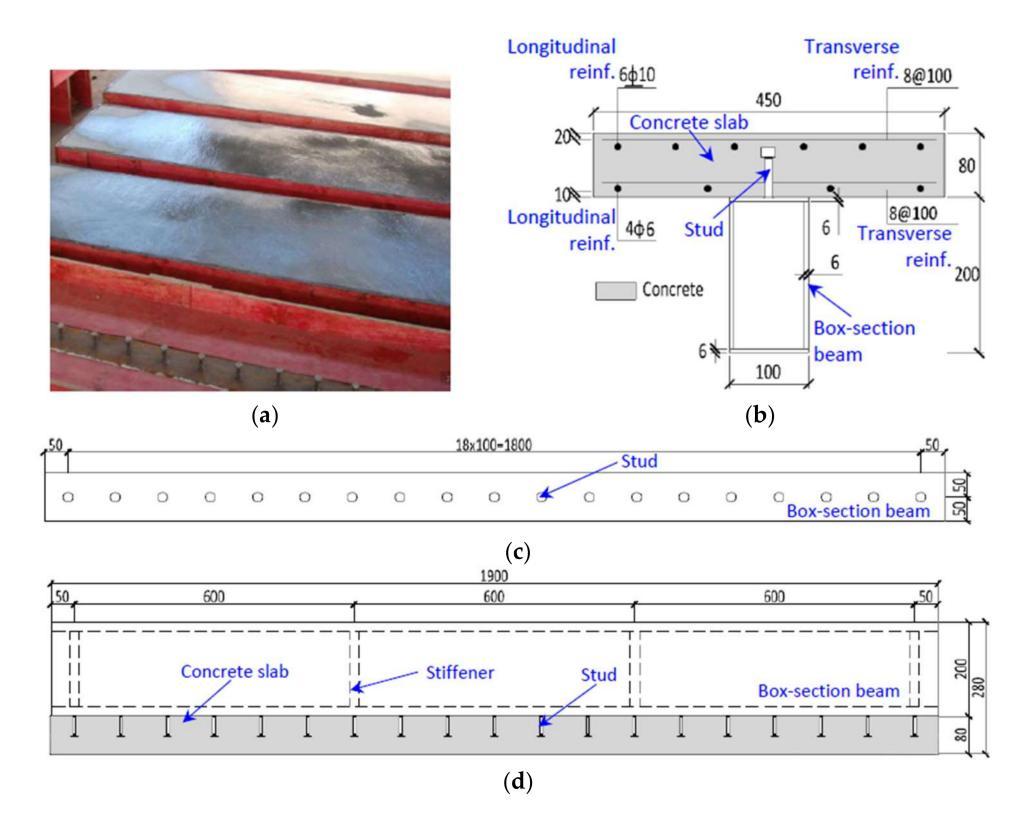
Figure 2. Details of the composite test specimens. (**a**) Casting concrete; (**b**) transverse view; Top view; (**d**) Front view.

In total, seven identical steel–concrete composite beams were constructed to facilitate the investigation on the corrosion evolution of stud shear connectors under indoor-accelerate environmental exposure. The design details of the composite beams are shown in Figure 2. The length, width and depth of each composite beam was kept constant at 1900 mm, 450 mm (measured from a concrete slab) and 280 mm, respectively. There were four steel stiffeners arranged inside the plate-welded-box girders to avoid the local buckling of the tube-wall. A single line of studs [17] was

welded on the top face of the box girder, with each stud spaced at a constant distance of 100 mm. The nominal diameter and height of the stud shank were 10 mm and 50 mm, respectively. In the concrete slab, two reinforcement grids were arranged at both the top and bottom with a concrete cover of 20 mm and 10 mm, respectively. Six longitudinal hot-rolled ribbed bars (HRBs) with a nominal diameter of 10 mm were arranged at the top of the concrete slab to resist the hogging moment, whilst four hot-rolled plain bars (HPBs) with a nominal diameter of 4 mm were at the bottom. For the transverse direction, the HPBs with a nominal diameter of 8 mm were placed with a constant spacing of 100 mm. The specimens were labeled according to the exposure periods shown in Table 1. The letters CB, a number, the letter M and the letter R referred to the composite beam, exposure time, month and repeating specimens, respectively. For example, CB12MR stood for the repeat specimen of the composite beam with a total exposure time of twelve months.

The composite beams were casted and cured in the position shown in Figure 2a. The concrete composition is summarized in Table 2. The concrete consisted of ordinary Portland cement, water, sand and stone, with maximum nominal size of 14 mm. The concrete mixture with a water/cement ratio of

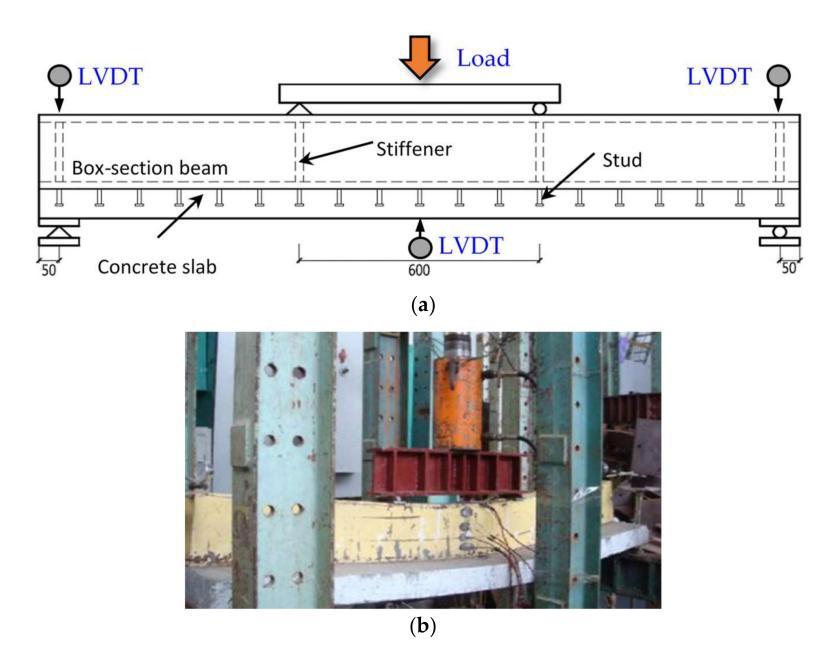
Figure 3. Test set-up for creating pre-cracks under the negative moment. (a) Schematic diagram; (b) test photo.

After 28-day curing in the laboratory environment, all the composite beams were loaded under a negative moment of 70% design capacity (84 kN·m) according to Eurocode 4 [21], except for the specimen CB2M which was tested at a 40% design capacity (48 kN·m). The test arrangement is shown in Figure 3. The composite beams were simply supported and tested in the reversed position where the concrete slab was at the bottom, to simulate the negative moment loading condition in practical engineering. The concentrate loading was applied on the distributive beam by the jack with a capacity of 500 kN. Three Linear Variable Displacement Transducers (LVDT) were placed at the mid-span and two ends, respectively, in order to obtain the deflection during the tests. The pre-load test was first conducted at a 10% design capacity to ensure all the equipment worked normally. All the composite beams were tested under the load control with each load-level at 20 kN to the specified load-level, i.e., 40% or 70% of the design capacity. The load was sustained for approximately 4 minutes before the next loading stage, and the crack development and width were recorded during this period.

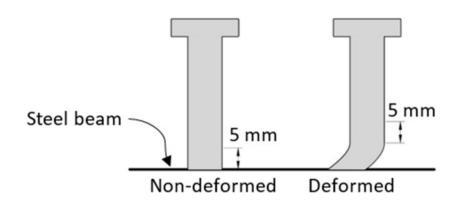
Figure 4. Schematic diagram of measured regions of diameter changes.

where A_0 was the cross-section area measured from the reference non-corroded stud shank; and D_1 was the average diameter within the measured region from the cleaned retrieved reinforcement. The measured regions were selected to (1) avoid the shear deformation areas; (2) and manifest the corrosion influence on the moment resisting performance of the composite beam. Therefore, typical measured regions for both deformed and non-deformed scenarios, are shown in Figure 4.

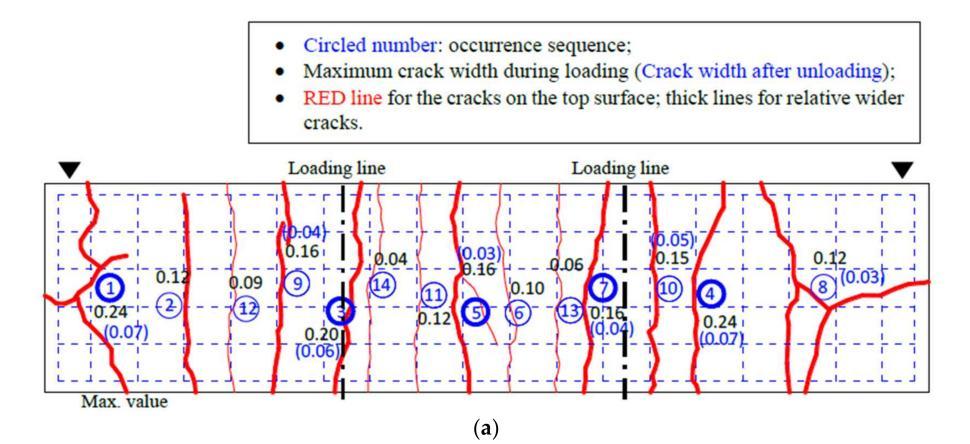
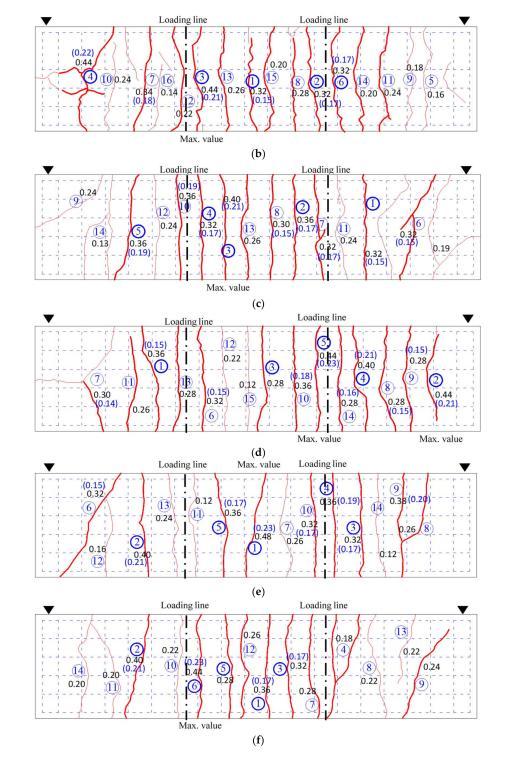
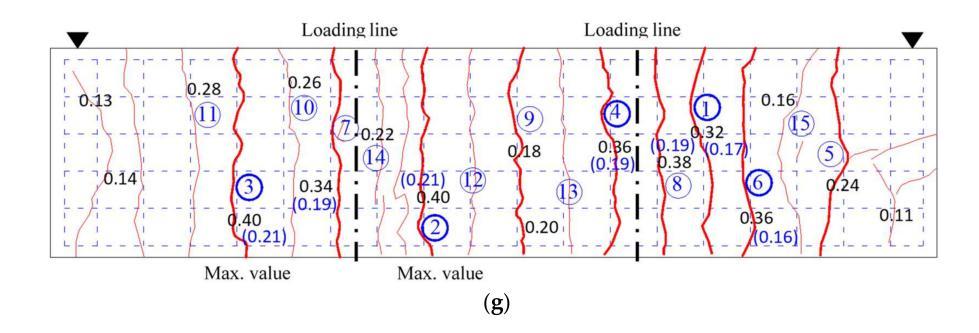
Figure 5. Load-induced crack maps of composite beams: (a) CB2M; (b) CB4M; (c) CB6M; (d) CB8M; (e) CB10M; (f) CB12M; (g) CB12MR.

During the pre-load tests, the crack widths and evolutions for the top surface (tensile zone) of the concrete slabs were recorded. It was observed that the first transverse cracks for each composite beam developed within the bending region or the concentrate loading regions at 10% ~15% of the design capacity calculated according to EC-4 [21]. As the load increased, a few diagonal cracks developed near two supports in the shear-tension zone. At 60% of the design capacity, the flexure cracks developed at approximately the same spacing of the transverse reinforcement. One can assume that the cracks on the concrete slabs were fully developed after the loading. The crack maps at the maximum load step were recorded as shown in Figure 5, where the cracks were presented in red lines (thick lines for the relatively wider cracks). In the crack maps, the crack propagation is indicated by the circled number in blue which manifests the occurrence sequence of cracks; whilst the maximum openings for each crack are presented via a black number. Moreover, in the parentheses, the maximum widths of typical cracks after unloading (number in blue) were also presented, as shown in Figure 5. It can be found that the maximum crack widths at the top surface (tensile zone) under and after loading were approximately 0.45 mm and 0.25 mm, respectively, at the mid-span of the composite beam. It should be noted that although the seven composite beams were of the same design and constructed using the same materials, the crack width and morphology were different for each of them, which would lead to the differing influences on the corrosion development.

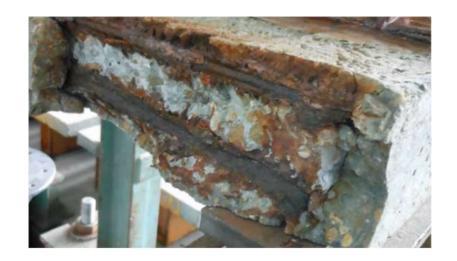
Figure 6. Concrete spalling of specimen CB12M.

As anticipated, the corrosion increased for both the reinforcement and shear studs with the number of wet–dry cycles. Figure 6 shows the corner concrete spalling from the concrete slab due to the severe corrosion of reinforcement after 12-month's exposure in the chloride environment combined with wet–dry cycles. However, there is no direct correlation between the location of transverse load-induced cracks and the corrosion development on both the reinforcement and studs of each specimen. Both general and pitting corrosion could be observed, as shown in Figure 7a,b. Moreover, severe pitting attacks combined with general corrosion could be found even in the bottom grids for specimen CB12M, as shown in Figure 7c.

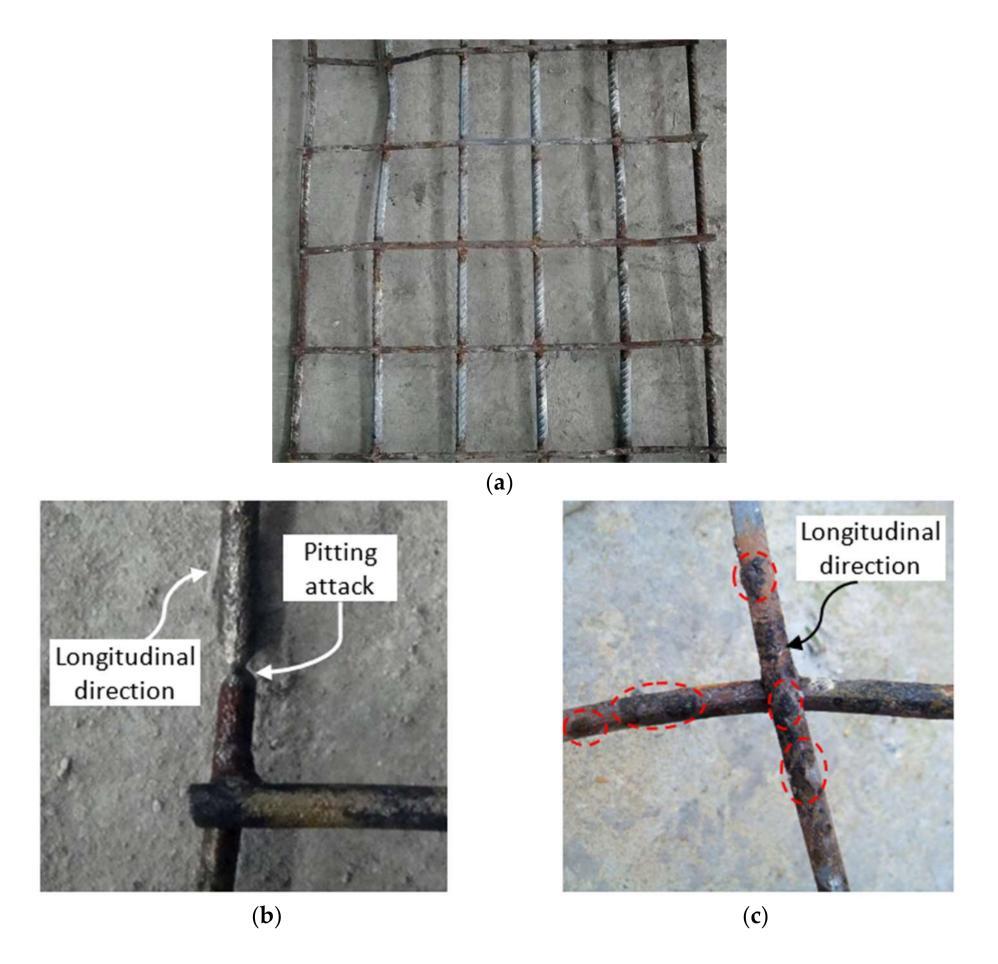
Figure 7. Corrosion pattern for the reinforcement grid in specimens CB6M and CB12M. (a) Upper reinforcement grid for CB6M; (b) Bottom reinforcement grid for CB6M; (c) Bottom reinforcement grid CB12M.

For the transverse reinforcement, the corrosion developed unevenly along the length of the beam and had some relationship with the locations of both wider cracks and concentrate loadings. The transverse reinforcement suffered from the more severe corrosion near the concentrate loading points, such as at the two ends and down 1/3 of the beam-span, and also from cracks with large widths, which can be identified in terms of the values of cross-section loss in the following section. For an individual transverse reinforcement, the corrosion initiated at the cross points is shown in Figure 7a for specimen CB6M.

For the longitudinal reinforcement, the severe corrosion regions were first developed in the points crossed with the transverse ones, as shown in Figure 7a,b for the specimens subjected to 6-month wet–dry cycles, which differed significantly from the findings [23] linked to the reinforced concrete beams. It was found [23] that for the crossing points in the reinforcement cage, the rebars suffered less from the corrosion attack when compared with the vicinity, since in that case the contacted stirrup would be sacrificed as a cathodic protection. However, this did not work in the case of composite beams due to the different connecting methods used in the reinforcement grids. It could be attributed to the spot-welding used in the connection of reinforcements in two directions. During the welding process, the chemical properties, microstructures and connecting surface will be significantly altered [13], making steel more susceptible to a corrosion attack, which will be elaborated on in the following Section 3.3.

The preferential corrosion attacks were observed in the steel grids and shear studs shown in Figures 7 and 8 respectively. They can be attributed to the galvanic corrosion. The different electrochemical potentials are found due to variations in the composites and microstructures in the weldments [13]. Moreover, the thermal history during the welding process will bring to each position of the heat-affected zone (HAZ) a unique microstructural feature with its own corrosion susceptibility. The small potential difference between the weldment (as the anodic), including the weld metal and HAZ, and the un-coated parent steel (as the cathode), leads to the formation of the macro cell around these regions, as shown in Figure 12.

The pitting corrosion was also demonstrated, as shown in Figure 7b,c. It can be attributed to the rough surface of the weldment covered by the oxide scale, welding slag and flux residue. These would make the weldments more prone to a localized attack due to the defects developed in the steel–concrete interface, where the electrical conductivity at the crack peak became relatively high when compared to the surrounding intact concrete.

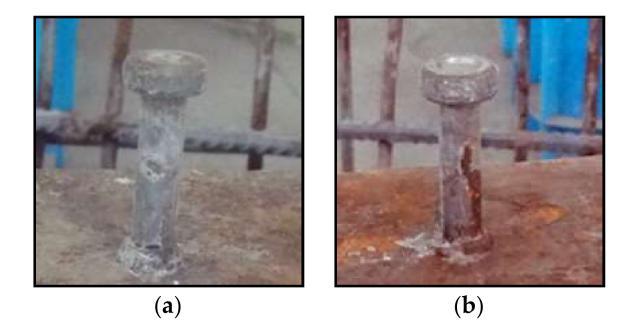
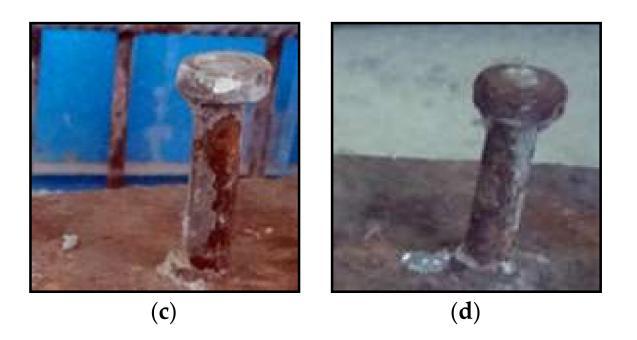
Figure 8. Different corrosion rates of studs in specimen CB6M. (a) 7th; (b) 2nd; (c) 3rd; (d) 17th.

Regarding the corrosion development of shear studs, both the distributions along the beam length and the stud shank were quite heterogeneous, as shown in Figure 8. Figure 8 presents the 7th, 2nd, 3rd, and 19th shear studs in the same test specimen of CB6M with corrosion degrees of 0.01%, 5.37%, 5.42% and 8.62%, respectively, and with different patterns, an unevenly distributed corrosion along the height and circumference of the shank. The severe pitting corrosion was also observed in the stud shank. For each individual stud, the corrosion occurred from the bottom shank welded with the steel beam and propagated upwards to the stud head. It could be attributed to the welding connection between the studs and the steel beam, and to the concrete defects or damaged concrete resulting from the complicated surface at the weldment regions, which will be demonstrated in the following Section 3.3.

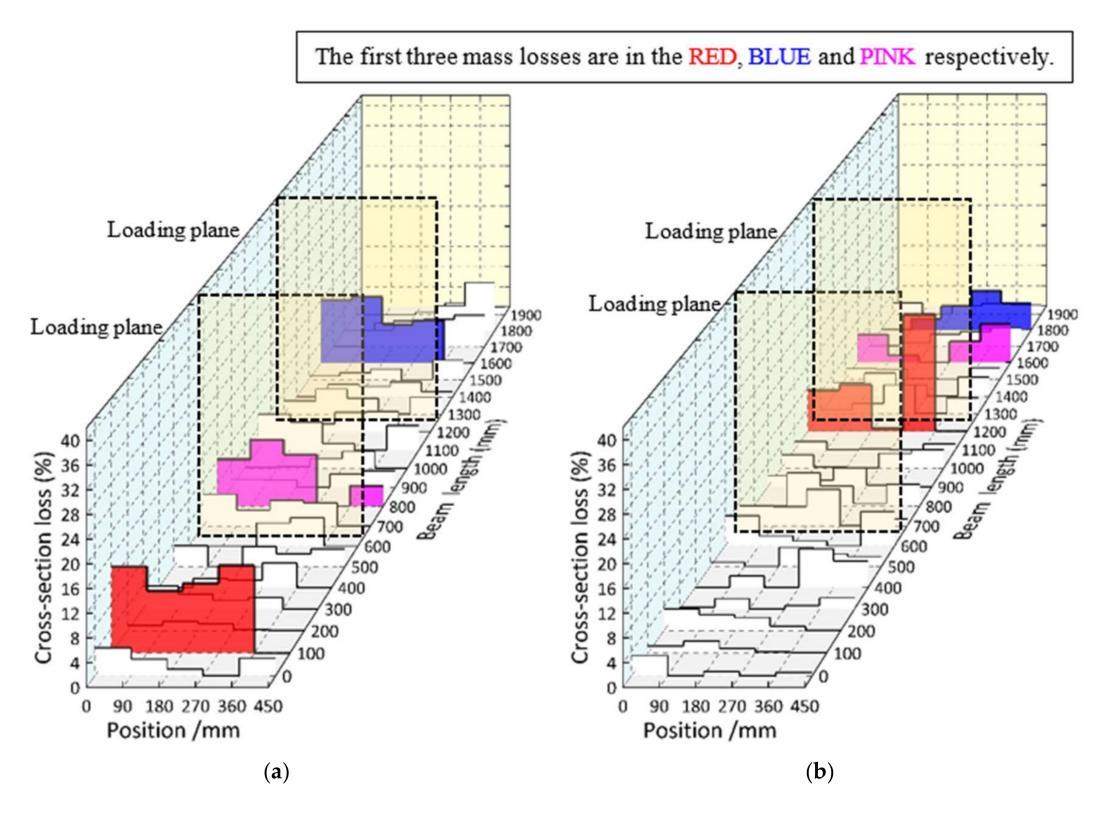
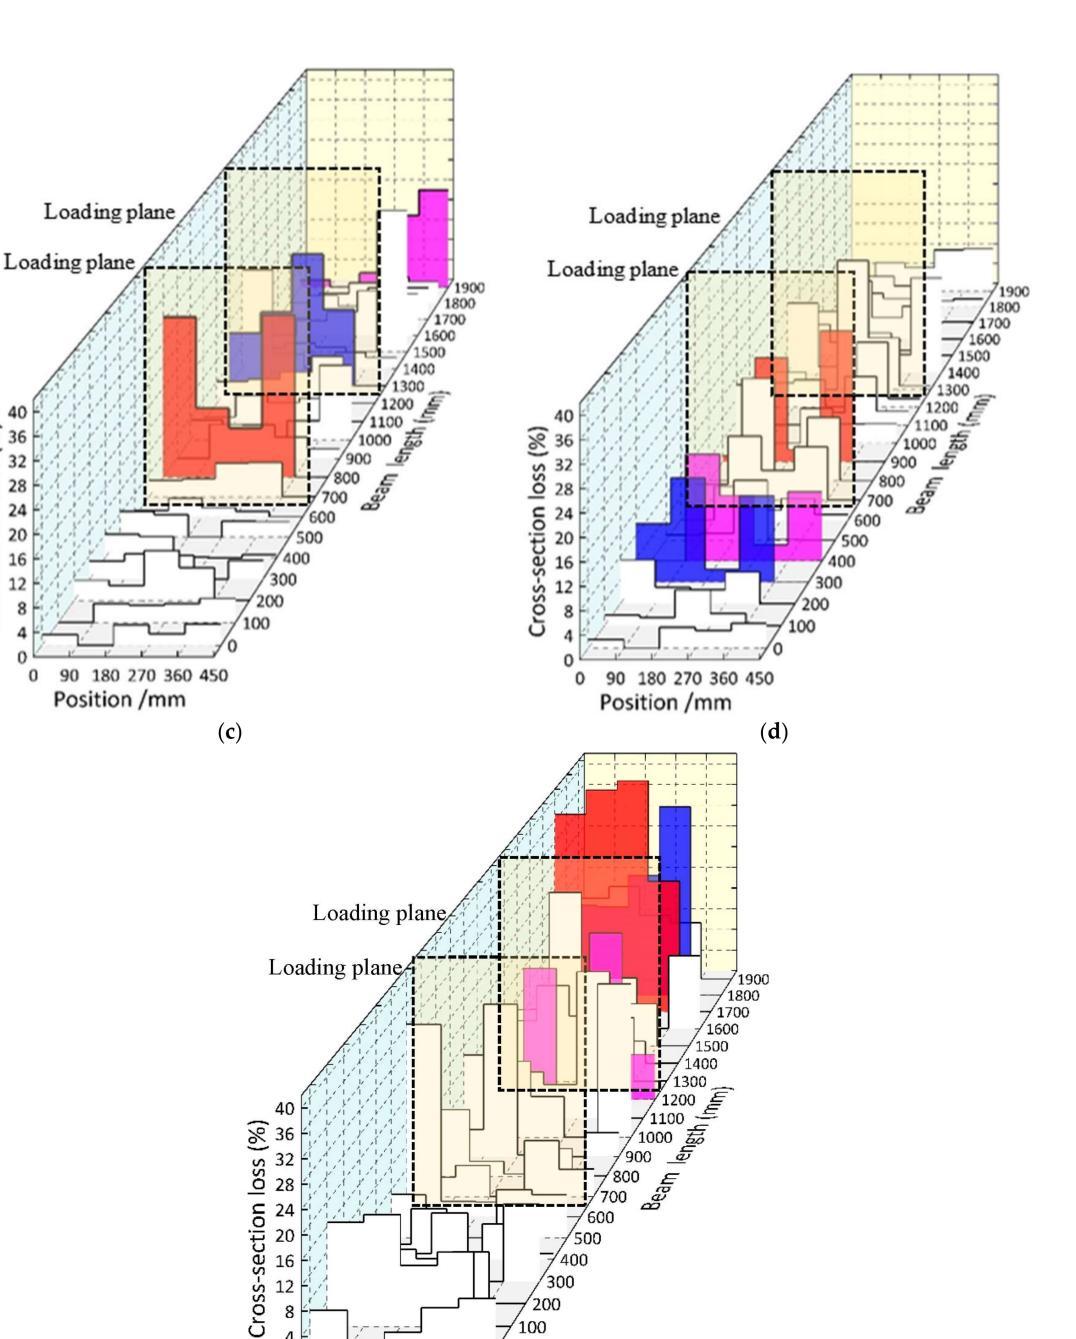
Figure 9. Cross-section loss distributions of the transverse reinforcement of the upper layer. (a) CB2M; (**b**) CB4M; (**c**) CB10M; (**d**) CB12M; (**e**) CB12MR.

The cross-section loss distributions at different positions of both the transverse and longitudinal reinforcement of the up grids are present in Figures 9 and 10, respectively. The relative mass loss, with respect to the average value, increased with the exposure times in the chloride environment. Discrepancies in the cross-section loss distributions were obtained in specimens CB12M and CB12MR, even though they were of the same design and had the same exposure time.

In Figure 9, the first three mass losses of the transverse reinforcement are indicated in red, blue and pink. The maximum cross-section losses were 14.45%, 22.55%, 29.05%, and 31.95% (the average value of two specimens) for composite specimens subjected to 2, 4, 10, and 12 months, respectively. Meanwhile, the average cross-section losses of the individual transverse reinforcement were 3.04%, 2.22%, 4.77%, and 7.21% for those specimens, respectively. The significantly non-uniformly distributed corrosion for the transverse reinforcement, even after a 12-month exposure, is demonstrated here.

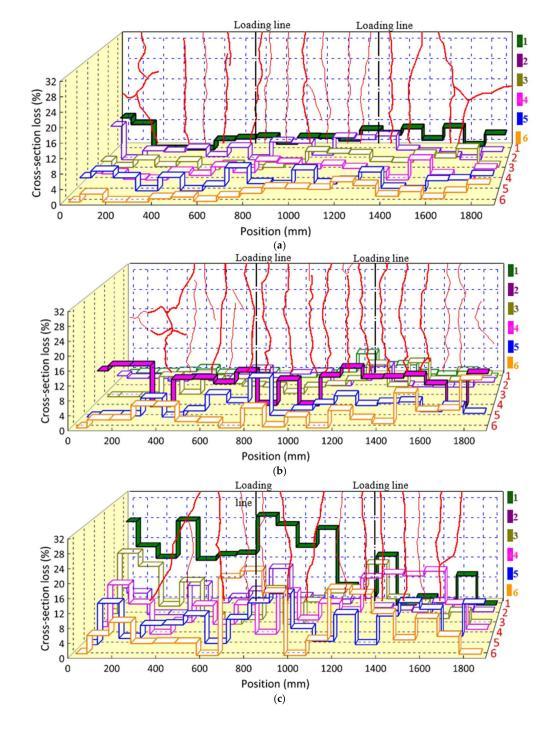
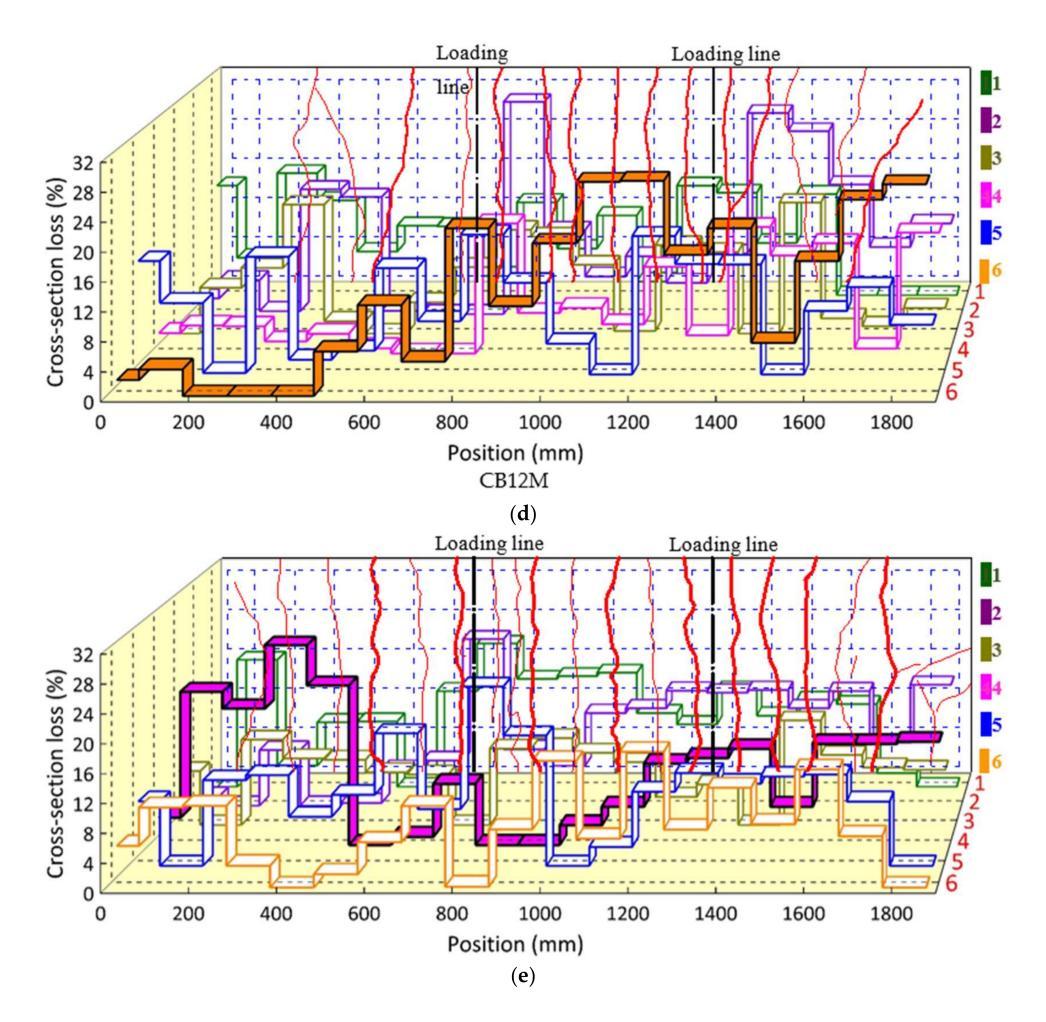
Figure 10. Cross-section loss distributions of the longitudinal reinforcement of the upper layer. (a) CB2M; (b) CB4M; (c) CB10M; (d) CB12M; (e) CB12MR.

In Figure 10, the longitudinal rebar with the largest average cross-section loss value is highlighted in the solid color bands for each specimen. It was found that the largest cross-section loss of rebar was generally located near the side of the slab where the chloride ion can easily access the rebar from two directions. Moreover, the relationship between the distribution of load-induced cracks and the cross-section loss are presented. There is no direct evidence for the strong correlation between the maximum transverse crack-width and the maximum mass loss. The maximum cross-section losses were 9.45%, 12.93%, 26.20%, and 29.3% (the average value for two specimens) for composite specimens subjected to 2, 4, 10, and 12 months, respectively.

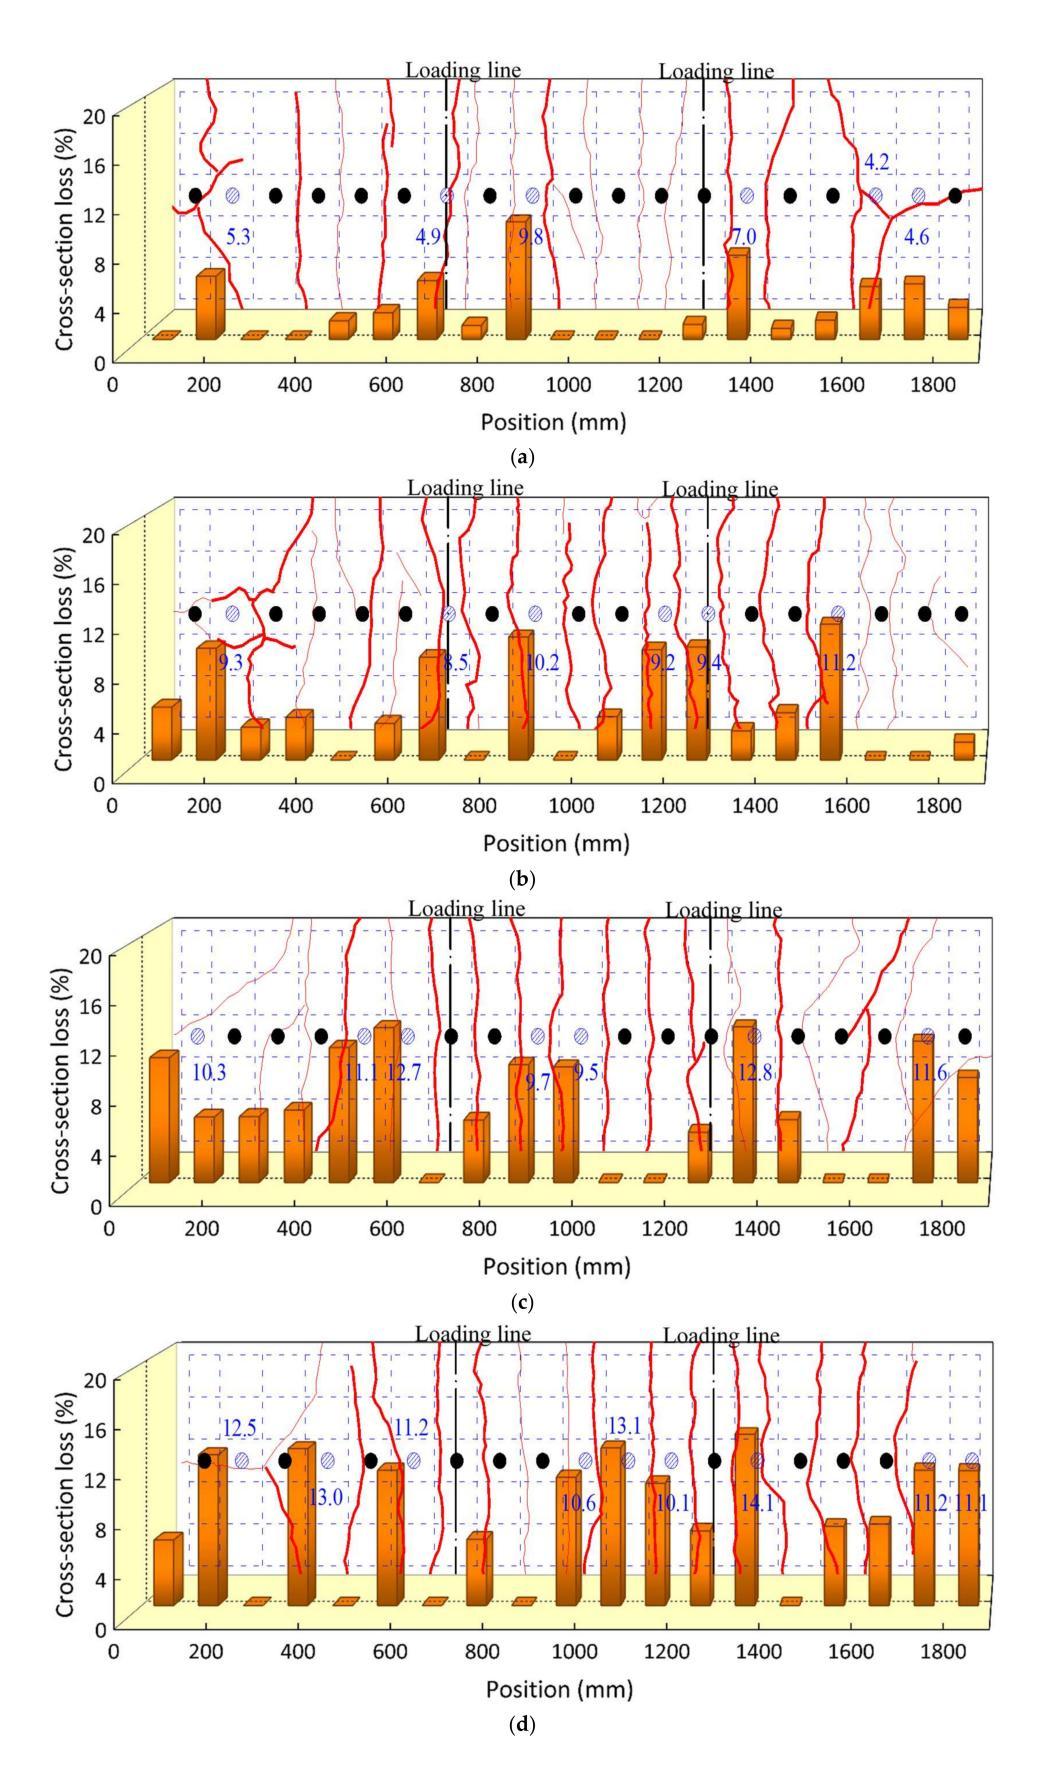
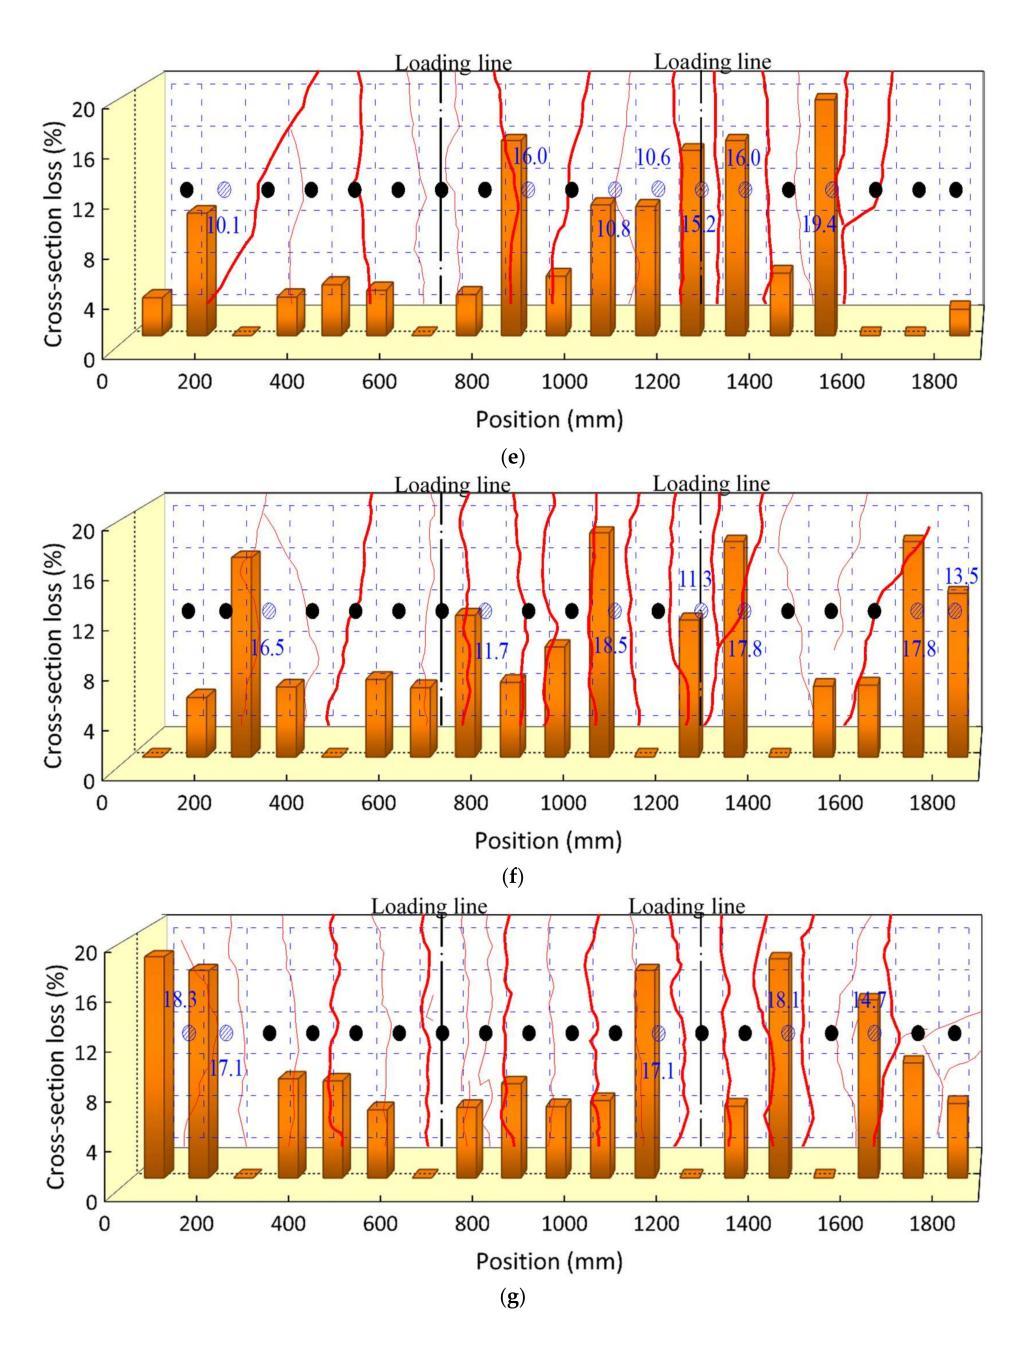
Figure 11. Cross-section loss distributions of the studs. (a) CB2M; (b) CB4M; (c) CB6M; (d) CB8M; (e) CB10M; (f) CB12M; (g) CB12MR.

The distributions of the cross-section loss of each shear stud along the length are presented in Figure 11. The cross-section loss with respect to the average value increased with the exposure times. The locations of the studs with a relative large cross-section loss for each specimen are marked in blue, along with the corresponding loss values. These locations seem to have occurred in a random pattern independent from the location of the load-induced cracks. The maximum mass losses were similar for specimens subjected to 10 and 12 months, at an approximate value of 19%. It should be noted that this similarity in the maximum cross-section loss may be due to the measured location as described in the experimental program.
