A Hybrid Process Integrating Reverse Engineering, Pre-Repair Processing, Additive Manufacturing, and Material Testing for Component Remanufacturing

Abstract: Metallic components can gain defects such as dents, cracks, wear, heat checks, deformation, etc., that need to be repaired before reinserting into service for extending the lifespan of these parts. In this study, a hybrid process was developed to integrate reverse engineering, pre-repair processing, additive manufacturing, and material testing for the purpose of part remanufacturing. Worn components with varied defects were scanned using a 3D scanner to recreate the three-dimensional models. Pre-repair processing methods which include pre-repair machining and heat-treatment were introduced. Strategies for pre-repair machining of defects including surface impact damage, surface superficial damage and cracking were presented. Pre-repair heat-treatment procedure for H13 tool steel which was widely used in die/mold application was introduced. Repair volume reconstruction methodology was developed to regain the missing geometry on worn parts. The repair volume provides a geometry that should be restored in the additive manufacturi

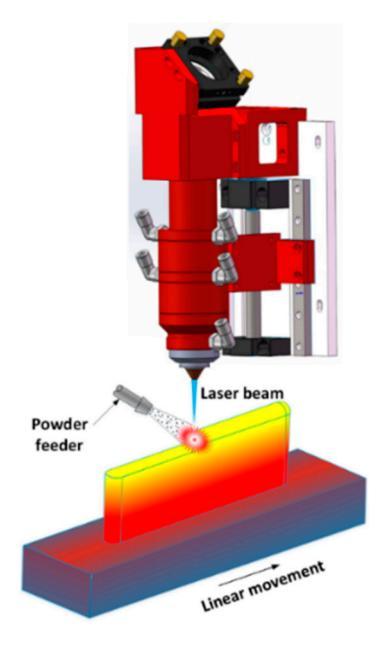
Figure 1. Schematic diagram of the laser-aided direct energy deposition process.

Laser-aided Direct Energy Deposition (DED) (Figure 1) is suitable for part repair. For example, varied shapes of grooves and slots were machined on AISI H13 tool steel substrates and then refilled by depositing H13 tool steel powder [7]. The process can fabricate high-quality repaired parts, but some defects may exist if the defect's boundary is too steep. Investigators prepared different groove-shaped defects on Stainless Steel and Ti-6Al-4V substrates and attempted to restore these missing volumes by modifying AM processing parameters [8]. The result shows that high quality repaired samples can be obtained with a reasonable combination of processing parameters. Defects on Ti-6Al-4V substrates were also generated and subsequently repaired by filling Ti-6Al-4V powder [9]. The mechanical qualification reveals good bonding strength and higher tensile strength within the deposits than the substrate. In summary, the DED process for repair has the following benefits: (1) less thermal input, which is required for repairing dimensional sensitive parts such as engine blades [10]; (2) good metallurgical bond between deposits and base metals [11]; (3) flexible integration with CNC (computer numerical control) machine or robot to develop a hybrid process to automate the repair [12].

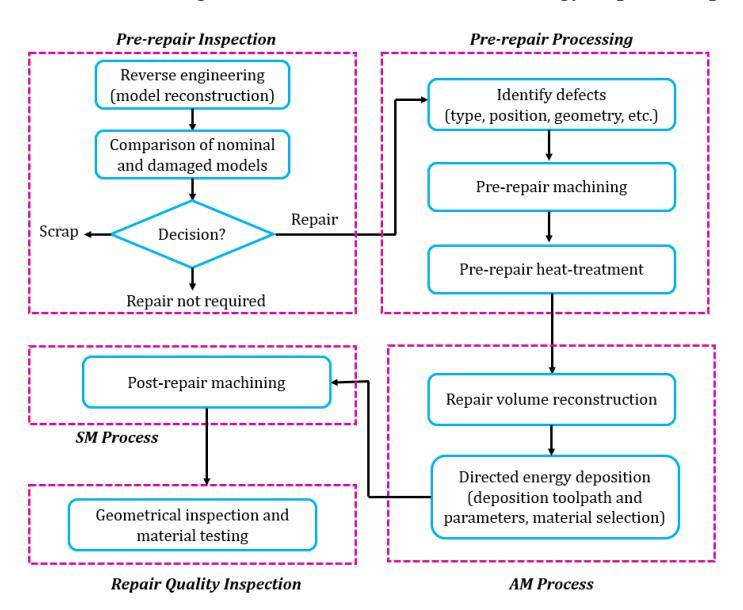
Figure 2. Diagram of the integrated hybrid process.

An integrated hybrid process for component remanufacturing in this study obeys the following procedure as shown in Figure 2: (1) pre-repair inspection; (2) pre-repair processing; (3) AM; (4) subtractive manufacturing (SM); (5) repair quality inspection. In the beginning, a complete inspection was performed on worn parts to assess the feasibility of repair. Considering the excessive variety of locations and geometries of defects, the inspection is highly a case to case basis. After that, pre-repair processing was conducted to guarantee the worn parts were repairable. Previous work in component repair is concentrated on post-machining. However, pre-repair processing is also crucial in the repair chain. Pre-repair machining discussed in this paper includes pre-repair machining and pre-repair heat-treatment. Pre-repair machining is required because many defects such as cracking are not directly accessible to AM systems. Such defects cannot be repaired without machining off materials surrounding the inaccessible defects. The inclination angle of boundaries of defects should also be considered in the machining process since it is reported that too steep walls cannot form sound bonding between filler material and substrates [19]. The AM process builds materials in the damaged area to restore the missing geometry in a layer-upon-layer fashion [20]. The key is to reconstruct

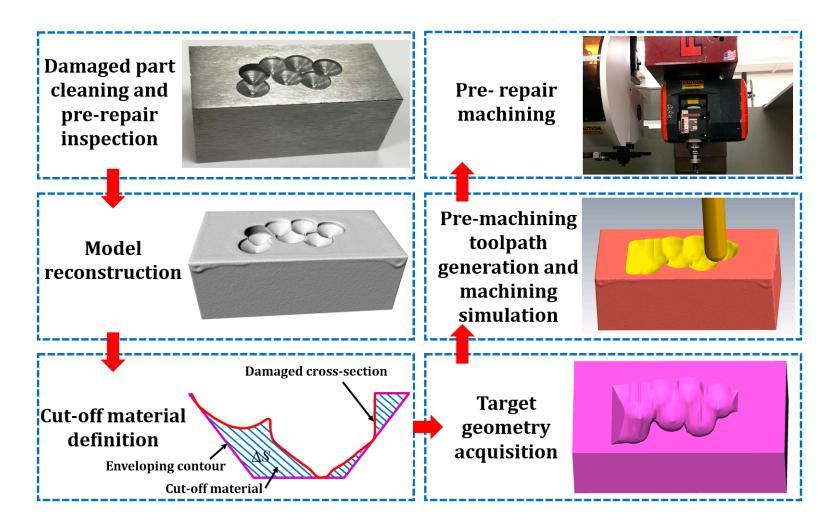
Figure 3. Pre-repair machining procedure for surface impact defects.

The machining procedure for surface impact defects such as dents, notches, grooves and material overcut is illustrated in Figure 3, which includes (1) damaged part cleaning and pre-repair inspection; (2) model reconstruction; (3) cut-off volume definition; (4) target geometry acquisition; (5) toolpath and program generation, and (6) machining.

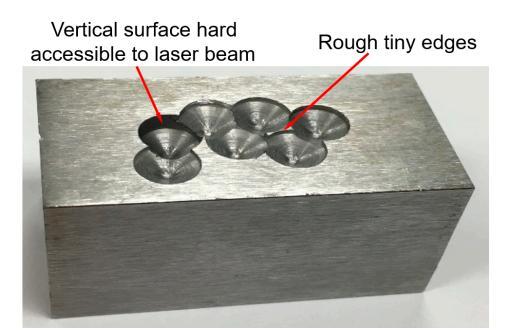
Figure 4. An H13 tool steel substrate with ball-indented defects.

An H13 tool steel block with dimensions of $50 \times 25.4 \times 25.4$ mm³, shown in Figure 4, was utilized as an example for illustrating machining strategy for surface impact defects. Ball-indented defects were randomly prepared on the surface of the substrate using an 8 mm drill bit. The holes on the block have varied depths and overlap ratios.

One can see in Figure 4 that the damaged substrate cannot be repaired directly due to at least two reasons. One is that vertical surfaces on the side of the holes are not accessible to the laser beam and powder feed nozzle for the 3-axis AM system. Therefore, materials surrounding vertical surfaces need to be machined to reveal a tilted surface to guarantee accessibility. Another reason is that the rough tiny edges in the damaged area complicate the toolpath planning for material deposition and may distort during deposition due to heat input. Such deformation could ruin the accuracy of the as-deposited geometry.

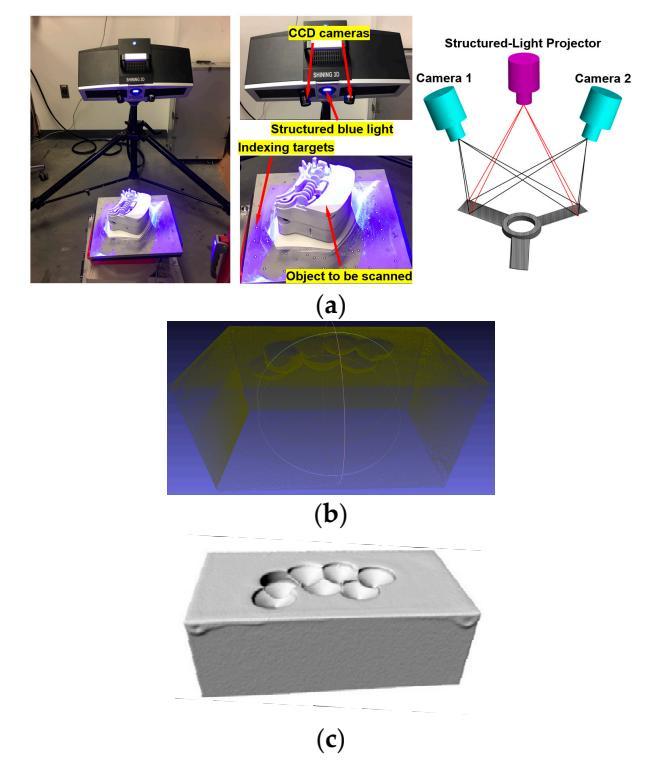
Figure 5. (a) 3D scanning setup; (b) reconstructed point cloud; (c) reconstructed STL model.

Recreating the model of worn part is required for pre-repair machining. In this research, models of damaged parts were reconstructed using a structured-light optical 3D scanner (OptimScan-5M, Figure 5a, Shining 3D, Hangzhou, China). The single scan range of the scanner is 100 × 75 mm². The single shot accuracy of the scanner is 0.005 mm and the volume accuracy is 0.8 mm/m. The scanner has a blue light projector that emits structured-light patterns on an object and two CCD cameras on the scanner measure the distorted dimensions of the pattern. The alteration in dimensions provides the three-dimensional coordinates of the object. In order to acquire a complete model, multiple scans are required, capturing different orientations of the object. For registering point cloud from different scans to a single model, indexing targets need to be randomly pasted around the object to be scanned. Figure 5b depicts the point cloud of the substrate. The point cloud was processed to create the STL (stereolithography) model shown in Figure 5c.

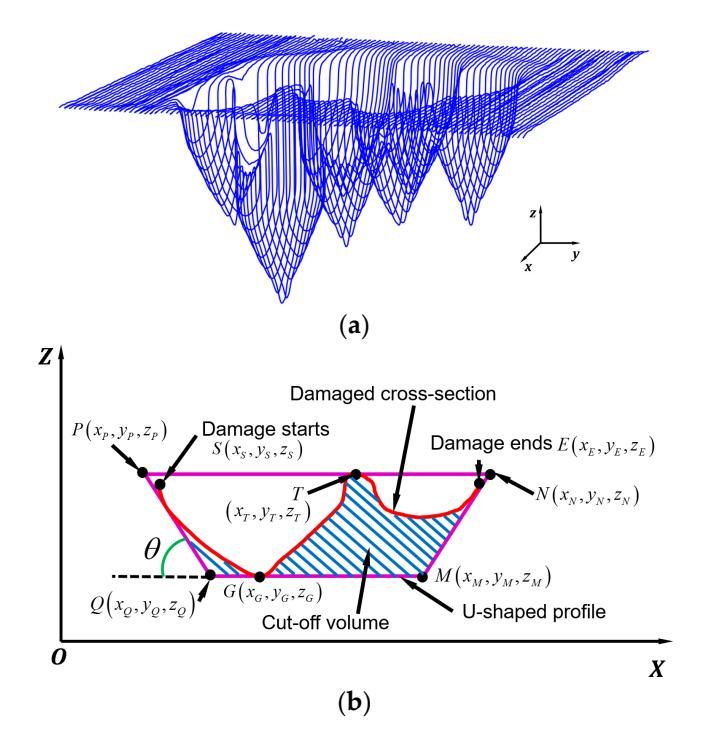
Figure 6. (a) Cross-sections of the block; (b) U-shaped boundary (UB) definition.

The STL model of the damaged part was sliced into several layers along the y-axis with a layer thickness of 0.5 mm as shown in Figure 6a. The slicing outputs a series of layers that combined

As shown in Figure 6b, two approaching lines PQ and MN with an inclination angle θ were utilized to approach the damaged cross-section. The damage starting point S and ending point Ewere known in the damage searching step. It is necessary to find points P, Q, M, and N to define the two approaching lines. Such points can be defined as follows: Z_P and Z_N were defined by finding the maximum z-coordinate on the damaged cross-section, which is Z_T . Z_Q and Z_M were defined by exploring the minimum z-coordinate on the damaged cross-section, which is Z_G . Since the damaged model was sliced along the y-axis, $Y_P = Y_Q = Y_M = Y_N = Y_S = Y_E$. X_P and X_N were randomly defined as long as X_P is less than the minimum x-coordinate of the damaged points and X_N is larger than the maximum x-coordinate of the damaged points. Once X_P , X_{N_r} and the sidewall inclination angle θ are defined, the coordinates X_Q and X_M can be calculated according to Equation (1).

Once the two approaching lines were defined, the relationship between the approaching lines and the cross-section was checked. If there is no intersection, a step was applied to X_P and X_N to make the lines approach the cross-section, and another checking iteration was conducted. Two lines that firstly have intersections with the damaged cross-section can be obtained and lines before this iteration were gathered, which is shown in Figure 6b.

One can see in Figure 6b that for UB, the bottom-line *QM* is parallel to the x-axis, and this may result in extra material cut-off in the polygon *GMETG*. This material over-cut becomes worse when one deep defect is presented while majority defects are shallow. To further minimize cut-off volume, the CHB was obtained as shown in Figure 8a. The convex-hull of any polygon can be easily obtained based on the existing algorithm [22]. However, one should notice that the convex hull cannot be directly utilized as the boundary for machining owing to the possibility of the steep area as shown in Figure 8a. The line segments in such regions have big tangents that cannot guarantee accessibility. Therefore, such lines need to be tilted. The algorithm for tilting lines is schematically depicted in Figure 8b and discussed below.

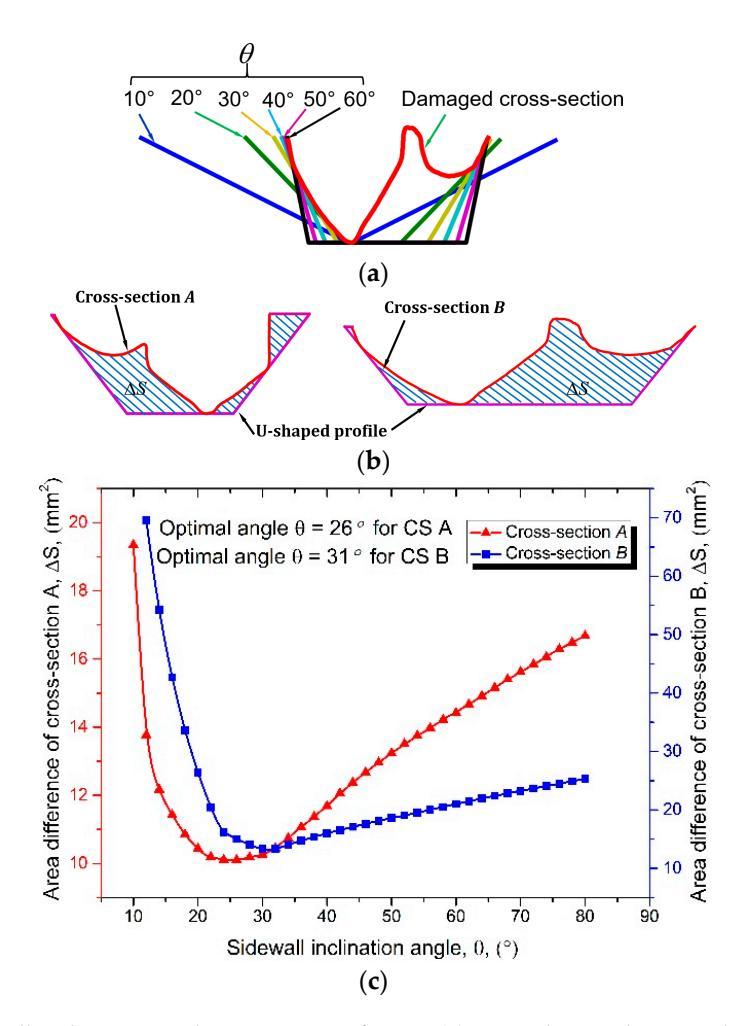
Figure 7. Sidewall inclination angle optimization for UB. (**a**) UB with varied approaching lines; (**b**) UB for cross-sections *A* and *B*; (**c**) relationship between area difference ΔS and inclination angle θ .

The inclination angle θ of the two approaching lines can be operator-determined and adjusted flexibly according to the specifications of the AM system. It should be noted that the inclination angle has a significant effect on the cut-off volume. A small θ gives good accessibility but may result in a much greater cut-off volume. An optimized θ needs to be determined which not only reveals good accessibility but also holds a minimized cut-off volume. For this purpose, a series of approaching lines with varied inclination angles were adopted to intersect a cross-section shown in Figure 7a. Inclination angle θ controls the accessibility and it should not approach 90°. The authors conducted a series of experiments that aimed to refill slots with different sidewall inclination angles and it was revealed that 75° can still yield a sound bi-material bonding and good material properties [20]. Therefore, the range of angle θ was limited to 10-75°. The area difference between UB and the cross-section, ΔS as shown in Figure 7b, indicates the cut-off area. A series of approaching lines were processed on cross-sections *A* and *B* as shown in Figure 7b and the relationship between ΔS and θ is plotted in Figure 7c.

It was observed from Figure 7c that for both cross-sections, the area ΔS decreases and then increases with the increase of angle θ . It was found that the optimal angle θ (angle that results in the minimum ΔS) for cross-section *A* is 26° and is 31° for cross-section *B*. The curves indicate that neither a minimum nor a maximum tilt angle can result in the minimum cut-off volume. Therefore, the optimal angle θ is highly dependent on the profile of the cross-section and should be determined for each one.

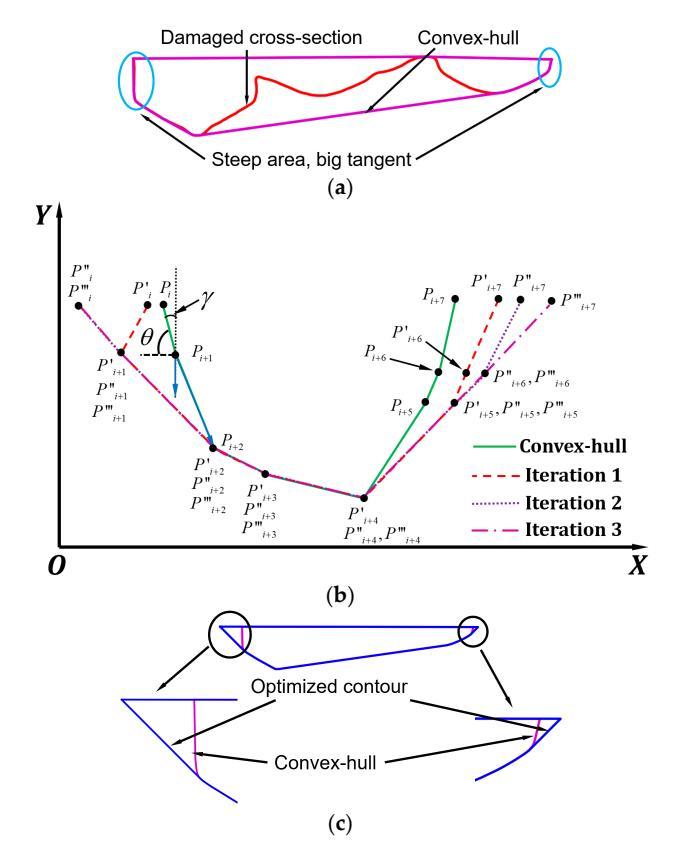
Figure 8. Sidewall inclination angle optimization for the convex-hull boundary (CHB). (a) CHB processed on a damaged cross-section; (b) schematic diagram showing optimization algorithm; (c) optimized contour.

Suppose polygon $P_iP_{i+1}\cdots P_{i+6}P_{i+7}$ is a convex-hull of one cross-section. The inclination angle of P_iP_{i+1} is indicated as θ . As θ is beyond the allowed angle, P_i needs to be rotated around P_{i+1} to P_i' . The coordinate of $P_i'(x_i', y_i', z_i')$ can be calculated according to Equation (2), where $(x_{i+1}, y_{i+1}, z_{i+1})$ is the coordinate of P_{i+1} and γ is the complementary angle of θ . The inclination angle of $P_{i+1}P_{i+2}$ also exceeds the allowed angle and therefore, P_{i+1} also needs to rotate around P_{i+2} to P'_{i+1} . After that, the polygon is $P'_iP'_{i+1}\cdots P'_{i+6}P'_{i+7}$. However, the inclination angle $P'_iP'_{i+1}$ still surpasses the desired angle and therefore, P'_i needs to be further rotated around P'_{i+1} to P''_i . After the second iteration, the polygon became $P''_iP''_{i+1}\cdots P''_{i+6}P''_{i+7}$. There is another iteration to move P''_{i+7} to P'''_{i+7} . Finally, the contour $P'''_iP'''_{i+1}\cdots P''_{i+6}P''_{i+7}$ is obtained that satisfies the accessibility, and therefore, can be used as the boundary for cut-off volume definition.

The algorithm was applied to a cross-section as shown in Figure 8a and the optimized contour is depicted in Figure 8c. As illustrated in Figure 8c, the steep area in the original convex-hull was successfully tilted.
