Article Low Cycle Fatigue Characteristics of Oxygen-Free Copper for Electric Power Equipment

Abstract: The effect of heat treatment on tensile and low cycle fatigue properties of the oxygen-free copper for electric power equipment was investigated. The heat treatment at 850 °C for 20 min, which corresponds to the vacuum brazing process, caused the grain growth and relaxation of strain by recrystallization, and thus, the residual stress in the oxygen-free copper was reduced. The tensile strength and 0.2% proof stress were decreased, and elongation was increased by the heat treatment accompanying recrystallization. The plastic strain in the heat-treated specimen was increased compared with that in the untreated specimen under the same stress amplitude condition, and thus, the low cycle fatigue life of the oxygen-free copper was degraded by the heat treatment. Striation was observed in the crack initiation area of the fractured surface in the case of the stress amplitude less than 100 MPa regardless of the presence of the heat treatment. With an increase in the stress amplitude, the river pattern and the quasicleavage fracture were mainly observed in the fracture surfaces of the untr

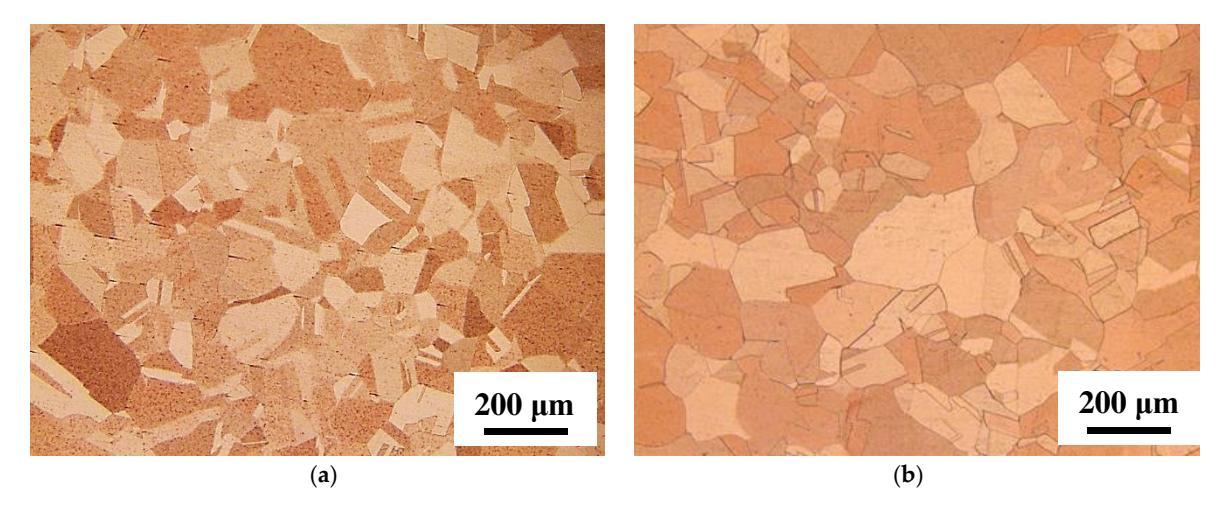
Figure 2 shows optical microscope images of the untreated specimen and the specimen with heat treatment at 850 °C for 20 min. Table 3 shows the average grain sizes estimated by the intercept method using Figure 2. It was confirmed that the grain growth occurs during heat treatment. Table 4 shows the measurement result of residual stress in the untreated specimen and the heat-treated one. In the untreated specimen, the compressive stress of 86.9 MPa to the longitudinal direction of the specimen remained. Table 4 indicates that the compressive stress was reduced from 86.9 to 70.3 MPa by heat treatment. It means that the grain growth by the heat treatment causes the relaxation of strain, and thus, the residual stress is reduced. Since the heat treatment temperature in this study was sufficient to cause a relaxation and secondary recrystallization, the grain growth was confirmed to be caused by the recrystallization. Figure 3 shows inverse pole figure (IPF) images estimated by EBSD analysis for the untreated specimen and the heat-treated one. The result of the EBSD analysis showed that a noisy IPF map was obtained in the untreated specimen. This means that the untreated specimen has a certain strain. In contrast, in the heat-treated specimen, the clear IPF map that consists of grains grown by recrystallization was obtained. These results correspond to the changes in the grain size and the residual stress by heat treatment shown in Tables 3 and 4. The deviation of the crystal orientation distribution such as a texture was not observed in the heat-treated specimen shown in Figure 3b.

Figure 2. Optical microscope images after etching treatment. (a) Untreated; (b) heat-treated at 850 °C for 20 min.

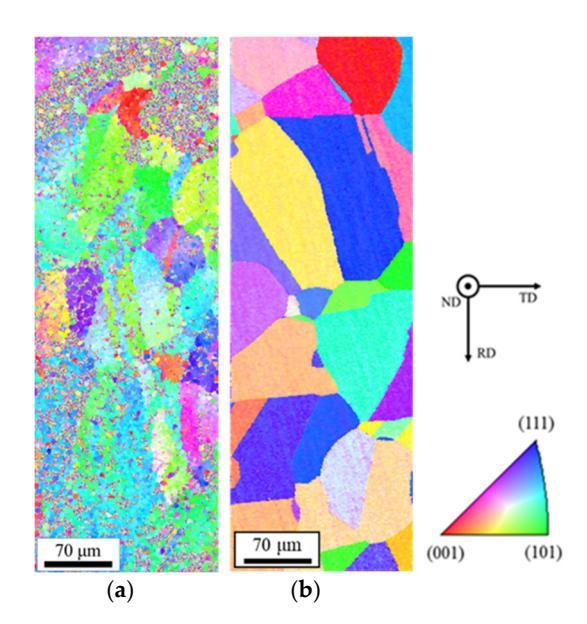
Figure 3. Inverse pole figure (IPF) maps estimated by electron backscattering diffraction (EBSD) analysis. (a) Untreated; (b) heat-treated at 850 °C for 20 min.

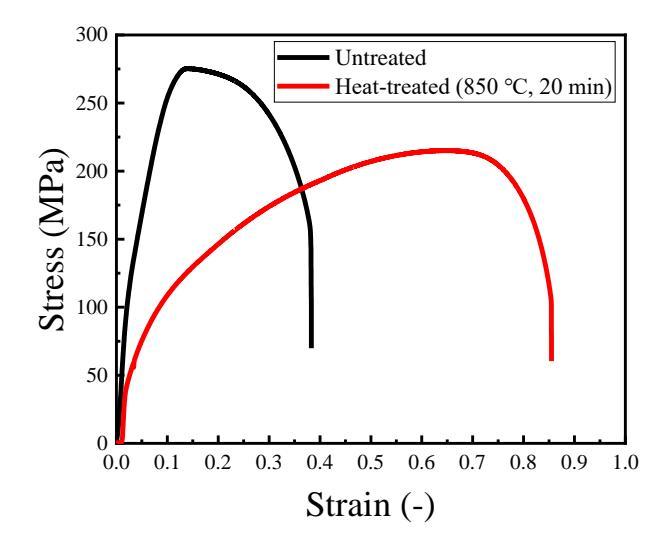
Figure 4 shows typical stress–strain curves of the untreated specimen and the heattreated one. It was found that the tensile strength was decreased and the elongation was increased by heat treatment accompanying recrystallization. In this study, three specimens were tested in each specimen types. Table 5 shows averages of tensile strength, 0.2% proof stress and elongation. From comparison of the average values, it was also confirmed that the tensile strength and the 0.2% proof stress were decreased, and the elongation was increased by heat treatment. Considering the results of the tensile test shown in Figure 4 and Table 5, the stress amplitude of the low cycle fatigue test was set to 50–200 MPa in this study.

Figure 4. Typical stress-strain curves of untreated and heat-treated specimens.

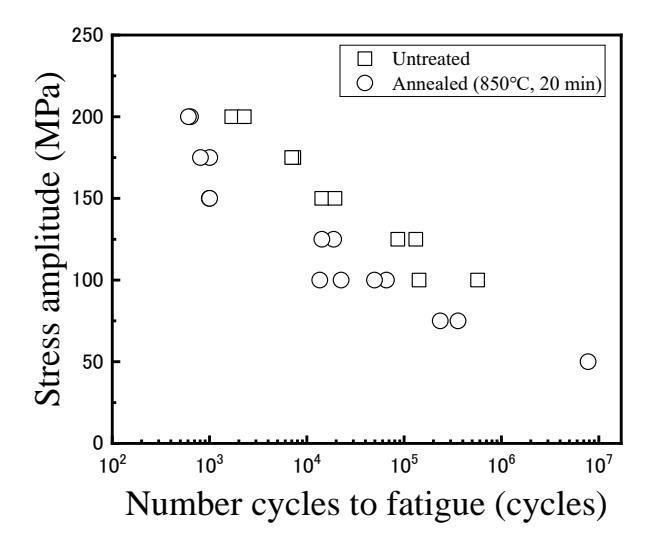
Figure 5 shows the results of the low cycle fatigue test. The fatigue life was found to be decreased by heat treatment accompanying recrystallization. The observation results of fracture surfaces are shown in Figures 6 and 7. In both figures, the areas that were estimated to be crack initiation areas by fracture surface observation are shown, and the bottom images are magnified images of upper ones. In the untreated specimens, striation that is a characteristic pattern in the fatigue failure was observed when the stress amplitude was 100 MPa. Under the stress amplitude condition, the fatigue life became more than 10^5 cycles. Thus, striation was confirmed to be observed in the high cycle fatigue region exceeding 10^5 cycles. In contrast, a river pattern and quasicleavage fracture were mainly observed in the fracture surface when the stress amplitude was more than 150 MPa, and the fatigue life became less than approximately 10^4 cycles. As shown in Figure 4, when the stress more than 150 MPa is loaded, strain arrives at a few percentages or more. In such conditions, corresponding to the low cycle fatigue region, a few percent plastic deformation occurs accompanying the river pattern and the quasicleavage fracture, and thus, the fracture mode without striation was observed.

Figure 5. Low cycle fatigue test results.

Compared with the width of striations in the case of stress amplitude of 100 MPa, the width of striation in the heat-treated specimen was larger than that in the untreated one. This means that the plastic strain amplitude imposed to the heat-treated specimen during the fatigue test was larger than that of the untreated one under the same stress amplitude condition. This is because the heat-treated specimen was softened by recrystallization, as shown in Figure 4. Since the plastic strain in the heat-treated specimen was increased compared with that in the untreated specimen under the same stress amplitude condition, the low cycle fatigue life of the C1020 oxygen-free copper was degraded by heat treatment, as shown in Figure 5.

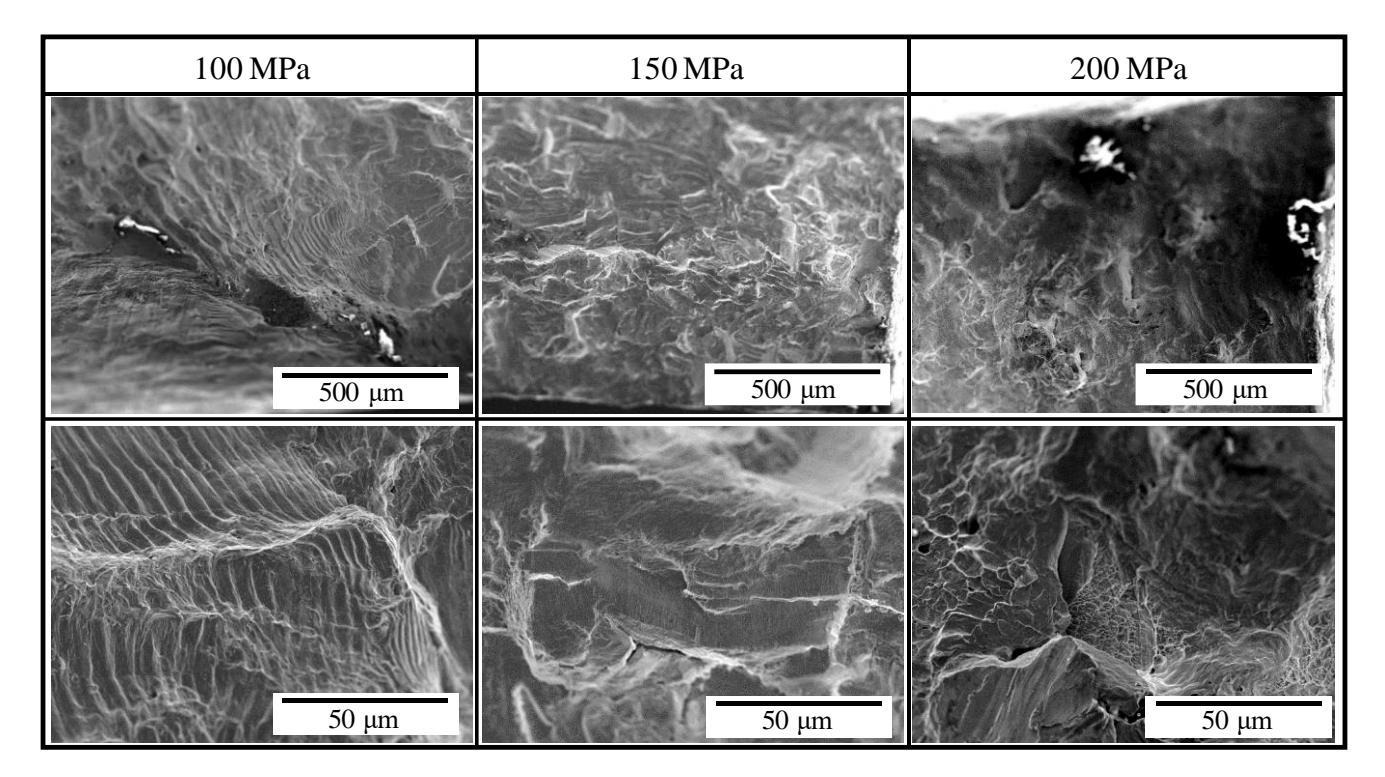
Figure 6. Secondary electron images of fracture surfaces of untreated specimens after the low cycle fatigue test. Bottom images are magnified images of upper ones.

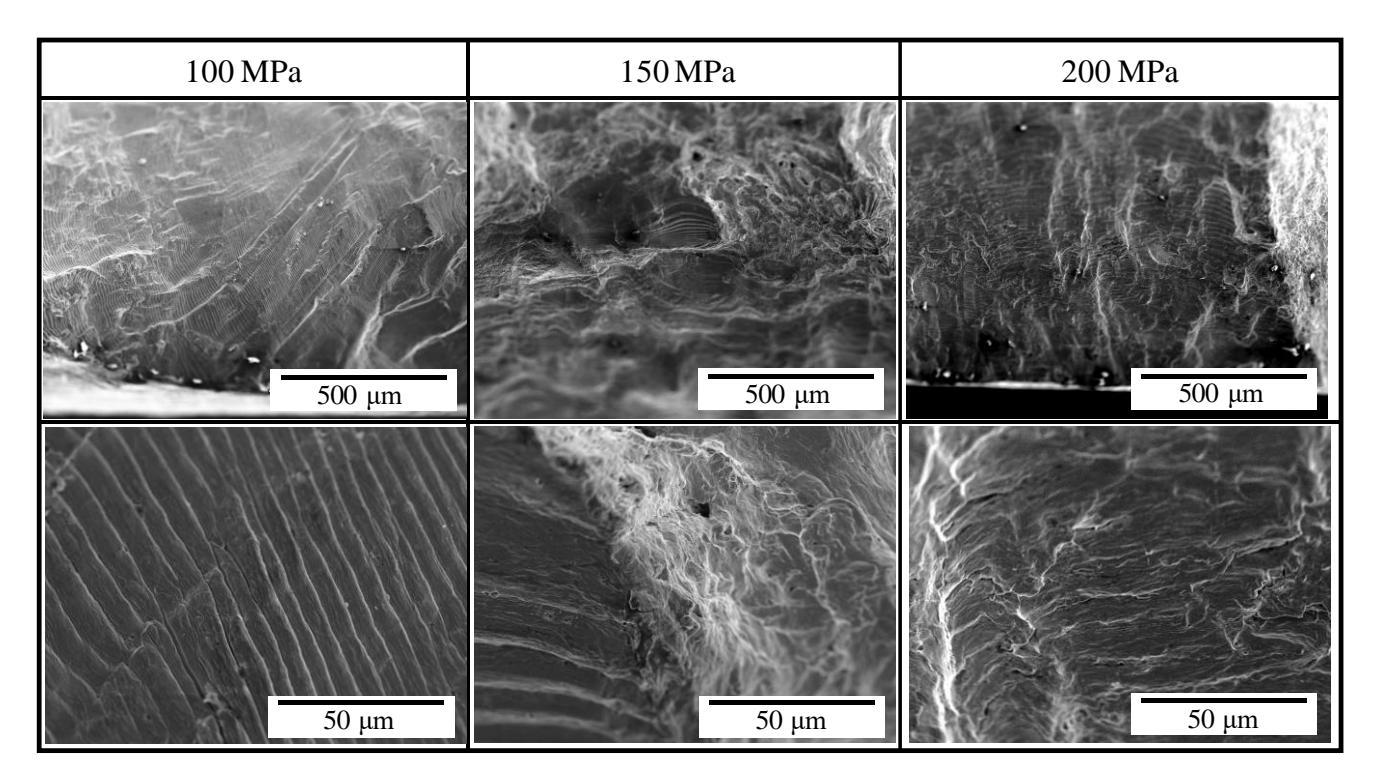
In the heat-treated specimens, striations were observed in the fracture surfaces regardless of the stress amplitude. When the stress amplitude was less than 100 MPa, and the fatigue life became more than 10^4 cycles, striations were observed clearly in almost the whole of the crack initiation area. In addition, river patterns and quasicleavage fracture were observed with striations in the fracture surfaces when the stress amplitude was more than 150 MPa. Under such stress amplitude conditions, the fatigue life became less than 10^3 cycles. As well as the untreated specimens, the tendency for the brittle fracture including the river pattern and quasicleavage to increase with an increase in the stress amplitude was found. Moreover, the width of striation was confirmed to be larger with the increase in the stress amplitude. This is because the strain is drastically increased with an increase in the loaded stress, as shown in Figure 4. Since the heat-treated specimen was softened by recrystallization, the brittle fracture including the river pattern and quasicleavage was considerably restrained even in strain at the level of dozens of percent, and thus, fracture surfaces with striations, river patterns, and quasicleavage were observed.

Figure 7. Secondary electron images of fracture surfaces of heat-treated specimens after the low cycle fatigue test. Bottom images are magnified images of upper ones.

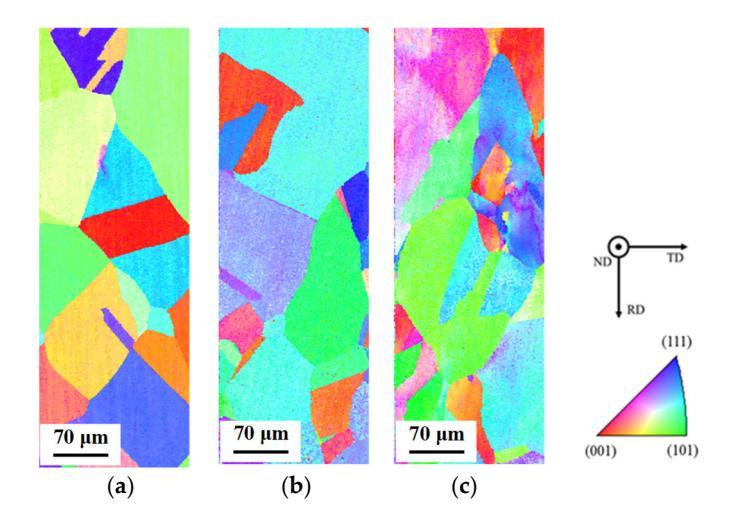
In this study, fatigue damage behavior was investigated by EBSD analysis. Figure 8 shows IPF maps of the center of the heat-treated specimens after the low cycle fatigue test. In the IPF maps, the grain boundary with misorientation more than 15° was defined as the high-angle grain boundary. When the stress amplitude was 100 MPa, the gradation appeared in several grains. Those grains were found to be deformed due to strain accumulated by the fatigue cycle.

Figure 8. IPF maps of heat-treated C1020 specimens after low cycle fatigue test. (**a**) Stress amplitude: 50 MPa (fatigue cycle: 7,786,201 cycles); (**b**) stress amplitude: 75 MPa (fatigue cycle: 235,144 cycles); (**c**) stress amplitude: 100 MPa (fatigue cycle: 49,676 cycles).

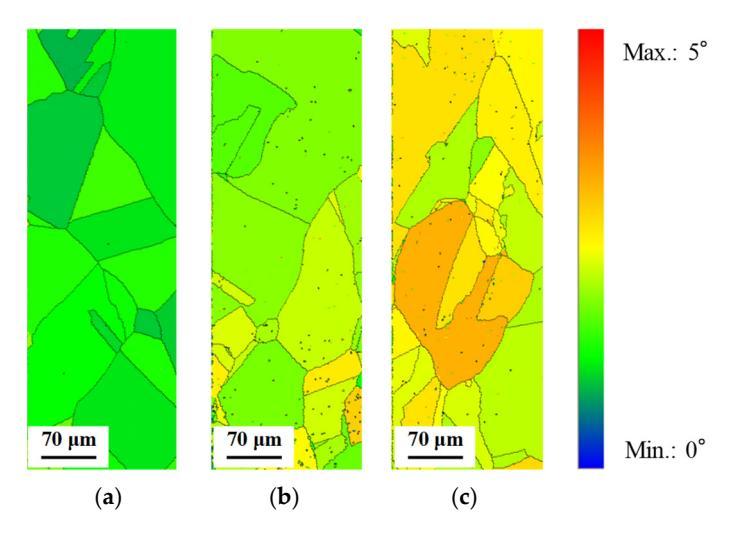
Figure 9 shows the grain average misorientation (GAM) maps for the IPF maps. The GAM map is the average misorientation in the grain, which is obtained by dividing the sum of the misorientation of all of the boundaries between pixels by the number of boundaries [18]. Figure 9 reveals that the GAM value was increased with an increase in the stress amplitude. Figure 10 shows the change of the GAM value with changing the stress amplitude compared with that of the initial specimen. The GAM value was confirmed to be scarcely changed compared with the initial specimen when the stress amplitude is 50 MPa. The GAM value was also confirmed to be increased with the increase in the stress amplitude from Figure 10. Although the difference in the misorientation that depended on each grain could be detected by the GAM maps, the misorientation in the grain which corresponds to the fatigue damage in the grain could not be detected.

Figure 9. Grain average misorientation (GAM) maps of heat-treated C1020 specimens after low cycle fatigue test. (**a**) Stress amplitude: 50 MPa (fatigue cycle: 7,786,201 cycles); (**b**) stress amplitude: 75 MPa (fatigue cycle: 235,144 cycles); (**c**) stress amplitude: 100 MPa (fatigue cycle: 49,676 cycles).

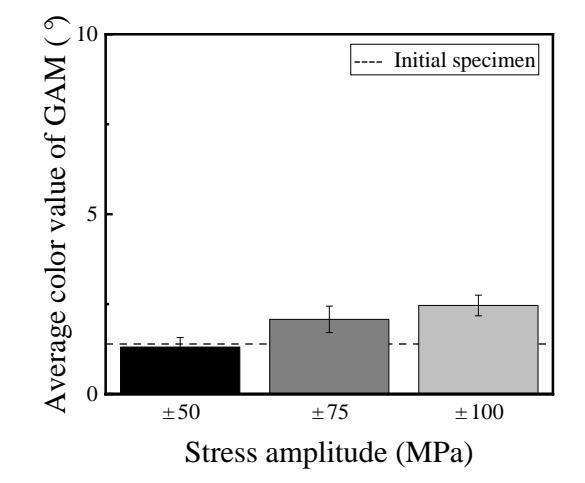
Figure 10. Relationship between GAM value and stress amplitude.

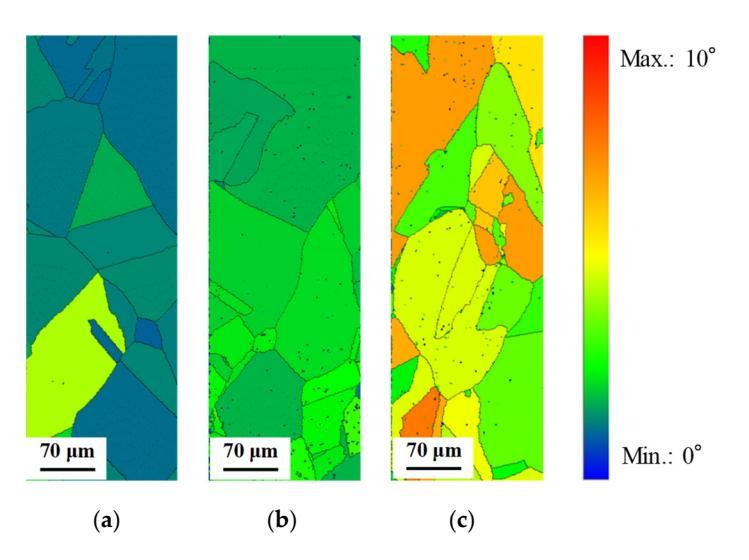
Figure 11 shows grain orientation spread (GOS) maps for the IPF maps. To obtain the GOS map, one pixel in the grain is set as the reference point. Next, the misorientation between another pixel in the grain and the reference point is investigated for all pixels in the grain. The average of the misorientations is defined as GOS by a grain unit [18]. From Figure 11, the GOS value is also increased with an increase in the stress amplitude. However, the distribution of the value in the observation area was slightly different between both GAM and GOS maps in the stress amplitude of 100 MPa. This seems to be dependent on the definition of both maps. The misorientation in the grain could not be also detected by the GOS map. Figure 12 shows the change of the GOS value with changing the stress amplitude compared with that of the initial specimen. As well as the GAM map, the GOS value was scarcely changed compared with the initial specimen when the stress amplitude was 50 MPa. In addition, the GOS value was increased with the increase in the stress amplitude. In the case of the stress amplitude of 100 MPa, the unevenness of the GOS values in the observation area became large. This result indicates that it is feasible to evaluate the fatigue damage of the specimen by the evenness of the GOS value.

Figure 11. Grain orientation spread (GOS) maps of heat-treated C1020 specimens after low cycle fatigue test. (a) Stress amplitude: 50 MPa (fatigue cycle: 7,786,201 cycles); (b) stress amplitude: 75 MPa (fatigue cycle: 235,144 cycles); (c) stress amplitude: 100 MPa (fatigue cycle: 49,676 cycles).

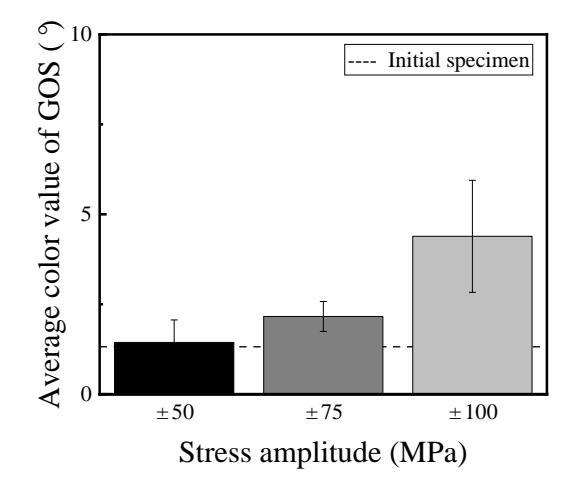
Figure 12. Relationship between GOS value and stress amplitude.

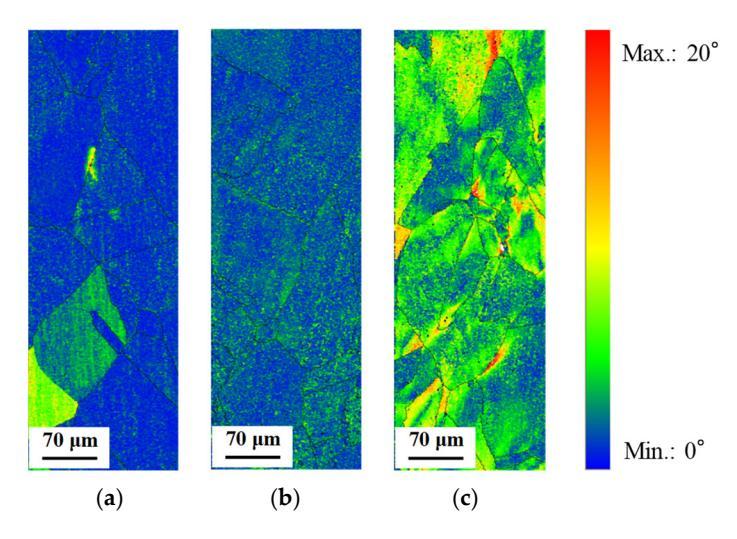
Figure 13 shows grain reference orientation deviation (GROD) maps for the IPF maps. The GROD map is created using the kernel average misorientation (KAM) map. Generally, hexagonal pixels are used in the EBSD analysis. To obtain the KAM map, the six misorientations between a certain one pixel and adjacent pixels are investigated, and the average of them is obtained by a pixel unit [19]. To obtain the GROD map, the misorientation between another pixel and the pixel with the minimum KAM value is investigated in the grain. The GROD map is obtained by a pixel unit as well as the KAM map [19]. Compared with Figures 8 and 13, it was found that the gradation in the grain shown in the IPF map corresponds well with the gradation in the GROD map is effective to investigate the fatigue damage degree in the grain.

Figure 13. Grain reference orientation deviation (GROD) maps of heat-treated C1020 specimens after low cycle fatigue test. (**a**) Stress amplitude: 50 MPa (fatigue cycle: 7,786,201 cycles); (**b**) stress amplitude: 75 MPa (fatigue cycle: 235,144 cycles); (**c**) stress amplitude: 100 MPa (fatigue cycle: 49,676 cycles).

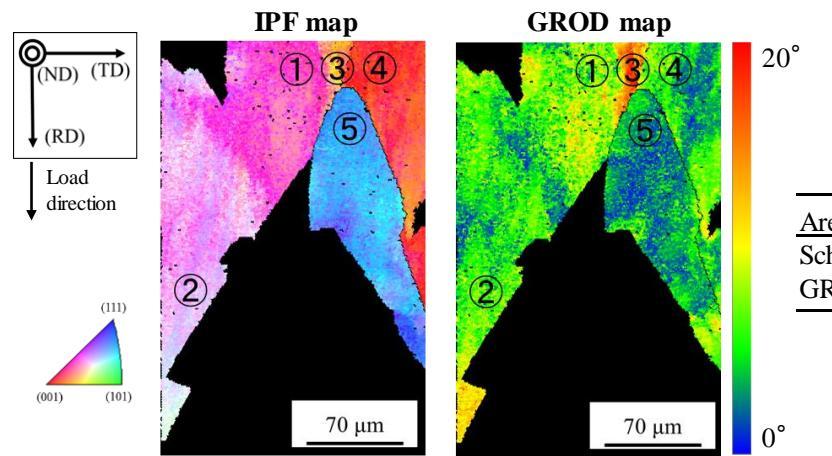
Figure 14 shows the IPF map and the GROD map of the area that shows the high GROD value in Figure 13c. The Schmid factor and GROD values for each area shown in Figure 14 are also indicated in the figure. The areas of (1), (2), and (3) exist in the same grain, and the areas of (4) and (5) exist in other grains, respectively. From Figure 14, the grain including (1), (2), and (3) and the grain including (4) was found to have high Schmid factors near 0.5. On the other hand, the grain including (5) had a smaller Schmid factor. Thus, sliding deformation occurs easily in the grains including (3) and (4) compared with the grain including (5). Therefore, stress concentration occurred in the vicinity of the grain boundary between the grain including (3) and the grain including (4), and thus, the large GROD value generated in the area of (3) in the vicinity of the grain boundary. The similar large GROD value was also shown in the area of (3) in the vicinity of the triple point of the three grains. In this way, high GROD values were detected in the vicinity of the grain boundaries and the triple points of grains in which stress concentration occurred easily.

Area	1	2	3	4	(5)
Schmid factor	0.45	0.48	0.48	0.46	0.39
GROD value	9.1	8.6	18	6.2	3.4

Figure 14. IPF map and GROD map of the area that shows the high GROD value in Figure 13c, and Schmid factor and GROD values for each area shown in the figure.

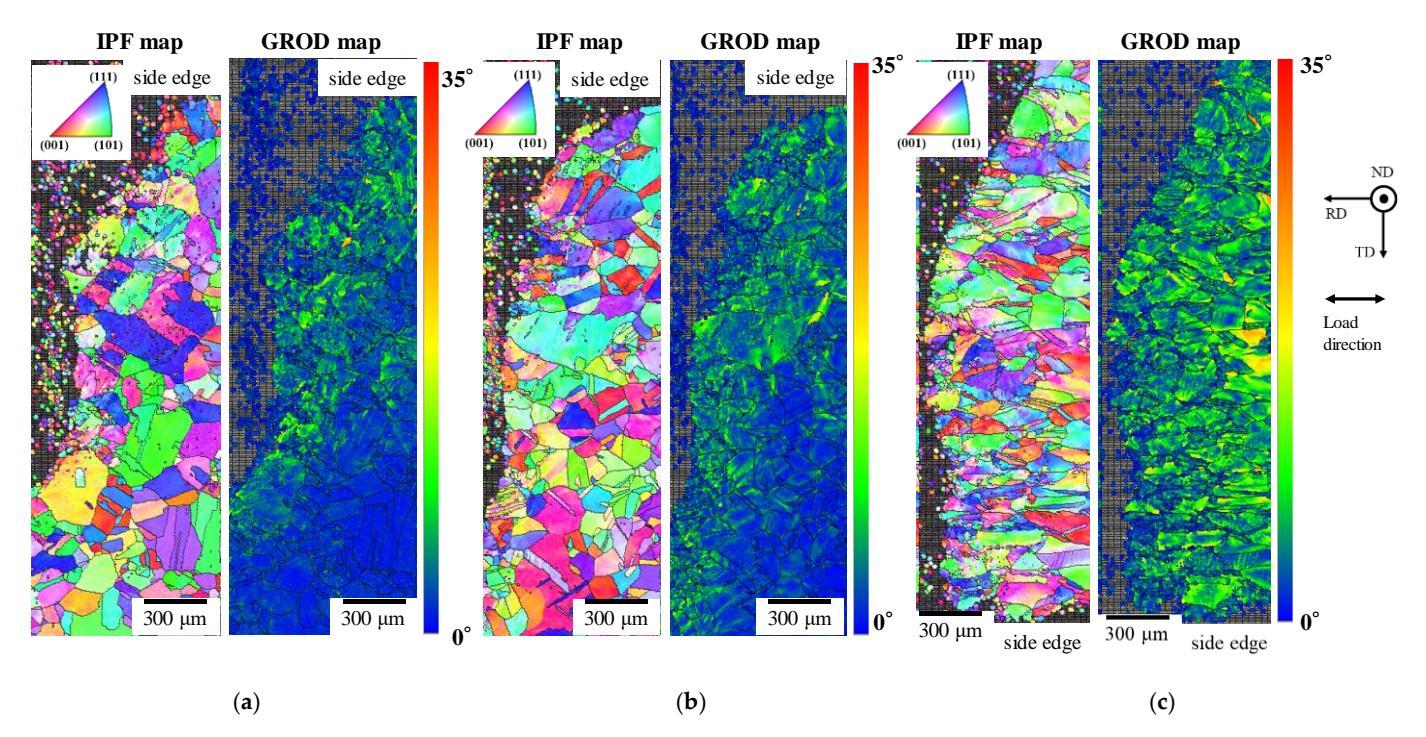
From the above-mentioned results, the GROD value was clarified to be effective to investigate the fatigue damage degree in the grain of the oxygen-free copper by low cycle fatigue. Figure 15 shows IPF maps and GROD maps of cross-sections of fractured areas after a low cycle fatigue test. The figure shows the regions that were assumed as crack initiation sides by the observation of the fractured surfaces. Compared with the GROD maps of the centers of the heat-treated specimens shown in Figure 13, the GROD values were found to be increased in the fractured areas. In addition, the region with high GROD values was expanded with an increase in the stress amplitude. The maximum GROD values were 28.4°, 27.8°, and 31.5° for the specimens investigated at stress amplitudes of 50, 75, and 100 MPa, respectively. The results indicate that the crack generated in the area in which the grains were deformed and the GROD value reached approximately 28°. Such a GROD value is possibly used to investigate the fatigue damage degree in the grain, the crack initiation behavior, and the crack progress behavior. However, the relationship between the GROD value and the plastic strain accumulated in the grain has not been clarified yet. Thus, further study is required to make the GROD value an index for the fatigue damage degree in the grain of the oxygen-free copper by low cycle fatigue.

Figure 15. IPF maps and GROD maps of cross-sections of fractured areas of heat-treated specimens after low cycle fatigue test. (a) Stress amplitude: 50 MPa (fatigue cycle: 7,786,201 cycles); (b) stress amplitude: 75 MPa (fatigue cycle: 235,144 cycles); (c) stress amplitude: 100 MPa (fatigue cycle: 49,676 cycles).

(5) From the results of the EBSD analysis for the fractured areas of the heat-treated specimens after the low cycle fatigue test, the crack was found to be generated in the area in which the grains were deformed and the GROD value reached approximately 28°.
