First Exploratory Study on the Ageing of Rammed Earth Material

Quoc-Bao Bui ^{1,*} and Jean-Claude Morel ²

Keywords: sustainable development; rammed earth; ageing; in-situ measurement

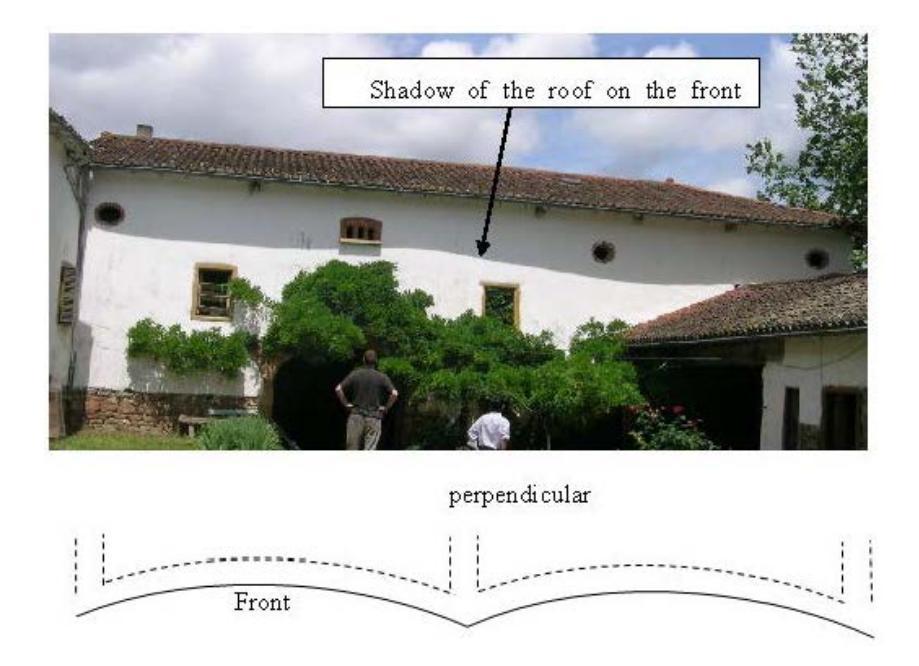
Figure 1. A rammed earth wall more than 200 years old. Upper: front view; bottom: plan.

Figure 1 presents an example of a rammed earth wall which is more than 200 years old. Note that the shadow of the roof on the front wall is not a horizontal straight line. This is due to the horizontal buckling of this wall that can be seen on the plan (Figure 1, bottom). The buckling phenomenon depends on several parameters (wall's slenderness ratio, eccentricity of the loading, boundary conditions, ...) but an important parameter which relates to material's characteristic is the creep phenomenon.

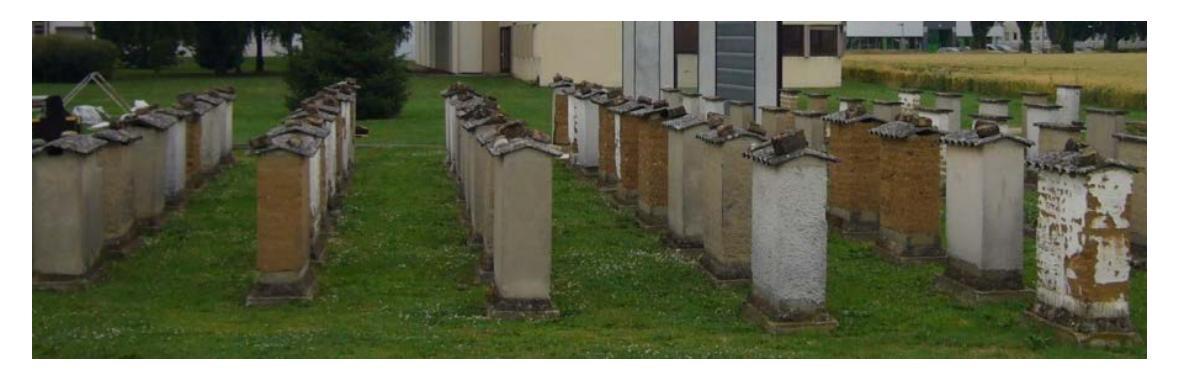
The wall specimens were built in 1985 (Figure 2) thanks to the Rexcoop program, controlled by the French Scientific and Technical Building Center (CSTB), near Grenoble, in a French Alpine valley, at an altitude of 212 m. The temperature of the site can vary from -20 °C to 38 °C for some particular years and its average varies from 2 °C to 20 °C. The annual rainfall is about 1000 mm, the direction of prevailing winds is NE-SW and the maximum wind speed is 21 m/s.

Figure 2. Rammed earth walls constructed and exposed for 22 years to natural weathering.

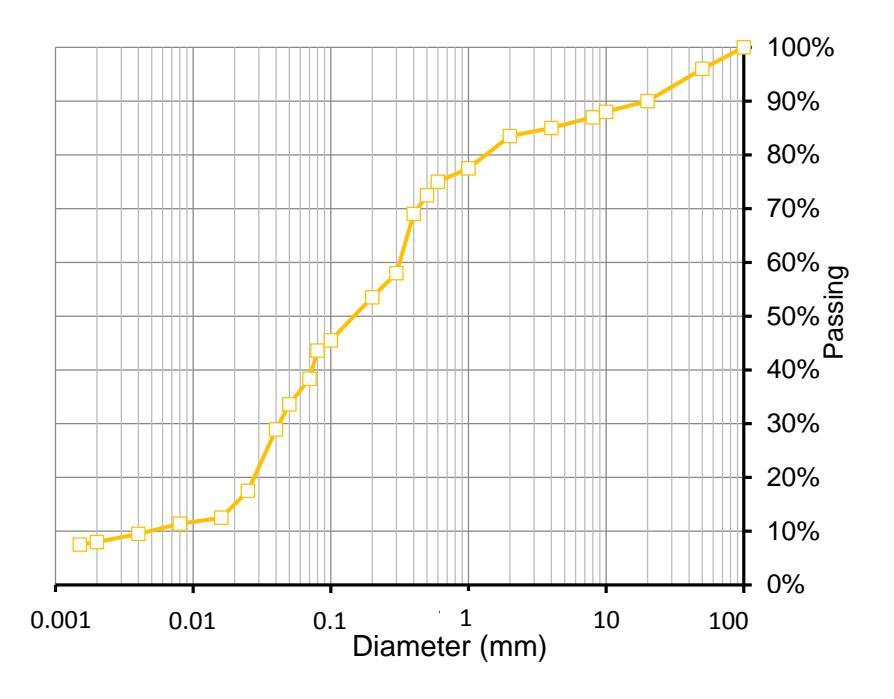
The rammed earth walls (1 m width \times 1.1 m height \times 0.4 m thickness) were manufactured on a concrete foundation with a 25 cm base exposed above ground level. A bituminous layer was painted on top of the base to prevent water from capillary rise penetrating into the RE walls. Local soil from a nearby site mixed with a cultivator was used for the RE walls. Three soils were used but in this study, only walls from one soil were investigated. Its grain size distribution is presented in Figure 3.

Figure 3. Grain size distribution of the used soil.

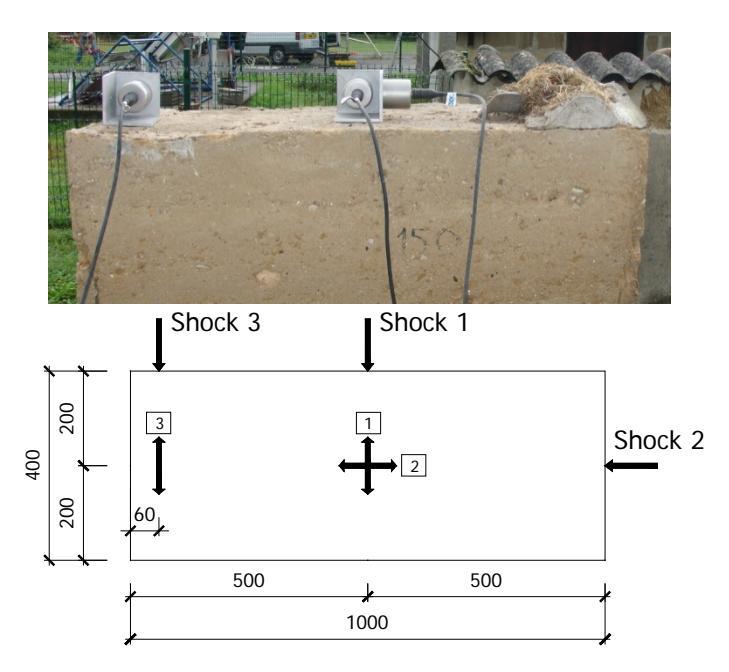
Three accelerometer sensors with a sensitivity of 1 μ g (with g being the gravity field equal to 9.8 m/s²) were placed on top of the wall (Figure 4): two sensors in the centre to measure two horizontal

accelerations following the two main axes of the wall; and another sensor on the edge to measure possible torsional movements.

The excitation consisted in a light shock (by a hammer) which was applied to the top of the wall. Three configurations were carried out (Figure 4, bottom): (1) a center shock following the transversal direction of the wall; (2) a center shock following the longitudinal direction of the wall; (3) an offset shock following the transversal direction. These configurations excite the possible vibration modes of the wall: transversal, longitudinal and torsional.

Figure 4. Arrangement of the sensors on the wall A (dimensions in mm).

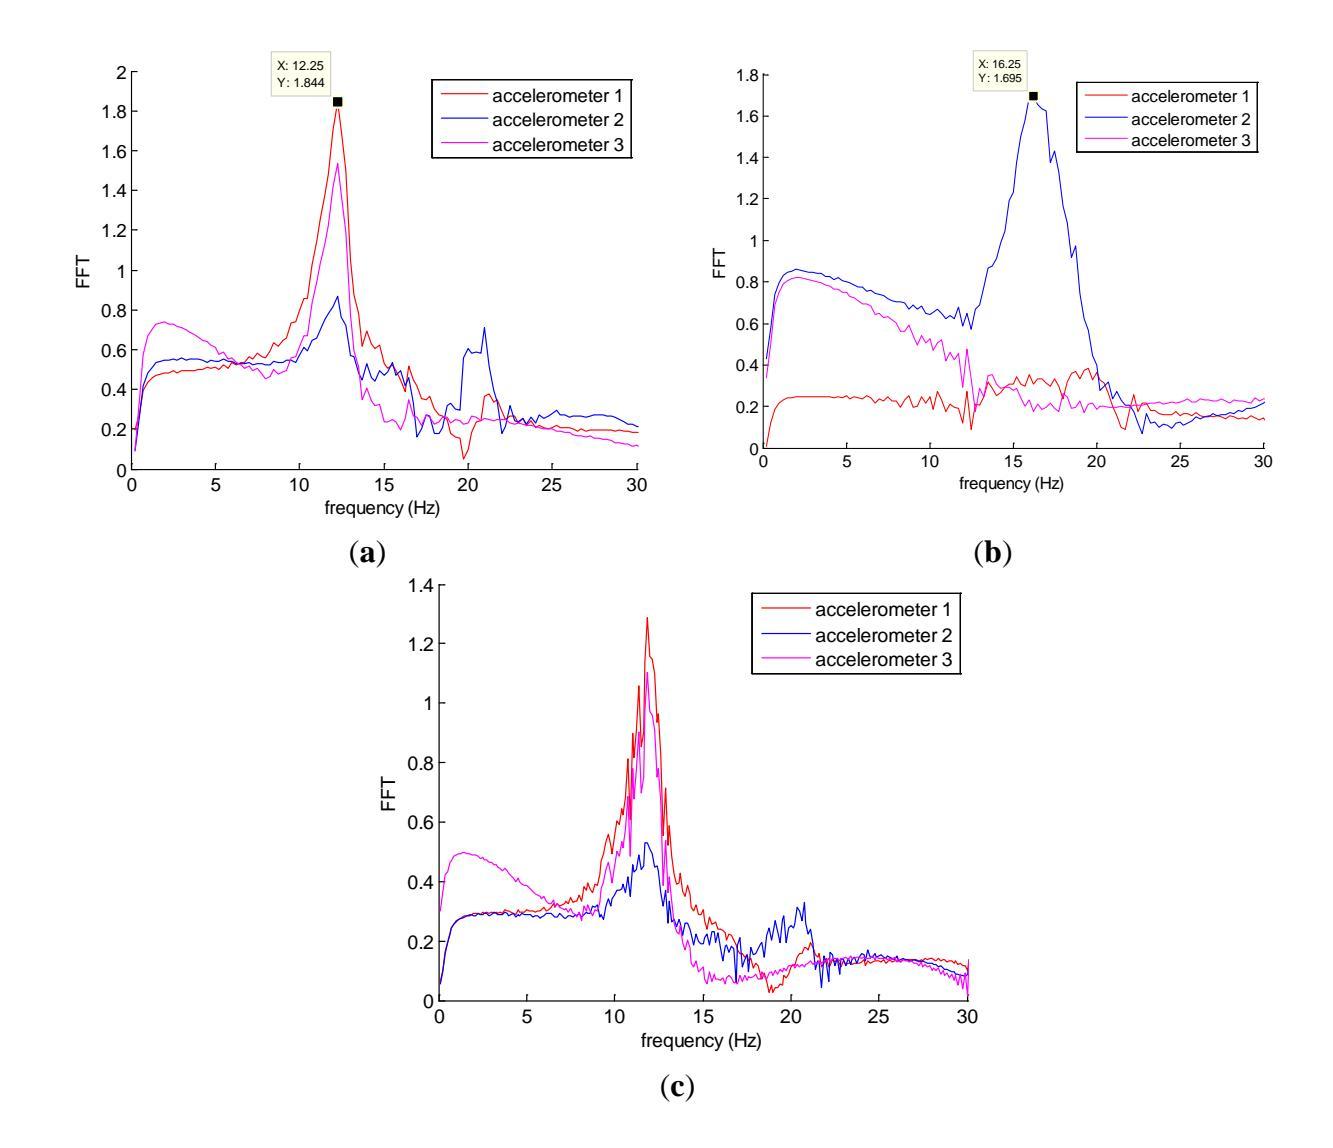
Figure 5 shows typical results obtained after a signal processing for the shocks 1, 2 and 3. Each peak corresponds to a modal frequency. In this case, the frequency of the first transversal mode is identified at 12.25 Hz. For shocks 1 and 3, sensor 2 does not give a clear signal because in these cases, excitations were perpendicular to the sensor 2; there was no major vibration in the wall's longitudinal direction. The result for sensor 3 is similar to that of sensor 1, since the torsion was not clearly captured (shocks were not important enough to solicit this mode). For shock 2, sensors 1 and 3 do not give significant information but sensor 2 captured the second vibration mode which is in the longitudinal direction. In this case, the second modal frequency is of 16.25 Hz. Results of two others walls are presented in Table 1.

Figure 5. A result of wall A induced by shock 1 (a); shock 2 (b); and shock 3 (c).Table 1. Frequencies measured and corresponding moduli identified by the model.

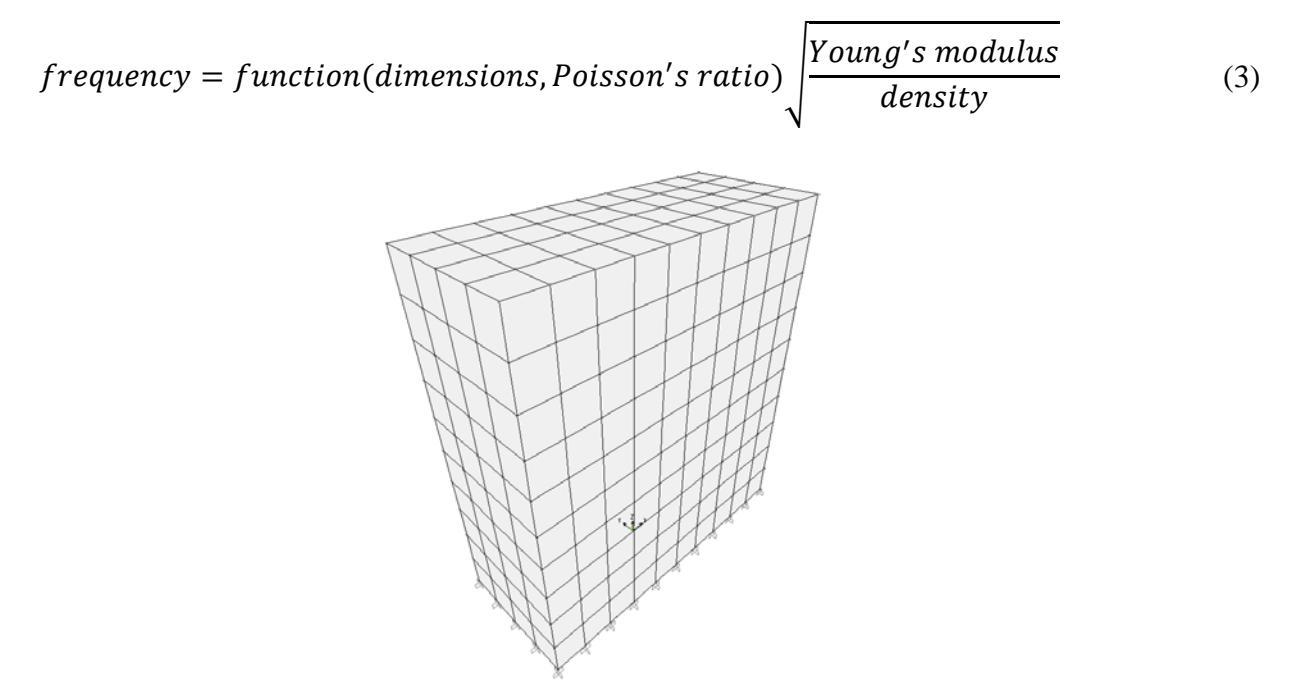
The walls are modelled with solid elements (Figure 6). Following the dynamic of structures theory, for given dimensions, the natural frequencies depend only on the density and the elastic characteristics of the material. For the modelling, the material was assumed isotropic (which is acceptable for dynamic measurements which were performed in very small strain [1]). The Poisson's ratio was taken of 0.22 following a previous study [7]. The nodes between the RE wall and the concrete foundation were restrained in translations. This boundary condition can be justified following the results presented

Figure 6. Wall A modelled with FEM.

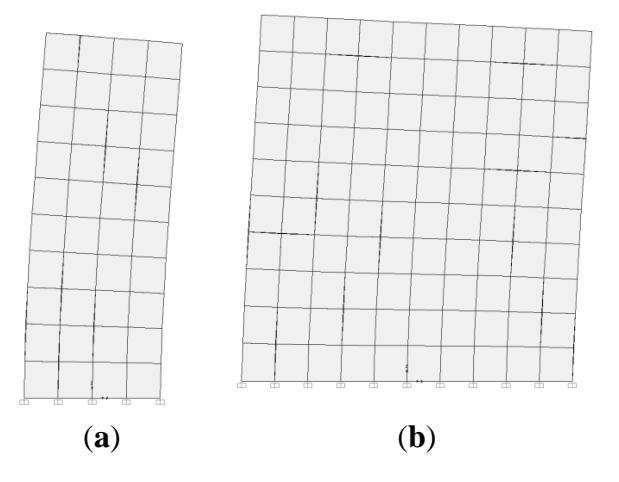
The dry density was measured in laboratory and will be presented in Section 3.2. The results of the identified modulus are given in Table 1. The first main modes of vibration are shown in Figure 7.

Figure 7. First vibration modes of the wall A. (a) First vibration mode, in the transversal direction; (b) second vibration mode, in the longitudinal direction.

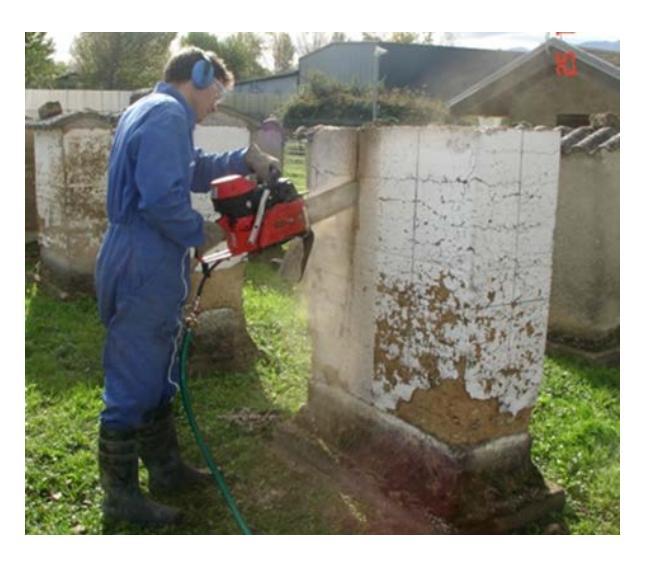
The specimens were taken from the walls using a chainsaw generally used to cut concrete and stones (Figure 8). Its blade was 30 cm long, meaning that the total thickness of the wall (roughly 41 cm) had to be cut in two steps. The disadvantages of using this method to take specimens are the generation of vibrations and the use of water, which can decrease the mechanical strength of the specimens, notably due to the splitting apart of the layers of earth.

Figure 8. Cutting a wall with chainsaw.

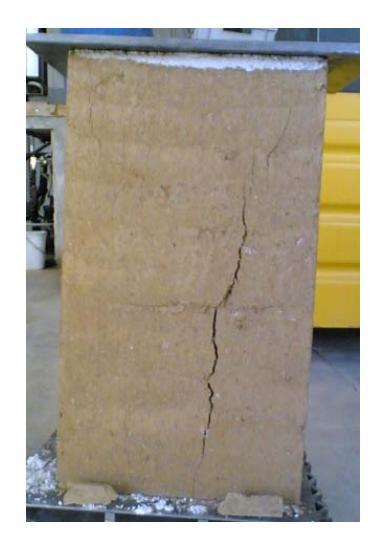
Discussions about the representativeness of specimens manufactured in laboratory were presented in the literature [1,9]. Indeed, to ensure a faithful representation of the *in-situ* wall material, the manufacturing mode and material used for laboratory specimens should be as identical as possible to those used *in situ*. The manufacturing water content and the compaction energy in the laboratory were chosen similar to that on site. The manufacturing water content was 10%. The specimens were rammed by an artisan of rammed earth with his pneumatic rammer. The dimensions of specimens tested in the direction perpendicular to the layers were 40 cm \times 40 cm \times 70 cm, with nine layers (Figure 9).

Figure 9. A specimen $(40 \times 40 \times 70)$ cm³ after the compression test.

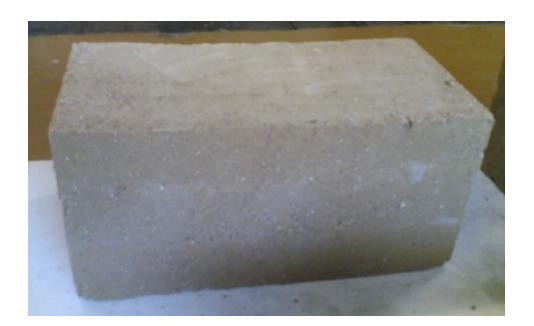
The specimens to be tested in the parallel direction were composed of three layers; their dimensions were 40 cm \times 40 cm and 20 cm high. Special attention was given during compaction of the last layer to obtain a surface that was as flat as possible. To achieve a slenderness ratio of 2, the specimens were then cut with a table saw. Two specimens ($40 \times 40 \times 20$) cm³ provided four specimens ($20 \times 20 \times 40$) cm³ for testing in the parallel direction (Figure 10). For specimens tested in the direction parallel to the layers, a surfacing was not necessary, because the two surfaces that were in contact with the formwork were sufficiently flat.

Figure 10. A specimen $(20 \times 20 \times 40)$ cm³ cut from a specimen $(40 \times 40 \times 20)$ cm³.
