# Article A Study of Frequency Domain Reflectometry Technique for High-Voltage Rotating Machine Winding Condition Assessment

Abstract: Detecting and locating local degradations at an incipient stage is very important for missioncritical high-voltage rotating machines. One particular challenge in the existing testing techniques is that the characteristic of a local incipient defect is not prominent due to various factors such as averaging with the healthy remainder, attenuation in signal propagation, interference, and varied operating conditions. This paper proposes and investigates the frequency domain reflectometry (FDR) technique based on the scattering parameter measurement. The FDR result presents the object length, wave impedance, and reflections due to impedance discontinuity along the measured windings. Experiments were performed on two commercial coils with artificially created defects. These defects include turn-to-turn short, surface creepage, loose coils, insufficient end-winding spacing, and local overheating, which are commonly seen in practice. Two practical water pumps in the field were also selected for investigation. The study outcome shows that FDR can identify a

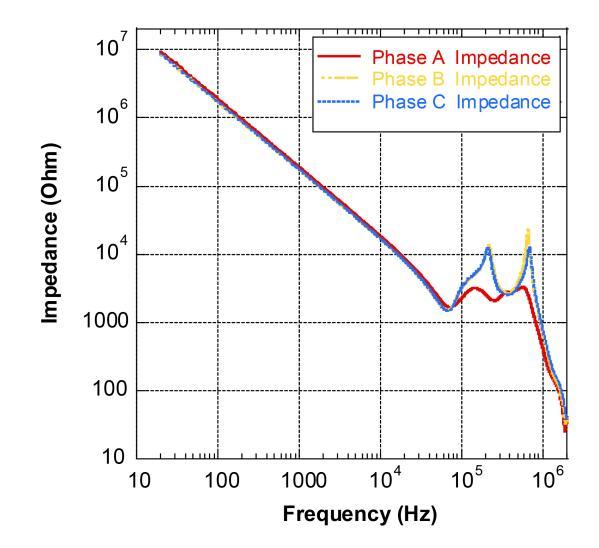
Figure 1. SFRA results of a motor.

The offline testing technique, sweep frequency response analysis (SFRA), has been successful in transformer winding mechanical condition evaluation [16]. However, its application for motor diagnosis is rarely seen in practice. Figure 1 shows an example

of SFRA testing results on a motor. The inductive property dominates most of the measurement frequency range. Extending the upper-frequency limit is required for winding deformation assessment. However, it is not feasible as the measuring technique in the radio frequency range is fundamentally different. Vibration and motor current signature analysis (MCSA) are two widespread mechanical condition monitoring techniques [17]. However, the machine design, sensor installation, and operating conditions (e.g., motor slip) also have a significant impact on the measurement results [18,19]. False indications, low sensitivity, and difficulty in fault interpretation are often encountered.

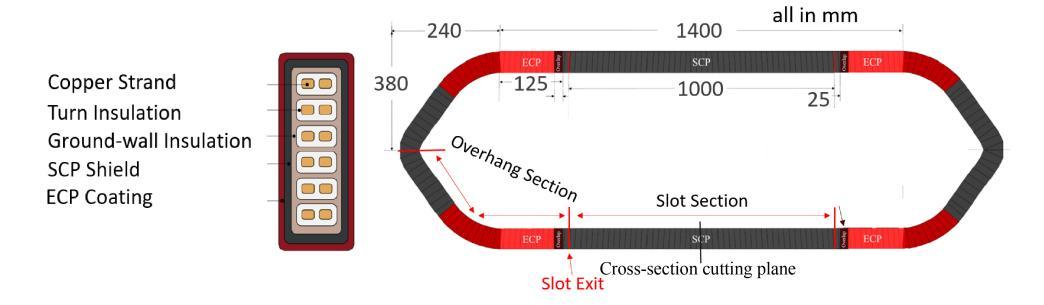
**Figure 2.** Structure and dimension overview of the stator coil under investigation—left: cross-section of the coil cut, right: coil geometry and dimension.

The structure of the stator winding coil rated at 6.6 kV is shown in Figure 2. There are six turns in total, and each turn consists of two copper strands. The overall length consists of two sections, the straight and overhang (end-winding) sections. Covering half of the coil, the straight section (wrapped by ECP and SCP) has a length of 1.4 m. The two overhang sections beside it amount to 1.0 m. The total coil length is 28.8 m, and the straight section length adds up to 16.8 m.

Most of the straight section is placed in the stator core slot; this part is wrapped with the conductive tape for slot corona protection (SCP). A stress-grading coating known as end corona protection (ECP), made from the nonlinear conduction of silicon carbide grains, is wrapped around the slot exit area. ECP reduces the local surface stress to prevent surface discharge around the slot exit area. The conductivity is negligible when the applied voltage is low but increases exponentially when the voltage approaches the nominal value [22]. With a high test voltage, the impact of ECP sometimes dominates the dielectric response and partial discharge activity, which makes the results interpretation difficult [23]. As the FDR testing uses a low voltage signal, the impact of ECP is not significant.

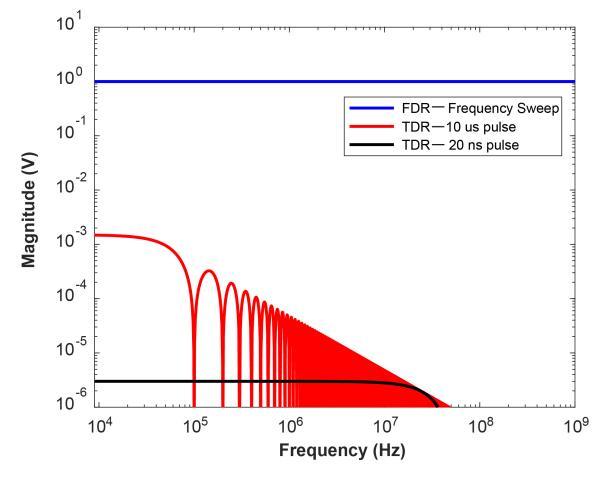
**Figure 3.** The spectra of the output signals: FDR frequency sweep signal with a magnitude of 1 V; two rectangular TDR pulses with the magnitude of 150 V, and pulse widths of 20 ns and 10  $\mu$ s, respectively.

The premium TDR instruments for field testing can output a voltage pulse with an adjustable width from 20 ns to 10  $\mu$ s and magnitude up to 150 V (e.g., Teleflex VX manufactured by Megger). The spectra of two rectangular pulses with a pulse width of 20 ns and 10  $\mu$ s, respectively, are shown in Figure 3. The voltage pulse with a larger pulse width contains more energy and travels further, but the spatial resolution decreases. As it takes a certain amount of time to launch the TDR pulse, there is a blind spot near the test terminal with a length from several meters to several hundred meters, depending on the pulse width [24], which is not suitable for measuring short objects.

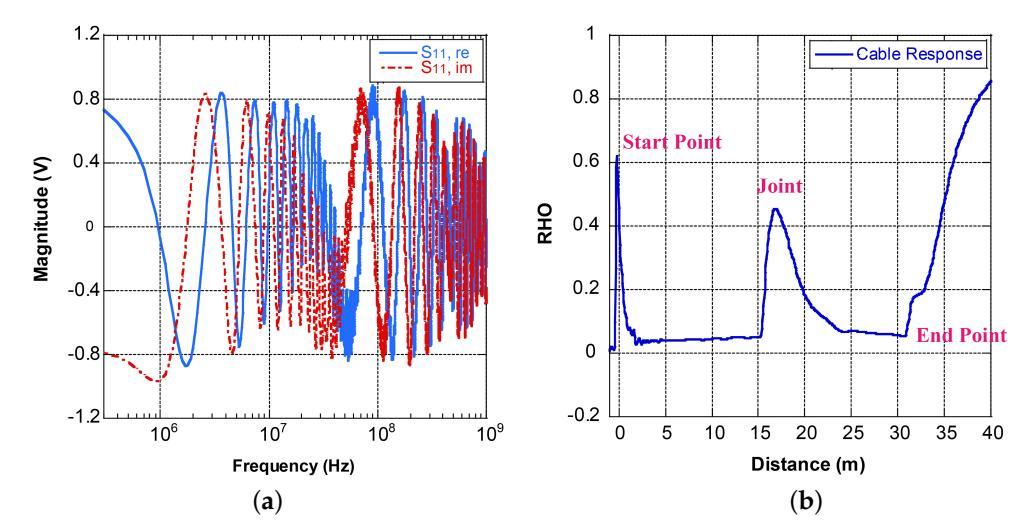
**Figure 4.** Illustration of the reflected signal: (**a**) frequency domain—voltage magnitude (or phase) vs. frequency, (**b**) time domain—magnitude vs. distance.

The FDR measurement is based on the vector network analyzer (VNA) technology. The instrument injects a series of sinusoidal voltages in a broad frequency range into the test object. The scattering parameter  $S_{11}$  is measured, which is defined as the ratio of the reflected voltage and incident voltage. Then, the data in the frequency domain

are transformed into the time domain to form a TDR-like display, as shown in Figure 4. The transformation can be achieved by the fast Fourier transformation (FFT) or chirp–Z algorithm [25,26]. Some commercial VNAs (e.g., Keysight M9800A) are integrated with the time domain analysis function, which performs the transformation automatically after the  $S_{11}$  data are obtained. The TDR-like display provides a more intuitive representation of the discontinuities in the test object. The distance is calculated by multiplying the time (x-axis after transformation) by half of the wave propagation speed. The FDR resolution and range are given by the following equations [27]:

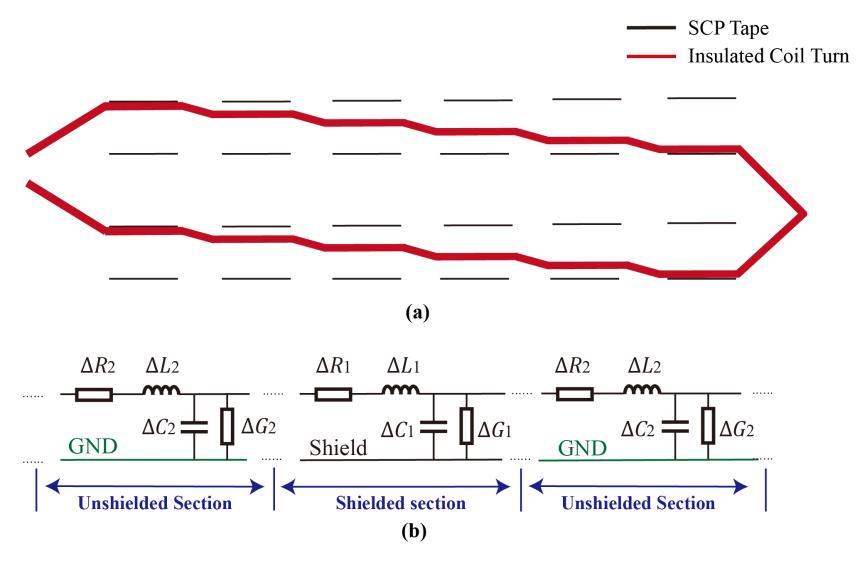
**Figure 5.** Transmission line model of the winding coil: (**a**) equivalent geometry, (**b**) lumped circuit elements.

In the RF frequency range, the wavelength of the injected signal is comparable with or shorter than the physical size of the test object. Thus, the transmission line model with distributed circuit elements has to be used for results analysis. The transmission line model of the winding coil is illustrated in Figure 5. Each section of four elements  $\Delta R$ ,  $\Delta L$ ,  $\Delta C$ , and  $\Delta G$  represents an infinitesimally short length of the shielded or unshielded section, which is then cascaded to the actual length. The circuit elements of the shielded and unshielded sections are different. This leads to the periodic change of the wave propagation mode along the coil.

FDR results interpretation is based on comparison. The comparison can be made over time, using three phases, or between apparatus of a similar type. The complex coil geometry, as shown in Figure 5, makes the precise transmission line model very difficult to establish. The simplified model does not take the capacitive coupling between coil turns into consideration. It is fortunate that the impact of the coupling does not cause problems in identifying and locating the defects. The coupling will be further studied in the simulation software (e.g., COMSOL Multiphysics 6.1).

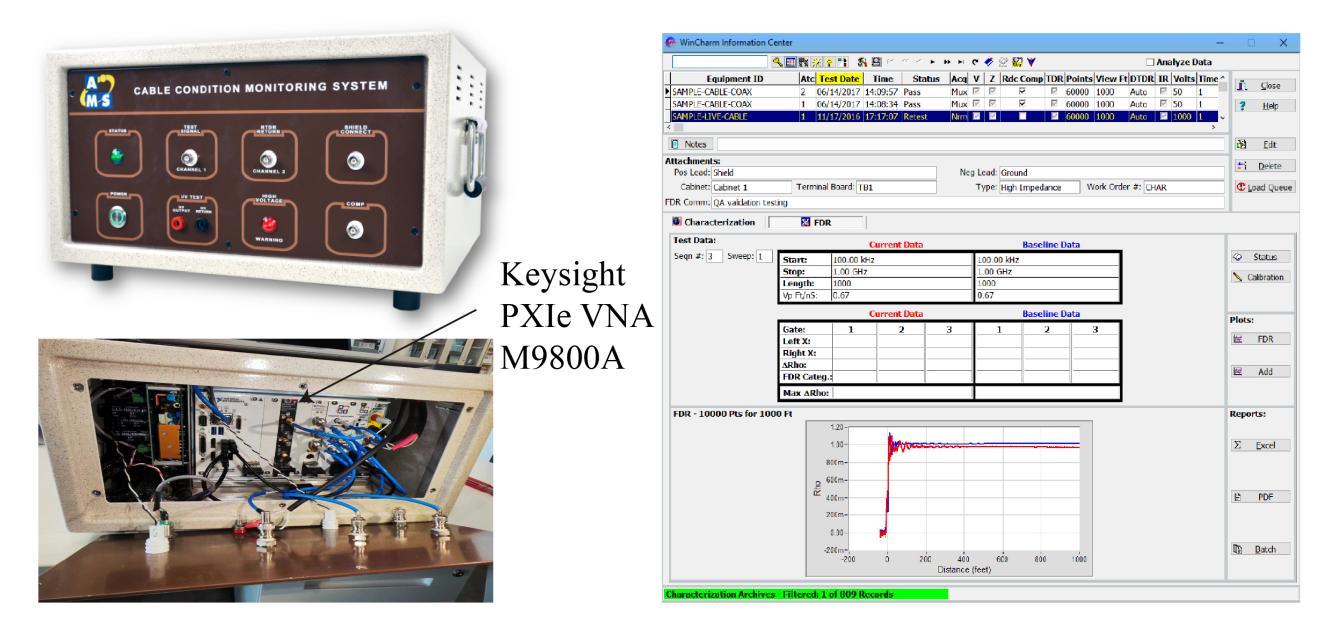
Figure 6. AMS CHAR system hardware and software.

The instrument used in this project is the CHAR system manufactured by the Analysis and Measurement Corporation (AMS), as shown in Figure 6. The high–performance Keysight M9800A VNA module is the key hardware for the  $S_{11}$  measurement. The Win-Charm V4.1 software automatically performs the transformation and presents the TDR-like results after the measurement. The frequency range of M9800A is 9 kHz to 4.5 GHz, and the typical system dynamic range reaches 140 dB. The dynamic range is defined as the source maximum output power minus the receiver noise floor. It is an important parameter as signals lower than the noise floor cannot be measured by the VNA. The higher dynamic range improves the measurement sensitivity and accuracy, which is suitable for unshielded object testing.

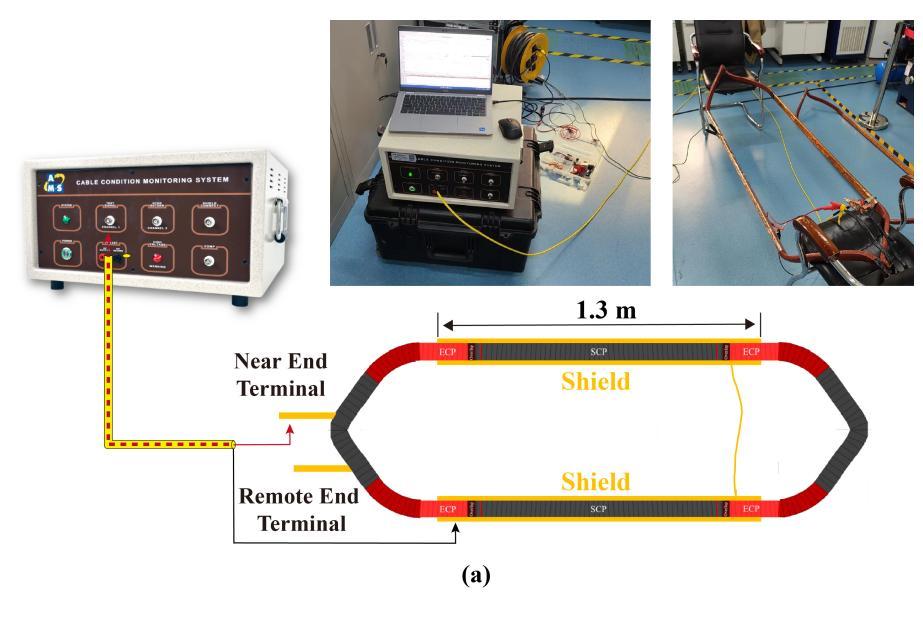
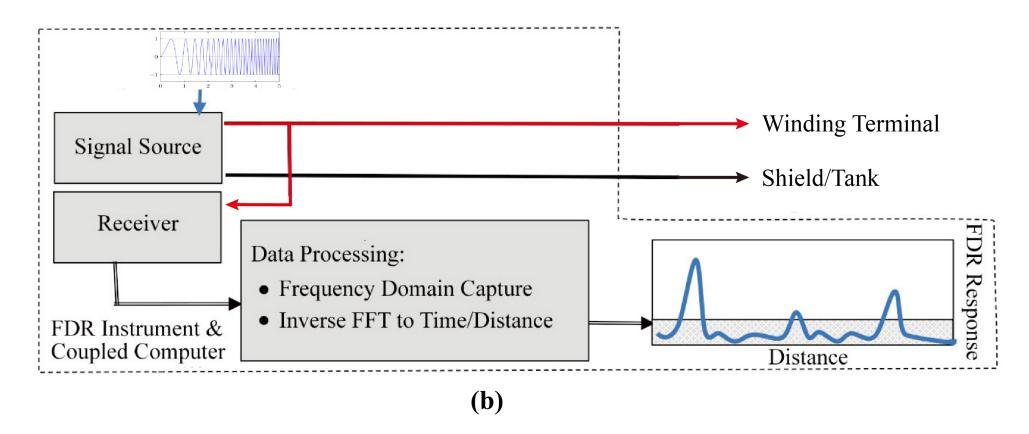
Figure 7. FDR measurement setup for the stator coils: (a) connection diagram, (b) schematic diagram.

The experimental setup for the stator winding coils is shown in Figure 7. The straight sections were wrapped with the copper tape and grounded. The shielded and unshielded lengths for each turn were 2.6 m and 2.2 m, respectively. The test signal was injected into one of the coil terminals via a coaxial cable. The FDR instrument ground, coaxial cable shield, and the copper tape shared the same ground. The software had a calibration function to reduce the impact of the test lead. By performing a test with the test object unconnected and test clips shorted, the test lead length was recorded and automatically compensated for the successive measurements.

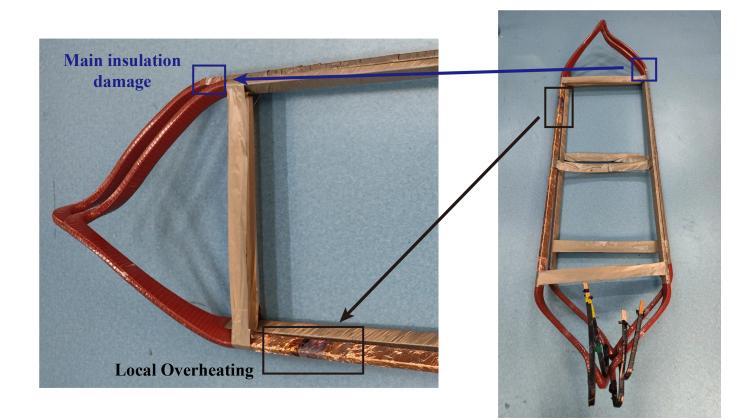
Figure 8. Artificially-made winding coil degradations.

Five typical faults that are commonly seen in practice [33] were artificially-created in the coils:

- End-winding discharge caused by main insulation damage, physically located at 2.4 m from the near end terminal;
- Turn-to-turn short between the first and second turns, physically located at 2.4 m (first turn) and 7.2 m (second turn) from the the near end terminal;
- Loose coil, simulated by loosening copper shield by 20 cm, physically located at 4.5 m from the near end terminal;
- Local overheating at 3.5 m from the near end terminal;
- Tracking between coils at the winding-end section, between the remote end terminal
  of the first coil and the overhang section of the second coil.

The end-winding discharge usually happens at the core exit area due to the ECP problem. The spot adjacent to the shield (2.4 m from the near end terminal) was selected as the discharge location. The insulation coating of the first turn was scratched to simulate the fault. For the short turn-to-turn fault, the spot below the damaged insulation of the first turn was selected. Overheating is more likely to happen within the slot, so the spot 3.5 m from the near end terminal was selected, as shown in Figure 8. A low resistive path from the conductor to the shield was created for the end-winding discharge and tracking between coil faults. For the shorted turn-to-turn fault, two adjacent coil turns were connected by a thin wire.

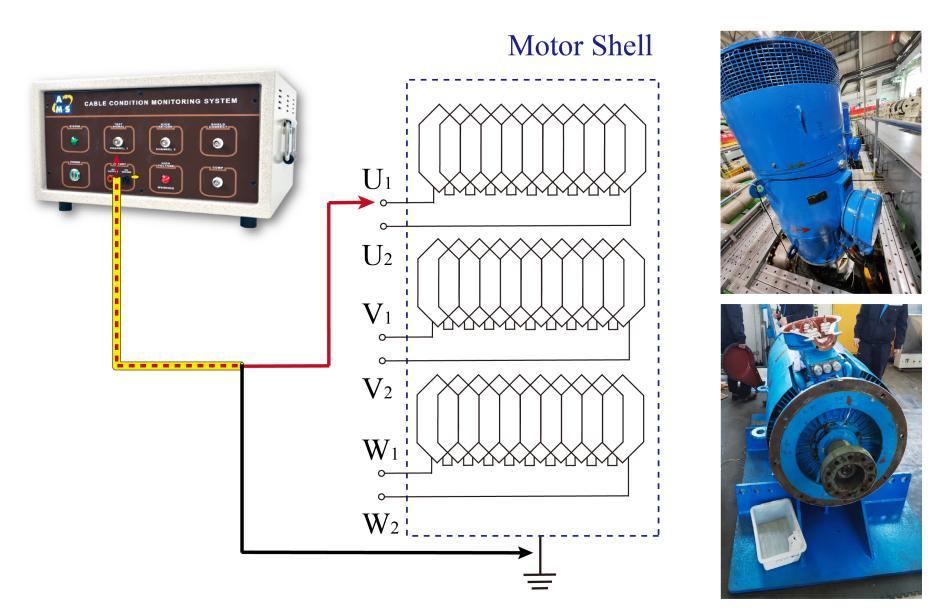
Figure 9. Schematic diagram of motor FDR testing in the field.

The distributed elements  $\Delta L_1$ ,  $\Delta L_2$ , and  $\Delta C_2$  of practical machines are not identical to the individual coils due to the existence of the stator core and shell. The core permeability is much higher than that of air at power frequency but decays to a low level in the radio frequency range [34]. The overhang sections are also shielded by the machine shell. Two water pumps of the same type in a nuclear power plant were also tested during the outage.

These pumps were manufactured by Safonovo Russia in 2002. The voltage rating was 6 kV, and the power rating was 250 kW. The pumps were aged but passed all routine testings. The test clips were connected to the phase terminal and shell ground from the terminal board, as suggested in Figure 9. Either phase terminal could be selected, with the other open (floating) or short to ground.

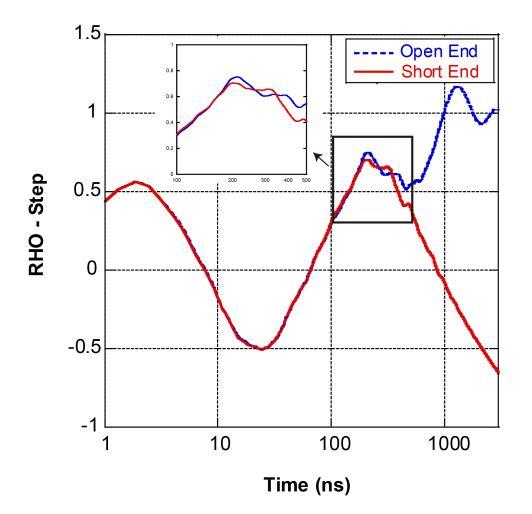
**Figure 10.** Step response of the coil in good condition—blue trace: remote end open, red trace: remote end short.

The coil in good condition was measured by the CHAR system as the first step. The voltage was injected to the near end terminal, with the far end terminal open and shorted to ground (shield), respectively. The time–magnitude results are shown as the step response in Figure 10 and the impulse response in Figure 11. The traces with the far end terminal open and short, respectively, start to diverge after 161 ns, which indicates the location of the remote end. The deviation can be observed clearly from the traces of the step response and impulse response with the logarithm scale y-axis. The impulse response with the linear scale y-axis needs to be magnified significantly before the differences can be observed. As a result, the step response and impulse response in the logarithm scale are selected for results presentation.

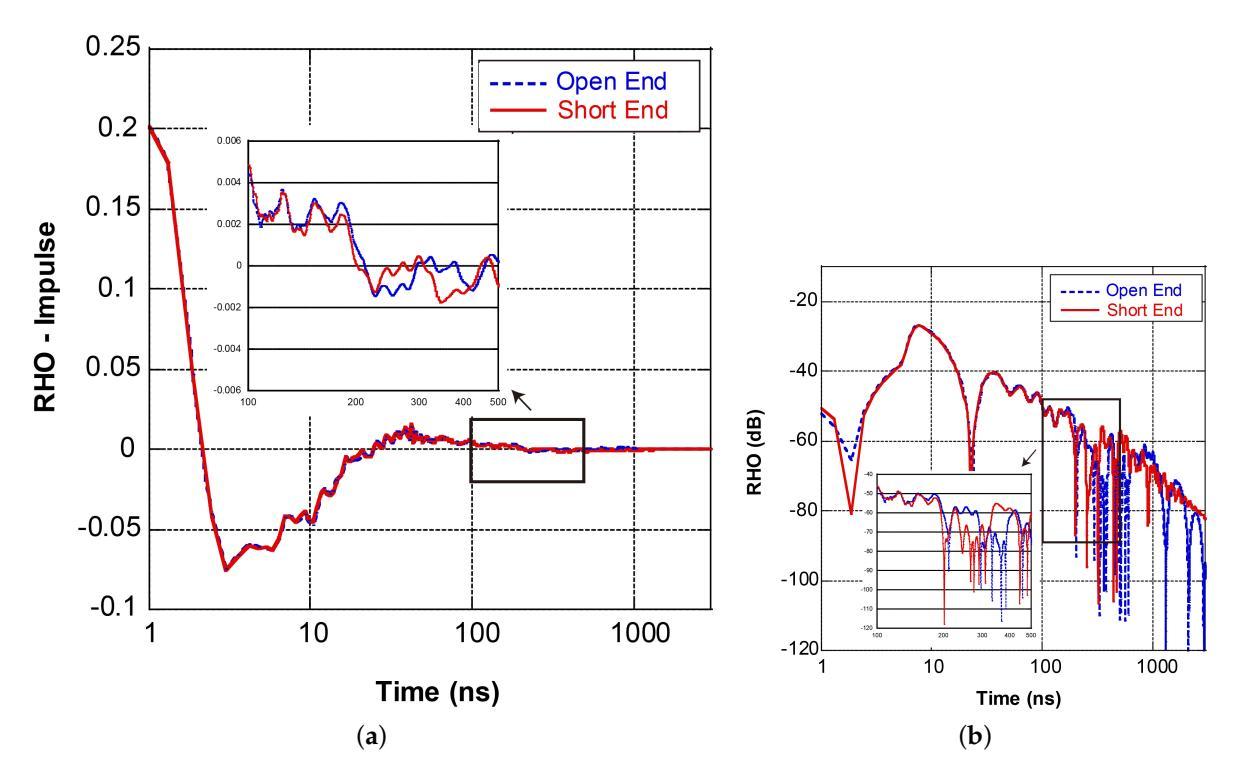
**Figure 11.** Impulse response of the coil in good condition: (**a**) y-axis in linear scale, (**b**) y-axis in logarithm scale.

Given the designed coil conductor length of 28.8 m and the shielded section length of 15.6 m, the reflection at 161 *ns* indicates that the wave propagates with an average speed of 179 m/µs. If the propagation speed in the unshielded section is assumed to be equal to the free-space light speed, then the propagation speed in the shielded section would be 133 m/µs. This implies that the relative permittivity of the epoxy–mica insulation  $\varepsilon_r$  is around 5, which is a reasonable value. Multiplying the x-axis data (time) with the average propagation speed (179 m/µs) changes the x-axis into distance starting from the test terminal.

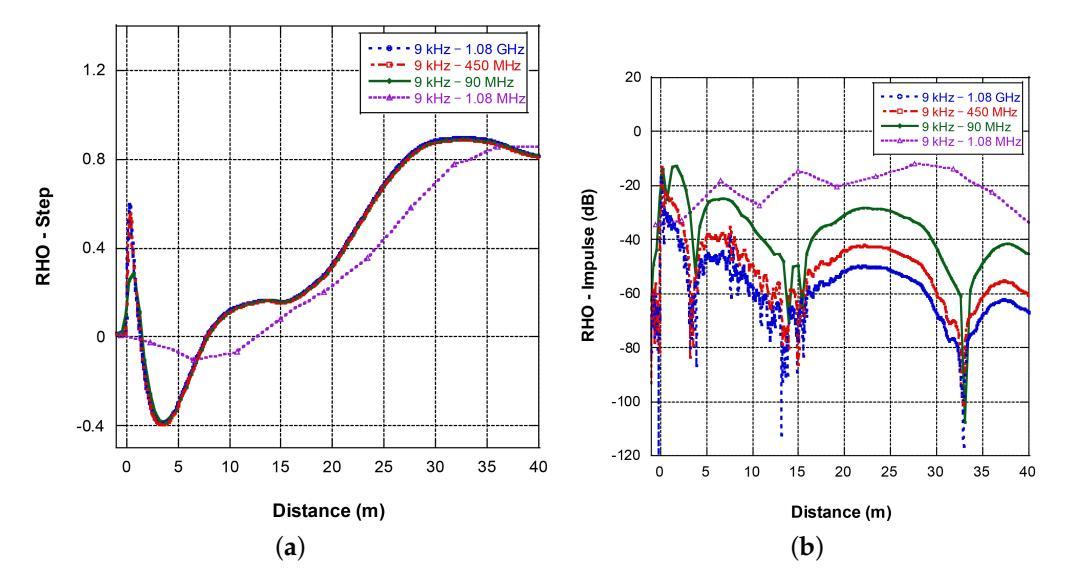
**Figure 12.** Impact of the test frequency band on the FDR results (the x-axis is changed to distance by multiplying the propagation speed): (**a**) step response, (**b**) impulse response in logarithm scale.

The frequency bandwidth has a significant impact on the measurement results [35]. The test frequency range of the M9800A VNA module is 9 kHz–4.5 GHz. The ideal transformation requires precise frequency domain measurement performed from DC to  $+\infty$ . Applying a higher upper frequency limit improves the spatial resolution, i.e., the sensitivity of identifying minor discontinuities, but the magnitude of the reflected voltage is more attenuated. After the reflected voltage drops below the noise floor, the discontinuity cannot be detected anymore, and a transformation error might occur. Figure 12 shows the time–transformed results using four frequency bands. The step response traces become almost identical after the upper frequency limit reaches 90 MHz. The 9 kHz–90 MHz impulse response trace has a similar trend to the traces of a broader bandwidth. However, minor variations are not observable. The 9 kHz–450 MHz trace provides the same details as the 9 kHz–1 GHz while exhibiting less attenuation, so the 9 kHz–450 MHz frequency band was selected for the subsequent experiments.

Compared with TDR, FDR has the advantages of higher output energy, a broader frequency bandwidth, and a very high dynamic range can be achieved. These advantages make it ideal for testing short and/or unshielded objects. Using a higher upper frequency limit is helpful in detecting minor condition changes, but higher–frequency components suffer more propagation attenuation. If the reflected signal magnitude attenuates below the noise floor, a transformation error might occur. In the experiment, four different frequency bands were compared, and a suitable one (9 kHz–450 MHz) was selected.

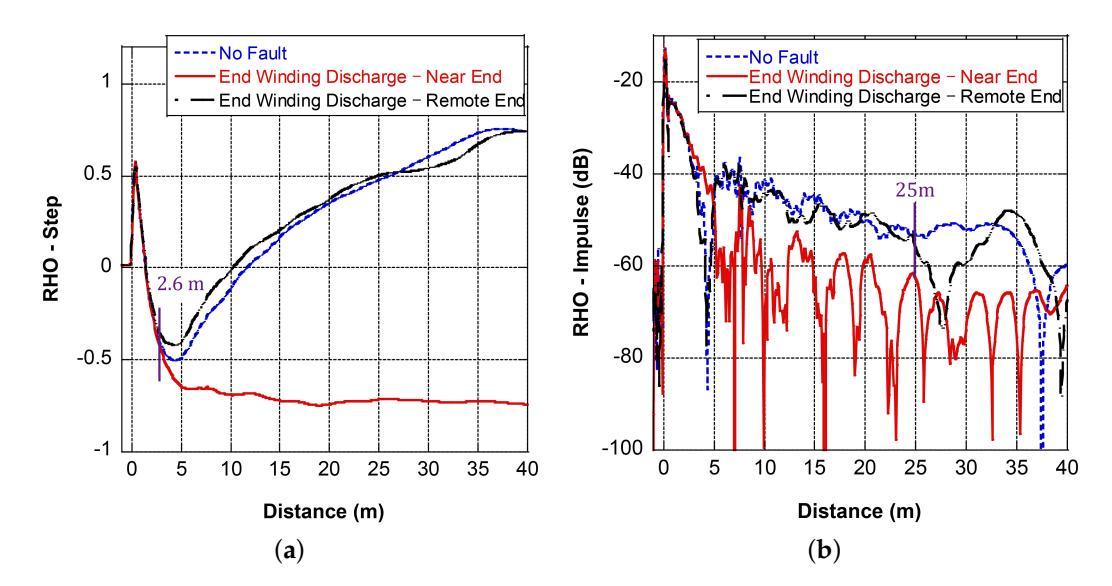
**Figure 13.** FDR results of the coil with the end-winding discharge fault, measured at the near end and remote end terminal, respectively: (**a**) step response, (**b**) impulse response in logarithm scale.

End-winding discharge can happen due to ECP degradation, insulation aging, or contamination. A low resistive path from the coil conductor to shield was created at the location approximately 2.4 m from the near end terminal. FDR measurements were then performed at the near end and remote end terminal, respectively, and the results are shown in Figure 13. The step and impulse responses of the near end measurement show that the fault distance is 2.6 m from the near end terminal. For the remote end measurement, the most remarkable deviation in the impulse response starts at 25 m (equivalent to 3.8 m for the near end measurement). This characteristic is more prominent when the measurement is performed at the near end terminal, which is closer to the fault location.

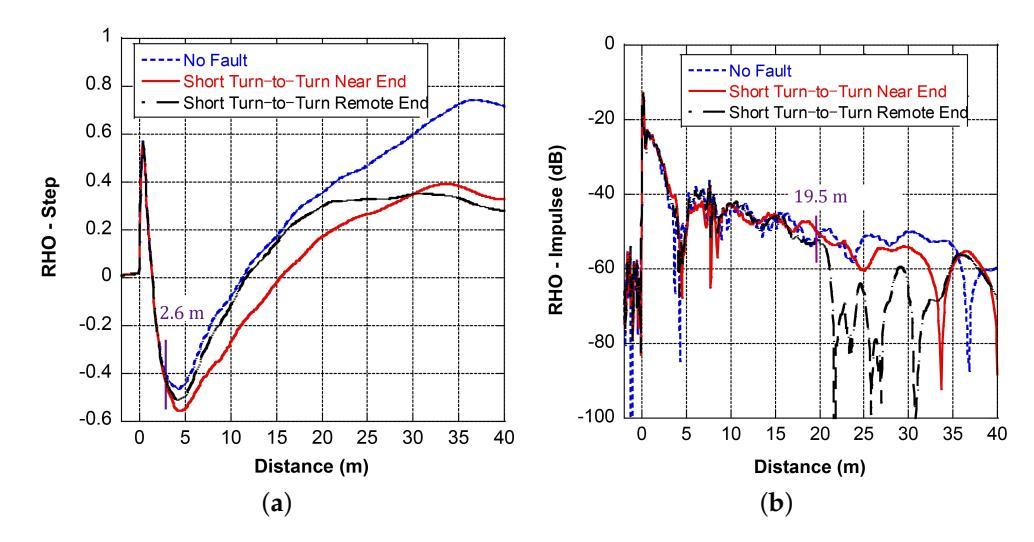
**Figure 14.** FDR results of the coil with the short turn-to-turn fault, measured at the near end and remote end terminal, respectively: (a) step response, (b) impulse response in logarithm scale.

Stresses due to transient overvoltage in the supply are a factor that contributes to turn-to-turn short failure over time [36]. The first and second coil turns were shorted at 2.4 m and 7.2 m, respectively. The corresponding FDR results are shown in Figure 14. The existence of the fault can be clearly observed from both the near end and remote end measurement results. The response has an obvious drop in magnitude at the fault location, and the apparent coil length is reduced. Although the deviation in the step response trace of the remote end measurement begins at around 17 m, the trend deviation starts at 21 m, which is very close to the actual value. The impulse response shows an obvious deviation at 19.5 m.

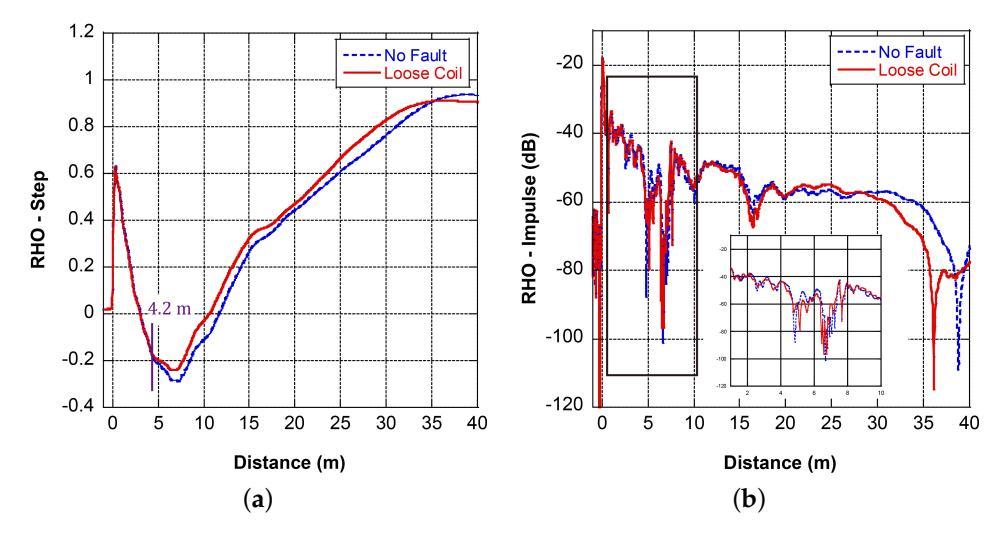
**Figure 15.** FDR results of the coil with the loose slot wedge defect: (**a**) step response, (**b**) impulse response in logarithm scale.

The loose slot wedge and SCP coating abrasion can happen due to machine vibration. This fault was simulated by loosening the copper tape in a 20 cm section, starting from the location of 4.5 m. In such a fault condition, the distributed capacitance reduces, so the wave impedance increases. As suggested by the results shown in Figure 15, the step response magnitude increases at the fault location. The impulse response exhibits some mild changes at the fault location, but the apparent coil length becomes shorter as the propagation speed increases.

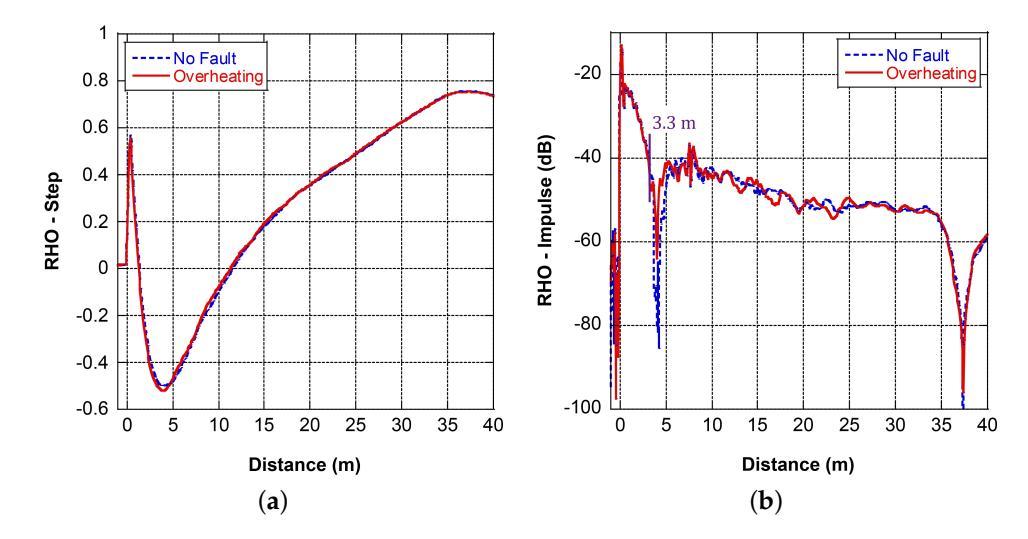
**Figure 16.** FDR results of the coil with the local overheating defect: (**a**) step response, (**b**) impulse response in logarithm scale.

Local overheating thermally stresses the winding insulation, contributing to main insulation delamination. A small segment in the shielded section was heated by burning. The IR results before and after overheating changed from 187.3 G $\Omega$  to 127.8 G $\Omega$ . The insulation resistance of this coil is quite high as it does not have the ECP coating (the coil with ECP had been damaged for the previous fault experiment). The resistance change might be negligible if the ECP coating (a small parallel resistor) would be present. A periodic oscillation pattern is observed from the impulse response trace as shown in Figure 16 because there are six overheated spots. The apparent coil length remains constant, and the change in the step response is minor.

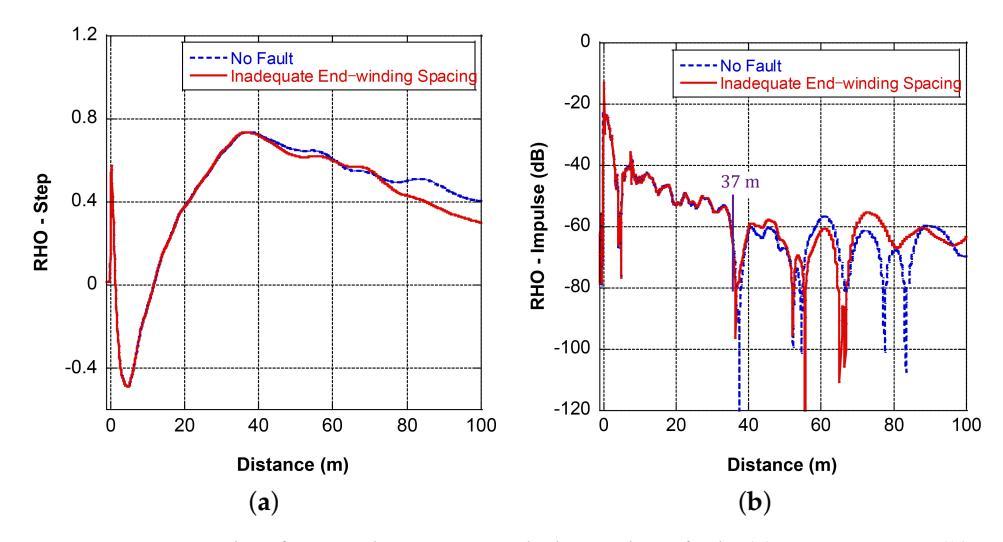
**Figure 17.** FDR results of two coils in series with the tracking fault: (**a**) step response, (**b**) impulse response in logarithm scale.

Tracking between coils can happen due to insufficient spacing between end windings and/or contamination. In the experiment, two coils were connected in series, and a low resistive path was created between two overhang sections of each coil. Figure 17 indicates that the fault changed both the step and impulse responses at the tracking spot.

Table 2 is a summary of the FDR testing results of the winding coils with various defects. The diagnosis of the FDR results is based on the changes in the magnitude and apparent coil length. The FDR has good sensitivity in identifying most defect types, except the local overheating. The deviation caused by local overheating can be observed, but the magnitude difference is not prominent. All the fault locations on a single coil are correctly identified. The tracking between coils creates a high–resistance parallel branch in parallel with the original circuit. The pattern starts to change from the location of 28.8 m, but the difference before 37 m is too small to be treated as a defect.

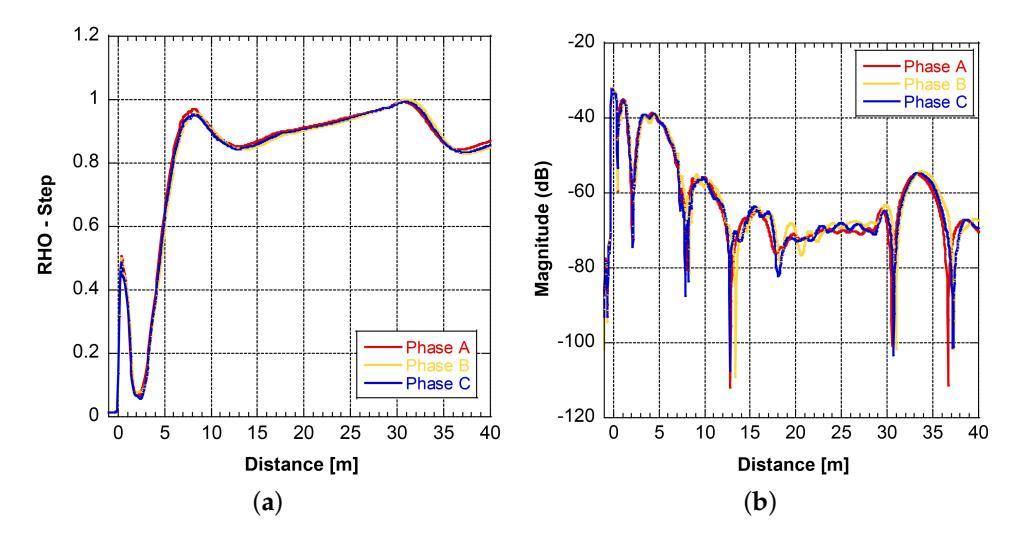
**Figure 18.** Three–phase FDR results of pump #1: (**a**) step response, (**b**) impulse response in logarithm scale.

Two water pumps were removed from service for maintenance. The distributed circuit elements of practical machines are different from the individual coils because all the winding sections are shielded, and the core material has a higher permeability. These pumps had been used in a harsh environment for around 20 years. FDR measurements were performed on three phases, as illustrated in Figure 9. Results are shown in Figures 18 and 19. The total conductor length of each phase was approximately 30 m. One more reflection peak was observed from the pump results compared to the coils, which could be the core impact.

Despite the long service period of these pumps, the good agreement of the three–phase results suggests that the health condition is good. Because it is very rare that the three phases are all deteriorated to the same extent, this supports the decision to place these pumps back in service. Connector-like reflections exist at the locations of 18 m for Phase B of Motor #1 and 9 m for Phase C of Motor #2. Trending will be helpful for decision–making after successive measurements are performed.
