# Effects of Multi-Pass Friction Stir Processing on Microstructures and Mechanical Properties of the 1060Al/Q235 Composite Plate

**Abstract:** Steel cuttings, holes and cracks always exist at the interfaces in the composite plate. Multi-pass friction stir processing (M-FSP) is proposed in this research to optimize the interface microstructure and the interface connection for the 1060Al/Q235 composite plate. Results show that the microstructures of 1060Al after M-FSP are fine and uniform owing to the strong stirring effect and recrystallization. Micro-defects formed by the welding can be repaired by the M-FSP. However, tunnel defects can also be formed in the matrix of aluminum by M-FSP, especially when the passes are one and two. The melting block and the melting lump in the composite plates are easy to become the source of crack. The shear strengths and the bending properties for the 1060Al/Q235 composite plate after M-FSP are the best when the passes are three, with the tool rotation speed of 1200 rpm and the forward speed of 60 mm/min. The optimized interfaces for the composite plate after M-FSP are mainly by the metallurgical bondings, with a certain thickness and discontinuou

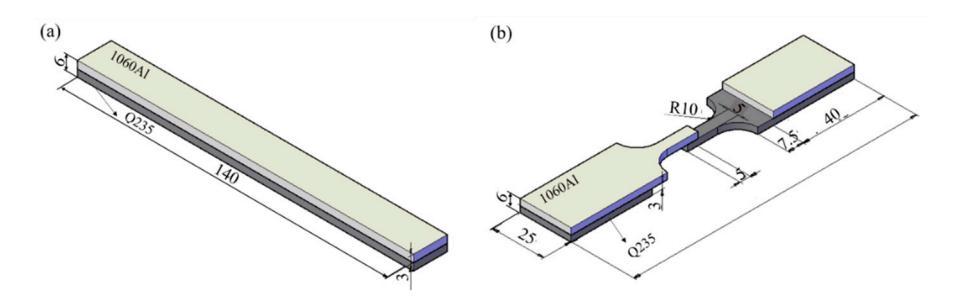
Figure 1. Dimensions of mechanical samples: (a) bending specimen and (b) shear specimen (unit: mm).

Based on the GB/T2651-2008 and the GB/T232-2010 standards, the shear specimens and the bending specimens were designed, as shown in Figure 1. Three shear testing samples and two bending testing samples were tested for each group in order to give a better reliability for the testing datum.

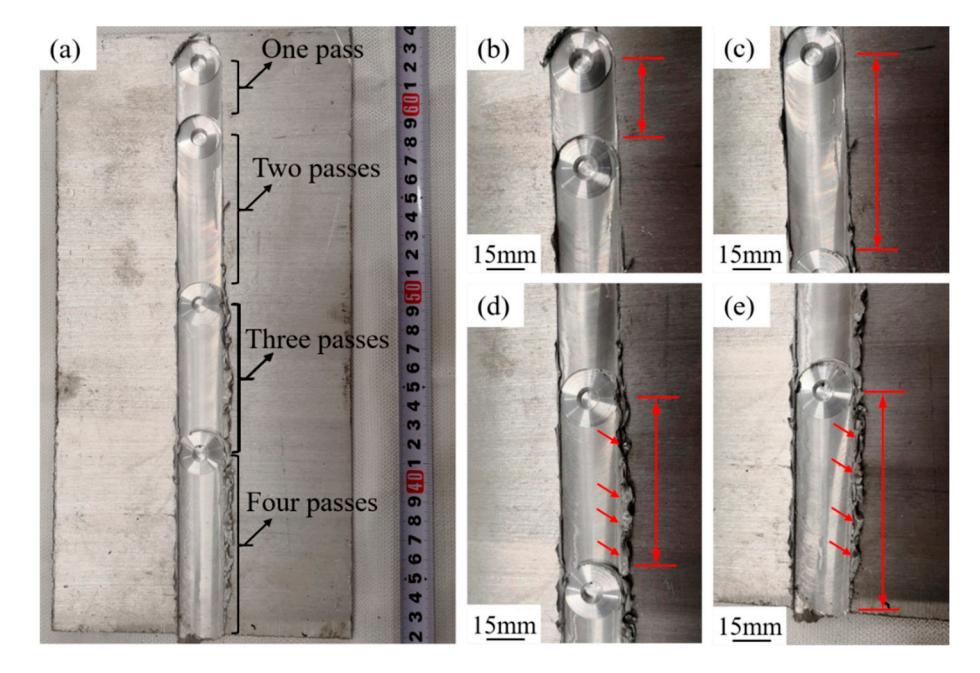
**Figure 2.** 1060Al/Q235 composite plate after multi-pass friction stir processing (M-FSP) with different passes: (**a**) 1060Al/Q235 composite plate after M-FSP; (**b**) single pass; (**c**) two passes; (**d**) three passes; (**e**) four passes.

Figure 2 shows the 1060Al/Q235 composite plate after M-FSP with different passes. The repair zone for the 1060Al/Q235 composite plate after M-FSP with different passes are well-formed with no defects in it. However, with the increase of pass, especially for the passes are four, there shows obvious toe flashes after friction stir processing, as shown in Figure 2e with the red arrows. Beside this, according to the continuous axial force resulting in the toe flashes after M-FSP, the thickness of the aluminum plate becomes thinner gradually. Therefore, only four passes friction stir processing have been applied in this study.

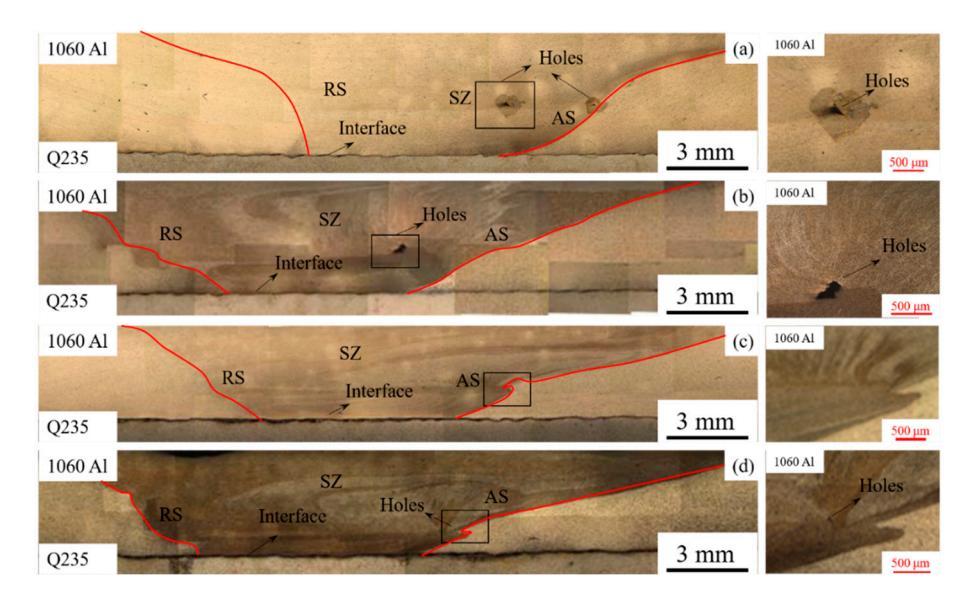
**Figure 3.** Microstructures of the repair zone for 1060Al/Q235 composite plate after M-FSP with different passes: (**a**) single pass; (**b**) two passes; (**c**) three passes; (**d**) four passes.

Figure 3 shows low-magnification OM images of the repair zone for the composite plate after M-FSP. Holes can be observed in the repair zone. The repair zone appears a shape of basins. The right place of the stirring zone (SZ) is the advancing side (AS) while the left place is the retreating side (RS).

The AS presents an abrupt "zigzag line" boundary distinctly and the RS is in a shape of a gradual change. This is because the temperature and flow fields on the AS are different from those on the RS [30–33].

Meanwhile, holes are clearly seen in Figure 3. For the single-pass FSP (Figure 3a), the area of the large hole is  $9.8 \times 10^3 \ \mu\text{m}^2$  and the smaller one is  $3.4 \times 10^3 \ \mu\text{m}^2$ . However, just one single hole is found in Figure 3b with the area of  $12 \times 10^3 \ \mu\text{m}^2$ . Although the area of the single hole increases, the total areas of the holes decrease. It is confirmed that the numbers and areas of the holes have been repaired by the plastic flow of aluminum after M-FSP. The hole disappears by the influence of repair for the plastic flow in aluminum when the passes of M-FSP are three, as shown in Figure 3c. However, when the passes of M-FSP are four, the hole appears again in the AS area (Figure 3d). Since the distances of these holes from the interface are nearly the same, these holes are the tunnel defects resulted after FSP. The areas of tunnel defects in repair zone with different passes are shown in Table 2. Therefore, with the increase of passes, the tunnel defects decrease. It can be concluded that M-FSP can also repair tunnel defects created by single-pass M-FSP.

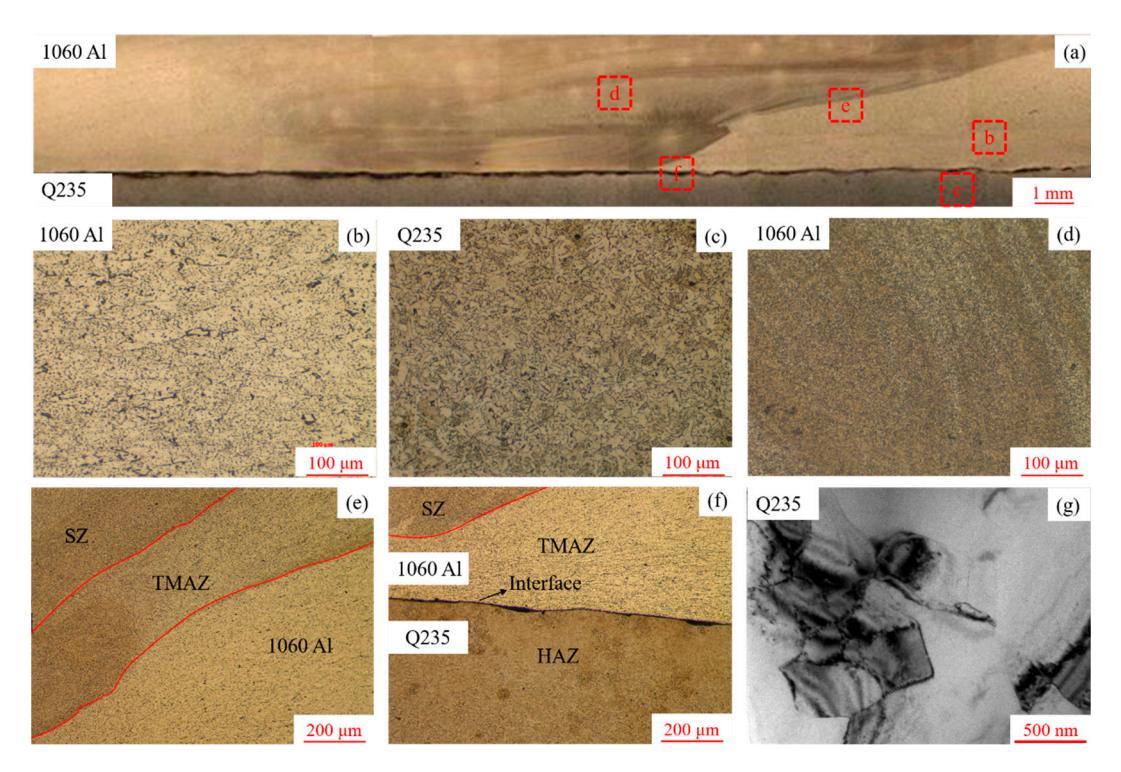
**Figure 4.** Microstructures of composite plate after friction stir processing (FSP) with different passes: (a) repair zone; (b) base metal (BM) of aluminum; (c) BM of steel; (d) stirring zone (SZ); (e) thermo-mechanical affected zone (TMAZ) in the aluminum side; (f) heat affected zone (HAZ) in the steel side and (g) transmission electron microscopy (TEM) image near the interface.

Figure 4 shows microstructures of the 1060Al/Q235 composite plate after FSP with different passes. The microstructures of base metal (BM) for the 1060Al are  $\alpha$ -Al (Figure 4b). The microstructures of BM for Q235 are ferrites and pearlites (Figure 4c). Compared with BM for 1060Al, the grains of repair zone for 1060Al are refined by the stirring effects of M-FSP (Figure 4d). The grain size of 1060Al after M-FSP is about 3.6 µm, much smaller than that before M-FSP (22.6 µm). Meanwhile, with the influence of temperature and stir, the microstructures of thermo-mechanical affected zone (TMAZ) are stretched (Figure 4e). Figure 4f shows the interface for the 1060Al/Q235 composite plate after FSP and also exhibits the microstructure of heat affected zone (HAZ) in the Q235 side. Moreover, Figure 4g shows TEM images of interface after M-FSP. The grain size of Q235 is about 600 nm. Even though it only stirs

in the aluminum size, the grains for Q235 have been refined by M-FSP, which improves the bonding properties of interface significantly

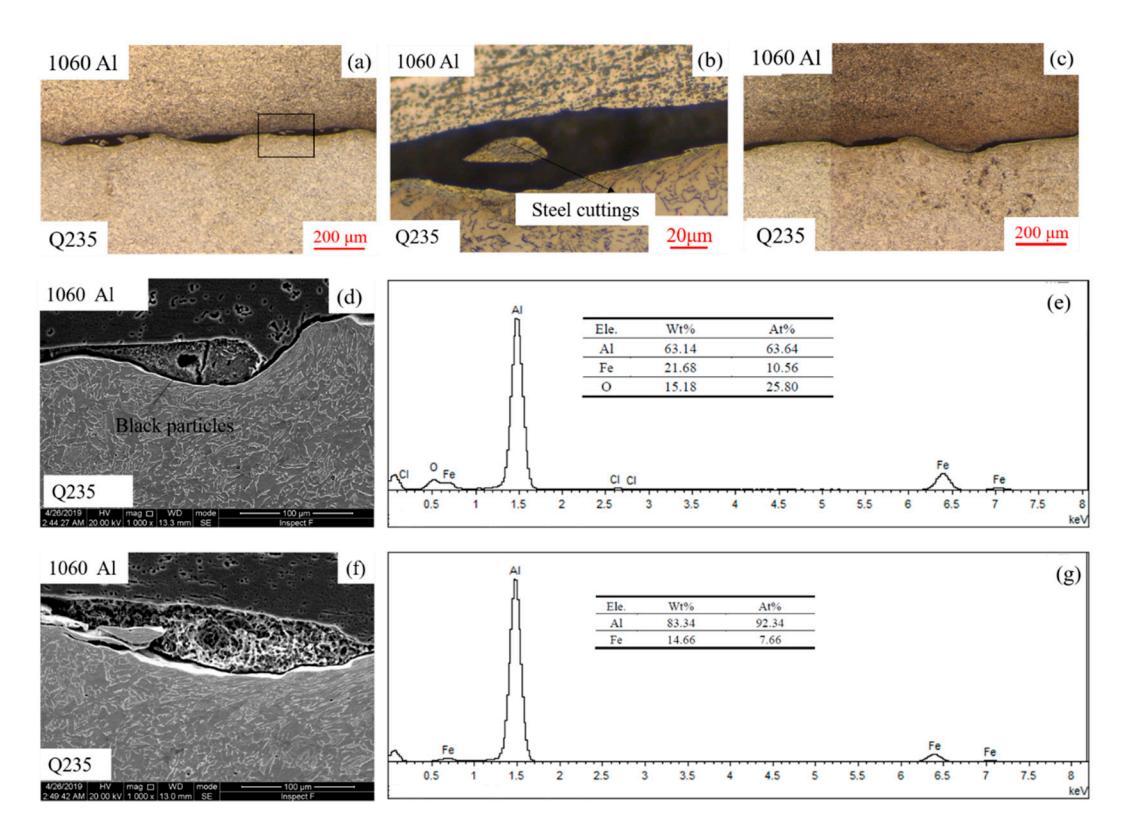
**Figure 5.** Comparisons between the unrepaired interface and the repaired interface: (**a**) and (**b**) unrepaired interface; (**c**) repaired interface; (**d**) and (**e**) Scanning Electron Microscope (SEM) and Energy Dispersive Spectroscopy (EDS) analysis of the unrepaired interface; (**f**) and (**g**) SEM and EDS analysis of the repaired interface.

Figure 5 shows comparisons between the unrepaired interface and the repaired interface. The steel cuttings are clearly seen at the interface of composite plate without FSP (Figure 5a). The sizes of steel cuttings are about 45 µm (Figure 5b). Such a large steel cutting has a severely disadvantage effect on the strength of the interface. Non-uniform and instantaneous temperatures caused by explosive welding are responsible for these steel cuttings. However, these steel cuttings disappear in the interface with FSP (Figure 5c). Through the temperature and plastic flows of aluminum stirred after FSP, these residual steel cuttings react with aluminum and other materials to form new IMCs at the interface. Figure 5d,e show the SEM and Energy Dispersive Spectroscopy (EDS) analysis of the interface for the BM. The black particles are the oxides of aluminum and iron by melting and reacting with oxygen in the air during explosive welding. They are a kind of brittle and hard phase which will reduce the bonding strength for the composite plate. While in Figure 5f,g, there are no steel cuttings and black particles at the interface. The IMCs at the interface are a kind of Al-rich phase [21]. This is to say that FSP can repair the defects remained by explosive welding and optimize microstructures and properties of composite plate.

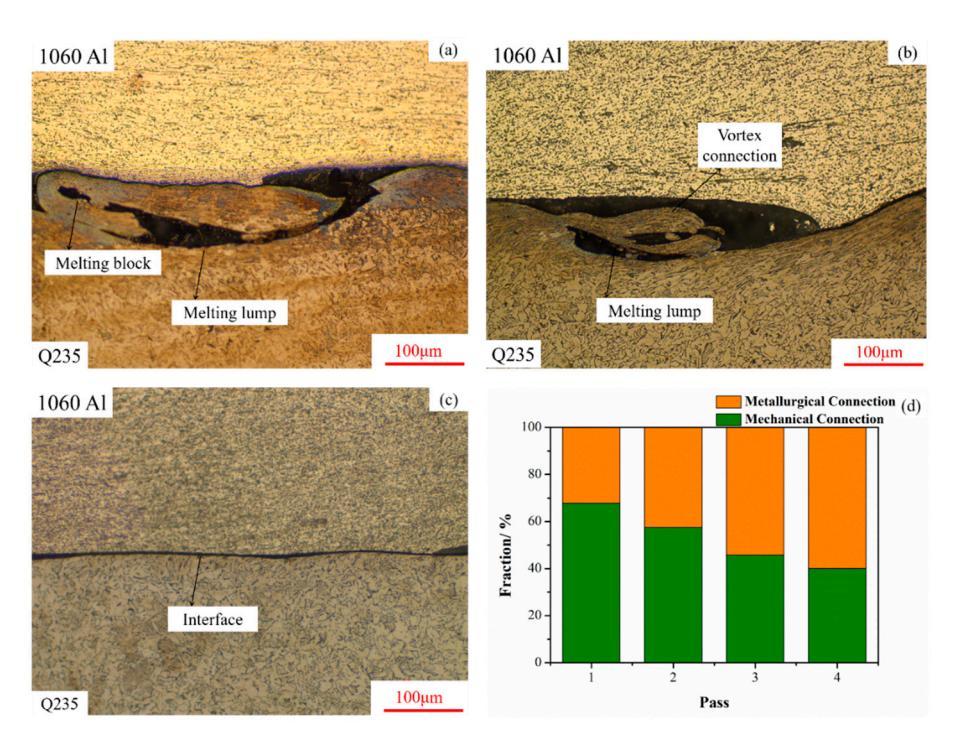
**Figure 6.** Interface connection mechanism of composite plate: (**a**) hook connections; (**b**) vortex connections; (**c**) metallurgical bondings; (**d**) Fractions for mechanical connections and metallurgical bondings to the interface of composite plate after FSP with different passes.

The interface connections mechanism of composite plate is shown in Figure 6. The mechanical connections consist of hook connections and vortex connections formed by multiple hooks (Figure 6a,b). These mechanical connections are the main connections of interface. Meanwhile, the IMCs formed by reaction of aluminum and steel are the main components of interface during explosive welding. The IMCs on the interface are the basis for the metallurgical bondings, as shown in Figure 6c. Actually, metallurgical bondings are made up of IMCs layers. However, these IMCs separated from the interface are disadvantageous to the properties of composite plate. IMCs show the appearance of melting block if the areas of IMCs are small. Conversely, IMCs show the appearance of melting lump if the areas of IMCs are large. Both the melting block and the melting lump are easy to become originals of crack. The IMCs layer with a certain thickness has a superior effect on the properties of composite plate [22]. Since explosive welding is an instantaneous welding process, the composite plate could not obtain enough thickness IMCs layer. Therefore, M-FSP is used to repair the bonding interface and obtain a proper thickness IMCs layer. With the increase of passes, the proportions of metallurgical bondings increase in the interface ((Figure 6d). The increase of passes brings the increase of heat input, which will aggravate the diffusion and metallurgical reaction at the interface. The IMCs layer becomes thicker due to this. Ultimately, the thick IMCs layer leads to the increase of metallurgical bondings.

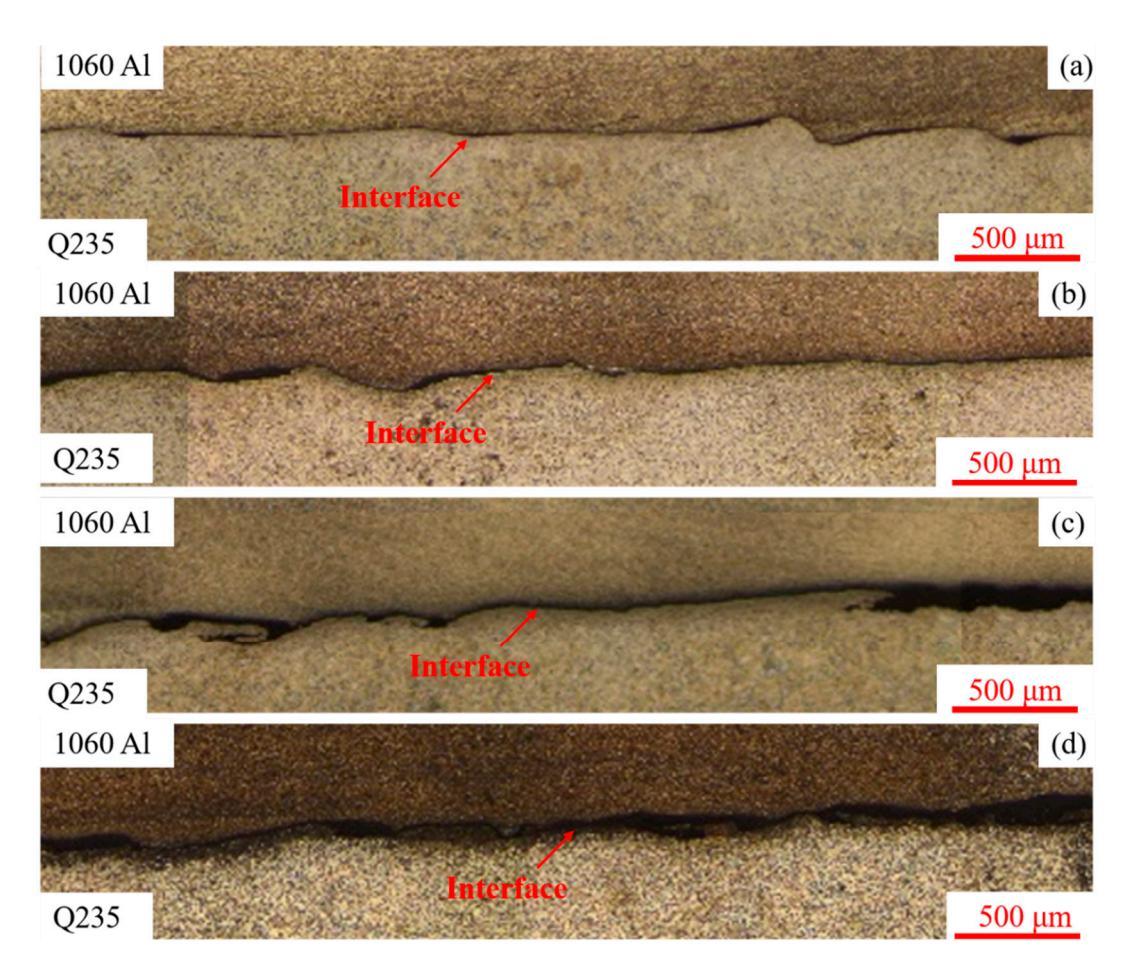
**Figure 7.** Interfaces of composite plate after FSP with different passes: (**a**) single pass; (**b**) two passes; (**c**) three passes; (**d**) four passes.

Figure 7 shows the interface of composite plate after FSP with different passes. With the increase of passes, the thickness of IMCs layers grows. The interface is flat and straight with just single-pass FSP (Figure 7a). In other words, FSP cannot repair the interface of composite plate with the single-pass FSP effectively. Compared with single-pass FSP, there is a little more thickness of IMCs in the interface with two passes. However, the effect of repair with two passes is still insufficient in contrast to the whole interface. That is to say, the effect of repair is not obvious (Figure 7b). The thickness of IMCs clearly increases with three passes. There is a superior effect of repair with the discontinuous mechanical connections (Figure 7c). The interface is so thick that the bonding strength of the interface is low. Too many passes make the heat input too large, which will make the interface too thick. Due to the existence of too thick interface, the original discontinuous mechanical connections have been connected together. The properties of composite plate must be affected with the too thick interface and continuous connections (Figure 7d). It is clear that too many passes will cause the deterioration of properties for the interface.

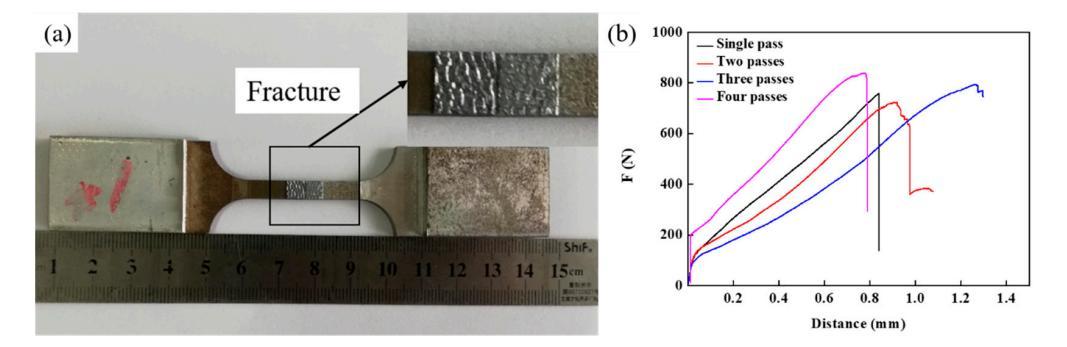
**Figure 8.** Fracture morphologies and strength of shear specimens: (**a**) fracture morphologies of shear specimens; (**b**) mechanical property curves of shear specimens.

Figure 8 shows the fracture morphologies and mechanical property curves for the shear specimens and the shear strengths are shown in Table 3. The fracture mode of shear specimens exhibits typical brittle fracture (Figure 8a). The curve of single-pass shows the phenomenon of yielding caused by the tunnel defects under the load. While the curve of two passes and three passes exhibit the brittle fracture more obviously (Figure 8b). Compared with the single-pass FSP, M-FSP has a uniform refinement effect on the aluminum and finally improves the strength of aluminum. When subjected to load, cracks preferentially appear at the interface and the samples break due to the fracture of the IMCs layer. The shear strengths of composite plate after FSP with different passes are shown in Table 3. Due to the yield strength of 1060Al is about 35 MPa and the shear strengths of specimens range from 28.87 MPa to 33.37 MPa, which show that the shear properties of composite plate after FSP are in line with requirements. From the shear strength and curves of different passes, it can be seen that when the passes are three and four, the shear strength is higher than those are one and two. Although the strength increase is not obvious, the shear properties of composite plate are still improved by M-FSP.

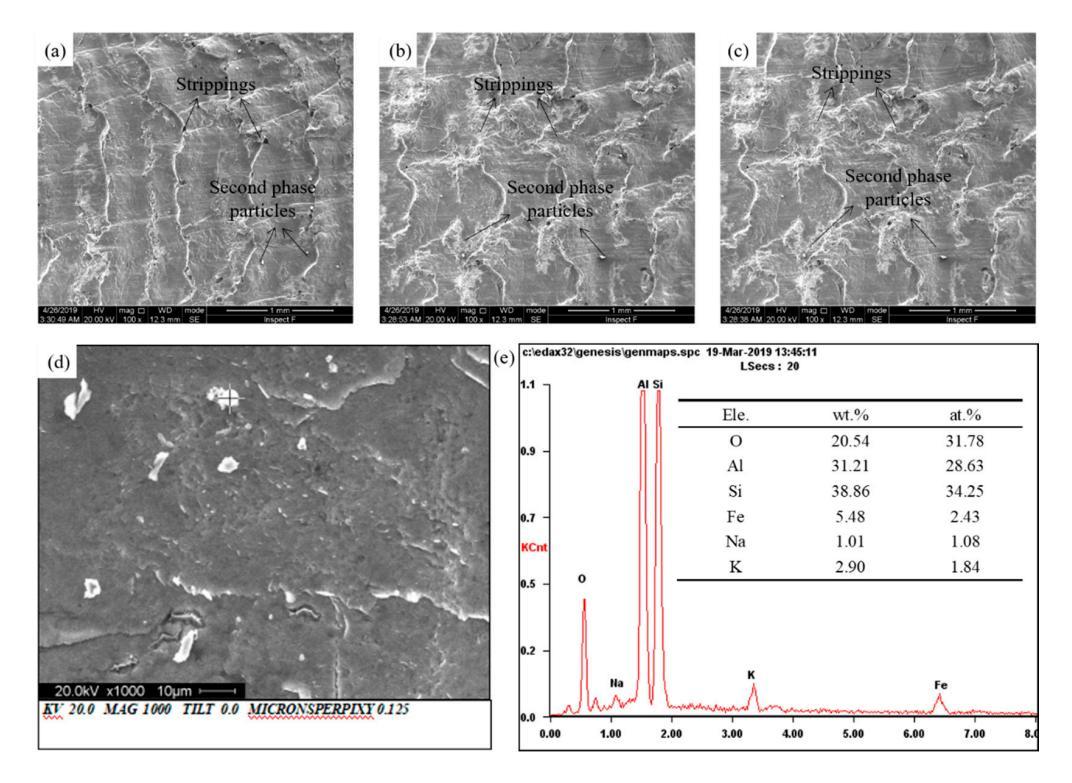
**Figure 9.** Scanning electron microscope (SEM) analysis of shear specimens: (**a**) single pass; (**b**) two passes; (**c**) three passes; (**d**) and (**e**) SEM and Energy Dispersive Spectroscopy (EDS) analysis of second phase particles.

The SEM and EDS analysis of shear specimens are shown in Figure 9. Strippings are found in the fracture surfaces, as shown in Figure 9a–c. Analysis shows that these strippings are formed by the failure of the original mechanical connections at the interface under the load. The second phase particles are also obviously seen in the SEM. The EDS result shows that Si element is contained in these particles, which indicates that the second phase particles are Al-Si compounds (Figure 9d). A small amount of dispersed Al-Si compounds can improve mechanical properties of composite plate.

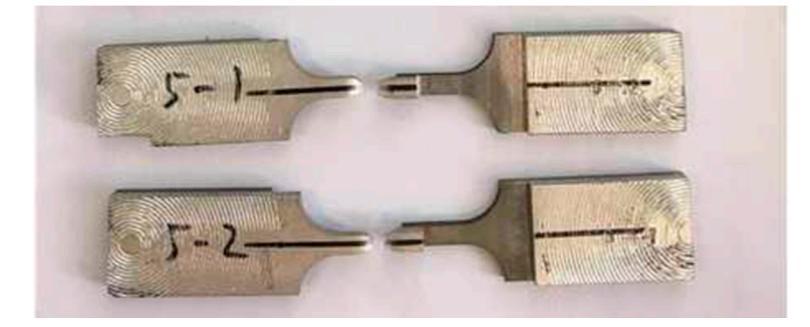
Figure 10. Shear specimens of BM.

The shear mechanical properties of BM are also carried out, as shown in Figure 10. The results show that the phenomenon of yield occurs on the aluminum side of BM. The maximum failure tensile force is 1777 N. However, the failure strength is not the shear strength, while is the tensile strength of 1060Al. The failure strength is 118.47 MPa, which is conformed to 1060Al standard specification. The fracture position of BM without FSP is in the aluminum side rather than at the interface. This is due to the refining effect of FSP in aluminum, which makes the aluminum obtain the grain refining strength after FSP. Therefore, FSP has an obvious repairing effect on the interface of composite plate.

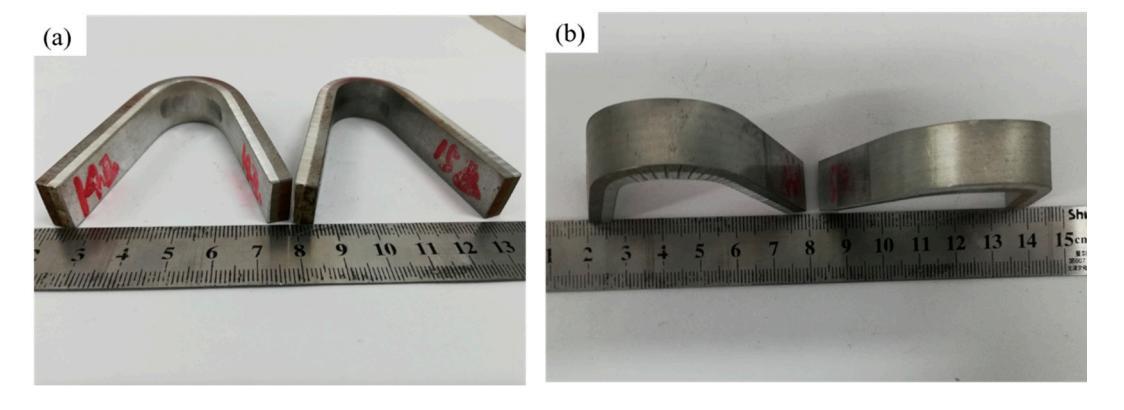
**Figure 11.** Bending specimens of composite plate after FSP with two passes: (**a**) compressed face; (**b**) tensile face

The results of bending test are shown in Table 4. The typical bending specimens are shown in Figure 11. Whether repaired or not, the bending strength is superior. Mainly due to the excellent plasticity of 1060Al, there are almost no cracks during the process of bending. However, cracks can be seen in aluminum after FSP with four passes, as shown in Figure 12. The failure angle of bending is 137°. Excessive axial force of the shoulder leads to the thinning of BM with the cracking phenomenon caused by the reduction of the bearing area in bending. Therefore, it should be well controlled in the M-FSP to ensure the properties of bending.

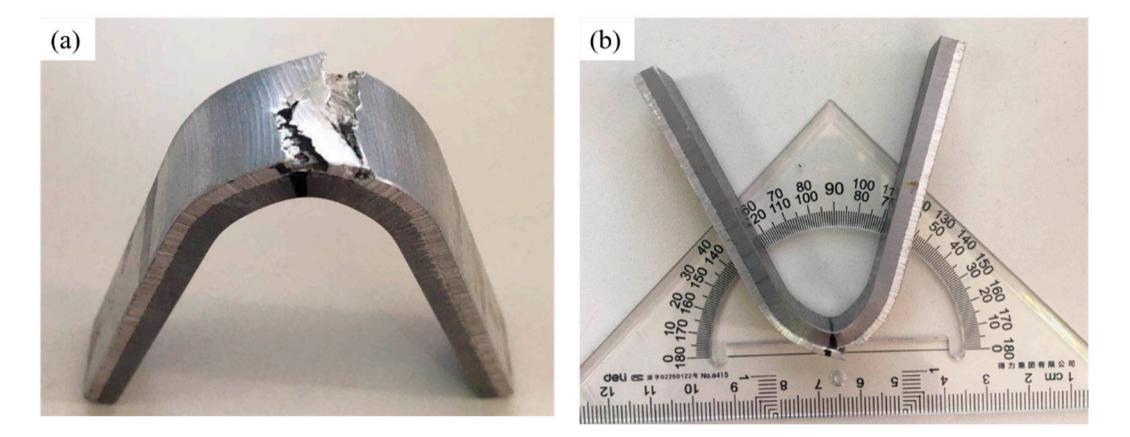
**Figure 12.** Bending specimens of composite plate after FSP with four passes: (**a**) tensile face; (**b**) bending diagram of angle measurement.

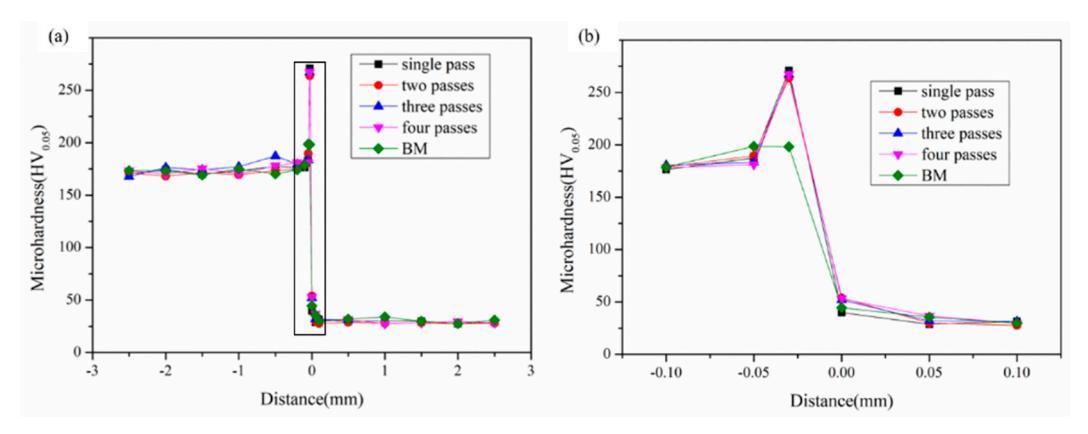
**Figure 13.** Microhardness of composite plate after FSP with different passes: (**a**) hardness of whole specimens; (**b**) hardness for the samples near the interface (partial enlargement of Figure 13a).

The microhardness of composite plates after FSP is shown in Figure 13. The microhardness is measured in the positive direction along the aluminum with the interface as the origin. The hardness on the interface near the aluminum side without FSP is  $44.54HV_{0.05}$ . While the maximum hardness of the interface after FSP can be achieved to  $53.83HV_{0.05}$ . It is believed that FSP can enhance performances of composite plate and has an obvious repairing effect. Meanwhile, FSP also has an effect of improvement on the properties of metal near the interface. The hardness of Q235 without FSP is  $198.5HV_{0.05}$  with the distance of  $30\mu$ m away from the interface, while the hardness can reach to  $270.9HV_{0.05}$  with the same distance after FSP. Although just repairing in aluminum, FSP can still strengthen steel through the plastic flows of aluminum.

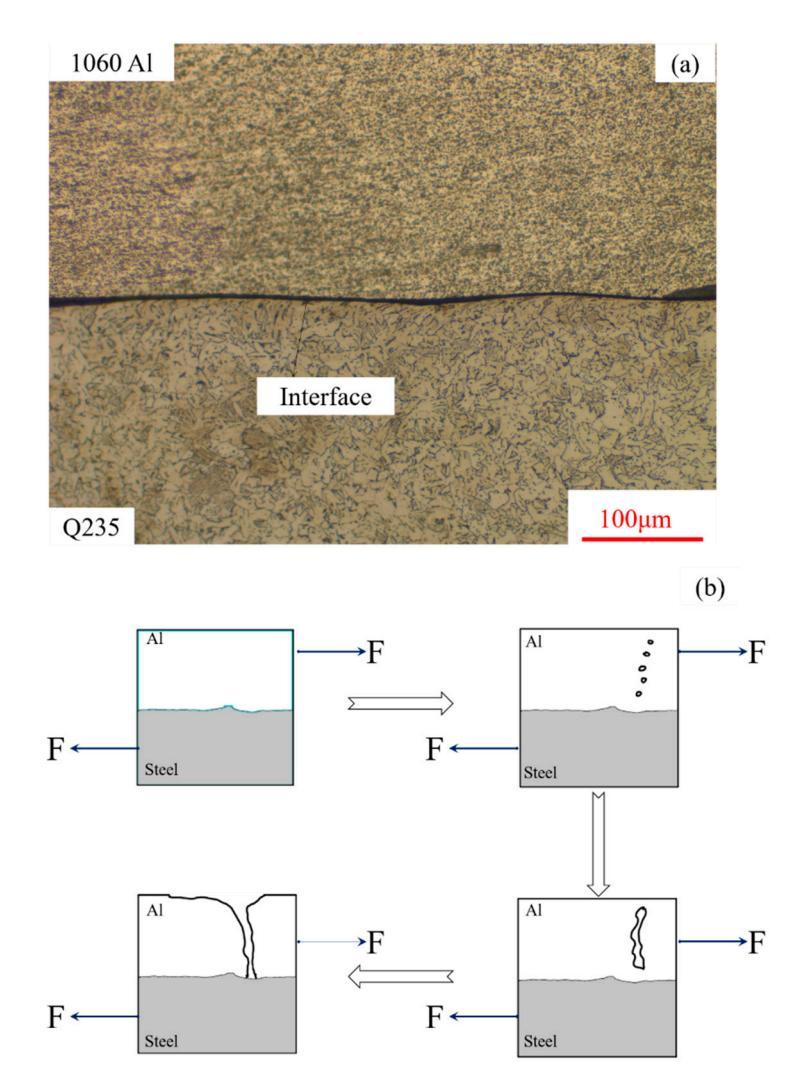
**Figure 14.** Failure mechanism of thin and flat interface: (**a**) physical diagram; (**b**) failure diagram of flat interface.

Firstly, when the interface of aluminum/steel composite plate is thin and flat, the crack extension stress of interface is small due to the flat interface. Meanwhile, the aluminum is so soft that it is easy to occur the phenomenon of yield. Several voids will preferentially be formed in the aluminum side. Cracks are formed by the accumulation and growth of voids with the gradually increasing load.

Eventually, cracks extend to the aluminum and lead to the failure of composite plate, as shown in Figure 14. This failure mostly occurs in the aluminum/steel composite plate without FSP. It is basically agreed with the yield fracture of BM in the shear test.

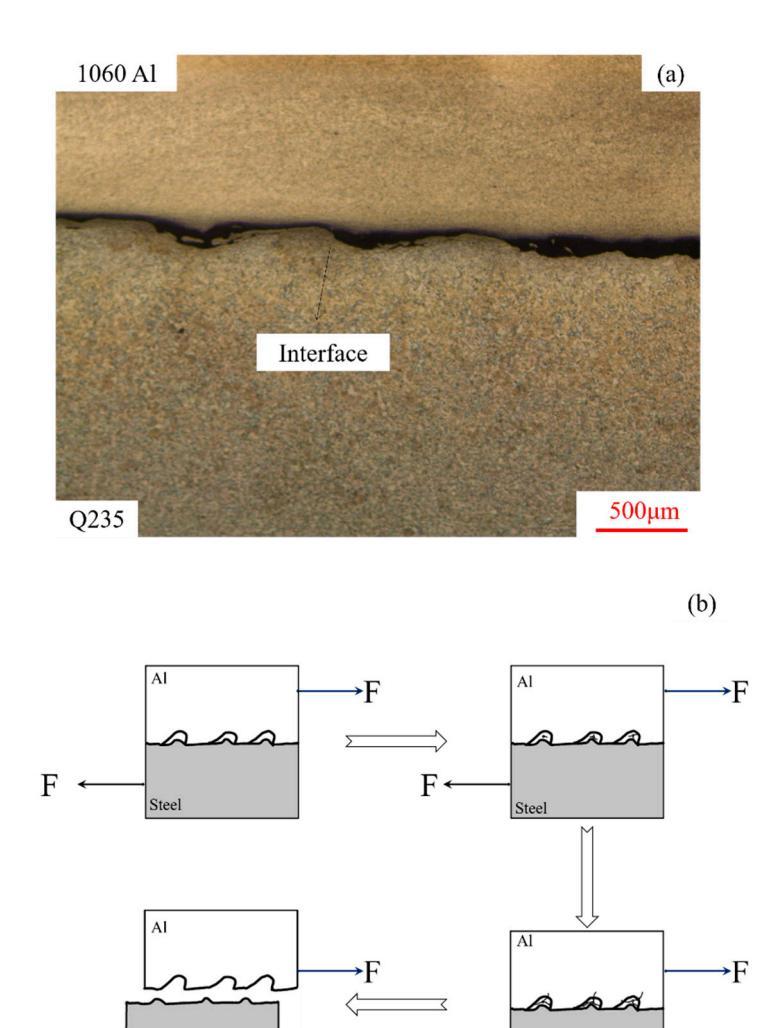
Figure 15. Failure mechanism of thick and discontinuous interface. (a) physical diagram; (b) failure diagram of flat interface.

Secondly, when the interface of aluminum/steel composite plate has a certain thickness and discontinuous mechanical connections, the crack extension stress of the interface is large. Several micro-cracks will preferentially be formed at the interface under the load. If the composite plate has been inadequately repaired by less passes, there could be some defects at the interface. The phenomenon of stress concentration caused by defects would accelerate the development of micro-cracks. Therefore, those micro-cracks would coalesce each other rapidly and ultimately lead to the fracture of the whole interface. However, if the composite plate has been adequately repaired by enough passes, the interface would have a certain thickness. The propagation of micro-cracks needs a path. In addition to this, those discontinuous mechanical connections improve the bonding strength of interface, which make the cracks propagate slowly. Thus, a larger load is needed to make the composite plate break. This failure occurs mostly in the aluminum/steel composite plate after repairing by FSP, which is basically consistent with the case of single, two and three passes, as shown in Figure 15.

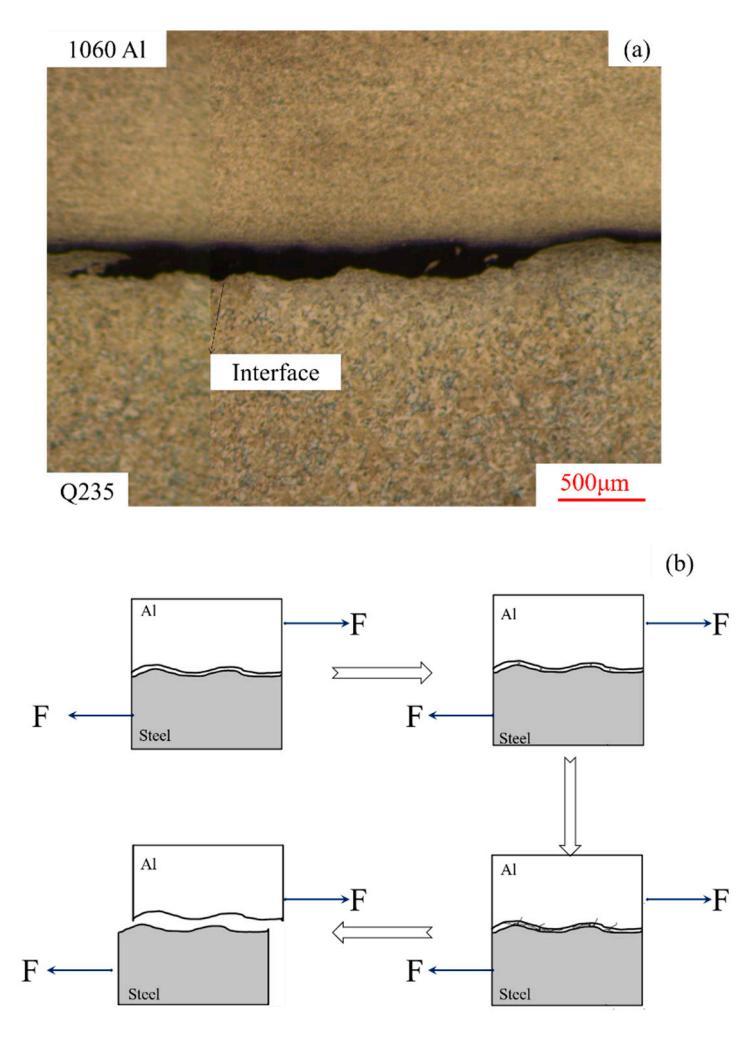
**Figure 16.** Failure mechanism of too thick and continuous interface: (**a**)physical diagram; (**b**) failure diagram of flat interface.

Thirdly, when the interface is too thick, although there are discontinuous mechanical connections at the interface, the overly thick interface connects the discontinuous mechanical connections to each other, which results in a bending and continuous interface. The crack extension stress of the interface is also large due to the bending interface. Micro-cracks will preferentially be formed at the interface under the load. Due to the thicker interface, those micro-cracks could easily bypass the mechanical connections. Therefore, the micro-cracks grow rapidly with the increasing load. Finally, the composite plate will break due to the fracture of the interface. This failure occurs more often in the composite plate after FSP with too many passes. The fracture of the aluminum/steel composite plate is basically the same as that of four passes, as shown in Figure 16.
