Article Complex Material and Surface Analysis of Anterolateral Distal Tibial Plate of 1.4441 Steel

Abstract: Nickel-based austenitic stainless steels are still common for manufacture of implants intended for acute hard tissue reinforcement or stabilization, but the risk of negative reactions due to soluble nickel-rich corrosion products must be considered seriously. Corrosion processes may even be accelerated by the evolution of microstructure caused by excessive heat during machining, etc. Therefore, this study also deals with the investigation of microstructure and microhardness changes near the threaded holes of the anterolateral distal tibial plate containing approx. 14wt.% Ni by composition. There were only insignificant changes of microhardness, grain size, or microstructure orientation found close to the area of machining. In addition, wettability measurements of surface energy demonstrated only minor differences for bulk material and areas close to machining. The cyclic potentiodynamic polarization tests were performed in isotonic physiological solution. The first cycle was used for the determination of corrosion characteristics of the implant after chemical passivation, t

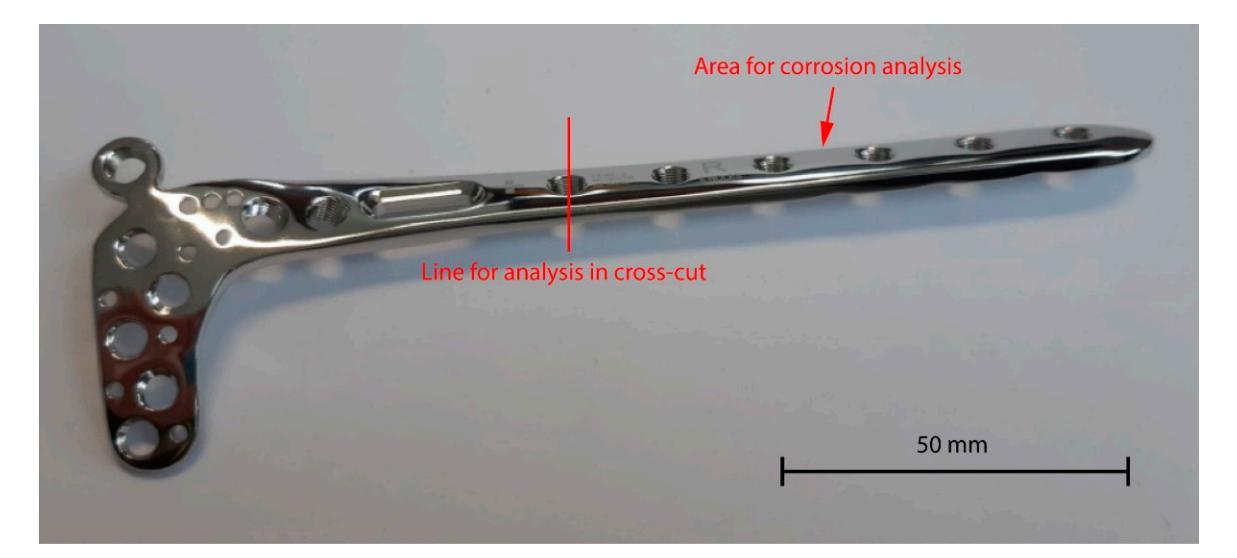
An AISI 1.4441 steel was used for manufacture of anterolateral distal tibial plates which was further tested by experimental techniques (Figure 1). It is an L-shaped board, anatomically shaped for the left and right sides in lengths of 2 rotations (90 mm) to 16 rotations (300 mm). There are holes in the plate for the angularly stable screws of 3.5 mm, possibly for 3.5/2.7 mm screws and K-wires of Ø 1.5 mm. Three screw holes are divergently directed in the distal part; the other two pairs of screws form their support and fix the fragments in a skew line to the distal screws. The distal part includes a protrusion allowing the fixation of a possibly broken Chaput tubercle. The holes are positioned in the shaft part of the plate, perpendicular to the plate. The anterolateral distal tibial plate is intended for osteosynthesis of complicated fractures of the distal tibia, some storey fractures, or fractures of the distal tibia with a fracture line in the frontal plane. The standardized chemical composition of the studied material is listed in Table 1. The surface of the plate was mechanically polished and pickled in a mixture of hydrofluoric and nitric acid to remove any free particles or to degrade and eliminate any grease and oil residues from previous manufacturing processes. The last step before repeated ultrasonic cleaning in distilled water was surface passivation with nitric acid at a concentration of 30% at a temperature of 50–60 $^{\circ}$ C for 20 min. The passivation prescription is in accordance with ASTM A967, widely considered as a standard for this type of material [6].

Figure 1. Anterolateral distal tibial plate with marked areas of analysis.

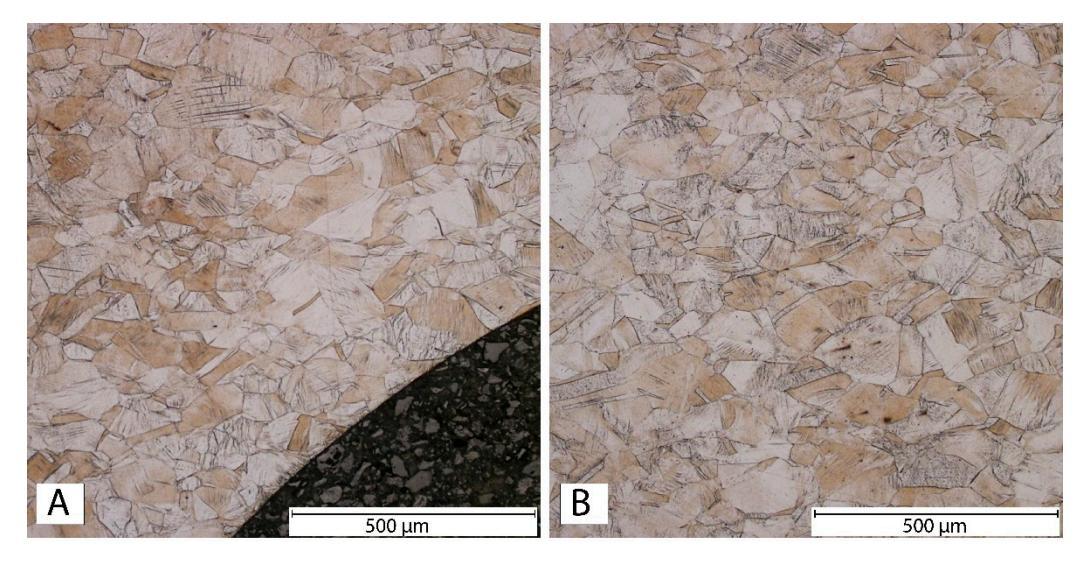
Figure 2A shows a longitudinal cut near a threaded hole. The microstructure near the thread contains equiaxial austenitic grains with no signs of carbide and oxide particles, neither inside of grains nor at the grain boundaries, and fully corresponds with the microstructure of the bulk material presented in Figure 2B. The microstructure near the threaded hole also shows no changes in texture, grain shape, or size. This area is crucial due to its role as a stress concentrator during force loading and transmitting into the rest of the application so any microstructural changes may cause cracks formation leading to premature failure. The machining cut was precisely driven through the grains which are indicated by the smooth interface between the threaded hole and mounting resin with no significant deformation zone visible in the materials' microstructure [16].

Figure 2. (A) Microstructure of material near the threaded hole, (B) microstructure of bulk material.

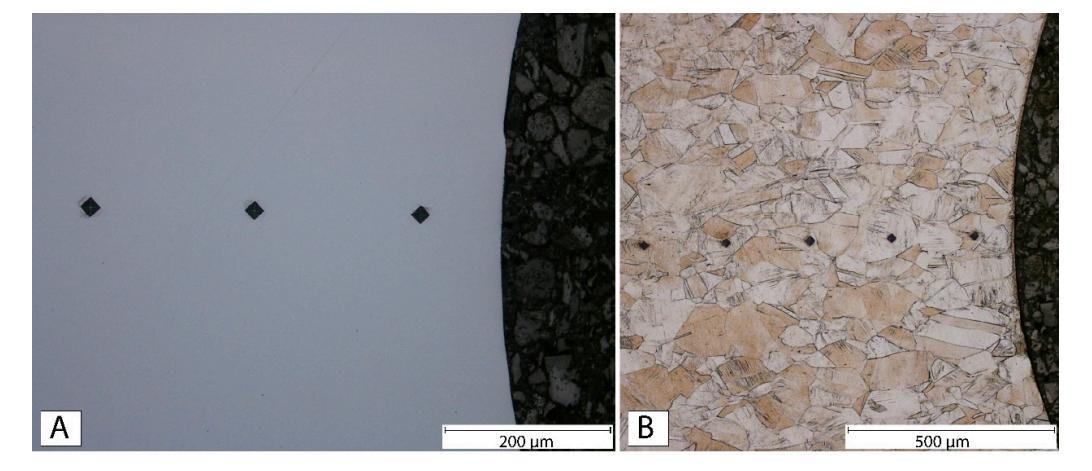
Figure 3. (A) Indents after polishing, (B) identic indents in the revealed microstructure.

The average microhardness is increased in comparison to previously published values [17]. As the difference between each value is significant and standard deviations are approximately 4% for the longitudinal and 6% for the transversal direction compared to average microhardness, the microstructure near the indents was further investigated. Figure 3A illustrates indents in a longitudinal cut after polishing and Figure 3B after etching where the lower magnification of microscope was used to capture more indents. Significant differences in microstructure were observed for each indent. The smallest indents (highest microhardness) were measured in grains showing a high level of deformation indicated by the presence of deformation twins [18]. Some high values also indicate the possibility of initiation of ε martensite transformation [19].

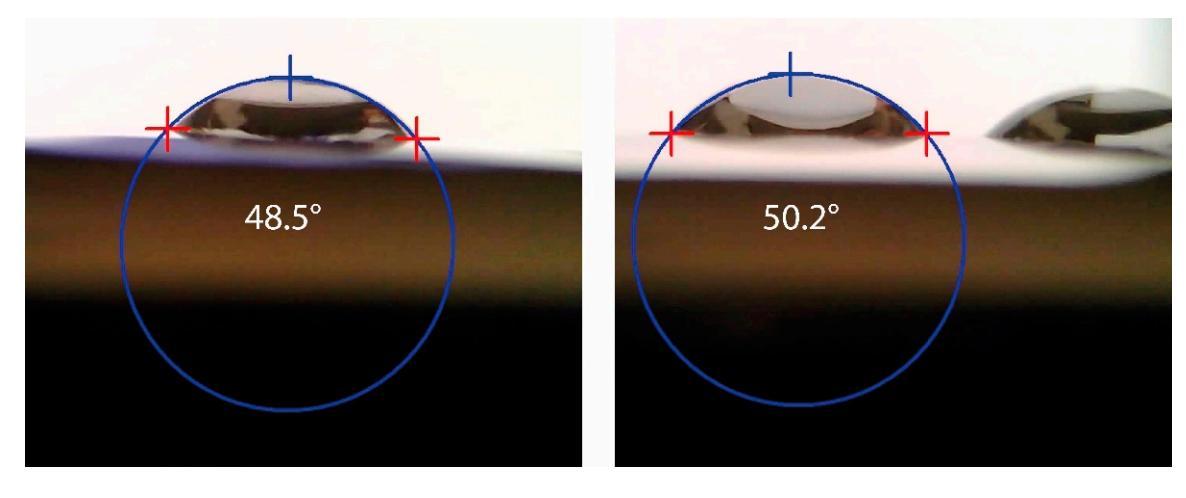
Figure 4. Water droplets on the surface of the tested sample. The value of contact angle evaluated is given.

of the tested implant surface forms a surface layer with moderate wettability represented by a contact angle of approximately 52°. This suggests that there will be predominantly soft fibrous tissue formed and bonded to the implants interfaces which will enable its safe resection if needed. Corrosion parameters of the passivated surface were measured by potentiodynamic polarization when 2 voltammetry cycles were performed. The first cycle was applied to determine the characteristics of the surface layer after the chemical passivation. The first cycle was stopped when the stable pitting occurred simulating real damage of the surface under extreme conditions. The second cycle of polarization was applied on the same surface to characterize the surface ability for self-passivation. It was found that surface after chemical passivation showed less noble corrosion potential, but its corrosion rate was approximately three times lower. Although the values of the corrosion rate are insignificant and will probably not cause any functional problems even after long-term exposure, the amount of nickel and other ions released during the corrosion process may cause pathological changes or even rejection of the implant. According to the outcomes of the presented work, the risk of fatal implant failure significantly increases if its surface is damaged by pitting corrosion during its lifetime.

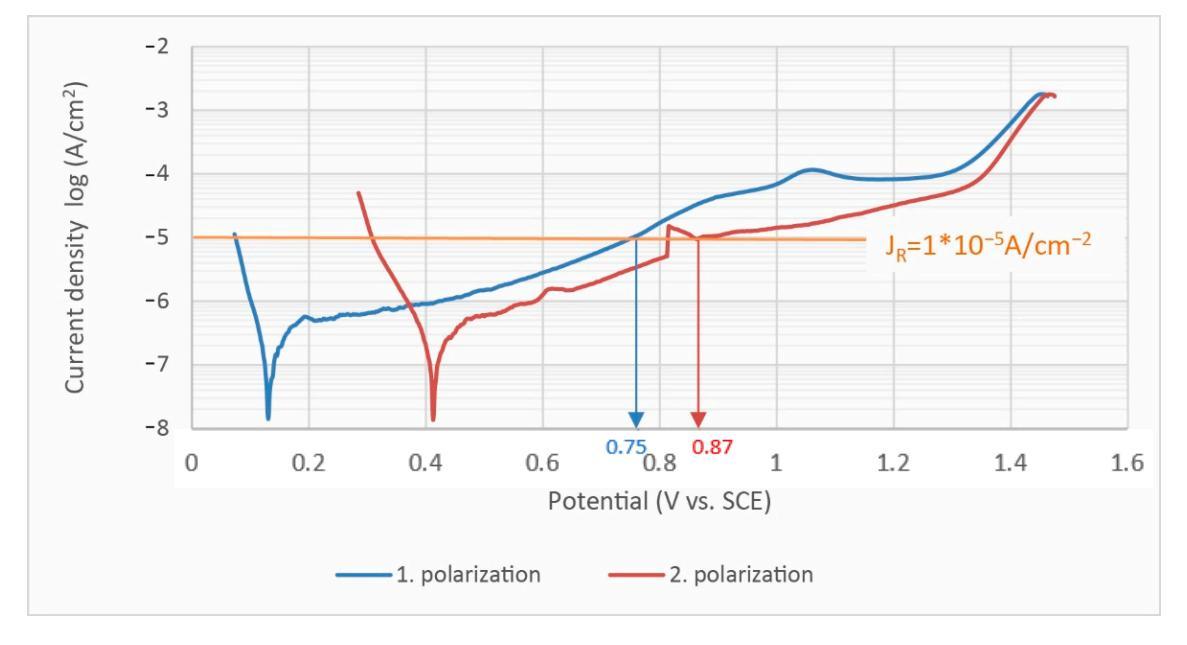
There were two polarization curves collected for the purpose of precise investigation of the tested application corrosion properties. The testing was repeated at the same location with no change of testing instrument. The first polarization curve represents the electrochemical properties after surface finishing procedures (machining, grinding, polishing, degreasing, chemical passivation, sterilization, etc.). The second curve illustrates the behavior of the same material as the previous polarization actively removed more thermodynamically active system elements (thick passive layer, secondary phases particles, oxide layers, deformed material layer, etc.) after the spontaneous formation of the passive layer in physiological solution on the previously corroded surface. Values of current density (Y-axis) and potential (X-axis) were continuously recorded during polarization. After the polarization procedure, the semilogarithmic polarization curve was drawn up from these points and is illustrated in Figure 5. Finally, the corrosion properties (corrosion potentials, polarization resistance corrosion current density, and a corrosion rate) were calculated from the initial part of the polarization curves with the characteristic "V-shape" by Tafel extrapolation automatically using Volta Master 10 software [21]. These are listed in Table 4. There was an exchange of two electrons (Fe⁰ \rightarrow Fe²⁺, Ni⁰ \rightarrow Ni²⁺, Cr⁰ \rightarrow Cr³⁺), and an average material molar mass of 56.2 g/mol and density of 7.8 g/cm³ was considered for calculation of corrosion rate by Faraday laws [22].

Figure 5. Polarization curves of 1.4441 for first and second polarization in physiological solution.

As the anodic part of the curve exhibits no inflection point, the pitting potentials represented by orange and blue arrows were determined from the critical value of current density 10 μ A/cm², which is given by the dotted green line in Figure 5. This potential is formally defined by destabilization of the passive layer or formation and spontaneous growth of corrosion pits, respectively. The values for each curve are marked on the potential axis.

The passivation layer is locally reduced electrochemically when breakdown potential in the transpassive region is reached during polarization accompanied by a steep increment of current density which indicates intensive corrosion of base material. There are two methods for the determination of breakdown potential, the first is mainly graphical as the coordinates of the inflection point are determined directly from the curve recordings [32,33]. It was suggested by [34–36] that pitting corrosion, as determined by zero resistance amperometry (ZRA), becomes stable above 10^{-5} A/cm⁻². Thus, pitting potentials can also be determined as the potential at which the current density reaches 10^{-5} A/cm⁻². It was found that previously corroded areas are repassivated by a more electrochemically stable layer as breakdown potential measured during the second polarization is shifted from 750 to 870 mV vs. SCE [37].

It was found that surfaces exposed to previous polarization show significant shifts of corrosion potential to more noble values when compared to as-received state (134 mV vs. 414 mV vs. SCE). This indicates that the passive layer formed on previously active areas is composed of more noble types of chromium-based oxides than the layer developed during chemical passivation. The influence of additional electrochemical passivation of areas remaining in the passive state during the first polarization was studied before [41] and may

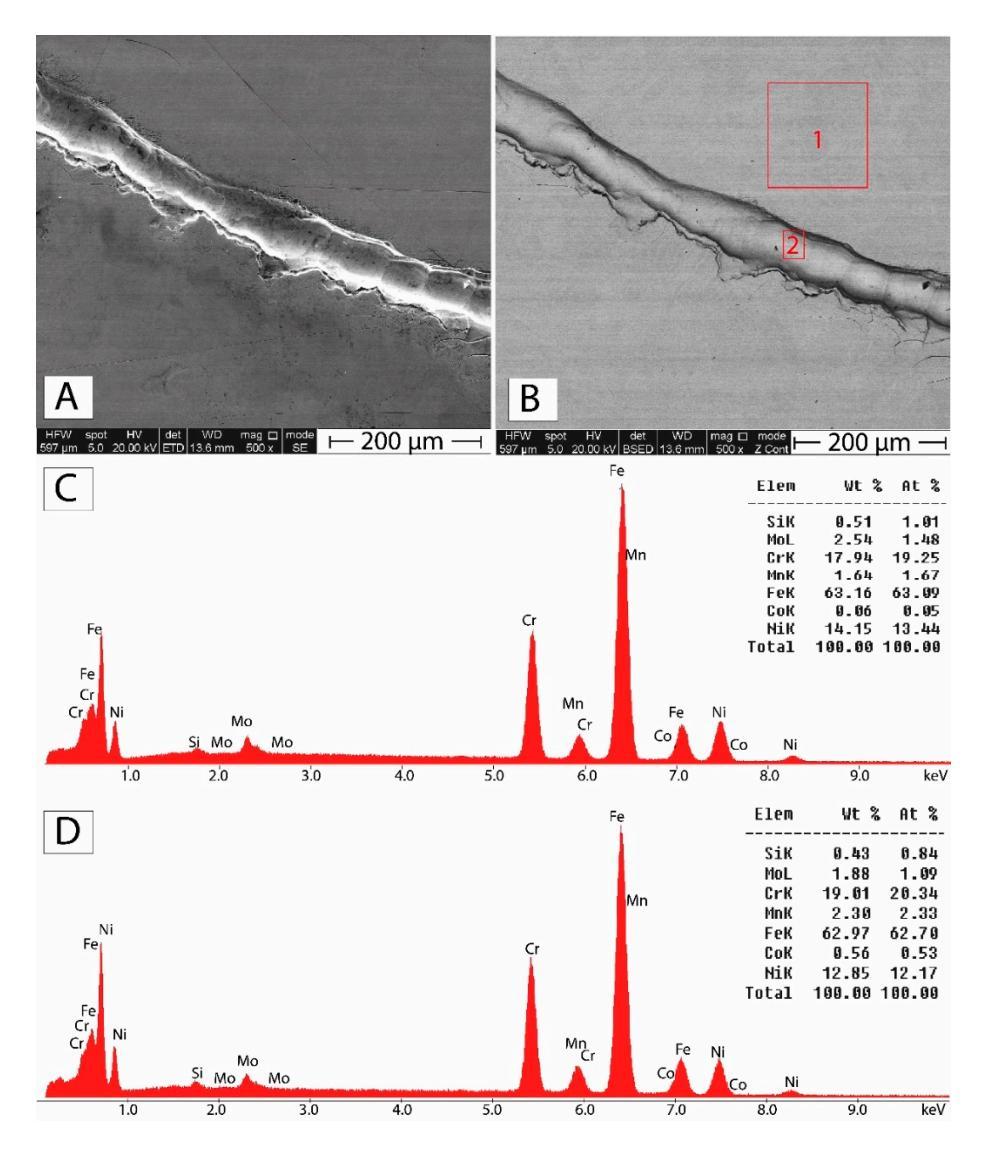
After the corrosion test was terminated, the area of interest was observed using a scanning electron microscope (SEM, FEI QANTA FEG 450, Brno, Czechia), in a regime of secondary (SE) and backscattered (BSE) electrons. The semiquantitative chemical analysis of marked areas was performed by energy-dispersive X-ray spectroscopy analysis (EDX). The result of the observation is illustrated in Figure 6. There was no significant difference

in the chemical composition of analyzed areas found by EDX, which indicates significant solubility of corrosion products [23].

Figure 6. (**A**) Surface after corrosion test in SE, (**B**) surface after corrosion test in BSE with marked areas of EDX analysis, (**C**) EDX spectrum for area No.1, (**D**) EDX spectrum for area No.2.
