Article Effect of Silicon Wafer Surface Stains on Copper-Assisted Chemical Etching

Abstract: Silicon wafer slicing is a crucial process during solar cell fabrication, but it often stains the silicon wafer surface. Thus, this work systematically investigated the composition, source, and cleaning method of typical white spot stains on silicon wafer surfaces. The EDS and XPS results showed that the white spot stains contained CaCO₃ and SiO₂ that were consistent with the filler components in sticky silicon ingot glue. The effects of stains on copper deposition and copper-assisted chemical etching were studied. White spot stains remained attached to the silicon surface after deposition and etching. These stains affected the uniform deposition of copper particles on the surface of the silicon wafer and also impeded the catalytic etching of copper particles. Finally, KOH solution was combined with an ultrasonic field to remove surface stains from the silicon wafer. This study provides important guidance for the removal of silicon wafer contaminants to fabricate high-efficiency solar cells.

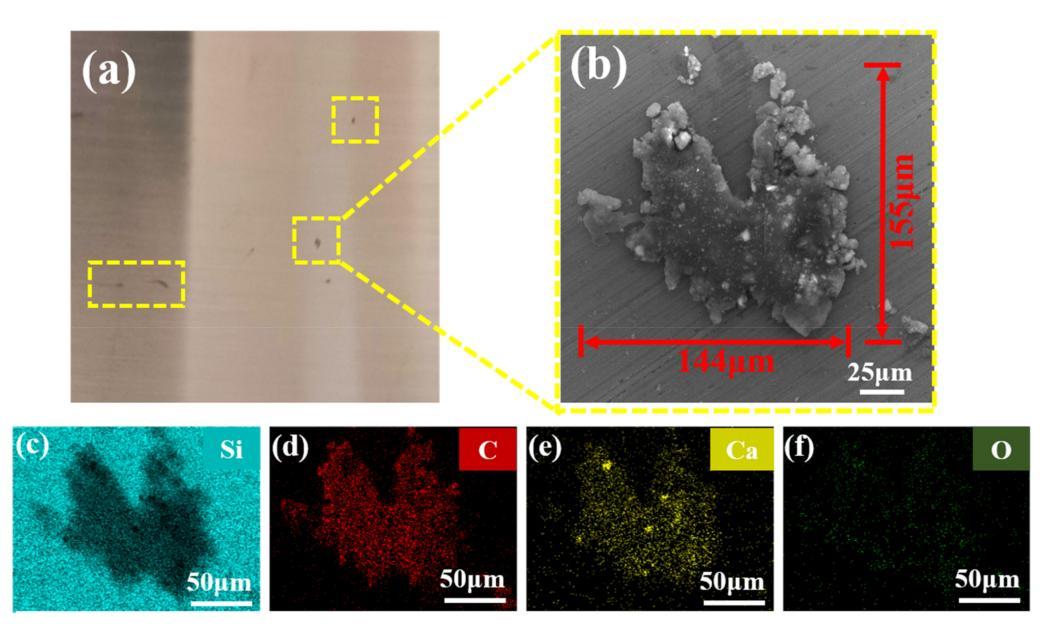
Figure 1a shows a photograph of the white-spot-stained silicon wafer. Visible white spot stains are shown in the three yellow boxes in the photograph. The irregular morphology of a white spot stain was observed by SEM, as shown in Figure 1b. The spot was about 144 μ m in length and 155 μ m in width. The surface of the material was distributed with different-sized highlights. EDS element maps are shown in Figure 1c–f, which show that the white spot stain contained C, Ca, O, and Si elements. C was present in the highest amount, so it is speculated that the white spot stains may be organic matter.

Figure 1. (**a**) Photograph of white-spot-stained silicon wafers, (**b**) SEM image of white-spot-stained silicon wafers, (**c**) elemental distribution of Si, (**d**) C, (**e**) Ca, (**f**) and O.

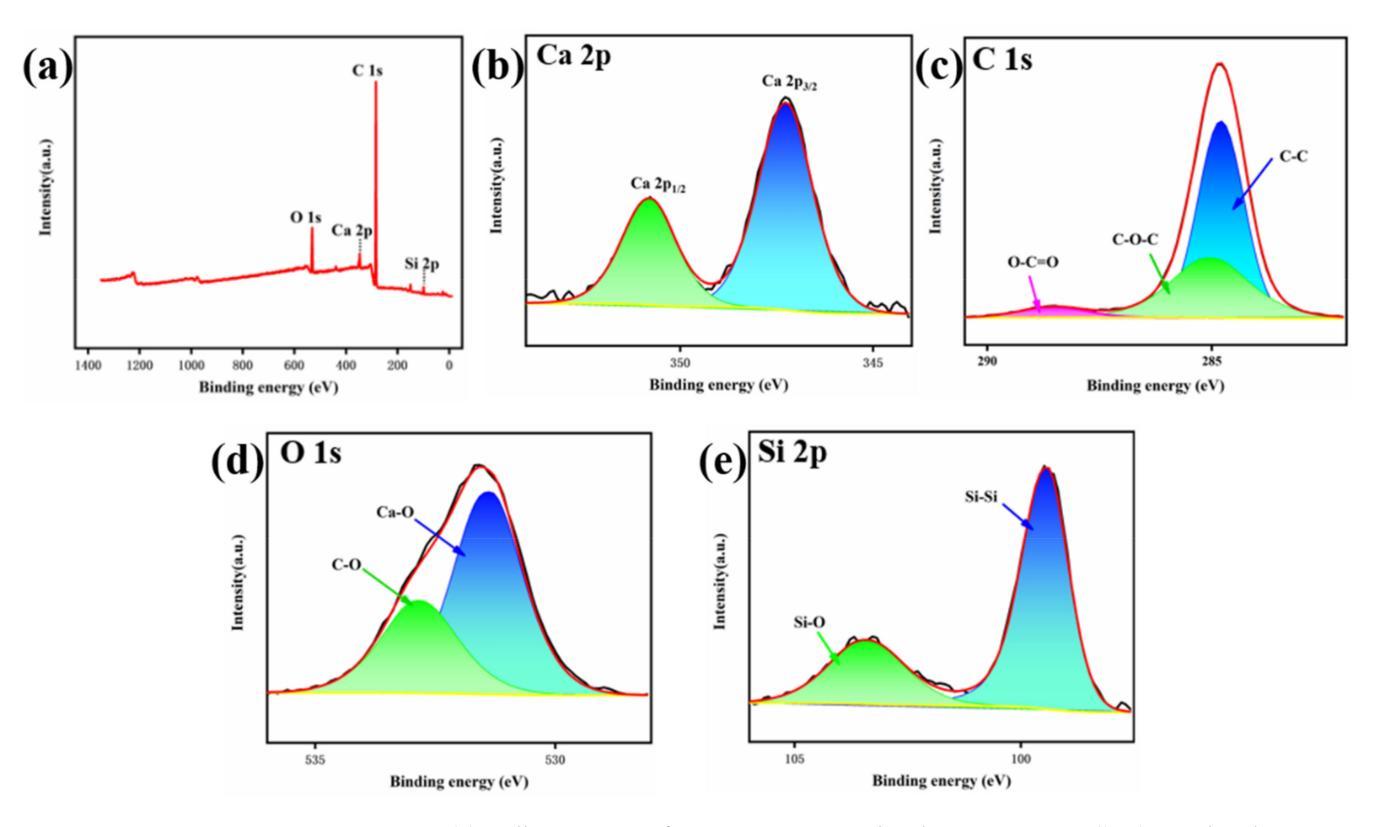
XPS was used to further analyze the valence states and composition of the white spot stains. The XPS spectrum in Figure 2a shows that the white spot stains mainly contained C, Ca, and O, and a small amount of Si. Based on the XPS spectrum in 2a, Ca 2p was deconvoluted into two peaks. The peaks of 347.07 eV and 350.6 eV correspond to Ca $2p_{3/2}$ and Ca $2p_{1/2}$, respectively (Figure 2b) [29]. The peaks at 531 eV in the O 1s spectrum and 347.07 eV and 350.6 eV in the Ca 2p spectrum show that the white spot stains contained CaCO3 particles (Figure 2d). The C 1s spectrum of the white spot stains was decomposed into three components: the peak of C-C was located at 284.7 eV, the peak of C-O-C was at 286.4 eV, and the peak of O-C=O (carbon in carbonate) was located at 289 eV (Figure 2c) [30]. The Si 2p spectrum presented two characteristic peaks at 99 eV and 103.3 eV, which corresponded to monatomic silicon and SiO₂, respectively (Figure 2e) [31]. During the production of some polymer materials, CaCO₃, SiO₂, and other inorganic fillers are often added to glues, rubbers, and other polymeric materials to ensure their mechanical properties and flame retardancy. The results further confirmed that the white spot stains emanated from organic polymer components [32,33].

Figure 2. (a) Full spectrum of XPS spectrum with white spot stain, (**b**–**e**) are the characteristic absorption spectra of Ca2p, C1s, O1s and Si2p.

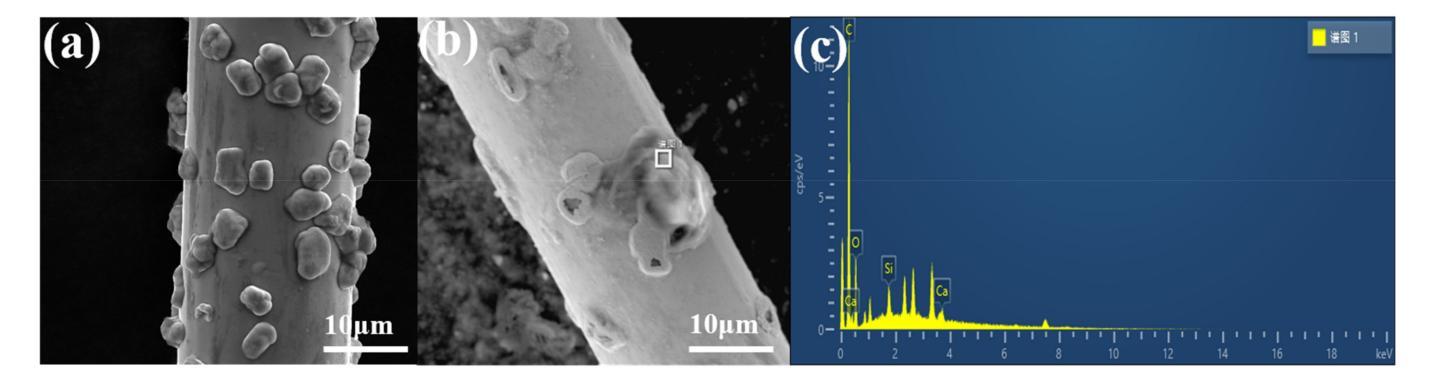
During the slicing of the silicon wafer, the surface of the silicon wafer will only contact the diamond wire. Therefore, the diamond wire was characterized using EDS, to determine the origin of the stain. Figure 3a shows a new diamond wire, where the surface of the line is covered with diamonds of varying sizes. In comparison with Figure 3a, the diamond on the surface of the line in Figure 3b has been worn to a flat structure, and some diamonds have fallen off. This indicates that it is a used diamond wire. There was a circular protrusion with a diameter of about 20 μ m on the surface of the diamond wire. The EDS analysis of the substance is shown in Figure 3b, which shows that it contained C, Ca, O, and Si. However, the diamond wire was nickel plated, and the main elements were Fe, Ni, and C. This means that the substance was not derived from the diamond wire. The elements in this substance are consistent with the elements in the white spot stain, meaning that it is also a polymeric material.

Figure 3. (a) SEM image of fresh diamond wire, (b) SEM image of waste diamond wire, (c) EDS spectrum of waste diamond wire surface substances.

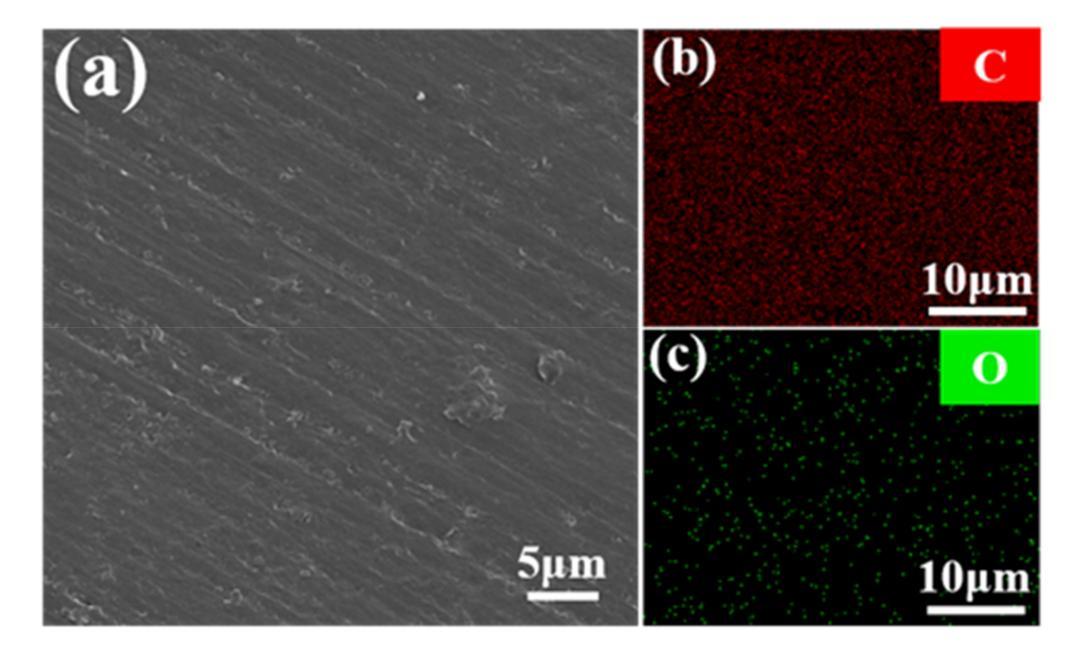
To determine where the substance on the diamond wire was introduced, the entire slicing process was analyzed. When slicing silicon wafers, sticky silicon ingot glue is used to hold the silicon ingots and plastic board together. The only polymeric materials that can come into contact with the diamond wire are those found in the sticky silicon ingot glue and the plastic board. The substances in these two elements were analyzed by EDS. Figure 4a shows an SEM image of the plastic sheet covered with slice marks caused by diamond wire slicing. The element maps in Figure 4b,c show that it only contained C and O, indicating that the substance was not introduced by the plastic board. Figure 5a shows an SEM image of sticky silicon ingot glue, in which several areas in the figure are brighter than others. The element map in Figure 5b–e shows that it contained C, Ca, O, and Si. The bright spots in the SEM image are Ca. Sticky silicon ingot glue contains the same elements as the white spot stain and diamond wire, indicating that the substance causing the stains emanated from the sticky silicon ingot glue.

Figure 4. (a) SEM image of plastic board, (b) elemental distribution of C and (c) O.

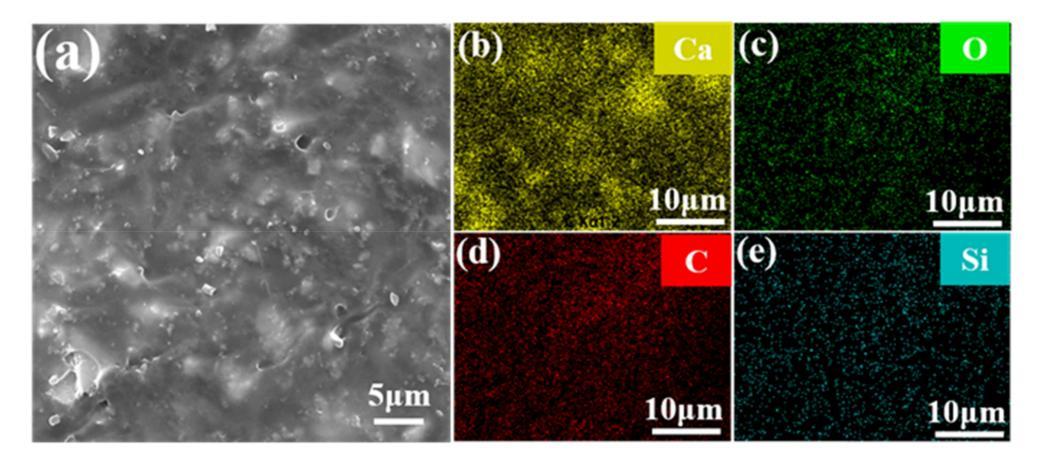
Figure 5. (a) SEM image of glue, (b) elemental distribution of Ca, (c) O, (d) C, and (e) Si.

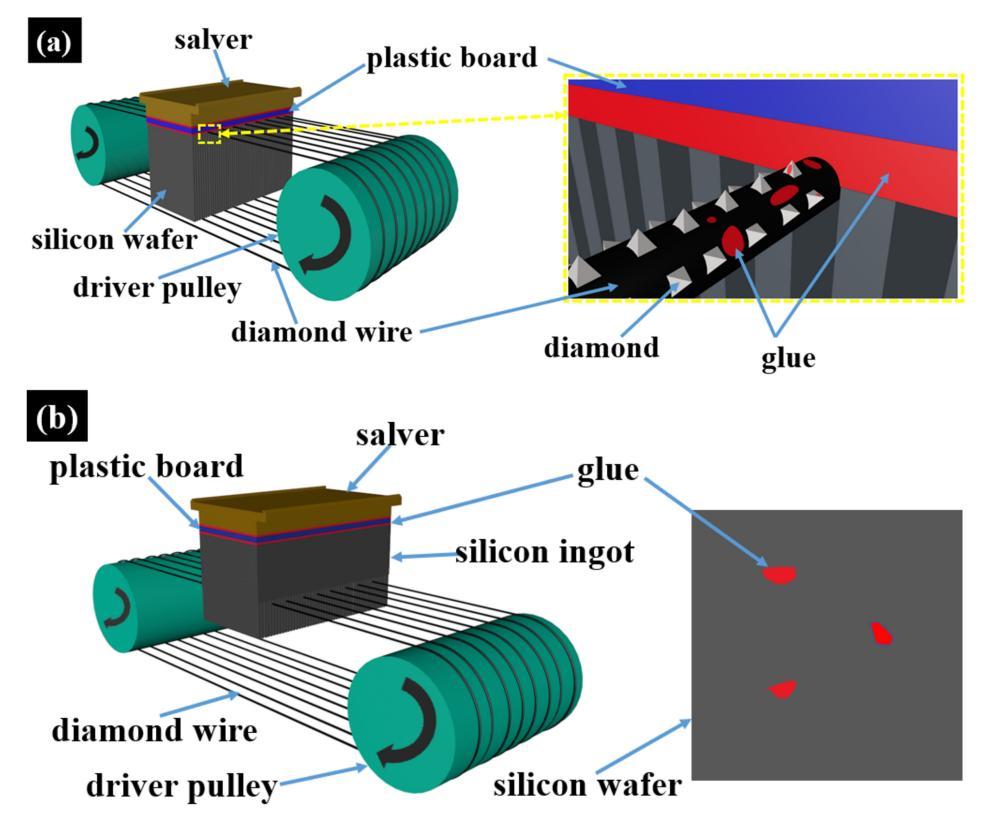
The process of restoring the white spot stains is shown in Figure 6. Yellow is the salver, red is sticky silicon ingot glue, blue is a plastic board, green is the driver pulley, and gray is a silicon wafer. Before slicing, the salver, plastic board, and silicon ingot needed to be bonded using sticky silicon ingot glue. After the glue solidified, the silicon ingot bonded with the salver and plastic board was installed on a diamond cutting machine for cutting. During the slicing process, the diamond wire moved at high speed under the action of the

drive pulley, and the diamond wire was fed vertically to the silicon ingot. The diamond wire threaded stress on the silicon ingot, and the diamonds were driven by the wire thread and ground the silicon ingot, thus slicing the silicon ingot. Due to uneven stress at each point of the wire, a line bow phenomenon occurred [34] in which the outer slicing depth was greater than the inner slicing depth. Therefore, the outer side of the silicon ingot was sliced before the inner side. Ensuring that the diamond wire had enough slicing depth was critical to ensuring that the silicon ingot was fully sliced. A plastic board was added in the middle of the silicon ingot and crystal bead. When the diamond wire sliced the plastic board, the silicon ingot glue. As a result, a large amount of sticky silicon ingot glue adhered to the diamond wire surface, so when the diamond wire sliced the next batch of silicon ingots, the glue on the diamond line rubbed against the silicon wafer and adhered to the silicon wafer, thus forming stains.

Figure 6. (a) Schematic diagram of diamond wire attachment stains, (b) schematic diagram of adhesion stains of the silicon wafer.

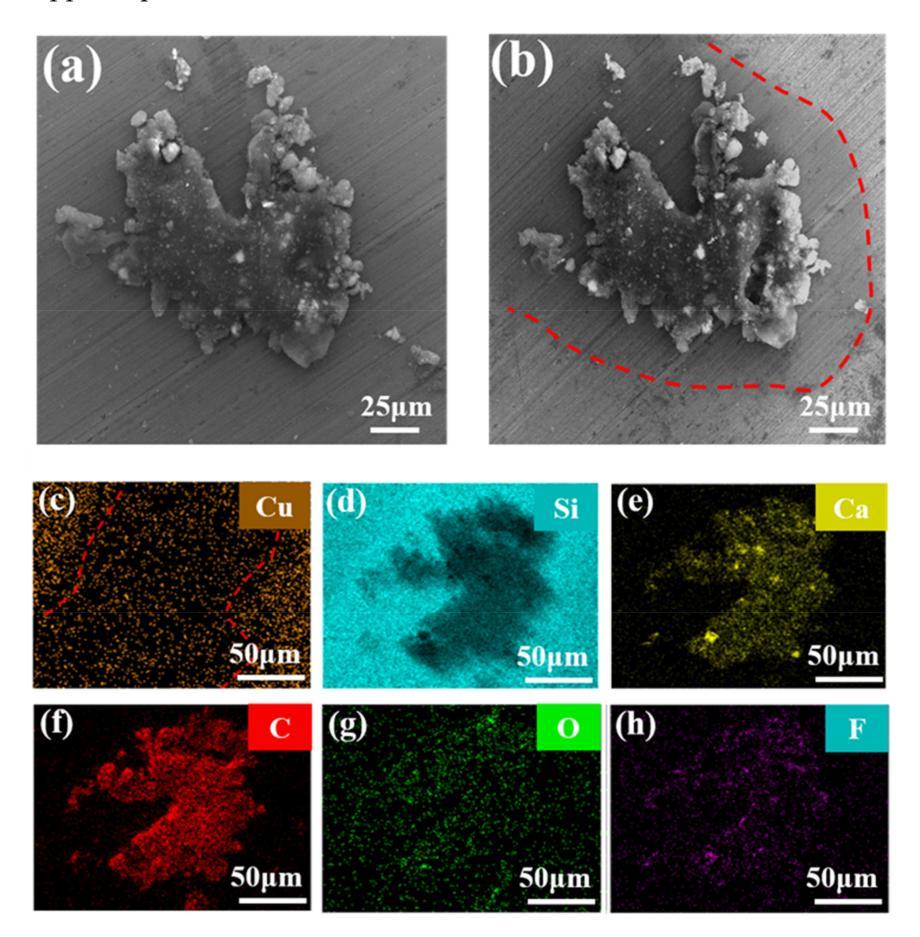
Figure 7a,b show the SEM diagram before and after the deposition of the silicon wafer in HF/Cu(NO₃)₂ solution. Due to the difference in electronegativity between Si and copper ion (Cu^{2+}) , the copper ion in the solution can acquire electrons from the wafer surface and form Cu particles; at this point, silicon is oxidized into SiO_2 , and the resulting SiO_2 is dissolved by HF in the solution and the fresh Si is exposed again. When the reduction of copper ions and oxidation of silicon occur periodically, more and more copper particles are deposited on the silicon wafer surface. Figure 7b shows that stain edges near the red dotted line were darker than those in the area outside the red dotted line. Compared with before deposition, the area outside the red dotted line was much brighter, showing that this area was deposited with copper. There were no significant differences in the stain morphology before and after deposition. The stain did not dissolve in the deposition solution. The EDS results show that the distribution of copper outside the red dotted line was denser than the distribution within the red dotted line. There were almost no copper deposits on the surface of the stain. At the edges of the red dotted line, only a very small amount of copper was deposited because CaCO₃ in the stain reacted with HF in the deposition solution via the equation 2HF + CaCO₃ \rightarrow CaF₂ \downarrow + CO₂ \uparrow + H₂O. The reaction generated CaF₂ precipitate, resulting in the rapid reduction of F⁻ around the stain. The pH increased, and the conductivity of the solution decreased. Therefore, F^- in the area outside the red dotted line was not added to the reaction interface outside the red solid line. Thus, concentration polarization occurred [35]. F^- in the HF solution easily reacted with Si atoms to form Si-F bonds, which greatly reduced the Si-Si bond strength. This made it easier for Cu²⁺ ions to obtain electrons and be reduced to elemental copper. The F⁻ concentration around the stain decreased, which decreased the rate of Cu²⁺ deposition, and resulted in uneven copper deposits [36].

Figure 7. (a) SEM image of white-spot-stained silicon wafer before and (b) after deposition, (c) elemental distribution of Cu, (d) Si, (e) Ca, (f) C, (g) O, and (h) F. (EDS maps in (c–h) were taken after deposition).

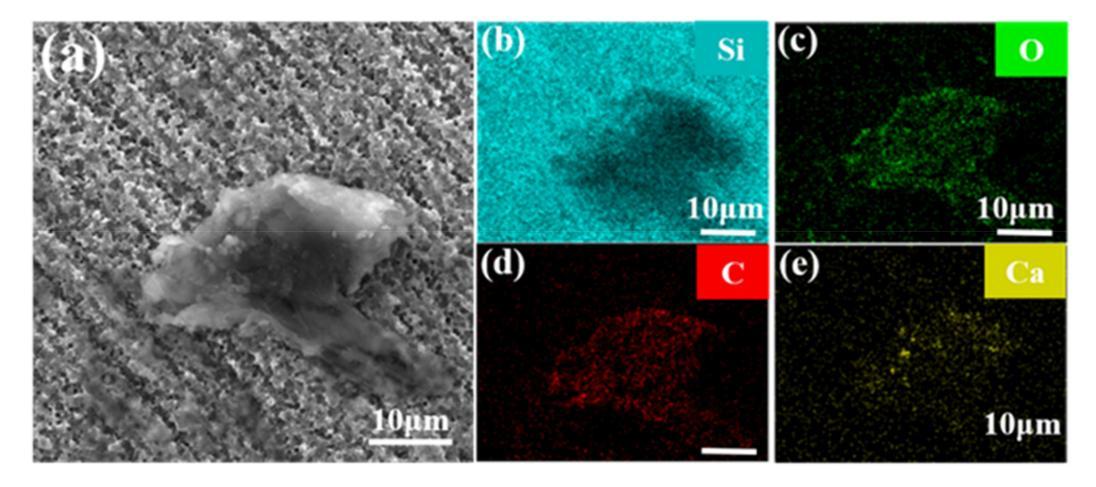
Figure 8 shows an SEM image of a white-spot-stained silicon wafer etched in $HF/Cu(NO_3)_2/H_2O_2$ solution at 40 °C for 7 min. There was oval-shaped material at the center of the picture, and the EDS results showed that the material was a stain adhered to the surface of the silicon wafer. After reacting for 7 min in a strongly oxidizing solution, the stain did not dissolve, and many nanopores were formed by the etching solution in areas that were not covered by the stain; cut marks are still visible. The silicon wafer was etched after KOH treatment, and a dense and uniform inverted pyramidal structure was formed on the silicon wafers, the diamond on the wire exerted a very strong force on the silicon ingot, which caused the dislocation of regularly arranged silicon atoms and formed an amorphous silicon layer. The presence of amorphous silicon layers slowed down the etching rate of the silicon wafers so that only a small amount of the silicon wafer was etched. KOH removed the amorphous silicon layer, which facilitated the deposition of copper particles and improved the etching results [37,38].

Figure 8. (**a**) SEM image of white-spot-stained silicon wafer after etching, (**b**) elemental distribution of Si, (**c**) O, (**d**) C, and (**e**) Ca.

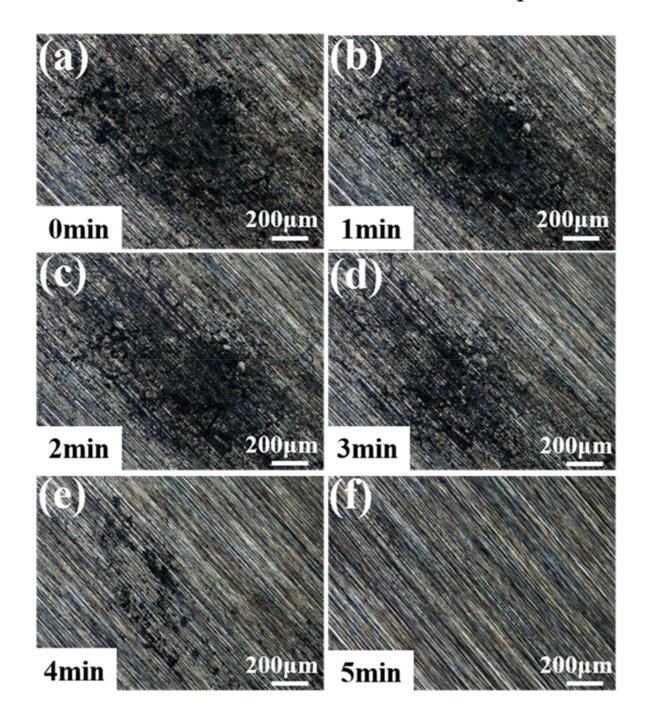
Figure 9. Evolution diagram of the dipped white spots with cleaning time, (**a**) MO image of white-spot-stained silicon wafer before cleaning, (**b**) cleaning for 1 min, (**c**) 2 min, (**d**) 3 min, (**e**) 4 min, (**f**) 5 min.

Sticky silicon ingot glue is an epoxy resin, whose hydrolytic degradation was accelerated by OH⁻ in the KOH solution. This reduced bonding performance. To understand the effect of KOH solution on stain removal, a metallographic microscope (MO) was used to observe changes in stain morphology at different cleaning times. Figure 9a shows an MO image of an uncleaned silicon wafer. A large amount of black material stained the surface of the silicon wafer. Figure 9b shows the stain morphology after cleaning for 1 min. The amount of stain shedding was very small, which exposed the silicon substrate. When cleaned for 3 min, the stain shedding was accelerated, and the stained area gradually shrank. Stains in the upper-left and lower-right corners were removed, and those in the middle part became sparser. After 4 min of cleaning, only a few spots remained on the wafer. At 5 min, no stains were visible under the microscope, and the stains were completely removed.
