# Article Effect of pH on Stress Corrosion Cracking of 6082 Al Alloy

## C. N. Panagopoulos<sup>1,\*</sup>, Emmanuel Georgiou<sup>2,3,\*</sup>, K. I. Giannakopoulos<sup>4</sup> and P. G. Orfanos<sup>1</sup>

**Abstract:** In this work, the effect of pH (3, 7 and 10) on the stress corrosion cracking behavior of 6082 aluminum alloy, in a 0.3 M sodium chloride (NaCl) aqueous based solution was investigated. The stress corrosion cracking behavior was studied with slow strain rate testing, whereas failure analysis of the fractured surfaces was used to identify the dominant degradation mechanisms. The experimental results clearly indicated that stress corrosion cracking behavior of this aluminum alloy strongly depends on the pH of the solution. In particular, the highest drop in ultimate tensile strength and ductility was observed for the alkaline pH, followed by the acidic, whereas the lowest susceptibility was observed in the neutral pH environment. This observation is attributed to a change in the dominant stress corrosion cracking mechanisms.

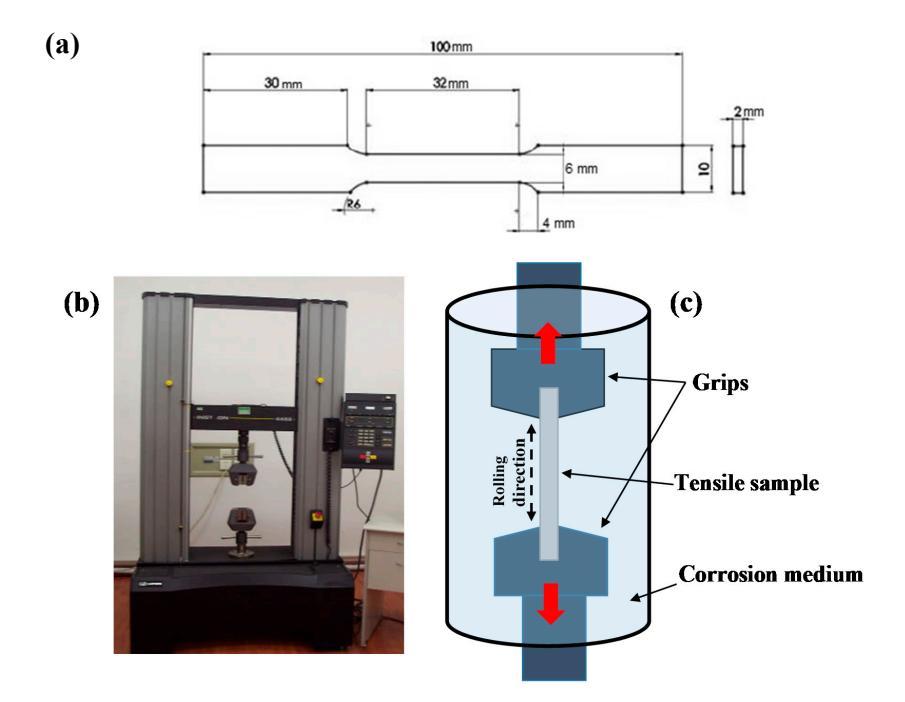
**Figure 1.** (a) ASTM E-8M tensile specimen; (b) Instron 4482 apparatus; and (c) schematic of stress corrosion setup.

The stress corrosion cracking (SCC) behavior of T6 treated 6082 aluminum alloy was determined by slow strain rate tests (SSRT) performed in an Instron 4482 (Instron, Norwood, MA, USA) apparatus (Figure 1b). Prior to testing, the grips were isolated to avoid the formation of any galvanic coupling (between the specimen and the grip) and/or contamination of the solution due to corrosion of the grips. The SSRT experiments were conducted in 0.3 M sodium chloride (NaCl) solution with three different pH values (pH = 3, 7 and 10) at 25 °C. A schematic of the SCC cell is given in Figure 1c. For each test 2 L of corrosive solution was used, and the pH of the solution was measured before and after the end of each test. In all experiments a strain rate of  $10^{-6}$  s<sup>-1</sup> was used. Reference tests were also performed in air at the same strain rate. For each pH and for the reference test in air, three independent tests were performed, and the values presented are the average of those results. Potentiostatic tests were also performed to investigate the evolution of the open circuit potential (OCP) of T6 treated aluminum alloy in the different pH by using a Potentiostat-Galvanostat and standardized electrochemical cells by EG&G (Edgerton, Germeshausen and Grier Inc., Gaithersburg, MD, USA). A standard calomel electrode (SCE) was used as the reference electrode and platinum as the counter electrode.

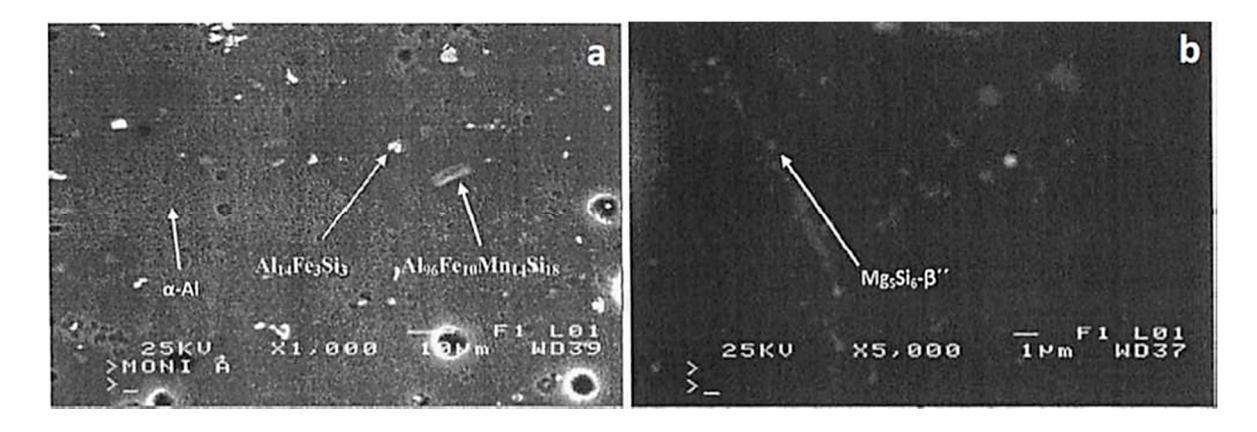
**Figure 2.** SEM micrographs showing (**a**) the microstructure of the T6 treated 6082 aluminum alloy and (**b**) the distribution of  $\beta''$  (Mg<sub>5</sub>Si<sub>6</sub>) precipitates along the grain boundaries of this alloy.

Figure 2a shows the typical microstructure of a T6 treated 6082 aluminum alloy. Apart from the aluminum solid solution, two different intermetallic phases could be observed, namely  $Al_{96}Fe_{10}Mn_{14}Si_{18}$  and  $Al_{14}Fe_3Si_3$  [22]. These phases appear to be well distributed within the matrix of this alloy. Further electron backscattering analysis at the grain boundaries of the alloy revealed the presence of fine  $\beta''$  (Mg5Si6) precipitates [23], which are mainly dispersed along the grain boundaries (see Figure 2b).

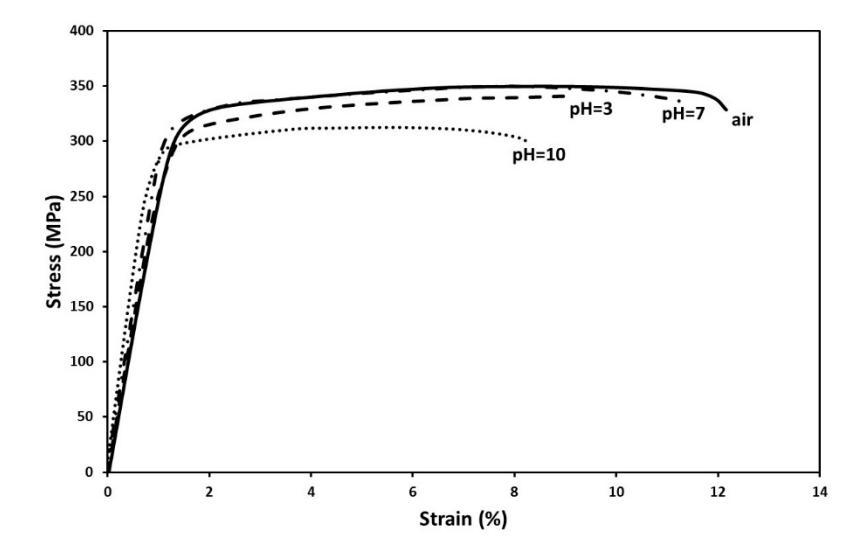
**Figure 3.** Effect of the pH of 0.3 M NaCl solution on the stress-strain curves of T6 treated 6082 aluminum alloy, obtained from the slow strain rate test (SSRT).

Figure 3 shows indicative stress strain curves obtained from the slow strain rate test (SSRT) experiments in the 0.3 M sodium chloride (NaCl) solution with different pH values (3,7 and 10).

From this figure it can be seen that in all SCC cases a decrease of ductility ( $\epsilon$ %) was observed, Table 1. This drop was more pronounced when the test was performed in an alkaline environment (pH = 10). In particular, the ductility of T6 treated 6082 aluminum alloy decrease from 12.1% (reference test in air) to 8.4%. This indicates a significant loss of ductility in the range of 30.6%. When the test was performed in an acidic environment (pH = 3), the ductility decreased from 12.1% to 9.2% (24% ductility loss) and in a neutral environment (pH = 7) it decreased to 11.3% (6.6% ductility loss). These results clearly illustrate the risk of embrittlement, even for ductile alloys such as aluminum alloys.

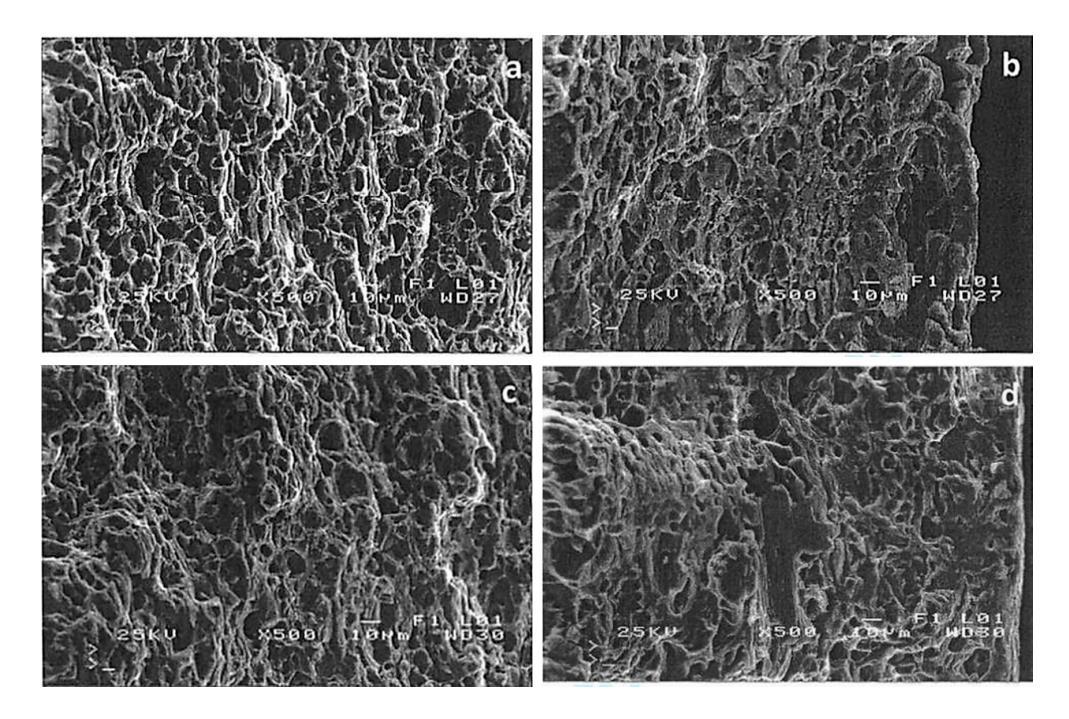
**Figure 4.** SEM analysis of the fractured surface of T6 treated 6082 aluminum alloy, after SSRT testing in (a) air, (b) pH = 3, (c) pH = 7 and (d) pH = 10.

Figure 4 presents SEM fractographies of 6082 aluminum alloy specimens after SSRT experiments in air (reference), acidic, neutral and alkaline environments respectively. In air, the main failure mechanisms were ductile (formation of dimples) and intergranular fracture (Figure 4a). A similar fracture pattern was also observed for the alloy tested under a neutral pH (Figure 4c). This confirms the similar mechanical behavior presented in Figure 3. However, localized brittle fracture zones were found in the outer layer of 6082 aluminum alloy after SSRT testing in the acidic and alkaline environment (Figure 4b,d, respectively). In both cases, the ductile fracture mechanism is maintained in the deeper layers of the alloy.

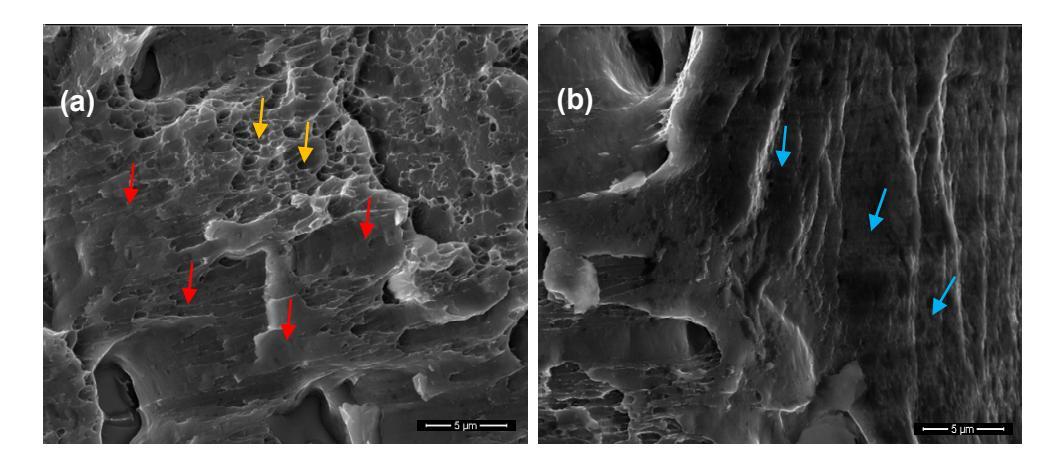
**Figure 5.** SEM analysis of brittle zones on the outer surface of the fractured surface of T6 treated 6082 aluminum alloy, after SSRT testing in (**a**) pH = 3 and (**b**) pH = 10.

Further analysis of the brittle zones shown in Figure 4b,d revealed cleavage-like morphologies [24], Figure 5a,b, respectively. In particular, at the surface layers of T6 treated 6082 Al alloy after SSRT testing in acidic pH, a brittle cleavage (flat surface patterns indicated by red arrows in Figure 5a) and ductile fracture identified by microvoids/dimples (indicated by yellow arrows in Figure 5a) were observed. This pattern is attributed to the presence of precipitates along the grain boundaries (Figure 2b) which provide an easy path for crack propagation via anodic dissolution [25,26]. It is believed that, the large difference in potential between the precipitates and aluminum matrix can create strong galvanic couples [26]. These galvanic couples can cause sharp crack advancement, resulting in an intergranular SCC mechanism [26]. In addition, brittle fracture by cleavage (indicated by blue arrows in Figure 5b) can be seen at the surface layers of the alloy after SSRT testing in alkaline pH. This brittle pattern is a result of both pinning of dislocations by the solute hydrogen atoms and to the formation and fracture of aluminum hydrides [20,27].

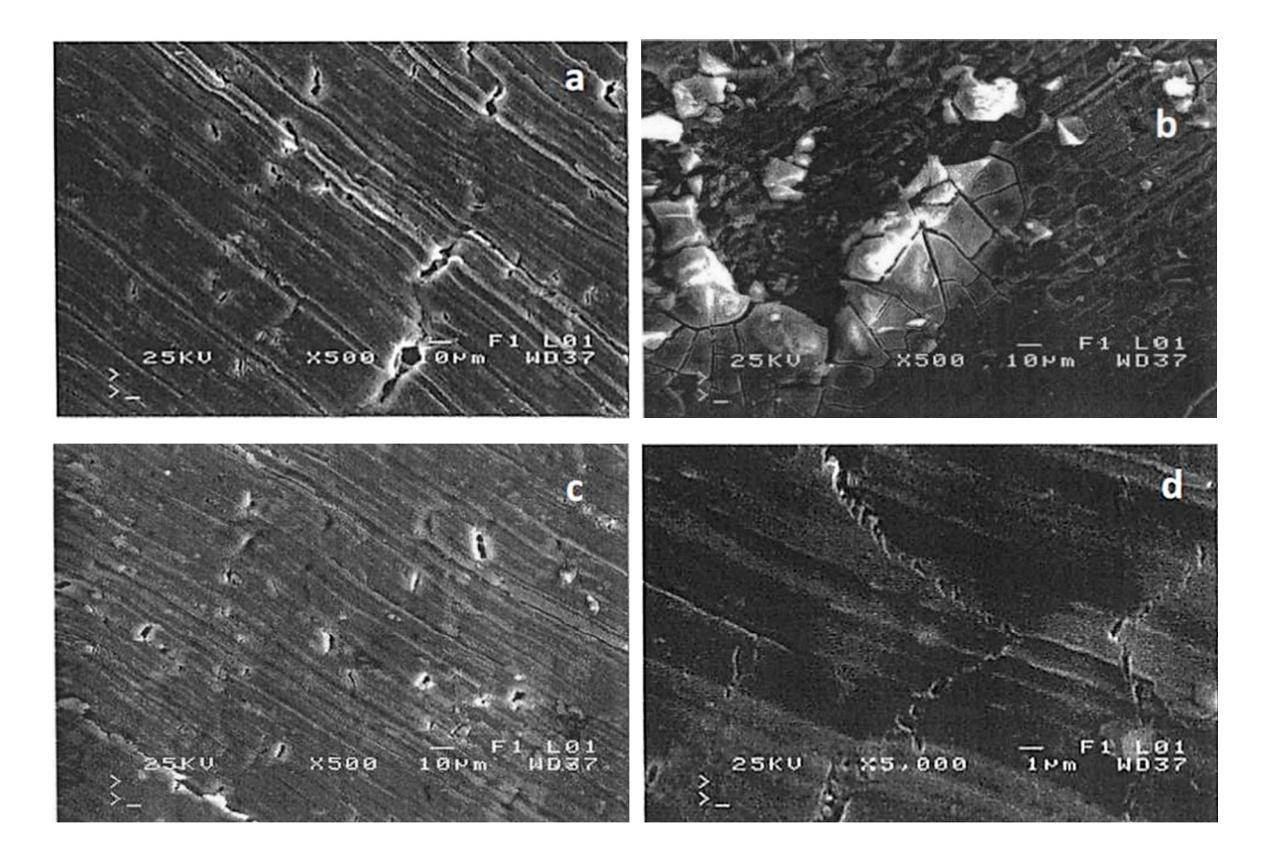
**Figure 6.** SEM analysis of the surface near the fractured area of T6 treated 6082 aluminum alloy, after SSRT testing in (**a**) air, (**b**) pH = 3, (**c**) pH = 7 and (**d**) pH = 10.

Analysis of the surface near the fractured area for all tested samples are presented in Figure 6. Some grinding lines due to the initial grinding can be discerned. In this figure, some distinctive patterns can be observed in each environment. For the 6082 aluminum alloy, which was SSRT tested in an acidic environment, an extended layer of corrosion products was observed. This layer was cracked due to tensile stresses (as indicated in Figure 6b). The corrosion products on the surface of the alloy were identified by XRD analysis to be mainly aluminum oxides (Al<sub>2</sub>O<sub>3</sub>), see Figure 7. However, when the SSRT tests were performed in a neutral pH, very limited corrosion products were observed (Figure 6c) and the surface morphology appeared to be very similar to that of the reference sample (experiment in air), see Figure 6a,c. In the case of SSRT testing in an alkaline pH, intergranular corrosion phenomena were seen (Figure 6d). This observation is attributed to the existence of precipitates along the grain boundaries, which have a different corrosion potential than that of the aluminum matrix. In particular, the  $\beta''$  (Mg5Si6) precipitates might have a similar corrosion potential to the aluminum matrix, but intermetallic phases such a-(AlFeMnSi) and Al-Si-Mg have a higher corrosion potential when compared to the same matrix. Thus, galvanic corrosion can take place at the grain boundaries. Furthermore, some aluminum oxides (Al<sub>2</sub>O<sub>3</sub>) were detected on the surface of the alloy after SSRT test in pH = 10, but to a lesser extent in comparison to those formed in the acidic

environment (Figure 6).

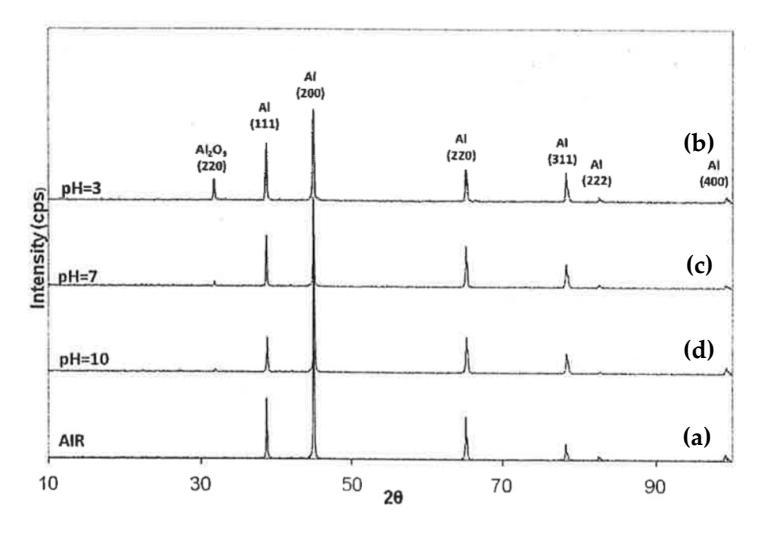
**Figure 7.** X-ray diffraction (XRD) analysis of the surface of T6 treated 6082 aluminum alloy, after SSRT testing in (**a**) air, (**b**) pH = 3, (**c**) pH = 7 and (**d**) pH = 10.

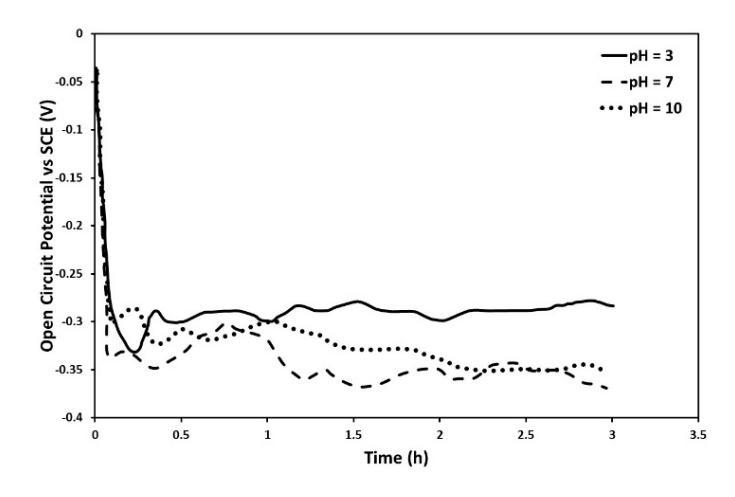
**Figure 8.** Effect of pH of 0.3 M NaCl solution on the open circuit potential (ocp) of T6 treated 6082 aluminum alloy as a function of immersion time.

From the fractographic analysis of the samples after SSRT testing it is evident that the change in pH resulted in different surface morphologies. To get a better insight into the effect of corrosion on the surface of 6082 aluminum alloy and to better understand the synergism between corrosion and wear, potentiostatic corrosion experiments were performed. Figure 8 shows the evolution of open circuit potential (OCP) of T6 treated 6082 aluminum alloy as a function of immersion time, for the three examined pH values of 0.3 M sodium chloride (NaCl) aqueous solution. From this figure, it can be observed that the OCP of the specimens at pH = 7 and 10 was more noble than that of pH = 3. Indeed, it is known that the pH of the corrosion environment can affect the stability of the oxide film (Al<sub>2</sub>O<sub>3</sub>), according to the Pourbaix diagram [28]. In particular, in neutral pH values a stable  $Al_2O_3$  oxide film is formed, passivating 6082 aluminum alloy and hindering the diffusion of the Cl<sup>-</sup> halide ions. Therefore, the corrosion phenomena are more intense in the acidic pH, when compared to neutral. In addition, hydrogen uptake will occur in an environment with alkaline pH [29]. However, it should be also taken into consideration that stress corrosion cracking involves the synergism between electrochemical and mechanical aspects. For example, mechanical stresses can accelerate the diffusion of halide and/or hydrogen ions enhancing corrosion and/or embrittlement phenomena [30]. On the other hand, the formation of corrosion products and surface defects (e.g., pits, blisters) are known to degrade the mechanical performance of materials [27].

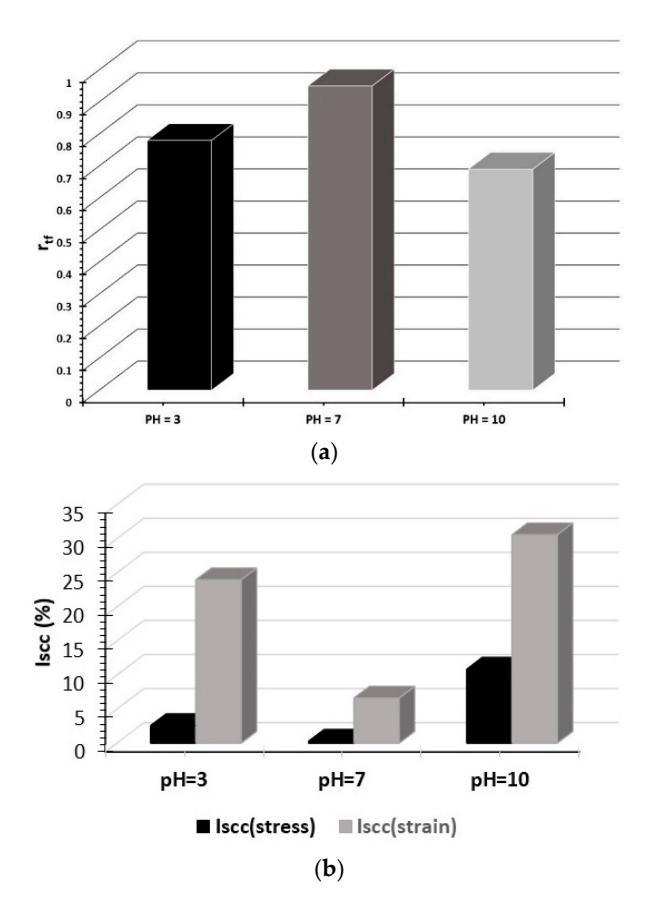
**Figure 9.** Effect of pH of 0.3 M NaCl solution on (**a**) the ratio of time-to-fracture ( $r_{tf}$ ) index and (**b**) the I<sub>SCC</sub> susceptibility index of T6 treated 6082 aluminum alloy.

To better compare these different SCC conditions, the ratio of time-to-fracture ( $r_{tf}$ ) index was evaluated. This index is calculated according to the equation  $r_{tf} = t_{fe}/t_{fc}$ , where  $t_{fe}$  and  $t_{fc}$ are the time to failure for the testing and control (air) environments, respectively. Figure 9a shows the rtf value of T6 treated 6082 aluminum alloy as a function of the pH of solution. From this figure it can be seen that this alloy is more susceptible to stress corrosion cracking in the alkaline environment, whereas the influence was very small at the neutral pH. In addition, the effect of pH on the stress corrosion resistance of T6 treated 6082 Al alloy was quantitatively assessed by using the susceptibility index I<sub>SCC</sub> [31]. This index is calculated by the following equation I<sub>SCC</sub> =  $[(\varepsilon_{air} - \varepsilon_{scc})/\varepsilon_{air}] \times 100$ , where  $\varepsilon_{air}$  is the elongation after testing in air (reference test) and  $\varepsilon_{scc}$  is the elongation after the SCC test. This index can be also described in terms of UTS [31]. The SCC susceptibility index is given in Figure 9b. Similar to the  $r_{tf}$  index, the I<sub>SCC</sub> index also confirms that the alkaline, followed by the acidic pH has the strongest influence on both the ductility and UTS of the alloy.
