Article

The Evaluation of the Fracture Surface in the AW-6060 T6 Aluminium Alloy under a Wide Range of Loads

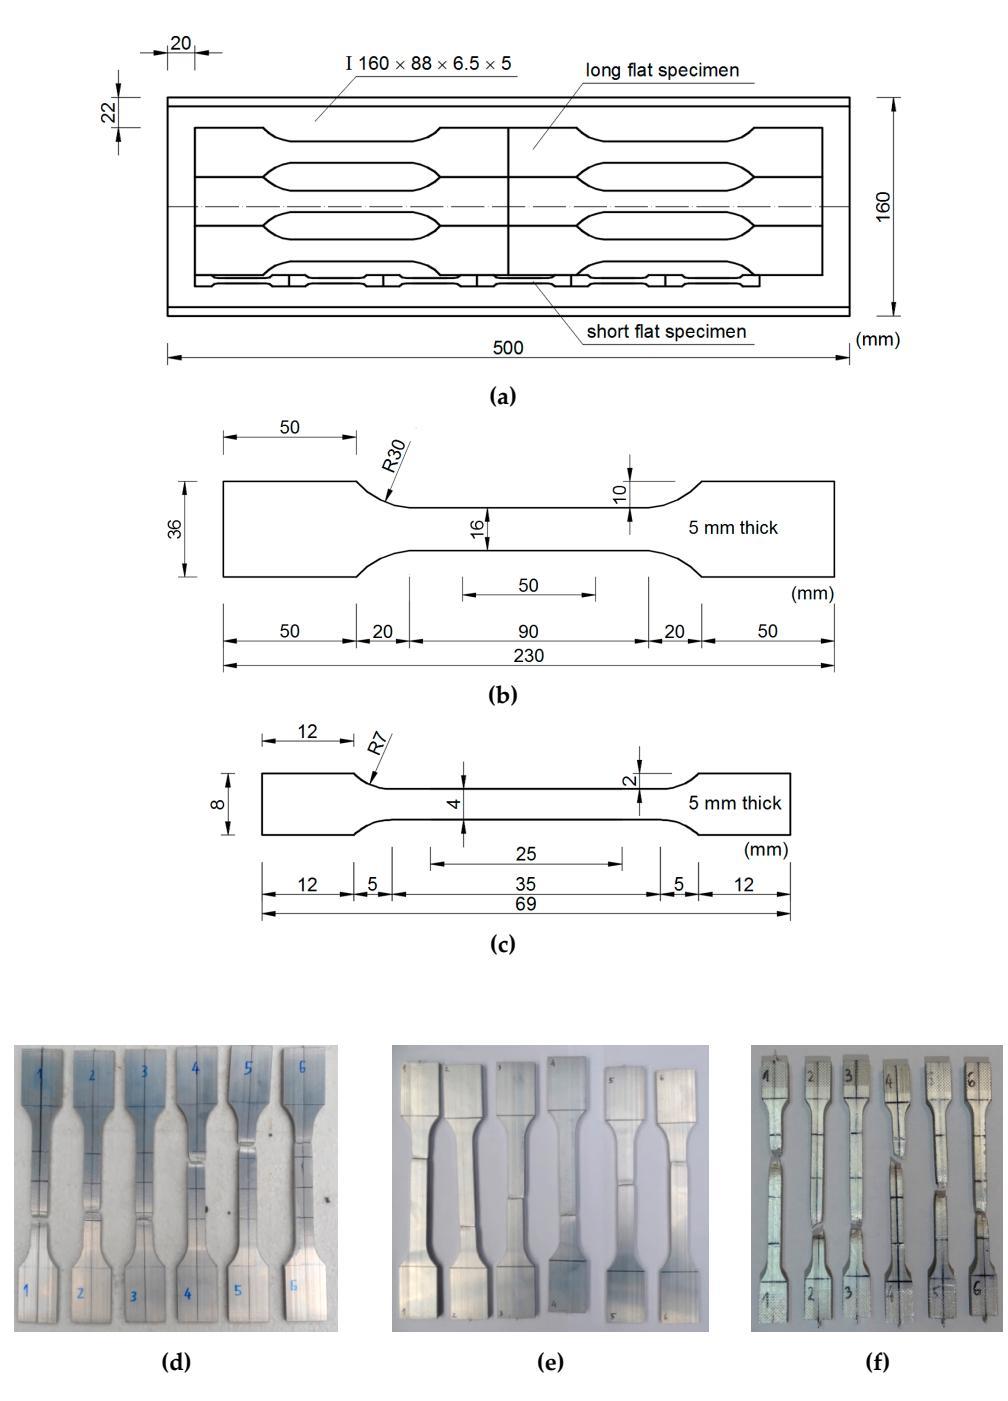
Figure 1. (**a**) I-beam; (**b**) dimensions of the long sample; (**c**) dimensions of the short sample; samples after tensile tests: (**d**) long samples from group 1; (**e**) long samples from group 2; (**f**) short samples from group 3.

The uniaxial tensile tests were divided into three groups (see Figure 1).

Flat specimens were used in all groups. The tests were conducted at room temperature. In the first group, the tensile tests were carried out in an Instron Satec testing machine (Instron, Grove City, PA, USA) using six long samples and an extensiometer (Epsilon, Jackson, WY, USA) with a 50 mm gauge. The initial stress rate \hat{R} of 2.0 MPa/s was used up to 0.2% of the nominal elongation (in the elastic range). In the plastic range, the strain rate $\dot{e} = 0.03$ mm/s was used. In these tests, the temperature of the samples was measured when cracks appeared using a FLIR S7000 thermal infrared camera (FLIR Systems, Wilsonville, OR, USA). In the second group, the tensile tests were conducted using six long samples and an Instron Satec testing machine at the strain rate $\dot{e} = 1.25$ mm/s. In the third group, the tensile tests were done using six short samples, an extensometer (Epsilon, Jackson, WY, USA) with a 25 mm gauge and an Instron ElectroPuls E10000 testing machine (Instron, High Wycombe, Buckinghamshire, UK). The initial stress rate \hat{R} of 2.0 MPa/s was used up to 0.2% of the nominal elongation (in the elastic range). In the plastic range, the strain rate $\dot{e} = 0.03$ mm/s was used. In all the test groups, the ultimate strength, Young's modulus and the yield strength (0.2% proof strength) were determined in accordance with the principles set out in the standard [30]. The geometry of the samples from group 3 was different than of the samples from groups 1 and 2, to evaluate the impact of the sample size on tensile strength. Both long and short flat samples were prepared in accordance with the rules presented in the standard [30]. The authors of this paper used proportional test specimens with a gauge length $L_o = 5.65\sqrt{S_o}$, where S_o represents the original cross-sectional area. The samples were cut out from two 500 mm long I-beams using waterjet cutting to limit the influence of heat on the strength parameters of the aluminium alloy. In the tensile tests, the tensile direction was parallel to the direction of extrusion (0°). The tensile direction has an impact on the tensile strength [31]. The ultimate tensile strength is higher in the 0° direction than in the 45° or 90° directions [31].

Figures 1d–f and 5 demonstrate the types of fractures of the AW-6060 T6 alloy. In the first and second groups of tests, ductile cup and cone type fractures occurred. In the third group of tests, shear fractures occurred. The modulus of elasticity of group 2 was not reported because the obtained values were not reliable. There was a slip in the initial part of the stress–strain curve. The samples had not been properly fixed in the clamps of the testing machine when the strain rate $\dot{e} = 1.25 \text{ mm/s}$ (the highest possible value of the strain rate for the Instron Satec testing machine). The mean value of the 0.2% proof strength of the samples from group 3 was only 1.03 times greater than the mean value of the 0.2% proof strength of the samples from group 1. Moreover, the mean value of the ultimate tensile strength of the samples from group 1. The size of the sample did not have an impact on the tensile strength. However, the authors wish to emphasize the fact that both long and short flat samples were proportional test specimens prepared in accordance with the rules presented in [30].

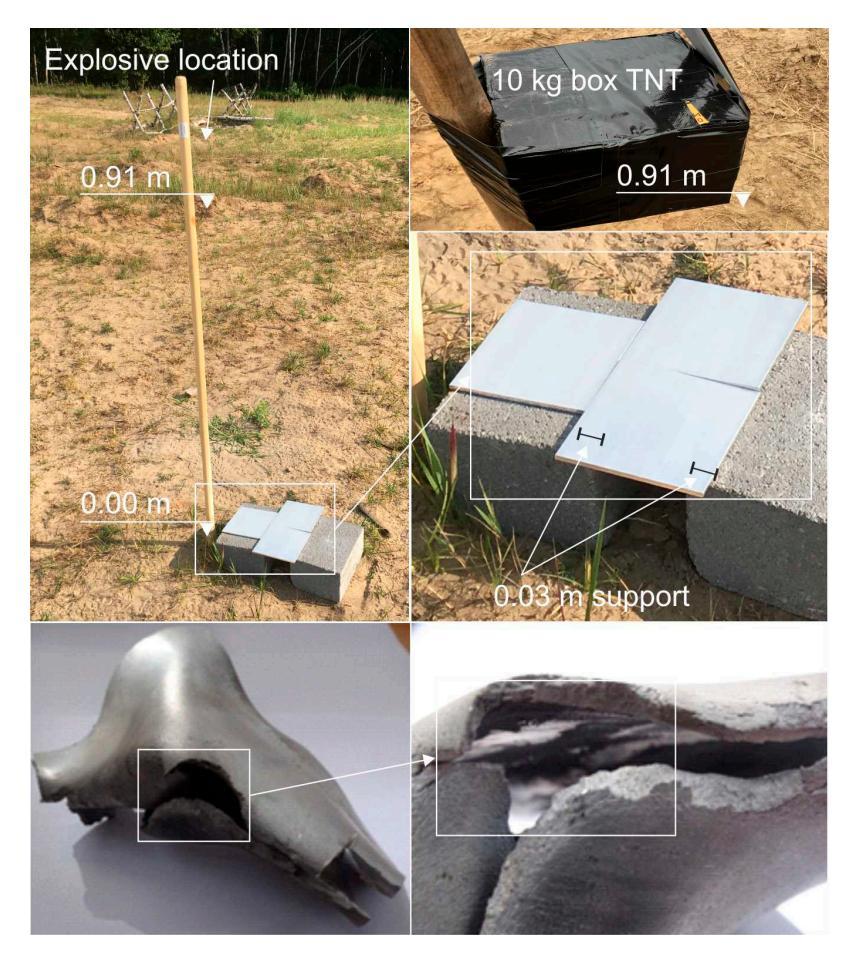
Figure 2. Explosion test: stand view, 10 kg TNT box, whole sample and torn edge.

It is difficult to assess the behaviour of civil engineering materials and composite structures loaded by high strain loading. It is equally difficult to investigate the reason for the initial failure (e.g., in the coupled loading scenario). In such a scenario, the blast wave accelerates some fragments which penetrate the obstacle. Finally, it is very hard to assess the real reason for failure and to be sure which loading reached the obstacle first—the projectiles or the explosive wave. Obviously, there are some recommendations in the STANAG code. For instance, versions 2920 [32] and 4569 [33] deal with the guidelines for steel armour sheet testing and its protection level under such loadings for the military certification of material. In this paper, the authors tried to find clear differences between different loading scenarios based on the failure surface of the obstacle. Plates (5 mm \times 150 mm \times 150 mm) made of the AW-6060 aluminium alloy were exposed to blast load (see Figure 2). The primary purpose of such an experiment was to obtain a failure edge base from the blast wave loading. The side-on pressure and impulse values were measured using a PCB pencil probe (PCB Piezotronics MTS Systems Corporation, Depew, NY, USA) located 0.95 m away from the charge centre. Finally, high intensity explosive loading was analysed. For this, 10 kg of TNT were placed 0.91 m away from the specimens. The estimated overpressure peak and the positive impulse values were 5341 kPa and 294 kPa \times ms respectively [34]. The distance was crucial to causing serious damage to the plates, while not removing the specimens far from their initial location. Moreover, the specimens were supported by concrete blocks. The depth of support was 0.03 m on each side of the plate. The authors performed a series of such experiments. In some of them, the specimens were seriously damaged. They were unsuitable for further analysis, because their edges had been damaged by the concrete fragments from the supporting block units. This occurred because the blast wave reflected from the ground and accelerated the concrete block. The concrete debris pushed the aluminium plate up to 50 m away from its initial position. In such cases, it was very difficult to determine the real reason for failure. The authors selected only one sample with a torn edge for further analysis. Obviously, the standard of the tests was far from laboratory conditions; however, it was good enough to capture the pure failure edge caused only by the rapid pressure wave action. As a result of the tests, the edge of the aluminium plate was

torn. It was very challenging to perform any measurements at such a close distance because of the risk of gauge destruction. Yet another important fact is that the diameter of the fireball obtained during the explosion of the 10 kg of TNT exceeded 7 m. For this reason, it was impossible to record the blast wave loading and the obstacle failure using high speed cameras.

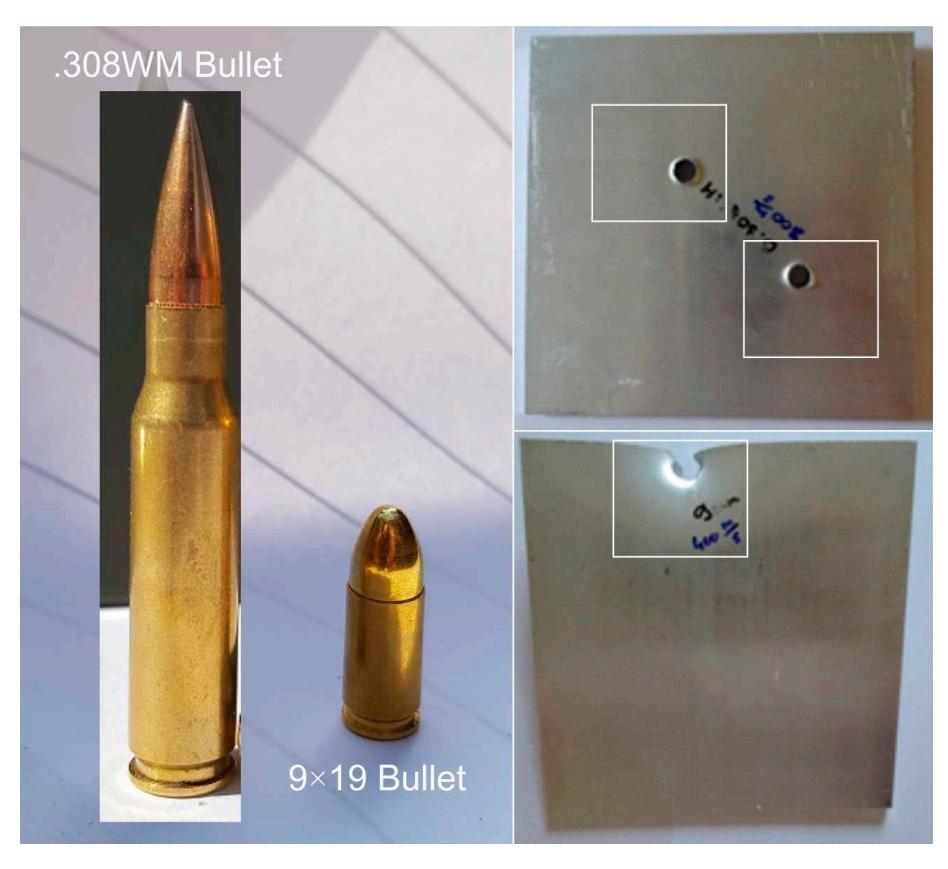
Figure 3. Failure patterns after gun shots: two sniper rifle shots vs. Glock pistol shot.

The remaining tests dealt with projectile perforation. In this case, a flying military bullet went through the obstacle. Nevertheless, the strain rates were much higher than in the previously presented explosive loading. In projectile perforation tests, the failure edge strongly depended on the bullet or fragment geometry. However, a similar value of the strain rate allowed the authors to obtain a constant failure mode on the damaged material edge. This methodology is relatively new, and there are no papers in which the assessment of the final failure allows for the prediction of the initial loading scenario. In a series of tests, two plates made of aluminium alloy were exposed to gun shots (see Figure 3). A sniper rifle (muzzle velocity = 806 m/s, .308WM ($7.62 \times 51 \text{ NATO}$) bullet) and a Glock pistol (muzzle velocity = 400 m/s, $9 \text{ mm} \times 19 \text{ mm}$ Parabellum bullet) were used. The distance between the barrel and the plates was 25 m. This distance ensured a stable flight of the .308WM bullet. The idea of the test was simple. The plates ($5 \text{ mm} \times 150 \text{ mm} \times 150 \text{ mm}$) made of the AW-6060 aluminium alloy were suspended in the air and fixed by threads. After the shot, the plates were found in a pile of sand located 2 m away from their original position.

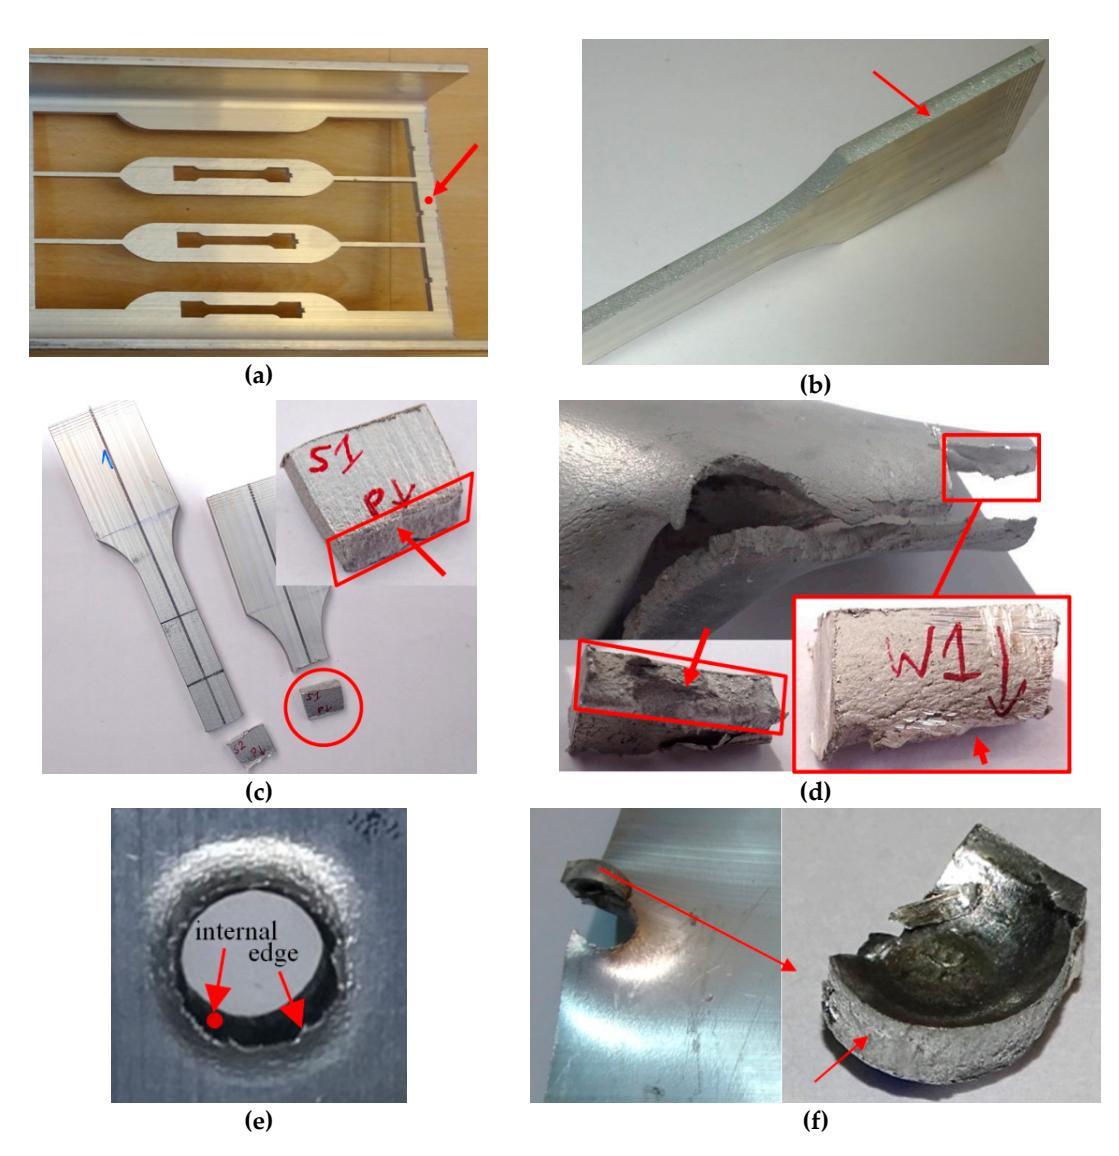
Figure 4. Surfaces observed by the authors of this article after: (**a**) extrusion; (**b**) waterjet cutting; (**c**) tensile test; (**d**) explosion test; (**e**) sniper rifle shot; (**f**) Glock pistol shot.

The tensile samples were cut out from extruded I-beams using waterjet cutting. The microstructures of the I-beam web (see Figure 4a) and the intersection zone of one sample (see Figure 4b) were observed under a scanning electron microscope (Tescan, Brno, Czech Republic) to collect additional information about the sample preparation. The authors of this paper expected to observe die lines—continuous deep grooves parallel to the direction of extrusion [35]—on the surface of the web. Additionally, they expected to observe abrasive wear tracks [36] on the fracture surface of the sample after waterjet cutting.

To achieve one of the goals of the present article, the fracture surfaces after the tensile tests (4c), the explosion test (4d) and the perforation tests (4e,f) were investigated using a scanning electron microscope. The SEM micrographs of the samples were obtained using a TESCAN Vega 3 scanning electron microscope (Tescan, Brno, Czech Republic) with a secondary electron (SE) detector. Due to the electrical properties of aluminium, the coating of the samples was not necessary. The SEM micrographs were supplemented by grey-scale intensity profiles.

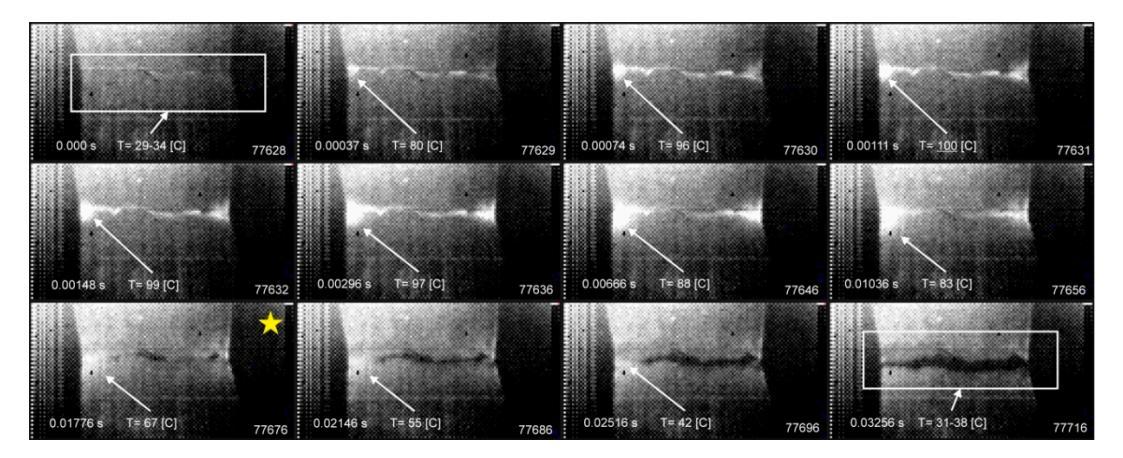
Figure 5. Sample temperature during the static tensile test.

The temperature of the samples from group 1 reached approximately 100 °C when failure occurred (see Figure 5). The important fact is that in the classic tensile static test the fracture time was 0.03256 s. Moreover, the temperature rose by approximately 100 °C only 0.00111 s after the first cracking appeared. This temperature value remained high for another 0.01 s. In Figure 5, the time representing the peak of the tensile force is marked with a yellow star. At that point, the outside specimen temperature was still 67 °C higher than the room temperature.

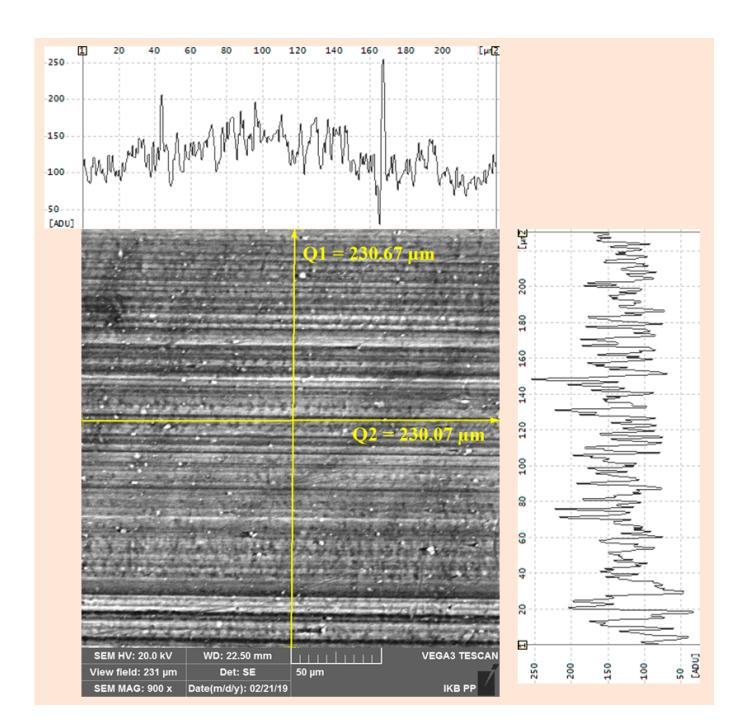
Figure 6. SEM micrograph of the extruded I-beam web with grey-scale intensity profiles along the depicted lines, magnification factor \times 900.

In Figure 6, one can observe die lines parallel to the direction of extrusion. The fracture surfaces after the tensile tests (Figures 7 and 8) were perpendicular to the direction of extrusion. The tensile direction was oriented at 0° with respect to the direction of extrusion. Due to the fact that the tensile direction has an impact on the tensile strength [31], the authors obtained the highest values of the ultimate tensile strength for the 0° direction. Moreover, the surface presented in Figure 6 is fibrous [40]. This structure is characterised by bands composed of very fine equiaxed grains [40].

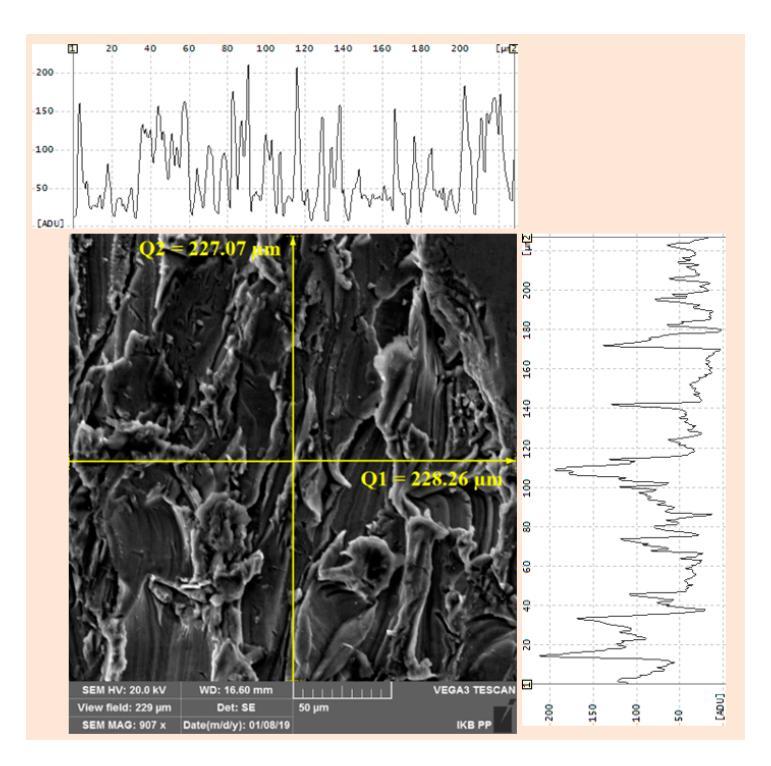
Figure 7. SEM micrograph of the fracture surface after waterjet cutting with grey-scale intensity profiles along the depicted lines, magnification factor ×900.

In Figure 7, the authors observed abrasive wear tracks caused by waterjet cutting. Figures 8 and 9 show the failure surfaces of the aluminium alloy specimens after tensile tests.

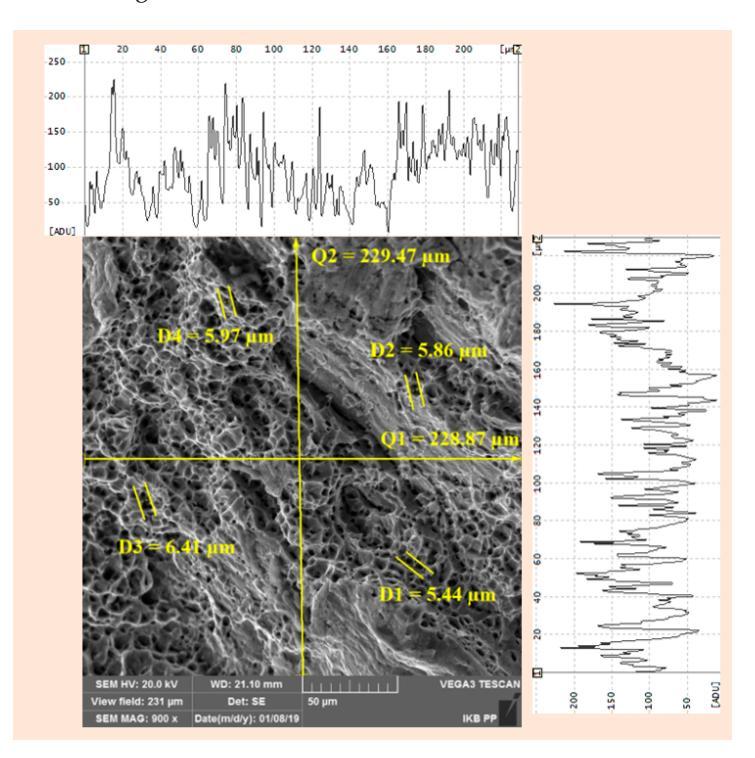
Figure 8. SEM micrograph of the fracture surface after a tensile test (strain rate $\dot{e} = 0.03 \text{ mm/s}$) with grey-scale intensity profiles along the depicted lines, magnification factor \times 900.

The dimple structure with deep spherical pores after the tensile tests demonstrated that the material sustained ductile fractures and had been overloaded (see Figures 8 and 9). The micro-dimples observed in Figures 8 and 9 were of varying sizes and shapes. The fracture surface after the tensile test (strain rate $\dot{e} = 0.03 \text{ mm/s}$) had 5.44–6.41-µm wide dimples. Motsi et al. showed that the fracture surface of the 5083-H0 aluminium alloy after a tensile test was characterised by micro-dimples, which became shallower with increasing strain rates [23]. The number of dimples on the fracture surfaces presented by Motsi el al. was higher at low strain rates than at intermediate strain rates. In the present article, the authors confirmed these findings. However, in the case of the 7017 aluminium alloy, Bobbili el al. suggested that the number of dimples was higher at high strain rates than at intermediate strain rates and that the number of dimples grew with the rise in temperature from 25 °C to 300 °C [14]. Bobbili el al. presented SEM micrographs of the fracture surface in Figure 7 of the article [14]. In the opinion of the authors of this paper, the number of dimples was higher at high strain rates than at intermediate strain rates at high temperature, but at room temperature, the number of dimples was higher at intermediate strain rates than at high rates in Figure 7 of the article [14]. This confirms the finding of the present authors that the number of dimples decreases with the rise in strain rates. However, this conclusion seems to be reliable only for the sample tested at room temperature, which should be further investigated in the future.

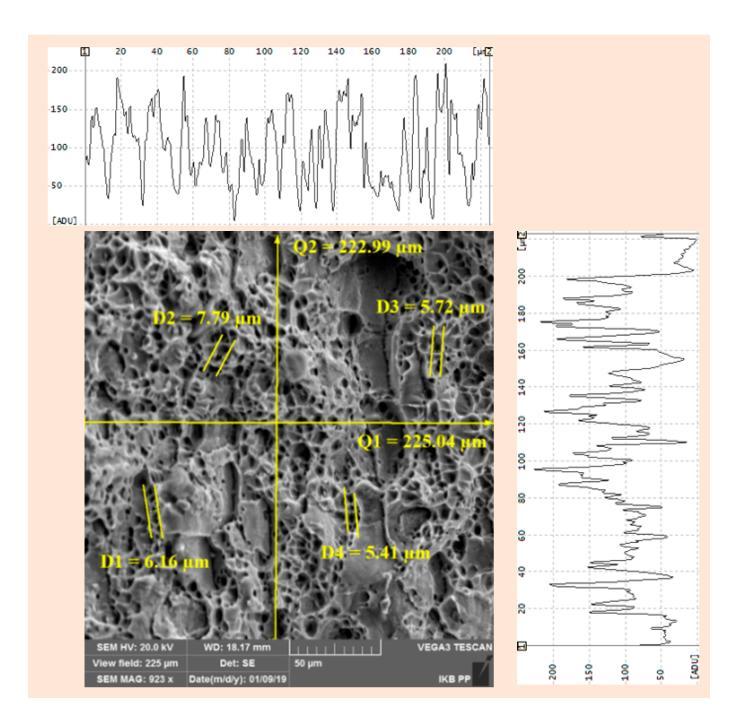
Figure 9. SEM micrograph of the fracture surface after a tensile test (strain rate $\dot{e} = 1.25$ mm/s) with grey-scale intensity profiles along the depicted lines, magnification factor ×900.

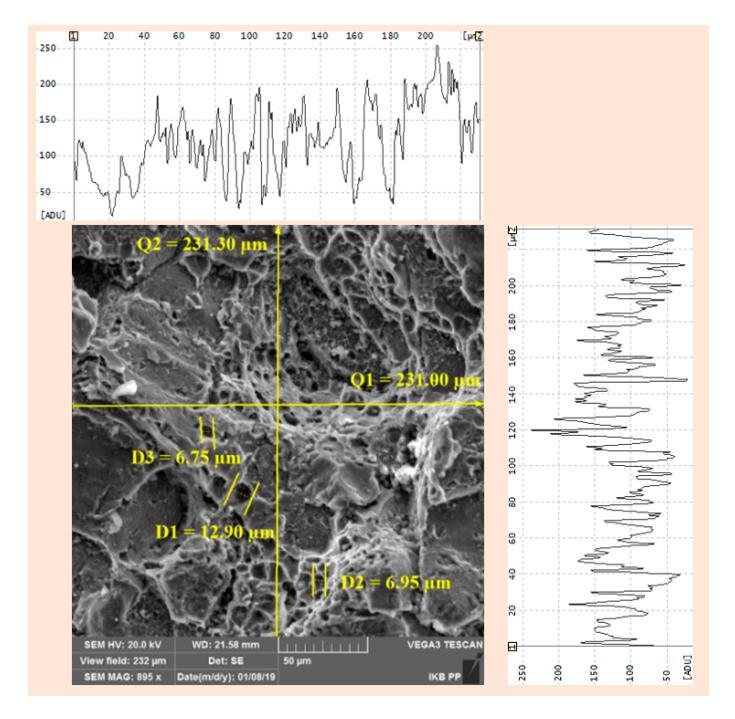
Figure 10. SEM micrograph of the fracture surface after explosion test with grey-scale intensity profiles along the depicted lines, magnification factor \times 900.

A small number of dimples with cleavage portions was observed on the fracture surfaces of the samples after the explosion test (see Figure 10). A large number of dimples with cleavage portions was noticed on the fracture surfaces of the samples after exposure to the Glock pistol shot (see Figure 13). The pores on the fracture surface after the Glock pistol shot had different shapes than the pores on the fracture surfaces after the tensile tests. The pores on the fracture surface after the explosion test were wider than the pores on the fracture surfaces after the tensile tests after the tensile tests and the Glock pistol shot. The cleavage portions suggest that the material was rapidly torn. They were not observed on the fracture surface after the tensile tests. The number of dimples on the fracture surface was higher after the tensile tests than after the explosion test and the Glock pistol shot. The width of the dimples in the fracture surface after the Glock pistol shot and the explosion test ranged from 4.75 to $14.32 \mu m$.

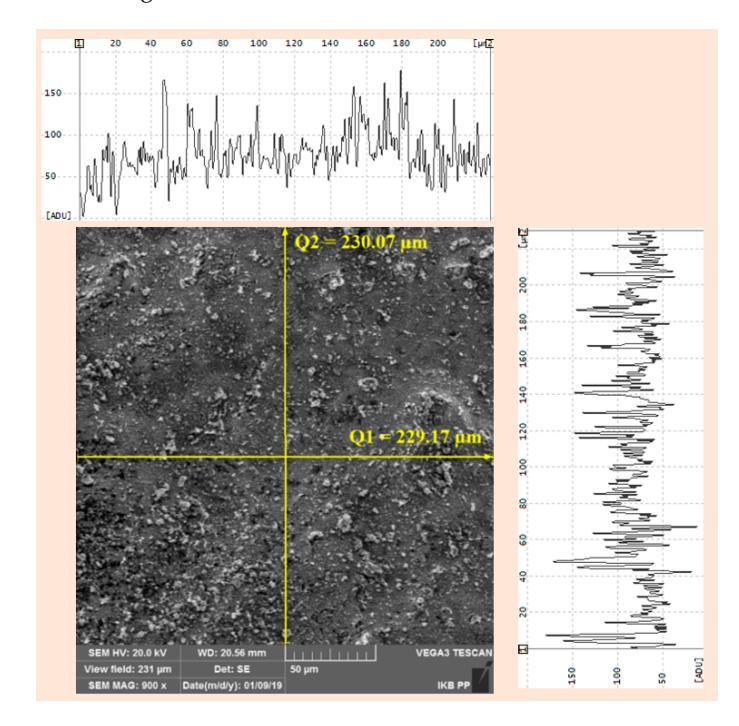
Figure 11. SEM micrograph of the fracture surface after sniper rifle shot with grey-scale intensity profiles along the depicted lines, magnification factor \times 900.

Two SEM micrographs were done after the sniper rifle shot, one for the inside surface and one for the fracture edge. Cleavage portions with no dimples were observed on the fracture surface of the sample after the sniper rifle shot (see Figure 12). The fractures after the sniper rifle shot were found to occur predominantly in the cleavage mode [41]. The material was rapidly torn. The fracture surface presented in Figure 11 appeared to be smooth. This occurred because the analysed surface was perpendicular to the bullet's trajectory and was subjected to bullet friction. The differences between the SEM micrographs of the fracture surfaces are evident.

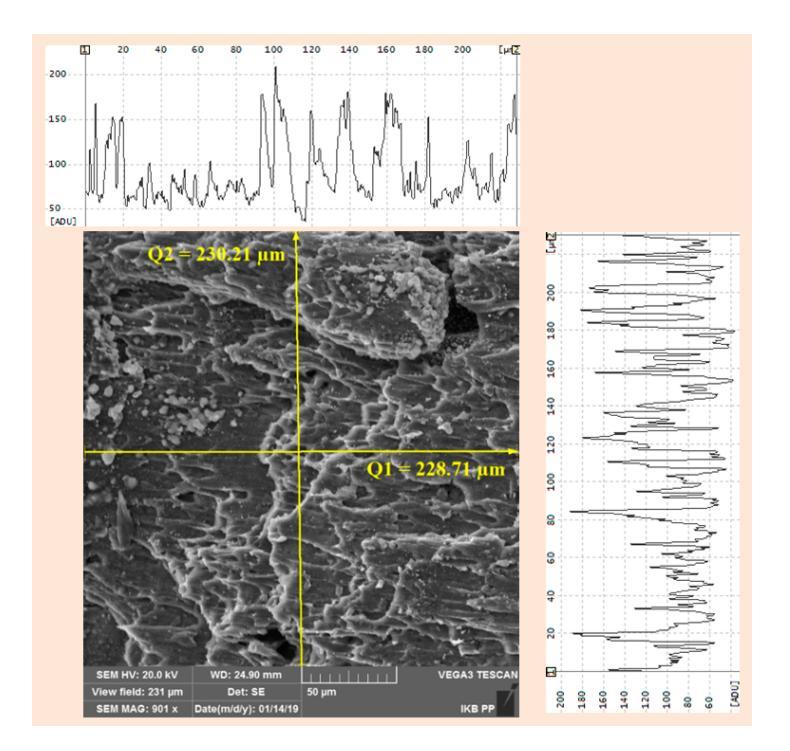
Figure 12. SEM micrograph of the fracture surface after sniper rifle shot with grey-scale intensity profiles along the depicted lines, magnification factor \times 900 (edge).

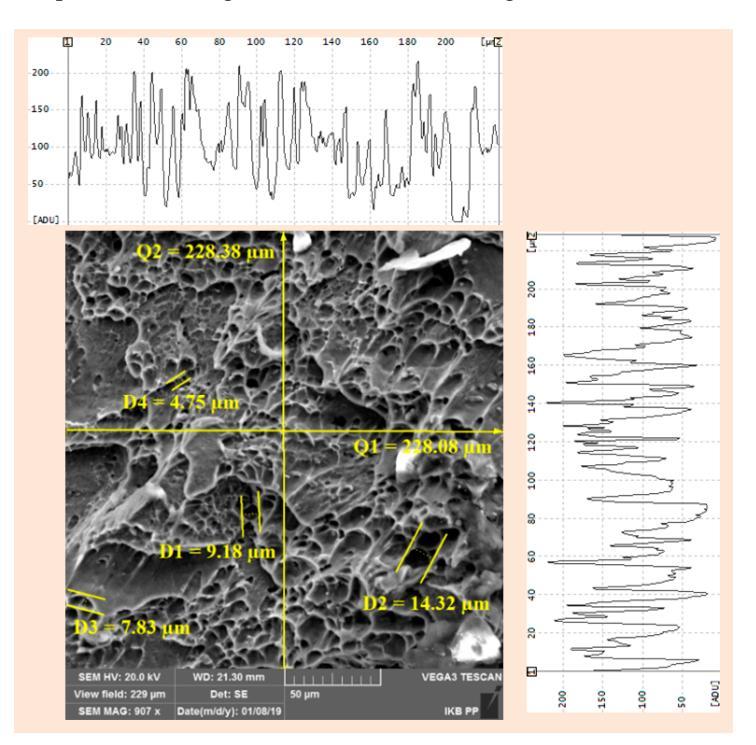
Figure 13. SEM micrograph of the fracture surface after Glock pistol shot with grey-scale intensity profiles along the depicted lines, magnification factor ×900.
