Article

Corrosion Study of Implanted TiN Electrodes using Excessive Electrical Stimulation in Minipigs

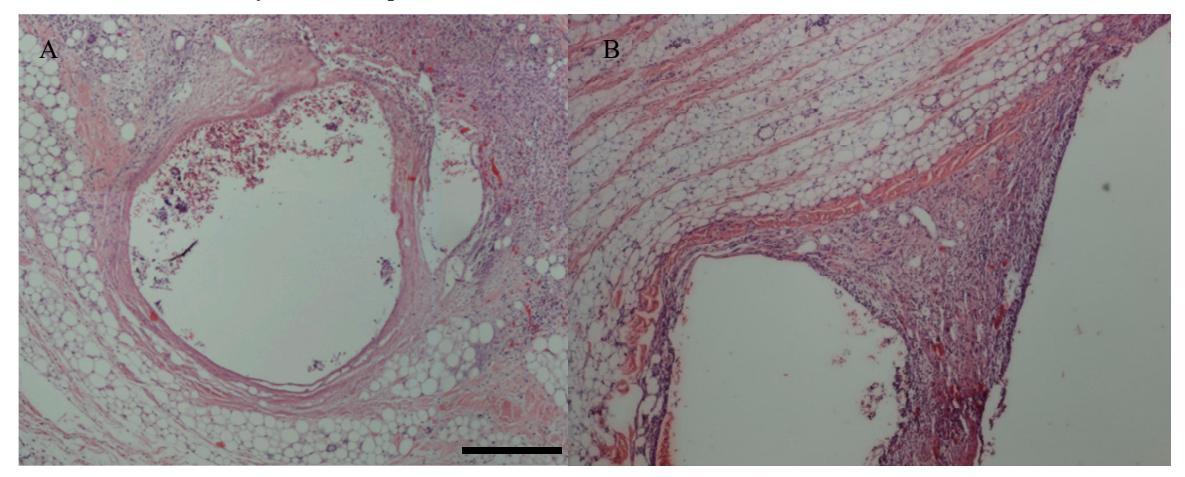
Figure S1. (a) Tissue around the tip of an electrode stimulated at 20 mA-200 Hz after 1 week of implantation. The tissue was stained using hematoxylin and eosin (H&E), which is the most commonly applied stain in medical diagnostics. Some inflammatory cells can still be observed, but capsule formation has begun to take place. (b) Cells around the silicone part of the electrode appear very similar to those around the electrode tip, indicating no signs of stimulation-induced tissue damage.

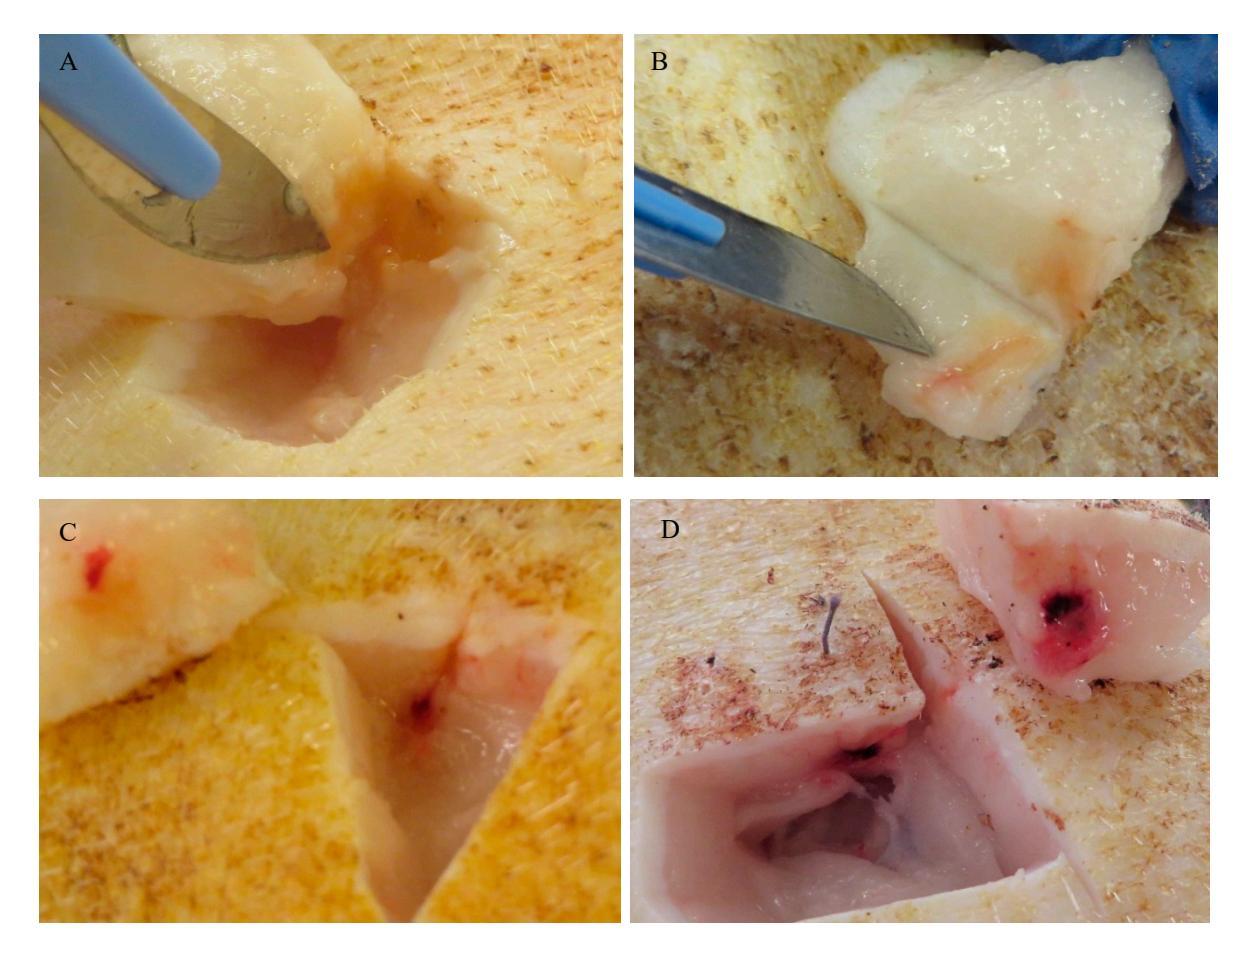
Figure S2. (a) The tissue around electrodes in group 1 showed no signs of tissue damage upon sacrifice. (b) The tissue around electrodes in group 2 showed some redness around the electrode tip, which likely is due to tissue damage. (c) The tissue around the electrode tips of electrodes in group 3 showed obvious tissue damage, but the tissue around the insulated parts was unaffected. (d) The tissue around the electrode tips of electrode tips of electrodes in group 4 showed even more extensive tissue damage and bleeding. Nevertheless the tissue around the insulated parts was unaffected.
