# Performance Assessment of a Renovated Precast Concrete Bridge Using Static and Dynamic Tests

**Abstract:** The article presents the development of a SHM (Structural Health Monitoring) strategy intended to confirm the improvement of the load-bearing capacity of a bridge over the Ružín Dam using static and dynamic load tests, as well as numerical simulations. The paper comprises measurements of the global response of the bridge to prepare a verified and validated FEM (Finite Element Method) model. A complex measuring system used for the tests consisted of two main parts: an interferometric IBIS-S (Image by Interferometric Survey-Structures) radar and a multichannel vibration and strain data logger. Next, structure–vehicle interactions were modelled, and non-linear numerical dynamic analyses were performed. As a result, the time histories of displacements of the structure from traffic effects were obtained. Their comparison with IBIS-S radar records proves that this method can be effectively used for assessing bridges subjected to common traffic loads. The results (measured accelerations) obtained by local tests in external pre-stressed cables are presented and a convenient method

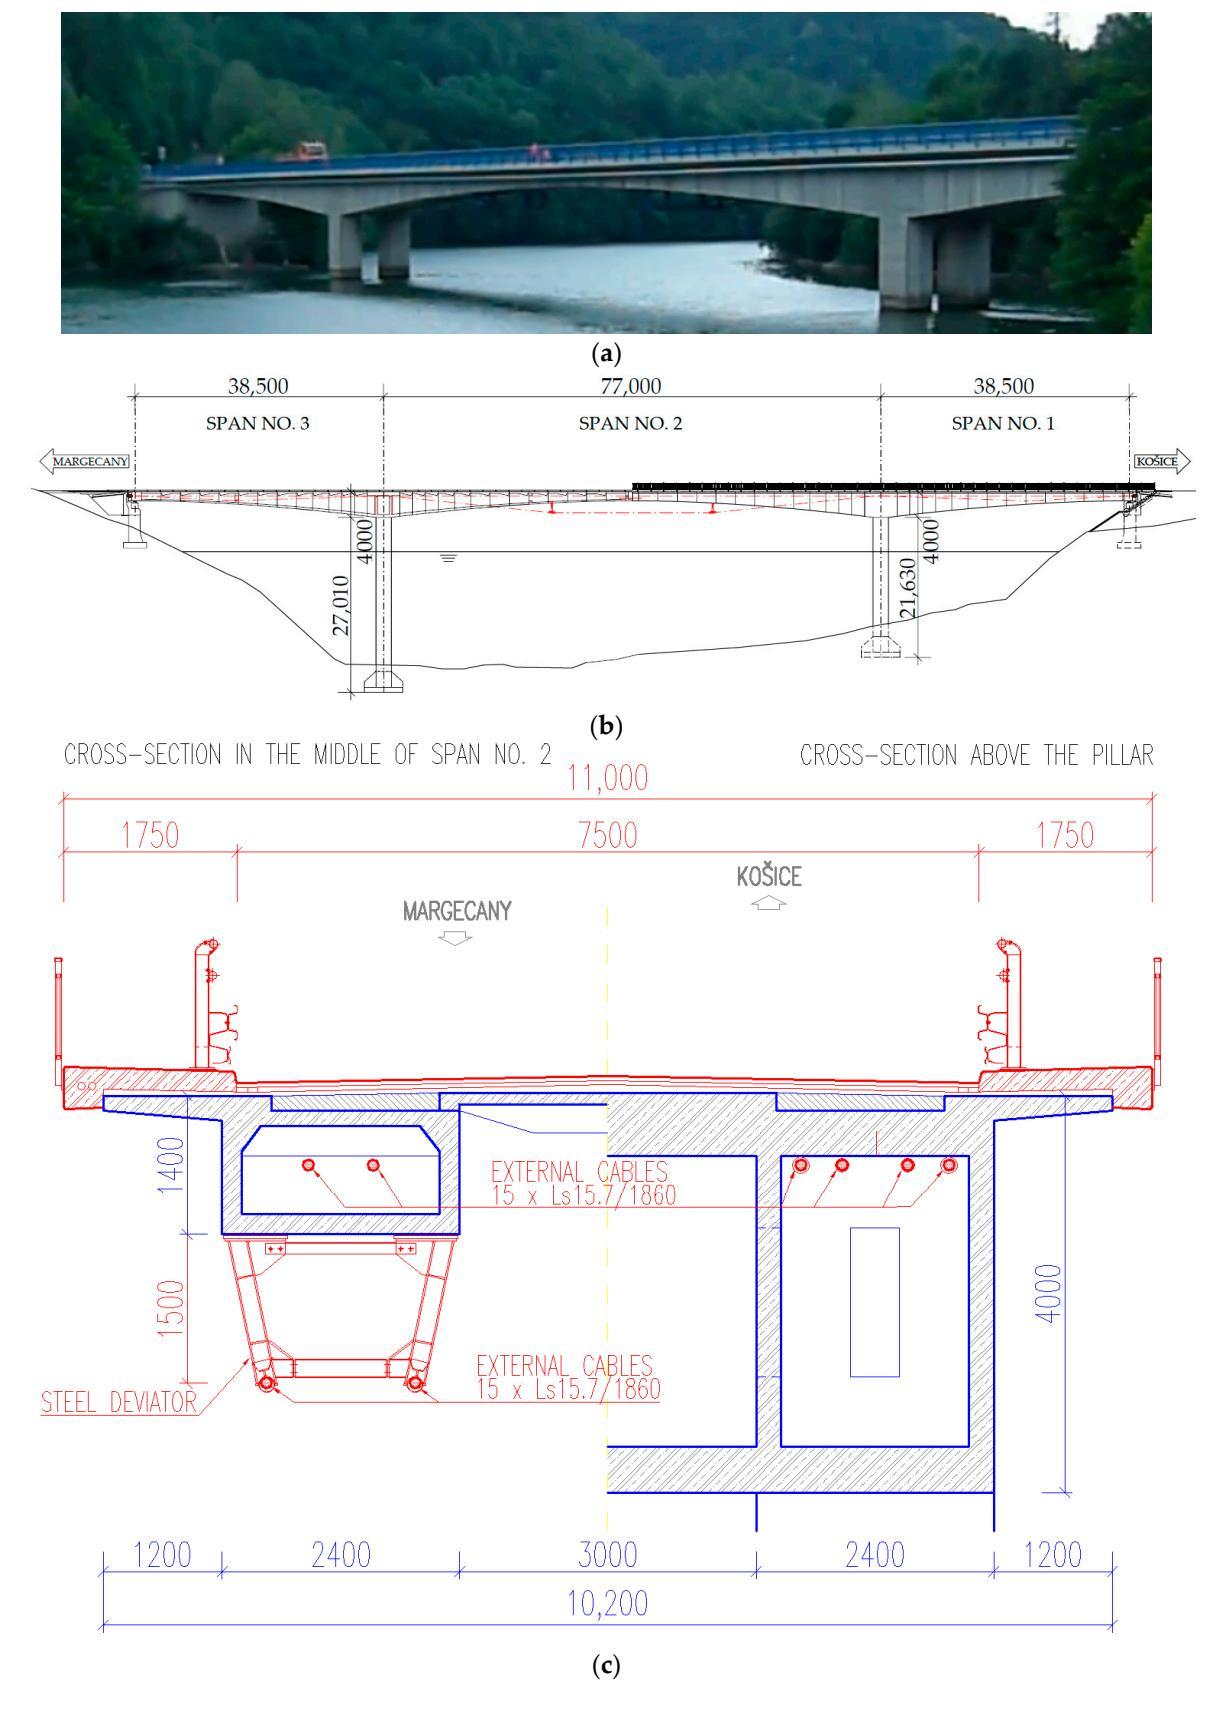
Figure 1. The bridge over Ružín Dam: (a) photo; (b) side-view; (c) cross-sections (dimensions in millimeters).

The bridge over the Ružín Dam has been in operation since 1967 and was renovated in 2017 (Figure 1) as a result of its full closure in 2016 due to its critical state. The reason for the closure and for the necessity to renovate was the permanent (visible) displacement in the middle of the main span. The bridge structure consists of two parallel tapered box-girders with various heights between 1.4 m and 4.0 m. Pre-cast slabs are embedded between the two box-girders. The width of the bridge comprises the road surface (7.5 m) and the walkways on both sides (1.75 m); overall, the bridge is 11.0 m wide. The total length of the bridge is 154.0 m.

The bridge was repaired by changing the original structural system. The reconstruction was carried out by reinforcement of the original joint in the middle of span no. 2 and by the addition of external pre-stressed cables (Figure 2). Pre-stressed cables consist of two groups. The first group of cables passes over the outer side of the box-girders and is fixed by additionally mounted steel deviators (two cables per box-girder). The second group of cables is placed inside the box-girders (two cables per box-girder). Therefore, the overall strengthening consists of eight cables (15 × LS15.7/1860; for geometric and material characteristics, see Tables 1 and 2).

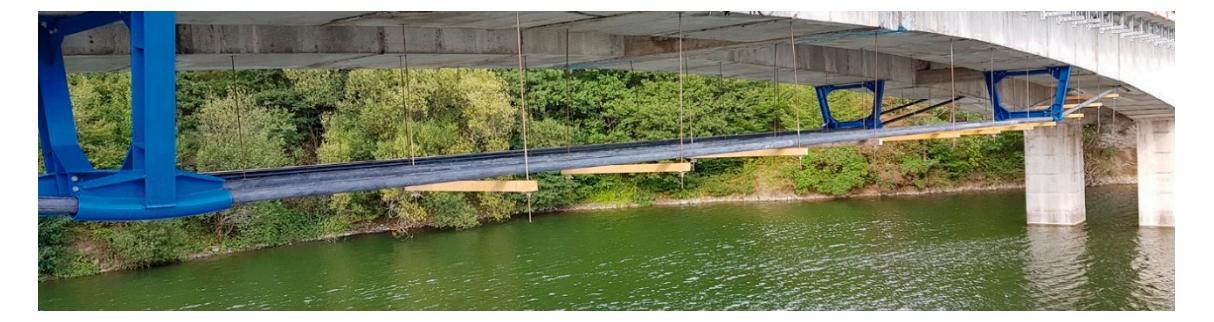
**Figure 2.** The reinforcement of the joint in the middle of the span no. 2 with external pre-stressed cables [18].

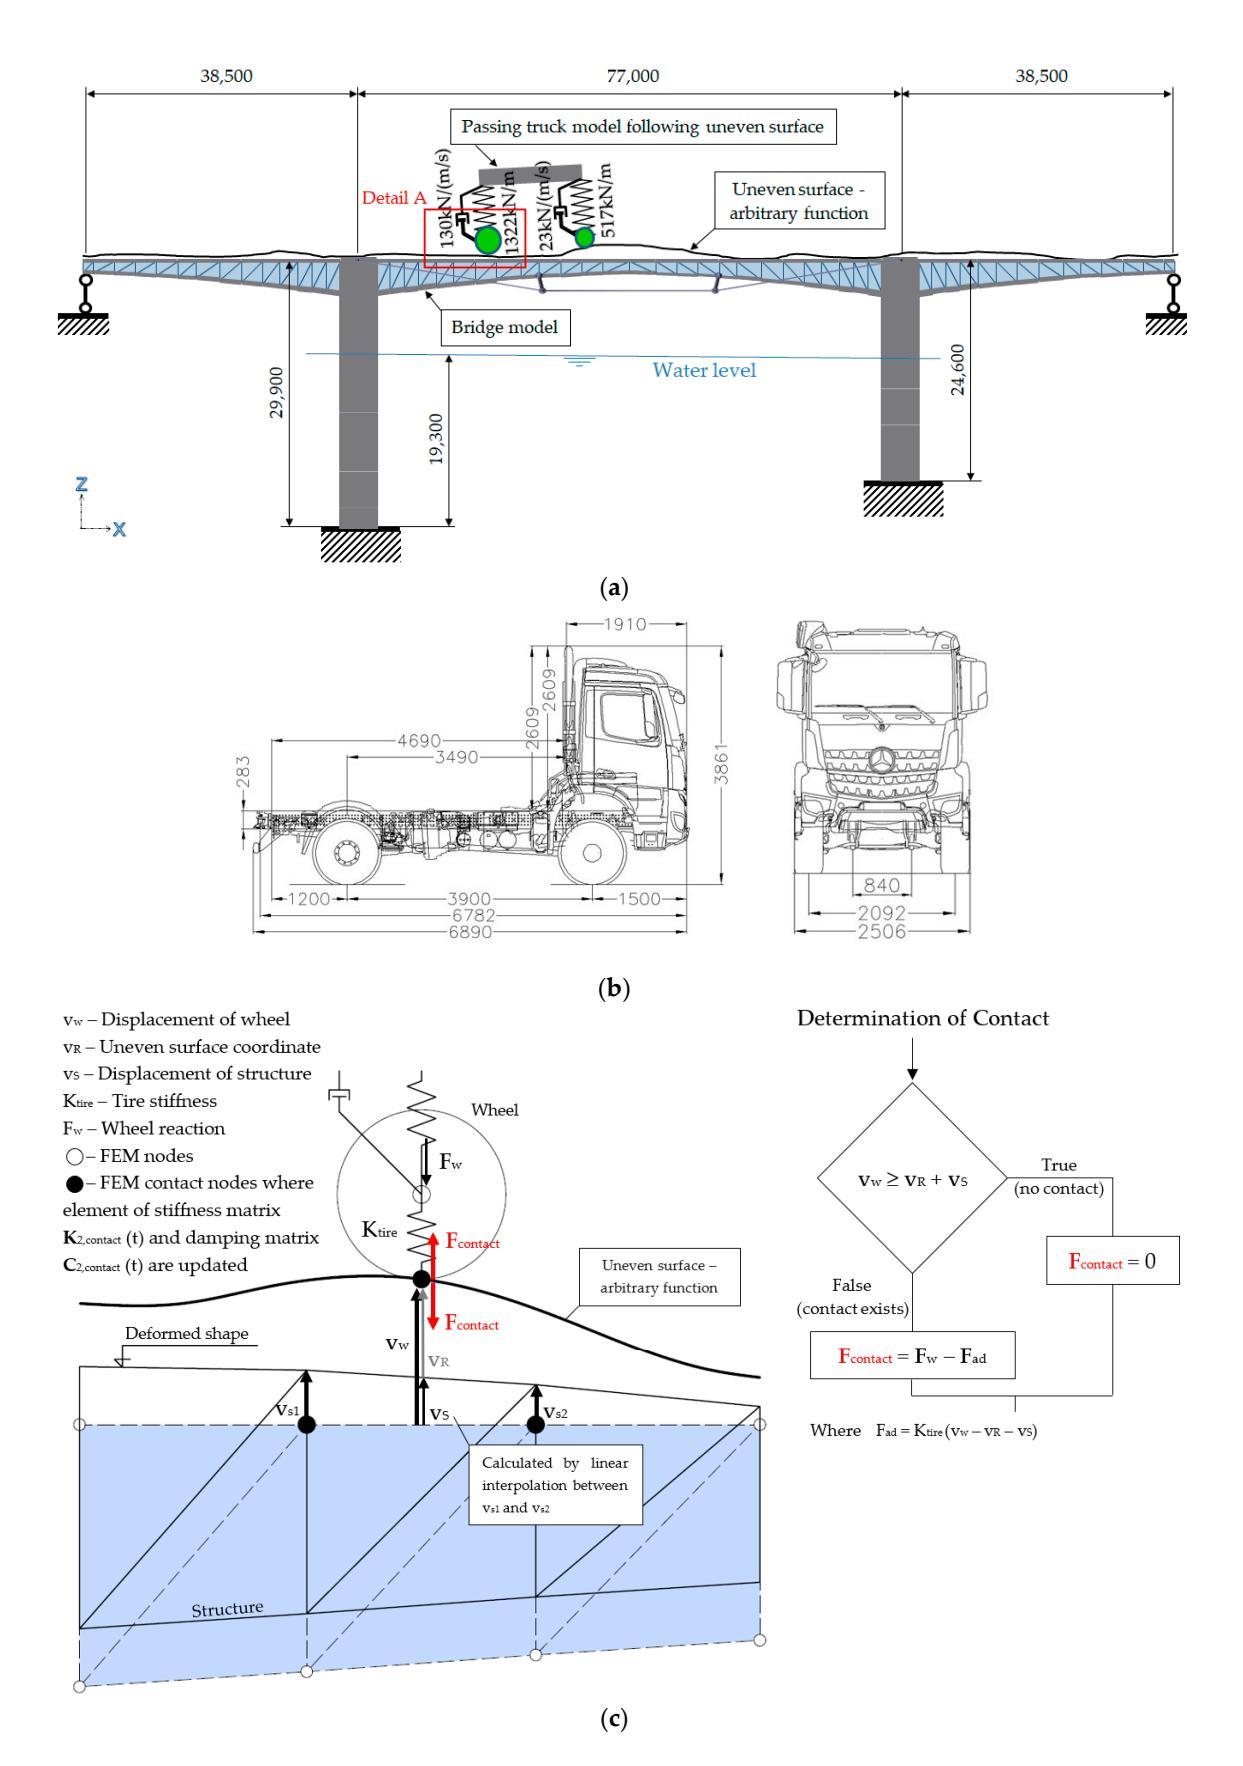
**Figure 3.** (a) The FEM model of the structure with (b) the passing truck (dimensions in millimeters); (c) detail A—determination of contact.

The 2D FEM model of the bridge and a passing truck were prepared (Figure 3) and numerical analyses were performed before executing the in situ tests in order to achieve the expected displacement of the bridge. The slab of box-girders was modelled with SHELL elements with a constant thickness of 0.2 m (width); flanges were modelled with BEAM elements: the upper flange had a constant height of cross section of 0.254 m, the bottom flanges had an increasing height of cross section, starting from 0.253 m in the middle of the span to 0.47 m in vicinity of the pier. The characteristics of cables are listed in Table 2. All concrete elements were modelled with Young's modulus of elasticity E = 36 GPa. Pillars were modelled with beam elements with cross sections of 2.4 × 2.4 m. Fixed supports were assumed for both pillars, with joint supports at the beginning of the first span and the end of the last span.

The added cables (characteristics in accordance with Tables 1 and 2) were considered TRUSS elements. MASS elements represent the extra weight of accessories. The contribution of the water mass on immersed piers was also added according to [20] with a value of 6800 kg/m.

The FEM model including both the structure and the vehicle was used for the evaluation of the dynamic tests. The code was prepared in such a way that it is possible to define the arbitrary function of an uneven surface (Figure 3a), which characterizes the displacement differences between truck contact DOFs (Degree of Freedom) and structure DOFs at particular time instances. These differences cause vertical inertial forces arising between the truck and the structure, and therefore result in additional dynamic load of the bridge. It is also possible to control the loss of contact. For the tested bridge, a new roadway was recently constructed, so only an arbitrary obstacle was assumed as an uneven surface. The tests included truck passage over the bridge at different velocities while crossing the uneven surface created by an artificial obstacle in the middle of span no. 2. The measurements were carried out during light traffic, so a particular case when only the testing truck was present on the bridge was analyzed. However, the dynamic response can also be analyzed assuming a complete traffic flow by recording all passing vehicles. The advantage of this method is that there is no need for significant traffic restrictions, which is the most convenient way of performing tests for bridge authorities.

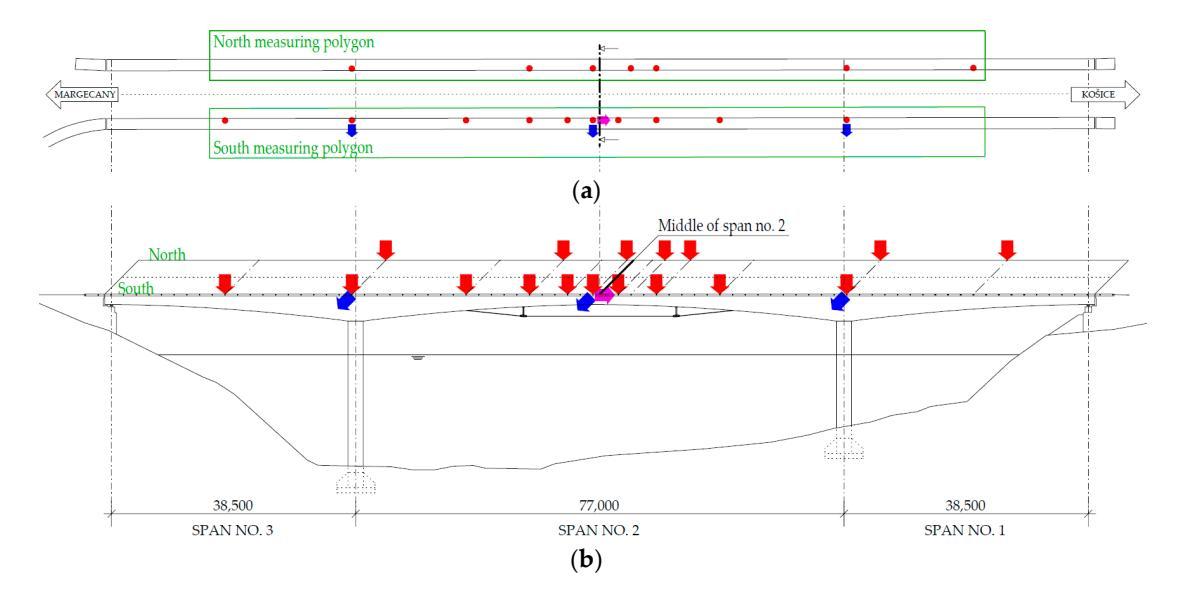
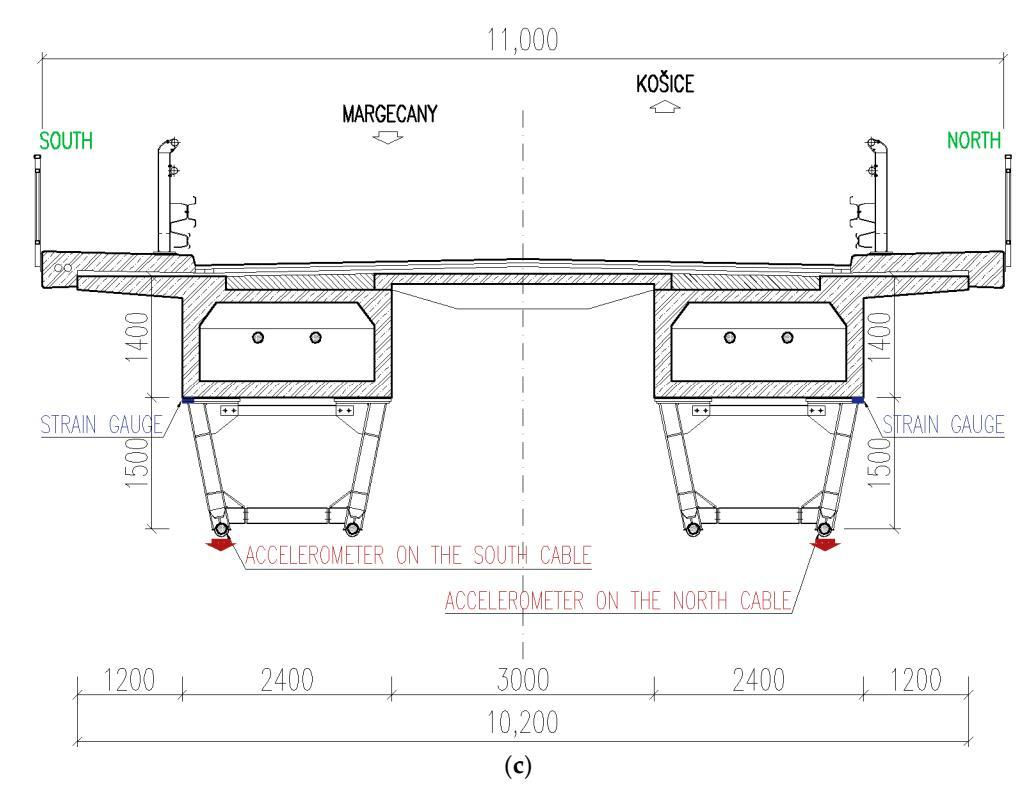
**Figure 4.** The measurement setup (**a**) top view; (**b**) side-view; (**c**) cross-section in the middle of span no. 2 (dimensions in millimeters).

A complex measurement system (able to measure accelerations, strains, and temperatures simultaneously by up to four devices) using National Instruments equipment was used. It was developed by one of the authors in collaboration with mechanical engineers [21]. It consisted of two devices for this procedure: NI cRIO (National Instruments Compact Reconfigurable Input Output) 9067 with four NI 9234 modules, and NI cRIO 9074 with two NI 9234 modules. The NI 9234 input module is an analogue-to-digital converter capable of measuring acceleration. The number of modules used allowed us to measure 24 channels. There was also one NI 9237 input module for the measurement of strain gauges. Temperature measurements formed an important part of the test. One NI 9211 input module allowed for measuring air temperature, as well as the structure temperature, using contact temperature sensors. Four temperature sensors, two strain gauges and 24 accelerometers were used simultaneously.

Accelerations in the Z-direction (vertical) were measured with 18 sensors (labelled with a red arrow); accelerations in the Y-direction (lateral) were measured with three sensors (labelled with a blue arrow, and accelerations in the X-direction (longitudinal) were measured with one sensor (labelled with a purple arrow). Two accelerometers were mounted by a magnetic pad on the external pre-stressed cables approximately in the middle of span no. 2 (Figure 8). Two measuring polygons using two measuring devices with separately connected accelerometers were placed along the footpaths to obtain the torsional mode shapes. The first polygon with eight accelerometers was on the north side, the second one with 16 accelerometers was on the south side. The synchronization of measuring devices was carried out via an FTP (file transfer protocol) using an FTP cable placed under the bridge girder to be protected from traffic. This arrangement of the devices reduces the measurement preparation time, as the necessary cable lengths were shortened.

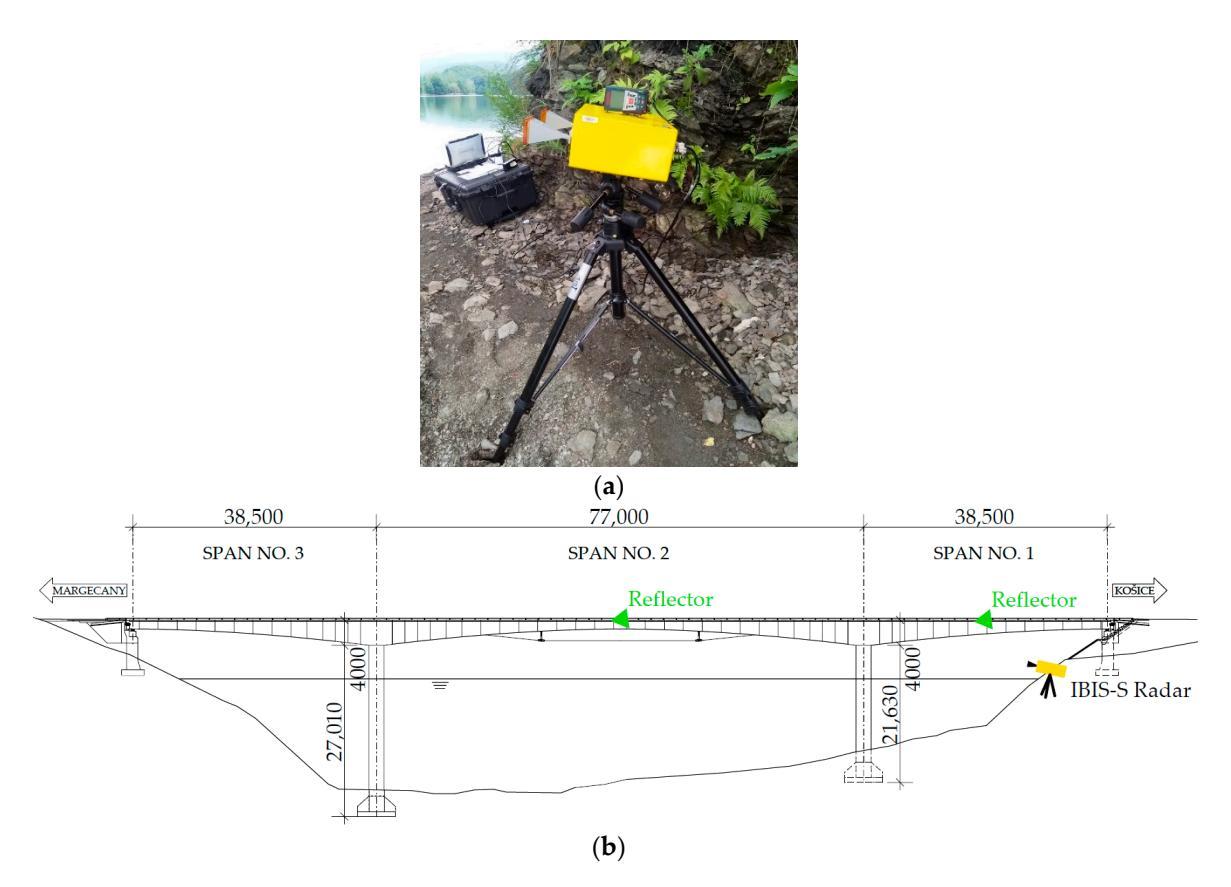
Figure 5. The Interferometric radar (a) IBIS-S device; (b) radar placement for the measurements.

Dynamic displacement measurements were repeatedly performed using the IBIS-S interferometric radar with type 3 antennas from IDS (Ingegneria dei Sistemi) (Figure 5a). The radar was used for static and dynamic tests of the bridge.

It is important to identify the measured point on the structure as accurately as possible. For this reason, two reflectors (Figure 5b) were used and mounted at the locations where significant displacements were expected. It is necessary to know the radial distance R and the corresponding vertical distance h from the radar (Figure 6).

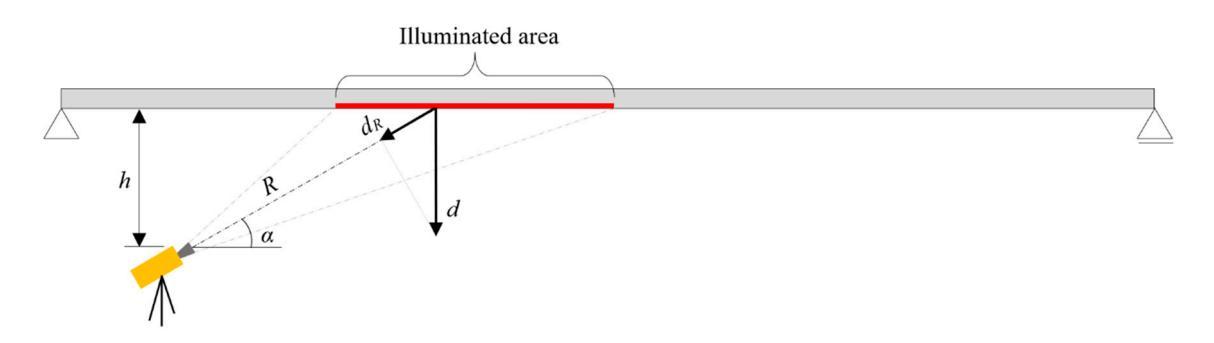
Figure 6. Projection of the measured displacement.

Radial displacement  $d_R$  must be projected in the direction of effective displacement d (in the vertical direction) (Figure 6).

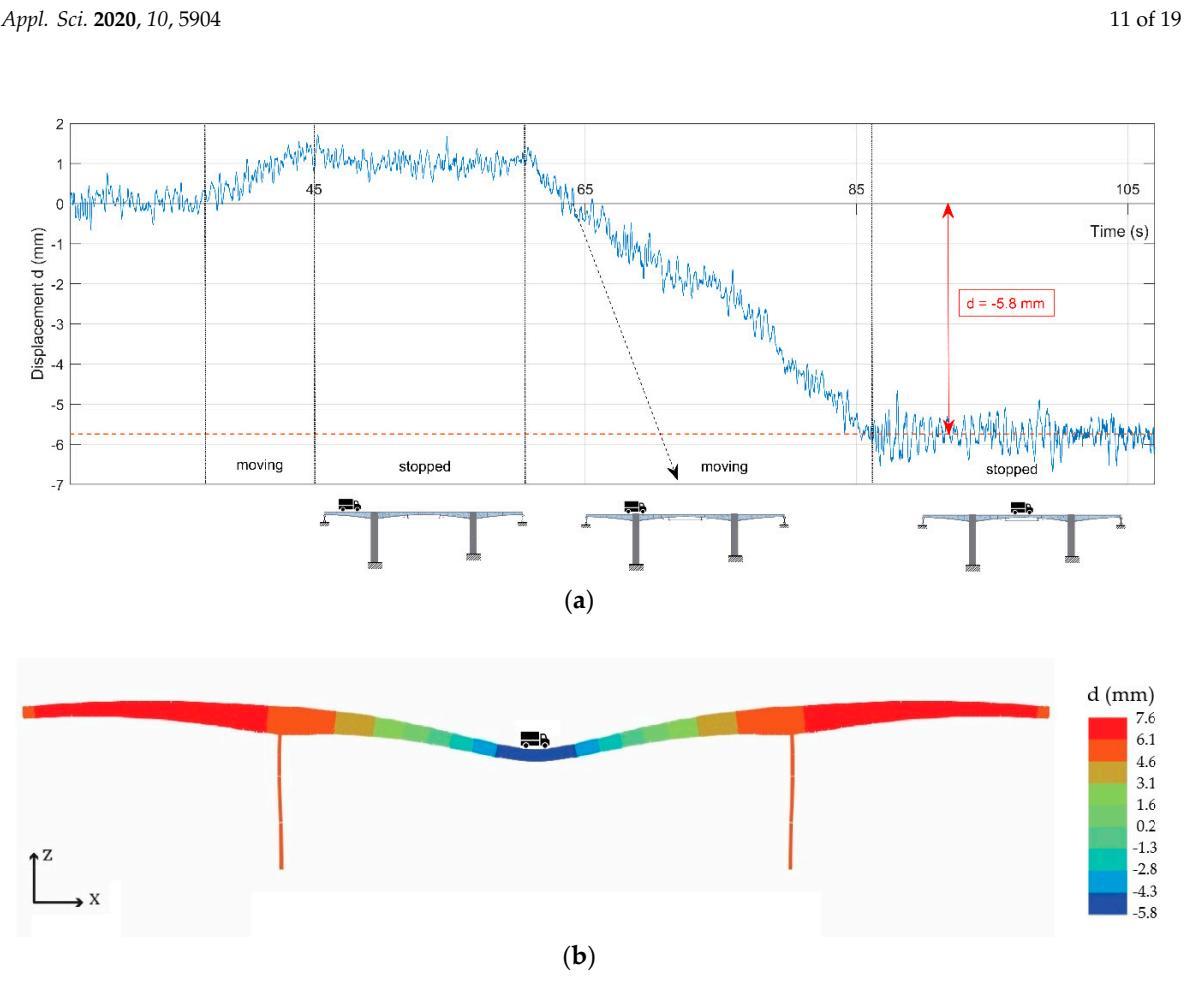
Figure 7. The displacement in the middle of span no. 2 caused by two heavy trucks (a) IBIS-S radar measurement; (b) results from FEM model.

During a test of static displacement, two trucks were passing slowly (a maximum speed of up to 5 km/h) over the bridge and stopped briefly in the middle of span no. 2. A displacement time history was recorded by IBIS-S radar. Figure 7 shows good conformity between test and numerical analysis.

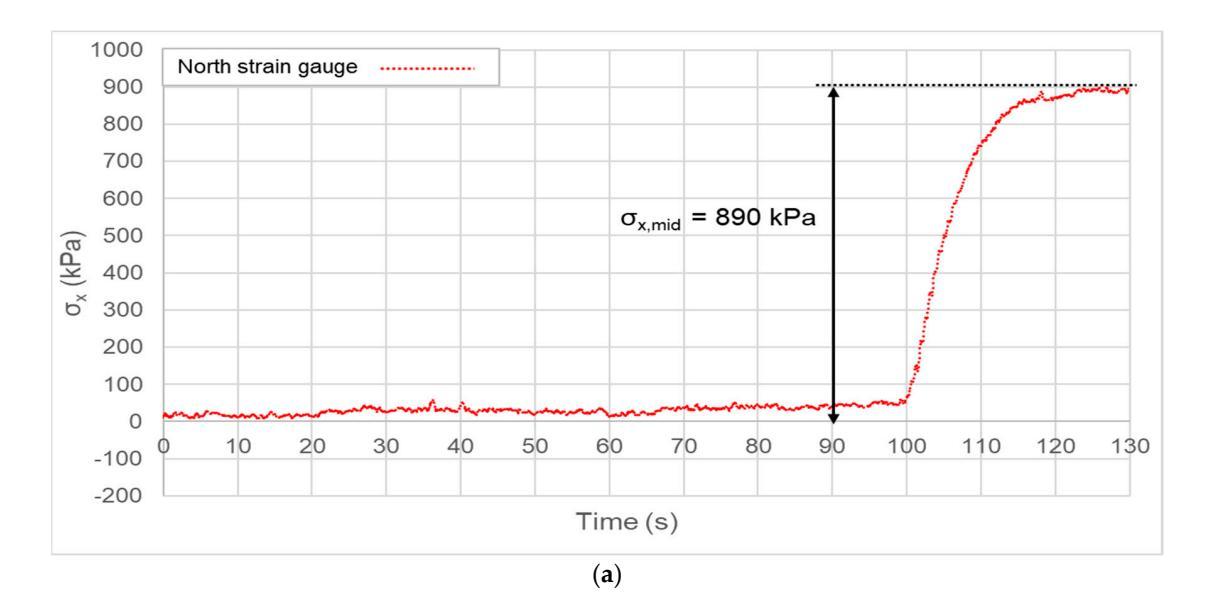
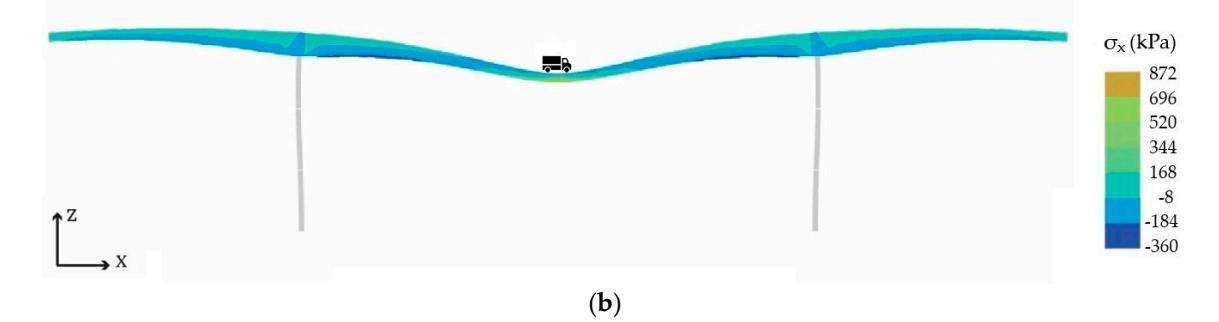
**Figure 8.** The strains in the middle of span no. 2 caused by two heavy trucks (**a**) measurement by strain gauges; (**b**) results from FEM model.

During a light traffic period (described in Section 4.3), two heavy trucks stopped in the middle of span no. 2. Figure 8 shows a comparison of stresses  $\sigma_x$  in the middle of span no. 2 (Figure 8) obtained by calculation from measured strains using strain gauges and E-modulus (Figure 8a), and numerical calculation from the presented FEM model (Figure 8b). It shows that the values correspond very well (measured value of 890 kPa vs. 872 kPa calculated by the FEM).

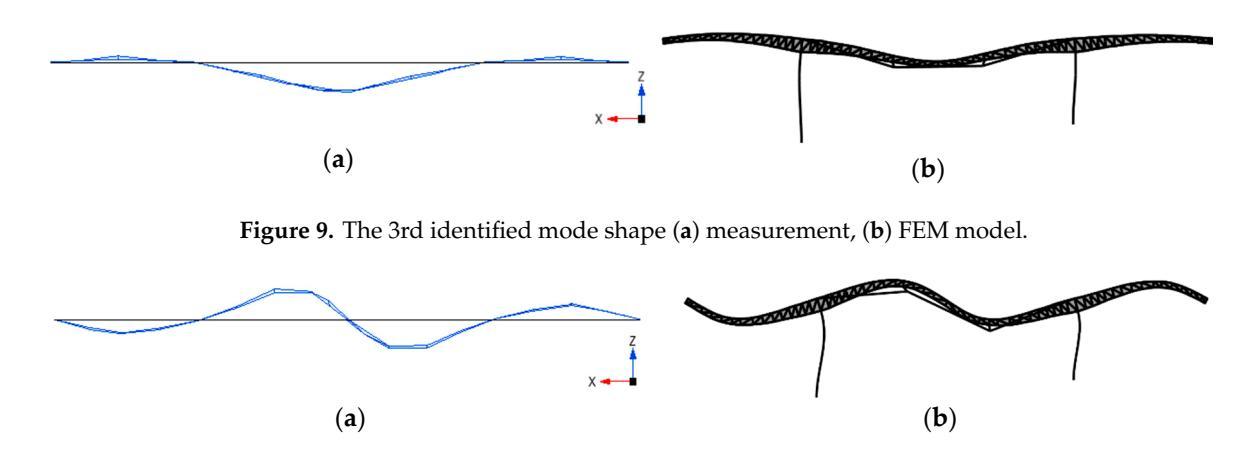
Figure 10. The 5th identified mode shape (a) measurement, (b) FEM model.

Table 6 shows the comparison of natural frequencies of the FEM model and the measurement. Since the FEM model is only 2D (coordinate system *X* axis vs. *Z* axis), natural frequencies and their corresponding mode shapes are only shown in *Z* directions. There is a good conformity between the measured and the calculated natural frequencies for the corresponding mode shapes.

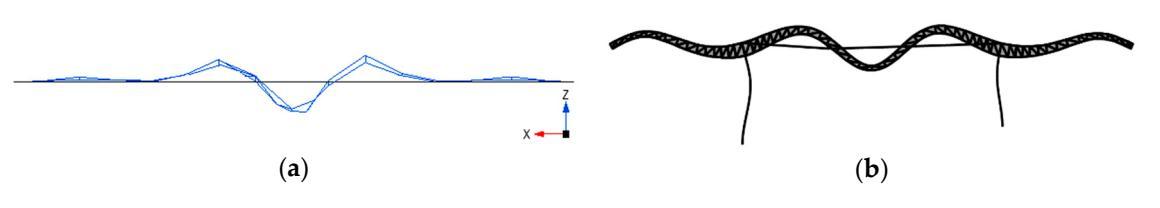
Figure 12. The 10th identified mode shape (a) measurement, (b) FEM model.

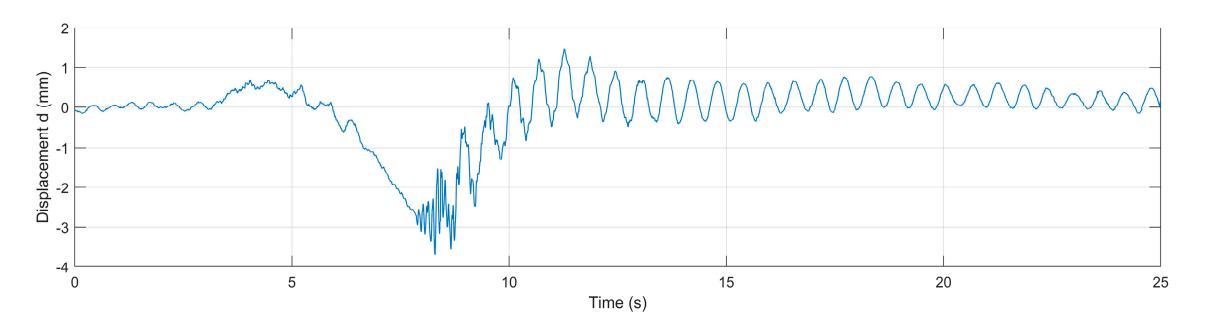
Figure 13. Displacement record by IBIS-S radar in the middle of span no. 2—the 3rd frequency.

The result of the SSI method (the third natural frequency) was compared to the natural frequency obtained by the IBIS-S radar. As seen in Figure 13, the response of the structure after the truck left the bridge (at about 13 s) can be described as free damped vibration. Specifically, ten sine waves appeared between the times  $t_1 = 13.72$  s of the first peak and  $t_2 = 19.56$  s of the last peak. Thus, the third natural period  $T_d$  of the structure can be calculated; the result is  $T_d = 0.584$  s. The third natural frequency related

to vibration in the vertical (Z) direction is then equal to 1.71 Hz. The same result of the third natural frequency was obtained from measured accelerations (Table 6). The identified natural frequencies from two independent devices (complex measurement system vs. IBIS-S radar) confirmed the precision of the performed measurements. However, some mode shapes could not be extracted from the measured acceleration data because of the relatively small number of accelerometers used, especially in the lateral (Y) direction.

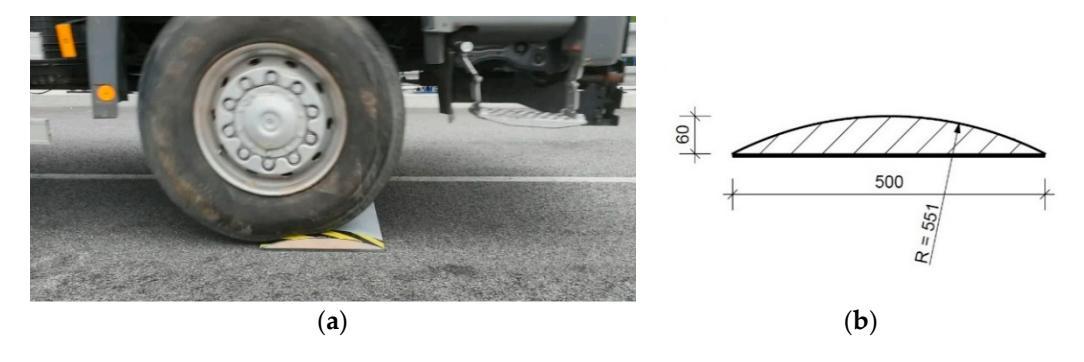
**Figure 14.** Artificial uneven surface placed in the middle of the span no. 2 (**a**) photo; (**b**) dimensions in millimeters (*R*—radius).

A two-axle truck was used (see Table 3, Truck 1) in the tests. An uneven surface was created by an obstacle placed in the middle of span no. 2 with a length of 0.5 m and a height of 0.06 m (Figure 14). As the axles of the truck hit the uneven surface, significant dynamic effects occurred (Figure 15).

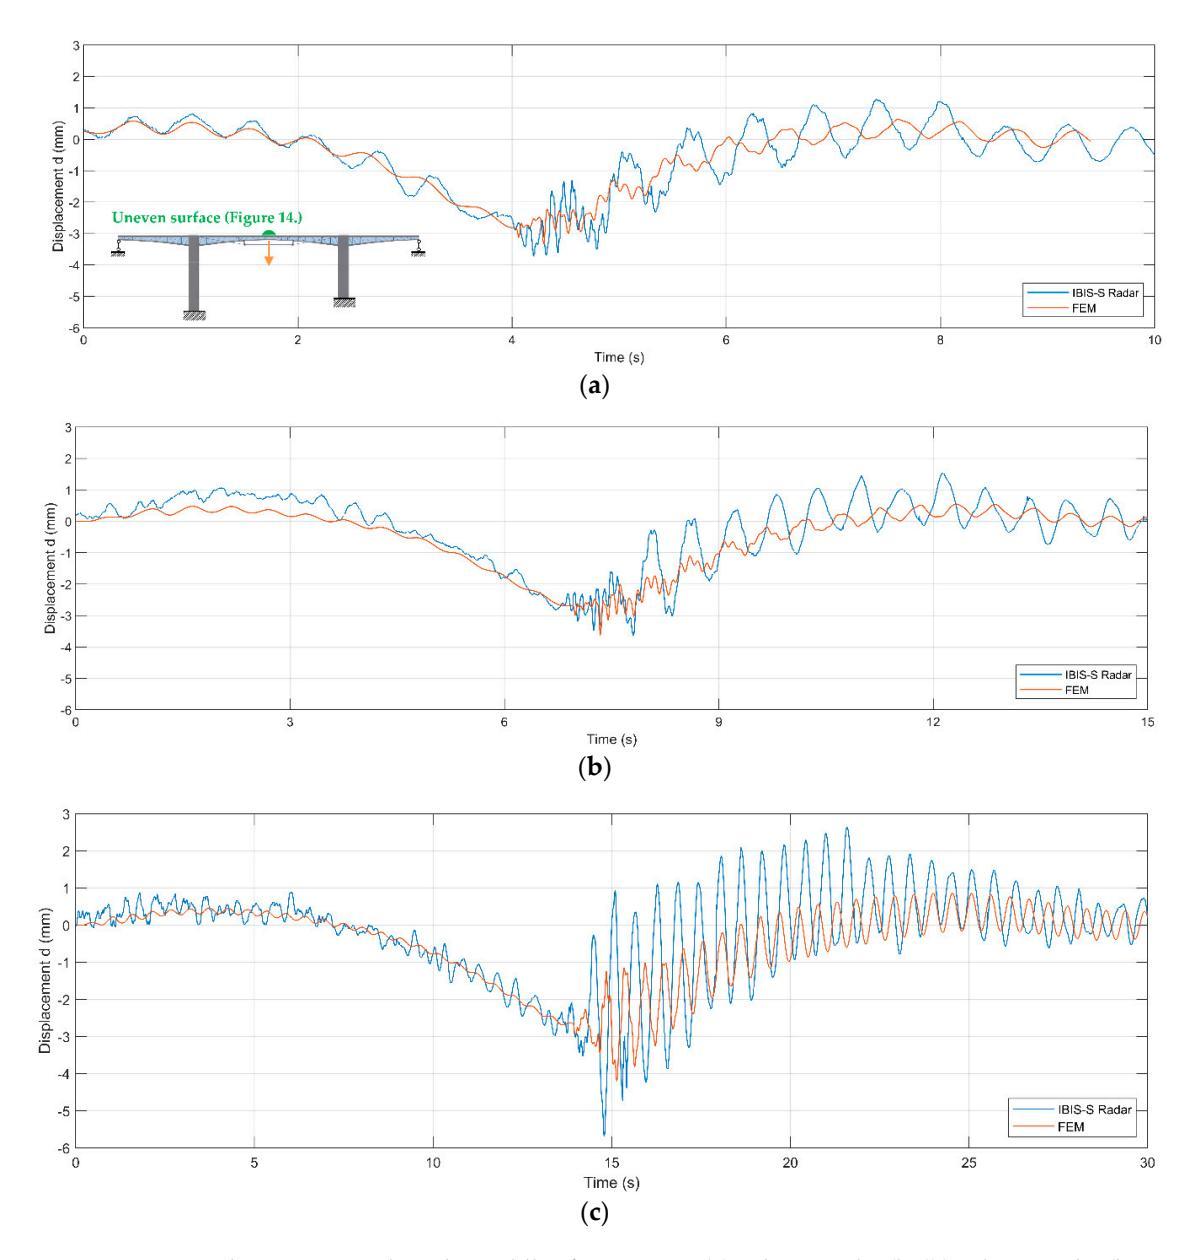
**Figure 15.** Displacement records in the middle of span no. 2. (**a**) Velocity 57 km/h; (**b**) velocity 36 km/h; (**c**) velocity 21 km/h.

Vertical displacements in the middle of span no. 2 were recorded by the IBIS-S radar. Both recorded and numerical results are presented in Figure 15. The comparison of the obtained results in Figure 15 shows that the overall responses, assuming different vehicle velocities (57, 36 and 21 km/h), of both test and analysis are similar. The most significant dynamic response is caused by the vehicle passing over the obstacle in the middle of span no. 2. The vehicle used during these tests (two-axle truck—Truck 1 from Table 3) had a substantial effect on the overall response. If there are other cars in the traffic flow, they can be also assumed, and the partial effects can be added.

The calculated time histories have slightly smaller dynamic amplitudes than the displacement measurement records. The reason for this could be caused by an inappropriate assumption of the stiffness of the tires (see Table 4). In this case, a rough estimation of tire stiffness was carried out by measuring changes in tire dimensions in the vertical and horizontal directions caused by gravitational forces. Tire pressure identification using sensors could be an option to obtain this data more accurately, as in [28]. This effect should be studied further in the future.

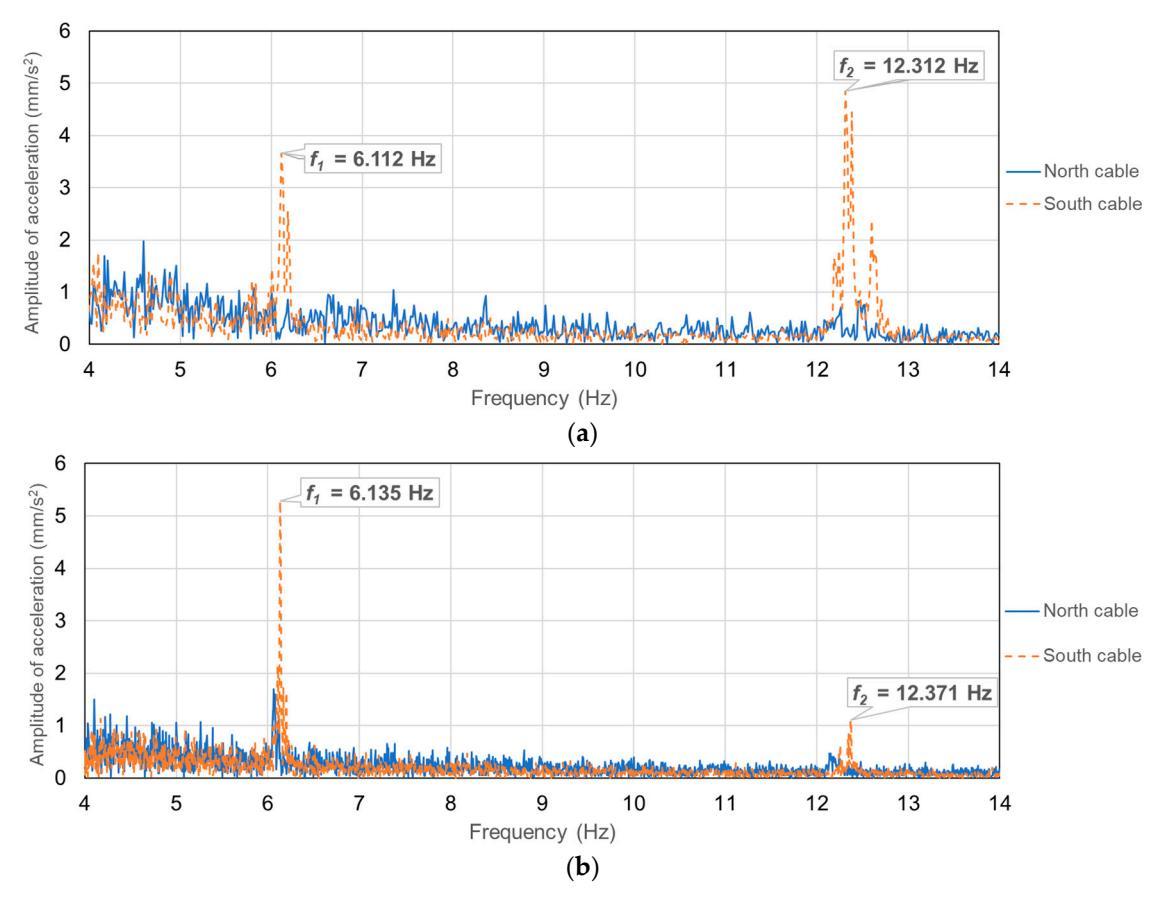
**Figure 16.** The response spectra of the cables. (**a**) Unloaded bridge; (**b**) loaded bridge ( $f_1$ —1st natural Figure 2. nd natural frequency).

To determine the axial forces  $N_{test}$ , accelerometers were mounted on two pre-stressed cables (on the northern and southern edge of the bridge, see Figure 8). The first natural frequencies of these cables  $f_1$  were found from the dynamic response achieved by using fast Fourier transform (Figure 16). Two situations were considered: an unloaded and a bridge loaded by two heavy trucks (according to Table 3). Both cables have the same geometric and material characteristics (see Tables 1 and 2), which is proven in Figure 16, where the first and second natural frequencies of both cables are the same.

The length of the cables was considered to be the free length between the deviators (see Table 1). The axial forces were calculated from this data using Equation (3) as follows:  $N_{test} = 2.67$  MN for the unloaded bridge and  $N_{test} = 2.69$  MN in case of the structure being loaded with two heavy trucks. The difference between them (0.02 MN) matches well with the numerical value calculated as the predicted effect of the applied gravity forces of the load. There is therefore a good reason to believe that the total forces represent their real values on the bridge.
