Article

Seismic Behavior of Concrete-Filled Circular Steel **Tubular Column–Reinforced Concrete Beam Frames** with Recycled Aggregate Concrete

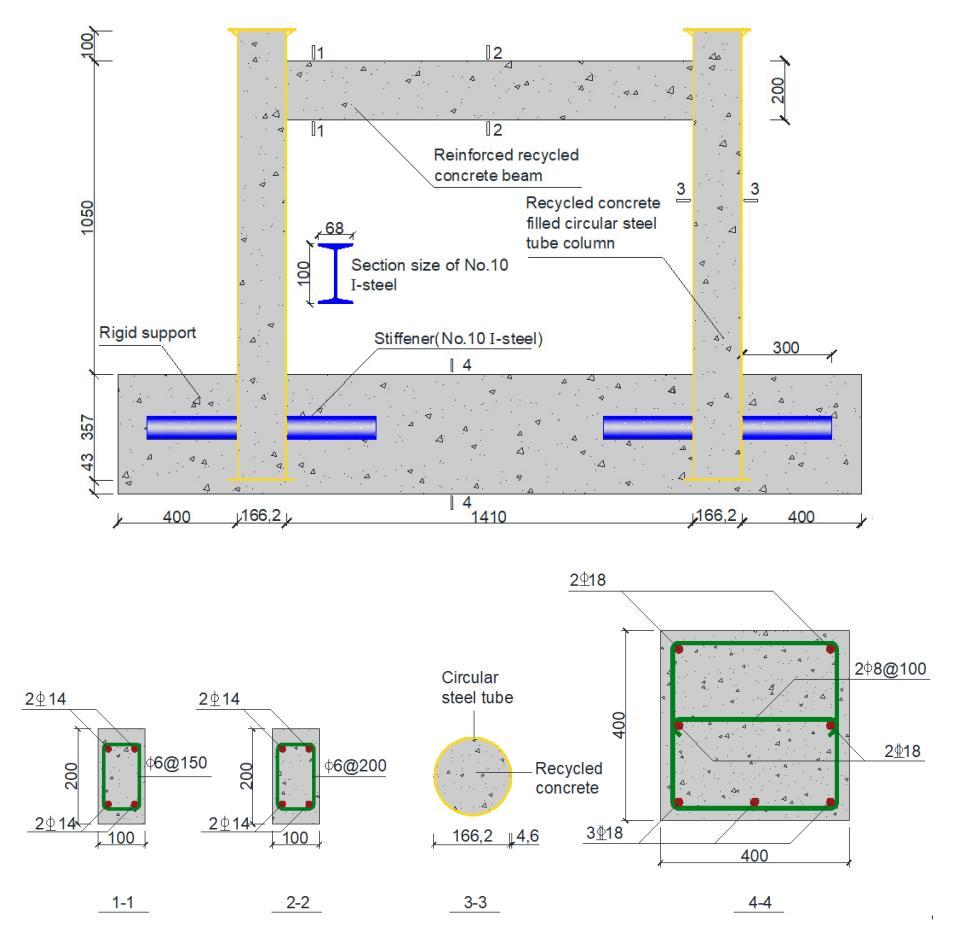
Figure 1. Specimen configuration and reinforcements.

In this test, one small-scale frame specimen was made with an RCA content equal to 100%, and the geometric ratio between the frame and the engineering prototype was 1:3. According to Chinese Standard GB50011-2010 [23], the required seismic design, including the construction details, was accomplished. The volume reinforcement ratio of the longitudinal reinforcement was 2.50% in the reinforced recycled aggregate concrete (RRAC) beam, and that of the stirrup in the encrypted area and non-encrypted area was 0.57% and 0.38%, respectively. No.10 I-steel with a flange width of 68 mm and web length of 100 mm was welded on the surfaces of both sides of the steel tube, with a length of 300 mm; a cover plate with a thickness of 8 mm was welded on the bottom of the steel tube at the end closest to the cast RAC; a cover plate with a thickness of 8 mm was reserved for the effective transmission of axial force. The detailed dimensions of the frame are illustrated in Figure 1; it should be highlighted that most of the vertical force of the specimen is borne by the RAC of the core at the end of loading. In order to reflect the ultimate force transmission path and stress state of the specimen, the axial load ratio (*n*) selected in this paper is only related to the concrete, and *n* is equal to $N/(f_cA)$ and taken as 0.8, where *N* is the axial load, *f*_c is the measured prism compressive strength of RAC with the Chinese standard

size of $150 \times 150 \times 300$ mm according to GB50010-2010 [24], and *A* is the cross-sectional area of column. In addition, the beam–column nodes of the RACFST frame adopt the form of rigid nodes connected by an external stiffening ring, as shown in Figure 2. It can be seen from the figure that the longitudinal bar in the beam was welded along the upper and lower flanges of the extended steel bracket to the junction of the reinforcing ring and the surface of steel tube, and the longitudinal bar and the upper and lower flanges adopted the form of a double-sided weld.

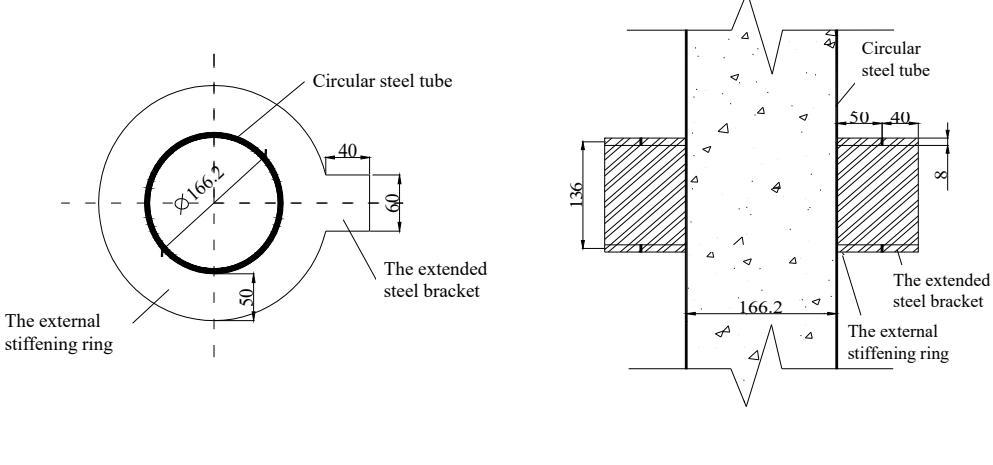
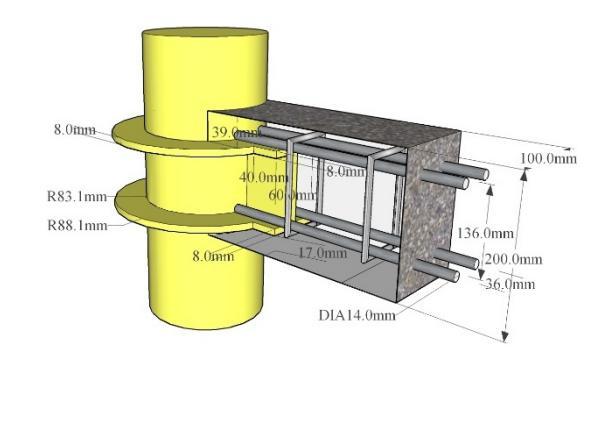
Figure 2. Details of the construction of the beam–column connection in (**a**) plane view, (**b**) elevation view and (**c**) spatial view.

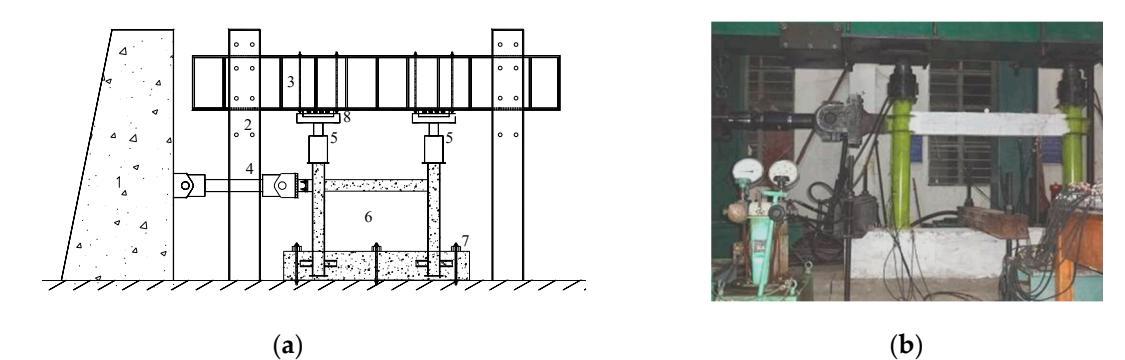
Figure 3. The test set-up arrangement of the (a) test device and (b) loading scene.

The schematic diagram of the test device is illustrated in Figure 3a, and the corresponding field layout of the test device is shown in Figure 3b. In Figure 3a, No.1, No.2 and No.3 represent the reaction wall, vertical reaction steel column and reaction steel beam respectively, in which the steel beam and steel column are connected by high-strength bolts. No.4 represents the electro-hydraulic servo actuator that can push and pull back and forth, which is connected to the specimen by high-strength bolts through a special loading end. In addition, No.5, No.6, No.7 and No.8 refer to the hydraulic jack, specimen, pressure beam made of steel and roller device, respectively. It should be noted that a roller device is placed between the jack and the reaction steel beam to facilitate the free horizontal movement of the jack with the specimen.

After the specimen was assembled according to the predetermined test axial pressure ratio, two identical hydraulic jacks were used to synchronously apply a constant vertical load to the top of the column, in order to simulate the actual situation in frame structures. After each of the vertical loads reached a stable value, the specimen was tested under a low-frequency cyclic lateral load. According to the Chinese standard of seismic test methods of buildings [26], the loading process included two main steps, namely a load-control step and a displacement-control step. In addition, in the load-control

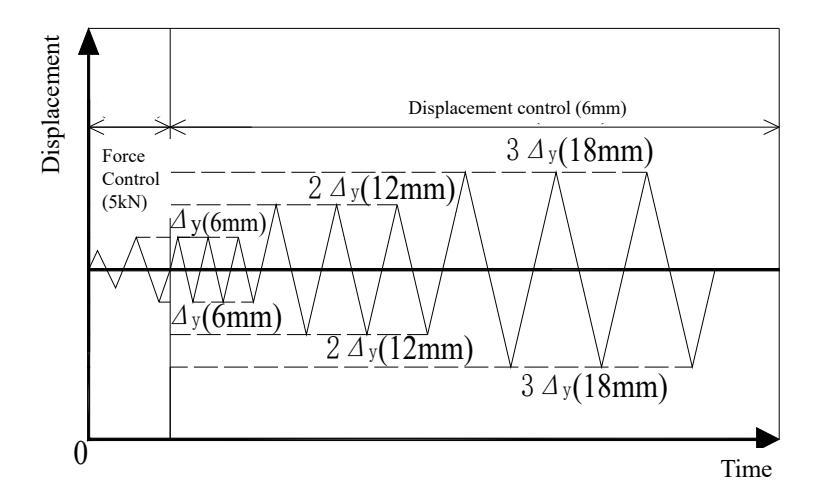
Figure 4. The loading system.

step, each step was cycled once, and in the displacement-control step, each step was cycled three times, as depicted in Figure 4. The specific loading steps were as follows. First of all, the load-control was adopted for graded loading, with each 5 kN being one level, until the specimen reached the yield load P_y . After that, the displacement-control was used, taking the multiple of the yield displacement Δ_y as the grade difference to control the loading progress. The yield displacement was the horizontal displacement of the column end when the steel tube or longitudinal bar in the frame first reached the yield strain, which in this test was 6 mm. Finally, the test was finished when the load of the specimen dropped to about 85% of the peak load P_u . During the test, the horizontal load and displacement were measured by the load and displacement sensor of the electro-hydraulic servo loading system. The strain of steel tube, longitudinal reinforcement, stirrups and beam RAC was measured by strain gauges. The arrangement of the layout of the strain gauges on the longitudinal reinforcement and stirrups in the frame beam is shown in Figure 5b.

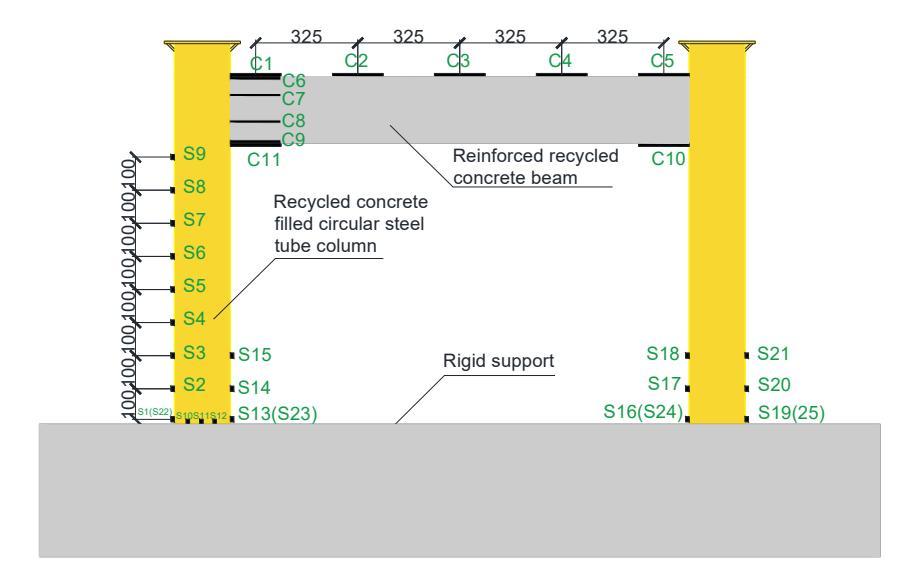
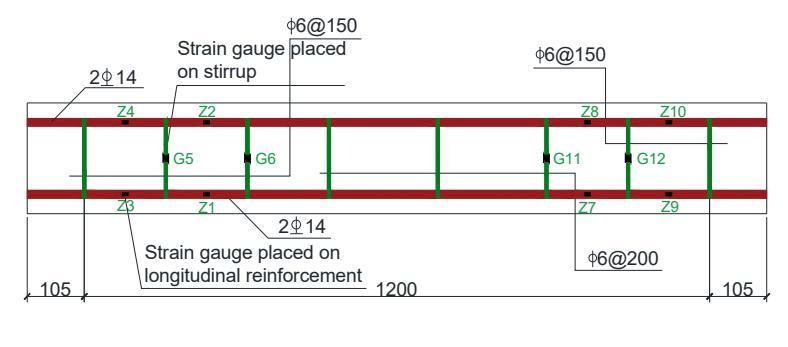
Figure 5. The arrangement of the strain gauges. (**a**) The layout of strain gauges on the steel tubes and RAC beam; (**b**) The layout of strain gauges on the longitudinal reinforcements and stirrups.

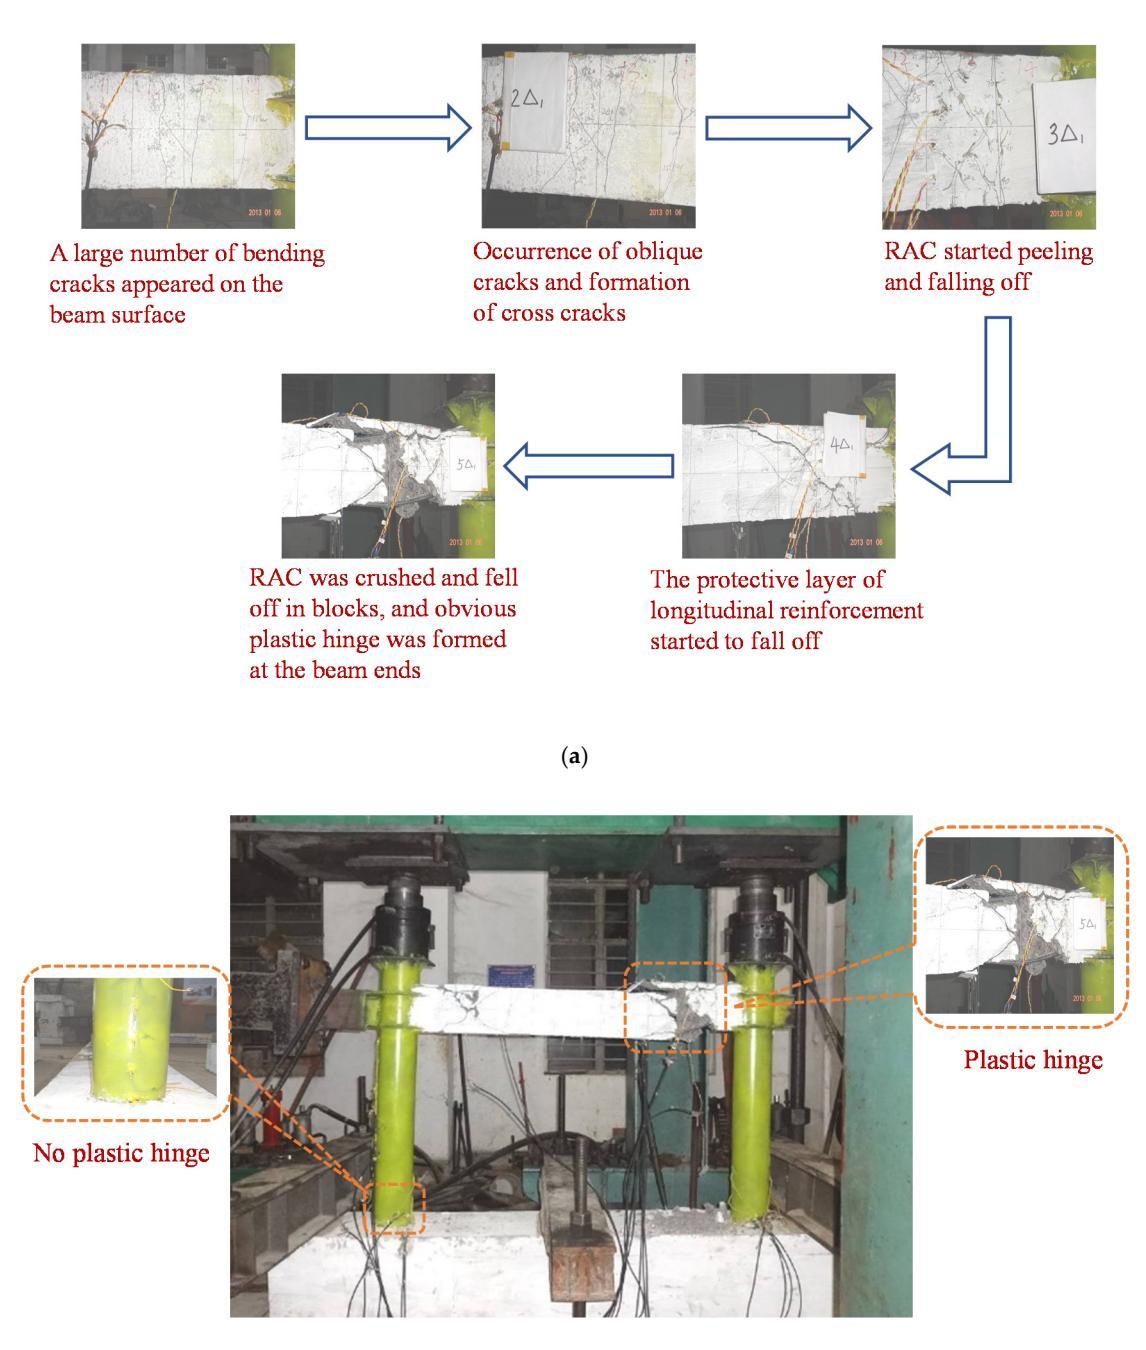
Figure 6. The failure modes. (a) The failure process of the beam; (b) The ultimate failure mode of the frame.

at the end of the test, the steel tube did not have bulges. The final failure mode of the RACFCST frame is shown in Figure 6.

(1) At the end of the beam of the RACFCST frame, bending cracks first appear, and then cross diagonal cracks evolve obliquely at 1/7~1/6 of the beam span and gradually develop into critical diagonal cracks. Finally, the RAC protective layer in the shear pressure area is lifted, forming a more

obvious bending shear plastic hinge. The strain at the bottom of the column reaches the yield strain, but the steel tube has no bulging and the plastic hinge is not obvious. In this test, the failure mode of beam results from bending shear failure, which meets the seismic design requirements of "strong shear weak bending". In the test of the RACFCST frame, the plastic hinge appears first in the beam and then in the column, which illustrates that the failure mechanism of the RACFCST frame structure results from beam hinge failure, which meets the seismic design requirements of "strong column and weak beam".

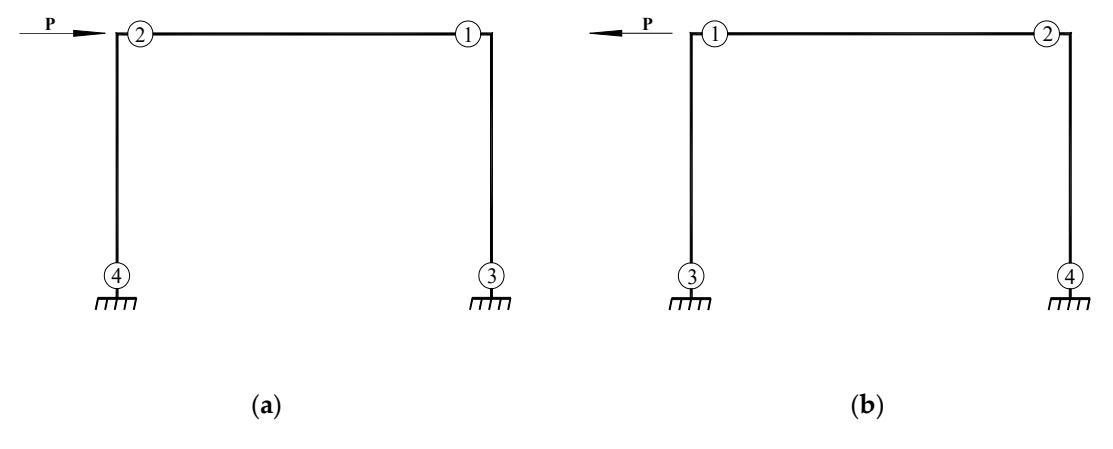
Figure 7. The sequence of the plastic hinges of the test frame under (**a**) positive loading and (**b**) negative loading.

(2) If the yields of the bottom steel tube and the end longitudinal bar are taken as the yield marks of the RACFCST column and beam respectively, according to the measured data of the strain at the bottom of the steel tube and the end of the longitudinal bar, we know the sequence of the plastic hinges of the frame, and the sequence of the plastic hinges in the specimen is shown in Figure 7. It can be seen from this figure that under the action of push-pull, the sequence of plastic hinge generation is from the beam end to column bottom, which indicates that the full failure of the RRAC beam delays the appearance of the plastic hinge at the column bottom, and that this kind of new structure can meet the energy dissipation mechanism of the beam hinge.

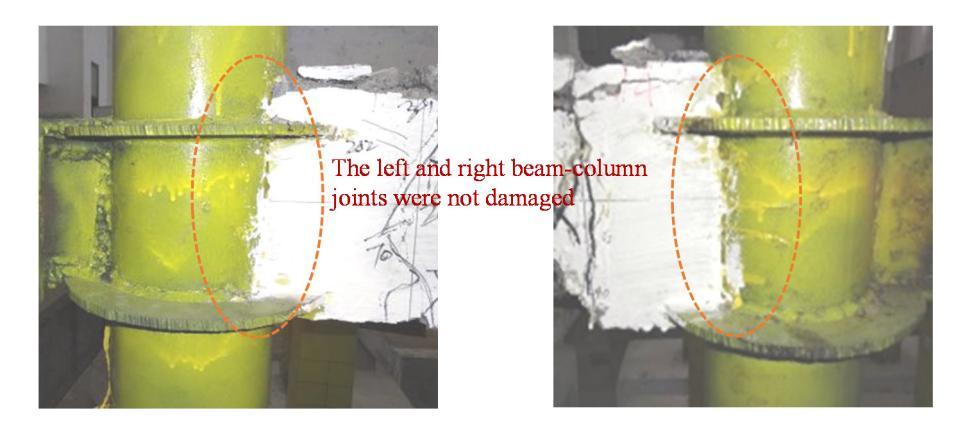
Figure 8. The core area of the joint.

(3) In the test, there is no vertical or diagonal crack at either end of the beam of the RACFCST frame, as shown in Figure 8. The reason is that the I-shaped extended corbel is arranged in this local area, and the corbel is welded with the stiffening ring outside the steel tube as a whole, which increases the strength and rigidity of the beam end and can effectively transfer the bending moment and shear force to the RACFCST frame column.

(4) The RACFCST frame node area adopts the connection mode of the external stiffening ring. According to the test phenomenon, the core area of the node remains intact (see Figure 8). It complies with the seismic design requirements of "strong node, weak component".

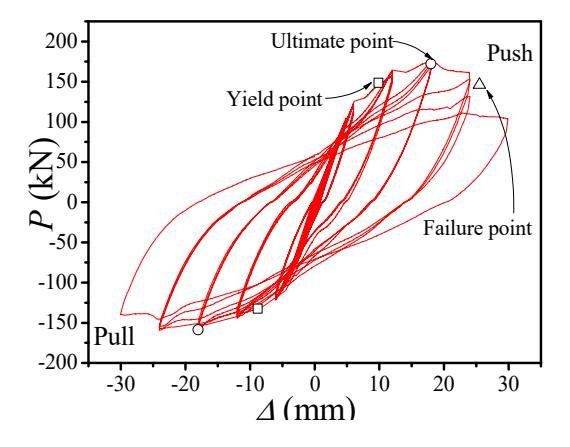
Figure 9. Hysteretic curves of the recycled aggregate concrete filled circular steel tube (RACFCST) frame.

The measured hysteresis curve of the frame is shown in Figure 9. It can be seen from the figure that the hysteresis curve of the RACFCST frame has the following characteristics:

(1) The hysteresis curve of the RACFCST frame is symmetrical and not pinched. The reason for this is that the lateral constraint of the external steel tube on the core RAC improves the strength and deformation performance of the core RAC, so that the cracking and crushing of the core RAC will not cause a sudden change in the lateral stiffness of the whole frame. Generally speaking, the hysteresis curve presents a relatively full spindle shape, and the energy dissipation capacity of the specimen is good.

(2) In the initial stage of load-control, the overall deformation of the frame is relatively small, the slope of the loading curve changes little, and there is basically no residual deformation after unloading. During the whole load-control stage, the hysteresis curve basically coincides, the hysteresis loop is not obvious, and the specimen is basically in the elastic stage.

(3) In the initial stage of displacement-control, there are many cracks at the end of the beam, and the steel bars in the beam yield first, which causes the hysteresis loop to fill gradually, and the residual deformation of the frame occurs after unloading. When the lateral displacement reaches about $\pm 2\Delta_y$, the frame begins to yield. After yielding, the hysteresis curve begins to incline to the displacement axis. With the increase in lateral displacement, the load acting on the specimen increases gradually, and the formed hysteresis loop becomes increasingly full. When the lateral displacement reaches $\pm 3\Delta_y$, the peak load of the RACFCST frame appears. At this stage, the three hysteresis loops deviate from each other more and the strength and stiffness of the specimen show obvious degradation. At the same time, the frame has significant residual deformation after unloading, which indicates that the specimen has acquired cumulative damage.

(4) When the lateral displacement goes up to $\pm 4\Delta_y$, the bearing capacity of the RACFCST frame decreases to the level of the failure load, but the lateral displacement of the specimen can still increase, which indicates that the energy dissipation capacity of the specimen has been fully developed. At this stage, the three hysteresis loops of the specimen have deviated greatly, the strength and stiffness degradation are very obvious, and the cumulative damage of the specimen has increased significantly.

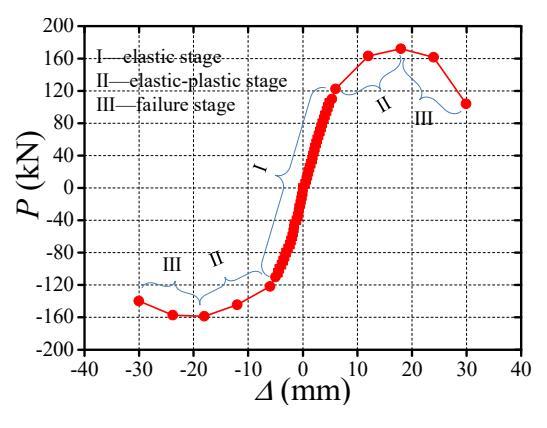
Figure 10. The skeleton curve of the RACFST frame.

The skeleton curve of the specimen refers to the envelope formed by the peak points of the first cycle under each loading stage of the P- Δ hysteresis curve. It can clearly reflect the strength and deformation performance of the structure. The skeleton curve of the RACFCST frame is illustrated in Figure 10. It can be observed in the figure that the skeleton curve of the frame can be divided into three stages, namely the elastic stage, elastic-plastic stage and failure stage. In the elastic stage, the skeleton curve is approximately a straight line with a constant slope. After entering the displacement-control, a turning point appears in the curve, indicating that the specimen enters the elastic-plastic stage. At this point, the curve slope decreases continuously, which indicates that the overall stiffness of the frame decreases to the minimum in the elastic-plastic stage. Then, the bearing capacity starts to decline, the displacement increases rapidly, and the frame structure enters the failure stage.

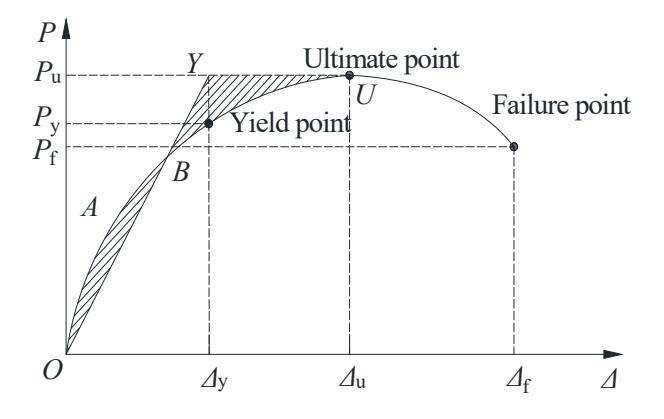
Figure 11. Characteristic points on the load-displacement curve.

Ductility is an important performance index in seismic research on structural engineering. In this paper, the energy equivalent method is used to calculate the displacement ductility coefficient $\mu = \Delta_u / \Delta_y$, where Δ_y is the yield displacement and Δ_u is the limit displacement, which is taken as the corresponding displacement value when the load drops to $0.85P_u$. Figure 11 shows how the initial yield point of the specimen can be determined by the energy equivalence method. As shown in the figure, two lines *OY-YU* are drawn to make the areas of the two shadows in the figure equal ($S_{OAB} = S_{BYU}$), and the *x* coordinate of the intersection of the two lines *OY-YU* and the skeleton curve is the initial yield displacement (Δ_y). The calculated values of μ and each characteristic point are listed in Table 5, where P_y and P_f are respectively the load values corresponding to Δ_y and Δ_f , and Δ_u is the displacement value corresponding to P_u . At the end of the loading, the positive load is reduced to $0.85P_u$, but the negative load is not, so only the positive ductility coefficient is given in the table, and the positive ductility coefficient of the frame is up to 2.58, which shows that the RACFST frame can meet the ductility requirements according to the design methods and construction measures.

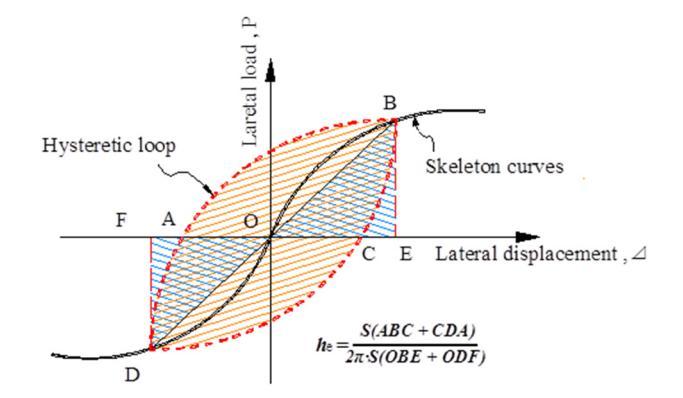
Figure 12. An energy dissipation capacity calculation diagram.

The equivalent damping ratios—those are, $h_e = S_{(ABC+CDA)}/(2\pi \cdot S_{(OBE+ODF)})$, in which $S_{(ABC+CDA)}$ is the area of the hysteresis loop of DABCD, and $S_{(OBE+ODF)}$ is the total area of the triangles of OBE and ODF—for evaluating the energy dissipation capacity calculated from the load–displacement hysteretic loops are shown in Figure 12. The purpose was to reflect the better energy dissipation capacity of the frame proposed in this paper compared with that of the RC frame proposed by Zhou et al. [22]. Figure 13 gives the equivalent damping ratios versus the maximum lateral displacement corresponding to the test frame and the contrasting RC frame. It can be found that the value of h_e increases with the increase in lateral displacement, which indicates that more energy is consumed. The reason is that the plastic hinge appears at the beam end and column end and develops continuously, which increases the energy dissipation capacity of the frame. When the lateral displacement is at the same level, the energy dissipation capacity of the gap in energy dissipation capacity between the two types of frame increases, which is mainly related to the good plastic deformation performance of the RACFCST frame is 0.156 and

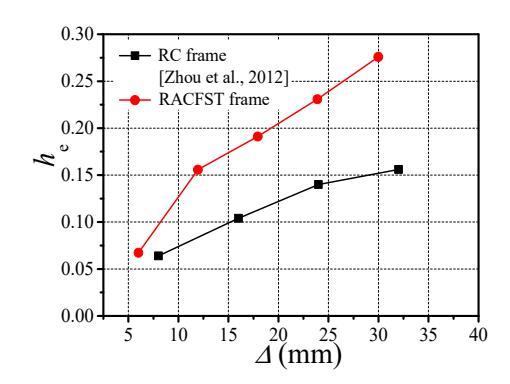
Figure 13. The energy dissipation capacity.

0.276, respectively, which shows that the energy dissipation capacity of the RACFCST frame is much better than that of the RC frame.

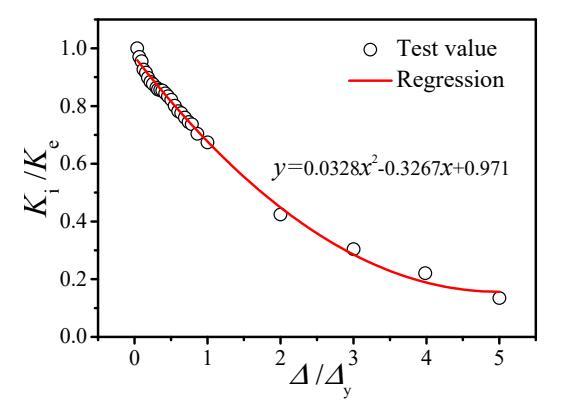
Figure 14. Stiffness degeneration.

The secant stiffness K_i is used to describe the stiffness degradation of the frame as shown in Figure 14, and the formula for calculating K_i can be found in Chinese standard JGJ 101-96 [26] as

It can be seen from Figure 14 that the secant stiffness decreases with the increase in displacement, and the stiffness degradation changes from fast to slow during the whole test. The main reason is that

before the yielding of the frame, there are many cracks on the beam, which makes the reduction rate of the bearing capacity less than the growth rate of the displacement, and the stiffness degradation is more rapid. However, when the plastic hinge appears at the beam end and column end, the good deformation capacity of the frame causes the bearing capacity to decrease slowly. At this point, the reduction rate of the bearing capacity is less than the growth rate of the displacement, and the stiffness degradation is relatively slow. At the same time, it can be seen from the figure that the stiffness degradation of the frame has obvious regularity. The RACFCST frame is distributed in the form of a quadratic function, and the mathematical expression is as follows:

where y is K_i/K_e ; x is Δ/Δ_i ; K_e is the elastic stiffness, which is calculated by the initial load divided the displacement corresponding to the initial load in the load-control stage; and a, b and c are the regression factors, which are equal to 0.0328, -0.3267 and 0.971, respectively.
