# Article Monitoring of Atmospheric Corrosion of Aircraft Aluminum Alloy AA2024 by Acoustic Emission Measurements

Thomas Erlinger \*<sup>D</sup>, Christoph Kralovec <sup>D</sup> and Martin Schagerl <sup>D</sup>

Institute of Structural Lightweight Design, Johannes Kepler University Linz, Altenberger Str. 69, 4040 Linz, Austria

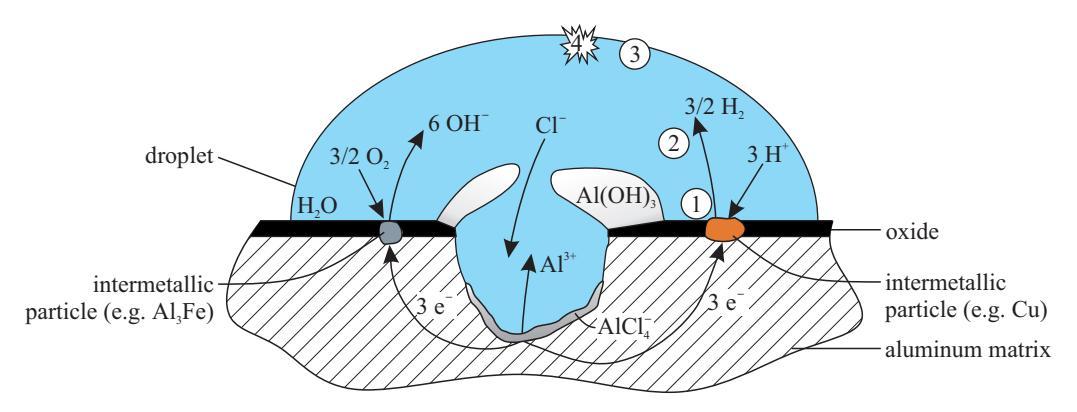
**Figure 1.** Mechanism of pitting corrosion of aluminum under a droplet of an aqueous solution [6]. H<sub>2</sub> bubble activity is distinguished into the following phases: (1) formation, (2) detachment from metal surface and movement, (3) arrival at droplet surface and growth, and (4) bursting of H<sub>2</sub> bubbles.

The corrosion of aluminum is eventually the sum of two electrochemical reactions occurring simultaneously but at different sites, namely anodic oxidation (release of electrons) and cathodic reduction (consumption of electrons). This leads to the overall corrosion reaction of aluminum in aqueous media:

where insoluble aluminum hydroxide Al(OH)<sub>3</sub> and H<sub>2</sub> are formed as the final products [6]. However, as the H<sub>2</sub> formation described by Equation (1) is reported to be an important basis for the AE-based corrosion detection of aluminum [26–28] its derivation in the case of pitting corrosion is presented below [6]. Pitting corrosion is initiated by the adsorption of the aggressive chloride ions (Cl<sup>-</sup>) into the naturally existing oxide film of aluminum. This generally takes place at the weak points of the oxide film, particularly at the microcracks in the neighborhood of the intermetallic particles (cathodic areas). The result is a breakdown of the oxide film at the weak points, and thus the exposure of the bare aluminum (anodic areas) to the solution. At these anodic sites, aluminum oxidation (dissolution of aluminum)

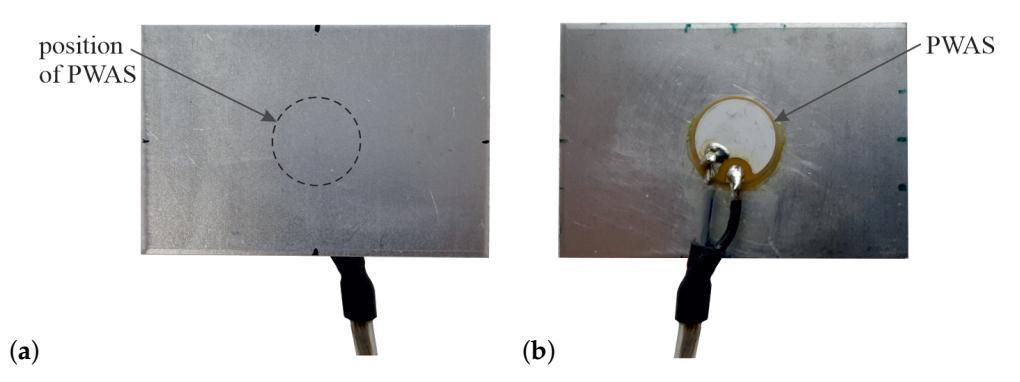
**Figure 2.** Aluminum specimen with applied and contacted PWAS: (**a**) top side and (**b**) bottom side with applied and contacted PWAS.

dimensions of  $\&pmummed 10 \text{ mm} \times 0.5 \text{ mm}$  and a Pi Ceramic PIC151 material type were applied to the center of the specimens as sensing elements for AE monitoring. Before the PWAS were adhesively bonded, the corresponding surface area on the specimen was slightly ground and cleaned with a commercially available universal cleaner. Finally, the sensors were electrically contacted with shielded cables. Figure 2 shows a fully prepared specimen.

Atmospheric corrosion was induced by a small droplet of a corrosive 50 g/L NaCl solution of pH 3 (glacial acetic acid added), which is slightly more aggressive than seawater and commonly used for the corrosion testing of aluminum (cf. DIN EN ISO 9227). The highest sensitivity of the sensor is given when the corrosion site is as close as possible to the PWAS. Therefore, the droplet was placed in the center of the top side of the specimen, i.e., opposite the PWAS (cf. Figure 2).

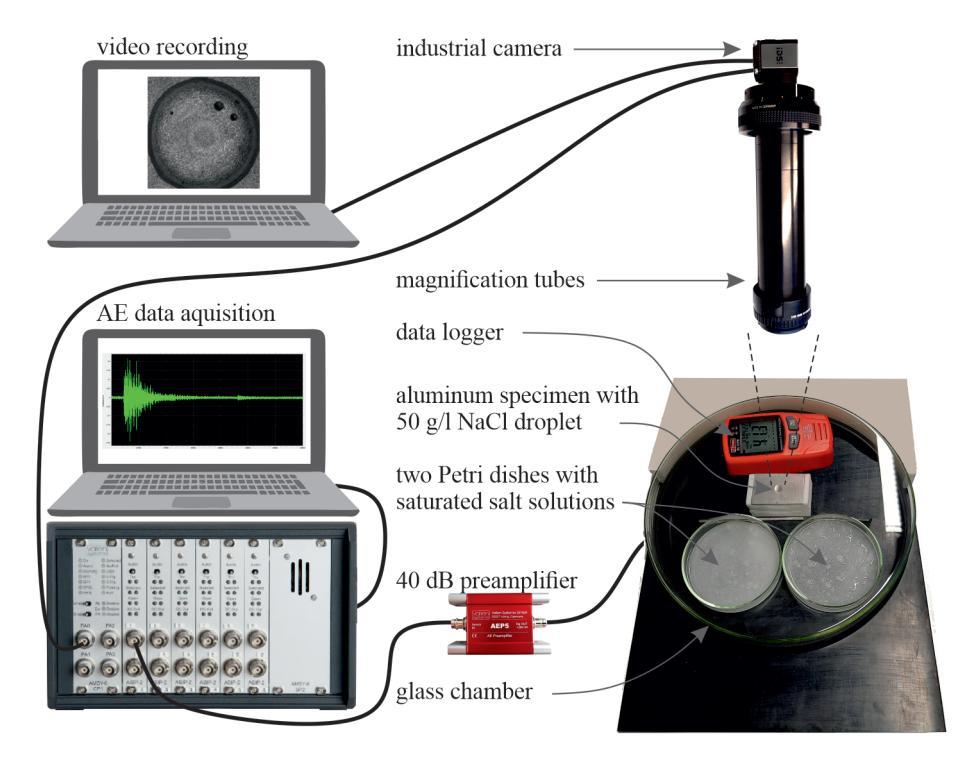
**Figure 3.** Experimental setup of the atmospheric corrosion experiment. AE monitoring of atmospheric corrosion during a controlled variation of the RH and additional visual observation of the corrosion by an industrial camera.

The experimental setup is presented in Figure 3. It consisted of a closed glass chamber with ambient air in which the RH was controlled and logged along with the temperature. The chamber was built using a big Petri dish with a dimension of  $\emptyset 200 \text{ mm} \times 35 \text{ mm}$ , which was placed upside down on a rubber mat and had a rubber sealing around the edge of the dish to obtain a tight chamber (cf. Figure 3). Additionally, two clamps were used to press the dish onto the rubber mat to further increase the tightness (not shown in Figure 3 for visibility reasons).

The specimen was placed on foam material inside the glass chamber and was cleaned with acetone before the droplet was deposited. The droplet was deposited manually by a small syringe. Initially, a surface of 5 mm in diameter was wetted by the droplet with an approximate volume of 0.03 mL. The sensor cable was led out through a tiny opening at the bottom of the rubber mat and connected via a preamplifier (type Vallen AEP5) with 40 dB amplification to the data acquisition (DAQ) system (type Vallen AMSY-6). The sampling rate was set to 20 MHz and the whole DAQ was controlled by an external notebook. The AE DAQ was performed in continuous mode, i.e., a gapless AE data stream was recorded, except for some time points described later. Consequently, the extraction of the AE hits was conducted during post-processing by a defined amplitude threshold. Furthermore, no digital frequency filtering was applied during the DAQ.

The droplet on the specimen was visually observed using an industrial camera (type IDS UI-3370CP Rev. 2), which was positioned vertically above and outside the Petri dish on a tripod. Extension tubes were mounted between the camera and the lens for the magnification of the droplet (cf. Figure 3). The resolution of the video recording was 2048 px  $\times$  2048 px. The recording was done in video sequences of 20 min duration and a framerate of 35 fps. The videos were recorded at selected times rather than continuously. The digital output from the camera was used to connect the internal flash signal, triggered at frame capture, to the AE DAQ system to enable synchronization between the AE and video data in post-processing. The camera was connected to a second external PC that controlled the video recording.

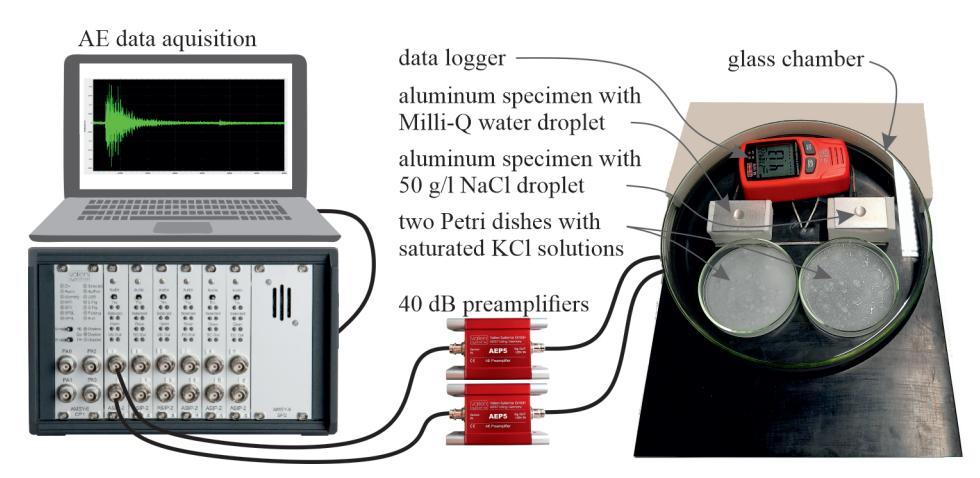
**Figure 4.** Experimental setup of the AE source identification experiment to compare the AE caused by the droplets of Milli-Q water and NaCl solution, respectively.

The experimental setup was similar to the one explained in Section 2.3 and is shown in Figure 4. On the first specimen, a droplet of Milli-Q water (water of the highest purity) was deposited and on the second specimen, a droplet of the 50 g/L NaCl solution was deposited. Each droplet initially wetted a surface of 9 mm in diameter and had a volume of approximately 0.1 mL. The two specimens, which were each placed on foam material, were put into the tight glass chamber, where both specimens were exposed to the same environmental conditions. The high RH was controlled by two small Petri dishes of saturated potassium chloride (KCl) solutions, with a theoretical equilibrium RH of 85% at room temperature (see Table 1) to prevent the evaporation of the droplets. After about 8.7 h, enough data were believed to have been acquired to draw reliable conclusions (based on previous tests), and the RH was rapidly decreased by exchanging the saturated KCl solution with a silica gel. The experiment was stopped after the complete evaporation of the droplets was visually observed so that dry specimens could be obtained. The sensor cables of both PWASs were led out through a tiny hole at the bottom of the rubber mat and connected via preamplifiers (type Vallen AEP5) with an amplification of 40 dB to the DAQ system (type Vallen AMSY-6). The same measurement equipment as that used for the atmospheric corrosion experiment was used. In addition, the same DAQ settings as those used for the atmospheric corrosion experiment were used, except for the sampling rate, which was 10 MHz for this experiment (the atmospheric corrosion experiment suggested this sample rate to be sufficiently high). The DAQ was controlled by an external notebook. The temperature and RH inside the glass chamber were measured using a data logger (type RS PRO RS-172TK). In contrast to the atmospheric corrosion experiment, no visual observations by video recording were conducted, as the aim of the experiment was a direct comparison of the AE activity.

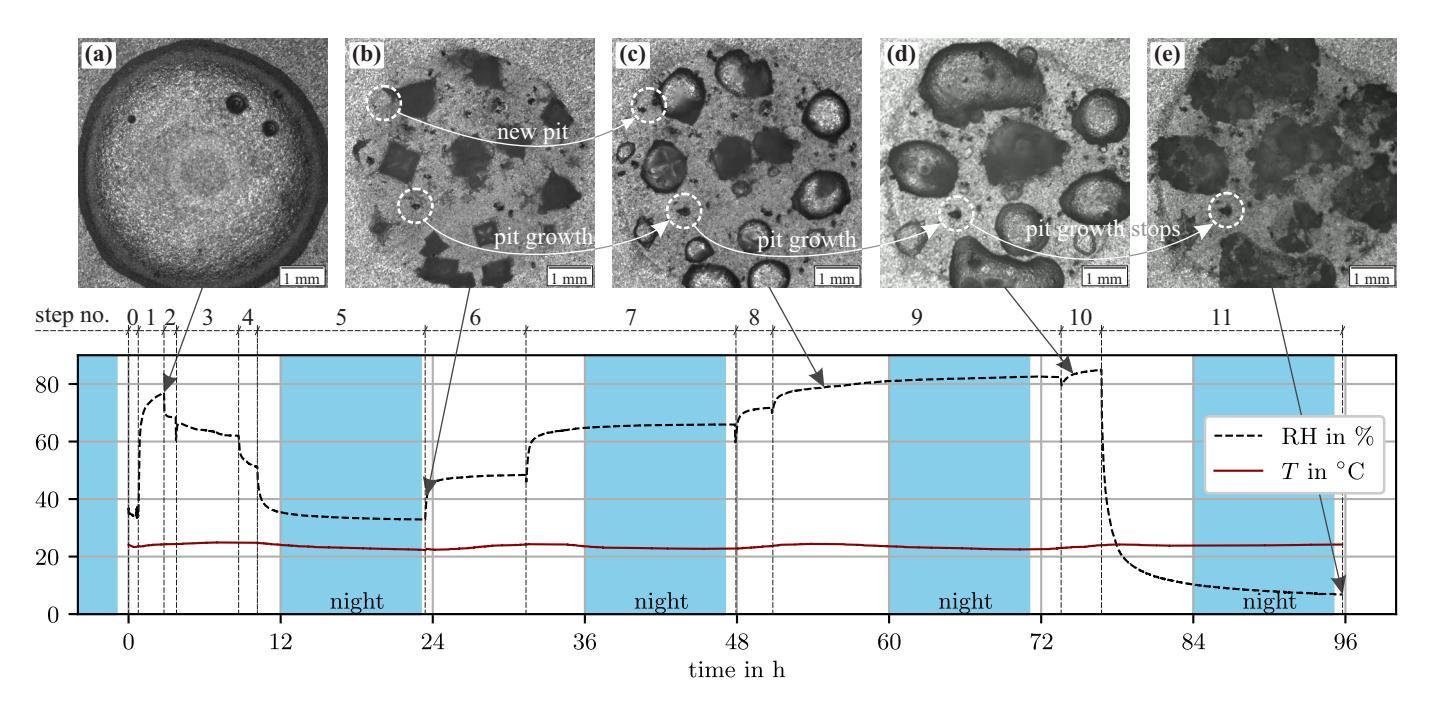
**Figure 5.** Relative humidity (RH) and temperature *T* during the atmospheric corrosion experiment, and exemplary images (a-e) of the deposited droplet and the corroded surface. The areas marked in blue represent the night times from 8 pm to 7 am.

Figure 5 shows the curve of the measured temperature T and RH during the atmospheric corrosion experiment, which lasted about 96 h. The temperature varied periodically with the day-night cycle; the minimum value during the night was 22 °C and the maximum value during the day was 25 °C. The initial RH was about 35%. The controlled variation started with a rapid increase in the RH, which approached about 77% RH at hour 2.8 (i.e., at the end of step 1). In steps 2 to 5, a controlled decrease to a low RH of about 33% at hour 23.5 was performed. In steps 6 to 10, the RH slowly increased again to a maximum RH of 85% at hour 76.7. Step 11 started with a rapid drop in the RH and then continued with a slower decrease to a final RH of 7% at hour 95.8. The times that the saturated salt solutions were exchanged, i.e., the changes between the steps, are indicated by vertical dashed lines and can also be seen in the abrupt drops or rises in the RH curve. Although the expected RH values, as given in Table 2, were not achieved for the saturated salt solutions used, the RH variations were suitable for simulating the dry and wet phases of the monitored specimen, as expected in the operation of aircraft components. Moreover, Figure 5 shows several images of the specimen's surface with the deposited droplet (extracted from the recorded videos) and the corresponding time points. Figure 5a shows the droplet at 2.8 h after the start of the experiment, where a high RH of 77% was present. Bubbles of different sizes are clearly visible in the droplet. Due to the absence of other bubble-forming processes and the corrosion taking place (as can be seen later), this was determined to be H<sub>2</sub> produced by corrosion processes. Figure 5b shows the surface of the specimen at hour 23.5, which was the end of the defined decrease of the RH to 33%. The steady decrease in the RH caused the water to slowly evaporate from the specimen's surface, whereas the NaCl crystals of the droplet solution remained on the surface. Furthermore, the formation of pits can be clearly seen in the figure. Figure 5c shows the surface at hour 54.9 at an RH of 79%. Due to deliquescence, the moisture in the humid environment was absorbed by the NaCl crystals, which resulted in numerous smaller droplets of another corrosive NaCl solution. Figure 5d depicts the situation at hour 74.6 with an RH of about 83%, which was only briefly before the maximum RH of 85% was reached. Due to the increasing duration and RH, the droplets increased further in size and partly merged. Moreover, by comparing Figure 5b–d, the growth of the already existing pits and the formation of new pits can be clearly observed. Figure 5e shows a completely dried-out but corroded surface after 95.8 h at an RH of 7%. Significant pits and NaCl crystals can be identified. The minor pit growth observed between Figure 5d, e was also expected, but due to the short time (about 2 h) in which the electrolyte was present on the specimen in this period, this was not visually apparent. After the rapid decrease in the RH at hour 76.7, the pit growth stopped.

For the monitoring of the corrosion propagation, the videos were visually inspected (results are presented in Figures 5 and 6). It was observed that the corrosion of aluminum and its constant production of H<sub>2</sub> also formed bubbles when there was only a small amount of electrolyte present on the aluminum surface. These bubbles are reported to be one of the major sources of AE in immersion-like tests [26-28]; thus, the observed small H<sub>2</sub> bubbles were believed to also be a major AE source in the present atmospheric corrosion experiment. To investigate this question, the recorded videos were processed using an algorithm implemented in Python 3.8 that automatically detects sudden changes such as moving, merging, or bursting bubbles. In the first step, background subtraction using the OpenCV package was conducted to highlight sudden changes in the videos. In the second step, event detection by evaluating the size of these changes using the imutils and OpenCV Python packages was performed. In cases when the detected events exceeded a certain threshold size, the events were considered to be relevant. For comparison with the AE data processing, a cumulative count of the detected events over time was generated. Figure 7 shows some exemplary results of a processed video recorded in step 1. The upper part of the images shows the originally captured frame and the lower part shows the corresponding processed frame. The original frame in Figure 7a shows several bubbles in the droplet, and few changes from the previous frame were detected, resulting in an almost black processed frame. Figure 7b shows the subsequent frame. The bubble on the upper-left edge of the droplet has burst, which was detected by the algorithm and is highlighted with a green rectangle. Additionally, two smaller events were detected in the lower-right corner of the frame.

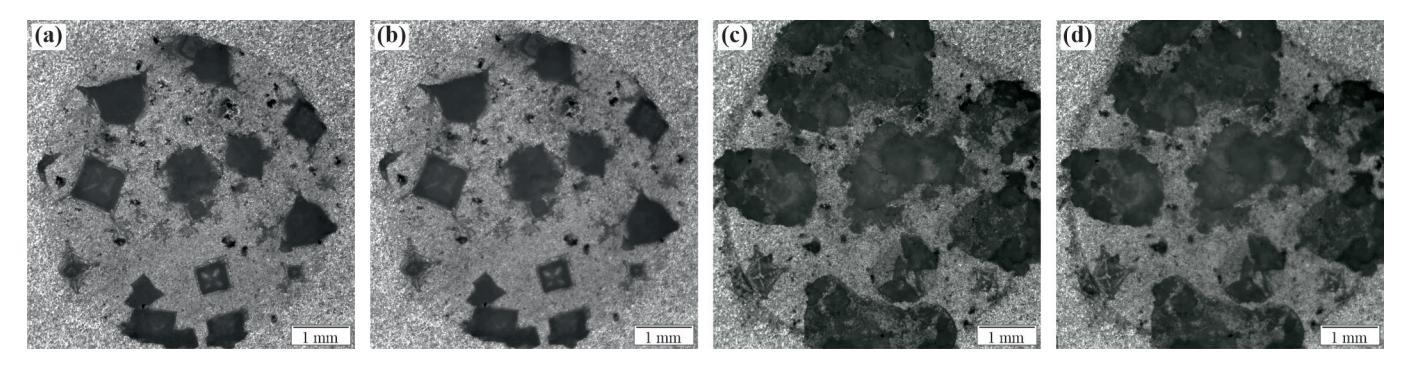
**Figure 6.** No progress in the corrosion during the defined dry phase, i.e., no difference can be seen between the corroded specimen surfaces (**a**) at hour 23.5 and (**b**) at hour 27.5. There was also no progress in the corrosion after the final evaporation of the droplet. (**c**) The specimen surface at hour 77.7 and (**d**) at hour 95.8.

Figure 6 illustrates that corrosion did not progress during the dry phases at a low RH, which can be seen by comparing the exemplary images of the corrosion site (extracted from the recorded videos) in these phases. Due to some issues with the video control, some periods exist where no videos were recorded, e.g., in the dry phase from hour 9.8 to hour 23.5. Therefore, Figure 6a shows the specimen's surface only at hour 23.5, i.e., at the end of the defined dry phase, and Figure 6b shows the surface at hour 27.5 at an RH of 47%, where the specimen's surface was also still dry. During this period, neither the pit growth, formation of new pits, nor changes in the deposits were identified. However, a closer look at the corresponding videos revealed that tiny bubble activity already started again at hour 27.5. Therefore, the dry phase at the end of the experiment was also analyzed. Figure 6c shows the dry specimen surface at hour 77.7 at an RH of 27% and Figure 6d shows the surface at the end (18.1 h later) of the experiment, i.e., the same frame shown in Figure 5e. No differences were found between Figure 6c, d. Moreover, no bubble activity was observed in the videos recorded during the corresponding time period. Thus, it is concluded that corrosion did not progress during the two dry phases of the experiment.

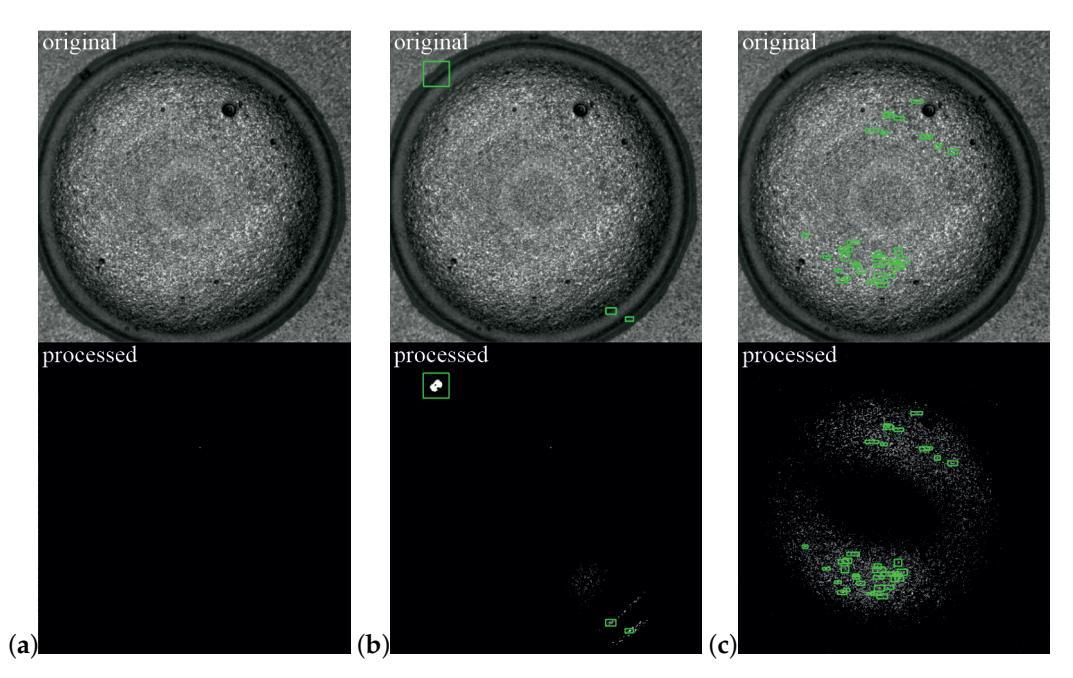
**Figure 7.** Example of results of the video processing algorithm. The upper part of the images represents the originally captured frames and the lower part, the processed frames. (**a**) Bubbles in the droplet can be seen in the original frame but the algorithm detected no activity, (**b**) shows the subsequent frame. The bubble on the upper-left edge of the droplet has burst, which was detected by the algorithm and is highlighted with a green rectangle. (**c**) Small vibrations in the test setup caused 37 detections at once; such disturbances were not considered in the subsequent analysis.

The authors decided that a threshold size of 60 pixels was a proper value to avoid the invalid detection of noise or other artificial objects caused by small vibrations or shocks to the setup. However, larger shocks to the setup caused several detections at the same time, which resulted in a heavily disturbed cumulative count (cf. Figure 7c). Such disturbances were removed from the cumulative count in a final processing step. The manual inspection of some processed videos revealed that there was predominantly H<sub>2</sub> bubble activity in the videos and that this activity was well captured by the video processing algorithm. Furthermore, the manual inspection revealed that in most cases, a maximum of three to four valid objects were detected between two consecutive frames. Thus, if five or more objects were detected simultaneously, the corresponding counts were removed. In another cleaning step, a check was performed to see if an event had been detected in the same frame or a nearby position in the previous frame. This avoided the multiple counting of single events of longer durations, e.g., if bubbles slowly moved or rose.

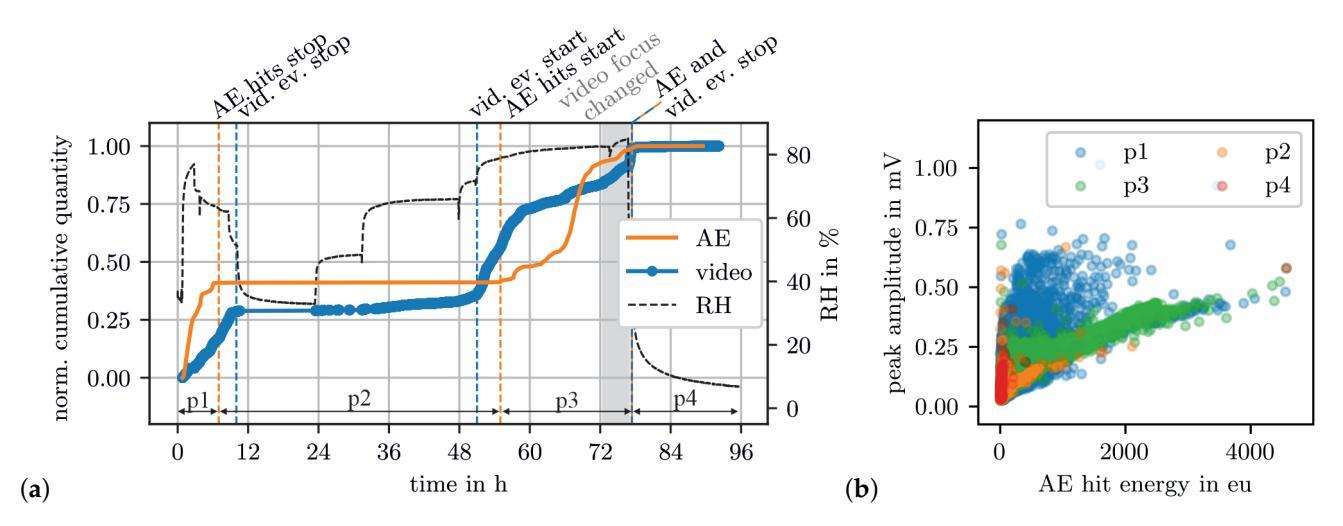
**Figure 8.** Results of the atmospheric corrosion experiment. (**a**) Measured relative humidity (RH) and calculated normalized cumulative AE hit energy and normalized cumulative video event count. The vertical dashed lines represent the times when the cumulative quantities indicated the stopping and starting of corrosion activity. The gray area marks a time span in which the focus of the camera was changed. (**b**) Peak amplitude versus AE hit energy of the four phases p1–p4 of the experiment.

The normalized cumulative AE hit energy and normalized cumulative video event count are shown together with the curve of the RH in Figure 8a. The normalization of the two cumulative quantities was performed using their maximum values, which were  $1.99 \times 10^6$  eu and 82,555 video events, respectively. As mentioned above, there were some periods where no videos were recorded, especially in the time span from hour 10.6 to hour 23.5, which is illustrated by the solid line without markers on the curve of the cumulative video event count in Figure 8a.

The curve of the cumulative AE hit energy showed its steepest increase at the beginning and clearly flattened after 3.7 h. At hour 55, the curve started to increase with a slope similar to that observed between hour 4 and hour 7, i.e., during the evaporation of the droplet. These similar slopes seem plausible since similar conditions prevailed at these times (similar amount of highly concentrated electrolyte at similar locations). Thereafter, the curve gradually increased again and between hour 67 and hour 69, a slope that was almost as steep as at the beginning was observed. From hour 70 onward, the curve began to flatten. After the last forced increase in the RH, a small intermediate increase in the AE hit energy was observed at hour 75. The forced drying at hour 76.6 led to the final stagnation of the curve. This trend clearly shows that the most energy was generated during the phases of high RH, i.e., at the beginning when the droplet was still present and during the phase of sufficient deliquescence of the NaCl crystals, thus suggesting the correlation of the AE activity with the amount of electrolyte present on the specimen. This is also illustrated in Figure 8b by the scatter plot of the peak amplitude versus the AE hit energy. The four colored clusters represent the AE signals of the two phases when a large amount of electrolyte was present on the specimen (p1 and p3) and the two phases when no or a small amount of electrolyte was present on the specimen (p2 and p4) during the experiment (cf. annotations in Figure 8a). During phases p1 and p3, signals with high energies and peak amplitudes were detected, leading to the above-described steep increases in the cumulative AE hit energy. However, during phases p2 and p4, AE signals were also detected. These signals were less frequent and had significantly lower energies and peak amplitudes, which describes the stagnation of the cumulative AE hit energy during these two phases, as seen in Figure 8a.

The slopes of the cumulative video event counts in the time spans at the beginning (hour 0 to hour 10) and at the start of the deliquescence of the NaCl crystals (hour 51 to hour 59) were similar. In the first time span, the focal plane of the camera was set near the droplet surface, where bubbles in the droplet are clearly visible. In the second time span, the focal plane was set at the specimen's surface, where small bubbles in and near the pits were observed. From hour 59 onward, more and more electrolyte in the form of single droplets were present on the specimen due to the ongoing deliquescence of the NaCl crystals. However, due to the focal plane settings of the camera, bubbles appeared to be blurred in the droplets of the electrolyte and were less well detected by the algorithm. This is considered the reason for the flattening of the cumulative video event count curve between hour 59 and hour 72.5. From hour 72.5 to hour 76, the setting for the focal plane was changed (see the gray marked area in Figure 8a). The focal plane was moved slightly above the specimen's surface. This modification made the bubbles partly visible. However, blurred bubbles were still present on the edges of the droplets, which were not detected by the algorithm. Thus, if there were several small droplets on the specimen, only a portion of the bubbles within these droplets was detected, i.e., changing the focal plane did not significantly change the trend in the cumulative video event count (cf. Figure 8a).

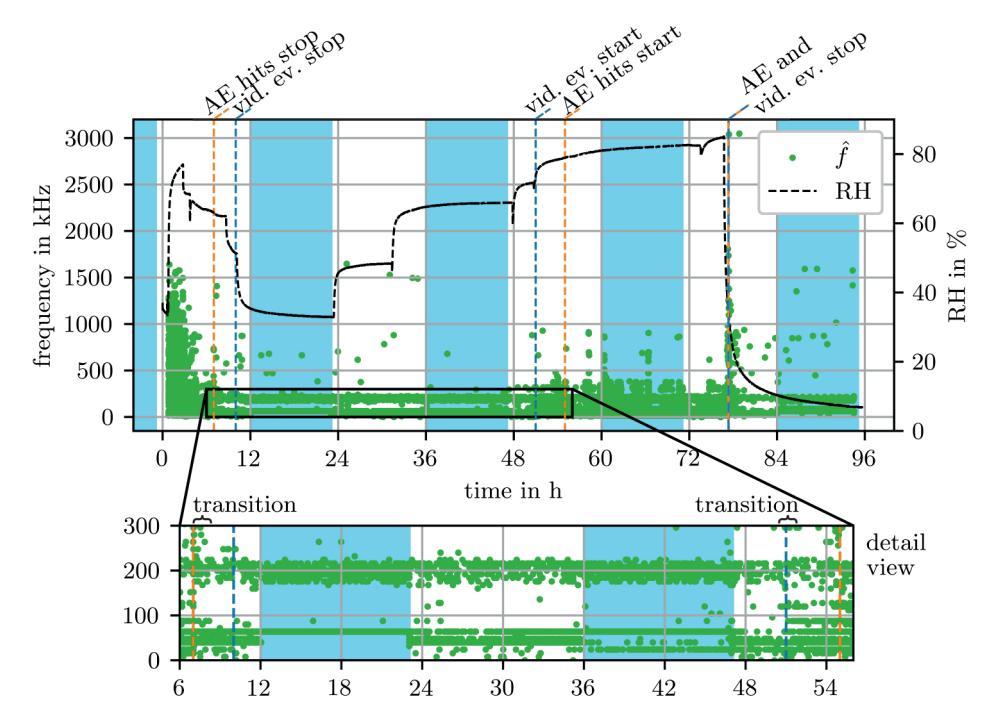
**Figure 9.** RH and results of the STFT-based frequency analysis of the entire AE data of the atmospheric corrosion experiment. The colored vertical dashed lines represent the times at which the cumulative AE hit energy and cumulative video event count indicate the stopping and starting of the corrosion activity. The areas marked in blue represent the night times from 8 pm to 7 am. The detailed view highlights the different frequencies at the day and night times, as well as the transitions between frequencies indicating the corrosion activity and constant frequencies due to background noise.

with  $i = 0 \dots n - 1$ , was extracted. The STFT was calculated using the command signal.stft in the Python package scipy. The Hann window with a window length of w = 2500 samples and window overlap of w/2 was used, leading to a time resolution of 62.5 µs and a frequency resolution of 8 kHz. Figure 9 shows the results of this frequency analysis, together with the curve of the RH.

Clear differences in the calculated frequencies between the wet and dry phases, i.e., the phases of high and low RH, can be seen. In particular, at the beginning, when the initially deposited droplet was present on the specimen, frequencies up to 1.5 MHz were yielded. The reduction in the RH, and thus the electrolyte on the specimen's surface, also resulted in a reduction in the frequency. Between hour 12 and hour 48, the same frequencies were consistently observed. In this time span, a low RH prevailed and the NaCl crystals had not yet started to deliquesce. A detailed analysis of these frequencies (using the experimental measurement of the electromechanical impedance spectrum of the specimen with the applied PWAS; see [42] for this measurement method) revealed that some of them (e.g., 24 kHz, 40 kHz, 64 kHz, 88 kHz) fit to the natural frequencies of the specimen (e.g., 25.8 kHz, 42.3 kHz, 63.7 kHz, 85.9 kHz). Moreover, it was observed that the day (7 am to 8 pm) and night times (8 pm to 7 am) clearly influenced these frequencies (cf. detail view in Figure 9). It was assumed that this was related to the building technology of the laboratory (heating control, electrical infrastructure, lighting, etc.). However, the specific reason could not be identified. This influence had to be considered when attempting to determine the transition from frequencies indicative of corrosion activity to frequencies due to background noise. The transition indicating the stopping of corrosion due to the lowering of the RH was suggested to have occurred at approximately hour 7.5, which was between the stopping points determined by the cumulative AE hit energy and cumulative video event count. The onset of corrosion activity due to the increase in the RH was determined to have occurred at approximately hour 51.2, which matched the point of the cumulative video event count.

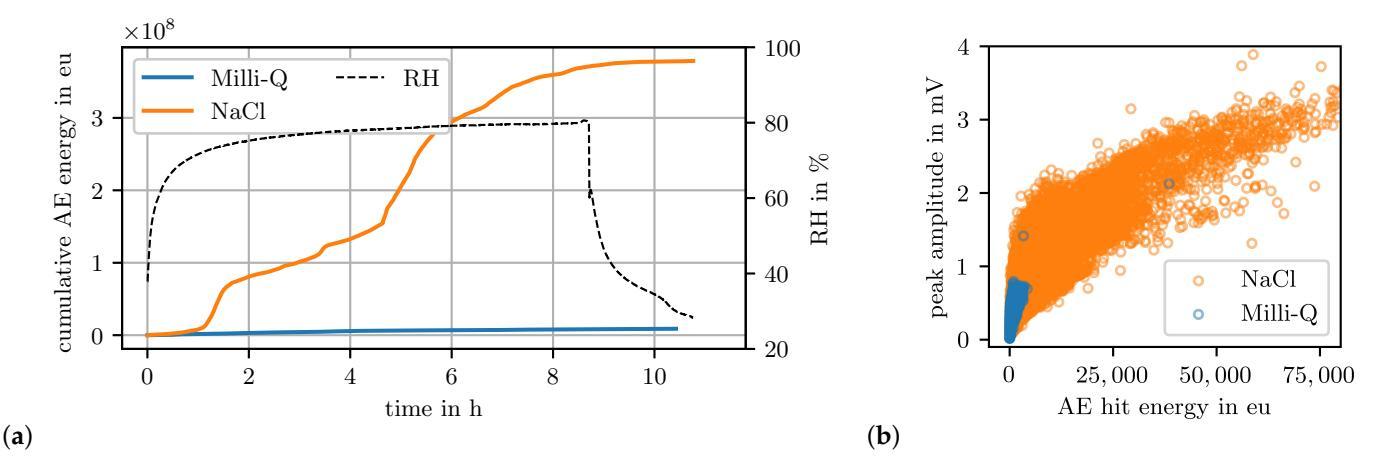
**Figure 10.** Results of the AE source identification experiment: (**a**) relative humidity (RH) and cumulative AE hit energy versus time and (**b**) peak amplitude versus AE hit energy caused by the droplet of Milli-Q water and the droplet of the NaCl solution, respectively.

The droplet of the NaCl solution led to significant AE activity of about  $1.187 \times 10^6$  hits over the 10.8 h of the experiment. Interestingly, the droplet of the Milli-Q water also generated a non-negligible number of about  $1.767 \times 10^5$  hits, i.e., a difference of a factor of 6.7. However, the cumulative AE hit energy (cf. Figure 10a) showed a clear difference between the Milli-Q water and the NaCl solution. The difference in the cumulative AE hit energy was a factor of  $3.785 \times 10^8$  eu/( $8.896 \times 10^6$  eu) = 42.5 at the end of the experiment.

This significant difference can be easily explained by considering the scatter plots of the peak amplitude versus the AE hit energy presented in Figure 10b, where the hit energy values and peak amplitudes of the signals due to the Milli-Q water can be seen to be much lower.

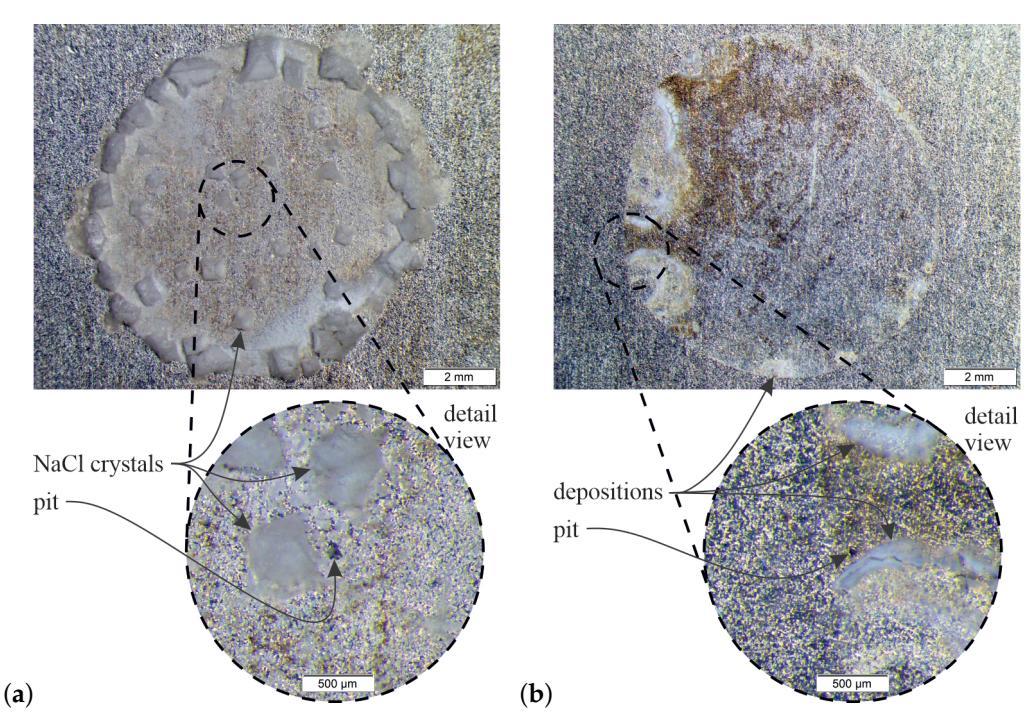
**Figure 11.** Microscopic images of the corroded surface of the specimen in the AE source identification experiment, i.e., after the evaporation of the droplets of (**a**) the NaCl solution and (**b**) the Milli-Q water. The detailed views show the exemplary pits that formed.

For further examination, the areas of the specimens that were initially wetted with the droplets were analyzed using optical microscopy (type Olympus SZX10 with DP26-CU camera). Figure 11a shows the corresponding surface caused by the NaCl solution droplet. The NaCl crystals that remained after the evaporation of the water of the solution can be seen. Moreover, some pits, indicating that corrosion happened, can be identified on the microscopic image, e.g., the detailed view shows a pit of an approximate size of  $115 \,\mu\text{m} \times 135 \,\mu\text{m}$ . Figure 11b shows the corresponding surface caused by the droplet of the Milli-Q water. The microscopic image indicates that due to the Milli-Q water, corrosion took place. This was concluded due to (i) the seemingly small pits that were observed (see the detailed view in Figure 11b with a pit of an approximate size of  $50 \,\mu\text{m} \times 60 \,\mu\text{m}$ ), (ii) some distinct discolorations that were observed over a wide area, possibly due to a uniform type of corrosion, and (iii) the white depositions that were observed on the specimen, which was most likely aluminum hydroxide Al(OH)<sub>3</sub> that formed during corrosion (cf. Figure 1 and Equation (1)). Metallographic or scanning electron microscopy (SEM) images could provide further insights into the corrosion (type and extent) that occurred. However, as this was not the primary aim of this study, no such analyses were conducted.

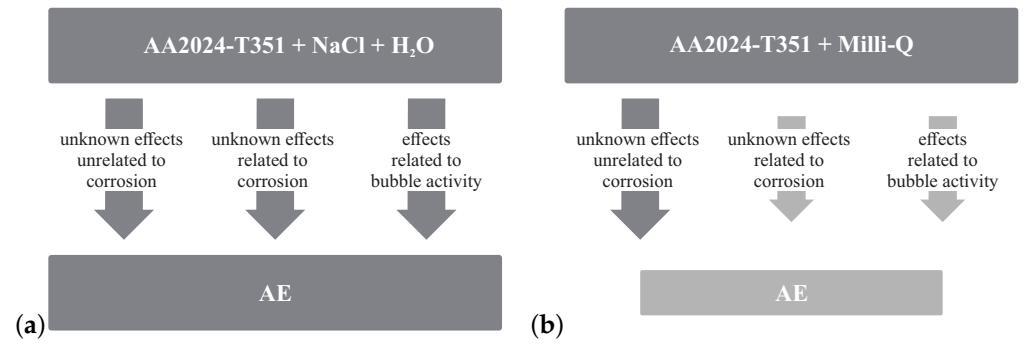
**Figure 12.** Classes of effects triggering AE activity on AA2024-T351: (a) corrosion and AE activity due to the NaCl solution and unknown contributions of different effects, (b) reduced corrosion and AE activity due to Milli-Q water, and consequently, reduced contributions of corrosion-related effects.

To systematically determine the source of the measured AE signals, all possible effects that may have provoked AE activity during the experiments are discussed. Figure 12a presents the classification of these effects. It is shown that atmospheric corrosion can be triggered on AA2024-T351 by a small droplet of a corrosive NaCl solution, as the visual observation clearly identified pits after some time. Hydrogen that formed during corrosion led to bubble activity, which was also seen in the videos, and the AE monitoring measured significant increases in the cumulative AE energy. All three observed phenomena, i.e., corrosion, bubbles, and increase in AE energy, were associated with the RH (cf. Figures 5 and 8a), strongly suggesting that bubble activity (origination, detachment, movement, arrival at droplet surface, growth, bursting) was the main source of the measured AE signals, which has been repeatedly claimed in the literature for different kinds of corrosion tests [26–28]. However, it cannot be excluded that there were other unknown effects that generated measurable AE signals. These other effects may or may not have been related to corrosion (cf. Figure 12). Since we attempted to answer the question of whether atmospheric corrosion can be clearly detected by AE, sources not related to corrosion should ideally be excluded or known, considering that Figures 8 and 10 show that the detected AE signals were dominated by corrosion-related effects. These results show that a sufficient amount of electrolyte (NaCl solution) results in corrosion and a large number of AE signals with comparatively high energies and peak amplitudes. In contrast, the different conditions with just a very small amount of electrolyte or Milli-Q water on the surface resulted in no or very little corrosion (cf. Figures 6 and 11) and at the same time, generated only a small number of AE signals with significantly lower energies and peak amplitudes.

However, the dominance of corrosion-related effects in the AE signals can be supported by considering Figure 12b. Figure 12b presents the classification of all possible effects that may have provoked AE activity during the experiments, but reduces the representation of the AE activity and its triggering effects, which are suppressed by the use of Milli-Q water instead of NaCl solution. The Milli-Q water generated corrosion and also measurable AE signals. However, as observed above, the corrosion caused by the Milli-Q water was found to be significantly less, which meant less formation of H<sub>2</sub> (cf. Equation (1)), i.e., less bubble activity and also fewer other effects that triggered AE activity related to corrosion. Thus, it can be concluded that the measured AE signals were strongly dominated by corrosion-related effects. However, non-corrosion-related effects that contributed to the measured AE activity cannot be fully excluded but were shown to be of minor importance.
