## **Supporting Information**

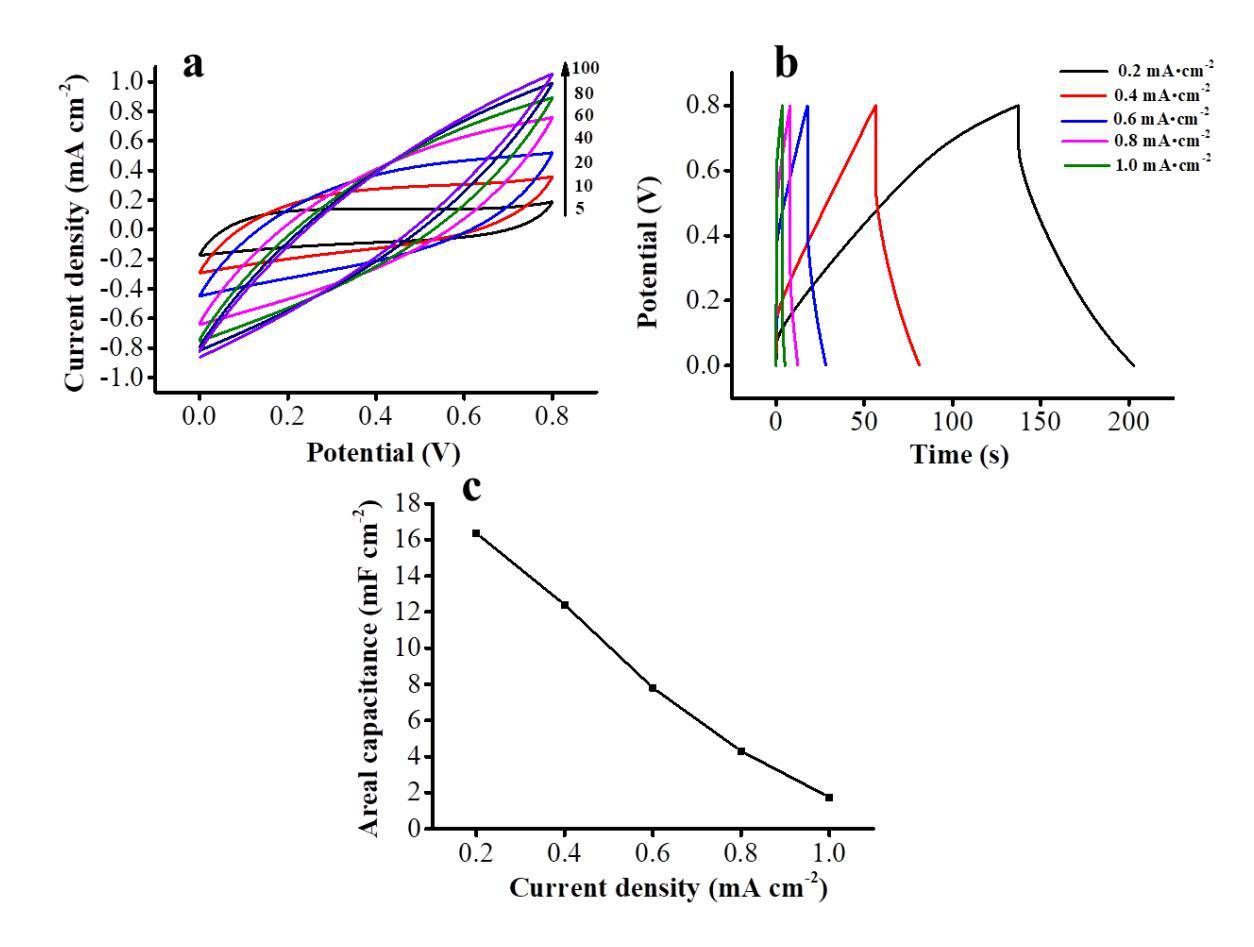
**Figure S1.** (a) CV curves of the composite with 20% PCL contents collected at different scan rates; (b) galvanostatic charge/discharge curves of MCP20S80 electrode film; (c) areal capacitances of MCP20S80 electrode film at different current density.

Figure S1(a) displays the CV curves of the MCP20S80 supercapacitors recorded with different sweep rates. The galvanostatic charge-discharge curves of the MCP20S80 supercapacitors at various current densities (0.2-1 mA cm<sup>-2</sup>) are shown in Figure S1(b). Based on the galvanostatic charge-discharge curves, the areal capacitances (Figure S1(c)) of the supercapacitors were calculated and plotted as a function of current densities.

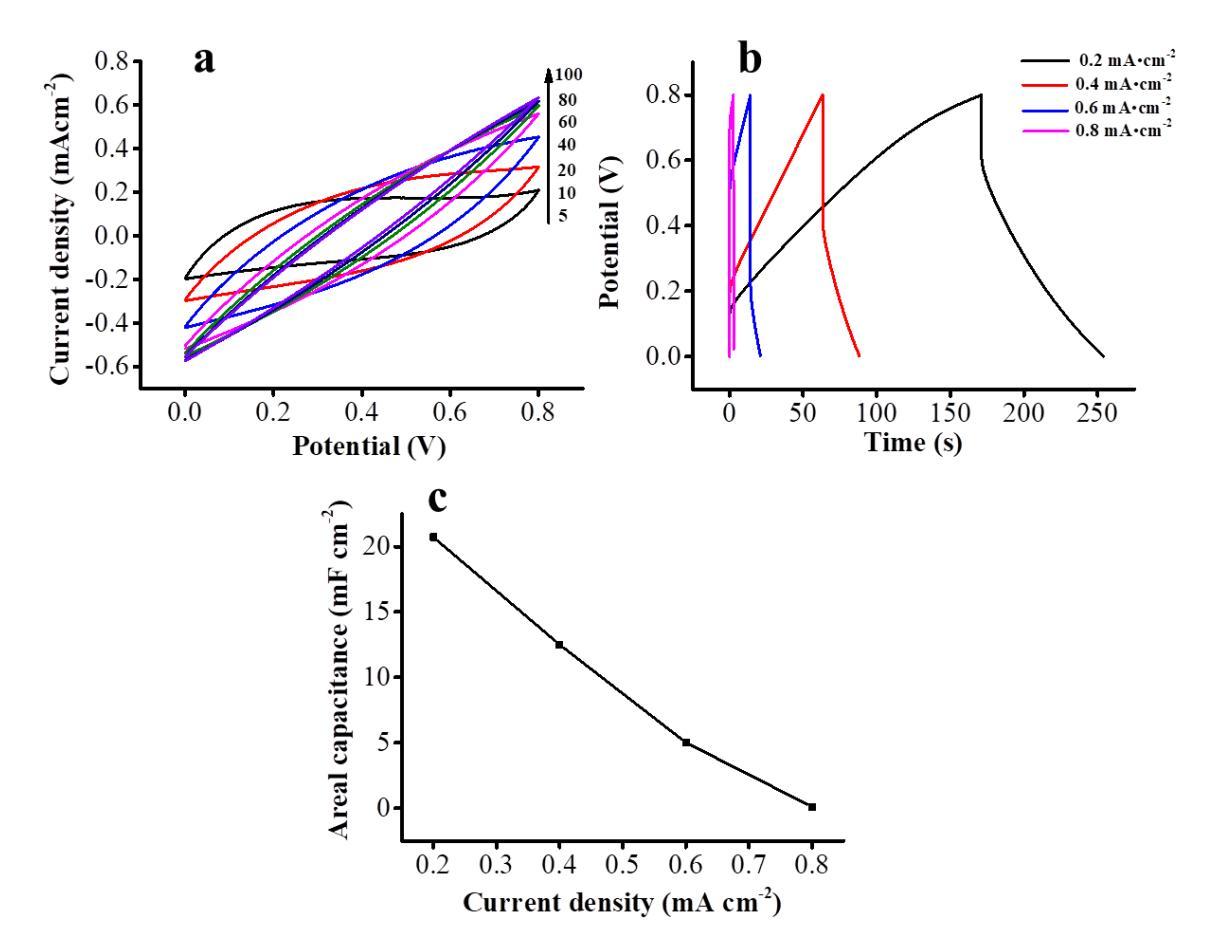
**Figure S2.** (a) CV curves of the composite with 60% PCL contents collected at different scan rates; (b) galvanostatic charge/discharge curves of MCP60S40 electrode film; (c) areal capacitances of MCP60S40 electrode film at different current density.

Figure S2(a) displays the CV curves of the MCP60S40 supercapacitors recorded with different sweep rates. The galvanostatic charge-discharge curves of the MCP60S40 supercapacitors at various current densities (0.2-1 mA cm<sup>-2</sup>) are shown in Figure S2(b). Based on the galvanostatic charge-discharge curves, the areal capacitances (Figure S2(c)) of the supercapacitors were calculated and plotted as a function of current densities.

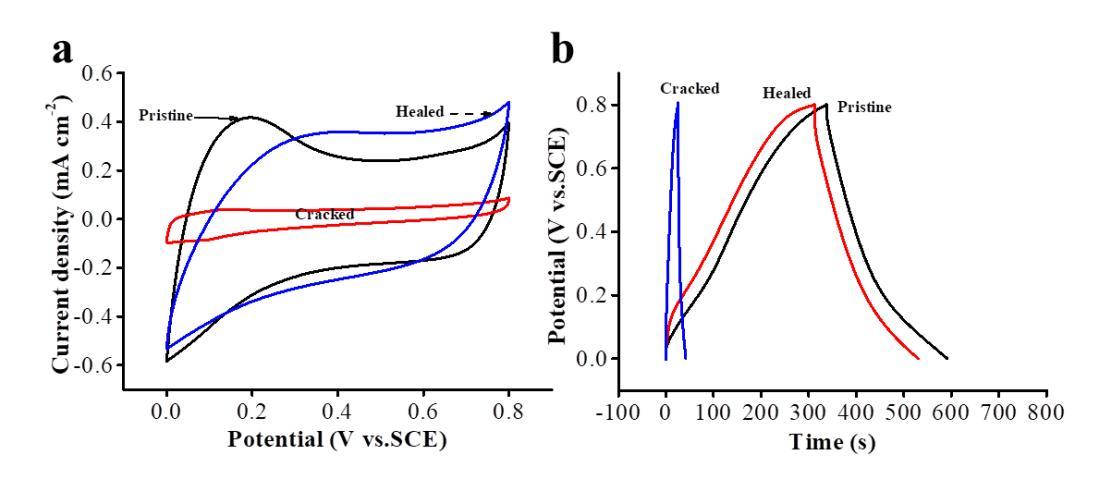
**Figure S3.** (a) CV curves of the MCP20S80 at different states collected at 5 mV s<sup>-1</sup>; (b) galvanostatic charge/discharge curves of MCP20S80 electrode film at different states collected at  $0.2 \text{ mA cm}^{-2}$ .

In order to disclose the thermal-triggered self-healing of the capacitors, CV measurements were performed. Figure S3(a) shows the CV measurements of the MCP20S80 in three states were obtained at a scan rate of 5 mV s<sup>-1</sup>. The galvanostatic charge-discharge measurements were executed at a current density of 0.2 mA cm<sup>-2</sup>, which are shown in Figure S3(b).

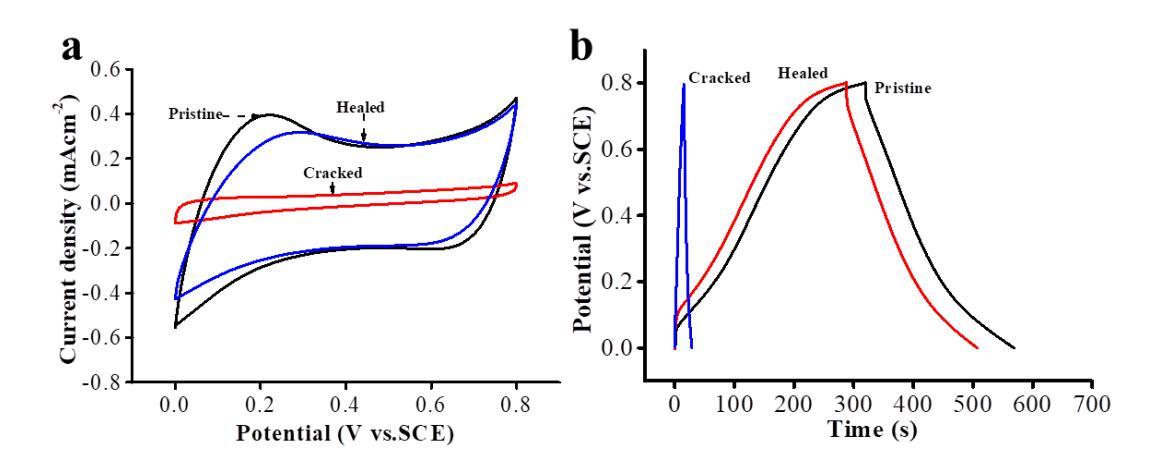
**Figure S4.** (a) CV curves of the MCP60S40 at different states collected at 5 mV s<sup>-1</sup>; (b) galvanostatic charge/discharge curves of MCP60S40 electrode film at different states collected at  $0.2 \text{ mA cm}^{-2}$ .

In order to disclose the thermal-triggered self-healing of the capacitors, CV measurements were performed. Figure S4(a) shows the CV measurements of the MCP60S40 in three states were obtained at a scan rate of 5 mV s<sup>-1</sup>. The galvanostatic charge-discharge measurements were executed at a current density of 0.2 mA cm<sup>-2</sup>, which are shown in Figure S4(b).
