Article Sensitization to Corrosion of Austenitic Stainless Steels: Watch Straps Intended to Come into Direct and Prolonged Contact with Skin

Abstract: Nine grades of steel from different European steelmakers, namely 304L, 316L, and 904L, were evaluated. The austenitic steels studied are used in the manufacture of watch straps. The evaluations have been carried out in accordance with the ASTM standards which specifically concern the forms of corrosion, pitting (G48-11, FeCl₃), intergranular (A262-15, Strauss method) test and Tuccillo-Nielsen test. The polarization electrochemical test on link watch straps was implemented by the microelectrode technique. Stress corrosion has also been investigated in the assembly of laser welded pin and link. It should be noted that, despite the fact that the grade of steel is in conformity with the classification standards, we note that the corrosion behavior is very different from one steelmaker to another. There are parameters that can change the quality of steel such as the technology process, casting volume, deoxidizers' addition, remelted steel process and traces of pollutants. In consequence, we observe an extensive dispersion of results conc

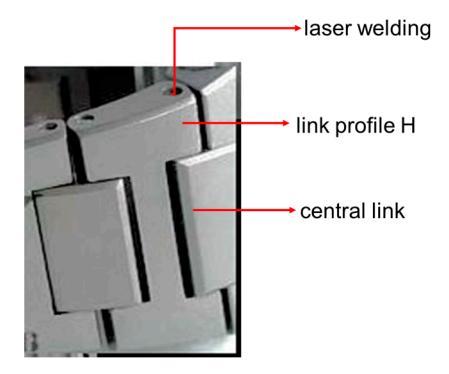
A watch strap is an assembly of several metallic components. For a better understanding, in Figure 1 we present a strand of a bracelet. It consists of a main link called the H profile, which is connected to two central links with the two pins driven into the holes of the links. In the assembly of the bracelets, the central link pin is welded by the plasma laser spot welding process.

Figure 1. Strands of a watch strap.

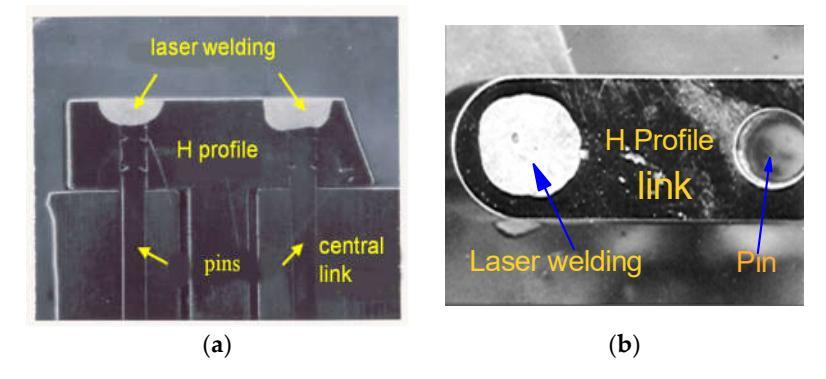
A light and rapid metallographic attack, carried out in the same way for all the samples, enabled us to highlight the welding cord, in order to determine the correct position of the microelectrode (Figure 2a,b).

Figure 2. (a) Longitudinal link/pin assemblies; (b) transverse link/pin assemblies.

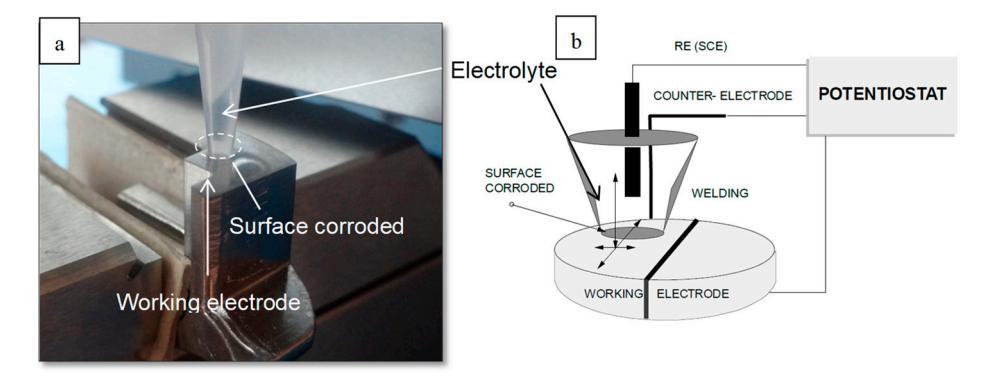
Corrosion assessment of welded link/pin assemblies were studied via the microelectrode technique. The schematic representation of the microelectrode technique is illustrated in Figure 3.

Figure 3. (a) Microelectrode; (b) the schematic representation of the microelectrode measurement system (RE: reference electrode).

The system consists of a circular test surface with a diameter of 200 μ m and, like the conventional cell, includes a working electrode (the surface of the sample to be tested), a counter electrode (platinum wire) and an SCE reference electrode. The electrolyte, with a volume of approximately 2 mL, is an artificial sweat according to standard EN 1811 (pH 4.5), not buffered with NaOH (1 g/L of urea, 5 g/L of NaCl and 940 μ m/L of racemic lactic acid). The measurement system is controlled by an Eg&G PARSTAT 4000 potentiostat–galvanostat (Princeton Applied Research, Oak Ridge, TN, USA), equipped with LC Low Current Interface, in a current scale with an auto-current ranging capability from 200 Ma–4 pA limit (80 fA minimum range). The measuring system is protected by a Faraday cage, surrounded by a Helmholtz cage (Figure 4).

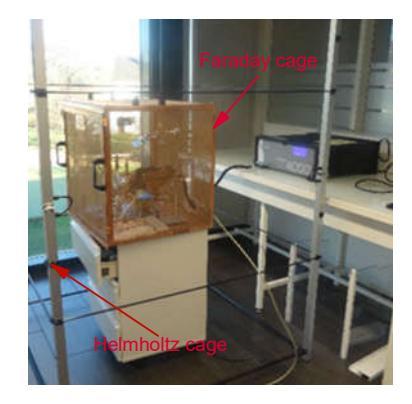
Figure 4. The microelectrode protected by the Faraday and Helmholtz cages.

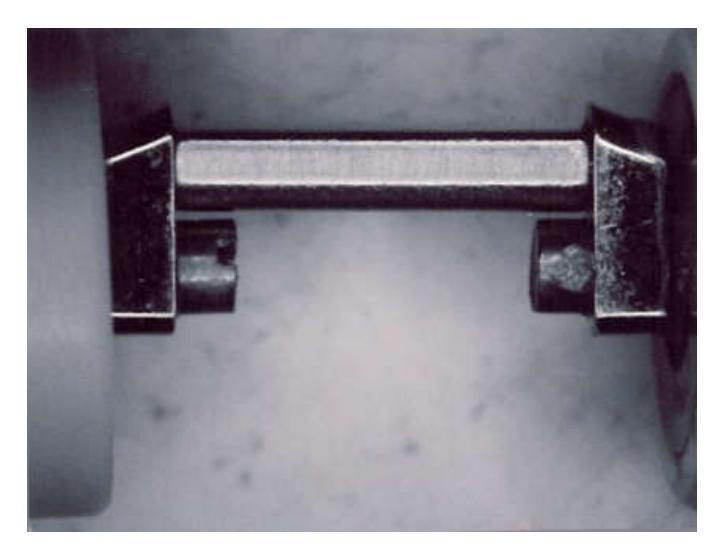
Figure 5. Sample fixed in the stress corrosion holders.

In order to evaluate the stress corrosion, two types of assemblies were considered: link (steel #4, 316L Ugima)/laser welded pin and link (steel #7, 316L SW)/driven knurled pin. The samples were fixed in sample holders, made of polytetrafluoroethylene (PTFE) rods, with the help of screwed metal elements (Figure 5). The metallic parts which are not subjected to the electrochemical test were protected by a silicone varnish, with an electrical insulation resistance (DEF STAN 59/47 Pt4) of 1015 Ohms. The test is thus specific to pins, chasing holes, welding channels and central link holes/pins (Figure 6).

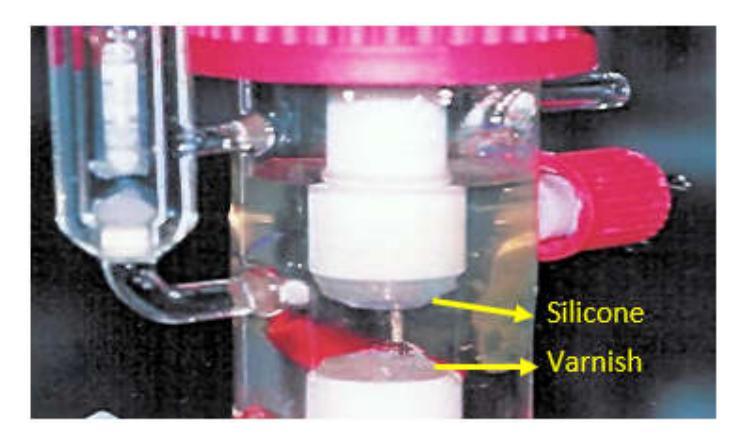
Figure 6. The electrochemical stress corrosion cell.

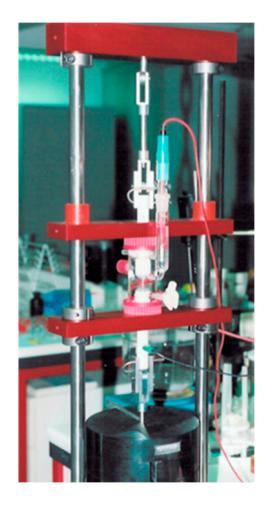
Figure 7. The electrochemical stress corrosion cell and the hanging weight system.

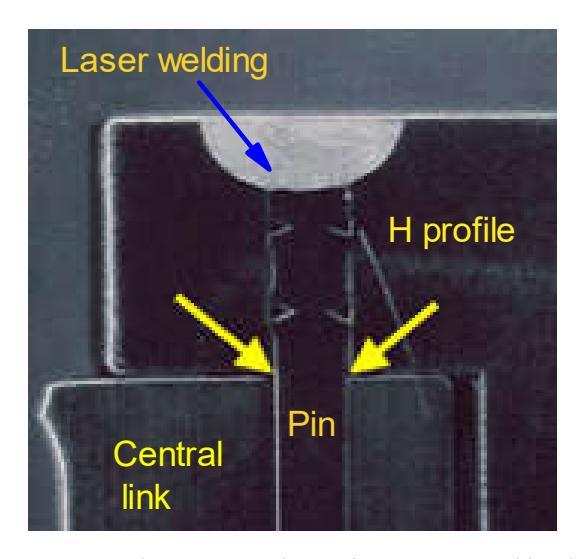
As a crevice corrosion process is involved, an adapted version of ASTM F 746-87 [37], test was used (Figure 8).

Figure 8. The arrows indicate the area targeted by the electrochemical stress corrosion test. Optical examination, magnification $10 \times$.

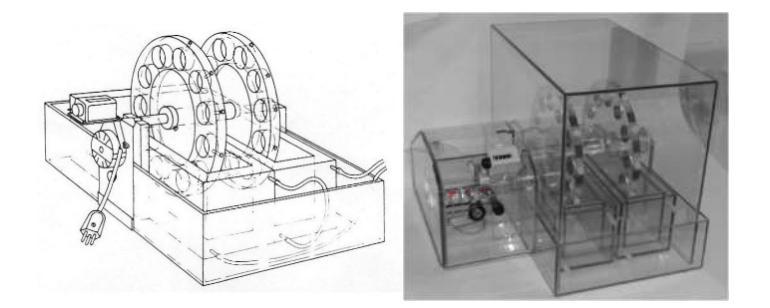
The Tuccillo–Nielsen test [38], frequently used for corrosion assessment of dental alloys, evaluates the degradation behavior of materials at the material–electrolyte interface, by a cyclic immersion system. The equipment consists of two carrying wheels, holding the samples, which are in a continuous rotation, at a speed of 1 rpm, so the samples alternately pass from the liquid medium to the gaseous medium. The equipment tanks are connected to a thermostat with external recirculation, so as to maintain a constant temperature of a maximum of 40 $^{\circ}$ C, during testing (Figure 9).

Figure 9. The Tuccillo–Nielsen system.

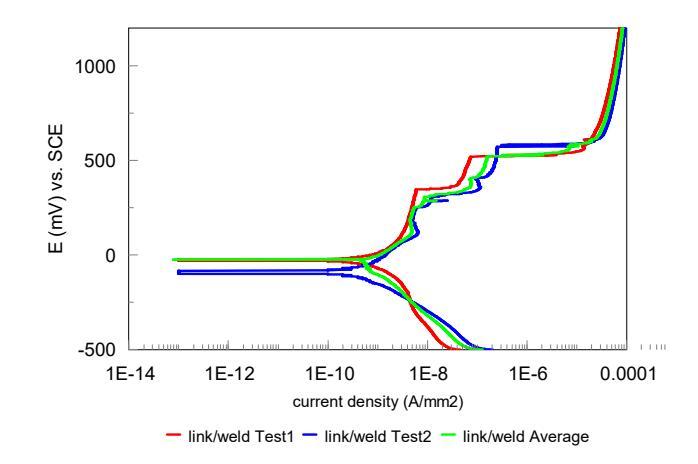
The polarization curves were drawn in a systematic way in the link, pin, laser weld areas and laser weld/link, laser weld/pin interfaces for the longitudinal surface (Figure 2a) and link, laser weld and laser weld/link interface for the transverse surface (Figure 2b). For a more precise representation of the corrosion behavior of the areas studied and for the reproducibility of the measurement technique, a large number of measurements were carried out. Therefore, the observations and comments were based on average values of current densities from the potentiodynamic scanning curves. In Figure 10, the scanning curves for the interface link/weld area of the transverse surface and the scanning curve of the average current values which were used for the interpretations are presented. The link is in 1.4441 grade steel, code #8. We measured two samples. The average value of the polarization curve obtained from two measurements is represented in green (Figure 10).

Figure 10. The potentiodynamic polarization curves measured for the interface link/weld area of the transverse surface and the average curve obtained from the experimental curves. Sample #8.

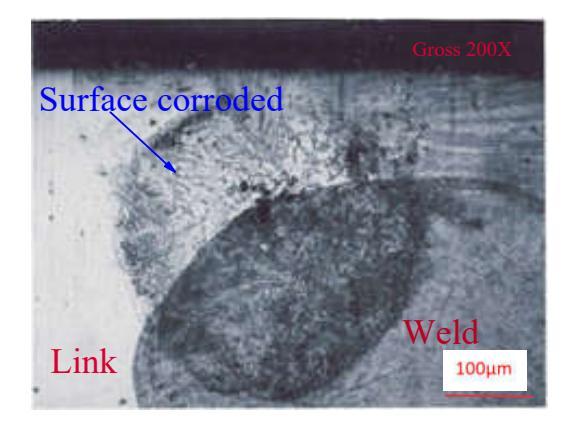
In Figure 11, we can see the positioning of the microelectrode in the welding/link interface on the transversal surface.

Figure 11. Electrochemical measurement at the laser welding/link H profile interface of the transversal surface (scale = 100 microns). Sample #8.

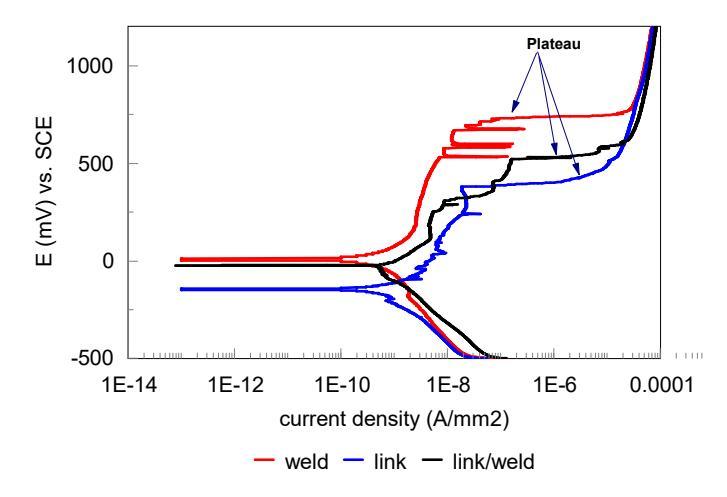
In Figure 12, two samples are shown, with the grade 1.4435, code #3. The average potentiodynamic scanning curves measured for the link H profile, weld and weld/link H profile interface areas are presented in Figure 12. It is noted that the weld area reveals a more noble behavior than the interface and the link. The electrochemical behavior of the interface was between that of the weld and that of the link, being closer to the electrochemical behavior of the weld. All the curves presented a plateau, specific to the localized pitting or crevice corrosion, in the current range of 10^{-8} to 10^{-5} A/mm². On the other hand, the plateau height is different, 750 mV SCE for the weld, 500 mV SCE for the welding/link interface and 400 mV SCE for the link. This means that the weld displayed a good corrosion behavior and that the pitting process reaches a potential of around 750 mV. In general, dissimilar elements in galvanic couplings, in an artificial sweat medium and in contact with the skin, generate potential differences of around 400 mV.

Figure 12. The average potentiodynamic polarization curves for the weld, link and link/weld interface areas. Sample #3.

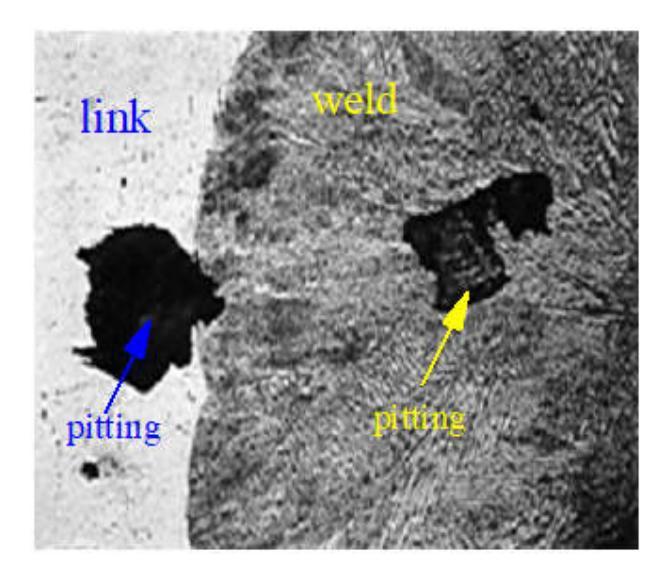
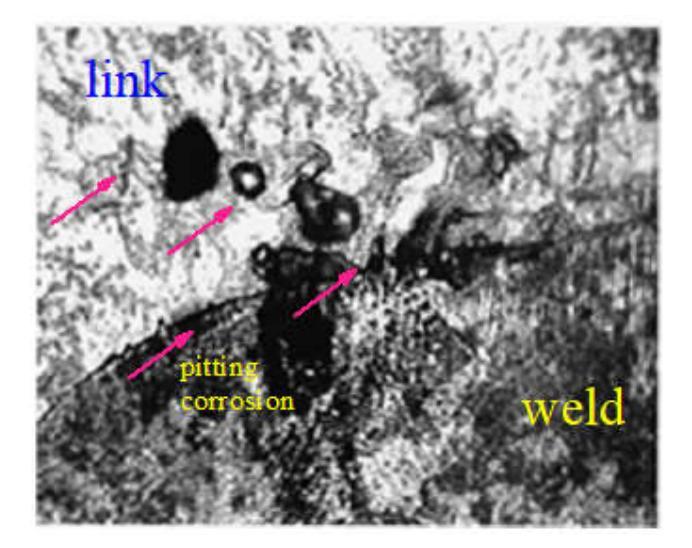
The optical examination of the tested areas is presented in Figures 13 and 14. When the microelectrode was placed at the weld/link interface, the corrosion process preferentially started at the interface (Figures 13 and 14).

Figure 13. Pitting corrosion of the link/weld interface of the transversal surface in Test 1. Optical examination, magnification $40 \times$, Sample #3.

Figure 14. Pitting corrosion of the link/weld interface of the transversal surface in Test 2. Optical examination, magnification $40 \times$. Sample #3.

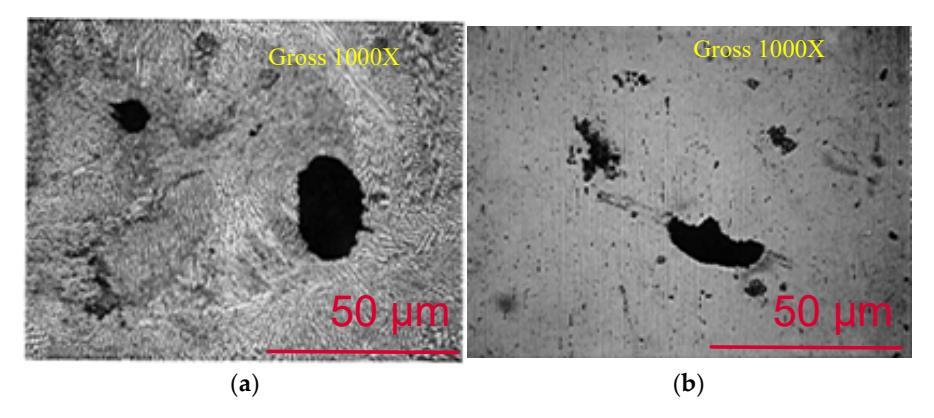
It should also be mentioned that the scanning electron microscope (SEM) examination and the intergranular corrosion tests did not reveal any microcracks in the laser welded and link H profile areas tested. On the other hand, pitting corrosion is evaluated in Figure 15a,b.

Figure 15. (a) Transversal surface of the weld. Corrosion pitting within the weld. Scale = $50 \mu m$, Sample #3. (b) Transversal surface of the link H profile. Corrosion pitting within the link. Scale = $50 \mu m$, Sample #3.

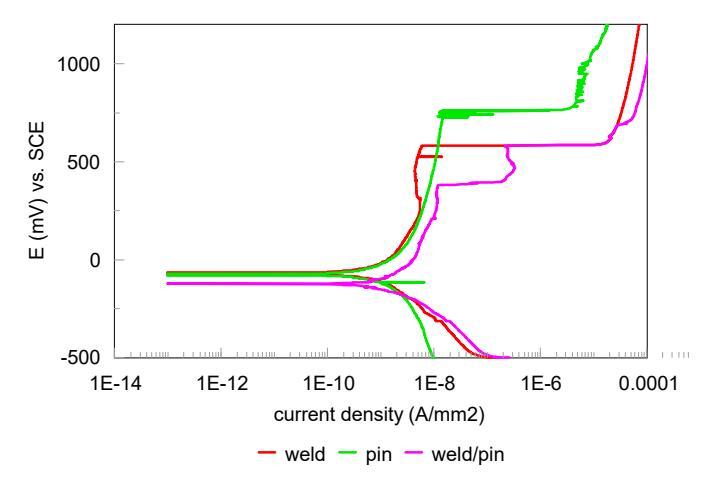
The average potentiodynamic scanning curves for the longitudinal surface are represented in Figure 16 (the pin/interface/weld assembly) and Figure 17 (the link/interface/weld assembly), Sample #3.

Figure 16. Average potentiodynamic polarization curves of the longitudinal surface weld, pin and the weld/pin interface. Sample #3.

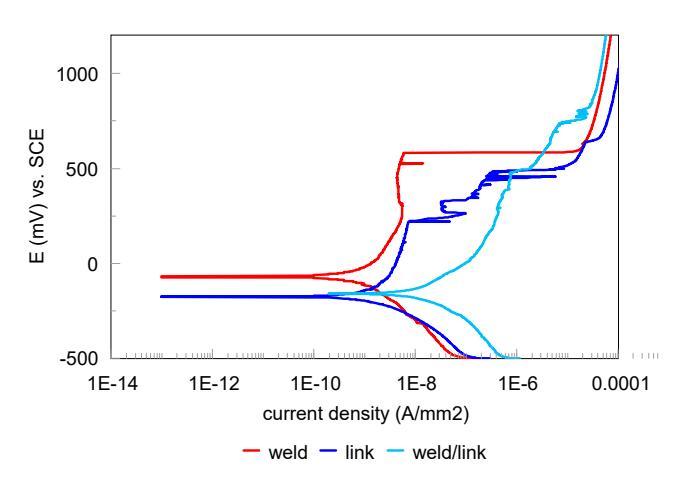
Figure 17. Average potentiodynamic polarization curves of the longitudinal surface (weld, link and weld/link interface). Sample #3.

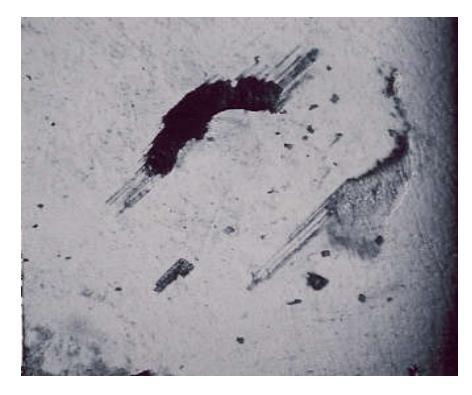
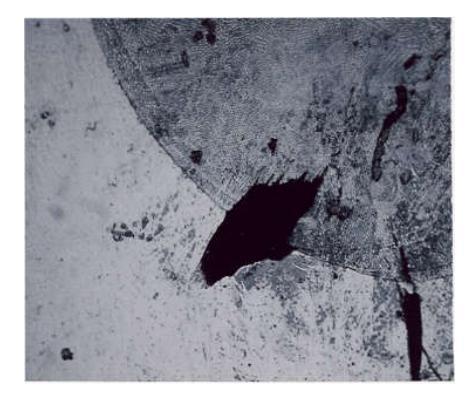
Analysis of the scanning curves of the pin/weld system has also revealed current plateaus at different heights of potential, however, this time the pin is more noble than the weld. Contrariwise, in the case of the link/weld system, the link exhibited poor behavior. The link/weld interface also displayed poor behavior. Pitting and crevice corrosion were generated in the microelectrode positioning zones. Evidence for poor behavior can also be noticed by looking at the SEM images in Figures 18 and 19.

Figure 18. Microelectrode positioned on the link, longitudinal surface. Optical examination, magnification $20 \times$, Sample #6.

Figure 19. Microelectrode positioned at the link/pin interface. Optical examination, magnification $20 \times$, Sample #6.

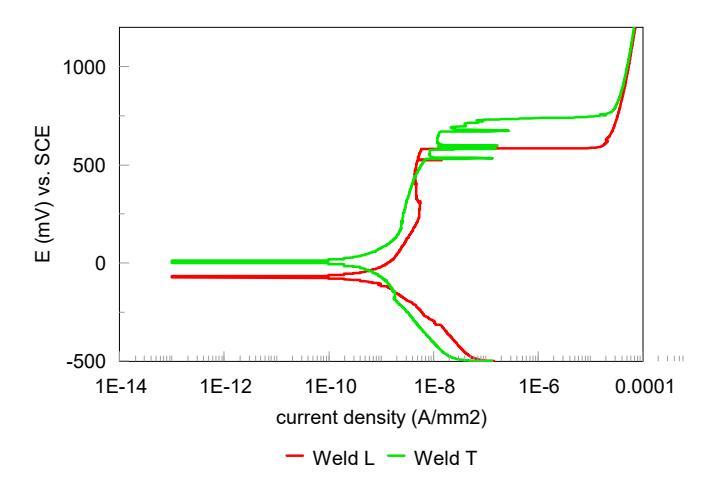
When comparing the potentiodynamic scanning curves of the weld, in transverse and longitudinal directions (Figure 20), no significant difference of corrosion behavior was noticed.

Figure 20. Comparative presentation of the average scanning curves of the weld in the longitudinal (L) and transverse (T) directions of the assembly. Sample #8.

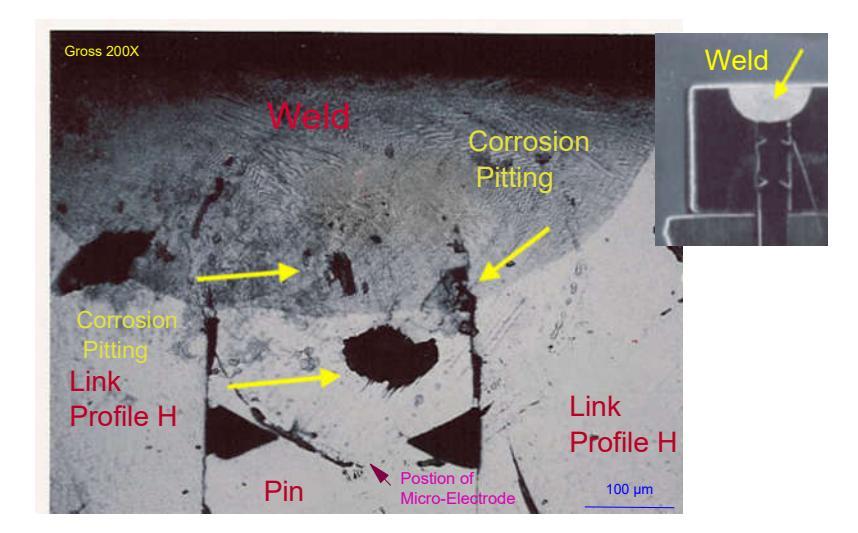
Figure 21. Microelectode positioned in weld/link/pin area, longitudinal surface. Optical examination, magnification 40×, Sample #4.

The steels #8 DIN 1.4441 (316L Med) and #9 DIN 1.4539 (904L) present a very good resistance to the morphologies of pitting and crevice corrosion, as outlined in Figure 21. They are strongly alloyed into oxidizing metals and form a strong passive layer. Additionally, they are the product of a vacuum process of primary melting and remelting, which contributes a high level of inclusion cleanliness and reduces the risk of pitting.

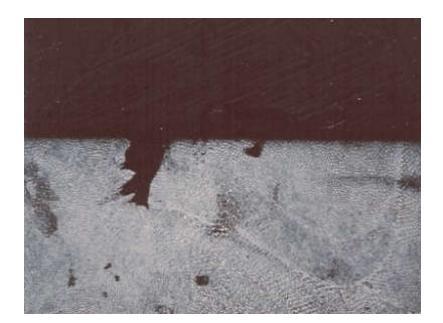
Figure 22. Microelectrode positioned in the weld area, longitudinal surface. Sample #4.

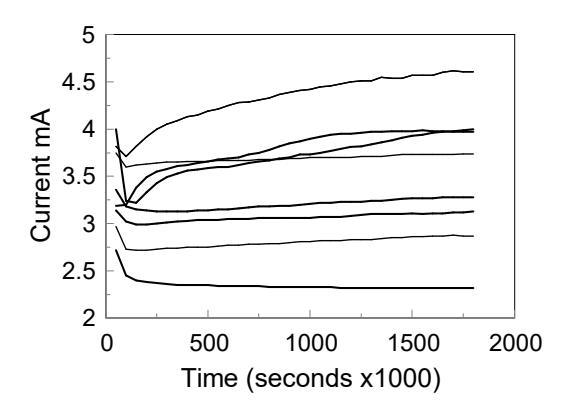
Figures 24 and 25 show the potentiostatic curves for the measurements before the fracture of the pin. The comparison of the curves has shown that the currents recorded for the last cycles are significantly higher in the link/driven pin assembly than in the link/welded pin assembly.

Figure 24. Potentiostatic polarization curves before the fracture of the pin, in the case of the link/welded pin assembly. Sample #4.

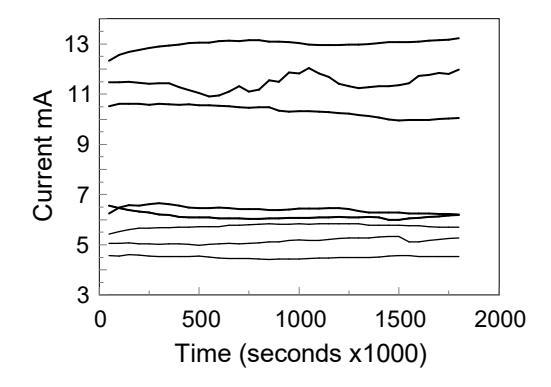
Figure 25. Potentiostatic polarization curves before the fracture of the pin, in the case of the link/driven pin assembly. Sample #7.

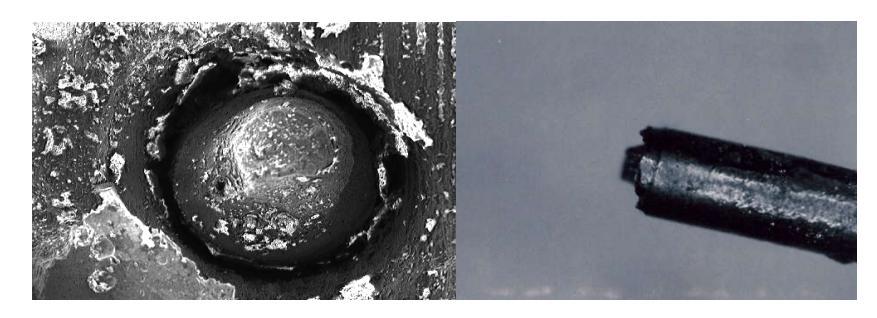
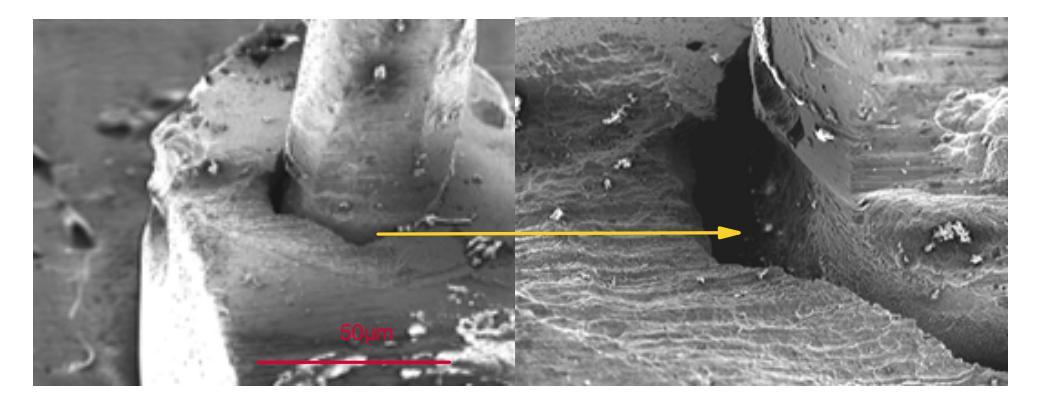
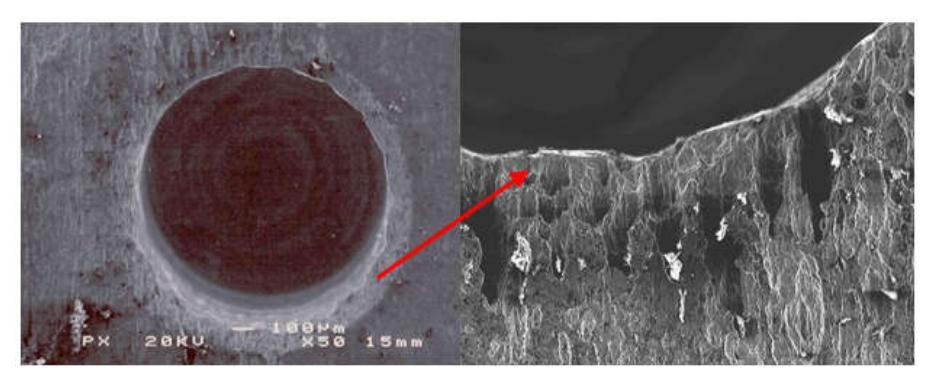
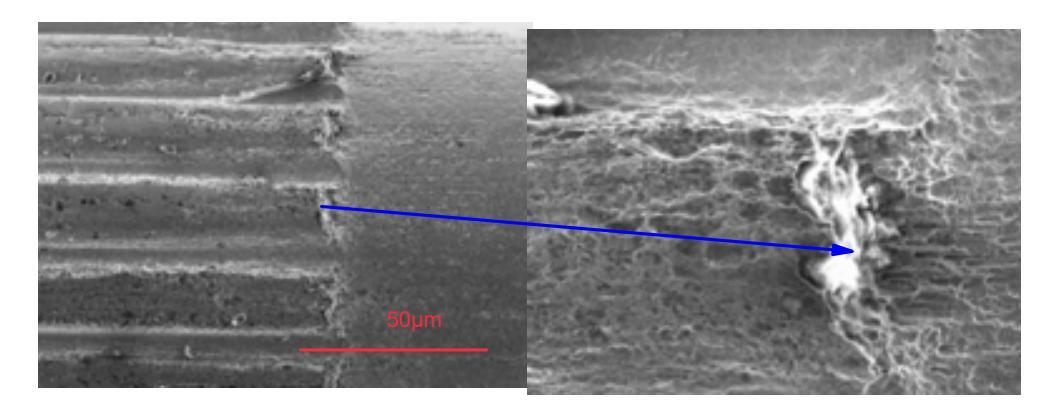
The fracture occurred after 45 cycles, in the case of the driven assembly, and after 154 cycles, in the case of the laser welded assembly (a ratio of 3.4 times) (Figures 26–29).

Figure 26. Fracture of the laser welded pin after 154 cycles. Optical examination, magnification $10 \times$, Sample #6.

Figure 27. Unbroken part of the laser welded pin assembly. Crevice corrosion. Scale = 50 μ m. Sample #4.

Figure 28. Corrosion around the flushing/hunting hole after 45 cycles (fracture). Scale = $100 \mu m$. Sample #7.

Figure 29. Corrosion in the grooves of the knurled pin after 45 cycles. Scale = $100 \ \mu m$. Sample #7.

The fracture mechanism of the pin/link assembly can be very different, depending on whether the pin is driven out or laser welded. In the case of laser welded pins, the penetration of the electrolyte into the empty spaces between the link hole and the pin triggers a localized crevice corrosion process which leads to a decrease in the pin diameter, due to degradation. However, it will take an extended amount time for the entire pin to degrade.

On the other hand, in the case of driven pins, the penetration of the electrolyte at the link/pin interface triggers a crevice corrosion process which results in the widening of the link hole and the degradation of the pin surface. Thus, it takes very little to loosen the assembly and to degrade it, as seen in Figures 27–29.

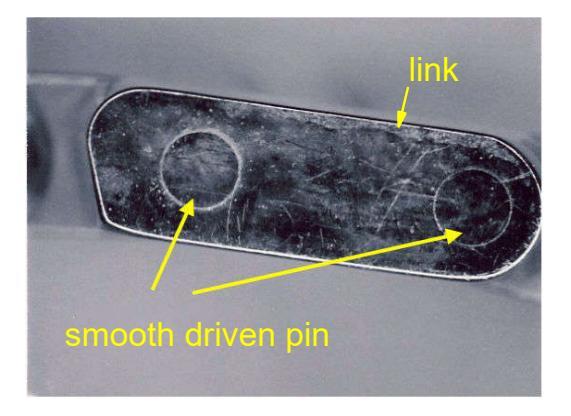
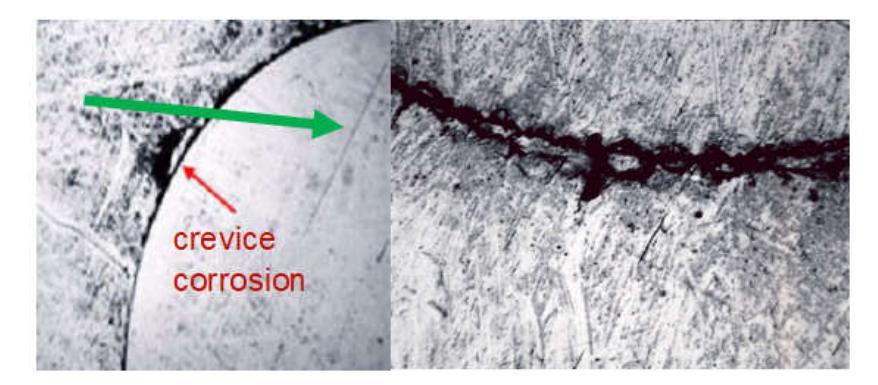
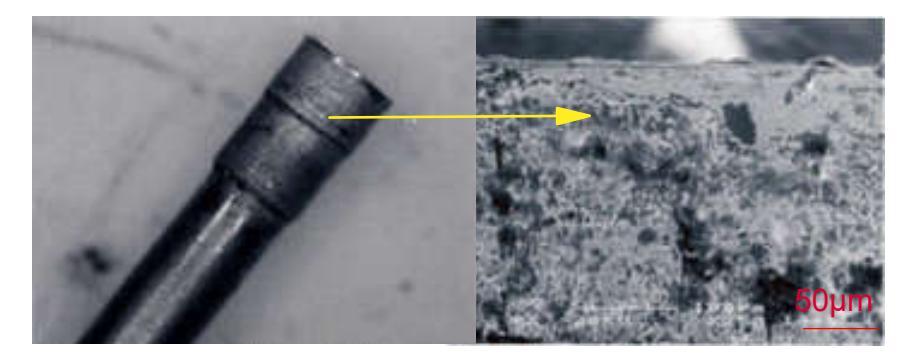
Figures 30 and 31 highlight crevice corrosion aspects at the smooth driven pin/link interface (H profile). It cannot be excluded that a galvanic cell feeds the crevice corrosion. Particularly, in Figure 31, it can be noticed that the pin is intact while the link part of the pin/link interface is dissolving. On the surface and between the links, there are no specific signs of corrosion. The smooth driven pin exhibits corrosion signs after disassembly (Figure 32).

Figure 30. Corrosion aspect at the link/smooth driven pin interface. Optical examination, magnification $10 \times$. Optical examination, magnification $5 \times$. Link sample #7 and pin sample #3.

Figure 31. Crevice corrosion at the link/driven pin interface. Optical examination, magnification 20×. Link sample #7 and pin sample #3.

Figure 32. Pin removed after the Tuccillo–Nielsen test. Scale = 50 μ m. Link sample #7 and pin sample #3.

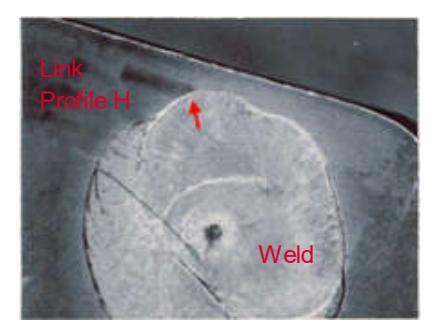
This corrosion in Figure 33 is much less obvious than in the case of the link/pin interfaces (Figures 31 and 32).

Figure 33. Corrosion at the laser weld/link interface. Optical examination, magnification 5×. Link sample #4 and pin sample #3.

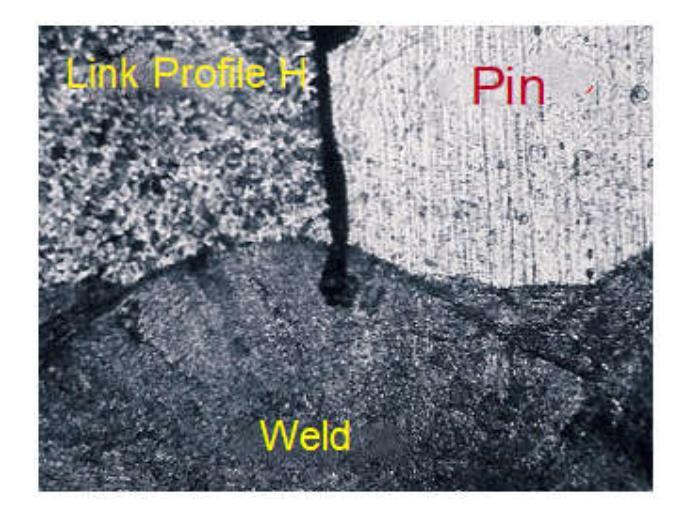
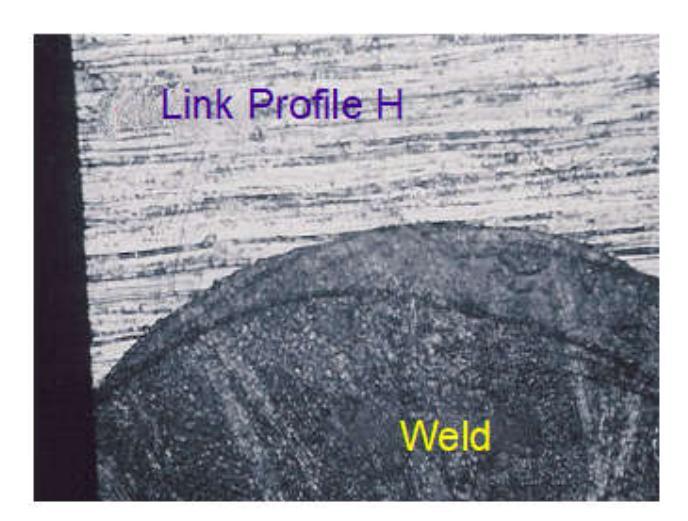
The Strauss test according to ASTM 262-15 [39] did not reveal intergranular corrosion, especially in proximity to the laser welds (Figures 34 and 35). No cracks were observed in the weld and laser welding did not cause local sensitization to intergranular corrosion.

Figure 34. Weld/link and weld/pin interfaces after the Strauss test. Longitudinal surface. Optical examination, magnification 40×. Link sample #4 and pin sample #3.

Figure 35. Weld/link and weld/pin interfaces after the Strauss test. Transversal surface. Optical examination, magnification $40 \times$. Link sample #4 and pin sample #3.

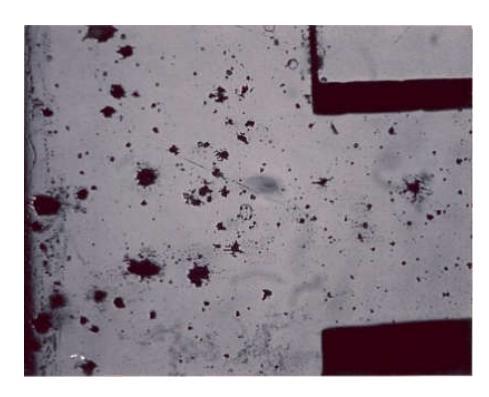
After the ferric chloride test, the links (H profile) displayed numerous pits on the longitudinal surface (Figure 36). The pins, on the other hand, showed no signs of pitting corrosion (Figure 37). The pin/link interstices exhibited signs of crevice corrosion (Figure 37a,b) and the weld (Figures 35 and 36) developed corrosion on the longitudinal surface. The part of the weld exhibited in Figure 36 is not in direct contact with the environment during wear. On the transverse surface, the at the weld/link interface, germination of a pitting corrosion process was observed (Figure 38a,b). These observations are explained by the orientation of the alloy's texture. As the H profile presents, in the case of the link, in regard to the texture, the inversion of the transverse and longitudinal surfaces occurs. This, however, is not the case of the pin.

Figure 36. Pitting corrosion in the longitudinal surface of the link (H profile). Optical examination, magnification 5×. Sample #5.

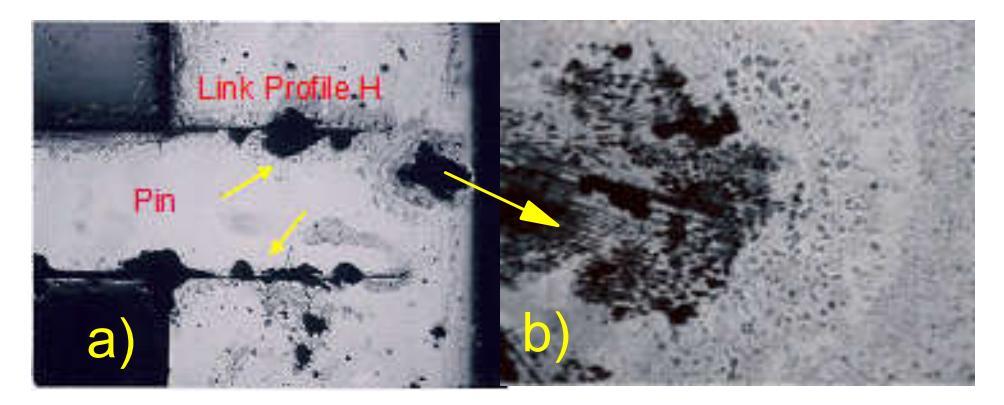
Figure 37. (a). Link, pin and weld after the FeCl₃ test. Longitudinal surface. Optical examination, magnification $10 \times$. Link sample #5 and pin sample #3.; (b) Corrosion around the weld/link interface after the FeCl₃ test. Transverse surface. Optical examination, magnification $20 \times$. Link sample #5 and pin sample #3.

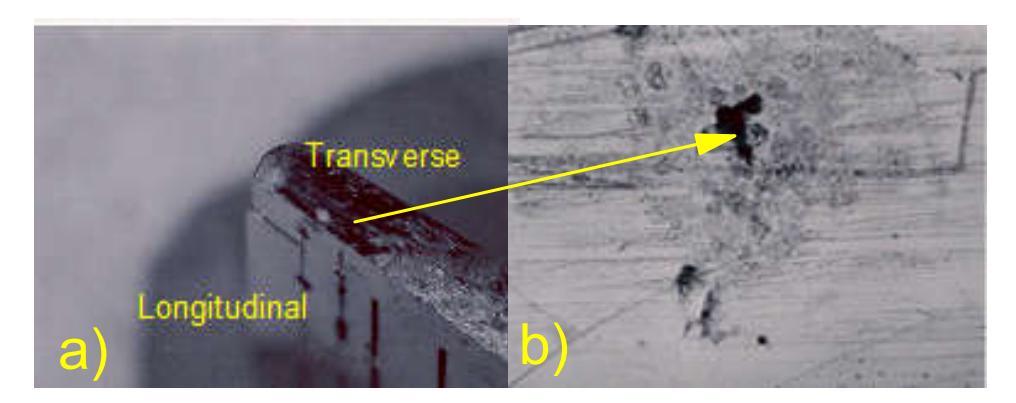
Figure 38. (a). Corrosion in the area of the weld/link interface after the FeCl₃ test. Transverse surface. Optical examination, magnification $10 \times$. Sample #5.; (b) Corrosion in the area of the weld/link interface. Transverse face. Optical examination, magnification $20 \times$. Sample #5.
