Influence of the Distribution of a Spray Paint on the Efficacy of Anti-Graffiti Coatings on a Highly Porous Natural Stone Material

Maurizio Masieri and Mariateresa Lettieri *

Institute of Archaeological Heritage-Monuments and Sites, CNR–IBAM, Prov.le Lecce-Monteroni, Lecce 73100, Italy; maurizio.masieri@cnr.it

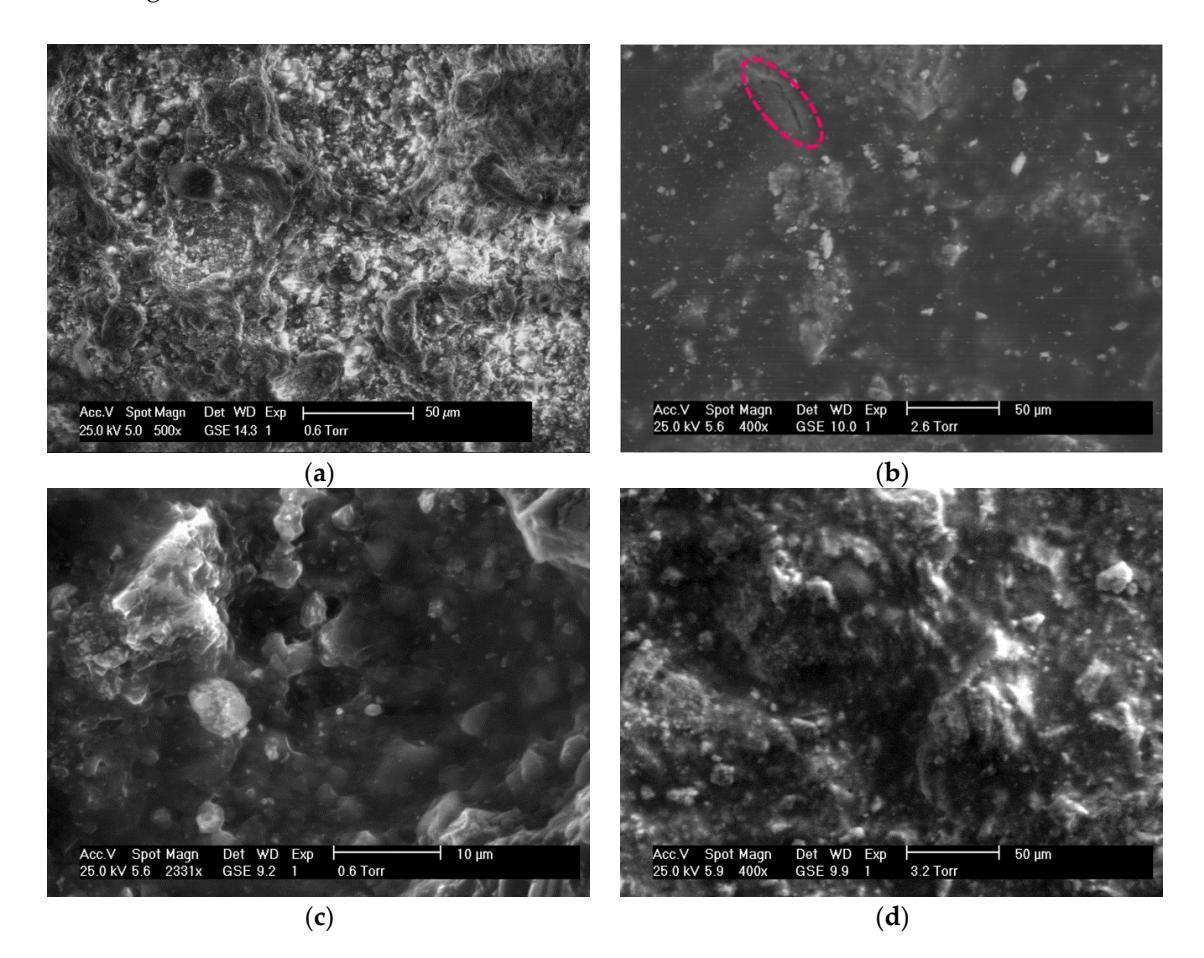
Figure 1. Environmental scanning electron microscopy (ESEM) images: (**a**) untreated stone surface; (**b**) stone surface treated with AG1 (crack in the coating is highlighted); (**c**) stone surface treated with AG2a; (**d**) stone surface treated with AG2(a + b).

The morphological appearance of the surfaces by ESEM observation is shown in Figure 1.

The AG1 coating produced a thick film and the morphological features of the stone were completely hidden. It is of note that some small cracks (highlighted in Figure 1b) were observed in the coating. This result was unexpected, since cracks are seldom seen in wax-based coatings. However, some studies described defects in the films where waxes as water emulsions were applied [3,46,47]. The AG2a product yielded a very thin coating; in fact, high magnifications were necessary to perceive this layer. The application of AG2b gave, as a whole, a thicker coating, even if the morphological features of the stone support were still easily recognised.

In the samples treated with AG1, after the staining, three separate layers were observed (Figure 4a). The most superficial level can be ascribed to the paint because the numerous bright points in this layer matched the Bi in the elemental maps (Figure 4c). Under the paint, a homogeneous coating only made of C accounted for the presence of a separate layer: that is, the AG1 coating. The average thickness of this film was around 5 μ m and no clear evidence of the penetration of the anti-graffiti product into the stone was observed. In fact, in examining the distribution maps (Figure 4c), high contents in C were not found where Ca was detected. The anti-graffiti product mainly remained on the surface in spite of the high porosity of the substrate, which usually enhances the penetration of both the protective product and the paint [28,32]. However, it is worth mentioning that, in some points, the brighter components, due to the Bi in the paint, were found also below the surface (Figure 4b). Near these areas, the protective coating seemed lacking and, as a consequence, the staining agent easily penetrated into the stone. It is likely that this latter phenomenon took place where the anti-graffiti coating was fissured (Figure 1b).

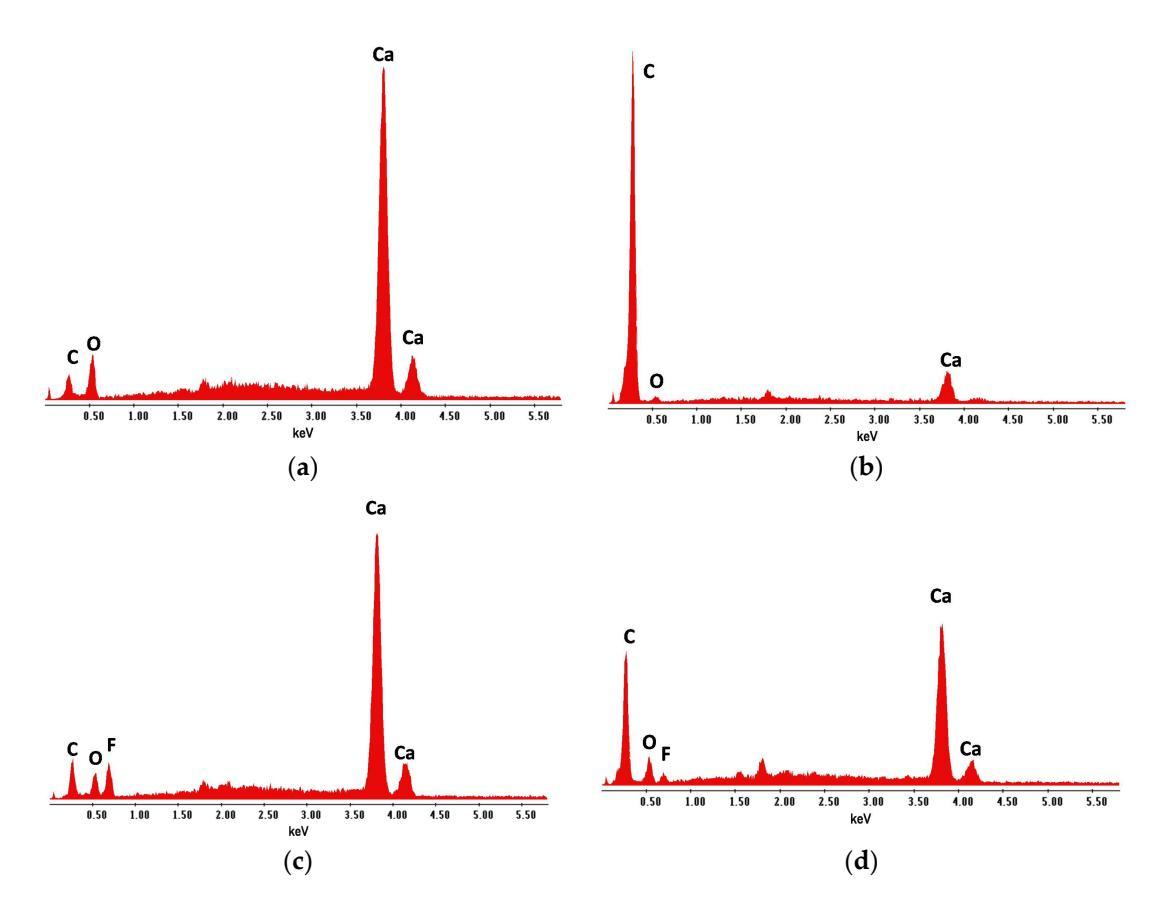
Figure 2. Energy-dispersive X-ray spectroscopy (EDS) spectra: (**a**) untreated stone surface; (**b**) stone surface treated with AG1; (**c**) stone surface treated with AG2a; (**d**) stone surface treated with AG2(a + b).

The EDS spectra acquired on the untreated and treated stone surfaces are reported in Figure 2.

The application of AG1 caused a strong increase of the carbon content on the surface (Figure 2b). At the same time, a noticeable reduction of the signal due to the calcium, which can be related only to the calcite of the stone material (Figure 2a), was measured. Both these results confirmed the presence of a thick wax-based coating on the investigated surface. The EDS spectra acquired in several points of the AG1 samples were always comparable, even where cracks were observed through the ESEM. This behaviour suggested that the stone surface was uniformly covered, in spite of the defects in the AG1 coating.

The microanalysis performed on the stone samples treated with AG2a revealed the presence of fluorine (Figure 2c), as expected, because of the fluorinated nature of the anti-graffiti primer. In this case, the signal of Ca was reduced just to a limited extent, as a consequence of a very thin coating on the surface. After the subsequent treatment with AG2b, the peak due to the Ca decreased further (Figure 2d), giving evidence of a thicker film on the stone. However, the Ca peak was high enough to indicate that the anti-graffiti products did not accumulate on the surface. In comparing these surfaces to the previous ones (i.e., the AG2a samples), the content in C increased, while the amount of F decreased. In fact, the AG2b product mainly contained waxes, with limited quantities of fluorinated polymers.

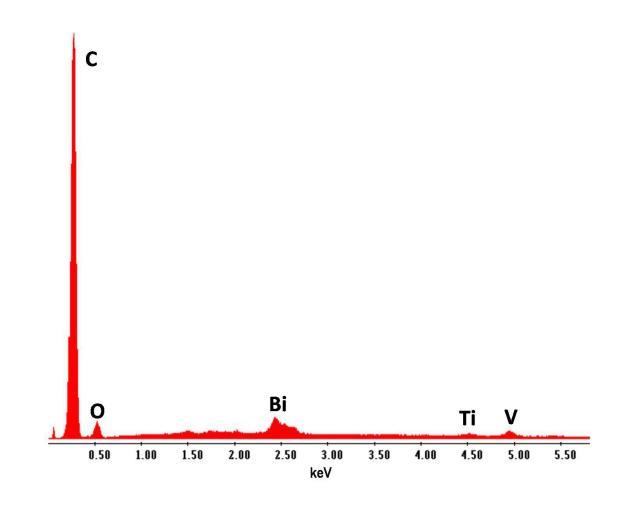
Figure 3. EDS spectrum acquired on the paint sprayed on aluminium stub.

The EDS spectra acquired on the paint sprayed on an aluminium stub revealed a very high content of C (Figure 3), in accordance with the presence of the methyl-methacrylate binder as the main component. Bismuth, along with traces of titanium and vanadium, was also found; these elements can be ascribed to pigments and/or to additives in the paint formulation, but further identification of the ingredients in the paint was not possible.

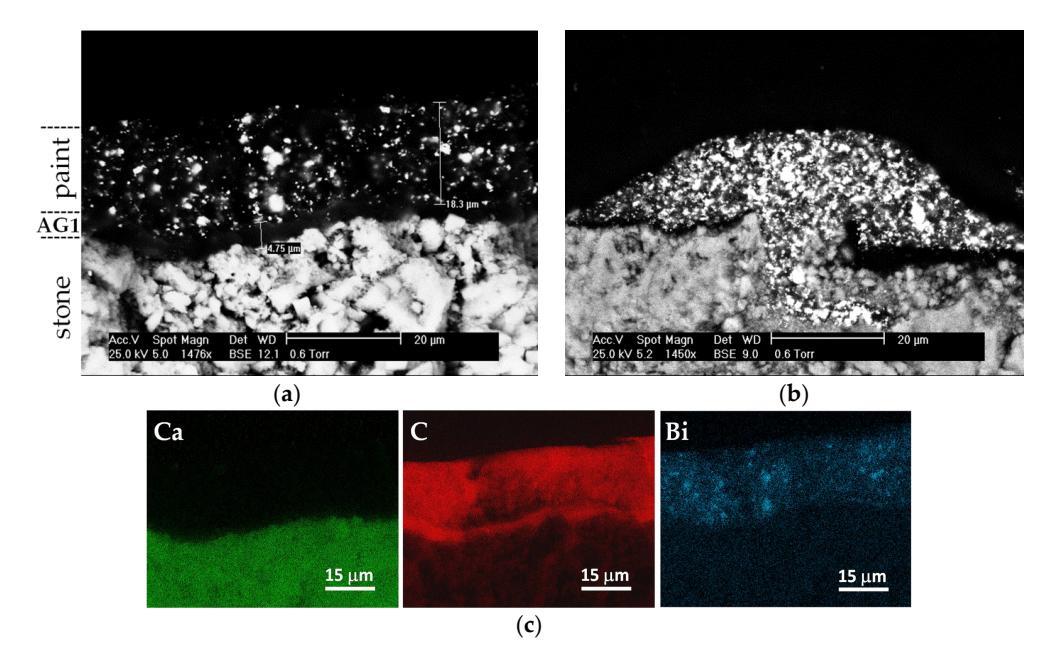
Figure 4. Fresh fractured surface of sample treated with AG1 after the staining: (**a**,**b**) ESEM images; (**c**) distribution maps of the elements acquired in the area showed in (**a**).

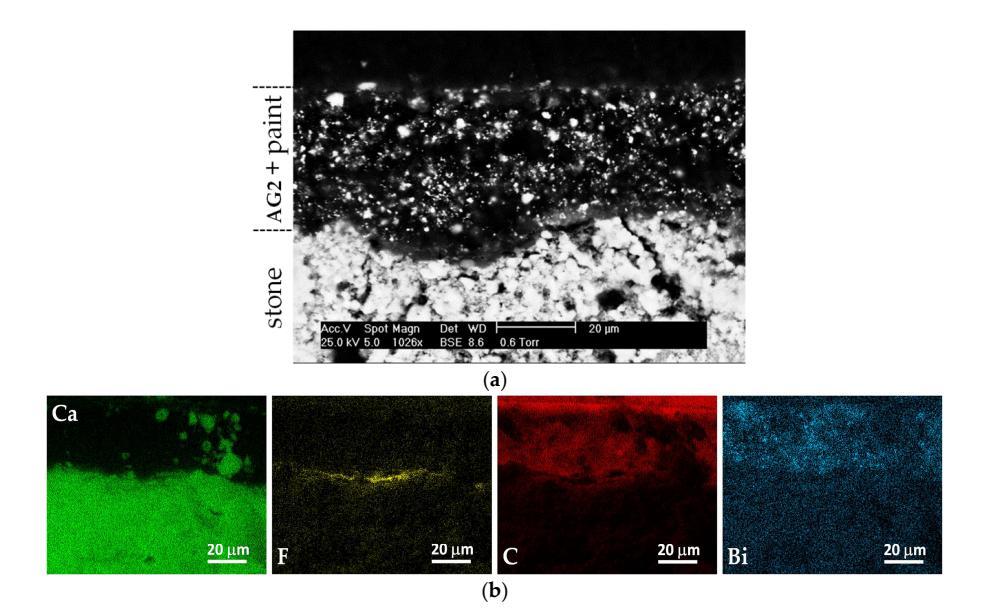
Figure 5. Fresh fractured surface of sample treated with AG2 after the staining: (**a**) ESEM image; (**b**) distribution maps of the elements.

In the stained samples previously treated with AG2, a uniform superficial layer coated the stone substrate (Figure 5a). In this case, it was difficult to distinguish the different products (i.e., AG2a, AG2b, and the paint) in separate layers. Only the presence of a very thin level of F (Figure 5b) revealed where the AG2a coating was located. The obtained results can support the hypothesis, made in a previous study [42], that the paint penetrated the AG2b coating, as a consequence of the high free volume fraction of this polymer film.

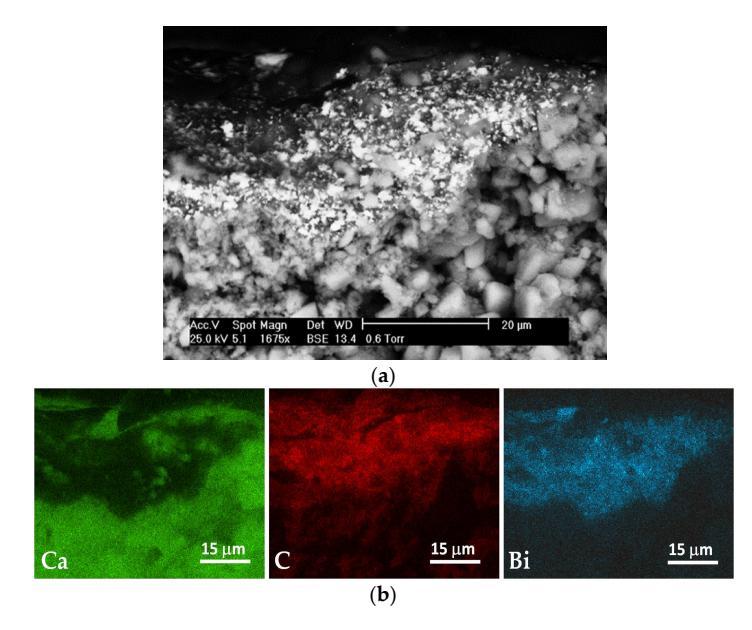
Figure 6. Fresh fractured surface of untreated sample (AG0) after the staining: (**a**) ESEM image; (**b**) distribution maps of the elements.

Finally, the stained untreated specimens were investigated. In these samples, since no barrier was applied on the stone surface, the paint easily permeated the substrate (Figure 6a). The Bi, and consequently the paint, was found not only on the superficial layer, but also inside the stone (Figure 6b). The penetration depth was not uniform, but the paint was often detected over 20 µm below the surface.

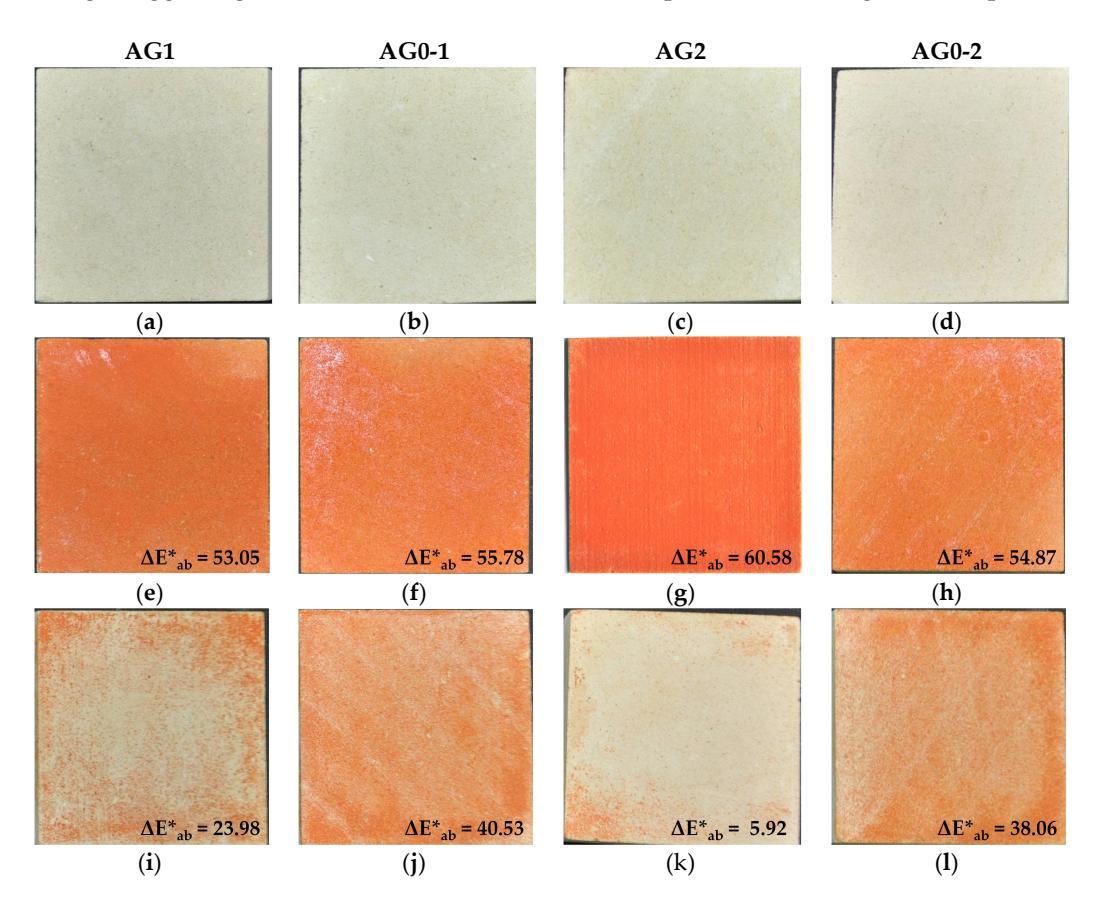
Figure 7. The stone samples before the treatments (**a**–**d**); after both the anti-graffiti treatment and the staining (**e**–**h**); and after the cleaning procedure (**i**–**l**). The colour variations by comparison with the untreated surfaces are reported.

After the paint application, naturally, the aspect of the stained surfaces dramatically changed (Figure 7e–h). This outcome was further corroborated by colour measurements since extremely high ΔE^*_{ab} values were calculated. Dissimilar colour variations were measured in the protected samples (Figure 7e,g), suggesting a different interaction between the protective coatings and the paint.

The cleaning procedure yielded an incomplete removal of the paint from the surfaces previously treated with AG1. The unsuccessful result, already clear to the visual inspection by the naked eye (Figure 7i–l), left the ΔE^*_{ab} values very high. Although the non-impregnating anti-graffiti products usually show a better efficacy [26], in the samples treated with AG1, the presence of the applied product only on the surface did not guarantee satisfactory results, as already found in other highly porous materials [28]. The paint was the only component in the most external layer, while the chemical remover was likely formulated to affect just the protective coating. In fact, the same chemical remover was ineffective on the paint alone (Figure 7j). Additionally, the paint penetrated into the stone (Figure 4b), through the cracks in the coating. Both these factors negatively influenced the stain removal.

On the contrary, the removal of the paint from the AG2 samples was quite successful (Figure 7k). In this case, the incorporation of the stain into the protective coating probably enhanced the anti-graffiti

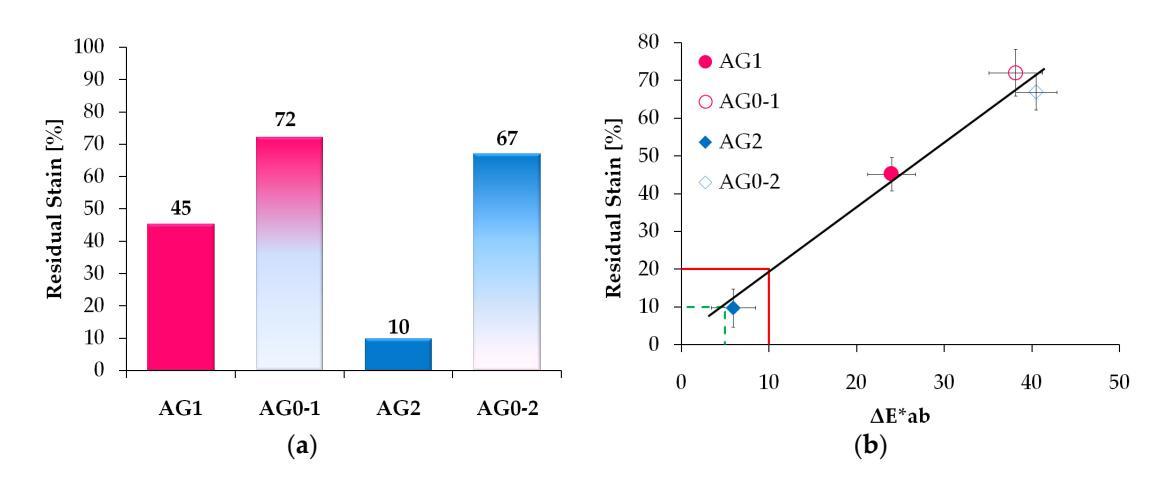
Figure 8. Residual stain (as defined in Equation (2)) on the surfaces after the cleaning procedures: (a) with respect to the previous treatment; (b) as a function of ΔE^*_{ab} (the standard deviations are indicated). In (b), the green lines define the optimal cleaning, the red lines indicate the threshold limit for suitable cleaning).

A residual stain (RS) of 45.20% was calculated for the AG1 samples, while RS was 9.77% for the AG2 specimens (Figure 8a). RS around 70% were found in the unprotected samples.

For each set of samples, the RS values were also reported as a function of the related ΔE^*_{ab} (Figure 8b), and a trend line was drawn. According to a classification followed by other researchers [27,49,50], when the ΔE^*_{ab} values are lower than 5, the colour changes, and the cleaning as well, are adequate; as the ΔE^*_{ab} values increase up to 10, the colour variations can be seen but they are still tolerable; ΔE^*_{ab} values higher than 10 produce clearly visible colour changes that cannot be accepted. Taking into account the results and the previous considerations, RS values below 10% can be judged acceptable; RS between 10% and 20% are not optimal, but tolerable; RS of 20% is the upper threshold. Above this latter value, the cleaning procedure does not give suitable results.
