# Article Research on Laser Additive and Milling Subtractive Composite Remanufacturing Process of Compressor Blade

Abstract: As an important energy conversion mechanism, centrifugal compressors play an important role in the national economy. The blade is one of the most critical components of the compressor. Damaged blades contain extremely high added value for remanufacturing. Thus, remanufacturing research on damaged and retired impeller/blade is getting more and more attention. Laser additive and milling subtractive composite remanufacturing technology is an effective means to achieve metal parts remanufacturing. In this paper, an advanced methodology for the remanufacturing of complex geometry and expensive components via reverse engineering, free-form surface modeling, laser additive repaired and machining is presented. The approach involves the integration of 3D non-contact digitization to obtain the point cloud data of damaged parts, adaptive free-form surface reconstruction to get the digital model of damage location, and laser additive manufacturing process containing slicing and path planning and subsequent multi-axis milling operation. The methodology has been successfu

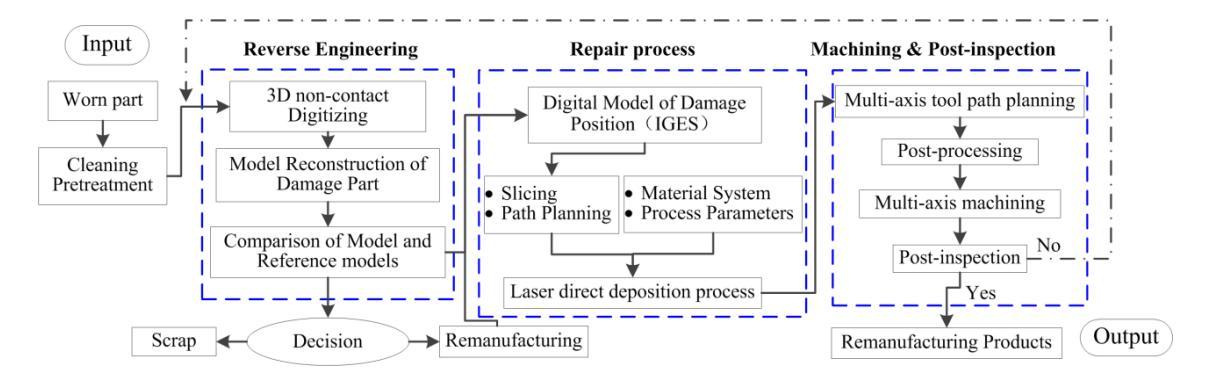
The proposed remanufacturing system consists of a chain of different processes. The general structure of the proposed remanufacturing system based on reverse engineering (RE) technology, LAM and, subsequent machining is shown in Figure 1. Using the 3D non-contact laser scanner system, the blade geometry data of polygon mesh format is quickly obtained through multi-view alignment, data filtering, and triangulation. In addition, a high-quality polygon mesh with no defects in the polygon modeling environment is created by the scanned data. Geometry reconstruction, based on RE system, was used to generate paths for laser direct deposition and subsequent milling subtractive in a CAD/CAM system (such as UG NX software). For complex components, the three-axis machining path for laser additive forming can be created in the reverse engineering module based on additional patch. Five-axis tool paths for milling subtractive manufacturing can be created based on the subtractive patch. By post-processing the generated toolpath, a CNC code (such as a G code) can be generated to drive the machine.

Figure 1. Overview of remanufacturing strategy.

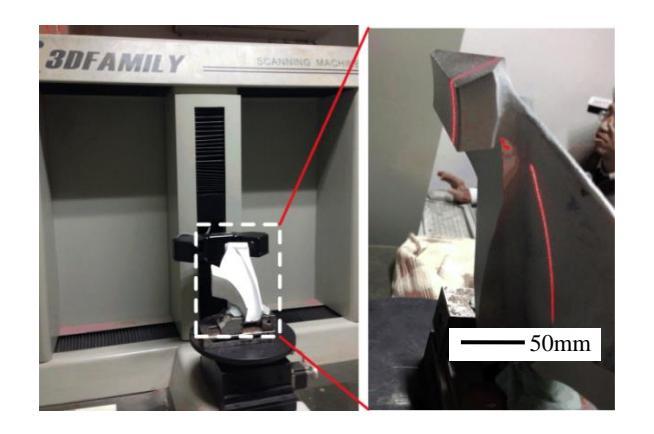
It is well known that compressors have a harsh service environment and, after long periods of operation, the blades often have deformation, tearing, and other defects. Therefore, the damage of the blade has many forms. In order to solve the difficulties caused by different forms of damage, and the part-to-part variation, the blade remanufacturing process must be able to adapt to each physically worn blade, which makes the acquisition of geometrical data an essential process. Therefore, 3D model reconstruction in blade remanufacturing requires a suitable digital system to provide sufficient and accurate data. In this work, a 3D Family laser scanner machine was chosen to scan worn blades, taking into account factors such as blade size, accuracy, scanning speed, data processing speed, and recovered blade data quality. The main parameters are shown in Table 1. The blade scanning process is shown in Figure 2.

Figure 2. Single blade scanning process.

Due to the complexity of the blade structure, it is difficult to obtain enough data for model reconstruction in a single scan. Therefore, it is necessary to scan the blades in all directions and then align these scanned data sets into a complete model. Thus, the single blade and three blades' parts were scanned and the point cloud data were obtained respectively.

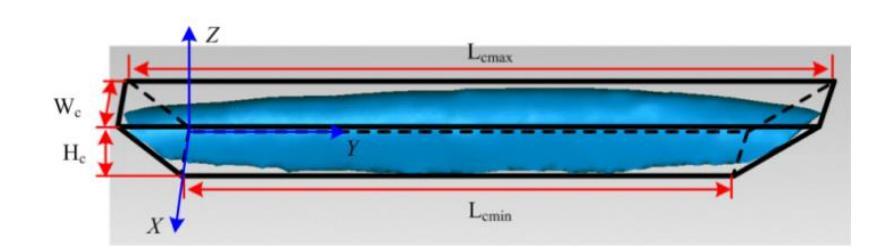
Figure 3. Simplified model of damage position.

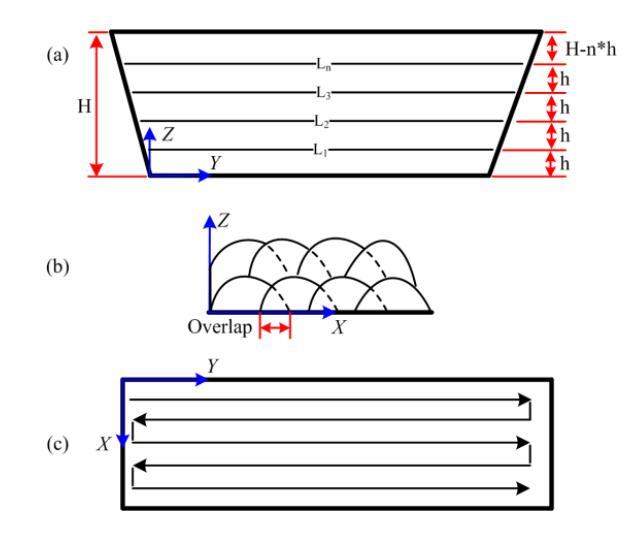
The LAM process was performed using a CO<sub>2</sub> multimode cross-flow laser operating with a coaxial powder head at output power of 4 kW with a 3-mm beam diameter. The beam scanning speed was 500 mm/min. FeCr alloy powder containing 1.5% wt La<sub>2</sub>O<sub>3</sub> was used in this study. The compositions of FeCr alloy mixture and the KMN steel are indicated in Table 2. The powder flow rate was 13.1 g/min. The geometry of the part to be repaired is shown in the blue part of Figure 3. In order to facilitate the planning of the laser repair path, the geometry is simplified, as shown by the thick black line in Figure 3. According to the simplified model of damage position, at the end of each layer the Z height was adjusted automatically. And the laser beam scanning was reciprocating scanning in each layer, as shown in Figure 4. The LAM process is shown in Figure 5.

**Figure 4.** Schematic diagram of slicing and path planning: (**a**) slice planning; (**b**) overlapping rate; (**c**) scanning path.

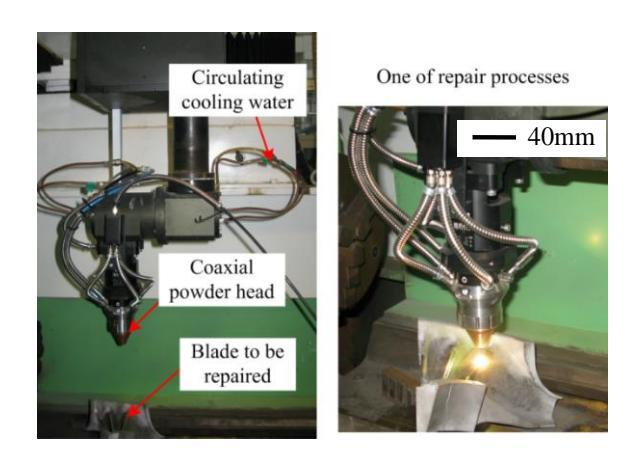
Figure 5. LAM process.

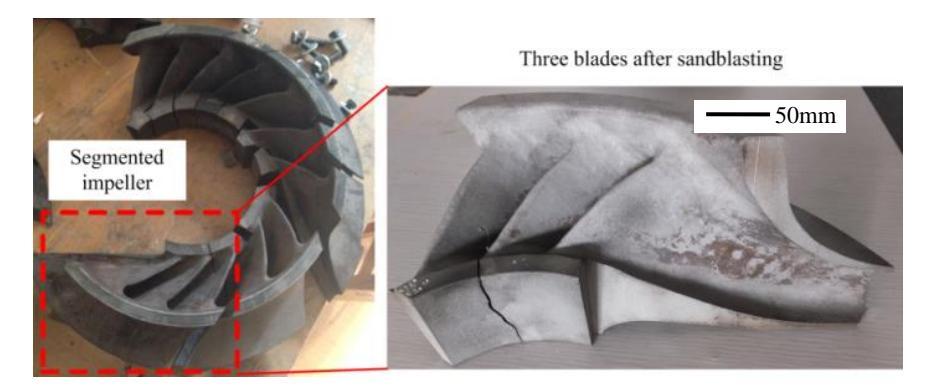
The blade, as remanufacturing objects, which is part of the KMN steel impeller, was provided by Shenyang Blower Works Group Corporation, China, as shown in Figure 6. One of the damage positions, which were preset in the blade edge used for remanufacturing, is shown in Figure 7.

Figure 6. Macro-morphology of impeller and blades.

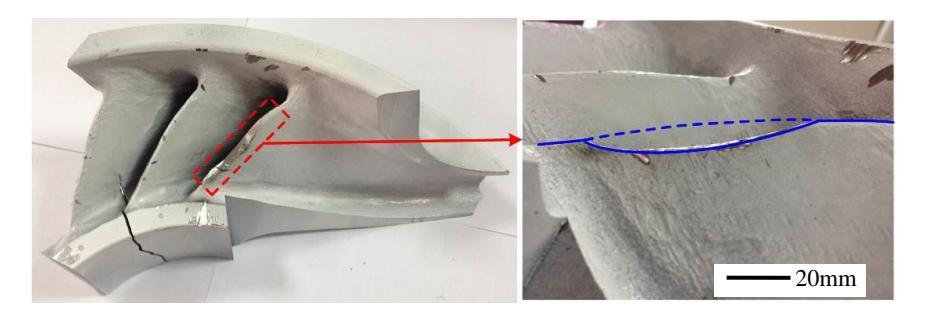
Figure 7. Morphology of blades with preset damage.

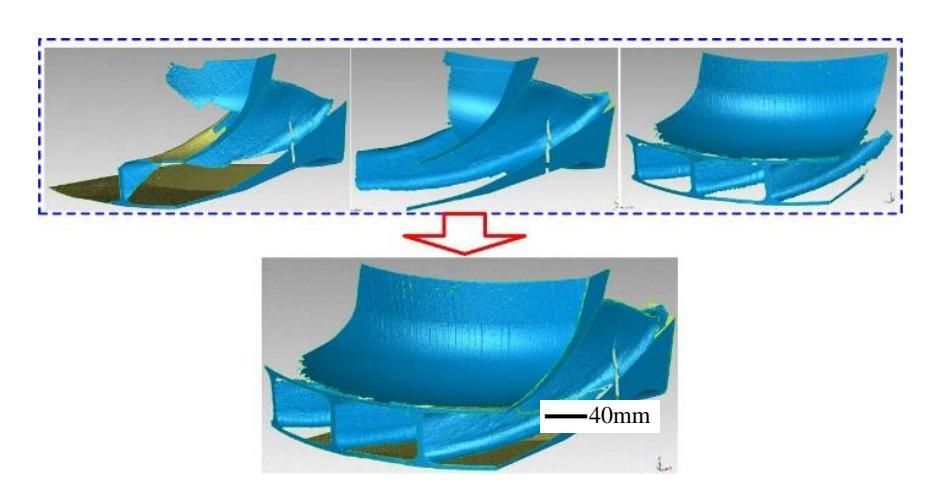
After the steps of filtering the point cloud data, multi-viewed piecing-together (as shown in Figure 8), deleted abnormal topological triangles, filled holes and gaps (as shown in Figure 9), and optimized and subdivided the model described in Section 2.2. The model of blades and damage position was obtained, as shown in Figure 10, and export as an IGES file.

Figure 8. Schematic diagram of multi-viewed piecing-together.

Step 2: Multi-viewed piecing-together. Since multiple scans were performed on irregular surfaces and places with large curvature during the scanning process, multiple point clouds were generated. It needs to splice multi-view data points, which will obtain the preliminary blades model.

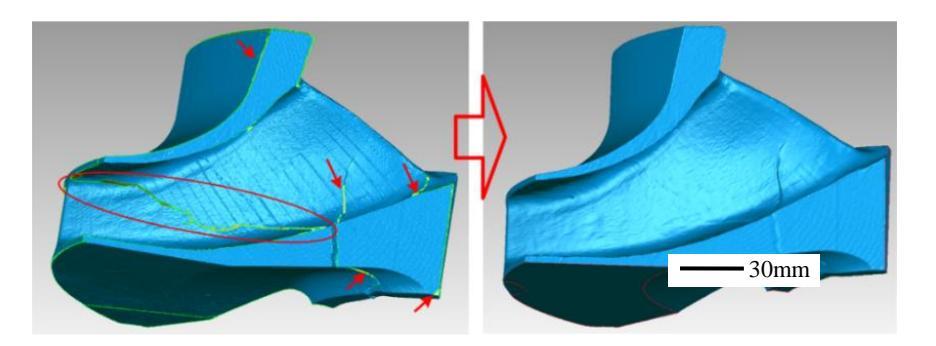
Figure 9. Schematic diagram of fill holes and gaps.

Step 4: Fill holes and gaps. In this work, most of the holes and gaps have no significant effect on laser direct deposition repairing, so it is just needs a simple filling operation.

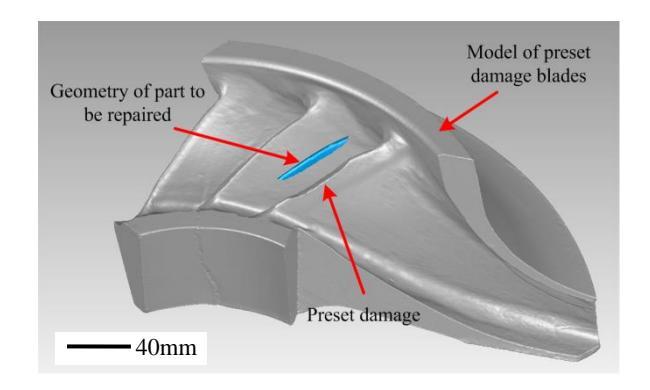
Figure 10. One of the model of damage position.

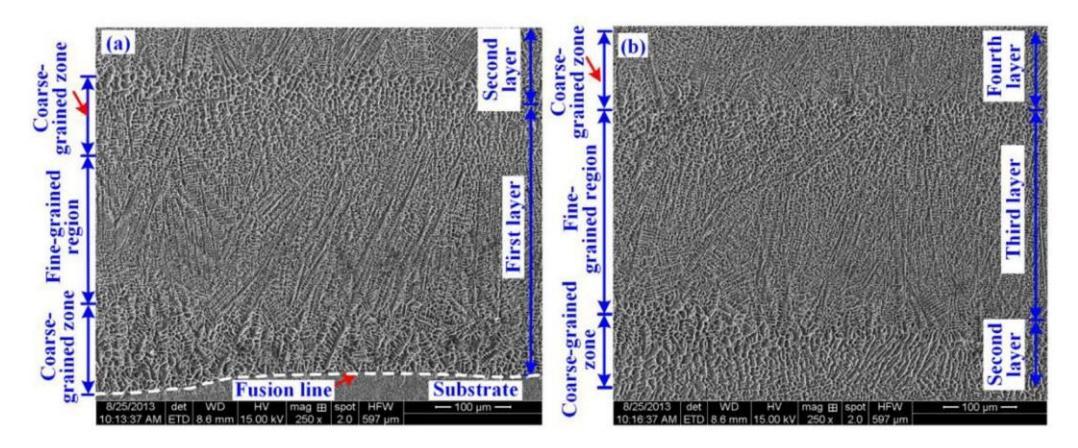
The microstructure of the LAM forming layer observed by SEM is also shown in Figure 11. It is apparent that the growth of the crystal grains is layer by layer. The middle position of each layer is a fine grained zone, and the junction of the layers is a coarse grained zone. The microstructure of each layer consists of dendrite, cell grain, and eutectic. It can be seen from XRD (Figure 12) that the phase of the LAM layer is mainly composed of Fe-Cr, CrO0.87, Fe9.7Mo0.3, MnNi, Cr9.1Si0.9, Cr7C3, Fe0.64Ni0.36 and BMn.

**Figure 11.** The grains structure of the specimen cross-section: (**a**) substrate and first layer, (**b**) second, third and fourth layer.

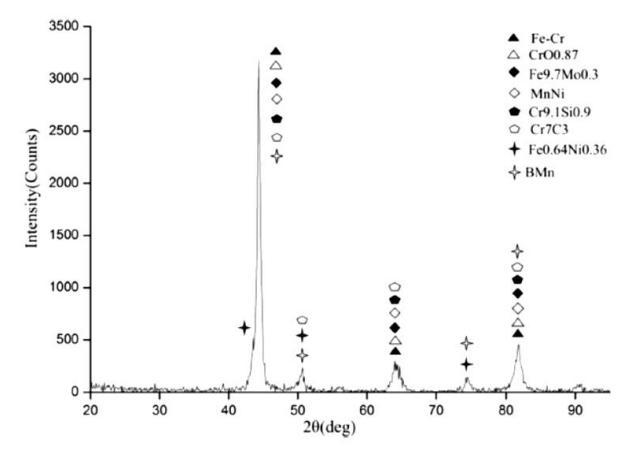
Figure 12. XRD results of LAM FeCr alloy.

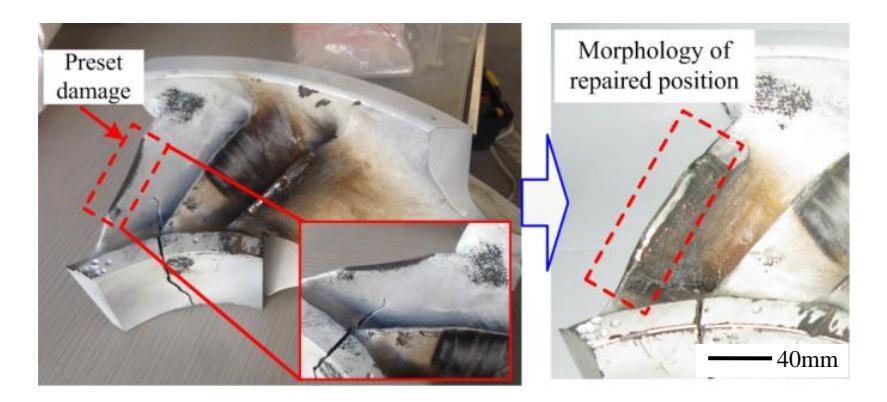
One of the repaired position morphologies before and after LAM is shown in Figure 13. It is shown that the repaired blade without cracks and blowhole defects has already been restored to original size. The total height and width of the repaired blade is greater than that of the reference model to some degree. Additionally, a slight overbuild is necessary to account for the subsequent milling.

Figure 13. Macro-morphology of one of the repaired position.

For the side milling operation, the VARIABLE\_ CONTOUR method was applied. In this case, machining features are the blade repaired position, as shown in Figure 13. Machining tool paths generated are shown in the blue lines in Figure 14, which are outputted as the ISO APT format and post processed as G-code for milling operation performed on a five-axis machining center.

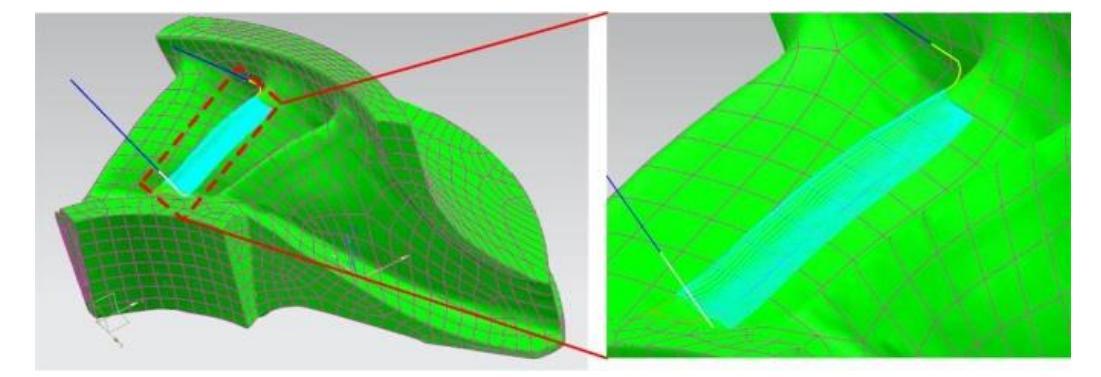
Figure 14. Multi-axis machining tool path.

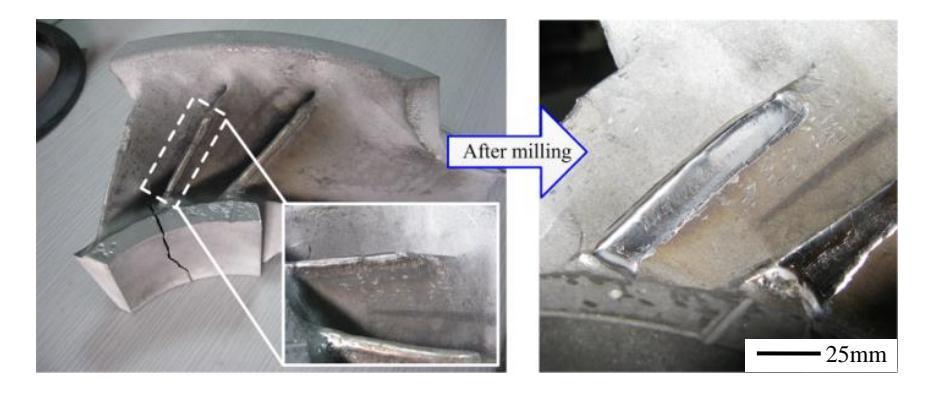
The macroscopic feature of the LAM repair blade before and after milling is shown in Figure 15. After post inspection, the final geometric tolerance of the remanufactured blade was shown to be within 150  $\mu$ m, while most of the remanufactured position was within 30  $\mu$ m of the desired geometry. After an accurate and detailed analysis, the entire process of centrifugal compressor blade remanufacturing was successfully completed.

Figure 15. Repaired position before and after milling.
