Article

The Effect of Electrolytic Hydrogenation on Mechanical Properties of T92 Steel Weldments under **Different PWHT Conditions**

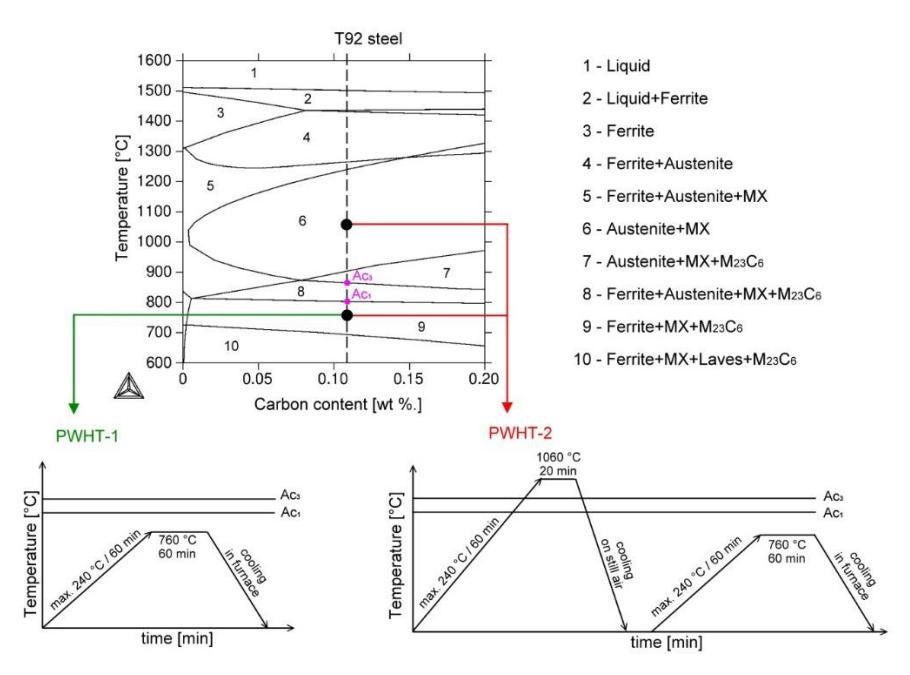
Figure 1. Calculated equilibrium phase diagram with schematic illustrations of individual post-welding heat treatment (PWHT) regimes applied in the present study for T92/T92 weldments (The T92 steel composition is indicated in the diagram by vertical dashed line at 0.11 wt.% C).

The two prepared weldments were individually subjected to mutually differing post-welding heat treatment (PWHT) procedures. Figure 1 shows schematic illustration of both these PWHT procedures in context with the equilibrium phase diagram including isoplethal section for T92 BM, computed by thermodynamic software ThermoCalc (version S, Thermo-Calc Software AB, Solna, Sweden) using thermodynamic database TCFE6.

The first T92/T92 weldment was conventionally tempered at 760 °C (i.e., below the Ac₁ temperature of T92 steel) for 60 min and then slowly cooled within the tempering furnace (see the PWHT-1 in Figure 1). On the other hand, the second T92/T92 weldment was subjected to its full renormalization consisting of the complete reaustenitization at 1060 °C (i.e., well above the Ac₃ temperature of T92 steel) for 20 min and subsequently cooled on still air, followed by its conventional subcritical tempering (see the PWHT-2 in Figure 1). From both weldments, twelve cylindrical tensile test specimens of cross-weld (c-w) configuration with partly discontinuous M6 thread (due to the above specified tube wall thickness) within their head portions were machined. A schematic illustration of the tensile test specimen is shown in Figure 2.

elements redistribution during performed reaustenitization, see Figure 1). Thus, the WMs represent the most heterogeneous regions within the renormalized-and-tempered weldments. This finding indicates the reason for their high propensity for the localization of plastic deformation and final failure occurrence during tensile straining. The corresponding fracture analyses for the hydrogen-free and hydrogen-charged weldments initially processed by the PWHT-2 are shown in Figures 15 and 16, respectively.

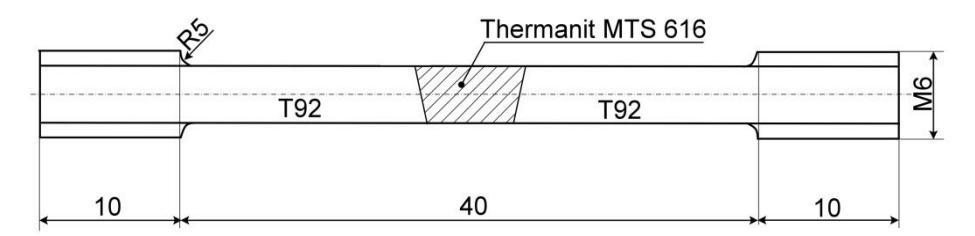
Figure 2. The tensile test specimen for cross-weld tensile testing of T92/T92 weldments (All dimensions are in mm), gauge length diameter 4 mm, gauge length 38 mm.

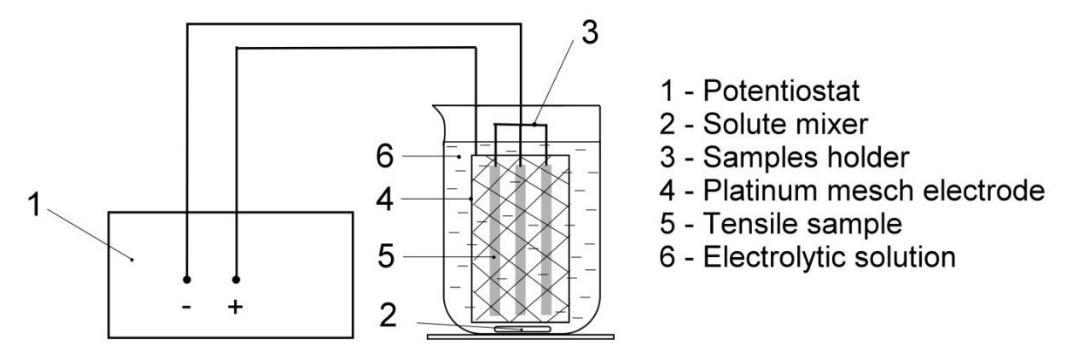
Figure 3. Schematic illustration of electrolytic hydrogenation.

already rather small (i.e., within experimental value scattering). A schematic illustration of the whole experimental setup is visualized in Figure 3.

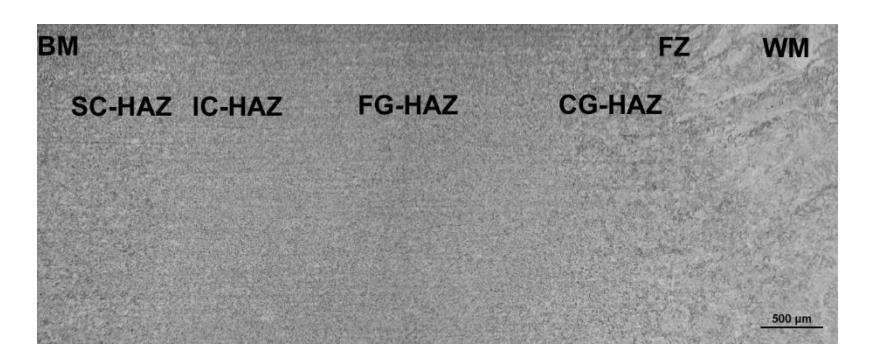
Figure 4. Light-optical micrograph of T92/T92 weldment after the tempering PWHT-1.

Since the qualitative microstructural characteristics of T92/T92 weldments are, in principle, symmetrically distributed with respect to the weld centerline, only one half part of the cross-weld microstructure was documented. Figure 4 shows the light-optical micrograph of T92/T92 weldment in conventionally tempered, i.e., PWHT-1 material state. It can be clearly seen that the weldment after the PWHT-1 exhibits a typical microstructural gradient consisting of individual microstructural sub-regions, i.e., BM, SC-HAZ, IC-HAZ, FG-HAZ, CG-HAZ, FZ, and WM. These microstructural sub-regions are generally formed of tempered martensitic-ferritic structures with different tempering

The microstructural transitions SC-HAZ/IC-HAZ, FG-HAZ/CG-HAZ, and FZ/WM are clear thanks to the observed differences in grain size and morphology. However, the microstructural transitions BM/SC-HAZ and IC-HAZ/FG-HAZ cannot be clearly differentiated by means of light optical microscopy and, thus, they are only roughly estimated in Figure 4. Figure 5 shows the light-optical micrograph of T92/T92 weldment in renormalized-and-tempered, i.e., PWHT-2 material state.

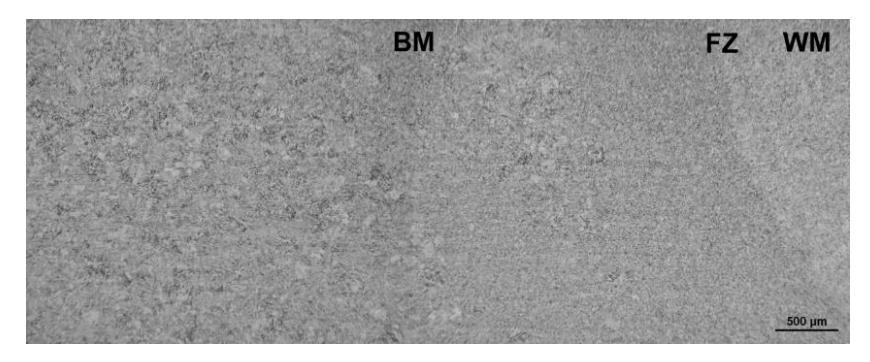
Figure 5. Light-optical micrograph of T92/T92 weldment after the renormalizing-and-tempering PWHT-2.

It can be seen that the weldment after the PWHT-2 shows quite homogenized microstructure as a consequence of the performed renormalization treatment. Within the renormalized-and-tempered weldment, only the regions of BM and WM can be clearly distinguished (Figure 5). This observation can be directly related to the homogenization effect of the applied PWHT-2 resulting in notable suppression of the original T92 HAZ microstructural gradient due to the performed renormalization. However, it should be noted that Figure 5 indicates also a certain microstructural refinement within the former CG-HAZ and WM regions compared to the microstructure of rest BM involving the renormalized-and-tempered regions of former SC-HAZ, IC-HAZ, and FG-HAZ. The detailed SEM-micrographs of individual microstructural zones of T92/T92 weldment after the PWHT-1 and PWHT-2 are shown in Figures 6 and 7, respectively.

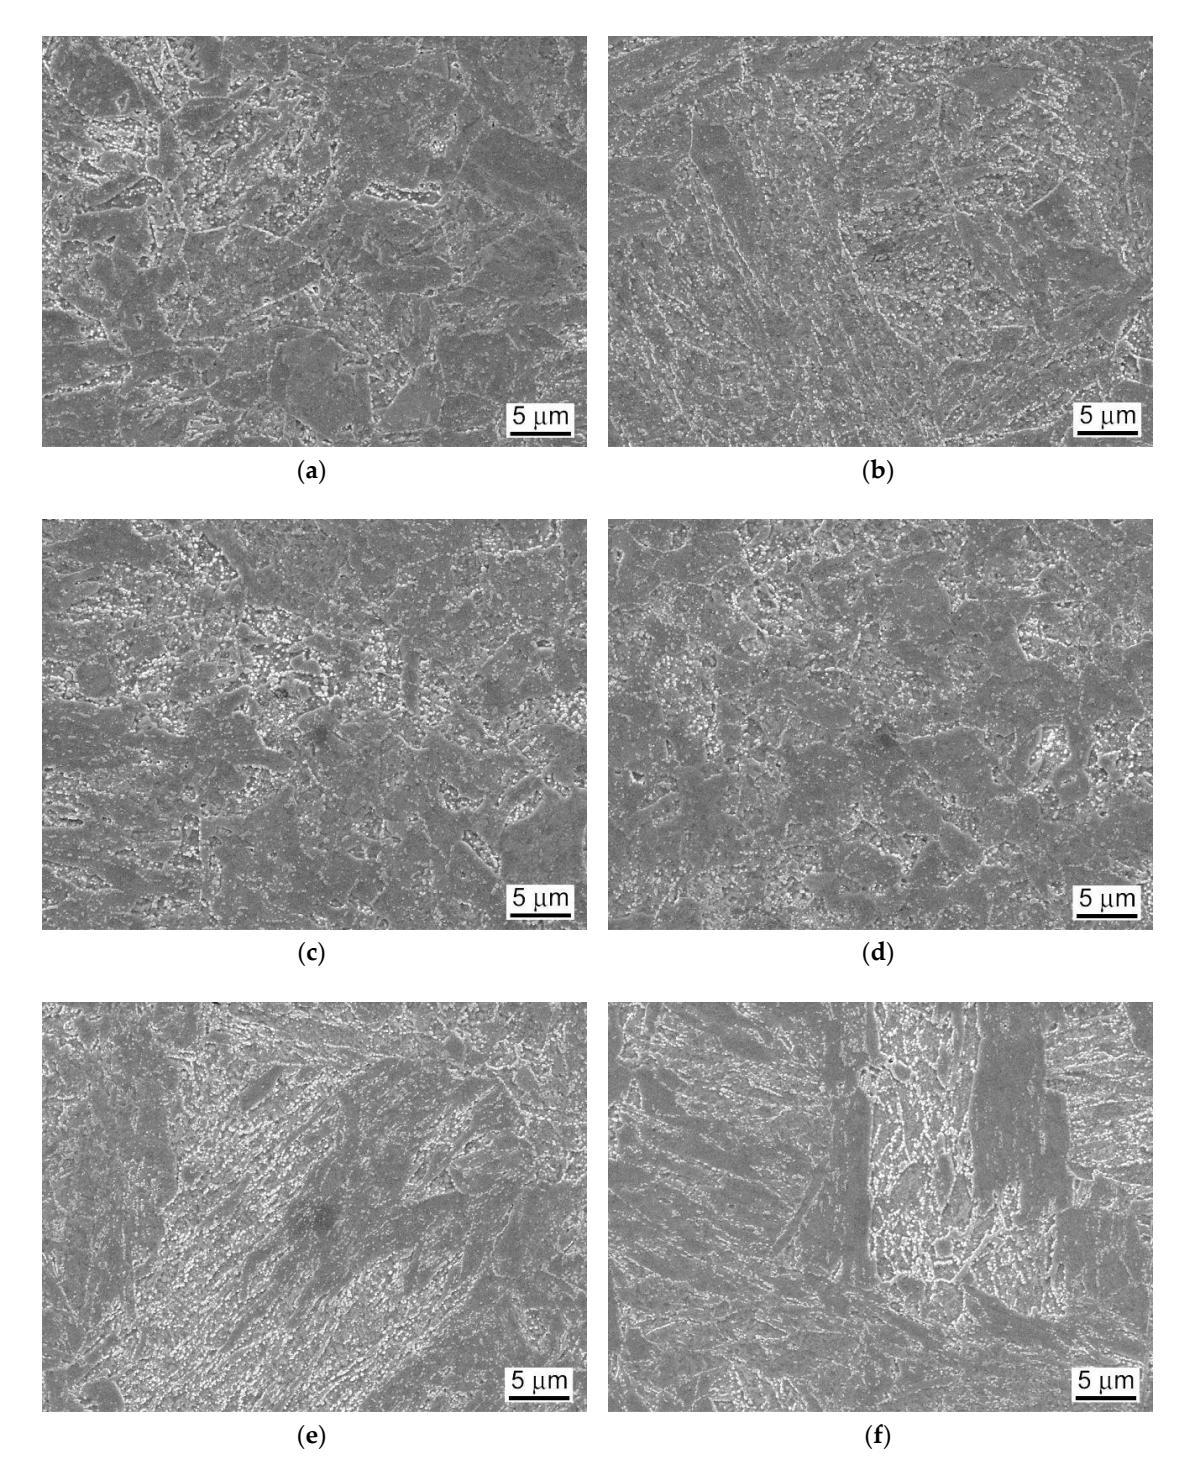
Figure 6. SEM-micrographs of individual microstructural zones of T92/T92 weldment after the tempering PWHT-1: (**a**) BM; (**b**) SC-HAZ; (**c**) IC-HAZ; (**d**) FG-HAZ; (**e**) CG-HAZ; and (**f**) WM.

By comparison of individual microstructures in Figures 6 and 7, it can be stated that the performed PWHT-2 did not induce full microstructural homogenization of studied weldment with respect to the grain size. Thus, from the observed microstructural characteristics in Figure 7, it cannot be explicitly judged about the appropriateness of the used PWHT-2. Although the original HAZ microstructural gradient has been considerably suppressed, some recognizable microstructural heterogeneity among former HAZ sub-regions is still to be observed. The originally fine-grained regions (IC-HAZ, FG-HAZ) related to PWHT-1 became notably coarse-grained after the PWHT-2. On the contrary, the originally coarse-grained regions (CG-HAZ and WM) became partly refined. The observed microstructural changes can be related to variant (non-uniform) microstructural evolution in individual sub-regions during the PWHT-2 due to pre-existing microstructural differences originated from the primary welding-induced microstructural changes. The IC-HAZ microstructure is formed in the region of BM heated up during the welding to inter-critical peak temperatures (i.e., the temperatures in Ac_1 - Ac_3 range). Accordingly, the IC-HAZ is formed of fine-grained microstructure consisting of over-tempered (i.e., non-transformed) martensite (i.e., ferrite with coarsened precipitates of original undissolved carbides) and newly formed martensite created on cooling from fine-grained non-saturated austenite. The FG-HAZ microstructure is formed in the region of BM heated up during the welding to peak temperatures just above Ac3 up to about 1100 °C. After subsequent cooling, the resulting FG-HAZ consists of newly formed martensite created from fine-grained non-saturated austenite and coarsened precipitates of original undissolved carbides. As shown in Figure 7, after the PWHT-2 both the IC-HAZ and FG-HAZ microstructures exhibit pronounced grain growth which can be related to the lower pinning effect of the coarsened carbide precipitates on the grain boundaries. Thus, the evolution of pronounced grain coarsening in both originally fine-grained IC-HAZ and FG-HAZ microstructures during the renormalization seems to be associated with their low thermal stability in as-welded material condition, enhancing the thermodynamic driving force for the observed microstructural changes. In contrast to the IC-HAZ and FG-HAZ regions, the original CG-HAZ and WM regions are created as a result of on-cooling phase transformations from the highest peak temperatures reached during the welding thermal cycle. Thanks to carbide dissolution at considered peak temperatures, these regions consist of coarse grain structures with the highest level of transformation (i.e., martensitic) hardening. During renormalization at 1060 °C (Figure 1) of these primarily coarse-grained microstructures, thermodynamic conditions for further grain growth are rather unfavorable due to a relatively low renormalization temperature compared to the considered highest peak temperatures. Instead, thanks to the effect of carbon supersaturation in these martensitic microstructures, the creation of newly formed (small) austenite grains on heating to the renormalization temperature is thermodynamically favored. This transformation behavior during the weld renormalization followed by on-cooling phase transformations and final tempering is assumed to be the reason for the creation of partly refined microstructures of CG-HAZ and WM after the PWHT-2.

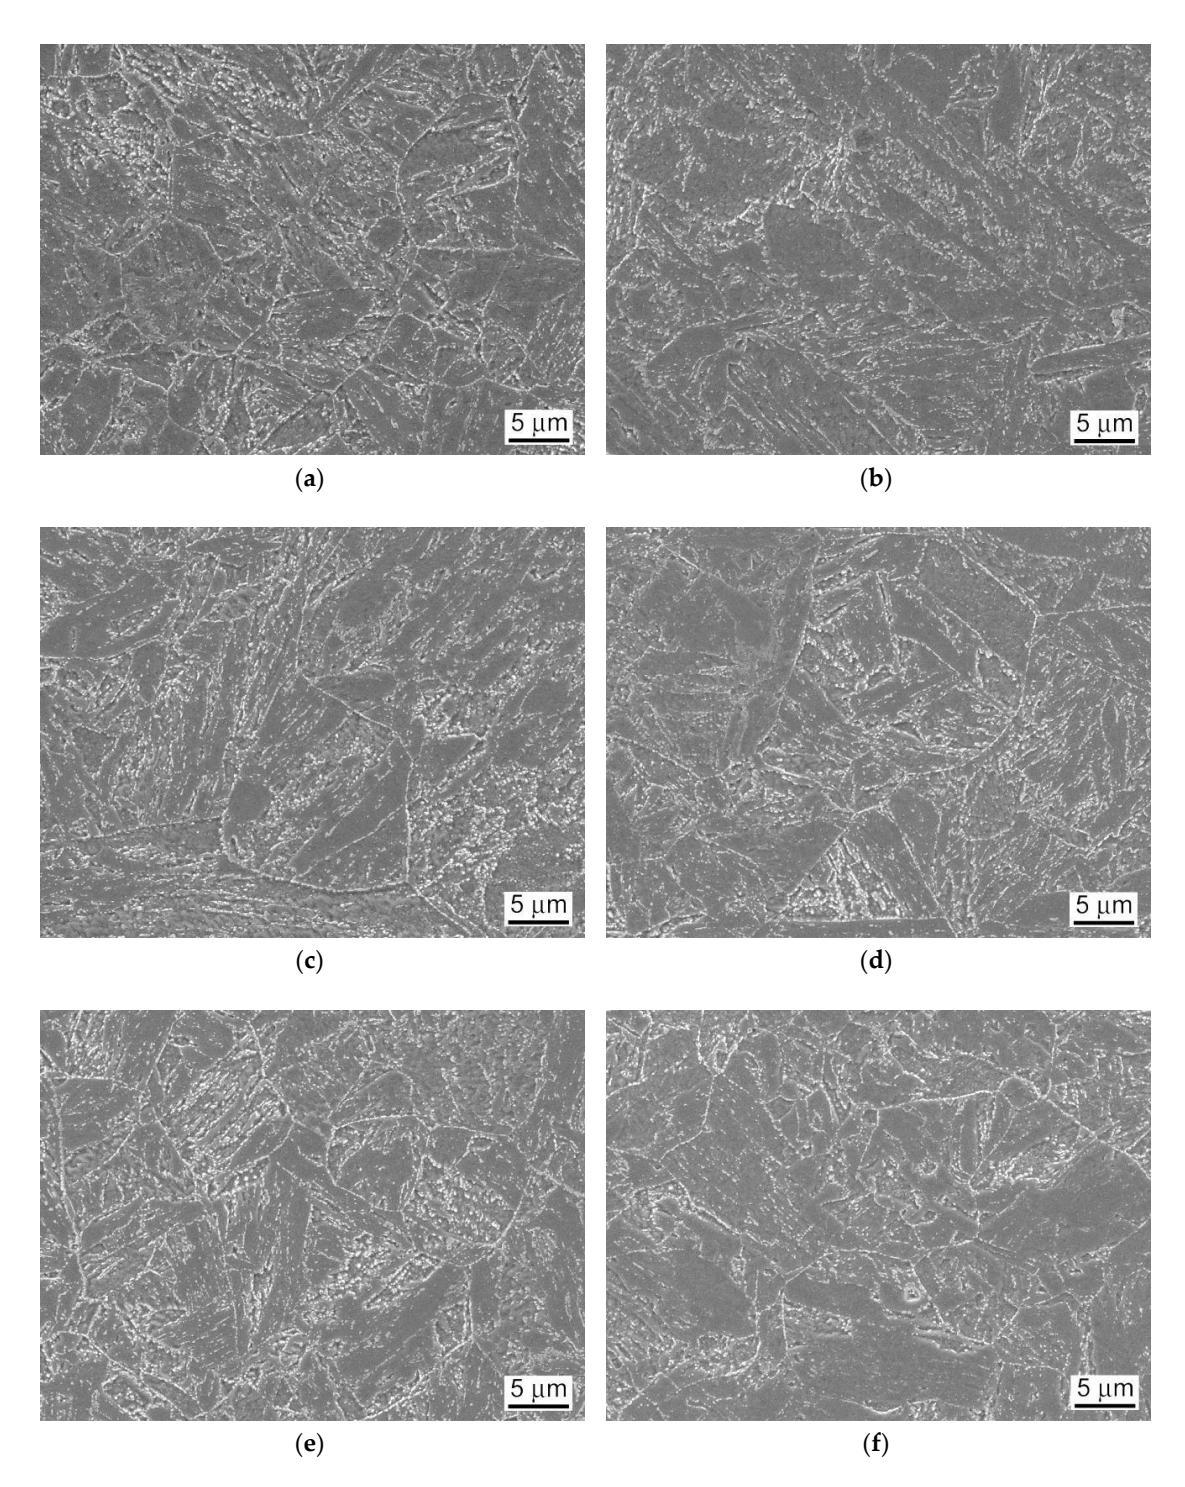
Figure 7. SEM-micrographs of individual microstructural zones of T92/T92 weldment after the renormalizing-and-tempering PWHT-2: (a) BM; (b) former SC-HAZ; (c) former IC-HAZ; (d) former FG-HAZ; (e) former CG-HAZ; and (f) WM.

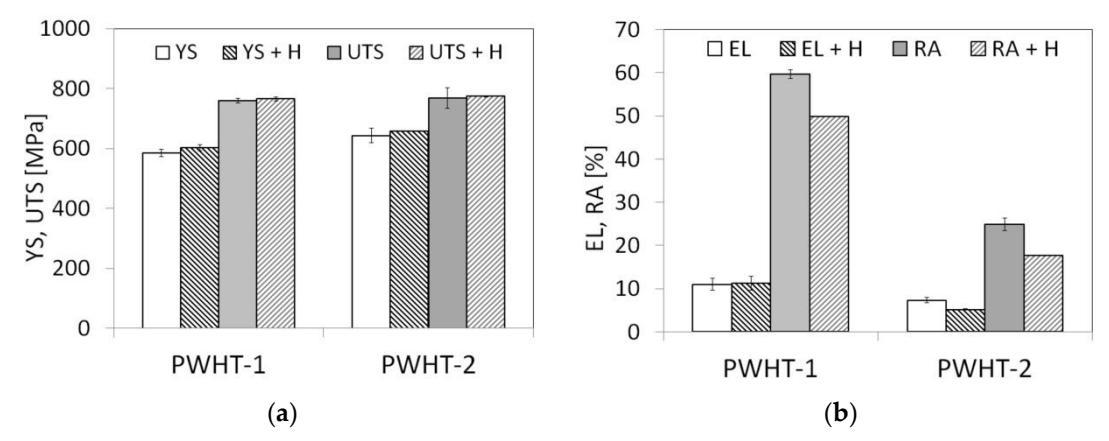
Figure 8. The effects of PWHT conditions and subsequent electrolytic hydrogenation on room-temperature tensile properties of investigated T92/T92 weldments: (a) strength properties and (b) deformation properties.

The effects of initial PWHT conditions in combination with subsequent electrolytic hydrogenation of the studied T92/T92 weldments on their room-temperature tensile properties are shown in Figure 8.

It can be seen that the renormalizing-and-tempering PWHT-2 of studied T92/T92 weldment resulted only in a small increase of the strength properties, i.e., the YS and UTS values, compared to those of the weldment after the tempering PWHT-1 (Figure 8a). Thus, it can be stated that the effect of various PWHT conditions on the resulting strength properties of studied weldment was rather insignificant. In addition, the differences in measured strength properties between the hydrogen-free and hydrogen-charged weldments in the both PWHT conditions were also quite negligible (Figure 8a). On the contrary, the renormalizing-and-tempering PWHT-2 of studied weldment resulted in a significant decrease of the deformation properties, i.e., the EL and RA values, compared to those of the weldment after the tempering PWHT-1 (Figure 8b). Additional hydrogen charging of the studied weldments in both PWHT material states led to further deterioration of their deformation properties (Figure 8b). However, the observed detrimental effect of the renormalizing-and-tempering PWHT-2 on the deformation properties of the weldments was much more pronounced in comparison with the effect of electrolytic hydrogenation. The measure of individual studied effects (i.e., the heat treatment procedure and electrolytic hydrogenation) on the plasticity deterioration can be quantitatively estimated using the so-called embrittlement index EI:

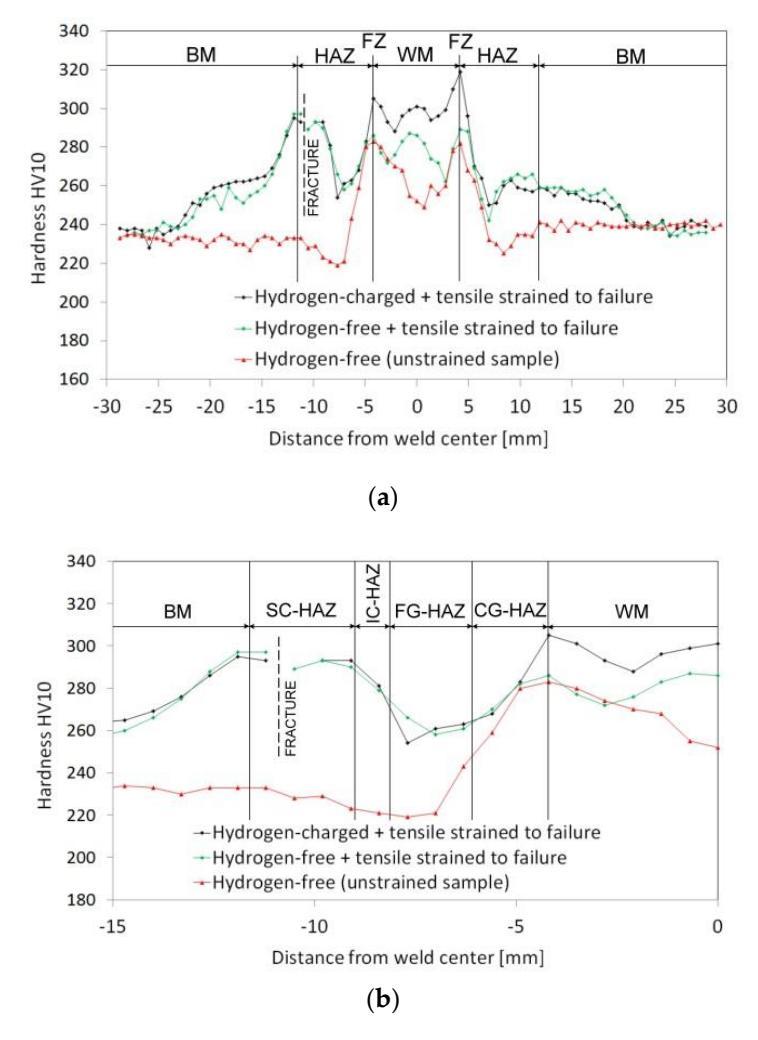
Figure 9. The effects of electrolytic hydrogenation and subsequent room-temperature tensile testing on cross-weld hardness profiles of T92/T92 weldments initially heat treated by conventional tempering PWHT-1: (**a**) overall hardness profiles and (**b**) detailed hardness profiles focused on the HAZ.

The hardness profiles of both the hydrogen-free and hydrogen-charged specimens show the strain-induced hardness peaks in the formerly soft (i.e., in the initial unstrained state) SC-HAZ in the location of tensile test fracture. Thus, the originally softer areas within the T92/T92 weldment in the PWHT-1 material state represent the locations of the localization of the highest plastic deformation during tensile testing.

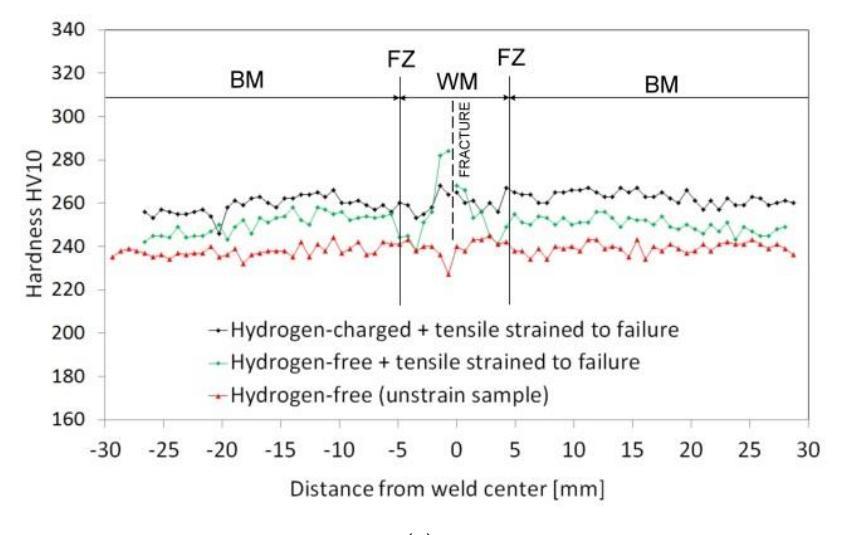
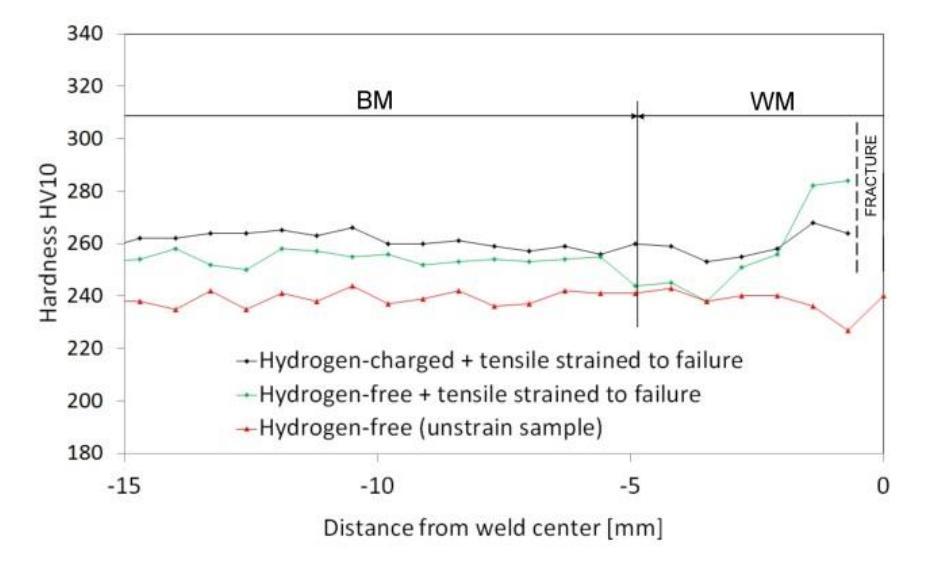
Figure 10. The effects of electrolytic hydrogenation and subsequent room-temperature tensile testing on cross-weld hardness profiles of T92/T92 weldments initially heat treated by renormalizing-and-tempering PWHT-2: (**a**) overall hardness profiles and (**b**) detailed hardness profiles focused on the former HAZ.

As already shown in previous section, the hardness profile of undeformed c-w sample of T92/T92 weldment after the PWHT-2 (Figure 10) showed somewhat lower hardness in WM compared to the rest BM portions. This observation may also be related to lower alloying of WM compared to BM. Thus, the preferential deformation of softer WMs during room-temperature tensile deformation of the welds after the PWHT-2 gave rise to their higher propensity for localization of plastic deformation and final failure occurrence. It can be concluded that the use of renormalizing-and-tempering PWHT-2 was found to be rather inconvenient for improving the microstructure and mechanical properties of the investigated T92/T92 weldments. However, based on the results obtained from the cross-weld tensile tests, the hydrogen embrittlement susceptibility of the investigated weldments was rather low for both the applied PWHT conditions.

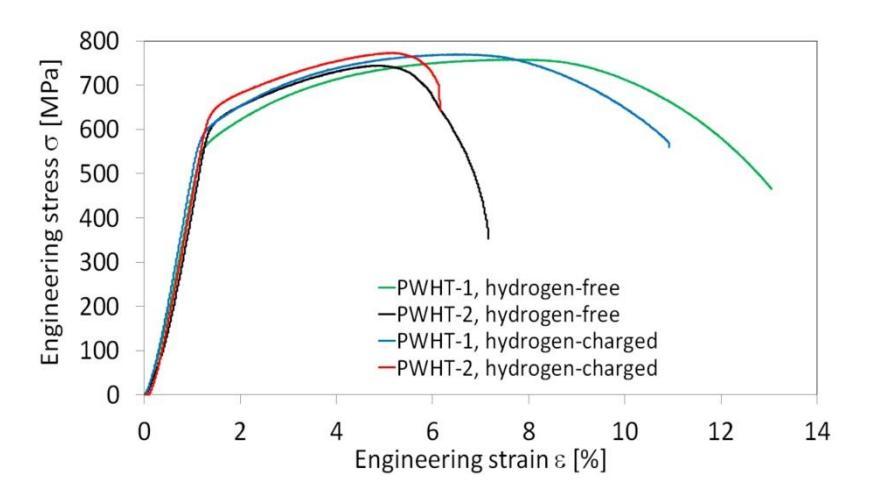
Figure 11. The effects of PWHT conditions and subsequent electrolytic hydrogenation on tensile deformation behavior of investigated T92/T92 weldments.

In our case, the reason to cause localized plasticity is related to the tri-axial stress state (i.e., the stress triaxiality) induced by plastic instability at local microstructural heterogeneities (microstructural notches), namely the HAZ microstructural gradient and WM microstructural heterogeneity in the PWHT-1 and PWHT-2 material states, respectively. For the sake of completeness, it should be noted that for the weldments in PWHT-1 material state, the increased strain hardening effects were observed not only at the final fracture locations but also at the locations of the concurrent necking areas (Figure 9a). The reason for this behavior was to be expected since the c-w configuration of investigated tensile samples implied symmetrical occurrence of equivalent HAZ microstructural gradients at the both sides of welded base materials. The undeformed weldment after the renormalizing-and-tempering PWHT-2 shows equalized course of hardness values as a result of the weld microstructure homogenization (Figure 10). Moreover, the hardness profile of hydrogen-free weldment, initially subjected to the renormalizing-and-tempering PWHT-2, shows after the tensile test the localized strain hardening at the location of final failure in WM. The hydrogen-charged weldment shows the same failure location but without the occurrence of significant strain hardening at fracture location. The observed WM failures occurred likely due to the fact that the WMs represent the critical microstructural regions even after the performed homogenization treatment due to their original as-cast microstructure and thus higher impurity content and inhomogeneity compared to the BM. For comparison, Figure 11 shows four selected engineering stress-strain curves representing the overall tensile deformation behavior of the studied T92/T92 weldments in their individual material states with respect to the used PWHT conditions and hydrogen charging application. From the obtained results, it can be concluded that the tensile deformation and fracture behavior of studied T92/T92 weldments is more sensitive to the initial PWHT conditions than to the applied electrolytic hydrogenation. In spite of the occurrence of certain hydrogen embrittlement in the studied weldments, it has been shown that the thermal deterioration caused by the use of renormalizing-and-tempering PWHT-2 is much more significant. This statement is additionally supported by the fact that the final failure locations are primarily pre-determined by the used PWHT conditions, i.e., regardless of hydrogen charging application. The T92/T92 weldments after the tempering PWHT-1 were always broken in their SC-HAZs, whereas the weldments after the renormalizing-and-tempering PWHT-2 always fractured in their WMs.

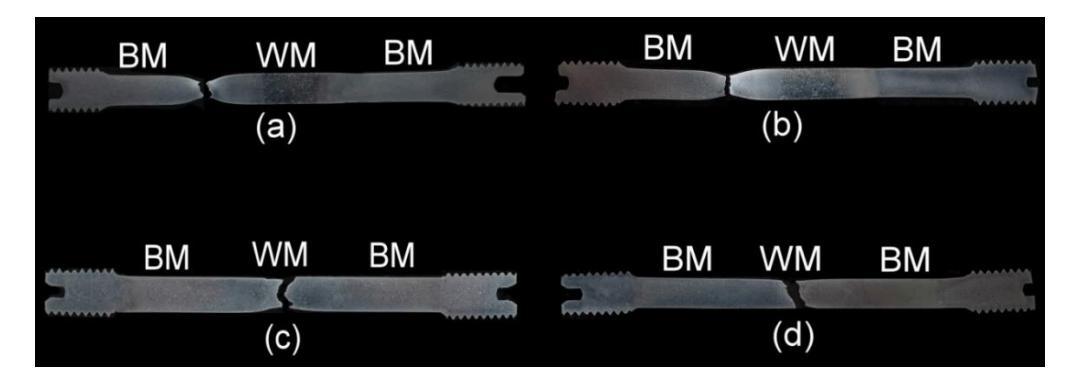
Figure 12. Photo-macrographs of fractured tensile samples' counterparts indicating various failure locations after room-temperature tensile tests of T92/T92 weldments in their individual material states: (a) "PWHT-1"; (b) "PWHT-1 + hydrogen"; (c) "PWHT-2"; (d) "PWHT-2 + hydrogen".

Figure 12 shows representative photo-macrographs of longitudinal sections of the fractured tensile samples' counterparts showing two different failure locations of the studied T92/T92 weldments in their all investigated material states.

As already discussed, and shown in Figure 12, the room-temperature fracture behavior of studied T92/T92 weldments during tensile straining is primarily controlled by the used PWHT conditions, whereas the effect of electrolytic hydrogenation is less critical. The observation of macroscopically ductile failures (Figure 12a,b) within the SC-HAZs of both the hydrogen-free and hydrogen-charged T92/T92 weldments after the tempering PWHT-1 and tensile straining, can be related to higher deformability of the over-tempered SC-HAZs compared to the BM and WM regions. The corresponding fracture analyses for the hydrogen-free and hydrogen-charged weldments initially processed by the PWHT-1 are shown in Figures 13 and 14, respectively. Although the both hydrogen-free and hydrogen-charged weldments in PWHT-1 material state were broken in a recognizably ductile manner in their SC-HAZs (see the fracture paths in Figures 13a and 14a), the signs of hydrogen embrittlement are clearly visible for the hydrogen-charged weldment. In Figures 13a and 14a the SC-HAZ microstructures beneath final fractures are characterized by intensive deformation of grains in a direction of dominating tensile stresses. The microstructure of hydrogen-free weldment after the PWHT-1 (Figure 13a) shows randomly

On the other hand, the observation of rather brittle failures (Figure 12c,d) within the WMs of both the hydrogen-free and hydrogen-charged T92/T92 weldments after the renormalizing-and-tempering PWHT-2 can be related to their lower deformability. It appears as a result of thermal embrittlement and possibly remaining microstructural heterogeneities of the original as-cast WMs microstructures (e.g., dendritic segregation) due to insufficient homogenization (i.e., short time for the alloying

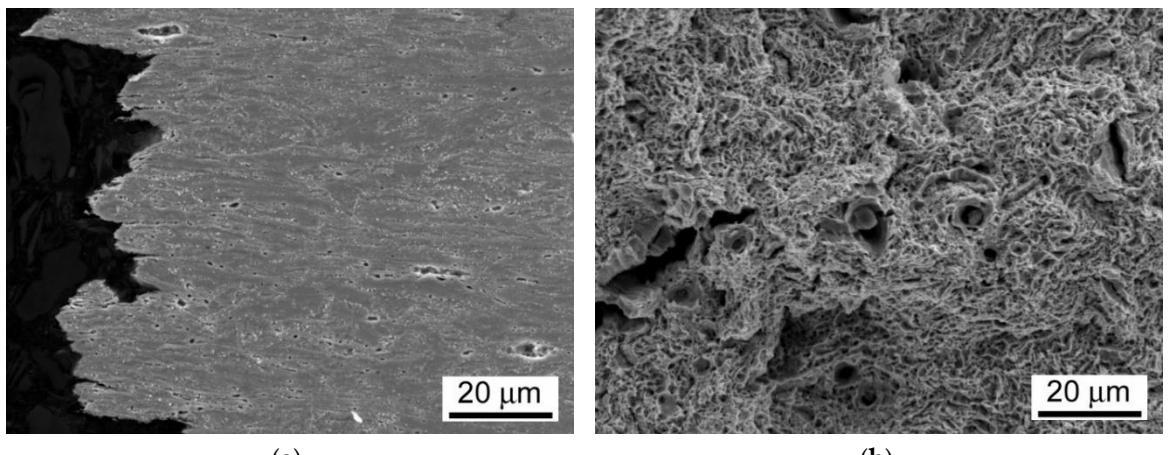
Figure 13. Fracture analysis of hydrogen-free T92/T92 weldment initially processed by the PWHT-1 and subsequently ruptured in SC-HAZ after the room-temperature tensile test: (**a**) fracture path and microstructure beneath the fracture; (**b**) fracture surface showing pure ductile dimple tearing.

distributed precipitates and signs of microvoid coalescence along the elongated grain boundaries indicating the origin of the formation of ductile dimples on the fracture surface (Figure 13b). Whereas the fracture surface of hydrogen-free T92/T92 weldment in PWHT-1 material state shows completely ductile dimple fracture (Figure 13b), the fracture surface of the hydrogen-charged weldment shows quasi-cleavage areas with typical "fish-eye" morphology due to the local hydrogen-embrittlement beside ductile dimple tearing areas (Figure 14b). The hydrogen-assisted cracks and even some grain fragmentation (Figure 14a). The "fish-eye" fractographic object on the fracture surface (Figure 14b) represents the hydrogen embrittled quasi-cleavage zone created radially along the central inclusion.

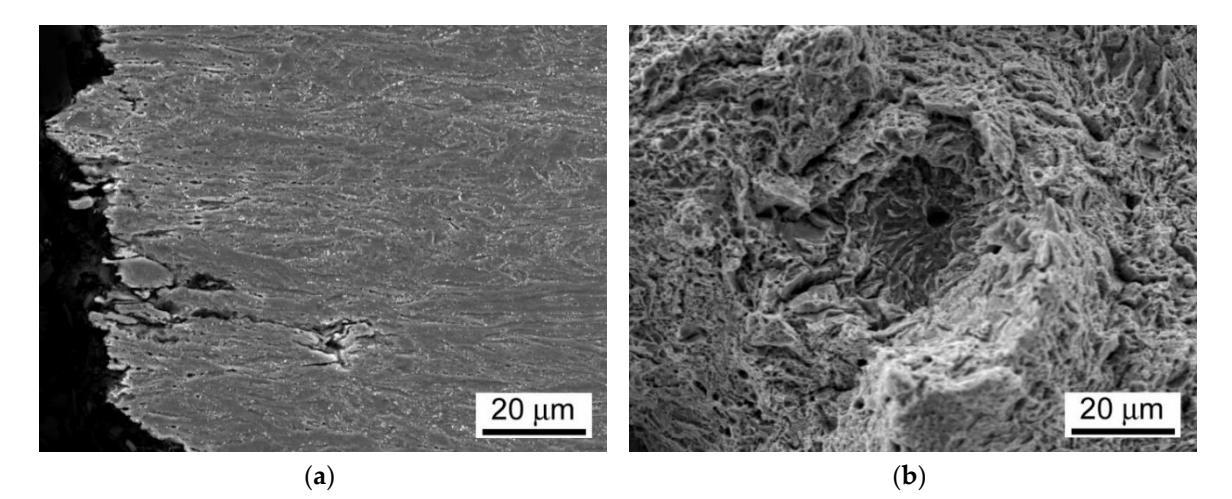
Figure 14. Fracture analysis of hydrogen-charged T92/T92 weldment initially processed by the PWHT-1 and subsequently ruptured in SC-HAZ after the room-temperature tensile test: (**a**) fracture path and microstructure beneath the fracture; (**b**) fracture surface showing mixed fracture consisting of both transgranular quasi-cleavage with a "fish-eye" morphology and ductile dimple tearing.

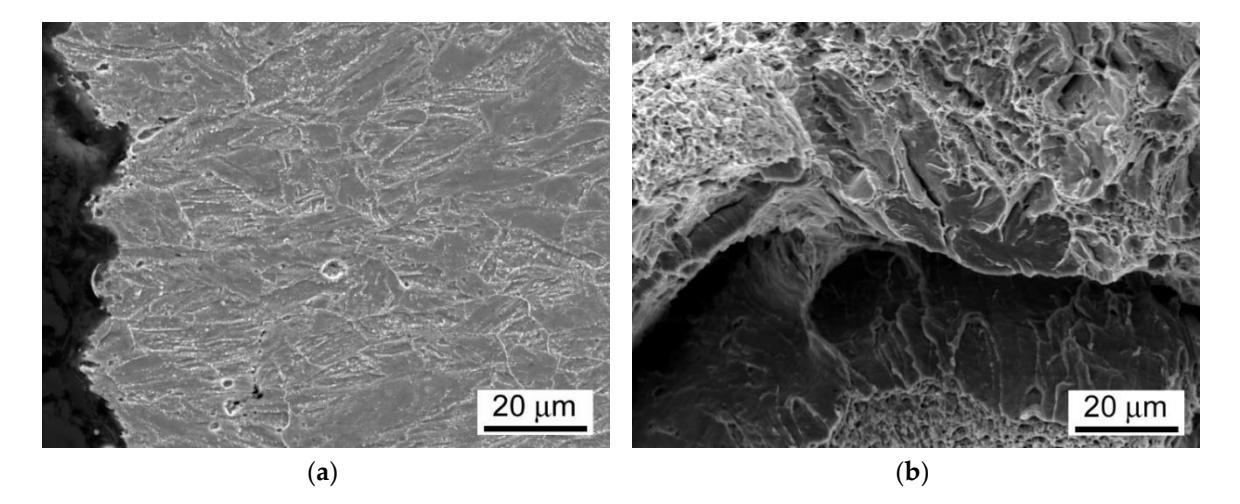
Figure 15. Fracture analysis of hydrogen-free T92/T92 weldment initially processed by the PWHT-2 and subsequently ruptured in WM after the room-temperature tensile test: (**a**) fracture path and microstructure beneath the fracture; (**b**) fracture surface showing mixed fracture consisting of both ductile dimple tearing and transgranular quasi-cleavage.

The fracture paths in Figures 15a and 16a indicate lower ductility failures for both the hydrogen-free and hydrogen-charged T92/T92 weldments after the renormalizing-and-tempering PWHT-2 compared to the weldments after the tempering PWHT-1 (Figures 13a and 14a). The clearer differences between the fracture mechanisms related to the hydrogen-free and hydrogen-charged weldments after the PWHT-2 are distinguishable on the fracture surfaces in Figures 15b and 16b. Whereas the fracture surface of hydrogen-free weldment exhibits mixed fracture mechanisms including the ductile dimple tearing

and transgranular quasi-cleavage (Figure 15b), the fracture surface of hydrogenated weldment shows even more complex fracture mechanisms involving transgranular quasi-cleavage with a "fish-eye" morphology besides ductile dimple tearing and some inter-lath decohesion (Figure 16b). The reason for the observed fracture morphology changes can be explained by considering local microstructural characteristics beneath the fracture surfaces. In Figures 15a and 16a the WM microstructures beneath final fractures are characterized by polygonal grains and sub-grains almost continuously decorated with coarsened secondary phase precipitates indicating thermal embrittlement induced by PWHT-2. That is why the both hydrogen-free and hydrogen-charged samples show mixed fractures consisting of both ductile dimple tearing and brittle transgranular quasi-cleavage (Figures 15b and 16b). The reason for the additional occurrence of "fish-eye" fracture morphology on the fracture surface of the hydrogenated sample treated by PWHT-2 (Figure 16b) is basically the same as in the case of hydrogenated sample after the PWHT-1. However, the higher level of thermal embrittlement after the PWHT-2 was at the same time the reason for higher grade of hydrogen embrittlement due to the existence of more nucleation sites for the creation of "fish-eye" fractographic objects.

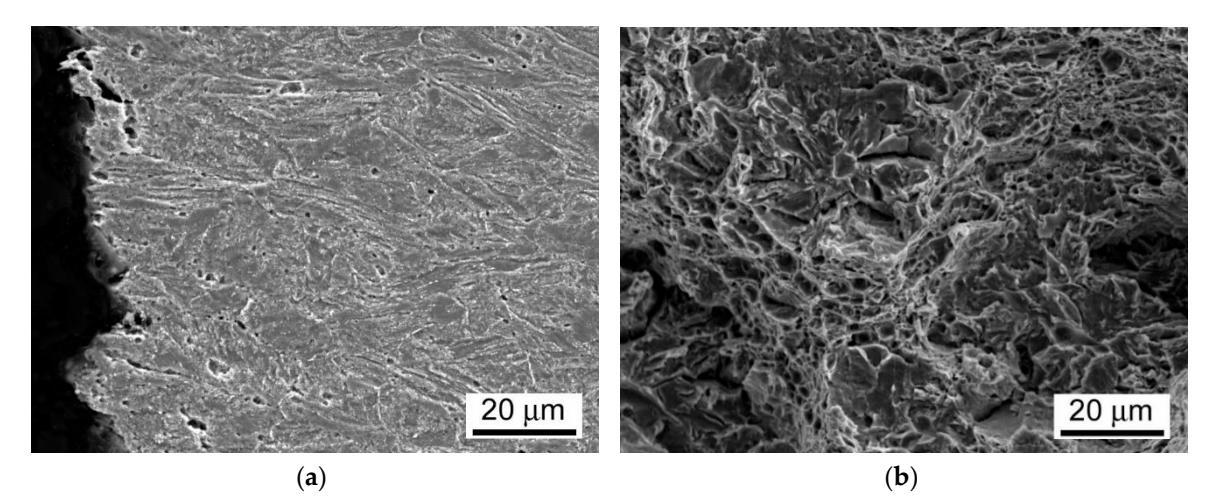
Figure 16. Fracture analysis of hydrogen-charged T92/T92 weldment initially processed by the PWHT-2 and subsequently ruptured in WM after the room-temperature tensile test: (**a**) fracture path and microstructure beneath the fracture; (**b**) fracture surface showing mixed fracture consisting of transgranular quasi-cleavage with a "fish-eye" morphology besides ductile dimple ridges and some inter-lath decohesion areas.
