Article

Selective Laser Melted M300 Maraging Steel—Material Behaviour during Ballistic Testing

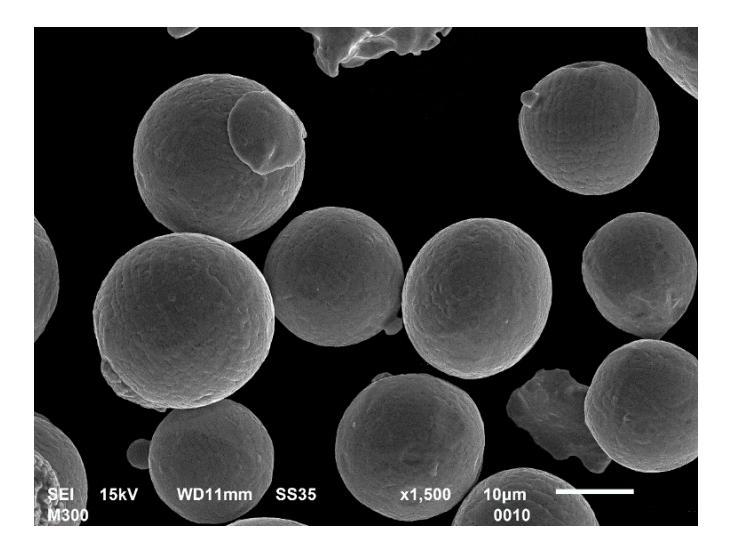
The material used for samples manufacturing was gas atomized M300 maraging steel (Carpenter Additive, Philadelphia, PA, USA). Our own scanning electron microscopy (SEM) observations (Figure 1) indicated that powder particles were characterised by spherical shapes (diameters of 20–63 μ m) with some satellites on the external surface.

Figure 1. SEM image of M300 powder grains.

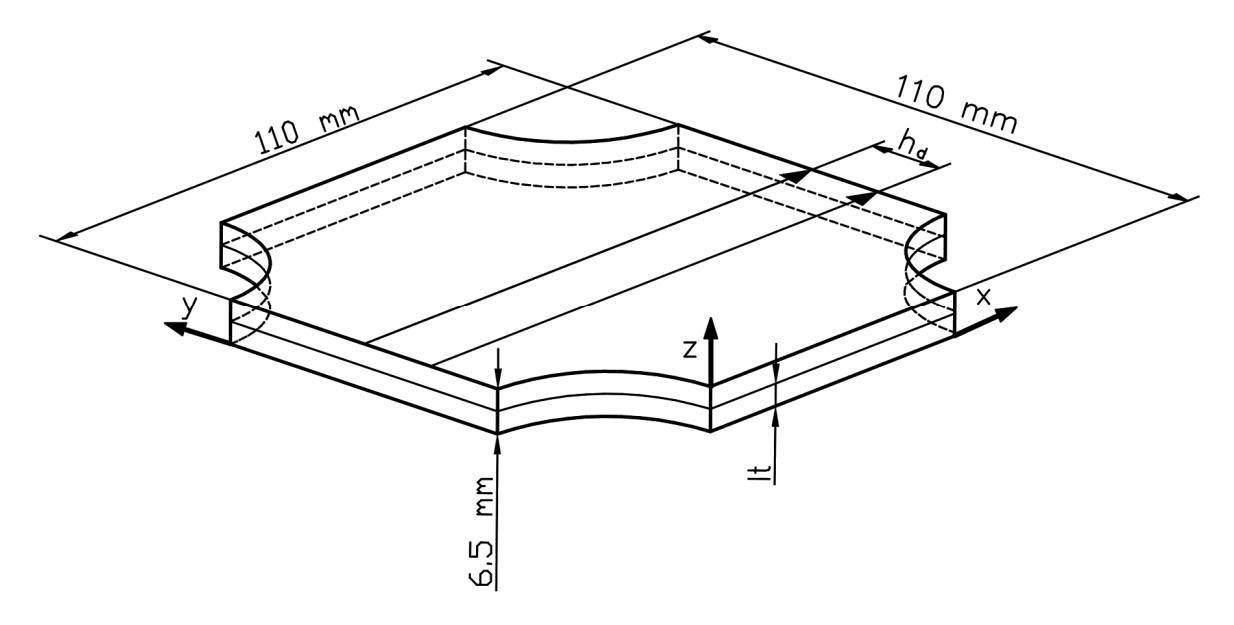
The above mentioned parameters (hatching distance and layer thickness) are shown in Figure 2. The usage of the parameters, as mentioned earlier, values generated energy density at the level of 69.44 J/mm³, which is consistent with the equation:

Figure 2. Explanation of layer thickness, hatching distance values, and sample plate dimension.

For ballistic tests, the samples had a cuboidal shape in the dimension of 110 mm \times 110 mm \times 6.5 mm (L \times W \times H). The height of the sample was selected to allow part penetration during the STANAG 4569 level I test (5.56 mm \times 45 mm NATO projectile (SS109) at 30 meters with a velocity of 910 m/s) and a lack of penetration after a 20% projectile velocity decrease. This approach was suggested to better to understand material behaviour during dynamic loading in ballistic testing. The plate sample, shown in Figure 3, was made in such a way to allow for ballistic testing in a perpendicular direction according to the substrate plate surface (through the deposited material's layers).

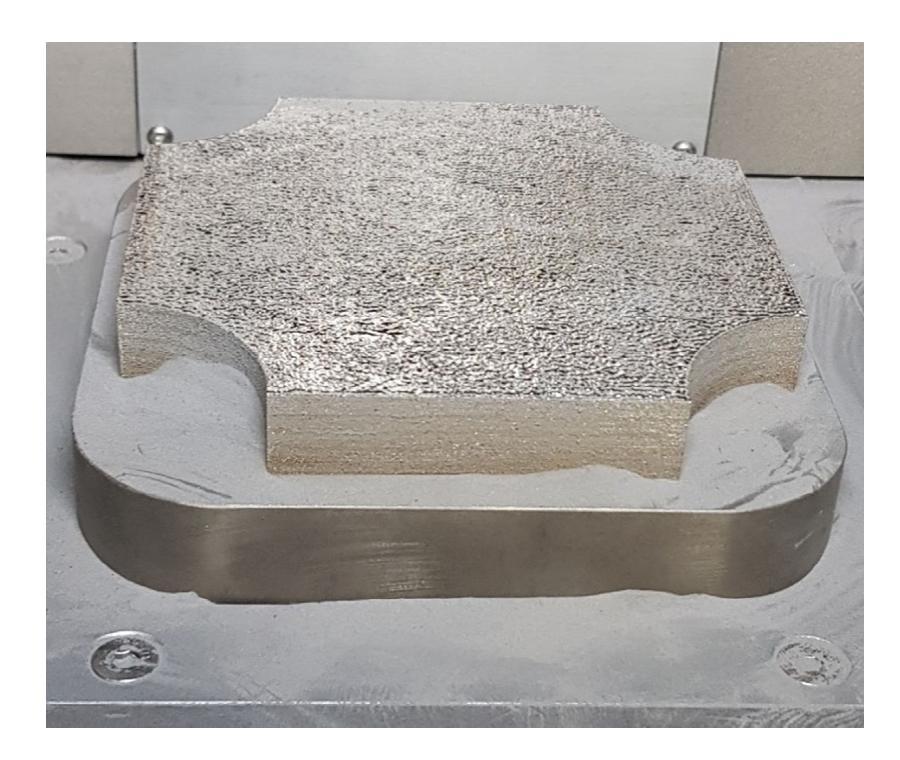
Figure 3. Sample panel on the SLM 125 HL's substrate plate.

Visible cylindrical undercuts on the panel's edges were necessary to allow substrate removal after the process was finished.

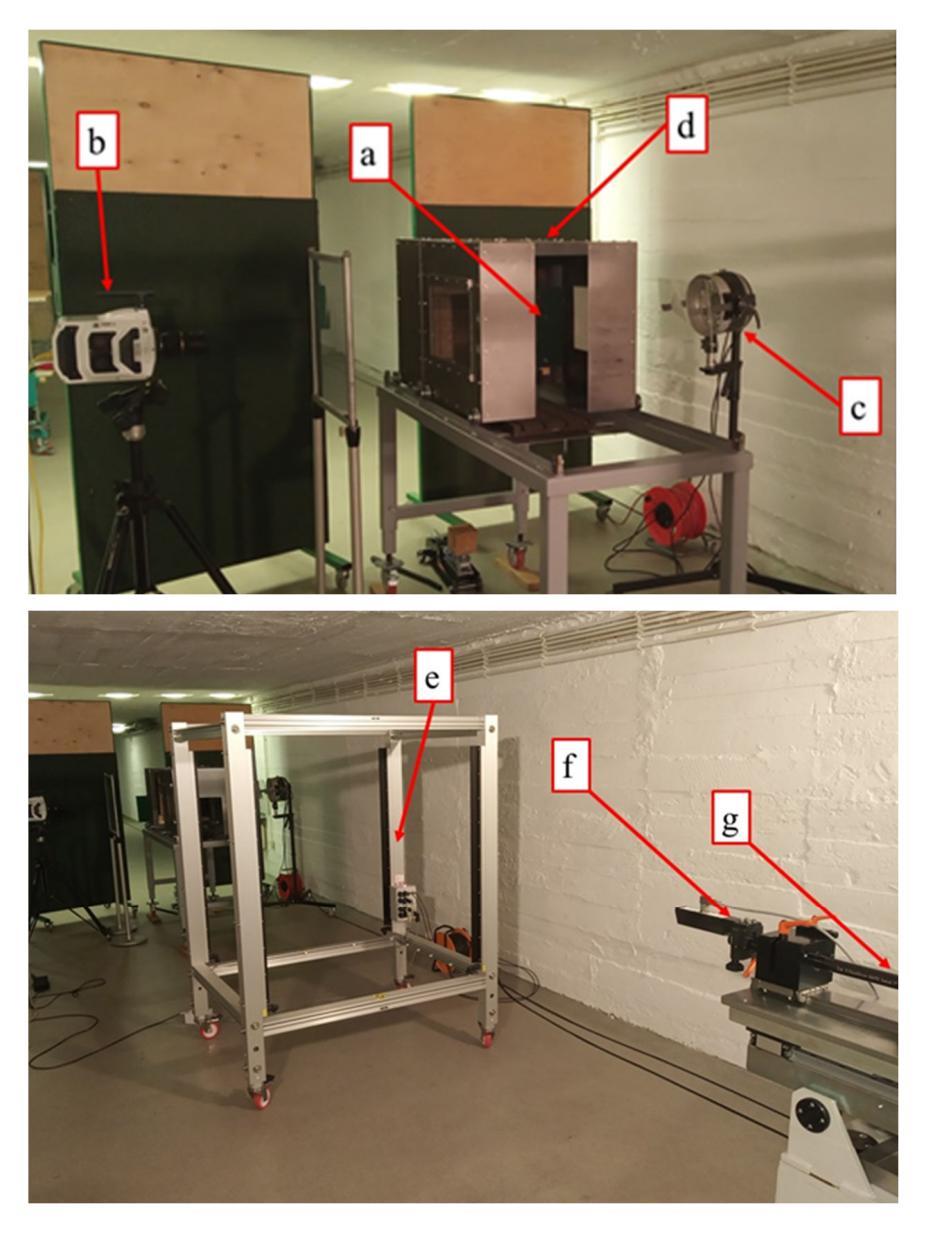
The ballistic tests were carried out using of the experimental stand presented in Figure 4. The stand consisted of a barrel launching system, calibre 5.56 mm (Figure 4g), and a specimen mount (Figure 4a) covered by a protective box with a bullet catcher (Figure 4d). To provide accurate values of impact velocity and to conduct the observation of terminal ballistics effects, a set of three devices were applied: an electromagnetic device for muzzle velocity measurement, EMG–1 (Figure 4f), an intelligent light screen, Kistler 2521A (Figure 4e) (Kistler, Switzerland), for bullet velocity measurement, and a high-speed camera, Phantom v1612 (Figure 4b) (Vision Research, Wayne, NJ, USA). Tests were conducted with 5.56 mm × 45 mm NATO M855 (SS109) steel core bullets. Following the results presented in [36], the expected value of the projectile velocity was equal to (935 \pm 6) m/s regarding the specimen distance for the under–investigation ammunition and applied barrel length. Accounting for the required 20% decrease of impact velocity for the second conditions set, the round propellant mass was adjusted to obtain the velocity of approx. 750 m/s.

Figure 4. Experimental stand for terminal ballistics tests: (a) investigated specimen mount, (b) high-speed camera, (c) light source, (d) protective box with bullet catcher, (e) intelligent light screen, (f) electromagnetic muzzle device, and (g) barrel launching system, calibre 5.56 mm.

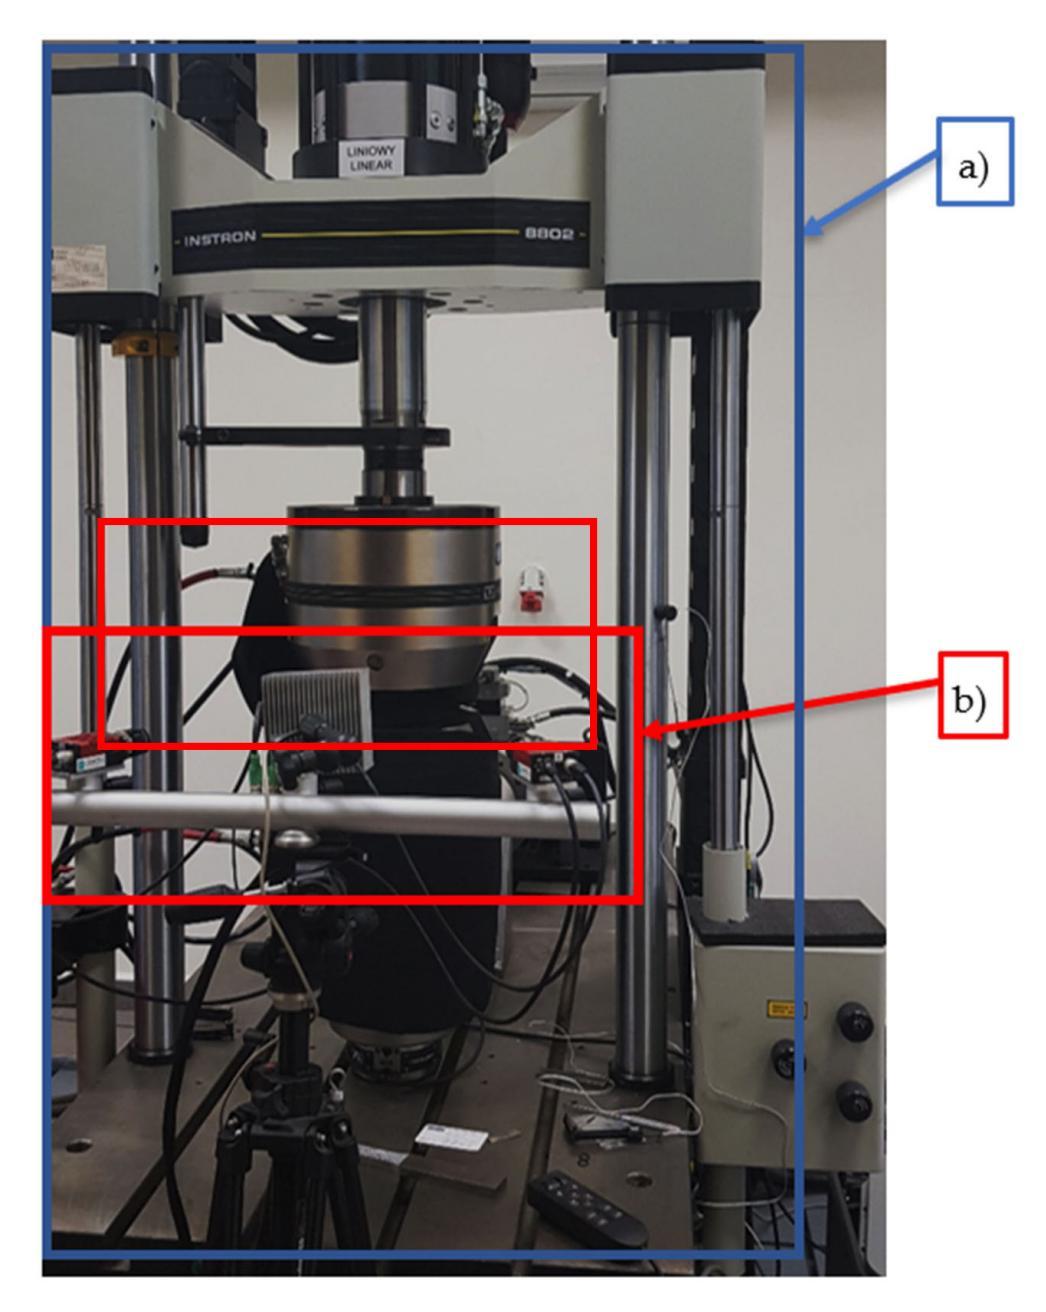
A Keyence VHX 7000 optical microscope (Keyence International, Mechelen, Belgium) was used for surface structural and fractures analysis. The material was mounted in resin, ground, polished, and etched to allow microstructural observations. Additional studies for determining powder grain shape and some microfracture phenomena were completed using a Jeol JSM-6610 SEM (JEOL Ltd., Tokyo, Japan) scanning electron microscope (SEM). To better describe material behaviour, tensile testing of samples was used. The tensile tests were carried out via the Instron 8802 (Instron, Norwood, MA, USA) testing machine. During those tests, digital image correlation (DIC) of the deformation process was made. DIC analyses, a non-contact optical technique to measure three-dimensional (3D) deformations, were made using Dantec Dynamics (Dantec, Ulm, Germany). The tensile testing rig with the DIC system is shown in Figure 5.

Figure 5. Servo-hydraulic pulsator for tensile tests Instron 8802 (**a**) with digital image correlation system DIC (**b**).

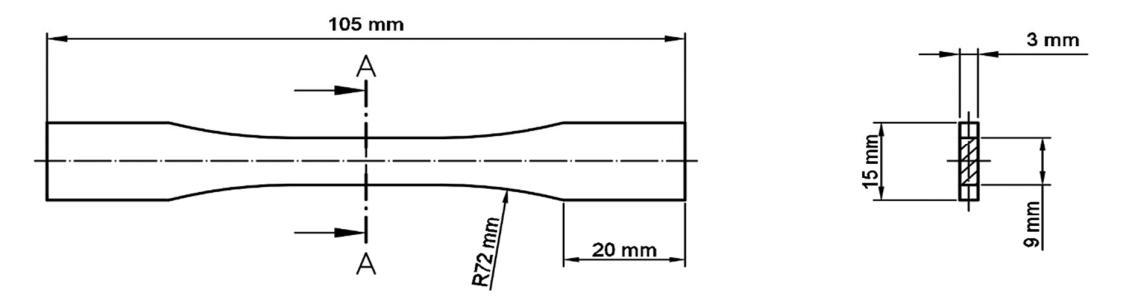
To check how the material's properties were changed after heat treatment, tensile tests were conducted on samples for which geometry was designed based on the ASTM E466 96 standard (Figure 6). For each material condition, five samples were tested.

Figure 6. Sample dimensions basing on the ASTM E466 96 standard.

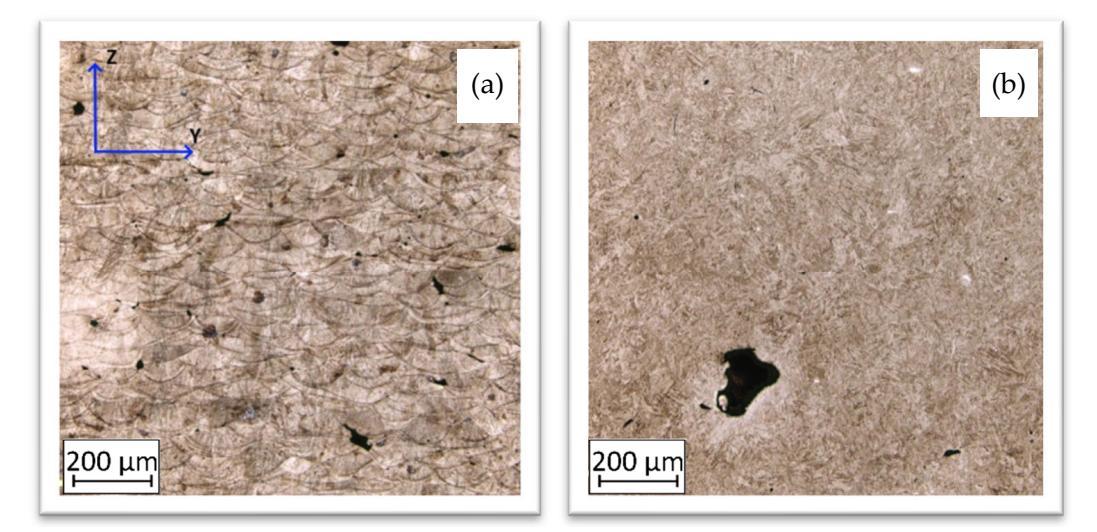
The images of the material microstructure in each condition are shown in Figure 7. Z-direction, visible in Figure 7, is a direction of the material's layers growth during AM process.

Figure 7. Microstructure of the AM M300 steel in BHT (a) and AHT (b) conditions.

Heat treatment resulted in a more homogeneous and fine-grained structure. It should be noted that the martensite needles were short and dark, which contributed either to an increase in hardness or a decreased material plasticity [39,40].

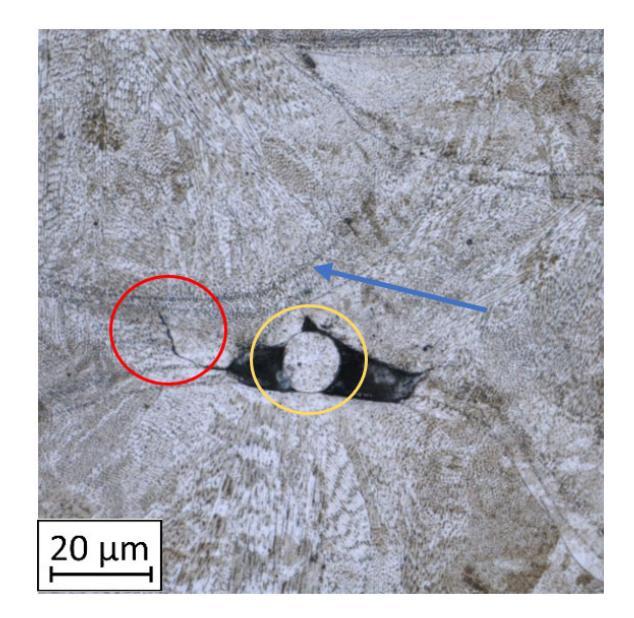
The material condition after the AM process is characterised by a typical, layered structure with visible molten pools [37,38]. The microstructure is very fine and regular in each molten pool, as is shown in Figure 8.

Figure 8. Microstructure of the AM M300 in BHT condition with marked crack (red circle) from non-melted grain (yellow circle) and visible melt-pool boundary (blue arrow).

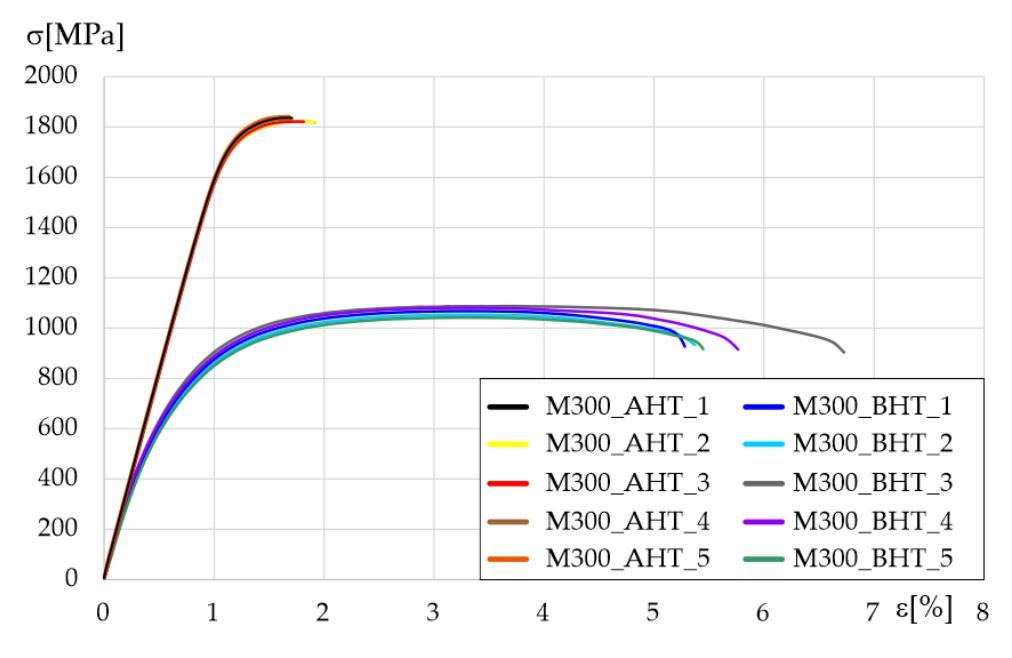
Tensile testing results for each sample group are shown in Figure 9. After heat treatment, tensile strength increased by almost 45% but, at the same time, elongation decreased by 67%, which significantly changed material properties, especially regarding its behaviour during dynamic loading such as ballistics testing.

Figure 9. Tensile test results of M300 steel in AHT and BHT conditions.

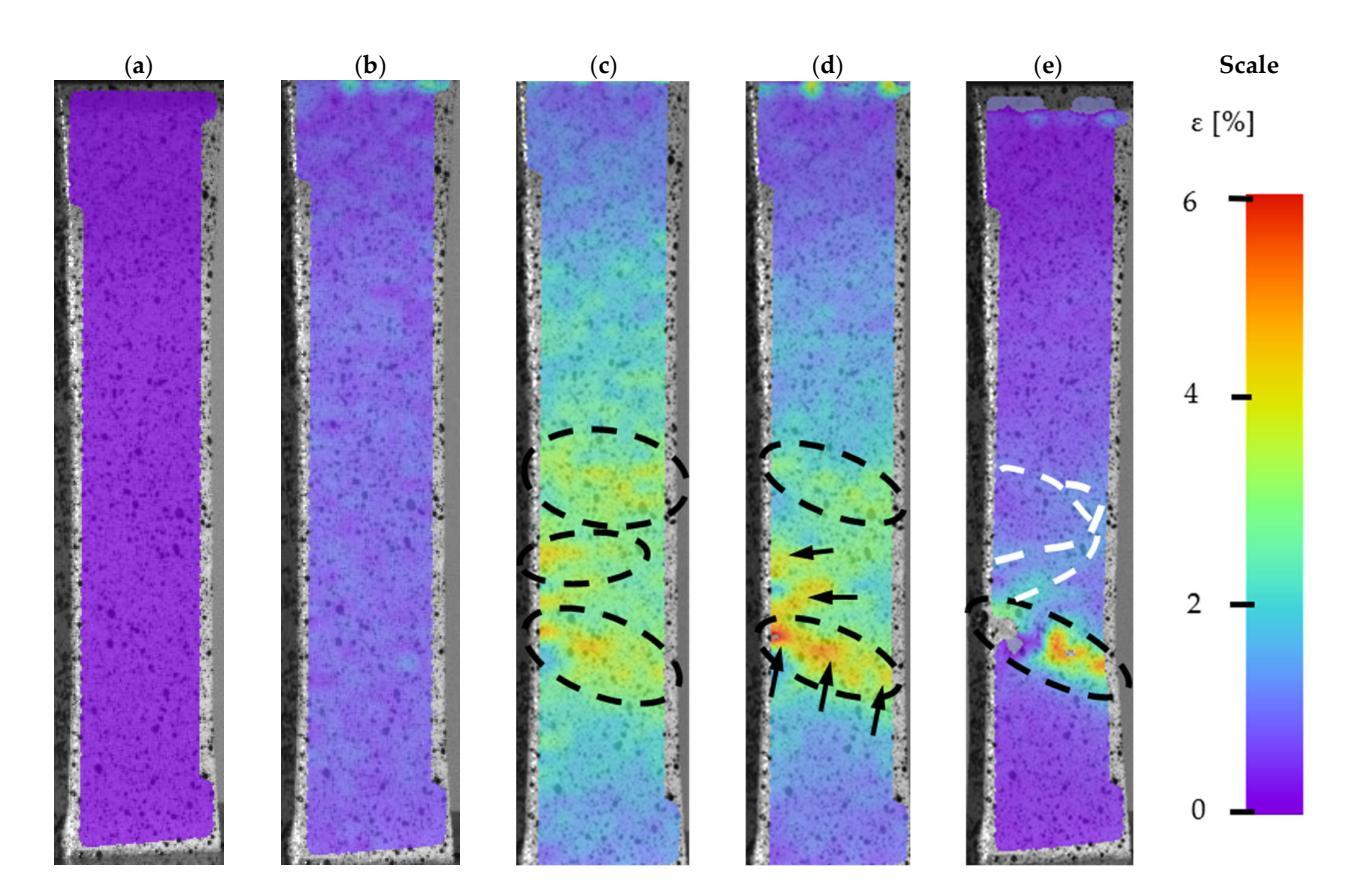
More advanced tensile analysis of the samples was possible by using a DIC system. To adequately describe material behaviour during tensile testing, images at a certain level were taken (Figure 10) for BHT samples and for (Figure 11) AHT samples.

Figure 10. DIC of M300 steel in BHT condition during tensile testing, (**a**) a reference sample before the tensile testing, (**b**) Rp 0.2% proof strength, (**c**) the ultimate tensile strength (UTS) point, (**d**) breaking point, and (**e**) a sample after a fracture.

In the conventional yield point, the distribution of strain fields was very even. The sample showed no defect connected with the manufacturing process. In the case of material strain at the ultimate tensile strength point, the areas of maximum strain were marked with oval lines. There was a banding effect visible, which is evenly distributed. Before sample destruction (Figure 10d), a significant deformation at the level of 5% revealed areas of potential sources of cracking. Their location and number might relate to part porosity, which is visible in Figure 7. Considering the DIC image after fracture (Figure 10e), deformation fields are visible despite the lack of load. The white-dotted line (Figure 10e) indicates relaxation by the fracture, which appeared as a strain banding.

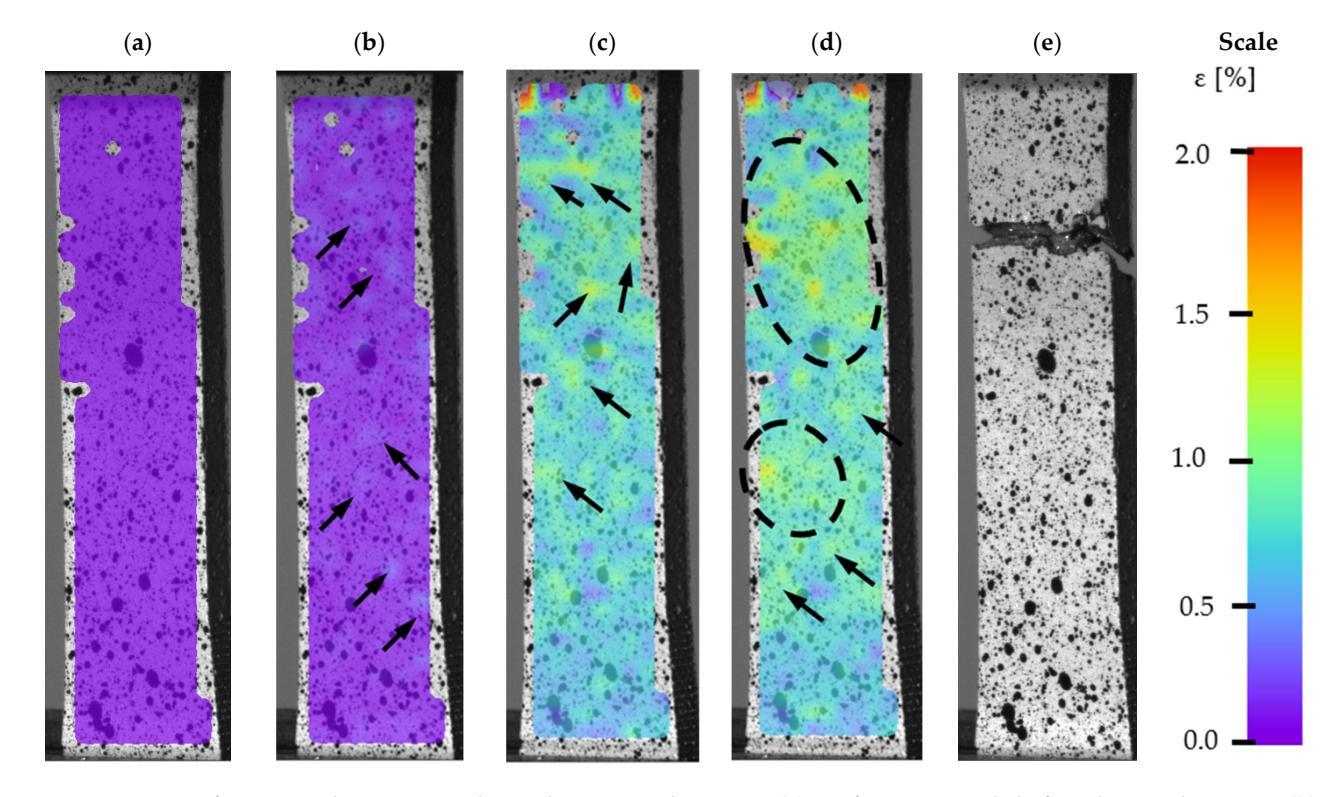
Figure 11. DIC of M300 steel in AHT condition during tensile testing, (**a**) a reference sample before the tensile testing, (**b**) Rp 0.2% proof strength, (**c**) the ultimate tensile strength (UTS) point, (**d**) breaking point, and (**e**) a sample after a fracture.

The DIC images captured during tensile tests of samples in the AHT condition are shown in Figure 11. To maintain consistency, the form of the obtained results is presented the same as in Figure 10. In the conventional yield point, there were visible small areas with increased strain value. This phenomenon could be related to the increased porosity caused by additional heat treatment [32]. The distribution of that area (marked using black arrows) is randomly placed on the whole sample's surface.

In the case of the DIC image at the UTS point, there were no zones of constant strain. Only small areas of increased strain values were visible (Figure 11, dashed line). After exceeding the UTS point, no necking formation was visible, which indicates the brittleness and low plasticity of the material. In the last part of the material fracture, the cracking process was very dynamic, which caused the scale in Figure 10e to go out of the range. The course of the fracture line, which is complex, may be related to the irregular porosity and brittleness of the material.

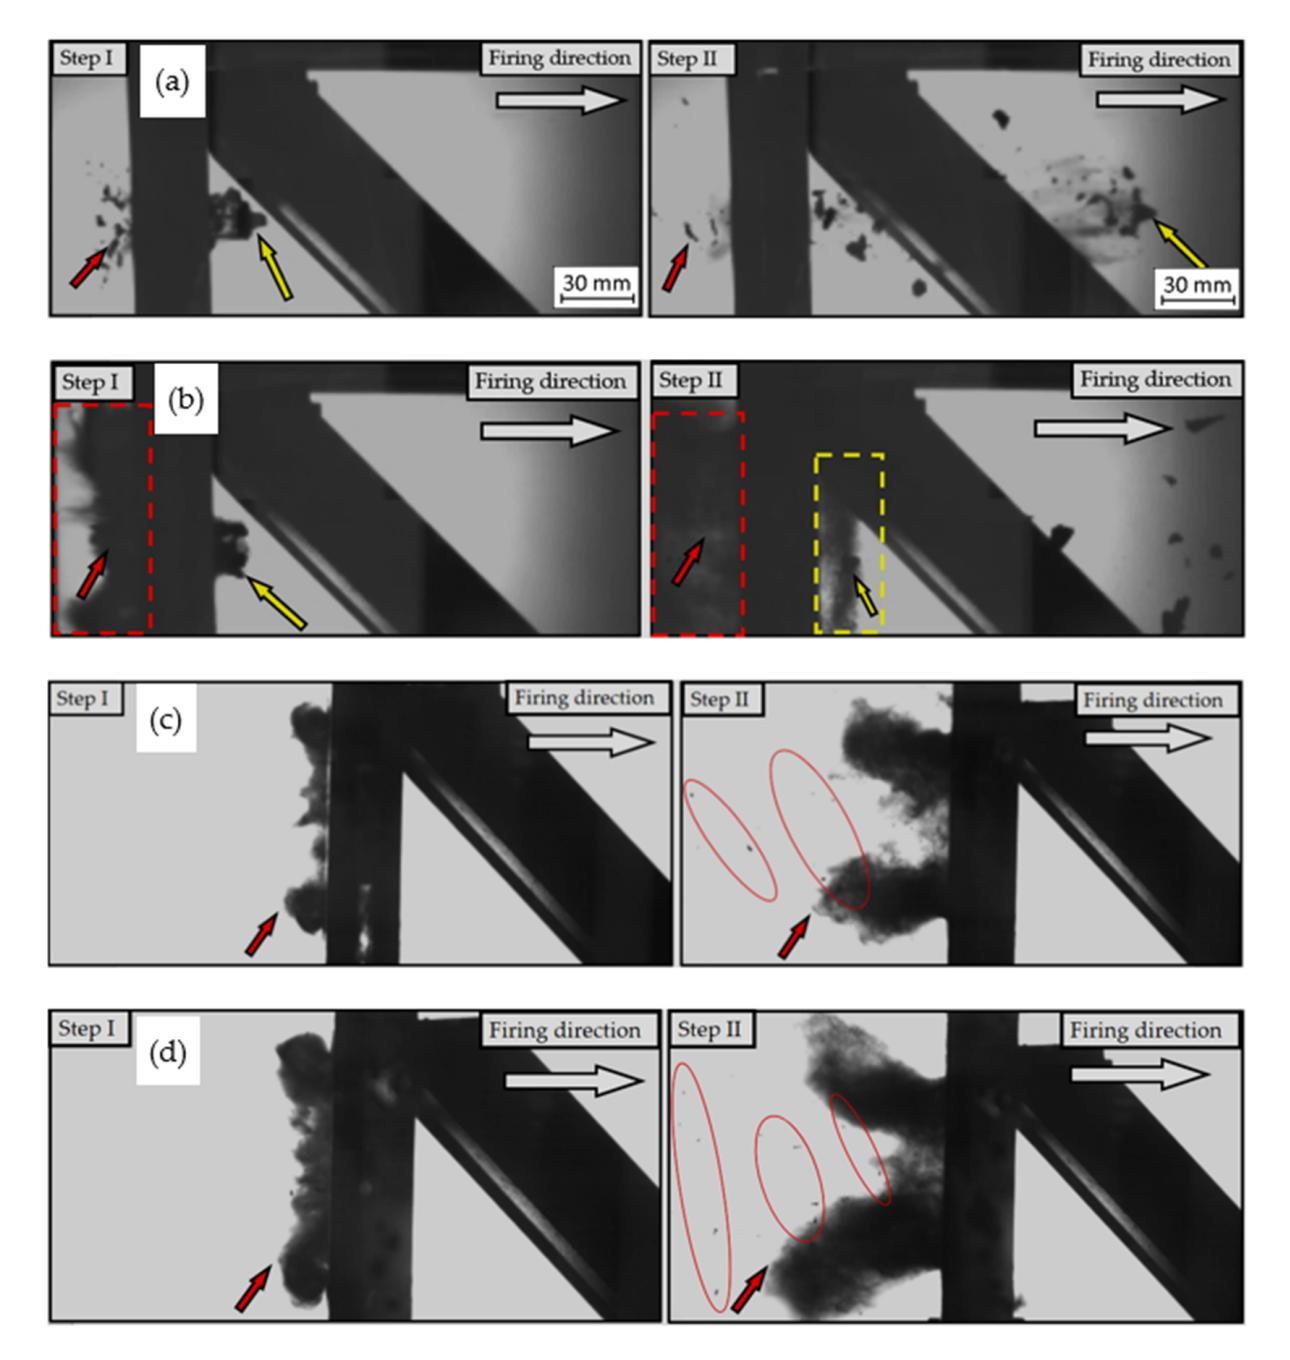
The material behaviour during the perforation of each target plate is shown in Figure 12. Figure 12 contains ballistic test results captured by a high-speed camera, which allowed for the determination of the perforation mechanism during projectile penetration.

There were many failure mechanisms for the sample in the BHT condition, which was penetrated by projectile with a velocity equal to 936 m/s (Figure 12a). The first one was the plugging mechanism, highlighted in Table 3 using a yellow arrow to show the cut-out plug. During that kind of mechanism, the fragmentation of the material appeared in the form of several pieces of material with additional reverse fragmentation (marked by a red arrow in Figure 12a) and the generation of numerous shards on both sides.

Figure 12. High-speed camera images captured during plates perforation: (**a**) BHT condition, 936m/s impact velocity; (**b**) AHT condition, 918m/s impact velocity; (**c**) BHT condition, 746m/s impact velocity; (**d**) AHT condition, 743m/s impact velocity.

Typical material fragmentation occurred for the AHT sample penetrated by a projectile with a velocity of 918 m/s (Figure 12b). A yellow arrow marked severed material parts. Particular attention should be paid to the dust formed during the penetration of this sample (it was marked with a yellow and red rectangle in Figure 12b) as this is a typical phenomenon in armour steels.

In the case of a plate in BHT condition, penetrated by a projectile with a velocity of 746 m/s, there was no perforation registered. In this case, a dust cloud had formed on the side of the projectile impact. Several small parts of the material were also spotted (Figure 12c Step II, red oval). This proves the plasticity of the material and good dispersion of the impact energy compared with plates in the AHT condition.

Regarding the last sample in AHT condition penetrated by a projectile with a velocity of 743 m/s, there was also no perforation. As in the previous case, a dust cloud was generated, but with more significant dimensions. Additionally, a greater number of tiny debris were noticed (Figure 12d, red ovals). Their increased number could be caused by a higher hardness of the material and its internal cracking.

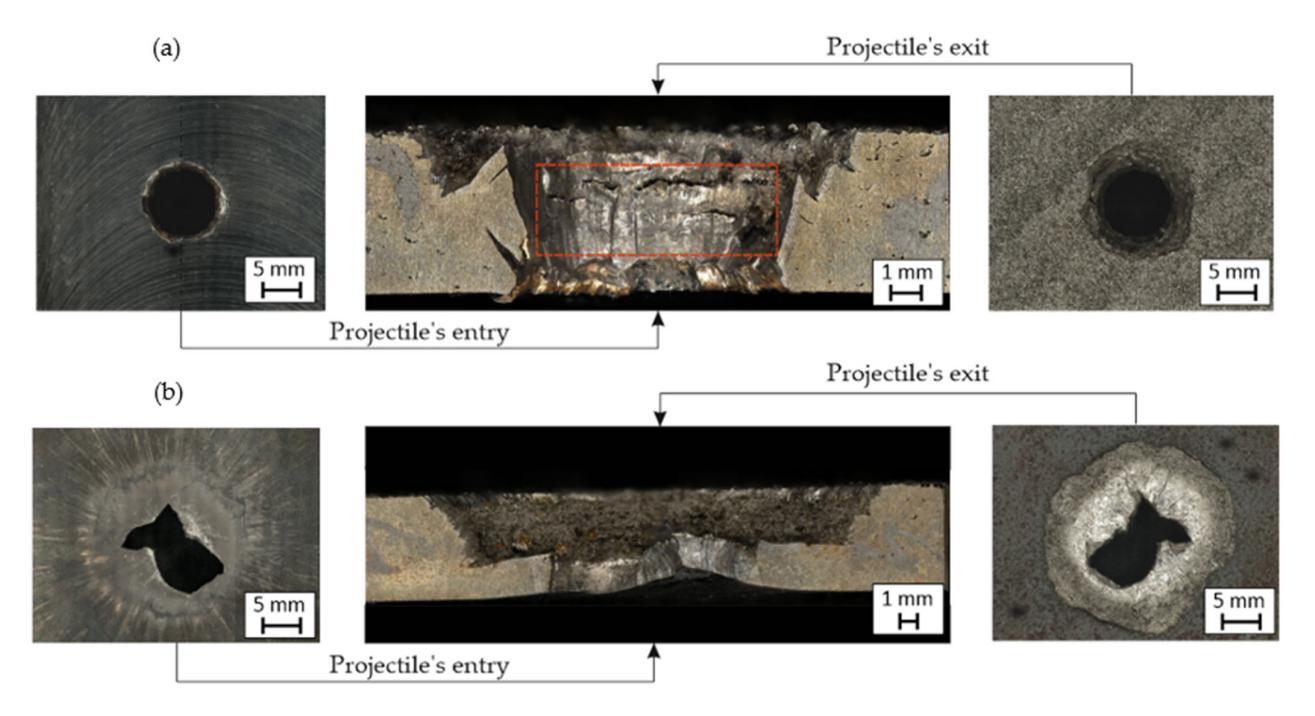
In the case of perforated plates penetrated by a projectile with a higher velocity (920 m/s), additional macroscopic analysis was completed as shown in Figure 13.

Figure 13. Fractures of projectile entry and exit of both penetrated plates: (a) BHT (b) AHT.

In both cases (BHT and AHT plates), many features were visible and characteristic of high-hardness material perforations. Comparing both cases, the material plate in the BHT condition seems to be more plastic than the AHT plates. The projectile's lead cap caused a slight deformation on the entry side and left a small amount of its material on the external perforation surface. On the other side, a plug with a diameter like the perforation size was pushed out by the projectile. The surface of the perforation, shown in Figure 14 (areas a), was characterised by a significant deformation, which indicates the material's ductility in that area. This phenomenon might cause a local increase in temperature during perforation due to friction between the surface of the projectile and the panel. That kind of approach was suggested by Kristoffersen et al. [9]. However, this issue requires more detailed research and will be a topic for further research. Additionally, there were cracks visible around the contact of the projectile and the plate, which indicates a material tendency for delamination (samples were manufactured layer-by-layer and perpendicular to the surface of the layer was the projectile impact) after such dynamic loading.

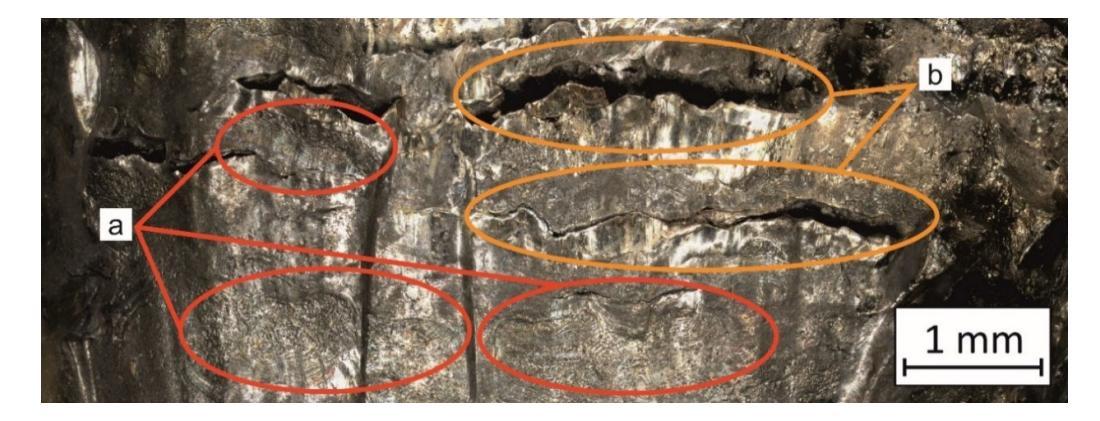
Figure 14. Perforation channel surface with visible deformed areas (a) and cracks (b) of the BHT plate.

In the case of the ATH panel, the perforation channel on the projectile entrance side had an irregular shape due to the brittle tearing of the material which appeared as short and straight crack paths. Further penetration mechanisms caused a radial fracture and detachment of a large material part several times larger area than the projectile's crosssectional area. That phenomenon also caused material fragmentation. However, the fragmentation of the material does not indicate its ballistic resistance as it is only a result of its low ductility. In the cross-section of the perforation channel, a horizontal border was visible (Figure 14, areas b) from which the radial tearing of the material began. It indicates an interlayer cracking mechanism which may be caused by the layered structure of the AM material.
