# Article **Precipitation Evolution in the Austenitic Heat-Resistant Steel HR3C upon Creep at 700** °C and 750 °C

Abstract: HR3C (25Cr-20Ni-Nb-N) is a key material used in heat exchangers in supercritical power plants. Its creep properties and microstructural evolution has been extensively studied at or below 650 °C. The precipitation evolution in HR3C steel after creep rupture at elevated temperatures of 700 °C and 750 °C with a stress range of 70~180 MPa is characterized in this paper. The threshold strength at 700 °C and 750 °C were determined by extrapolation method to be  $\sigma_{10^5}^{700} = 57.1$  MPa and  $\sigma_{10^5}^{750} = 37.5$  MPa, respectively. A corresponding microstructure investigation indicated that the main precipitates precipitated during creep exposure are Z-phase (NbCrN), M<sub>23</sub>C<sub>6</sub>, and  $\sigma$  phase. The dense Z-phase precipitated dispersively in the austenite matrix along dislocation lines, and remained stable (both size and fraction) during long-term creep exposure. M<sub>23</sub>C<sub>6</sub> preferentially precipitated at grain boundaries, and coarsening was observed in all creep specimens with some continuous precipitation of g

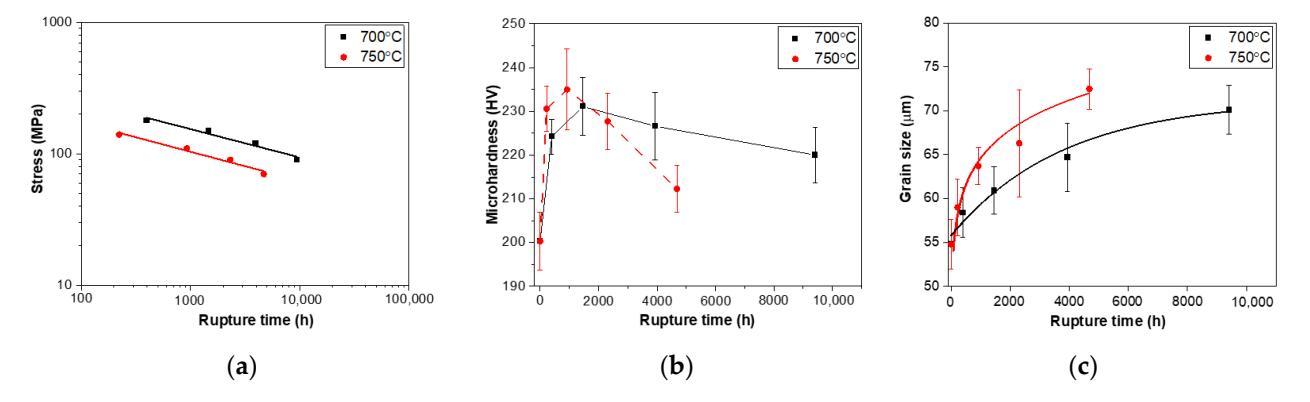
Figure 1. (a) The log-log plot of stress versus rupture time, (b) microhardness versus rupture time, and (c) grain size versus rupture time.

The relationship between the applied stress and microhardness as a function of time till rupture is shown in Figure 1. The curve in Figure 1a shows that the long-term creep rupture strengths of HR3C can be expressed by linear regression:

Figure 1b shows the variation of Vickers microhardness with rupture time. The microhardness increases rapidly at the early stages of the creep test and reaches the maximum value of 231 HV at 700 °C/1463 h and 235 HV at 750 °C/2310 h. Then, the microhardness decreases again with prolonged creep duration. The early increase in microhardness results from the continuous precipitation of  $M_{23}C_6$  in the early stage of the creep.

The average grain size of HR3C steel was measured with low-magnification optical microscope images by the average grain intercept (AGI) method according to ASTM E112-13. The variation in grain size is shown in Figure 1c below. According to the ideal grain growth,

The calculated value of k with the fitting curves is 0.162 and 0.372 at 700 °C and 750 °C, respectively, which means the grain growth rate at 750 °C is much faster than at 700 °C.

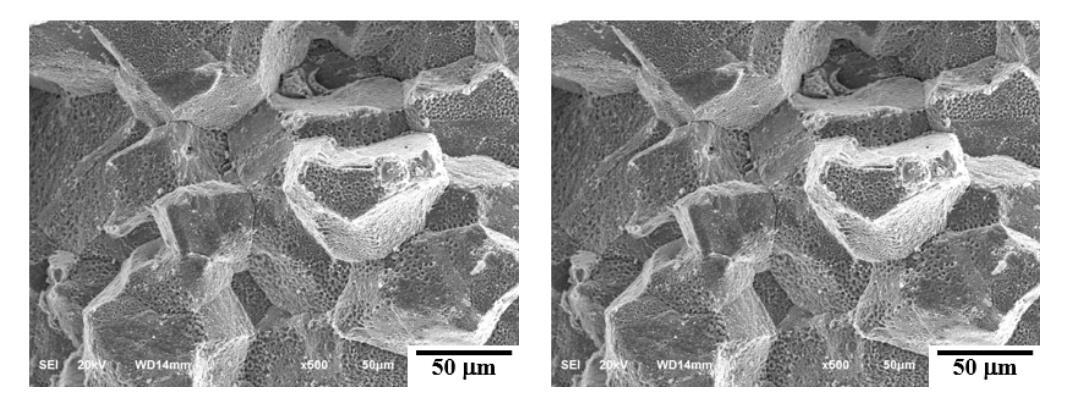
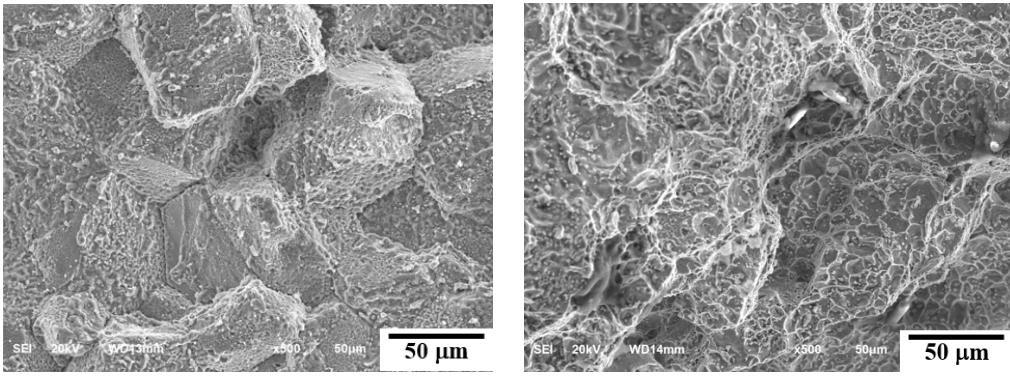
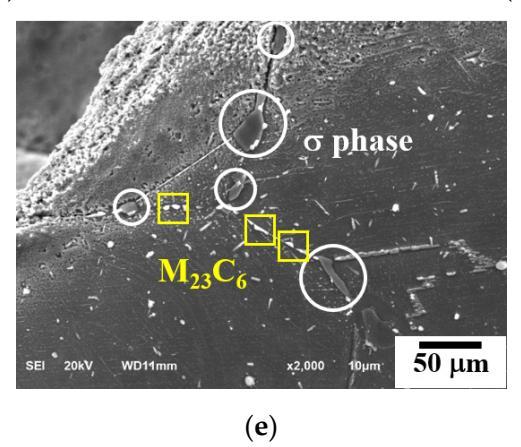
**Figure 2.** SEM micrographs of crept fractures: (**a**) 700 °C/180 MPa/398 h, (**b**) 700 °C/150 MPa/1463 h, (**c**) 700 °C/120 MPa/3945 h, (**d**) 700 °C/90 MPa/9411 h, and (**e**) electropolished fracture surface of (**d**).

SEM micrographs of the rupture surface at 700 °C and 750 °C are shown in Figures 2 and 3, respectively. Figures 2a–c and 3a,b show a totally intergranular brittle fracture feature with cleavage and a rock candy fracture surface. However, with decreasing applied stress and increasing time to rupture, a dimpled morphology appears on the grain facets at 700 °C/90 MPa/9411 h in Figure 2d and 750 °C/90 MPa/2310 h, 750 °C/70 MPa/4680 h in Figure 3c,d. Creep is a time-dependent deformation under a constant load or stress at elevated temperatures. Generally, the creep of a metal has three stages.

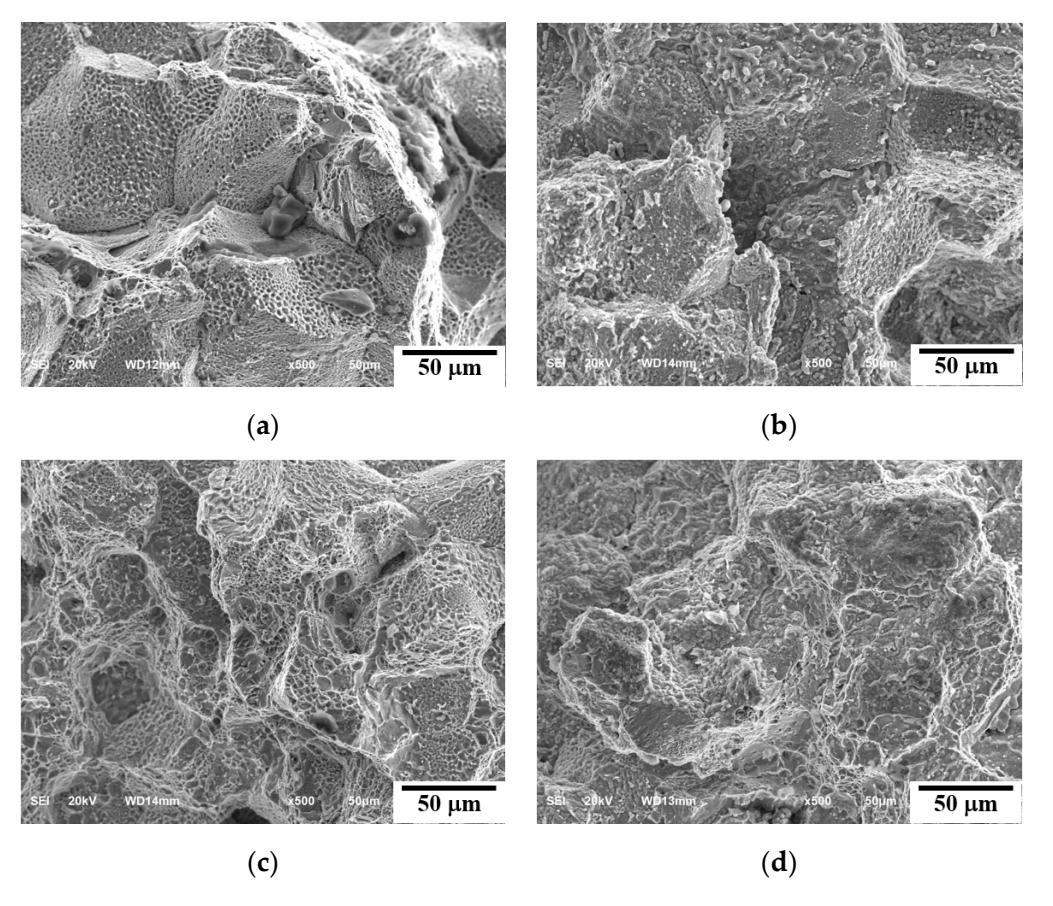
**Figure 3.** SEM micrographs of crept fractures: (**a**) 750 °C/150 MPa/222 h, (**b**) 750 °C/110 MPa/925 h, (**c**) 750 °C/90 MPa/2310 h, and (**d**) 750 °C/70 MPa/4680 h.

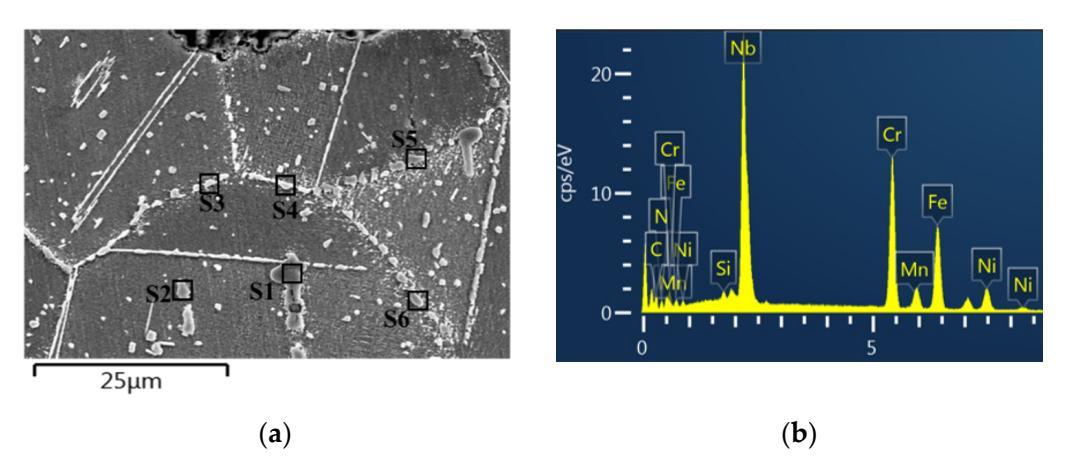
**Figure 4.** EDS analysis of precipitates in the 700  $^{\circ}$ C/90 MPa/9411 h crept specimen: (a) SEM micrographs in the near-fracture region, (b) the corresponding spectrum of site 1 (S1) and (c) EDS results of S1 $^{\circ}$ S6 in (a) with red letters for major elements.

Typical precipitates of HR3C steel after the creep rupture test and the corresponding EDS results are shown in Figure 4. The EDS shows excessive precipitation at the grain boundaries and inside the grains. The large undissolved particles inside the grains are Cr- and Nb-rich nitrides at site 1 and site 2 (S1 and S2) in Figure 4a, and are the primary Z-phase. The continuous chain-like precipitates in the grain boundary are identified as Cr-rich  $M_{23}C_6$  carbides at site 3 and site 4 (S3 and S4) in Figure 4a. In addition, the large blocky particles (~2 µm) are Fe- and Cr-rich  $\sigma$  phases at site 5 and site 6 (S5 and S6).

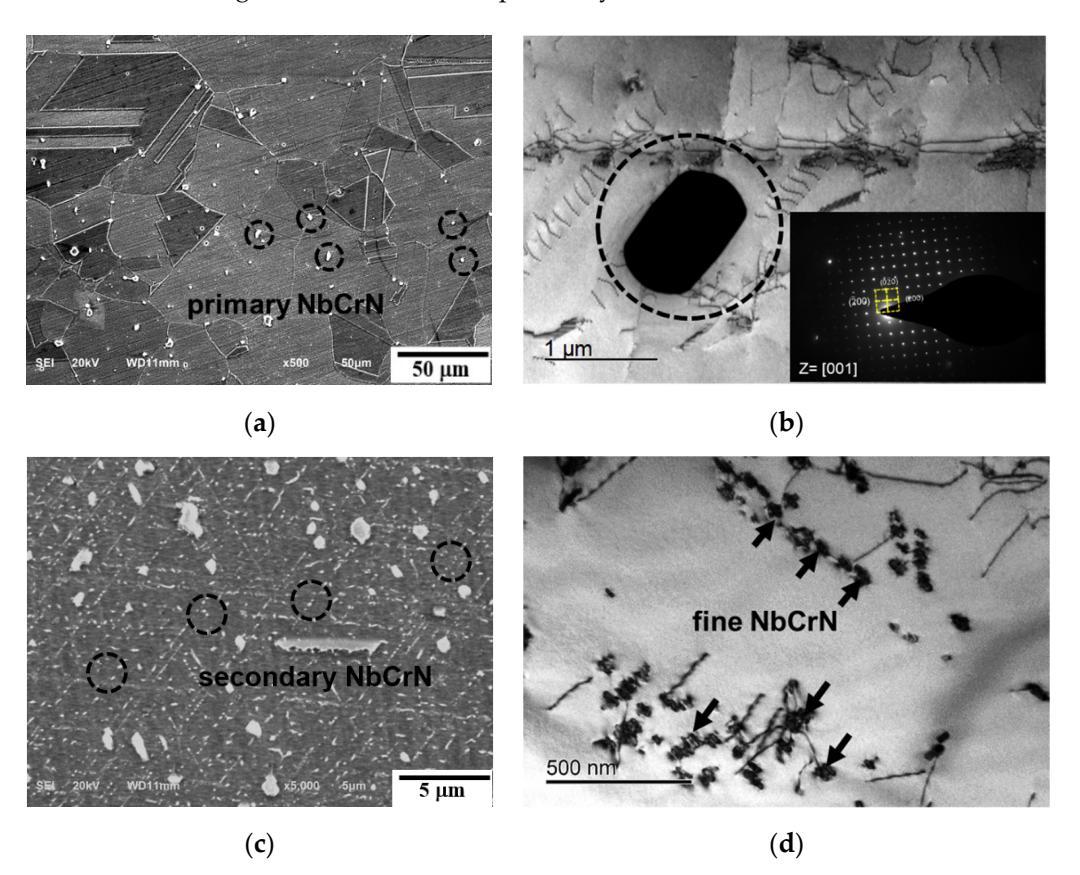
**Figure 5.** SEM and TEM micrographs of Z-phase in the specimen of: (**a**,**b**) as-received, (**c**,**d**) 700 °C/ 90 MPa/9411 h.

Figure 5 shows the Z-phase particles in the as-received and creep rupture specimens of 700  $^{\circ}$ C/90 MPa/9411 h. In the as-received specimen, the Z-phase precipitated in the austenite matrix uniformly, as shown in Figure 5. These coarse undissolved particles are considered as primary Z-phase with a size of ~1 µm. This was also reported by Zieliński, A [17]. In specimens with longer times to rupture, a fine Z-phase is observed, as shown in Figure 5c,d, also called the secondary Z-phase, with a size of ~50 nm. By interacting with the dislocations, present in high density, this fine dispersion of Z-phase enhances the strength of the matrix, as reported by Hu et al. [18].

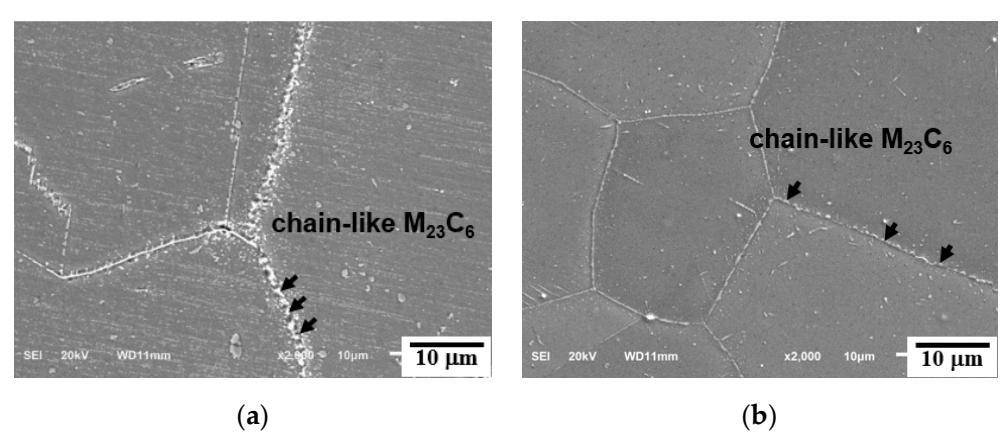
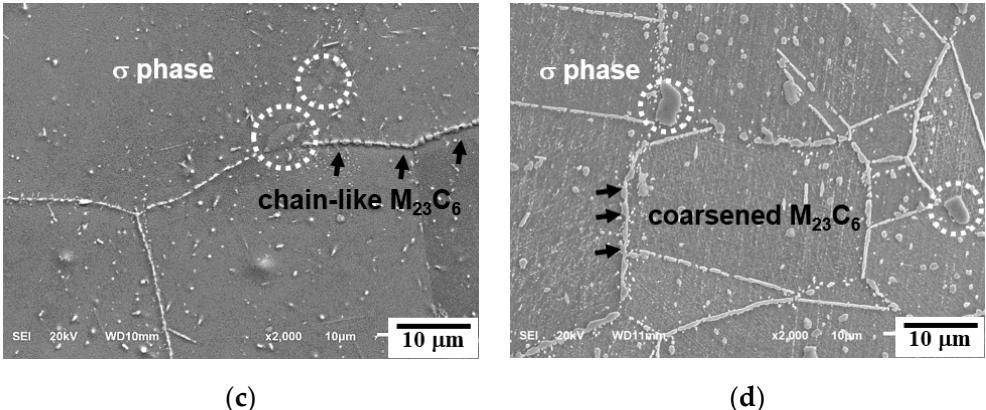
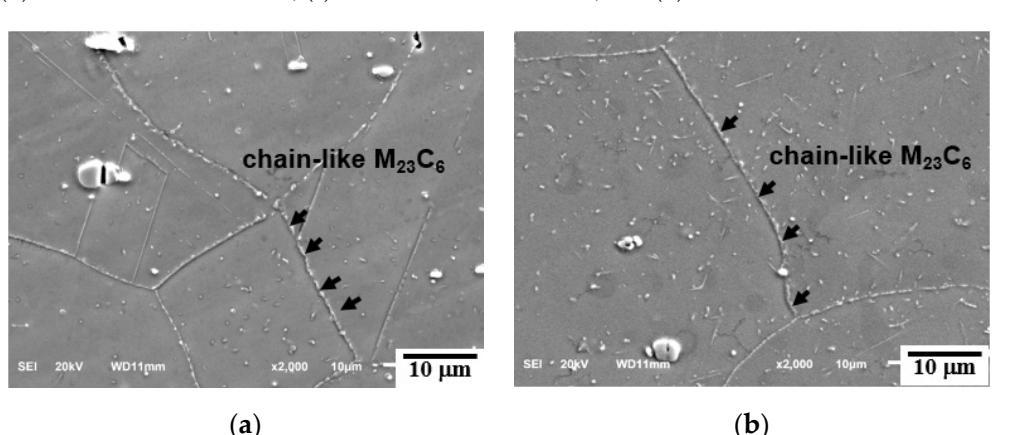
**Figure 6.** SEM micrographs from cross-sectional fractures of creep specimens: (**a**) 700 °C/180 MPa/398 h, (**b**) 700 °C/150 MPa/1463 h, (**c**) 700 °C/120 MPa/3945 h, and (**d**) 700 °C/90 MPa/9411 h.

The SEM micrographs of a triple junction of the grain boundaries of creep-ruptured specimens at 700 °C and 750 °C are shown in Figures 6 and 7. The  $M_{23}C_6$  precipitation is a diffusion-type phase transformation controlled by the driving force for nucleation and the diffusion of the C and Cr atoms in the austenite steel. Therefore, as shown in Figures 6a and 7a, the rod-like  $M_{23}C_6$  particles (~200 nm) preferentially precipitated at the grain boundaries at the early stage of creep due to the higher interfacial energy of grain boundaries and its higher atom diffusion rate compared to those of the grain interiors [19,20]. With prolonged creep time, the  $M_{23}C_6$  particles at the grain boundaries coarsened (up to ~600 nm) and gradually grew into chains, thereby decreasing the pinning efficiency. Meanwhile, the granular  $M_{23}C_6$  particles (~200 nm) continuously precipitated in the matrix with the extension of the creep rupture time.

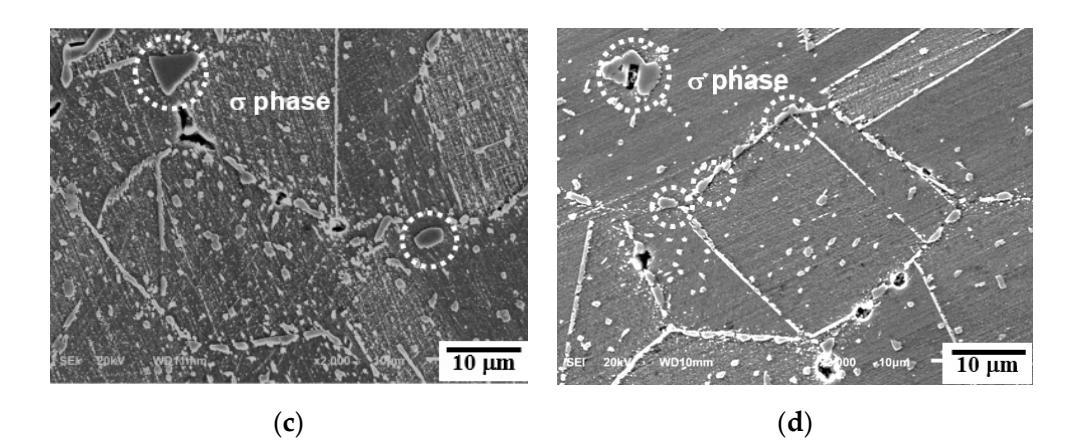
**Figure 7.** SEM micrographs from cross-sectional fractures of creep specimens: (**a**) 750 °C/150 MPa/222 h, (**b**) 750 °C/110 MPa/925 h, (**c**) 750 °C/90 MPa/2310 h, and (**d**) 750 °C/70 MPa/4680 h.

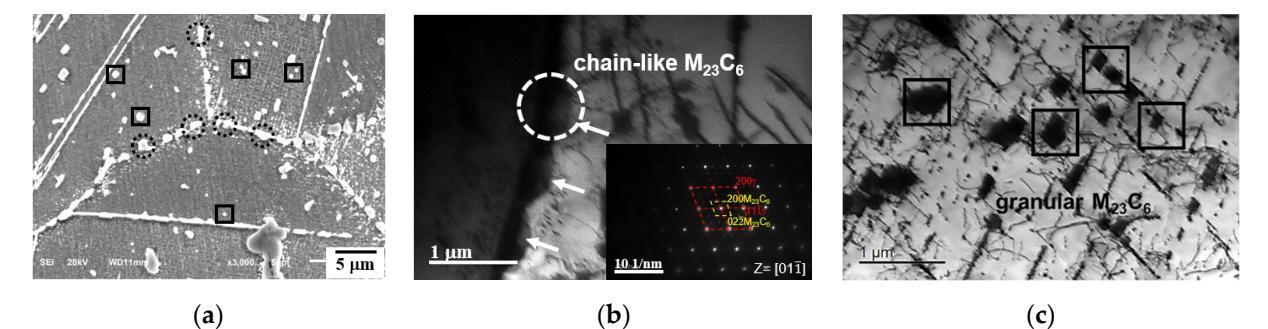
**Figure 8.** Distribution of  $M_{23}C_6$  in the 9411 h crept specimen: (a) SEM micrographs of two kinds of  $M_{23}C_6$ , (b) TEM micrographs of coarsened  $M_{23}C_6$  distributed along the grain boundary, and (c) TEM micrographs of fine  $M_{23}C_6$  in the grain interior. Precipitates in dotted circles indicate chain-like  $M_{23}C_6$  at the grain boundary and precipitates in solid rectangles indicate granular  $M_{23}C_6$  in the grain interior.

Figure 8 shows the distribution of  $M_{23}C_6$  in the 9411 h crept specimen. The chain-like  $M_{23}C_6$  carbides distributed along the grain boundaries and fine granular  $M_{23}C_6$  carbides precipitated in the grain interior are shown in Figures 8b and 8c, respectively. Consistent with Figures 6a and 7a, the preferred precipitation of  $M_{23}C_6$  carbides at the grain boundaries occurred due to the grain boundary having a higher interfacial energy and a faster diffusion rate for alloying atoms than in the grain interior [21]. The  $M_{23}C_6$  carbides precipitated in the grain boundaries could provide good creep resistance due to the pinning effects of grain boundaries at the early stage of creep. However,  $M_{23}C_6$  carbides noticeably weakened the grain boundaries and increased the risk of embrittlement. In addition, the growth of Cr-rich  $M_{23}C_6$  consumed Cr from the matrix and contributed to the formation of a Cr-depleted region near the grain boundaries, resulting in intergranular corrosion [23–25]. On the other hand, the fine  $M_{23}C_6$  precipitated in the grain interior increased the strength of the matrix through precipitate hardening and preventing the motion of dislocations according to the Orowan law, as shown in Figure 8c.

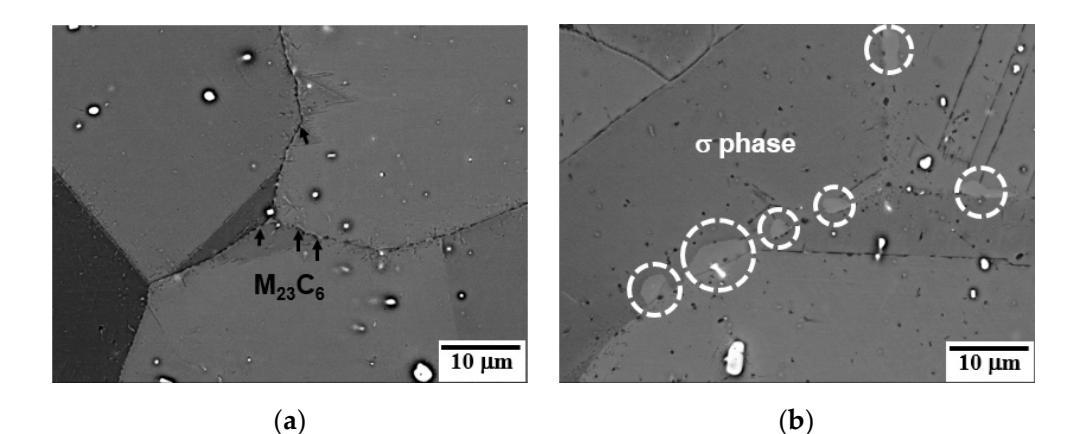
**Figure 9.** ECCI micrographs from cross-sectional fractures of creep specimens: (**a**) 700 °C/180 MPa/ 398 h, (**b**) 700 °C/90 MPa/9411 h, (**c**) 750 °C/150 MPa/222 h, and (**d**) 750 °C/70 MPa/4680 h.

The ECCI micrographs of precipitations in the grain boundaries are shown in Figure 9. It can be seen that only  $M_{23}C_6$  carbides are observed in the grain boundaries at the beginning of the creep process, Figure 9a,c. At creep times of 3945 h at 700 °C and 2310 h at 750 °C, the blocky  $\sigma$  phase was observed at the grain boundaries. It can be seen that the blocky  $\sigma$  phase grew and connected to a larger  $\sigma$  phase "island", serving as nucleation sites for high stress concentration and creep cavities and leading to the propagation of cracks on the grain boundaries and an eventual intergranular fracture, as shown in Figure 9d.

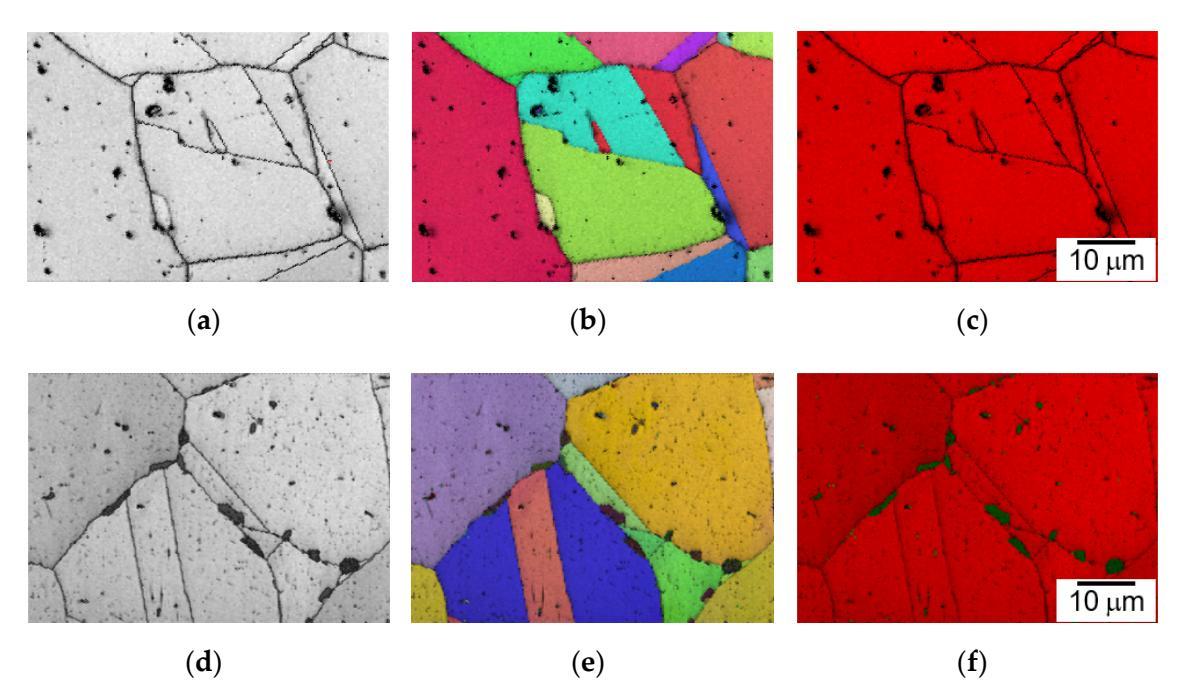
**Figure 10.** EBSD micrographs of 398 h crept specimen: (**a**) image quality, (**b**) inverse pole figure, and (**c**) phase map with grain boundary; and 9411 h crept specimen with  $\sigma$  phase: (**d**) image quality, (**e**) inverse pole figure, and (**f**) phase map with grain boundary.

The EBSD micrographs of 398 h and 9411 h crept specimens at 700 °C are shown in Figure 10. As shown in Figure 10a–c, there is no  $\sigma$  phase observed at 398 h. At 9411 h, the blocky  $\sigma$  phase formed along the high-angle grain boundaries, as presented in Figure 10d–f.

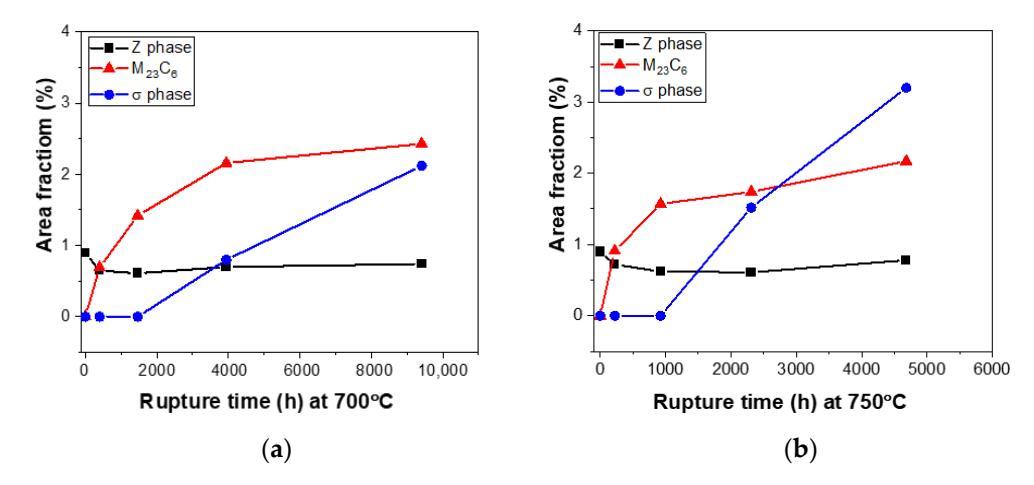
**Figure 11.** Precipitation evolution of Z-phase,  $M_{23}C_6$ , and  $\sigma$  phase at (**a**) 700 °C and (**b**) 750 °C.

Figure 11 shows the area fractions of Z-phase,  $M_{23}C_6$ , and  $\sigma$  phase at the two temperatures. Note that the fraction of Z-phase changes little with creep time and temperature compared to the  $M_{23}C_6$  and  $\sigma$  phase due to its slower nucleation and growth rate [10]. In addition, the size of the fine Z-phase remains s at ~50 nm. In contrast, the fraction of  $M_{23}C_6$  and  $\sigma$  phase grow linearly with creep time. The growth rate of  $M_{23}C_6$  gradually decreases at both temperatures. This has two main reasons: (1) though the preferred  $M_{23}C_6$ precipitate at the grain boundaries is easily coarsened with increasing creep time, the fine  $M_{23}C_6$  carbides in the grain interior are stable; (2) the precipitation of  $\sigma$  phase consumes the Fe and Cr, presumably suppressing the formation of  $M_{23}C_6$  carbides [11]. The early increase in microhardness results from the continuous precipitation of  $M_{23}C_6$  in the early stage of the creep as shown in Figure 2b. The growth of the  $\sigma$  phase is linear at the grain boundaries (the first three data points are  $\sigma$  phase free). The growth rate of  $\sigma$  phase at 750 °C is almost twice that at 700 °C.
