Article Analysis of the Mechanical Properties and Damage Mechanism of Carbon Fiber/Epoxy Composites under UV Aging

Citation: Shi, Z.; Zou, C.; Zhou, F.; Zhao, J. Analysis of the Mechanical Properties and Damage Mechanism of Carbon Fiber/Epoxy Composites under UV Aging. *Materials* **2022**, *15*, 2919. https://doi.org/10.3390/ ma15082919

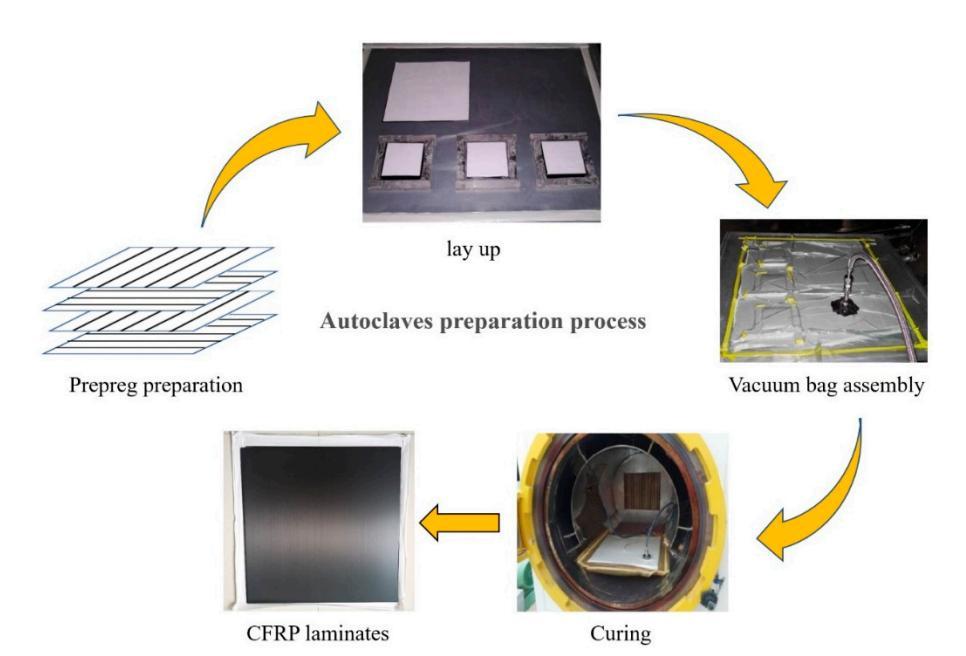
molding process, and the preparation procedures are shown in Figure 1. First, the laminate lay-up design was considered, and the prepreg was cut to the desired shape. Then, the lay-up was performed, encapsulated in a vacuum bag, and placed in an autoclave for curing, where the curing temperature of the autoclave was 130 °C, the curing time was 2 h, and the pressure was 1.5 MPa, as shown in Figure 2. After the CFRP composites were cured, we waited for the temperature inside the tank to drop to room temperature and ensured complete pressure relief before opening the hatch to remove the material. Next, the raw edges of the composites were removed and numbered for backup. Finally, the required test specimens were cut.

Figure 1. CFRP composite preparation process.

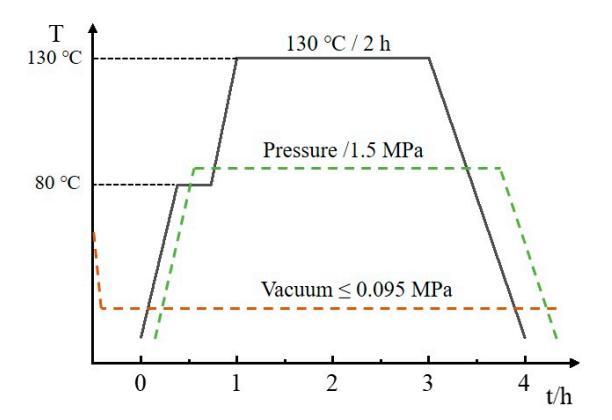
Figure 2. Autoclave molding process parameters.

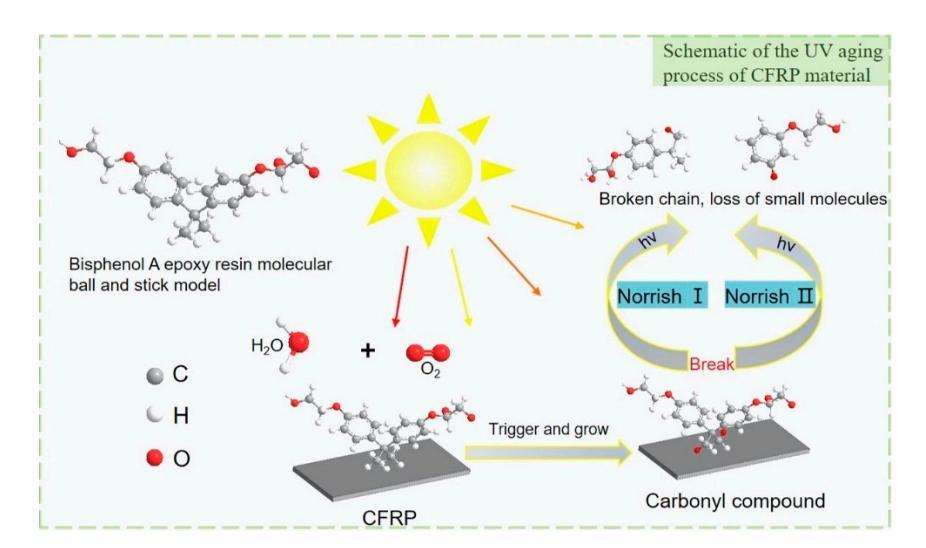
Figure 3. UV aging of CFRP material.

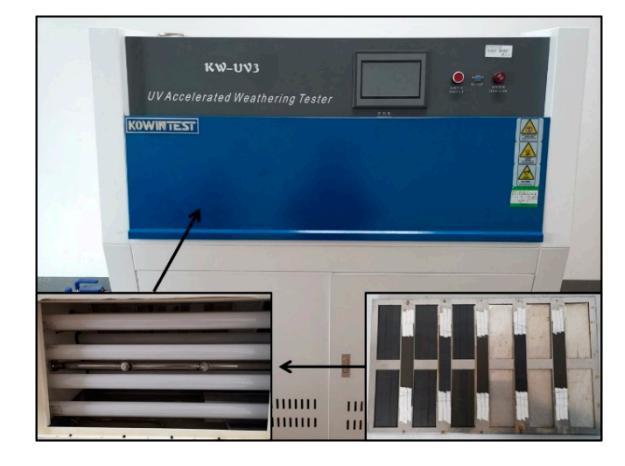
An artificial indoor UV irradiation accelerated aging test method was used to study the evolution of the mechanical properties of the carbon fiber composites under UV single factor without setting condensation conditions. The experimental apparatus adopted the KW-UV3-A UV-aging tester. As shown in Figure 4, four UVA-340 lamps placed at an angle emitted UV light at a wavelength of approximately 340 nm to ensure that each part of the specimen received the same amount of UV radiation. The temperature was set to 70 °C, and the irradiation intensity was set to 1 W/(m²·nm) according to the maximum power of the machine. Specimens were exposed to only one surface during irradiation and were periodically removed from the aging chamber for test characterization.

Figure 4. UV exposure chamber.

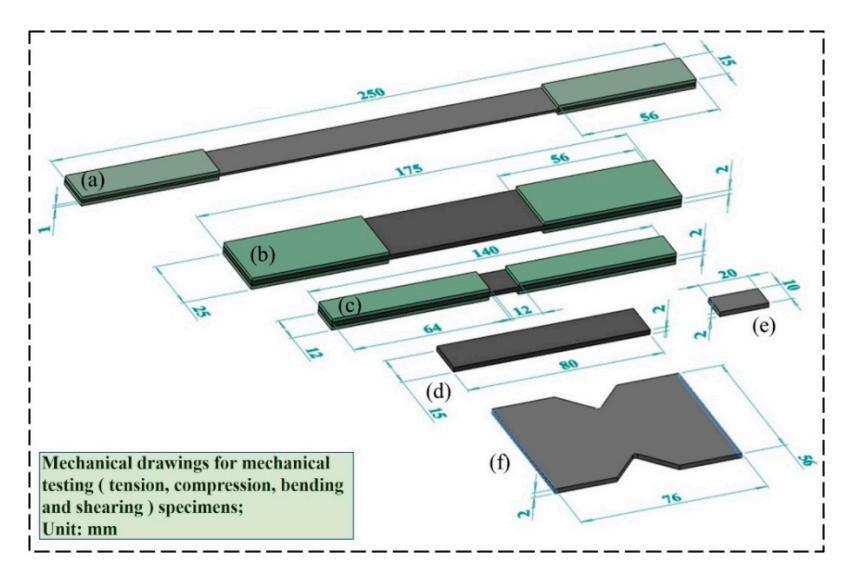
Figure 5. (a) 0° tensile specimen; (b) 90° tensile specimen; (c) 0° compression specimen; (d) bending specimen; (e) interlaminar shear specimen; (f) V-notched rail shear specimen.

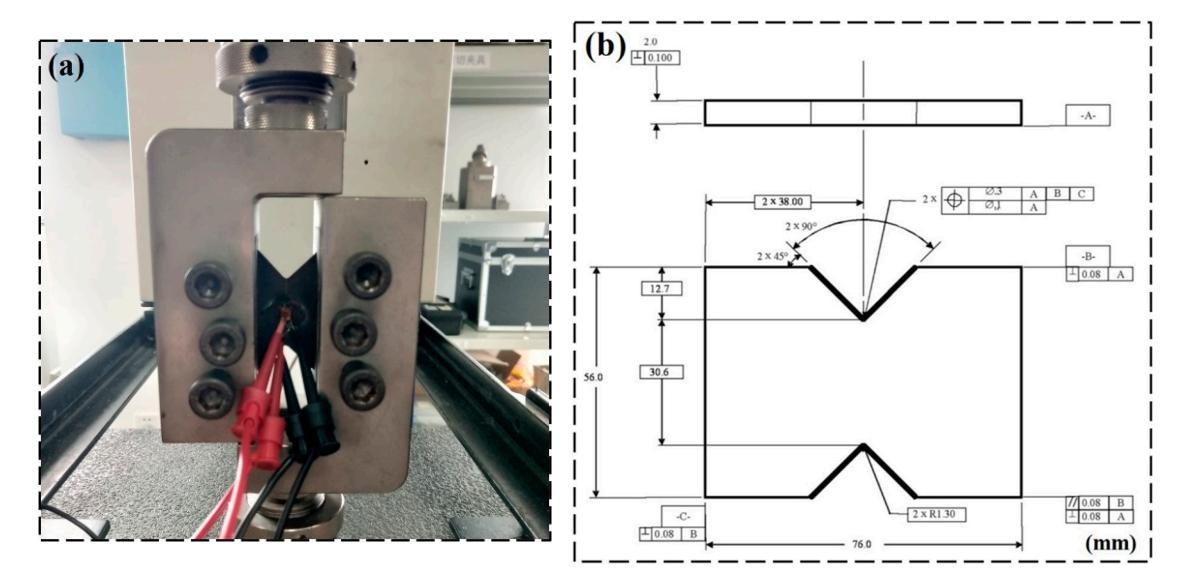
The in-plane shear mechanical properties of CFRP laminates were tested using the V-notched rail shear test method, which has a higher accuracy compared to the traditional $\pm 45^{\circ}$ off-axis tension. The V-notched rail shear method was a combination product of the double rail shear method and Iosipescu shear method, using two pairs of loading rails to hold the V-notched specimen on both sides, when the tensile load was applied, the rails transferred the shear load to the specimen through the specimen surface as shown in Figure 6a. Compared with the Iosipescu shear method, this method uses in-plane shear loading instead of applying the load at the upper and lower ends of the specimen and uses a larger test cross-sectional area, which can provide a higher shear load on the specimen. The standard based on this method is ASTM D7078 [19], the specimen size is shown in Figure 6b, the loading rate was 2 mm/min, the specimen lay-up was $[0/90]_{4S}$, and the specimen thickness was 2 mm. Strain gauges were pasted in the center of the specimen, and the strain gauges were located at $\pm 45^{\circ}$ of the loading axis at both ends of the specimen notch center. Five specimens were tested in each group, and the average value of the shear strength/modulus obtained from the test was recorded as the final test value.

Figure 6. (a) V-notched rail shear apparatus illustration; (b) V-notched rail shear specimen mechanical drawing; all dimensions in mm.

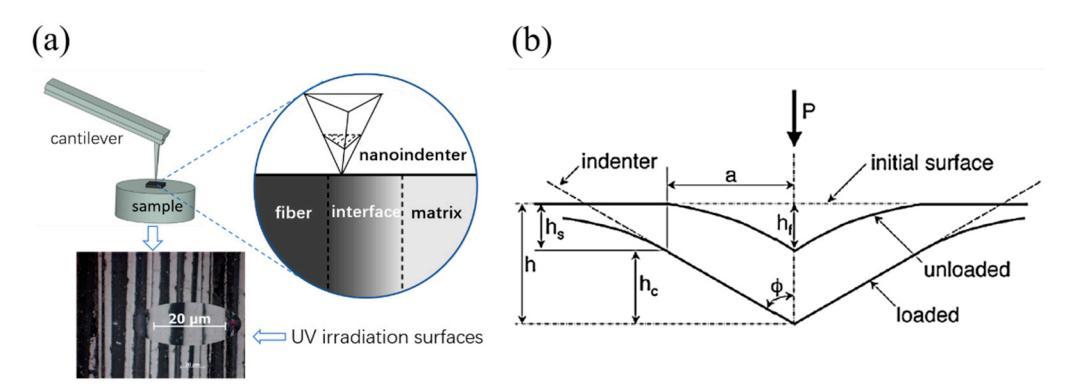
Figure 7. Illustrative descriptions of (**a**) a schematic diagram of nanoindentation test; (**b**) schematic plot of nanoindentation parameters.

where A_c is the contact area and h_c is the contact depth as is shown in Figure 7b. When using Berkovich indenter, the contact area, A_c , is a function of h_c [23]:

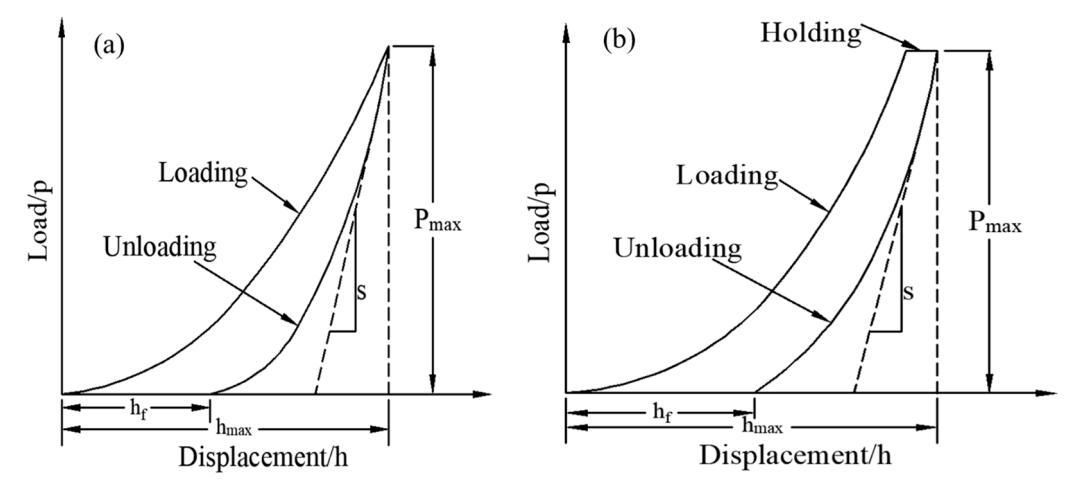
Figure 8. Typical load–displacement curve for nanoindentation: (**a**) curve with no load holding; (**b**) curve with load holding.

The reduced modulus (E_r) can be obtained from the unloading curve (Figure 8) and is calculated as follows [24]:

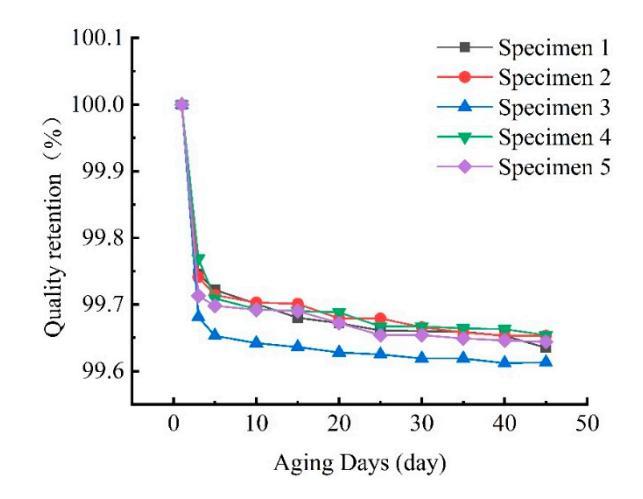
As can be seen in Figure 9, the mass loss was faster in the initial stage of UV irradiation, mainly due to the volatilization of water molecules caused by high temperature, and then became slower in the late stage of aging, mainly due to the formation of surface resin shedding, which was also confirmed in the SEM microscopic morphology below. As the aging time increases, the mass loss will become quite limited.

Figure 9. The relationship curve between mass retention rate and time under UV irradiation.

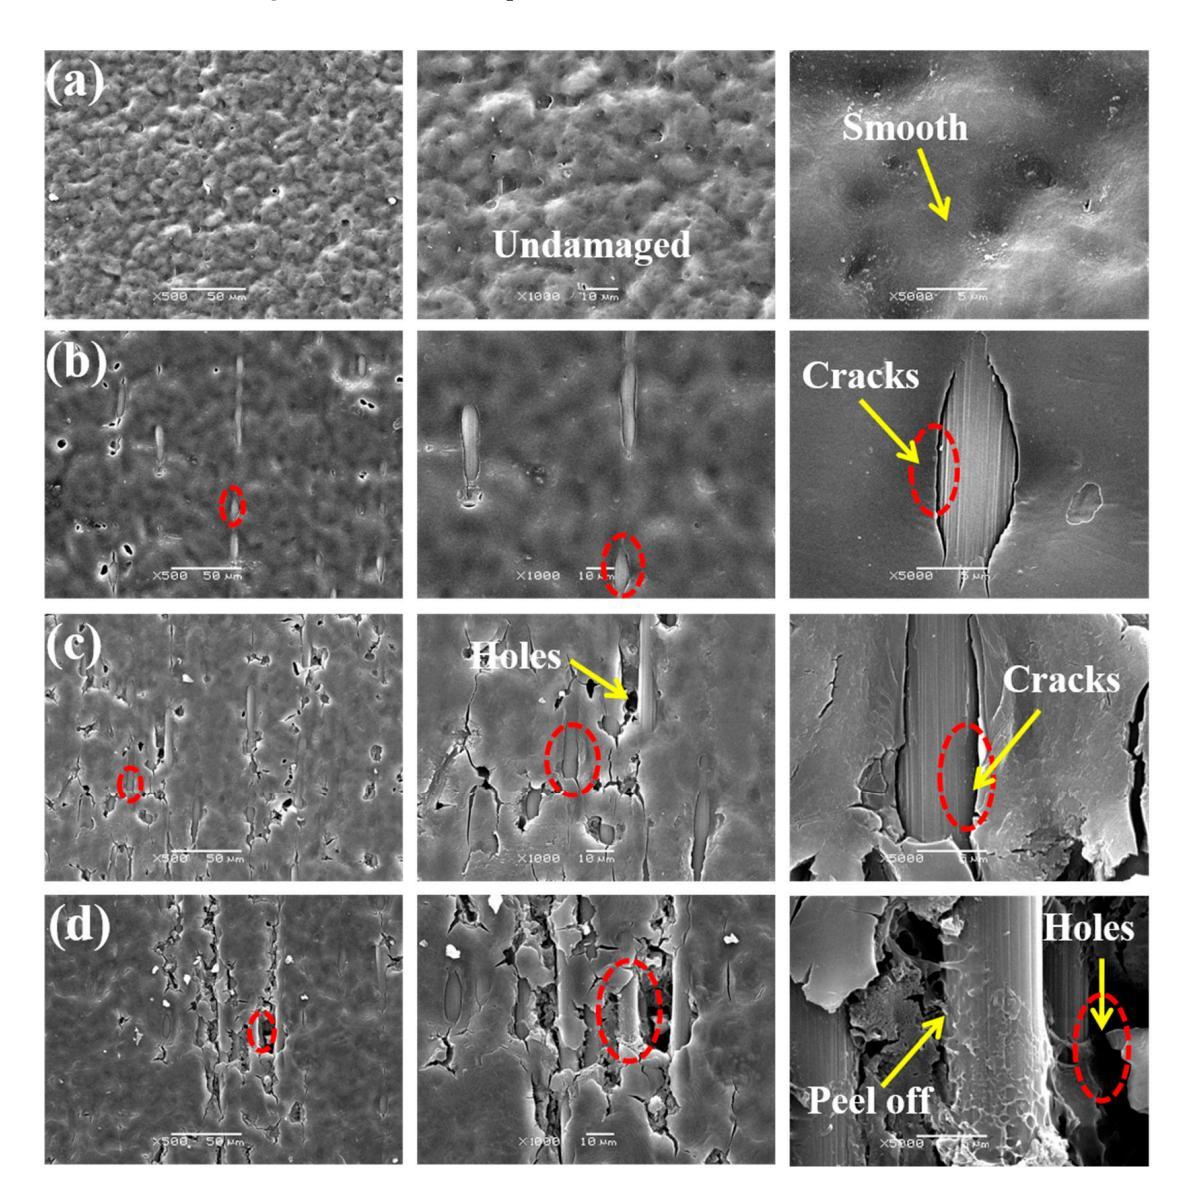
With the increase of UV irradiation time, the damage on the surface of the specimen gradually increased, as shown in Figure 10, and the surface of the unaged specimen was uniformly covered with resin matrix, no fiber exposure, and after 10 days of UV aging, the phenomenon of fiber exposure was produced, fine cracks were created at the junction of the fibers with the matrix, and no obvious damage occurred to the matrix. After 40 days of aging, there was more obvious damage to the matrix, many holes appeared on the surface of the specimen, and the gap where the fibers bond to the matrix increased. The matrix on the surface of the specimen also produced cracks, and the damage further increased. After 80 days of aging, the holes were further enlarged, and some fibers were completely exposed, the cracks in the matrix began to expand inward and the resin matrix was peeled off, which explained the loss of quality of the specimens in the late aging period.

Figure 10. Surface microscopic morphology of CFRP specimens with different UV aging times: (a) unaged; (b) 10 days; (c) 40 days; (d) 80 days.

UV aging had an obvious damage effect on carbon fiber composites, the main mechanism is as follows: ultraviolet rays are more energetic and active compared with visible light, and the energy of UV can make some of the covalent bonds break. Therefore, under UV irradiation, resin and other macromolecular chains break, and the small molecular fragments produced by the break will occupy a large amount of space and produce small cracks. Moreover, resin and fiber have different coefficients of thermal expansion, the deformation of the resin is greater than that of the fiber at high temperatures, which generates thermal stress at the interface and destroys the deformation coordination relationship between fiber and resin, causing the fiber and resin to de-bond, further aggravating the expansion of cracks.

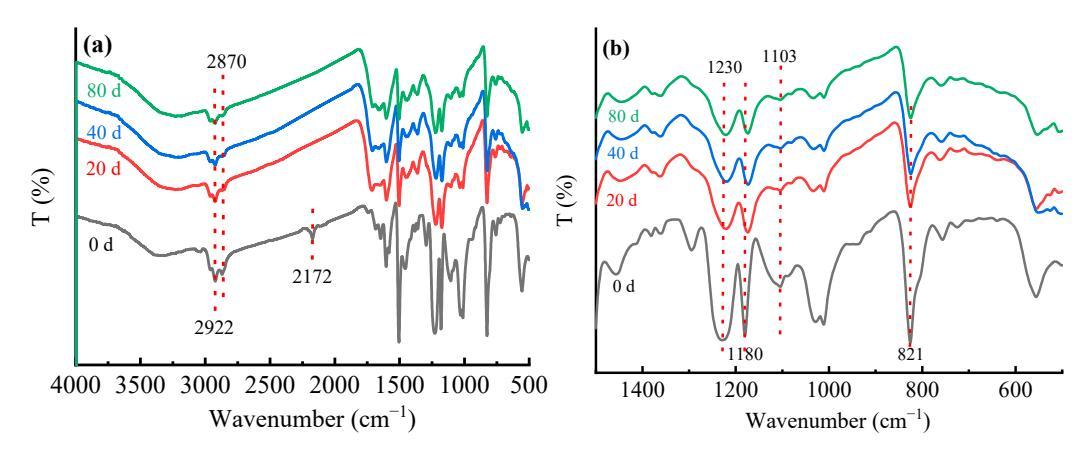
As shown in Figure 11, the absorption peak at 2172 cm^{-1} disappeared after 20 days of UV irradiation, which may be the C=C/C=N stretching vibration peak in the epoxy resin curing agent dicyandiamide, after UV aging, all the unreacted curing agents remaining in the epoxy resin participated in the reaction, so the characteristic peak disappeared, which also indirectly proves that UV aging will make the composites produce post-curing. The absorption peaks at 2922 cm⁻¹ and 2870 cm⁻¹, related to C-H, decreased and the susceptible hydrocarbon groups were oxidized on the surface of the CFRP specimens after a long period of aging. The small shoulder peak near 1750–1716 cm⁻¹ was a carbonyl absorption peaks of aromatic ether (1230 cm⁻¹), aliphatic ether (1103 cm⁻¹), 1180 cm⁻¹ (C-O), and C-H absorption peak of disubstituted benzene near 821 cm⁻¹ decreased, indicating that the UV aging process caused some of the chemical bonds to oxidize, chain-break, and generate free reactive radicals, and the reactive radicals combined to generate small molecules and become loose, which was the direct cause of the resin peeling off of the surface layer, macroscopically manifested as weight loss.

Figure 11. The FTIR spectra of the CFRP before and after aging: (a) full spectrum; (b) fingerprint region.

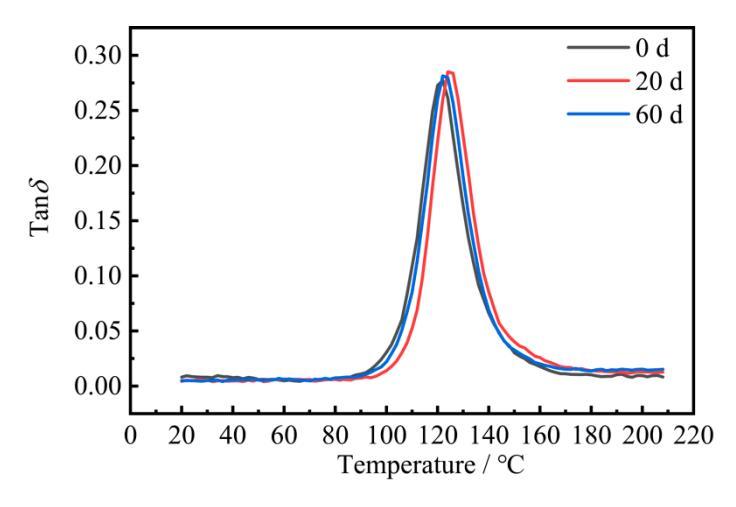
Figure 12 shows the loss factor curves of the CFRP composites before and after UV aging, and the peak temperature of the loss factor was the glass transition temperature (Tg) of the composites. The glass transition temperature (Tg) was 121 °C before aging, Tg was 125 °C after 20 days of aging, and Tg decreased to 122 °C after 60 days of aging, with the glass transition temperature first increasing and then decreasing.

Figure 12. CFRP loss factor-temperature curve.

In the early stage of UV aging, UV irradiation produced post-curing of the composites and cross-linking reaction, which made the glass transition temperature increase. In the late stage of UV aging, in the epoxy resin group under UV irradiation, chain-breaking occurred, cross-link density decreased, and the damage effect of UV was greater than the favorable effect of the post-curing part, resulting in a decrease in the glass transition temperature and a decrease in the thermal stability of the material.

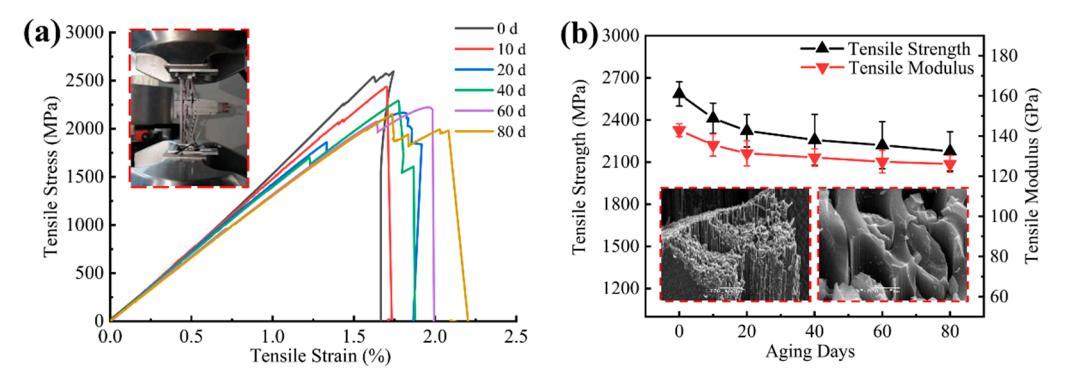
The longitudinal tensile stress–strain curve showed typical brittle fracture characteristics, and the tensile strength and modulus decreased with the increase in UV aging time as shown in Figure 13. The strength decreased by 16% and the modulus decreased by 12% after 80 days of aging. The decline rate was faster in the first 20 days of UV aging and tended to level off in the later ultraviolet exposure stage, which was due to the fact that UV aging of carbon fiber composites mainly acts on the surface layer, and it is difficult for the damage to continue to expand to the interior as the aging time increases. UV aging reduced the degree of bonding between fibers and resin, and although the fibers were less affected by UV irradiation, the overall load-bearing capacity of the composite depends on the degree of bonding between the reinforcement phase and the matrix phase, and the debonding of the surface layer fibers from the matrix will lead to premature failure of some fibers during tension. As shown in Figure 13a, the tensile process of the specimens in the later aging stage showed premature fracture of some fibers, which made the integral stress–strain curves produce a stepped shape.

Figure 13. (**a**) Longitudinal direction tensile stress-strain curve; (**b**) longitudinal tensile strength/ modulus versus aging time.

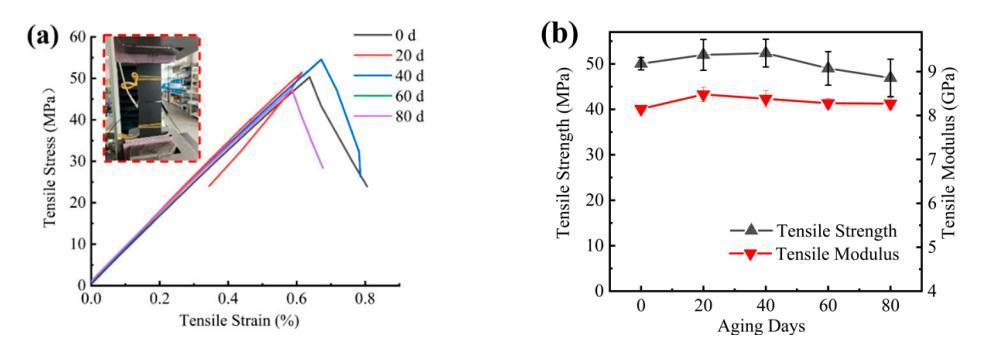
The 90° tensile specimen corresponded to the mechanical properties of the matrix. As shown in Figure 14, the transverse tensile strength/modulus tended to increase at the beginning of aging and then decreased at the later stage of aging as the post-curing effect was weaker than the UV aging effect [25], which is in accordance with the aging law of polymer materials [26–28]. The strength decreased by 6%, and the modulus increased by 1% after 80 days of aging. The highest increase in modulus was 4% after 20 days of aging. The highest increase in modulus of aging. The transverse tensile strain at break decreased by 7% after 80 days of aging, indicating that UV aging made the matrix brittle.

Figure 14. (a) Transversal direction tensile stress–strain curve; (b) transversal direction tensile strength/modulus versus aging time curve.

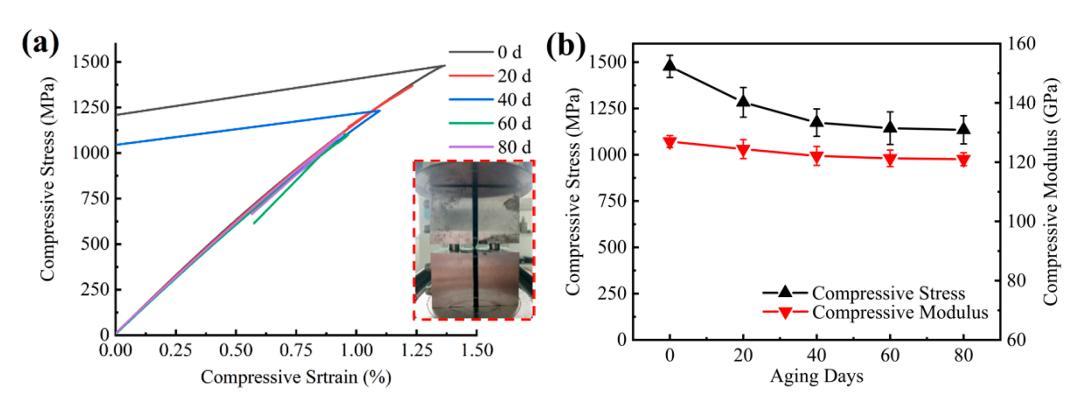
Longitudinal compression and longitudinal tension had similar mechanical property change trends with aging time as shown in Figure 15. The decline was faster in the early aging period and tended to level off in the latter aging period, and its strength decreased by 23% and the modulus decreased by 5% over 80 days of aging. The damage mode mostly presented as blooming in the middle of the gauge (BGM) and various longitudinal splits of the gauge (SGV), which is an acceptable failure mode, and the experimental data were valid.

Figure 15. (a) Longitudinal direction compression stress–strain curve; (b) longitudinal direction compression strength/modulus versus UV aging time curve.

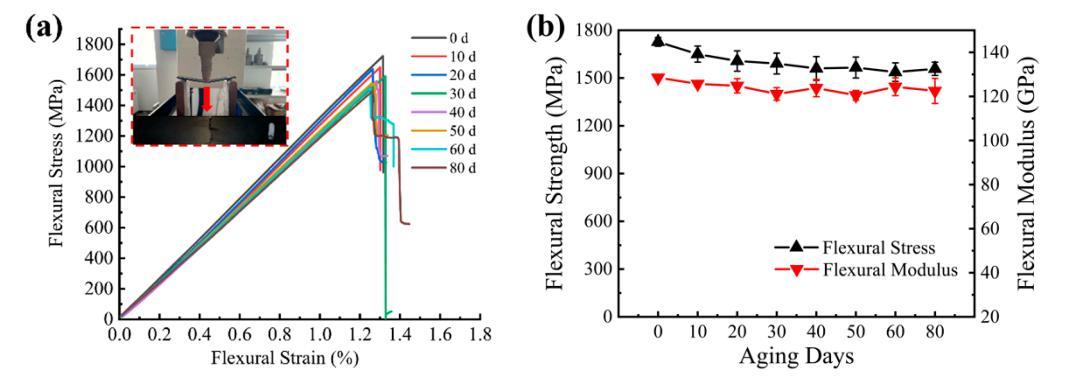
Bending and interlaminar shear tests were conducted on CFRP using the three-point bending method. The main failure damage mode of three-point bending was compression failure, since the compression failure strain (1.3%) of the material was less than the tensile failure strain (1.7%). Therefore, the failure of the upper surface occurred first as shown in Figure 16a. The flexural strength/modulus decreased rapidly in the first 20 days of UV aging, and a fluctuation in the decline trend was seen in the later aging period, with the flexural strength decreasing by 10% and the flexural modulus decreasing by 5% after 80 days of UV as shown in Figure 16b. The damaging effect of UV irradiation on the surface layer of the specimen leads to poor bonding between the fiber and the matrix, which is the cause of its flexural mechanical decline.

Figure 16. (**a**) Longitudinal direction flexural stress–strain curve; (**b**) longitudinal direction flexural strength/modulus versus UV aging time curve.

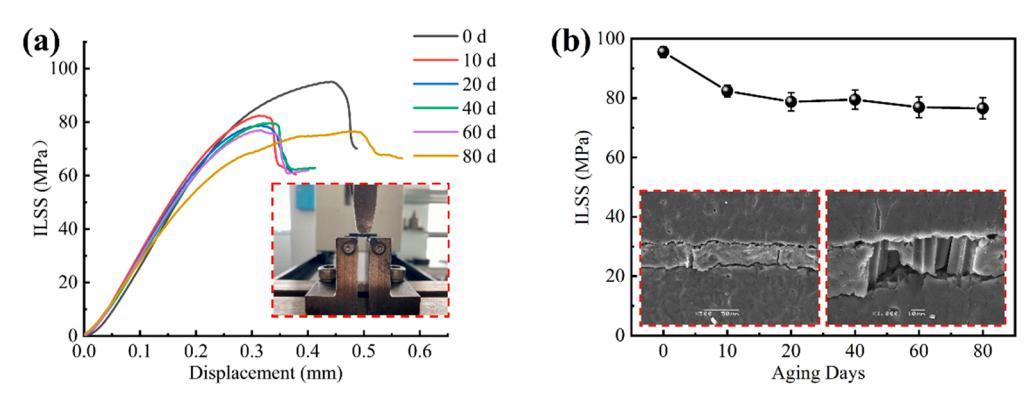
The interlaminar shear strength decreased faster in the first 10 days of UV aging, and the decreasing rate tended to level off in the later ultraviolet exposure stage as shown in Figure 17. With the increase in loading force, the layer on the layer produced out-of-plane shear stress, which caused the damage between the layers and transferred it to the surface of the specimen; when the maximum interlaminar load of the specimen was reached, the surface of the specimen then produced a crack, as shown in Figure 17b, and the fibers partially fractured. After 80 days of aging, the interlaminar shear strength decreased by 20%.

Figure 17. (a) Interlaminar stress–displacement curve; (b) interlaminar shear strength versus UV aging time curve.

UV aging has a more pronounced effect on the interlaminar properties of CFRP laminates. The interlaminar shear strength reflects the overall bonding strength of the composite and is an important evaluation index of the mechanical properties of fiber composites.

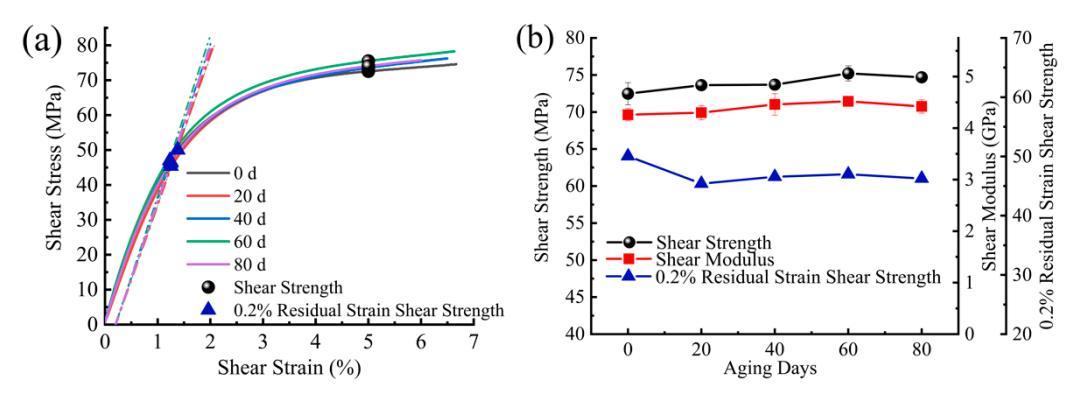
The in-plane shear strength/modulus showed an increasing trend at the beginning of aging as shown in Figure 18. This may be because the in-plane shear mechanical properties were more sensitive to the post-curing effect between the fibers and the resin and showed an overall upward trend. The value of 0.2% strain is usually used in engineering as the tolerance value for setting the residual strain, and the corresponding residual strain shear strength was noted as $\tau_{s(0.2)}$. The residual strain shear strength was used to determine the approximate linear limit of the material stress–strain curve, starting with the residual strain tolerance value of 0.2% and making a straight line with the slope of the secant elastic modulus (shear modulus). The stress value at the intersection with the shear stress–strain curve was the residual strain shear strength. The residual strain shear strength showed an overall decreasing trend, with the greatest decrease at the beginning of aging, 9% at 20 days of aging, and 8% at 80 days of aging.

Figure 18. (a) V-notched shear stress–strain curve (in-plane); (b) in-plane shear properties during exposure to UV radiation.

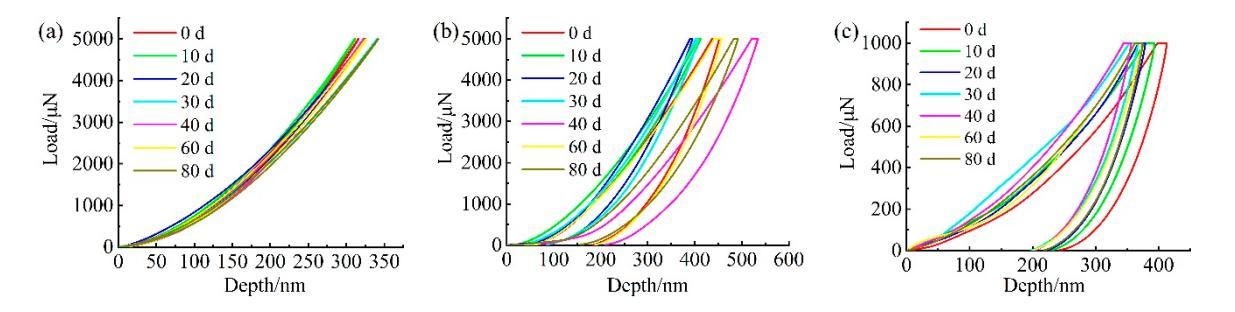
Typical load displacements of the nanoindentation response at each phase of the UV-aged surface of the carbon fiber composite are shown in Figure 19. The elastic–plastic

properties of the material can be analyzed from the perspective of the area-energy method enclosed by the indentation curve [29,30]. As shown in Figure 19, the area enclosed by the loading and unloading curves represents the energy loss during the indentation process, which is caused by plastic deformation, and the larger the area, the more plastic the material. It can be seen that the load–displacement curve of the fiber showed typical brittle material characteristics, as shown in Figure 19a, the matrix material showed typical plastic material characteristics, and the interface phase was in between with a certain plastic toughness. With the increase in UV exposure, the maximum indentation depth of each phase changed, and the indentation depth responded to the hardness characteristics of the material, while the unloading stiffness was related to the elastic modulus, according to Oliver and Pharr's theory [21,22]. The microhardness and elastic modulus values that could be obtained from the indentation curve are shown in Figure 20.

Figure 19. Nanoindentation test load vs. indentation depth curve at different aging times: (**a**) fiber phase; (**b**) interface phase; (**c**) matrix phase.

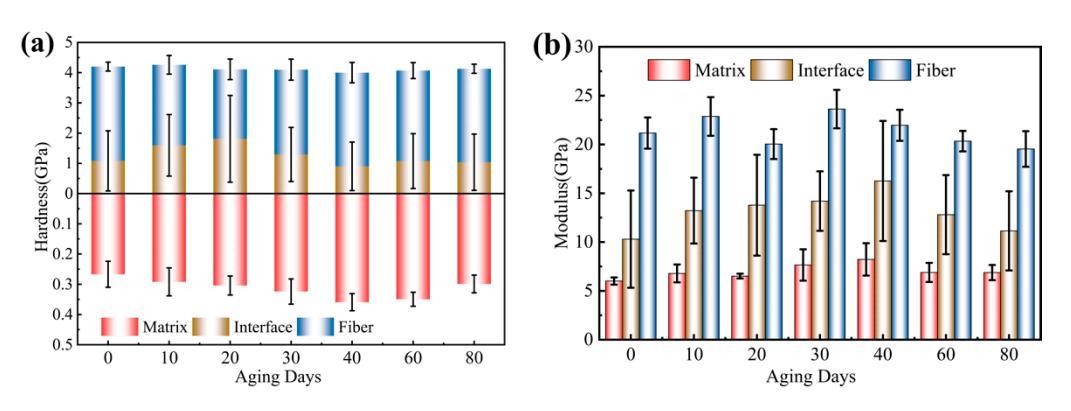
Figure 20. (**a**) Relationship between hardness and aging time for each component; (**b**) relationship between the modulus of each component and aging time.

The hardness of the fibers was less affected by UV irradiation, and the modulus had an increasing–decreasing trend, which may be due to the effect of UV irradiation on the graphite microcrystalline structure of the fibers, resulting in a decrease in their modulus at the later stage of aging, while the hardness and modulus of the matrix were more affected by UV irradiation, which had an embrittlement effect on the matrix material. The overall hardness and modulus tended to increase, and the modulus/hardness reached the maximum values after 40 days of aging, and the modulus increased by 37% and the hardness increased by 35%, respectively. The high hardness fibers will play a strengthening role on the surrounding low hardness resin. In the early aging period, the UV embrittlement effect of the resin at the interface was the dominant effect, leading to the increase in its hardness, and in the late aging period, the near-fiber effect declined, leading to the premature decrease in its hardness. The modulus of the interface area has a similar law to that of the matrix.

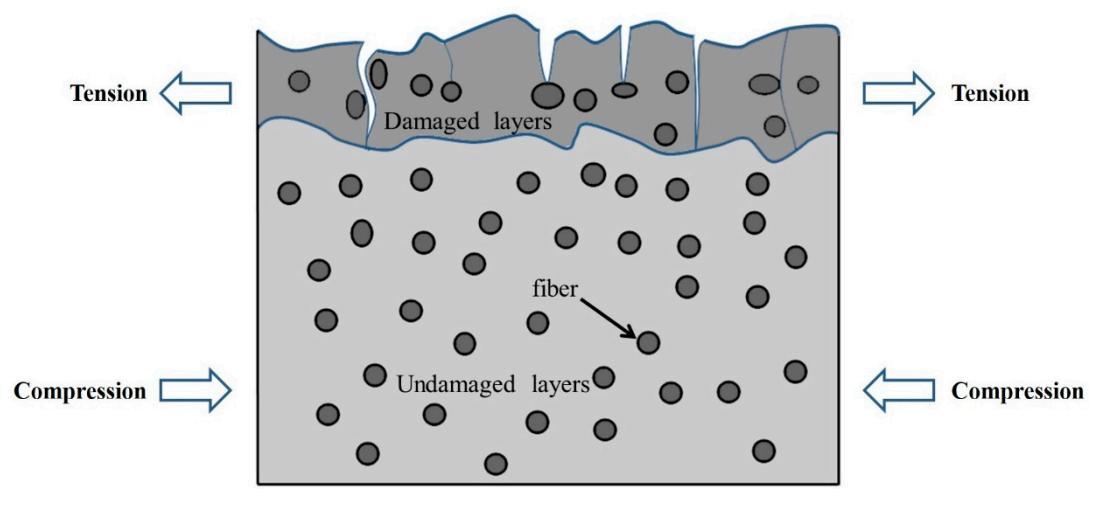
As UV aging acts only on the surface layer, the surface resin peels off causing a reduction in free volume, and the damaged surface layer tries to contract, but the undamaged layer at the bottom prevents it from contracting. This constraint introduces tensile stresses in the damaged layer and compressive stresses in the undamaged layer as shown in Figure 21 [11]. This tensile stress results in cracking of the damaged layer, which explains the further expansion of cracks on its surface. This leads to a continuous deterioration of the mechanical properties of the material.

Figure 21. Schematic diagram of damaged layer crack expansion.
