Abstract: Conveyors play a very important role in modern manufacturing processes, and one of the most popular types is the belt conveyor. The main elements of a conveyor include a conveyor belt, roller sets, a supporting frame and a drive and control system. The reliable operation of the conveyor depends on the strength and durability of individual elements (especially the belt). Conveyor belts are made from various materials and have received a lot of attention in the scientific and research community. This article presents tests of the strength of the rubber belt material and its damage under load. The belt consists of two internal layers covered with a PVC coating on the outside, and the nominal belt thickness was 2 mm. In the experiment, various configurations of longitudinal and transverse damage were verified, and statistical methods were used to analyze the results. The obtained test results provided a new understanding of the propagation of conveyor belt damage and helped to improve the strain gauge-based monitoring system.

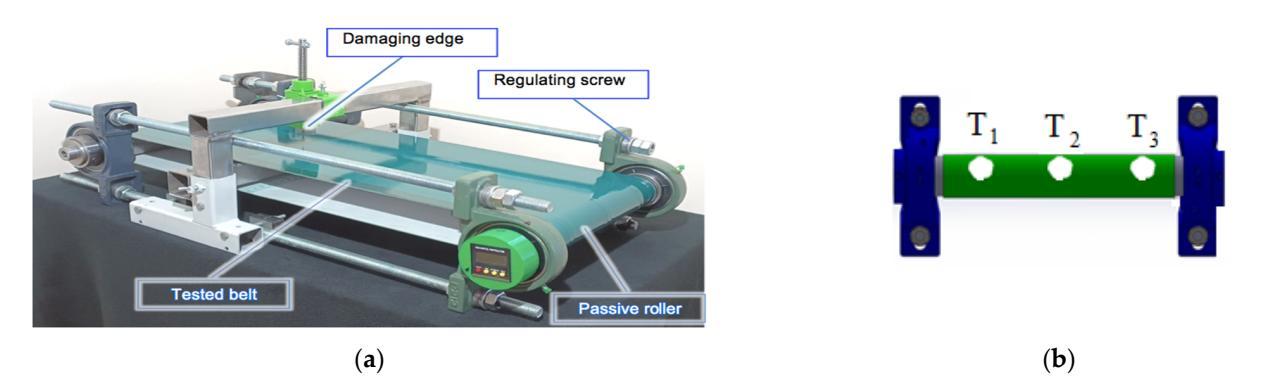
The work used a newly developed monitoring system, which is the subject of a patent application. Its main sensing element was a strain gauge CP152NS (IEE S.A., Bissen, Luxembourg), controlled by a data processing system, and described in detail elsewhere [22]. Three identical strain gauges denoted as T1, T2, and T3 were placed on the surface of the conveyor's passive roller in the manner shown in Figure 1. During the conveyor operation, the belt generated pressure on the roller which was registered by the strain gauges and further processed.

The test rig consisted of two rollers, passive and active ones, and the rubber belt between them. The system made it possible to regulate the rollers' position to ensure the necessary tension of the belt. The data processing system was placed inside the passive roller. It communicated with an external computer using a Bluetooth wireless connection. The dedicated program was prepared specially for the data record and further analysis. An example of the registered data was published along with the initial results of machine learning tests for the load identification [32].

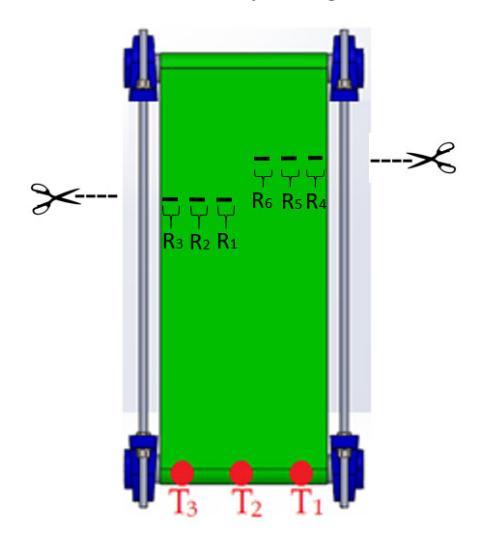
Since the damage to the belt was irreversible, the monitoring of the damaged belt was performed after sequential addition of more damage. The sequence of cuts was denoted as R1, R2, and R3 on the right side of the belt and R4, R5, R6 on the left side, respectively, as shown schematically in Figure 2.

Figure 2. Sequence of cuts to the belt during the tests.

Each individual damage was exerted perpendicularly to the belt movement direction, and its length was 50 mm. After adding each subsequent cut, the conveyor worked for ca. 10 min at a roller rotational speed $f_1 = 400$ rpm corresponding with a belt linear speed of $v_1 = 0.5$ m/s. During this time, 10,000 indications of the strain gauges were sampled and registered. The as-obtained results were compared with those obtained under similar work conditions of the belt without damage and loads.

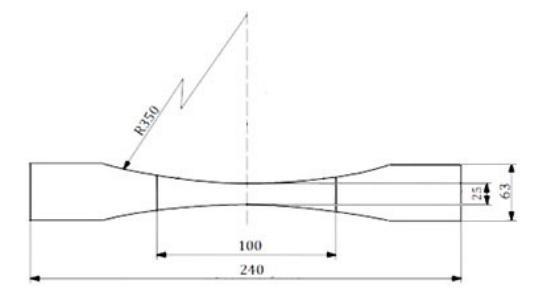
The shape and dimensions of the test piece were measured in accordance with Figure (Figure 3 in standard EN ISO 283:2023).

Figure 3. Type C test piece (in mm).

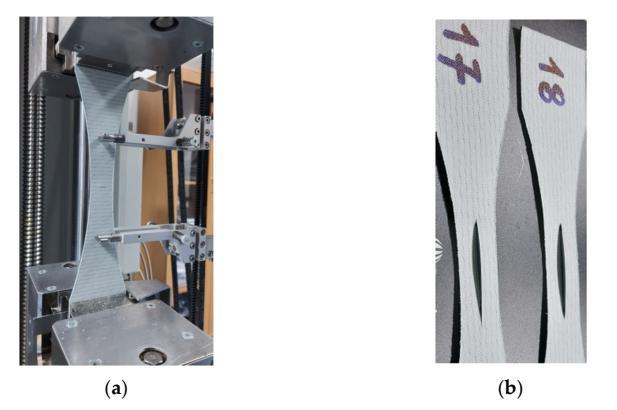
Figure 4 shows the examples of the tested samples.

Figure 4. Samples of the belt material: (**a**) example of the sample with perpendicular damage during the tensile test; (**b**) examples of the samples with longitudinal damage before the tensile test.

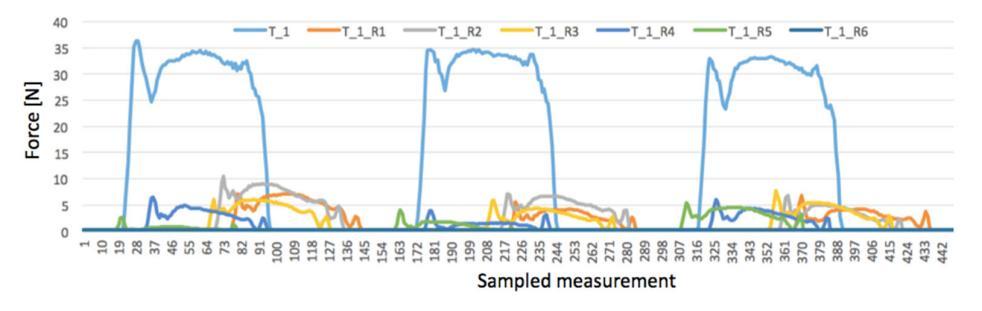
Figure 5 demonstrates the impact of damage on the response of the T1 strain gauge.

The curve denoted as T_1 in Figure 5 corresponds with undamaged belt, where the T1 strain gauge under belt pressure registered forces close to 35 N. After the very first damage R1, a drastic drop in the registered forces below 10 N can be seen. Another significant decrease is seen after the R4 cut was made, in direct proximity with the T1 strain gauge. However, when all cuts R1-R6 were in place, its indication was 0.2 N.

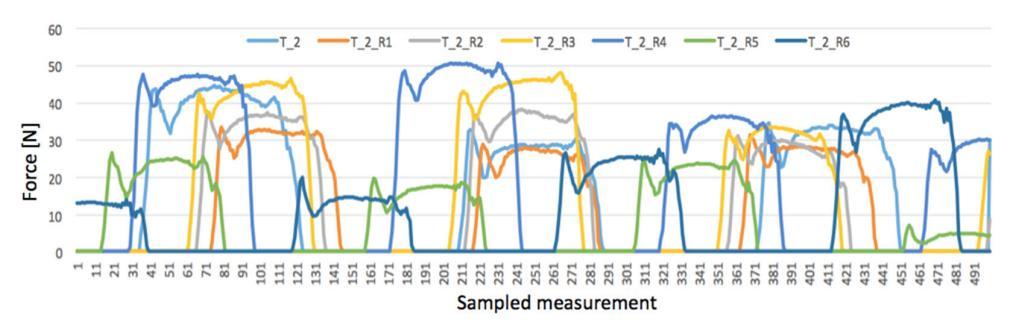
Figure 6. Signal registered by T2 strain gauge after cuts R1-R6 were added.

The reaction of the middle strain gauge T2 was quite different, as illustrated in Figure 6. First of all, it should be noted that the strain gauge T2 placed in the middle area of the roller exhibited significant differences between the registered force values, although not as large as in the case of the T1 strain gauge (Figure 5). The signal was different in each rotation, both for the undamaged belt and after each subsequent cut was made. For instance, the curve denoted as T_2_R4 (after R4 cut) reached 50 N at first roller rotation (sampled measurement 211), while at the third rotation, it was just 36.5 N (sampled measurement 361). Moreover, even the undamaged belt generated large differences in curve T_2; at the first rotation (sampled measurement 81), the strain gauge registered a signal of 44.7 N, while at the second one, it registered a signal of just 28.8 N (sample measurement 81). In fact, this phenomenon was typical for a rubber belt during conveyor's operation, caused by complex dynamical stresses inside the material stretched between two rotating rollers [36].

On the other hand, the indications of the T2 strain gauge may seem different from the predicted or expected behavior of the system. While the pressing force on the strain gauge T1 significantly decreased after each cut, the graphs in Figure 5 show some increase in the force when the cuts from R1 to R4 were made. Only after the R5 cut did the pressing force on the middle strain gauge decrease. However, this phenomenon can be explained when considering the changes in force distribution on the roller after the damage. While the overall resultant force on the passive roller remained the same, the damaged area of the belt pressed on it with smaller force. So, it could be expected that in other areas along the passive roller, the force would increase. This can be presented schematically, as is shown in Figure 7. Unfortunately, the third strain gauge generated an excessive error during the damage test, so it is problematic to interpret its indications at this stage of the investigations. For this reason, the force distribution on the left side of the roller is presented as hypothetical.

It can be seen that the cuts R1–R3 weakened the left side of the belt, shifting maximal pressing forces on the roller and causing an increase in T2 and a decrease in T1 indications. However, cut R5 weakened the entire belt, which was detected as a drop in T2 indications by ca. 50% from 44.8 N down to 22.3 N. With the damage to the entire belt width with cuts R1–R6, the weakened belt exerted no pressure on the strain gauge T1, which indicated a signal of constantly F = 0.23 N. At the same time, the pressing force on T2 increased by 17%, which indicated that the middle area of the belt was loaded with maximal stresses.

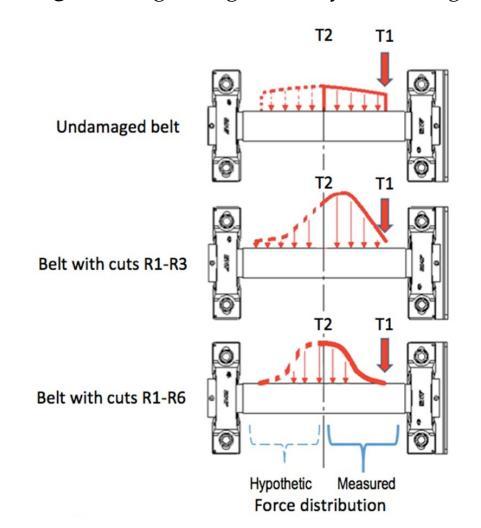
Figure 7. Signal registered by T2 strain gauge after cuts R1–R6 were added.

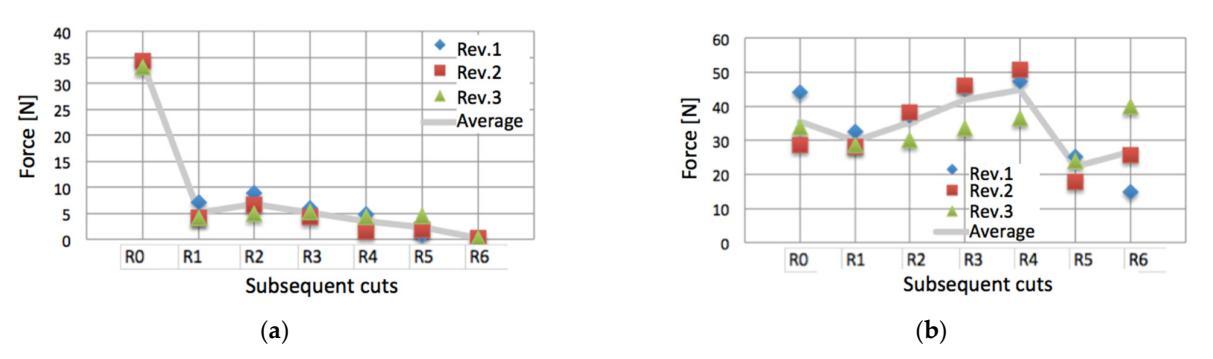
Figure 8 presents the experimental results of the changes in strain gauges' indications for the first three roller revolutions after the appearance of subsequent cuts from R1 to R6. The line of average results indicates the overall trend.

Figure 8. Indications of the strain gauges during three revolutions after the appearance of the subsequent cuts R1 to R6: (**a**) strain gauge T1; (**b**) strain gauge T2.

Noteworthy, after the cut R2 was made, the shifted pressure distribution caused an increase in pressing forces on both the T1 and T2 strain gauges. Moreover, while the middle strain gauge T2 was less loaded under the undamaged belt, the damaged belt caused a several times larger load on it, as compared to the T1 gauge. In addition, the T2 gauge almost always exhibited a much larger dispersion of the indications than T1. The largest dispersion of $R_{max} = 25$ N took place after the last cut R6, when the sides of the belt did not bear any load (T1 indication was zero), demonstrating the highly instable dynamics of the inner stresses.

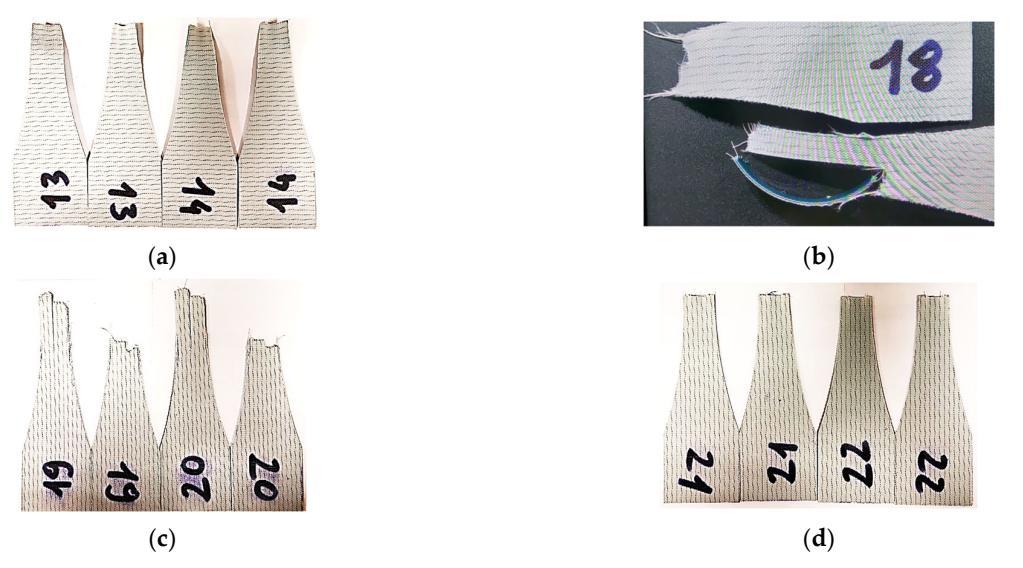
Five-element samples were used to analyze the results. Figure 9 shows sample photographs of the tested samples after rupture.

Figure 9. Samples after the test: (**a**) sample no. 13 and 14; (**b**) sample no. 18; (**c**) sample no. 19 and 20; (**d**) sample no. 21 and 22.

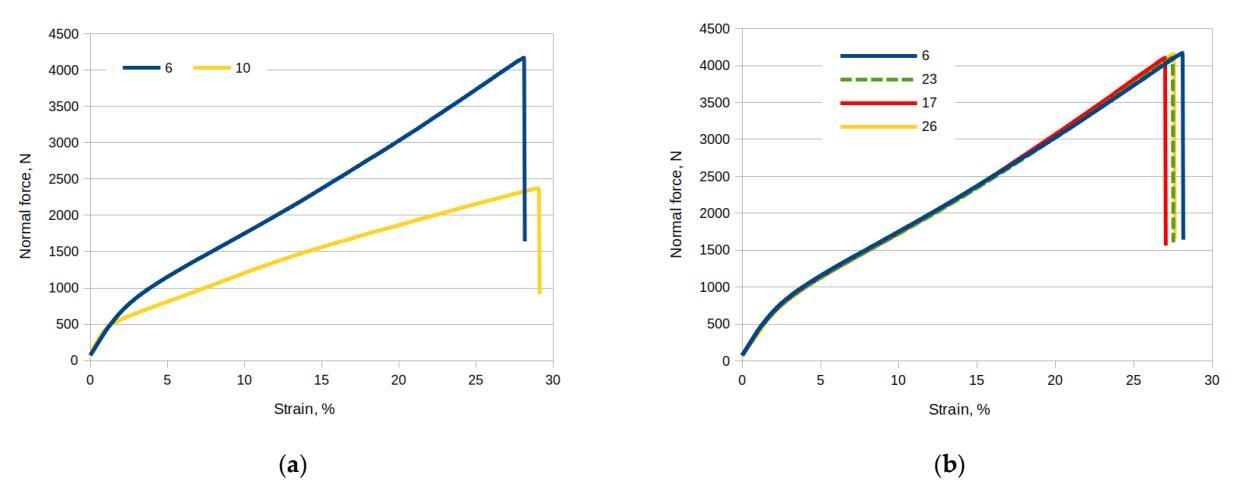
Figure 10 shows the normal force vs. strain curves. Figure 10a shows a comparison of sample no. 6 (cut along the fibers) with sample no. 10 (cut transversely to the direction of the fibers), both samples without damage. The value of the breaking force of sample no. 6 (cut along the fibers) is much larger than for sample no. 10 (cut transversely to the direction of the fibers), at almost double. Figure 10b shows a comparison of samples cut along the fibers. Sample No. 6 has no damage, sample no. 17 has a longitudinal damage of 70 mm cut through the sample, sample no. 23 has a longitudinal damage cut on the surface, and sample no. 26 has a longitudinal damage of 45 mm cut through the surface. The occurrence of damage and the size and type of damage do not affect the value of the breaking force. The occurrence of damage reduces the "strain" value slightly.

Figure 10. Normal force waveforms as a function of strain for selected samples: (**a**) comparison of sample no. 6 with no. 10; (**b**) comparison of samples no. 6 with no. 17, 23 and 26.

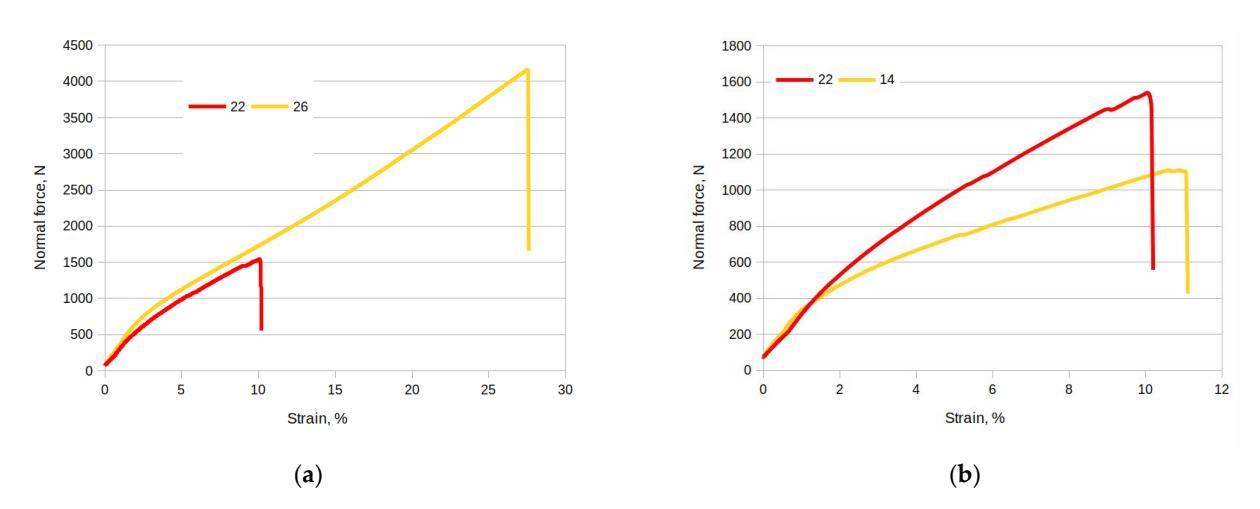
Figure 11a compares a sample cut along the fibers with longitudinal damage (sample no. 26) with a sample with transverse damage (sample no. 22). The sample with transverse damage (sample no. 22) has a much lower breaking force than the sample cut along the fibers with longitudinal damage (sample no. 26), at almost three times the level. This also results in much lower elongation. Figure 11b compares the force curves of transversely damaged samples, where sample no. 22 is cut along the fibers, while sample no. 14 is cut across the fibers. For sample no. 22, the breaking force has a much higher value than for sample 14, but the elongation is greater for sample 14.

Figure 11. Normal force waveforms as a function of strain for selected samples: (**a**) comparison of sample no. 22 with no. 26; (**b**) comparison of sample no. 22 with no. 14.

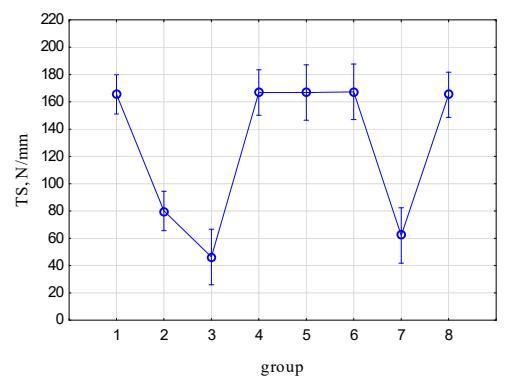
Figure 12 shows the mean tensile strength (TS) values and the 95% confidence interval. Table 2 presents the results of the ANOVA analysis with the post hoc test for intergroup relations. The type and size of damage have no significant impact on the tensile strength (TS) value for longitudinal stretching and longitudinal damage samples.

Figure 12. Mean tensile strength (TS) values and 95% confidence interval.

The TS value is significantly different between Group 3 and the remaining groups, except for Group 7. Group 3 and Group 7 are transversely cut samples. They have the lowest TS value and significantly, at the p = 0.05 level, they do not differ from each other (Group 3, transverse stretching of the belt, Group 7, longitudinal stretching of the belt). The samples in the groups without damage differ significantly at the level of p = 0.05 (Group 1, longitudinal stretching of the tape, Group 2, transverse stretching of the tape). After making cuts, the decisive factor for the TS value is the incision. The occurrence of longitudinal damage (cutting) does not cause a significant difference in the TS values (Groups 1, 4, 5, 6 and 8); instead, what determines the tensile strength value is whether the tape fibers have been cut. The length of the incision and its depth have no influence on TS (Groups 4, 5, 6 and 8).

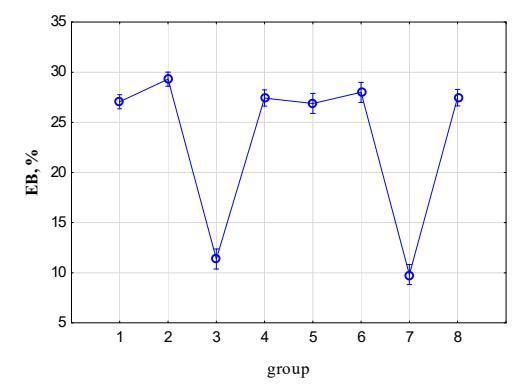
Figure 13 shows the mean elongation at break (EB) values and the 95% confidence interval. Table 3 presents the results of the ANOVA analysis with the post hoc test for intergroup relations.

Figure 13. Mean values of elongation at break (EB) and 95% confidence interval.

The EB value is significantly different for Groups 2, 3 and 7 from the remaining groups. Therefore, the direction of sample cutting is important for the EB value (Group 1, longitudinal stretching of the tape, Group 2, transverse stretching of the tape). Elongation at break has the greatest value for Group. 2 (samples cut across the grain). There are no significant differences between Groups 1, 4, 5, 6 and 8 at the significance level of p = 0.05.

The occurrence of longitudinal damage (cutting) does not cause a significant difference in the EB value (Groups 1, 4, 5, 6 and 8); instead, the decisive factor for the EB value is whether the tape fibers have been cut. The length of the incision and its depth have no effect on EB (Groups 4, 5, 6 and 8).

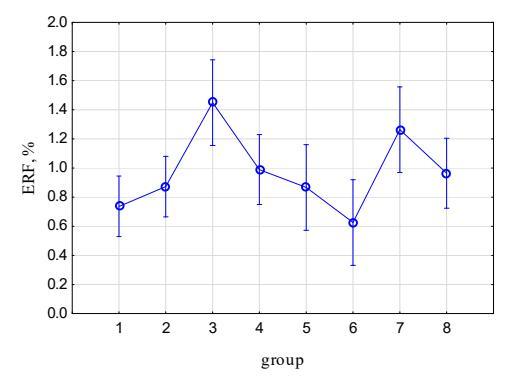
Figure 14 shows the mean values of elongation at the reference force (load) (ERF) and the 95% confidence interval. Table 4 presents the results of the ANOVA analysis with the post hoc test for intergroup relations.

Figure 14. Mean values of elongation at the reference force (load) (ERF) and 95% confidence interval.

For Groups 3 and 7, there are no statistically significant differences (p = 0.05). ERP prolongation for Group 7 shows no significant difference from Groups 4 and 5. These results confirm the results of the previous ANOVA analyses.

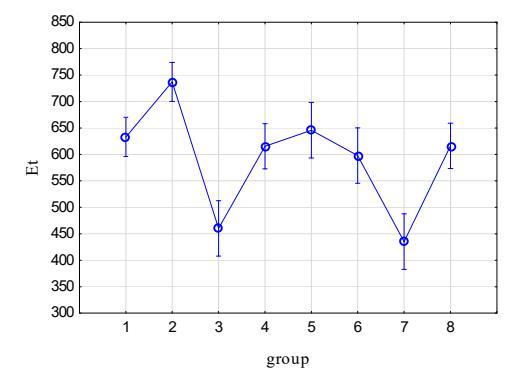
Figure 15 shows the mean tensile modulus (Et) values and the 95% confidence interval. Table 5 presents the results of the ANOVA analysis with the post hoc test for intergroup relations.

Figure 15. Mean tensile modulus (Et) values and 95% confidence interval.

Tensile modulus. The Et value is significantly different between Group 3 and the remaining groups, except for Group 7. Group 3 and Group 7 are transversely cut samples. They have the lowest Et value and do not differ significantly from each other (Group 3 has a transverse marking and Group 7 has a longitudinal marking). The samples of Groups 1 and 2 differed significantly when they did not have incisions; after making the incisions, the decisive factor for the Et value is the incision (Groups 4, 5, 6 and 8).

The highest average Et value is for undamaged samples with a longitudinal marking.
