Article Mechanical Performance Degradation of Decaying Straight Mortise and Tenon Joints: Tusi Manor, Yunnan–Tibet Region

Abstract: The straight mortise and tenon joints (SMTJs) of Tusi Manor, situated in the Yunnan–Tibet region of China, tend to undergo decay. This study aims to investigate the mechanism performance degradation of SMTJs due to decay. Five full-scale SMTJs were constructed and incubated with wood-rot fungi for 0, 6, 12, 18, and 24 weeks. Cyclic loading tests were conducted to assess the damage mechanisms and extent of mechanical property degradation at these different stages of decay, supported by ABAQUS finite element simulation software. The results revealed a progressive increase in damage with prolonged decay time. Comparison between decayed and undecayed specimens showed a maximum load-bearing performance degradation rate of 5.17%, 11.83%, 17.34%, and 23.54% after 6, 12, 18, and 24 weeks of fungal incubation, respectively. The cumulative energy efficiency degradation rates were 8.38%, 9.51%, 23.13%, and 33.31%, respectively. SMTJs mechanical performance degradation is correlated with wood mechanical property degradation as a function of the S-family. Finite e

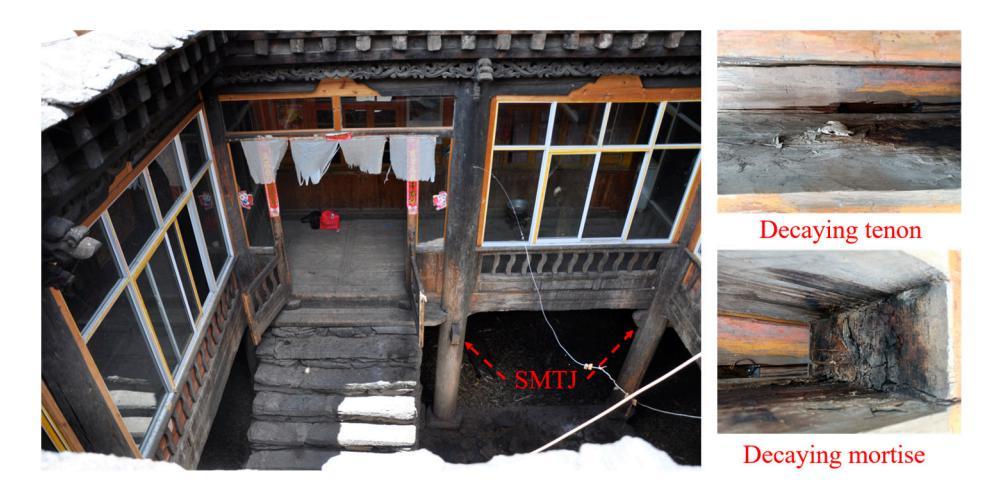
Figure 1. Decay phenomenon of SMTJ in Tusi Manor.

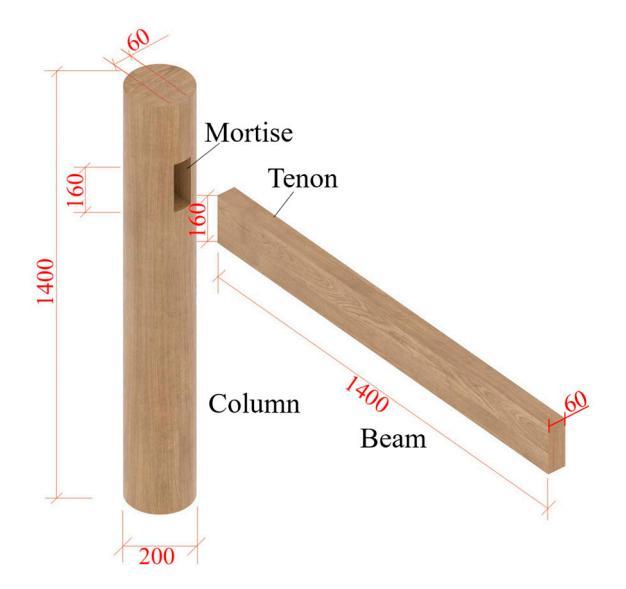
The column section of the SMTJs was circular, with a diameter of 200 mm and a length of 1400 mm. The beam's dimensions were 1400 mm \times 60 mm \times 160 mm, as illustrated in Figure 2. All the raw materials for the specimens were from the same growing batch of wood, and the beams and columns were both made of tree trunks at a height of about 1.5 m from the ground. The columns were made of logs, and the beams were made of sapwood from the logs. The total number of SMTJ specimens was 5, control group specimens were designated as SJ-1, while specimens decayed for 6, 12, 18, and 24 weeks were labeled SJ-2, SJ-3, SJ-4, and SJ-5, respectively.

Figure 2. Straight mortise and tenon joints.

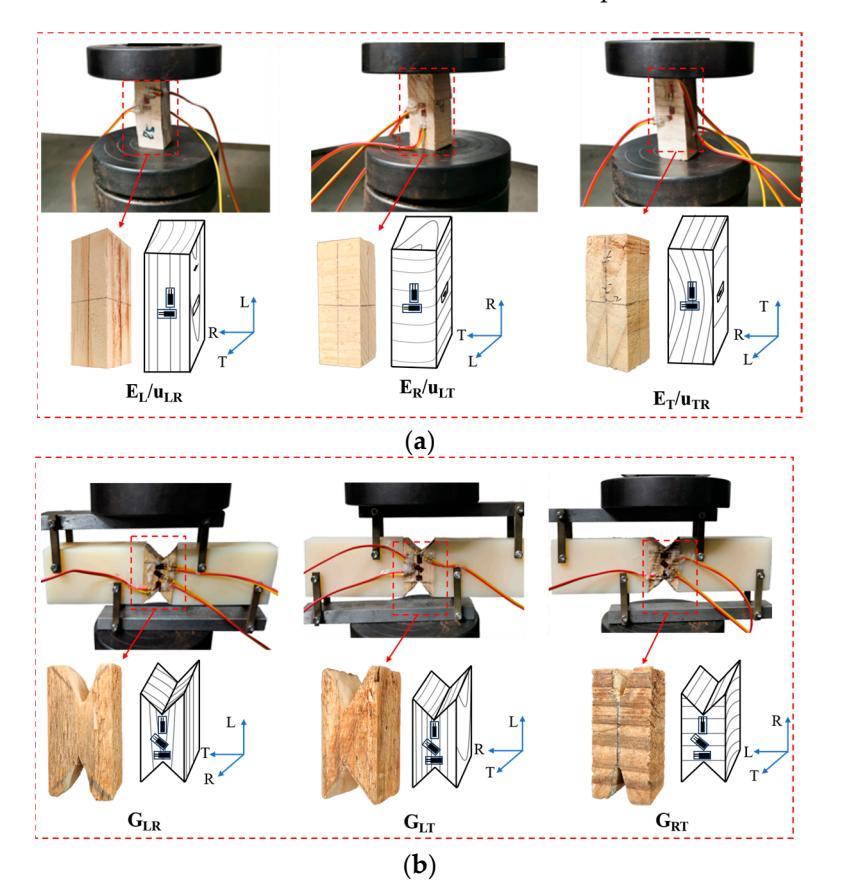
To study the changes in the mechanical properties of *Pinus kesiya* var. langbianensis wood before and after decay, according to the specifications for sampling radial tensile, radial compressive elastic modulus, and radial shear test specimens in national standard (GB/T 1927.2-2021) [34], 60 wood grain compressive elastic modulus test specimens, 60 cross-grain radial compressive elastic modulus test specimens, 60 cross-grain chord compressive elastic modulus test specimens, 60 radial shear elastic modulus specimens, and 60 tangential shear elastic modulus specimens were taken from the logs of *Pinus kesiya* var. langbianensis. The compression elastic modulus and Poisson's ratio tests for wood were performed using the full cross-section compression test method. The test methods for longitudinal compressive elastic modulus, as well as compressive elastic modulus and Poisson's ratio in the cross-grain direction, mainly referred to the provisions in the national standard (GB/T 1927.12-2021) [35]. Poisson's ratio was tested by bonding strain gauges to the surface of the specimen, with strain gauges bonded in the vertical direction to measure compressive strain, and strain gauges bonded in the horizontal direction to measure expansion strain, as shown in Figure 3a.

Figure 3. Wood property test process. (**a**) Testing process for compressive modulus of elasticity and Poisson's ratio; (**b**) shear modulus testing process.

Once the samples underwent the specified decay cycles, they were removed from the high-humidity environment and transferred into a constant temperature and humidity chamber. Upon reaching equilibrium, with the moisture content stabilized at approximately 12%, the mechanical properties of the samples were tested using an electronic universal mechanical testing machine controlled by a microcomputer (Electronic universal testing machine, manufacturer: Shenzhen Sansi Testing Equipment Co., Ltd. (Shenzhen, China), model: CMT-5504), as shown in Figure 3.

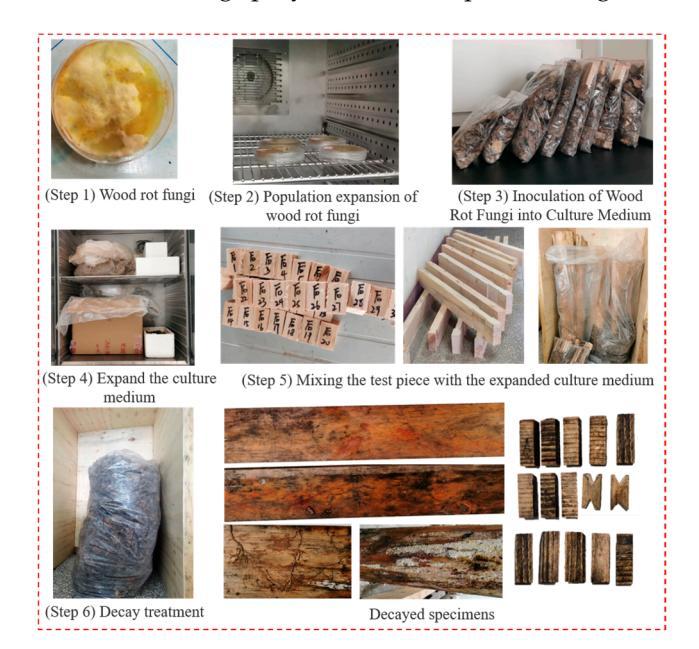
According to the national standard (GB/T 13942.1-2009) "Durability of Wood Part 1: Laboratory Test Methods for Natural Corrosion Resistance" [39], the selection of fungal species in wood rot fungi is required. The experimental strain of brown rot fungus was selected as CFCC86617, sourced from the China Forestry Microbial Collection Center, which is a common decaying fungus in the ancient wooden structures in northwest Yunnan [40]. In the experiment, *Pinus kesiya* var. langbianensis was used as a substrate for brown rot fungi. The SMTJ specimens were too large to place in glassware as containers for decay testing, as prescribed in the specifications. Consequently, polyethylene plastic bags and closed wooden boxes were employed as cultivation spaces for fungal decay, as outlined in a previous study [41]. To ensure optimal fungal activity, each polyethylene plastic bag was equipped with an outlet vent for adequate oxygen supply. The bags were also regularly humidified using spray bottles, as depicted in Figure 4.

Figure 4. Wood rot fungus culture specimen.

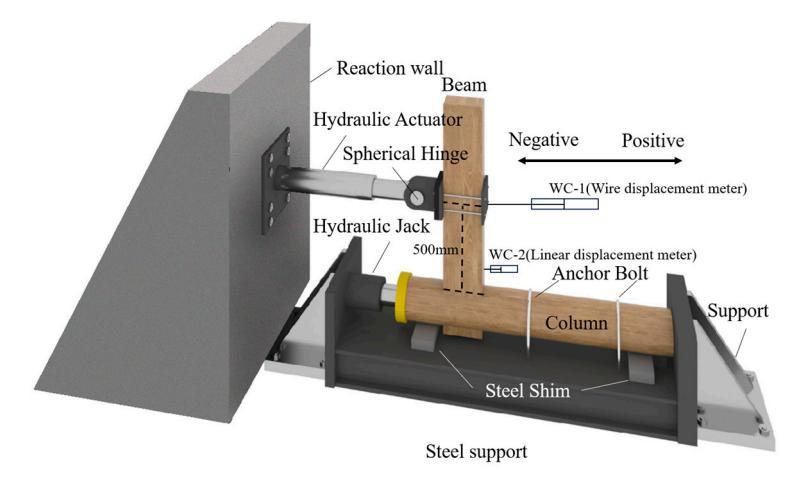
To mitigate the P- Δ effect on the SMTJs during testing, a column was installed in the test device horizontally. An actuator was used to apply horizontal cyclic loads to the cantilevered end of the beam, with a spherical hinge support connecting the loading point of the actuator to the beam, as illustrated in Figure 5. The loading point was positioned 500 mm away from the upper edge of the column. A wire displacement meter with a measuring range of 250 mm was set at the loading point (WC-1). To prevent lateral displacement or instability of the joint specimen during loading, the base of the column was fixed on a cast iron base, and a hydraulic jack was used to apply an axial load of approximately 20 kN to the column head side. Steel rings and lower steel plates were utilized to secure the middle part of the column. The actuator was designated as a positive load when applied toward the right end and as a negative load when applied toward the left end. The load and horizontal displacement at the loading point were determined using sensors connected to the actuator. A displacement gauge (WC-2) with a range of 200 mm was positioned 100 mm below the upper end of the column to verify the accuracy of (WC-1) data.

Figure 5. Loading device and measurement point.

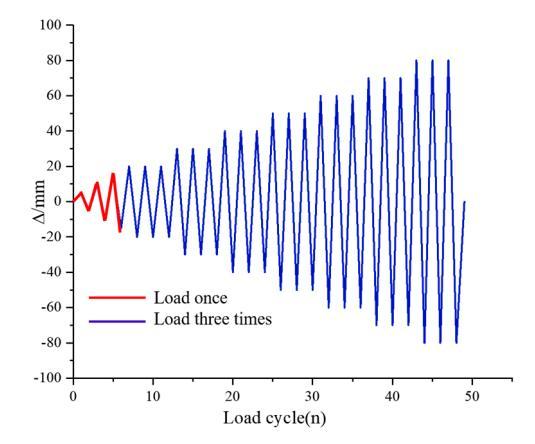
The cyclic load test was conducted according to the pseudo static loading scheme for the "Column end test", recorded in Part 4 of JGJ/T 101-2015 "Code for Seismic Testing of Buildings" [42]. A displacement-controlled graded loading approach was employed. To ensure controlled loading before the yield section, the loading process was divided into several stages. The first three stages involved one cycle of loading with a 5 mm amplitude. Following the completion of the third stage, the displacement for each subsequent stage was increased by 10 mm; each stage included three cycles of loading. The loading process

was terminated when the loading displacement exceeded 105 mm or the joint was severely damaged. A schematic diagram of the loading system is given in Figure 6.

Figure 6. Loading system.

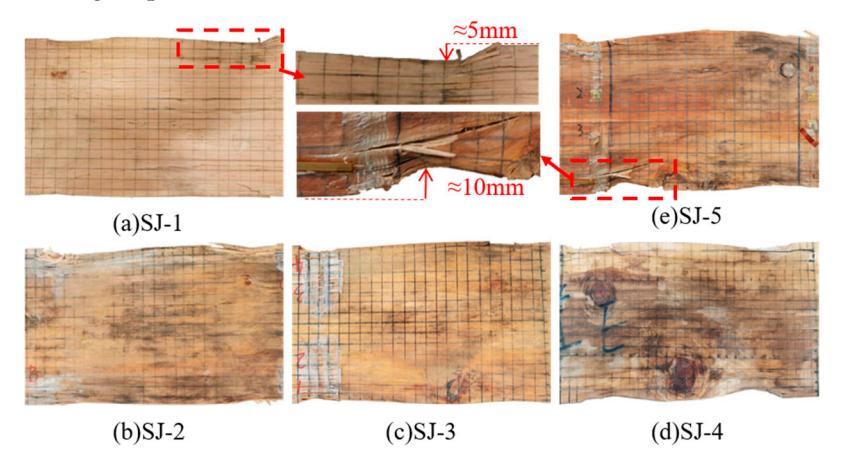
The specimens were extracted for further examination after loading to assess the failure morphologies on both the tenon side and front. Corresponding visuals are provided in Figures 7f and 8. The findings revealed a gradual increase in the transverse compression deformation of the tenon as the decay time progressed, while the plastic deformation increased significantly. These observations remained consistent even under the same loading displacement.

Figure 8. Tenon deformation. (**a**) The deformation of SJ-1; (**b**) the deformation of SJ-2; (**c**) the deformation of SJ-3; (**d**) the deformation of SJ-4; (**e**) the deformation of SJ-5.

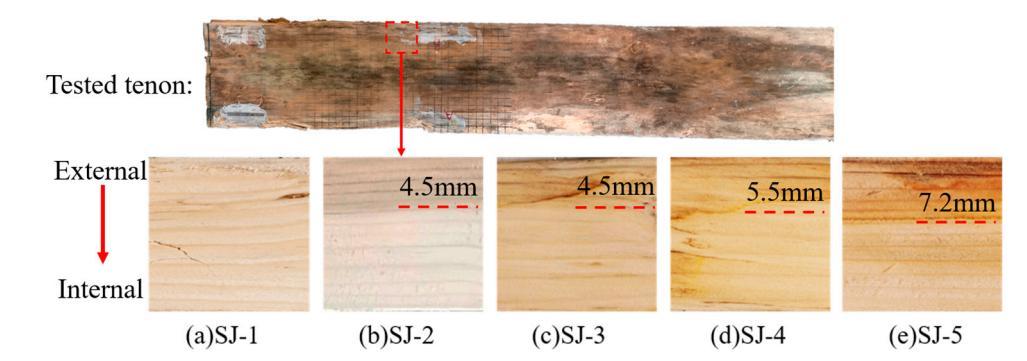
To visually observe the color changes inside the mortise tenons with different degrees of decay, after testing the tenons, the parts near the main force-bearing areas of the tenons were cut from the outside to the inside, with the cut surface parallel to the grain direction of the wood. The cut line was along the midline in the thickness direction of the mortise tenon, as shown in Figure 9. Notably, areas affected by decay exhibited a darker coloration, with decay intensity positively correlating with decay cycle duration. Furthermore, the decay appears to spread more uniformly throughout the internal structure, with the size of the decayed area displaying a direct relationship with the length of the decay cycle. The coloration within the decayed areas varied; generally, the outer end face had a darker shade, and color distribution within the decayed region became less uniform with prolonged decay cycle duration.

Figure 9. Internal color change in tenons.

Determining the specific depth and area of decay is challenging due to the nature of fungal activity and its nonlinear development. As shown in Figure 9, the decay cycle gradually increased when the tenon decayed. To address this, the external decay layer was set to various depth gradients ranging from 0 mm to 30 mm (complete decay), with 5 mm intervals in the simulation. The material parameters corresponding to each depth gradient

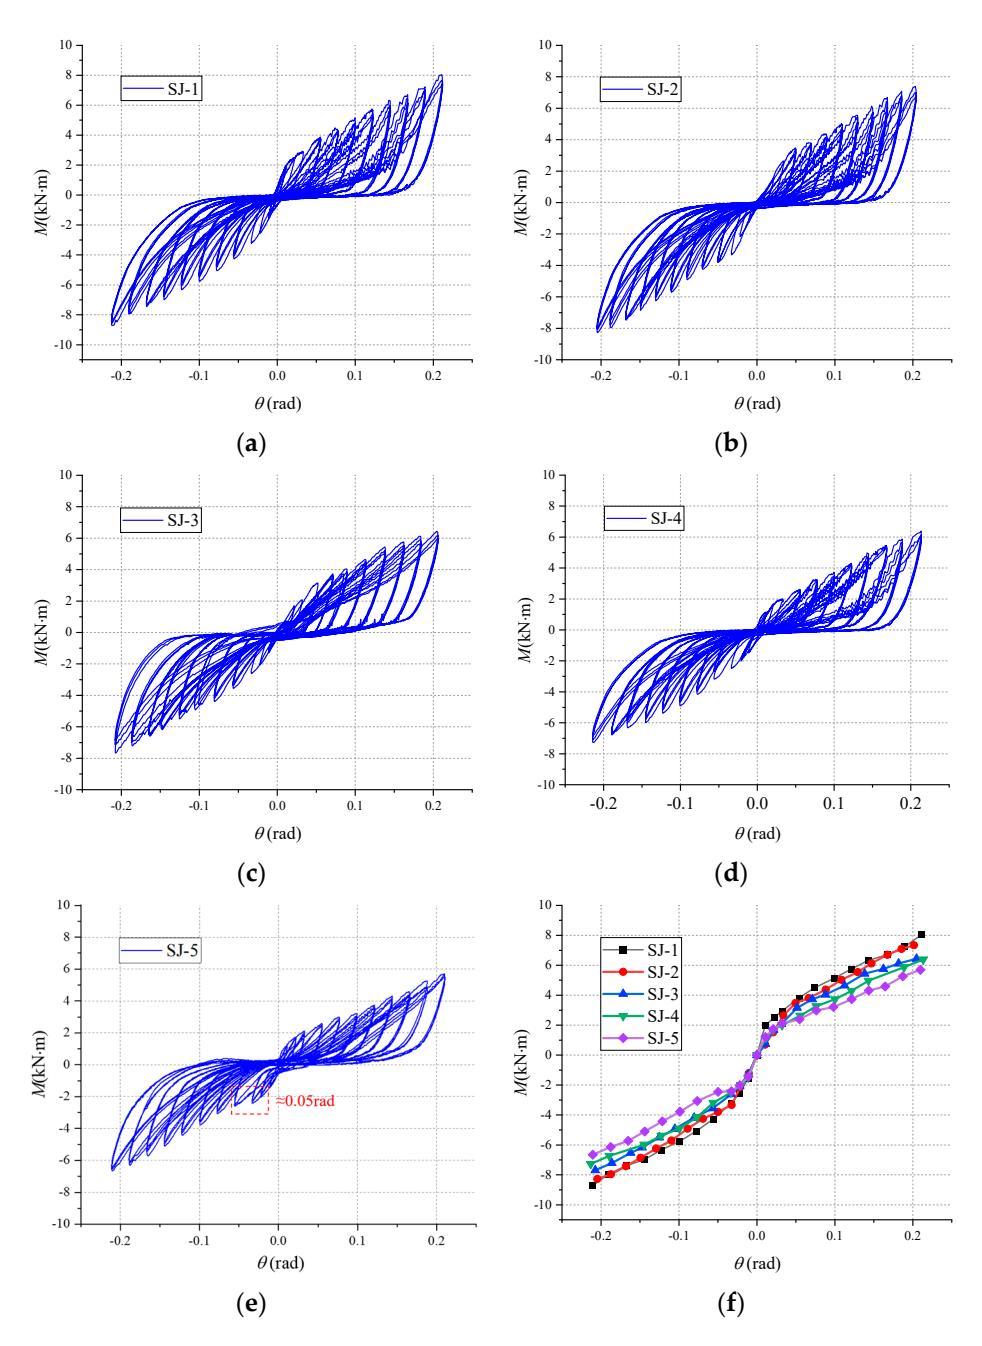
where P represents the load applied by the actuator, H denotes the distance between the upper surface of the column and the loading point, and Δ signifies the horizontal displacement of the loading point. Hysteresis curves and skeleton curves of the decayed SMTJs are provided in Figure 10.

All the hysteresis curves of the joints are reverse S-shaped with a noticeable pinch phenomenon. This indicates that SMTJs experienced slipping under low-cycle repeated loads. Furthermore, as the loading displacement and decay period increased, the slip phenomenon became more pronounced. Initially, the positive and negative bending moment values of the hysteresis curves are symmetrical corresponding to the early stage of experimental loading. This symmetry deteriorates relative to the later stages of loading, with the negative bending moment surpassing the positive loading bending moment. This can be attributed to the increased deformation of the SMTJs during the loading process, leading to slip phenomena. There was slightly more slippage during forward loading compared to negative loading, resulting in a decrease in the bending moment value during forward loading.

The hysteresis curve envelope initially presents a full shape for specimens SJ-1, SJ-2, SJ-3, SJ-4, and SJ-5, which grows less pronounced corresponding to the later stages of loading. This decrease indicates that the energy-dissipation performance of the joint deteriorated as the decay period and loading angle increased. Apart from a sudden significant slip of SJ-5 at a turning angle of around 0.05 rad, which led to a certain degree of decrease in the bending moment value, joints with longer decay cycles were more prone to deformation during loading. This caused an increase in clearance between the mortise and tenon in the later stages of loading, reducing frictional energy consumption in the joint.

Figure 10. (a) M-θ hysteresis curves of specimens cultured for 0 weeks. (b) M-θ hysteresis curves of specimens cultured for 6 weeks. (c) M-θ hysteresis curves of specimens cultured for 12 weeks. (d) M-θ hysteresis curves of specimens cultured for 18 weeks. (e) M-θ hysteresis curves of specimens cultured for 24 weeks. (f) M-θ skeleton curves of specimens.

Figure 10f illustrates the forward loading section of the SMTJs, where there are two distinct stages: the elastic stress stage and the plastic development stage. The elastic stress stage encompasses the initial loading stage and progresses until the slope of the skeleton curve in the forward loading section significantly declines. During this stage, the mortise and tenon gradually compressed, while the bending moment rapidly increased with the rotation angle. As loading continued, the joint began to exhibit plastic failure, resulting in a gradual increase in bending moment values and a decrease in the slope of the skeleton curve. The skeleton curves of the five cycles show where SJ-1 and SJ-2 remained in the elastic stage until reaching a loading angle of approximately 0.05 rad, while SJ-3 reached this stage at 0.035 rad, SJ-4 at 0.03 rad, and SJ-5 at 0.02 rad. This indicates that as the decay cycle increased, the degree of joint decay intensified, the elastic stress stage

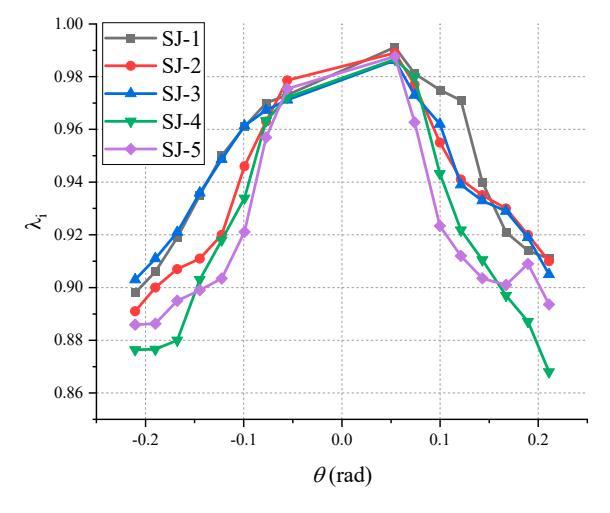
where the strength degradation factor for the i-th loading stage is denoted as λ_i . $P_{i,1}$ represents the peak load of the first cycle in the i-th loading stage, and $P_{i,3}$ represents the peak load of the third cycle in the same loading stage. By utilizing Equation (3) and referring to Figure 11, it is possible to calculate the variation pattern of the strength degradation factor for each node.

Figure 11. Strength degradation.

As shown in Figure 11, there was a gradual increase in the strength degradation factor of all joints as loading displacement increased; this trend intensified as the decay duration increased. Initially, during the early loading stages, the strength degradation among joints was relatively uniform. However, at a loading angle of approximately 0.20 rad, the strength degradation factors of specimens SJ-1 and SJ-2 both stabilized around 0.9, while specimens SJ-4 and SJ-5 had already dropped below 0.88. This disparity can be attributed to the larger decay period causing significant internal damage within the tenon. Consequently, the joint experienced substantial deformation during the third loading stage, leading to a reduction in the bending moment value.

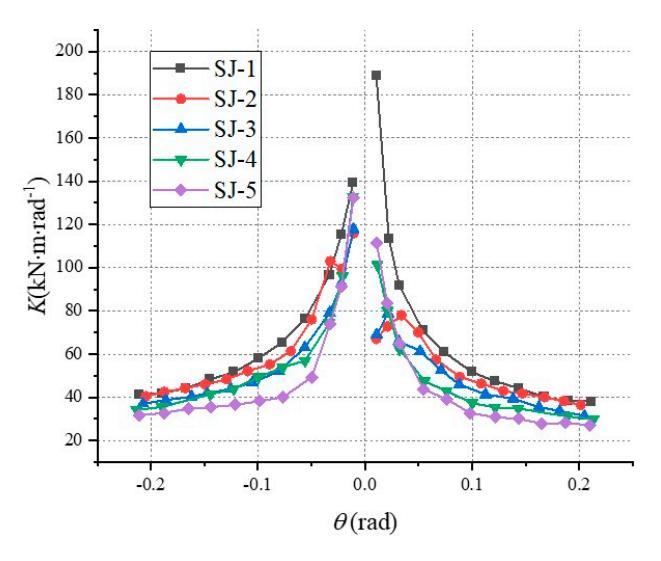
where K_i is the secant stiffness under the i-th level loading displacement, M_i is the peak bending moment under the i-th level loading displacement, and θ_i is the joint rotation angle corresponding to M_i . The rotational stiffness of each joint calculated through Equation (4) is depicted in Figure 12.

Figure 12. Stiffness degradation.

As depicted in Figure 12, the stiffness reduction in all joints exhibits a consistent trend; SMTJs stiffness gradually decreased as the loading displacement increased. Initially, the stiffness declined rapidly until the loading angle exceeded 0.05 rad, after which point the decrease became slower and eventually stabilized. With an increase in decay depth, the initial stiffness of the joint significantly decreased. Furthermore, the disparity between the initial stiffness of the joint and the stiffness at the end of the loading process also increased as the decay depth increased.

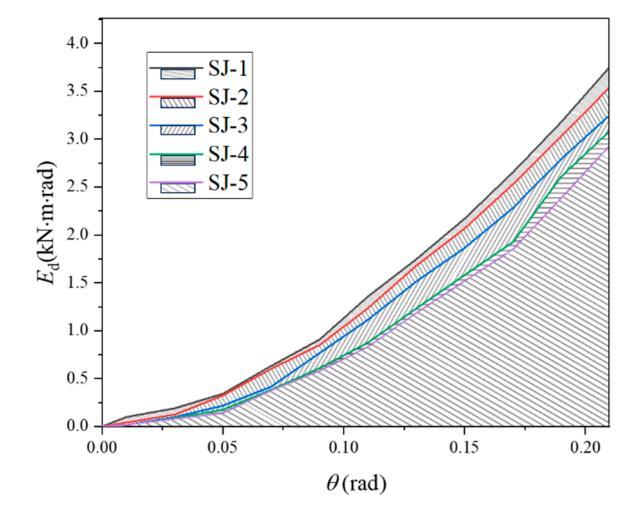
The hysteresis curve represents the energy-dissipation (Ed) capacity of the joint. The area enclosed by the hysteresis curve indicates the amount of energy consumed during loading and unloading cycles. In this experiment, the area of the hysteresis curve decreased as the degree of decay in the specimens intensified. By comparing the area surrounded by the hysteresis curves of different specimens, as shown in Figure 13, it becomes clear that

Figure 13. Hysteresis curve envelope area.

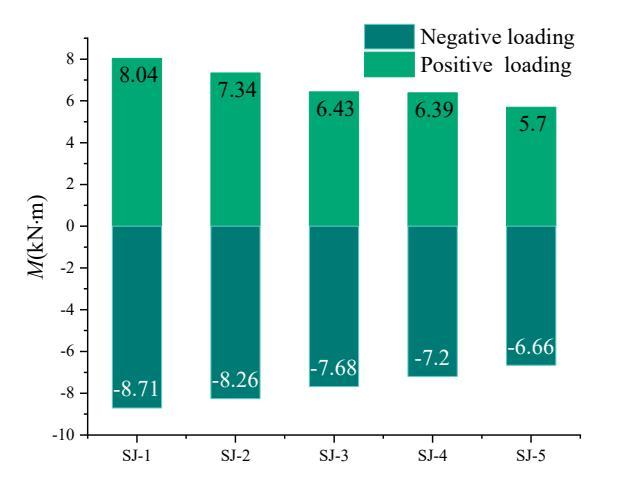
Figure 14 shows how the ultimate bearing capacities of the specimens decreased as the decay cycles increased. For example, the 6-week-decayed SMTJs exhibited a decrease in the ultimate bearing capacity of approximately 5.17%, while after 12 weeks, this decrease was 11.83%, and it was 17.34% after 18 weeks and 23.54% after 24 weeks. In summary, the energy-dissipation capacity decreased and the load-bearing performance of the SMTJs was significantly affected as the extent of decay deepened. The decrease in the ultimate bearing capacity also became more pronounced with longer decay cycles.

Figure 14. Degradation of ultimate bearing performance.

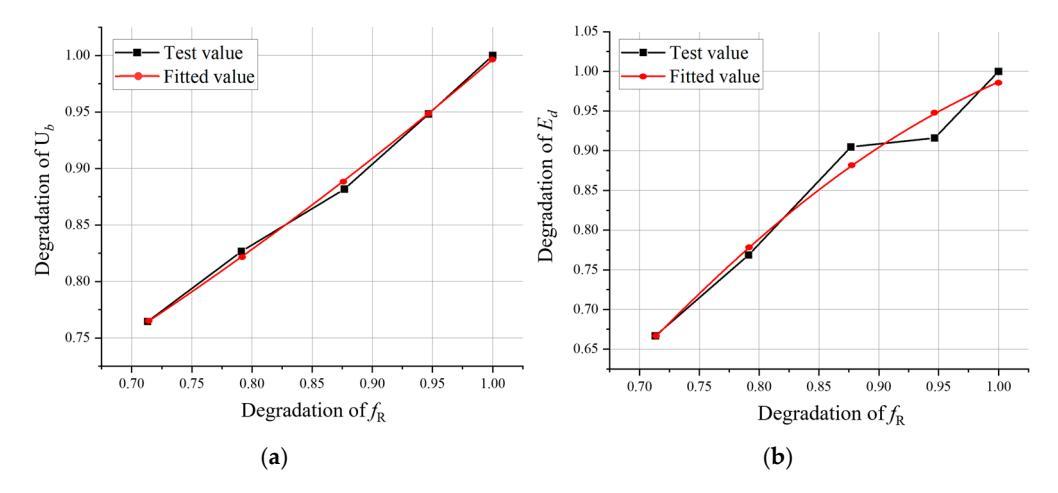
Given the degradation characteristics of mechanical properties in SMTJs, we utilized the sigmoid function, which is commonly employed in machine learning [45], to model the relationship between material property degradation and transverse compressive performance degradation. Employing Origin 2021 data analysis software, the least squares method was applied for numerical fitting to determine the functional relationship between transverse compressive strength and SMTJs mechanical properties, as depicted in Figure 15.

Figure 15. Relationship between seismic performance of joint and degradation of mechanical properties. (a) The degradation relationship of ultimate load-bearing performance; (b) the degradation relationship of cumulative energy consumption performance.

Both formulas have determination coefficients greater than 0.95, indicating a strong fitting effect. In practical engineering applications, the degradation of wood transverse compressive strength is relatively straightforward to measure. By analyzing the decrease in wood transverse compressive strength, it is possible to predict the degradation relationship between the ultimate bearing capacity and cumulative energy consumption performance of SMTJs.

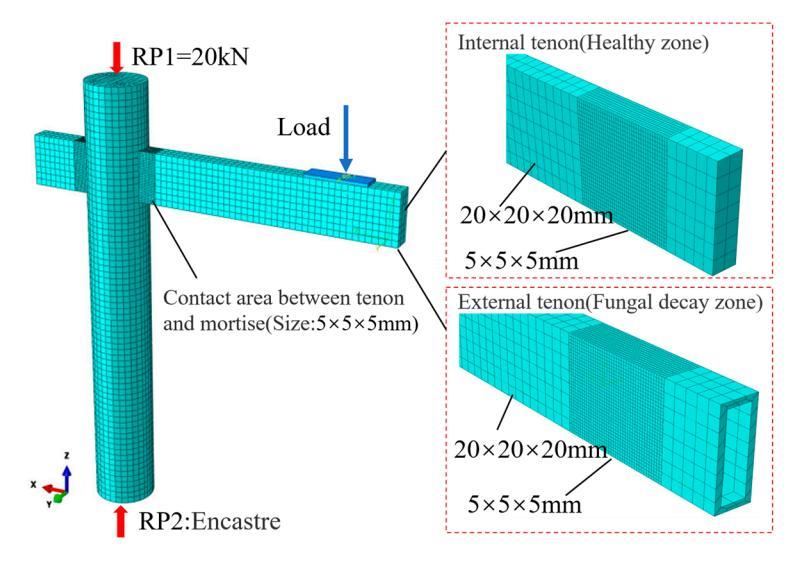
were analyzed, and the decay depth design group closest to the experimental value was selected for comparison. To ensure calculation accuracy and minimize computation time, in the primary contact areas between the tenon and mortise, a 5 mm side length hexahedron was used to divide the external decay layer beam and internal grid, while the remaining parts were divided into 20 mm side length hexahedrons, as depicted in Figure 16.

Figure 16. Finite element model.

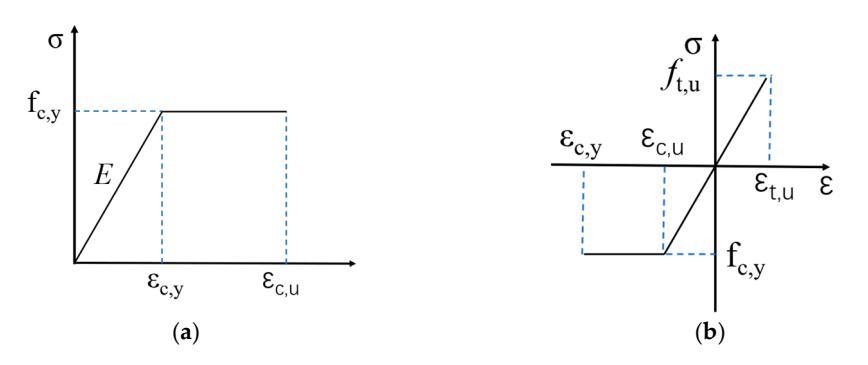
The compression behavior along the grain of the wooden beam is described here using an ideal elastic–plastic model. The transverse compression is characterized as a double broken line constitutive model. It is important to note that the joint's tensile elastic modulus is equivalent to the compressive elastic modulus. The resulting constitutive model is shown in Figure 17.

Figure 17. Wood constitutive model. (**a**) The longitudinal compressive constitutive law; (**b**) the transverse compressive constitutive model.

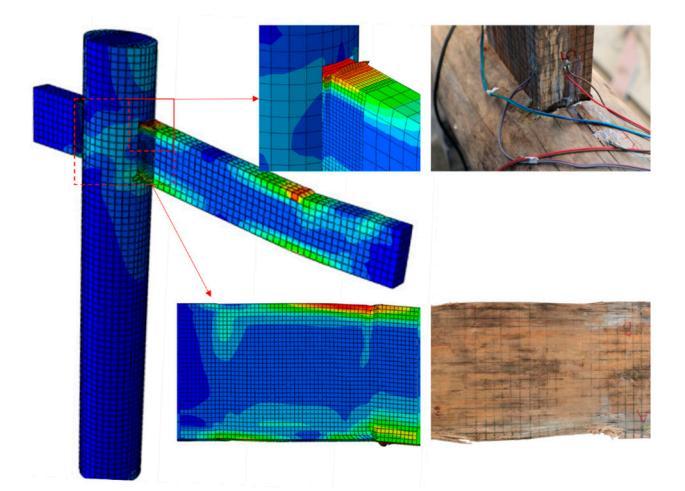
As depicted in Figure 18, an increase in loading displacement led to plastic compression failure at the tenon, accompanied by a gradual widening of the gap between the tenon and the upper and lower surfaces. Towards the end of the loading process, a minor protrusion appeared near the compressed region of the tenon, while a noticeable depression was observed within the compressed area. These findings support the experimental deformation results, thereby validating the accuracy of the proposed model.

Figure 18. Comparison of finite element and experimental deformation.

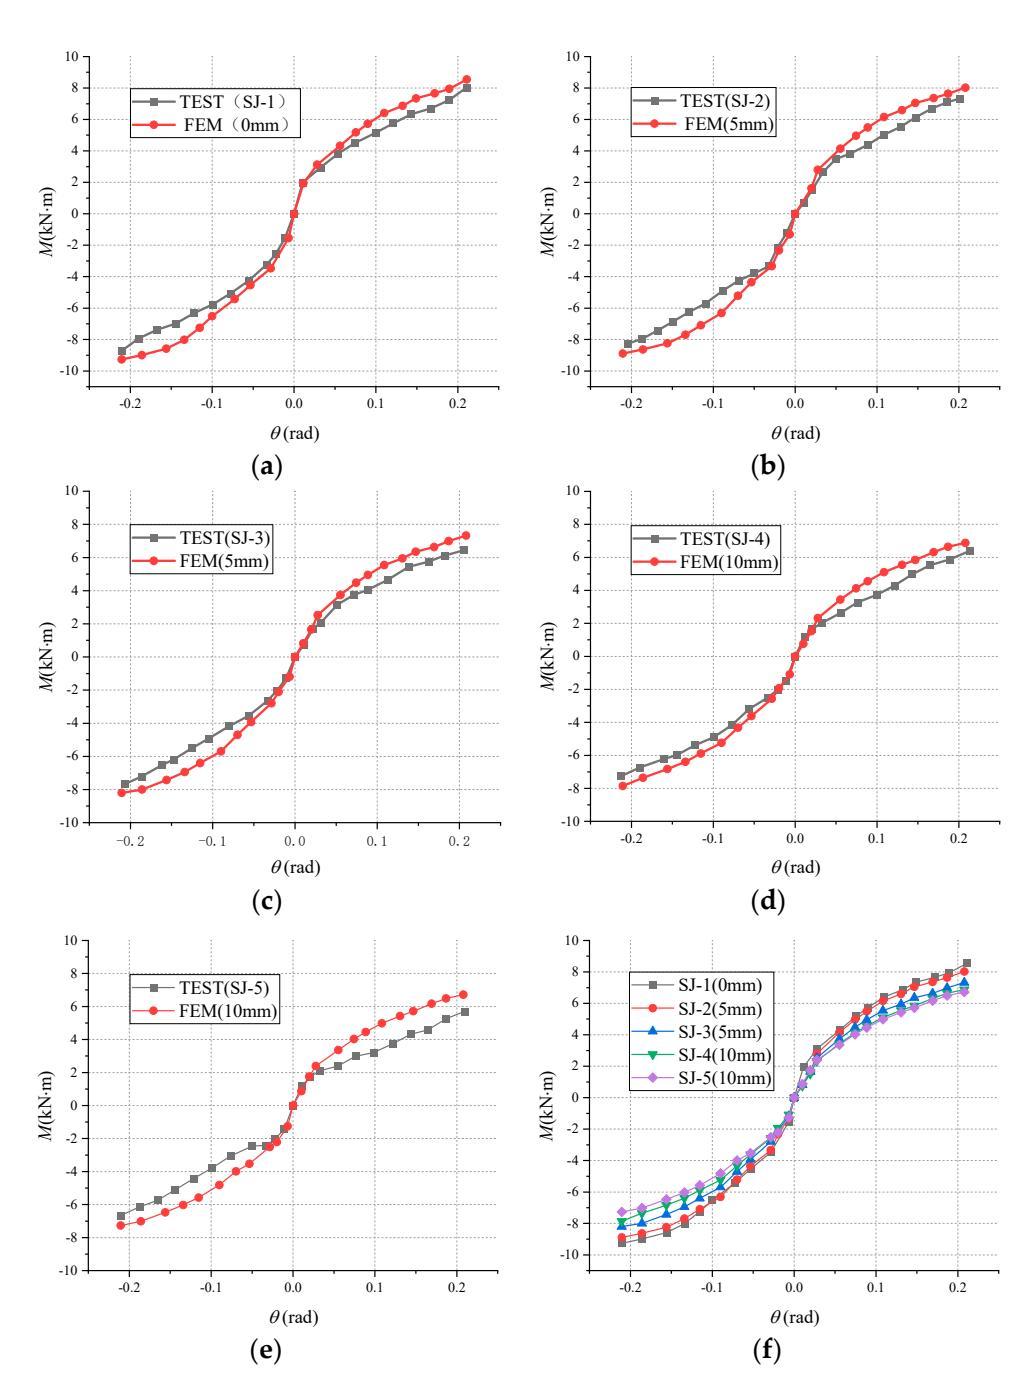
In the finite element simulations, a decay depth gradient was applied with 5 mm intervals for each decay cycle. The decay depth group that most closely matched the experimental values was selected for subsequent analysis. Specimens SJ-2 and SJ-3 exhibit the closest decay depth at 5 mm, whereas specimens SJ-4 and SJ-5 had the closest decay depth of 10 mm. The SMTJs exhibited a decay depth range of 0–5 mm within 12 weeks, which extended to 5–10 mm between 12 and 24 weeks. Notably, a significant portion of the node remained unaffected by decay, contributing to its retained load-bearing capacity. A comparison between the finite element simulation results and the experimental findings is illustrated in Figure 19.

Upon comparing the finite element skeleton curves of the SMTJs, we found that the bending moment values simulated by the finite element method slightly exceeded the corresponding experimental values when rotation angles were kept constant. This discrepancy can be attributed to the presence of initial defects (e.g., knots) in the experimental wood, whereas finite element analysis assumed an ideal homogeneous wood without such imperfections. Furthermore, as the decay period extended, the disparity between the finite element simulated skeleton curve and the experimental skeleton curve gradually increased. This escalation can be attributed to an amplification of material property variations at different decay depths within the tenon having diminished the uniformity of the decay.

Figure 19. (**a**) Non-decayed specimen. (**b**) Outer layer decay depth: 5 mm. (**c**) Outer layer decay depth: 5 mm. (**d**) Outer layer decay depth: 10 mm. (**e**) Outer layer decay depth: 10 mm. (**f**) Finite element skeleton curve diagram.

From the loading process until the plastic enhancement stage, significant differences were noted between the finite element simulation and experimental values. During experimentation, the joint experienced greater sliding in the forward loading stage compared to the reverse loading, with the sliding magnitude increasing as the loading angle increased. Consequently, there was a pronounced reduction in the node's bending moment. Table 2 presents an error analysis of values obtained from both finite element simulations and experiments. Notably, the initial stiffness error range is the smallest. This can be attributed to the wood exhibiting elastic behavior during the initial loading phase; the constitutive model employed in the finite element analysis fits well with this elastic stage.

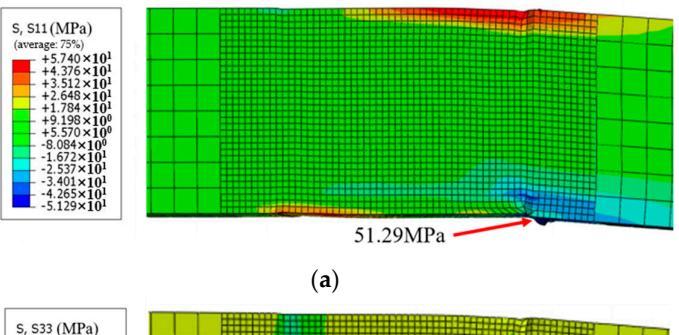
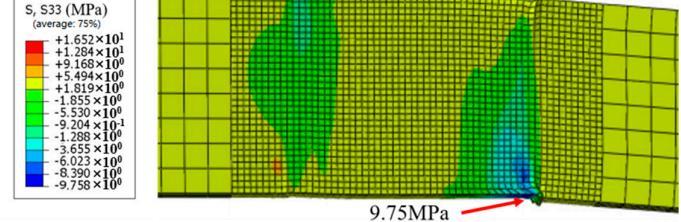
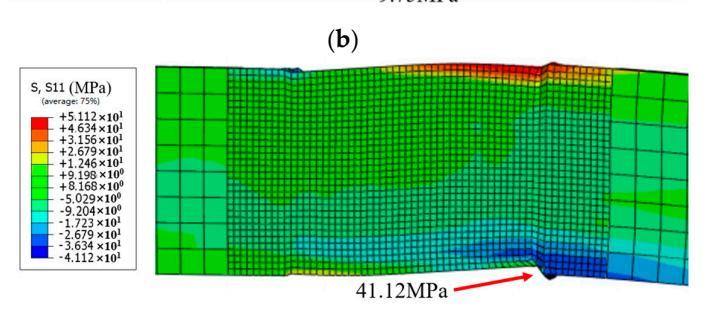
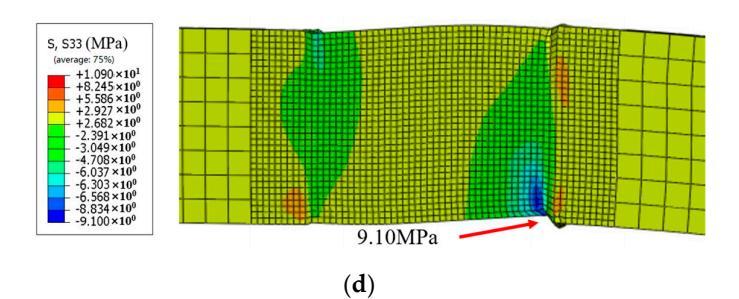
Figure 20 shows a stress cloud map of the tenon after rotating it to 0.20 rad, with the non-decayed specimen SJ-1 and the specimen with a 10 mm decay depth (SJ-5) as examples. The compressive stress on the upper and lower end faces of the tenon joint resulted in a maximum compressive stress of 51.29 MPa for specimen SJ-1. For specimen SJ-5, the value was 41.12 MPa. This value does not exceed the compressive strength (0 weeks: 65.1 MPa; 24 weeks: 51.2 MPa) of the wood along the grain, suggesting that the nodes were not damaged along the grain direction. The stress cloud map in the S33 direction reveals maximum compressive stresses of 9.75 MPa and 9.10 MPa for specimens SJ-1 and SJ-5, respectively. These values are close to the compressive strength of the wood's transverse grain (0 weeks: 6.07 MPa; 24 weeks: 5.09 MPa), implying that transverse compression deformation would occur at the tenon. However, simulating fracture phenomena in specimens SJ-1 and SJ-5 was difficult in ABAQUS/CAE2021 due to the lack of a constitutive model that accurately represents wood fracture. The maximum tensile stress occurred near the compression area of the tenon and mortise, as the deformation of units in the compression area generated tension in the nearby units, causing an uplift near the compression area of the tenon.

Figure 20. Stress nephogram of tenon. (**a**) Stress nephogram of tenon of specimen SJ-1 (S11: grain direction); (**b**) stress nephogram of tenon of specimen SJ-1 (S33: radial direction); (**c**) stress nephogram of tenon of specimen SJ-5 (S11: grain direction); (**d**) stress nephogram of tenon of specimen SJ-5 (S33: radial direction).
