Article Mechanical Performance of Amorphous Metallic Fiber-Reinforced and Rubberized Thin Bonded Cement-Based Overlays

Citation: Javed, A.; Gillani, S.A.A.; Abbass, W.; Riaz, M.R.; Hameed, R.; Abbas, S.; Salmi, A.; Deifalla, A.F. Mechanical Performance of Amorphous Metallic Fiber-Reinforced and Rubberized Thin Bonded Cement-Based Overlays. *Sustainability* **2022**, *14*, 8226. https://doi.org/10.3390/su14138226

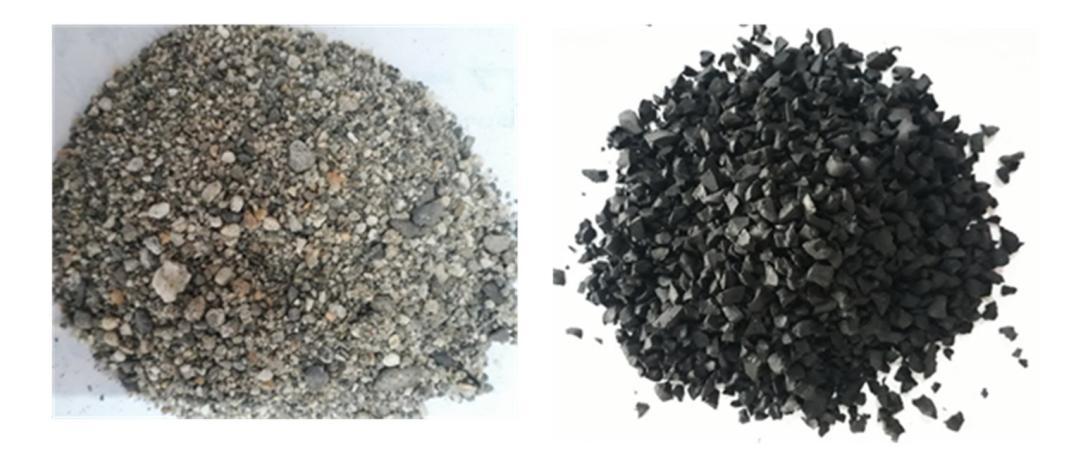
Figure 1. Sand and rubber aggregates.

For the substrate layer, mortar constituted of ordinary Portland cement, fine aggregates, and superplasticizer and for the repair layer, mortar constituted of rubber and steel fibers, in addition to ordinary Portland cement and fine aggregates. The fine aggregates used in mortar were obtained from Lawrencepur quarry, Pakistan (Figure 1). The grain size of sand was in the range of 0–4 mm. For gradation of the sand, standard sieve shaker was used in which stack of sieves were placed and shaking was carried out for 10 to 15 min. After shaking, the mass retained on each sieve was measured to calculate the fineness modulus of sand. Specific gravity of sand was measured by using pycnometer of capacity 50 mL. The specific gravity and fineness modulus of Lawrencepur sand were 2.73 and 2.82, respectively. The grading curve of Lawrencepur sand is provided in Figure 2. A third-generation superplasticizer (i.e., Sika ViscoCrete 3110 was used in the mortar for the required workability and for avoiding the segregation of rubber aggregates). The addition of fibers in the cement mix induces a reduction in its workability whereas lighter aggregates (i.e., rubber aggregates cause segregation in the cement mix). Since, the specific gravity of rubber aggregates used in this study is 1.2 which is lesser than that of sand (i.e., 2.73). To tackle these problems, a third-generation superplasticizer (i.e., Sika ViscoCrete 3110 was used in the mortar for the required workability and to avoiding the segregation of rubber aggregates). This superplasticizer also includes properties of viscosity modifying agent. The slump was maintained by adjusting the dosage of superplasticizer in all mix compositions, including the control mortar, to consider the effect of admixture on the behavior of materials.

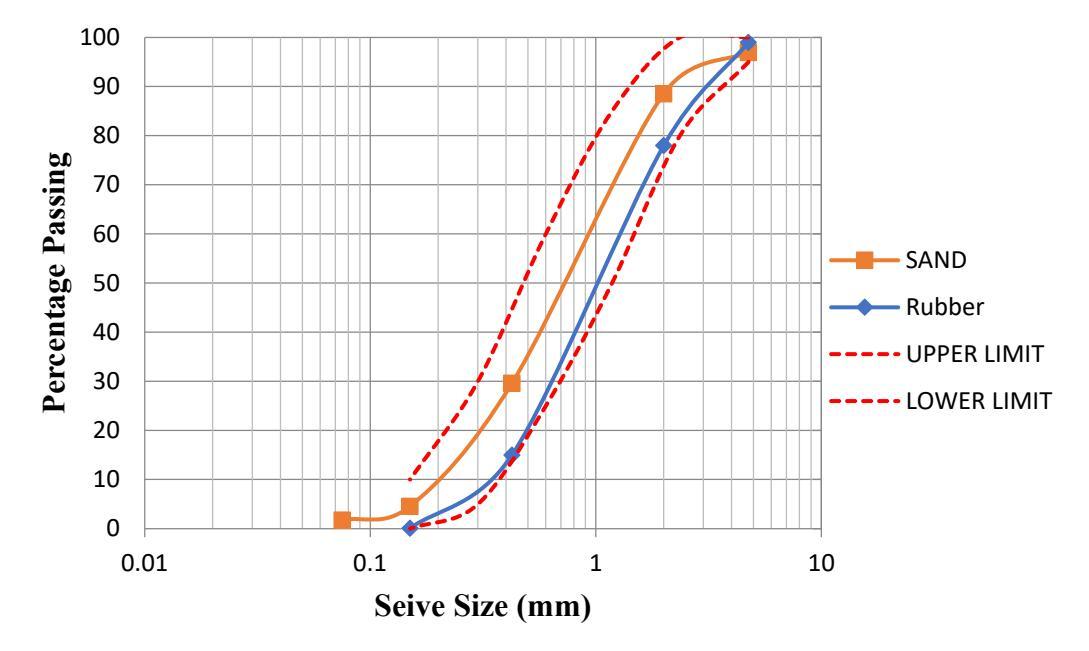
Figure 2. Grading curve of sand and rubber aggregates along with ASTM limits.

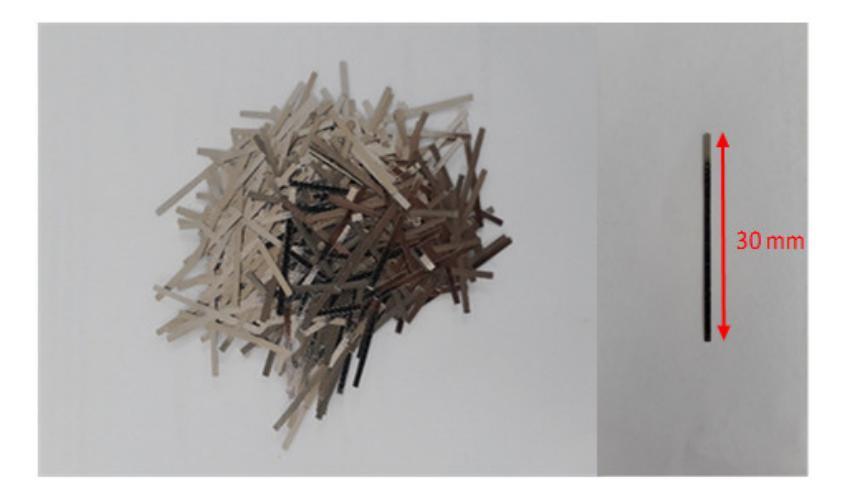
Figure 3. Amorphous metallic fibers of 30 mm length.

Amorphous metallic fibers were used in the mortar for repair overlays. Research had shown that material having high tensile strength reduced the risk of cracking and delays the crack initiation and propagation [7,22]. Amorphous metallic fibers are very flexible, straight, and easy to handle. In addition to that, these fibers are corrosion-resistant [12]. The image of metallic fibers used is shown in Figure 3. The amorphous metallic fibers used are FF30L6 FibraFlex provided by Saint Gobain Seva. The characteristics of Amorphous metallic fibers and other types of fibers used by previous researchers are presented in Table 1. Rubber aggregates were made by grinding end-of-life tires. The sand was partially replaced by rubber aggregates by equivalent volume in different percentages. Literature on rubber aggregates has also shown that the use of rubber aggregates improved strain capacity before macro-cracking [5]. The specific gravity of rubber aggregates used is 1.2 whereas the specific gravity of sand is 2.73. The rubber aggregates used in this study are shown in Figure 1. The maximum size of rubber aggregates used does not exceed 4 mm which is comparable to the size of sand particles. The particle size distribution curve of rubber aggregates was obtained by sieve analysis performed in accordance with ASTM C33 and presented in Figure 2. To enhance the durability of thin bonded overlays, the work approach adopted in this research is presented in a flow chart shown in Figure 4.

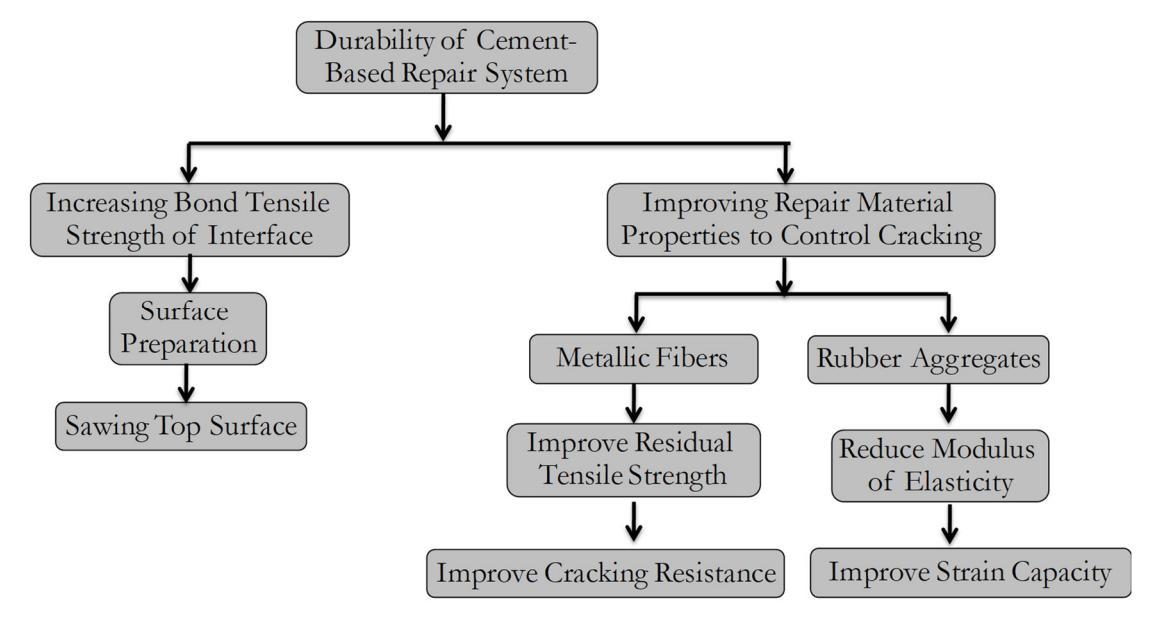
Figure 4. Flow chart showing the work approach adopted to enhance the durability of cement-based repairs.

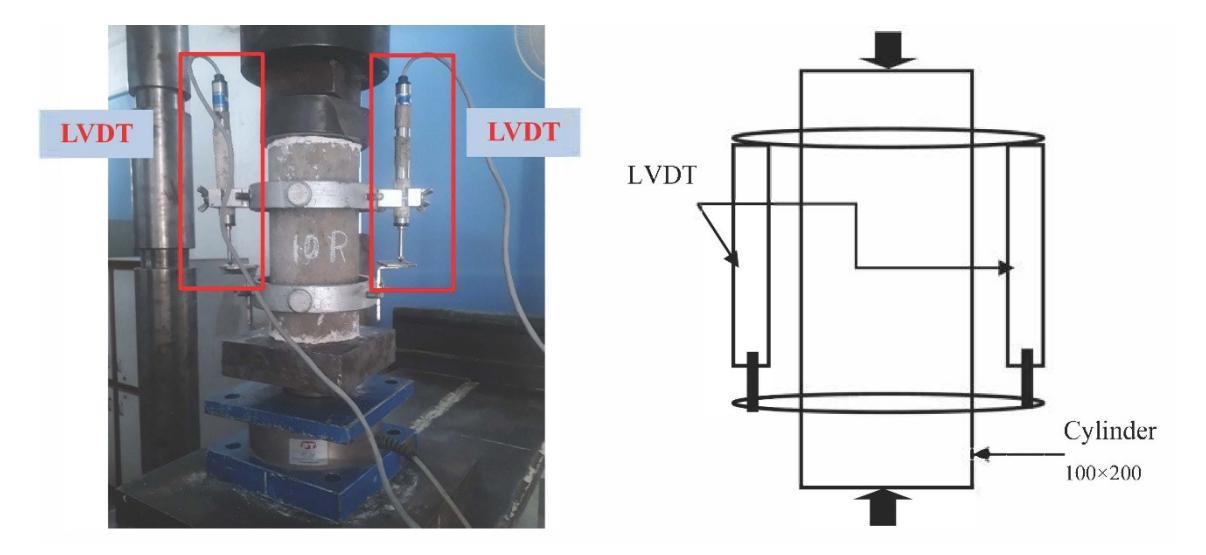
Figure 5. Actual test setup and its schematic representation for compression and MOE test.

Compressive strength tests were conducted after 28 days on cylindrical. specimens having dimensions of 100 mm diameter. and 200 mm height. The compression tests were performed in accordance with ASTM C39. For each mix, three samples were tested. The test setup for the compression test is shown in Figure 5. Modulus of Elasticity (MOE) tests. were. conducted after 28 days on cylindrical. specimens having dimensions of 100 mm diameter. and 200 mm height. The tests were conducted. according. to ASTM C469. The test setup for the MOE test is shown in Figure 5. Two LVDTs were attached to the specimen to measure deformations which were used to calculate strain.

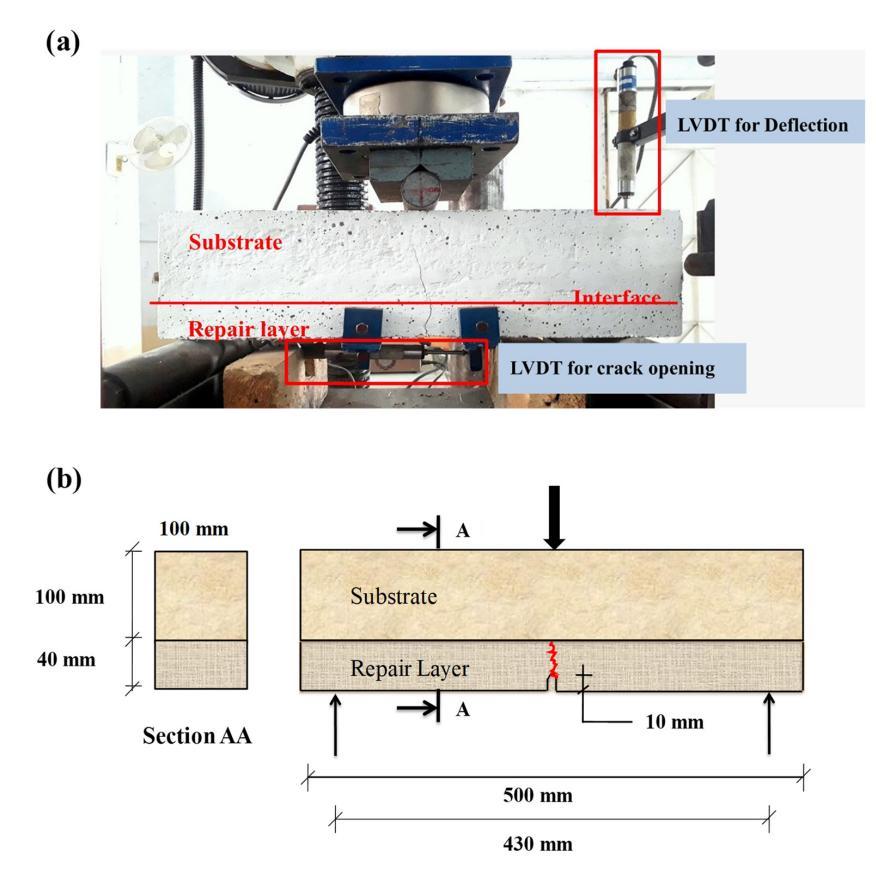
Figure 6. (a) Actual test setup for three-point bending test; (b) schematic diagram.

The composite specimens consisted of a thin repair layer on top of the substrate simulating repaired beam. Cementitious substrates without rubber aggregates and fiberreinforcement 0R0F were prepared to have the real application. Prism beams were cast in two phases. In the first phase, the substrate layer was cast which simulated the structure to be repaired. The size of the substrate layer was $100 \times 100 \times 500$ mm. After the substrate layer had been water cured for 28 days, the top surface of the prism was prepared for the casting of the repair overlay. Surface preparation must provide good anchorage to the new layer. Different techniques are available for the preparation of mortar surface to give better bonding. The technique used to prepare and level the surface of the substrate was sawing the top 5 mm layer. In the second phase, a cement-based overlay was cast over the substrate after the preparation of the surface. Mold was modified and arranged to cast a 40 mm repair layer over a 100 mm substrate with a 10mm notch at the center. Sixteen different repair layers were cast over the substrate according to the design mix presented in Table 2. Cast composite prisms were then water cured for 28 days at controlled temperature of 20 °C and relative humidity of 98%. Then the cleaned surface was white washed for clear visibility of cracks during testing.

Three-point static bending test was carried out on Shimadzu Universal Testing Machine having a loading capacity of 1000 KN to study the behavior of the overlay–substrate under flexure. A schematic diagram of the repaired composite prism under three-point static bending test and the complete actual testing setup are shown in Figure 6. This test was conducted according to the RILEM TC 162-TDF [47]. These tests were conducted at a loading rate of 0.5 mm/min. Two LVDTs were attached with the composite prism to measure the mid-span deflection and the crack mouth opening (CMOD). CMOD was measured by the LVDT attached at the notch location in the mid span and the vertical deflection of the composite specimens was monitor by other LVDT sensor at the support location.

Under flexural loading, the crack was initiated from the tip of the notch in the overlay, which eventually travels towards the interface. The values of force, deflection, and crack mouth opening displacement (CMOD) were automatically recorded. by the data. acquisition. system. of Shimadzu Universal Testing Machine.

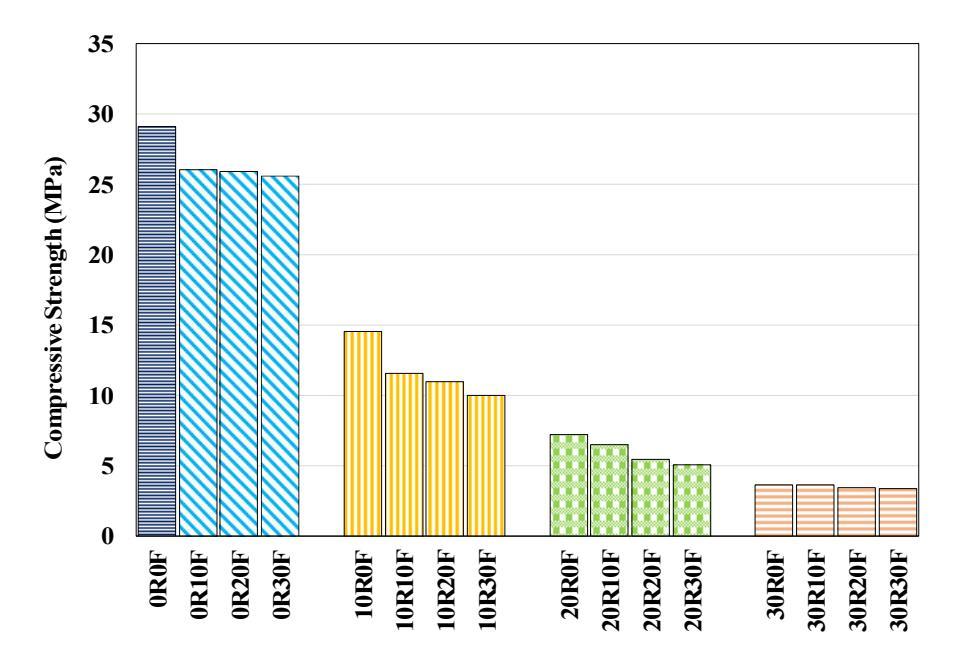
Figure 7. Compressive strength of mortar mixes.

Compressive strength results of all mortar mixtures are presented in Figure 7. The average of three specimens is shown in Figure 7. Results showed that with the addition of rubber aggregates in the mixtures, the compressive strength of the specimen was decreased. It can be observed that 30% partial replacement of natural aggregate with rubberized aggregate showed around an 80% decrease in compressive strength. It may be attributed to the fact that rubber aggregates are weak as compared to the natural aggregates leading to a decrease in compressive strength [8]. Also, the low stiffness of rubber aggregates, as well as poor bonding between cement matrix and rubber particles, result in a loss in compressive strength.

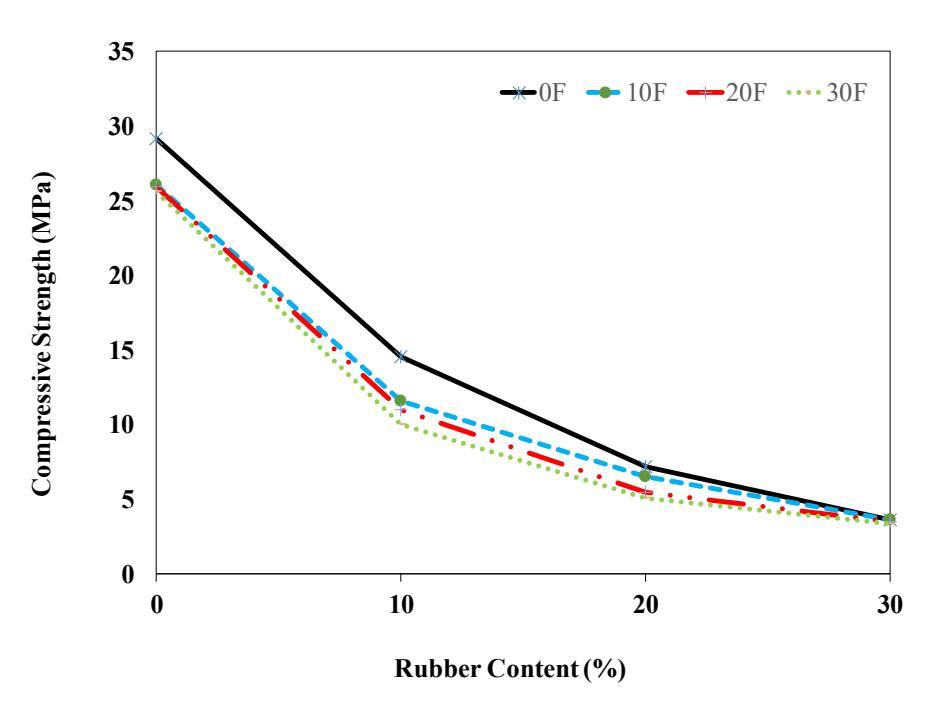
Figure 8. Compressive strength with different percentages of rubber aggregates.

Figure 8 presents the compressive behavior of mortar with different percentage replacements of rubberized aggregate. Test results show slight reduction in the compressive strength with addition of metallic fibers (i.e., about 8%, which is not so significant). This reduction may be attributed due to the fact that the packing of the matrix is disturbed and compressive strength of the fiber-reinforced mortar is primarily dependent upon fiber-matrix bond. Also, the fibers used in current research is hydrophobic in nature and contribute lesser towards compressive strength enhancement. Results obtained for compressive strength of repair mortars incorporating steel fibers and rubber aggregates are in good agreement with previous research studies [5,8,20].

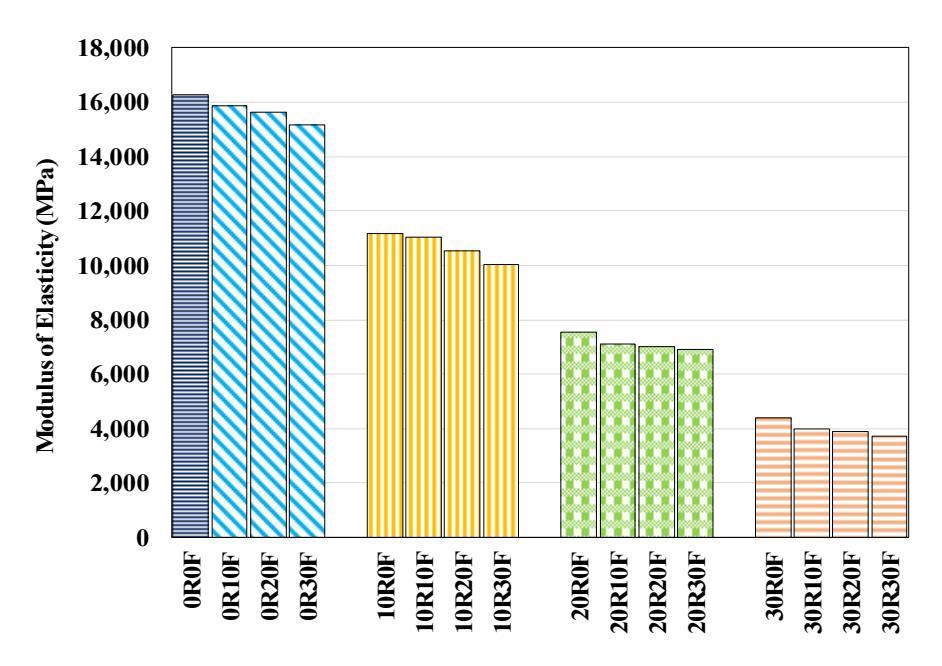
Figure 9. Modulus of elasticity of mortar mixtures.

Modulus of elasticity results of different mortar mixtures are shown in Figure 9. For each mix, three samples were tested. The test results of MOE in compression for all mortar mixtures with different replacements of rubber aggregates are presented in Figure 10. Results revealed that with the addition of steel fibers in the mortar mixture, there was a negligible reduction in modulus of elasticity. Further, the modulus of elasticity decreased with the increased content of rubber aggregates. It can be observed that with a 30% partial replacement of natural aggregate with rubber aggregate, the modulus of elasticity is reduced by around 60%. This reduction in MOE may be attributed to the lesser stiffness of rubber aggregates. Similar findings are reported by previous researchers [30]. This reduction may be attributed to poor bonding between cement paste and rubber aggregate and low modulus of elasticity of rubber aggregate according to the rule of mixture law [8].

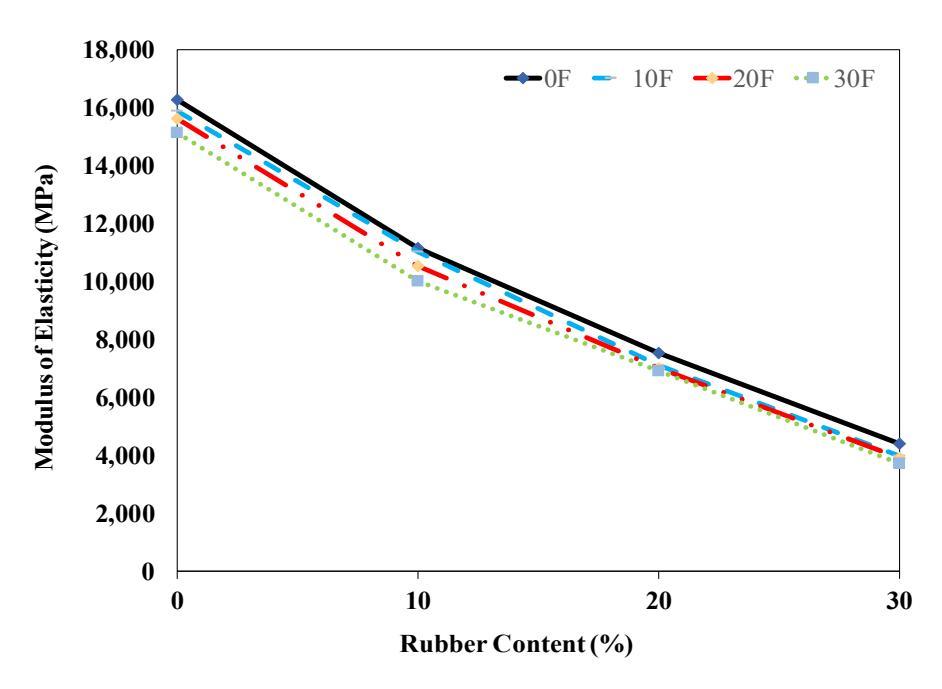
Figure 10. Modulus of elasticity with different percentages of rubber aggregates.

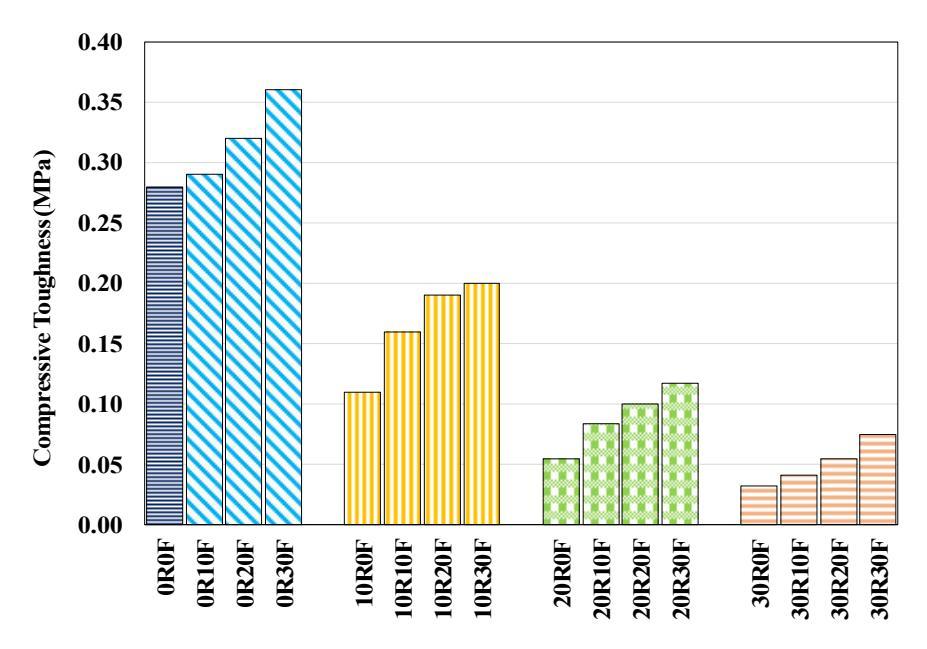
Figure 11. Compression toughness of mortar mixes.

Compression toughness was calculated by obtaining the area under. the stress-strain. curve up to 60% of peak load. Compression toughness results of all mortar mixes are presented in Figure 11. Test results of compressive toughness for all mortar mixtures with different fiber contents are presented in Figure 12. Compression toughness of mortar mixes with a combination of steel fibers and rubber aggregates showed significant reduction with an increment of rubber content and there was a minor increment with the addition of steel fibers. The reduction in compression toughness due to the addition of rubber aggregates was mainly due to low. stiffness. of rubber and the bond. defects. at rubber-cement. paste. interface. These experimental results are in good agreement with the study carried out on compressive toughness of rubberized steel fiber reinforced concrete [20].

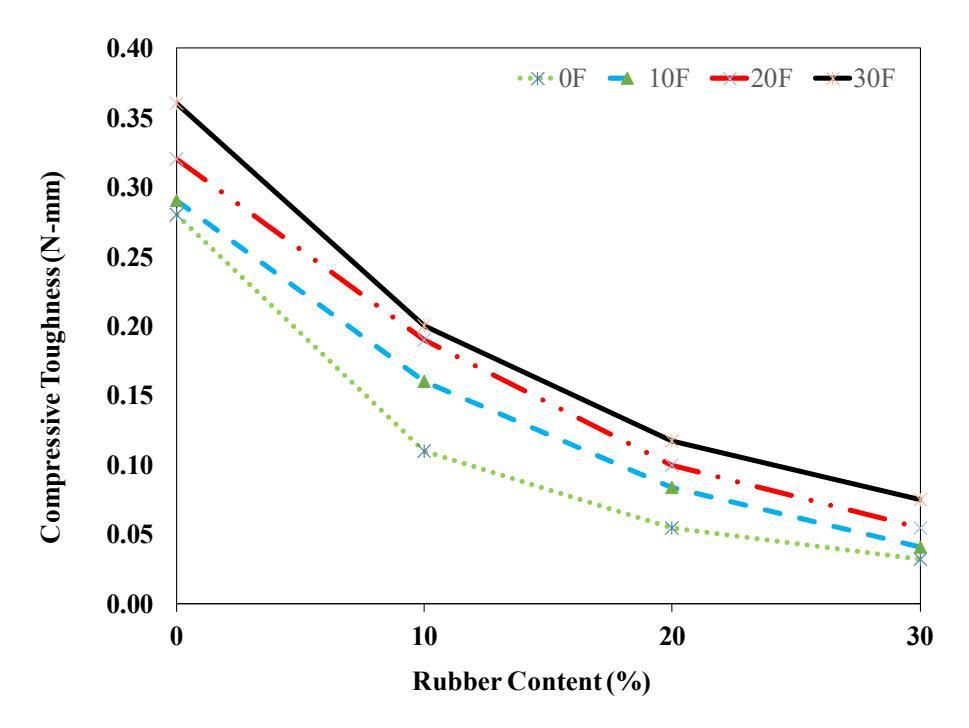
Figure 12. Compression toughness of mortar mixes with different rubber content.

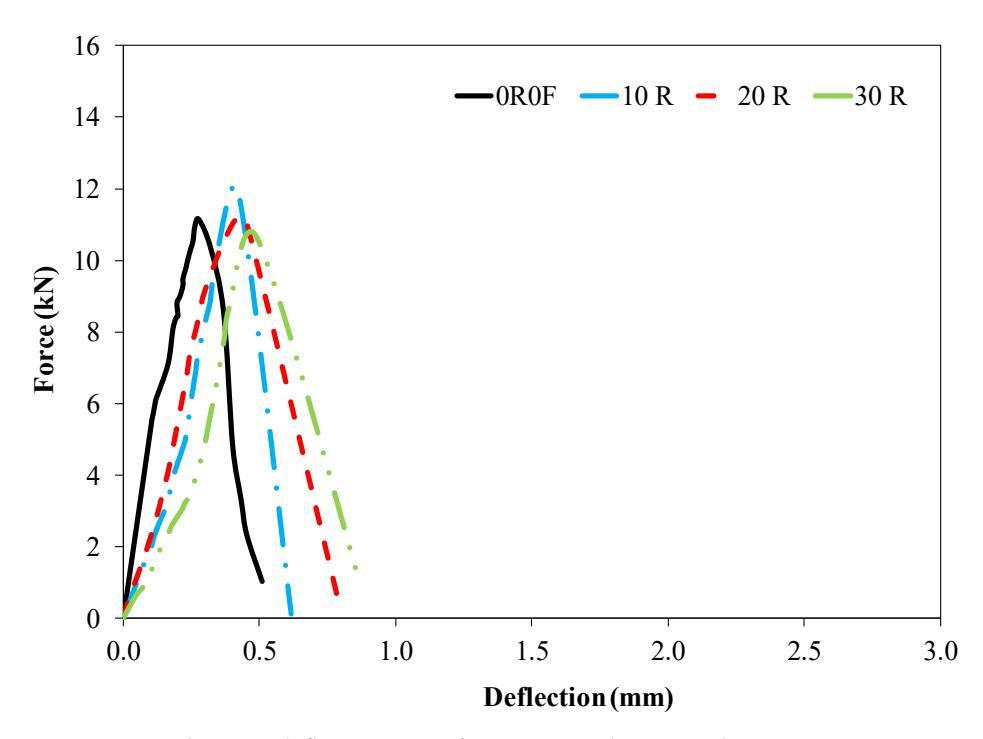
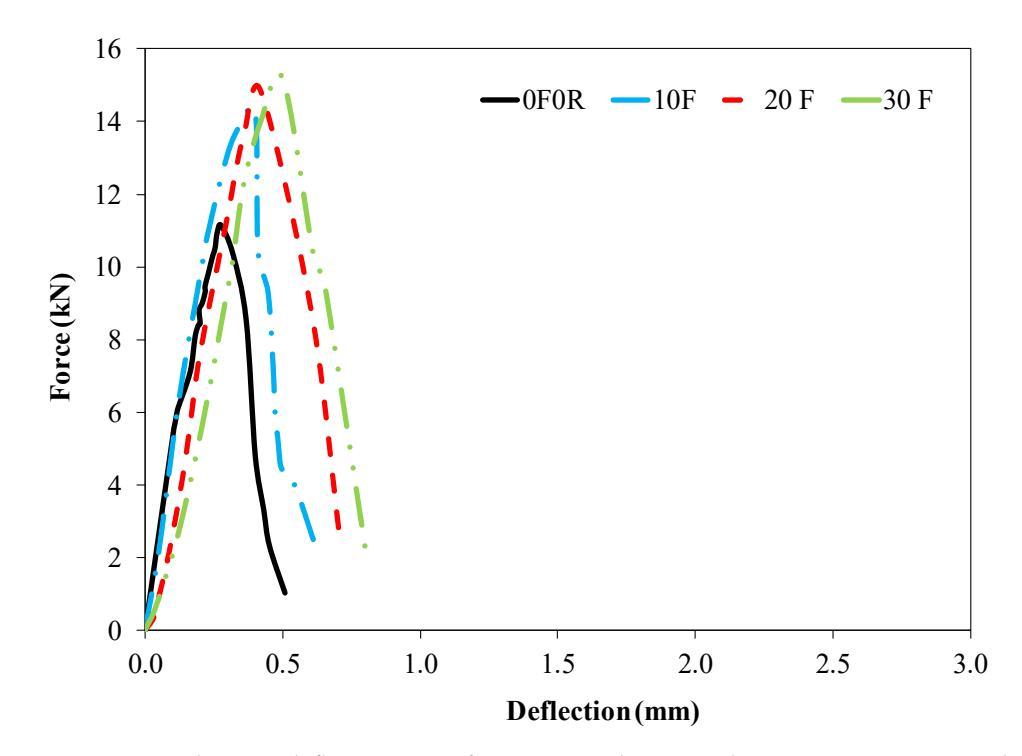
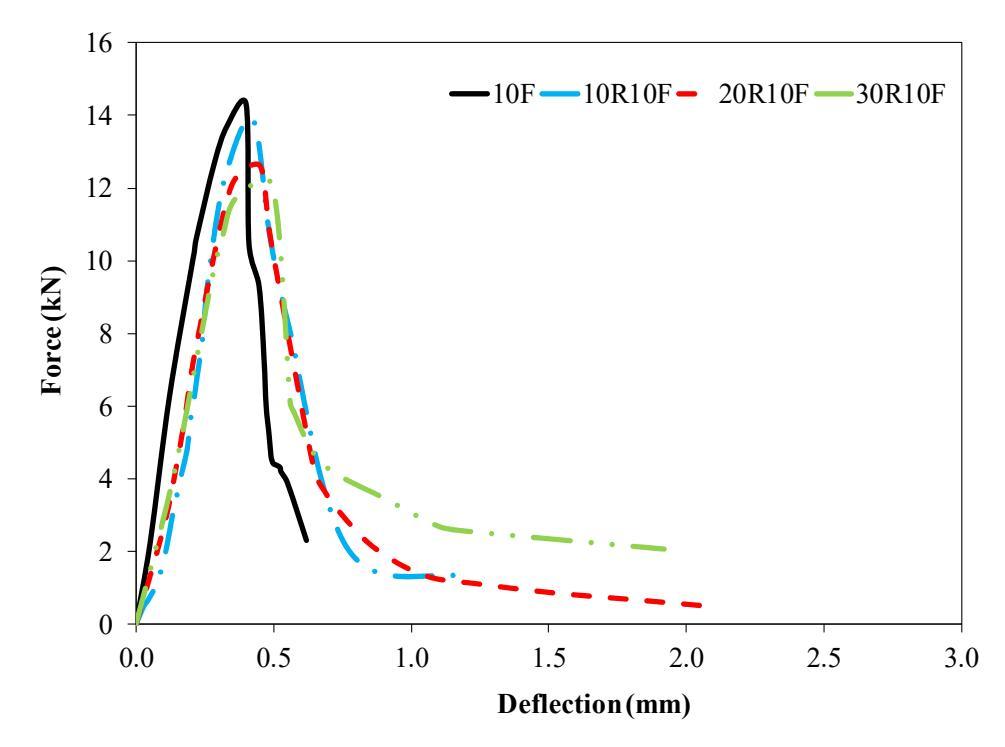
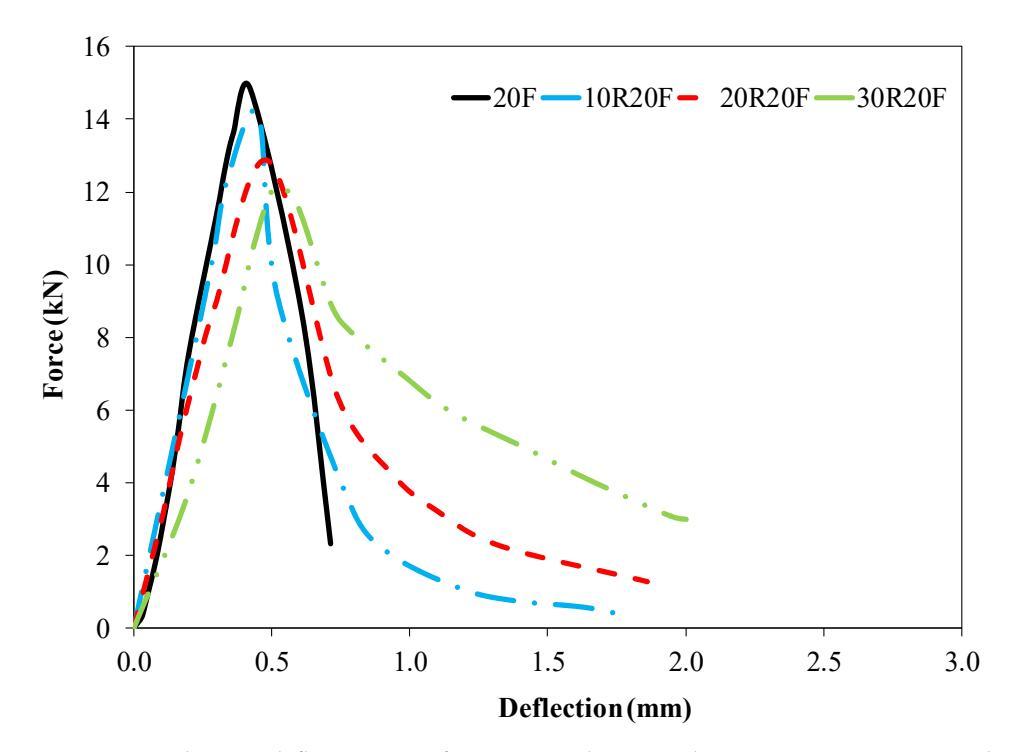
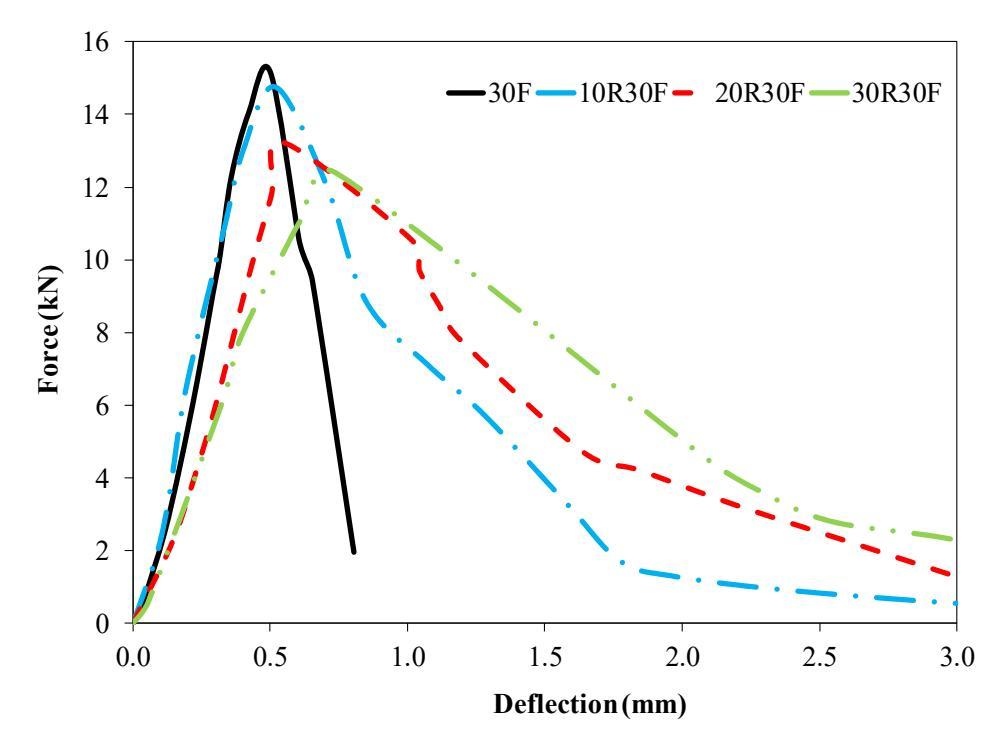
Figure 13. Load versus deflection curve for composite beams with 0R0F, 10R0F, 20R0F, and 30R0F repair mix composition.

Figure 14. Load versus deflection curve for composite beams with 0R0F, 0R10F, 0R20F, and 0R30F repair mix composition.

Figure 15. Load versus deflection curve for composite beams with 10F, 10R10F, 20R10F, and 30R10F repair mix composition.

Figure 16. Load versus deflection curve for composite beams with 0R20F, 10R20F, 20R20F, and 30R20F repair mix composition.

Figure 17. Load versus deflection curve for composite beams with 0R30F, 10R30F, 20R30F, and 30R30F repair mixture composition.

The relationship between force and deflection of composite prisms having different types of repair materials are presented in Figures 13–17. The curve of each repair mix composition represents the average of three prism specimens.

The curves show that peak load as well as the corresponding deflection increased as compared to the control mortar with fiber reinforcement of repair material. The deflection capacity of material at ultimate load was increased with addition of rubber aggregate and steel fibers. The synergetic effect of rubber aggregates and metallic fibers was ensured through decreased cracking and improved ductility of repaired material. With the increase of fiber content in repaired beams, the post-peak residual strength also increased. The increase in the deflection of the composite prisms was due to the bridging action provided by the steel fibers against the crack opening. Similarly, an increase in peak load and corresponding deflection was observed in recent study conducted on rubberized fiberreinforced overlays [44].

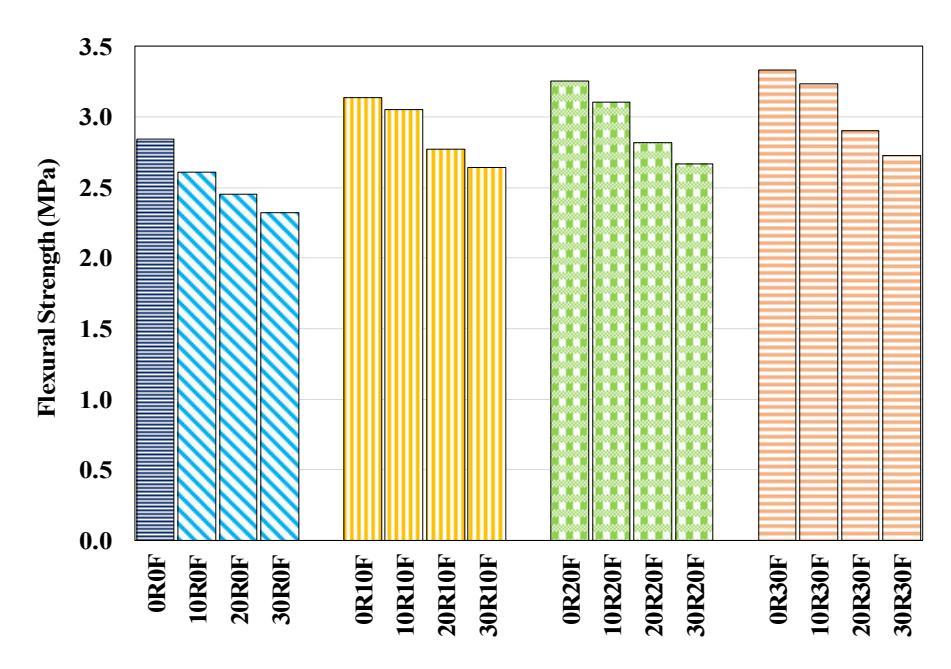
Figure 18. Flexural strength of different mortar mixes.

Flexural strength results of all composite prisms studied in this research program are presented in Figure 18. Flexural strength slightly decreased with the increment of rubber content and slightly increased with the increase in fiber content. These results showed the same trend as shown by the compressive strength, but the reduction rate is lesser than that of compressive strength results.

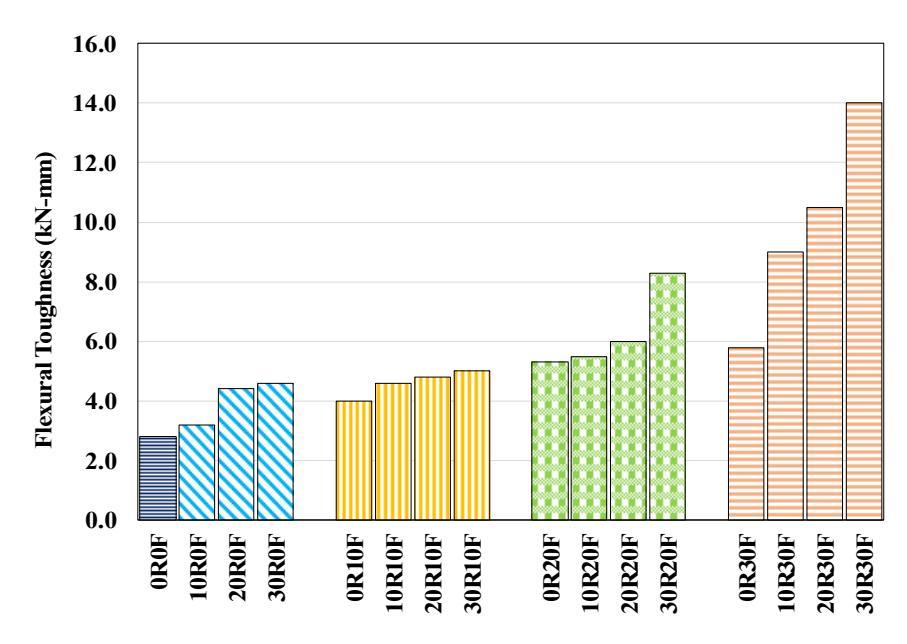
Flexural toughness was calculated by obtaining the area. under. the stress-strain. curve. up to 60% of. peak. load. Flexural toughness results of all of the mortar mixes studied in this research program are shown in Figure 19. The average flexural strength of the control prism came out to be 2.84 MPa. The flexural toughness of mortar mix incorporating 10 kg/m³, 20 kg/m³ and 30 kg/m³ of amorphous metallic fibers came out to be 4 MPa, 5.3 MPa and 5.8 MPa with the increment of 42%, 89%, and 107%, respectively. With the 10%, 20% and 30% replacement ratios of rubber content, the flexural toughness improved to 3.2 MPa, 4.4 MPa, and 4.6 MPa, respectively, with increments of 14%, 57%, and 64%, respectively, as compared to the control prism. Results indicated that with the increase in rubber aggregates, there is an increase in the flexural toughness of composite prisms.

Results showed. that fiber. reinforcement. of mortar. showed an increment in flexural toughness. For composite prism with repair mix composition of 10R10F, 20R10F and 30R10F, the average flexural toughness was 4.6 MPa, 4.8 MPa and 5 MPa. The increment rate was 64%, 71%, and 78%, respectively, as compared to that of the flexural toughness of composite prism with a repair mix composition of 0R0F. Similarly, for composite prism with repair mix composition of 10R20F, 20R20F and 30R20F, the average flexural toughness was 5.5 MPa, 6 MPa, and 8.3 MPa with increases of 96%, 114%, and 196%, respectively.

For composite prisms with repair mix composition of 0R30F, 20R30F, and 30R30F, the average flexural strength of composite prisms was 9 MPa, 10.5 MPa, and 14 MPa with the increment rate of 221%, 275%, and 400%, respectively.

Flexural toughness is enhanced considerably in the presence of rubber content. Deformability of mortar is improved by incorporating rubber as it reduced the local stresses which occur around micro-cracks. It was noticed that the rubberized fiber-reinforced composites especially 30R30F exhibited more toughness as compared to the other mixtures, demonstrating the synergetic effect produced by the combined use of fibers and rubber aggregates in repair material. This enhancement in flexural toughness can also be validated from the previous research carried out on the flexural toughness of concrete incorporating both crumb rubber and steel fibers [35].

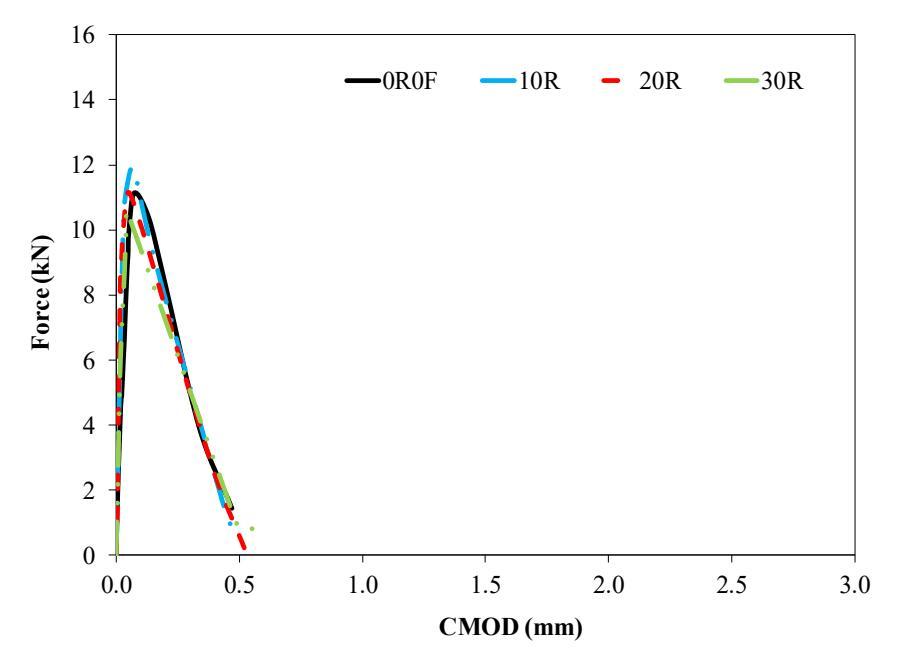
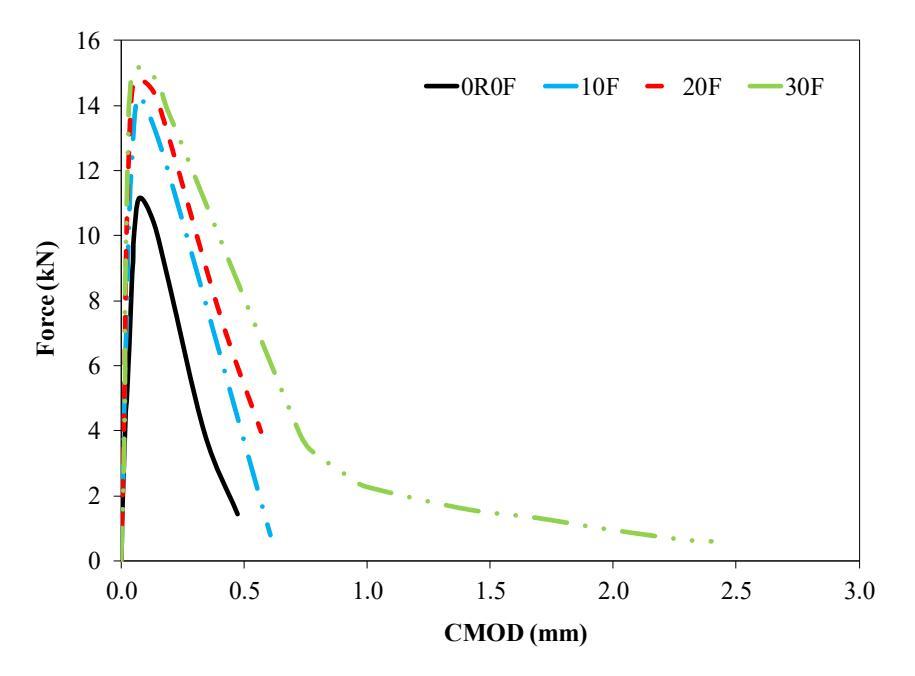
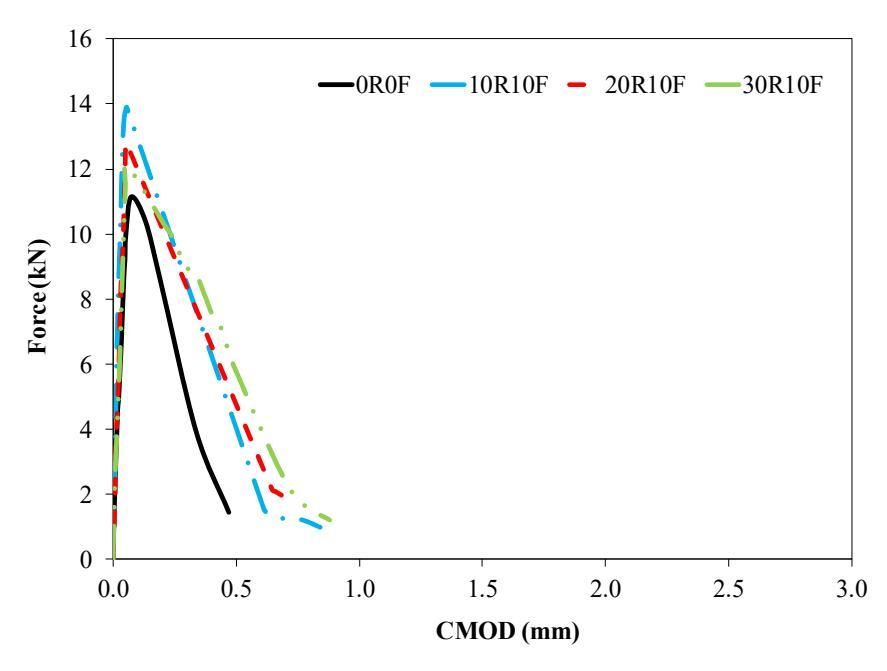
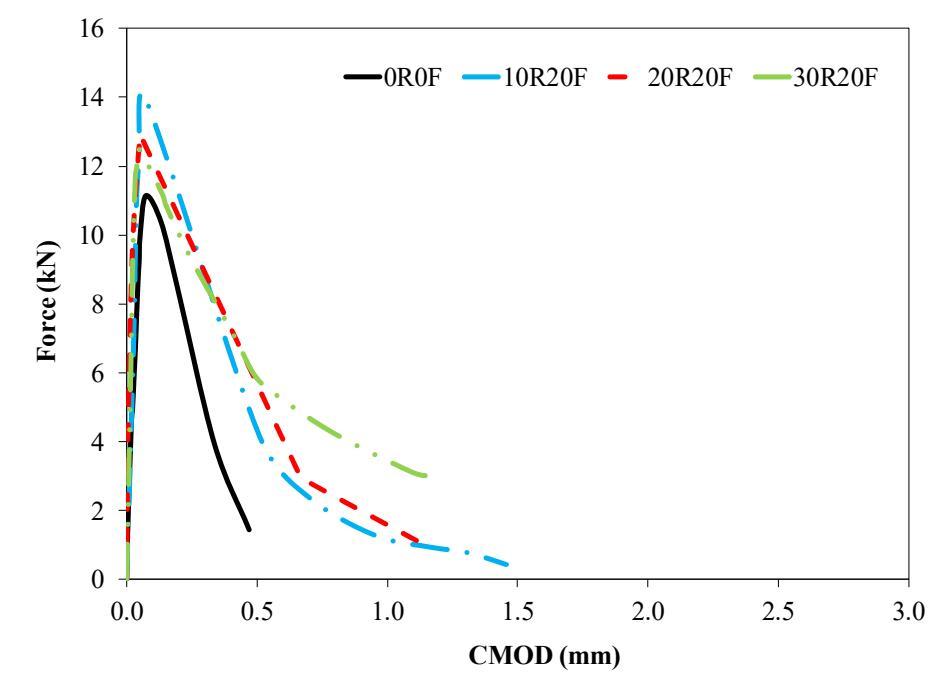
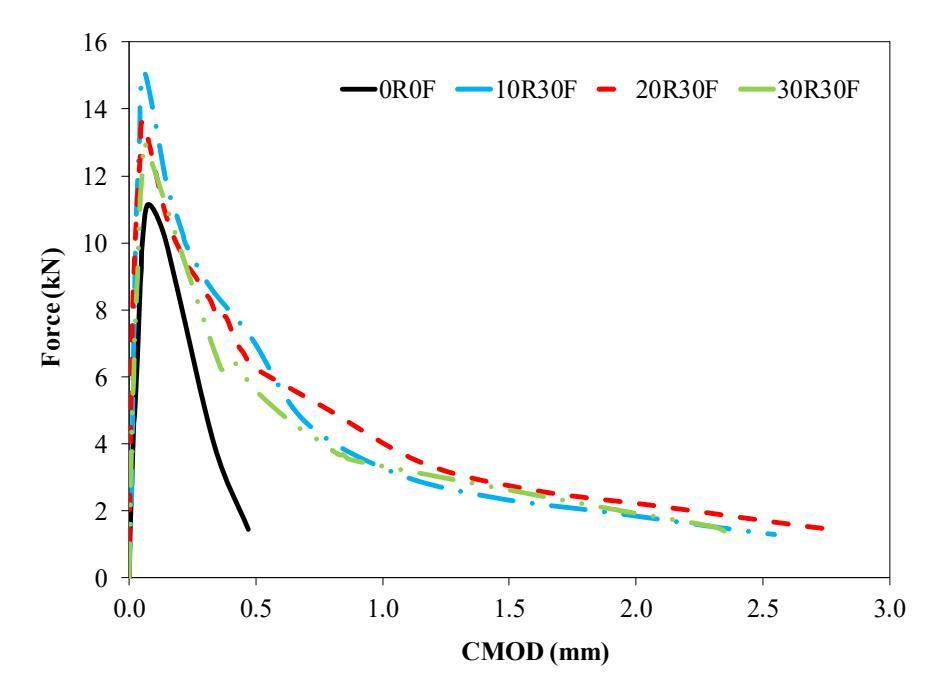
Figure 20. Load versus CMOD curve for composite beams with 0R0F, 10R, 20R, and 30R repair mix composition.

Figure 21. Load versus CMOD curve for composite beams with 0R0F, 10F, 20F, and 30F repair mix composition.

Figure 22. Load versus CMOD curve for composite beams with 0R0F, 10R10F, 20R10F, and 30R10F repair mix composition.

Figure 23. Load versus CMOD curve for composite beams with 0R0F, 10R20F, 20R20F, and 30R20F repair mix composition.

Figure 24. Load versus CMOD curve for composite beams with 0R0F, 10R30F, 20R30F and 30R30F repair mix composition.

The relationship. between. force. and CMOD of composite. prisms having. different types of repair materials. are presented in Figures 20–24. The curve of each repair mix composition represents the average of three prism specimens.

It was observed from the load versus CMOD curves that at any notch opening value, the corresponding value of force was higher as compared to the control mortar, especially, for the composite beams with the repair mixtures incorporating higher steel fiber content. For example, at a notch opening of 0.3 mm the corresponding force is 6 kN, 9.8 kN, 10.2 kN and 12 kN for 0R0F, 0R10F, 0R20F and 0R30F, respectively, as shown in Figure 21. These results also revealed that the steel fibers reinforcement played an important role in controlling notch opening and retraining the cracks under flexure loading. In the postpeak region, steel fibers control the cracks from further propagating by bridging action and provide higher post-peak residual strength. The values of CMOD at peak load are presented in Figure 25. The results revealed that rubber incorporation controls the notch

opening up to the peak load by delaying micro-crack propagation to become macro cracks. For instance, at peak load the highest notch opening is observed for 0R0F (i.e., about 74 μ m) and minimum for 30R0F (i.e., 44 μ m).

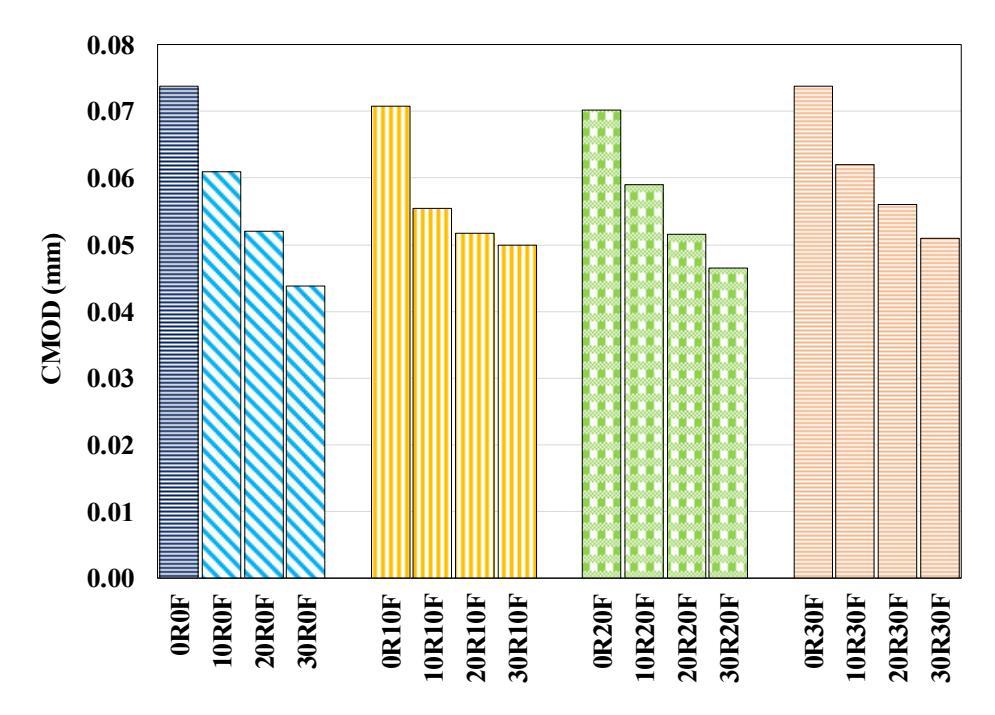
Figure 25. CMOD values at peak load for different repair mix compositions.

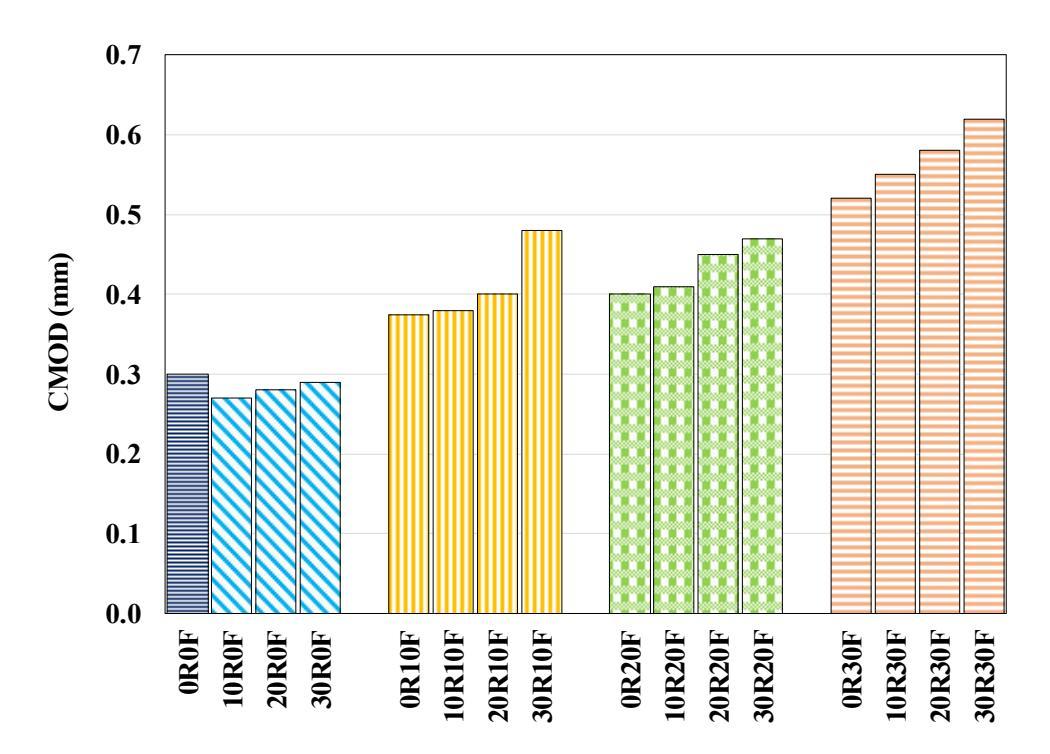
Figure 26. CMOD values in post-peak region (at 50% peak load) for different repair mix compositions.

The CMOD values at post-peak load (i.e., 50% of peak load) are presented in Figure 26. In the post-peak region, steel fiber actively plays its role in controlling the notch opening by providing bridging action, but the rubber does not show a significant impact in controlling the notch opening in the post-peak region.
