# Article Study on the Stability of Cut Slopes Caused by Rural Housing Construction in Red Bed Areas: A Case Study of Wanyuan City, China

Citation: He, H.; Dong, X.; Du, S.; Guo, H.; Yan, Y.; Chen, G. Study on the Stability of Cut Slopes Caused by Rural Housing Construction in Red Bed Areas: A Case Study of Wanyuan City, China. *Sustainability* **2024**, *16*, 1344. https://doi.org/10.3390/ su16031344

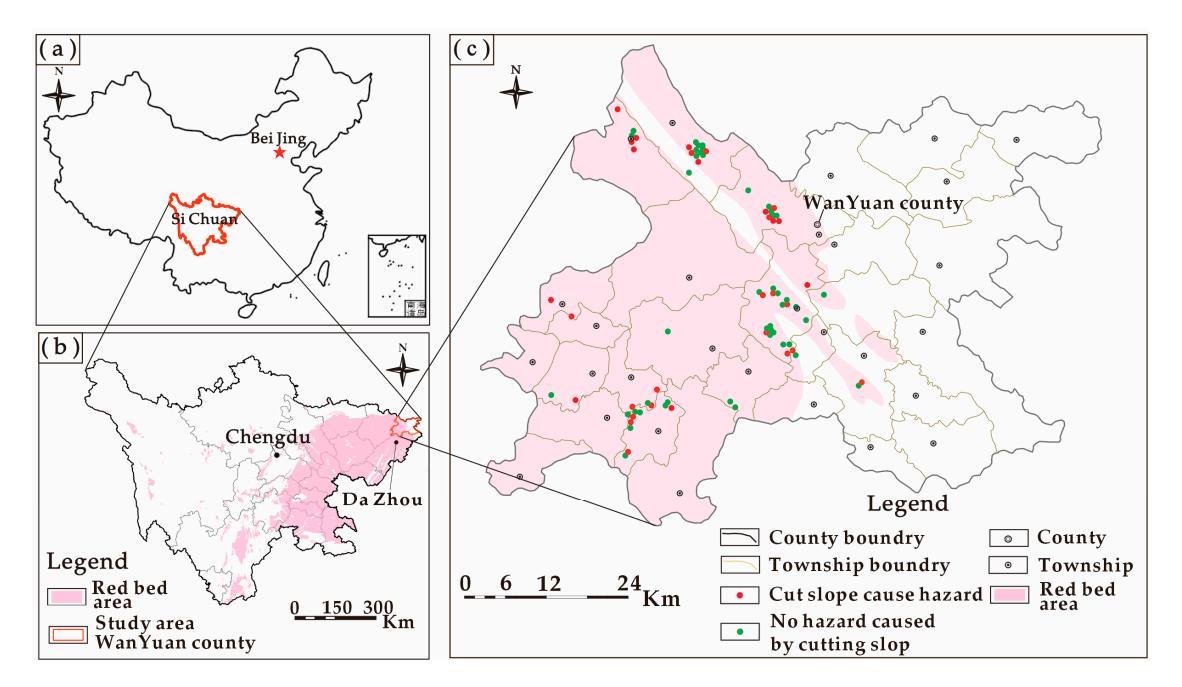
**Figure 1.** Overall of slope cutting sites caused by rural housing construction in study area. (**a**) the location of Sichuan Province; (**b**) the location of study area and distribution of red beds in Sichuan Province; (**c**) the distribution of 76 slope cutting sites caused by rural housing construction in red beds of Wanyuan county.

Wanyuan City is located 150 km northeast of Dazhou City, Sichuan Province, where Sichuan Province meets Shanxi Province (Figure 1a). The overall topography of Wanyuan City is characterized by high elevations in the northeast and low elevations in the southwest. The northeast region is mainly mountainous and composed of canyons. Most areas in the middle, southwest, and northwest are middle-elevation and low-elevation mountain platform landforms. The southern part is mainly platform canyons. Red beds are distributed in the central and western areas in Wanyuan City (Figure 1c). The flat areas in Wanyuan City are basically occupied by engineering construction or basic farmland

From April to October, 2022, the research team investigated 76 red bed slope cutting sites in the study area. It can be found from Figure 1c that the distribution of slope cutting sites is quite uneven on the horizontal plane. The sites are densely distributed in some villages and towns with limited flat land resources, while fewer or no sites exist in some villages and towns with relatively more flat land resources. From the perspective of topography, influenced by factors such as capital, technology, and construction machinery, the slope cutting sites are mostly located at the foot of slopes where the Quaternary cover is relatively thick.

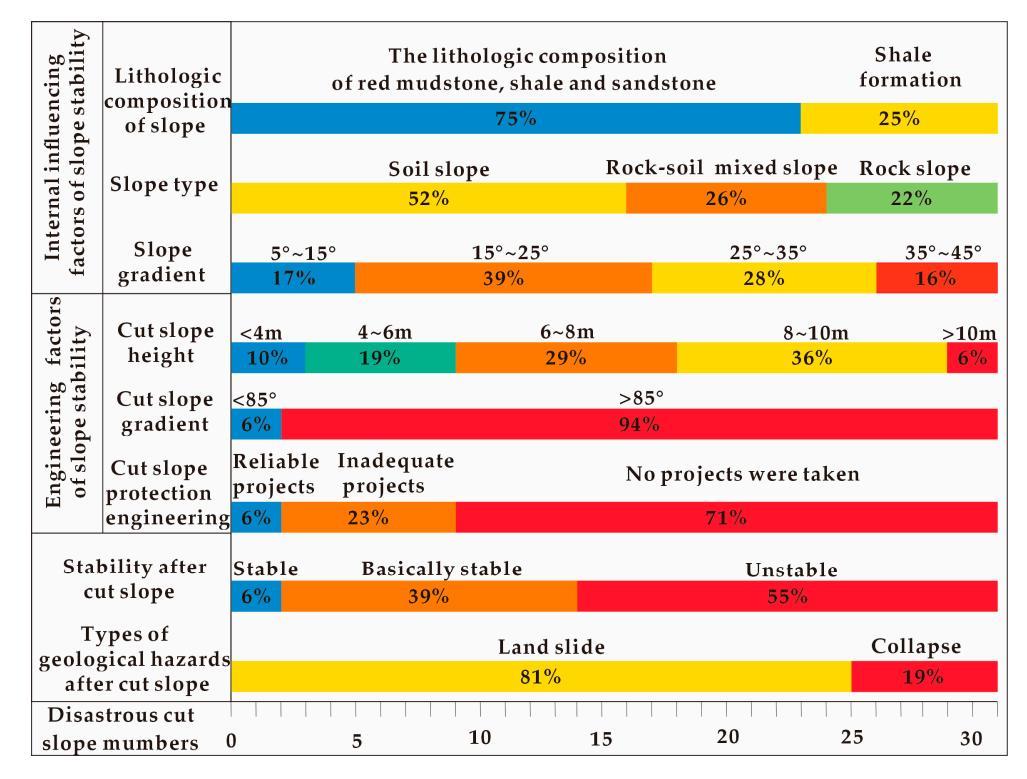
Figure 2. Statistics on stability of disastrous cut slopes.

Figure 2 shows the investigation results of 31 disaster-causing slope cutting sites generated by rural housing construction in the research area. The cutting slopes are mainly composed of red mudstone, shale, and sandstone, accounting for 75%. The slope types include soil slopes (accounting for 52%), rock–soil mixed slopes (accounting for 26%), and rock slopes (accounting for 22%). The gradients of these natural slopes are 15–25° (accounting for 39%), 25–35° (accounting for 28%), and 5–15° (accounting for 17%), respectively. The cut slope heights are mainly 8–10 m (accounting for 36%) and 6–8 m (accounting for 29%). In order to obtain larger building areas, most of the cut slopes are excavated vertically, and the cut slope gradients exceeding 85° account for 94%. Twenty-nine (accounting for 94%) cut slopes have not been subjected to engineering, or the treatment measures have been

insufficient, while 55% of the cut slopes are in an unstable state. Landslides are the main type of hazard caused by slope cutting (accounting for 81%), which mainly occurs in soil and rock–soil mixed slopes.

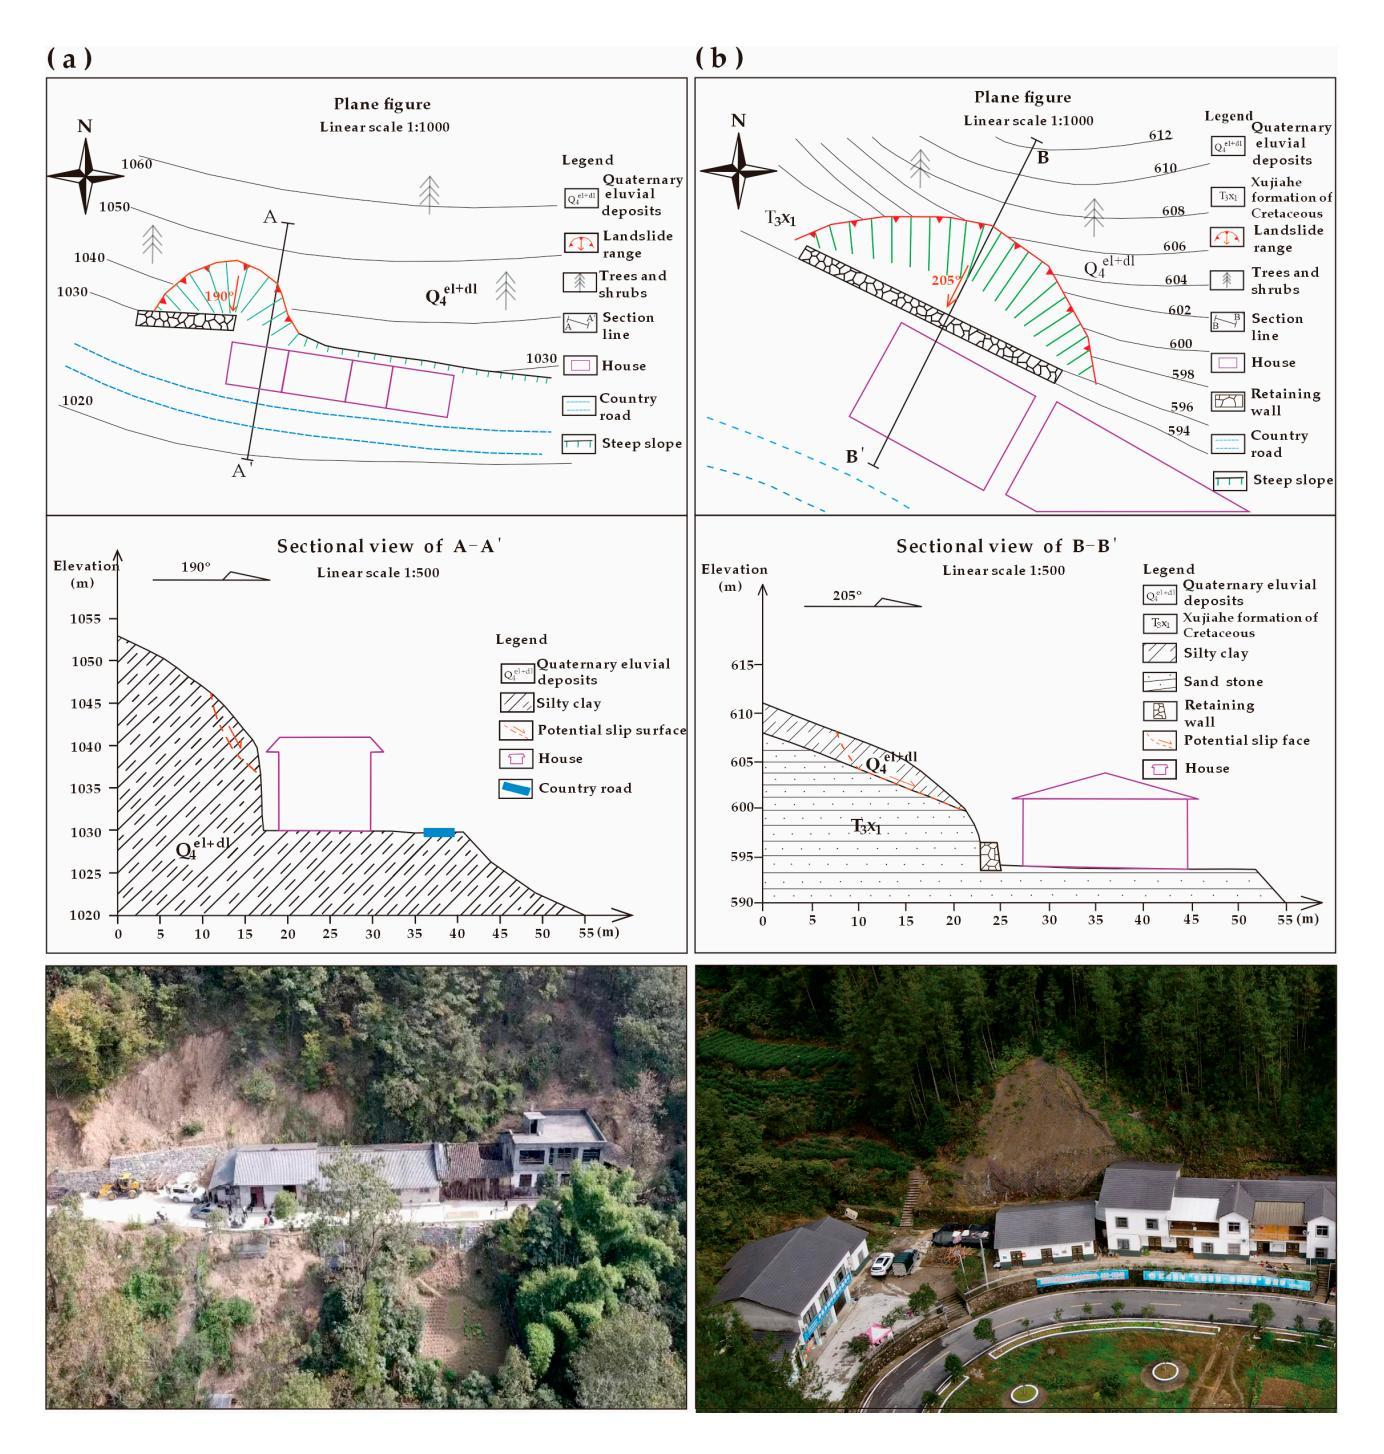
Figure 3. Typical slop cutting sites. (a) Soil slope; (b) rock–soil mixed slope.

Figure 3a shows a typical soil slope cutting site, which is located behind Chen Qigang's house in Wenjiaping Village in Baiguo Town. This gentle slope is on a low-elevation mountain, and cutting was performed at the foot of the slope. The slope gradient is about 20°. The cut height is about 8.5 m, the inclination is 190°, and the cut gradient is 83°. Slope cutting revealed that the surface covering the stratum is Quaternary eluvial silty clay, which is brownish-yellow and contains plant roots. Soil slopes are widely distributed in the study area and have the following common characteristics: (1) the Quaternary overburden at the foot of soil slope is often thick; (2) slope cutting is convenient, but the slope is unstable; (3) usually, there is no unified sliding surface during a failure, and the sliding scale is relatively small.

Figure 3b shows a typical rock–soil mixed slope, which is located in Maoping Village in Jingxi Town. This gentle slope is also on a low-elevation mountain, and cutting was performed at the foot of the slope too. The natural slope gradient is less than 20°. The cut height is about 13 m, the inclination is 205°, and the cut gradient is 65° at the top and 85° at the bottom. Slope cutting revealed that the surface covering the stratum is Quaternary eluvial silty clay, which is yellow-brown and 2.5 m thick, and the underlying bedrock is layered sandstone; the rock stratum is nearly horizontal. Compared with the soil slope

damaged by slope cutting, the landslide volume of the rock–soil mixed slope is larger, so the damage would be relatively worse. In August, 2020, a landslide with a volume of about 200 m<sup>3</sup> occurred at this slope cutting site, which damaged the house at the toe of this slope.

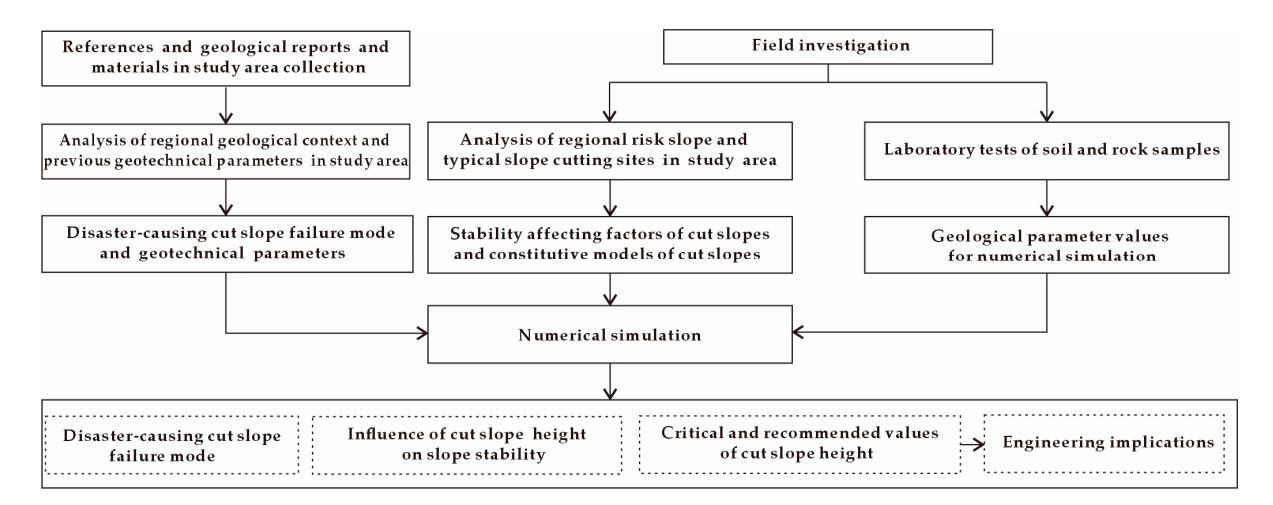
Figure 4. Flowchart of the methodology.

The constitutive models and geotechnical parameters were determined based on the collection and analysis of geological materials and reports, as well as field investigations and laboratory tests. Geo Studio software were used for numerical model construction and simulation. The flowchart of the methodology is shown in Figure 4. The details of the analysis are as follows.

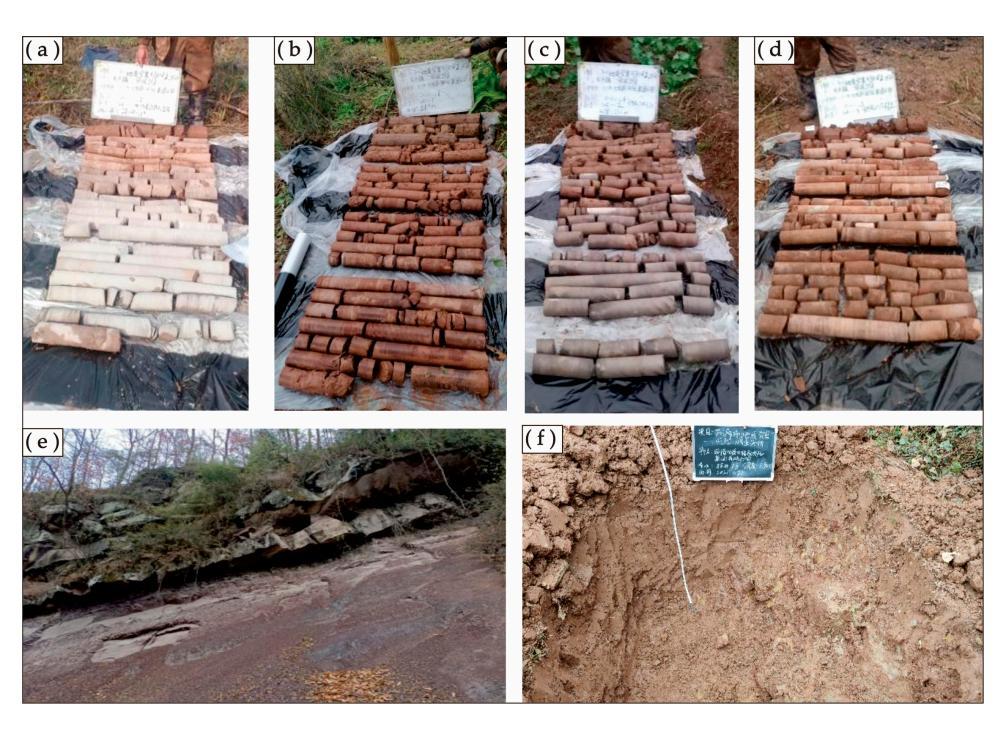
**Figure 5.** Soil and rock samples obtained from investigation, drilling, and prospecting trench. (**a**–**d**) Samples from drilling; (**e**) moderately weathered sandstone; (**f**) prospecting trench.

The soil and rock samples were collected in the red beds area of Wanyuan city via field investigation and engineering drilling (Figure 5). The geotechnical parameters of the samples were analyzed, including the density, cohesion, internal fiction angle, Poisson's ratio, and elastic modulus. All test methods and steps followed the "Geotechnical test method standard (GB/T 50123-2019)" [25]. The historical geotechnical parameters of soil and rock were collected from a local government department at the same time. These geotechnical parameters were obtained from different times at different positions in red beds of Wanyuan city. Average values (Table 1) were used to construct numerical models.

The main type of rock is sandstone in the study area (Figure 5e). According to the laboratory analysis of the sandstone drilling samples, the content of sand and gravel (2–0.05 mm) is generally more than 50%, followed by silt and clay. The cements of sandstone are siliceous, calcareous, calcareous argillaceous, and argillaceous, and the carbonate content is about 20–25%. Sandstone has low strength, strong water permeability, and easy weathering after excavation. The main average geotechnical parameter values of moderately weathered sandstone are shown in Table 1.

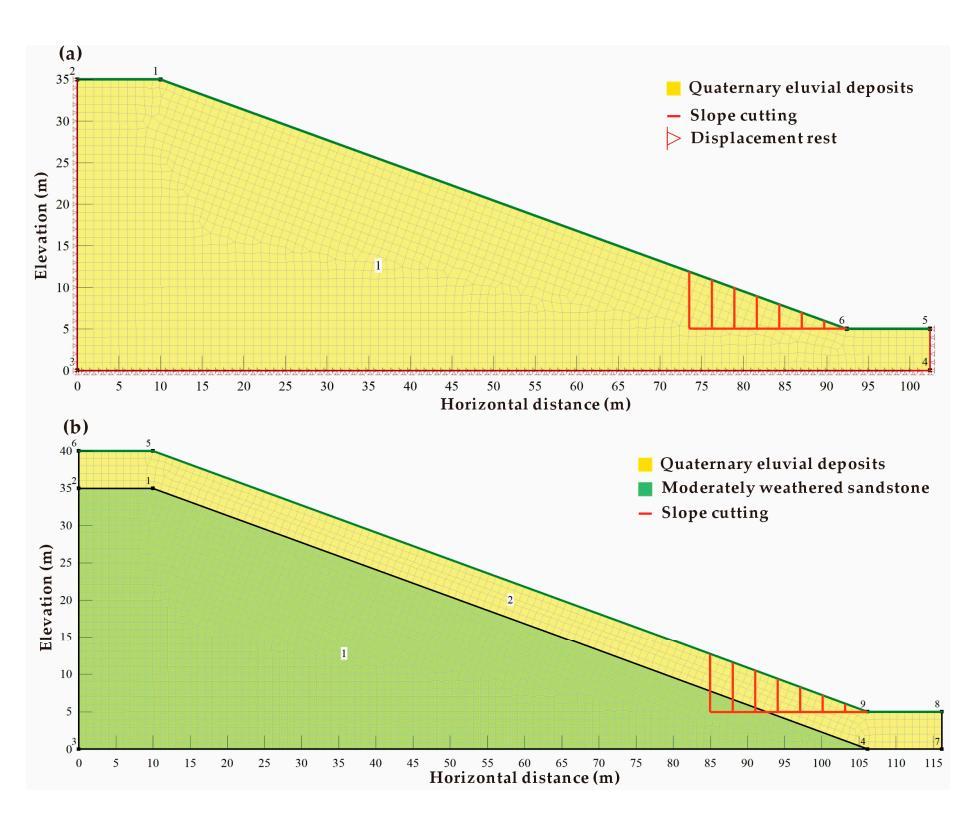
**Figure 6.** The two-dimensional numerical model of 20 natural slope. (**a**) Numerical model of soil slope; (**b**) numerical model of rock–soil mixed slope.

- 1. Model area setting: To control a single variable, the main profile of the cut slope was selected as the model area, the slope height of soil slope was set to be 35 m, and the slope height of rock–soil mixed slope was set to be 40 m. Slope models with different slope gradients were constructed by changing the horizontal distance from the toe to the top of slope, and the different slope cutting conditions were simulated by changing the excavation heights at the toe of the slope.

- 2. Determination of the constitutive model: The soil slope was generalized as a Mohr– Coulomb model composed of homogeneous eluvial silty clay layers. The rock–soil mixed slope was generalized as a Mohr–Coulomb model consisting of a eluvial silty clay layer and moderately weathered sandstone bedrock.

The two-dimensional numerical models of the soil and rock–soil mixed slopes obtained through the above modeling steps are shown in Figure 6, and this paper only takes the 20 slope gradient as an example to present.

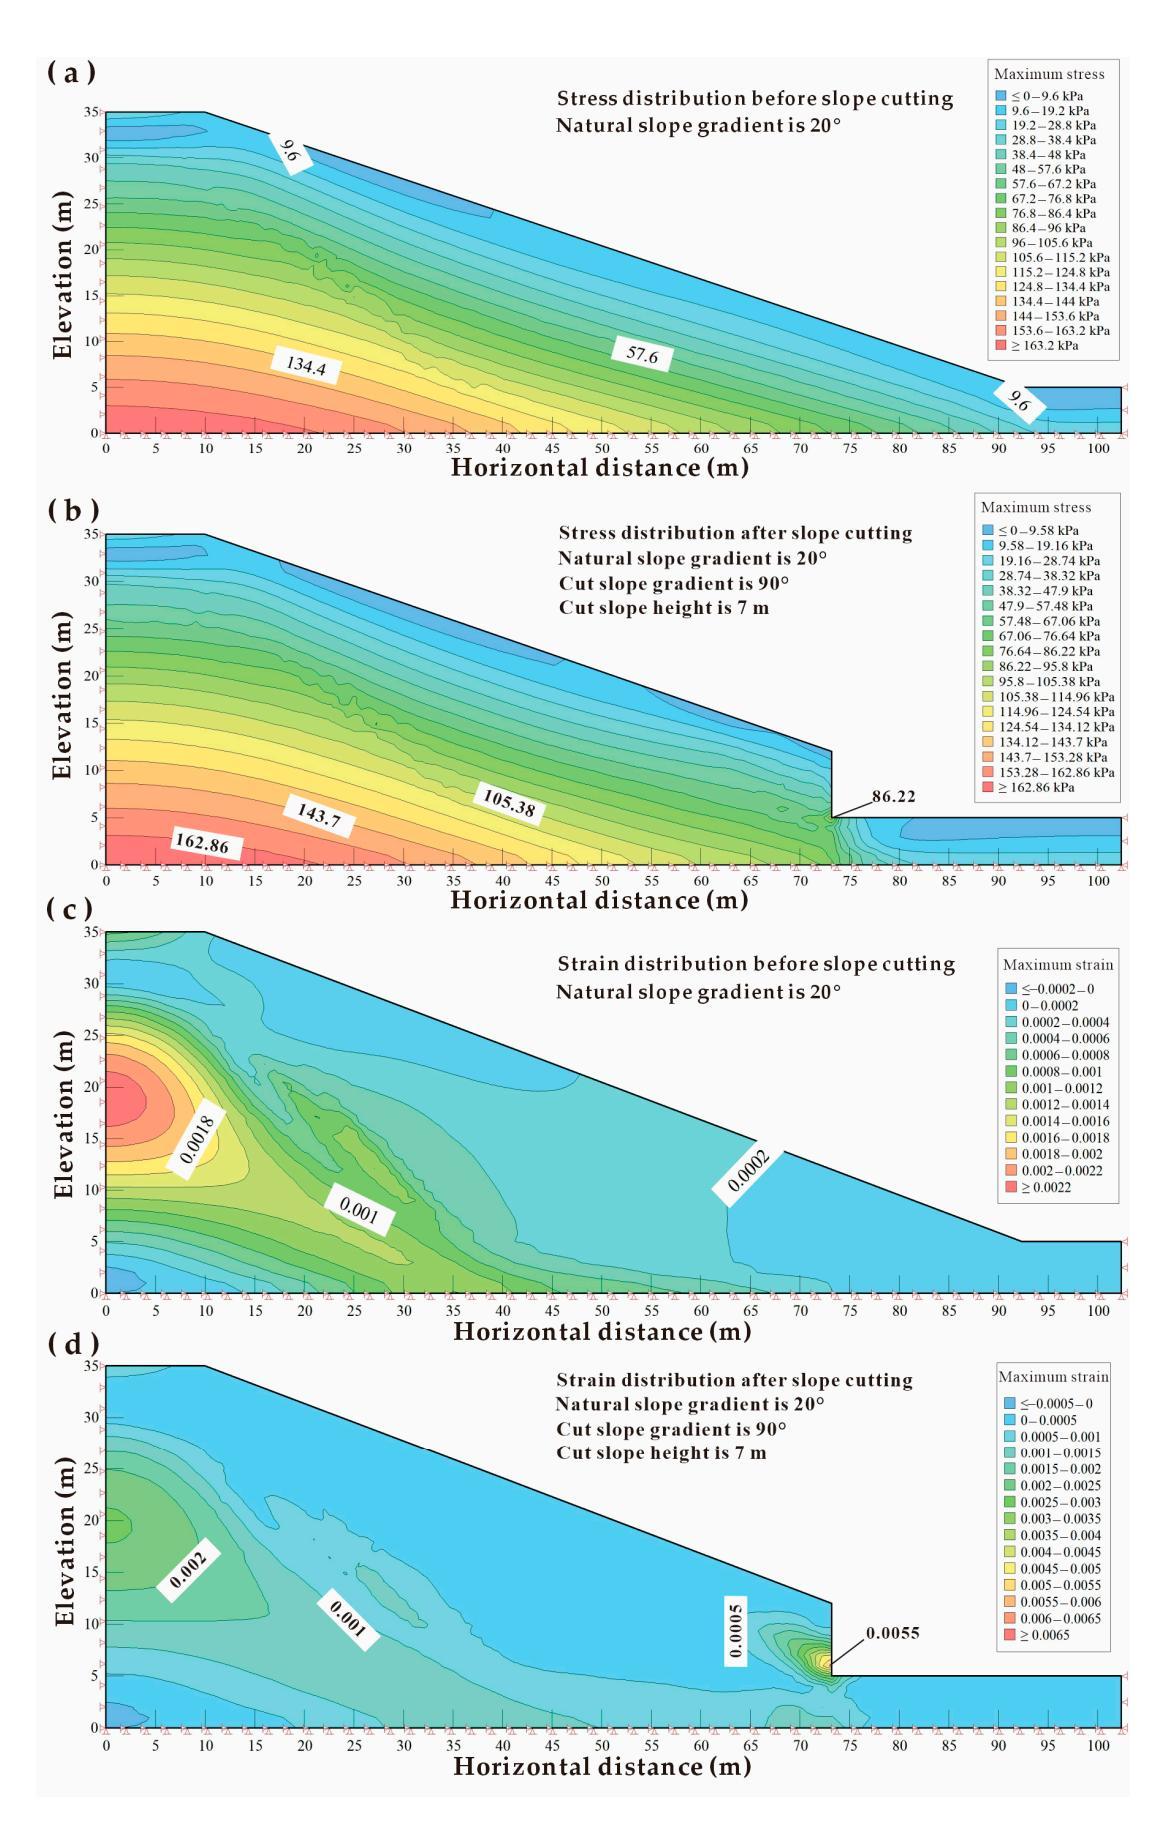
**Figure 7.** Stress and strain distribution of soil slope caused by slope cutting (natural slope gradient is 20). (a) Stress distribution before slope cutting; (b) stress distribution after slope cutting; (c) strain distribution before slope cutting; (d) strain distribution after slope cutting.

In order to further analyze the influence of slope cutting on the stability of a soil slope, this paper took 20 soil slopes as an example to compare and analyze the stress–strain changes before slope cutting and when the slope cutting height was 7 m (Figure 7). Before cutting the slope, the horizontal stress value at the top of the slope was about 9.6 kPa, and the horizontal stress value at the toe of the slope was about 19.2 kPa. The maximum shear strain appeared inside the slope, and the slope was in a stable state. When the cutting height was 7 m, the horizontal stress at the top of the slope changed slightly, while the stress value at the toe went up to 86.2 kPa; thus, stress concentrated at the toe. The maximum strain value appeared at the bottom of the cut slope, and the most unstable area was within 1 m near the bottom of the cut slope. With the increase in the cutting height, the potential shear fracture surface moved to the inner area of the slope, and the thickness and volume of the sliding body increased.

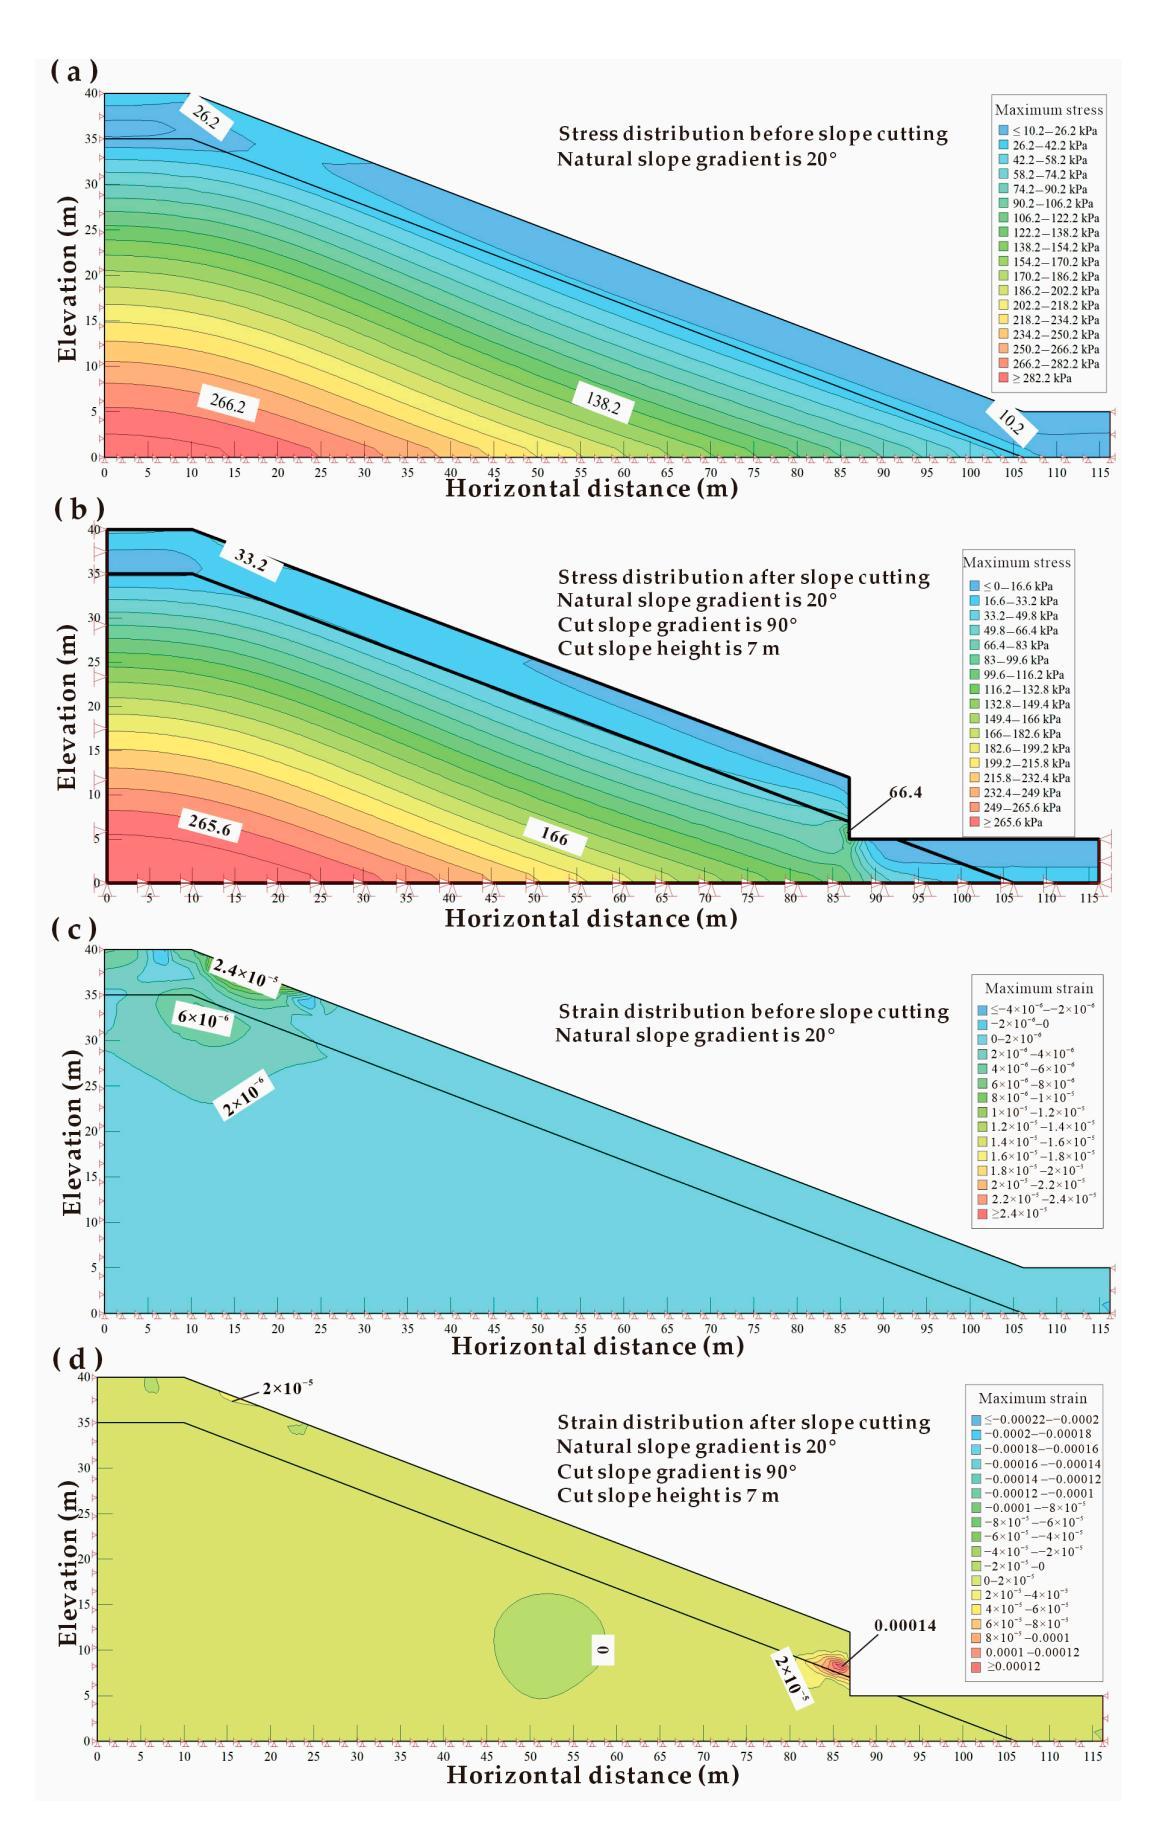
**Figure 8.** Stress and strain distribution of rock–soil mixed slope caused by slope cutting (natural slope gradient is 20). (**a**) Stress distribution before slope cutting; (**b**) stress distribution after slope cutting; (**c**) strain distribution before slope cutting; (**d**) strain distribution after slope cutting.

Figure 8 presents the stress–strain distribution of the rock–soil mixed slope with a natural slope gradient of 20°. Before cutting the slope, the horizontal stress at the top of the slope was about 26.2 kPa, and the horizontal stress at the toe was about 10.2 kPa. The horizontal stress at the top of the slope was greater than that at the toe. The maximum shear strain occurred near the top of the slope, which means that the top of the slope is unstable. When the slope cutting height was 7 m, the horizontal stress at the top of the slope changed slightly by about 33.2 kPa, while the stress value at the toe increased to 66.4 kPa; thus, stress concentrated at the toe. The maximum strain value appeared at the soil–rock intersection on the cut slope surface, and the most unstable area ranged from 2 to 10 m in the direction of the soil–rock contacting surface. During the process of cutting, the rock–soil mixed slope experienced two events: soil and rock excavation. The redistribution of stress and strain in the soil excavation stage was the same as that in the soil slope, and after excavating the bedrock, the rock–soil contact area became highly unstable.

Figure 9b presents the disaster-causing failure mode of the rock–soil slope. The overburden is stable before slope cutting (Figure 8a). After cutting the slope, the overlying soil layer loses the support of that at the foot of the slope and gradually changes as follows: (1) deformation and small-scale collapses happens at the top of cut slope; (2) the deformation and displacement of the front edge of the overlying soil layer gradually increase, and tension cracks that appear at the middle–upper position of the overlying soil layer expand inward; (3) due to various internal and external factors, such as gravity and rainfall, the cracks extend deeply and reach the rock–soil interface, and the overlying soil layer breaks into small pieces and slides down; (4) the upper region of the slope fails bit by bit, and the soil layer blocks slide down piece by piece till the slope becomes stable.

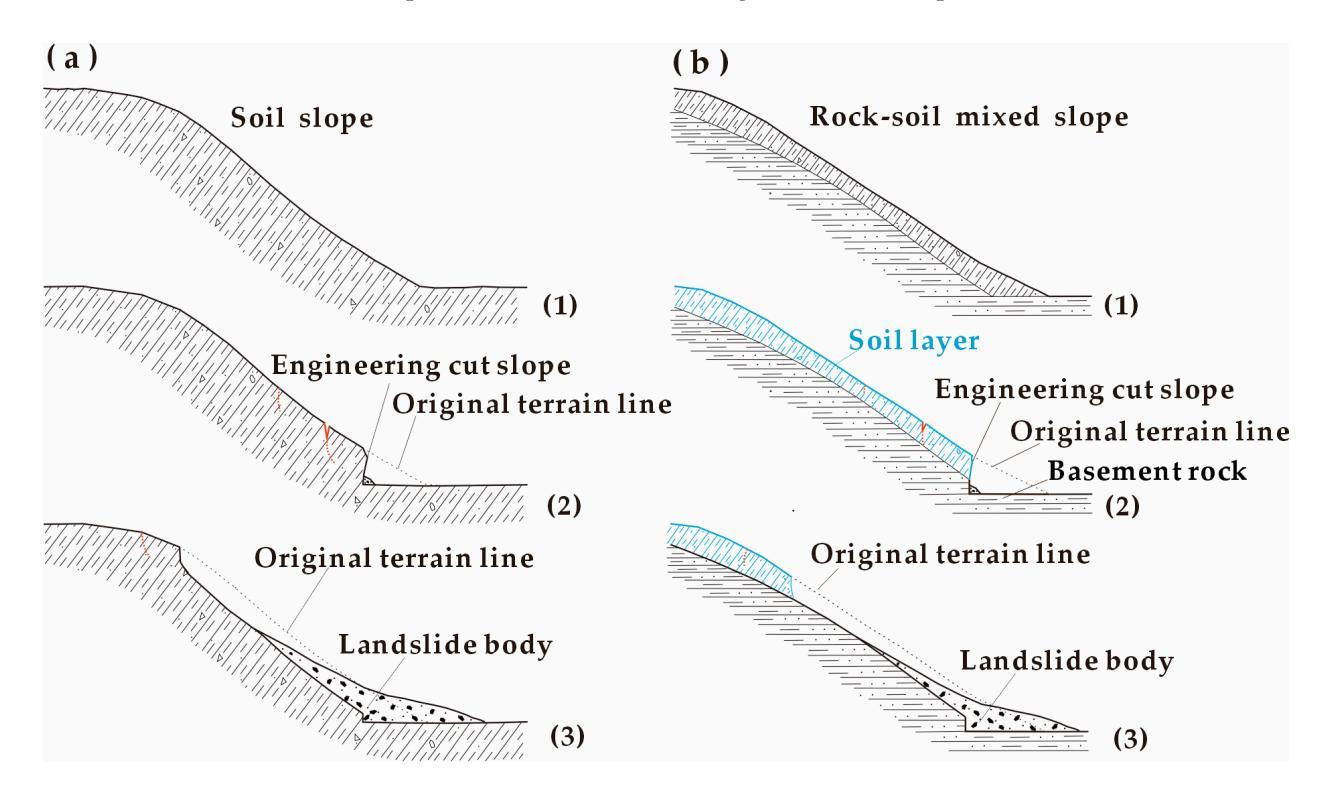
**Figure 9.** Disaster-causing cut slope failure modes. (a) Failure mode of soil slope; (b) failure mode of rock–soil mixed slope. (1) The shape of the natural slope before slope cutting; (2) slope failure after slope cutting; (3) final probable equilibrium state after slope cutting.

Figure 9a presents the disaster-causing failure mode of the soil slope. The shape of the natural slope is changed by slope cutting, and it loses the support of the toe. Stress concentrates at the bottom of the cut slope face (Figure 7b), and the top of the cut slope face creeps gradually, even presenting small-scale damage or a collapse. Slope cutting destroys the vegetation on the surface of the original slope, and the soil hidden inside it is exposed. Under the continuous influence of weathering, the physical–mechanical properties of the soil continue to worsen, the cut slope gradually becomes unsteady, and lastly, a shallow landslide will happen. Over time, the upper part of the slope fails bit by bit, and the landslide materials accumulate on the new slope surface or at its foot. The gradient of the new slope is smaller than that of original, and the slope becomes more stable.

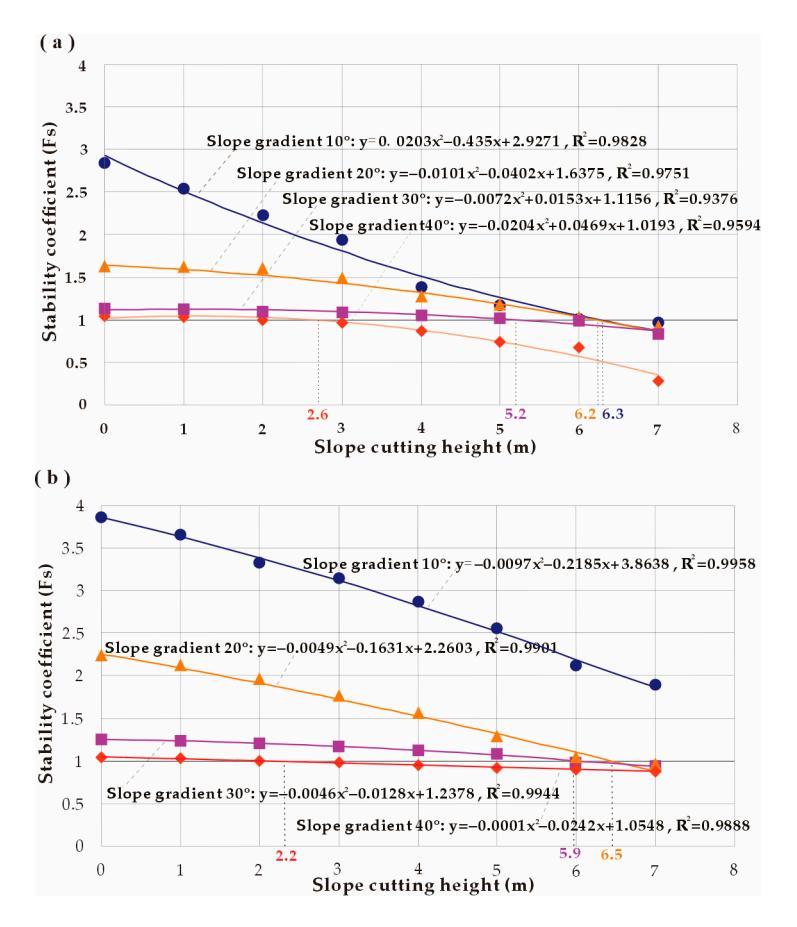
**Figure 10.** Fitting curves of slope cutting height and stability coefficient. (**a**) Fitting curves of soil slope; (**b**) fitting curves of rock–soil mixed slope.

SPSS software (2018 R2) was utilized to fit the slope cutting height and stability coefficient in Table 3, and the fitting function curves are shown in Figure 10. In the figure, the ordinate is the stability coefficient, and the abscissa is the slope cutting height. On the whole, the cutting height and stability coefficient of both the soil and rock-soil mixed slopes are negatively correlated. For the soil slope, with the increase in the cutting height, the stability coefficient of  $10^{\circ}$  reduces quickly, and then slowly, while those of  $20^{\circ}$ ,  $30^{\circ}$ , and  $40^{\circ}$  reduce slowly, and then quickly; the rate of the 30 natural slope gradient is the gentlest. For the rock-soil mixed slope, with an increase in the cutting height, the stability coefficients of the  $10^{\circ}$  and  $20^{\circ}$  slopes decrease relatively quickly, while those of the  $30^{\circ}$  and  $40^{\circ}$  slopes decrease relatively slowly.
