Cement-Based Repair Materials and the Interface with Concrete Substrates: Characterization, Evaluation and Improvement

Xuemin Song ^{1,†}, Xiongfei Song ^{1,†}, Hao Liu ¹, Haoliang Huang ^{1,2,*}, Kasimova Guzal Anvarovna ³, Nurmirzayev Azizbek Davlatali Ugli ⁴, Yi Huang ⁵, Jie Hu ^{1,2,*}, Jiangxiong Wei ^{1,2} and Qijun Yu ^{1,2}

Keywords: repair; interfacial microstructure; bonding strength; concrete substrates

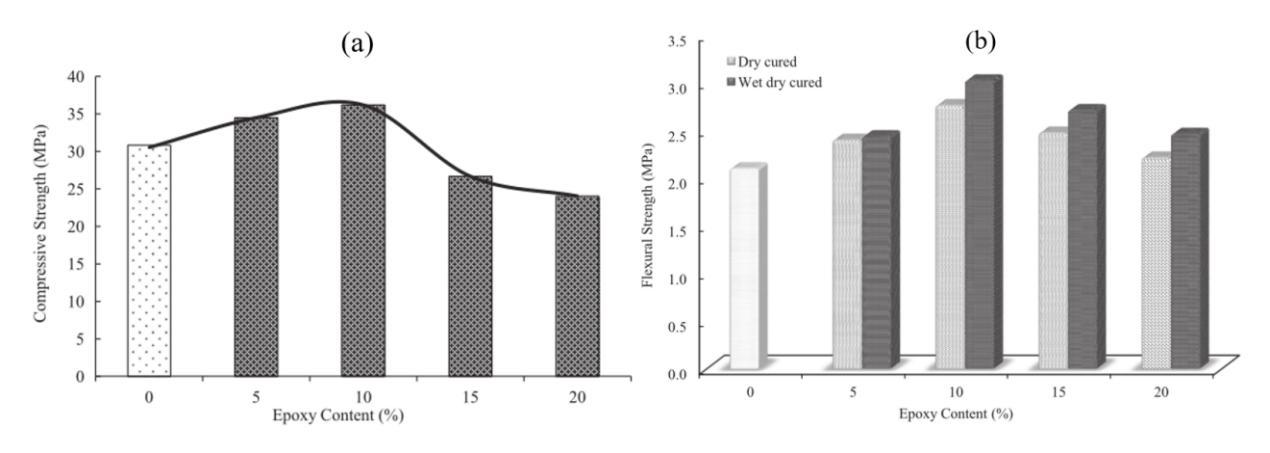
Figure 1. The mechanical strength of epoxy mortar: (**a**) Relationship between compressive strength and epoxy content for wet–dry curing; (**b**) Relationship between flexural strength and epoxy content for wet curing and wet–dry curing [37]. (Adapted and reprinted with permission from ref. [37], © 2015, *Construction and Building Materials*).

The epoxy-modified cement mortar (EC) has been widely studied for concrete repair [30–32] due to its good compatibility with cement-based materials [33,34]. Saccani et al. [35] studied the adhesion and durability of water-based epoxy resin-modified cement mortar used to repair deteriorated concrete structures under high temperatures. The experimental results showed that the EC had good adhesion to the concrete substrate under heating conditions and the mechanical stress caused by differential thermal expansion coefficients. An aqueous epoxy resin was used to modify ordinary Portland cement with four different dosages [36]. It was found that the flexural strength of Portland cement mortar could be improved with epoxy resin reinforcement. It was found that when the epoxy resin was 5% by weight of cement, the mortar has the highest mechanical strength and interfacial bonding strength. (see Table 8). Ariffin et al. [37-39] studied the mechanical property of epoxy resin-modified cement mortar with different resin contents and found that that the modified mortars with a resin content of 5% and 10% had compressive strengths of 33 MPa and 36 MPa, respectively, at 28 days. However, when the epoxy resin content exceeded 10%, the mechanical properties of the modified mortar decreased with an increase in the resin content (Figure 1). This can be attribute to the unhardened epoxy resin left in polymer-modified mortars. The excessive epoxy resin inside the mortar probably hinder the hydration and polymerization process. Wang et al. [40] found that the epoxy resin can repair the damaged concrete structure by filling cracks. Due to the good mechanical properties and adhesion of epoxy resin, it can restore the integrity of repaired concrete.

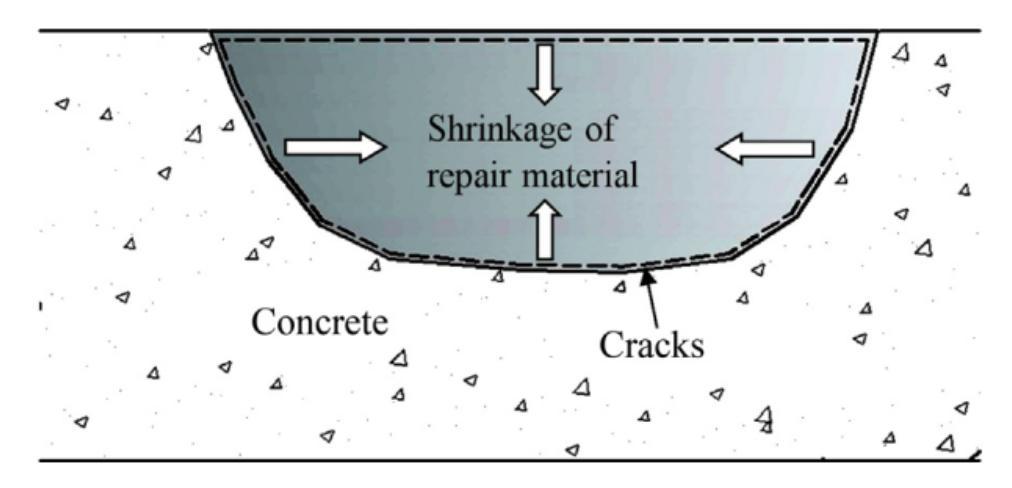
Figure 2. Schematic illustration of shrinkage of repair materials in patch repair [11]. (Adapted and reprinted with permission from ref. [11], © 2014, *Construction and Building Materials*).

According to the literature [51], the interface between the repair material and old concrete is similar to the bond between cement paste and aggregates. Therefore, this interface is called the "interfacial transition zone" [51]. The interface is an inherently weak zone, in which the porosity is relatively high and the pore size is large [52]. After the repair material is applied on the substrate surface, a certain incompatibility, inconsistent expansion and shrinkage occur due to the difference in the composition of the two materials (see Figure 2) [11,53,54]. These induce interfacial stress concentration effects and consequently cause interface delamination [53].

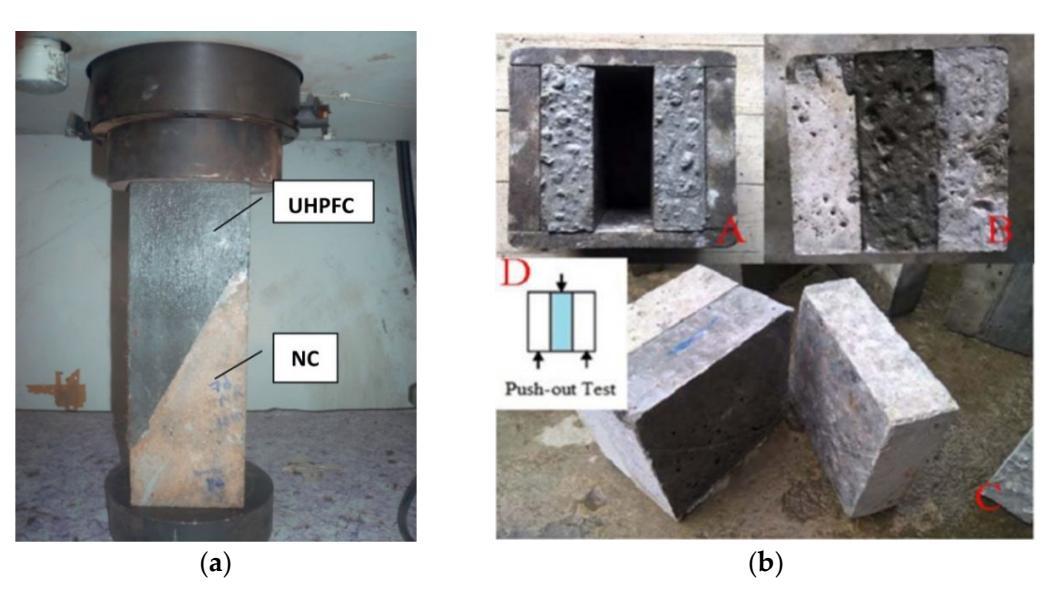
Figure 3. Tests for shear bond strength between repair materials and concrete substrate. (a) slant shear test set-up for the composite specimen; (b) push-out test for the composite specimen (A, B: preparation of samples; C: the damage mode; D: Schematic diagram of load force) [58]. (Adapted and reprinted with permission from ref. [58], © 2012, *Construction and Building Materials*).

The bond strength between the cement-based repair material and the substrate can be evaluated by means of various testing methods, such as shear bond strength testing (see Figure 3), flexural bond strength testing (see Figure 4), pull-out bond strength testing (see Figure 5) and split-pull bond strength testing (see Figure 6). Flexural bond strength testing is the same as flexural strength testing except for the method of preparing the samples. It can not only determine the flexural bond strength, but also show monolithic failure mode of the repair interface through different fracture positions and sectional conditions [54]. In shear bond strength testing, the samples are fixed and a load perpendicular to the interface is applied. It can determine the shear resistance performance of the repair materials [55]. Pull-out bond strength testing is a direct method to determine the tensile strength. In this test, a square steel block was bonded with the sample surface using epoxy glue, and a vertical pull force was loaded until the interface broke. Split-pull bond strength testing is an indirect tensile test. In this test, the applied force was parallel to the bond line interface of the specimens, and the loading was applied steadily. Then, the split tensile strength can be calculated through the maximum load and bond area. Albidah et al. [56] adopted a core pulling testing method to determine the bond strength between geopolymer repair mortar and old concretes (see Figure 7). In addition to studying the macroscopic mechanical property of interfacial adhesion in concrete surface repair, some scholars have also proposed new methods for testing the bond performance. When the flexural bond strength testing was taken, at the same time, Qian et al. [11] also proposed a new bond performance testing method (see Figure 8) to quantitatively evaluate the impermeability and interfacial bond performance between the repair material and the concrete. The shear-tension strength was determined in this test. A frustum hole was made in the substrate and repair mortar was cast into the hole to approximate half height. When a force is exerted on the upper surface of the frustum in the specimen, shear and tension stress will occur along the interface (see Figure 8). The shear-tension strength can be calculated through the maximum force P. Garbacz [57] adopted a nondestructive impact–echo technique to evaluate the interface quality in a repaired system. For this method, a stress wave that can propagate in the material and have a certain interface reflection was generated by a low-energy impact steel ball and then was detected by piezo electric sensors after propagating through the structure. Accordingly, the amplitude of the obtained spectral peak could be used to reflect the interface bond strength in the repair system (see Figure 9).

In summary, there are flexural bond strength tests to determine the bend resistance and monolithic failure mode of the repair interface; shear bond strength tests, slant shear tests and push-out tests to determine the shear resistance; and pull-out bond strength tests, split-pull bond strength tests and core pull-put bond strength tests to determine the tensile resistance. In addition, the nondestructive impact—echo technique provides a non-destructive method to evaluate the adhesive property of repair interface.

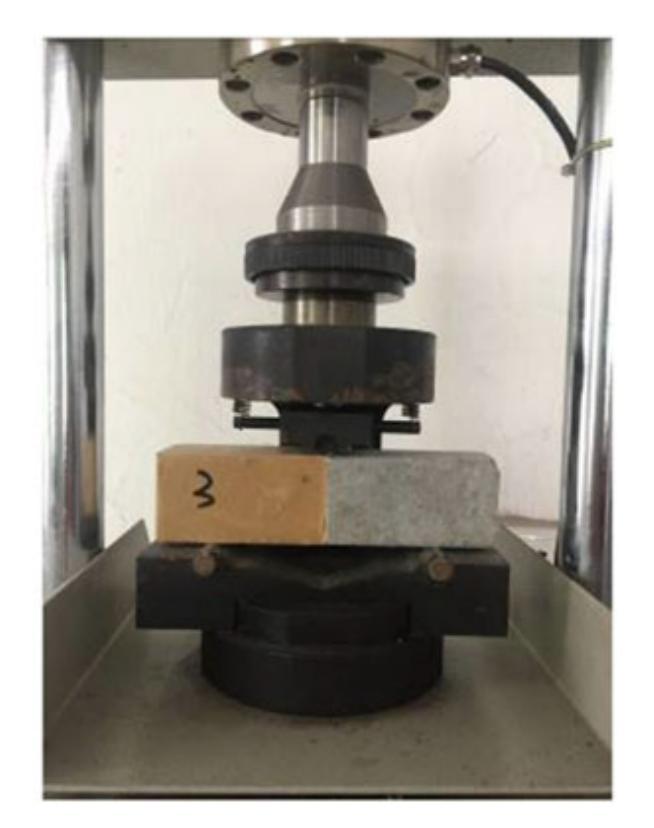
Figure 4. Tests for flexural bond strength between repair materials and concrete substrate [59]. (Adapted and reprinted with permission from ref. [59], © 2018, *Construction and Building Materials*).

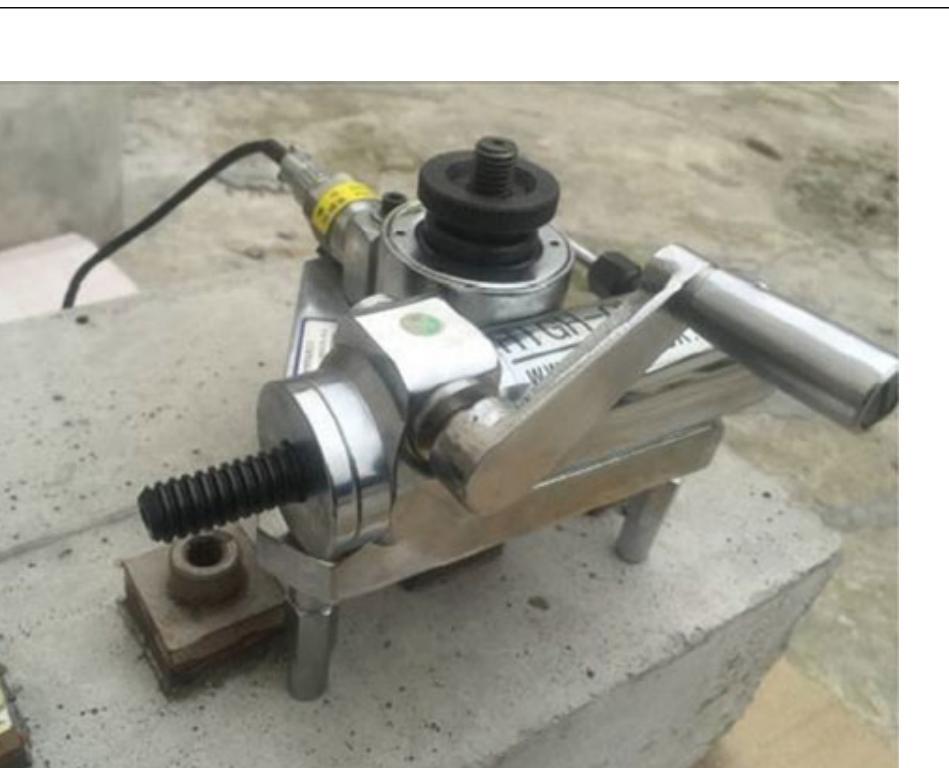
Figure 5. Tests for pull-put bond strength between repair materials and concrete substrate [59]. (Adapted and reprinted with permission from ref. [59], © 2018, *Construction and Building Materials*).

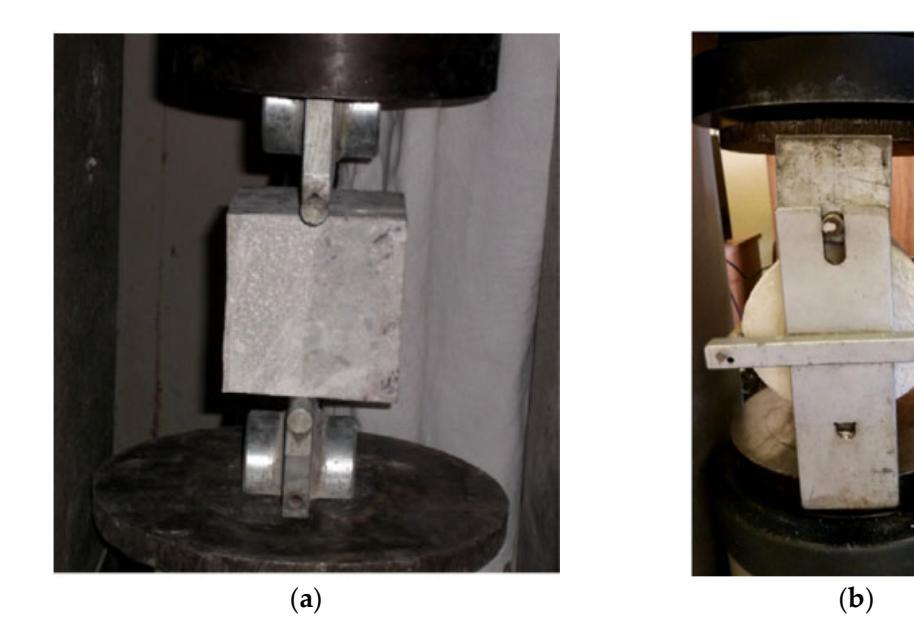
Figure 6. Tests for spilt bond strength between repair materials and concrete substrate. (**a**) cube specimen; (**b**) cylinder specimen [60]. (Adapted and reprinted with permission from ref. [60], © 2017, *Construction and Building Materials*).

Through the flexural bond strength tests and the split bond strength tests method, Karima et al. [60] investigated the bond strength and the failure mode of the interface between a special concrete with 100% of limestone filler and concrete substrate. They found that the special concrete had good adhesion to NC. Qin et al. [59] employed the flexural testing method to evaluate the interfacial bond properties of different types of repair materials. Bentz et al. [66] not only performed pull-out and shear bond strength tests, but also carried out interfacial microstructure analysis and neutron photography observation (a technology to display the internal structure of samples by using the attenuation of the neutron beam penetration) to study the influence of the water saturation and surface roughness of the substrates on the bond strength between repair materials and the substrates.

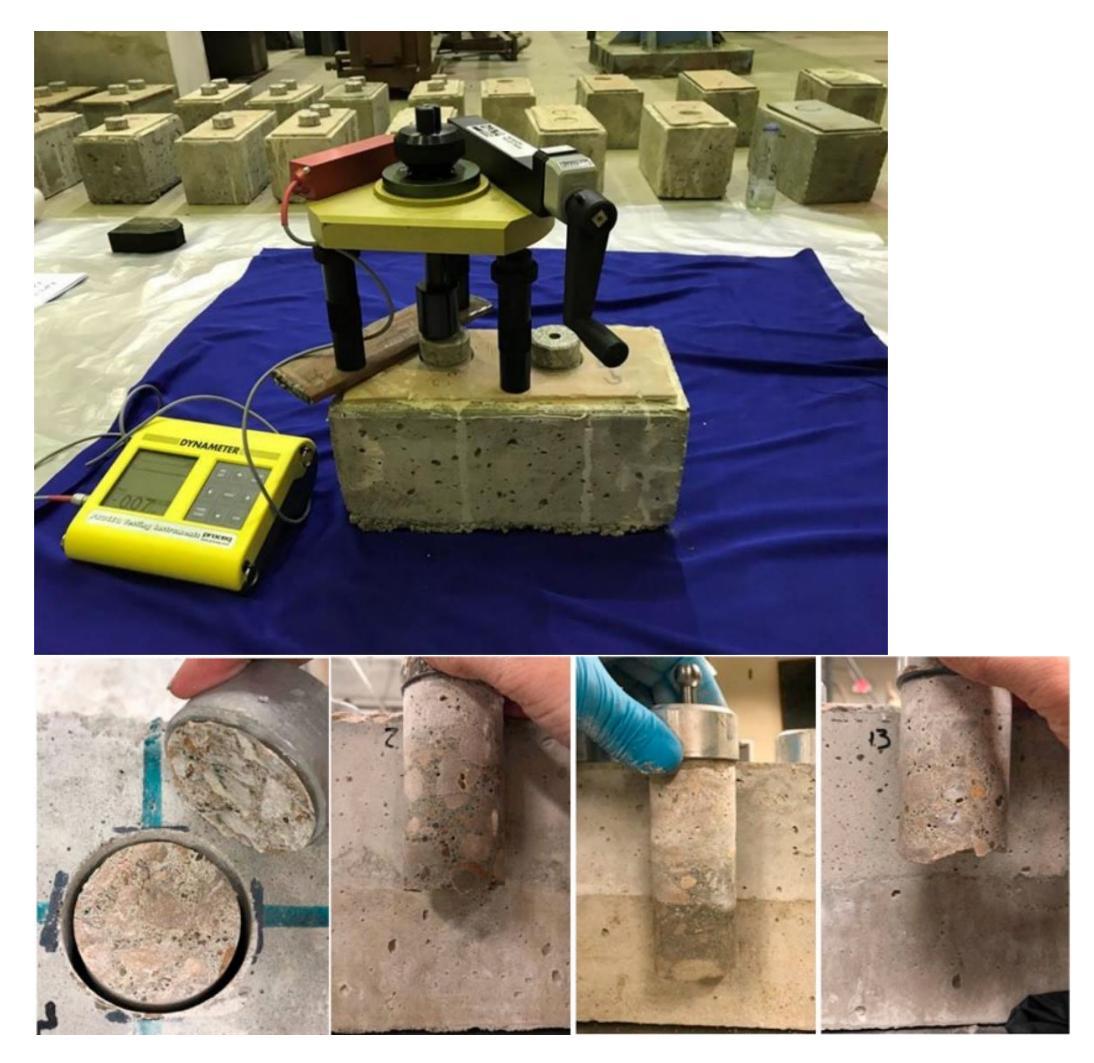
Figure 7. Tests for core pull-put bond strength between repair materials and concrete substrate [56]. (Adapted and reprinted with permission from ref. [56], © 2020, *Journal of Materials Research and Technology*).

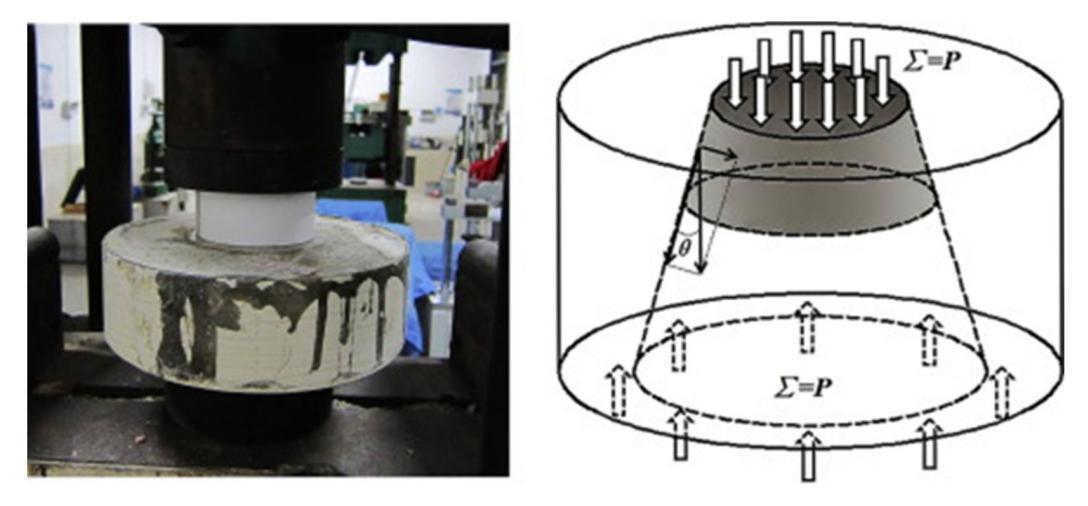
Figure 8. Tests for flexural bond strength between repair materials and concrete substrate [11]. (Adapted and reprinted with permission from ref. [11], © 2014, *Construction and Building Materials*).

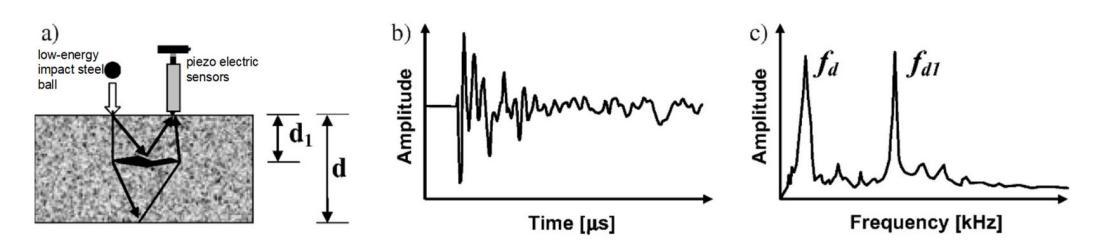
Figure 9. A nondestructive impact–echo technique to evaluate the interface quality in a repaired system: (a) Scheme of the impact–echo method; (b) example of waveform (time-domain spectrum); (c) corresponding frequency when defect in concrete is observed [57]. (Adapted and reprinted with permission from ref. [57], © 2017, *Construction and Building Materials*).

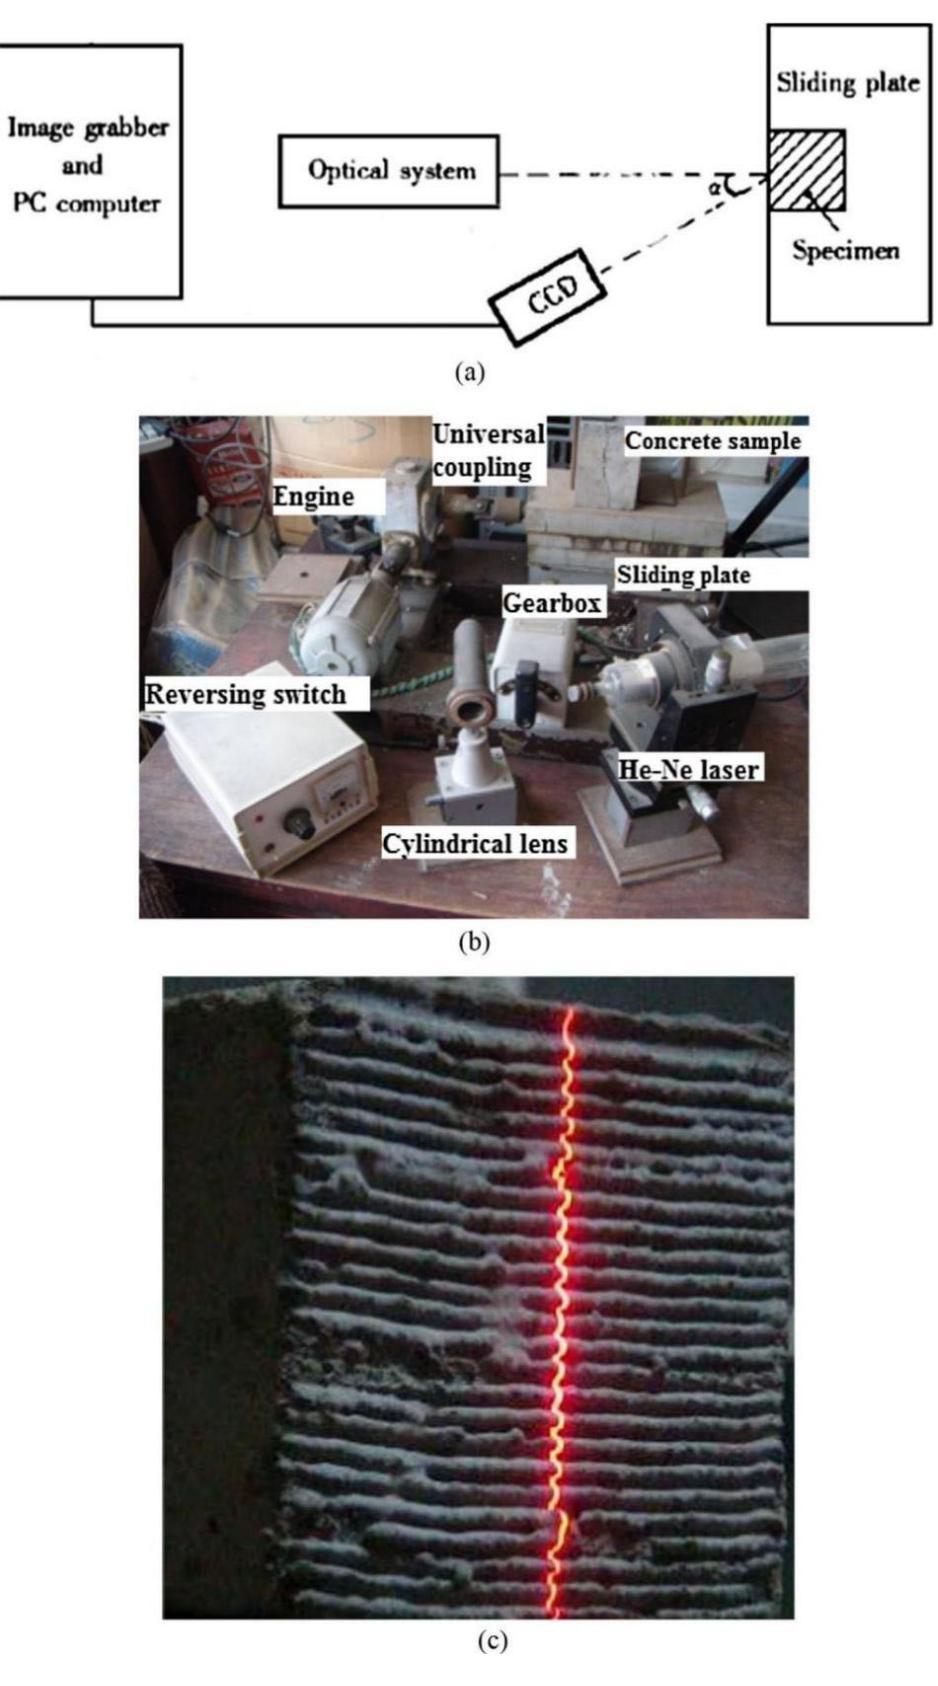
Figure 10. Laser triangulation method to quantified the surface roughness of concrete substrate to be repaired. (**a**) Schematic diagram of laser triangulation ranging test apparatus; (**b**) Installation diagram of laser triangulation ranging test apparatus; (**c**) 3D image of the concrete surface [67]. (Adapted and reprinted with permission from ref. [67], © 2017, *Construction and Building Materials*).

Zhou et al. [53] characterized the interfacial microstructure between ordinary cementbased repair material and concrete substrate through scanning electron microscopy (SEM). Combining mercury intrusion porosimeter tests and nonevaporating water tests, they found that the moisture transport between cement mortar and substrate affected the interface porosity and the interface bond strength. Through SEM analysis, Gomaa et al. [27] found that a denser microstructure with more calcium aluminate silicate hydration product existed in the interface between alkali-activated concrete and the concrete substrate than in the interface with ordinary concrete. At the same time, Gomaa et al. [27] established the laser triangulation method (which is used to accurately characterize the three-dimensional profiles of the sample, see Figure 10) to quantify the surface roughness of the concrete substrate and collect concrete interface morphology data for determining the relationship between the fractal dimension of the interface and bond strength by using the fractal theory, which was recently used to analyze pore structure of cement-based materials [67–70].

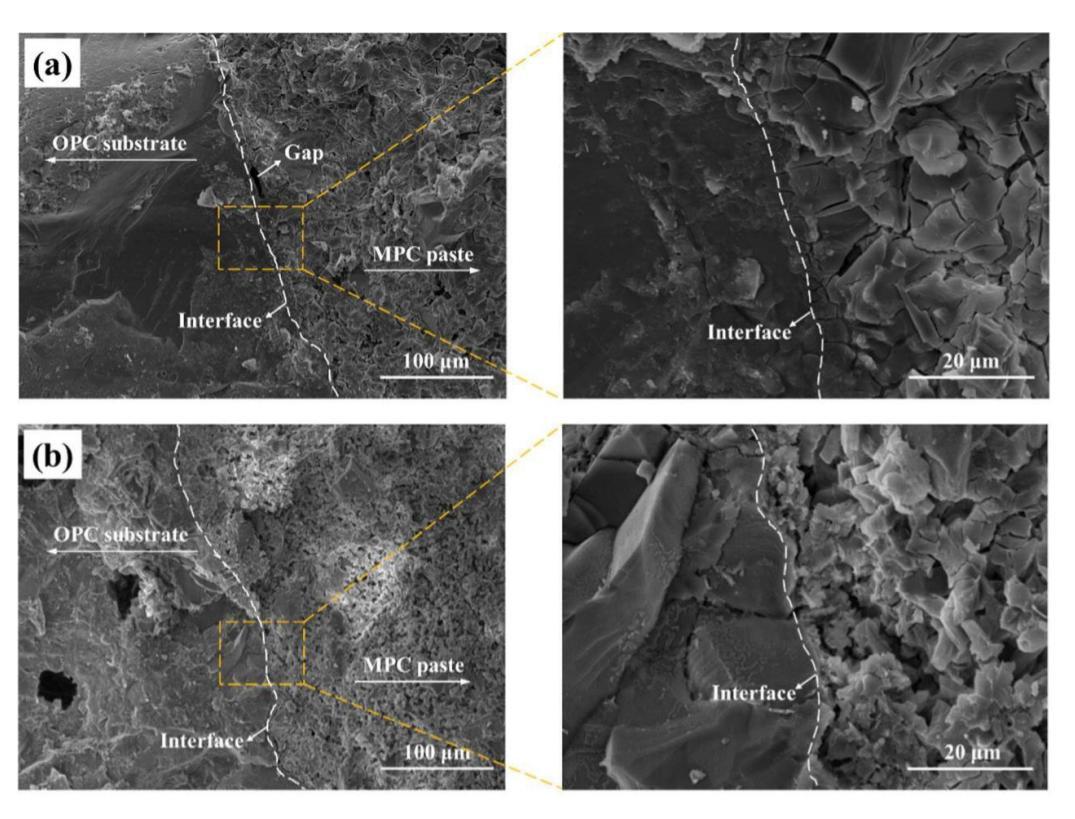
Figure 11. SEM micrograph of the microstructure of the interface (Magnification $500 \times$ and $3000 \times$) between old OPC substrate and different MPC matrices with different molar ratios of magnesia and phosphate (7-day-old samples): (a) M/P = 10; (b) M/P = 14 [59]. (Adapted and reprinted with permission from ref. [59], © 2018, *Construction and Building Materials*).

Qian et al. [11] used SEM and X-ray diffraction technology to study the interface between MPC-based repair material and concrete substrate. They found that the weak acid property brought by phosphate in the repair material induces "the etch" on the substrate surface, so that the material could penetrate into irregular pores and react with the hydration products of Portland cement. The interfacial bonding performance is improved both due to the mechanical interlocking and chemical bonding (see Figures 11 and 12). It can be seen that a higher M/P ratio results in a less condensed microstructure with the formation of less struvite reaction products and more unreacted magnesia grains in the substrate as well as the interfacial zone. Therefore, a loose microstructure appears, as the insufficient hydrates cannot bond all the anhydrous grains. In contrast, the low M/Pratio results in the formation of a continuous struvite phase which can bond the unreacted magnesia grains in MPC mortar and the sand particles and hardened OPC paste in OPC substrate together, acting as an adhesive [59]. Wang et al. [45] adopted SEM to characterize the microstructure of the asphalt mortar-substrate interface. They demonstrated that the high bond strength of such interface was mainly due to the mechanical interlocking between asphalt mortar and substrate. Through mechanical testing and SEM observation, Zhang et al. [71] found that the interfacial bond strength between ultra-high-performance concrete (UHPC, as a repair material) and concrete substrate was high. The interface microstructure and bond strength were greatly improved by calcium-silicate-hydrate (C-S-H) generated by the secondary reaction between the silica fume in UHPC and the Ca(OH)₂ in the old concrete substrate. Pang et al. [72] used a digital reflective polarizing microscope and SEM to characterize the microstructure of the interface between epoxy-modified mortar and concrete, with nano-silica modified silane as the interfacial coupling agent. It was found that the application of silane-based interfacial coupling agent significantly improved the bond strength of the repair interface because of the reaction between silane and both concrete and epoxy. Moreover, nano-silica modification mitigates the negative effect of dealcoholization of siloxanes on the hydration of the cement.

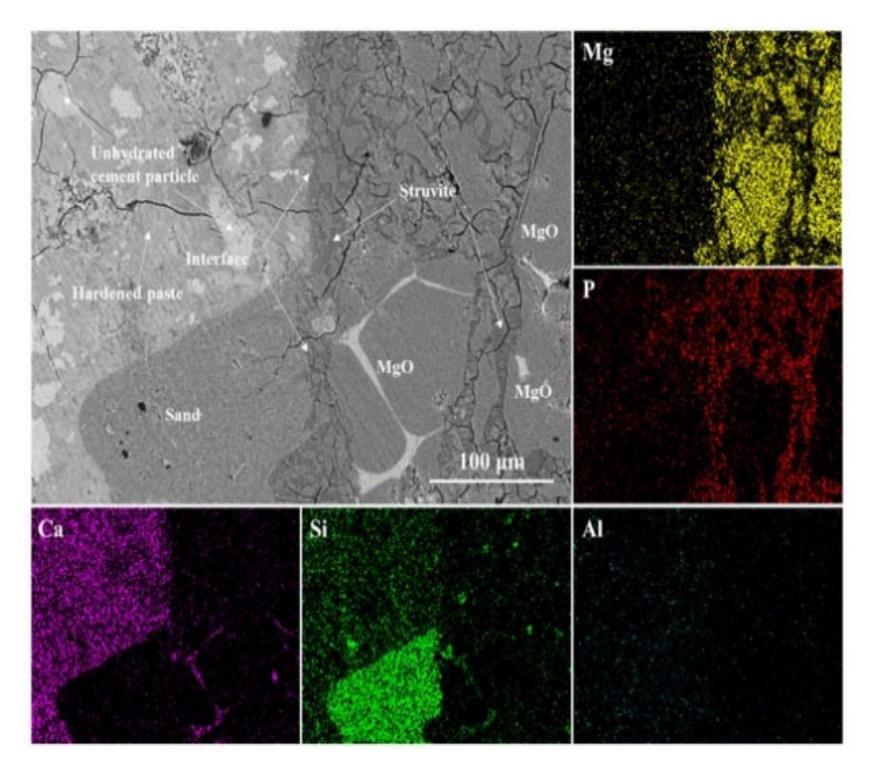
Figure 12. Backscattered electron image and elemental maps of the interface between old OPC substrate and MPC matrix, (M/P = 6) [59]. (Adapted and reprinted with permission from ref. [59], © 2018, *Construction and Building Materials*).

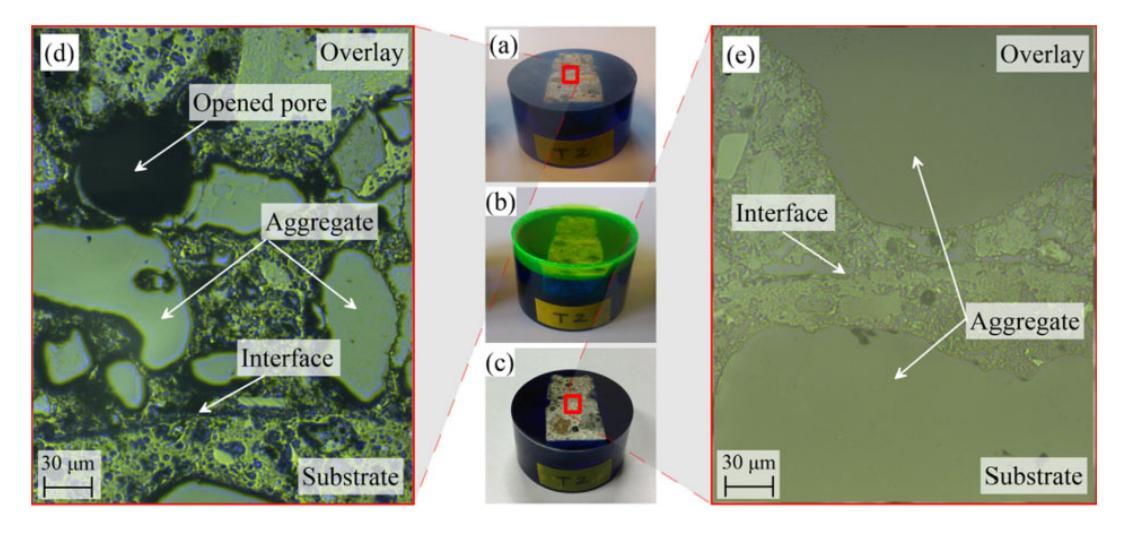
Figure 13. Optical microscopy view of the surface of concrete specimens to be repair. Samples: (a) after preliminary grinding (open pores appeared); (b) after the second immersion in epoxy resin in a vacuum chamber; (c) after final grinding and polishing. The optical microscopy view of the surface: (d) after preliminary grinding; (e) after final grinding and polishing [73]. (Adapted and reprinted with permission from ref. [73], © 2019, *Construction and Building Materials*).

Sadowski et al. [73] employed a nanoindentation technique to study the micromechanical property of the heterogeneous layer of cement mortar and concrete substrate and to determine the depth of the interfacial zone (see Figures 13 and 14). The regions where indentation modulus (M) and hardness (H) fluctuate are the interface regions. When the substrate has higher M and H values, the lowest values of M and H often appear in the interface region close to the overlay, and the maximum values of M and H are obtained in the near surface layer of the substrate, which can be attributed to the penetration of the new cement paste of overlay into the substrate.

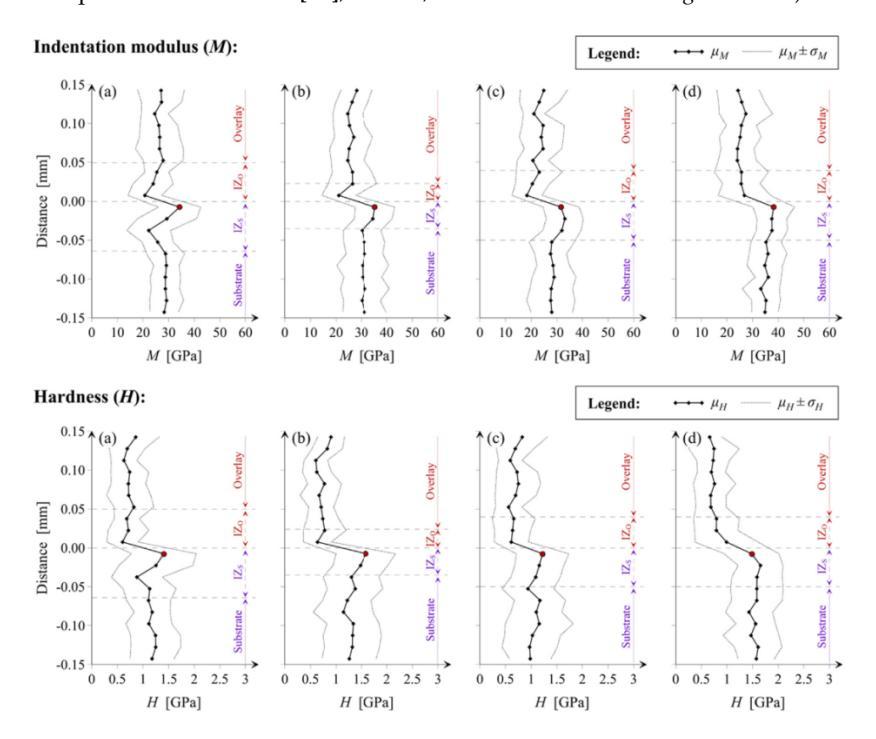
Figure 14. Exemplary maps of indentation modulus (*M*) and hardness (*H*) within the interface between cement mortar and concrete substrate [73]. (Adapted and reprinted with permission from ref. [73], © 2019, *Construction and Building Materials*).

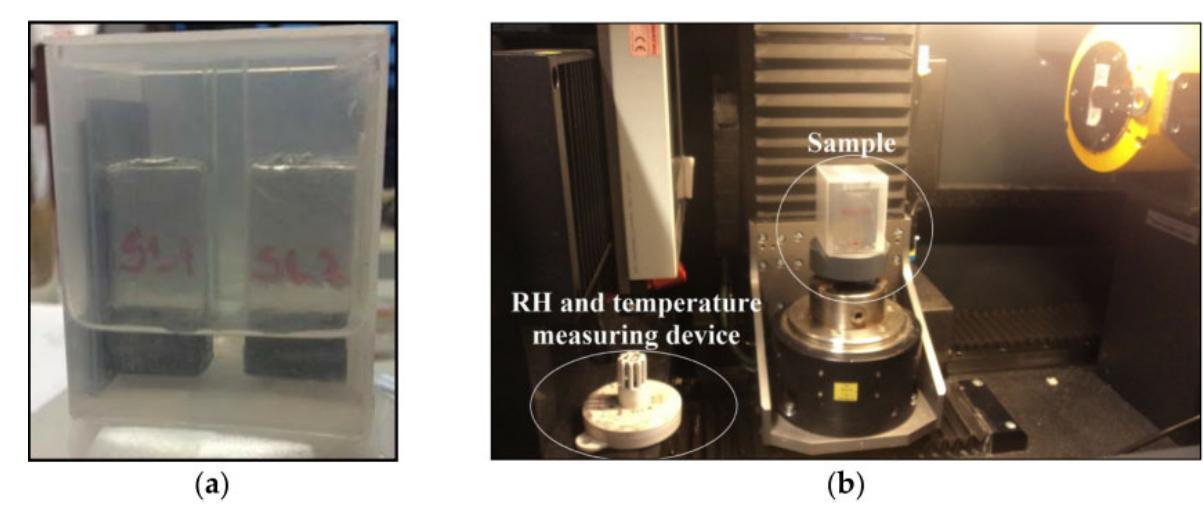
Figure 15. Sample for moisture exchange measurements; (**a**) two specimens are placed in a plastic container pior to X-ray testing; (**b**) the X-ray system with the position of the sample and temperature and RH sensors [77]. (Adapted and reprinted with permission from ref. [77], © 2015, *Materials* (Basel)).

The quality of repair is affected not only by the repair material but also by external additives and the concrete substrate to be repaired [74]. Feng et al. [75] proposed that an increase in roughness of the old concrete surface was beneficial to the shear bond strength because of the boost of mechanical interlock. Yazdi et al. [76] applied different surface removal techniques to make rough substrate surfaces and further studied their effects on the bond strength and failure mode of the repair material-substrate interface. The experimental results showed that sandblasting on the substrate surface had the most significant improvement effect on the interface bond strength because of the increase in roughness. Julio et al. [65] drew a similar conclusion. Lukovic et al. [77] found that the water exchange between the substrate and the repair material had an important impact on the interfacial bond property (see Figure 15). When the substrate was pre-saturated, the interfacial bond strength was highest. Courard et al. [78] found that the water content in concrete substrate could significantly affect the cement hydration and microstructure in the repair system due to the moisture exchanged between the repair material and the substrate, and then influenced the interfacial bond strength. The experimental results showed that when the water saturation degree of the concrete substrate's surface was between 50% and 90%, the interfacial bond performance was best. However, Bentz et al. [66] found that, according to slant shear bond strength tests and pull-out bond strength tests, the bond strengths between the repair and substrate were similar with different humidity of the substrate.

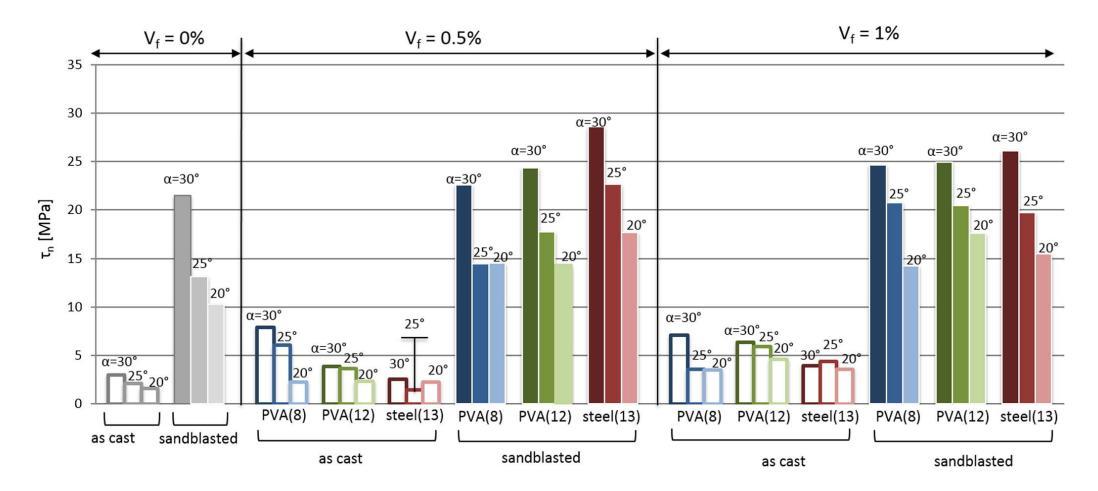
Figure 16. Effect of fiber on the shear bond strength between fiber reinforced concrete and concrete substrate (substrate–repair shear bond strength: τ_n , plotted as a function of the fiber volume fraction in the repair mortar; V_f, the bond plane inclination; α , the substrate treatment: sandblasted or "as cast"; the type of fiber reinforcement: PVA or steel (13 mm) [79].) (Adapted and reprinted with permission from ref. [79], © 2018, *Construction and Building Materials*).

Zanotti et al. [79] studied the effect of steel fiber on the bond strength between cementbased repair material and old concrete. The interface microstructure revealed that the steel fiber in repair mortars can effectively improve the bond strength between the repair material and concrete. As seen in Figures 16 and 17, due to the roughness of the substrate surface, there are many concavities distributed on the interface. Steel fibers settled inside the larger concavities and created a "dowel effect" as they intersected the shear/fracture plane. Feng et al. [62] investigated the adhesion of the interface between concrete and ultra-high-toughness cement-based repair composites. The cement-based repair composite modified by steel fibers had an advantage of significant toughness over the ordinary cementbased repair material. Liu et al. [80] found that a cement mortar, which was modified with a small amount of polypropylene fiber/silica fume and used as a repair material for concrete structure, exhibited improved interfacial bond mechanical properties, which contributed to both the anti-cracking effect from polypropylene fiber and densification reinforcement action to the interfacial transition zones of both fiber–matrix and aggregate–cement paste from silica fume.

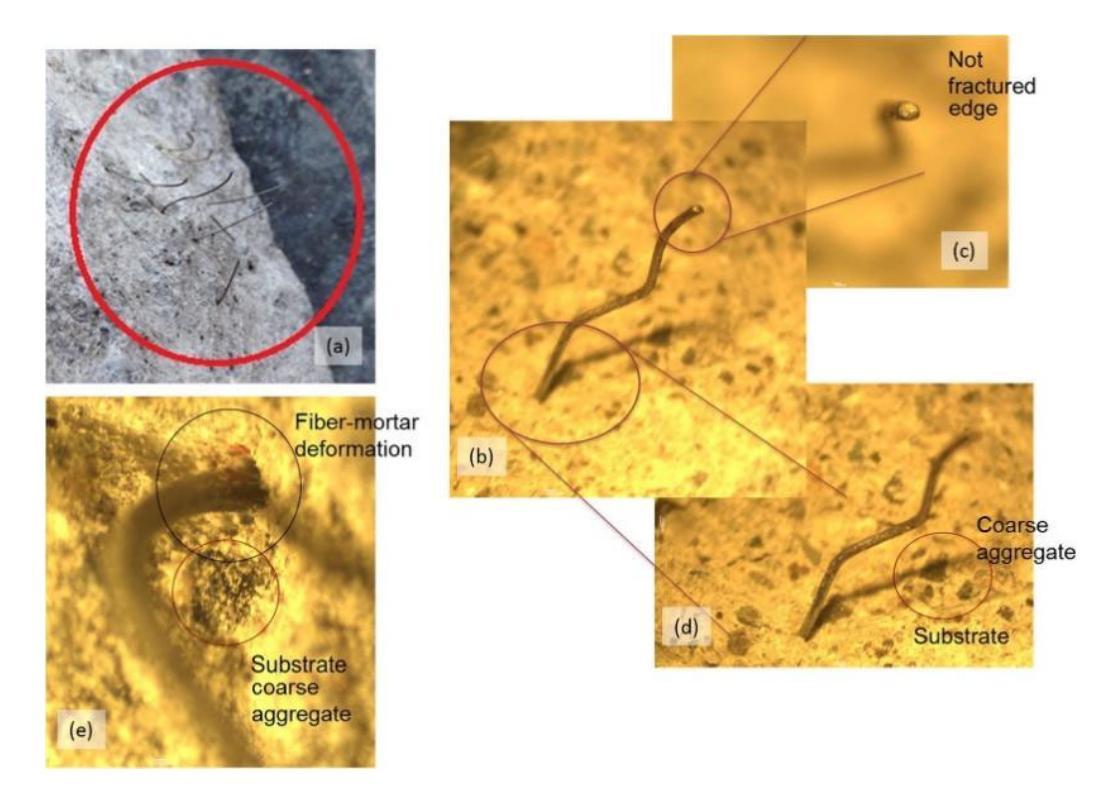
Figure 17. Fracture surface of a sandblasted substrate where steel fibers are bound to repair mortar after failure (**a**) and fiber-concrete details from optical microscope (**b**–**e**). [79]. (Adapted and reprinted with permission from ref. [79], © 2018, *Construction and Building Materials*).

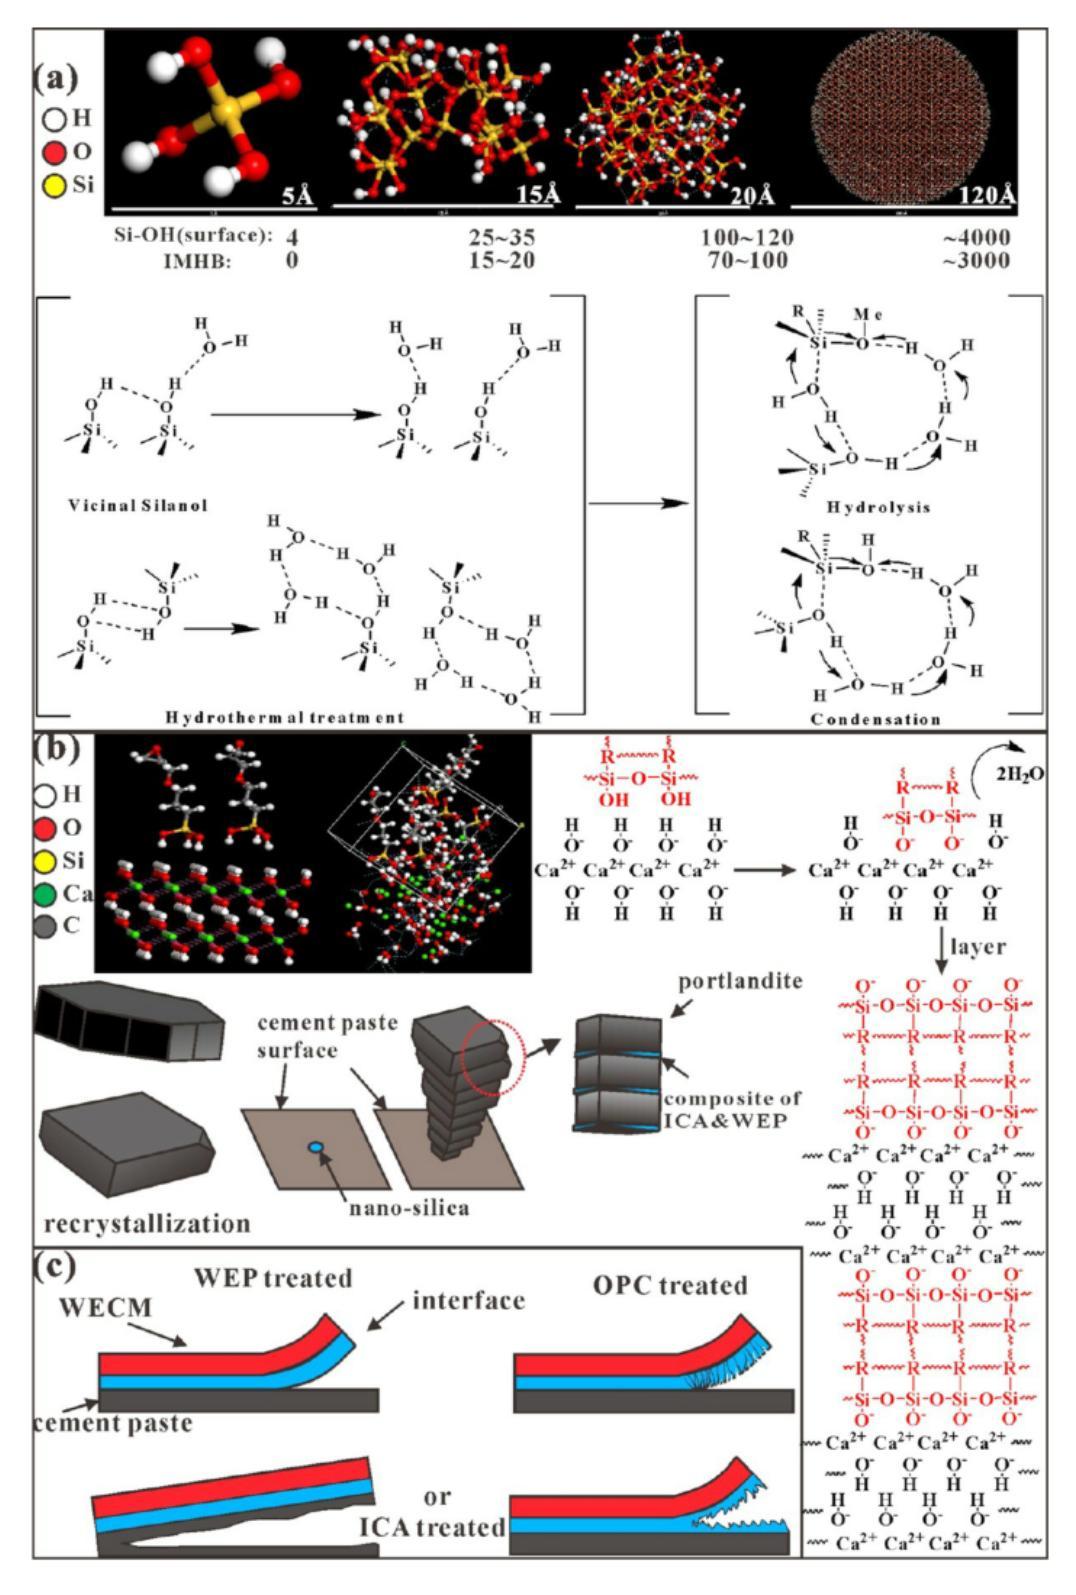
Figure 18. Nano-silica-modified silane as an interfacial coupling agent between epoxy-modified mortar and concrete structure: (**a**) Mechanism of the catalytic effect of hydrothermally treated nano-silica on SCA hydrolysis and condensation, (**b**) fine-grained effect and interfacial coupling effect of SCA on portlandite, (**c**) damage schematic of the interface treated by different means [72]. (Adapted and reprinted with permission from ref. [72], © 2018, *ACS Applied Materials & Interfaces*).

and old concretes. They concluded that this interfacial agent significantly improved the bond performance between repair material and substrate. Espeche et al. [82] believed that the application of self-compacting micro-concrete made up of a common cementitious mortar (cement, a mix of sand type fine aggregates, a superplasticizer admixture and polymers) as the interfacial agent could reduce the shrinkage of new concrete and generate C–S–H, calcium hydroxide and ettringite in the repaired surface of old concrete. Neves et al. [83] covered a concrete surface with polymer as the interfacial agent and found that the interaction between polymer and hardening cement mortar played a significant role in increasing the interfacial bond strength. Through the bottom-up design for concrete surface, Tatar et al. [84] found that surface functionalization by silane could significantly improve the interfacial fracture energy and durability of cement repair. They suggested that the cohesion between epoxy resin and substrate combined both mechanical interlocking and chemical bonding to improve the interface durability [84]. Xiong et al. [85] found that a silane coupling agent could effectively improve the microstructure of the interfacial transition zone between repair material and old concrete and, consequently, enhance the interfacial adhesion of the repaired layer. Pang et al. [72] applied nano-silica-modified silane as an interfacial coupling agent (SCA) between epoxy-modified mortar and concrete structure. They found that the interfacial agent could improve the bond strength and toughness of the interface between epoxy-modified mortar and concrete structure (see Figure 18).
